Report No. UMCEE 92-31

# **Field Investigation of Damage to Islamic Monuments Caused by the Egyptian Earthquake of October 12, 1992**

December 1992

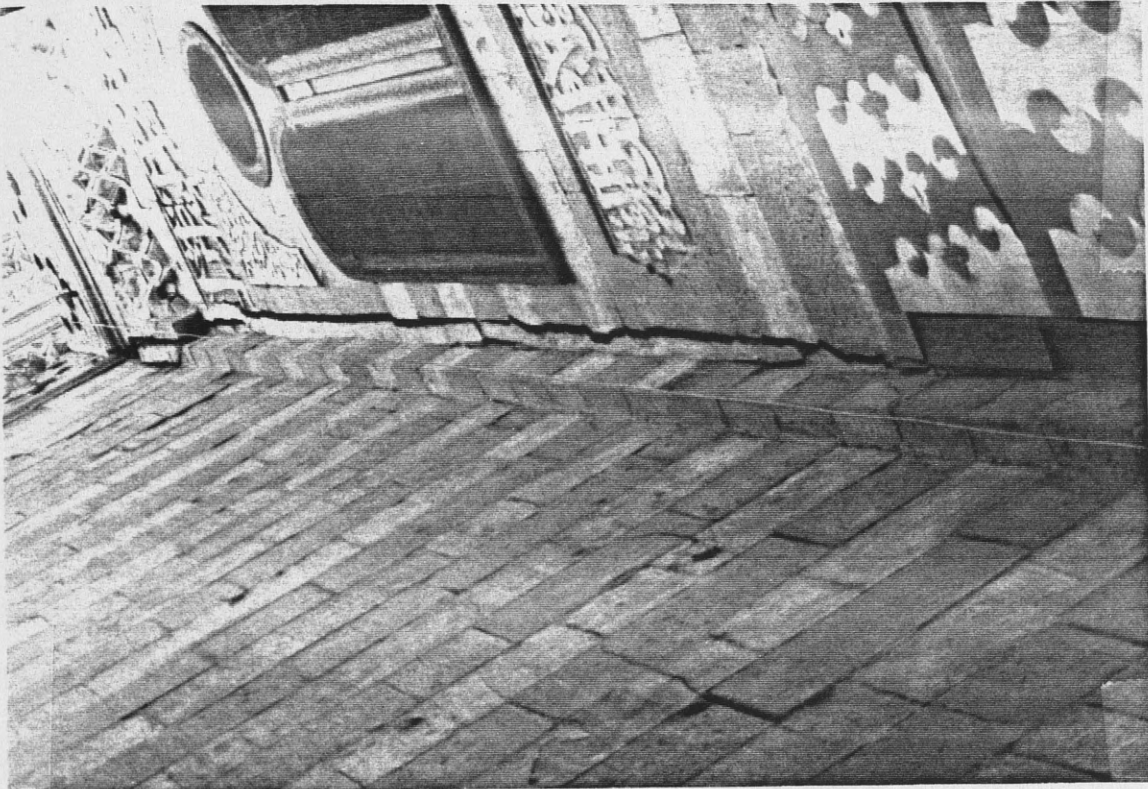
The height of the mosque was approximately equivalent to a four story building with a minaret tower attached to the southeast corner (Fig. 1). Cracks were visible on all external faces of the mosque. There was one very large crack at a reentrant corner along the east wall where the minaret tower was connected to the mosque (Fig. 2). This appeared to be an old crack that was clearly related to uneven settlement that resulted in the minaret tower leaning slightly away from the mosque. Any increase in the width and length of this crack due to the earthquake could not be determined.

Fig. 2 Crack between minaret tower (left) and mosque

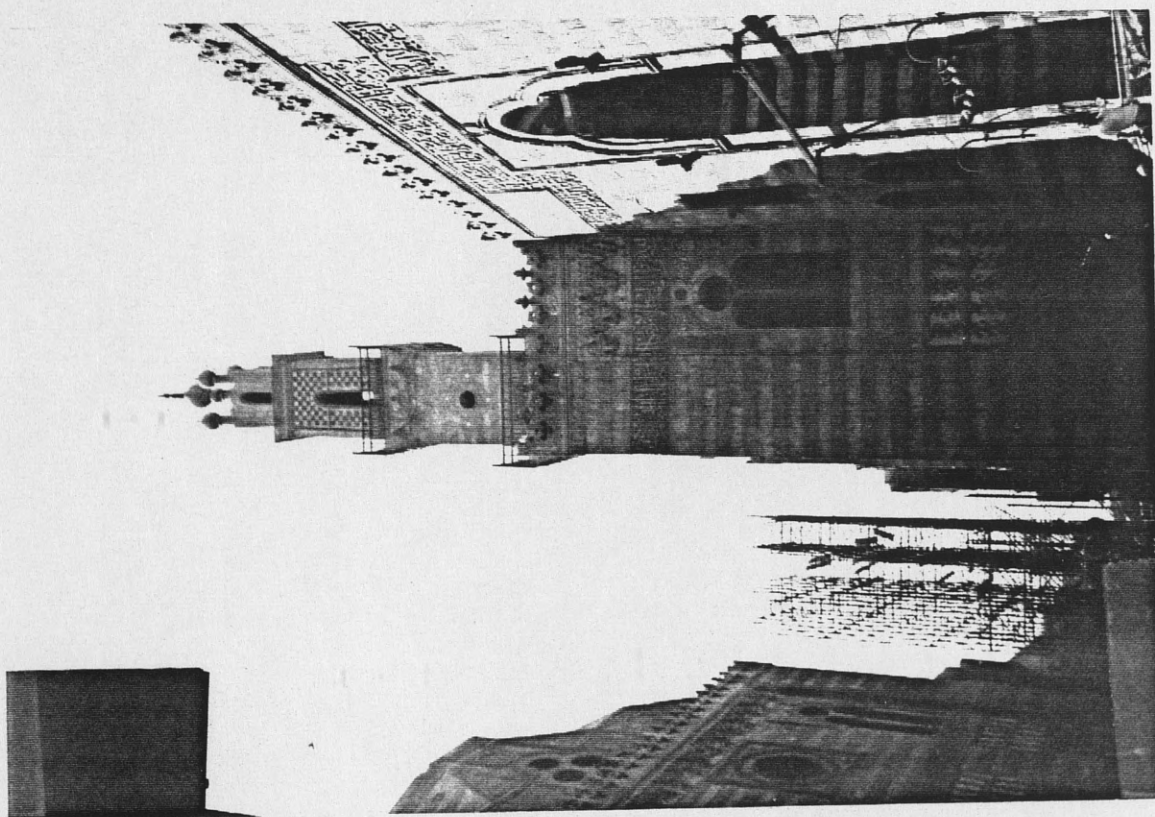
Fig. 1 Sultan El-Ghuri Mosque and minaret tower

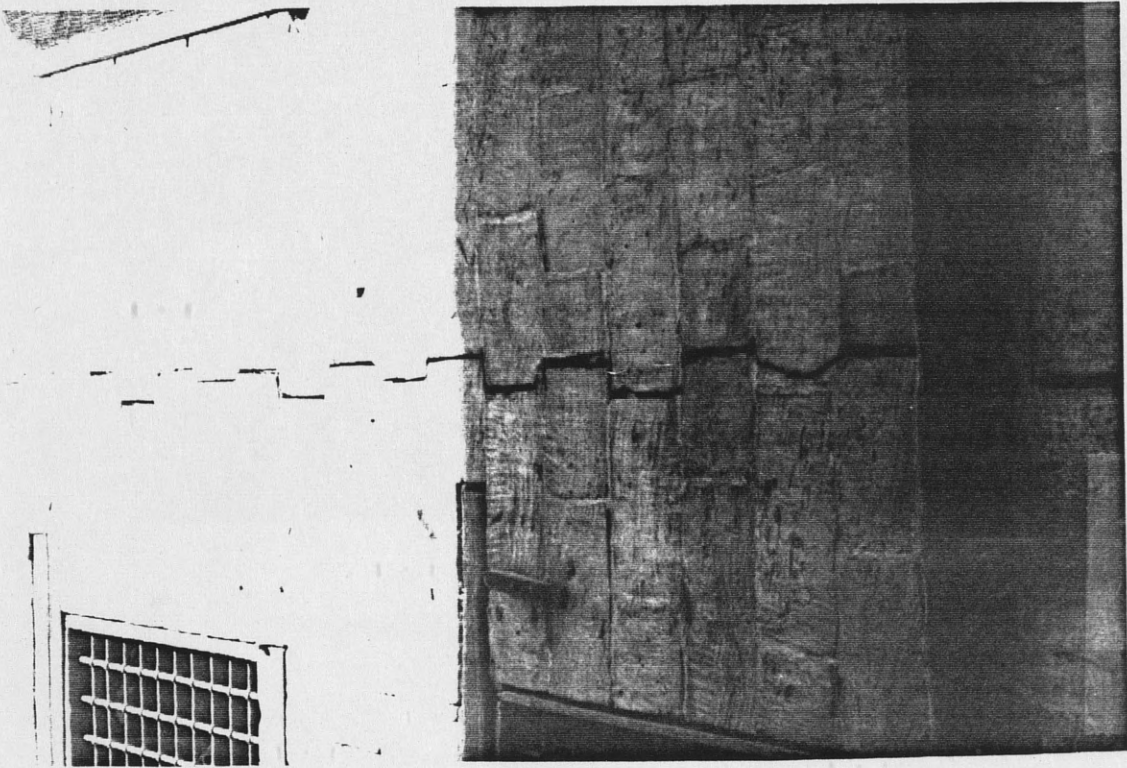
A crack in the south wall, approximately thirty feet away from the southeast corner of the mosque, was observed to be wider near the base of the mosque than at the top (Fig. 3). This crack seemed to indicate uneven lateral movements near the base of the mosque. Again, there was no clear evidence that the earthquake had significantly changed the width and length of this crack.

Fig. 3 Crack along south wall of El-Ghuri Mosque

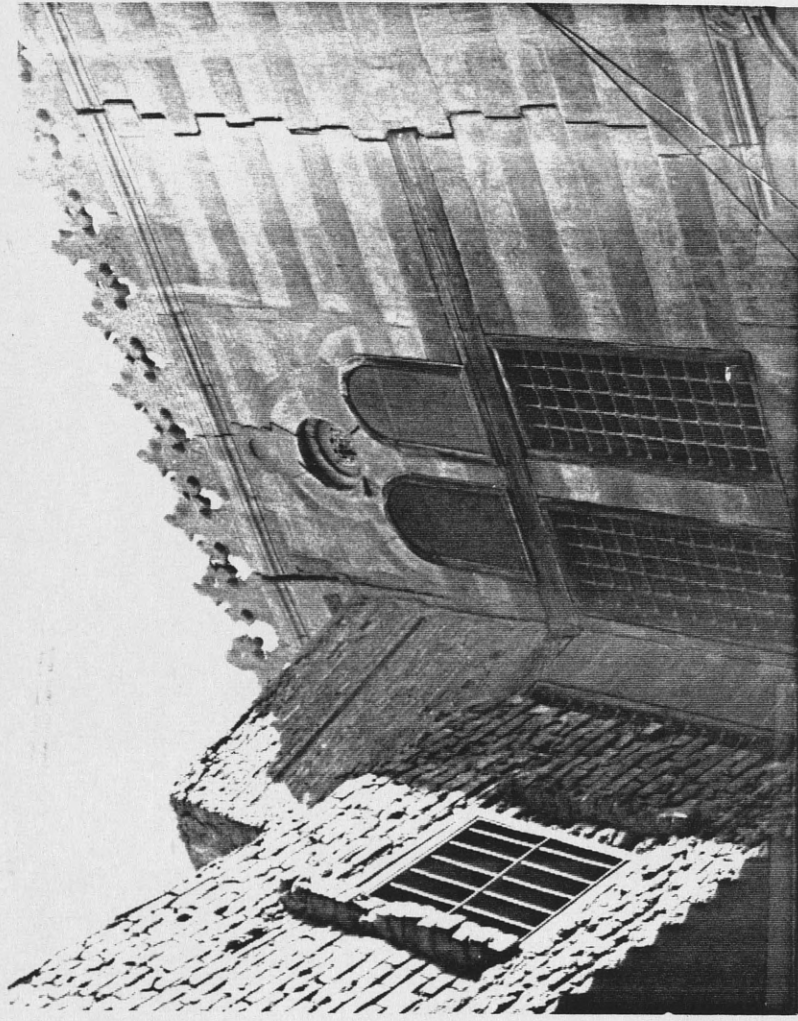
On the west side of the mosque there were numerous windows and reentrant corners. Cracks were clearly visible in several locations (Figs. 4 and 5). All of these cracks seemed to be old cracks and were certainly not caused by the earthquake. Plaster strips had recently been applied across some of these cracks (Fig. 5). It was reported that the strips were all applied within the last three months before the earthquake. The strips had been placed across the cracks to study movement along or across the cracks due to settlement or other causes. However, in this case they served as an excellent indicator of movements due to the earthquake. The plaster strips shown in Fig. 5 appeared to be undamaged.

One other concern was the safety of the ornamental parapet wall around the top of the mosque. In some cases cracks in the walls extended up through the parapet (Fig. 4). It appeared that portions of the parapet could fall during a significant aftershock or future earthquake.

Fig. 4 Cracks in west wall of El-Ghuri Mosque

A related safety issue is the parapet walls and other appendages attached to the mosques and other buildings. These elements should be checked to determine how well they are anchored to the base structure. If any appear to be loose, they should either be removed or repaired to ensure proper anchorage.

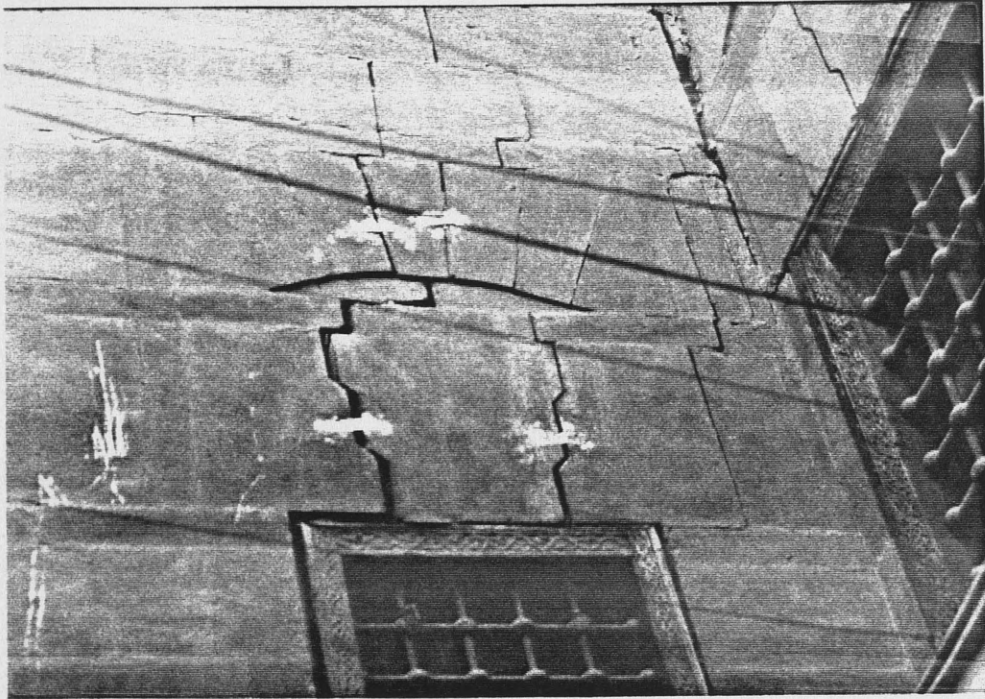
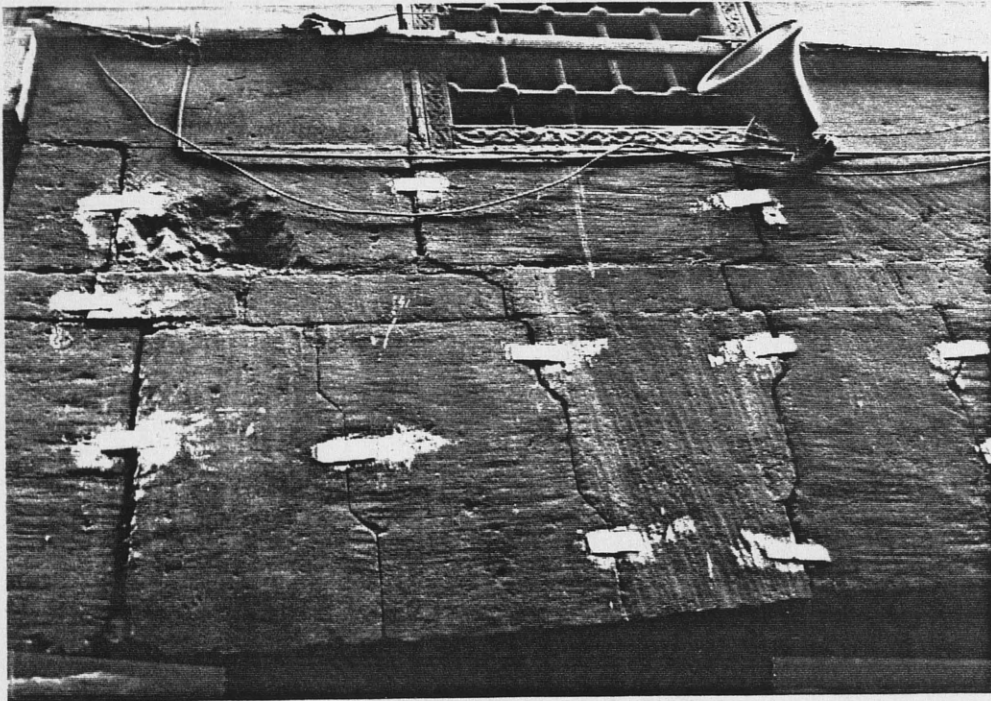
Fig. 5 Plaster strips across cracks in west wall of mosque

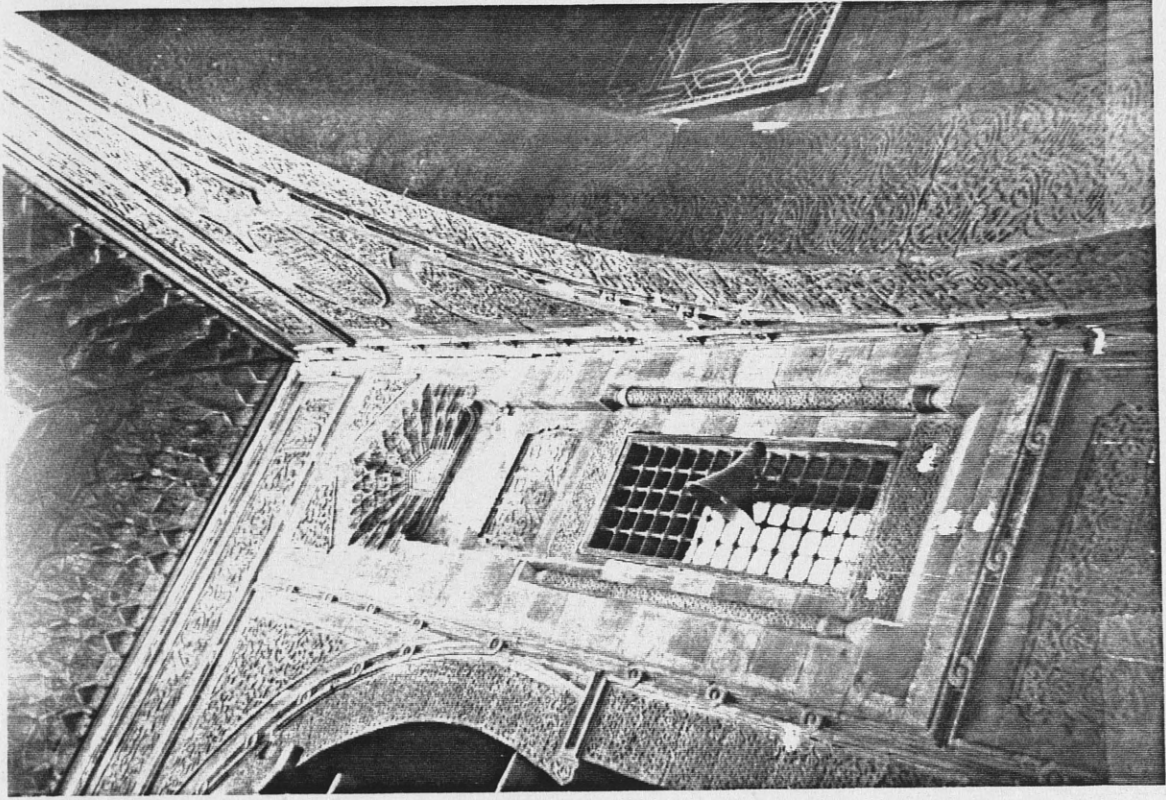
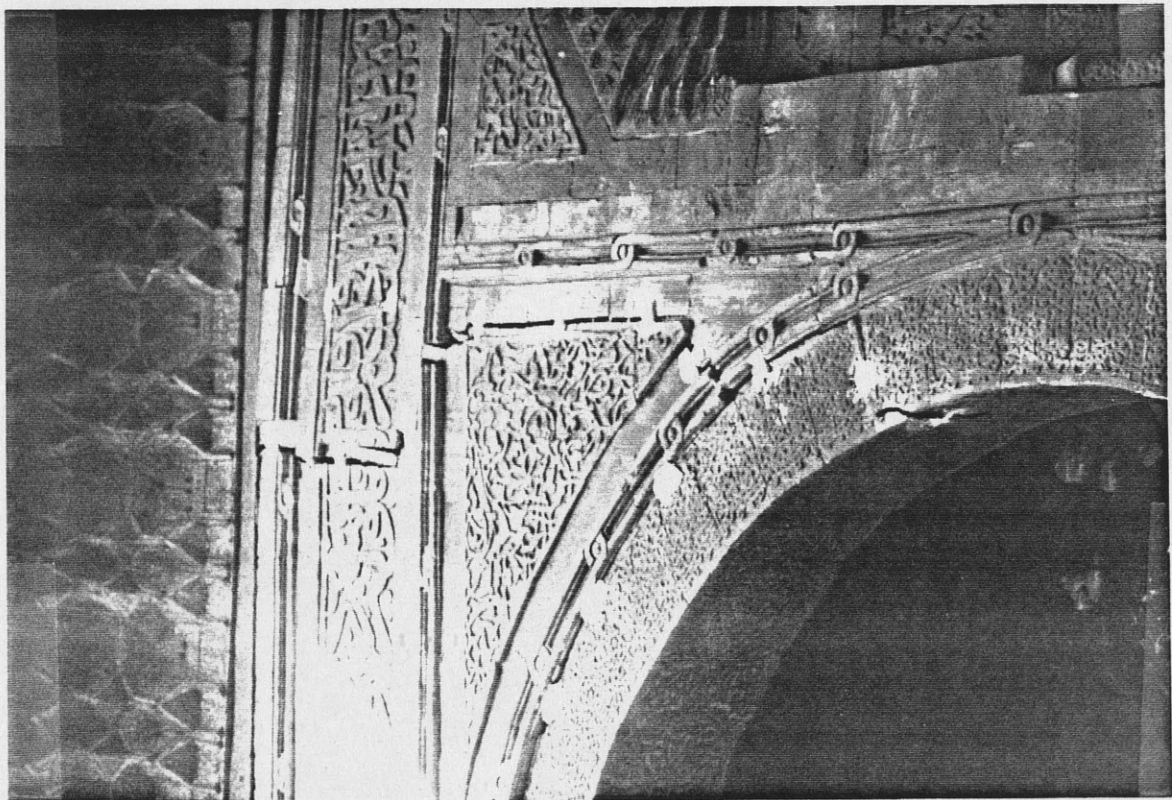
Inside the mosque there were more cracks and numerous plaster strips across several of the cracks (Fig. 6). Again, most of the plaster strips were not broken. Of the ones that were cracked and could be observed closely, the width of the cracks in the plaster strips varied between 2 to 5 mm. These strips were spanning cracks that varied in width from 15 to 40 mm.

Fig. 6 Interior of El-Ghuri Mosque with plaster strips across some of the cracks

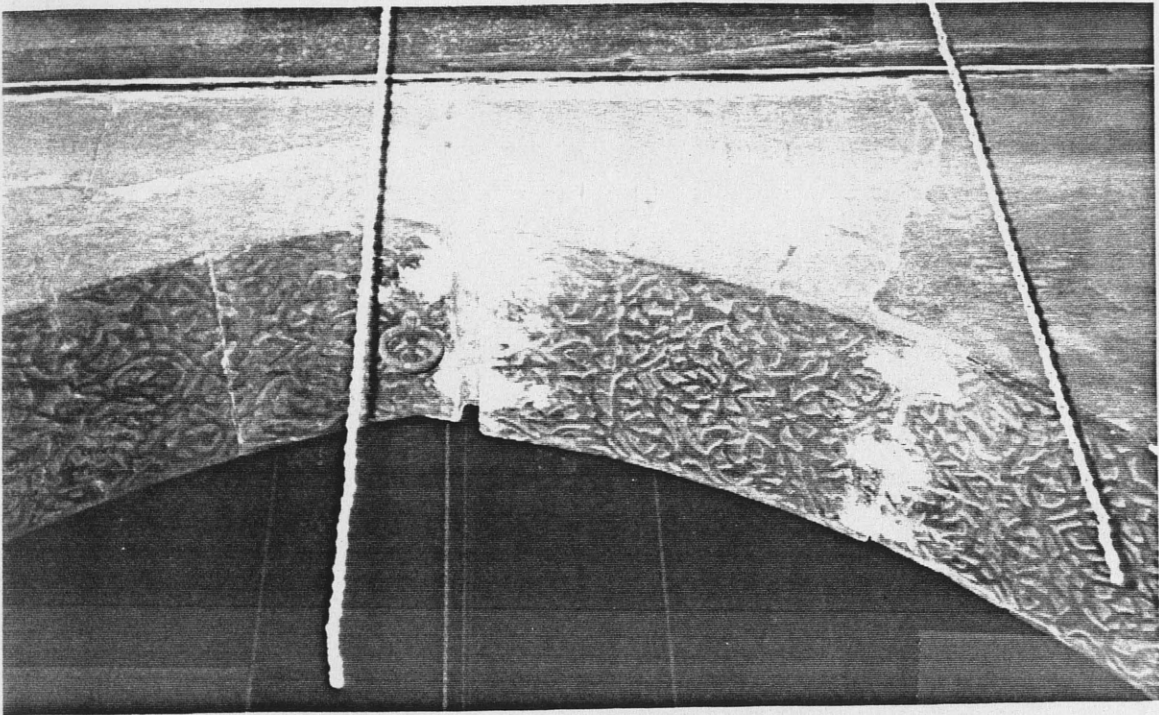
There were several archways within the mosque and some of them had significant damage (Figs. 7 and 8). It was reported that some of the ornate material attached to these archways had fallen during the earthquake. Plaster strips had again been applied across some of the preexisting cracks in the arches and the majority of the strips had not been broken. In some of the smaller archways the keystone was loose. At these locations plaster strips had been applied across the cracks and the keystone had apparently been braced before the earthquake. It appeared that additional damage to these archways during the earthquake was small.

Fig. 7 Major archway across interior of El-Ghuri Mosque

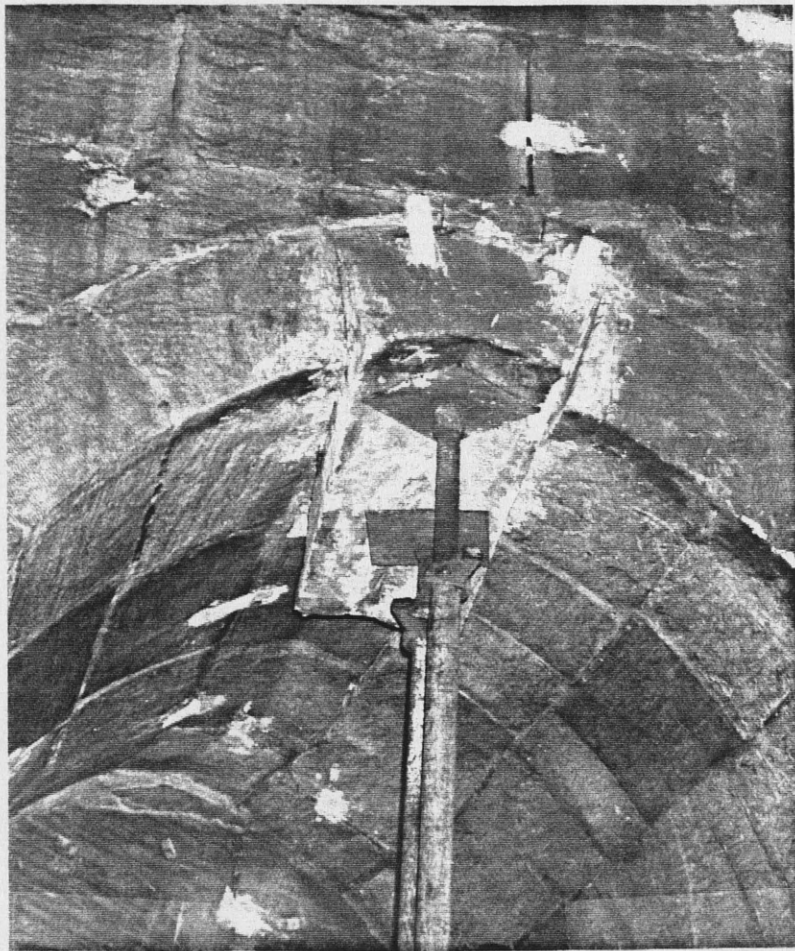
Fig. 8 Loose keystone in arched ceiling over hallway

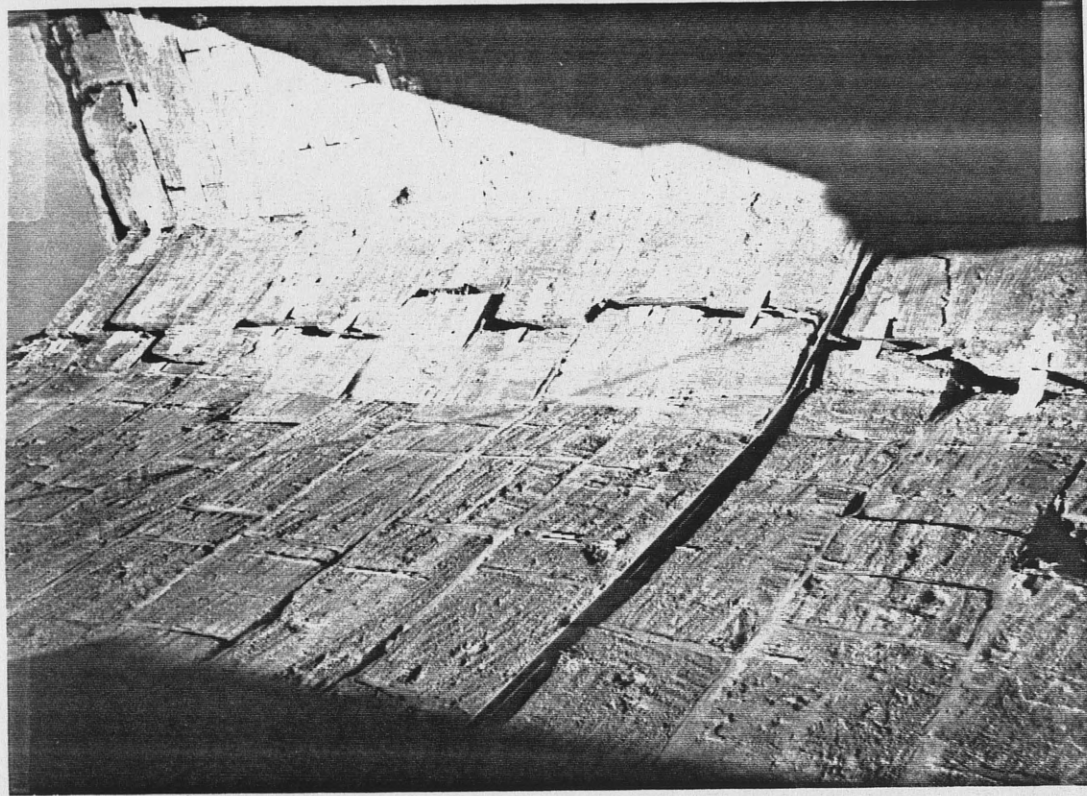
(b) Exterior walls

At some wall intersections, both inside and outside of the mosque where plaster strips had also been applied, the strips were broken in a manner that indicated more significant differential movement between the adjacent walls during the earthquake (Fig. 9). These movements seemed to indicate that due to the preexisting cracks, continuity between these walls had been lost. Thus, they moved independently during the earthquake.

Fig. 9 Cracks at wall intersections of El-Ghuri Mosque

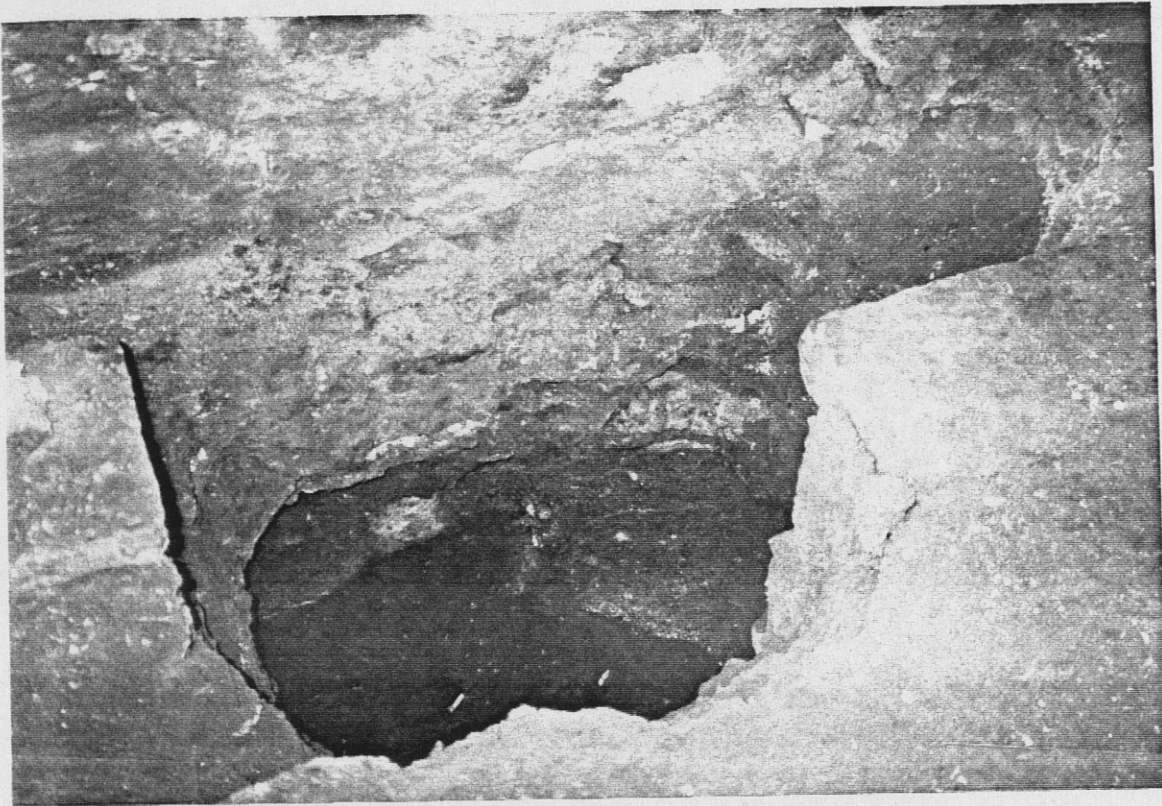
There were some excavations in the foundation below the mosque. In each hole, water was present within one meter of the base of the foundation (Fig. 10). The limestone blocks in and just above the foundation level were discolored, indicating capillary rise from the groundwater level. This water partially dissolves the limestone and when it evaporates on the exposed surfaces, it leaves behind a yellowish mineral deposit. In some cases the discoloration extended more than one meter above the top of the foundation.

Fig. 10 Groundwater visible in excavation below basement of El-Ghuri Mosque

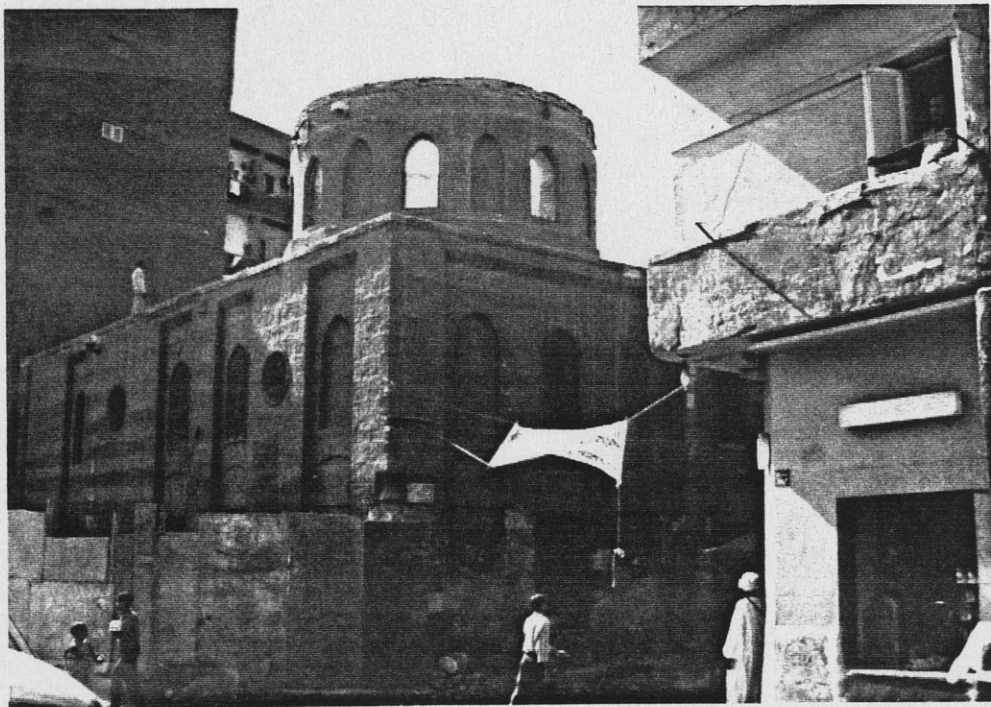
The dome of the El-Dashtwati Mosque collapsed during the earthquake (Fig. 11). At the time of the team's visit, debris from the dome was still on the ground, either inside the tower structure, which had been covered by the dome, or outside on the street (Fig. 12). A crew from the Egyptian Antiquities Organization had cleared around the dome support ring to eliminate the danger from falling debris. The dome structure had been constructed using two layers of bricks and mortar. The dome covered a tower about three stories high. The

Fig. 11 Collapsed dome of El-Dashtwati Mosque

overall building was approximately square, with the tower part occupying a quarter of the area near one corner. The team was told that the mosque was built during the Turkish empire at the end of the 18th or early in the 19th century. The structure was primarily stone masonry. Several cracks were observed along the walls, some of which were clearly present prior to the earthquake (Fig. 13). It was the team's opinion that the cracks could be patched, the structure repaired, the dome ring strengthened, and the dome rebuilt using either restoration materials or modern materials.

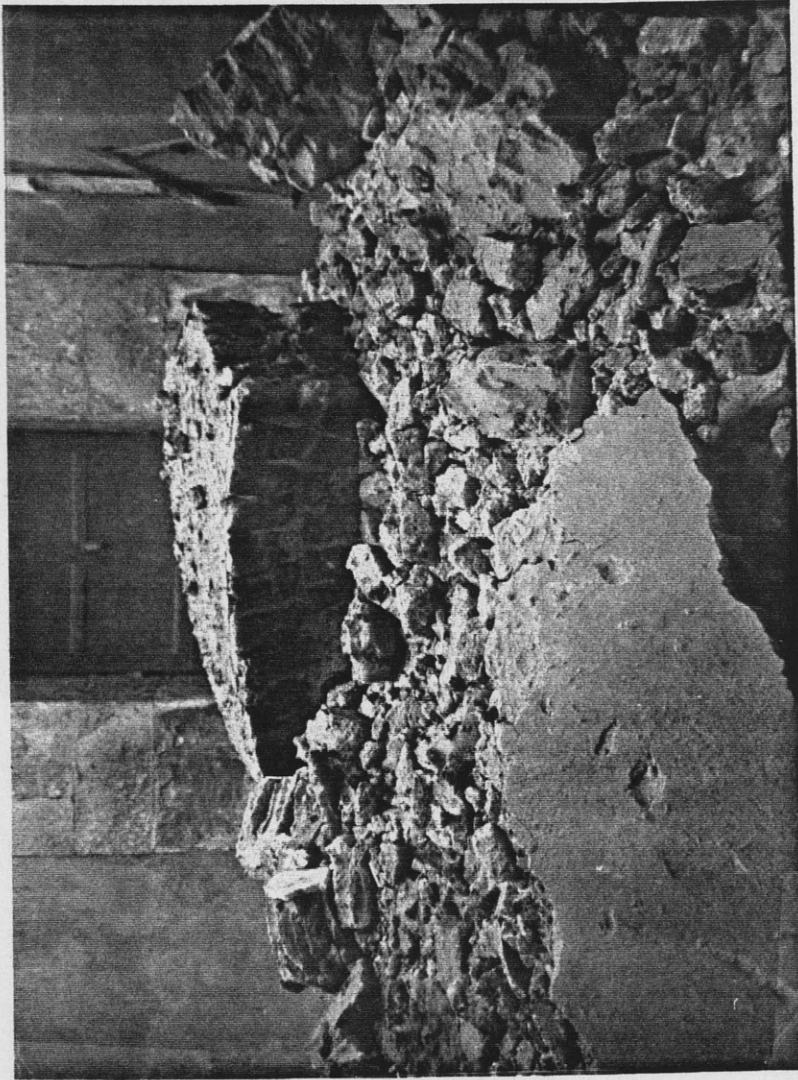
(a) Inside mosque

Fig. 12 Debris from collapsed dome at El-Dashtwati Mosque

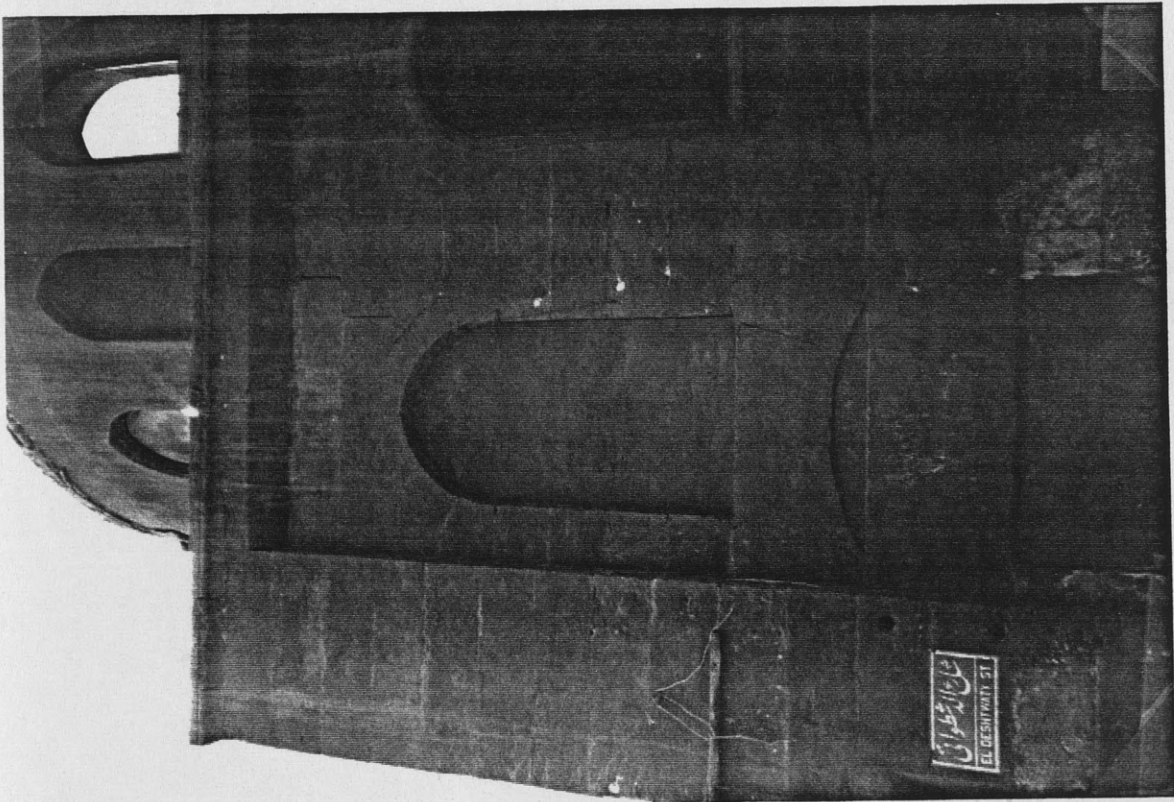
Fig. 13 Cracks in walls of El-Dashtwati Mosque

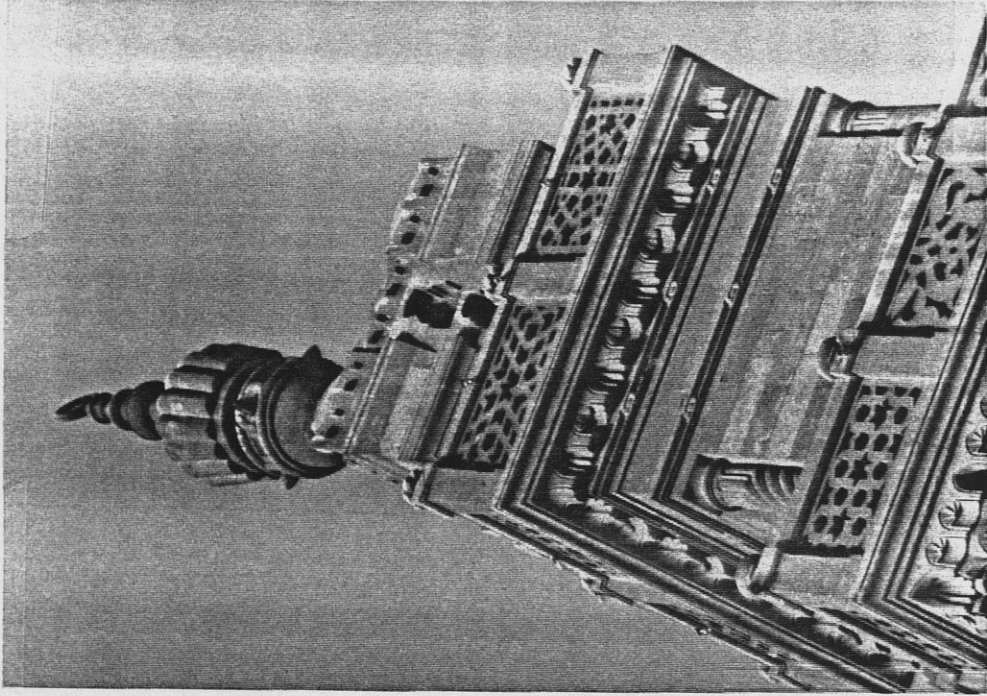
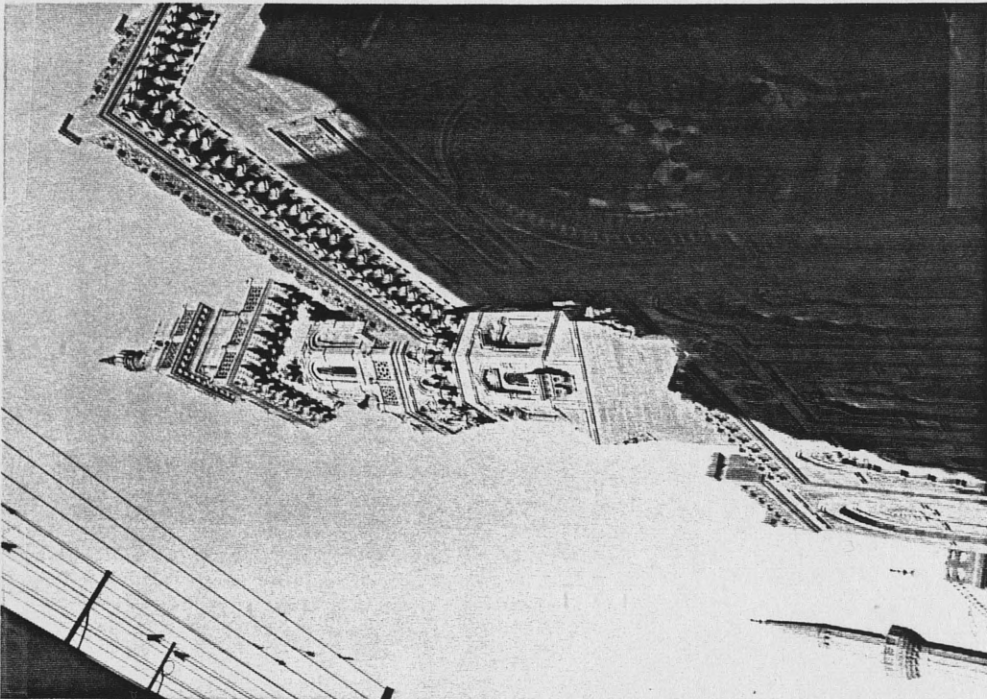
The most significant damage at the Al-Hanafi Mosque was the collapse of three of four ornate columns at the top of the minaret tower. The one remaining column is shown in Fig. 14. The other three columns failed during the earthquake and crashed onto the street below (Fig. 15). There was no indication of any reinforcement in the columns and the ornate tops seemed to be a series of unreinforced stone slices placed on top of each other (Fig. 15 b). There was a single dowel bar running through a small diameter hole in the center of these slices, but it was not grouted in place. The dowel bar was apparently used to align the slices, but not intended to offer shear or moment resistance for the ornate top.

Fig. 14 Minaret tower at Al-Hanafî Mosque with one remaining ornate column

The one column at the top of the minaret tower should be removed or attached more securely to the tower. All four columns can be easily replaced, but the new columns must have a basic seismic resistance to lateral accelerations as described in the section on recommendations.

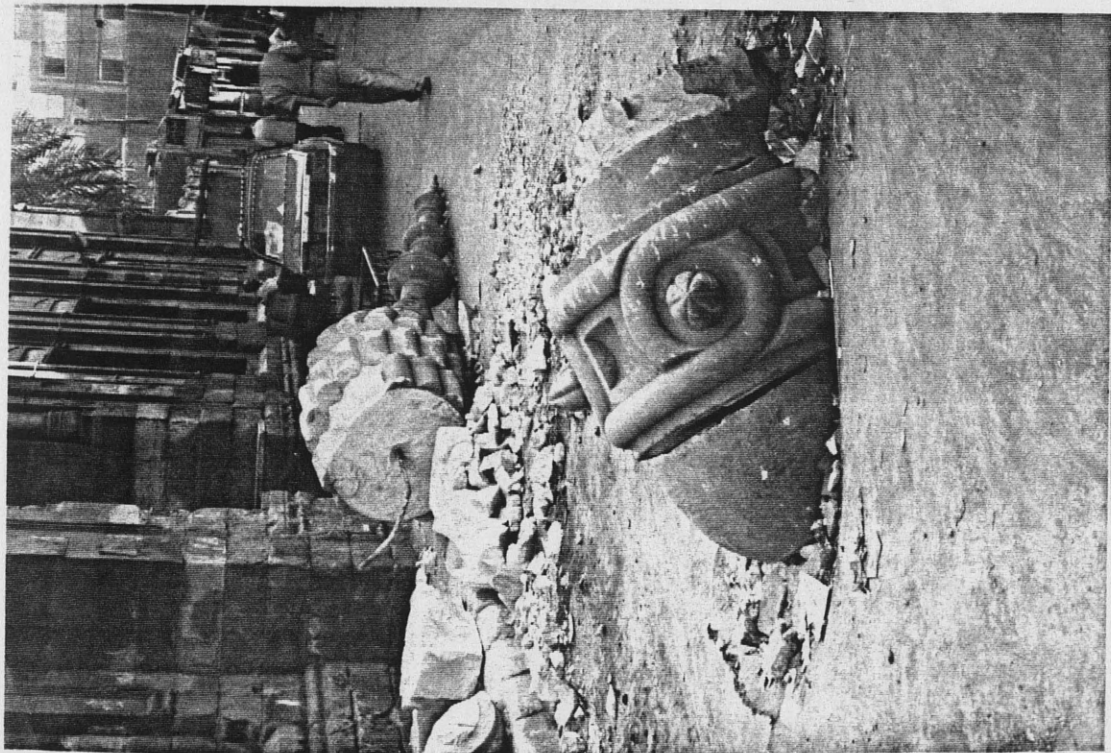
(a) Lower portion of ornate column

Fig. 15 Debris from collapsed minaret tops in street adjacent to mosque

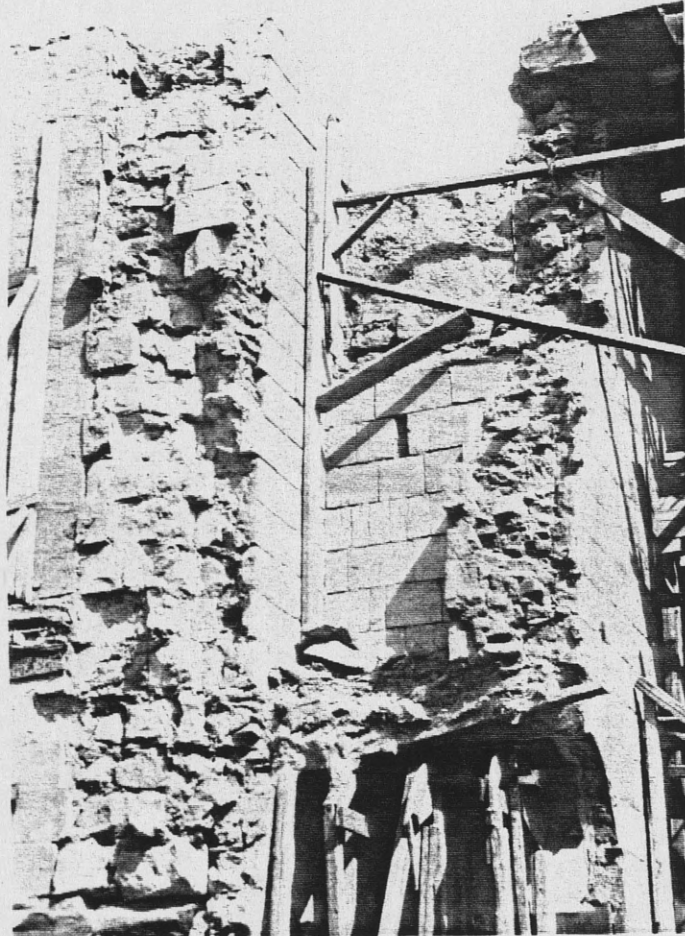
Among all of the sites visited, the mosque of Sultan Khani Bey El Rama was in the worst condition. It provided the most dramatic evidence of the repercussions of inappropriately controlled local dewatering. It was reported to the inspection team that during local pumping to draw down the water, the mosque's minaret tilted, rotated and collapsed. The location where the minaret tower broke away from the mosque is shown in Fig. 16. Local residents recount that as the minaret was falling, the decorative top of the minaret was launched as an airborne projectile (due to centripetal acceleration). Two individuals in a house across the street from the mosque were reported to have been crushed by the projectile. While the inspection team could neither confirm nor find contradiction to this account, it was very evident that the collapse predated the earthquake. If dewatering was the culprit for the collapse, it is very likely that the drawdown was too rapid, thereby inducing high hydraulic gradients which piped fine grained soil out of the foundation.

Fig. 16 Location where minaret tower broke away from Mosque of Sultan Khani Bey

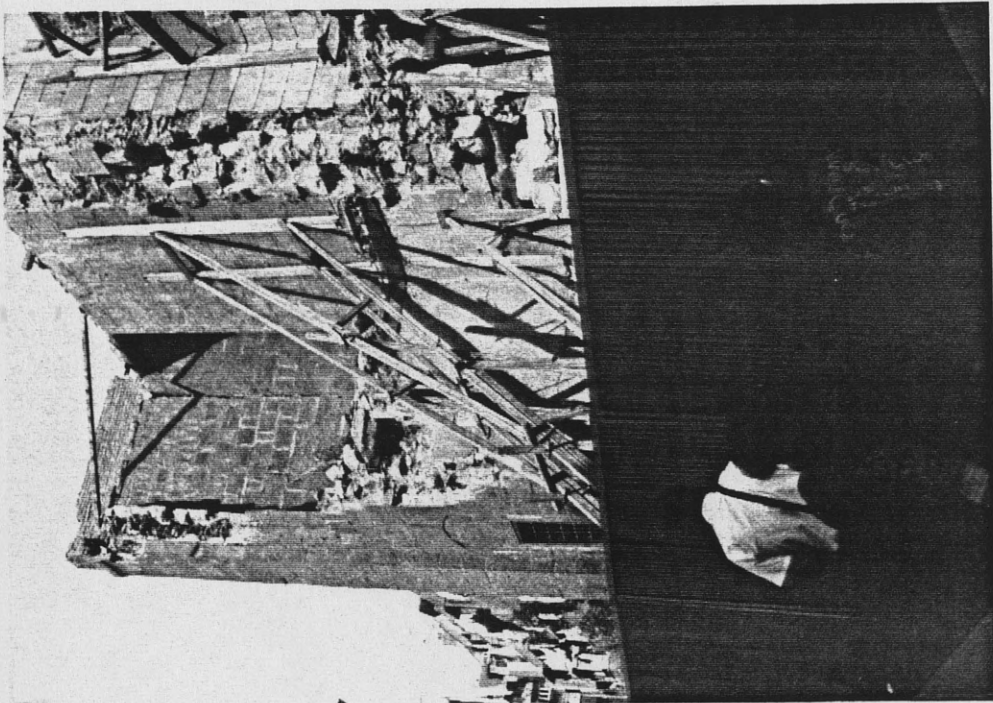
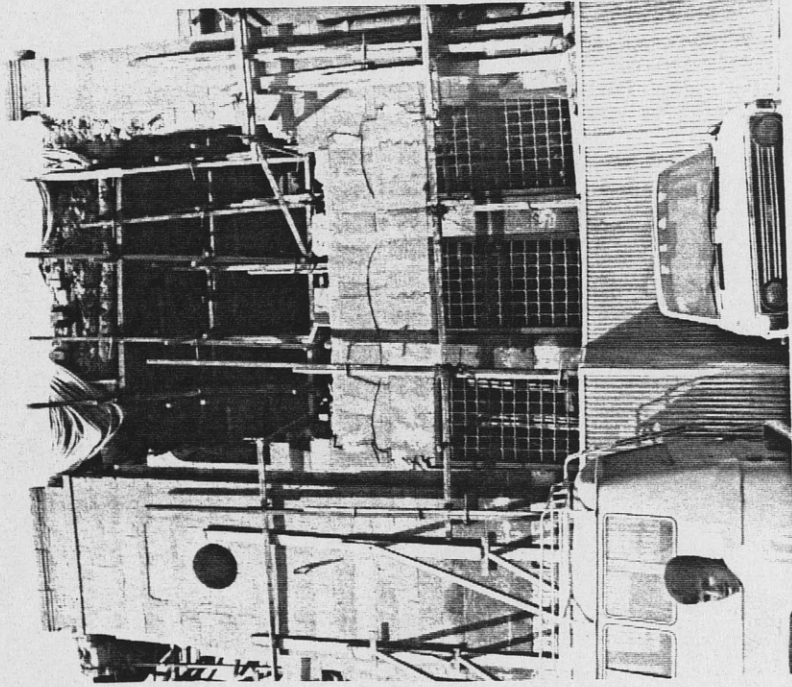
The overall state of the Khani Bey Mosque was very poor (Fig. 17). Groundwater was visible in an open pit at less than one meter depth (Fig. 18). Differential settlements were in evidence. Access to much of the building was difficult because of collapsed stairways, imposed barriers and debris. Any

earthquake induced damage was indistinguishable from other damage. Some walls have been shored in an attempt to prevent further collapse. Many interior areas are dangerous. Repair and restoration of this mosque would be very difficult if not impossible.

Fig. 17 Deteriorated state of Khani Bey Mosque

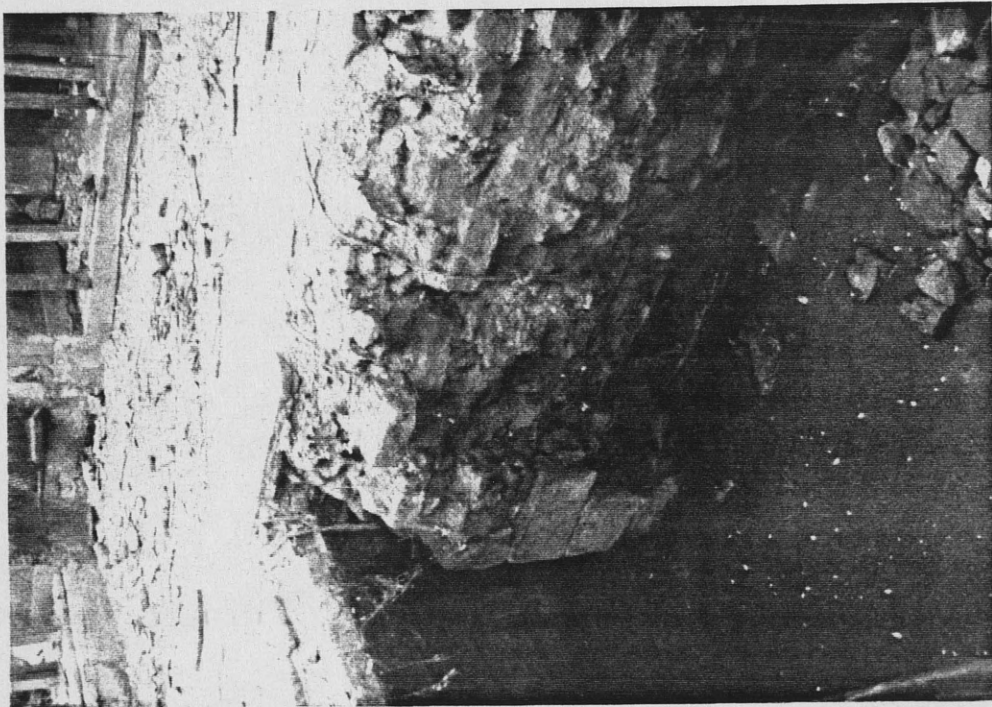
Fig. 18 Groundwater in excavation below Khani Bey Mosque

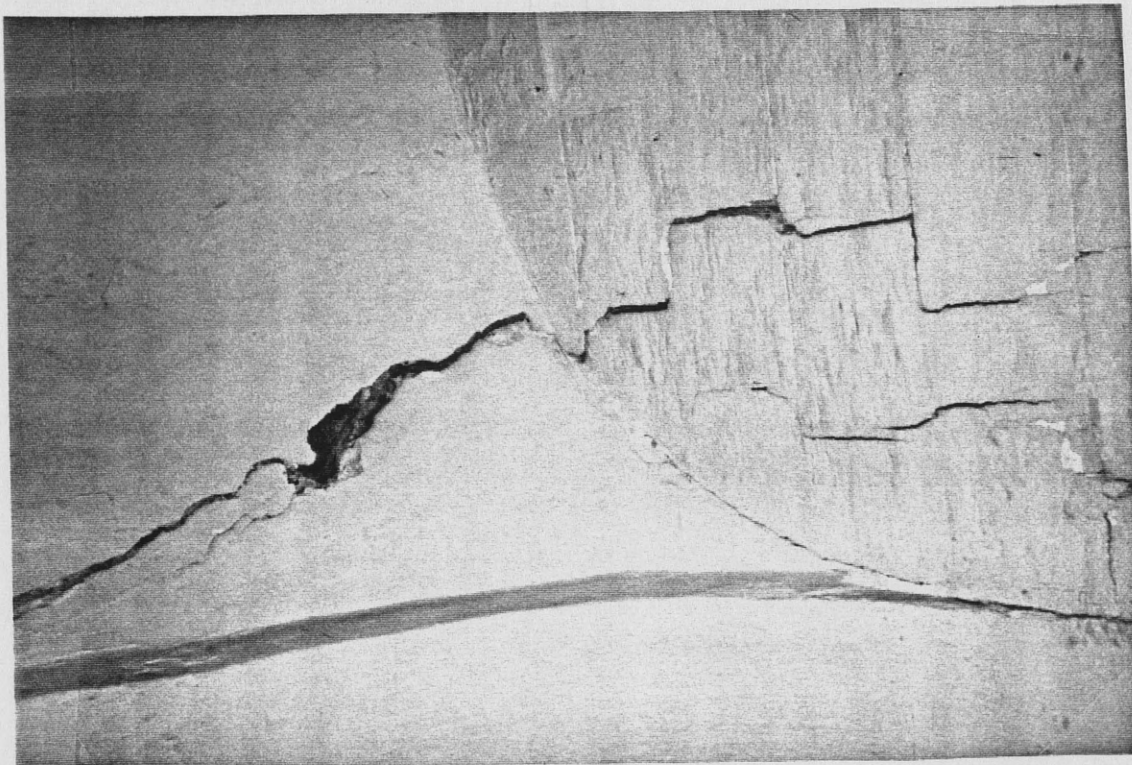
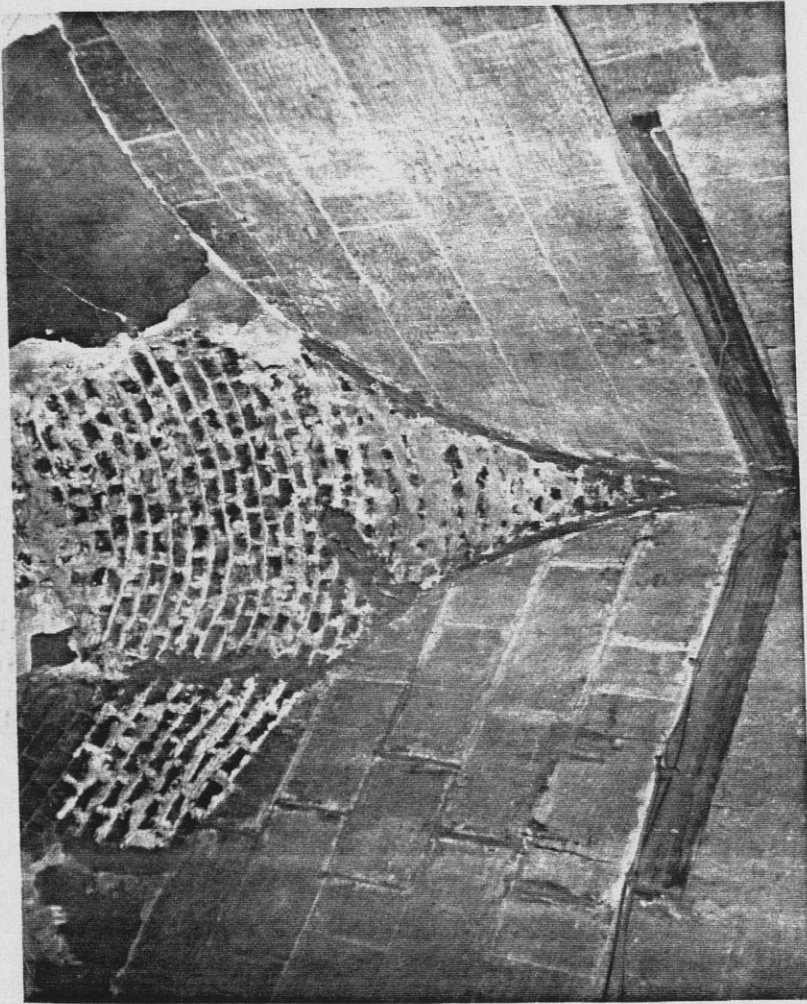
This structure was apparently a sort of convent where the Dervishes came for temporary retreat from the outside world. It is about 250 years old. In the present, it serves as a preschool. It is a one story high square structure with an open interior courtyard and garden (Fig. 19). Rooms are aligned along the periphery of the square. They all open on the inside to a covered corridor surrounding the courtyard. The roof structure is made of a series of masonry domes and arches. Several wide cracks were observed on the inside of the domes and in some rooms the mortar covering on the inside of the brick dome had spalled off and fallen (Fig. 20). Several cracks in the walls, domes and arches probably existed prior to the earthquake, but were amplified by it (Fig. 21). Most of the cracks could be structurally repaired and patched, restoring the structure to at least its pre-earthquake condition.

Fig. 20 Cracked and spalled domes inside Takkayah Preschool

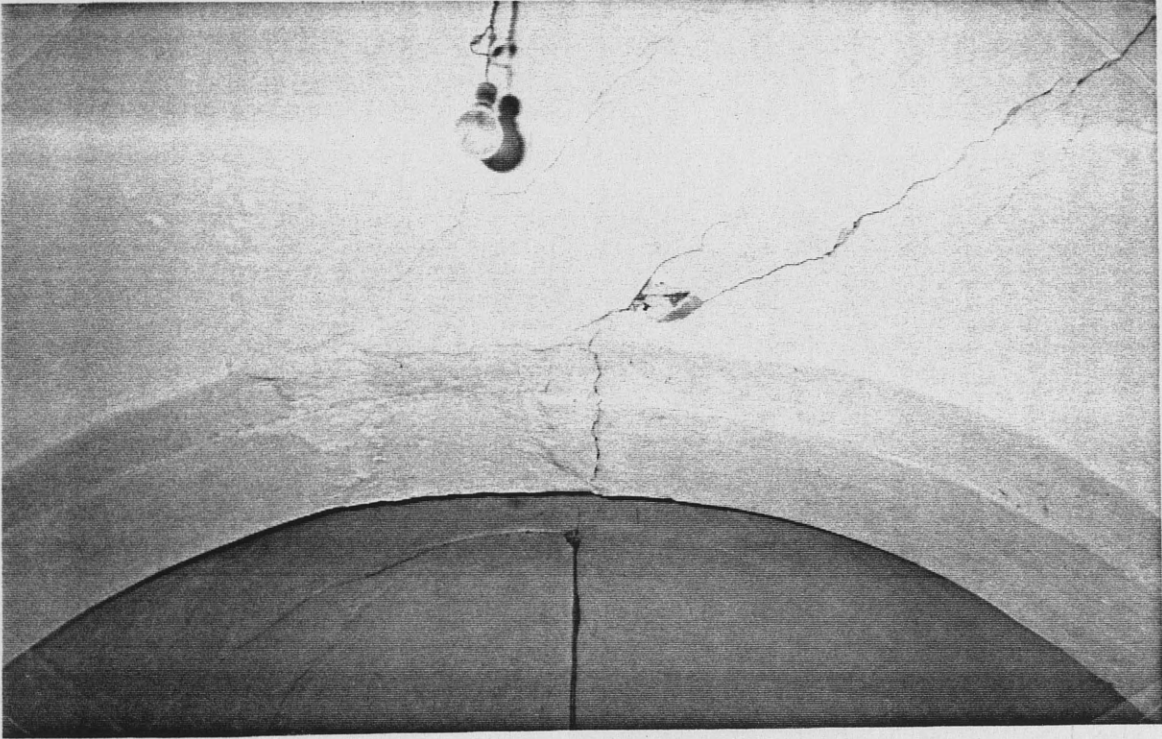
(a) Arch inside preschool

Fig. 21 Cracked arches inside and in courtyard of Takkayah Preschool
