Report No. UMCEE 92-31

# **Field Investigation of Damage to Islamic Monuments Caused by the Egyptian Earthquake of October 12, 1992**

December 1992

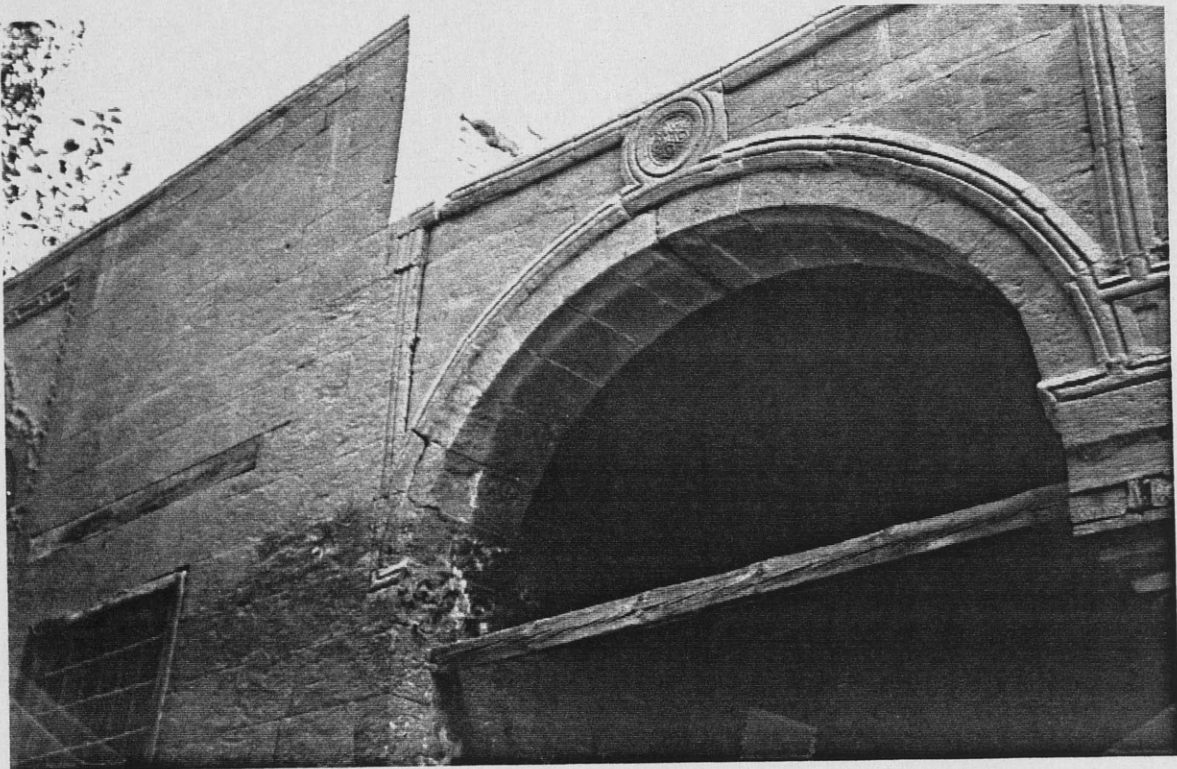
(b) Arch in courtyard

This structure was apparently a sort of convent where the Dervishes came for temporary retreat from the outside world. It is about 250 years old. In the present, it serves as a preschool. It is a one story high square structure with an open interior courtyard and garden (Fig. 19). Rooms are aligned along the periphery of the square. They all open on the inside to a covered corridor surrounding the courtyard. The roof structure is made of a series of masonry domes and arches. Several wide cracks were observed on the inside of the domes and in some rooms the mortar covering on the inside of the brick dome had spalled off and fallen (Fig. 20). Several cracks in the walls, domes and arches probably existed prior to the earthquake, but were amplified by it (Fig. 21). Most of the cracks could be structurally repaired and patched, restoring the structure to at least its pre-earthquake condition.

Fig. 21 Cracked arches inside and in courtyard of Takkayah Preschool

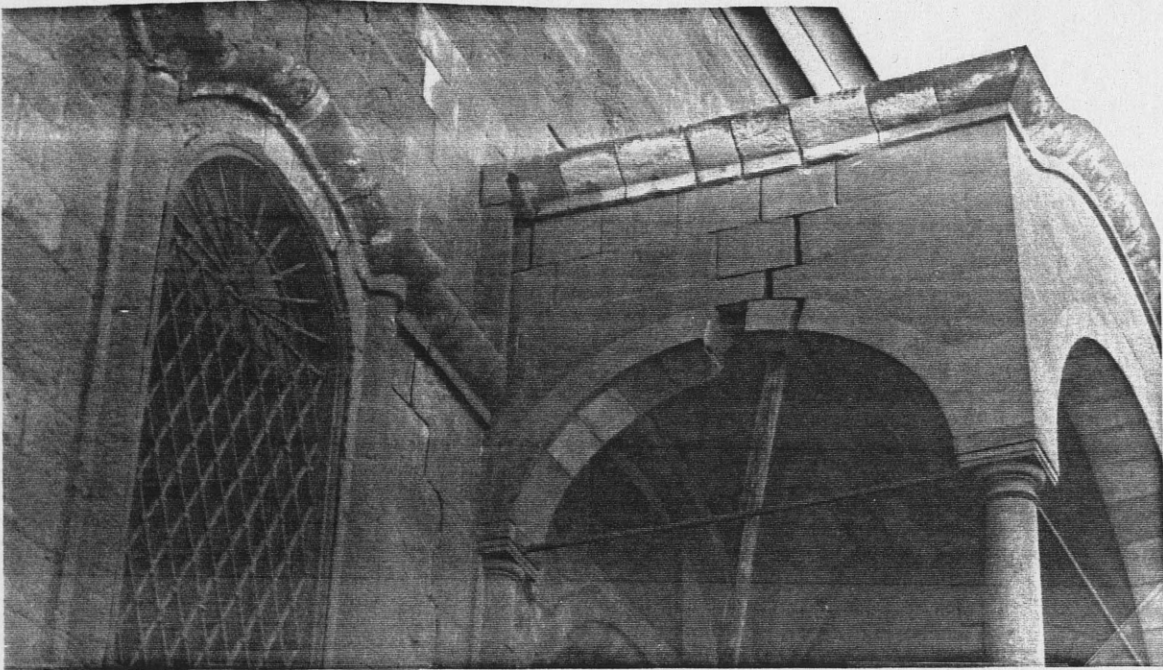
(a) Post supporting loose stone in arch

The facade of this court building had several severe cracks. In particular, the arches of the roof structure covering the porch were in a state of semi-collapse, held together by few shores (Fig. 22). There was evidence that part of the damage was present prior to the earthquake as indicated by a shore that was holding a loose keystone at the top of one of the arches. Since the stones of the facade were still in excellent condition, the team concluded that there should be no problem in restoring the structure to its original service condition.

Fig. 22 Porch of courthouse in the Citadel or the Mohammad Ali Mosque

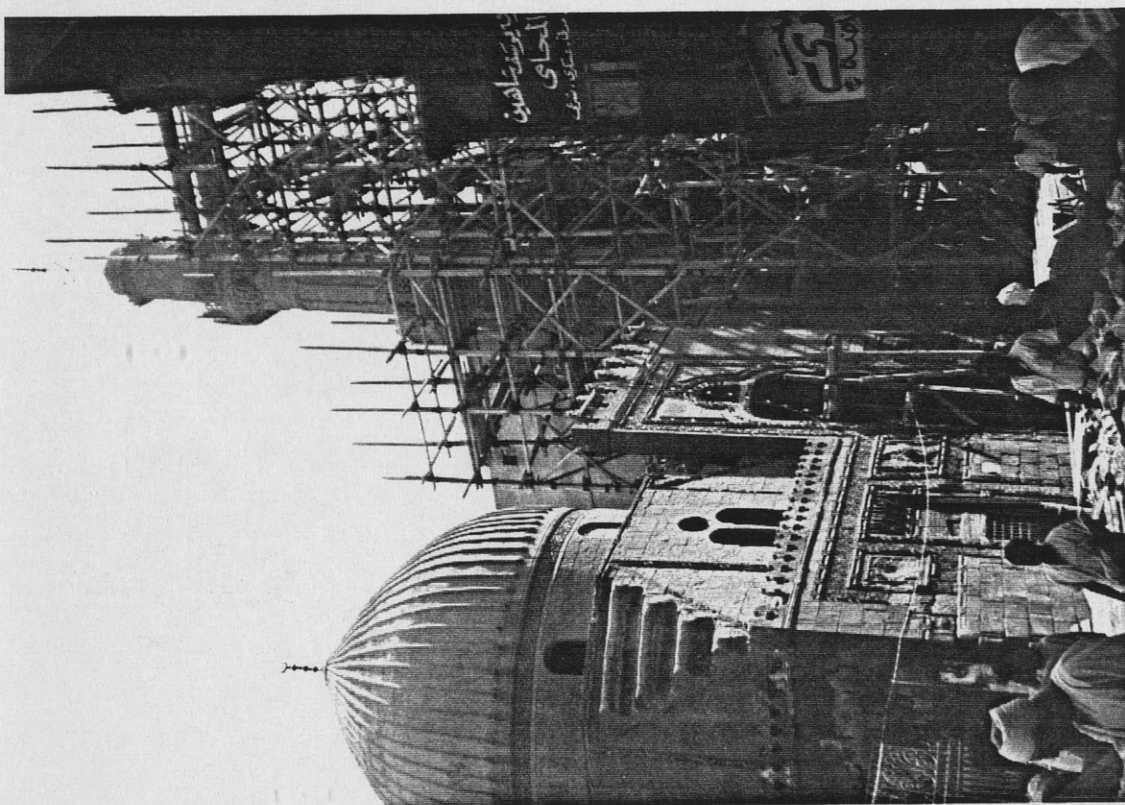
The Al-Kadi Yahya Mosque was in good shape, but the minaret tower was leaning noticeably toward the street (Fig. 23). Scaffolding had been erected in the street to support and arrest any future movement of the minaret. An inspection of the circular portion of the minaret tower that projected above the roof of the mosque revealed a continuous crack running around the perimeter of the circular section. The crack had sharp edges, indicating that it was caused by tension, but in a couple locations there were small compression spalls along the crack (Fig. 24). Thus, the cracked had apparently opened and closed at least once during the earthquake as the tower shook back and forth in response to the ground motion. The interior of the mosque and minaret tower were not inspected.

Fig. 23 Leaning minaret tower at Mosque Al-Kadi Yahya

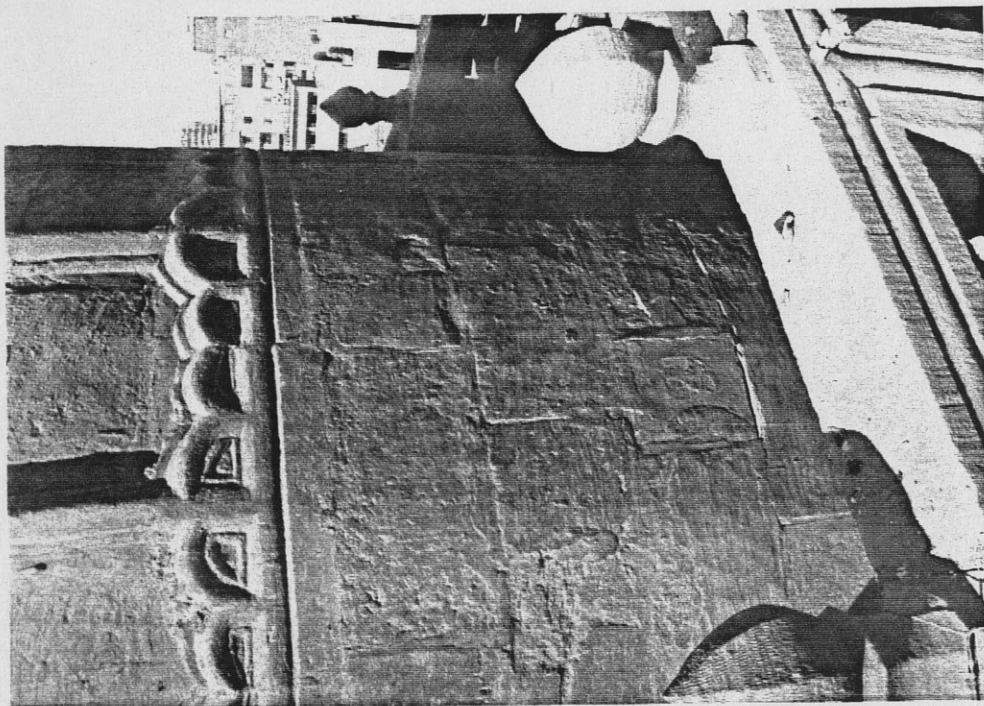
Fig. 24 Cracking and spalling along cracks in minaret tower section above roof of mosque

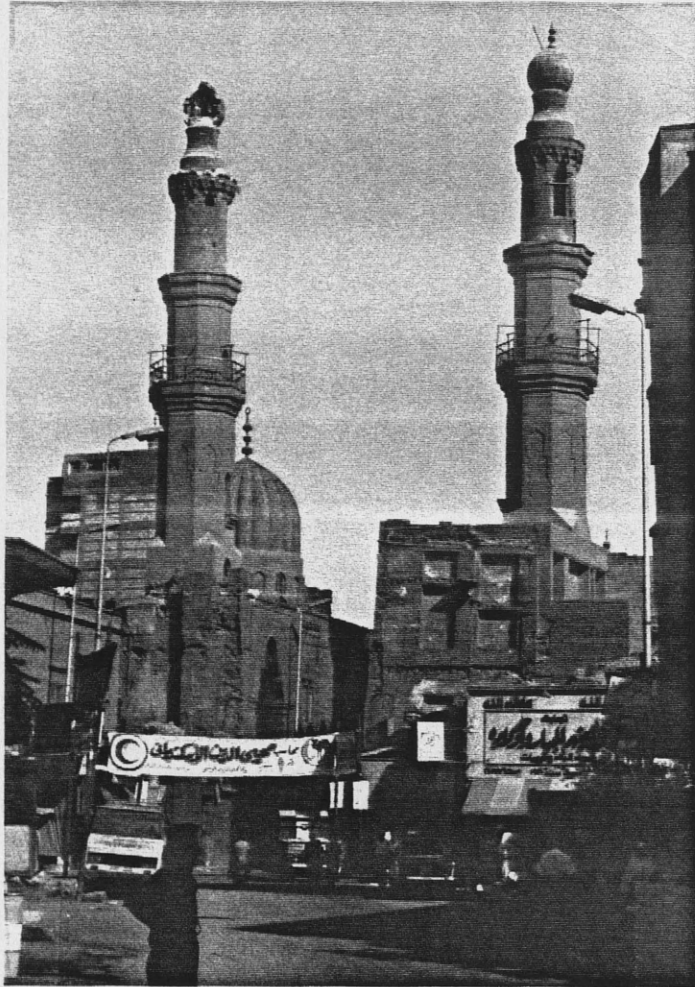
The top of the minaret tower partially collapsed during to the earthquake (Fig. 25). The team was only able to observe the failure from far away. The top

Fig. 25 Partially collapsed top of minaret at Amir Shaykhu Mosque

of this minaret should be removed and replaced with a more properly designed ornate top. A second minaret tower, which had a very similar top, was located across a narrow street from the minaret with the partially collapsed top. The top of this second minaret should be inspected and modified for increased seismic resistance.
