DYNAMIC TESTING OF RESTRAINT  
SYSTEMS AND TIE-DOWNS FOR USE  
WITH VEHICLE OCCUPANTS SEATED IN  
POWERED WHEELCHAIRS

FINAL REPORT

Lawrence W. Schneider  
The Highway Safety Research Institute  
The University of Michigan  
Ann Arbor, Michigan 48109

April 1981

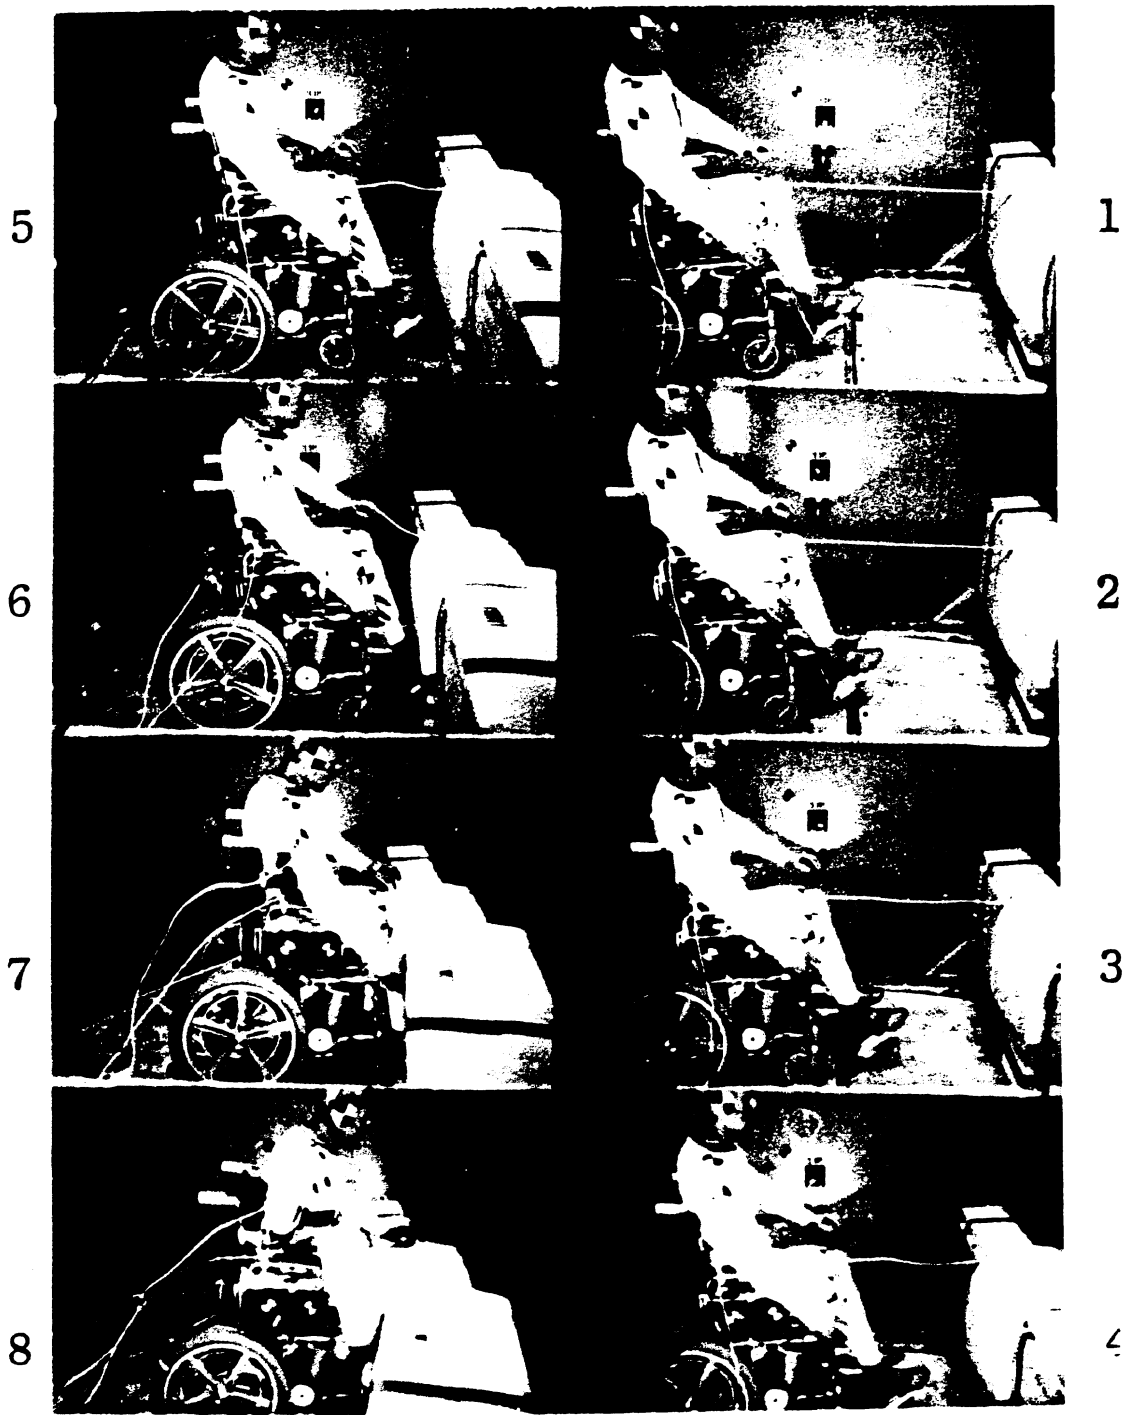
Time Sequence Photo for Test 80M001

Prior to impact the chair moved backward on the sled due to the sled acceleration (approx. .5 G), producing slack in the lap belt. The ring of the right lift ring assembly broke at the sharp bend on impact, releasing the lap belt and allowing the wheelchair to move unrestrained into the padded front of the sled. The velcro fastening on the chest belt did not hold. The chair sustained little or no damage.

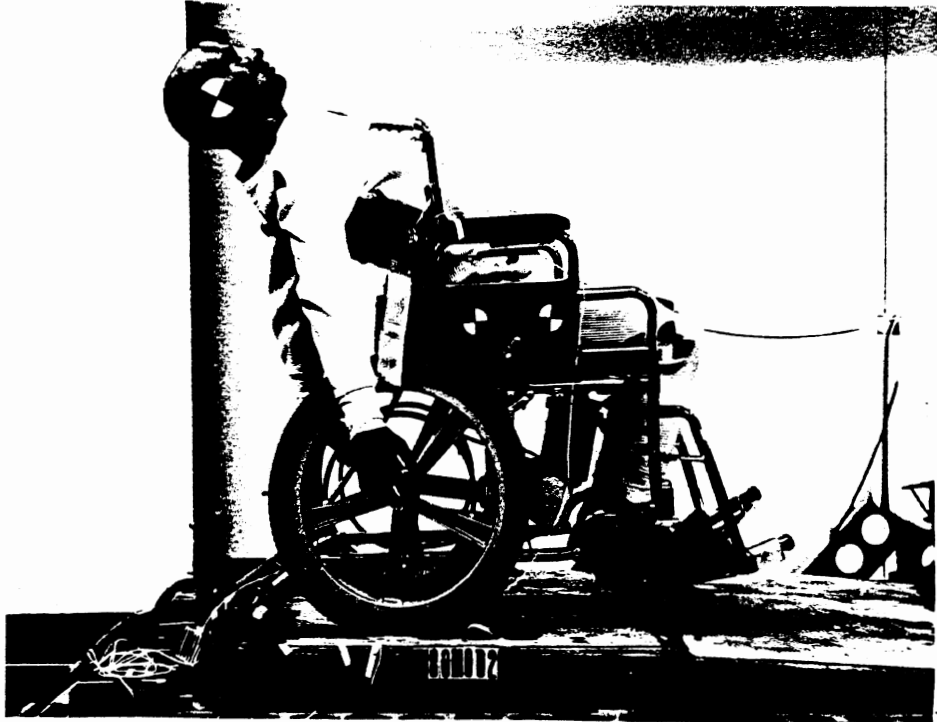
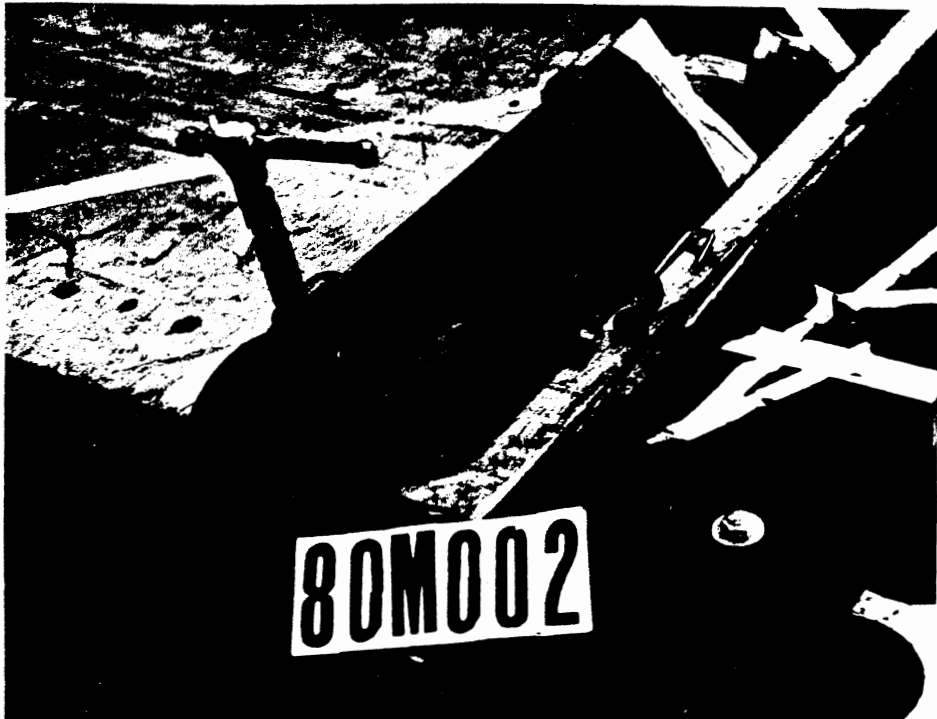
Post-Impact Photos for Test 80M002

The chair did not move on sled acceleration and the lap belt remained taut until impact. Upon impact the ring of the left ring assembly broke at the sharp bend, releasing the chair and dummy, which moved forward and impacted with the padded front of the sled. The velcro belt released, allowing the dummy's torso to flex forward. The chair back upholstery was torn loose on dummy rebound. The chair sustained little or no damage to the frame.

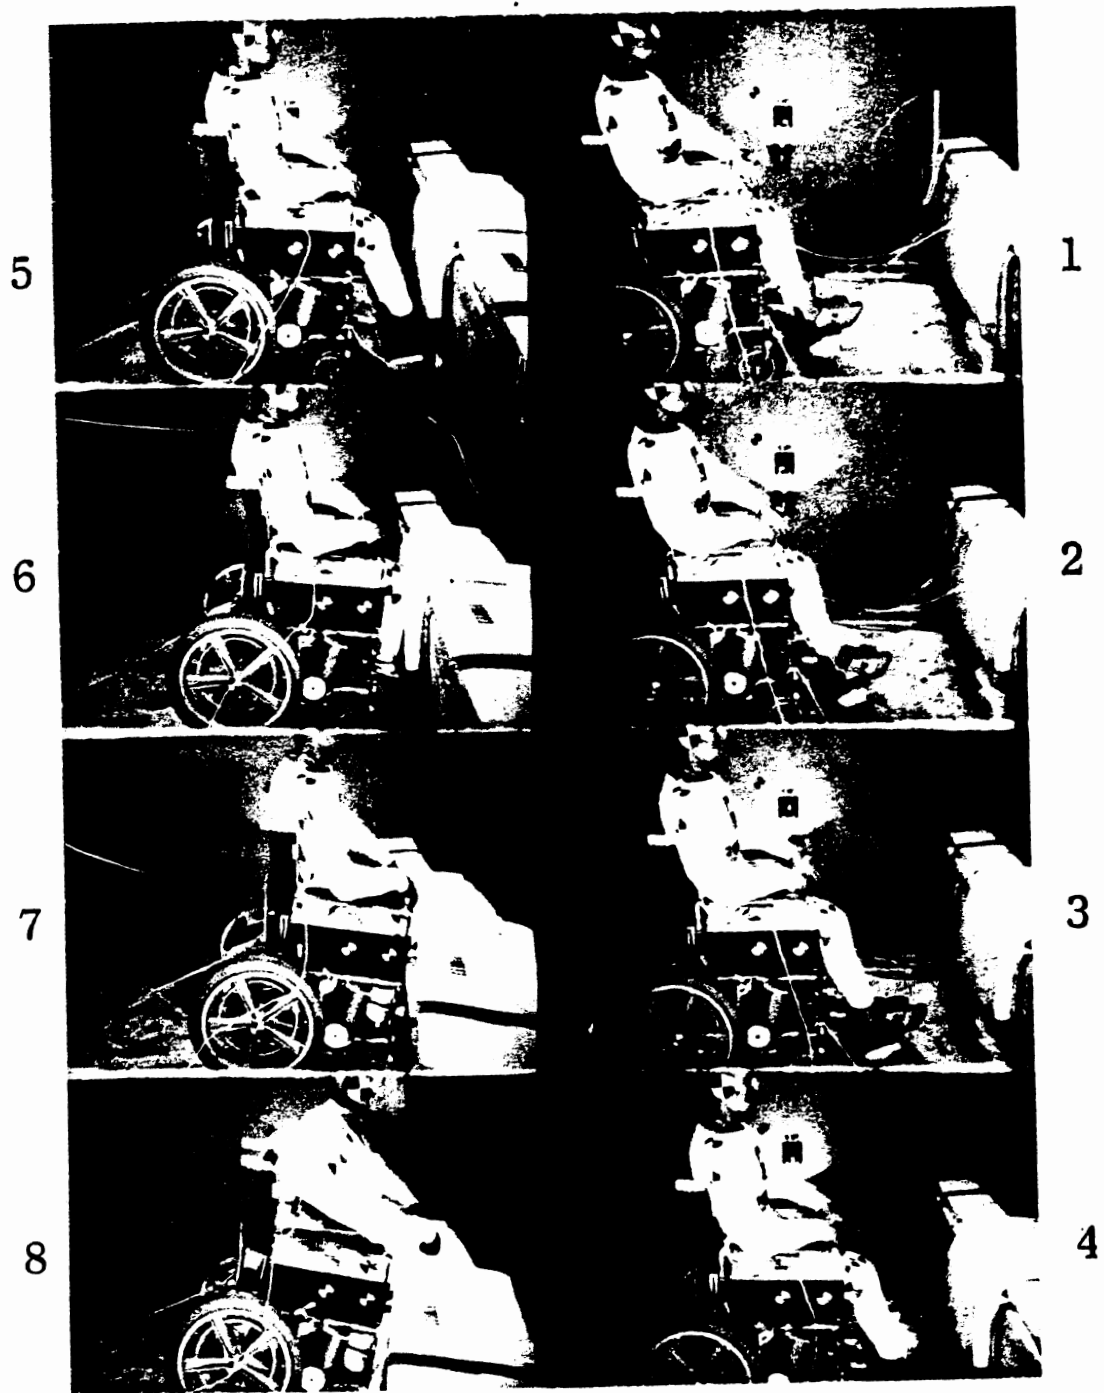
Time Sequence Photo for Test 80M003

The ring of the lift ring assembly broke at the sharp bend, releasing the wheelchair to move forward into the padded front of the sled. The T-bar and hook bolt bent significantly and the velcro belt came loose, allowing the dummy to fall to the floor.

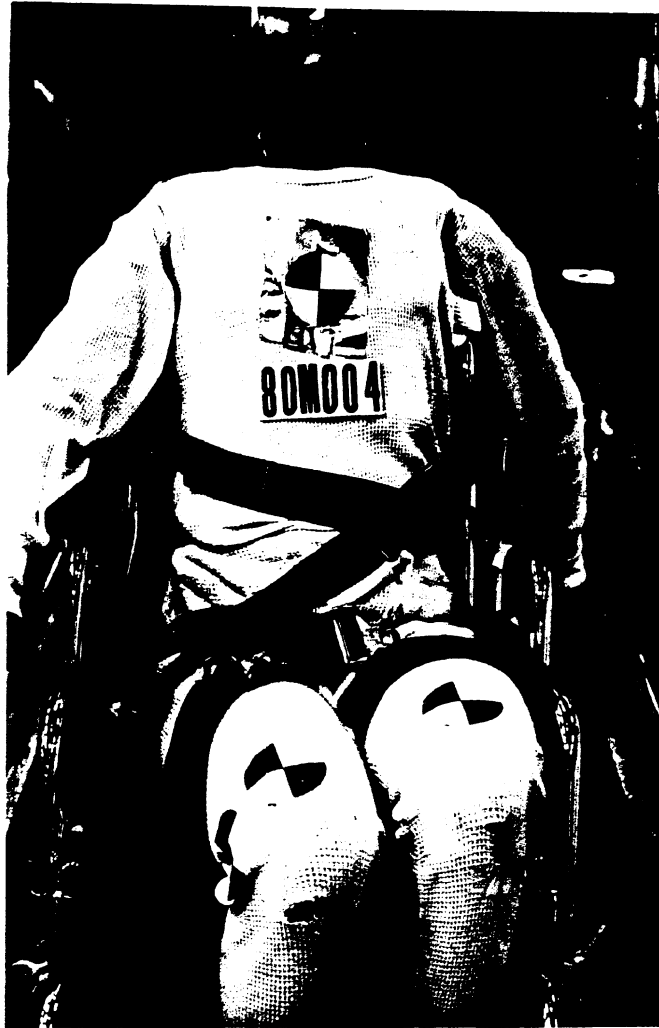
Post-Test Photo for Test 80M004

The rings from the lift ring assemblies securing the T-bar and one side of the lap belt broke at the sharp bends, allowing the wheelchair to move into the padded front of the sled. The T-bar itself bent and fractured, and the lap belt also unbuckled. Although the velcro on the chest belt held, the stitching tore out, allowing the belt "D" ring to slide through the double webbing and produce significant belt slack.

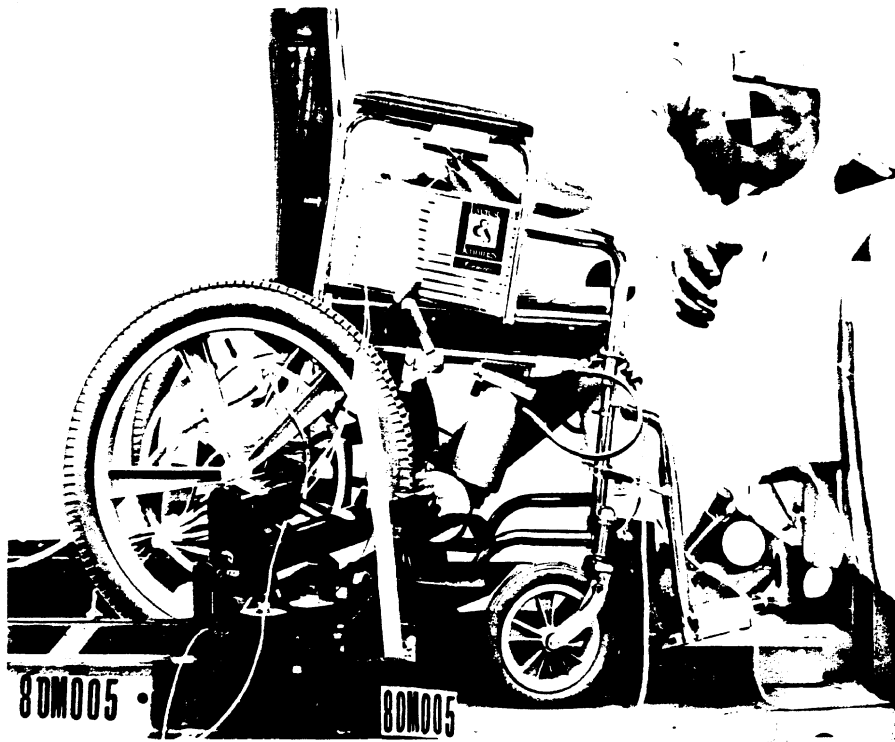
Post-Impact Photos for Test 80M005

There was no significant restraint of the chair by the power lock-down. The lock-down arm slid off the frame with little apparent effect on wheelchair movement. When the arm did interact with the chair frame at the cross-bars, the power lock-down rotated out of the way as the chair moved forward. The chair moved into the padded front of the sled with little or no turning, so that the dummy's knees absorbed most of the energy. During the test the lap belt stayed secure and the dummy remained in the chair. The chair sustained little damage other than bending of the motor brackets.

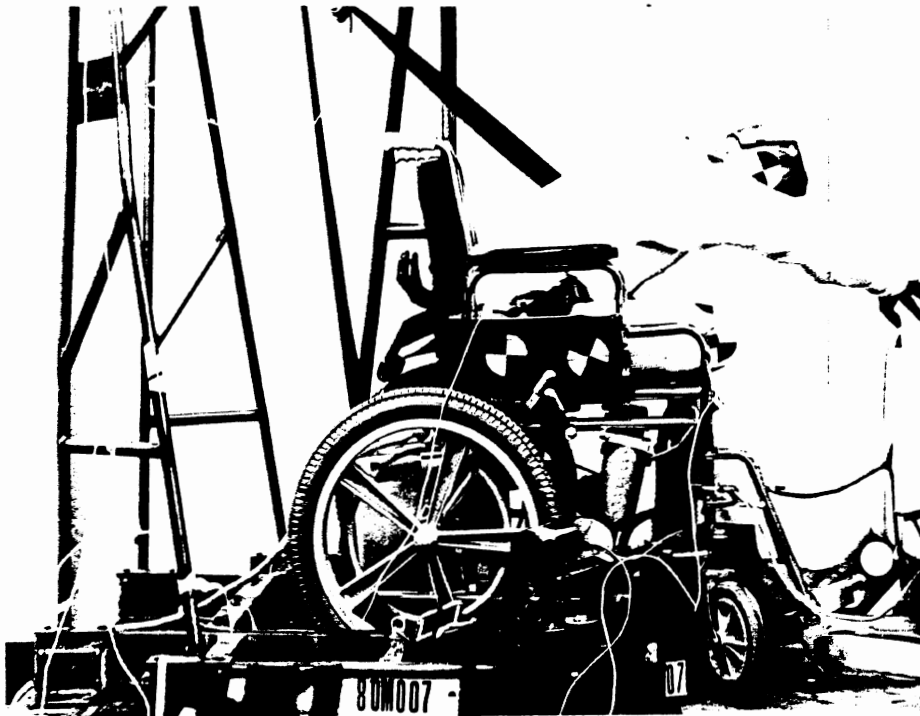
Stop Action During Impact Test 80M007

The power lock-down did not restrain the chair. The chair and dummy moved forward into the passive belt system, causing the stitching around the metal ring in the floor-mounted belt to break, releasing the chair to move out of the power pan and into the front of the sled. The chair sustained little damage.

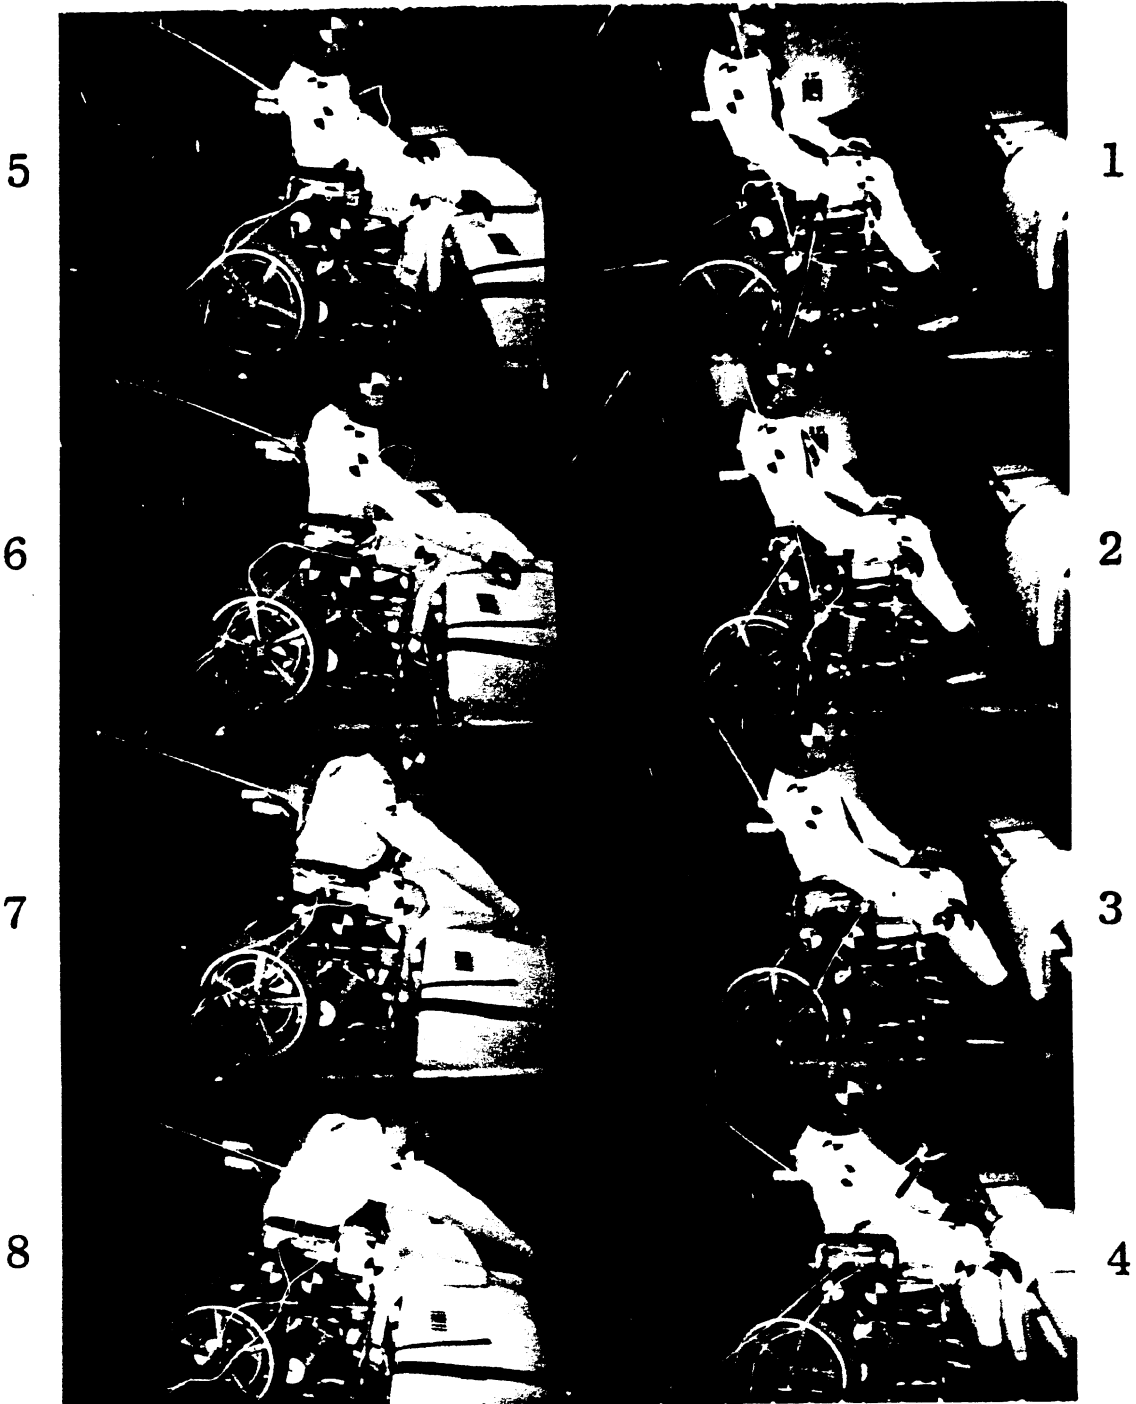
Time Sequence Photo for Test 80M008

The results were the same as in test 80M007, except that higher belt loadings were achieved before the belt webbing ripped through the bolts at the metal ring, releasing the chair and dummy. The chair arms and frame were bent during impact.

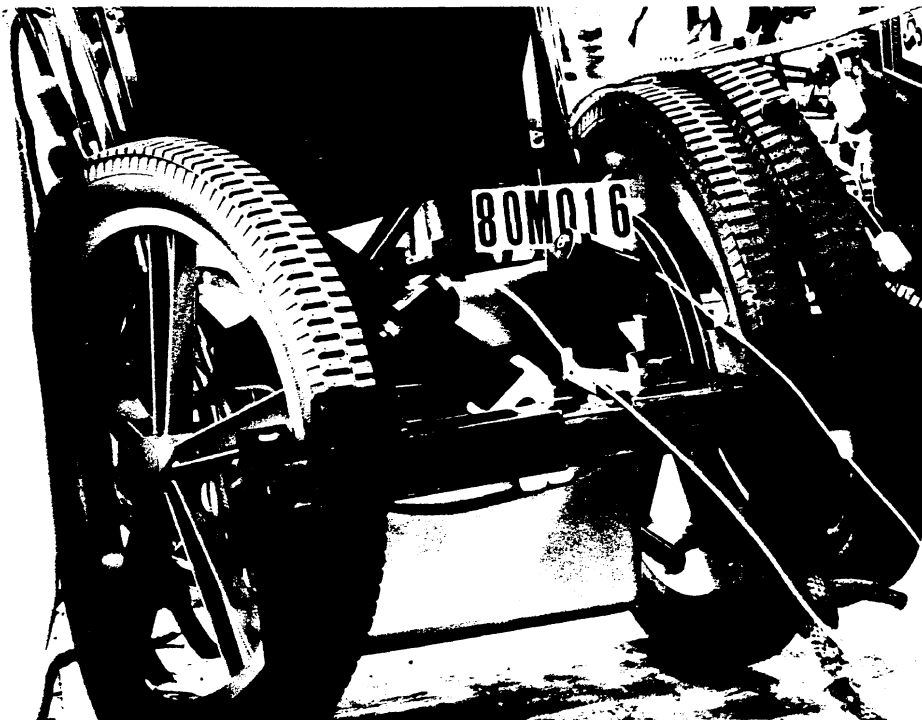
Post Impact Photos for Test 80M016

The rim pin fixtures of the stanchion slid along the bar to the front of the stanchion bar. The front chair impacted into the padded front of the sled, fracturing the left magnesium wheel rim and badly bending the chair. The rear chair impacted into the front chair and then flipped backward over the stanchion, with the dummy ending upside down and hanging off the side of the sled. Both lap belts held the dummies in the chairs.

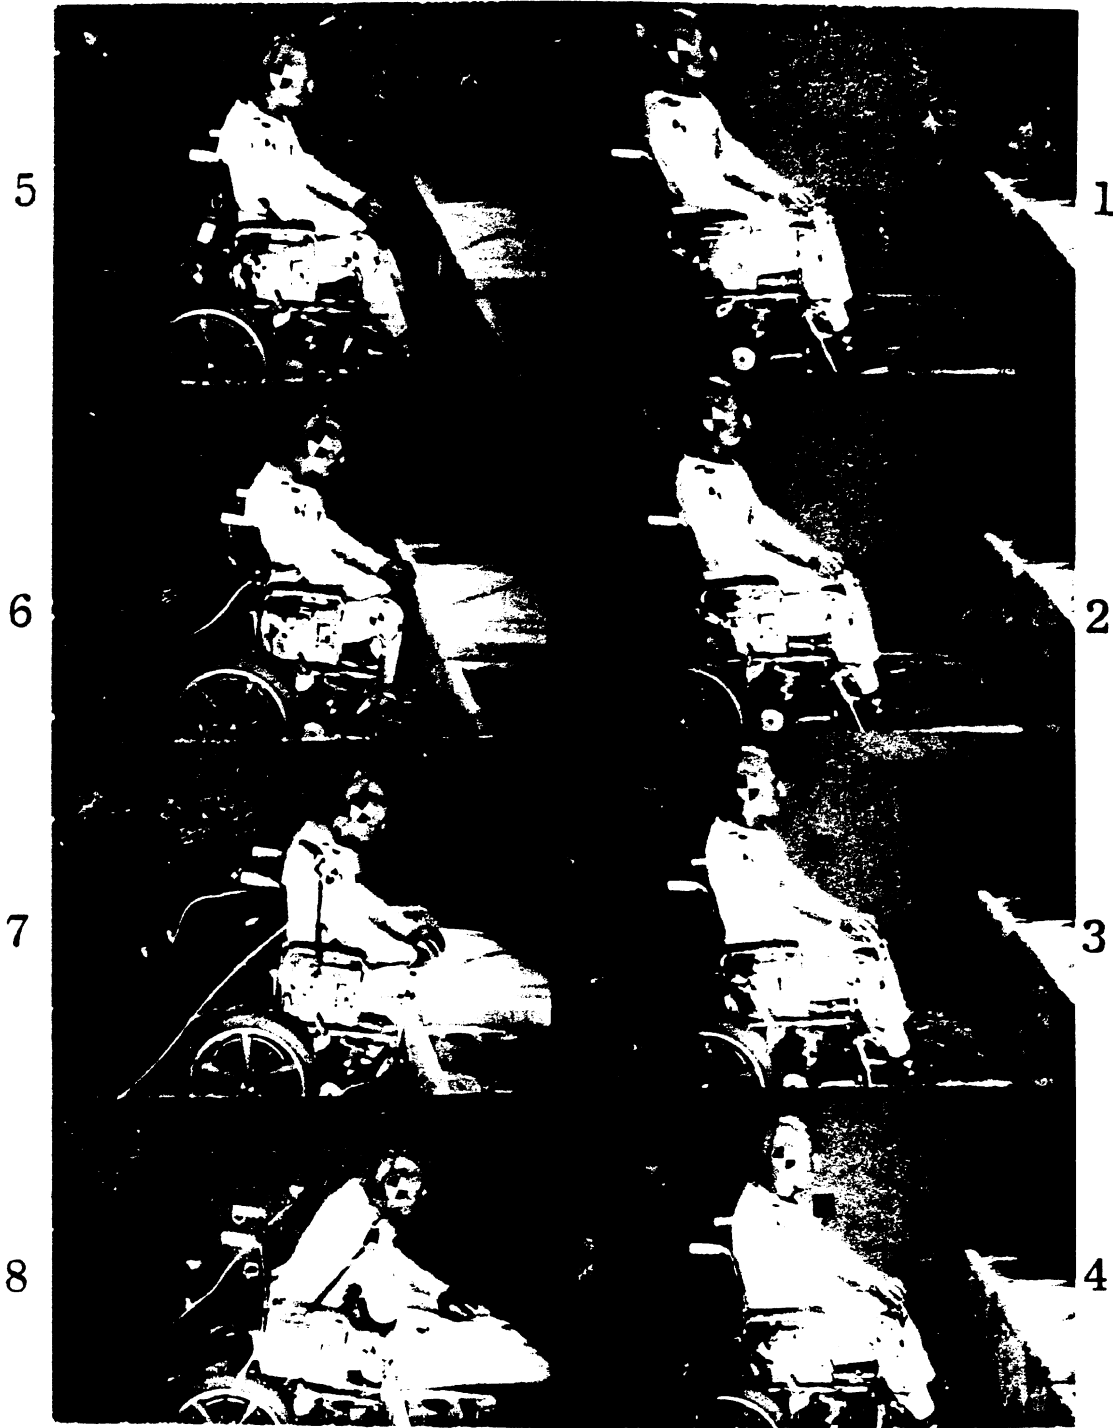
Time Sequence Photo for Test 80M021

All three of the lift rings broke at the sharp bend, completely releasing the chair and dummy to impact into the padded front of the sled. After impact the dummy fell to the floor unrestrained. The wheelchair sustained little or no damage.

The lift-ring assemblies currently in use for anchoring lap belts and T-bar bolts were simply not intended for forces generated by a 110 pound wheelchair in any kind of crash. These are "off-the-shelf" trap door rings which can be purchased in most any hardware store. The weak point is clearly the sharp bend in the ring, which appears to have been cold formed from a piece of standard rod. Replacement of these ring assemblies by heavy duty eye bolts or some other strengthened hardware is essential for effective wheelchair restraint.

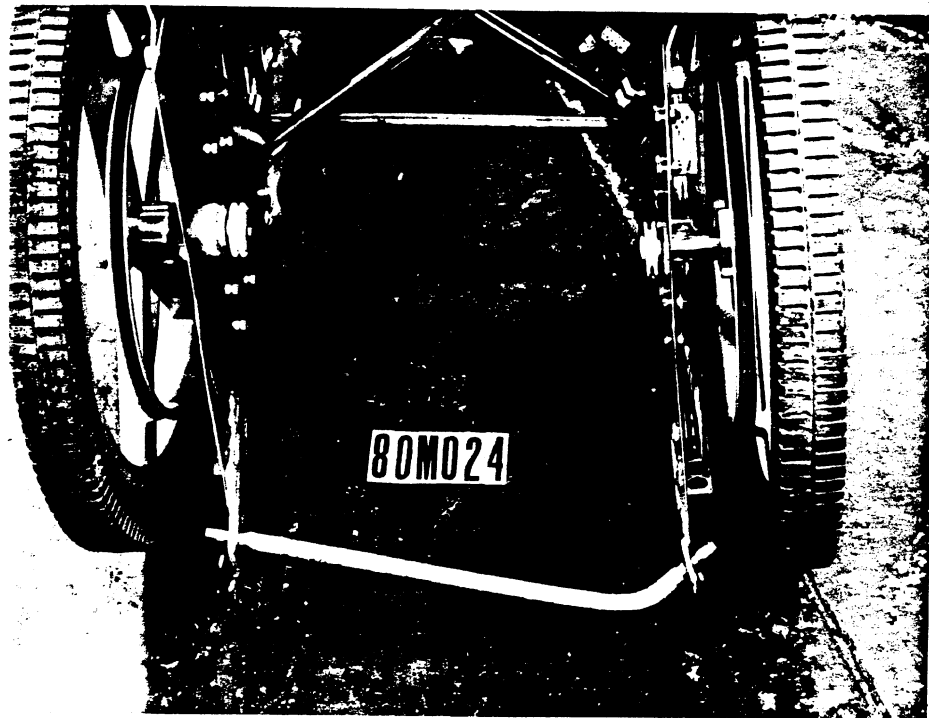
Post-Impact Photos for Test 80M024

The CCI power pan retrofit tie-down system provided excellent wheelchair securement, and the chair sustained only minor damage due to the asymmetric forces. The dummy was well restrained, but the shoulder belt pressed into the dummy's neck due to the angle of impact.

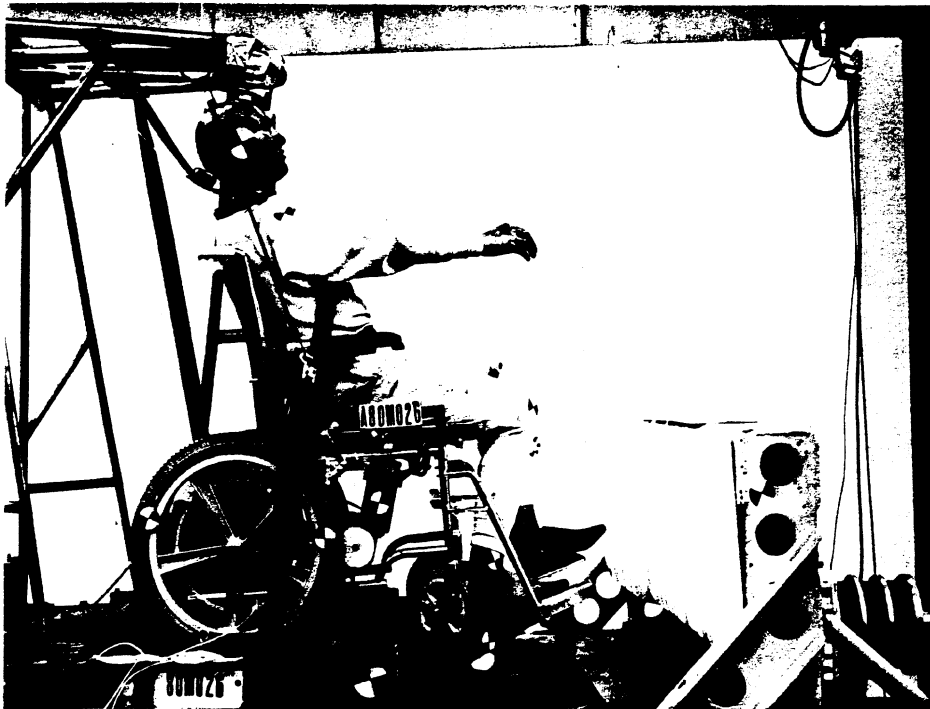
Post Impact Photo of Test 80M026

The wheelchair was secured well by the CCI tie-down system, but a knot in the floor belt broke loose at the metal ring, allowing considerable forward translation of the dummy. The chair sustained little or no damage.
