AN EXPERIMENTAL STUDY OF THE INITIATION AND PROGRESSION OF DAMAGE IN COMPRESSIVELY LOADED COMPOSITE LAMINATES IN THE PRESENCE OF A CIRCULAR CUTOUT

January 16, 1989

Abstract

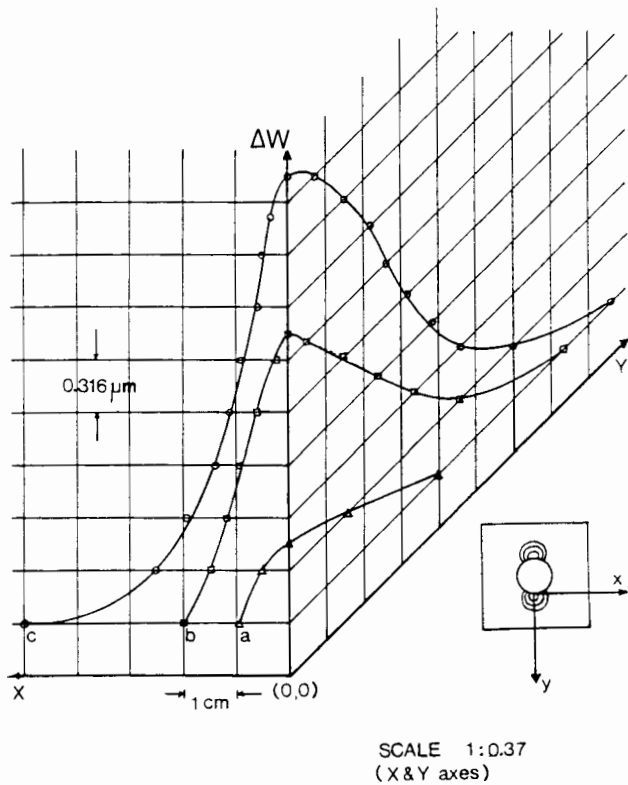
Figure 8 Summary of displacements corresponding to Figure 7.

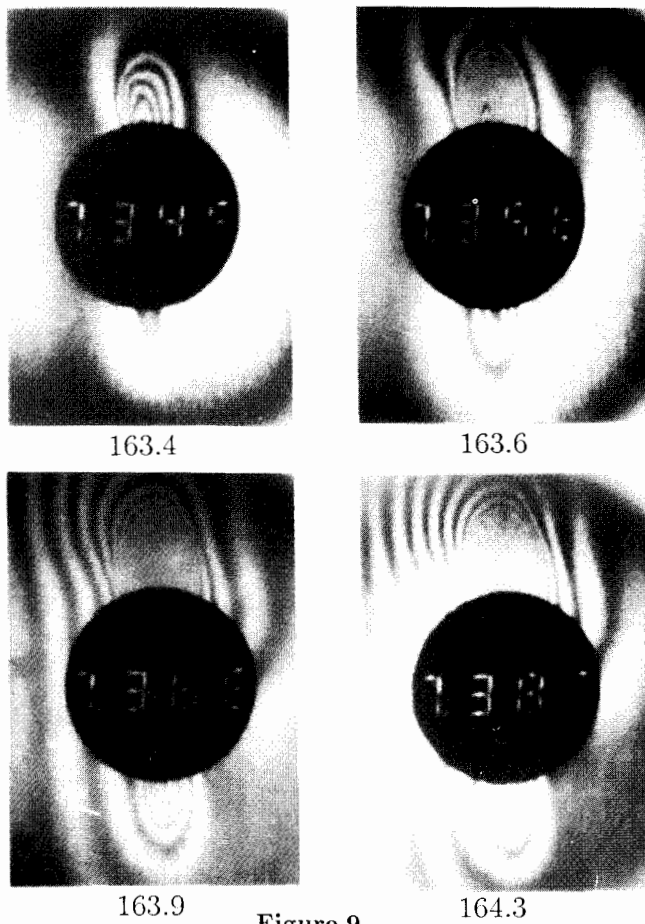
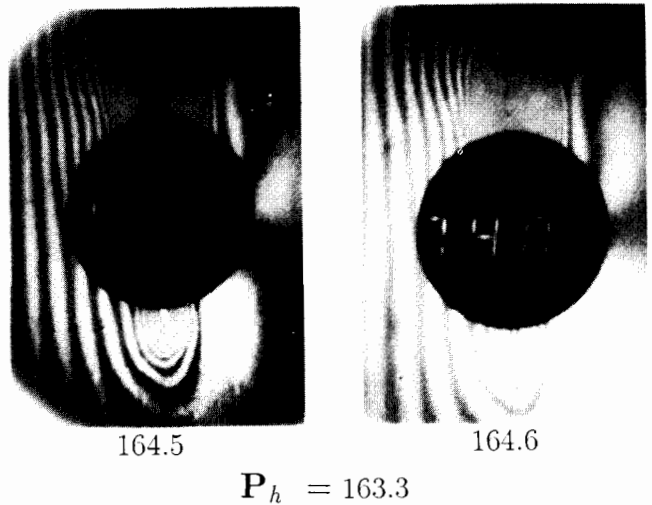
Figure 9 Buckling and spreading of delaminated portions just prior to catastrophic failure (specimen TB11).

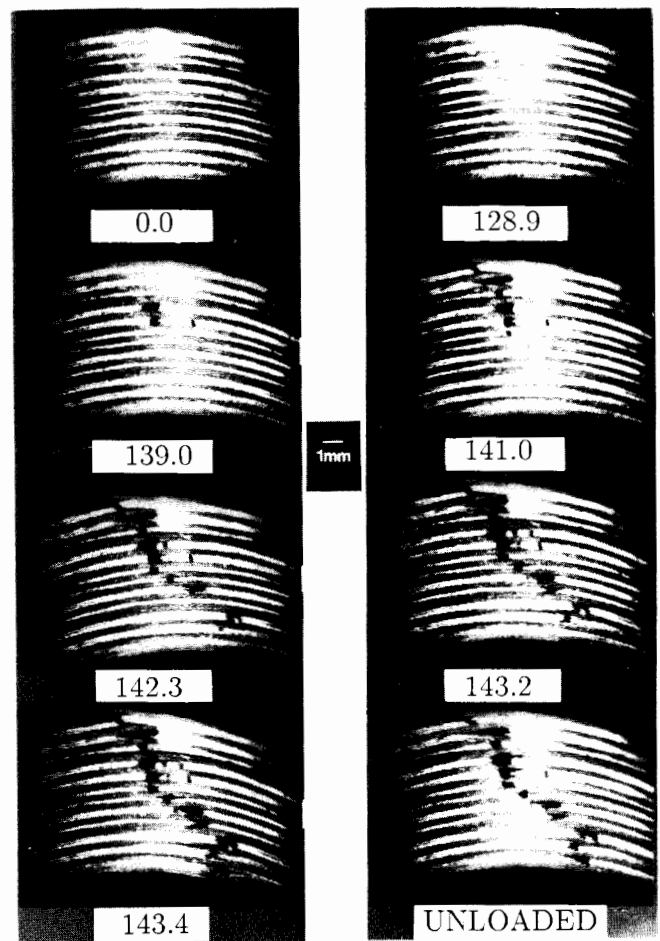
In a type A specimen (42% 0^0 plies as contrasted with 8% in type B), the mechanisms leading to failure initiation and propagation is as discussed before for type B specimen, apart from the levels of applied load at which the different events take place. This is evident from the results presented in Tables 1 and 2. A sharp localised cluster of fringes is seen to form at the edge of the hole which spreads very rapidly with a small increase in applied load. The area in which the fringes are unresolvable extends out to about 80% of the hole radius, from the hole edge. A corresponding set of photomicrographs, typical of these specimen, is shown in Figure 10. Here, the initial 0^0 fiber failure occurs at 139 kN. With increasing load the remaining 0^0 plies undergo failure. Adjacent to some of the damaged 0^0 plies, delamination cracking is found to occur. Notice the damage to all 0^0 plies and the formation of

surface buckles on both surfaces of the specimen. A picture of the damaged, unloaded specimen is shown in the last frame of Figure 10.

Figure 10 Hole surface photomicrographs showing damage progression (spec. TB17).

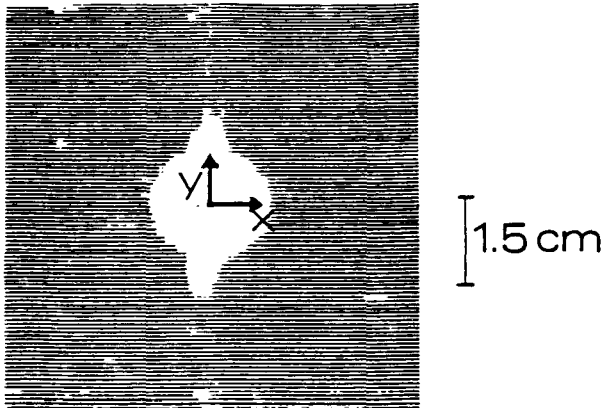
TB16

Bearing in mind the information obtained from the surfaces of the specimen, we now turn to a discussion of post experiment sectioning studies. Shown in Figure 11 is a typical C-scan map of a damaged specimen. In this figure, the extent of the damaged area is contained within about one hole radius. The damaged area is a function of the maximum load to which the specimen is loaded. Sectioning through the damaged area and observation under an optical microscope revealed several inclined narrow zones of fiber breaks within the 0^0 layers, identified as *Fiber Kink bands*. A typical section through the damaged area is shown in Figure 12. Here, the interior 0^0 plies show several kinking failures. A typical complimentary kink band is shown in Figure 12(b). The geometry of a typical kink band is summarised in Figure 13. We note in Fig. 12(b) a kink band inclination (α) of 65^0 to the load carrying direction. The lengths of the fibers in the inclined zone measure to $50-84 \mu m$. More importantly it must be pointed out that the region between the inclined zone appeared undamaged and oriented parallel to the fiber direction. In a study by Evans et al.[10], carbon fiber bundles of width $\approx 400 \mu m$ oriented in three orthogonal directions were set in a Graphite matrix and subjected to localised impact. Post-experimental examination revealed typical *kink orientation* angles α of $45^0 - 60^0$ and kink boundary orientation β obeying $\beta \approx \frac{\alpha}{2}$ for broad ($\frac{L}{d} \geq 0.1$) kinks. Here β is measured from the *perpendicular* to the fiber direction. For narrow kinks β was found to increase and α random. Corresponding results in our study which fall into the category $\frac{L}{d} \geq 0.1$ indicate $\beta \approx 25^0 - 30^0$ and $\alpha \approx 15^0 - 30^0$. However, no definite trend between α and β can be established. This type of kinking failure has also been observed in other studies dealing with compressive strengths of laminates (see for example [9]-[11]).

Figure 11 C-scan map of typical damaged specimen (spec. TB16).

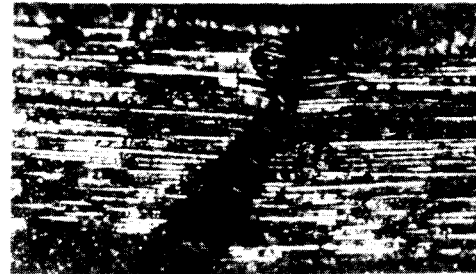
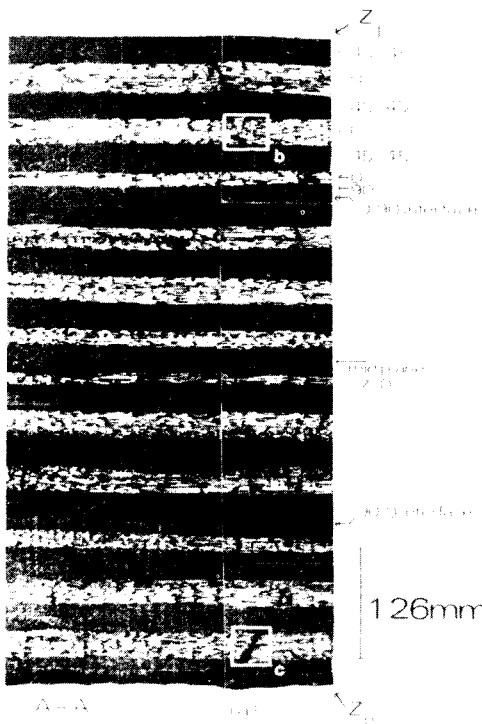
Figure 12 Internal damage at the vicinity of the hole (spec. TB15). a) Entire cross section. b) Complimentary kink in second 0° layer from top. c) Magnified view of damage to bottom 0° layer.

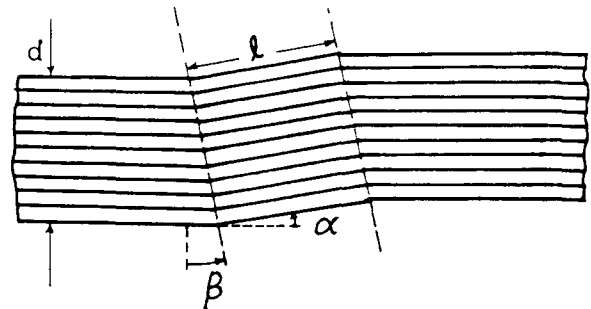
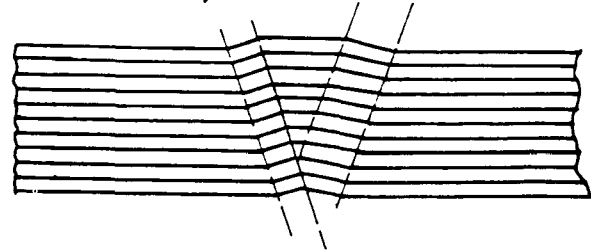
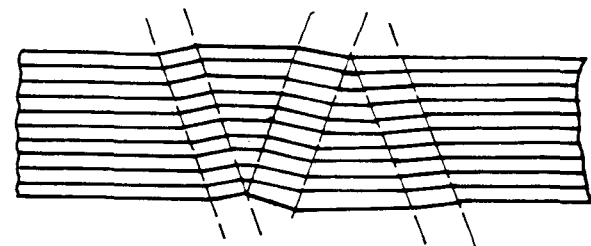
Figure 13 Geometry of typical kink bands.

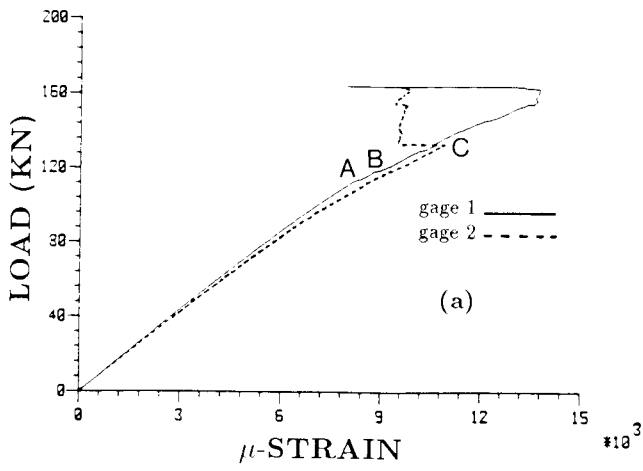
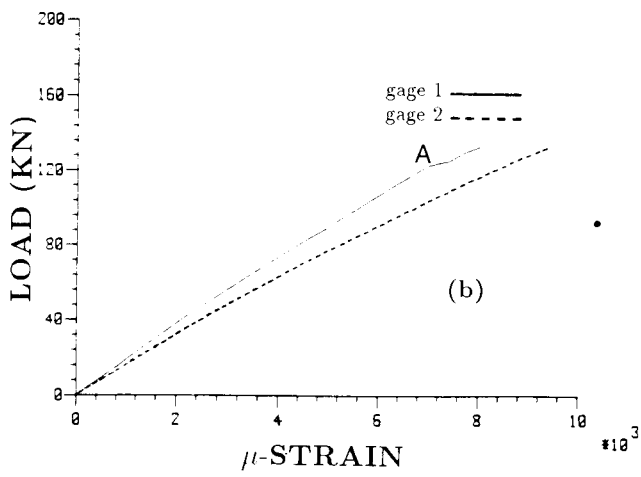
(location H), is shown. Notice that the strains are seen to increase linearly with increasing far-field load. When the far-field load reaches P_i (corresponding to microbuckling of the 0^0 plies), the load vs strain behavior shows a kink (marked 'A'), implying a localized softening. For the type B specimen (Fig. 14(a)), with failure of other 0^0 plies, the softening continues (marked 'B'), until reaching 'C', when strain reversal is detected on one gage. This reversal occurs because the delaminated portions closest to the surface on which the gage is attached undergo *buckling*. The buckling results in tensile strains on the outer surface, due to bending, causing a net reduction in the compressive strain. For the type A specimen, beyond failure initiation, data can be collected only upto the point where surface buckles form due to delamination. At this time, the large out of plane displacements encountered during the rapid propagation and growth of the delaminated portions result in the strain gages being peeled off of the surface, disrupting the data acquisition. The averaged microbuckling strain for the two types of specimen are listed in Table 3.

Figure 14 Strain gage response for (a) type B (spec. IM28) and (b) type A (spec. IM21) specimens.
