ICE STRENGTHENING OF GREAT LAKES BULK CARRIERS

Department of Naval Architecture and Marine Engineering
The University of Michigan

MICHU-SG-82-200
N.A.M.E. Report No. 263
\$2.00

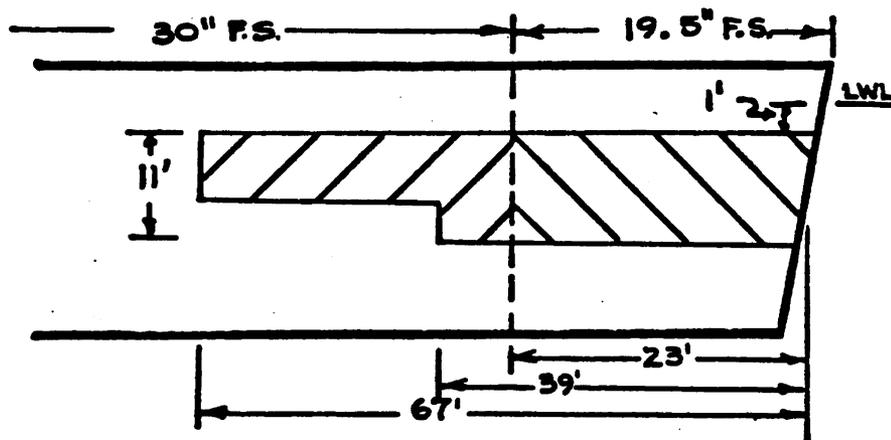
SHIP A

AREA REFERENCED	PRESSURE INDEX			
	PLATE		FRAME	
	P_o	P_a	P_o	P_a
#1	58	190	295	339
#2	24	80	267	348

Damages caused by operation in ice were incurred on several occasions over a span of twenty years. Some of the repaired areas were subsequently damaged again. Eventually, the original 22.5 lb. mild steel plate of both areas indicated above was replaced with 40.8 lb. mild steel plate, giving the results shown in the table. There is no indication that repairs were ever made to the frames.

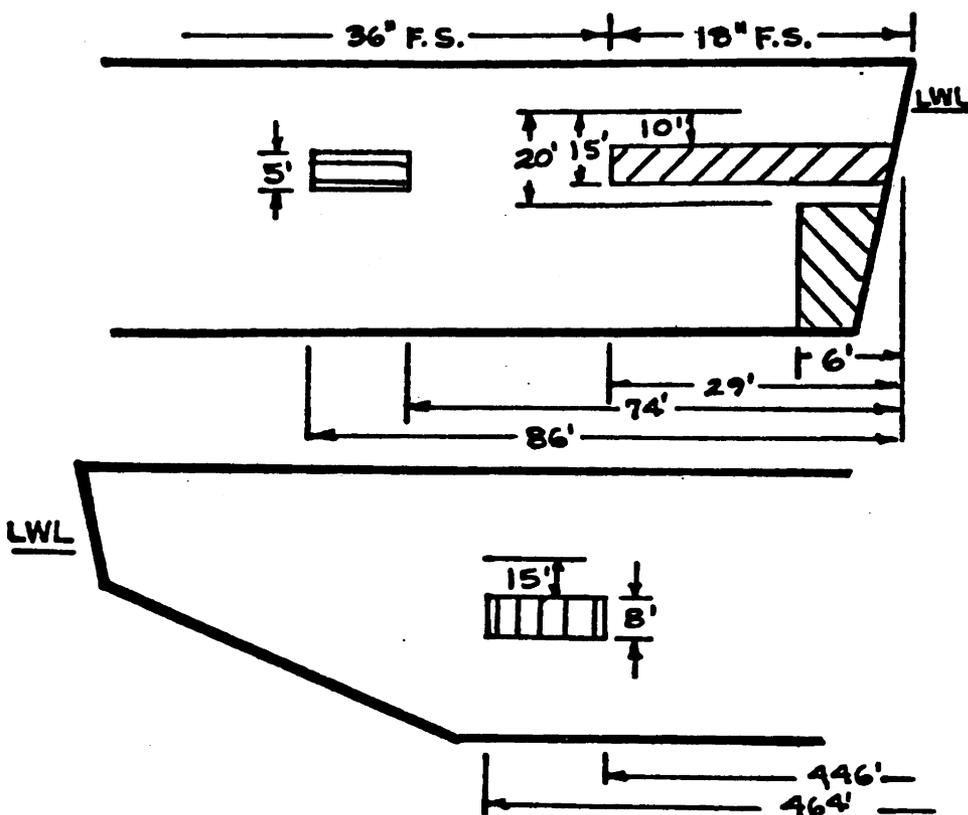
SHIP B

Ice damages occurred in 1977 and were located both port and starboard in the vicinity of the areas indicated. Repairs were made to the shell plate using 100,000 psi yield stress material of the same weight as the original 25.5 lb. mild steel plate. The survey report indicated that many frames had failed and in all areas, but it was proposed to replace them in kind in areas 1, 2, and 4, and to halve the spacing in area 3.

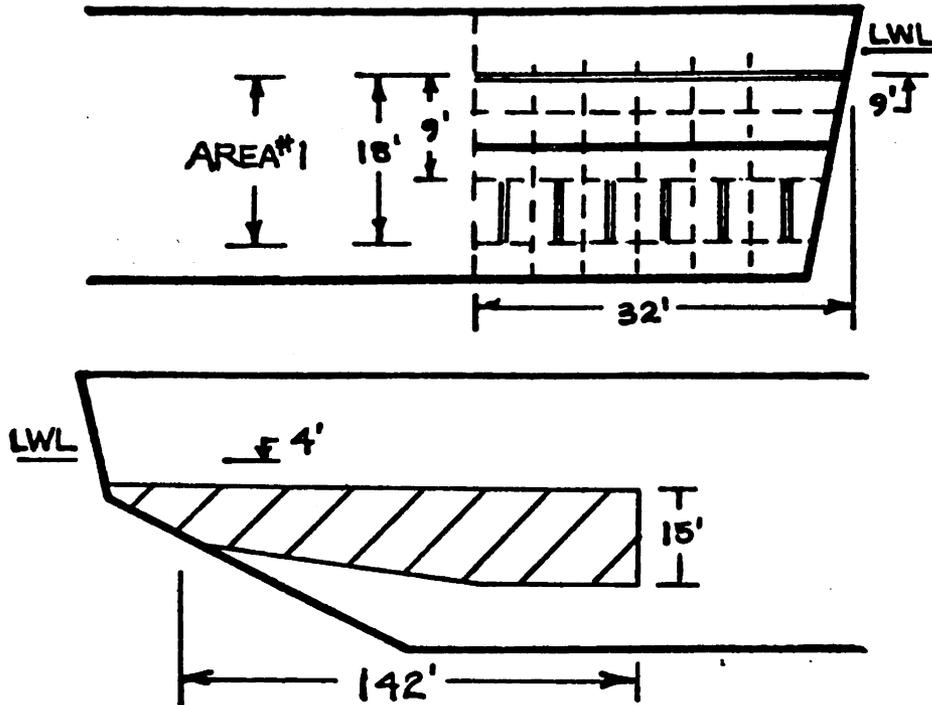
SHIP C

This ship was initially fitted with 100,000 psi yield stress plating. The weight of plate in the modified area is 30.6 lb. It is presumed that no ice damages were incurred but that ice strengthening was done in anticipation of winter operation. In area #1 two shell stringers and intermediate frames were added as indicated by the doubled lines in the illustration. Area #2 is longitudinally framed. Here, transverse pieces were placed between longitudinal frames to divide the plating into three equal spaces between web frames.

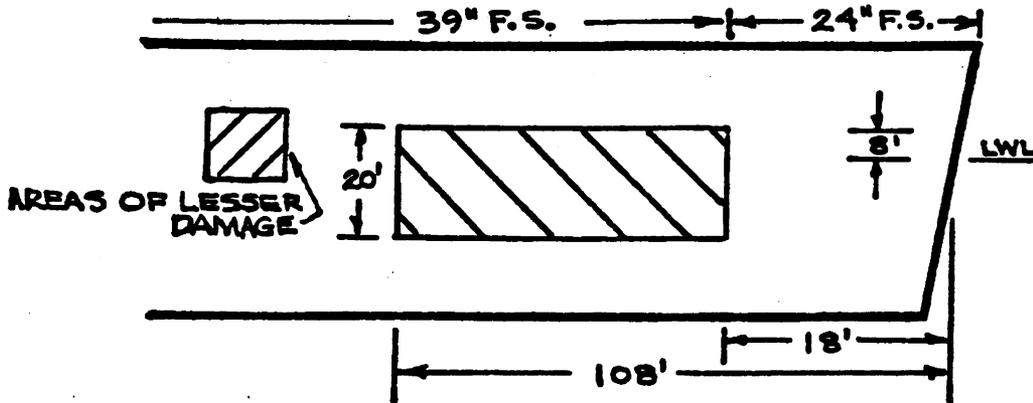
SHIP D

NOTE: THERE WAS NO DAMAGE AT BOW WHERE PLATE $P_0 = 125$ AND FRAME $P_0 = 220$

Ice damage did not occur at the bow of this ship where one might normally expect. The area forward of area #1 is of 40.8 lb. mild steel plate, but in areas #1 and #2 the plate was 25.5 lb. mild steel. There was apparently no damage to frames. Area #1 was strengthened with additional intermediate frames, and 100,000 psi yield stress plating of 25.5 lb. weight. Area #2 damage was small and was repaired using high yield strength plating of 100,000 psi yield stress.

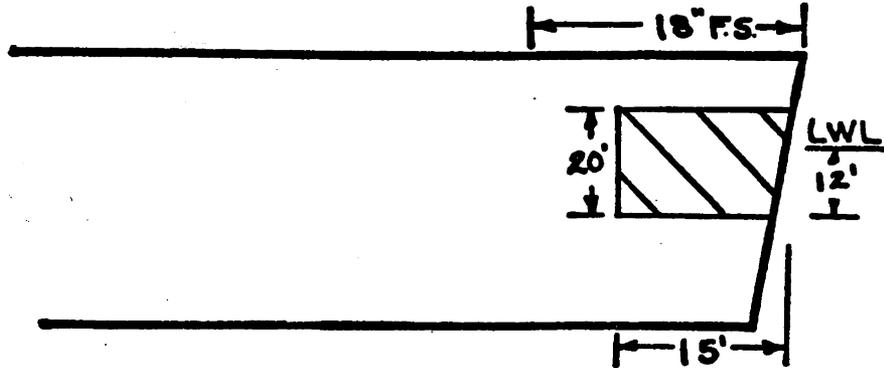
SHIP E

Ship E represents two sister ships which incurred almost identical damages in the same winter season. Ice damages in the stern area were quite severe. The plating had been stove-in, rivets had been broken, and the plating had started to tear in several locations. Frames, shell stringers and breast hooks were crippled. The original shell plate was doubled in this area with two thicknesses of 25.5 lb. mild steel plate. The damaged area was completely rebuilt. The doubled shell plate was replaced by one thickness of 40.8 lb. mild steel plate. New stringers were built, and frames were replaced using heavier material and larger brackets.

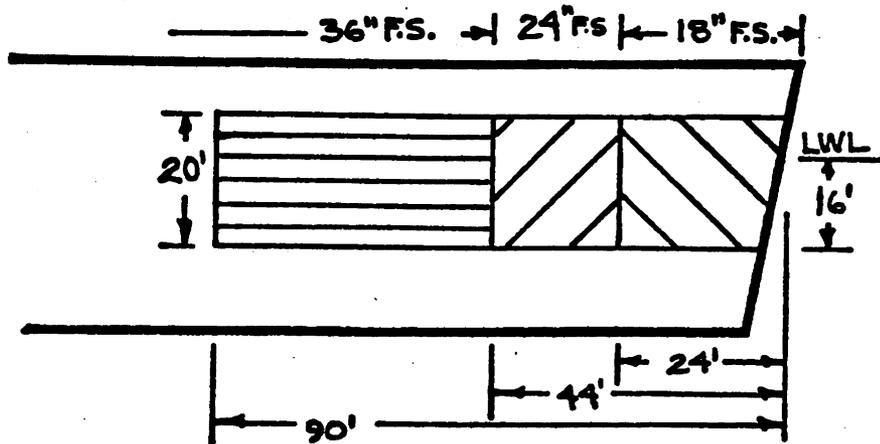
SHIP F

It is not certain whether this ship suffered ice damage or was ice strengthened in anticipation of winter operation. Original scantlings were not readily available and therefore, were estimated for the comparisons. For ice strengthening, 40.8 lb. mild steel plate replaced the assumed 22.95 lb. mild steel plate. The frames in areas #1, #2, and #3 were replaced with 15" x 5" x 1/2" F.P. The original frames were assumed to be 8" x 3-1/2" x 21.4# C-sections in area #1, and 10" x 3-1/2" x 28.3# C-sections in areas #2 and #3.

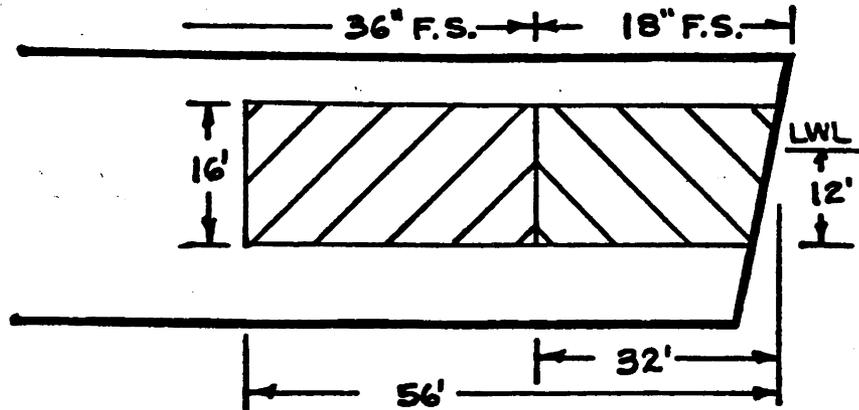
SHIP G

In preparation for winter operation two sister ships were ice strengthened as illustrated above. The shell plate was reinforced by the use of flat bars on edge running longitudinally and intercostal with the frames so as to reduce the vertical spacing of shell plate supports. No modifications were made to frames.

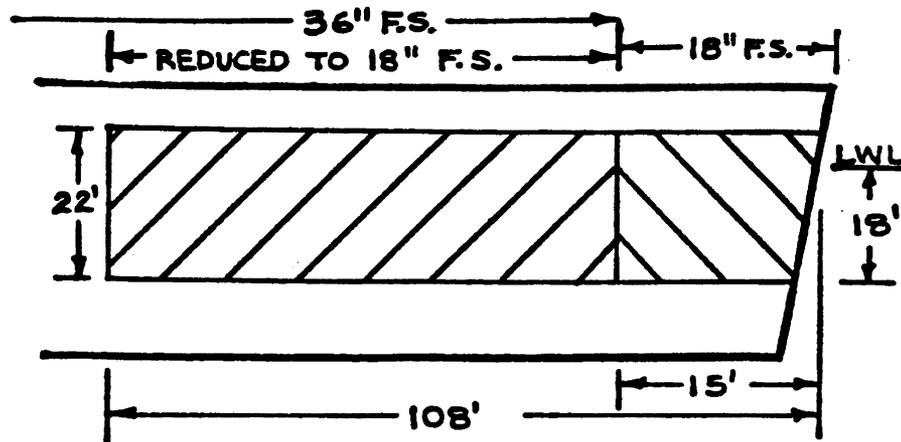
SHIP H

The forward part of this ship, area #1 above, had 28.05 lb. mild steel plate which suffered ice damage and was replaced with 100,000 psi yield stress material of the same scantling. The major portion of the ice strengthening modification took place in area #2 where plating and some frames had been ice damaged. In area #2 shell plating of mild steel was replaced with high yield stress material of the same, 28.05 lb. weight, and intermediate frames were added. Shell stringers were extended from area #1 through area #2.

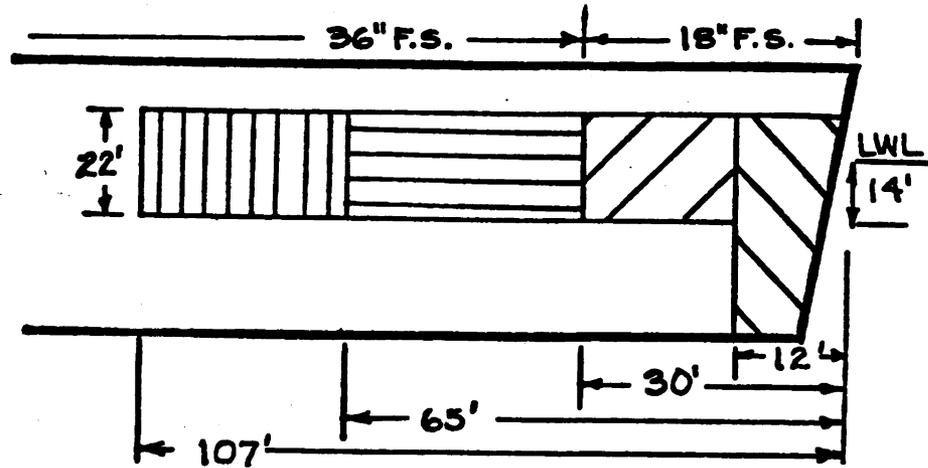
SHIP I

This ship incurred ice damages on several occasions and repairs were often made to local areas as required. Eventually ice strengthening was completed as illustrated above. The original 28.05 lb. mild steel plate was replaced with 100,000 psi yield stress plating of the same weight in all four areas. Stringers were extended into area #4. Stringers and breast hooks were reinforced in areas #1 and #2. The shell plating in area #1 was reinforced by the use of flat bars on edge intercostal with frames.

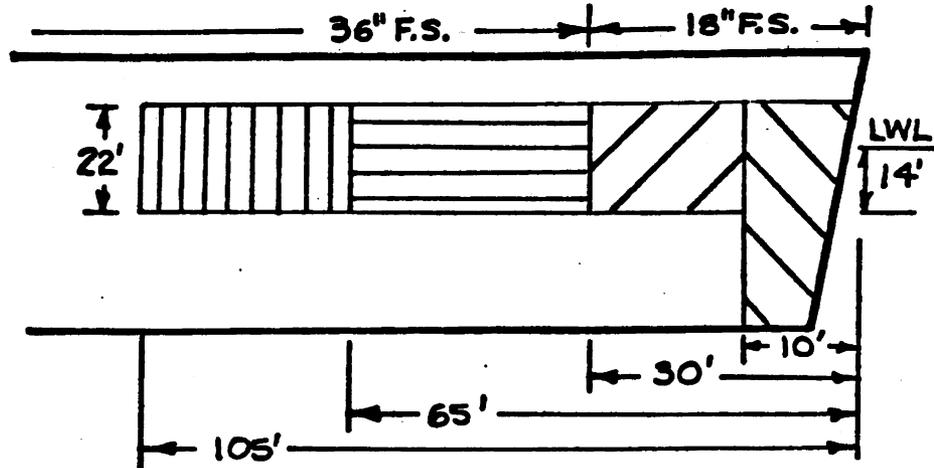
SHIP J

This ship had a record of ice damages and repairs similar to those of Ship I. Although the ice strengthening modifications varied in minor detail, the end result was essentially the same as for Ship I.
