A SPURIOUS PULSE PROBLEM IN A GAS FLOW PROPORTIONAL COUNTER

Daniel J. GRADY and J. Craig ROBERTSON *

Department of Nuclear Engineering, The University of Michigan, Ann Arbor, Michigan 48109, USA

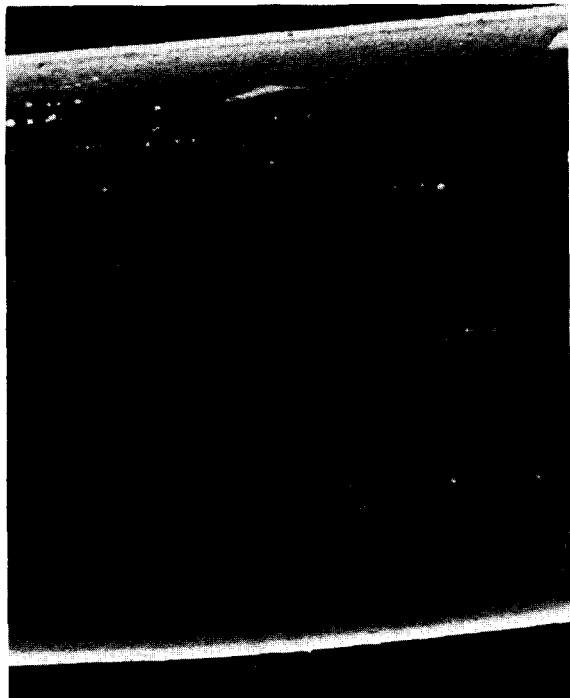
Anode wires which had been operated at 1950 V for one week, as well as a control sample of the wire, were examined with a scanning electron microscope (SEM). Fig. 1 is an electron micrograph of the control wire at a magnification of 760X. This wire, never used in the detector, was perfectly free from deposits of any sort.

Fig. 1. Electron micrograph of a control wire at 760X magnification shows no remarkable surface defects or deposits.

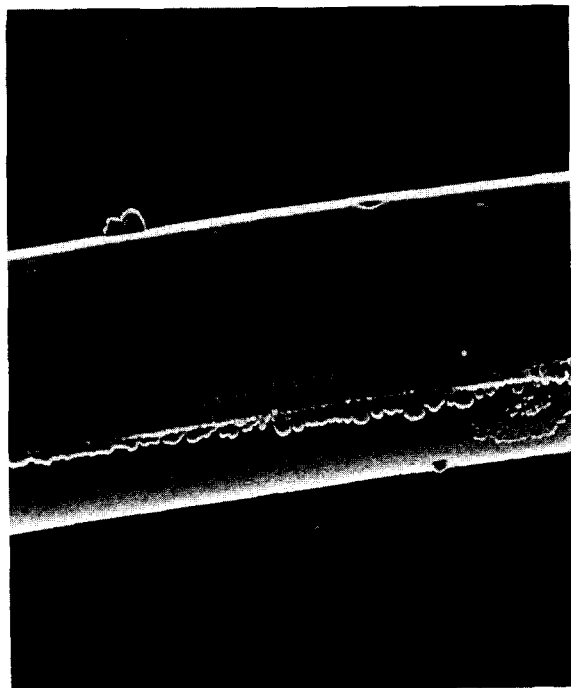
Quite the opposite is true of the wires used in the detector and exposed to the P-10 gas. The two micrographs in figs. 2 and 3 demonstrate the interaction of a component of the gas with a component of the anode wire (made of phosphor-bronze). The dendritic deposit on the wire in fig. 2 (380X magnification) appears to follow a die line from the drawing of the wire. This suggests that the growth of the deposits initiated at surface defects on the wire and supports the possibility that the interaction is chemical in nature.

Fig. 2. Electron micrograph of a portion of the anode exposed to the gas and operated at 1950 V for one week. Magnification of 380X shows dendritic deposit along axis of wire apparently along die line.

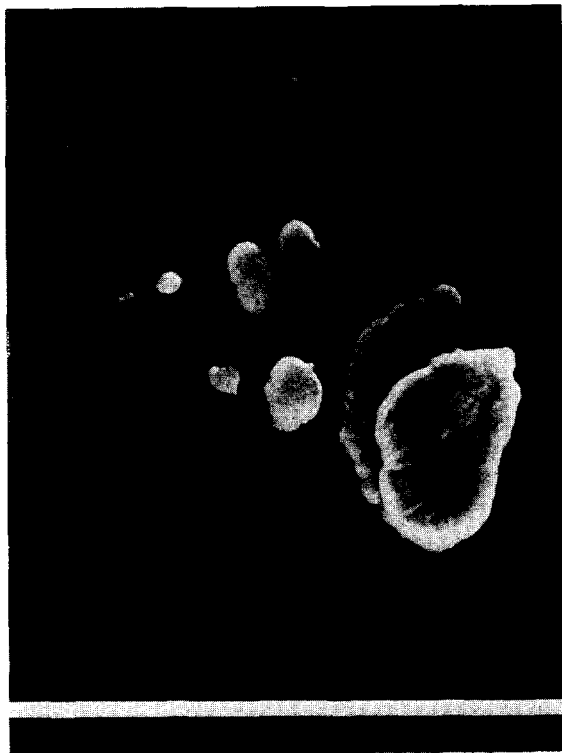
Figure 3 (1900X magnification) is a micrograph of the wire surface beneath a deposit which was inten-

Fig. 3. Electron micrograph of the wire surface beneath an intentionally removed portion of the deposit at 1900X magnification. The exaggerated die lines and the smooth, deep pit are characteristic of chemical attack on the wire surface.

tionally removed. Both the smooth pit and the deep, exaggerated die lines observed in this photograph are also characteristic of the results of chemical attack, further substantiating the chemical interaction theory.

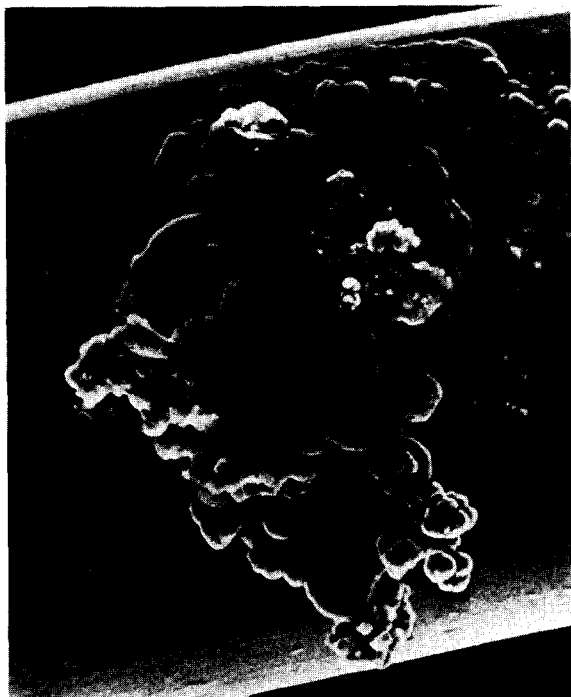
Fig. 4. Electron micrograph of a large deposit at 2000 \times magnification shows evidence of surface charging. Bright areas of the deposit are locations of electron buildup from the SEM beam. This phenomenon suggests that the spurious pulse mechanism may be like a shorting insulator.

on the CRT display of the SEM. This effect is common in non-conductive samples which accumulate electric charge from the electron beam. On the micrograph of fig. 4 (760 \times magnification) the effect is manifested by relatively bright spots on the photograph. This charging effect suggests a potential mechanism for the formation of the spurious pulses.

It is possible that the copper sulfide deposits act as insulators. Electrons produced by ionizing events in the detector and multiplied by the avalanche effect could accumulate on these deposits until enough charge existed to allow a short to the anode. The resulting pulse would depend upon factors such as deposit thickness and resistance, but the pulse could certainly be mistaken as a true signal pulse.
