UMTRI-83-3

Biomechanical Accident
Investigation Methodology

Final Report
February 1983

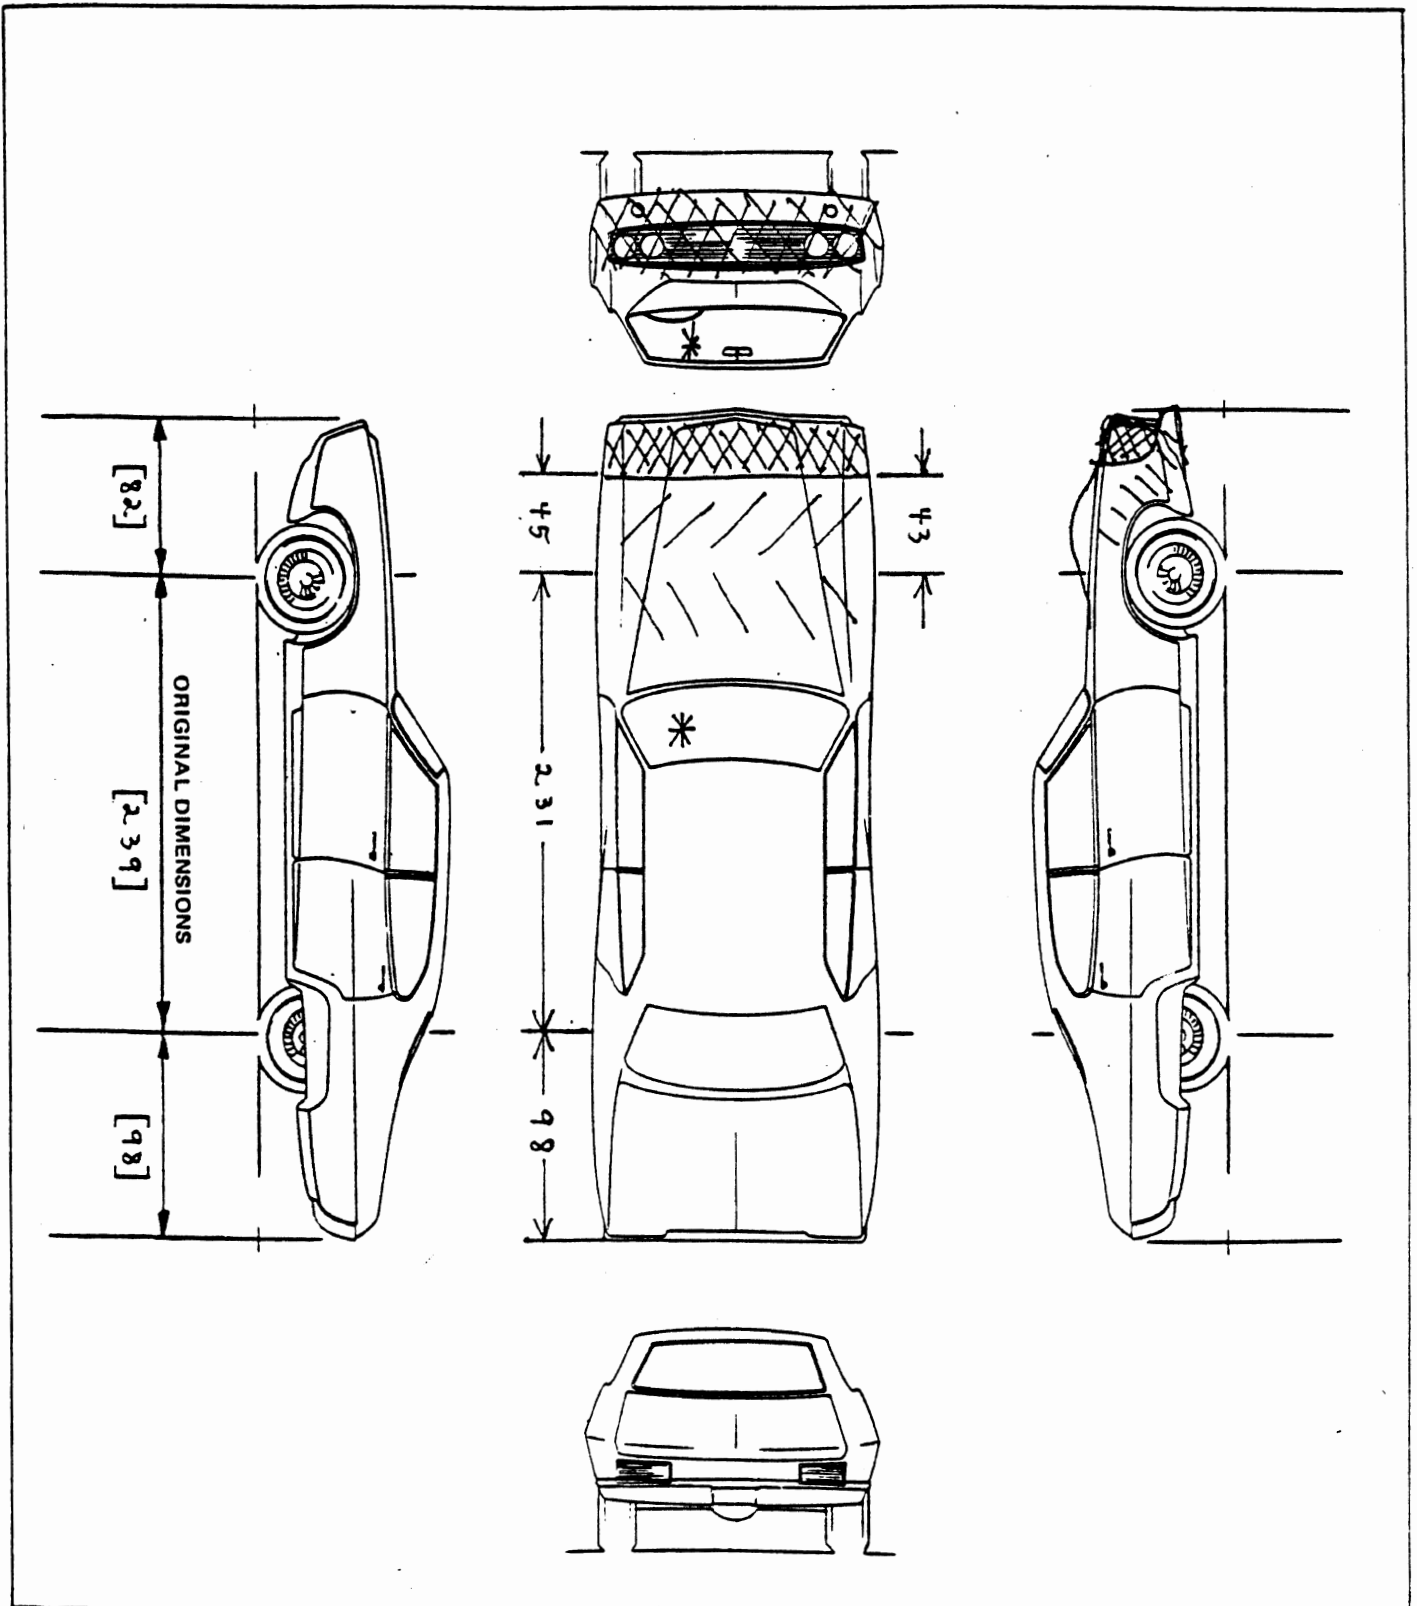
Figure 2. Vehicle Damage (Case No. 9).

In this case a 1981 Mercury Lynx driven by a 35 year old male was driving on a freeway when it struck the rear of a 1972 Chevrolet Nova which was stopped on the paved right shoulder of the roadway. Figure 1 is a schematic of the accident scene showing the square rear-end impact as well as the well-defined resting points of the vehicles. Figure 2 shows the damage to the front end of the Lynx.

Interior damage to the vehicle was moderate. Driver contact deformed the left sunvisor and contiguous windshield header. After the windshield was starred, continued head travel caused a jagged tear in the laminate of about 20 cm (7.87 in) and an outward bulge of 4 cm (1.57 in). Chest contact with the steering wheel caused it to fold around the hub and forward nearly to the instrument cluster eyebrow. The vehicle steering column was configured to include a V-joint flexible coupling and the right shear capsule was separated about 35 mm (1.38 in). Also, there was obvious upward rotation and lateral right movement of the column. Although they did not appear to be damaged, the driver may have had his left hand between the steering wheel rim and the two control levers on the left of the steering column or the left side of the instrument cluster eyebrow. The left end of the lower panel below the headlight switch was deformed by the driver's

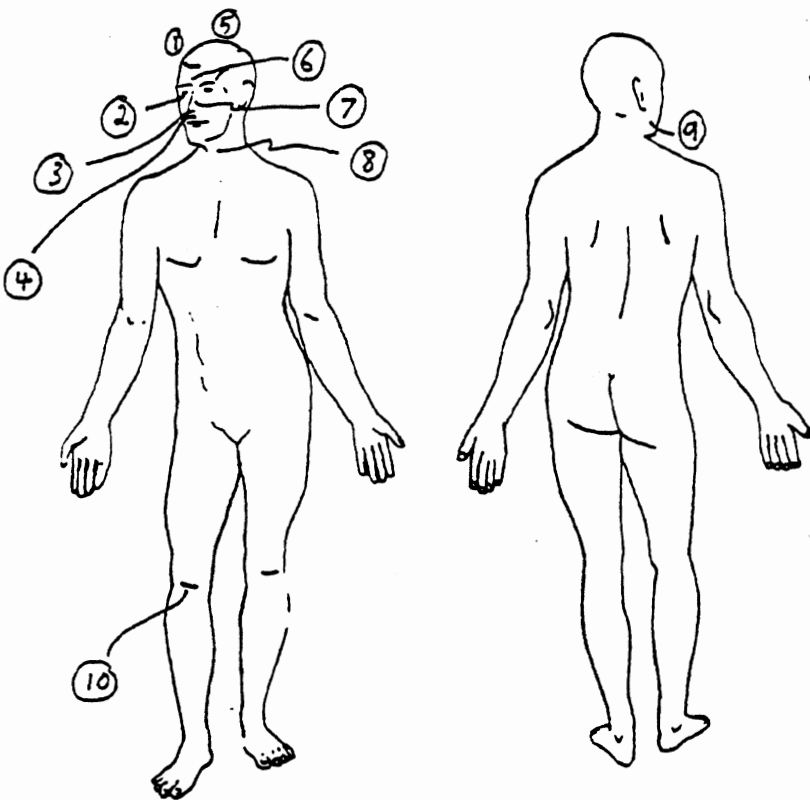
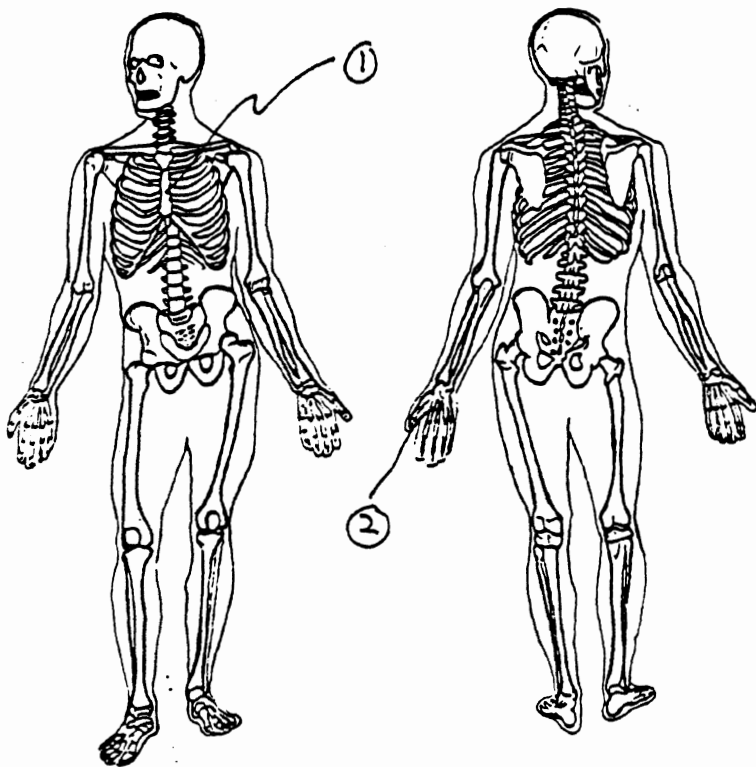
1. Abr. Rt. Forehead
2. Abr. Rt. Cornea
3. 2 cm. Lac. Rt. Nostril
4. 6 cm. Vert. T+T Lac. Rt. Upper Lip
5. Unconscious (2-3 min)
6. Abrs. Both Eyelids
7. Abr. Nose
8. Possible Fx. Larynx with pneumolarynx + hemorrhage Rt. Vocal Cord
9. Abr. Rt. Jaw
10. Cont. + Abr. Rt. Knee

- ① Cracked Sternum
- ② Comminuted Fxs. Proximal and mid portion 4th and 5th Lt. Metacarpals

This large, 35 year old male sustained significant head impacts against the header and windshield. The force levels of 1800-1900 lbs. associated with these impacts would not be expected to cause frontal bone skull fractures although they approach the lower limits of frontal fracture tolerance for flat impact surfaces. Similarly, the head accelerations associated with these two impacts are moderately severe (peaks near 120 G's). Additional head acceleration peaks around 80 G's are also present, and the entire head acceleration-time history (Figure 15) is characterized by significant time durations as well as acceleration magnitudes. This subject was concussed for 2-3 minutes.

The size and position of the subject and the vehicle interior geometry combined to produce a uniform contact of the chest squarely with the steering wheel. Although uniform, the loading was severe enough to fracture the sternum. The predicted load peak was approximately 2000 lbs. which is similar in magnitude to those produced by experimental studies on chest impact with cadavers. The chest accelerations associated with the impact were less than 50 G.

The contact of the subject's legs with the instrument panel produced an average force of 1300 lbs. in each femur and 1000 lbs. into each lower leg. This resulted in a total femur load of approximately 2300 lbs. in each leg as the lower leg force would be transmitted by shear to the upper leg. The lower leg load was close to tolerable values for knee joint ligamentous damage in cadavers. The subject was tall and had robust legs. Neither the average lower leg loads of 1000 lbs. nor the total femur loads of 2300 lbs. were likely near the tolerance of this subject.

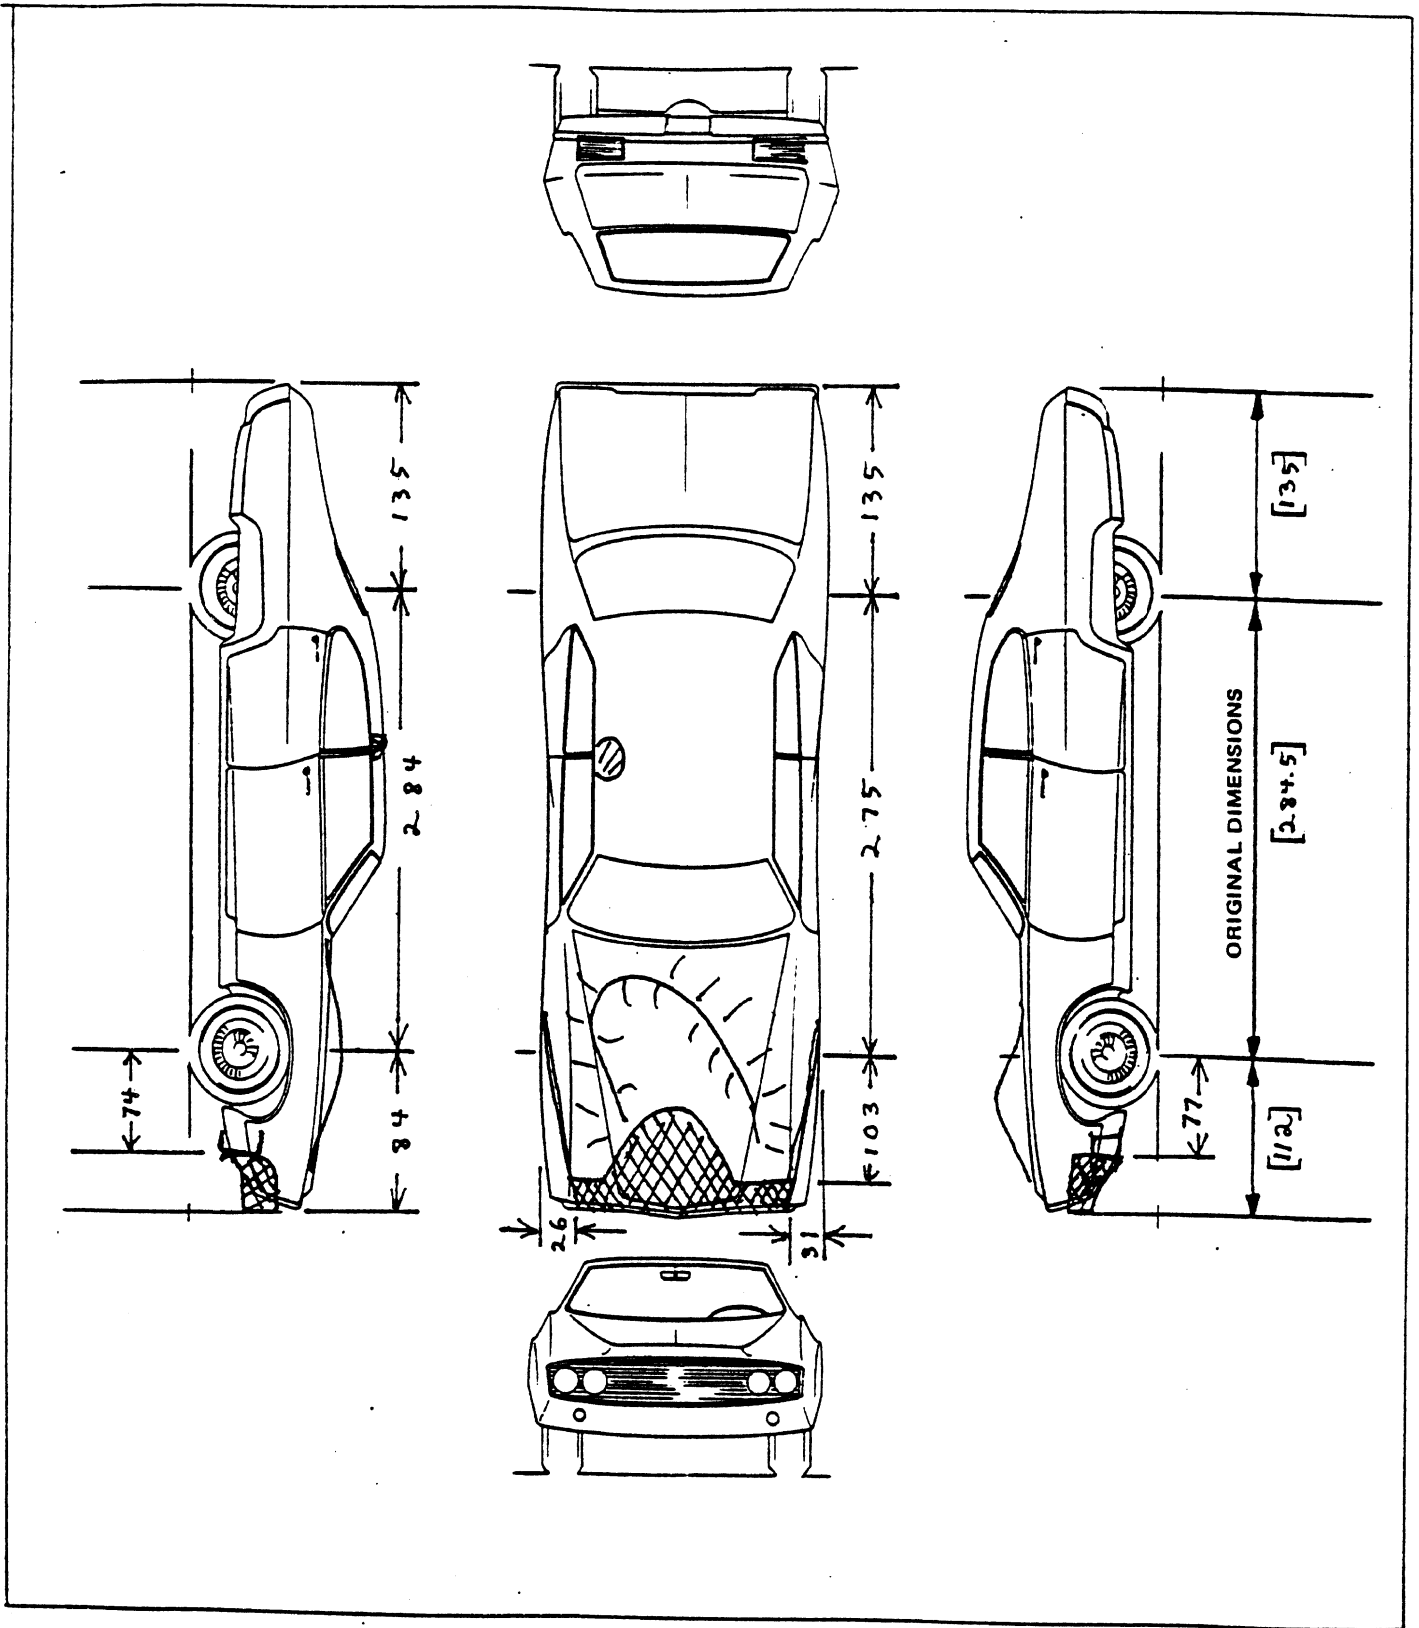
Figure 17. Vehicle Damage (Case No. 10).

In this case a 1977 Oldsmobile Cutlass S was forced off the roadway and struck a 56 cm diameter tree directly head-on. Frontal crush of the car was 93 cm. Figure 16 is a schematic of the accident showing the well-defined vehicle motions. Figure 17 shows the severe and almost perfectly symmetric damage sustained by the vehicle.

Interior damage to the vehicle was moderately heavy. The left sunvisor and header were damaged and the windshield was starred by the driver. The lower half of the steering wheel rim was severely bent and the spokes were slightly deformed. This caused the energy absorbing device to be compressed about 123 mm (4.84 in) and the shear capsules were separated. Upward force by the driver caused the steering column to rotate upward, but separation of the shear capsules necessitated its final state to be down. Driver contact broke the mid and lower panel areas to both the left and right of the column.

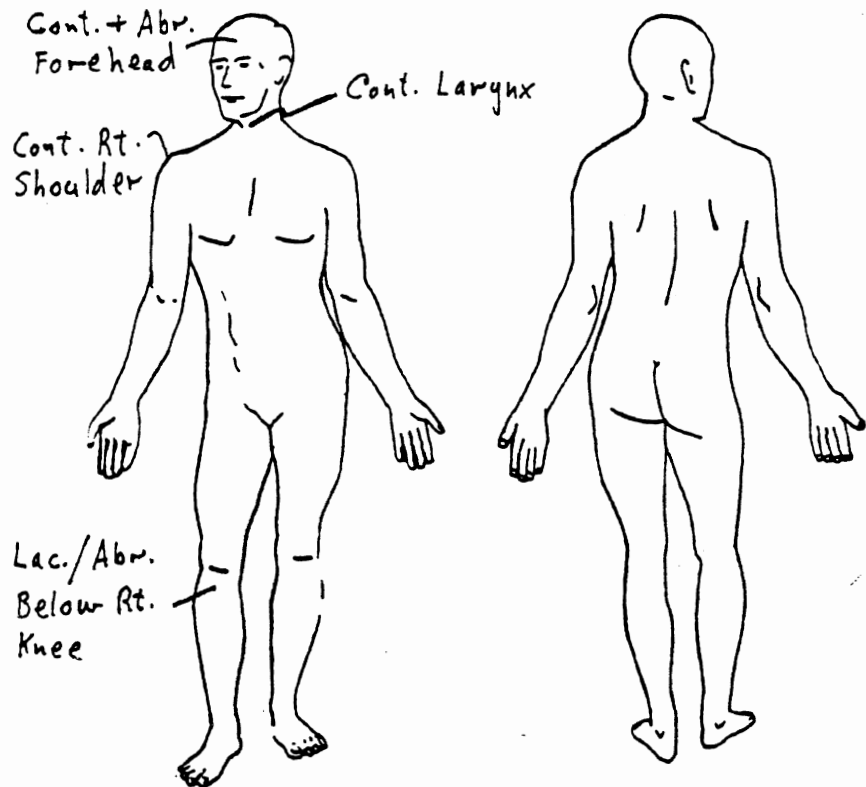
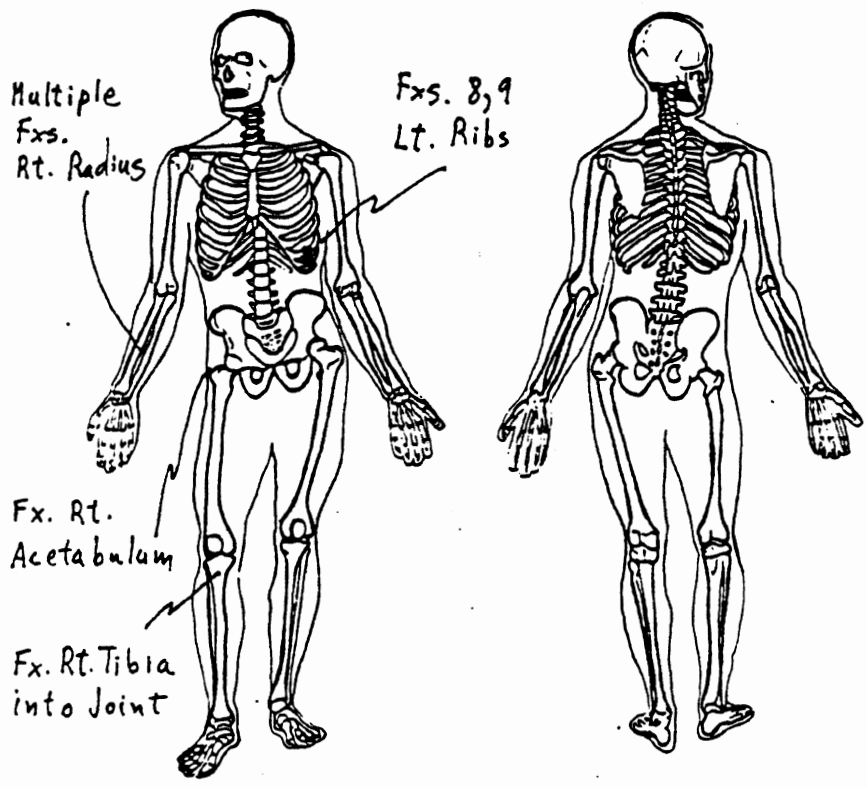
Figure 18. Occupant Injuries (Case No. 10).

Briefly Unconscious

This case involves a more severe frontal crash than in Case 9 (28.6 mph versus 22.9 mph) with an older, smaller male driver (50 years old) of a larger car. The contact of the head with the header was not as severe as the windshield contact, which produced a peak of 1600 lbs.--well below frontal bone fracture tolerance. The head acceleration associated with the windshield contact was higher than that of Case 9 (150 G peak) but with a lesser duration. Similar longer duration acceleration peaks around 80 G occurred late in both crashes. The subject was only briefly unconscious.

The contact of the subject's chest with the steering wheel was not as uniform or aligned as in Case 9 due to configurational differences in the vehicle interior and the subject positioning. A peak chest load of 1200 lbs. was produced. The fractures of the 8th and 9th ribs on the left side may have been due to the interaction of the bottom half of the steering wheel as shown in Figure 21. The age of the subject may also have had an influence on the production of skeletal damage at the lower load of 1200 lbs. Despite the lower load, the peak chest accelerations were slightly higher (55 G) than in Case 9.

The average femur contact force was 1550 lb. on each leg. The average tibial force was 900 lb. per leg and the total average femur load would be 2450 lb. per leg. The deformation of the instrument panel due to knee contact was greater on the left side and may have contributed to more of the load being carried by the right leg. The fracture of the right tibia occurred with a predicted load of at least 900 lbs. Both the age and the lesser lower leg development of their subject may have also influenced the initiation of this fracture at loads successfully sustained in Case 9. The subject also sustained a fracture of the right acetabulum, again at a load of at least 2450 lbs. but most likely greater than that. Both of these

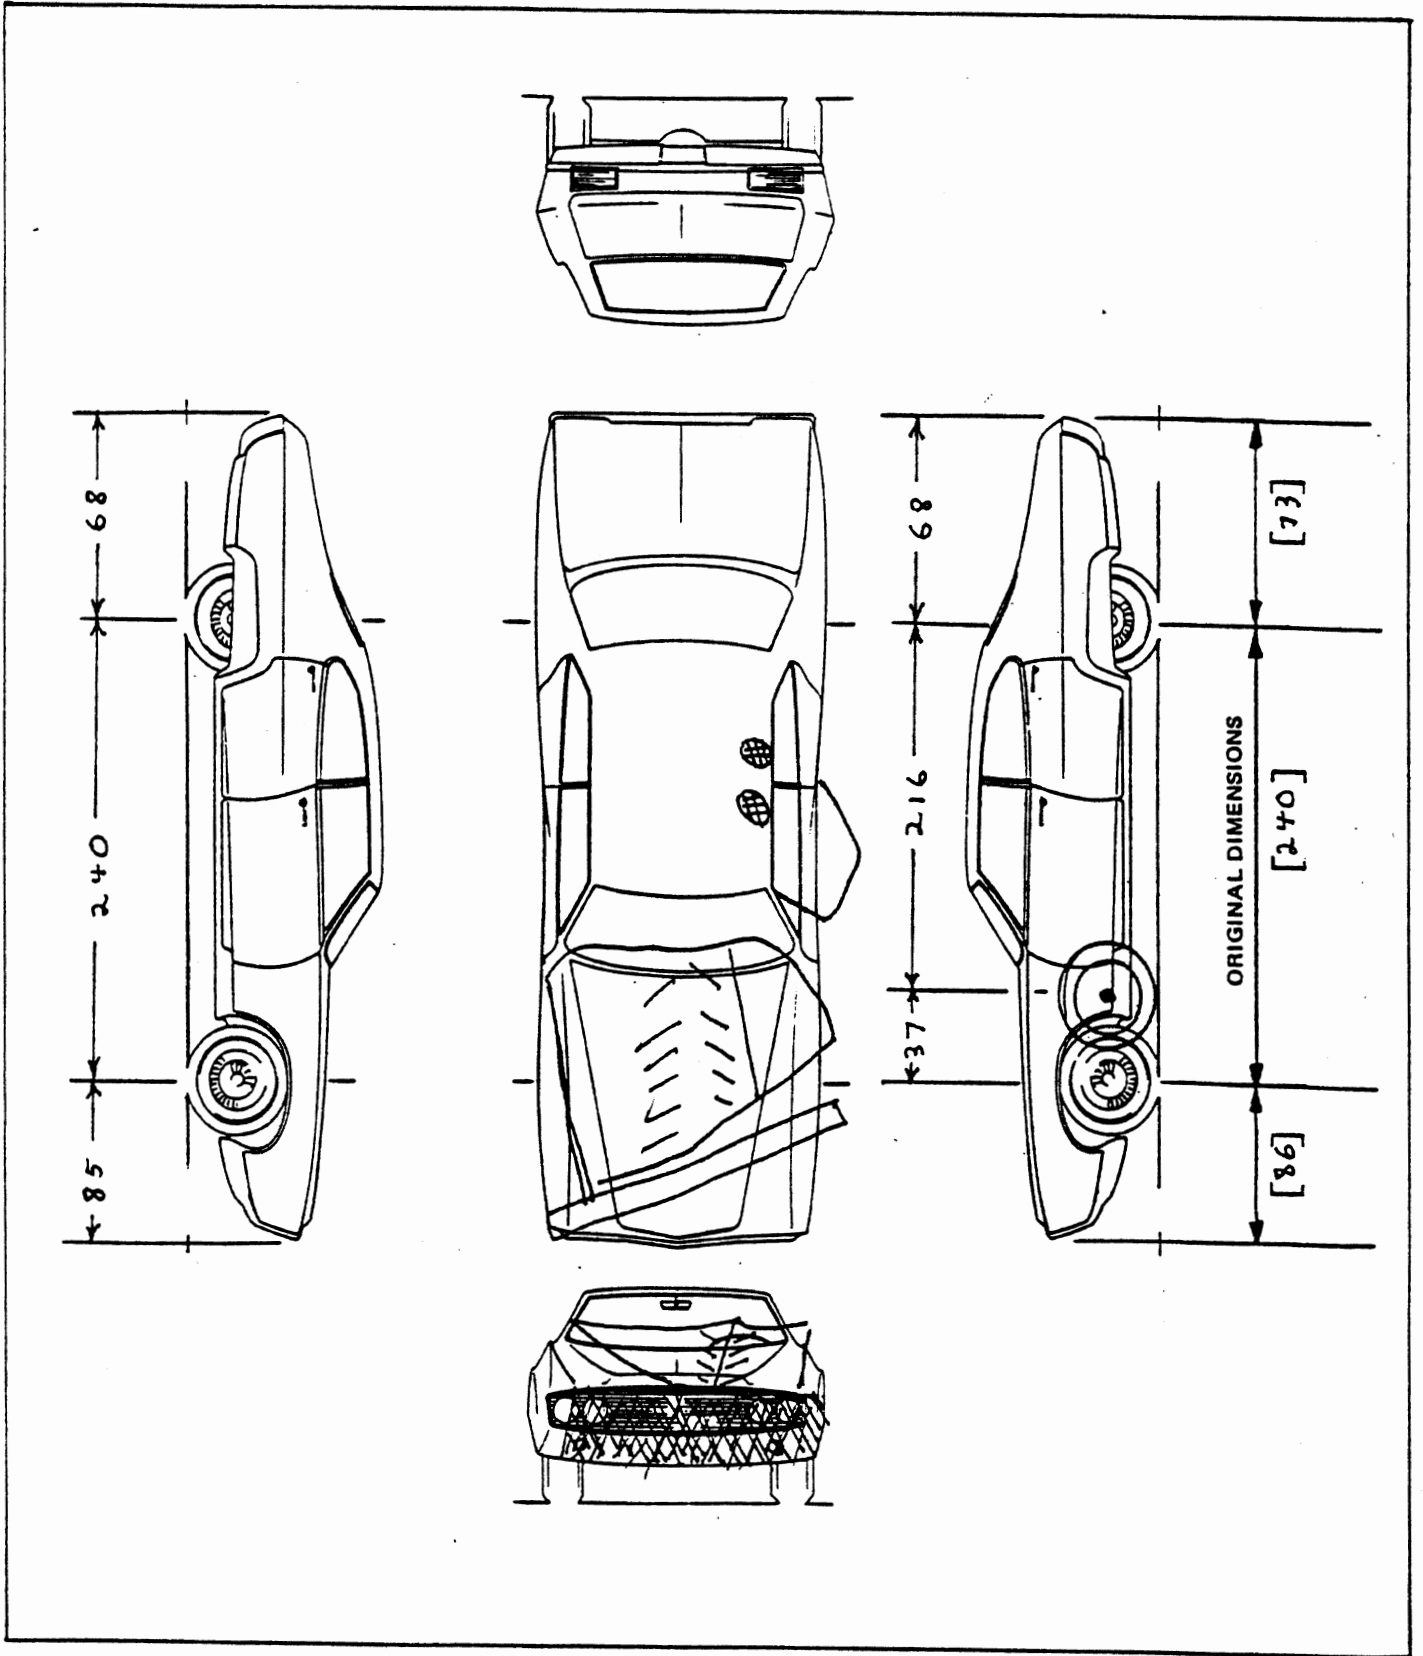
Figure 29. Vehicle Damage (Case No. 13).

In this case a 1980 Volkswagen Rabbit was driving on a two-lane road. A Chevrolet Blazer crossed the centerline on an icy turn. The impact energy transfer was nearly "head-on" for the Rabbit. Figure 28 is a schematic of the accident scene. Figure 29 shows the damage to the vehicle.

The fairly extensive damage to the vehicle interior was concentrated in the left front corner of the passenger compartment. The left end of the instrument panel was partially separated from the deformed left A-pillar. The steering wheel rim was slightly deformed from the driver apparently bracing his hands against it. There was some evidence of steering column movement to the left and slightly upward. The interior of the left door was deformed and the glass broken out due to impact but it is unknown if there was contact by the driver. There was intrusion of the instrument

panel which forced the knee bolster back toward the driver's knees. The floorpan was buckled and the driver's seat adjuster deformed. The instrument panel around the instrument cluster was damaged and the damaged rear-view mirror was dislodged from the severely crazed windshield, but it is unknown if there was any occupant contact.

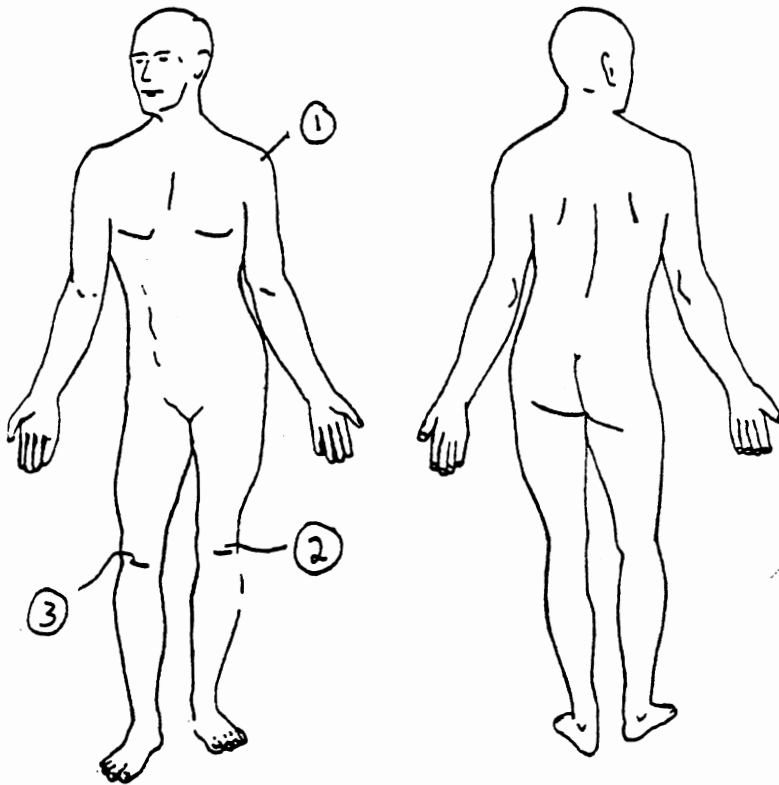
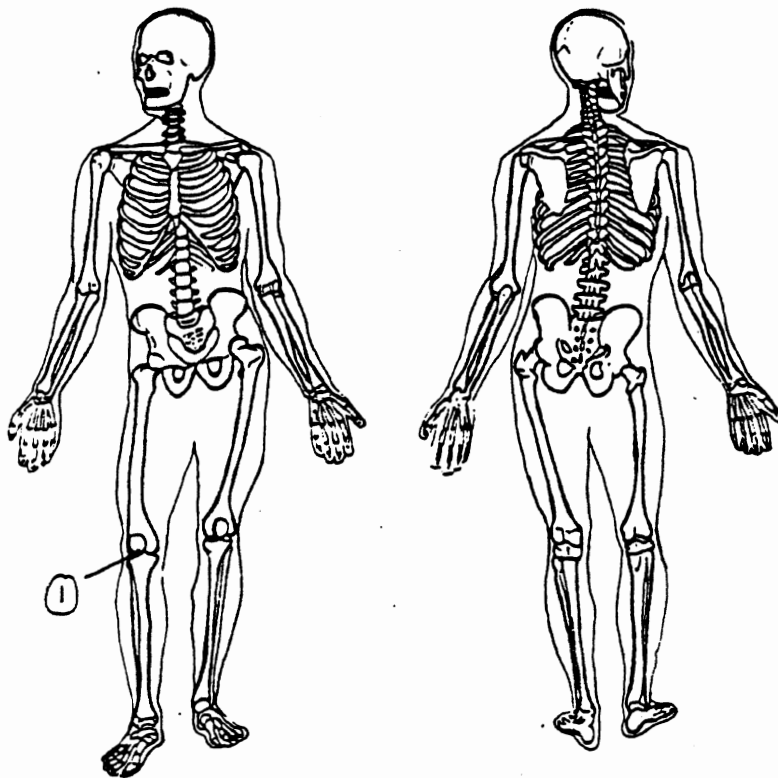
1. Cont. Left Shoulder
2. Partial tear. Lt. Posterior Cruciate Ligament
3. Tear, Rt. Anterior Cruciate Ligament

1. Split Fx. Rt. Tibial Plateau, Crushing Lateral Plateau, Avulsion Tibial Spine

The upper torso belt loads reach 2600 lbs. during the crash without skeletal damage. This value is significantly greater than cadaver based limits for rib fracture due to belt loading.

The subject's lower leg geometry produced significant loading to the lower legs by contact with the knee bolster. The peak average force acting on each tibia was 2100 lbs., well above the level for ligamentous damage to cadaver knee joints. Both knee joints received ligament damage with the right tibial plateau sustaining a split fracture at these high load levels.

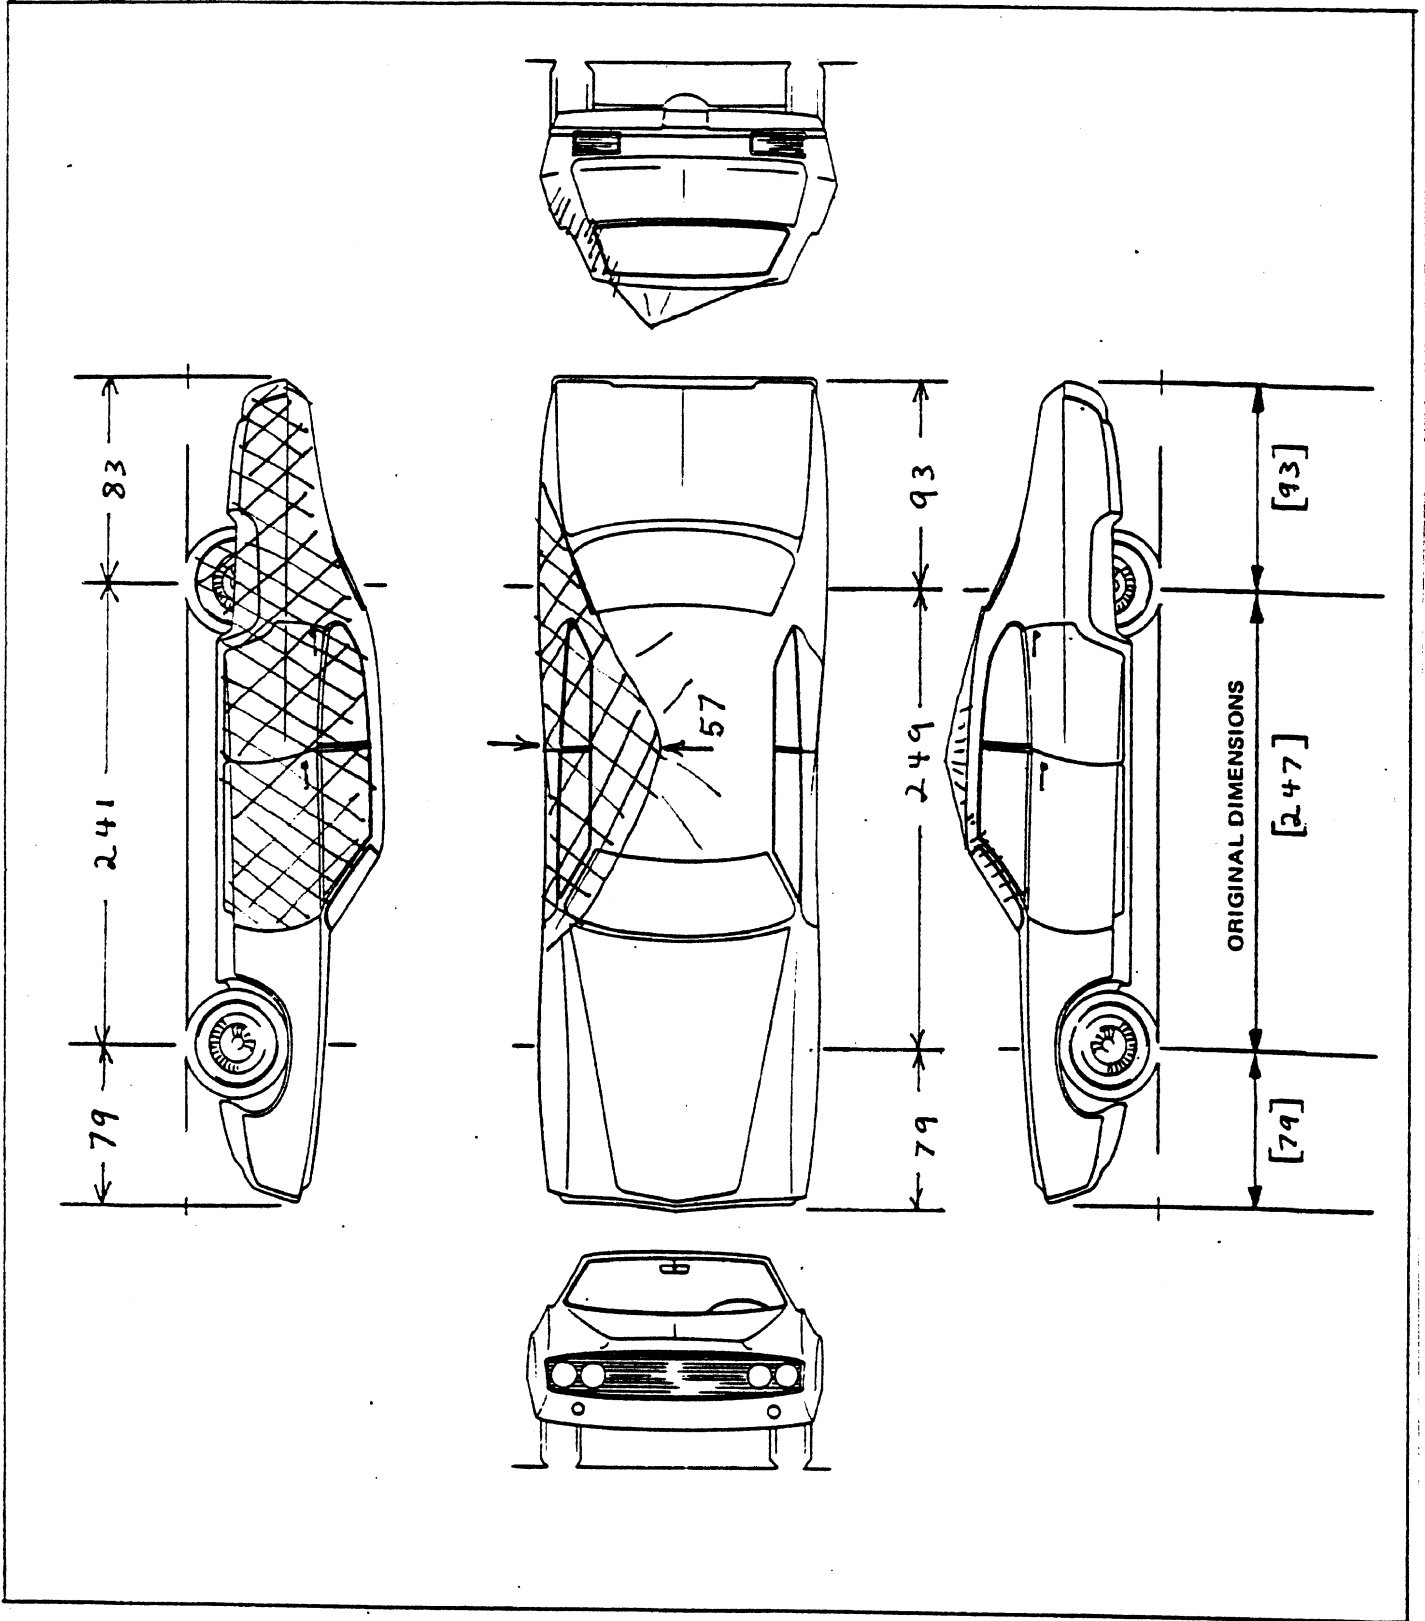
Figure 41. Vehicle Damage. (Case No. 14).

In this case a 1980 Chevrolet Chevette was struck in the side by a C/20 Chevy Van. Intrusion was extensive on the passenger's side. The female driver of the Chevette was wearing a lap-shoulder belt and sustained minimal injuries. A schematic of the accident scene is shown in Figure 40. Damage to the Chevette is shown in Figure 41. Although there was a spin by the subject vehicle, it appeared that the primary force vector was

Damage was extensive to the right side of the passenger compartment. The floor-mounted T-bar shift lever was bent to the right by the driver causing its plastic housing to crack. Deformation of the right upper A-pillar crazed the right half of the windshield, deformed the header, bowed the right sunvisor and deformed the roof in the front right corner. The front right door intruded about 41 cm (16.14 in) damaging its latch housing and the front right seat cushion and seat adjuster. Its window sill was also contacted by the driver. The right B-pillar intruded about 46 cm (18.11 in) damaging the front right seat back and causing it to bend to the left behind the driver's seat back. Intrusion of the right roof side rail deformed the roof.

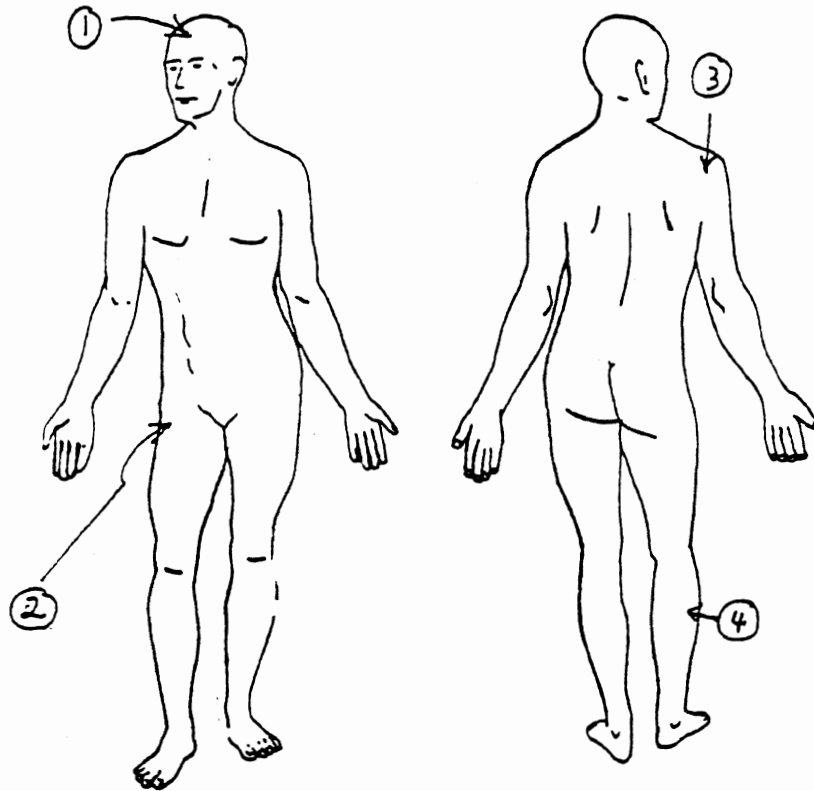
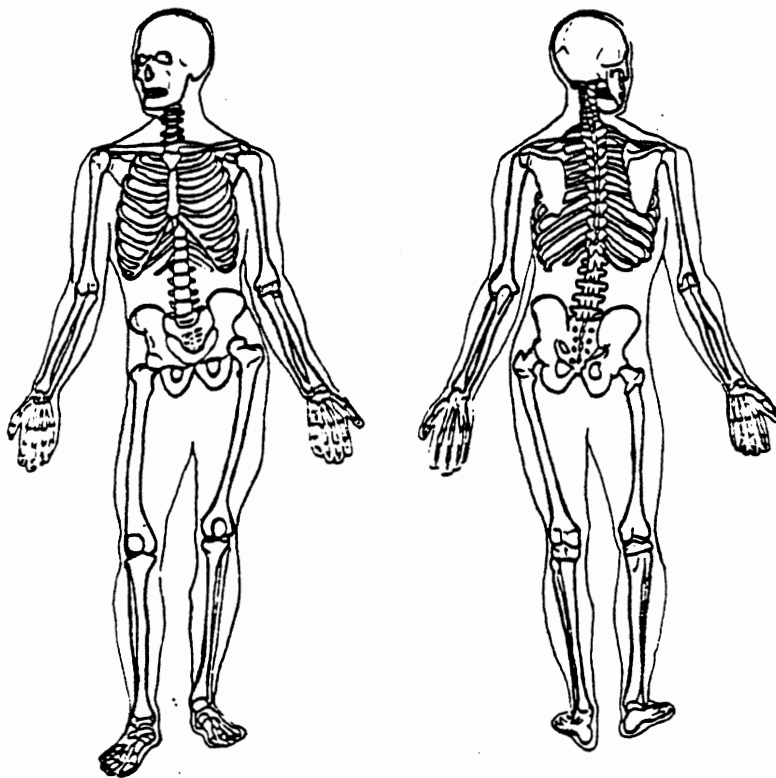
Figure 42. Occupant Injuries (Case No. 14).

1. Lac. Rt. Frontal Scalp
2. Cont. Rt. Proximal Anterior and Medial Thigh
3. Lac. Posterior Rt. Shoulder.
4. Cont. Rt. Calf

This was a severe far-side impact involving a female driver restrained by a three-point belt system. The intrusion of the right side of the vehicle provided a significant head contact point which produced an abrupt 1350 lb. peak force to the head. The contact resulted in a laceration to the right frontal scalp of the subject. The load peak was well below skull fracture tolerance for a flat surface impact to the frontal bone. The lateral head accelerations were low except for the abrupt contact spike with a peak of 140 G. The vertical head accelerations were equally as high but with much greater duration during this contact. The subject was not concussed.
