AIAA-2004-34309

An Evaluation of the Discharge Chamber of the 30,000 Hr Life Test of the Deep Space 1 Flight Spare Ion Engine

This paper summarizes the results of a post-test evaluation of the discharge chamber of an extended life test of the DS1 spare flight ion thruster (FT2). In particular, results are presented on the discharge chamber magnetic field measurements, films and film deposits, and the high voltage main isolator.

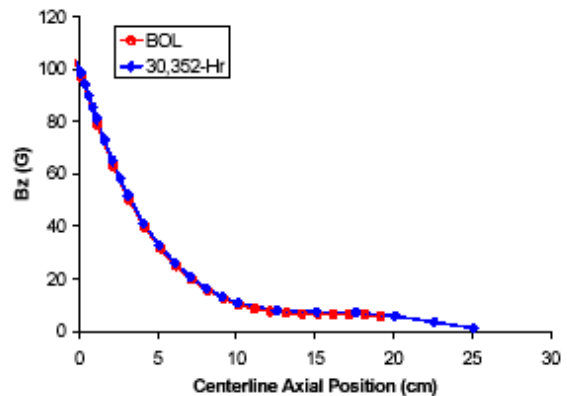
Figure 4 is a plot of the centerline magnetic field strength at BOL and after 30,352 hours of operation. BOL data from Reference 17 taken at GRC were used as a baseline to identify any changes over the test. Centerline “zero” is defined as the center of the keeper electrode. The data indicate that there was no measurable degradation in the internal discharge chamber magnetic circuit throughout the interior of the discharge chamber, which corresponds to the absence of change in the discharge performance from BOL.

Figure 4. Comparison of magnetic field along the thruster axis for BOL and end of test.

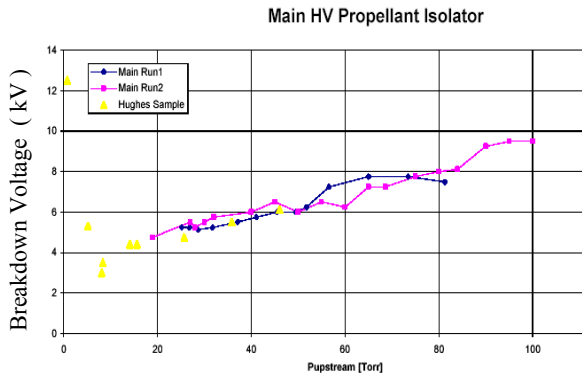
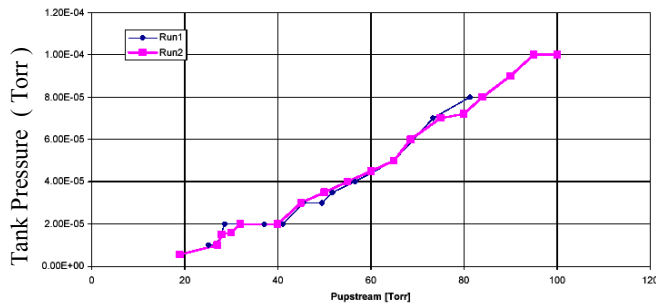
representative of the full flow rate throttle range, was investigated. Comparison of the 30,000-hr isolator and an unused control isolator of the same design indicated virtually identical breakdown performance over the full range of pressures. The data are shown in Figures 5-6.

Figure 5. Main HV Propellant Isolator data from the ELT.

Figure 6. Main HV Propellant Isolator data from the ELT.

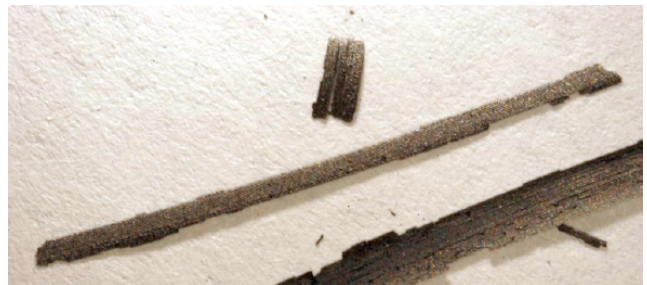
Films collected off of external surfaces such as the front mask were collected and film thicknesses were measured. Films such as those shown in Figure 8 from the front mask were up to approximately 50 microns in thickness and consisted mostly of carbon, likely sputtered from the graphite beam target at the back of the vacuum chamber. A list of samples and from where they were collected is shown in Table 1.

Figure 8. Carbon deposit collected from the downstream face of the thruster front mask.

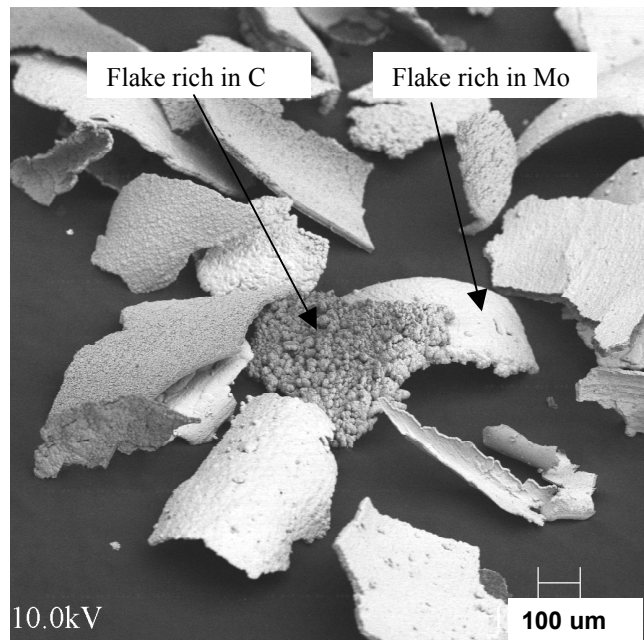
An SEM of a typical set of flakes collected from the bottom of the discharge chamber is shown in Figure 9. In this particular sample the dark grainy surface of the flake in the center of the SEM is rich in carbon, as determined by energy dispersive spectroscopy (EDS) analysis which determines qualitatively the elemental content of the sample within a few tens of angstroms of the surface, but the lighter colored pieces located next to it are rich in molybdenum (again determined via analysis). From visual inspection and EDS analysis it appears that most flakes are a mixture of mostly carbon and molybdenum.

The majority (>60%) of the flakes were less than 0.1 mm in length, although a few large flakes (less than 1%) were on the order of 1mm in length. SEM analysis of the less than 0.1 mm long cross-sectioned flakes revealed multiple layers of molybdenum and carbon. The atomic composition of the flakes ranged from 40 to 70% carbon, and 1-30% molybdenum, with trace amounts of tantalum and stainless steel depending upon the location where the flake was collected.

The source of molybdenum was likely sputter erosion of the discharge side of the screen grid, and the discharge keeper electrode plate. Some samples had substantial tantalum content that may have been

sputtered from the tantalum keeper tube and discharge cathode heater (Reference 12). Chrome and iron may have come from the stainless-steel sputter containment mesh and the test facility. Although the flakes were multi-compositional, the majority were in the greater than 70% carbon composition range, suggesting the flakes are a facility induced effect, and would not have formed if the engine were operated in space (Reference 12). Carbon deposition found to be on many of the thruster's interior and exterior surfaces is a direct result of re-deposition of sputter eroded carbon atoms from the graphite panels that line the chamber. A crude total mass estimate of the flakes found on the bottom of the discharge chamber is 21 mg +/- 5 mg, neglecting samples collected using Teflon tape. A detailed analysis of some of the flakes collected from the discharge chamber is presented in Reference 18.

Figure 9. Flakes collected from the discharge

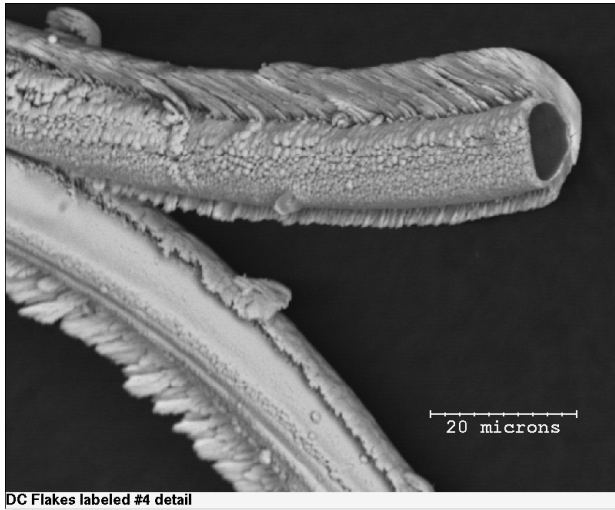
Few of the samples collected were of sufficient size to bridge the gap between the screen and accel grids. However, a few samples collected from the discharge chamber appeared as long thin tubes, as shown in Figure 10. EDS analysis indicates that these samples are molybdenum-coated fiberglass fibers, likely from the insulation used in the internal wiring of the thruster (but used external to the discharge chamber). Fibers that slough off the thruster wiring and wind up in the discharge chamber could become sputter-coated with sufficient molybdenum over time, spall and if of sufficient size

to bridge the gap between the screen and accel grids could cause a screen/accel grid short. Future missions may have to re-evaluate use of this type of wiring insulation.

Figure 10. Molybdenum-coated fiberglass strands found in the ELT discharge chamber.

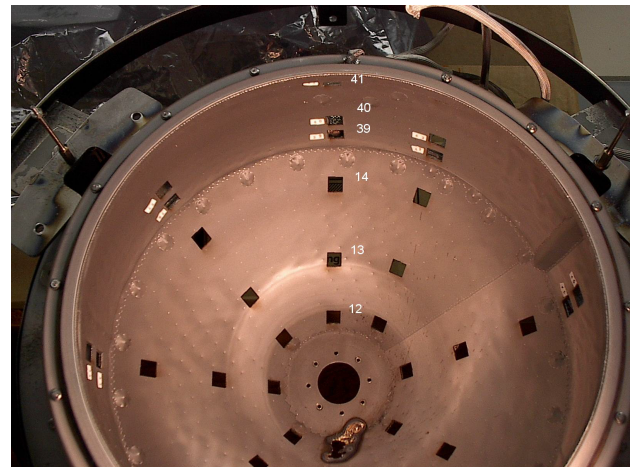
using backscatter x-ray or EDS analysis. Then the samples were epoxied, polished and viewed in the SEM to determine film properties and thickness. A photograph of the discharge chamber with samples removed is shown in Figure 12. The damaged area near the bottom of the photograph is damage caused by improper laser cutting at that location.

Figure 12. Photograph showing discharge chamber after samples were removed via laser-cutting.

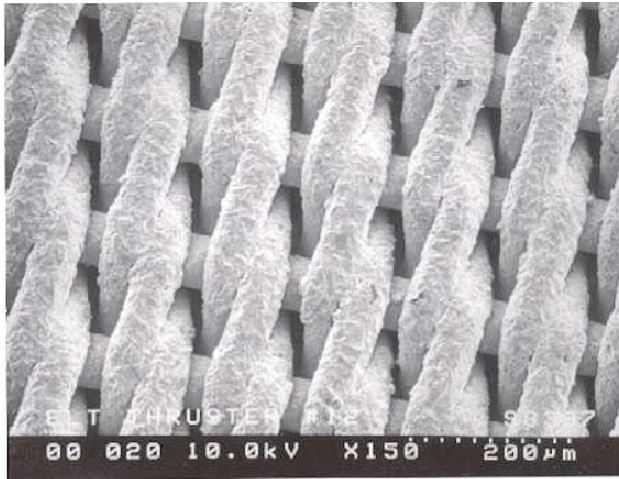
thickness and composition as a function of distance from the screen grid electrode. SEM analysis indicates the deposits are 5 microns thick near the cathode (samples 9 and 12) and 10 microns thick near the screen grid (samples 38 and 41). A list of sample locations and film thicknesses for a row of holes (Figure 12) is shown in Table 2.

Figure 13. Sample #12 nearest cathode magnet ring.

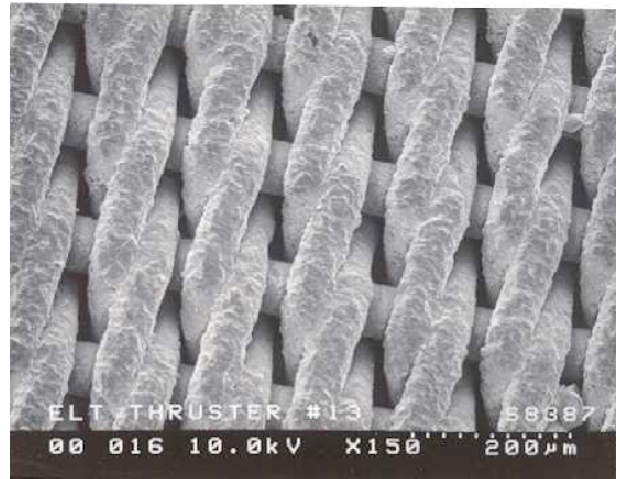
Figure 14. Sample #13 in the conical section of the discharge chamber.

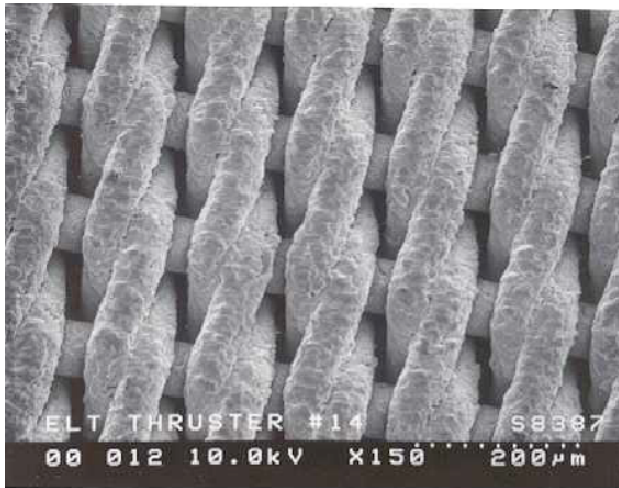
Figure 15. Sample #14 near the cone/cylindrical

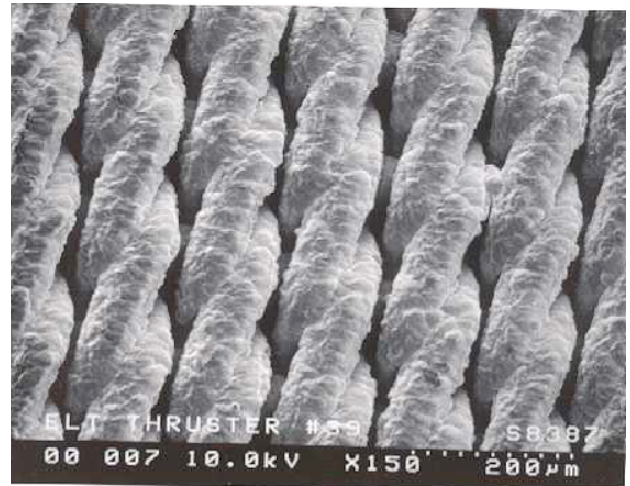
Figure 16. Sample #39 nearest mid-magnet ring.

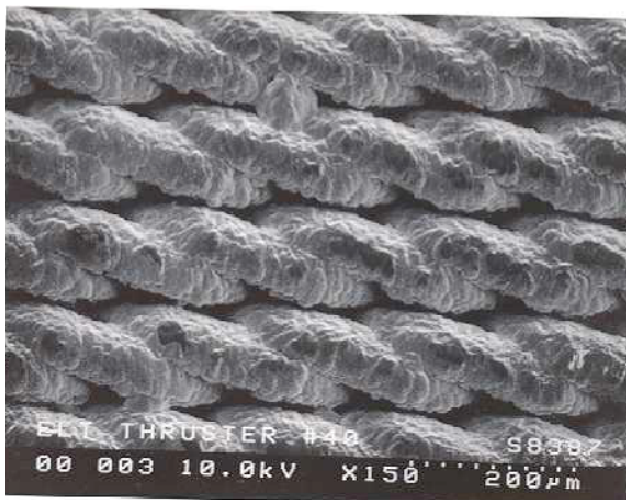
Figure 17. Sample #40, midway in the cylindrical portion of the discharge chamber.

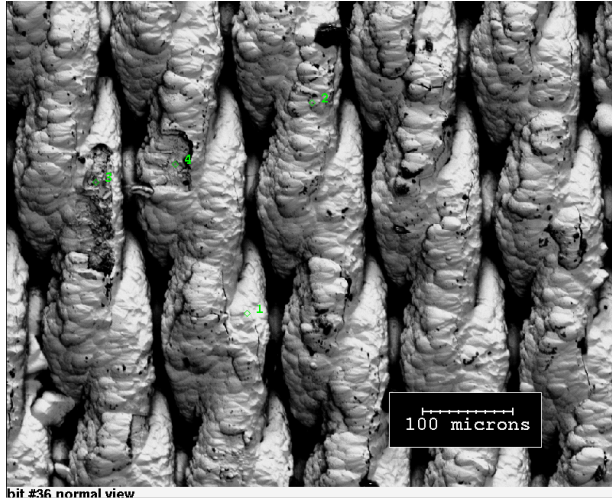
bit #36 normal view

Photographs of adhered films are shown in Figures 13-18. The films appear to have adhered very well to the mesh in all locations except where flake samples were removed from the discharge chamber (Figures 19-20). SEM photographs indicate that only samples #36, 37 and 38, which were taken from the cylindrical portion of the discharge chamber where flakes were collected, had spalled films. It is likely that at these locations the films were spalled from handling.

Figure 19. Sample #37 SEM indicates that films have spalled from the mesh. This sample was taken midway in the cylindrical portion of the discharge chamber.

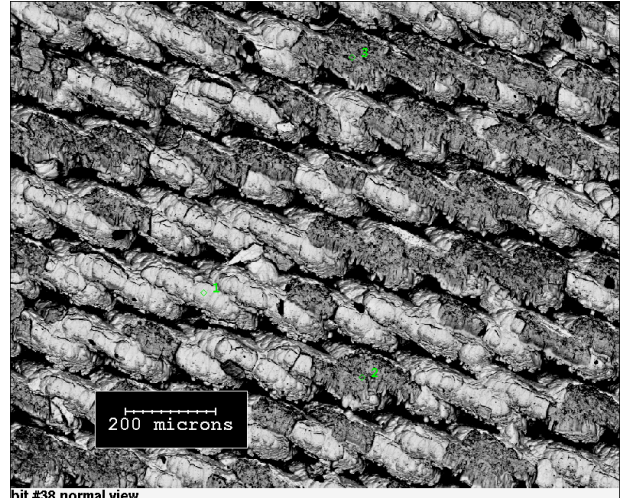
bit #38 normal view

Figure 20. Sample #38 SEM indicates that films have spalled from the mesh. Sample was located nearest the screen grid.

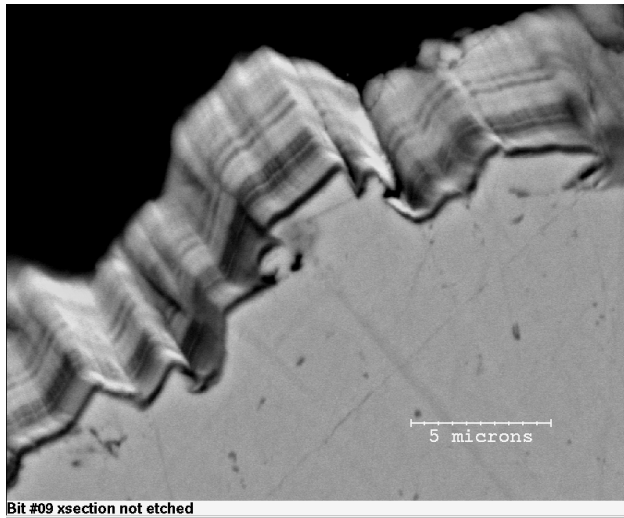
Bit #09 xsection not etched

Figure 21. Film layer seen edge on from sample #9, taken from an area nearest the cathode.

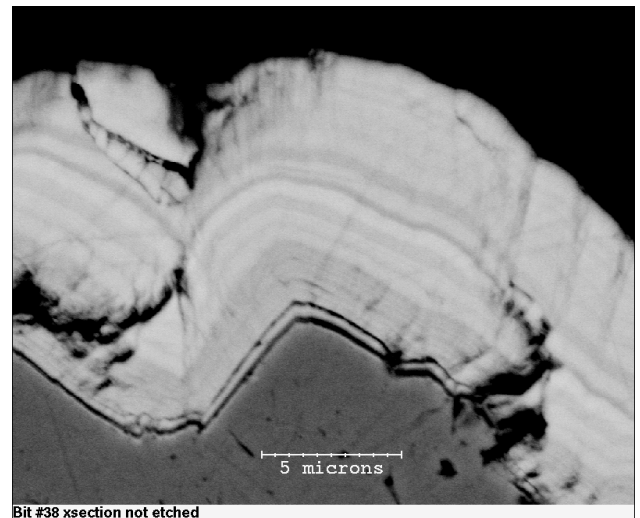
Bit #38 xsection not etched

Figure 22. Film layer from sample #38, which was located closest to the screen grid.
