Report to the Atomic Energy Commission
Concerning the Deformation
of the Ford Nuclear Reactor
Shim-Safety Rods

DEFORMATION OF THE FORD NUCLEAR REACTOR

SHIM-SAFETY RODS

December 1960

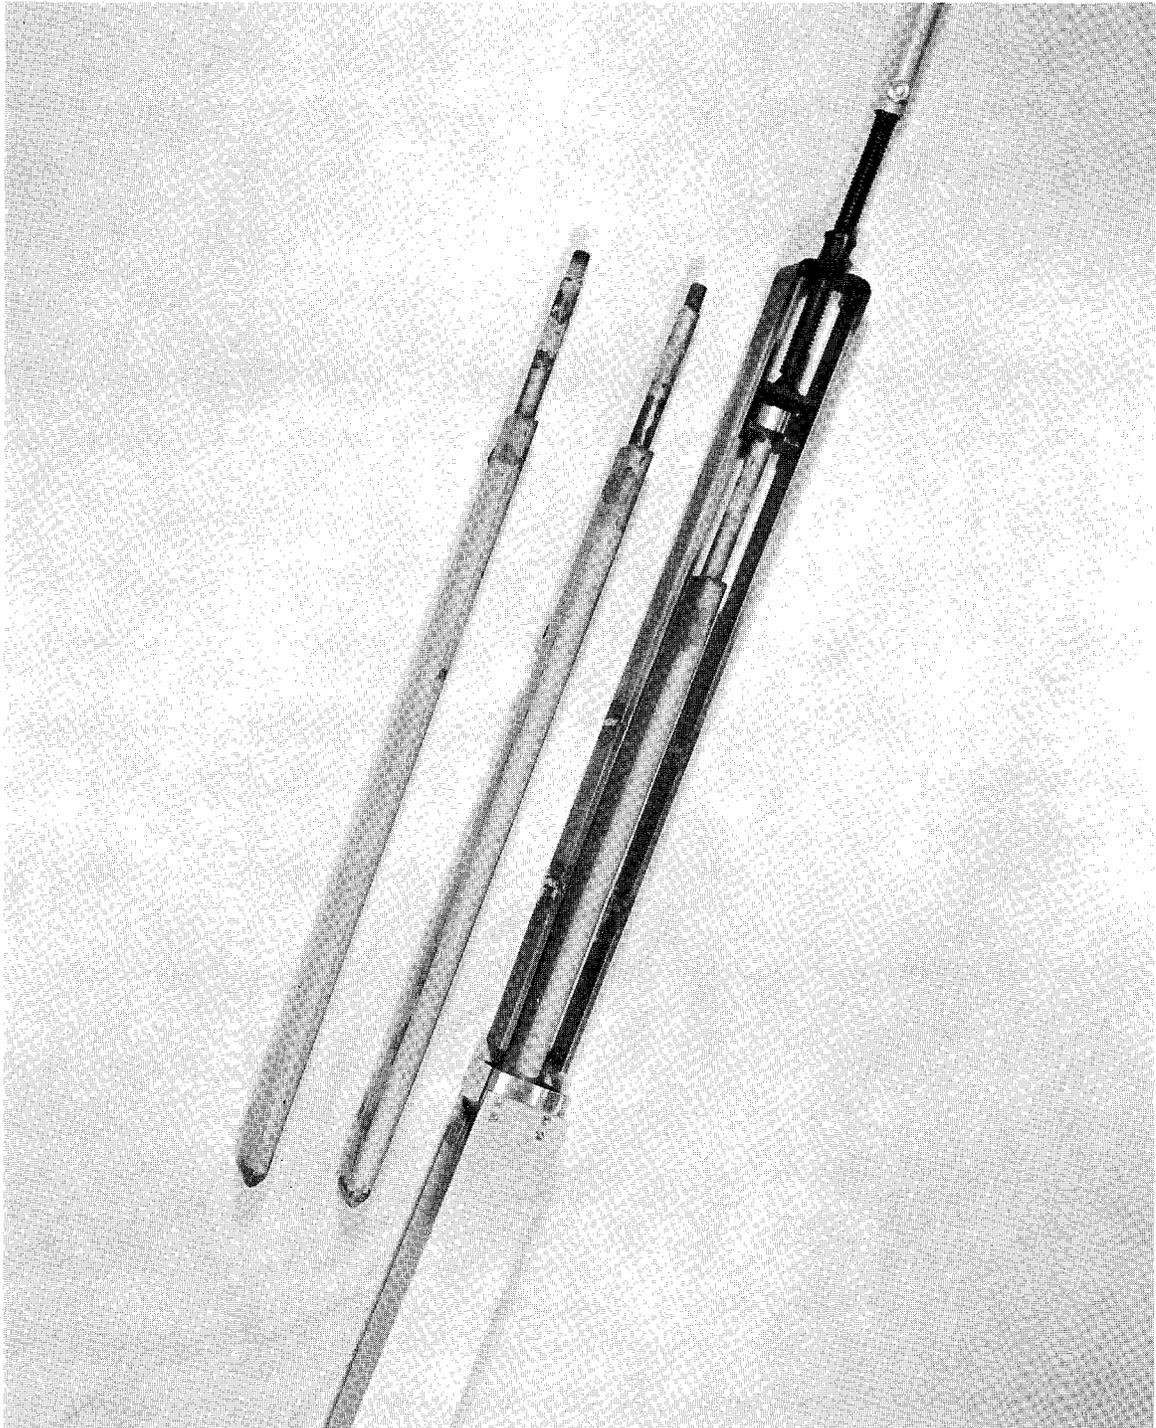
PLATE I - REMOVAL DEVICE

The reactor was further secured and fuel was removed from the lattice along with the special control element containing safety rod 1-A. The rod-element assembly was moved to a holder in the center of the reactor pool. A grappling tool pulled the rod about ten inches out of the control element before the rod jammed again. Inspection showed noticeable swelling of the rod.

This device attached to the special fuel element was used to remove shim-safety rod 1-A. Rods 1-B and 1-C are also shown.

During the extraction procedure the fuel element was kept submerged in four feet of water for radiation shielding purposes. There was no serious galling of the rod during the removal procedure, nor was there any off-gassing from the rod. There was no evidence of corrosion or damage to the external surface of the rod. Also, there was no apparent damage to the special fuel element.

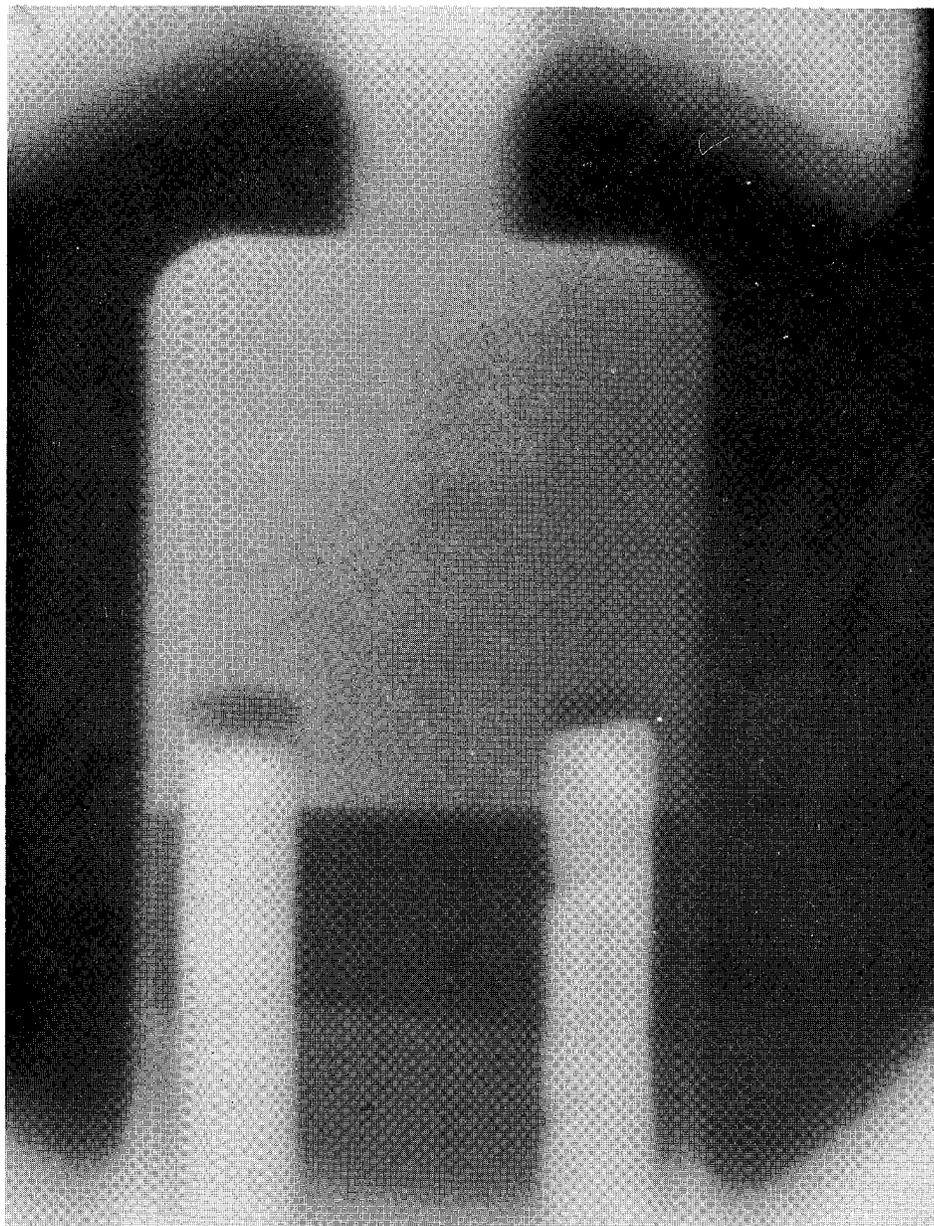
PLATE II - RADIOGRAPH OF THE TOP END OF A SHIM-SAFETY ROD

Complete radiographs were taken to determine the conditions inside the rods. The most significant finding from these radiographs was the presence of a void above the B_4C powder in the rods. This is shown in Plate II on page 11. Dye penetrant tests indicated pitting on the surface of the rods but no cracks were revealed.

The light vertical rods are lead filled ballast tubes. The darkest area between the two tubes represents the void above the powder.

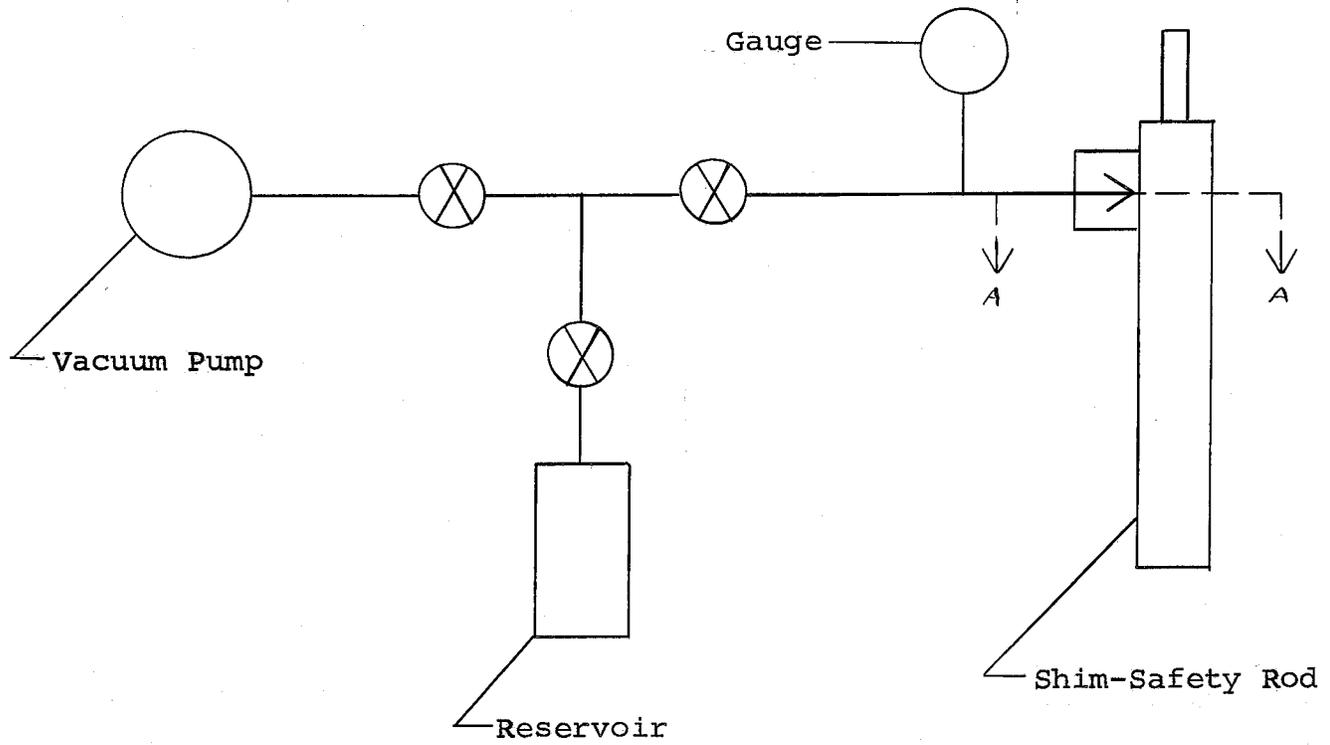
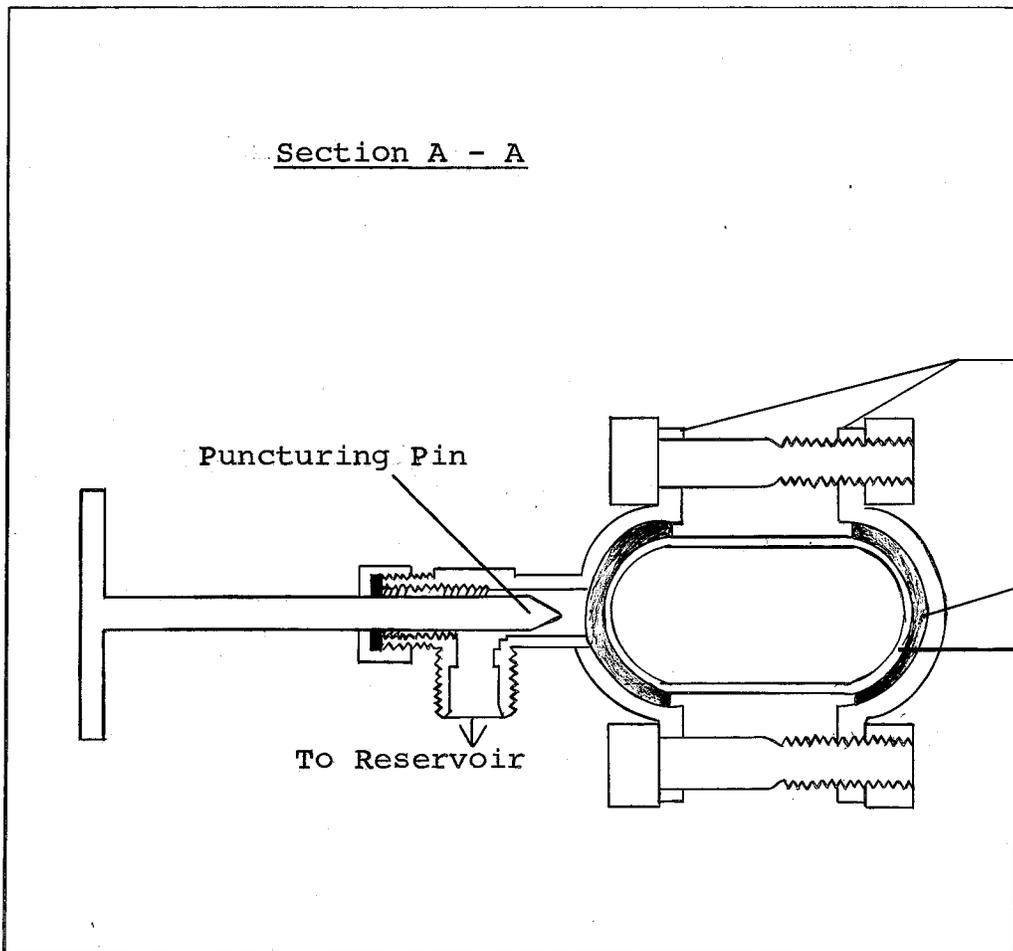
SKETCH II - GAS REMOVAL APPARATUS

The apparatus shown in Sketch II, page 12, was set up to measure any existing pressure and to collect any gas contained in the rod. The apparatus consisted of a self-sealing puncturing device with a pressure-vacuum gauge and an evacuated reservoir for collecting gas samples from the rod. Two rods, 1-A and 1-B, were punctured at the top where the voids were located. After the gas samples were removed, both rods were subjected to internal pressures of 40 psig while immersed in water.

When pressure measurements were made on the two shim-safety rods, 1-B had a pressure of 20 psig while rod 1-A, the deformed rod, was at atmospheric pressure. The gas samples from 1-A, 1-B and 2-C were analyzed using a mass spectrometer.

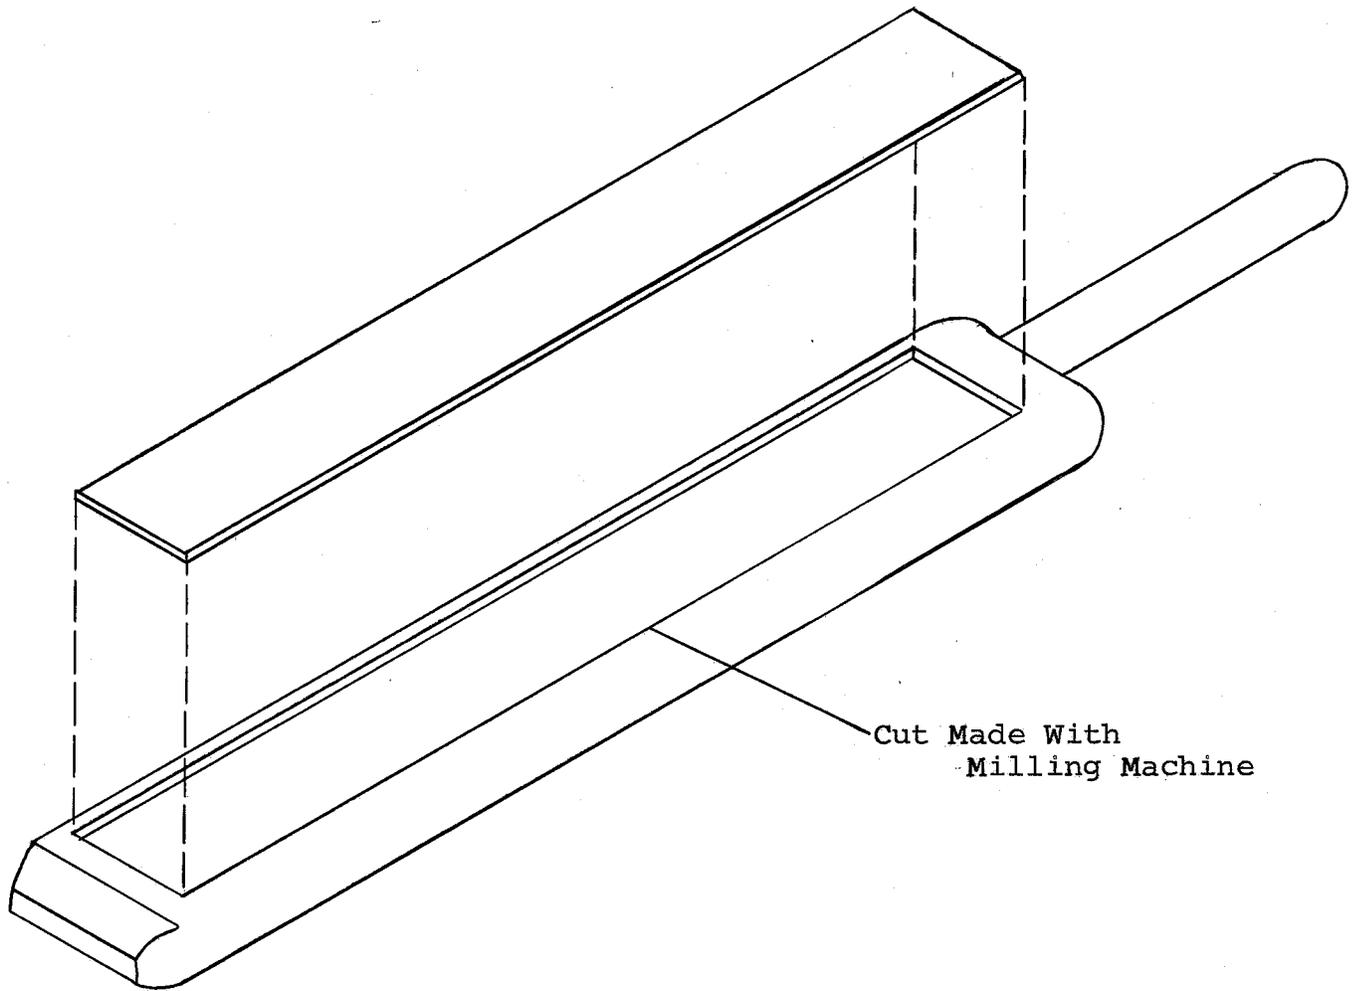
SKETCH III - ROD SECTIONING DIAGRAM

The rods were then opened by cutting out a section on one side of each rod. The section that was removed is shown in Sketch III on page 13. Care was taken to avoid getting aluminum shavings in the B_4C powder. Samples of the powder were removed from different positions along the length of the rod.

The B_4C in rod 1-A, the deformed rod, was found to be in a caked rather than a powdered form as in rod 1-B. The hard layer was concentrated between the ballast rods along the lower six inches of the shim rod. This cake had a grayish appearance unlike the characteristically black color of B_4C powder. The powder removed from the lower portion of rod 1-A was found to contain approximately 5 weight per cent water.

Oxidation was prevalent on the interior walls at the lower end of rod 1-A. A crust of Al_2O_3 surrounded the lead filled aluminum ballast rods.

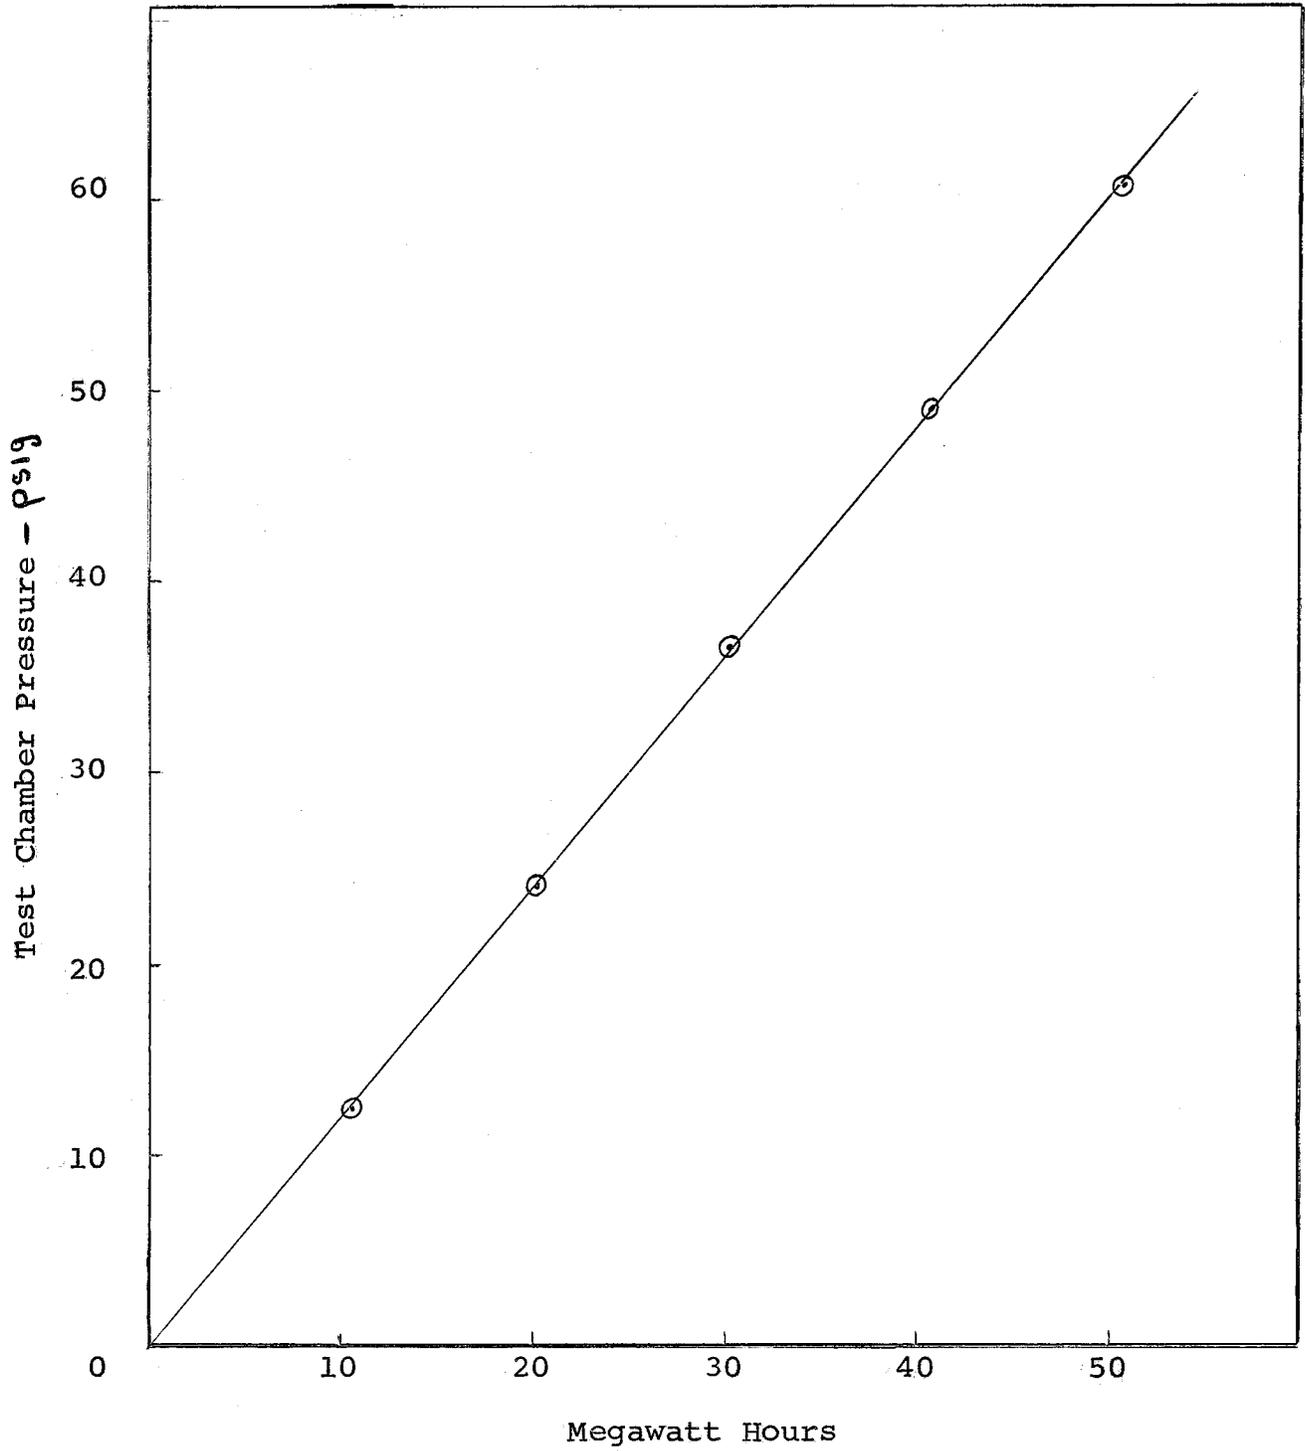
GRAPH I - TEST CHAMBER PRESSURE VS MEGAWATT HOURS

small, aluminum sealed vessels, one containing water and the other water and B_4C powder were installed adjacent to the reactor core in a thermal flux of 5×10^{12} neutrons per square centimeter-second and a gamma field of 5×10^7 roentgens per hour. Pressures in these chambers were monitored over a period of three days during which time the reactor operated at a power level of one megawatt for 50 hours. The pressure in the chamber containing water and B_4C powder increased linearly with respect to reactor operating time at a rate of 1.2 psig per hour. See Graph I, page 19. This test chamber had a volume of 295 cc and contained 10 grams of water and 25 grams of B_4C powder. The pressure in the chamber containing water only was 1.1 psig after 50 hours of reactor operation as compared to 60 psig in the chamber containing both water and B_4C powder.

Analysis showed that the gas generated in the water- B_4C chamber contained predominantly a hydrogen-oxygen gas mixture in a 2:1 ratio, similar to the finding for rod 2-C.
