PROFILE ANALYSIS OF THE LTPP SPS-6 SITE IN ARIZONA

1. Report No. UMTRI-2010-17		2. Government Accession No.		3. Recipient's Catalog No.	
4. Title and Subtitle Profile Analysis of the LTPP SPS-6 Site in Arizona				5. Report Date July 2010

14. Sponsoring Agency Code	
15. Supplementary Notes					
16. Abstract <p>This report characterizes the longitudinal profiles of five pavement sections within the Arizona Specific Pavement Studies 6 project throughout their service life. This project was built and monitored as part of the Long-Term Pavement Performance Study. Road profile measurements were collected on this site about once per year since the fall after it was opened to traffic. This study analyzed the profiles in detail by calculating their roughness values, examining the spatial distribution of roughness within them, viewing them with post-processing filters, and examining their spectral properties. These analyses provided details about the roughness characteristics of the road and provided a basis for quantifying and explaining the changes in roughness with time, relating post-rehabilitation roughness with rehabilitation type, surface preparation, and profile properties, as well

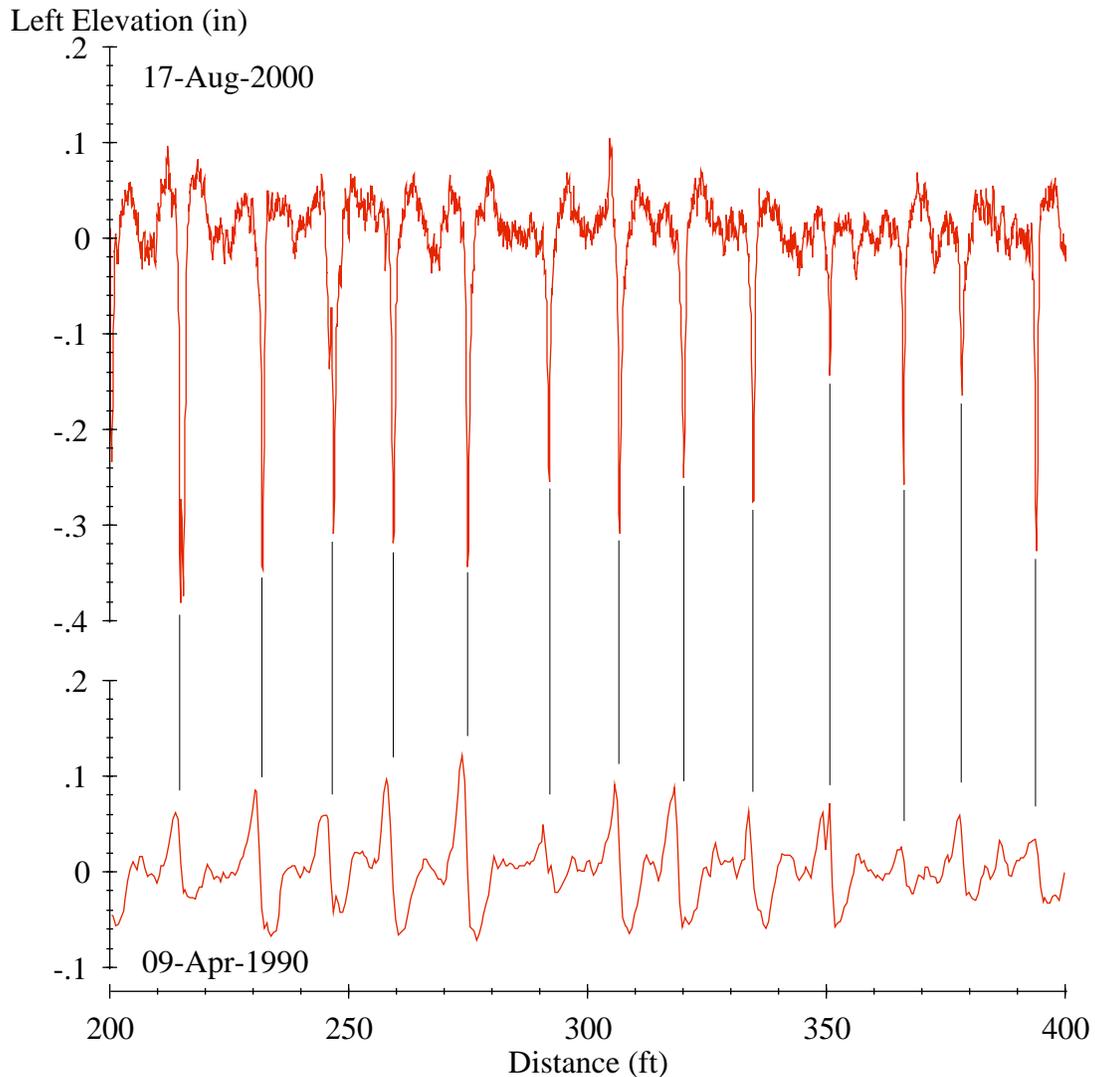
Figure 24. Joint and crack locations on section 0603.

On section 0603, profiles late in the monitoring history (starting in August 2000) included narrow dips throughout the entire section, and in the same locations where joint faults appeared in the pre-rehabilitation profiles. Figure 24 illustrates the close relationship. The figure shows segments from both profiles after application of an anti-smoothing moving average filter with a base length of 10 ft. In the faulted profile of April 1990 the filter distorts the faults, and they appear as abrupt downward changes in elevation that follow each upward spike. However, the filter makes the faults easier to see.

Figure 24 shows that the narrow dips on section 0603 appear in the same pattern and in the same locations as the faults on the left side of the lane, which occurred in a pattern that approximated the original joint spacing of 15-13-15-17 ft. On the right side, not shown, the same pattern of faults before rehabilitation and narrow dips caused by transverse cracks late in the monitoring history is also present. However, the pattern is shifted about 1 ft downstream because of the skewed saw cuts. The synchronization process itself did not guarantee this alignment. Profiles collected before rehabilitation were only aligned to those afterward using data within section 0601 and extrapolation over the rest of the site.

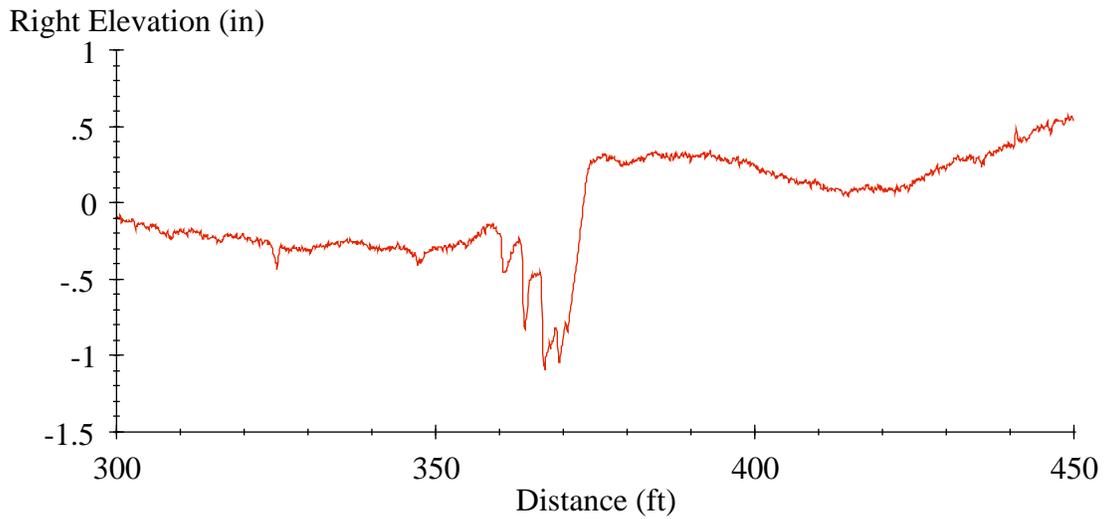
Figure 29. Right side profile of section 0661 in August 2000.

Figure 29 shows the elevation profile that produced the roughness profile of Figure 28, and Figure 30 provides a photo of the distress that caused the disturbance. As shown, the profile includes a significant dip, and significant disturbances within the dip. Figure 30 illustrates that significant localized fatigue is present between the fog line and about 5 ft into the section from the right side. This fatigue cracking developed in the winter/spring of 1999/2000, and is consistent with a “soft spot” in the pavement structure, possibly caused by excessive water buildup in the unbound layers. Many of the fines have pumped up to the pavement surface and are visible in Figure 30.
