ICE STRENGTHENING OF GREAT LAKES BULK CARRIERS

Movses J. Kaldjian

William R. Reid, Jr.

MICHU-SG-82-200
N.A.M.E. Report No. 263
\$2.00

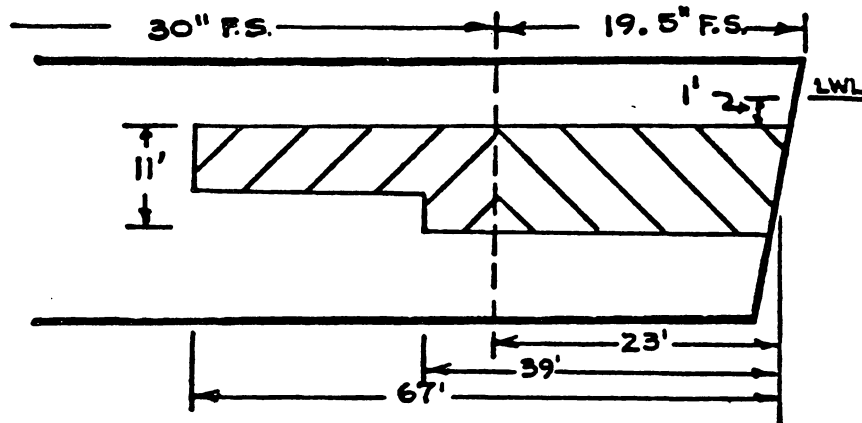
SHIP A

AREA REFERENCED	PRESSURE INDEX			
	PLATE		FRAME	
	P_o	P_a	P_o	P_a
#1	58	190	295	339
#2	24	80	267	348

Damages caused by operation in ice were incurred on several occasions over a span of twenty years. Some of the repaired areas were subsequently damaged again. Eventually, the original 22.5 lb. mild steel plate of both areas indicated above was replaced with 40.8 lb. mild steel plate, giving the results shown in the table. There is no indication that repairs were ever made to the frames.

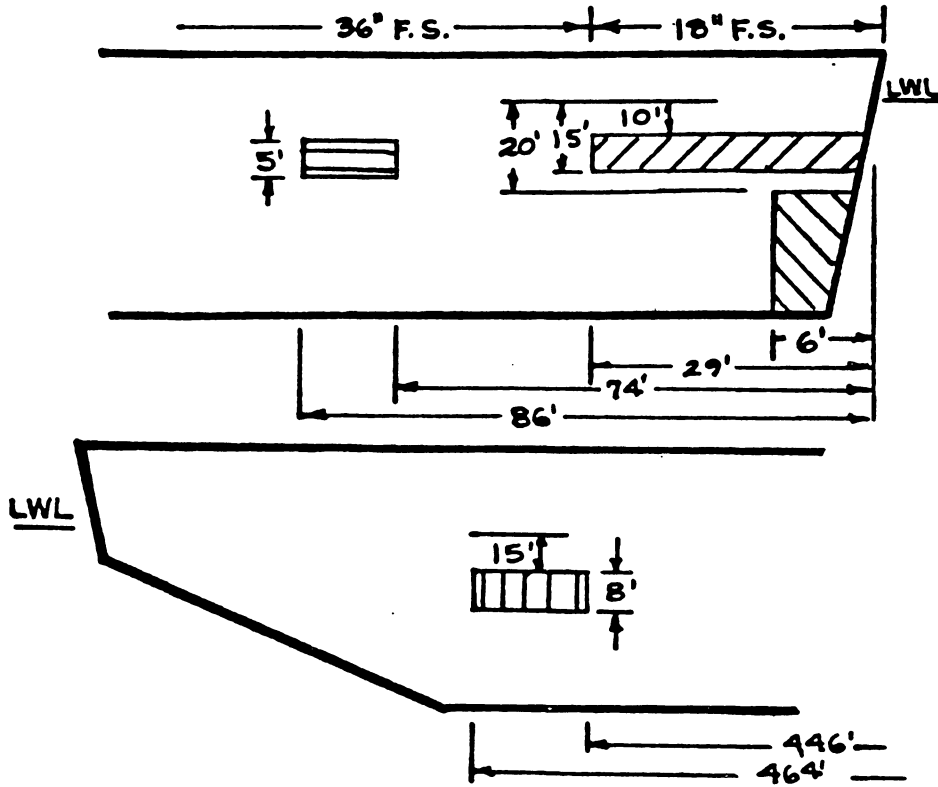
SHIP B

AREA REFERENCED	PRESSURE INDEX			
	PLATE		FRAME	
	Po	Pa	Po	Pa
#1

102	318	338	338
#2

102	318	271	271
#3

36	318	272	495
#4

24	79	97	97

Ice damages occurred in 1977 and were located both port and starboard in the vicinity of the areas indicated. Repairs were made to the shell plate using 100,000 psi yield stress material of the same weight as the original 25.5 lb. mild steel plate. The survey report indicated that many frames had failed and in all areas, but it was proposed to replace them in kind in areas 1, 2, and 4, and to halve the spacing in area 3.

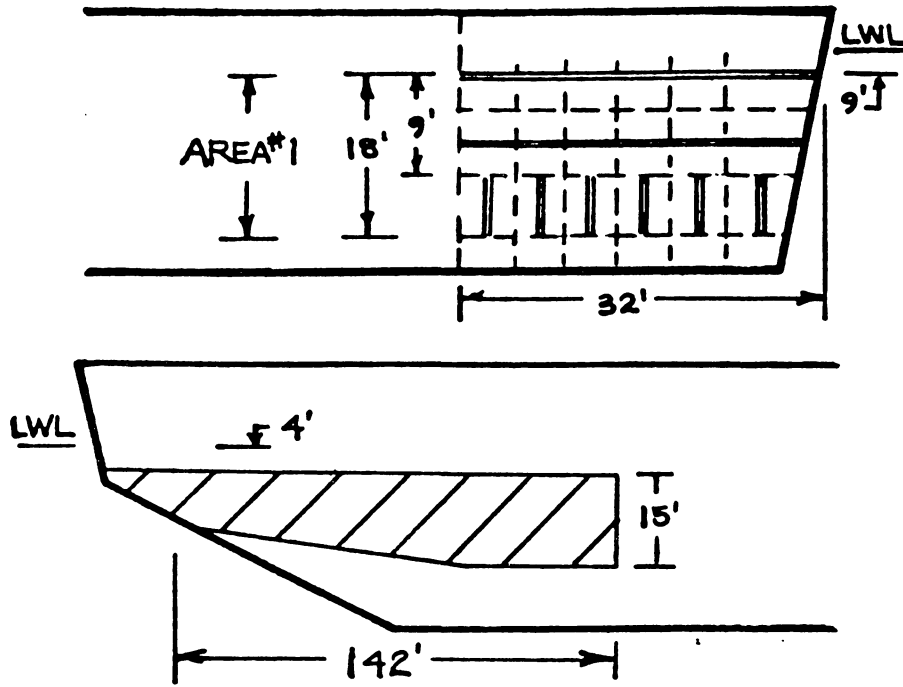
SHIP C

AREA REFERENCED	PRESSURE INDEX			
	PLATE		FRAME	
	P _o	P _a	P _o	P _a
#1

391	527	440	1764
#2

161	391	294	294

This ship was initially fitted with 100,000 psi yield stress plating. The weight of plate in the modified area is 30.6 lb. It is presumed that no ice damages were incurred but that ice strengthening was done in anticipation of winter operation. In area #1 two shell stringers and intermediate frames were added as indicated by the doubled lines in the illustration. Area #2 is longitudinally framed. Here, transverse pieces were placed between longitudinal frames to divide the plating into three equal spaces between web frames.

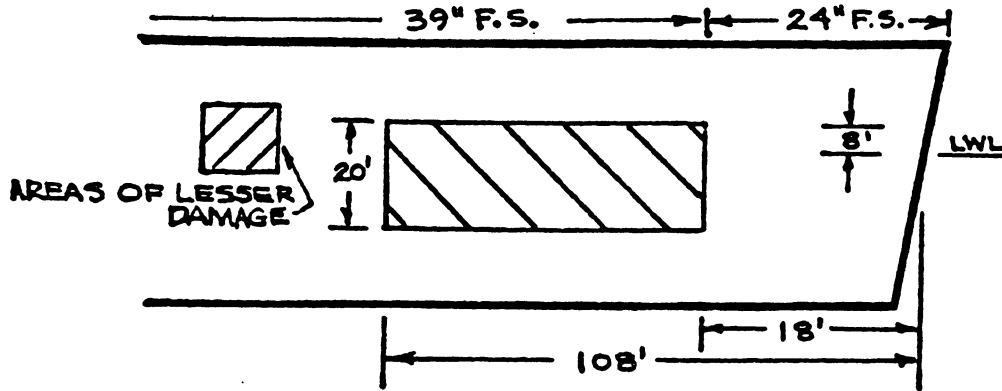
SHIP D

NOTE: THERE WAS NO DAMAGE AT BOW WHERE PLATE $P_0 = 125$ AND FRAME $P_0 = 220$

AREA REFERENCED	PRESSURE INDEX			
	PLATE		FRAME	
	P_0	P_a	P_0	P_a
#1

23	231	143	276
#2

23	61	143	143

Ice damage did not occur at the bow of this ship where one might normally expect. The area forward of area #1 is of 40.8 lb. mild steel plate, but in areas #1 and #2 the plate was 25.5 lb. mild steel. There was apparently no damage to frames. Area #1 was strengthened with additional intermediate frames, and 100,000 psi yield stress plating of 25.5 lb. weight. Area #2 damage was small and was repaired using high yield strength plating of 100,000 psi yield stress.

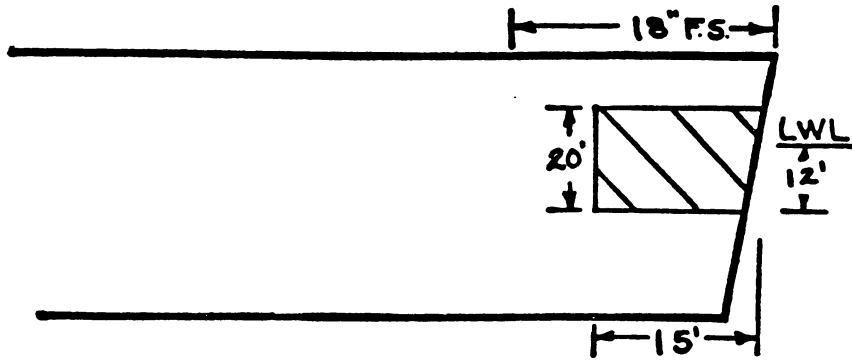
SHIP E

AREA REFERENCED	PRESSURE INDEX			
	PLATE		FRAME	
	Po	Pa	Po	Pa
#1

182	267	251	1946

Ship E represents two sister ships which incurred almost identical damages in the same winter season. Ice damages in the stern area were quite severe. The plating had been stove-in, rivets had been broken, and the plating had started to tear in several locations. Frames, shell stringers and breast hooks were crippled. The original shell plate was doubled in this area with two thicknesses of 25.5 lb. mild steel plate. The damaged area was completely rebuilt. The doubled shell plate was replaced by one thickness of 40.8 lb. mild steel plate. New stringers were built, and frames were replaced using heavier material and larger brackets.

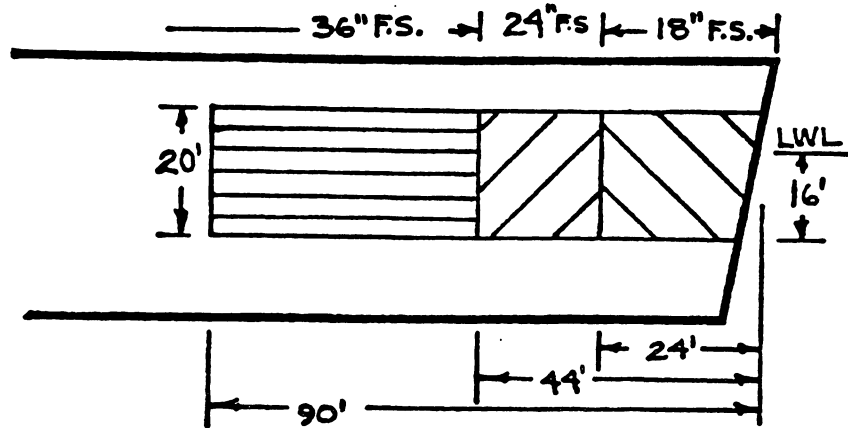
SHIP F

AREA REFERENCED	PRESSURE INDEX			
	PLATE		FRAME	
	Po	Pa	Po	Pa
#1

74	233	340	1184
#2

45	144	227	491
#3

25	79	151	339

It is not certain whether this ship suffered ice damage or was ice strengthened in anticipation of winter operation. Original scantlings were not readily available and therefore, were estimated for the comparisons. For ice strengthening, 40.8 lb. mild steel plate replaced the assumed 22.95 lb. mild steel plate. The frames in areas #1, #2, and #3 were replaced with 15" x 5" x 1/2" F.P. The original frames were assumed to be 8" x 3-1/2" x 21.4# C-sections in area #1, and 10" x 3-1/2" x 28.3# C-sections in areas #2 and #3.

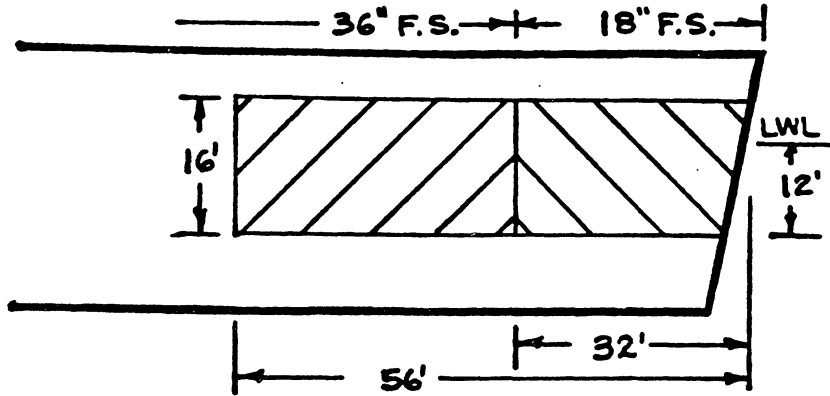
SHIP G

AREA REFERENCED	PRESSURE INDEX			
	PLATE		FRAME	
	P _o	P _a	P _o	P _a
#1

81	199	231	231
#2

24	69	159	159

In preparation for winter operation two sister ships were ice strengthened as illustrated above. The shell plate was reinforced by the use of flat bars on edge running longitudinally and intercostal with the frames so as to reduce the vertical spacing of shell plate supports. No modifications were made to frames.

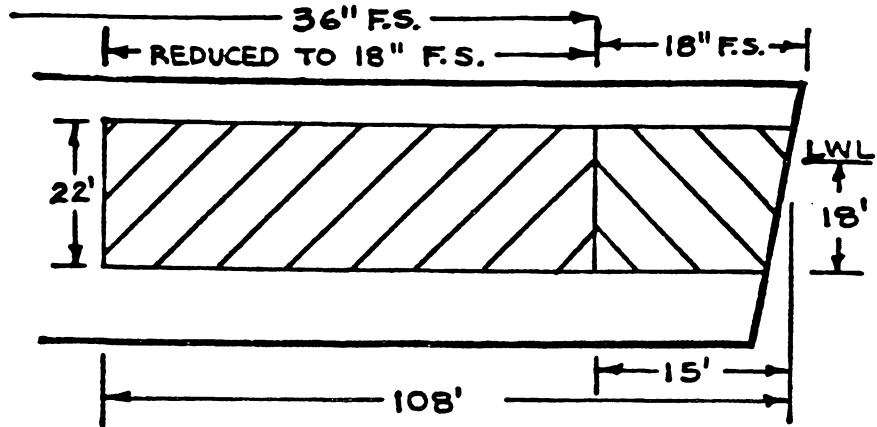
SHIP H

AREA REFERENCED		PRESSURE INDEX			
		PLATE		FRAME	
		P _o	P _a	P _o	P _a
#1

107	335	1698	1698
#2

31	335	159	558

The forward part of this ship, area #1 above, had 28.05 lb. mild steel plate which suffered ice damage and was replaced with 100,000 psi yield stress material of the same scantling. The major portion of the ice strengthening modification took place in area #2 where plating and some frames had been ice damaged. In area #2 shell plating of mild steel was replaced with high yield stress material of the same, 28.05 lb. weight, and intermediate frames were added. Shell stringers were extended from area #1 through area #2.

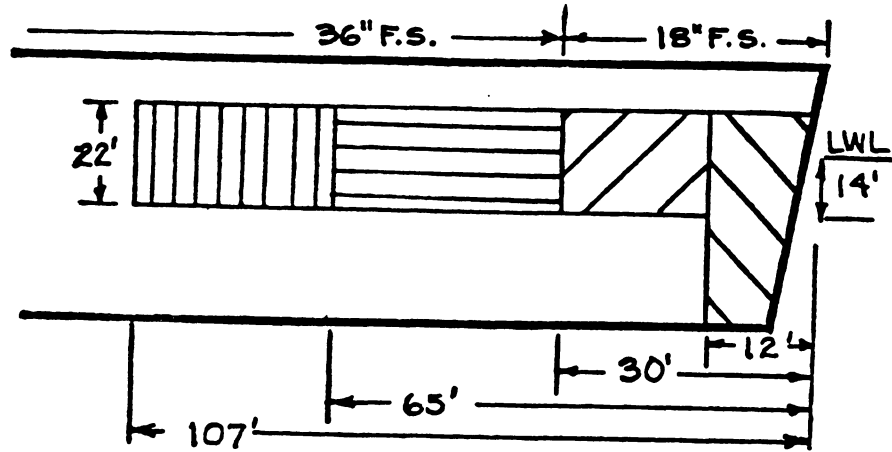
SHIP I

AREA REFERENCED	PRESSURE INDEX			
	PLATE		FRAME	
	Po	Pa	Po	Pa
#1

81	336	318	566
#2

81	252	318	318
#3

27	84	238	238
#4

21	84	119	238

This ship incurred ice damages on several occasions and repairs were often made to local areas as required. Eventually ice strengthening was completed as illustrated above. The original 28.05 lb. mild steel plate was replaced with 100,000 psi yield stress plating of the same weight in all four areas. Stringers were extended into area #4. Stringers and breast hooks were reinforced in areas #1 and #2. The shell plating in area #1 was reinforced by the use of flat bars on edge intercostal with frames.

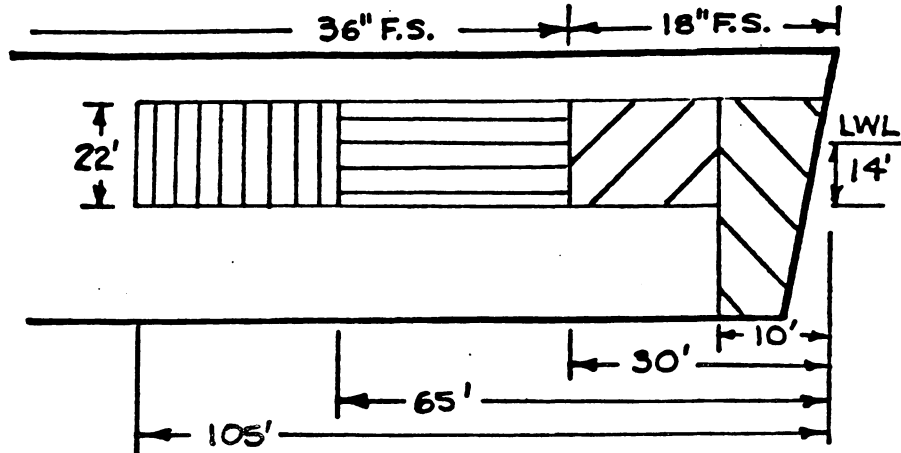
SHIP J

AREA REFERENCED	PRESSURE INDEX			
	PLATE		FRAME	
	P _o	P _a	P _o	P _a
#1	81	336	318	566
#2	81	252	318	318
#3	27	84	238	238
#4	21	84	119	238

This ship had a record of ice damages and repairs similar to those of Ship I. Although the ice strengthening modifications varied in minor detail, the end result was essentially the same as for Ship I.
