Report No. UMCEE 92-31

Field Investigation of Damage to Islamic Monuments Caused by the Egyptian Earthquake of October 12, 1992

**James K. Wight
Roman D. Hryciw
Antoine E. Naaman**

December 1992

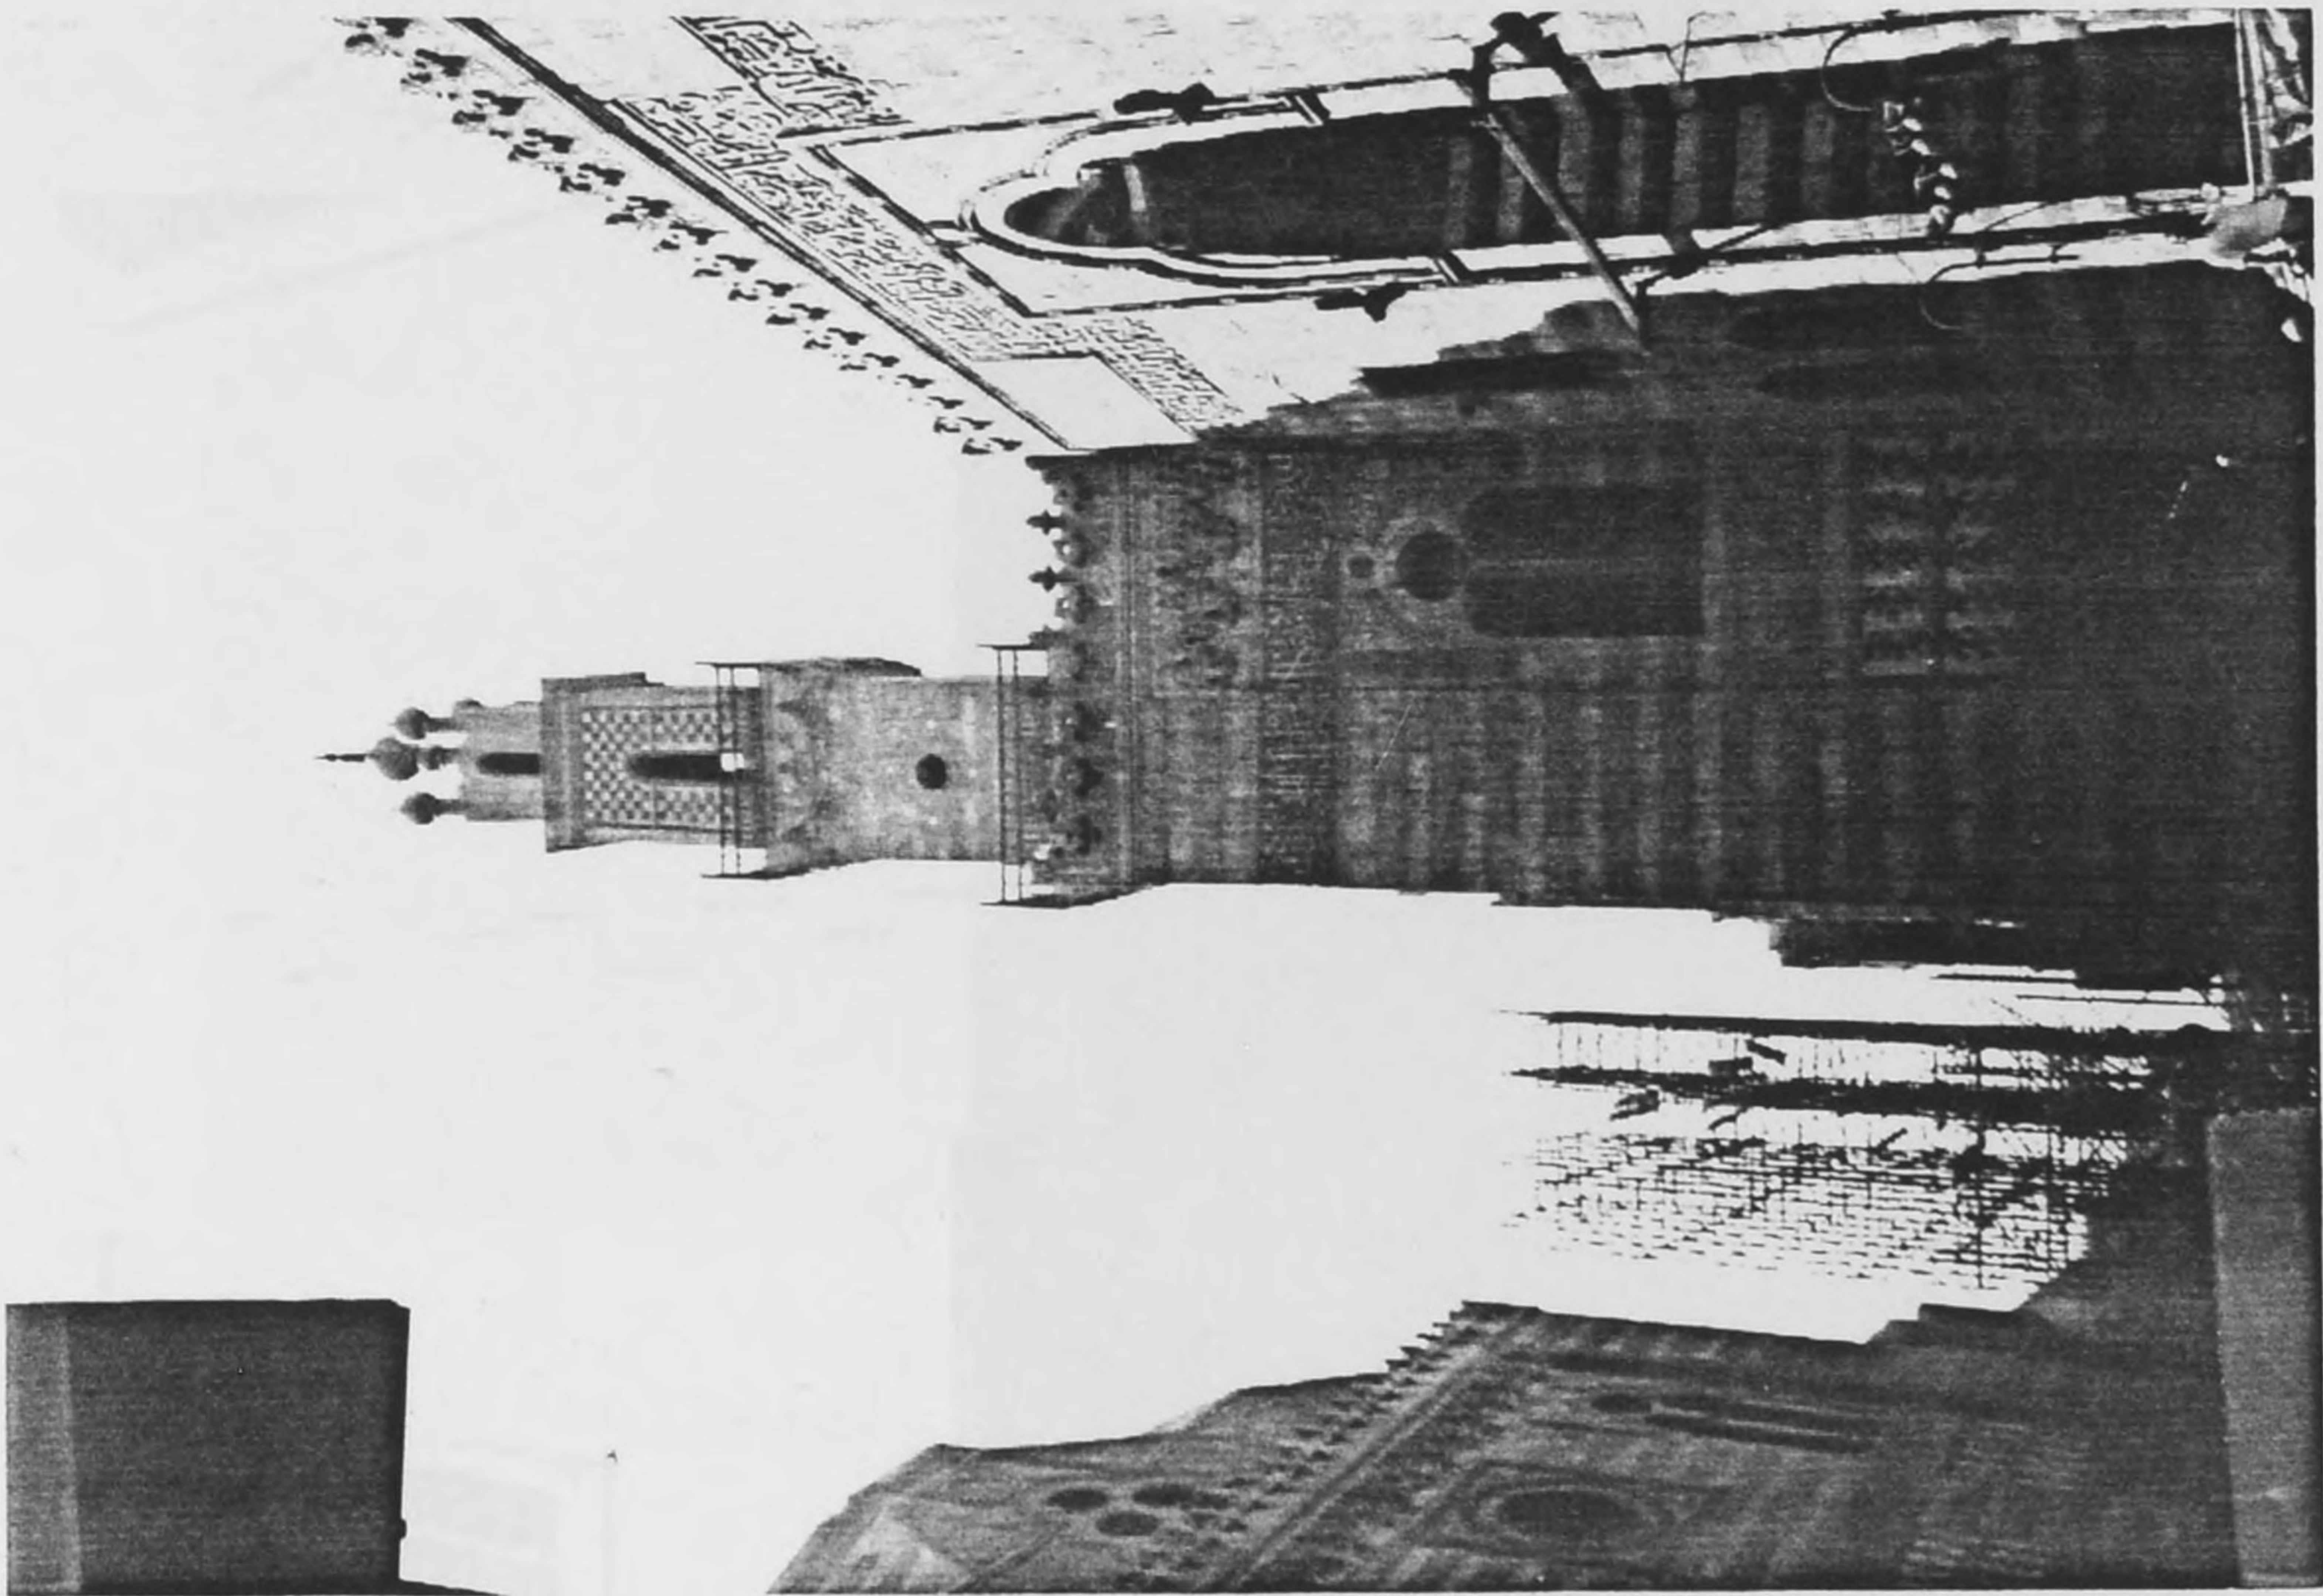
The height of the mosque was approximately equivalent to a four story building with a minaret tower attached to the southeast corner (Fig. 1). Cracks were visible on all external faces of the mosque. There was one very large crack at a reentrant corner along the east wall where the minaret tower was connected to the mosque (Fig. 2). This appeared to be an old crack that was clearly related to uneven settlement that resulted in the minaret tower leaning slightly away from the mosque. Any increase in the width and length of this crack due to the earthquake could not be determined.

Fig. 1 Sultan El-Ghuri Mosque and minaret tower

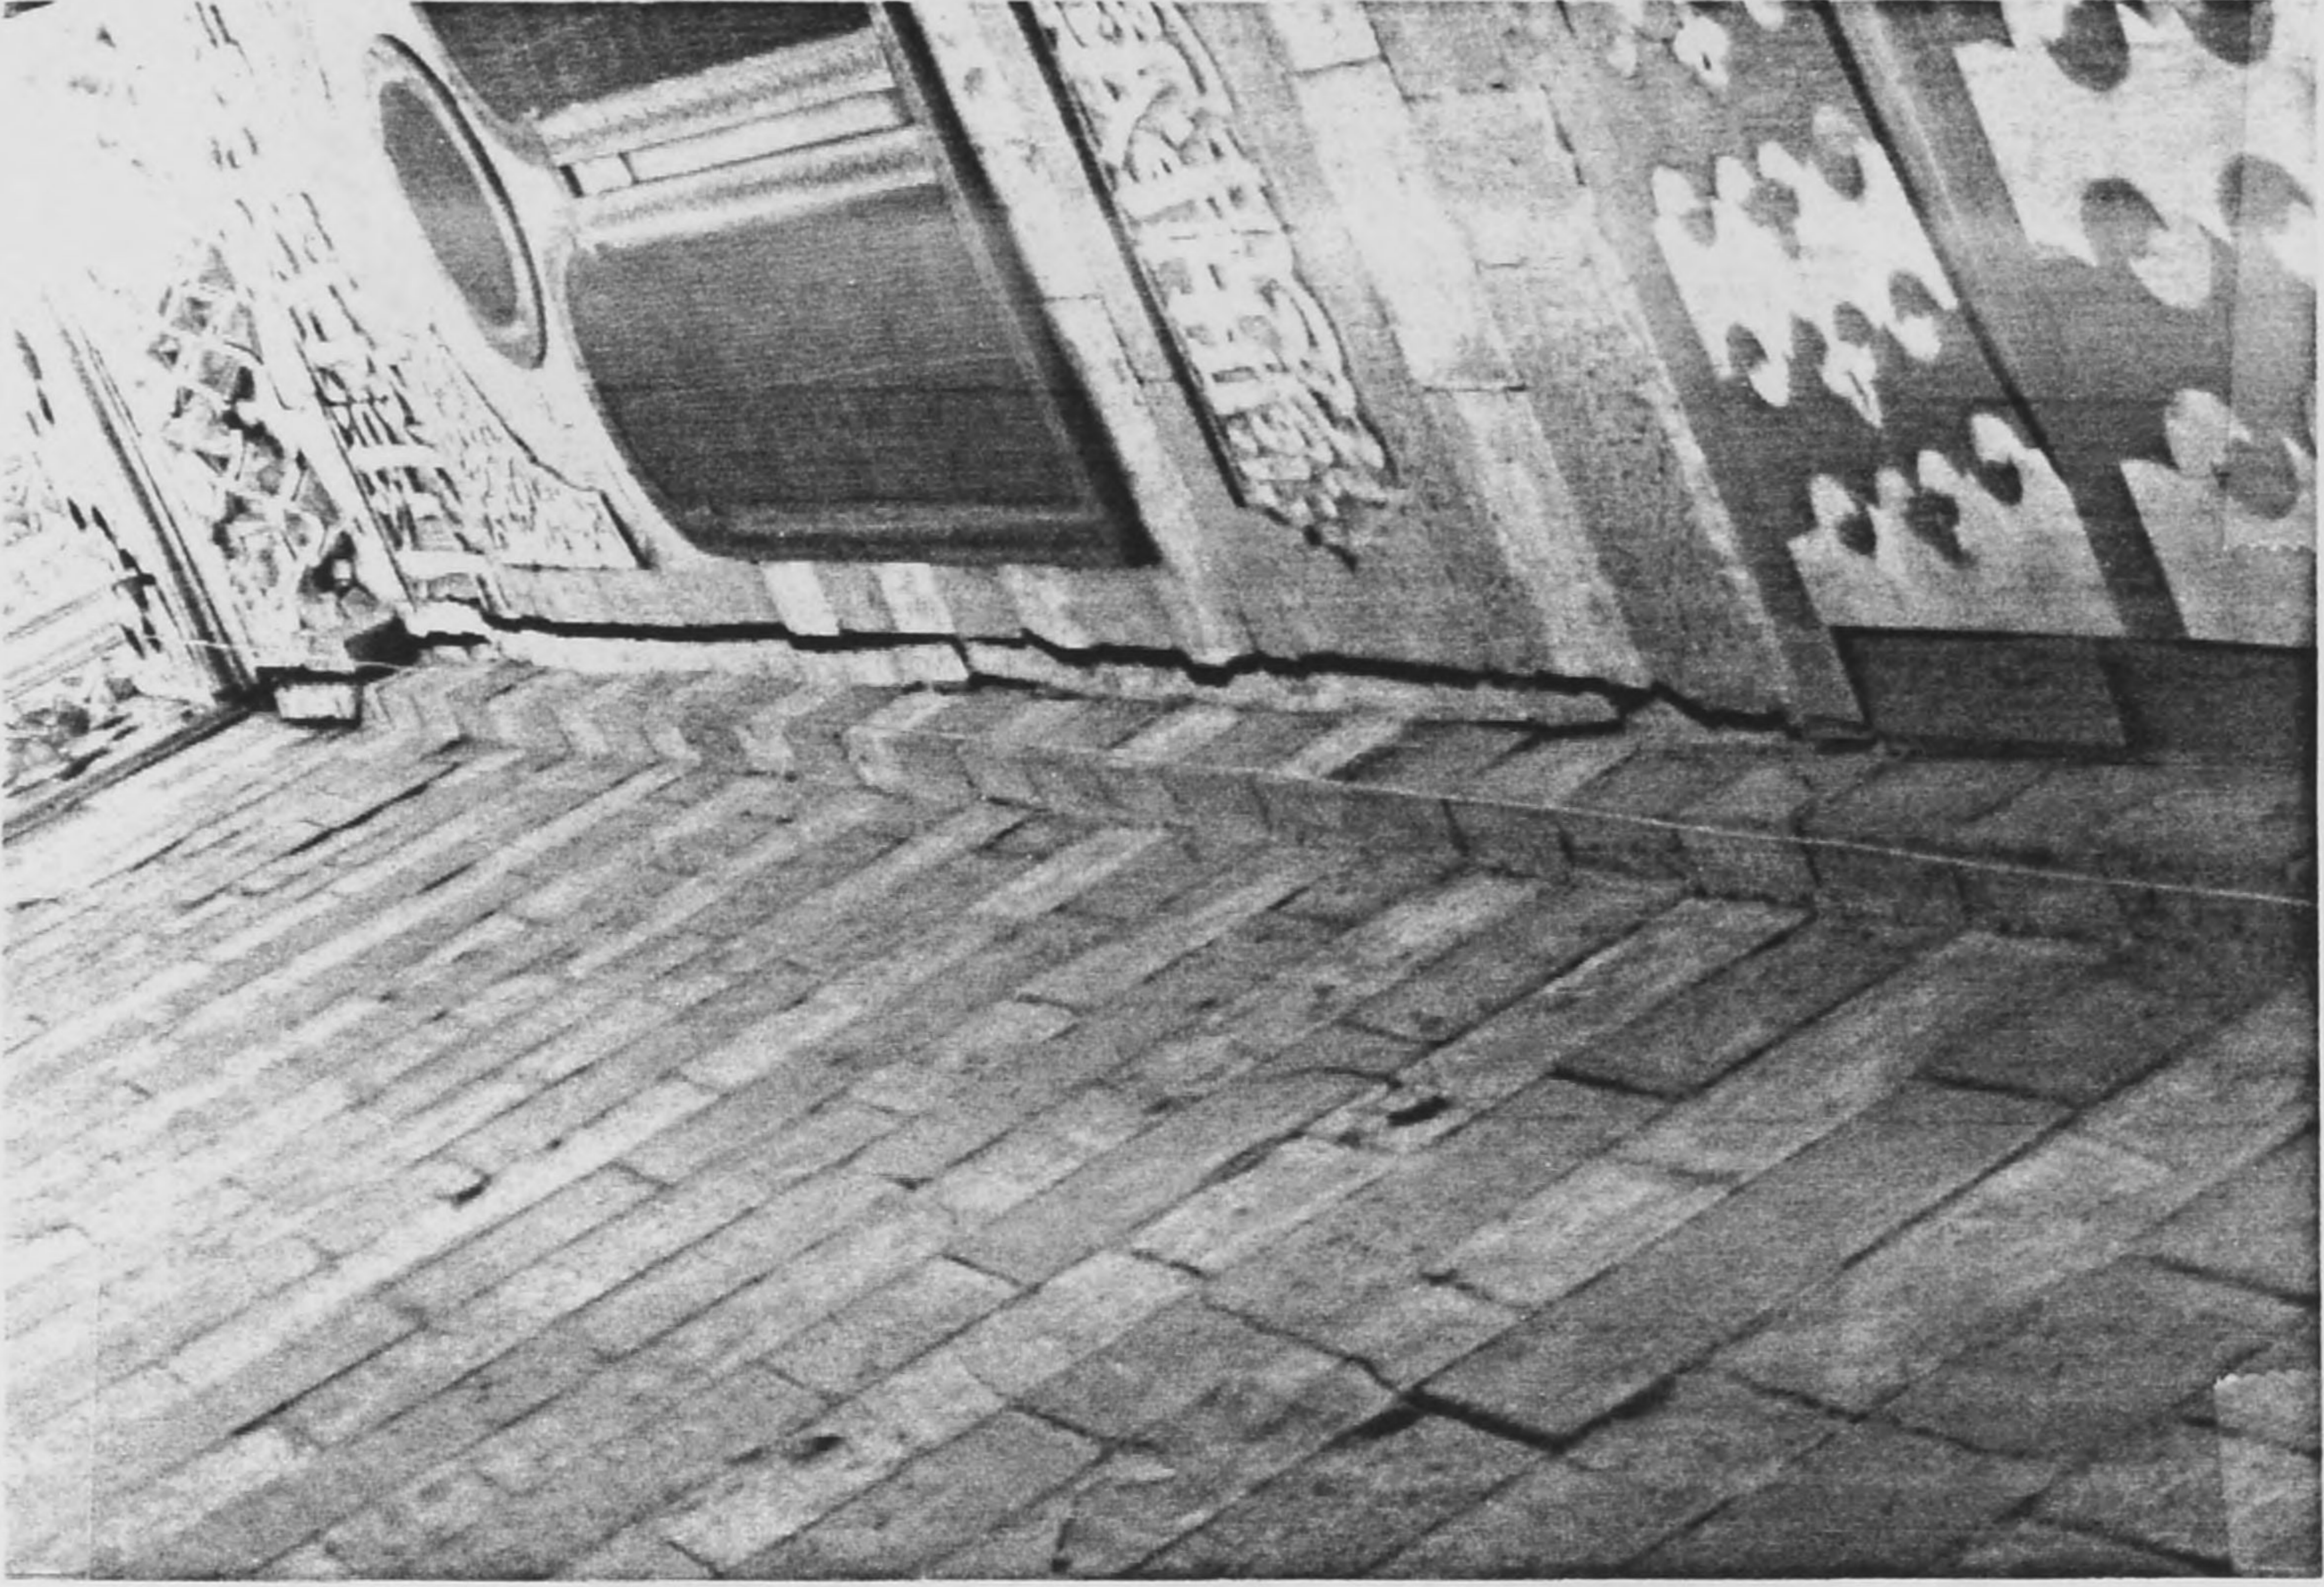
Fig. 2 Crack between minaret tower (left) and mosque

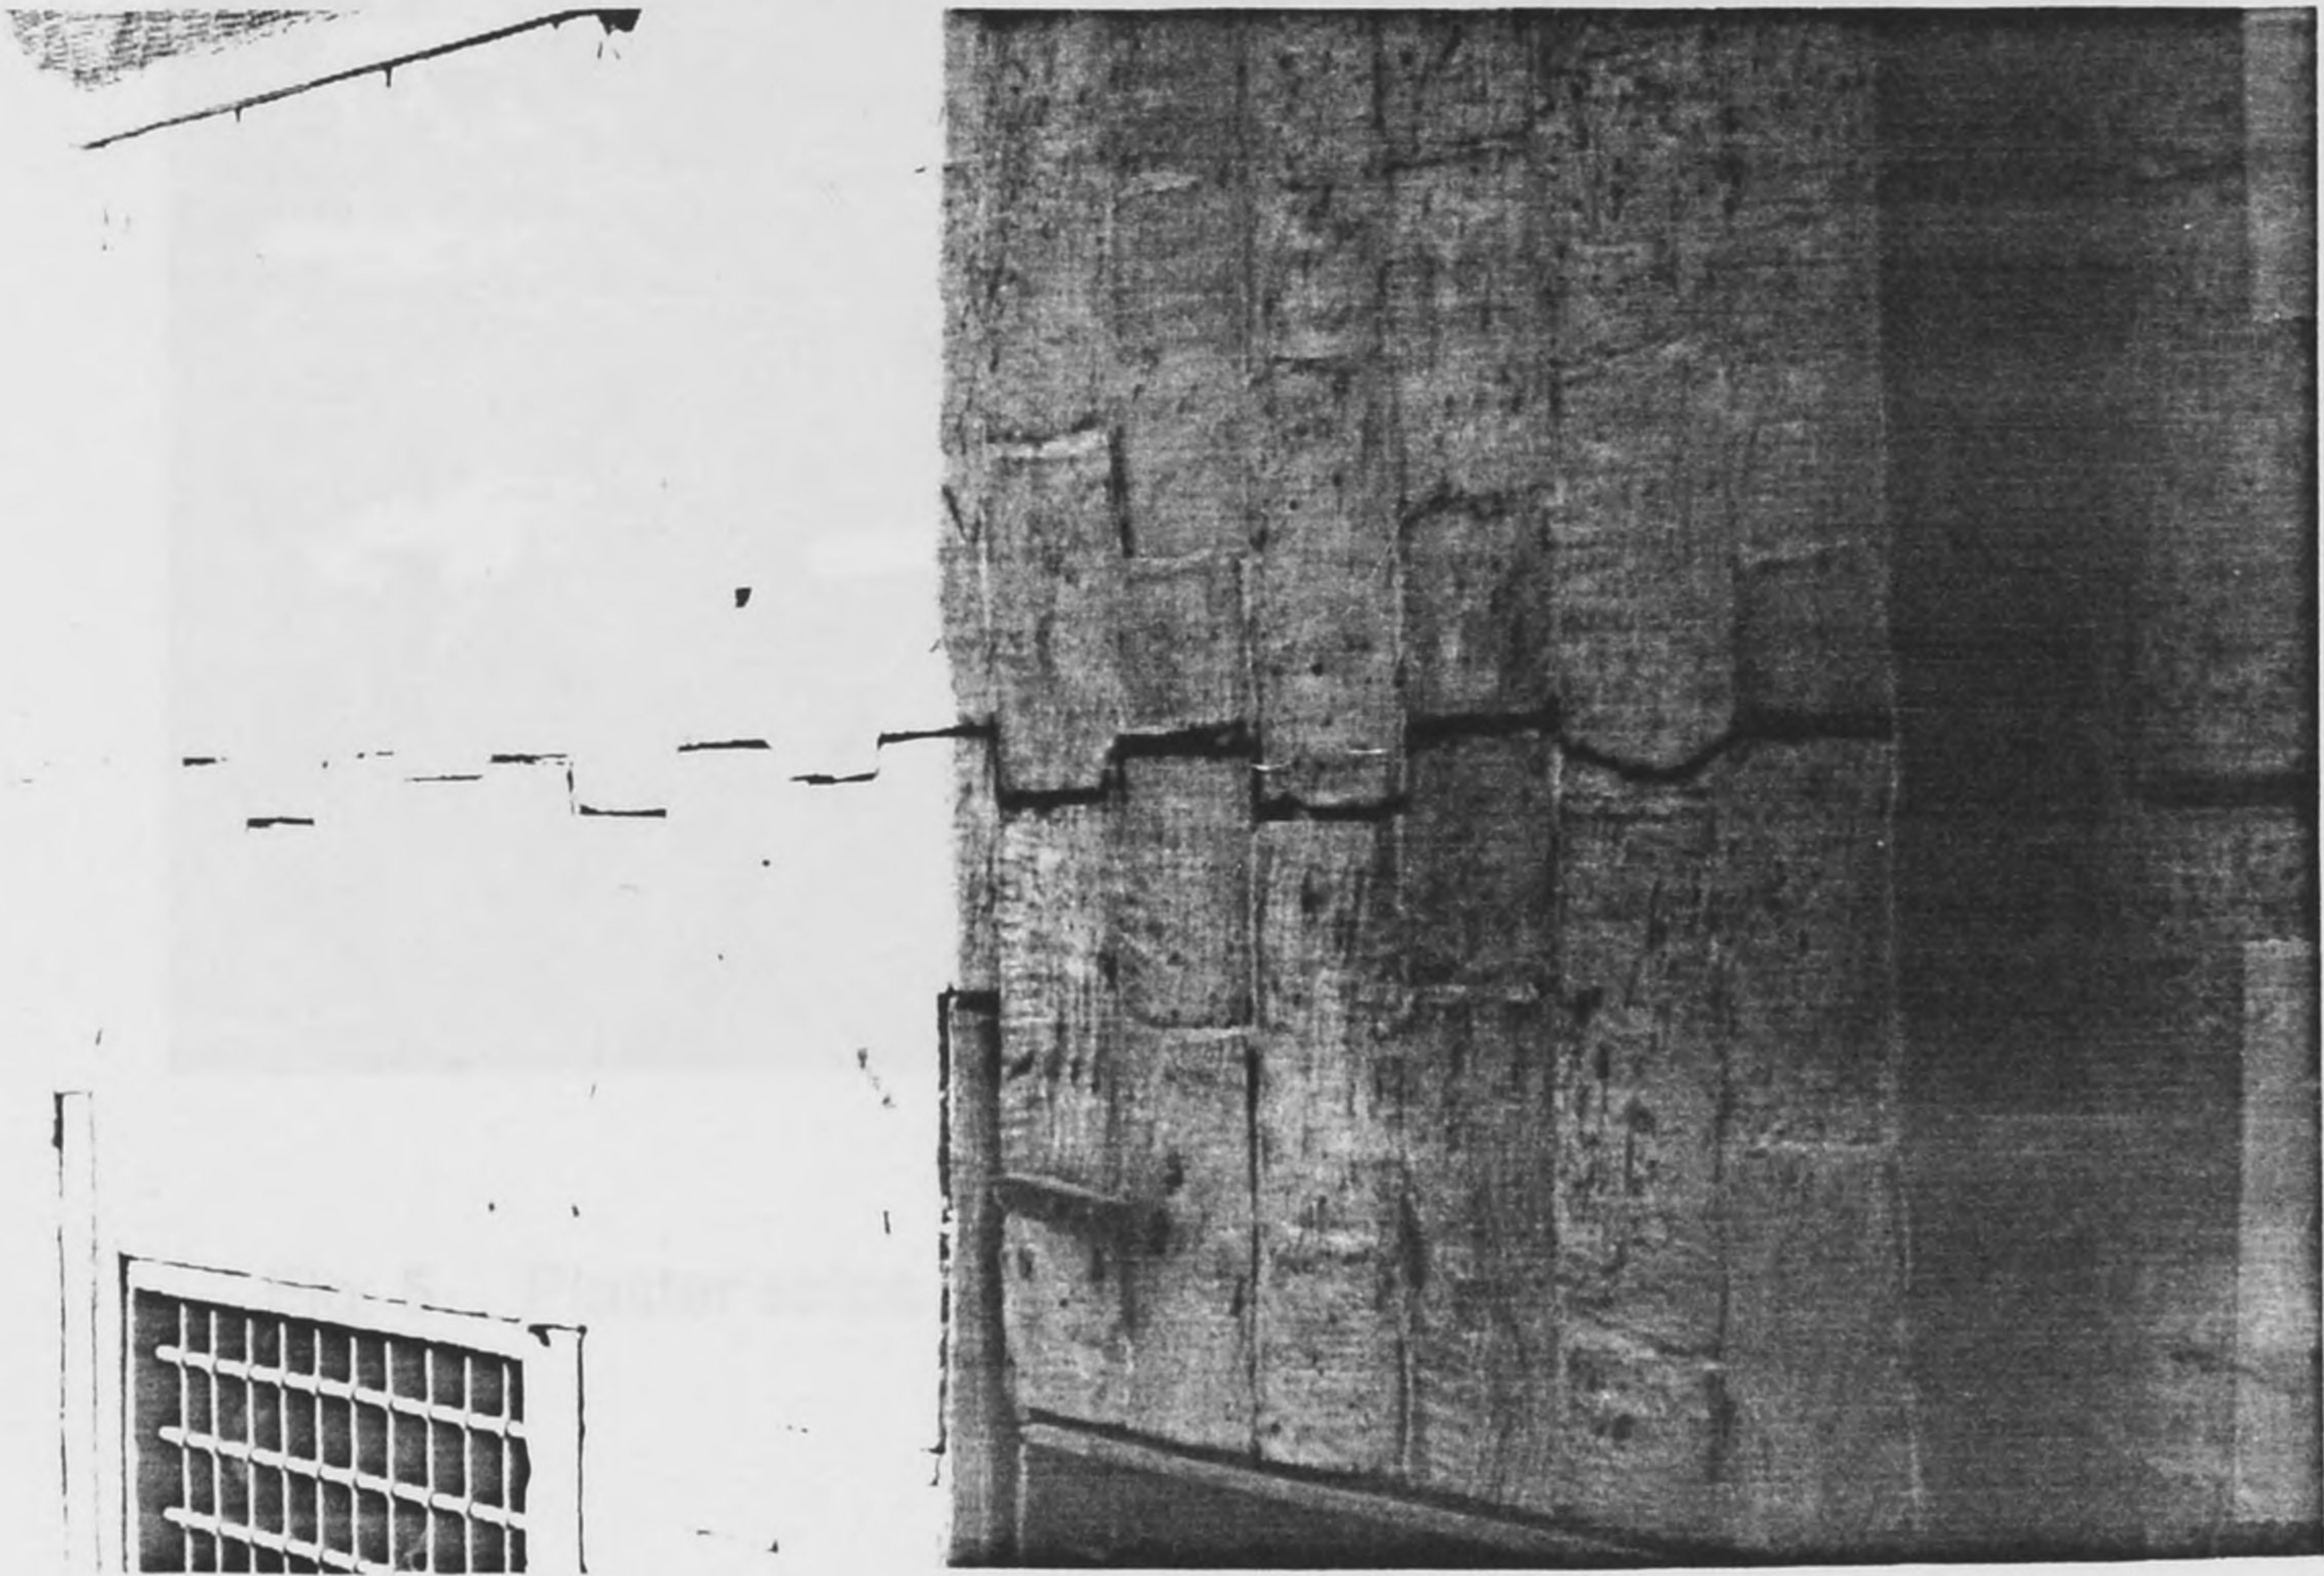
A crack in the south wall, approximately thirty feet away from the southeast corner of the mosque, was observed to be wider near the base of the mosque than at the top (Fig. 3). This crack seemed to indicate uneven lateral movements near the base of the mosque. Again, there was no clear evidence that the earthquake had significantly changed the width and length of this crack.

Fig. 3 Crack along south wall of El-Ghuri Mosque

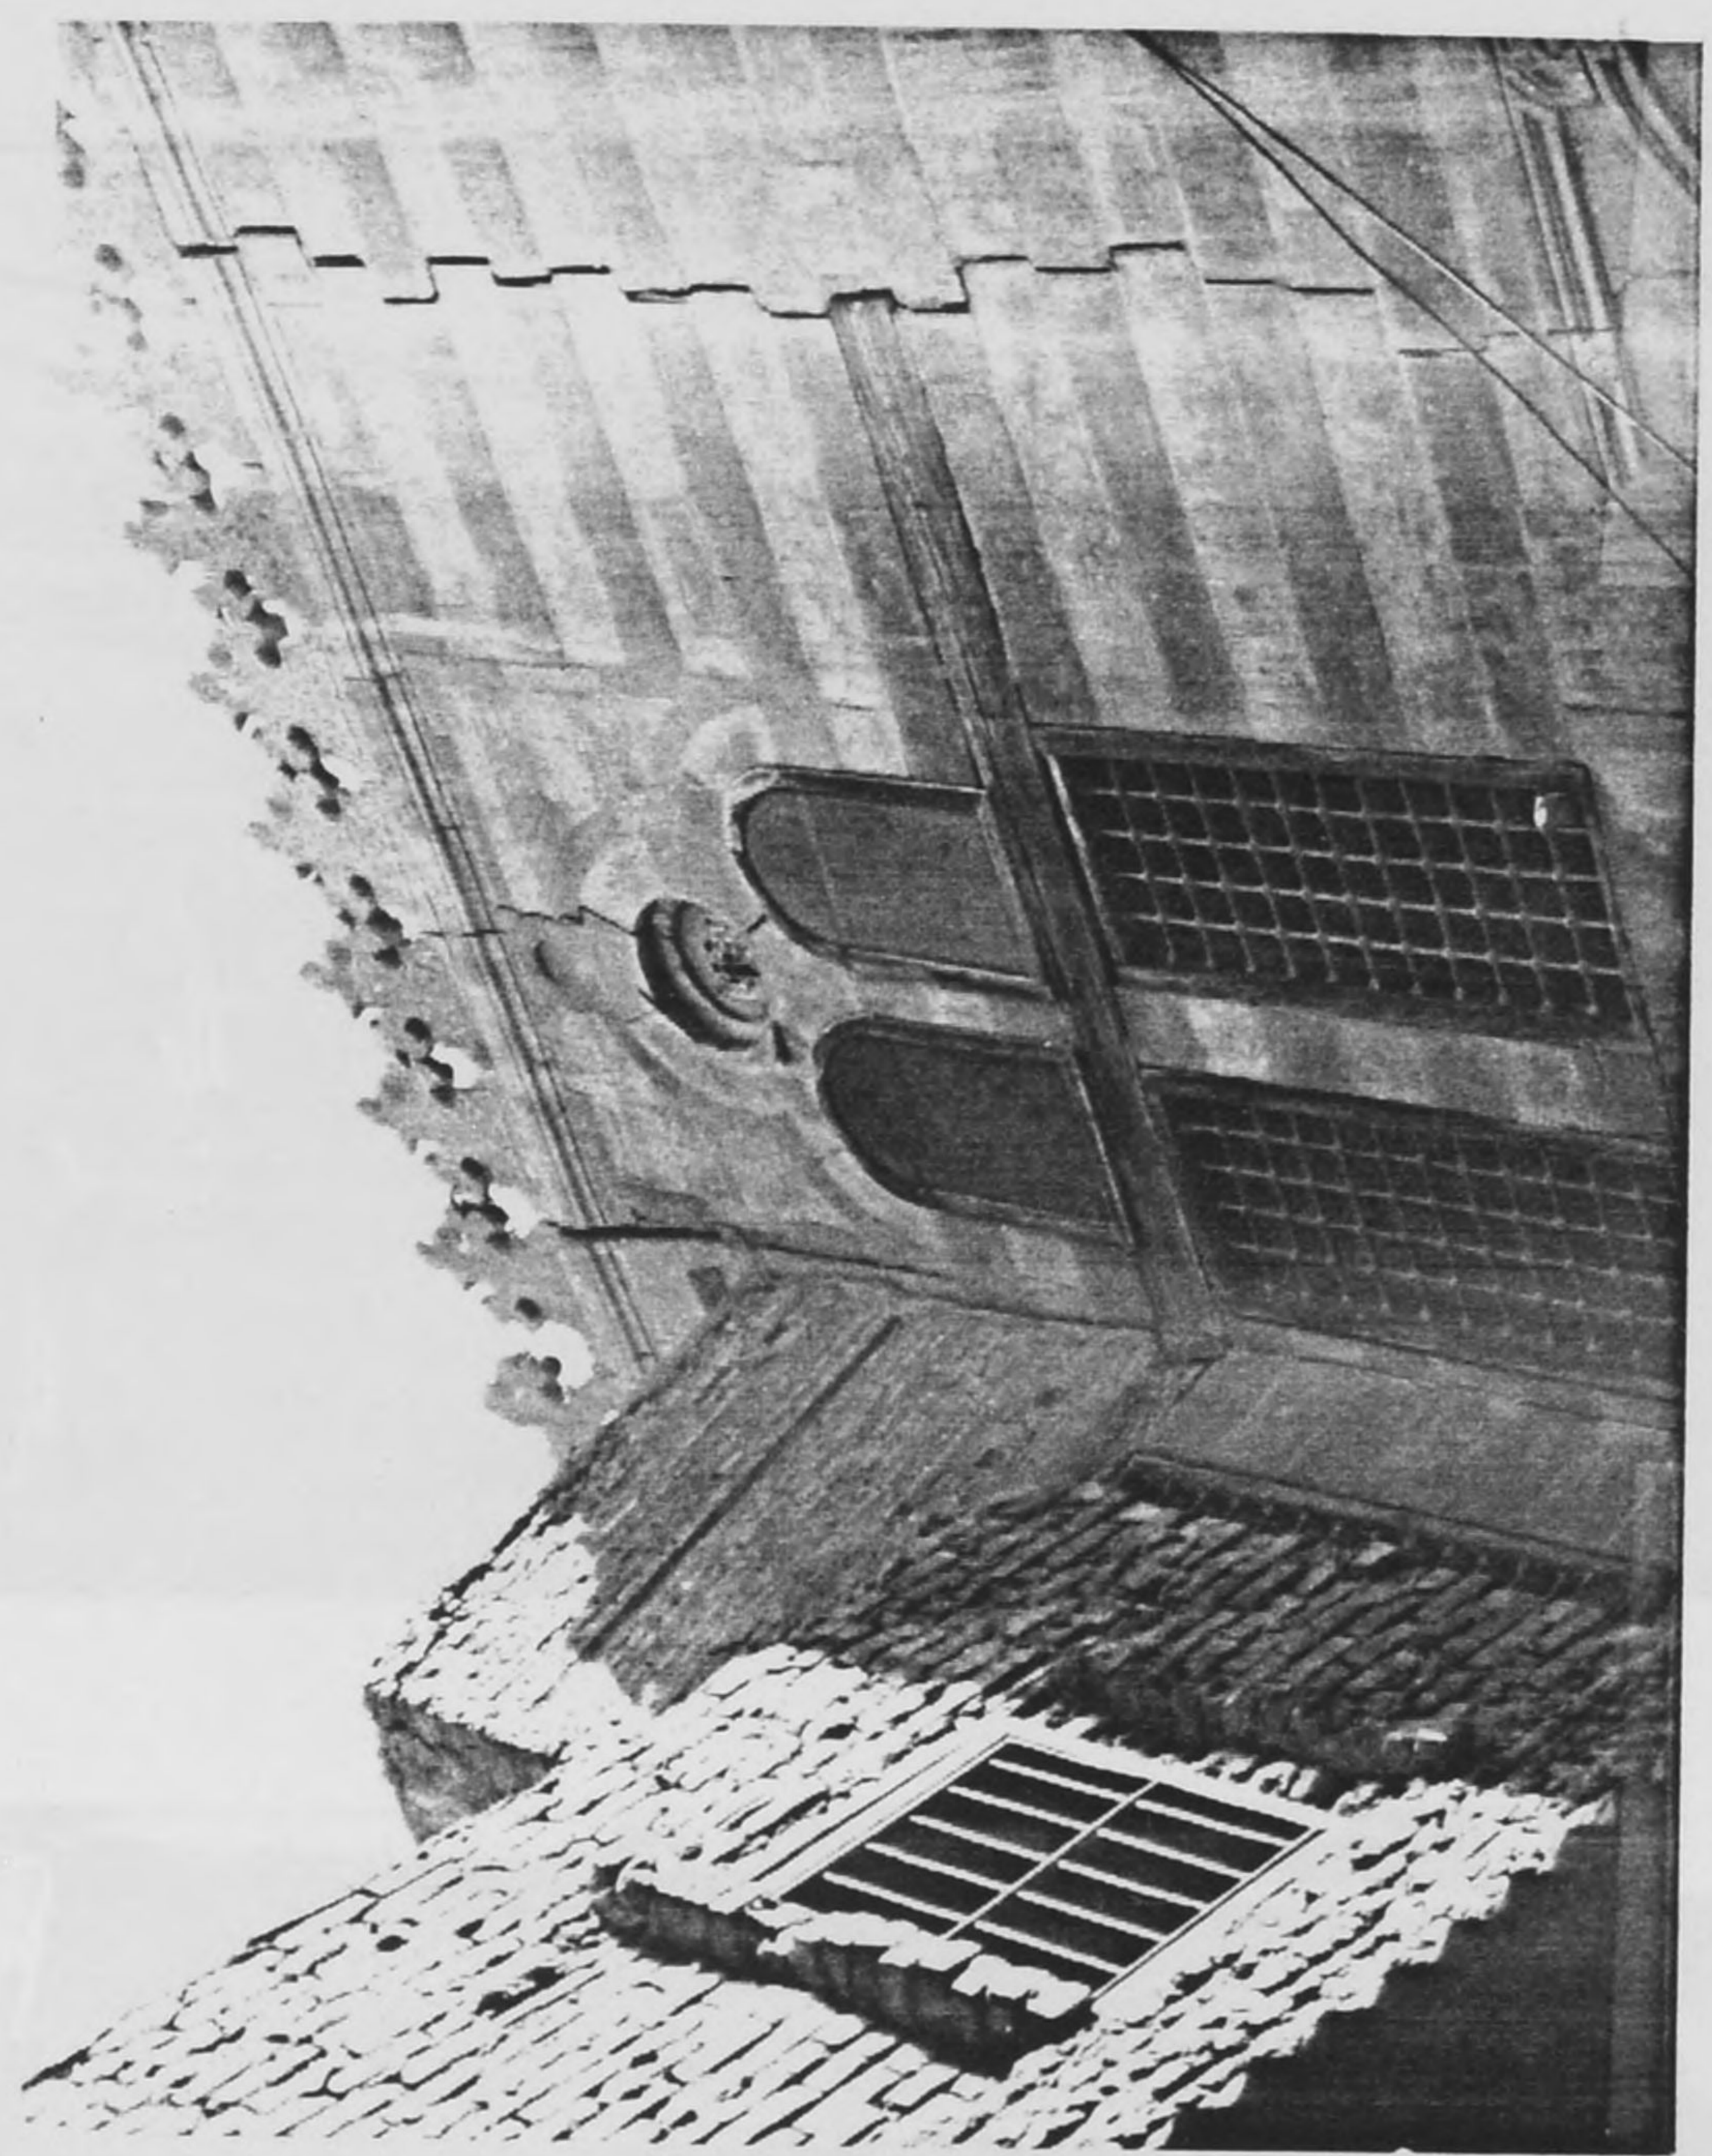
On the west side of the mosque there were numerous windows and reentrant corners. Cracks were clearly visible in several locations (Figs. 4 and 5). All of these cracks seemed to be old cracks and were certainly not caused by the earthquake. Plaster strips had recently been applied across some of these cracks (Fig. 5). It was reported that the strips were all applied within the last three months before the earthquake. The strips had been placed across the cracks to study movement along or across the cracks due to settlement or other causes. However, in this case they served as an excellent indicator of movements due to the earthquake. The plaster strips shown in Fig. 5 appeared to be undamaged.

One other concern was the safety of the ornamental parapet wall around the top of the mosque. In some cases cracks in the walls extended up through the parapet (Fig. 4). It appeared that portions of the parapet could fall during a significant aftershock or future earthquake.

Fig. 4 Cracks in west wall of El-Ghuri Mosque

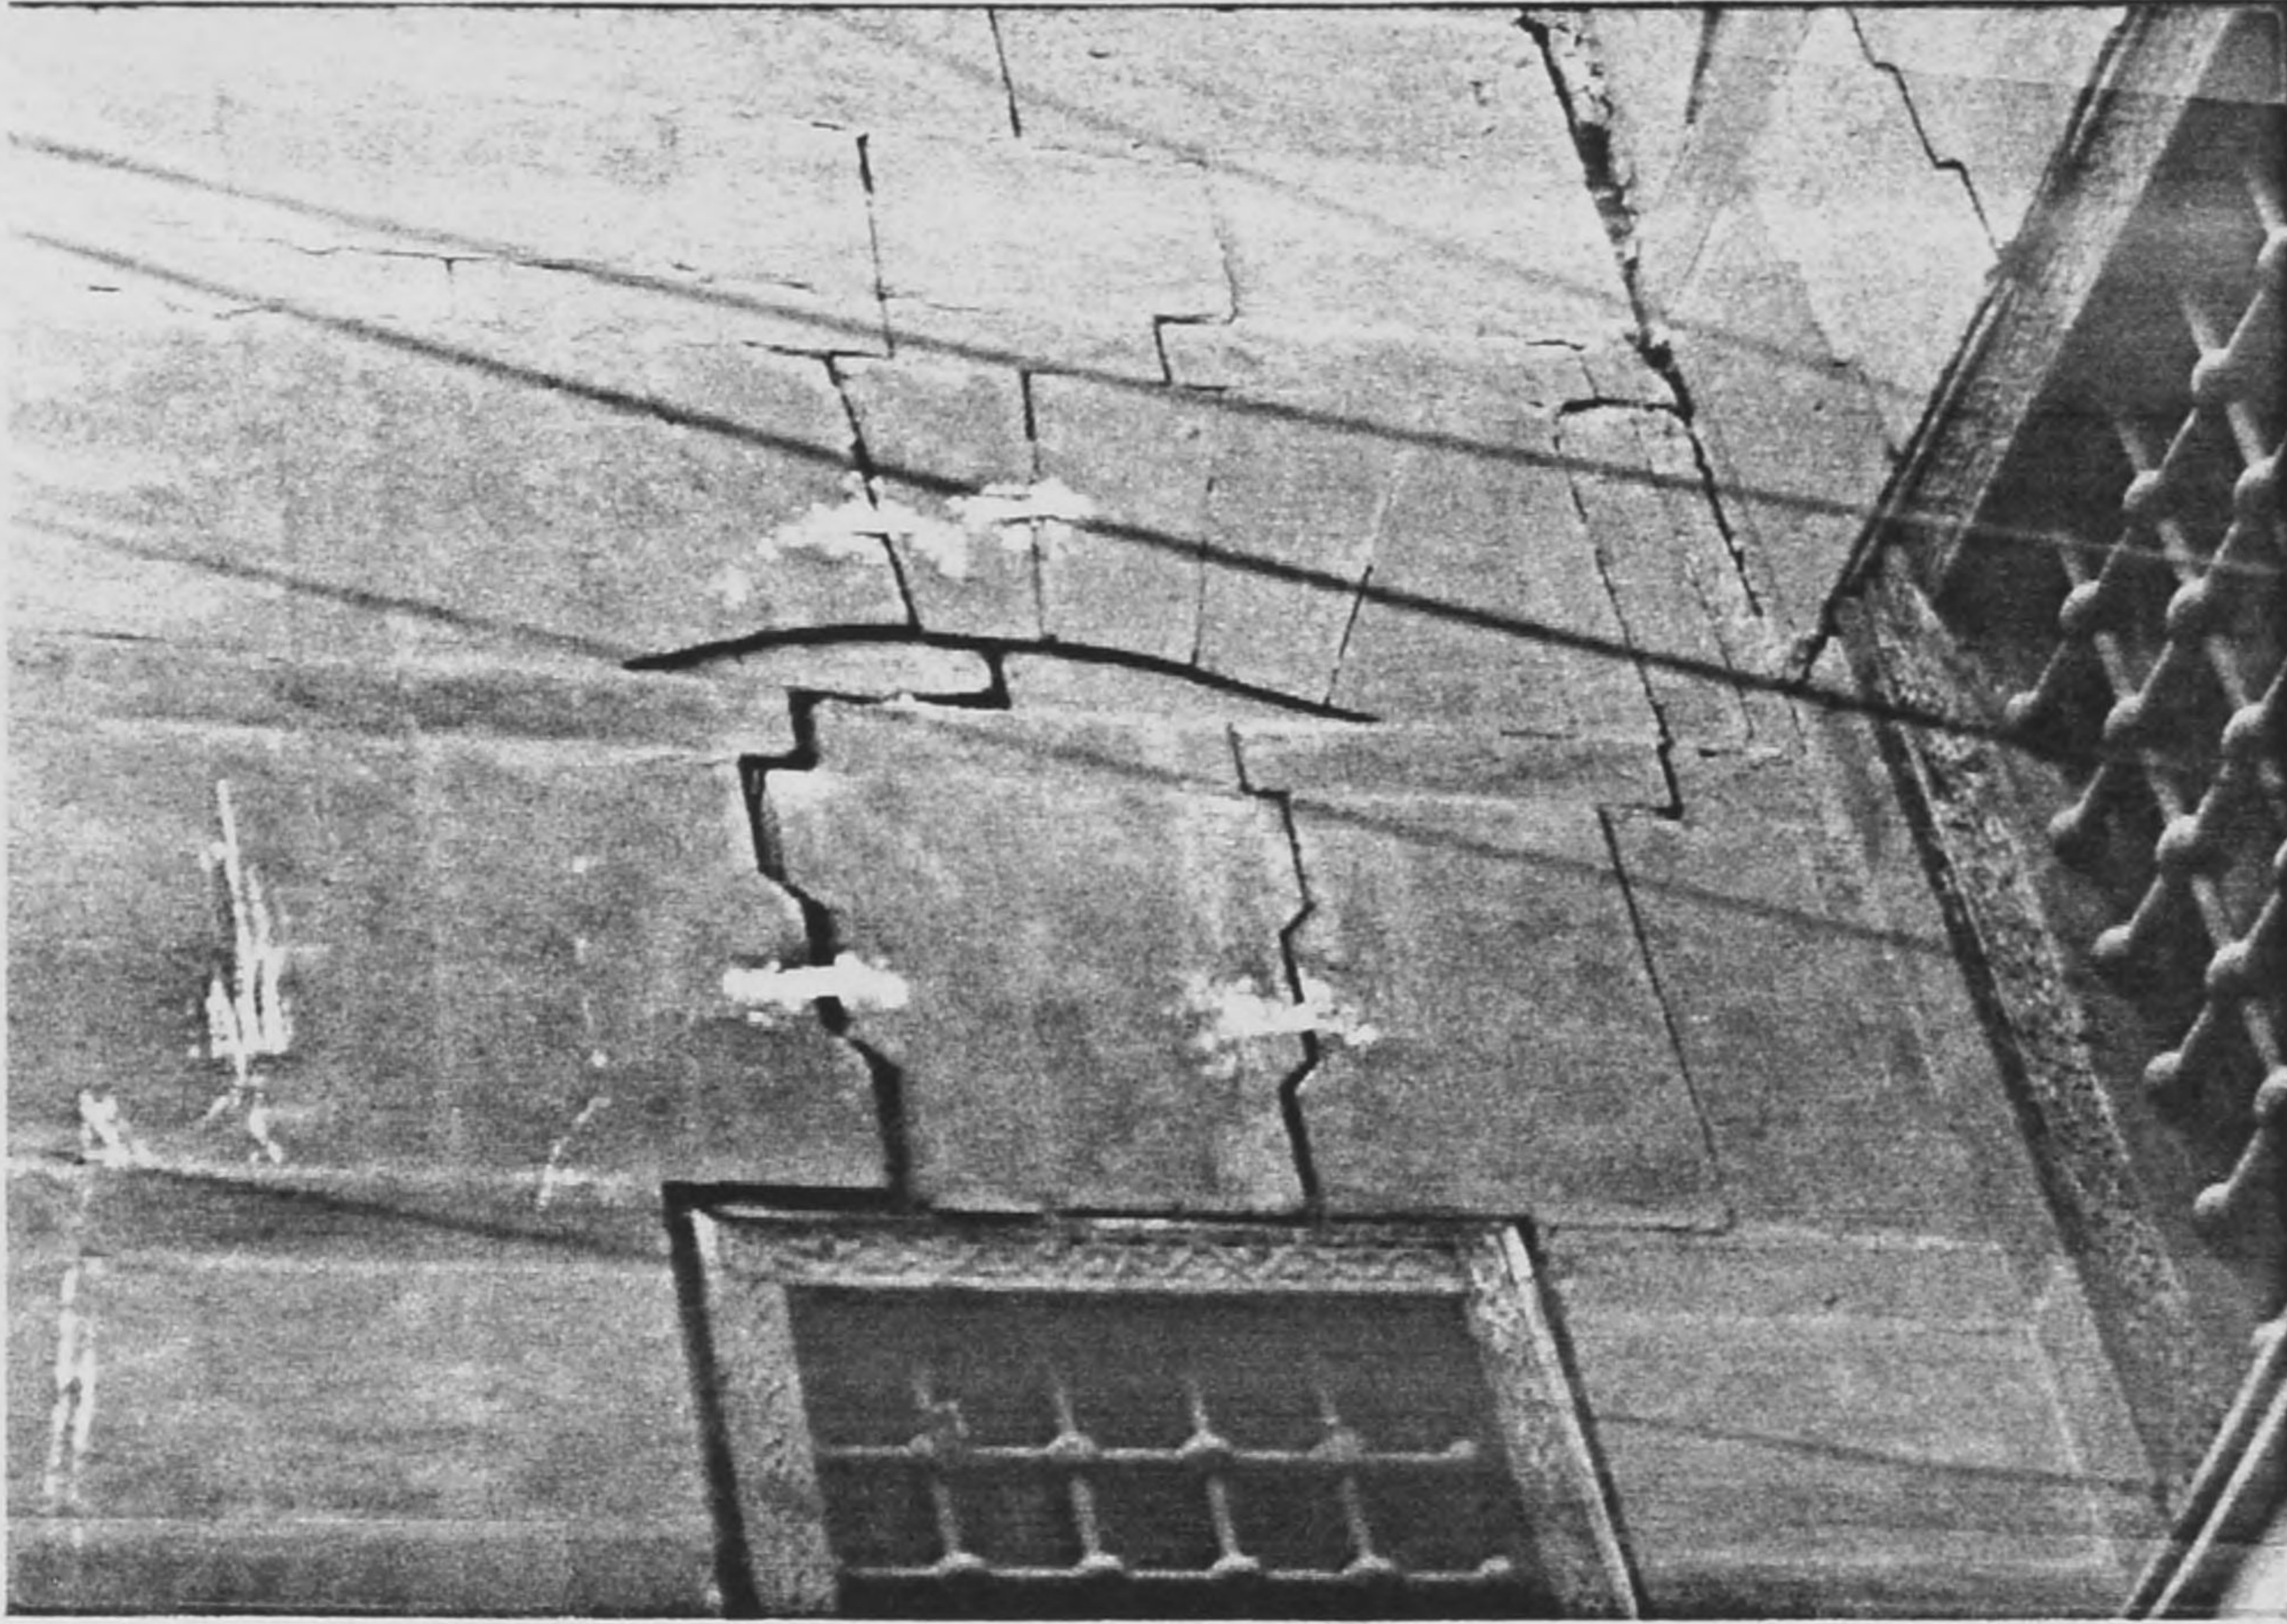
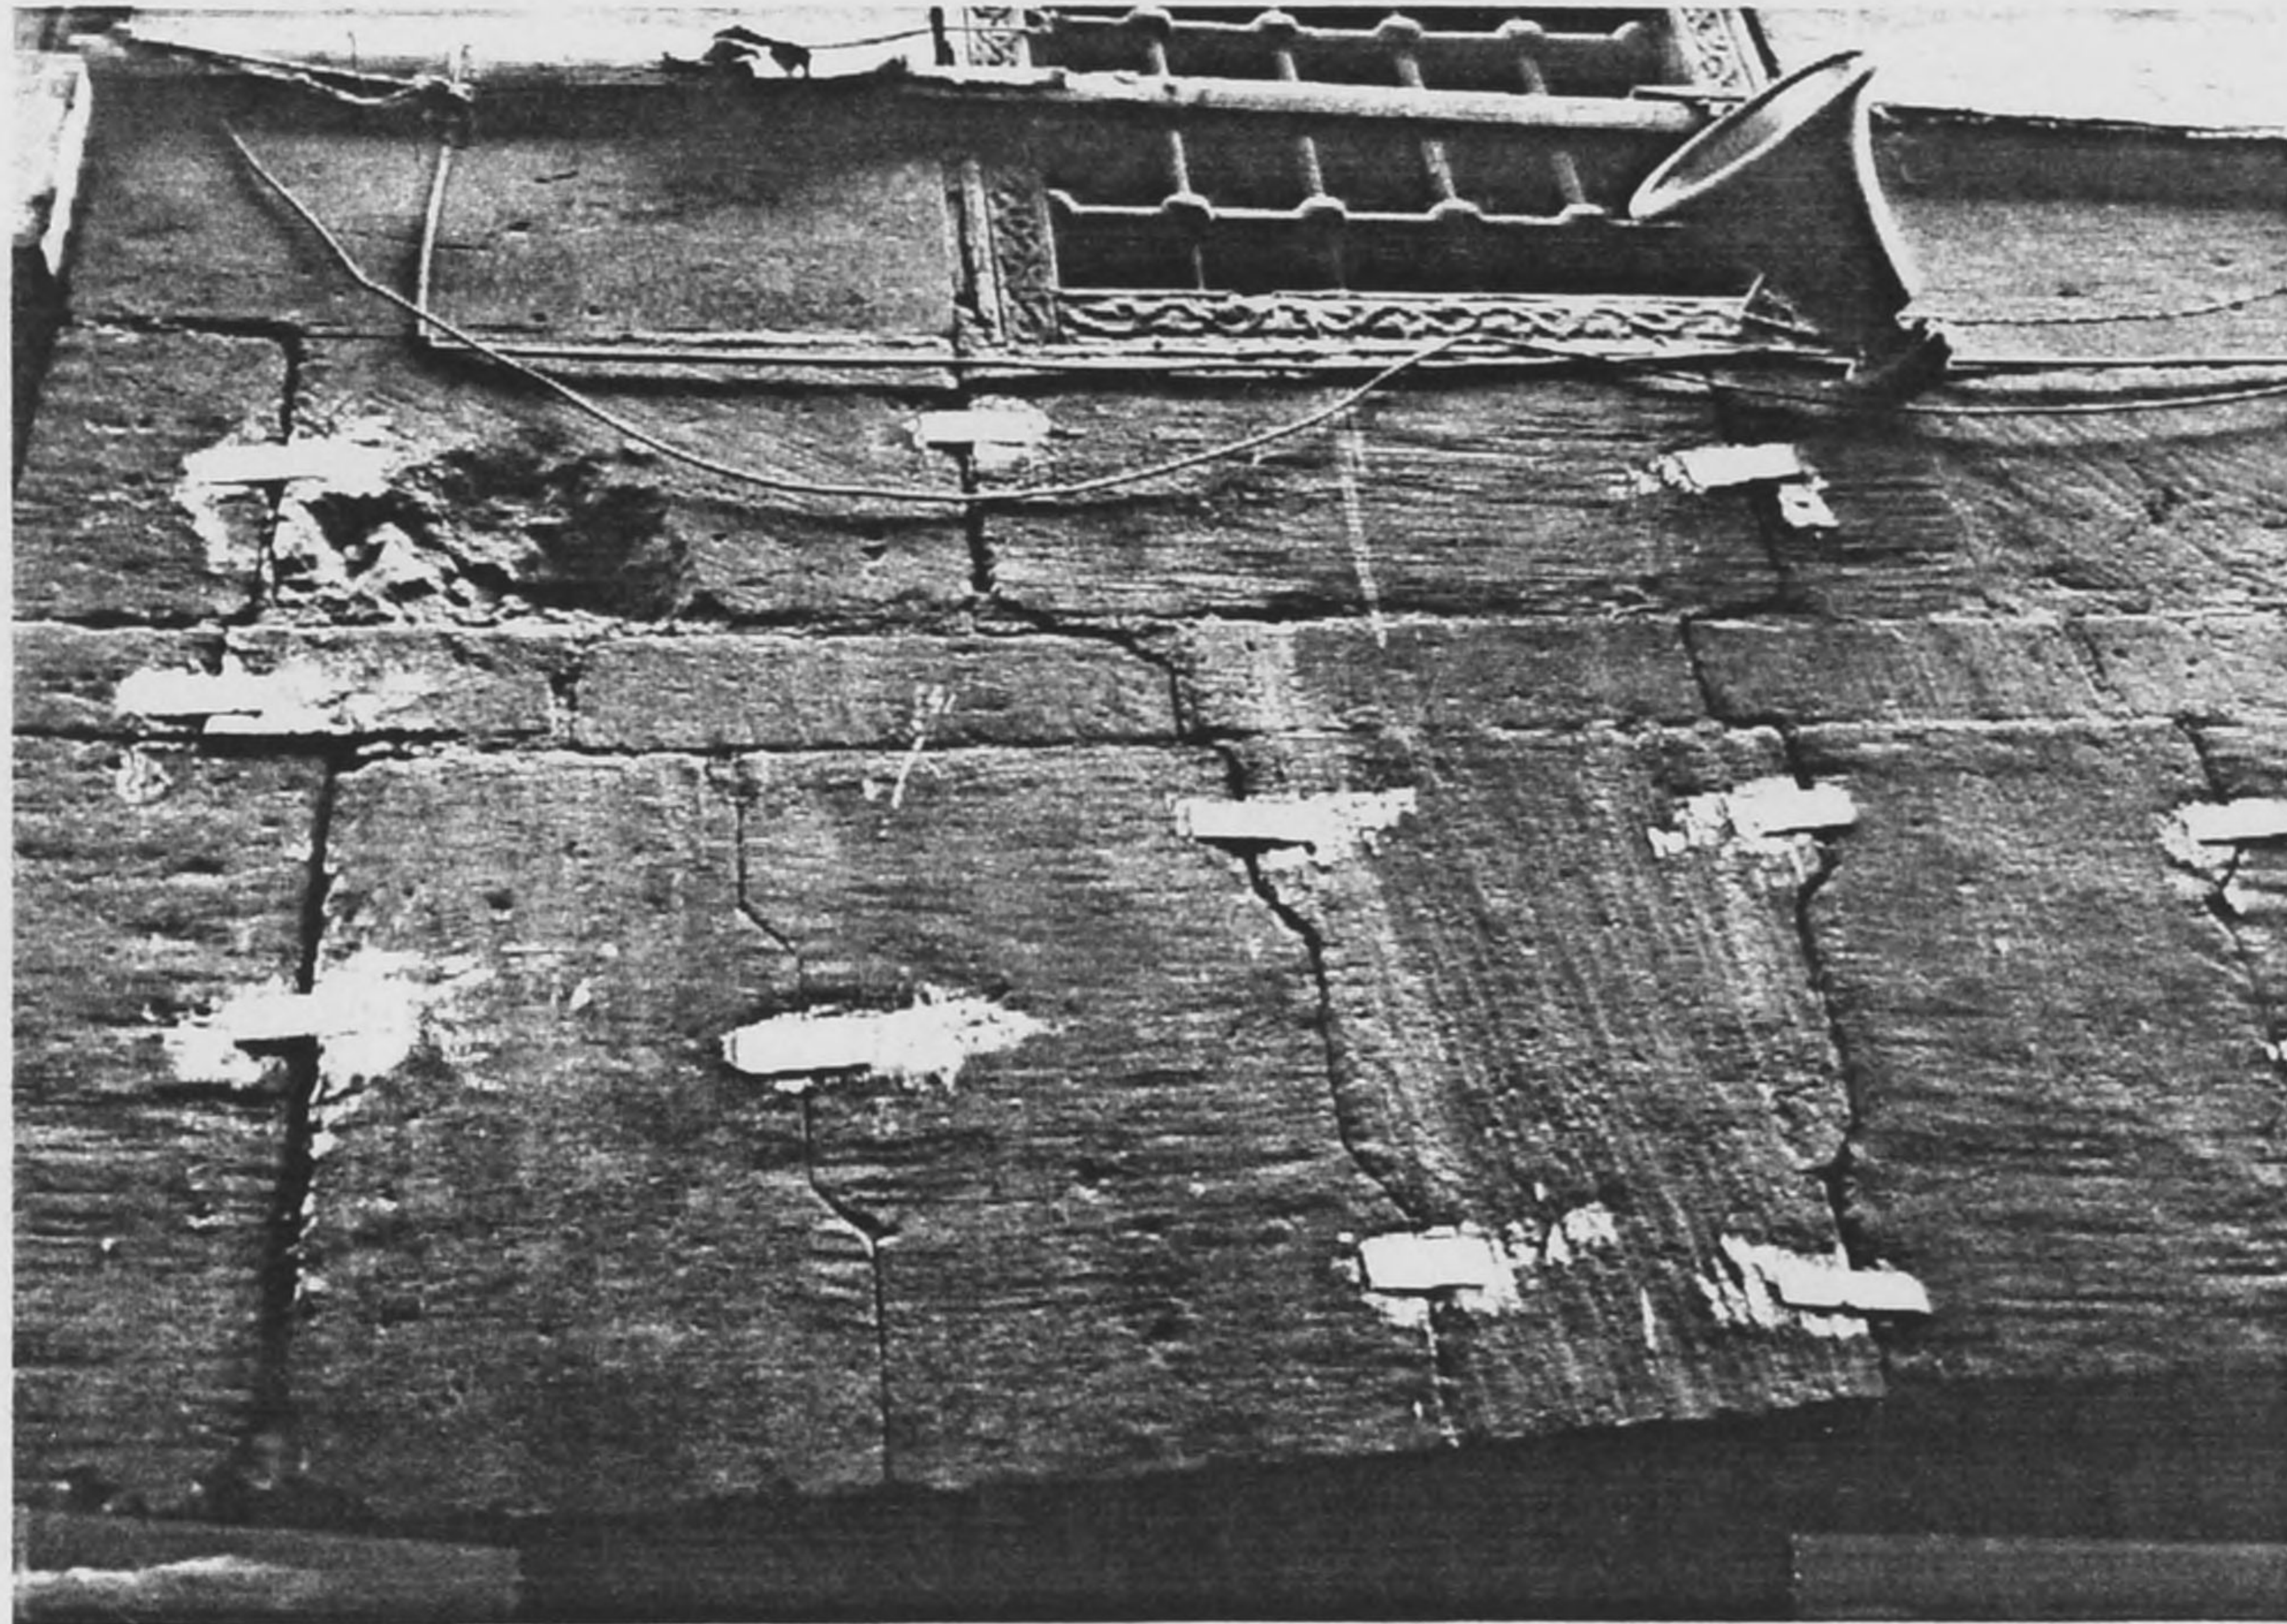
Fig. 5 Plaster strips across cracks in west wall of mosque
