Report No. UMCEE 92-31

Field Investigation of Damage to Islamic Monuments Caused by the Egyptian Earthquake of October 12, 1992

**James K. Wight
Roman D. Hryciw
Antoine E. Naaman**

December 1992

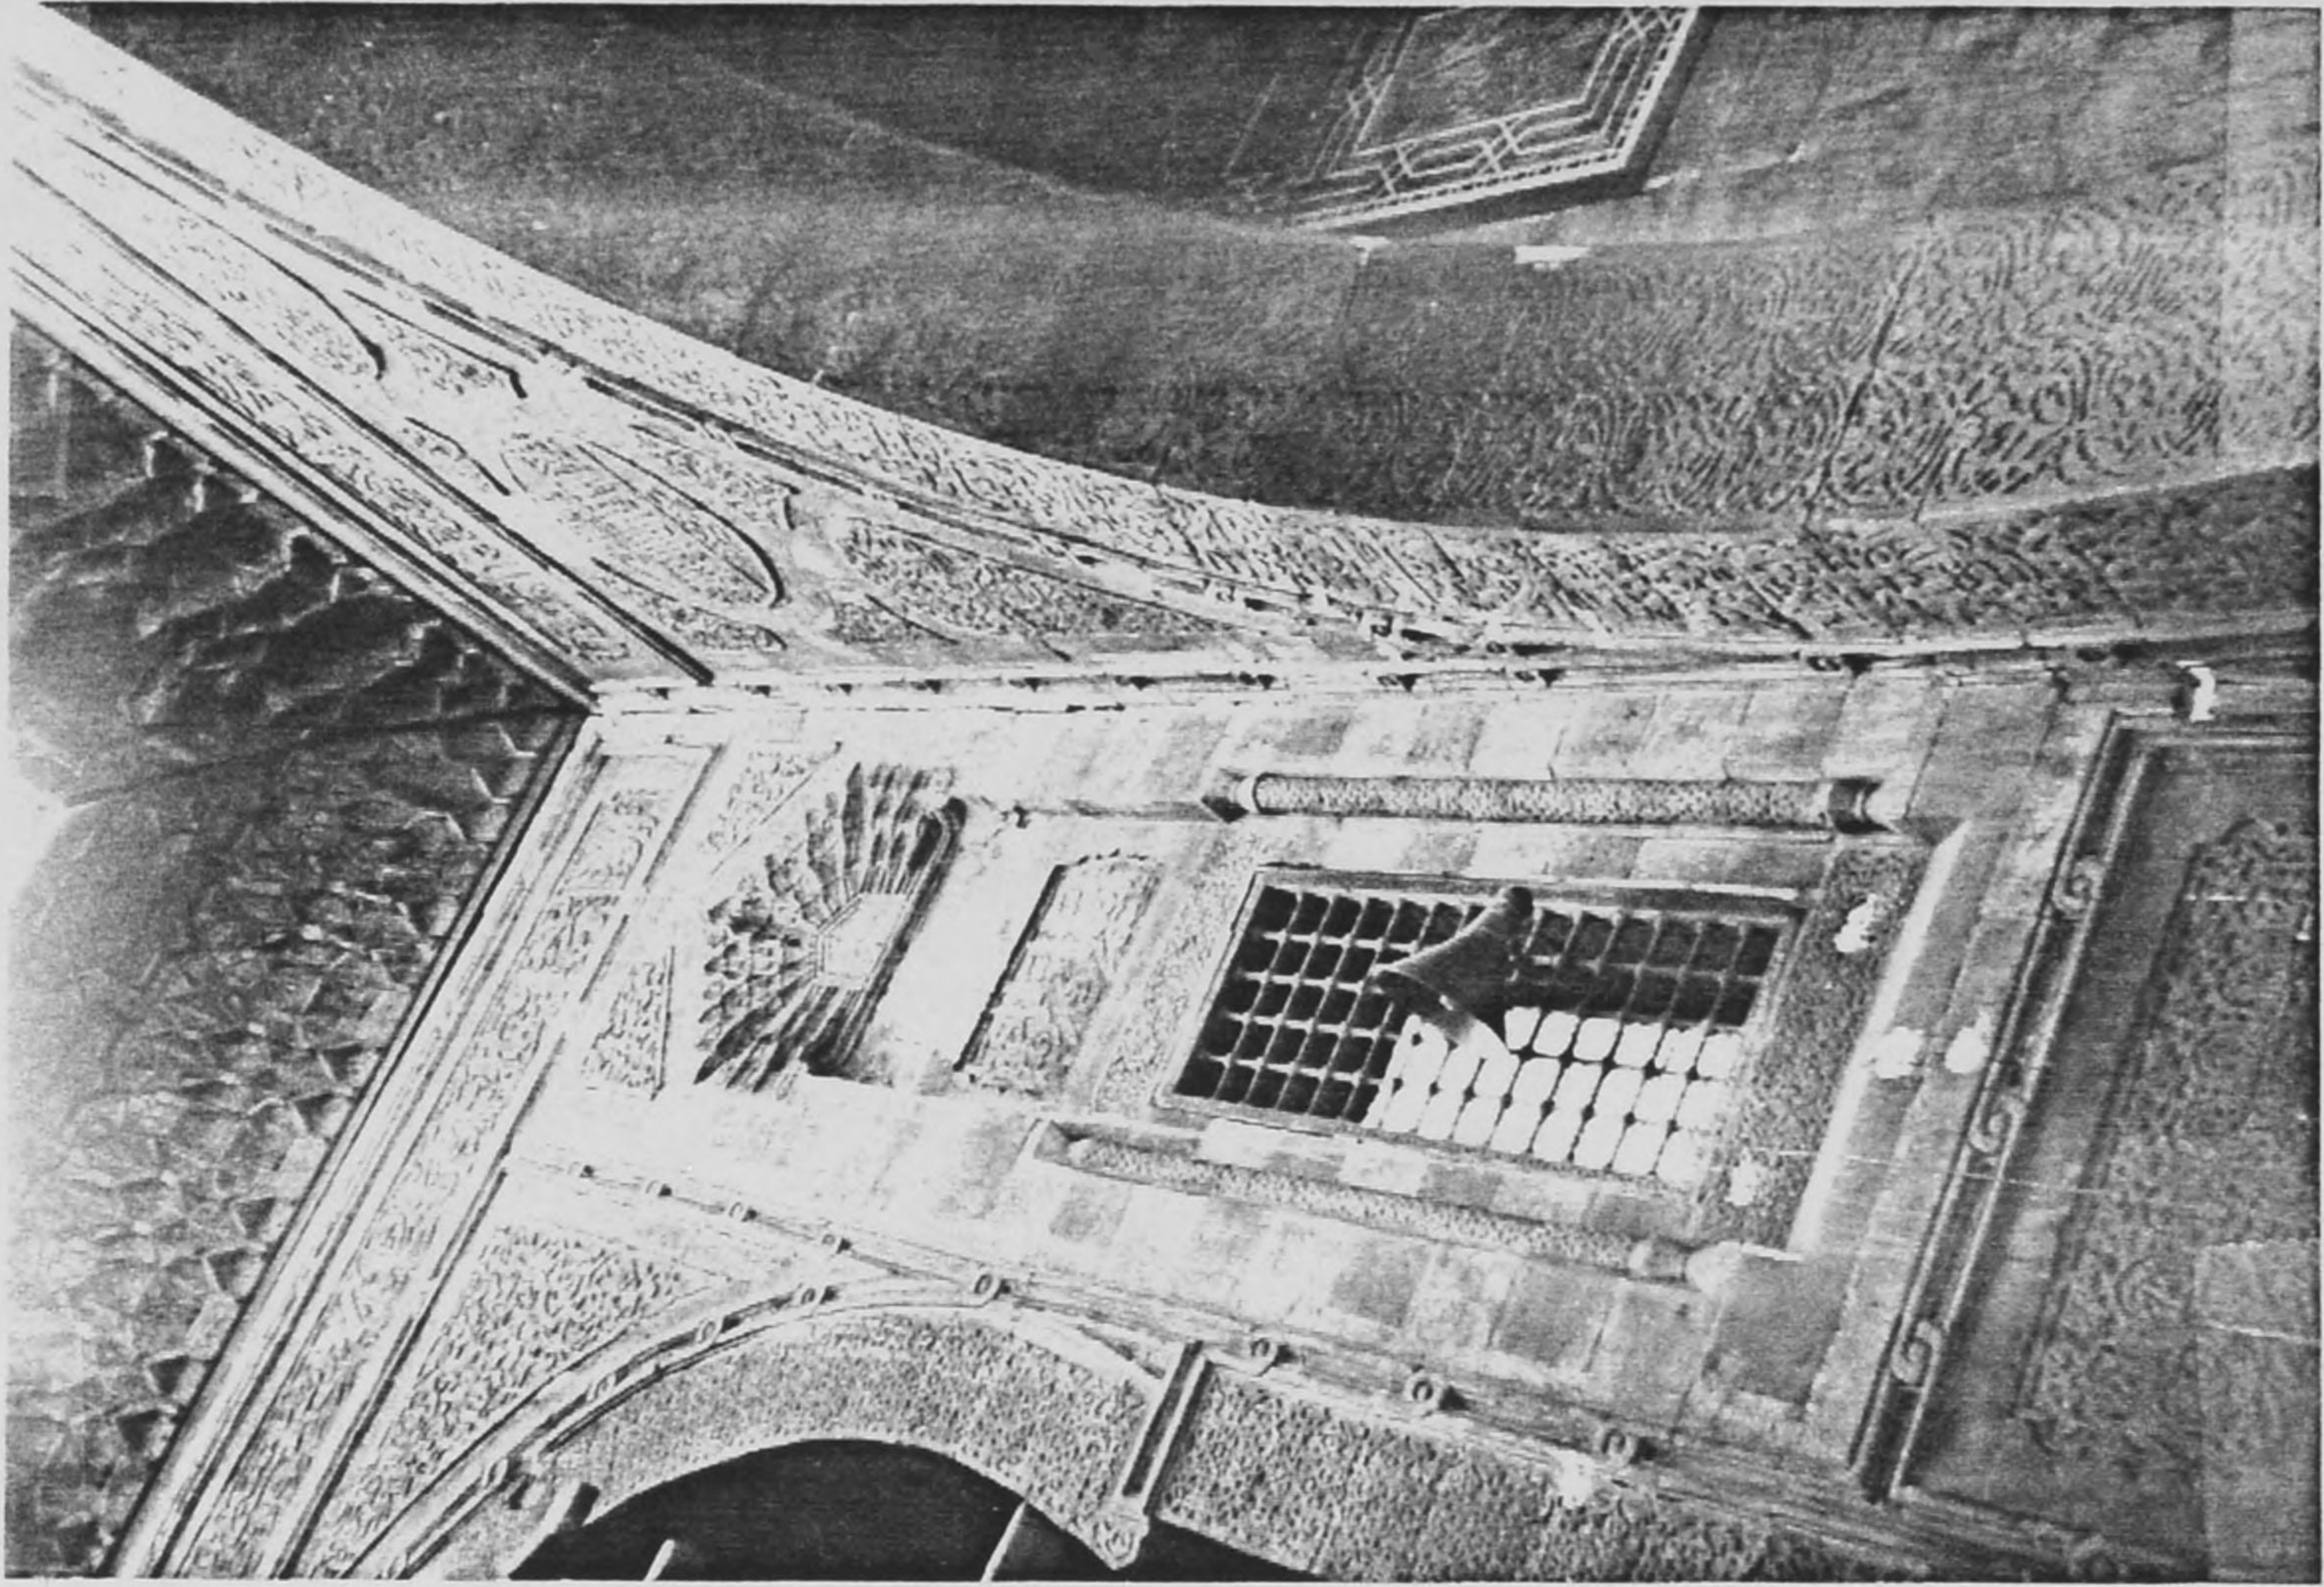
Inside the mosque there were more cracks and numerous plaster strips across several of the cracks (Fig. 6). Again, most of the plaster strips were not broken. Of the ones that were cracked and could be observed closely, the width of the cracks in the plaster strips varied between 2 to 5 mm. These strips were spanning cracks that varied in width from 15 to 40 mm.

Fig. 6 Interior of El-Ghuri Mosque with plaster strips across some of the cracks

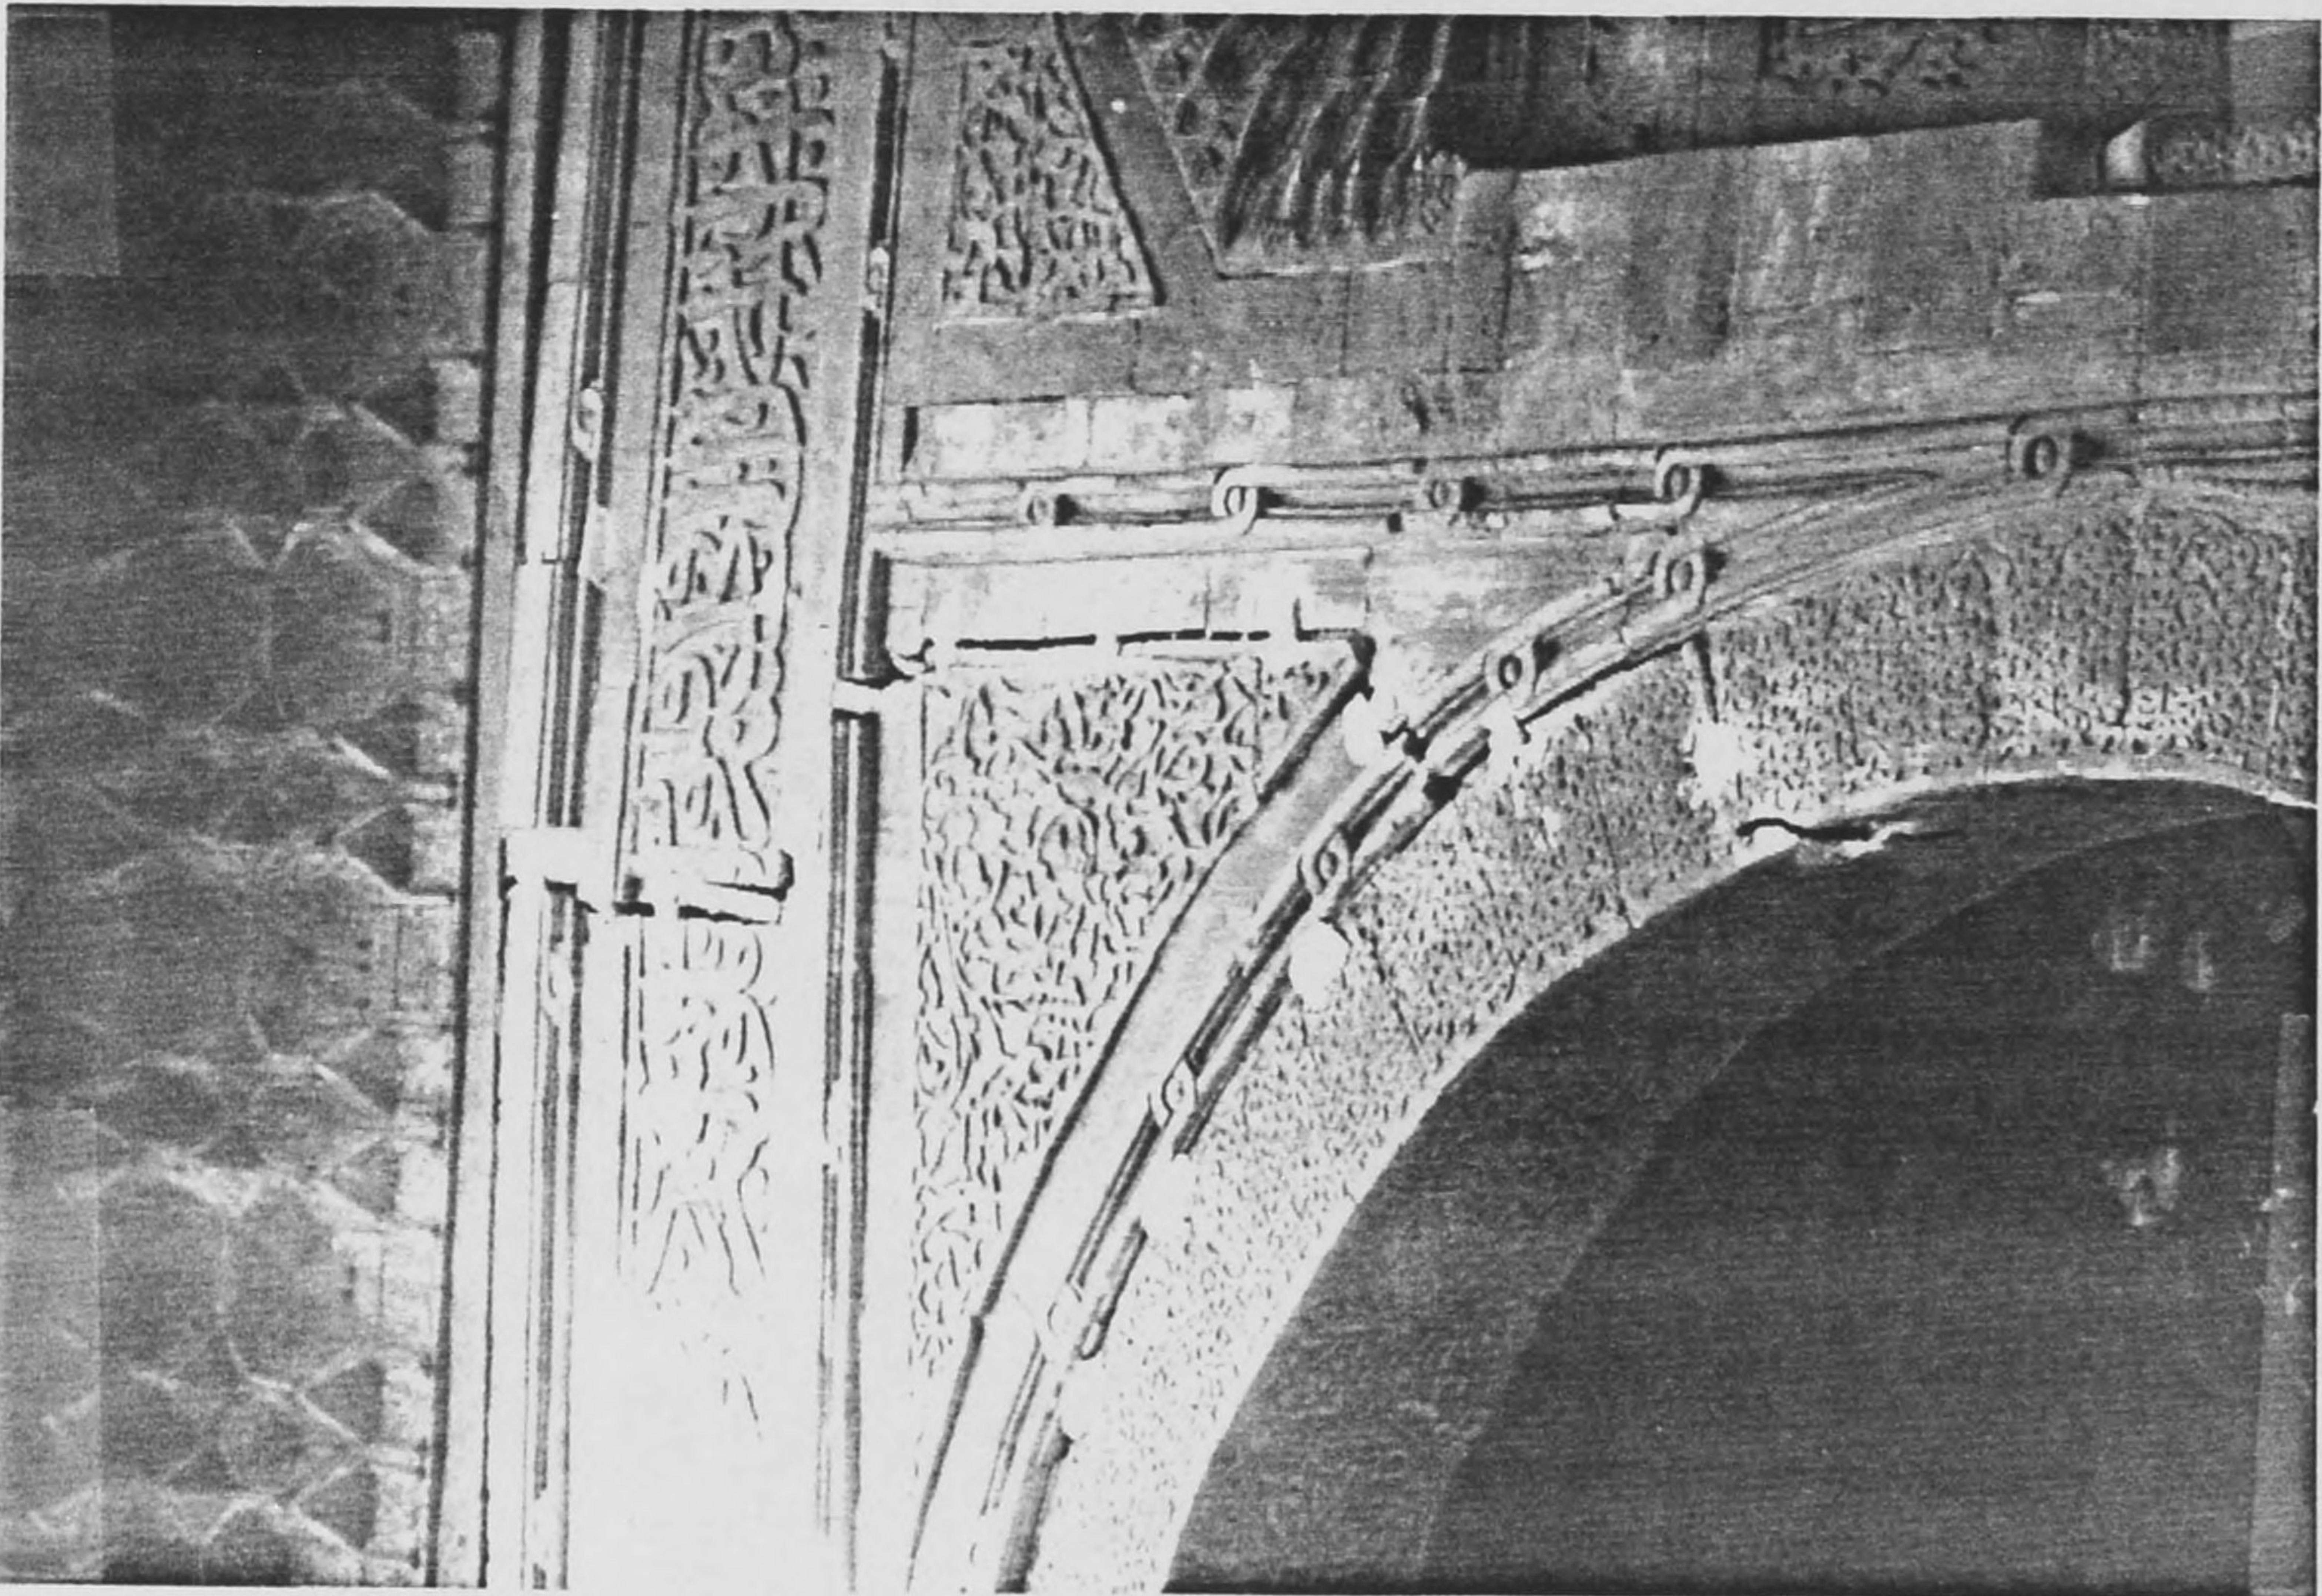
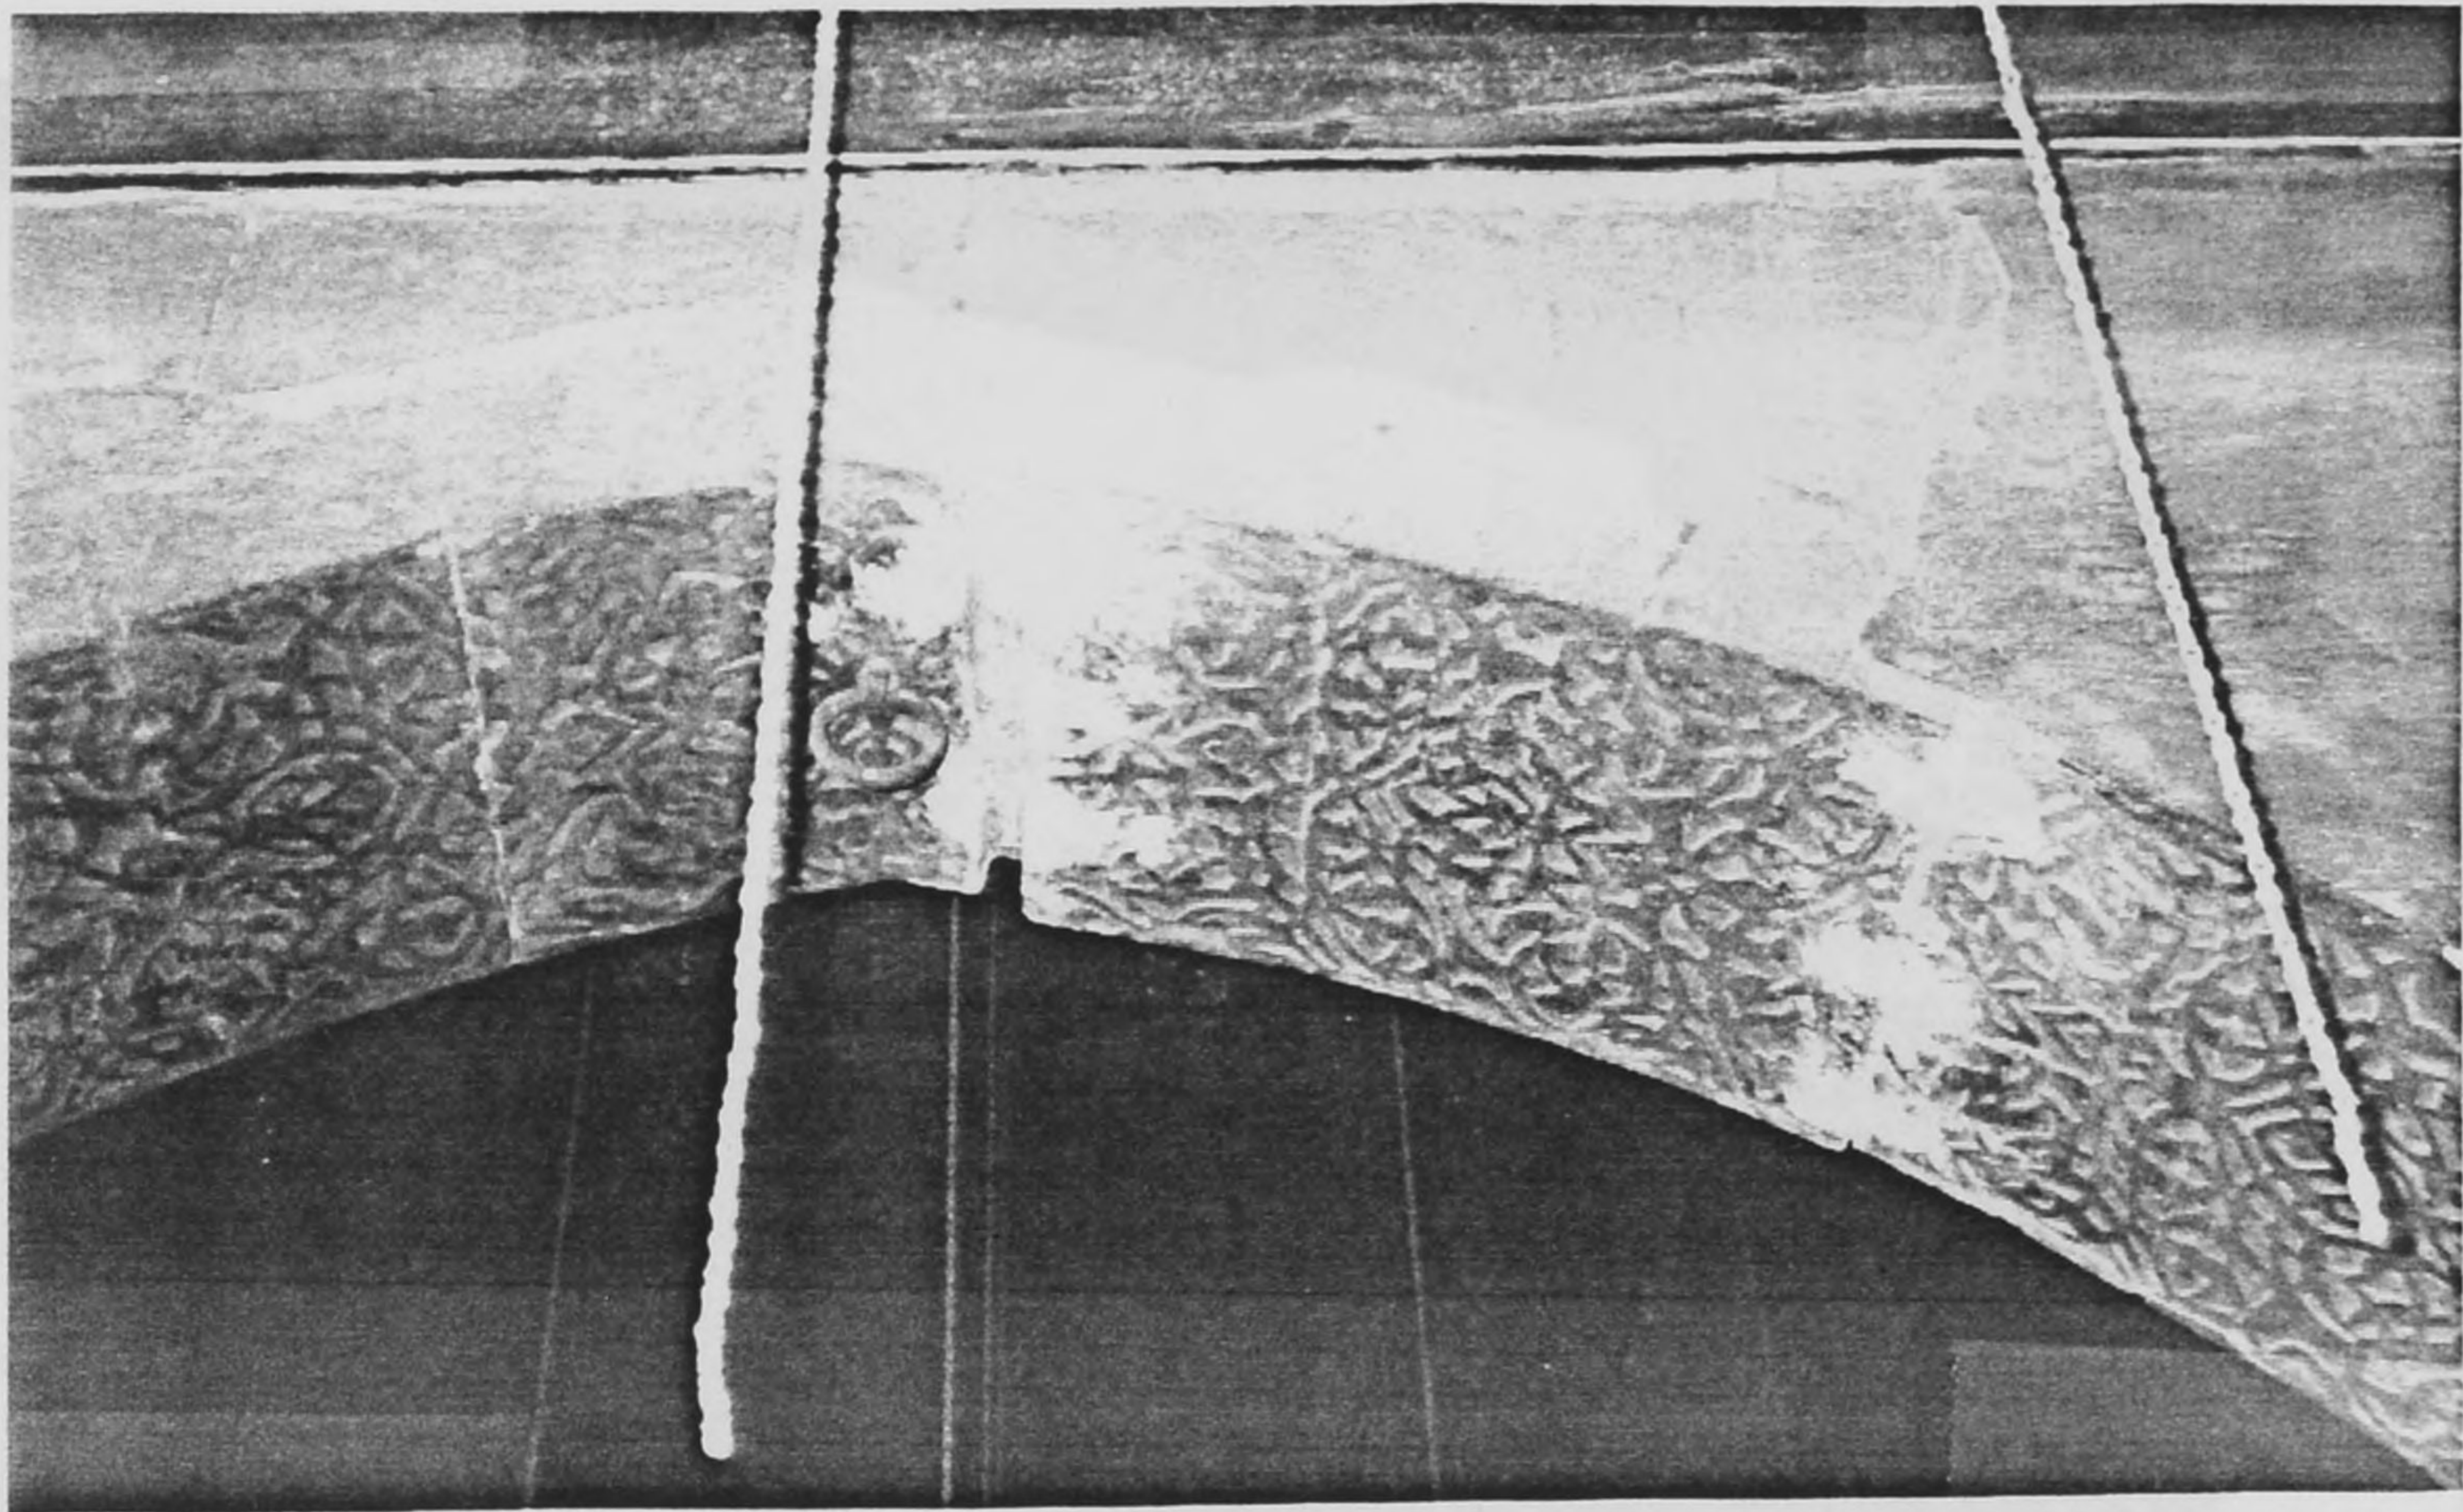
There were several archways within the mosque and some of them had significant damage (Figs. 7 and 8). It was reported that some of the ornate material attached to these archways had fallen during the earthquake. Plaster strips had again been applied across some of the preexisting cracks in the arches and the majority of the strips had not been broken. In some of the smaller archways the keystone was loose. At these locations plaster strips had been applied across the cracks and the keystone had apparently been braced before the earthquake. It appeared that additional damage to these archways during the earthquake was small.

Fig. 7 Major archway across interior of El-Ghuri Mosque

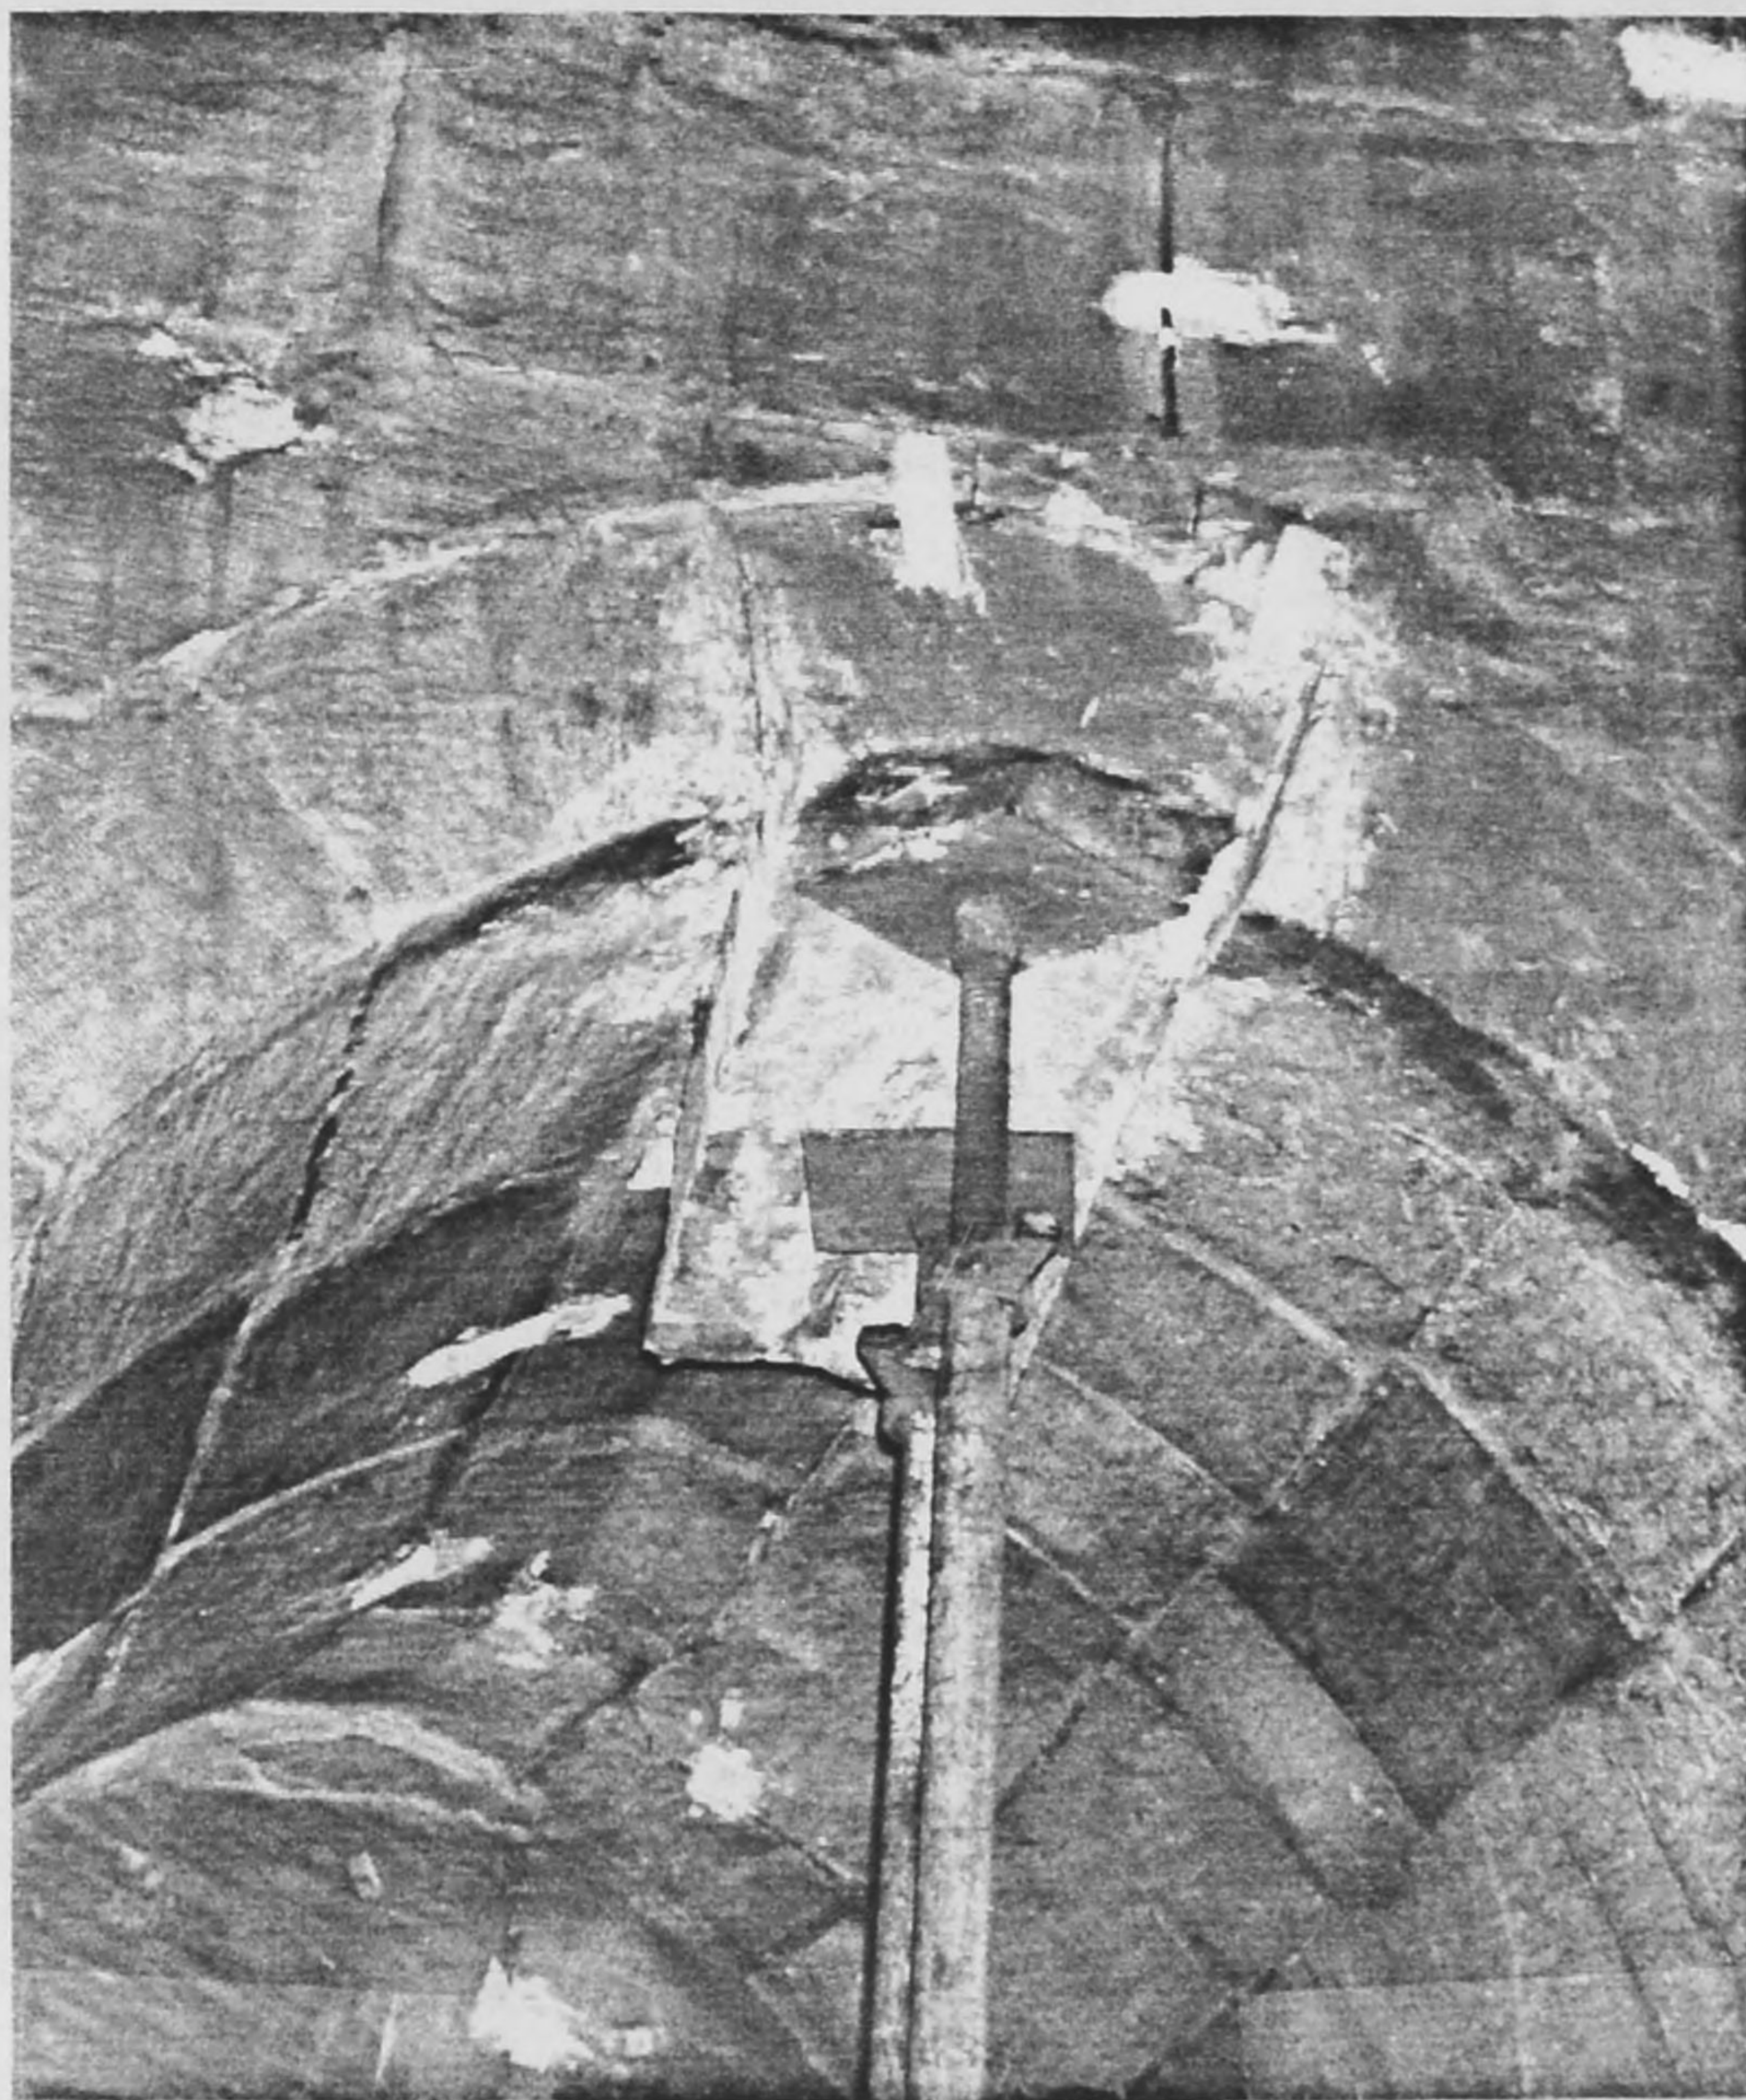
Fig. 8 Loose keystone in arched ceiling over hallway

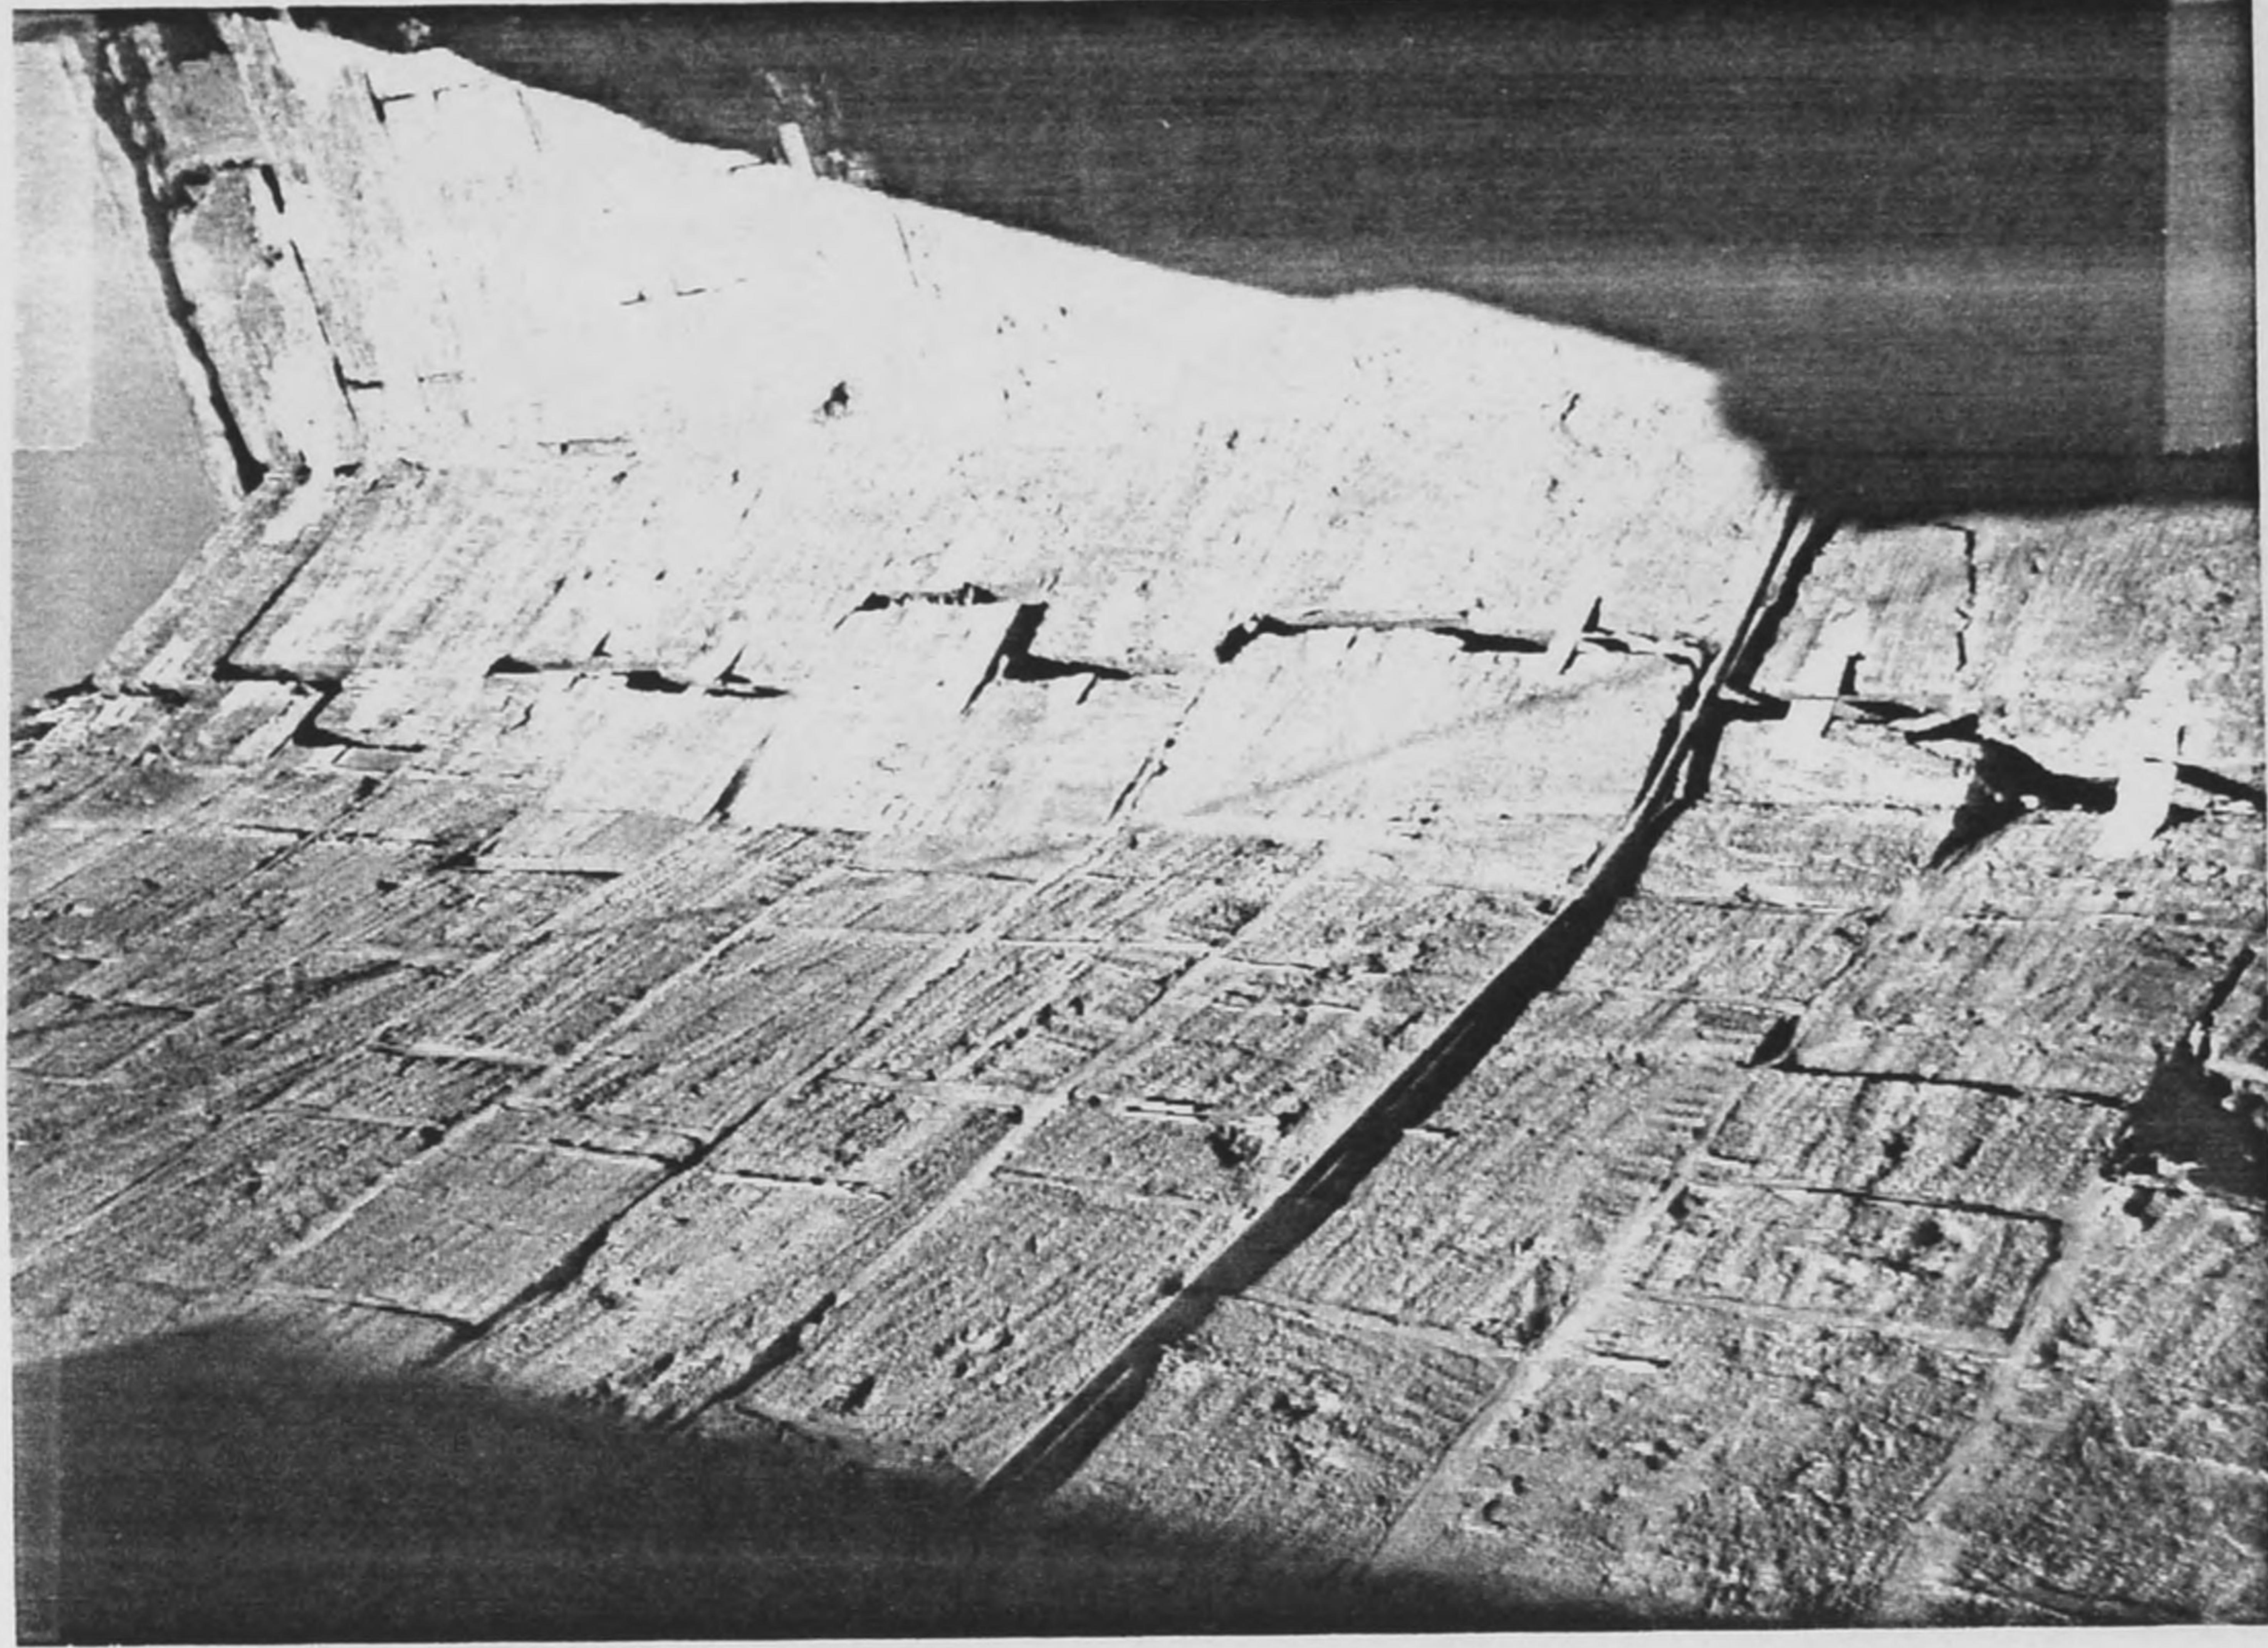
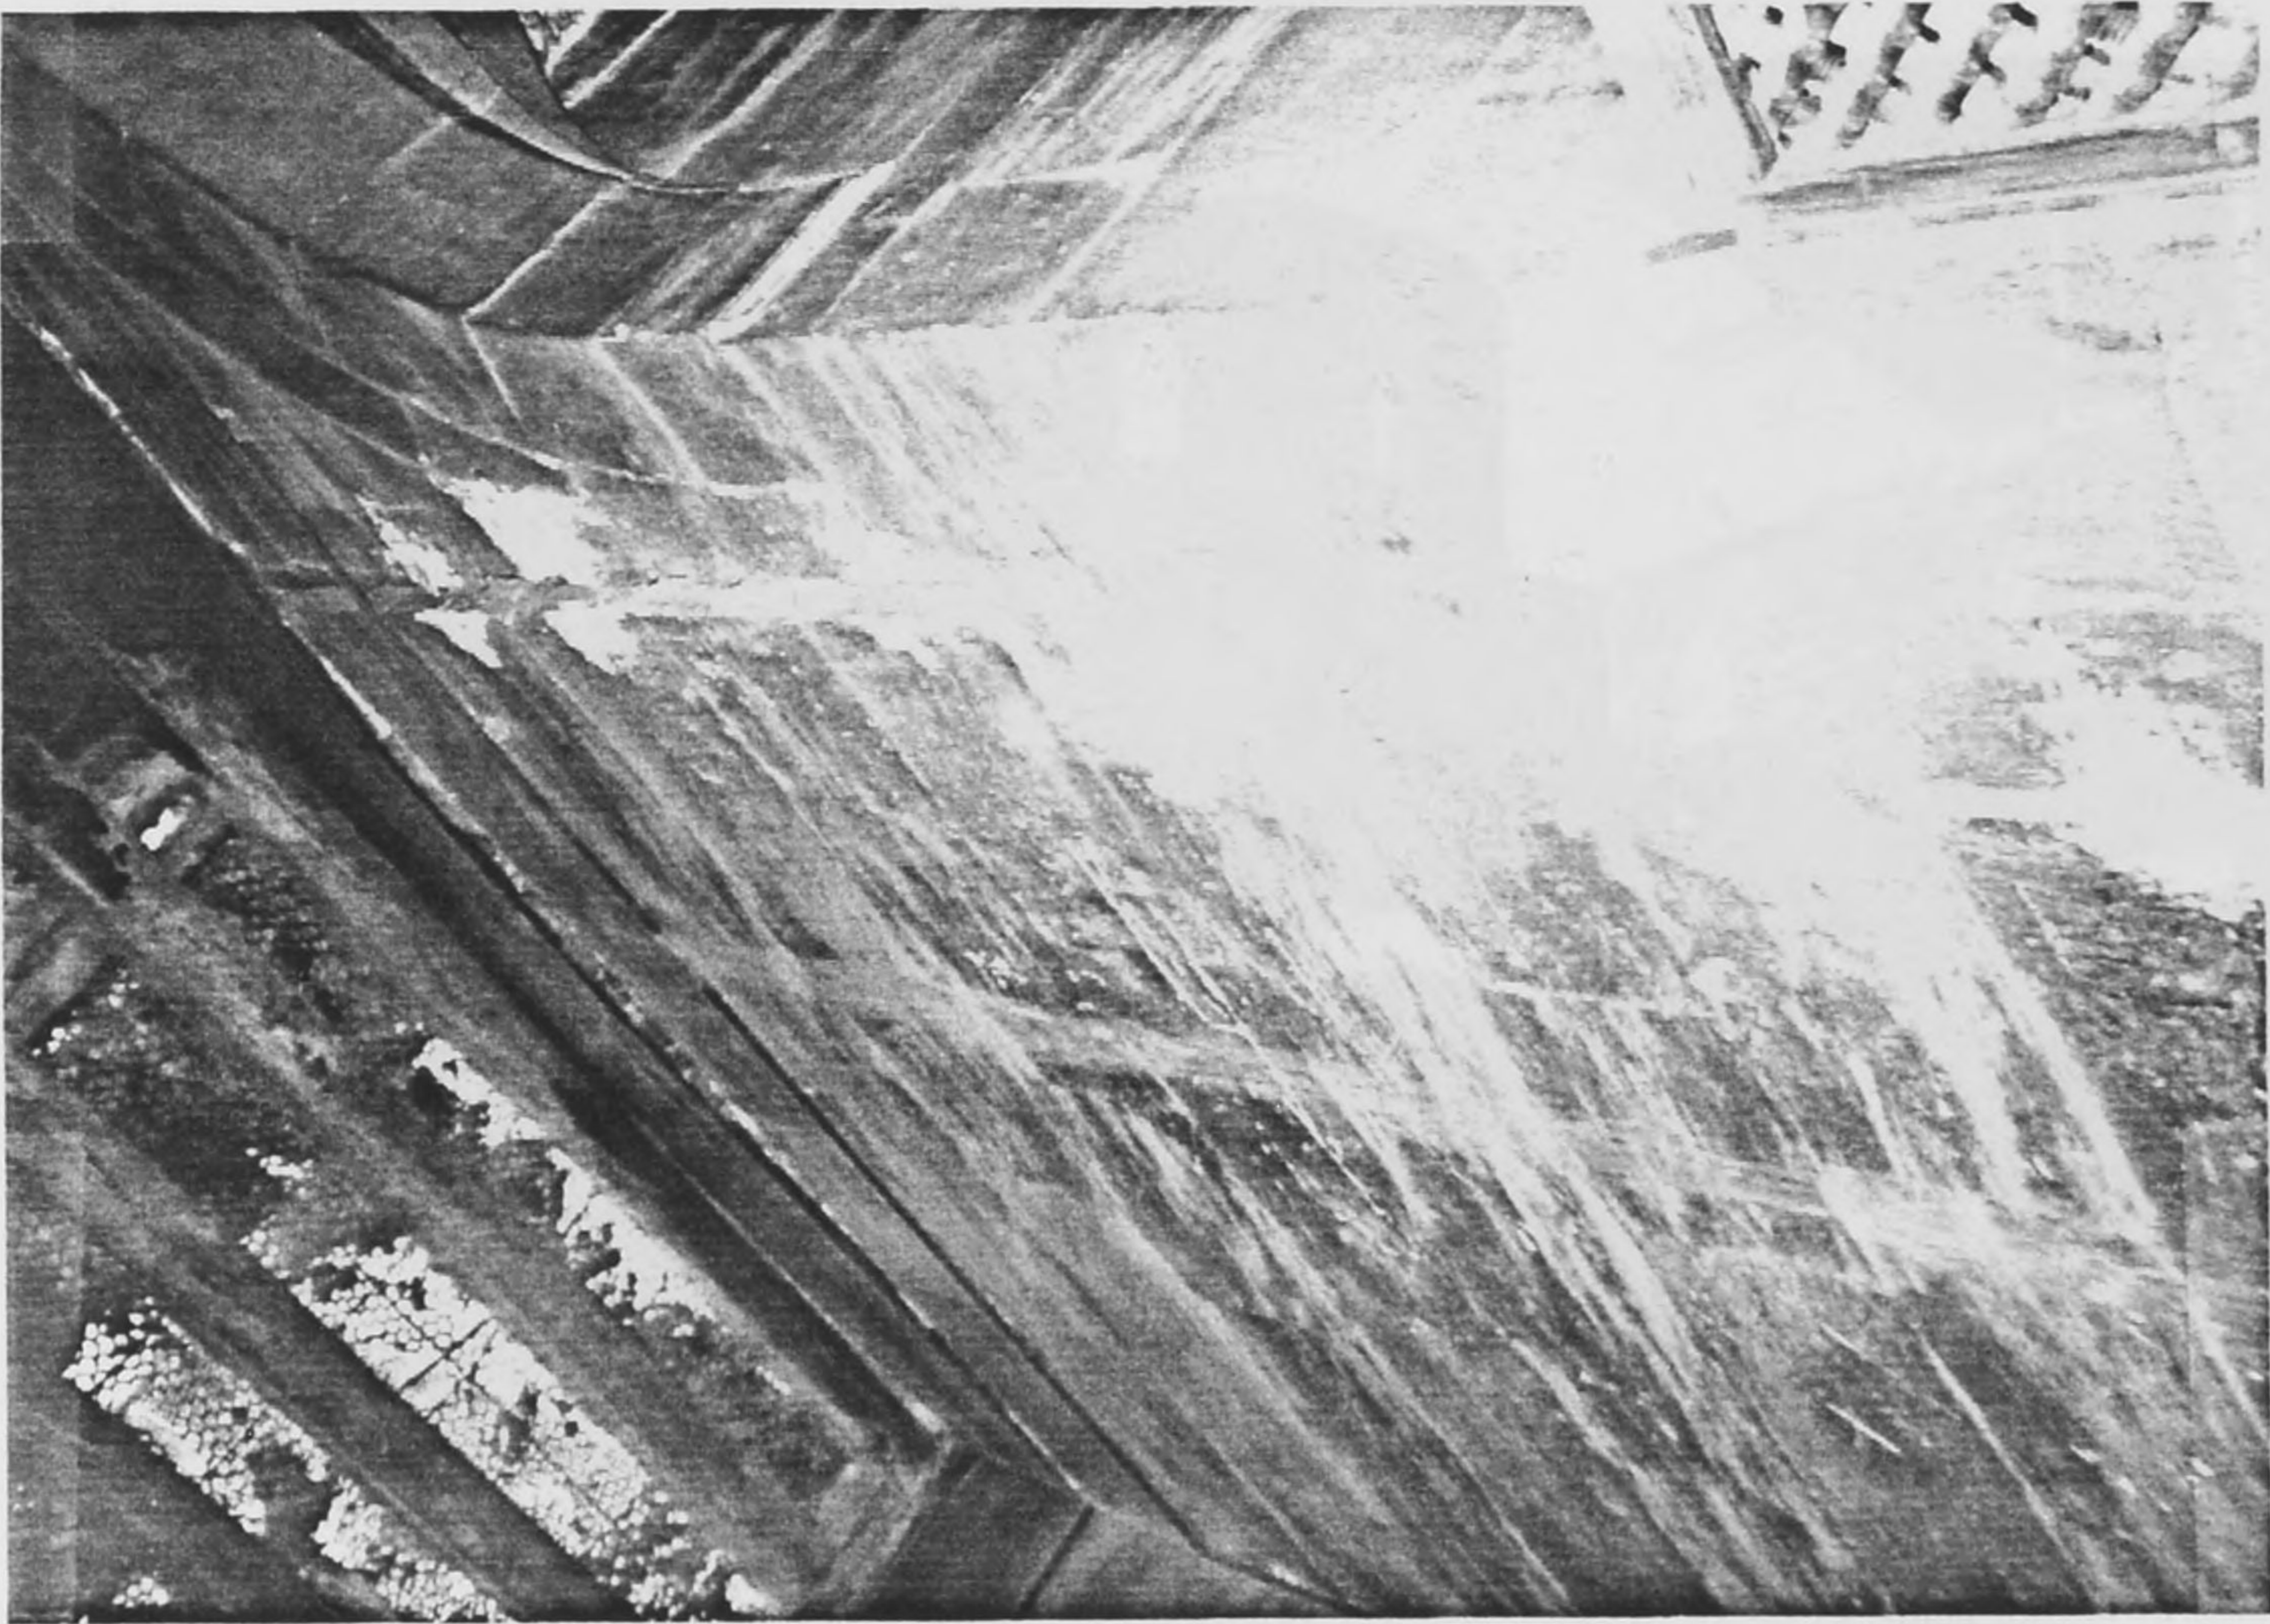
At some wall intersections, both inside and outside of the mosque where plaster strips had also been applied, the strips were broken in a manner that indicated more significant differential movement between the adjacent walls during the earthquake (Fig. 9). These movements seemed to indicate that due to the preexisting cracks, continuity between these walls had been lost. Thus, they moved independently during the earthquake.

Fig. 9 Cracks at wall intersections of El-Ghuri Mosque
