Report No. UMCEE 92-31

Field Investigation of Damage to Islamic Monuments Caused by the Egyptian Earthquake of October 12, 1992

**James K. Wight
Roman D. Hryciw
Antoine E. Naaman**

December 1992

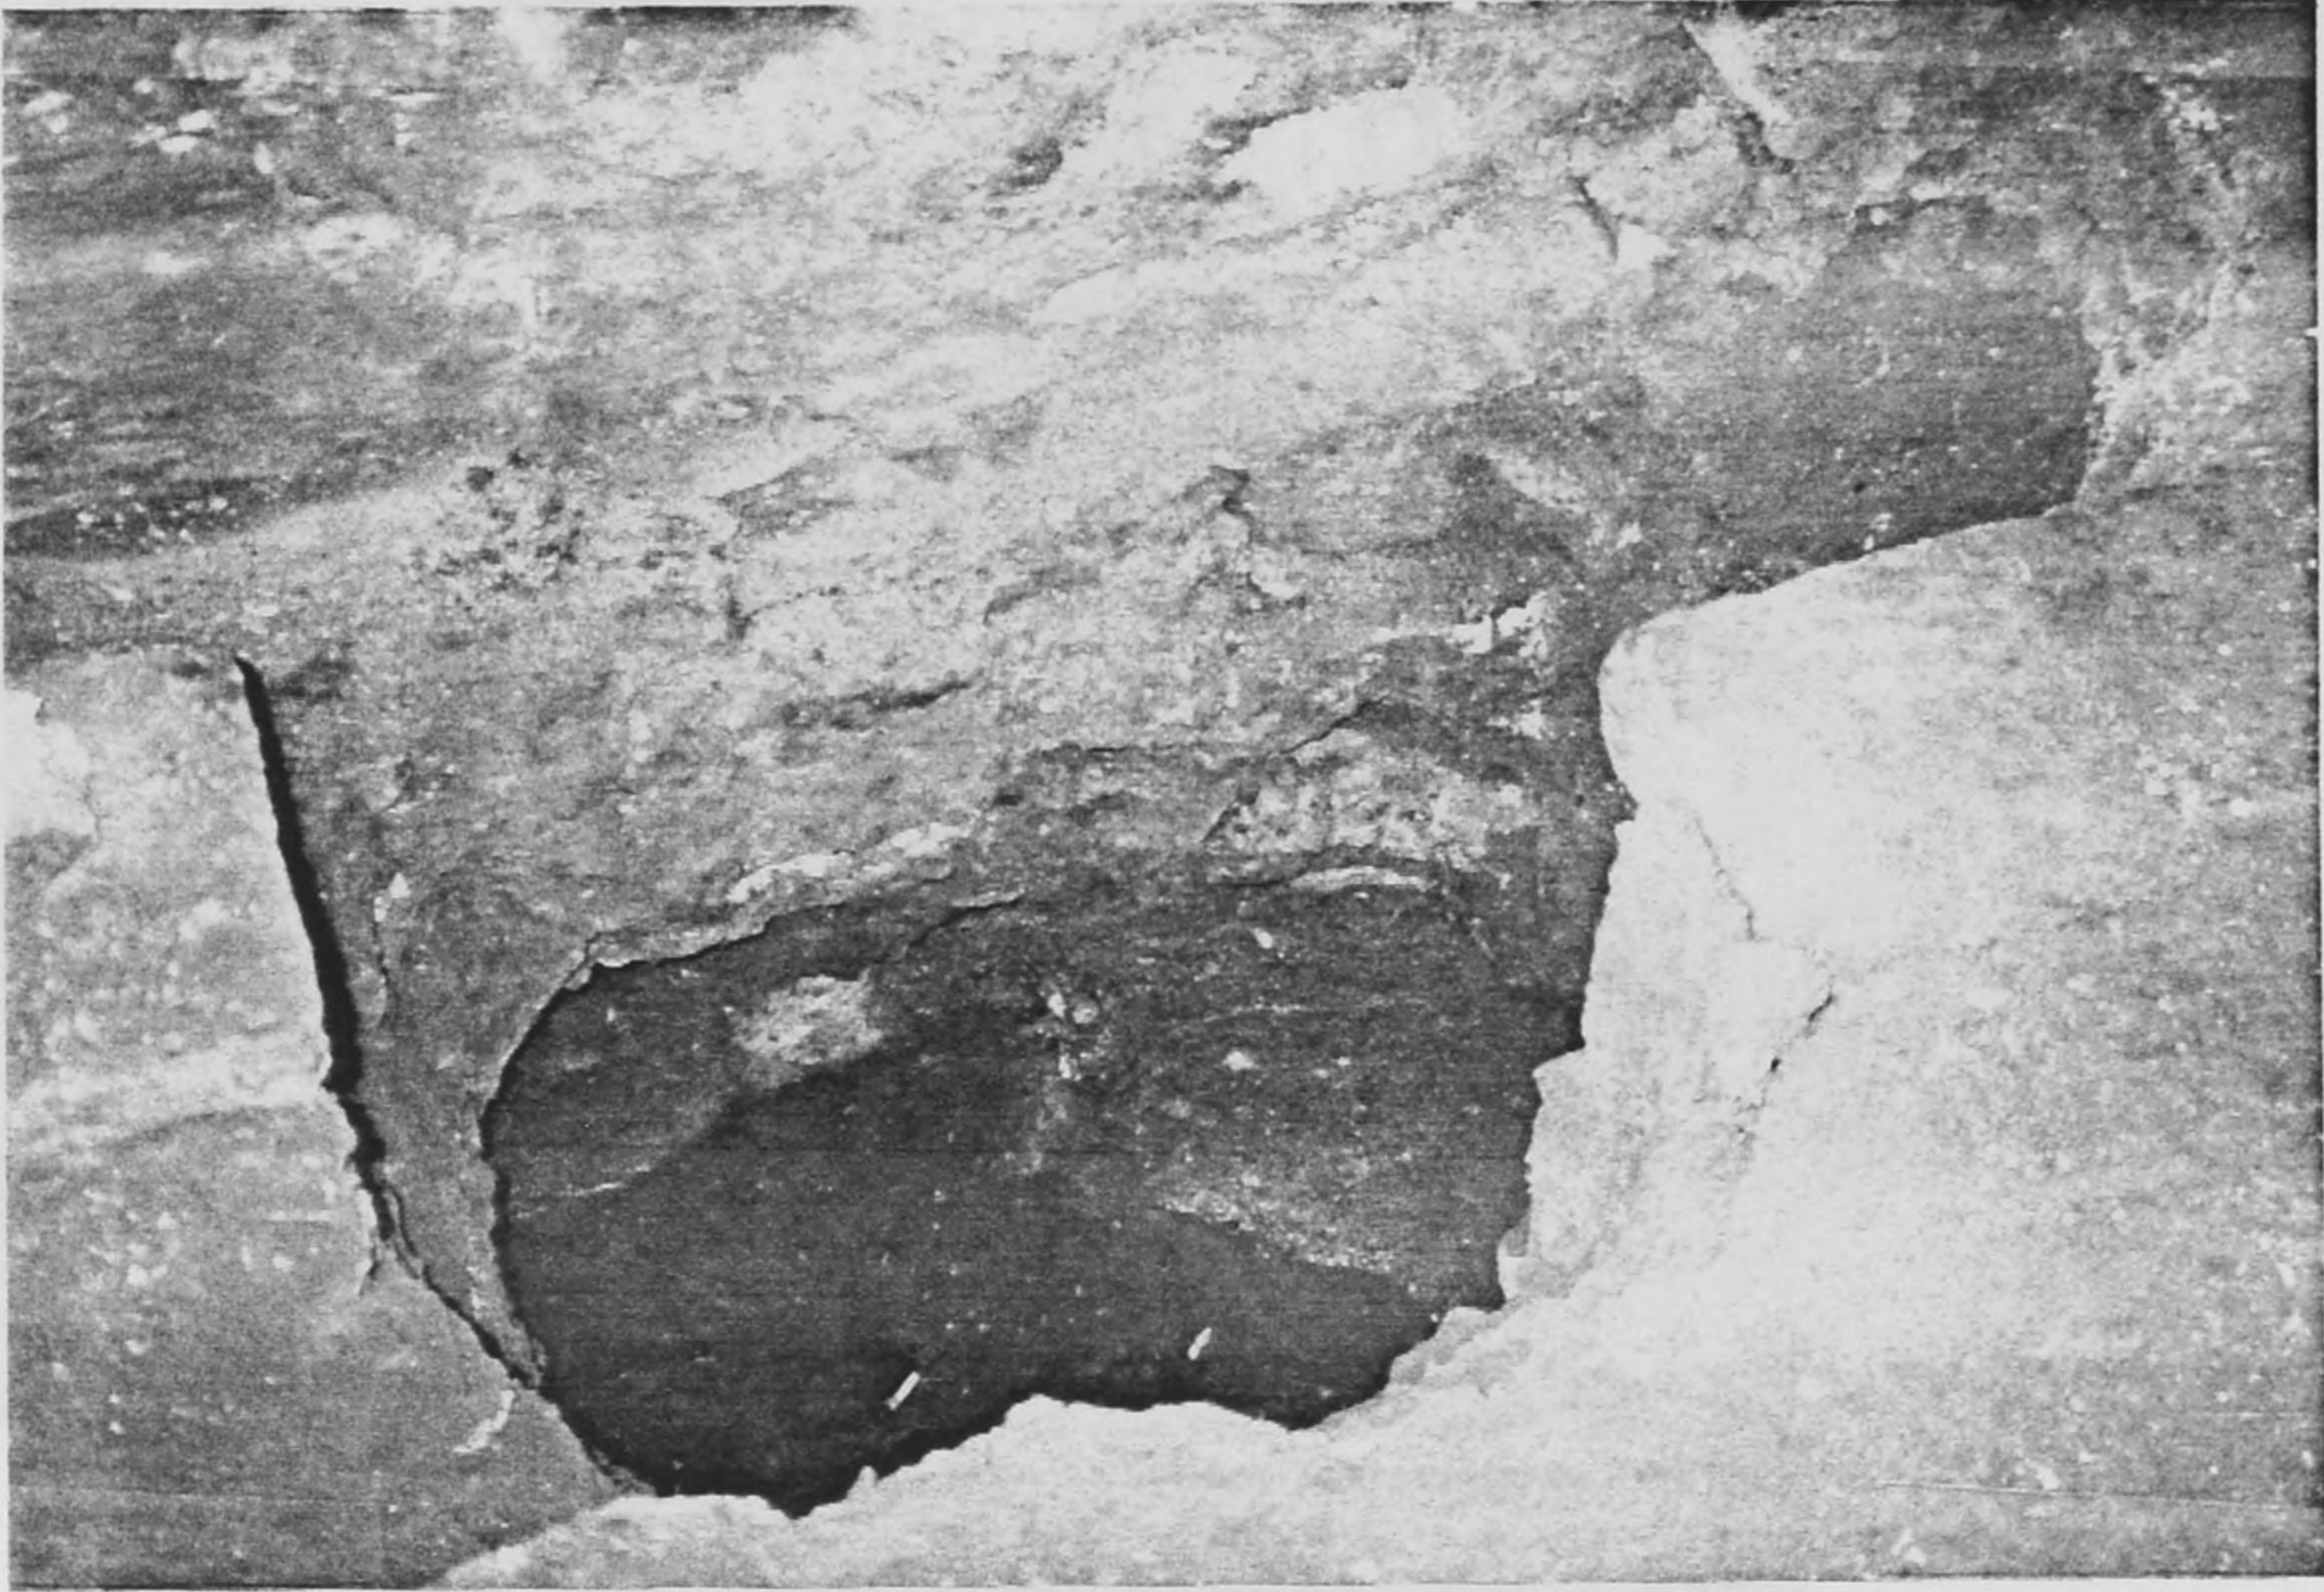
There were some excavations in the foundation below the mosque. In each hole, water was present within one meter of the base of the foundation (Fig. 10). The limestone blocks in and just above the foundation level were discolored, indicating capillary rise from the groundwater level. This water partially dissolves the limestone and when it evaporates on the exposed surfaces, it leaves behind a yellowish mineral deposit. In some cases the discoloration extended more than one meter above the top of the foundation.

Fig. 10 Groundwater visible in excavation below basement of El-Ghuri Mosque

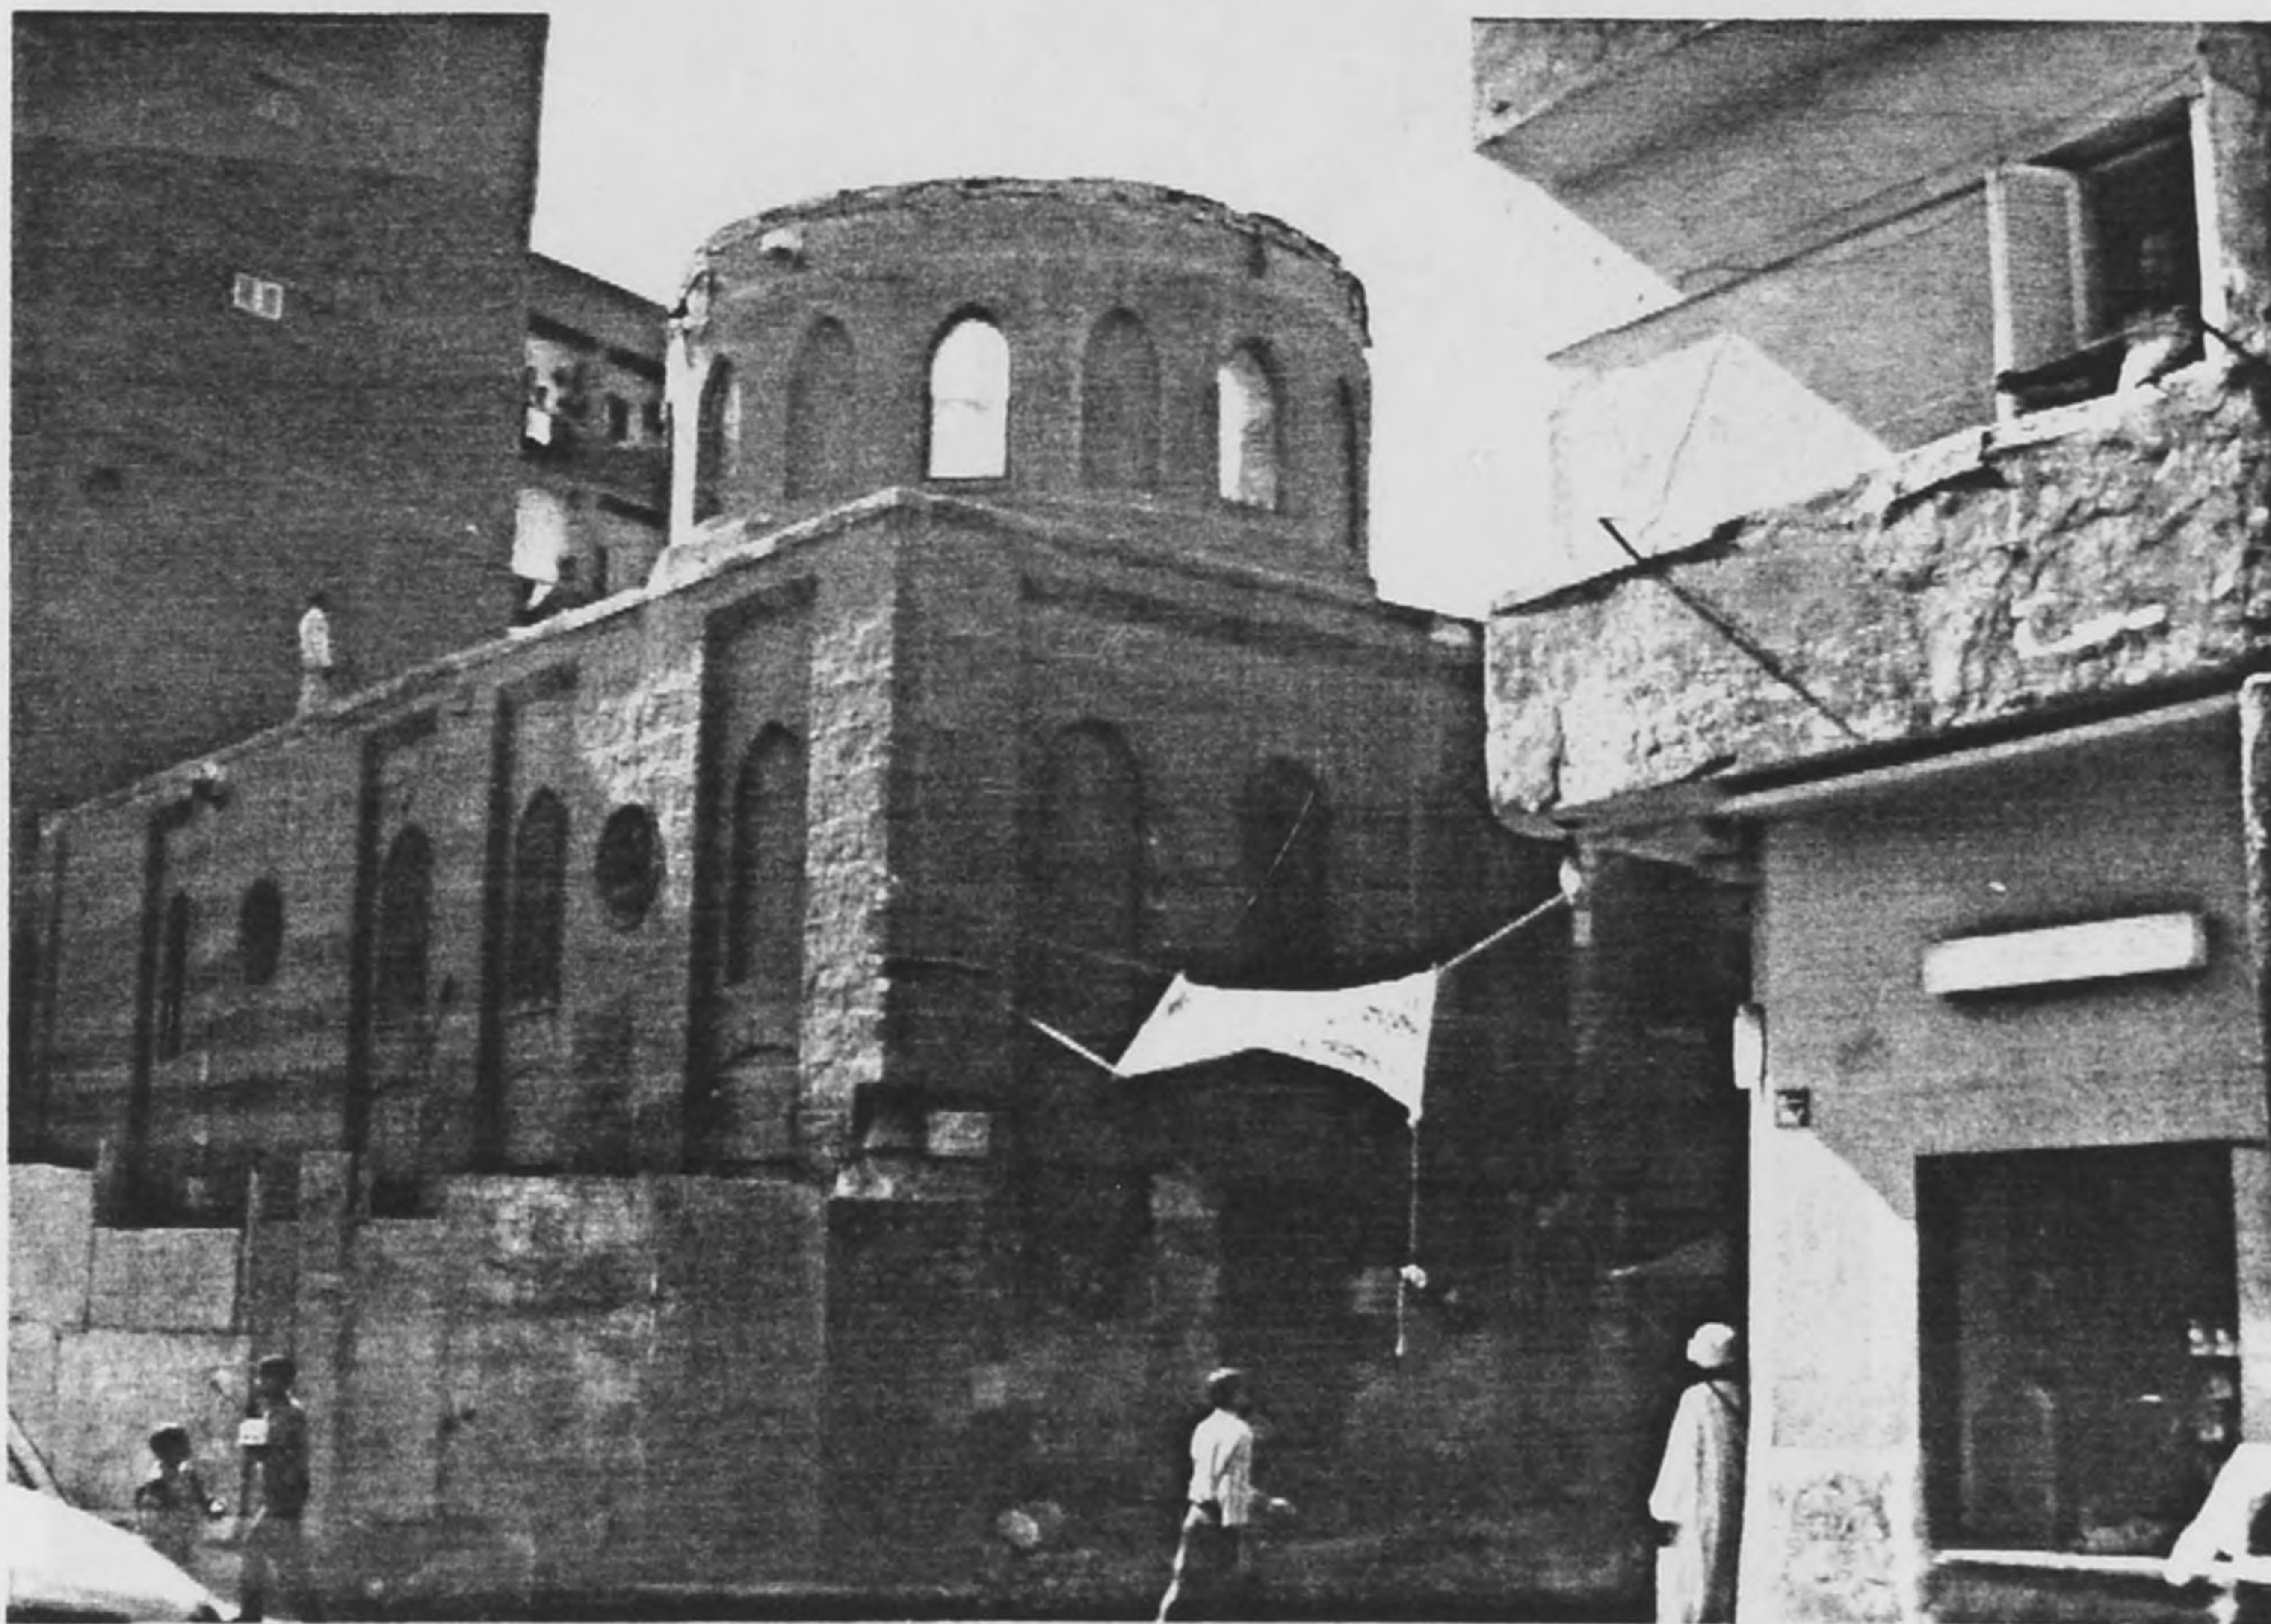
The dome of the El-Dashtwati Mosque collapsed during the earthquake (Fig. 11). At the time of the team's visit, debris from the dome was still on the ground, either inside the tower structure, which had been covered by the dome, or outside on the street (Fig. 12). A crew from the Egyptian Antiquities Organization had cleared around the dome support ring to eliminate the danger from falling debris. The dome structure had been constructed using two layers of bricks and mortar. The dome covered a tower about three stories high. The

Fig. 11 Collapsed dome of El-Dashtwati Mosque

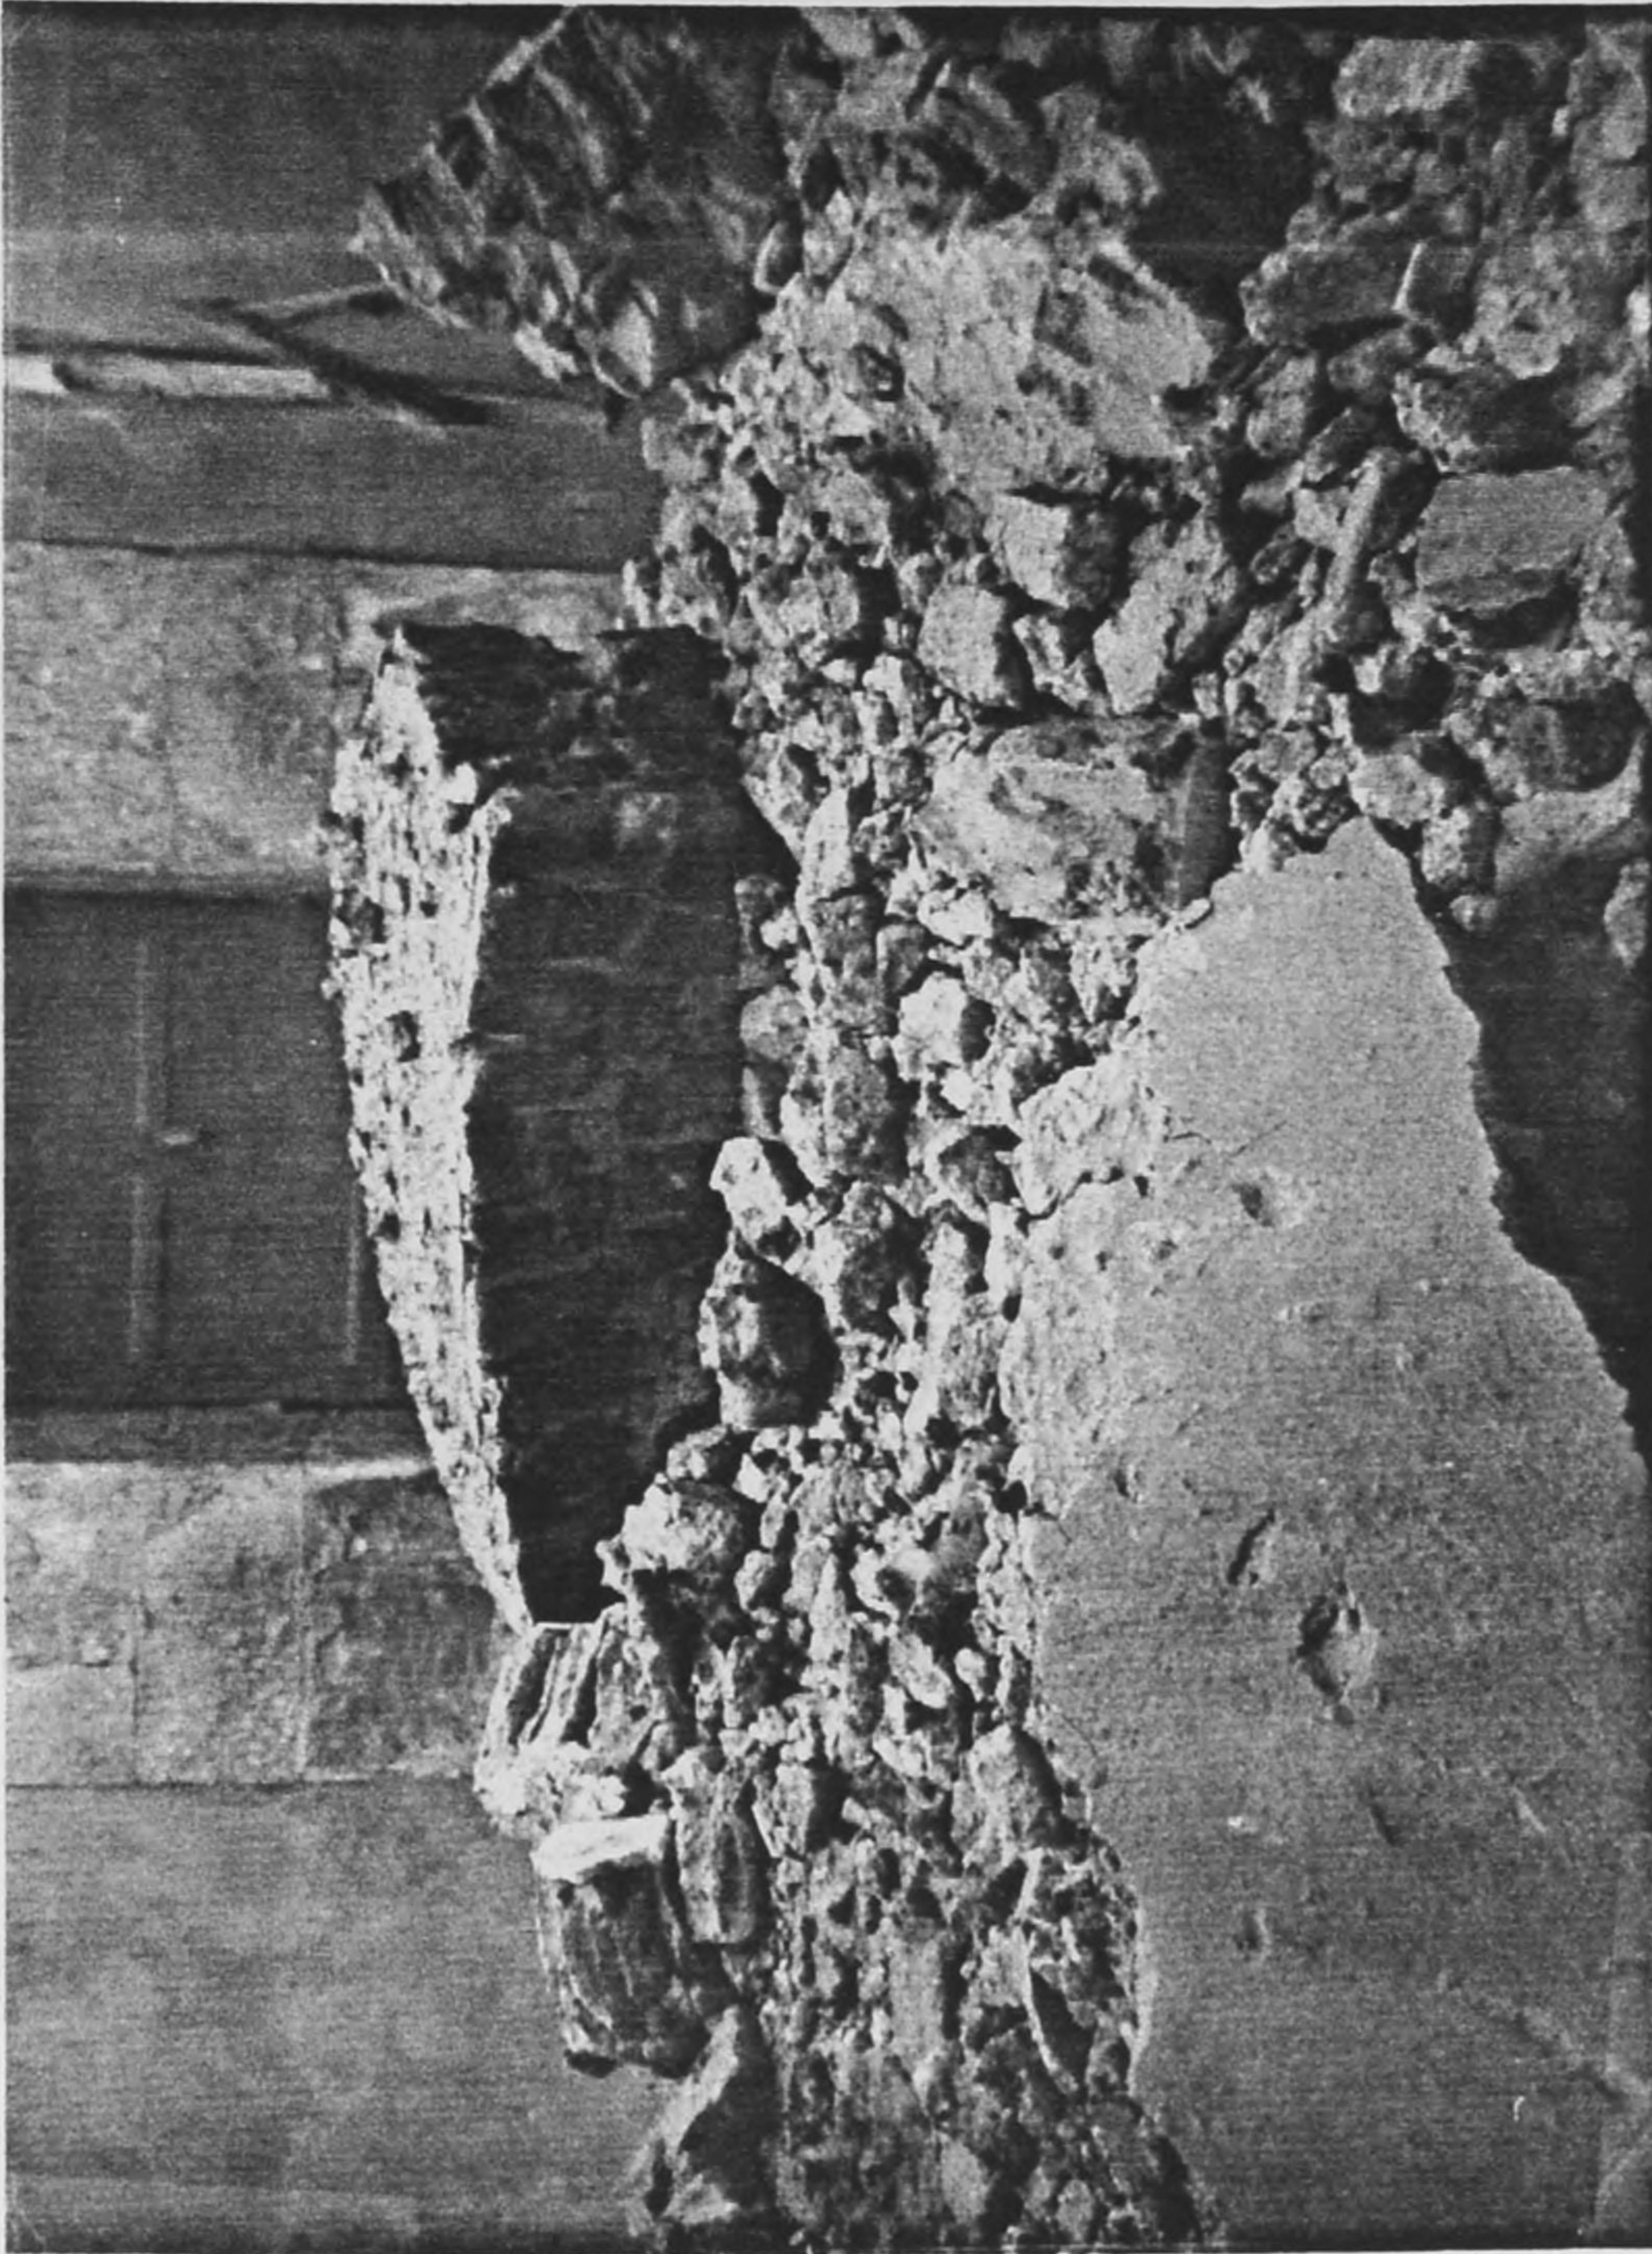
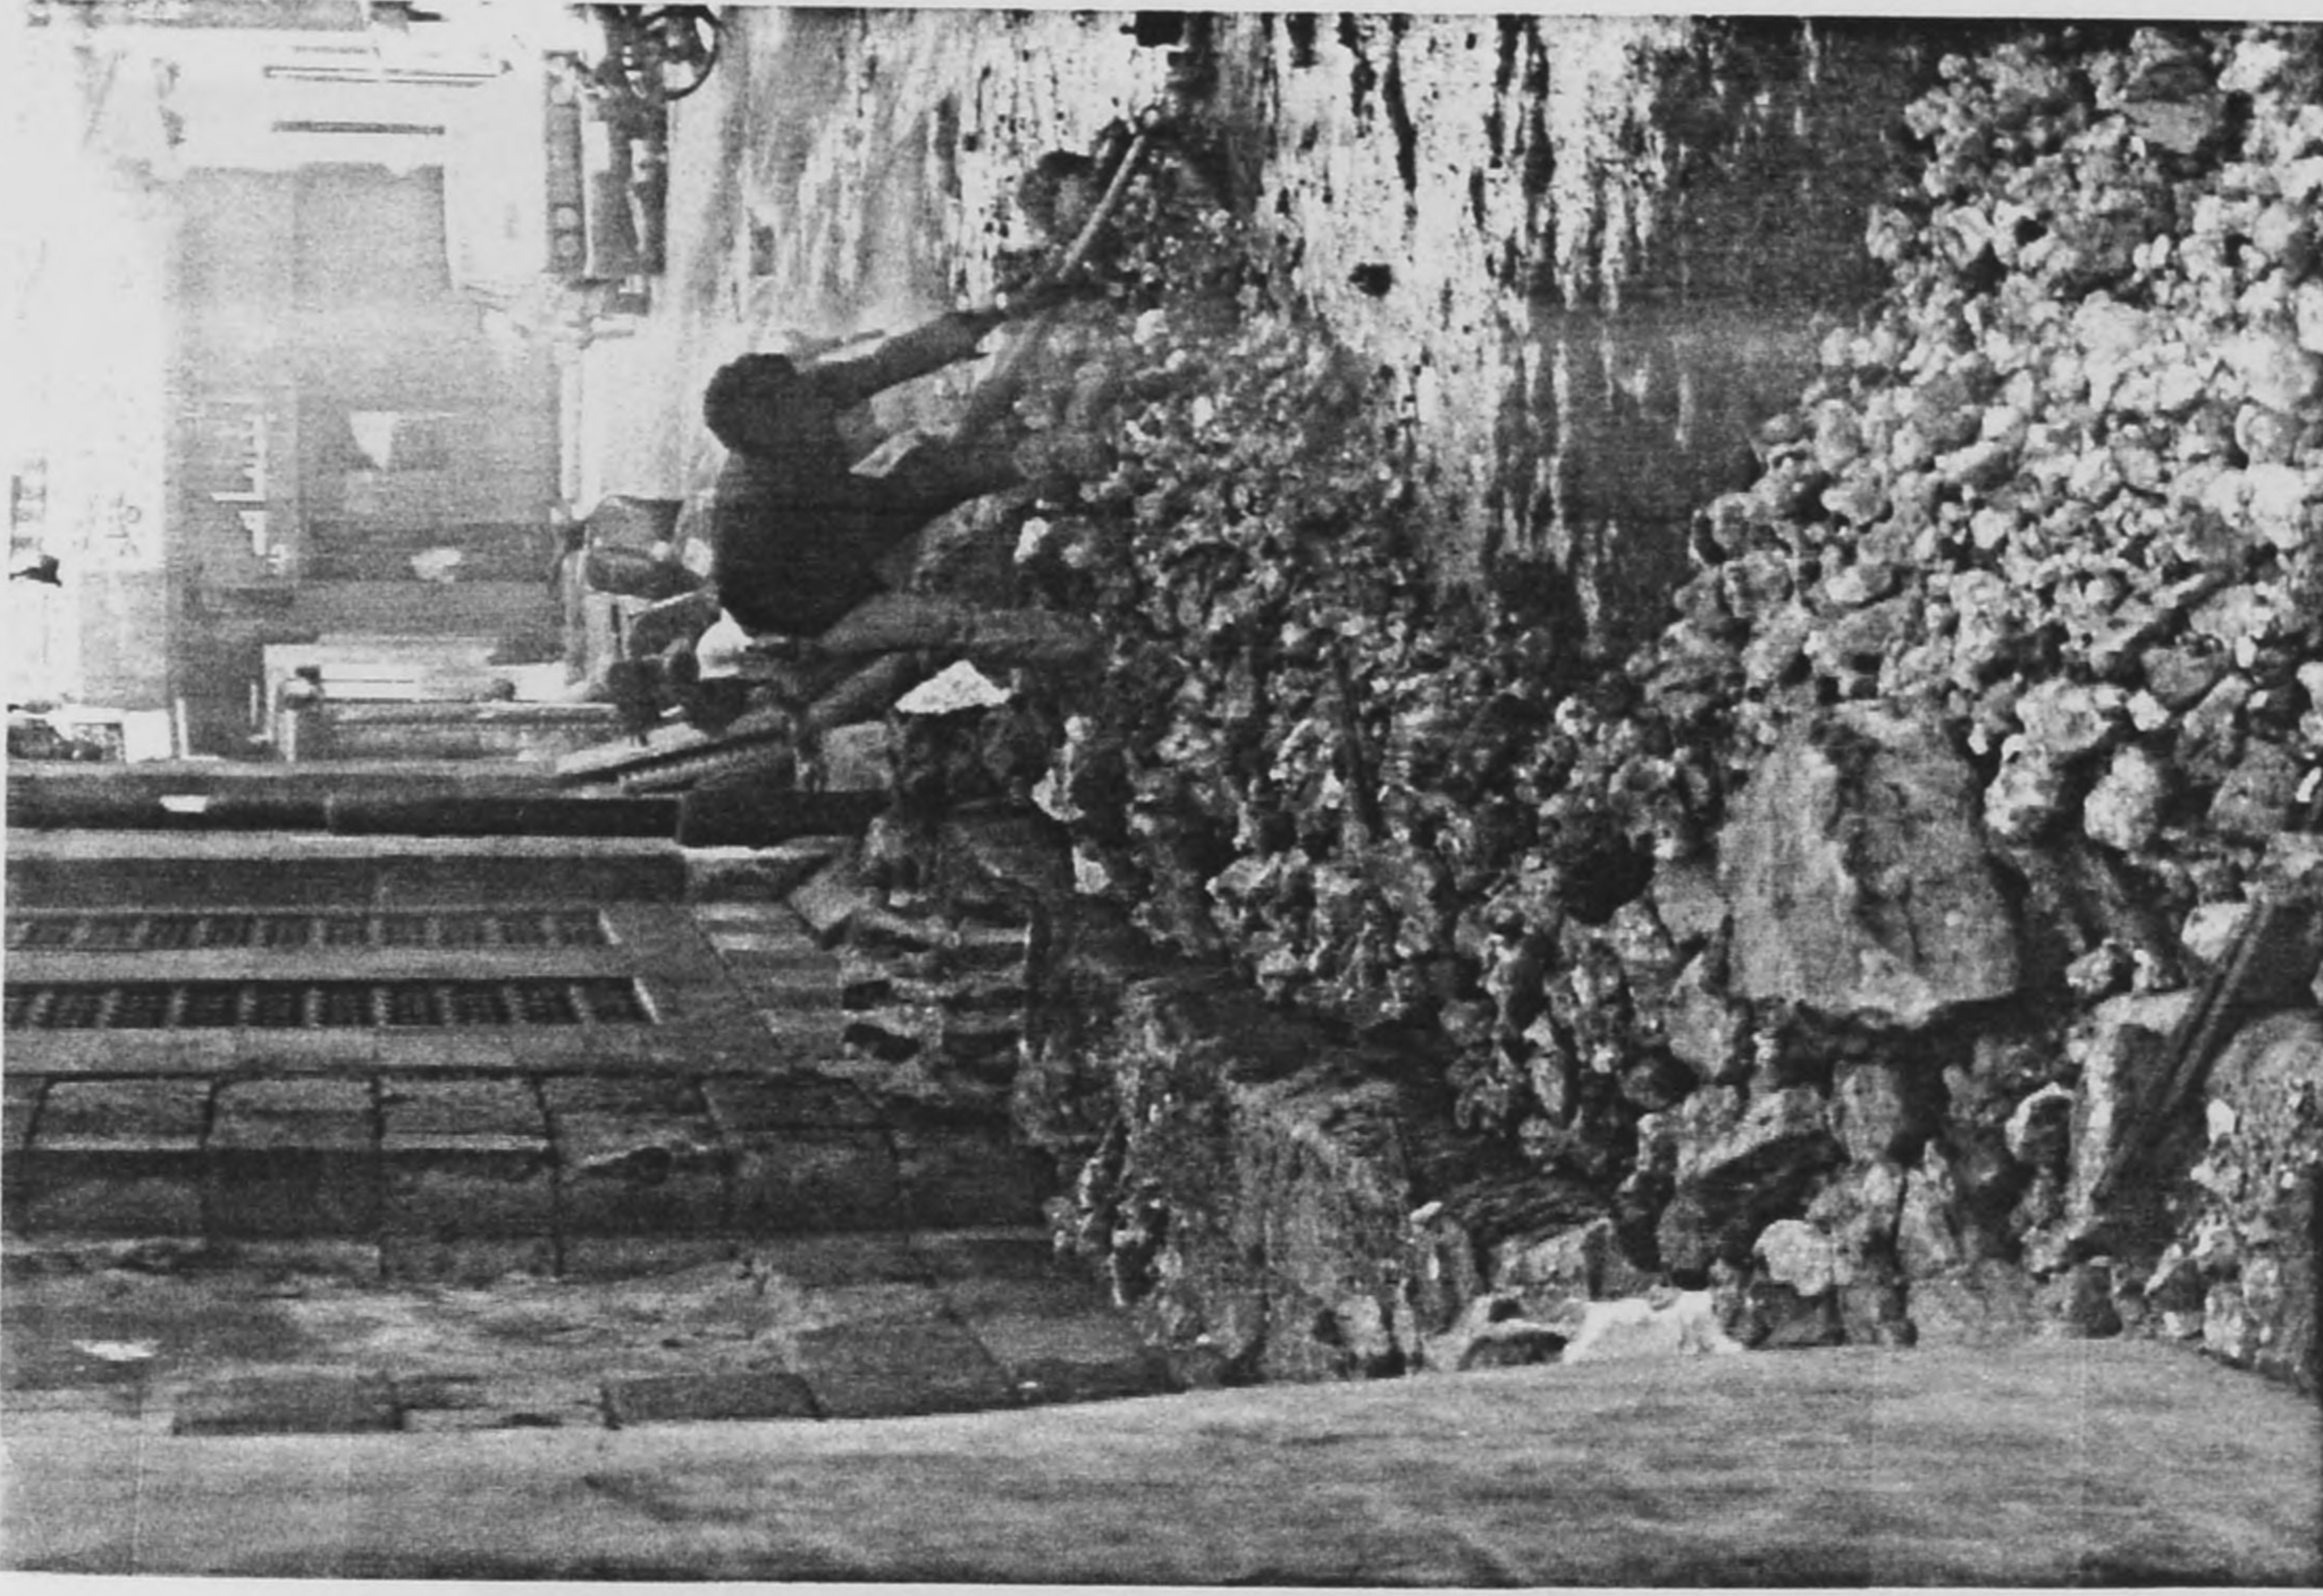
Fig. 12 Debris from collapsed dome at El-Dashtwati Mosque

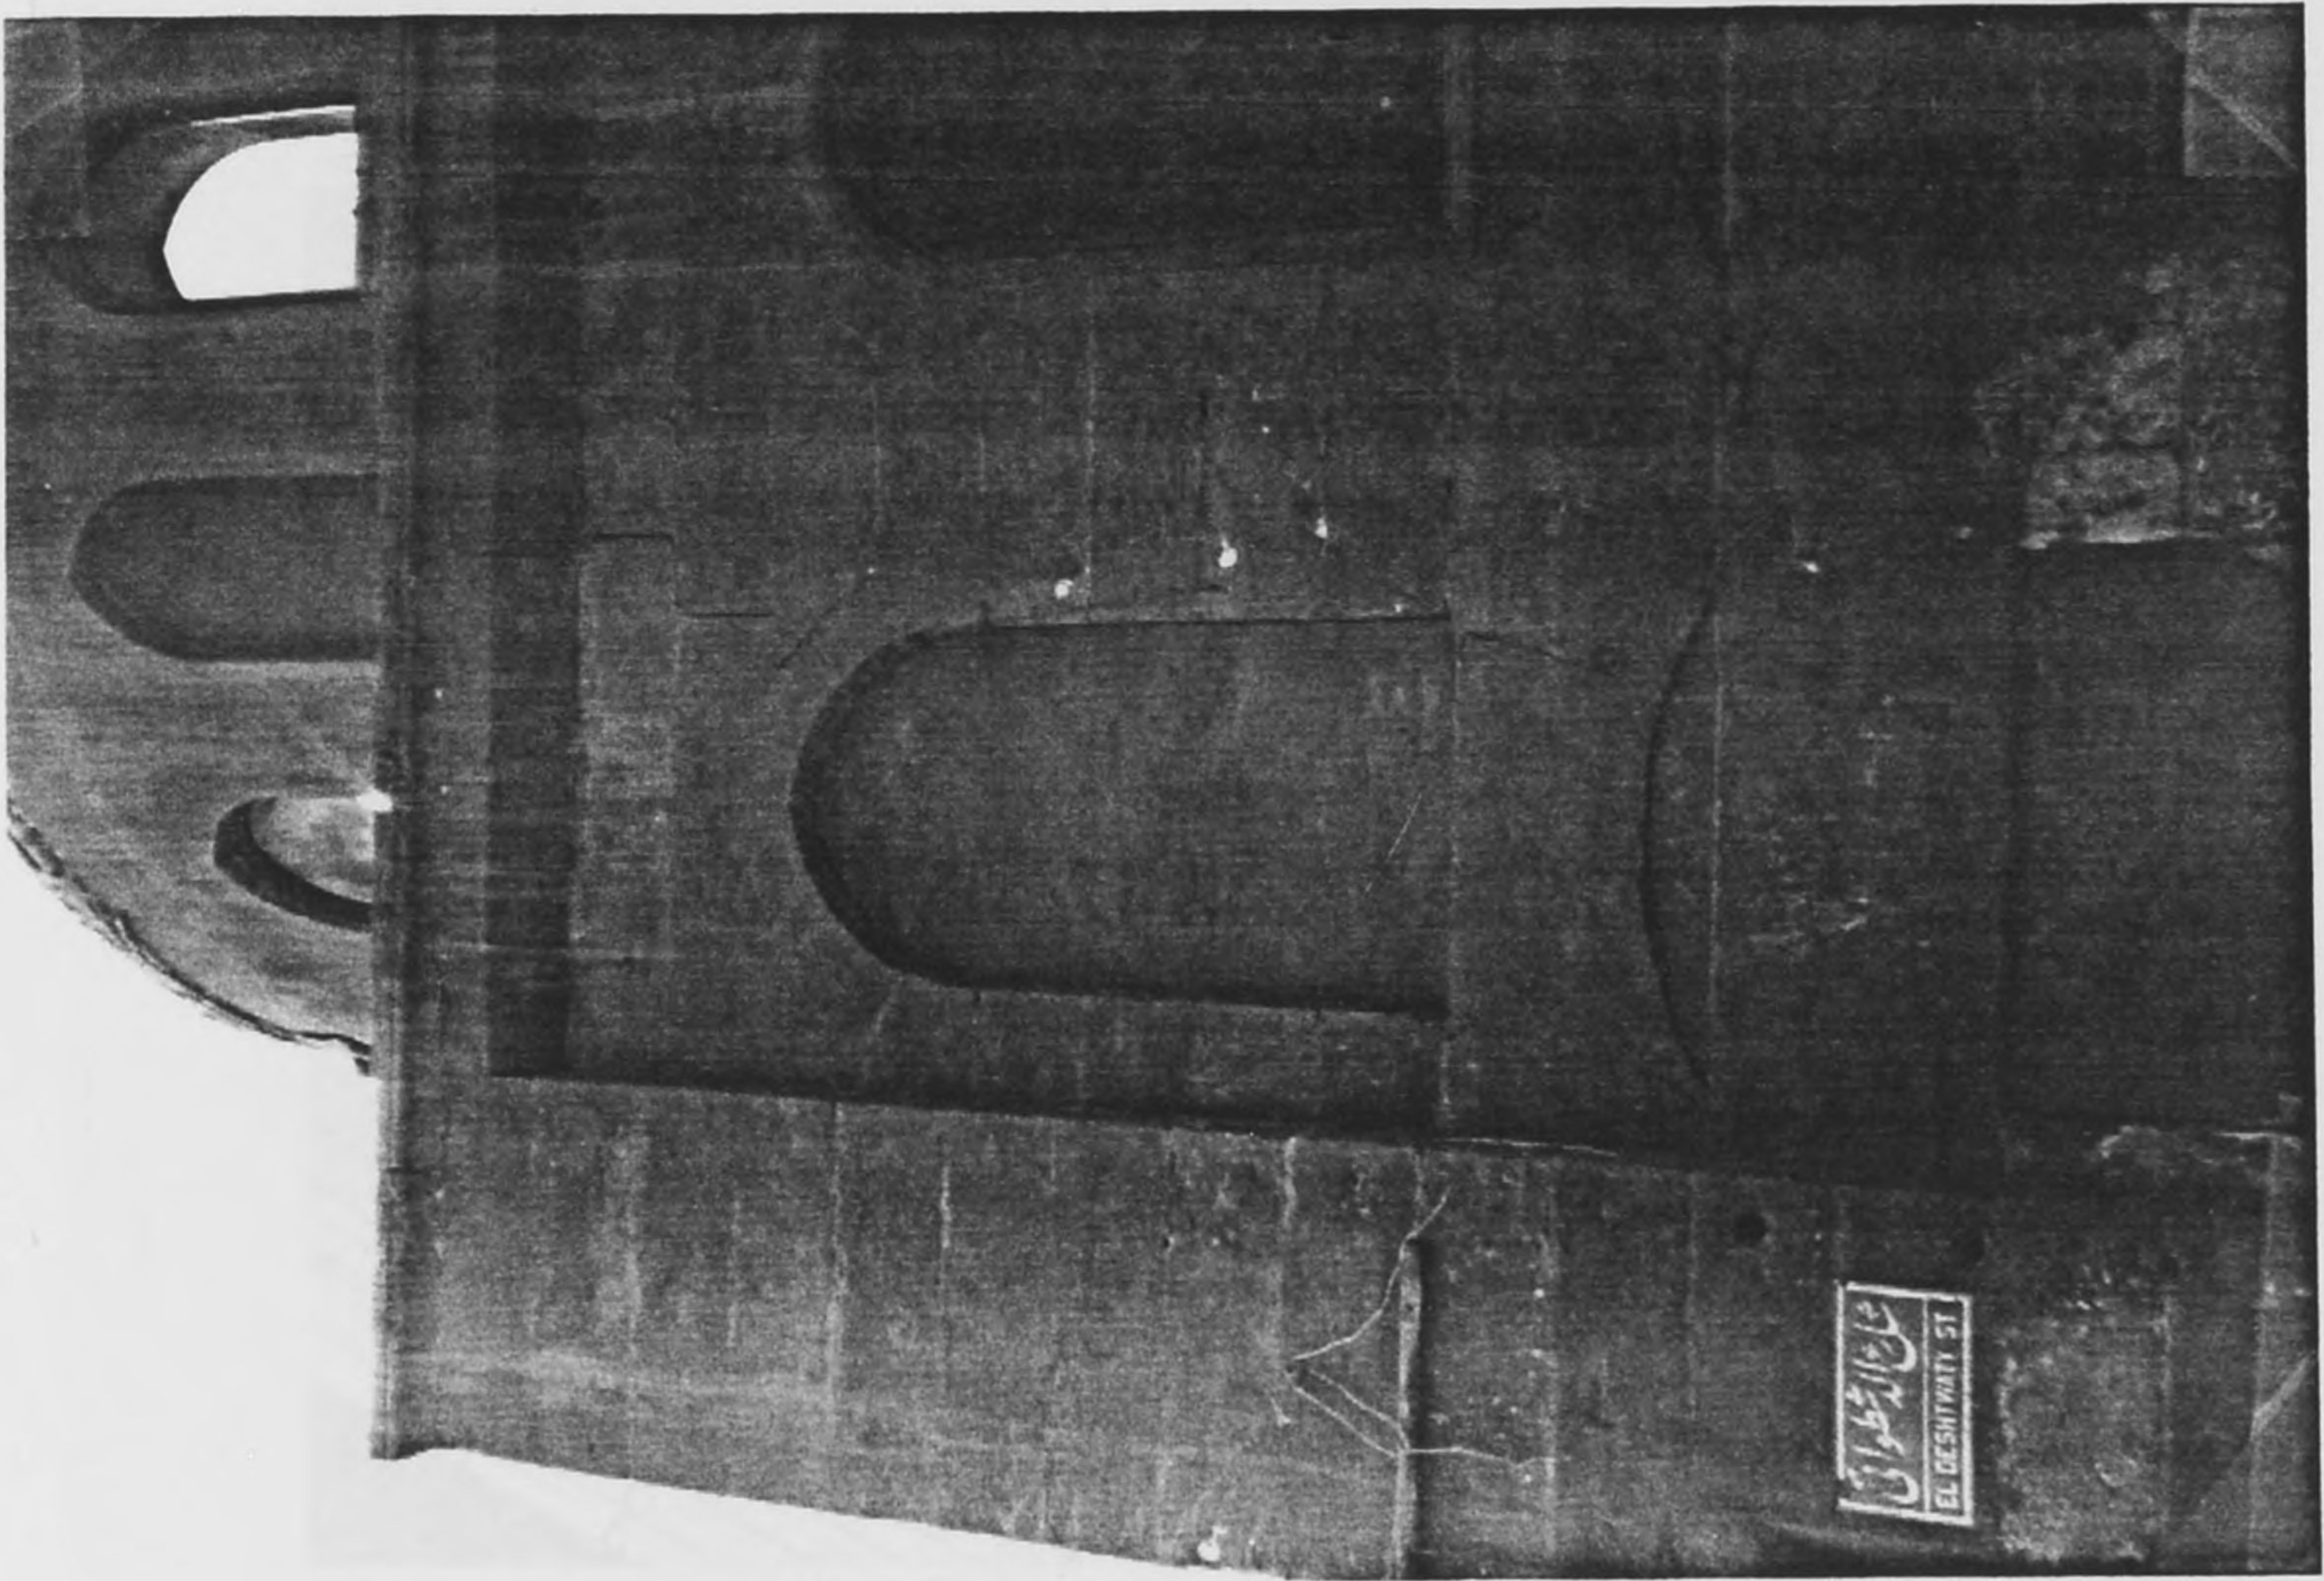
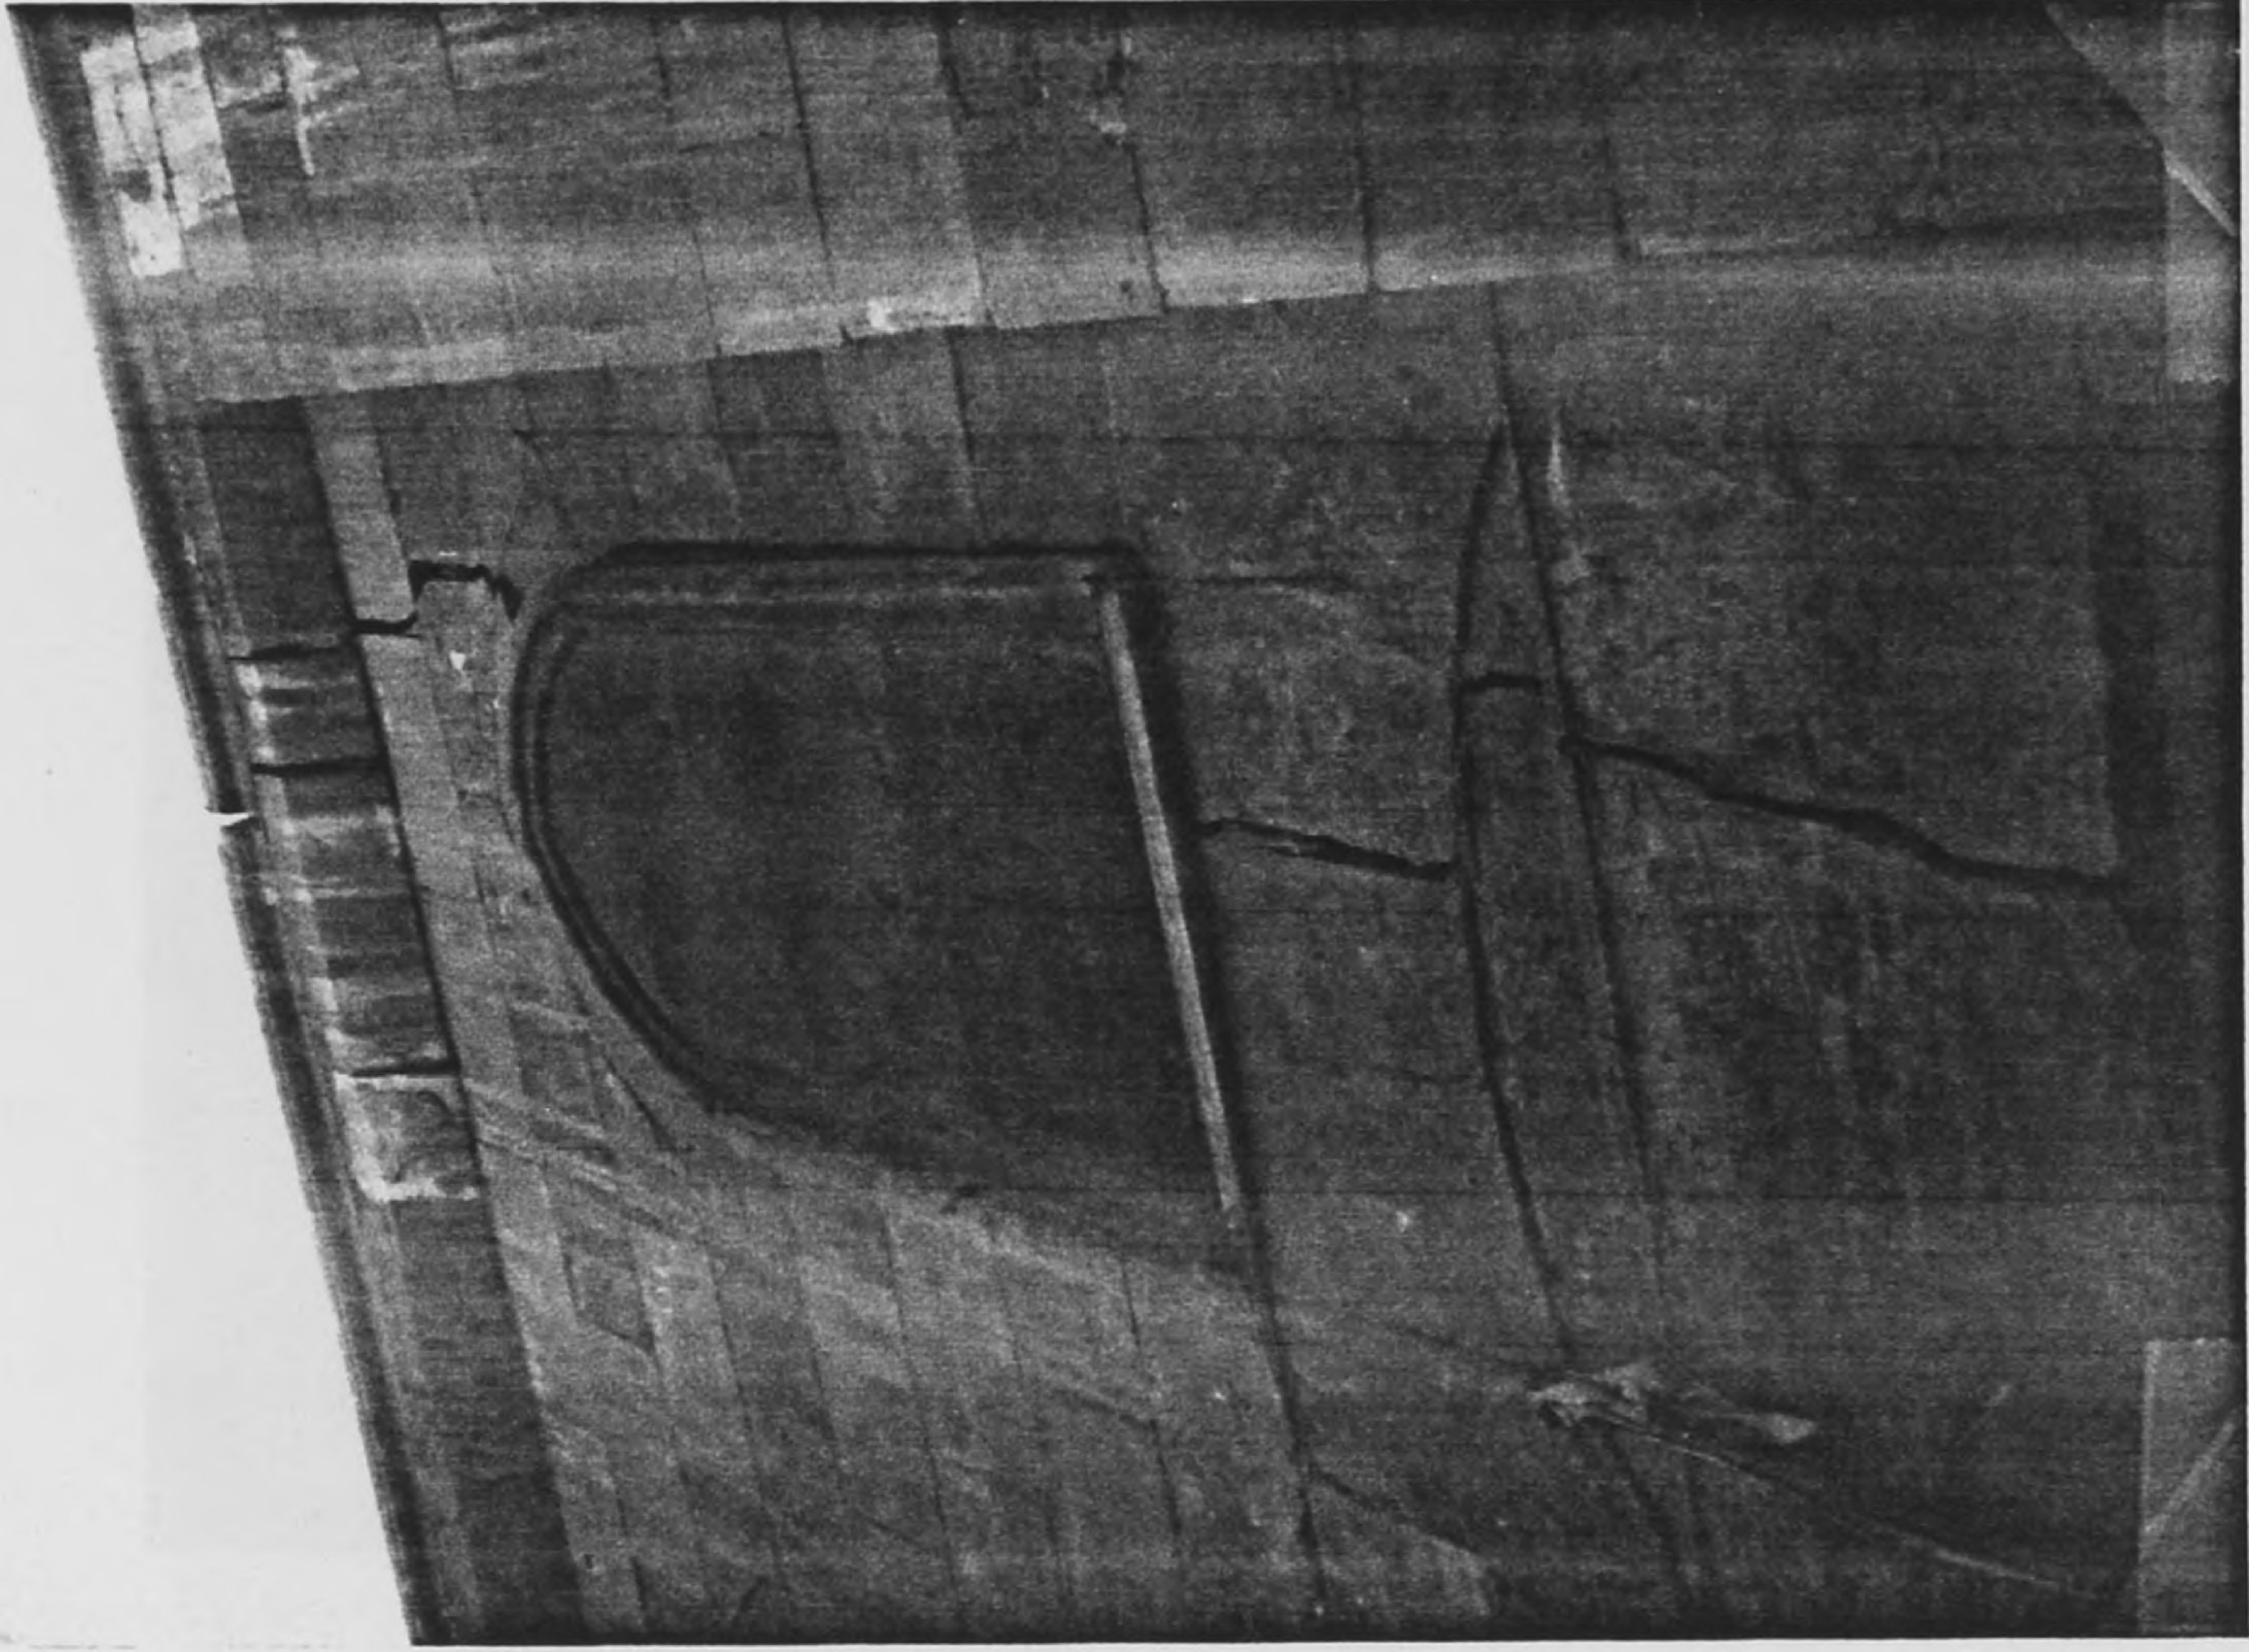
overall building was approximately square, with the tower part occupying a quarter of the area near one corner. The team was told that the mosque was built during the Turkish empire at the end of the 18th or early in the 19th century. The structure was primarily stone masonry. Several cracks were observed along the walls, some of which were clearly present prior to the earthquake (Fig. 13). It was the team's opinion that the cracks could be patched, the structure repaired, the dome ring strengthened, and the dome rebuilt using either restoration materials or modern materials.

Fig. 13 Cracks in walls of El-Dashtwati Mosque
