Report No. UMCEE 92-31

Field Investigation of Damage to Islamic Monuments Caused by the Egyptian Earthquake of October 12, 1992

**James K. Wight
Roman D. Hryciw
Antoine E. Naaman**

December 1992

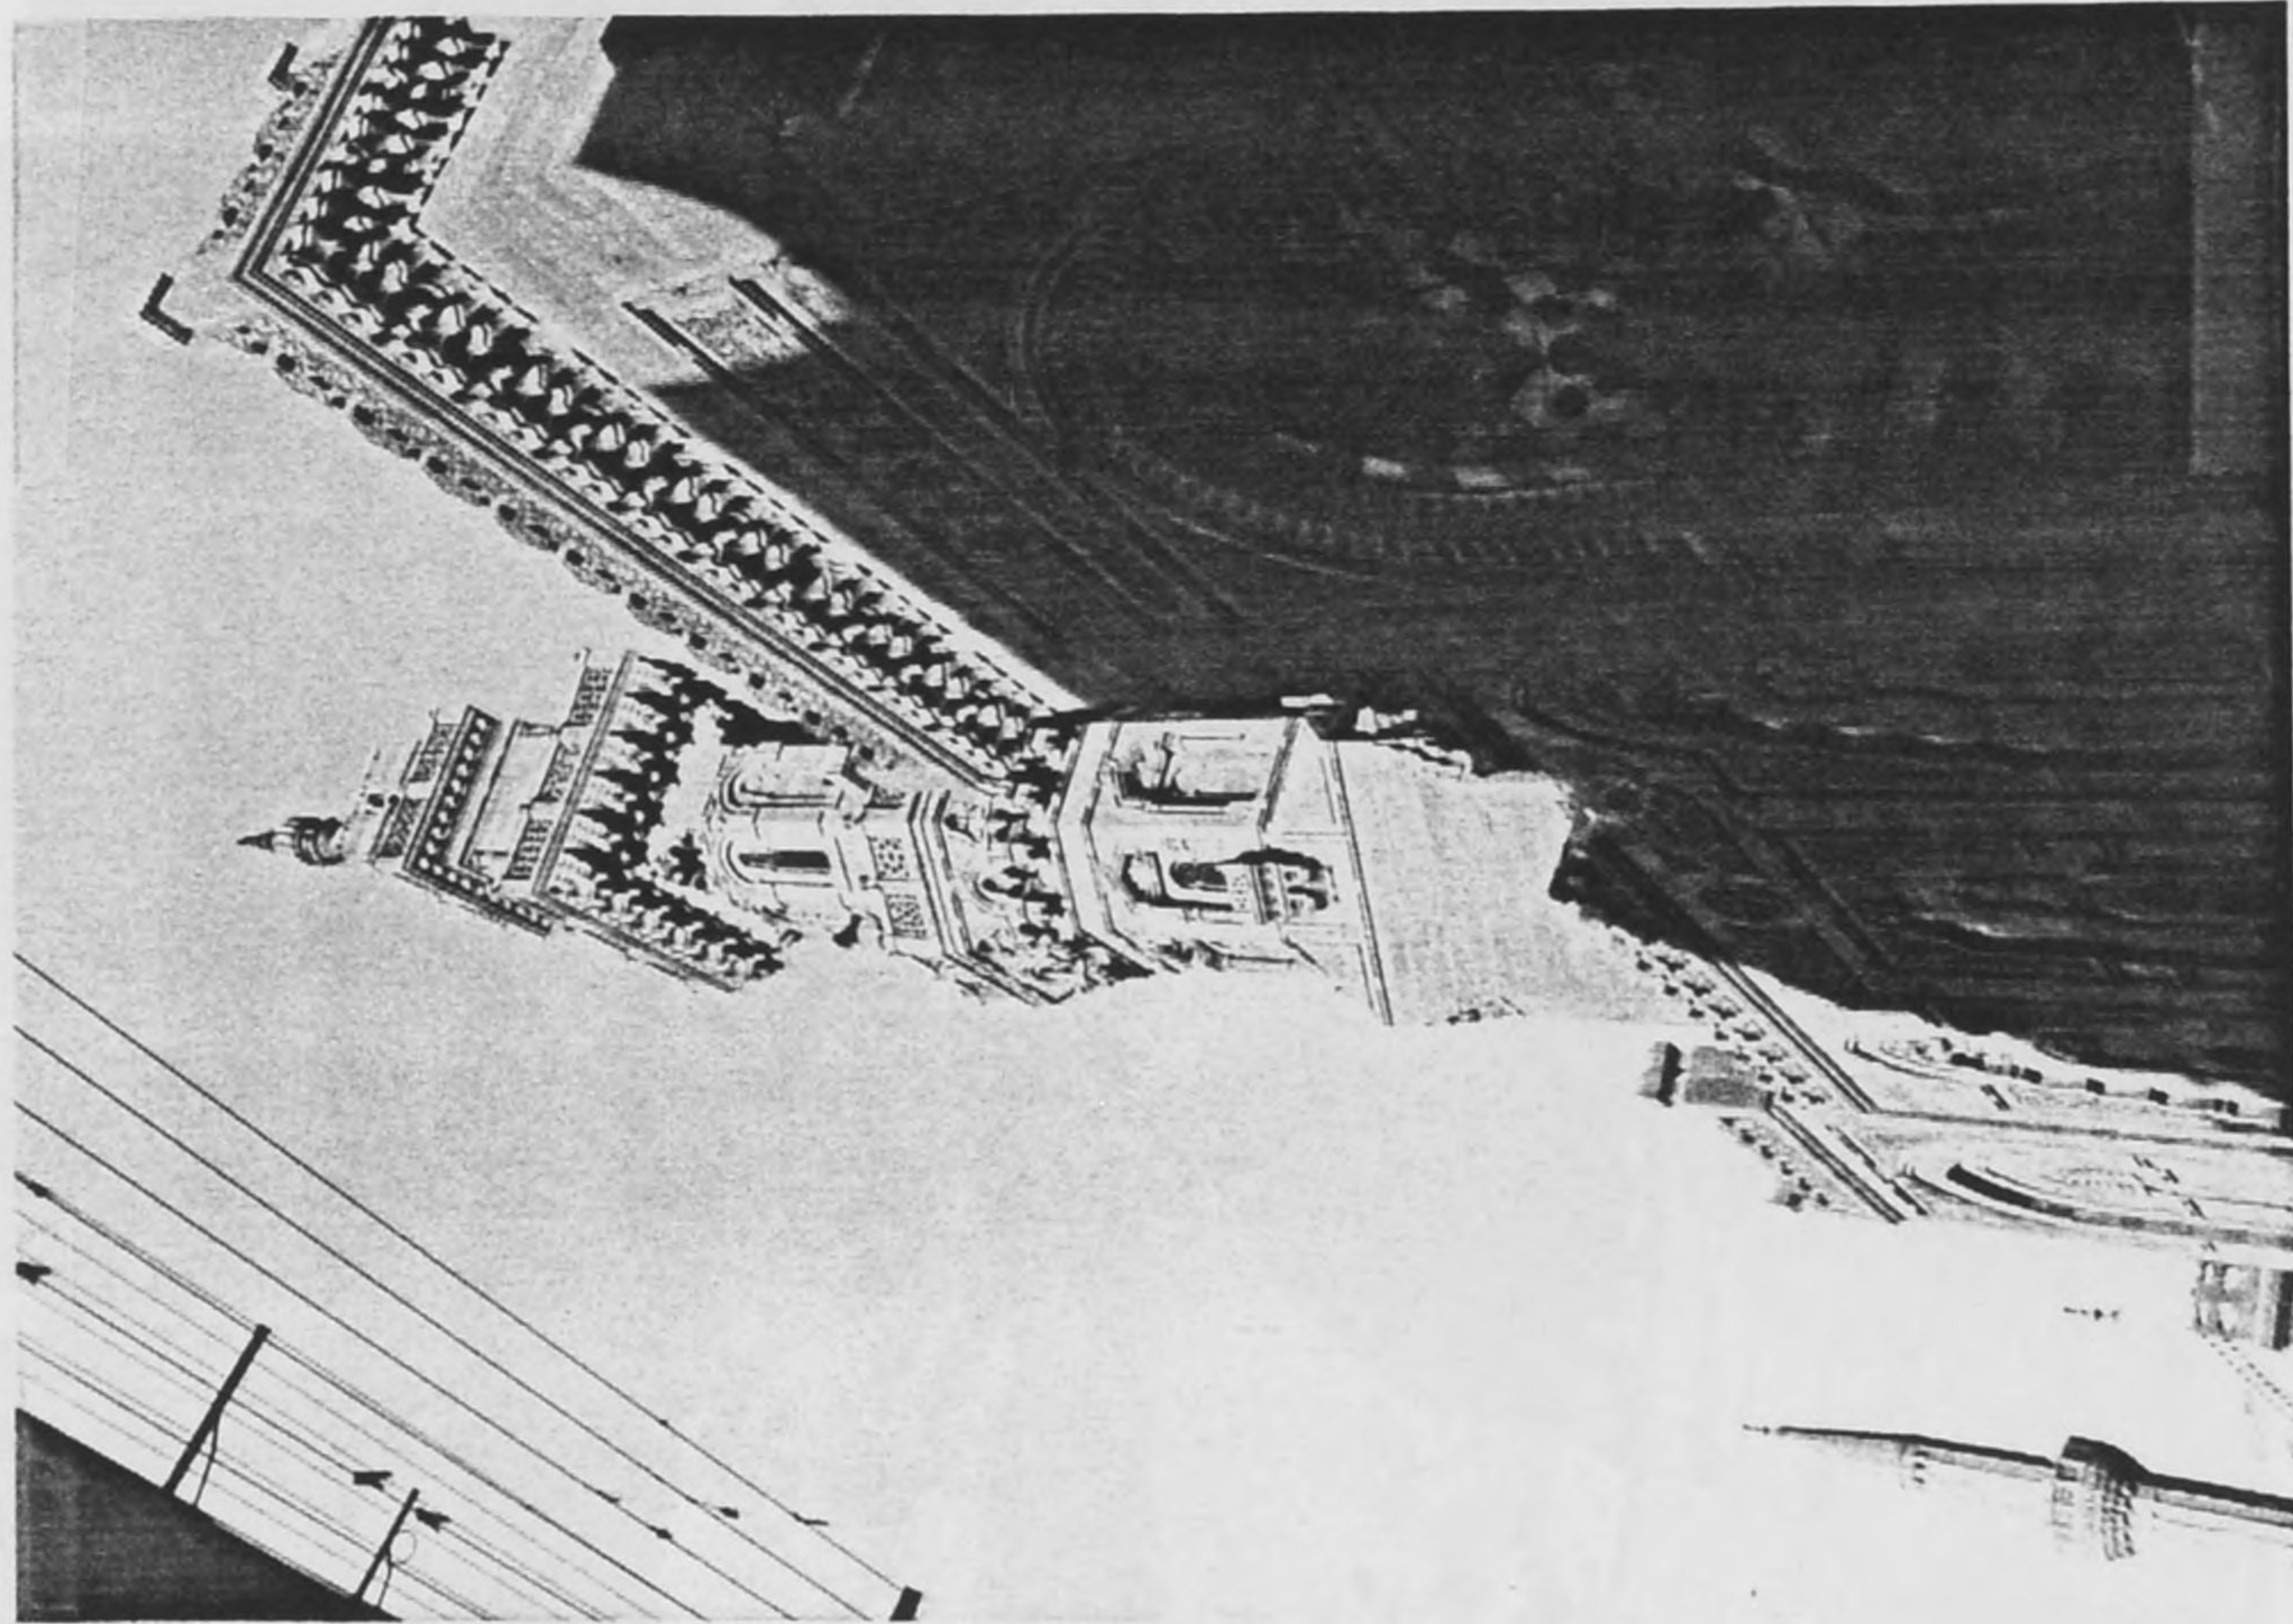
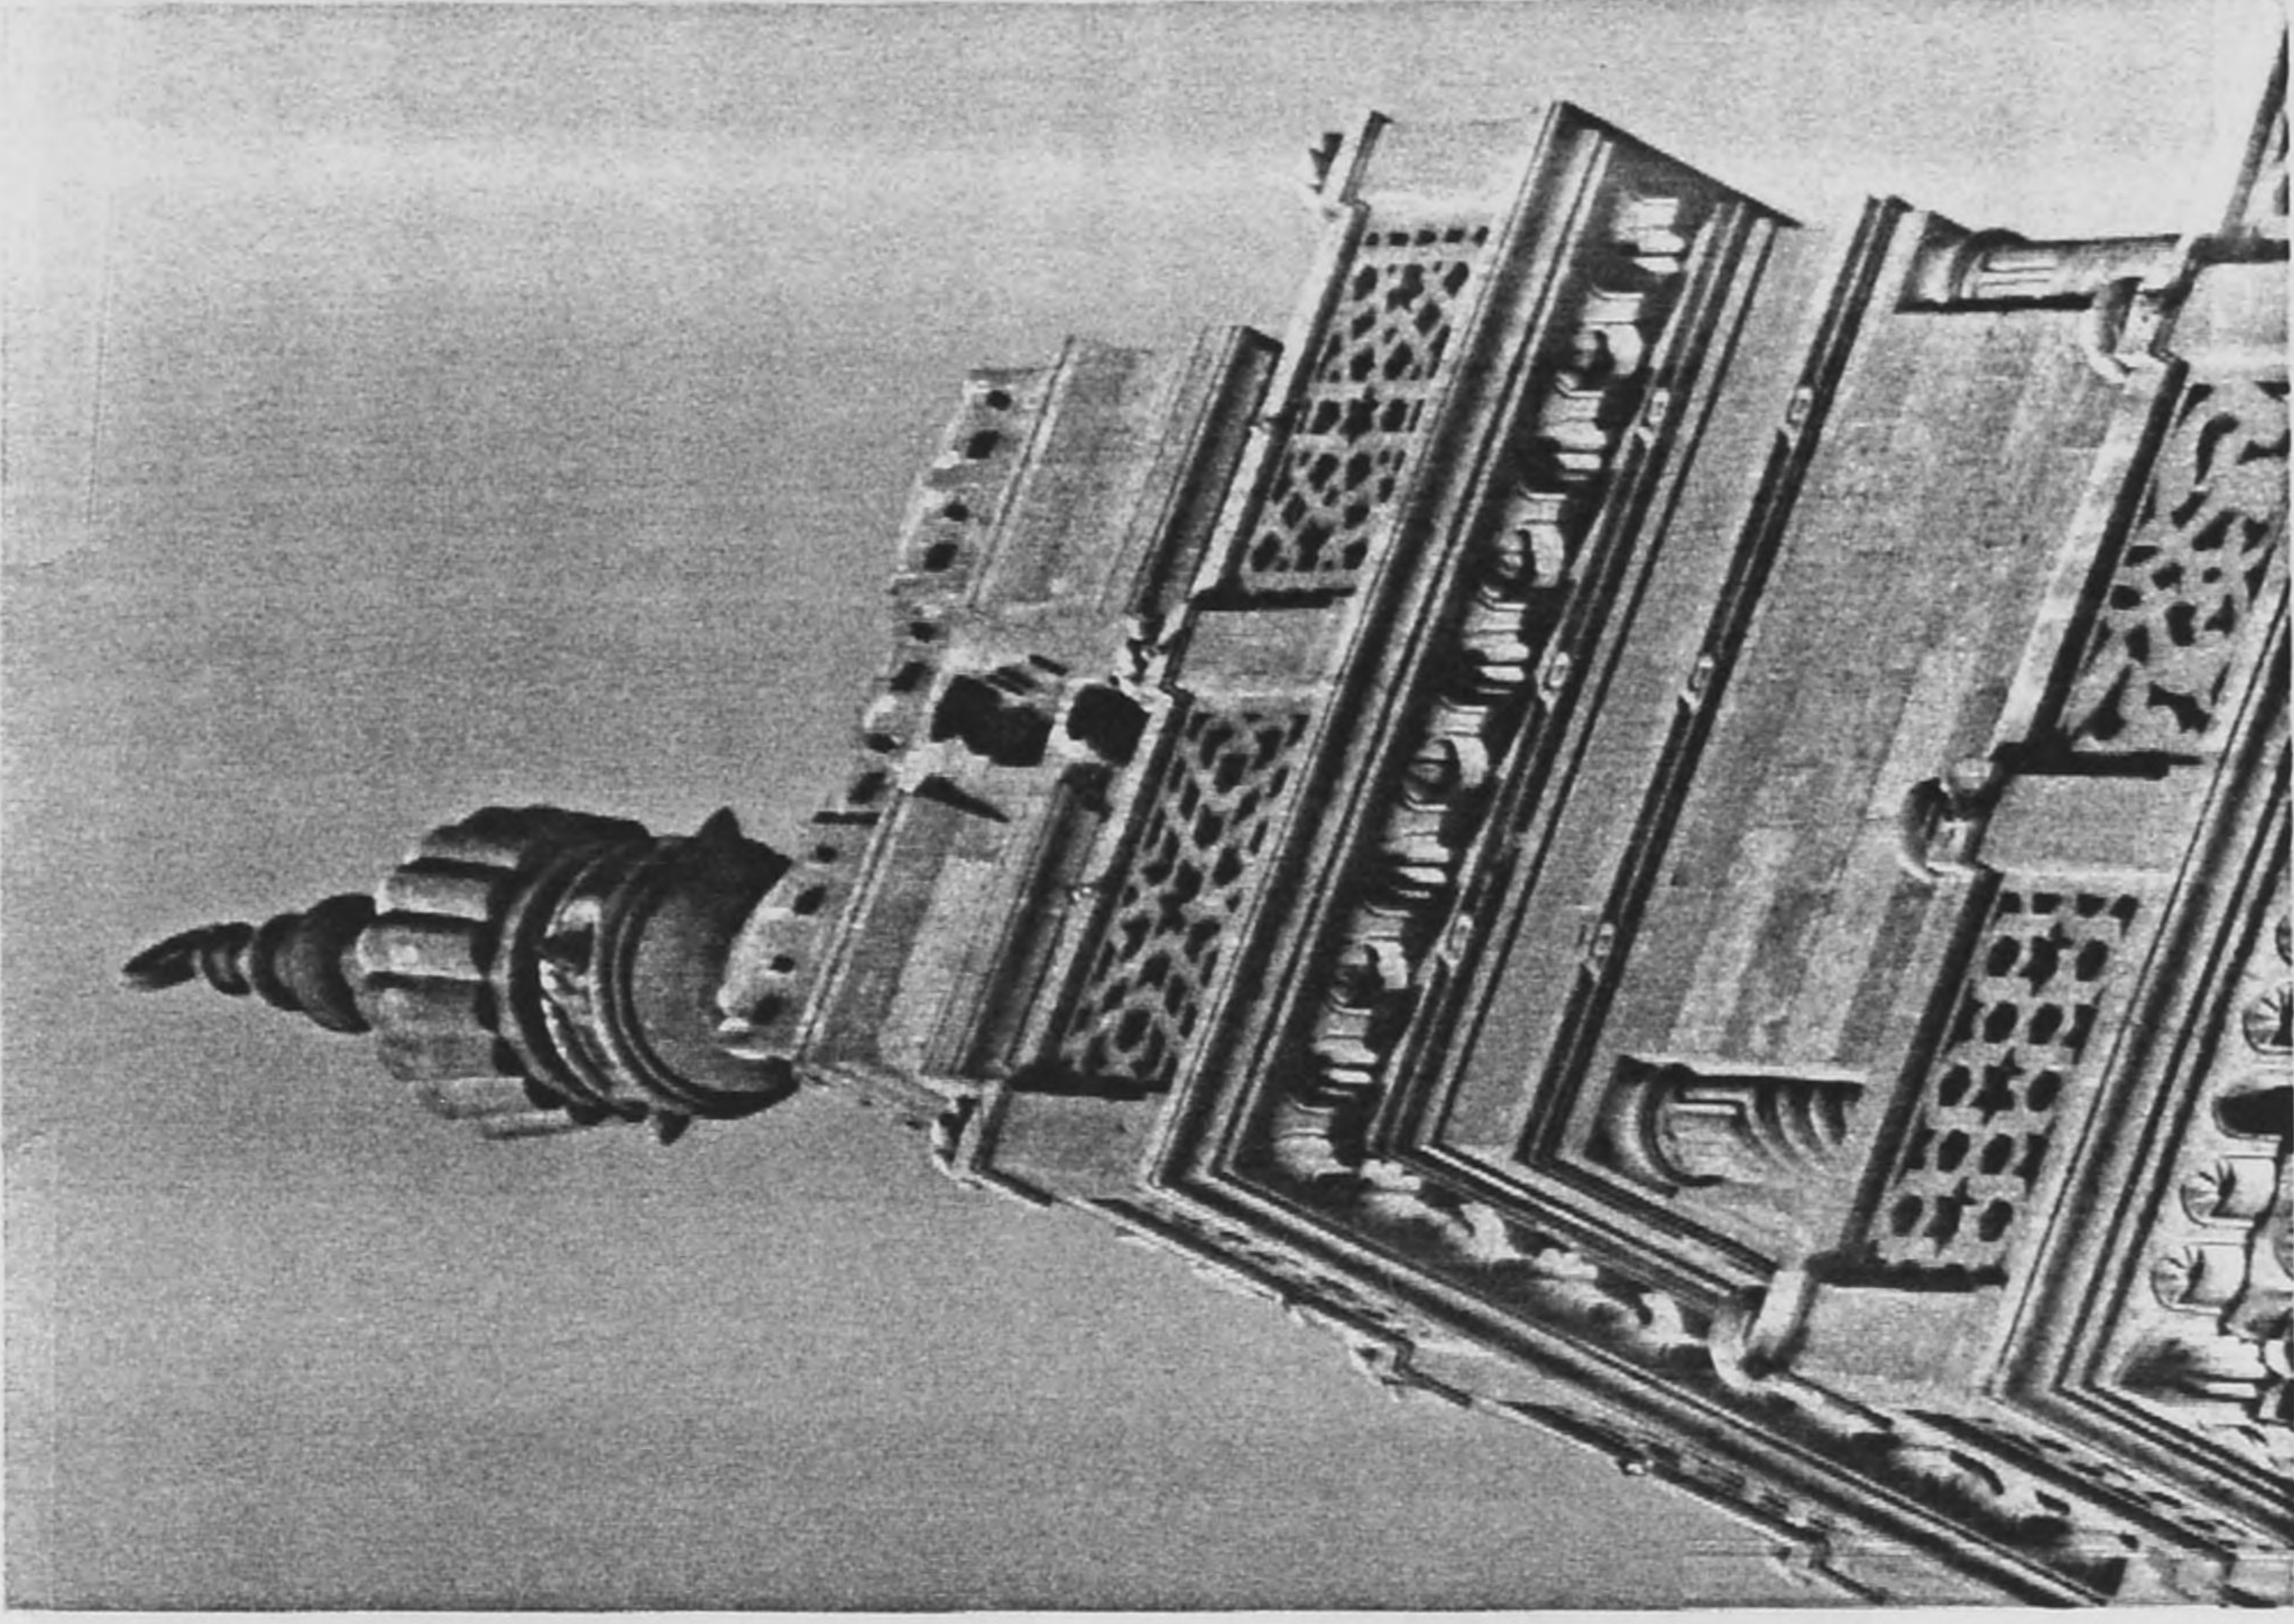
The most significant damage at the Al-Hanafi Mosque was the collapse of three of four ornate columns at the top of the minaret tower. The one remaining column is shown in Fig. 14. The other three columns failed during the earthquake and crashed onto the street below (Fig. 15). There was no indication of any reinforcement in the columns and the ornate tops seemed to be a series of unreinforced stone slices placed on top of each other (Fig. 15 b). There was a single dowel bar running through a small diameter hole in the center of these slices, but it was not grouted in place. The dowel bar was apparently used to align the slices, but not intended to offer shear or moment resistance for the ornate top.

Fig. 14 Minaret tower at Al-Hanafī Mosque with one remaining ornate column

The one column at the top of the minaret tower should be removed or attached more securely to the tower. All four columns can be easily replaced, but the new columns must have a basic seismic resistance to lateral accelerations as described in the section on recommendations.

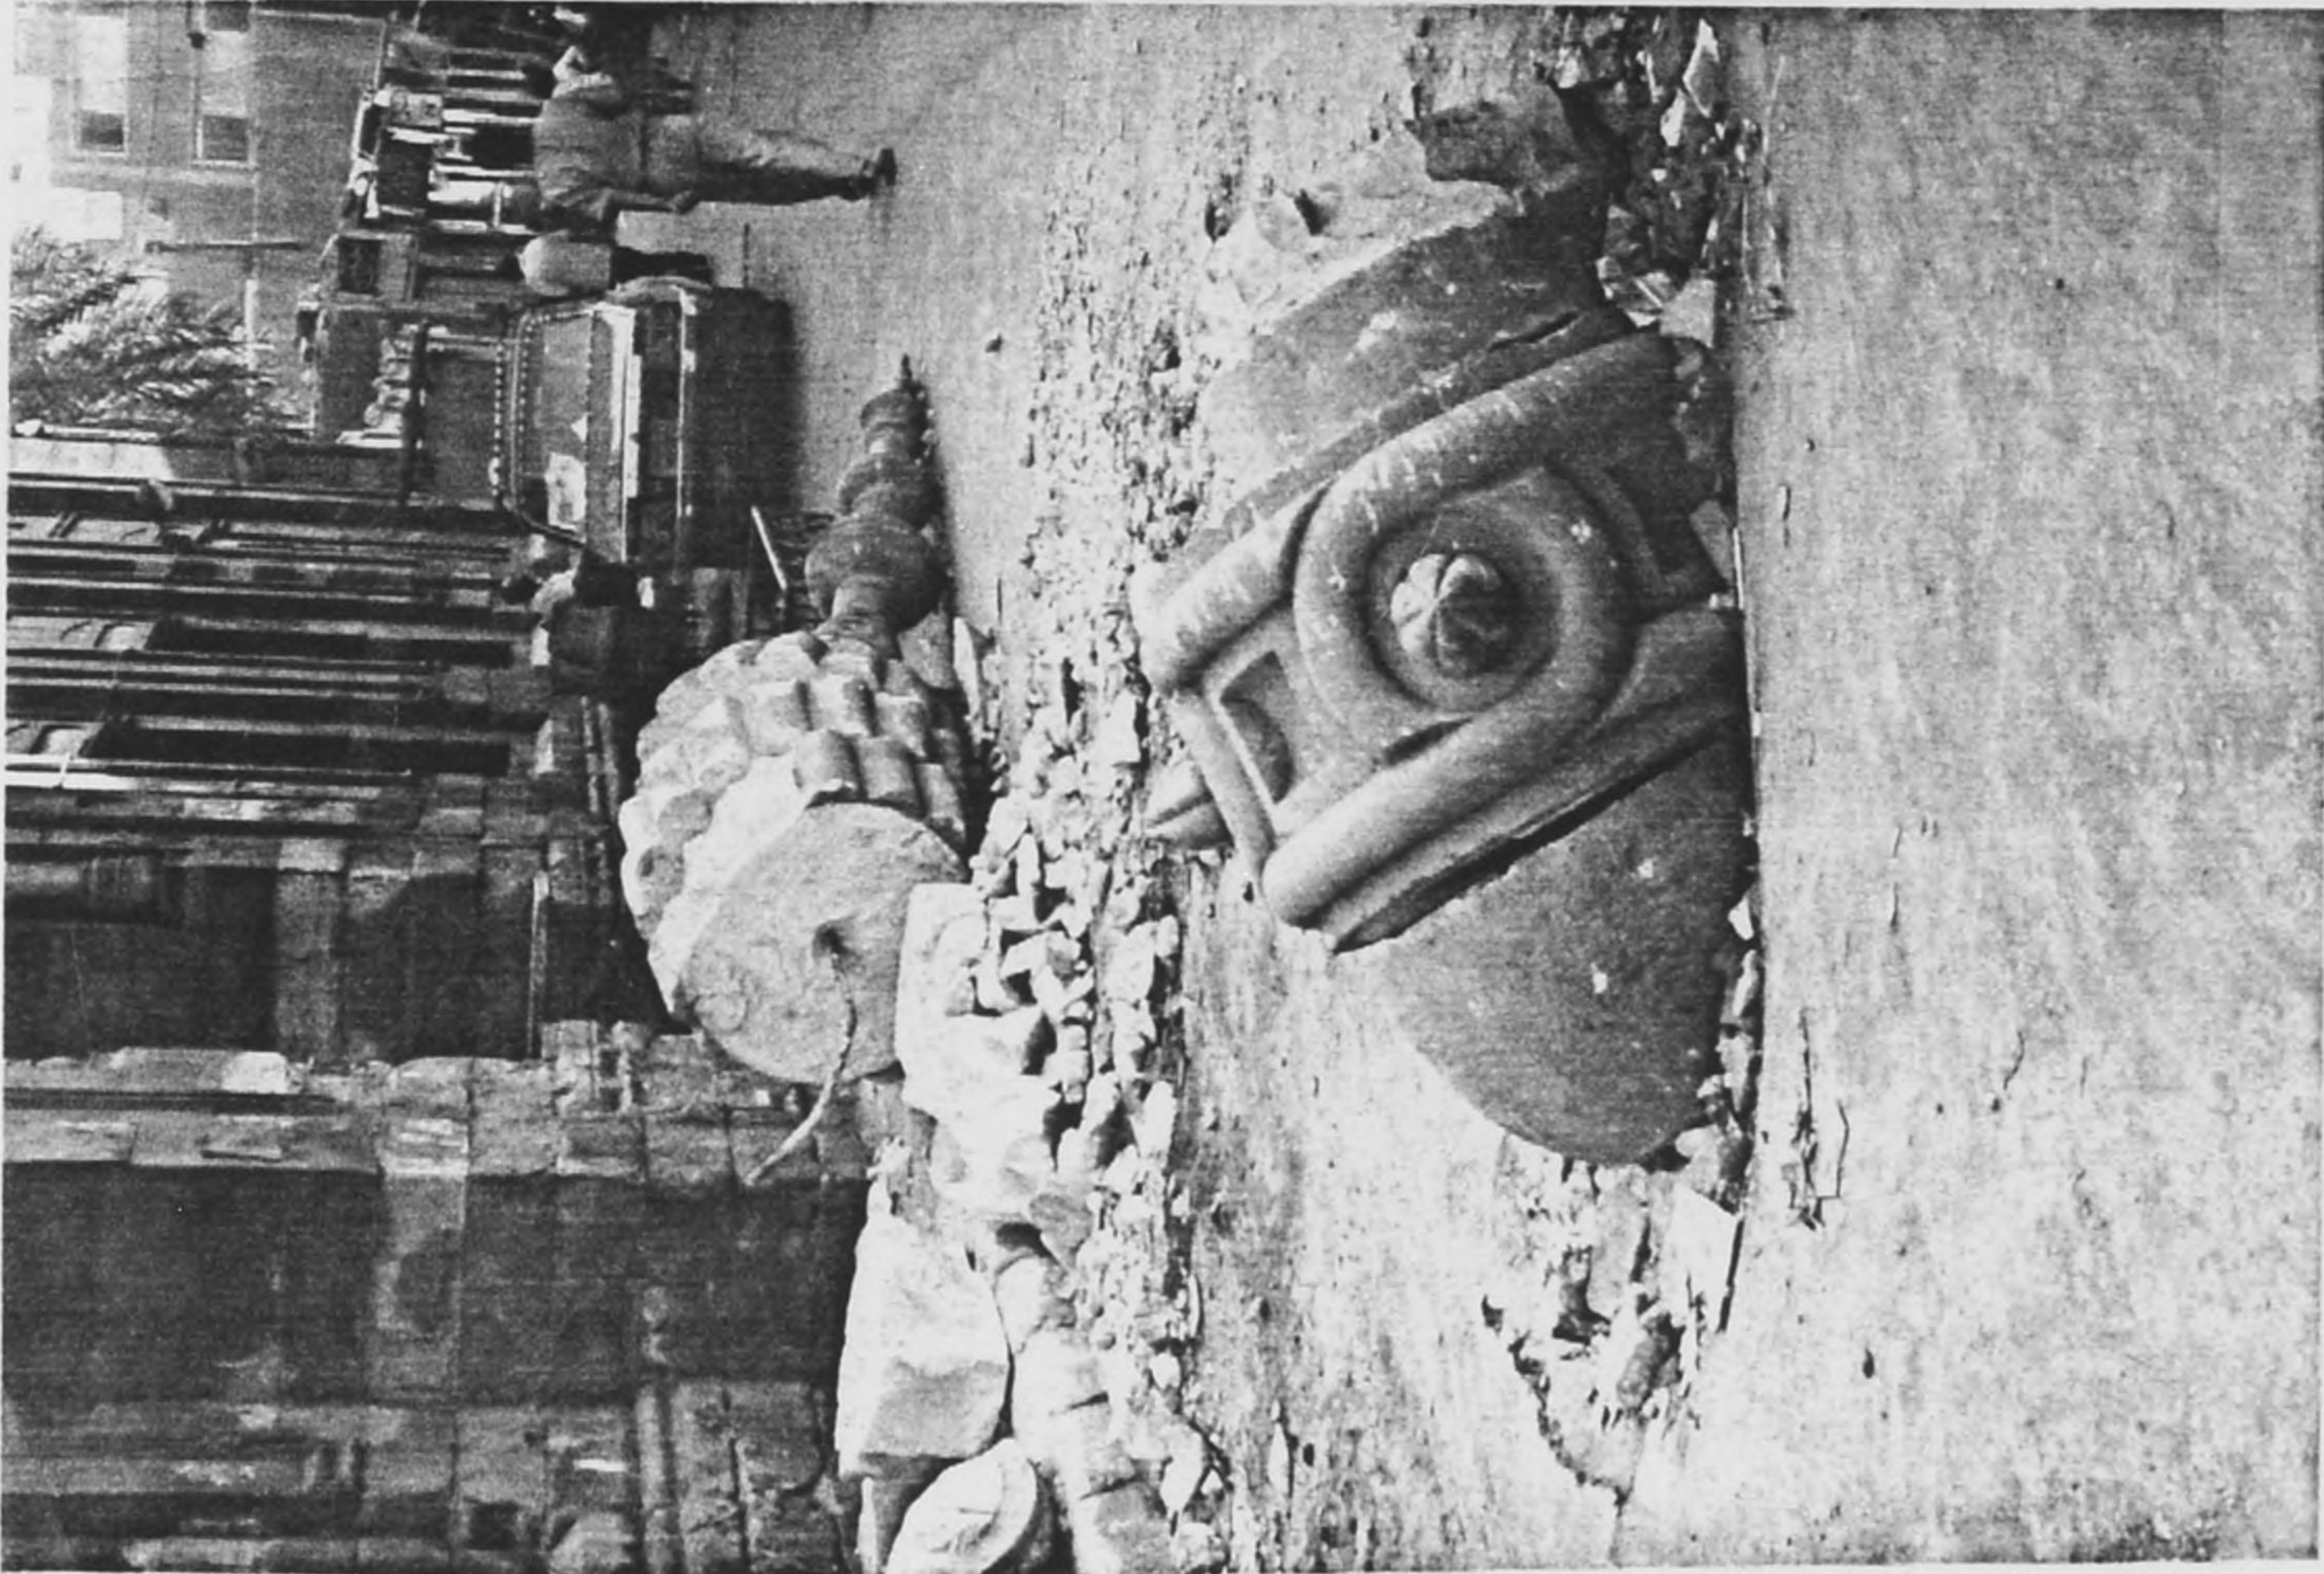
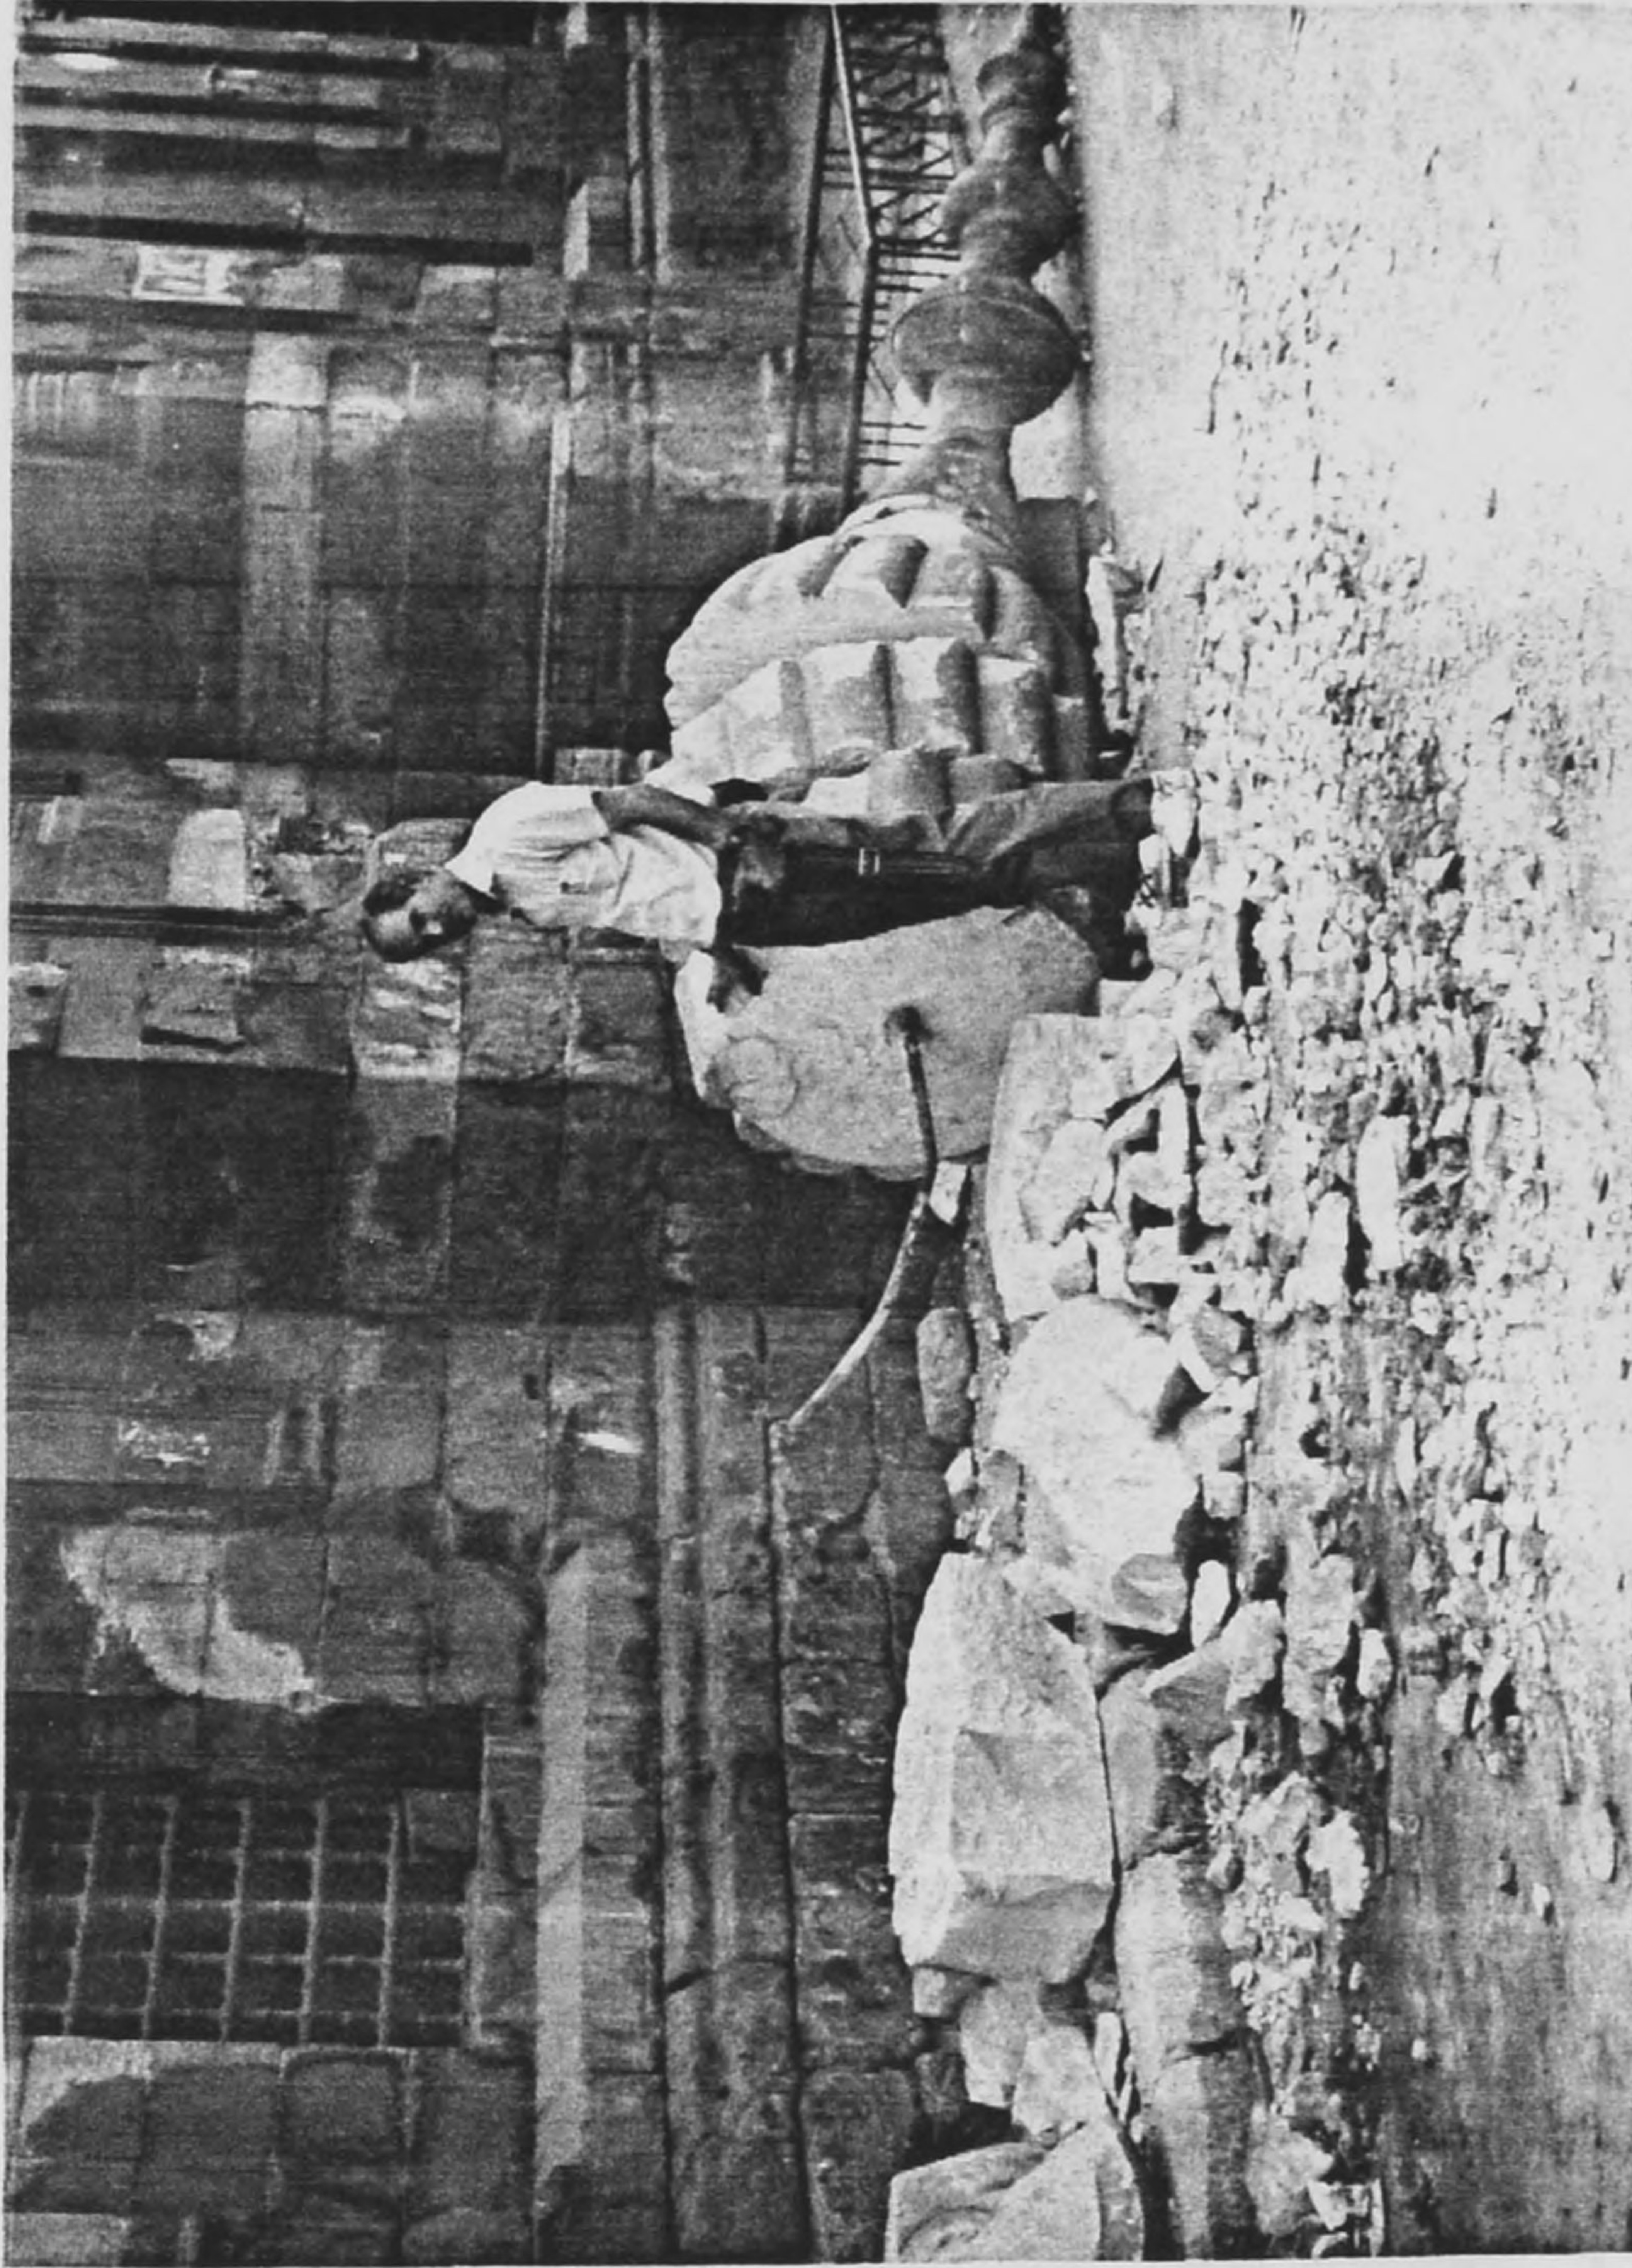
Fig. 15 Debris from collapsed minaret tops in street adjacent to mosque

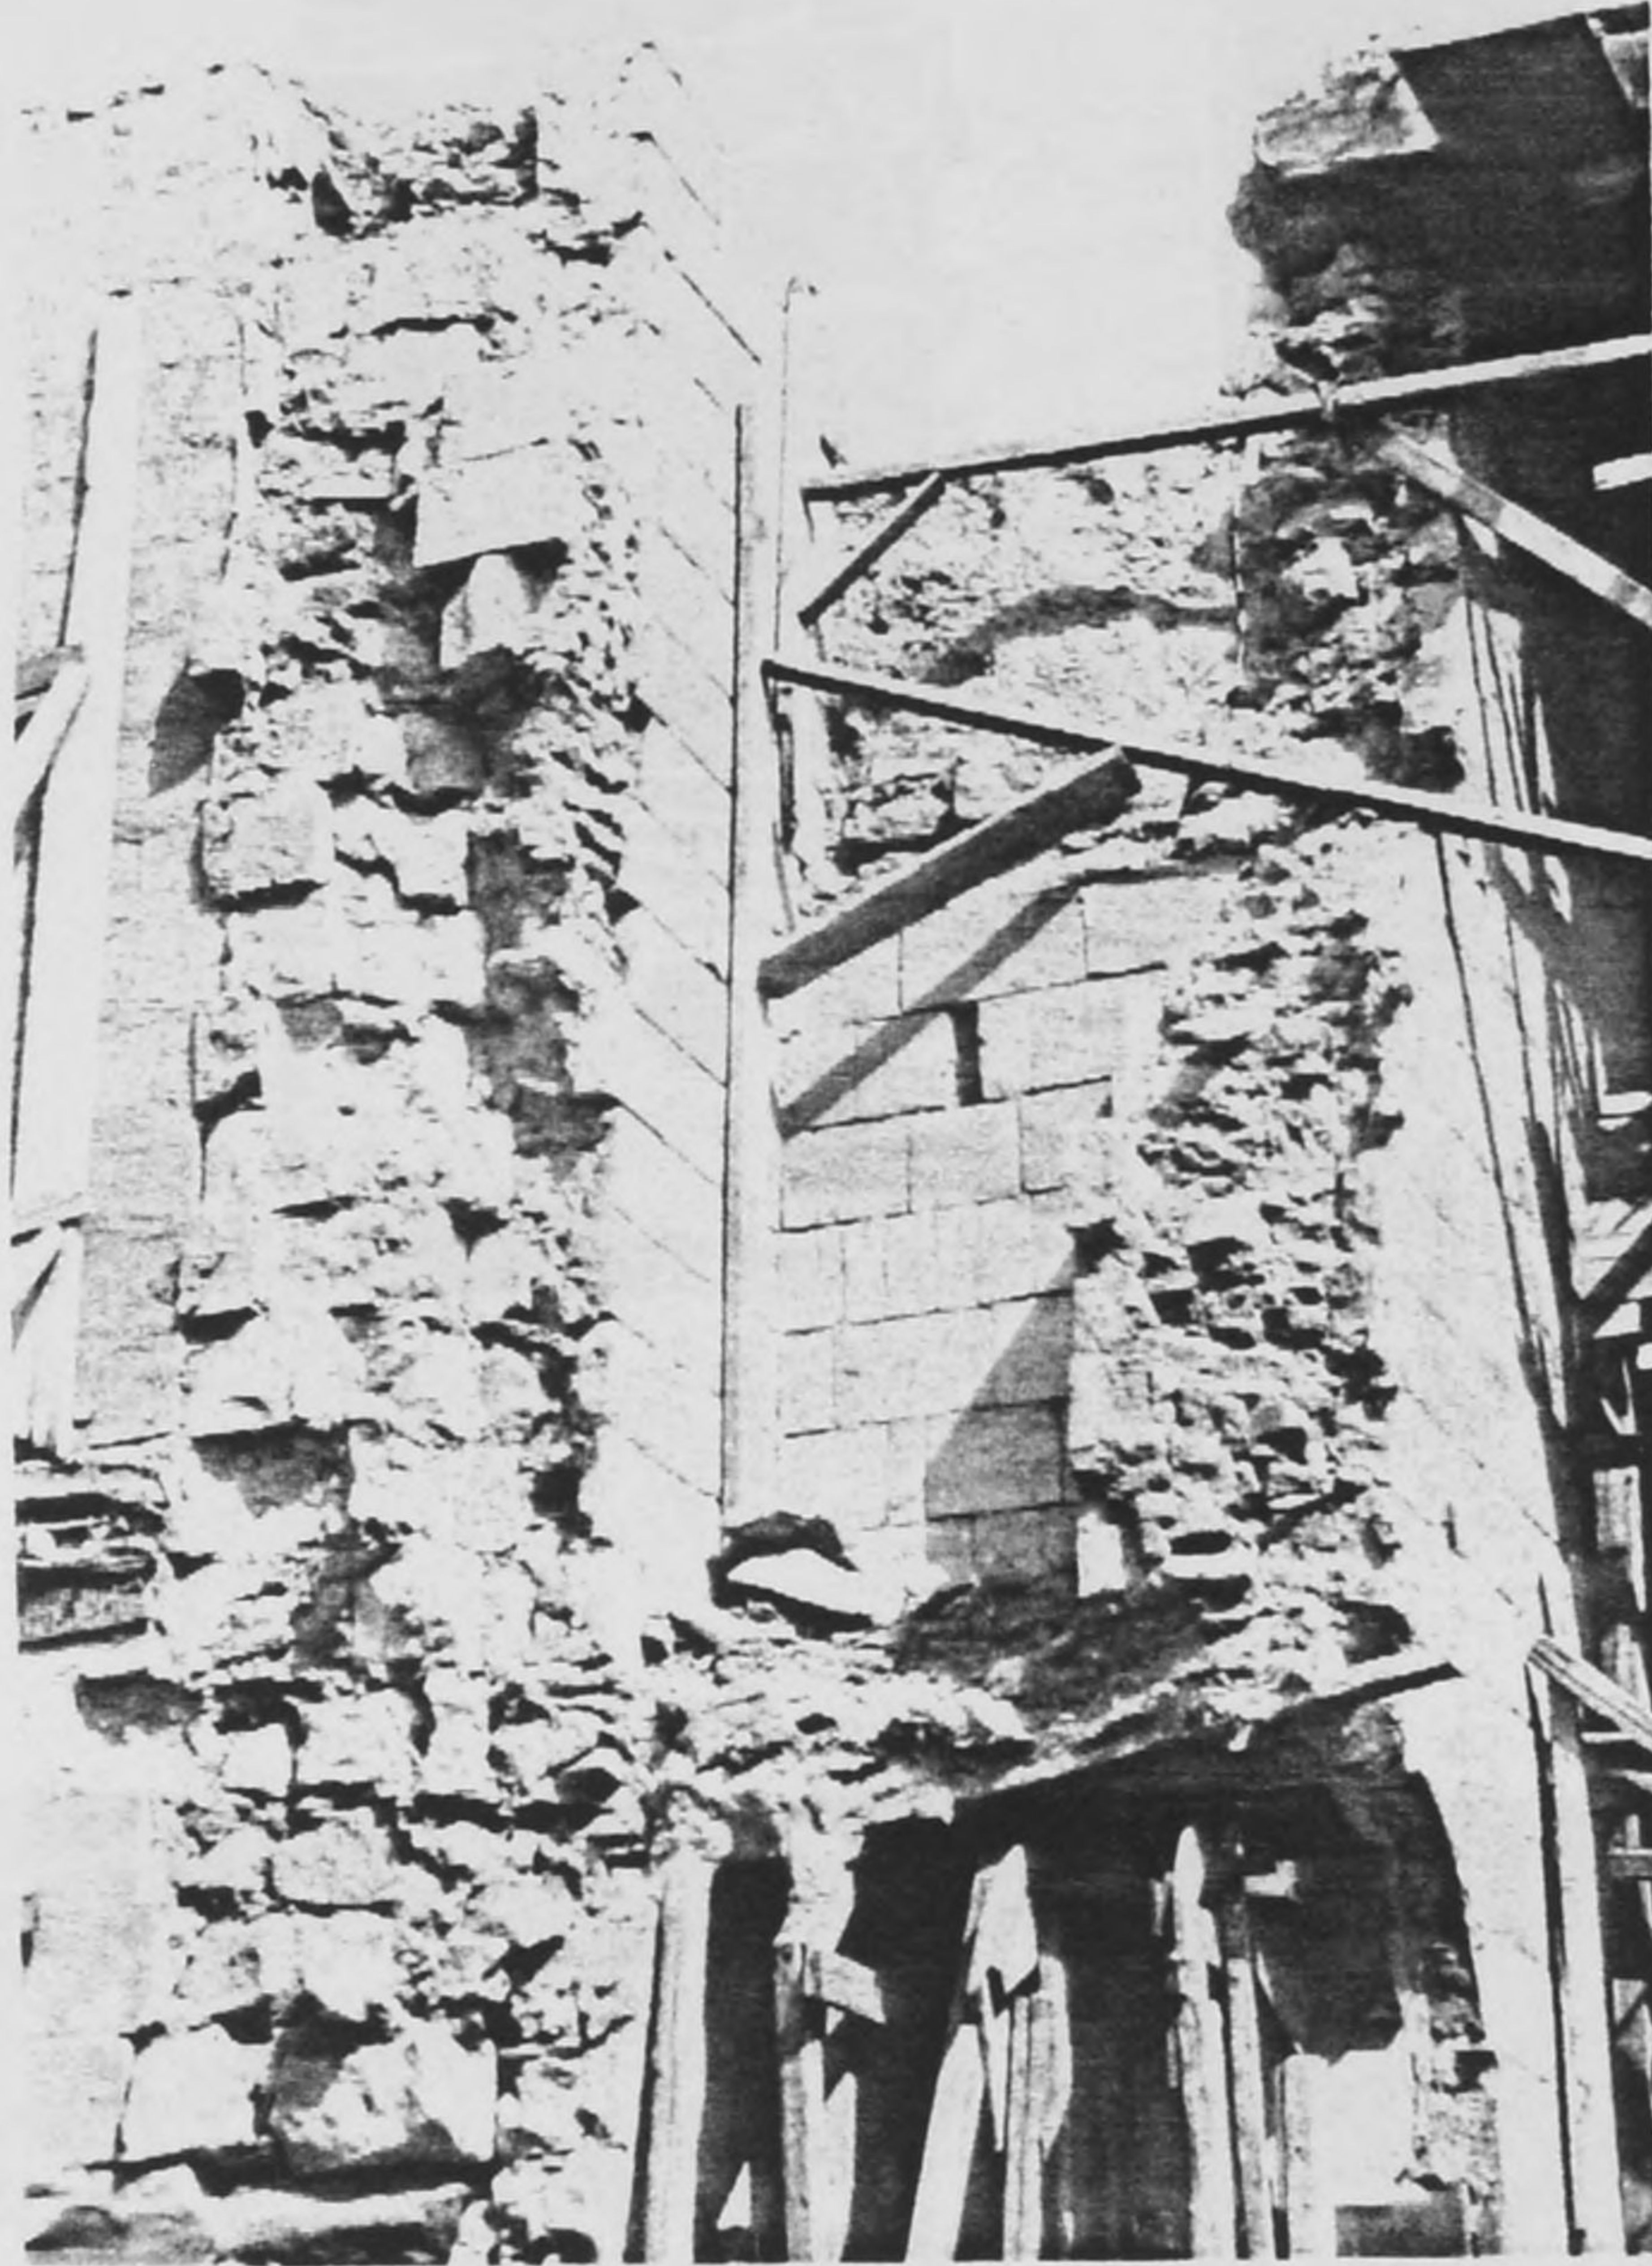
Among all of the sites visited, the mosque of Sultan Khani Bey El Rama was in the worst condition. It provided the most dramatic evidence of the repercussions of inappropriately controlled local dewatering. It was reported to the inspection team that during local pumping to draw down the water, the mosque's minaret tilted, rotated and collapsed. The location where the minaret tower broke away from the mosque is shown in Fig. 16. Local residents recount that as the minaret was falling, the decorative top of the minaret was launched as an airborne projectile (due to centripetal acceleration). Two individuals in a house across the street from the mosque were reported to have been crushed by the projectile. While the inspection team could neither confirm nor find contradiction to this account, it was very evident that the collapse predated the earthquake. If dewatering was the culprit for the collapse, it is very likely that the drawdown was too rapid, thereby inducing high hydraulic gradients which piped fine grained soil out of the foundation.

Fig. 16 Location where minaret tower broke away from Mosque of Sultan Khani Bey
