Report No. UMCEE 92-31

Field Investigation of Damage to Islamic Monuments Caused by the Egyptian Earthquake of October 12, 1992

**James K. Wight
Roman D. Hryciw
Antoine E. Naaman**

December 1992

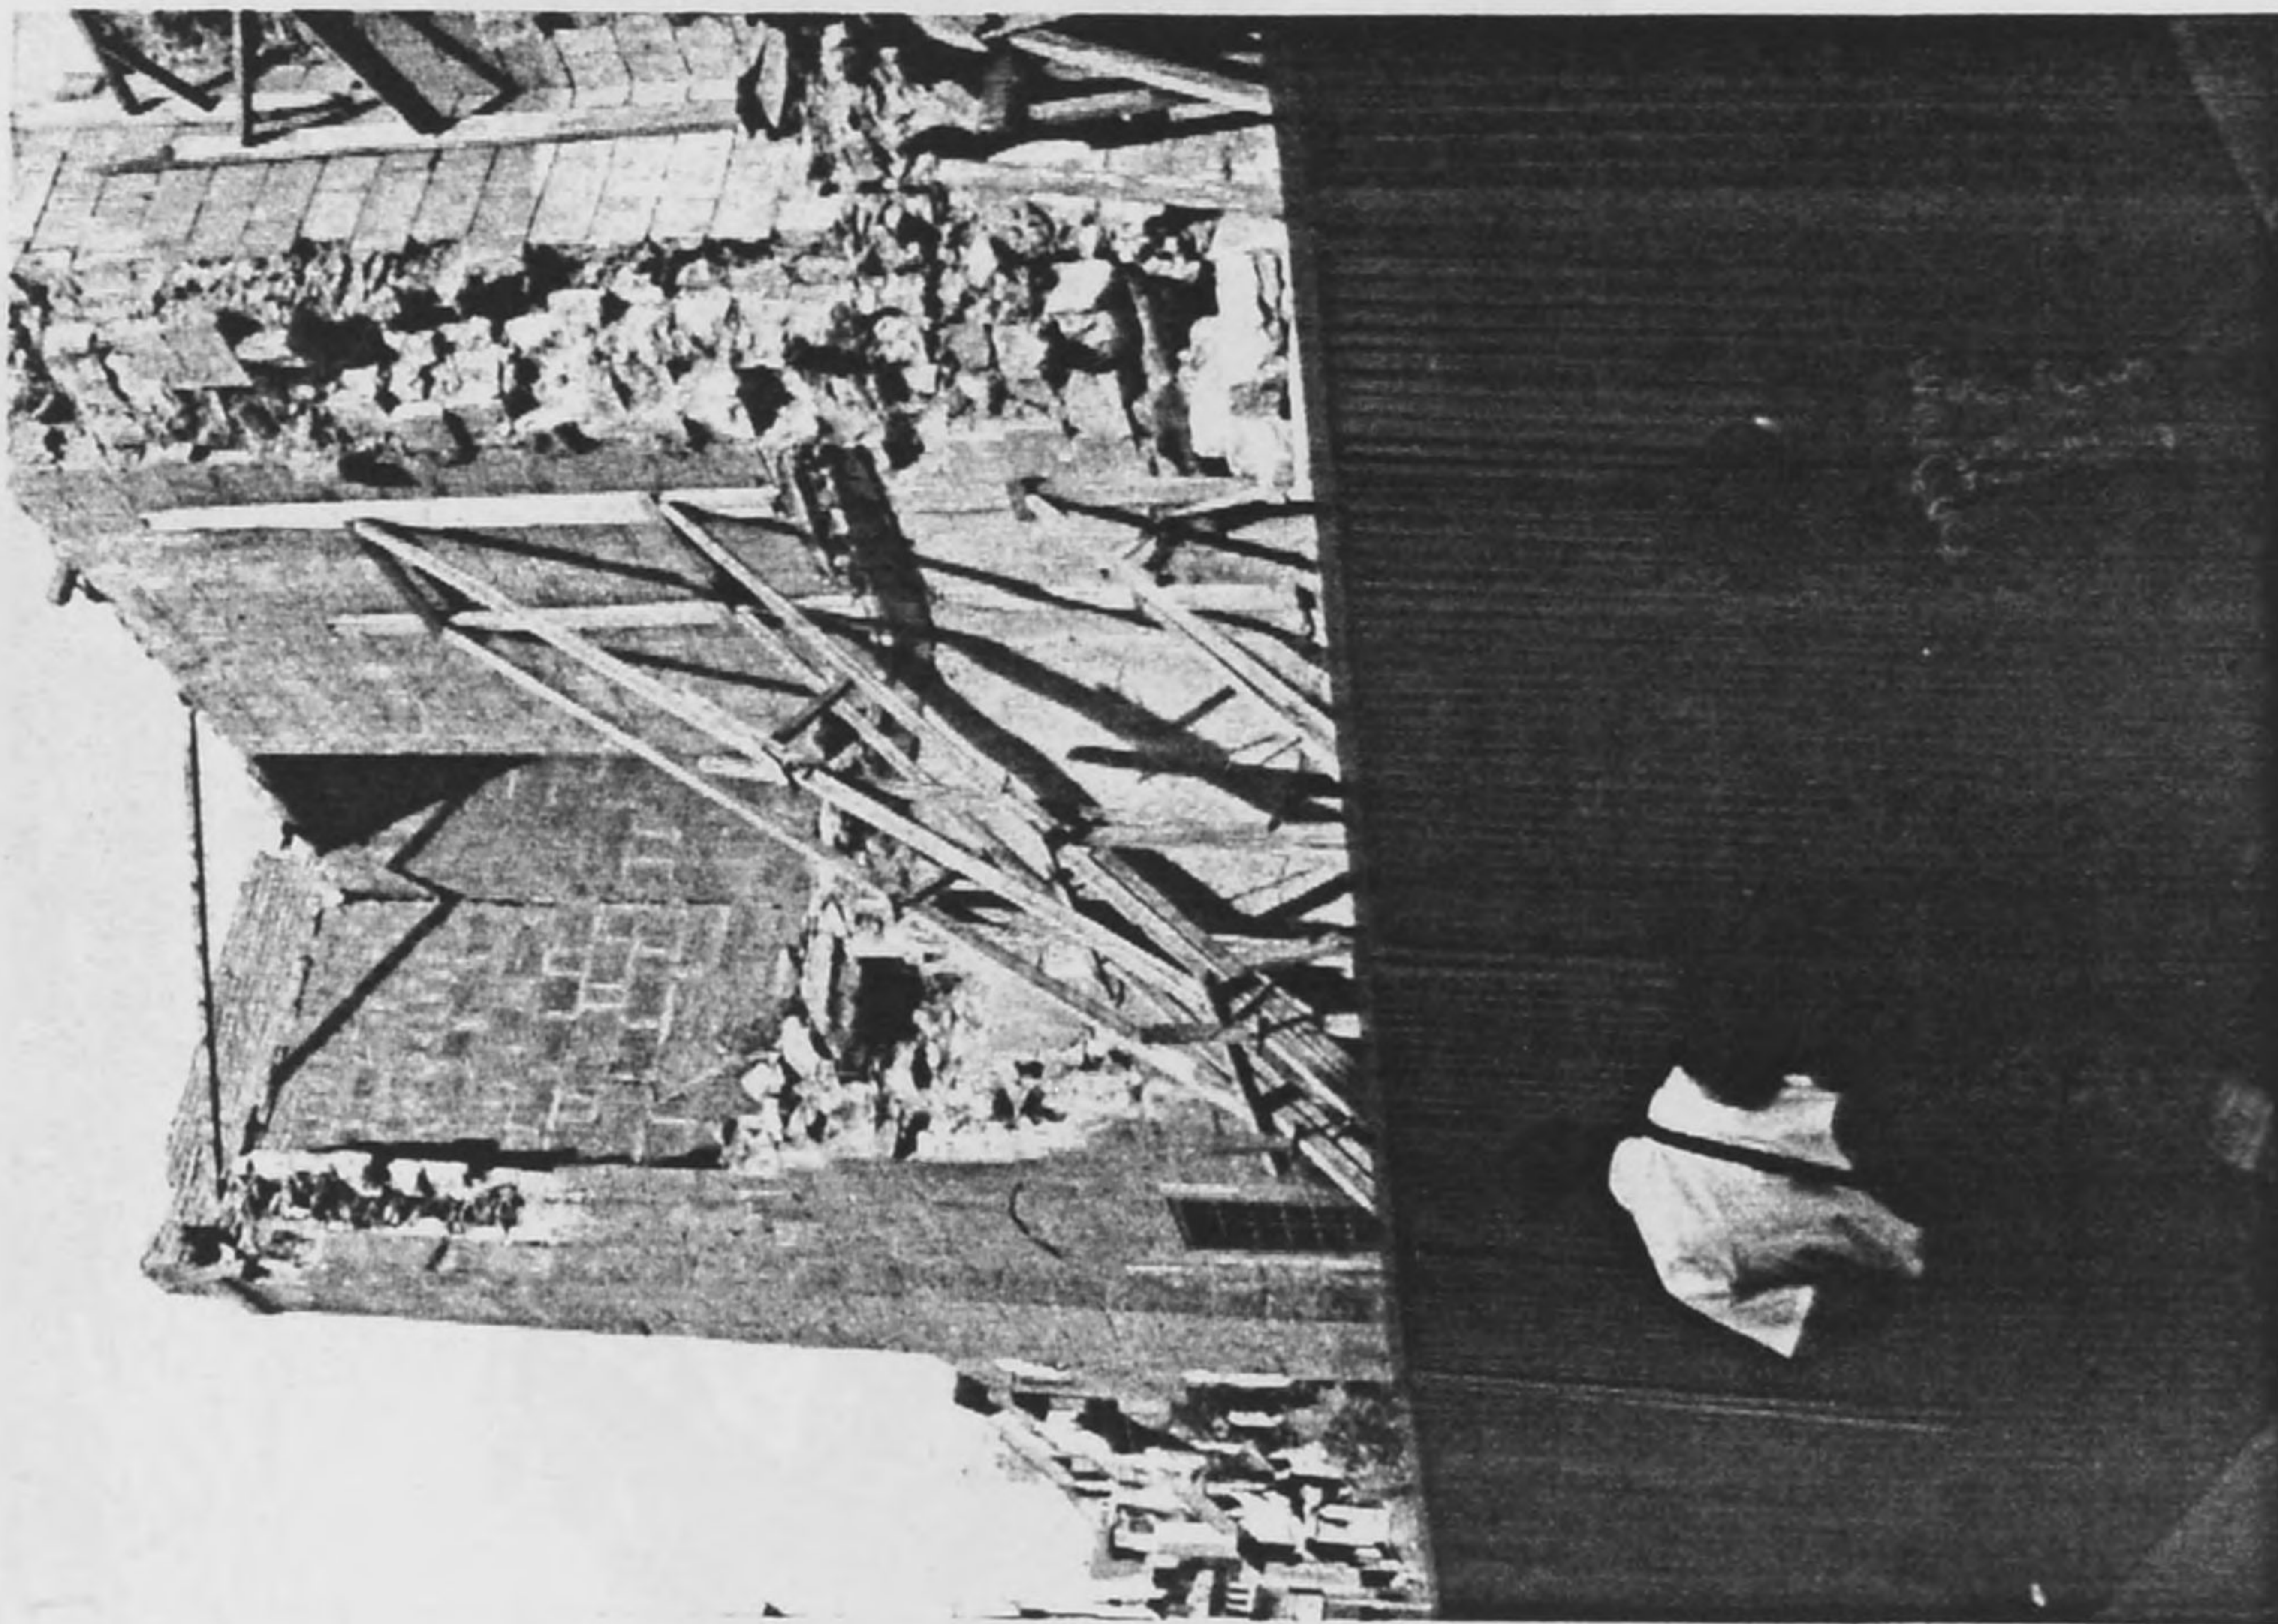
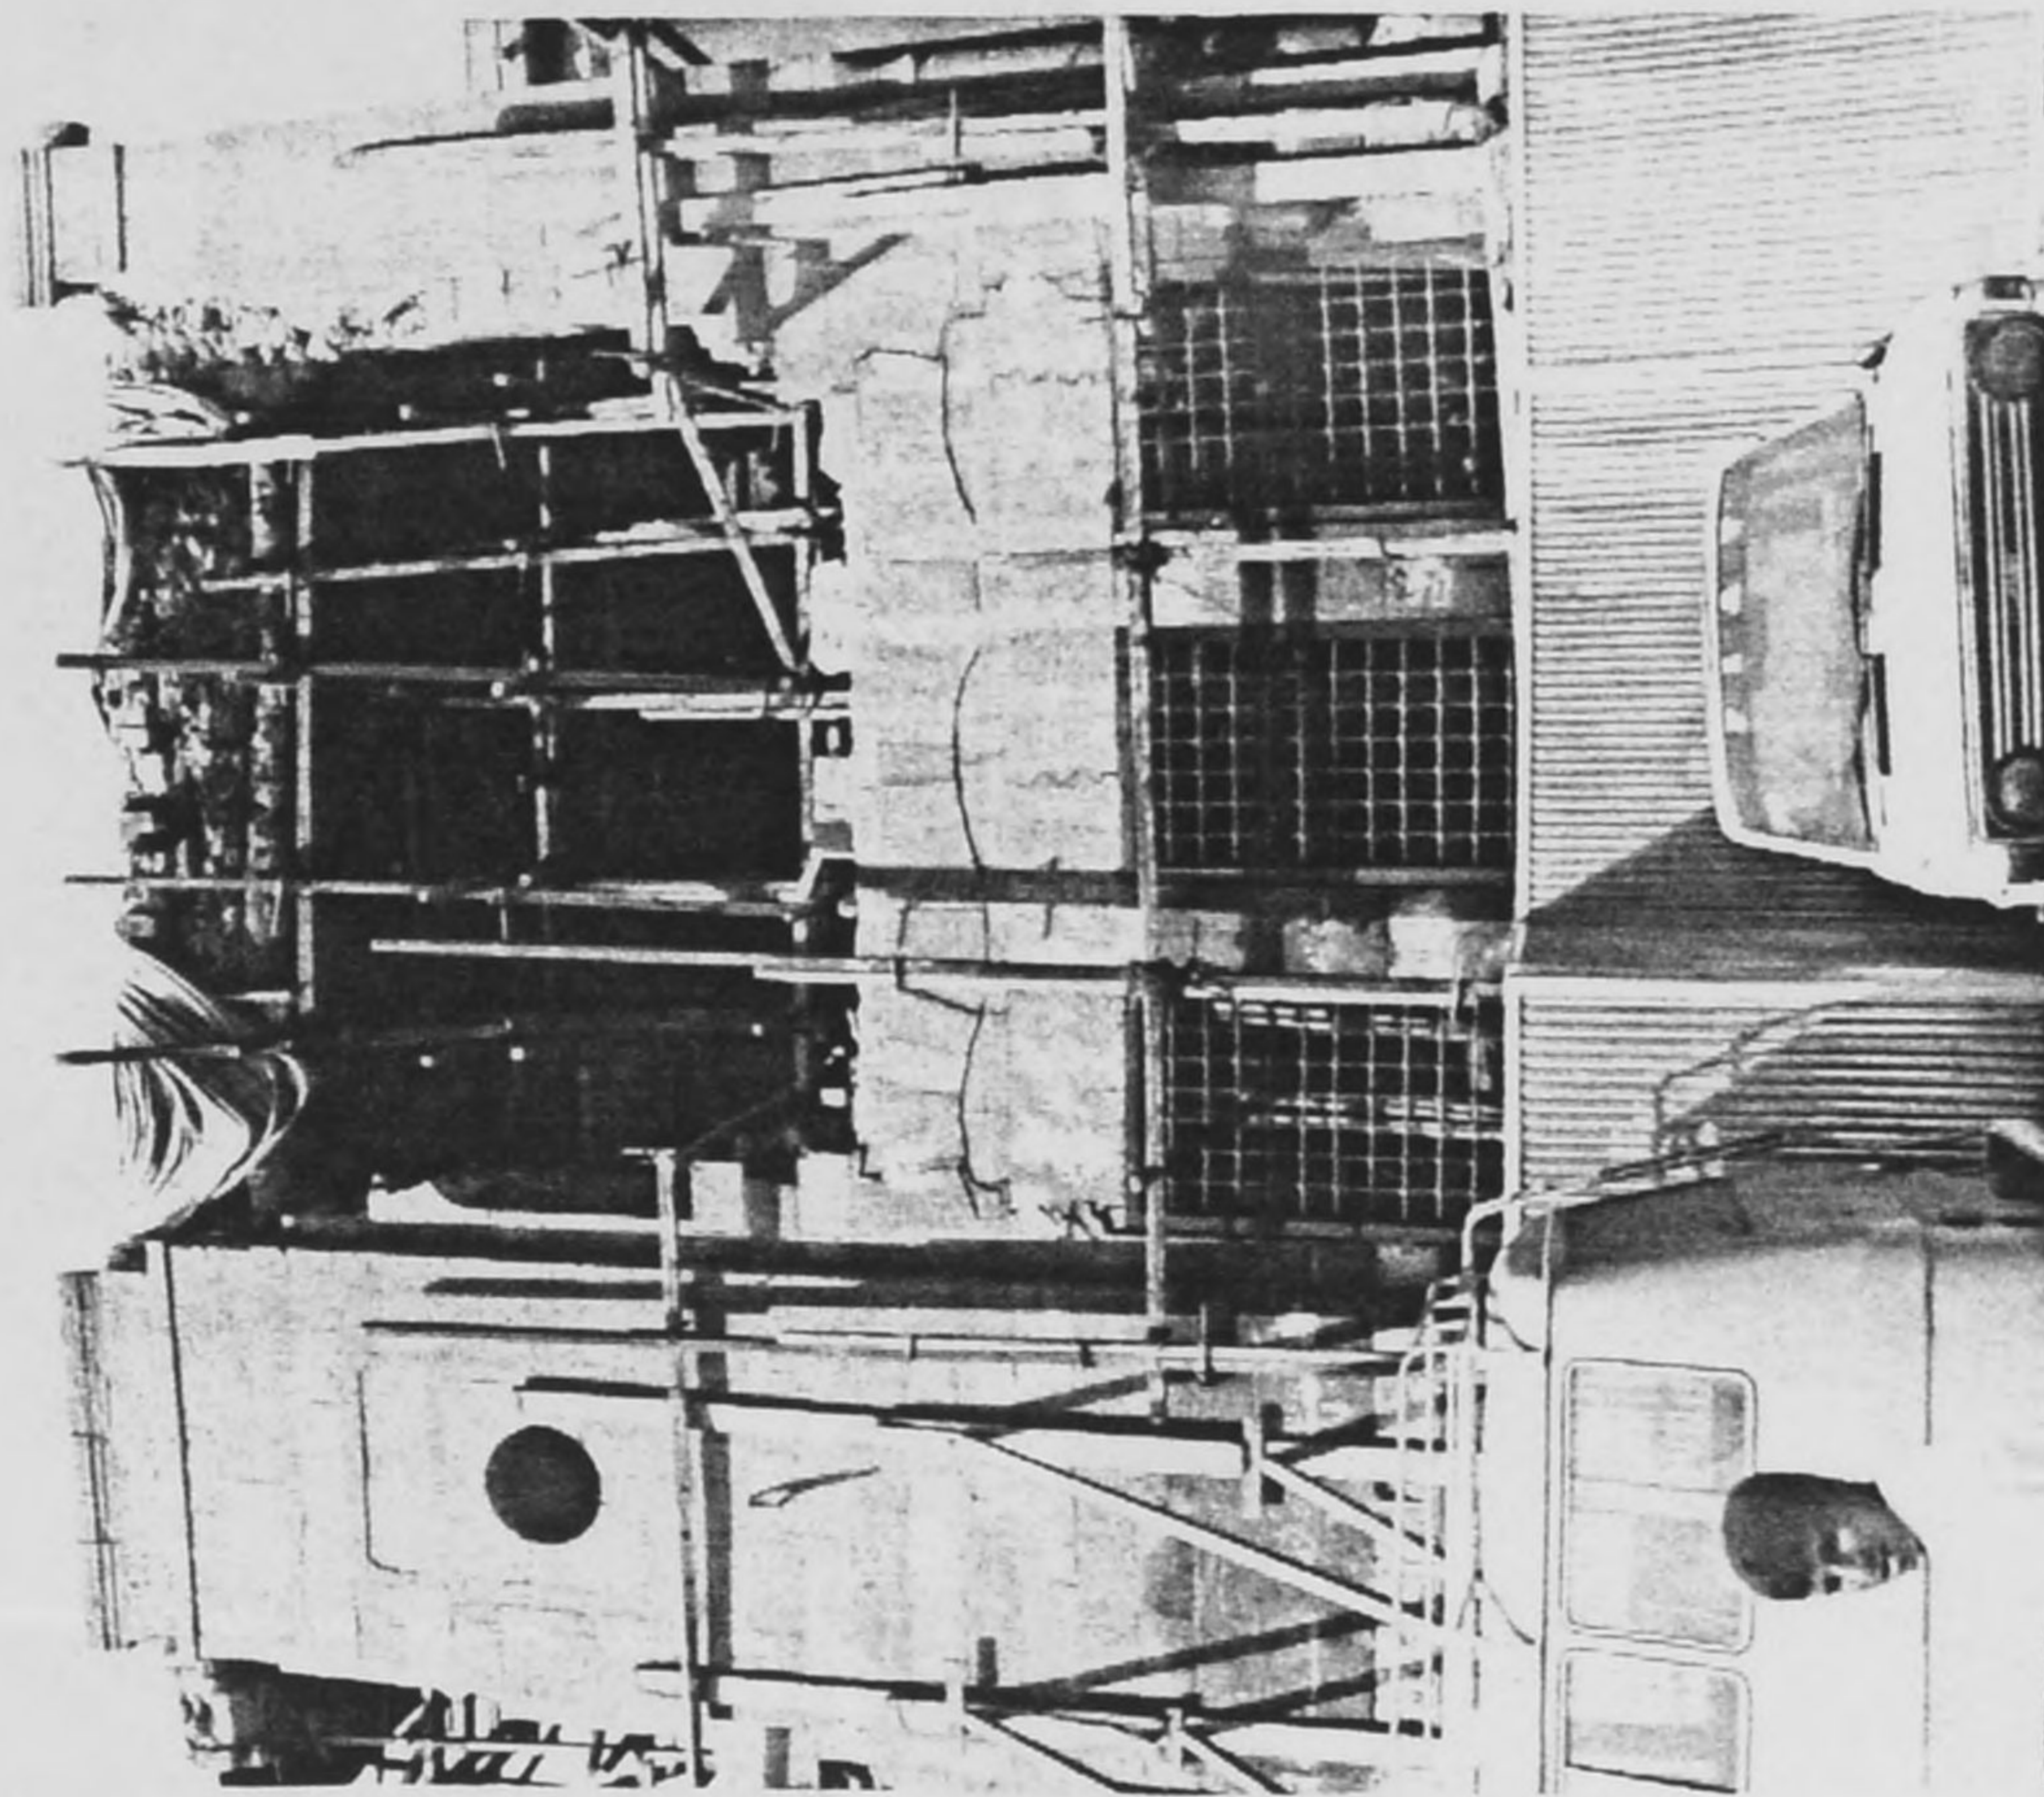
The overall state of the Khani Bey Mosque was very poor (Fig. 17). Groundwater was visible in an open pit at less than one meter depth (Fig. 18). Differential settlements were in evidence. Access to much of the building was difficult because of collapsed stairways, imposed barriers and debris. Any

earthquake induced damage was indistinguishable from other damage. Some walls have been shored in an attempt to prevent further collapse. Many interior areas are dangerous. Repair and restoration of this mosque would be very difficult if not impossible.

Fig. 17 Deteriorated state of Khani Bey Mosque

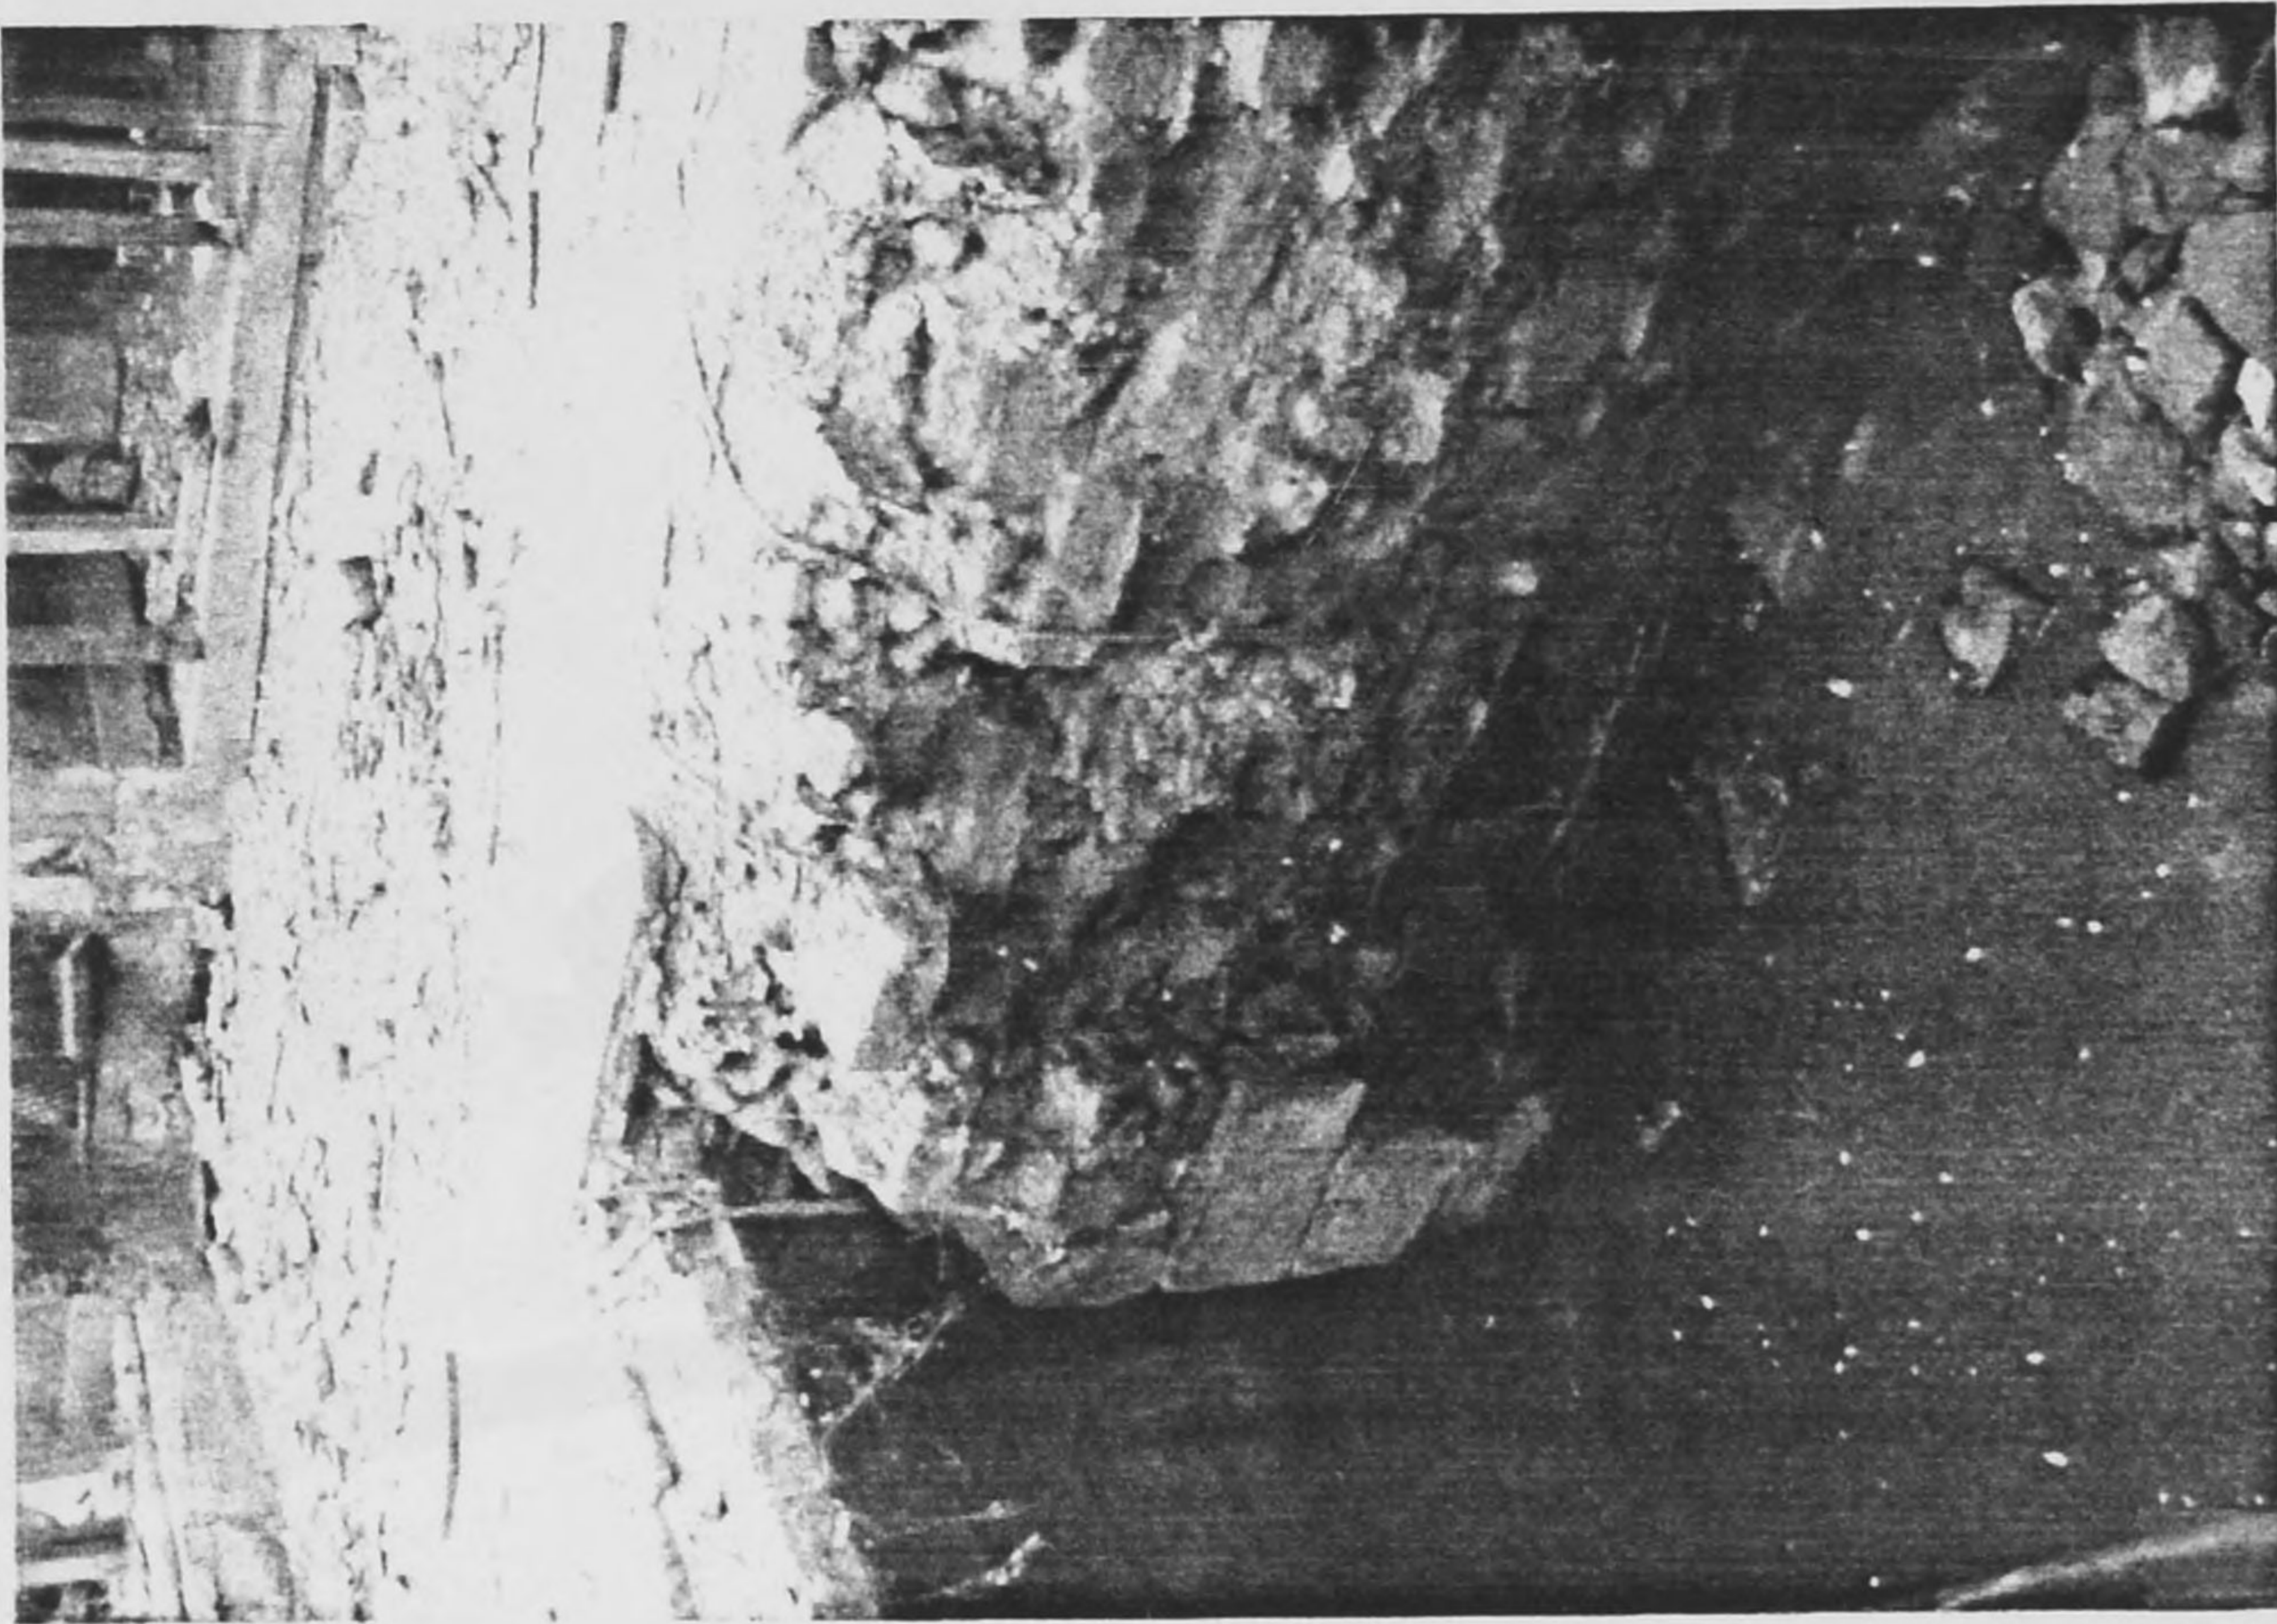
Fig. 18 Groundwater in excavation below Khani Bey Mosque

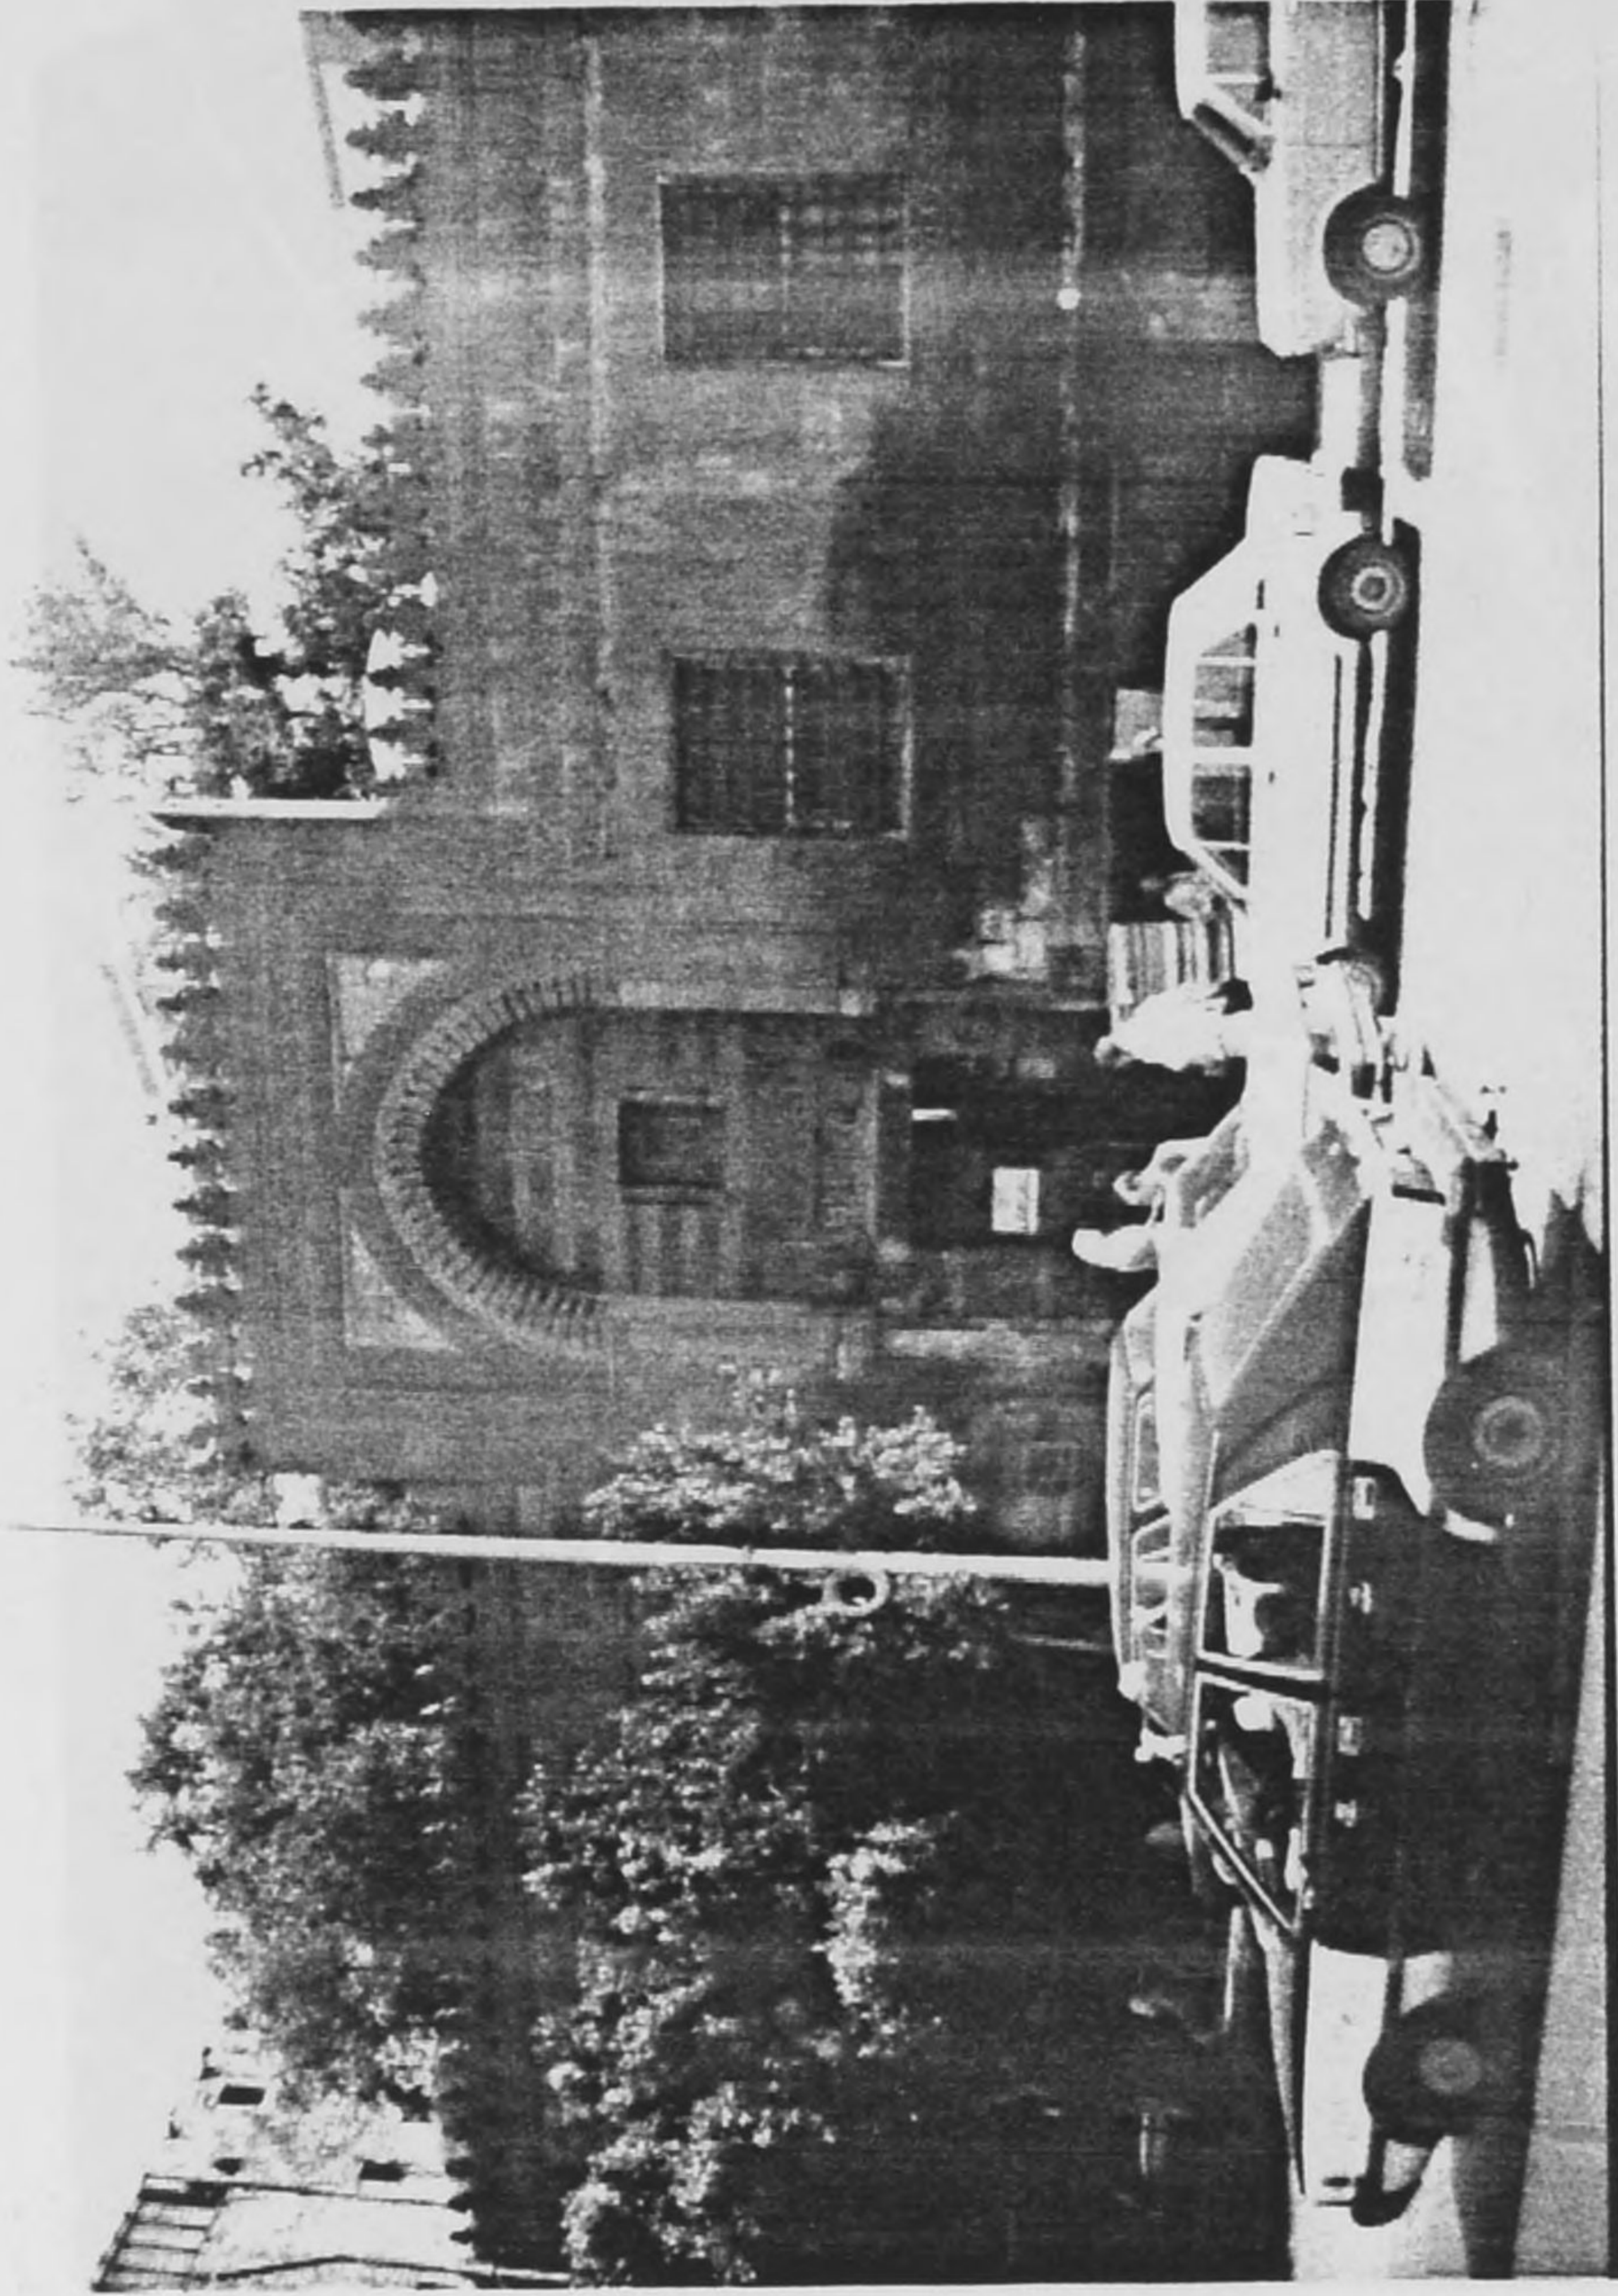
This structure was apparently a sort of convent where the Dervishes came for temporary retreat from the outside world. It is about 250 years old. In the present, it serves as a preschool. It is a one story high square structure with an open interior courtyard and garden (Fig. 19). Rooms are aligned along the periphery of the square. They all open on the inside to a covered corridor surrounding the courtyard. The roof structure is made of a series of masonry domes and arches. Several wide cracks were observed on the inside of the domes and in some rooms the mortar covering on the inside of the brick dome had spalled off and fallen (Fig. 20). Several cracks in the walls, domes and arches probably existed prior to the earthquake, but were amplified by it (Fig. 21). Most of the cracks could be structurally repaired and patched, restoring the structure to at least its pre-earthquake condition.

Fig. 19 Front of Sultan Mahmoud Takkayan Preschool

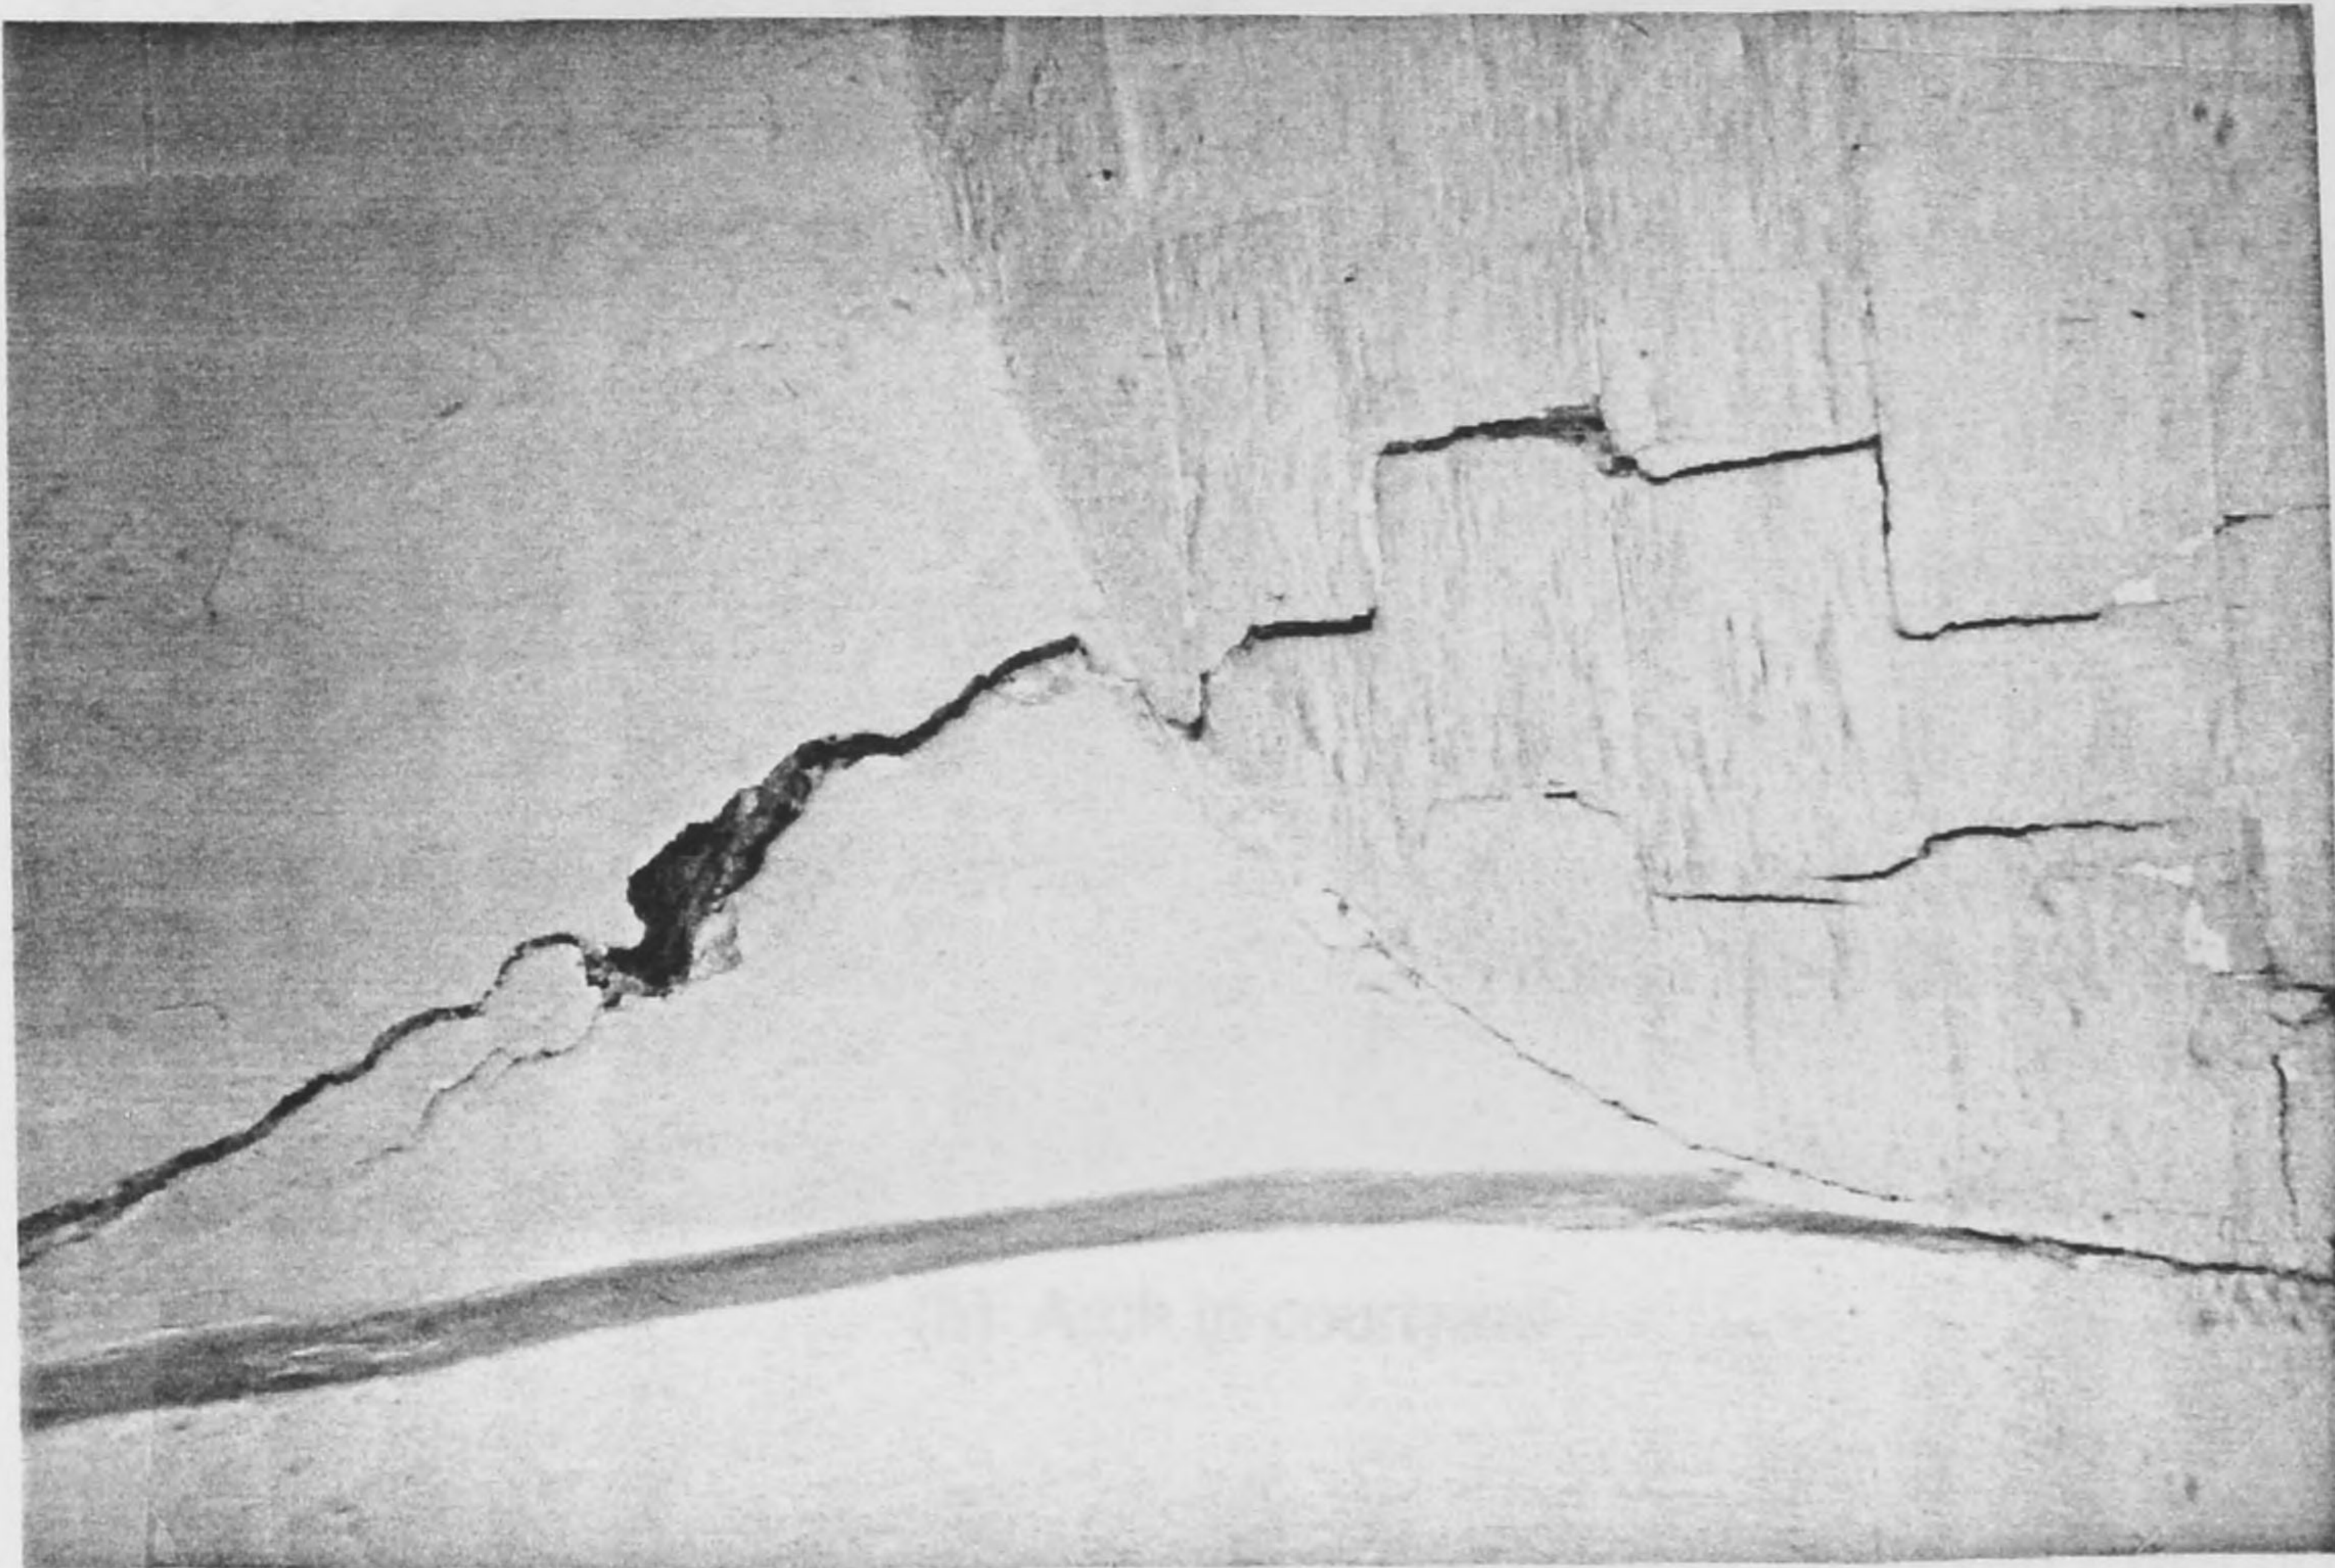
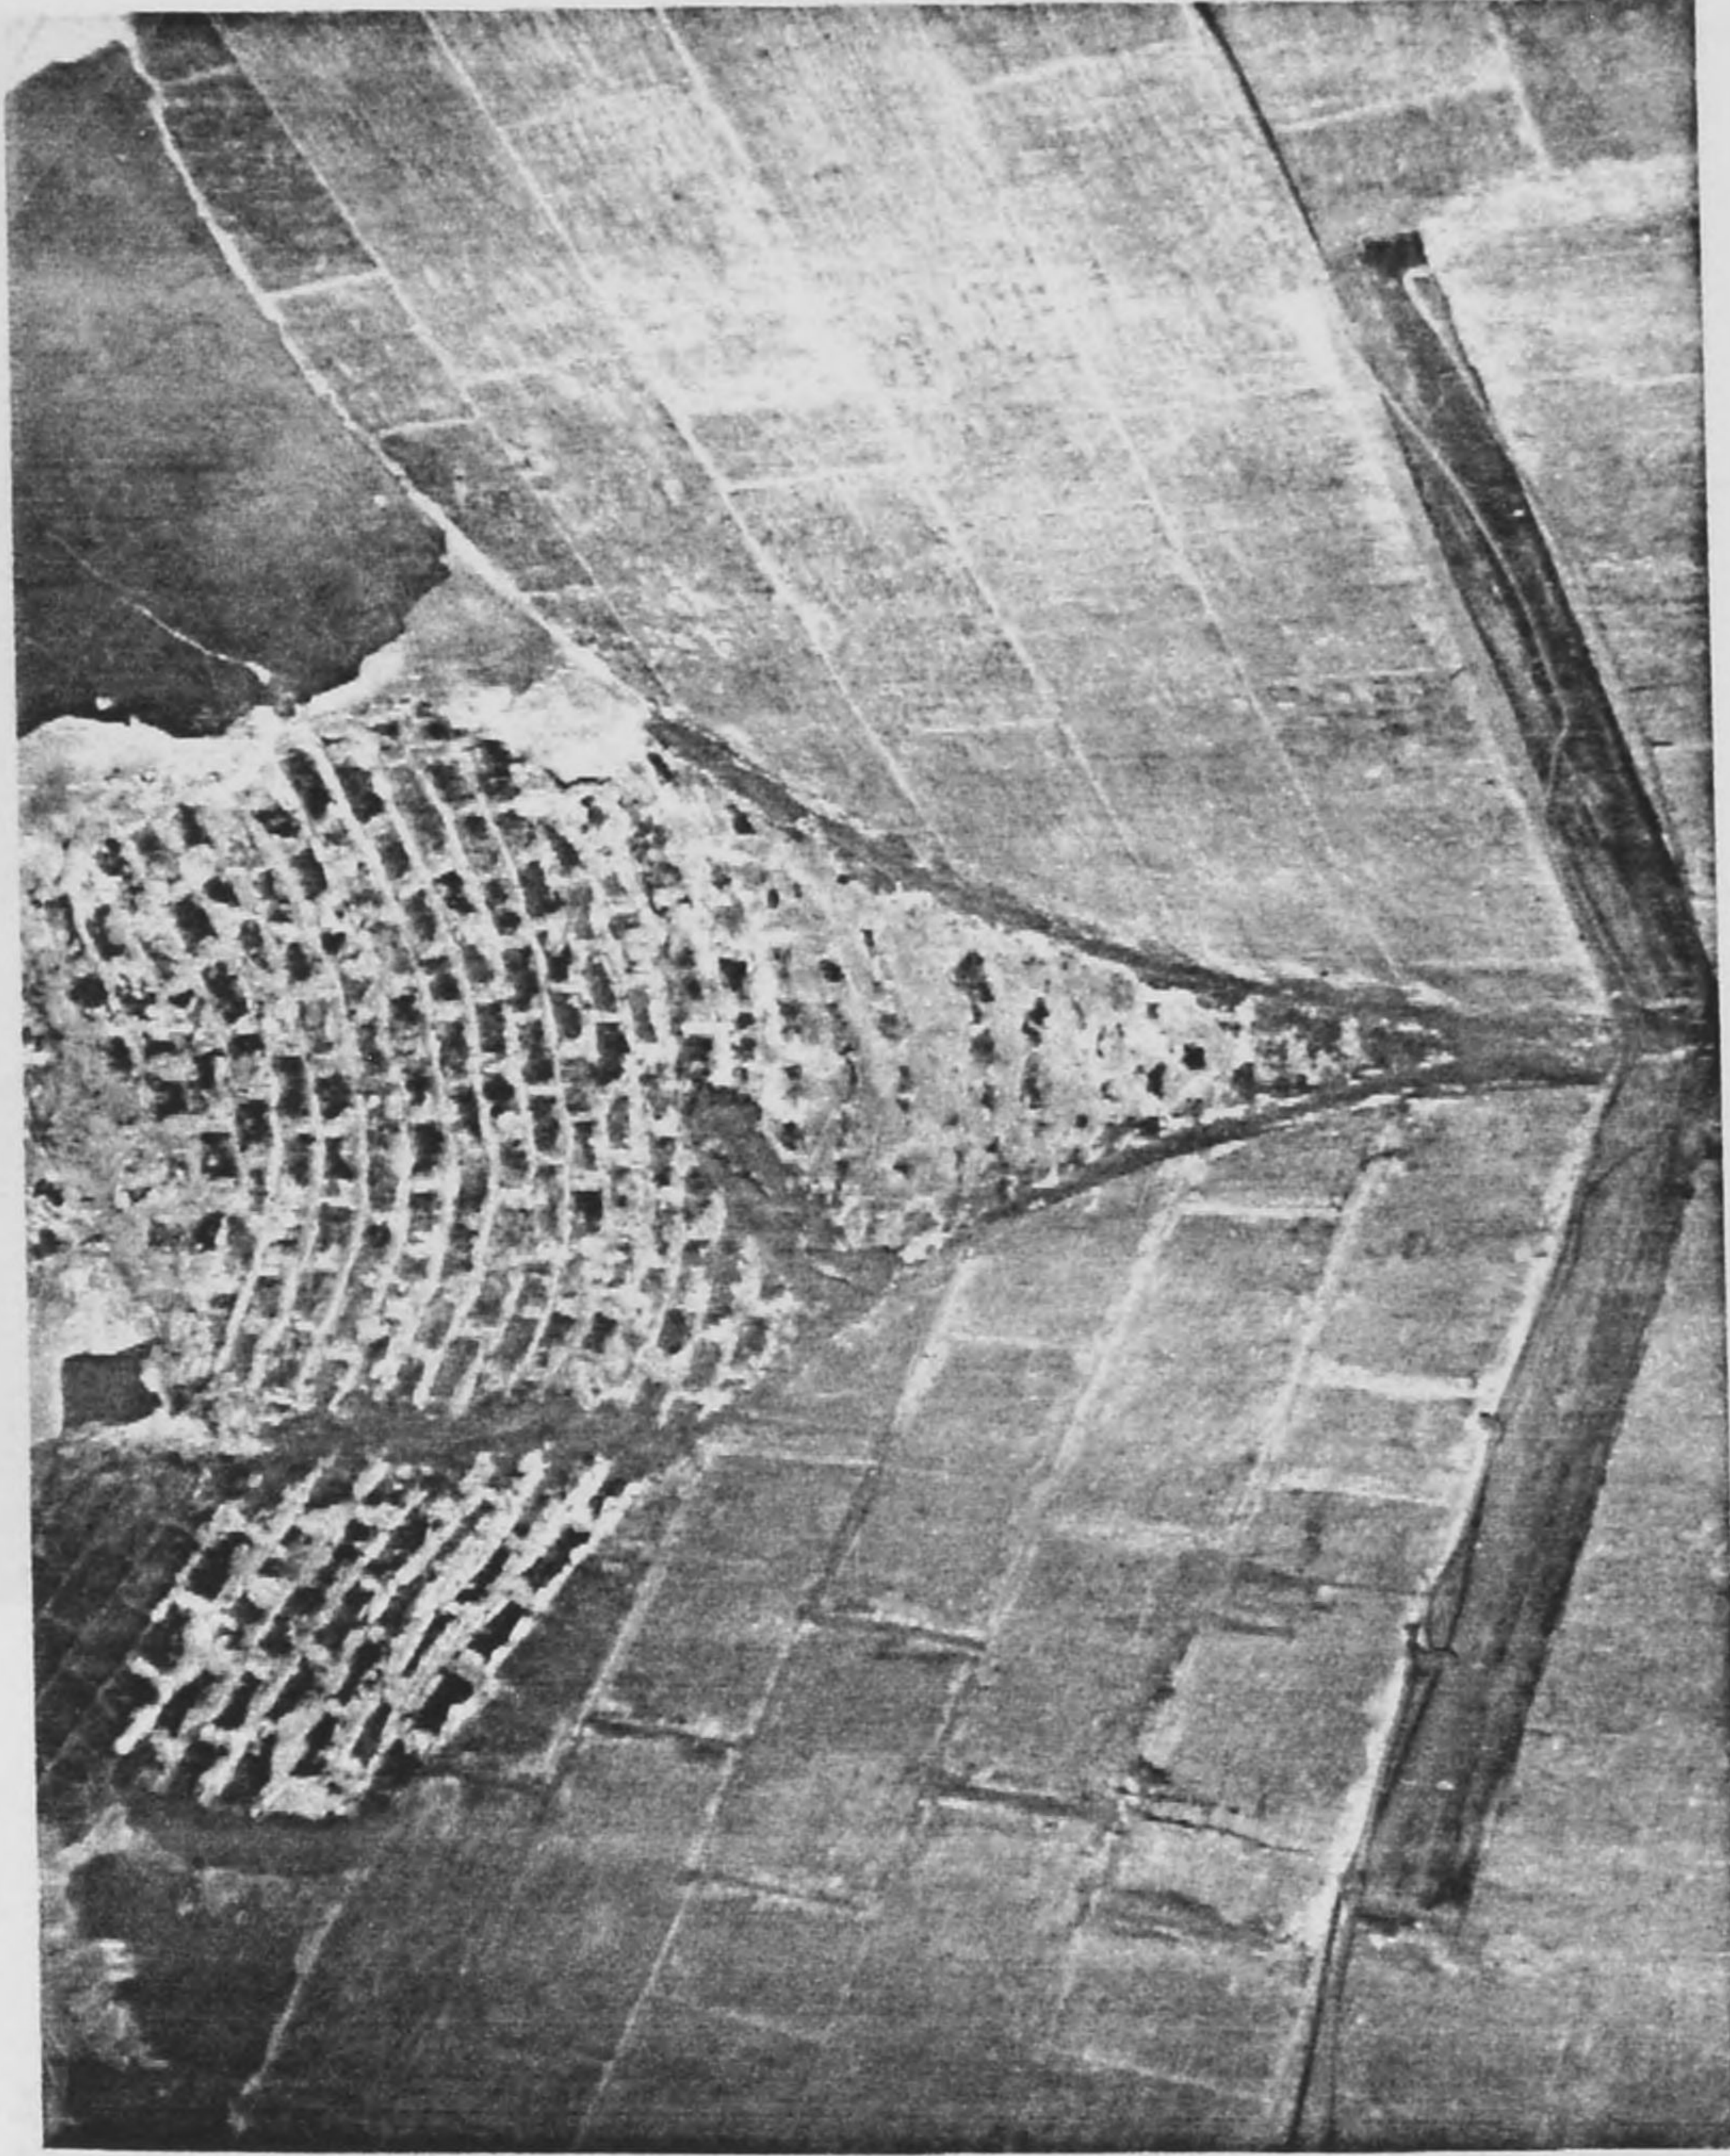
Fig. 20 Cracked and spalled domes inside Takkayah Preschool
