Report No. UMCEE 92-31

Field Investigation of Damage to Islamic Monuments Caused by the Egyptian Earthquake of October 12, 1992

**James K. Wight
Roman D. Hryciw
Antoine E. Naaman**

December 1992

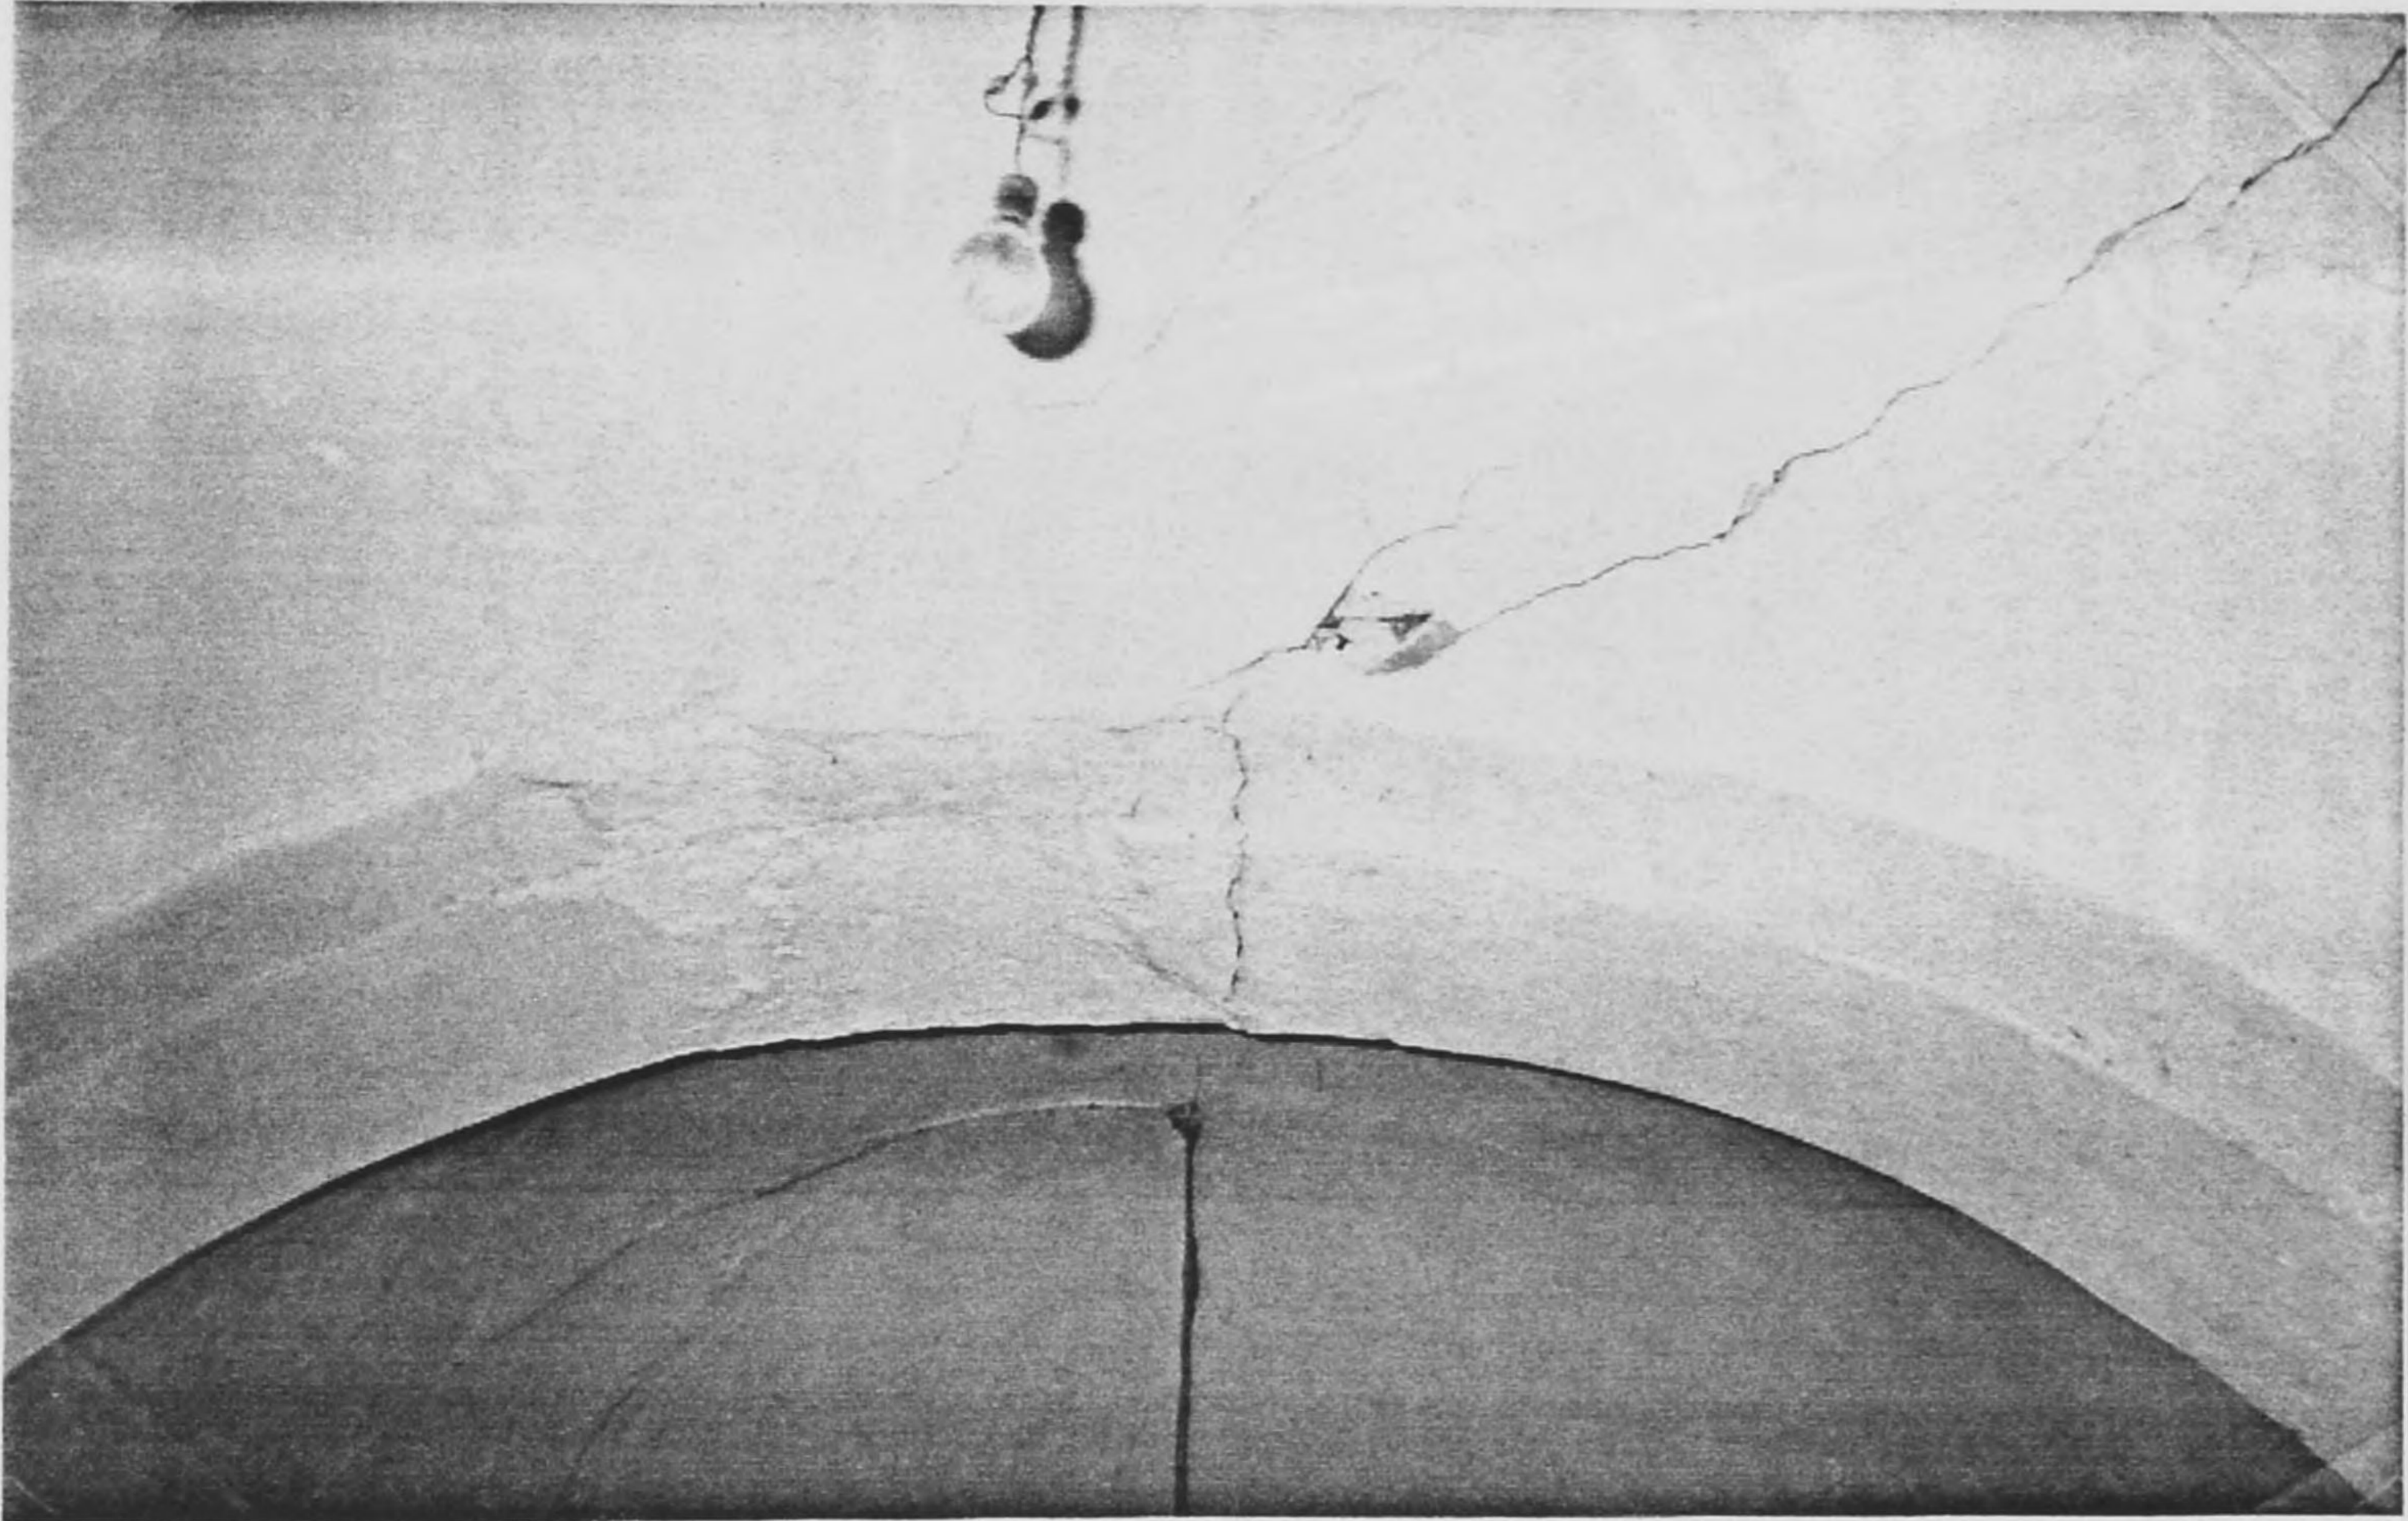
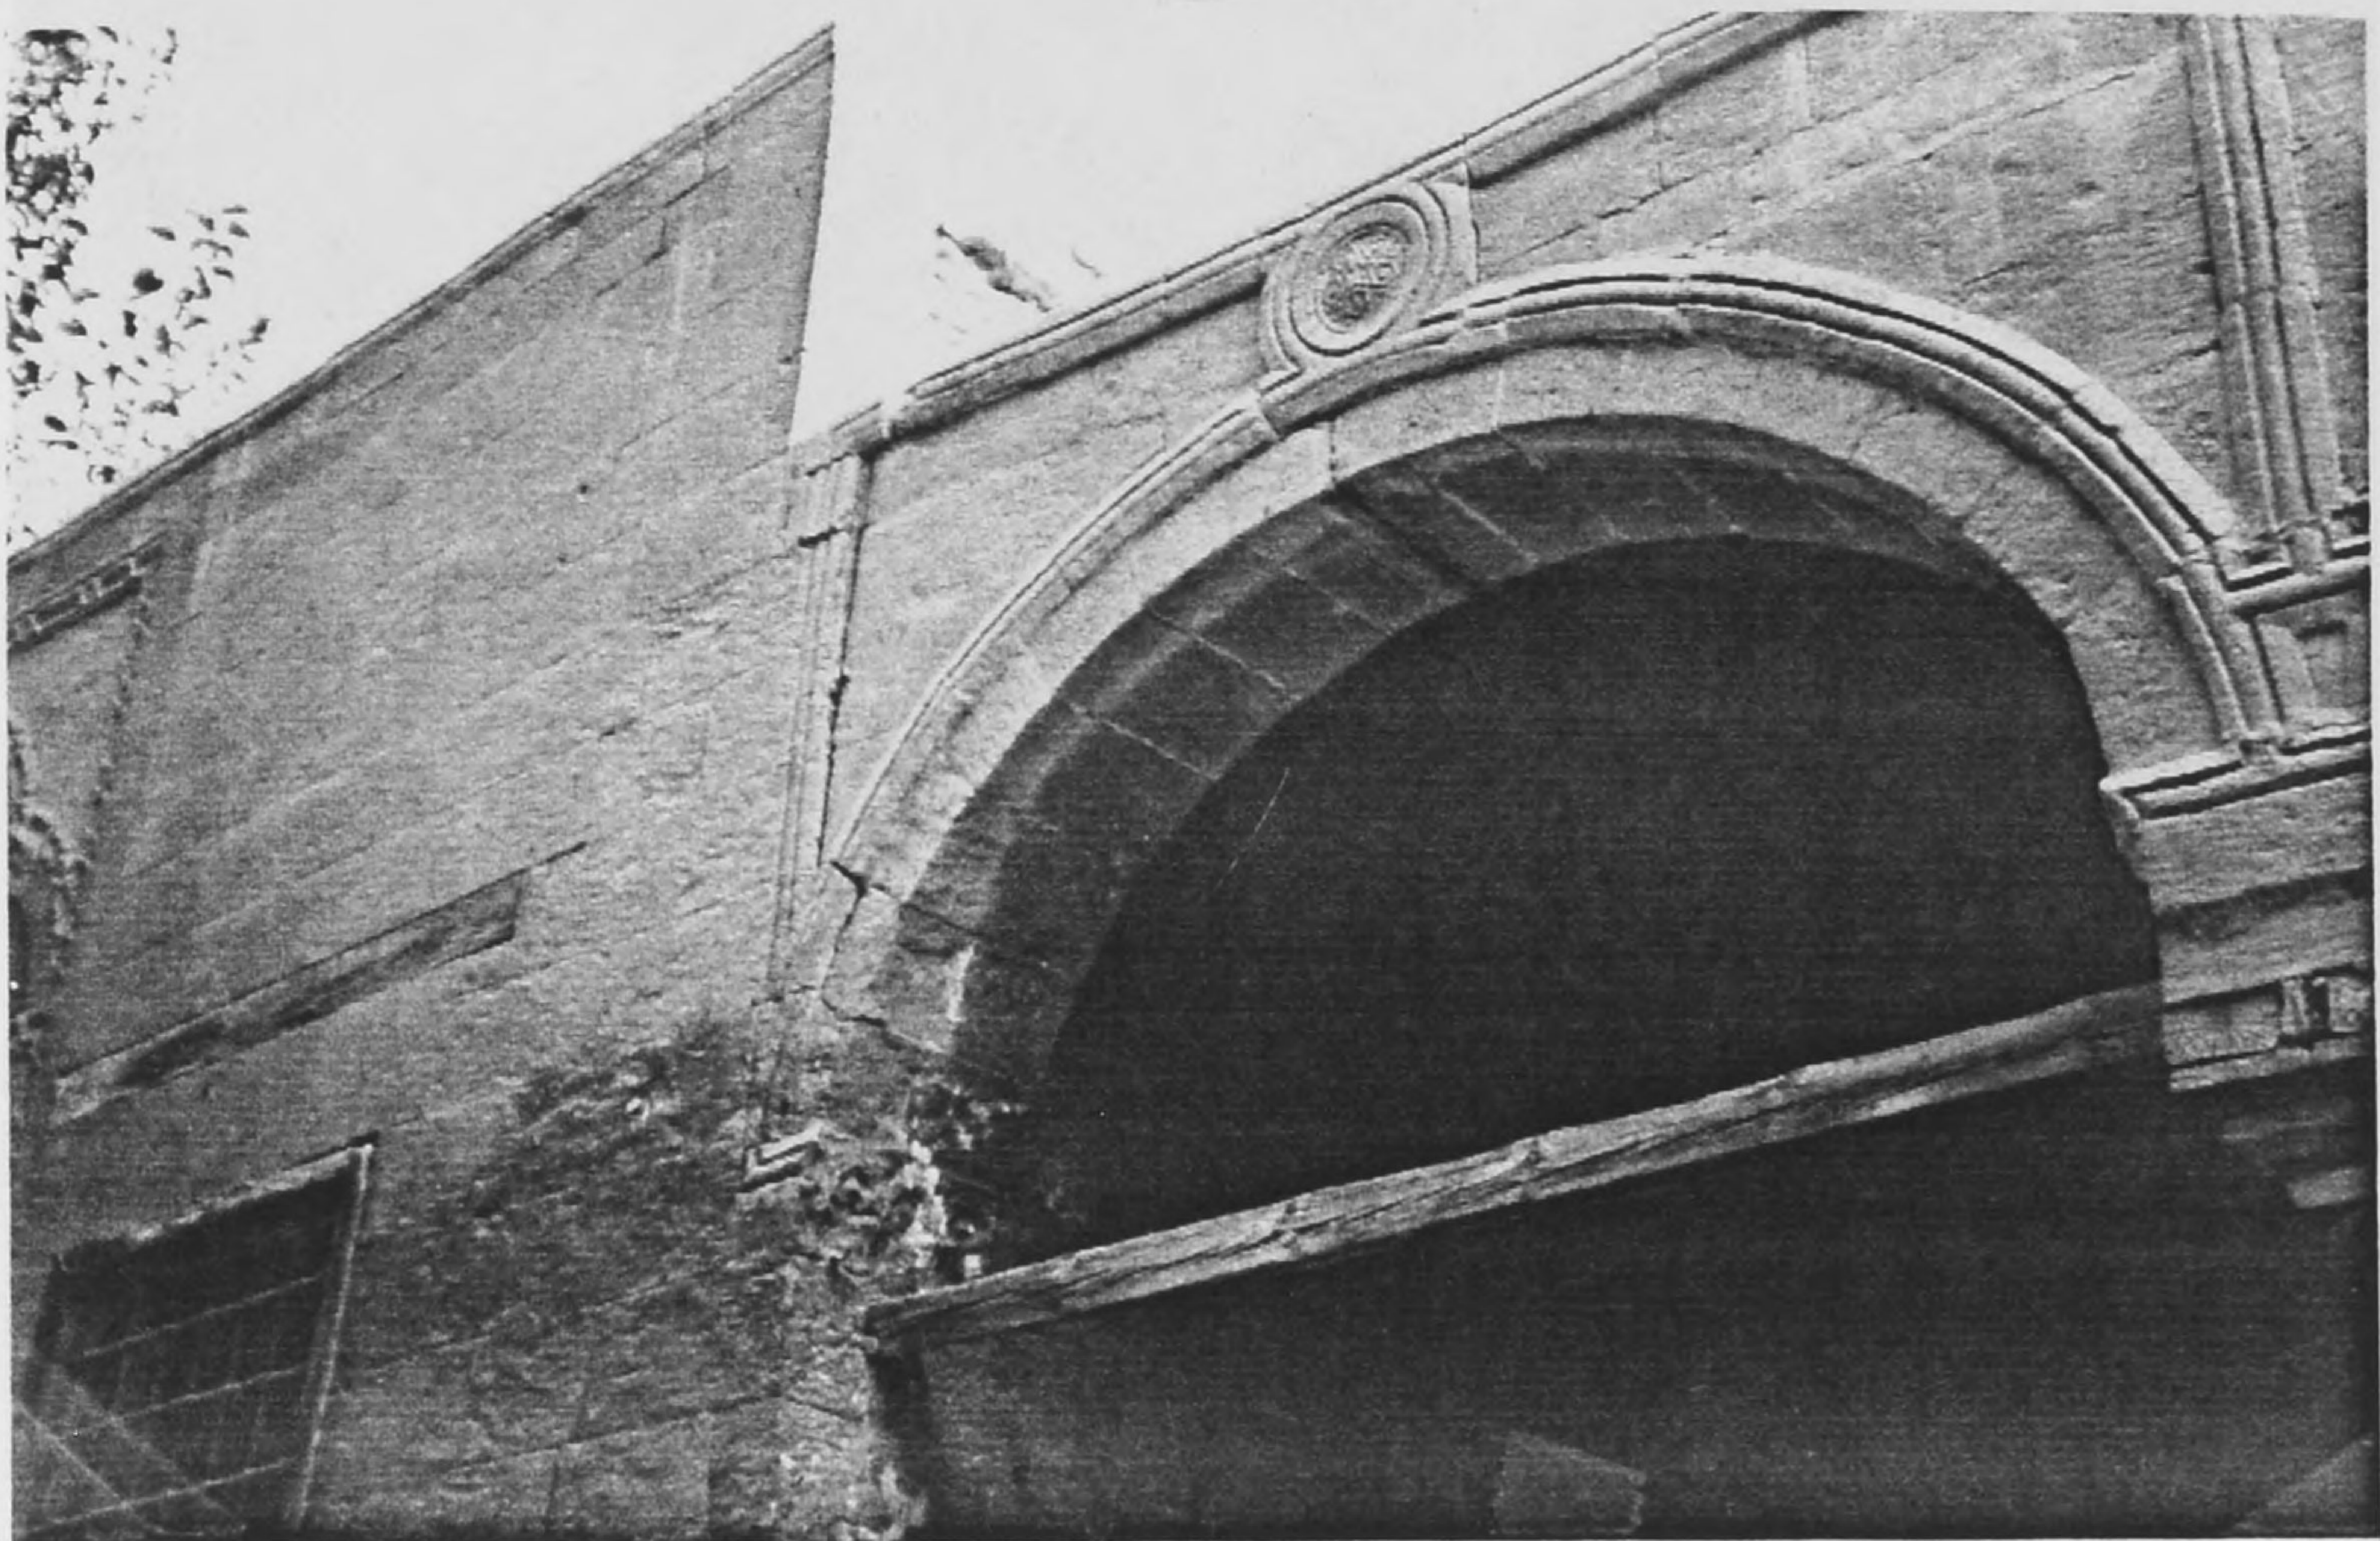
Fig. 21 Cracked arches inside and in courtyard of Takkayah Preschool

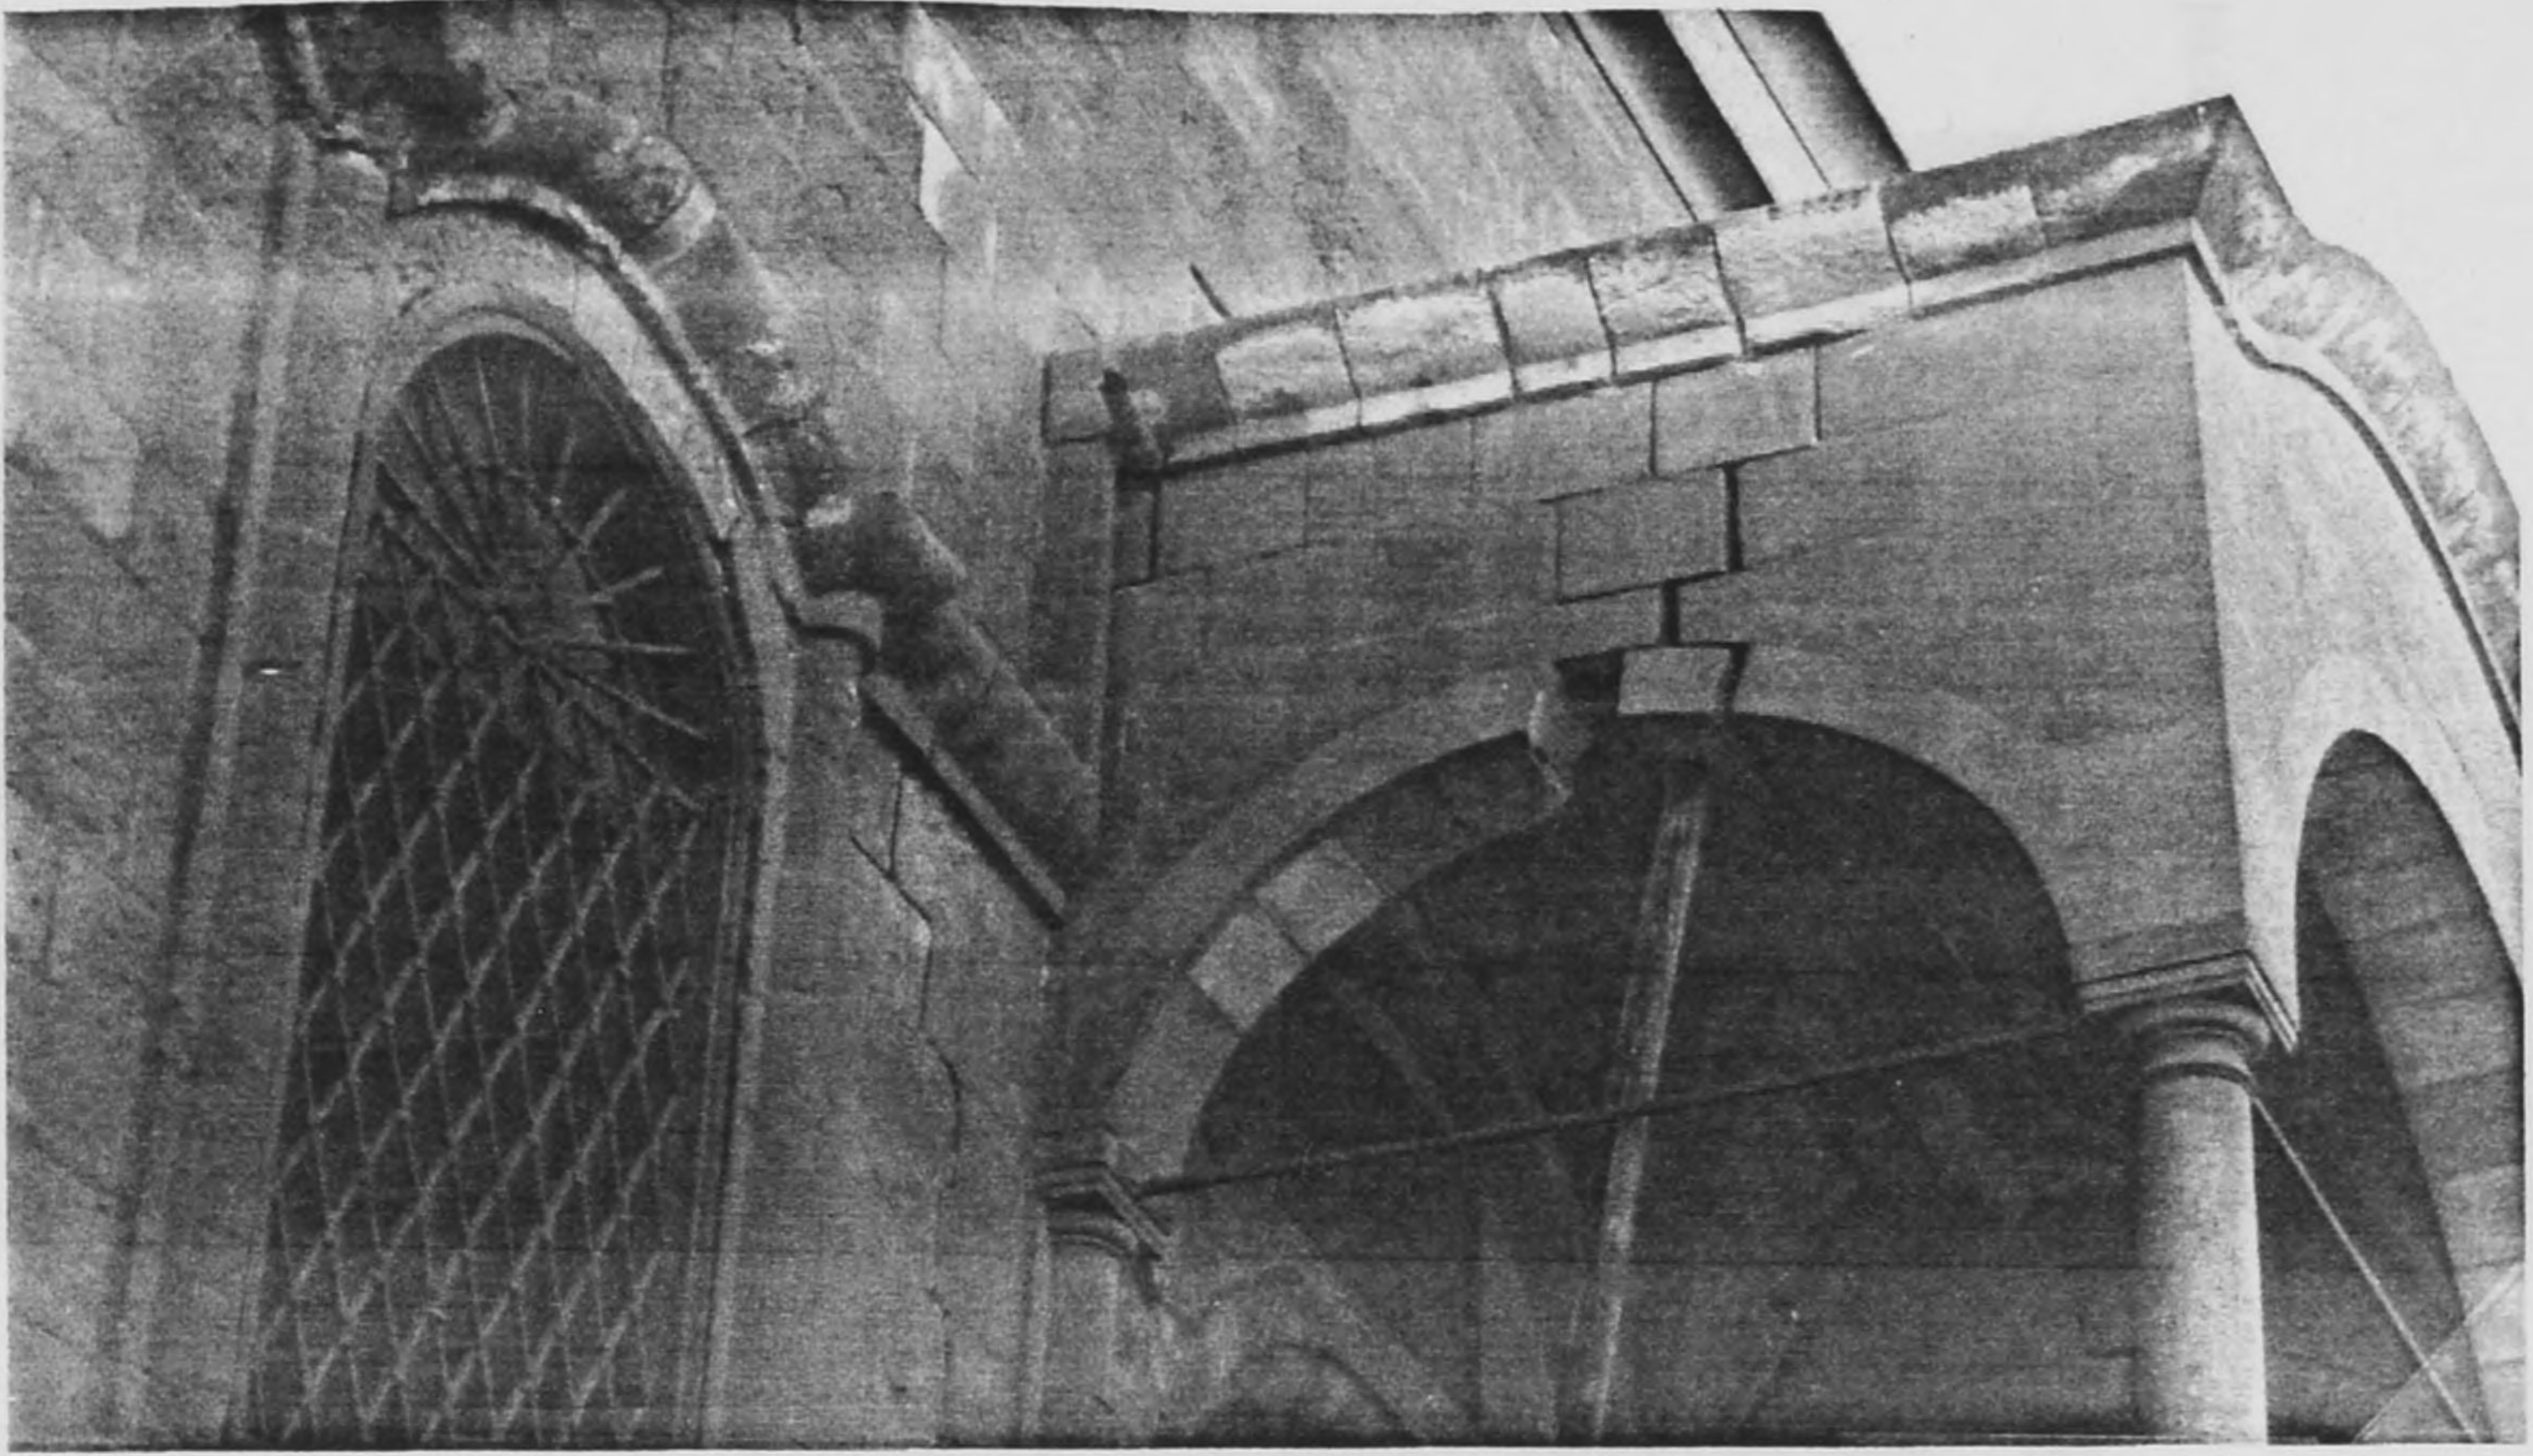
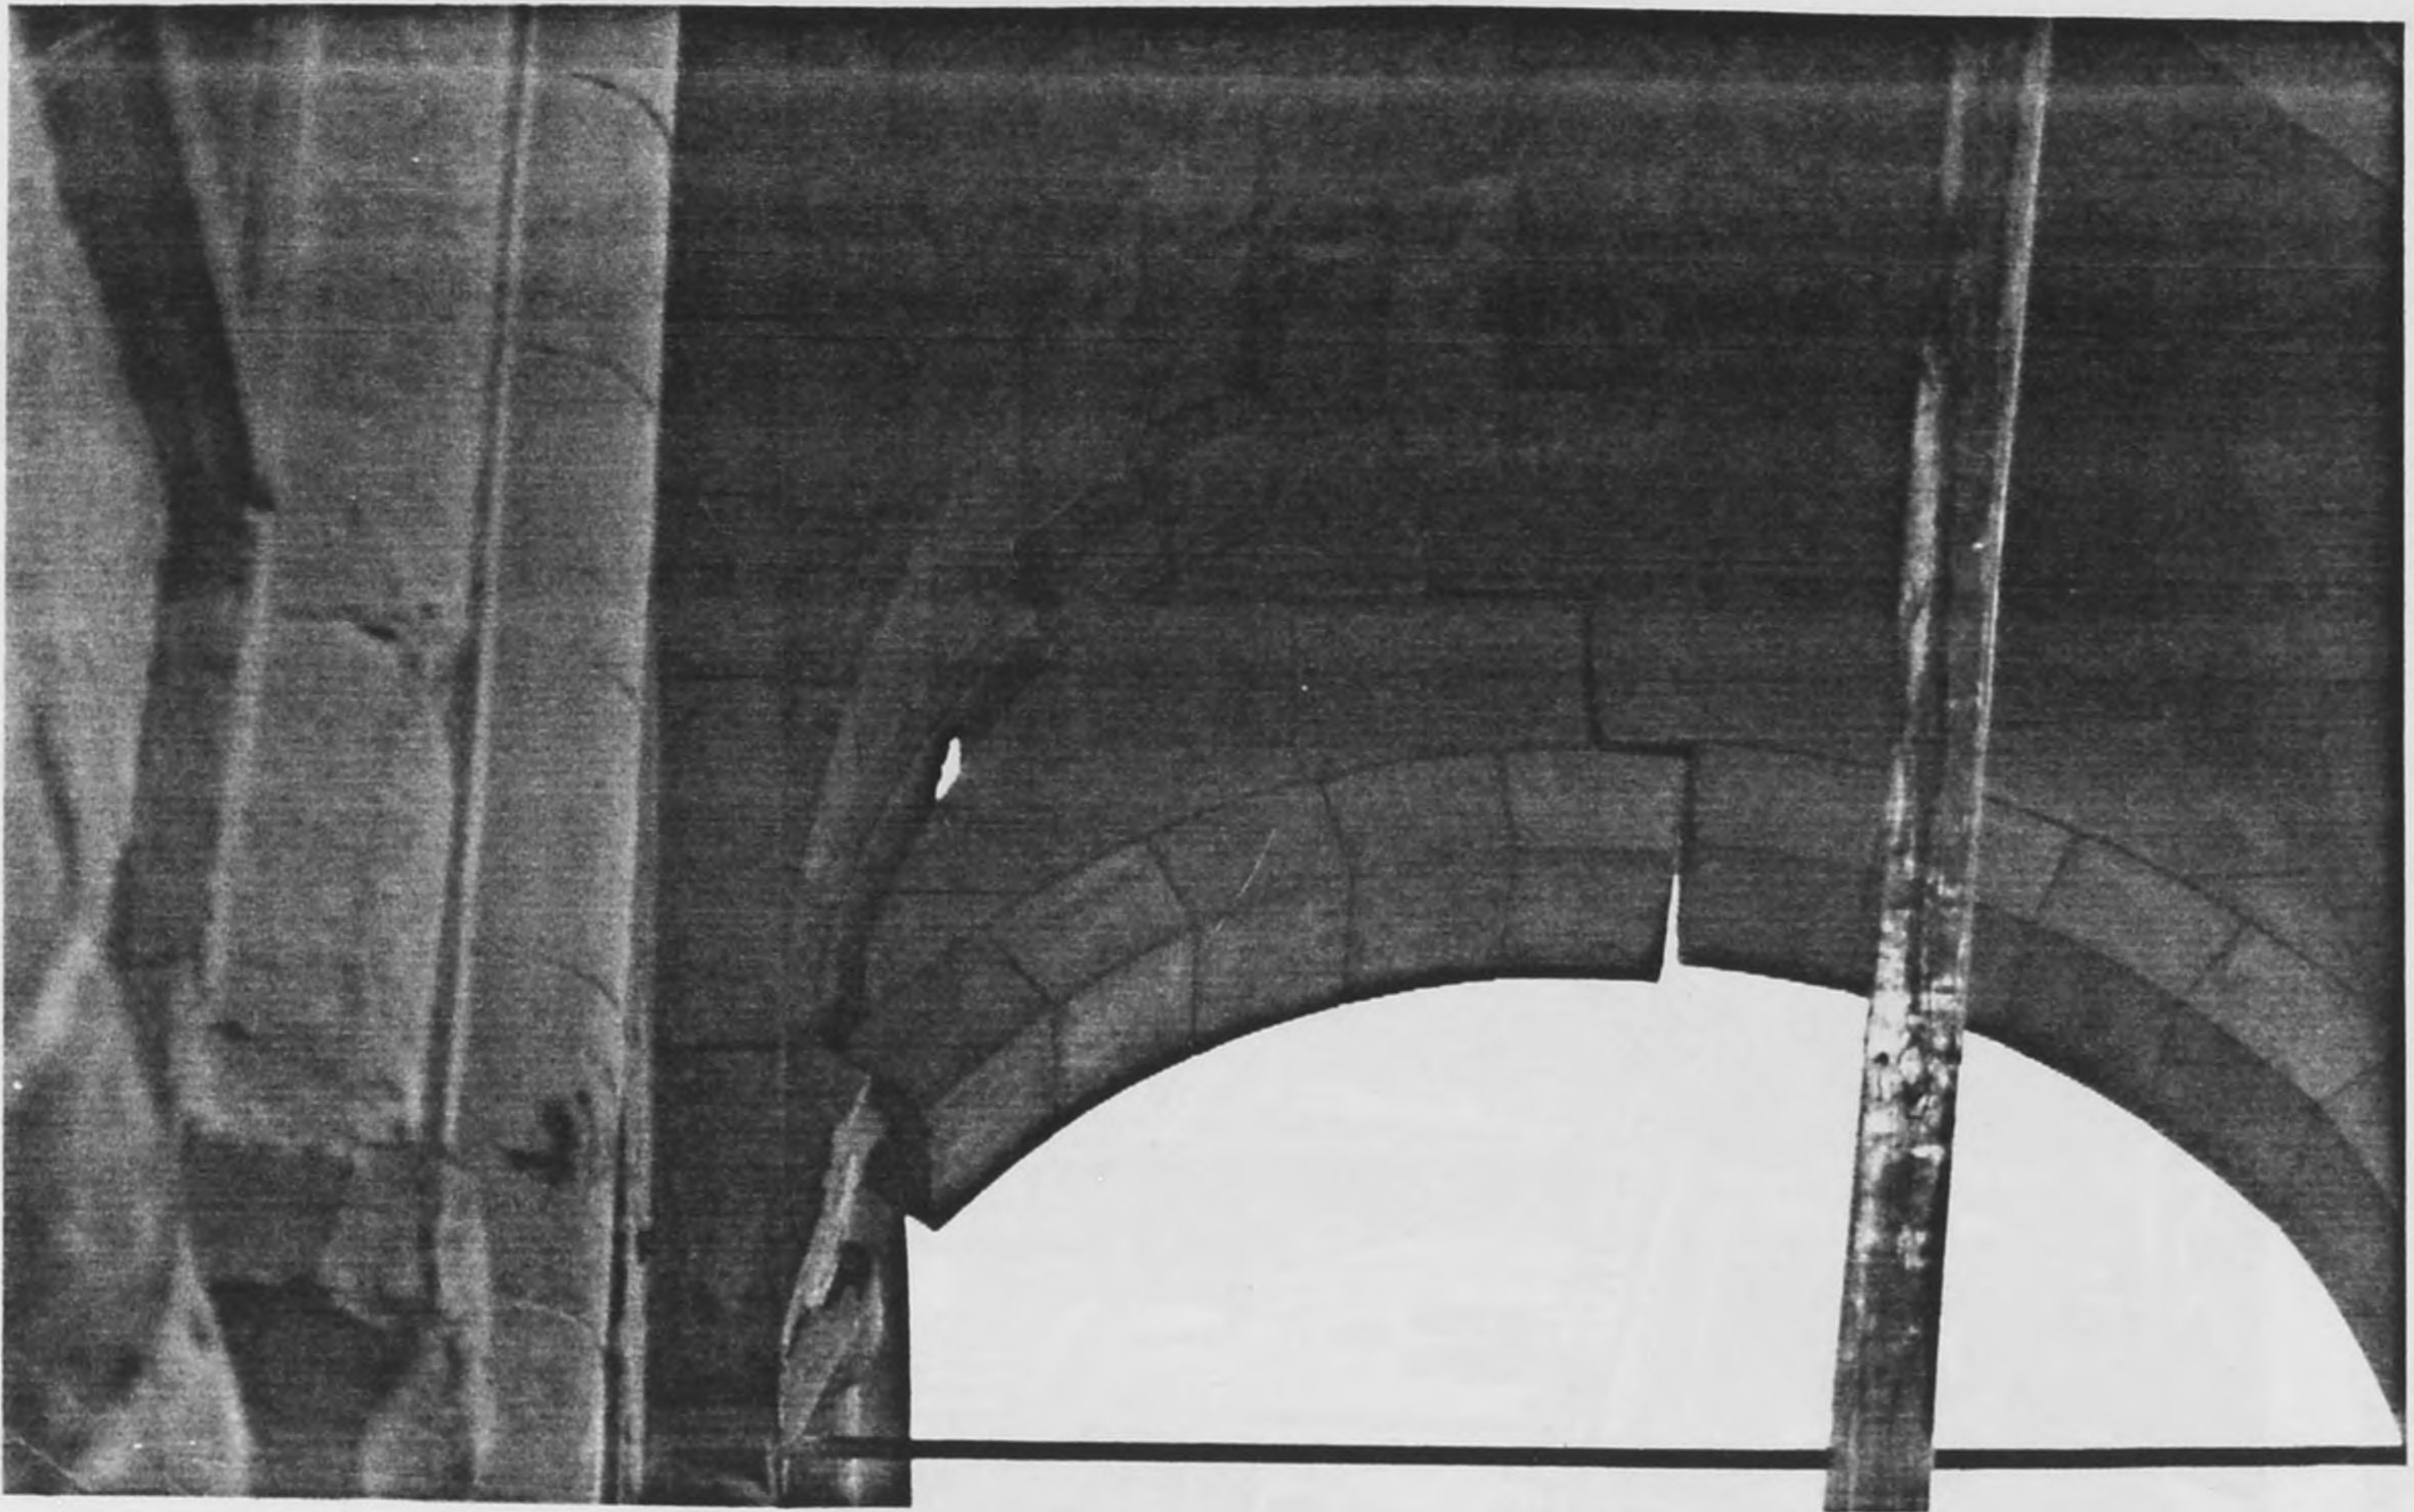
The facade of this court building had several severe cracks. In particular, the arches of the roof structure covering the porch were in a state of semi-collapse, held together by few shores (Fig. 22). There was evidence that part of the damage was present prior to the earthquake as indicated by a shore that was holding a loose keystone at the top of one of the arches. Since the stones of the facade were still in excellent condition, the team concluded that there should be no problem in restoring the structure to its original service condition.

Fig. 22 Porch of courthouse in the Citadel or the Mohammad Ali Mosque

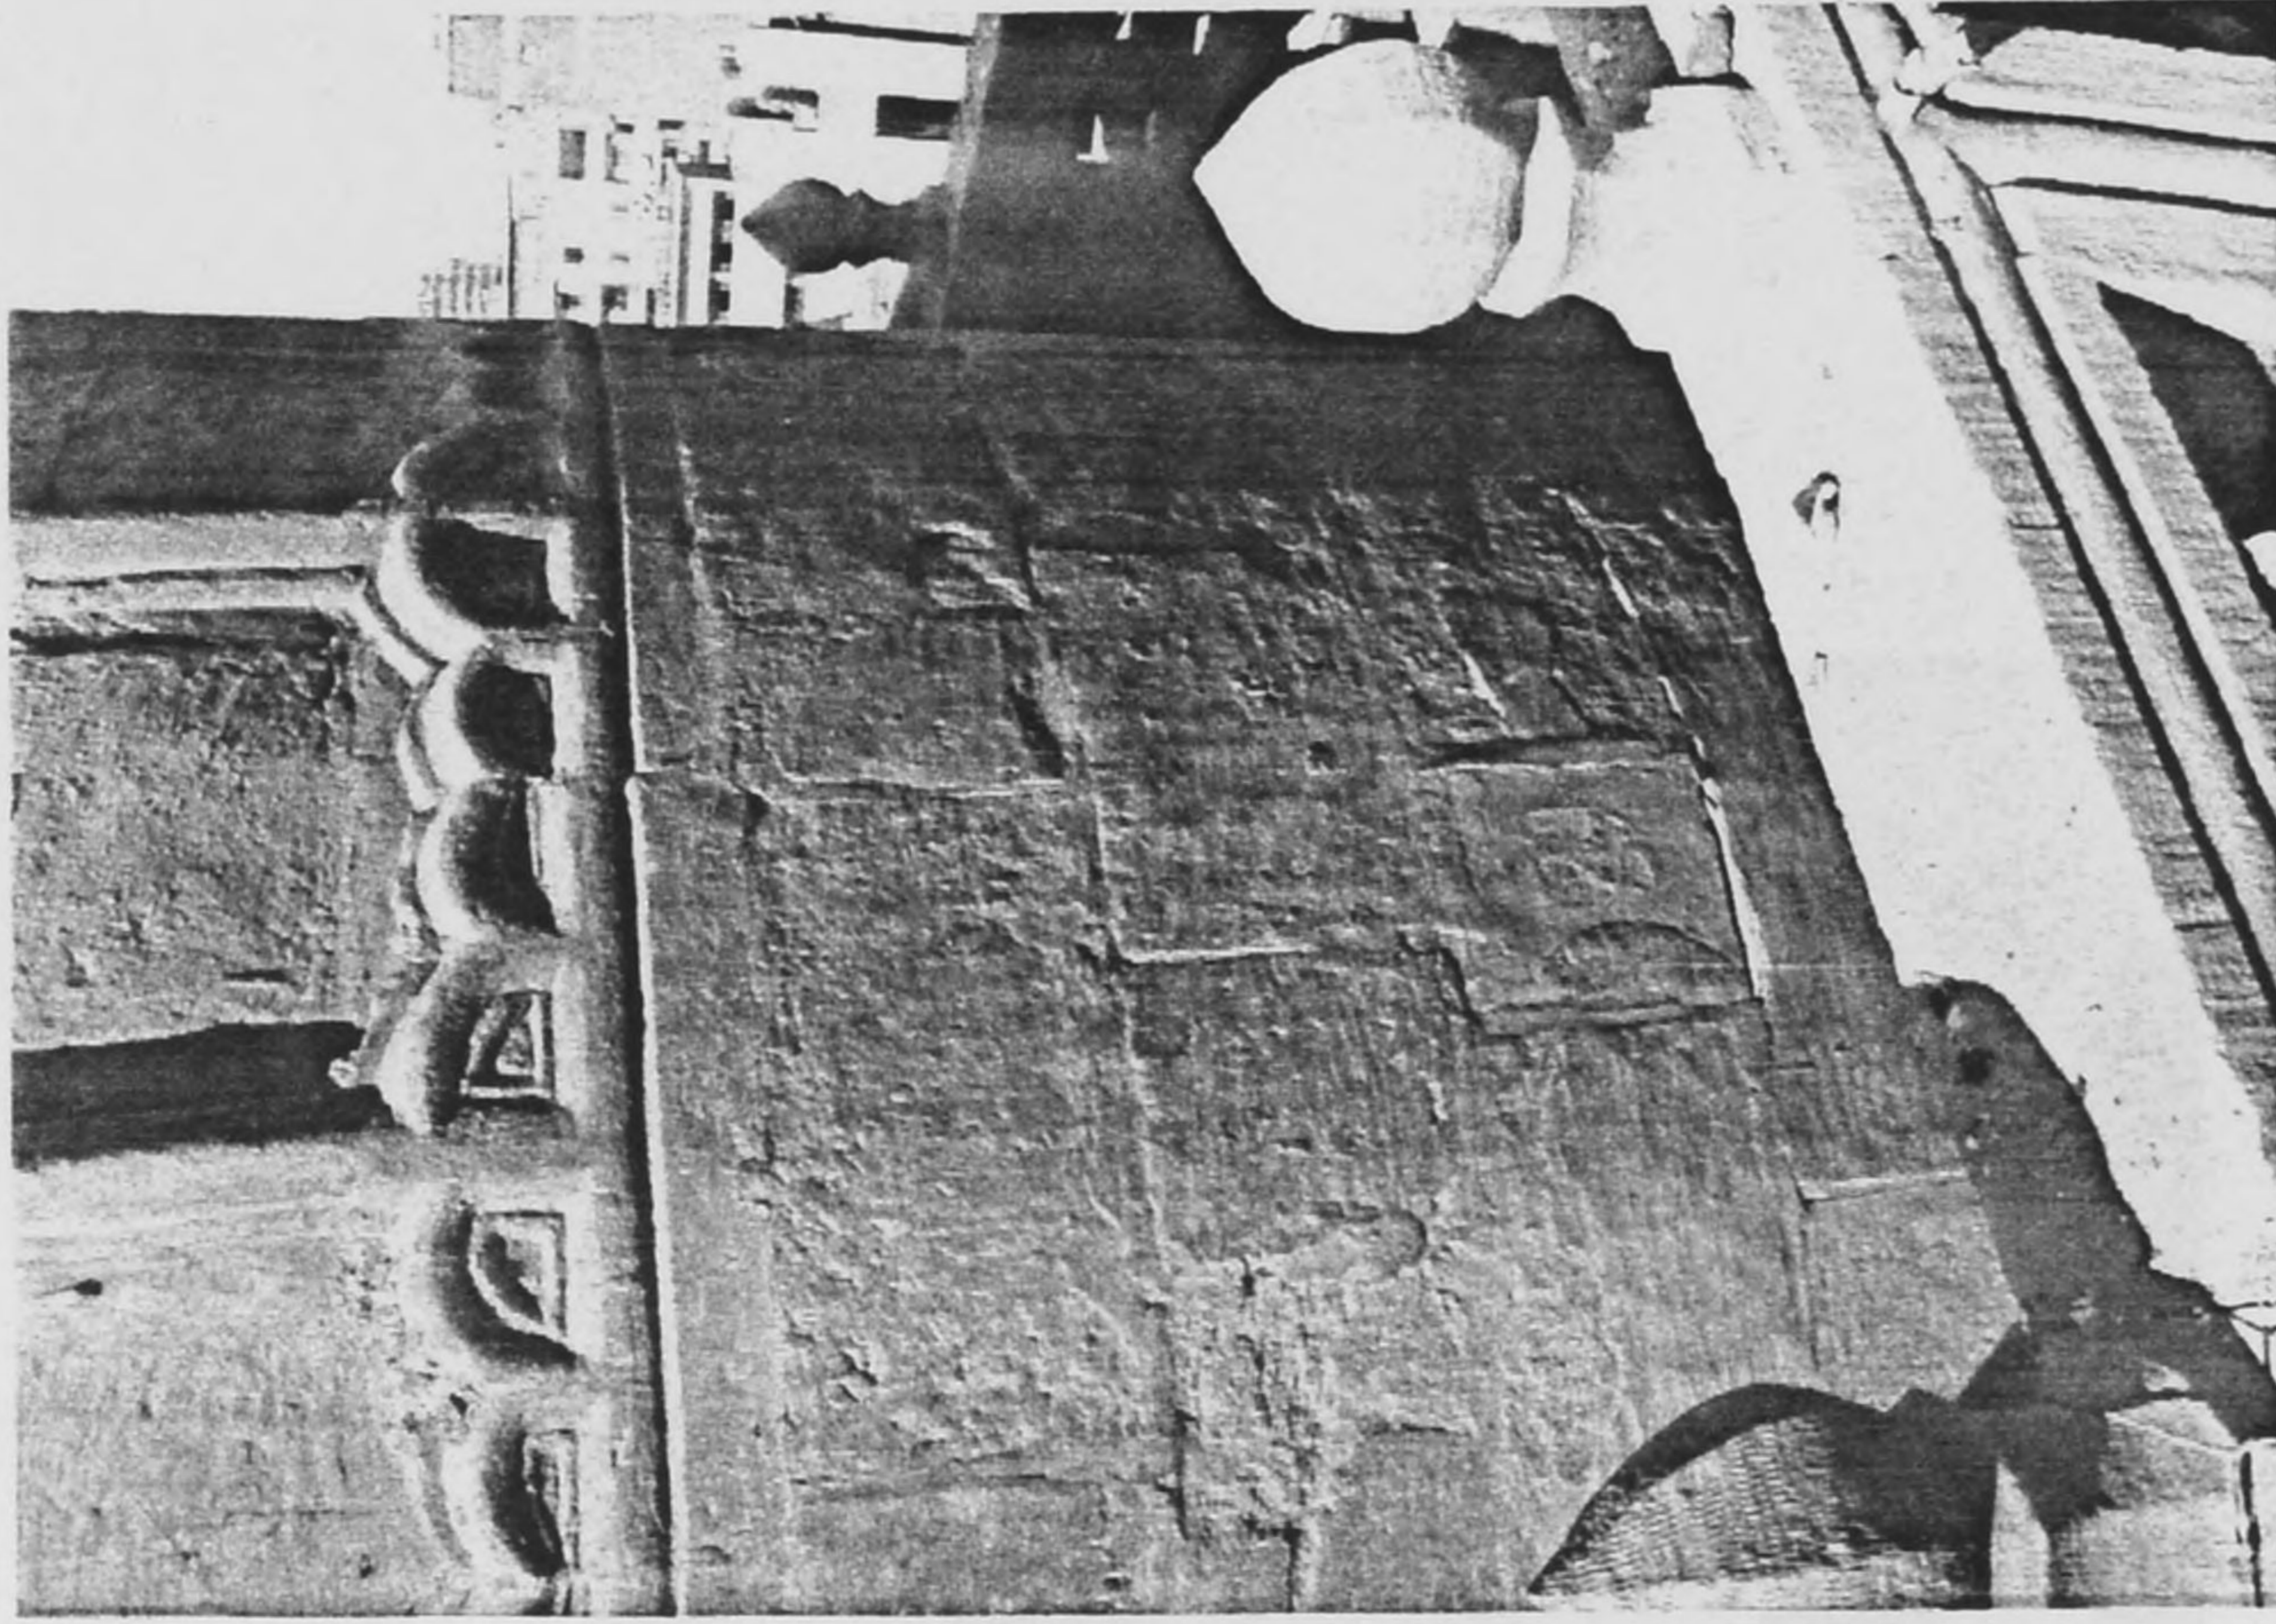
The Al-Kadi Yahya Mosque was in good shape, but the minaret tower was leaning noticeably toward the street (Fig. 23). Scaffolding had been erected in the street to support and arrest any future movement of the minaret. An inspection of the circular portion of the minaret tower that projected above the roof of the mosque revealed a continuous crack running around the perimeter of the circular section. The crack had sharp edges, indicating that it was caused by tension, but in a couple locations there were small compression spalls along the crack (Fig. 24). Thus, the cracked had apparently opened and closed at least once during the earthquake as the tower shook back and forth in response to the ground motion. The interior of the mosque and minaret tower were not inspected.

Fig. 24 Cracking and spalling along cracks in minaret tower section above roof of mosque

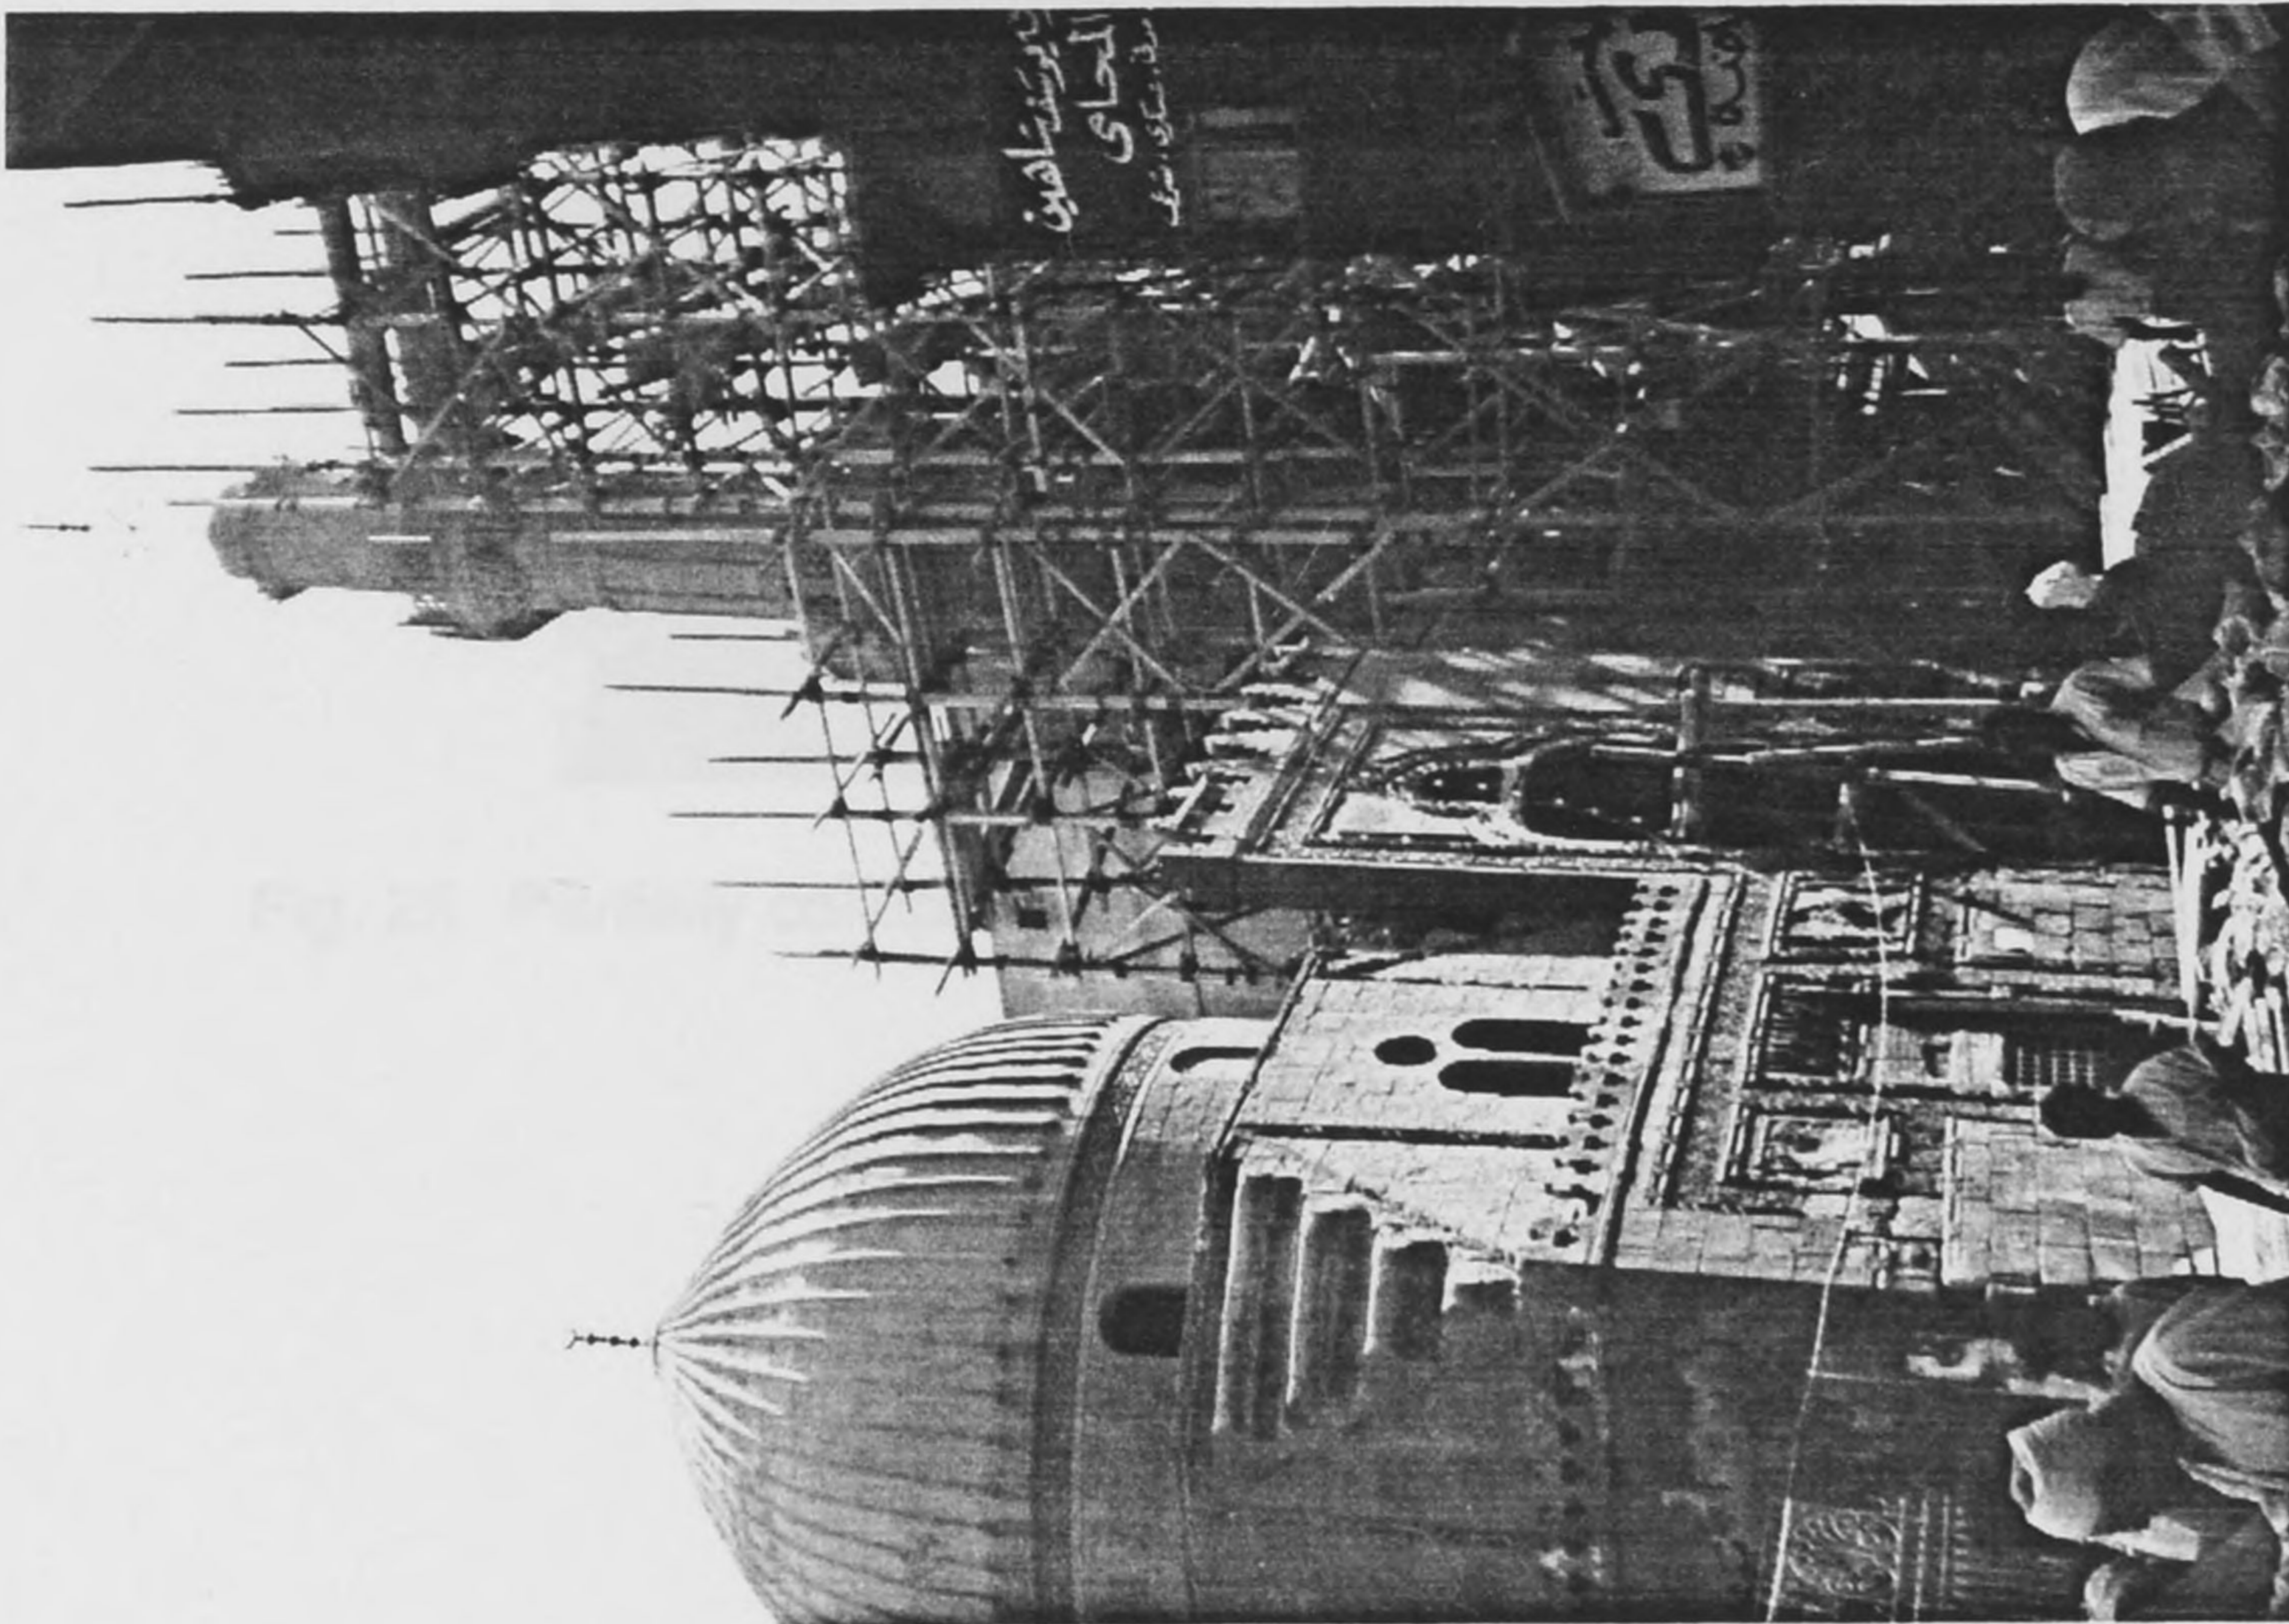
Fig. 23 Leaning minaret tower at Mosque Al-Kadi Yahya
