Report No. UMCEE 92-31

Field Investigation of Damage to Islamic Monuments Caused by the Egyptian Earthquake of October 12, 1992

**James K. Wight
Roman D. Hryciw
Antoine E. Naaman**

December 1992

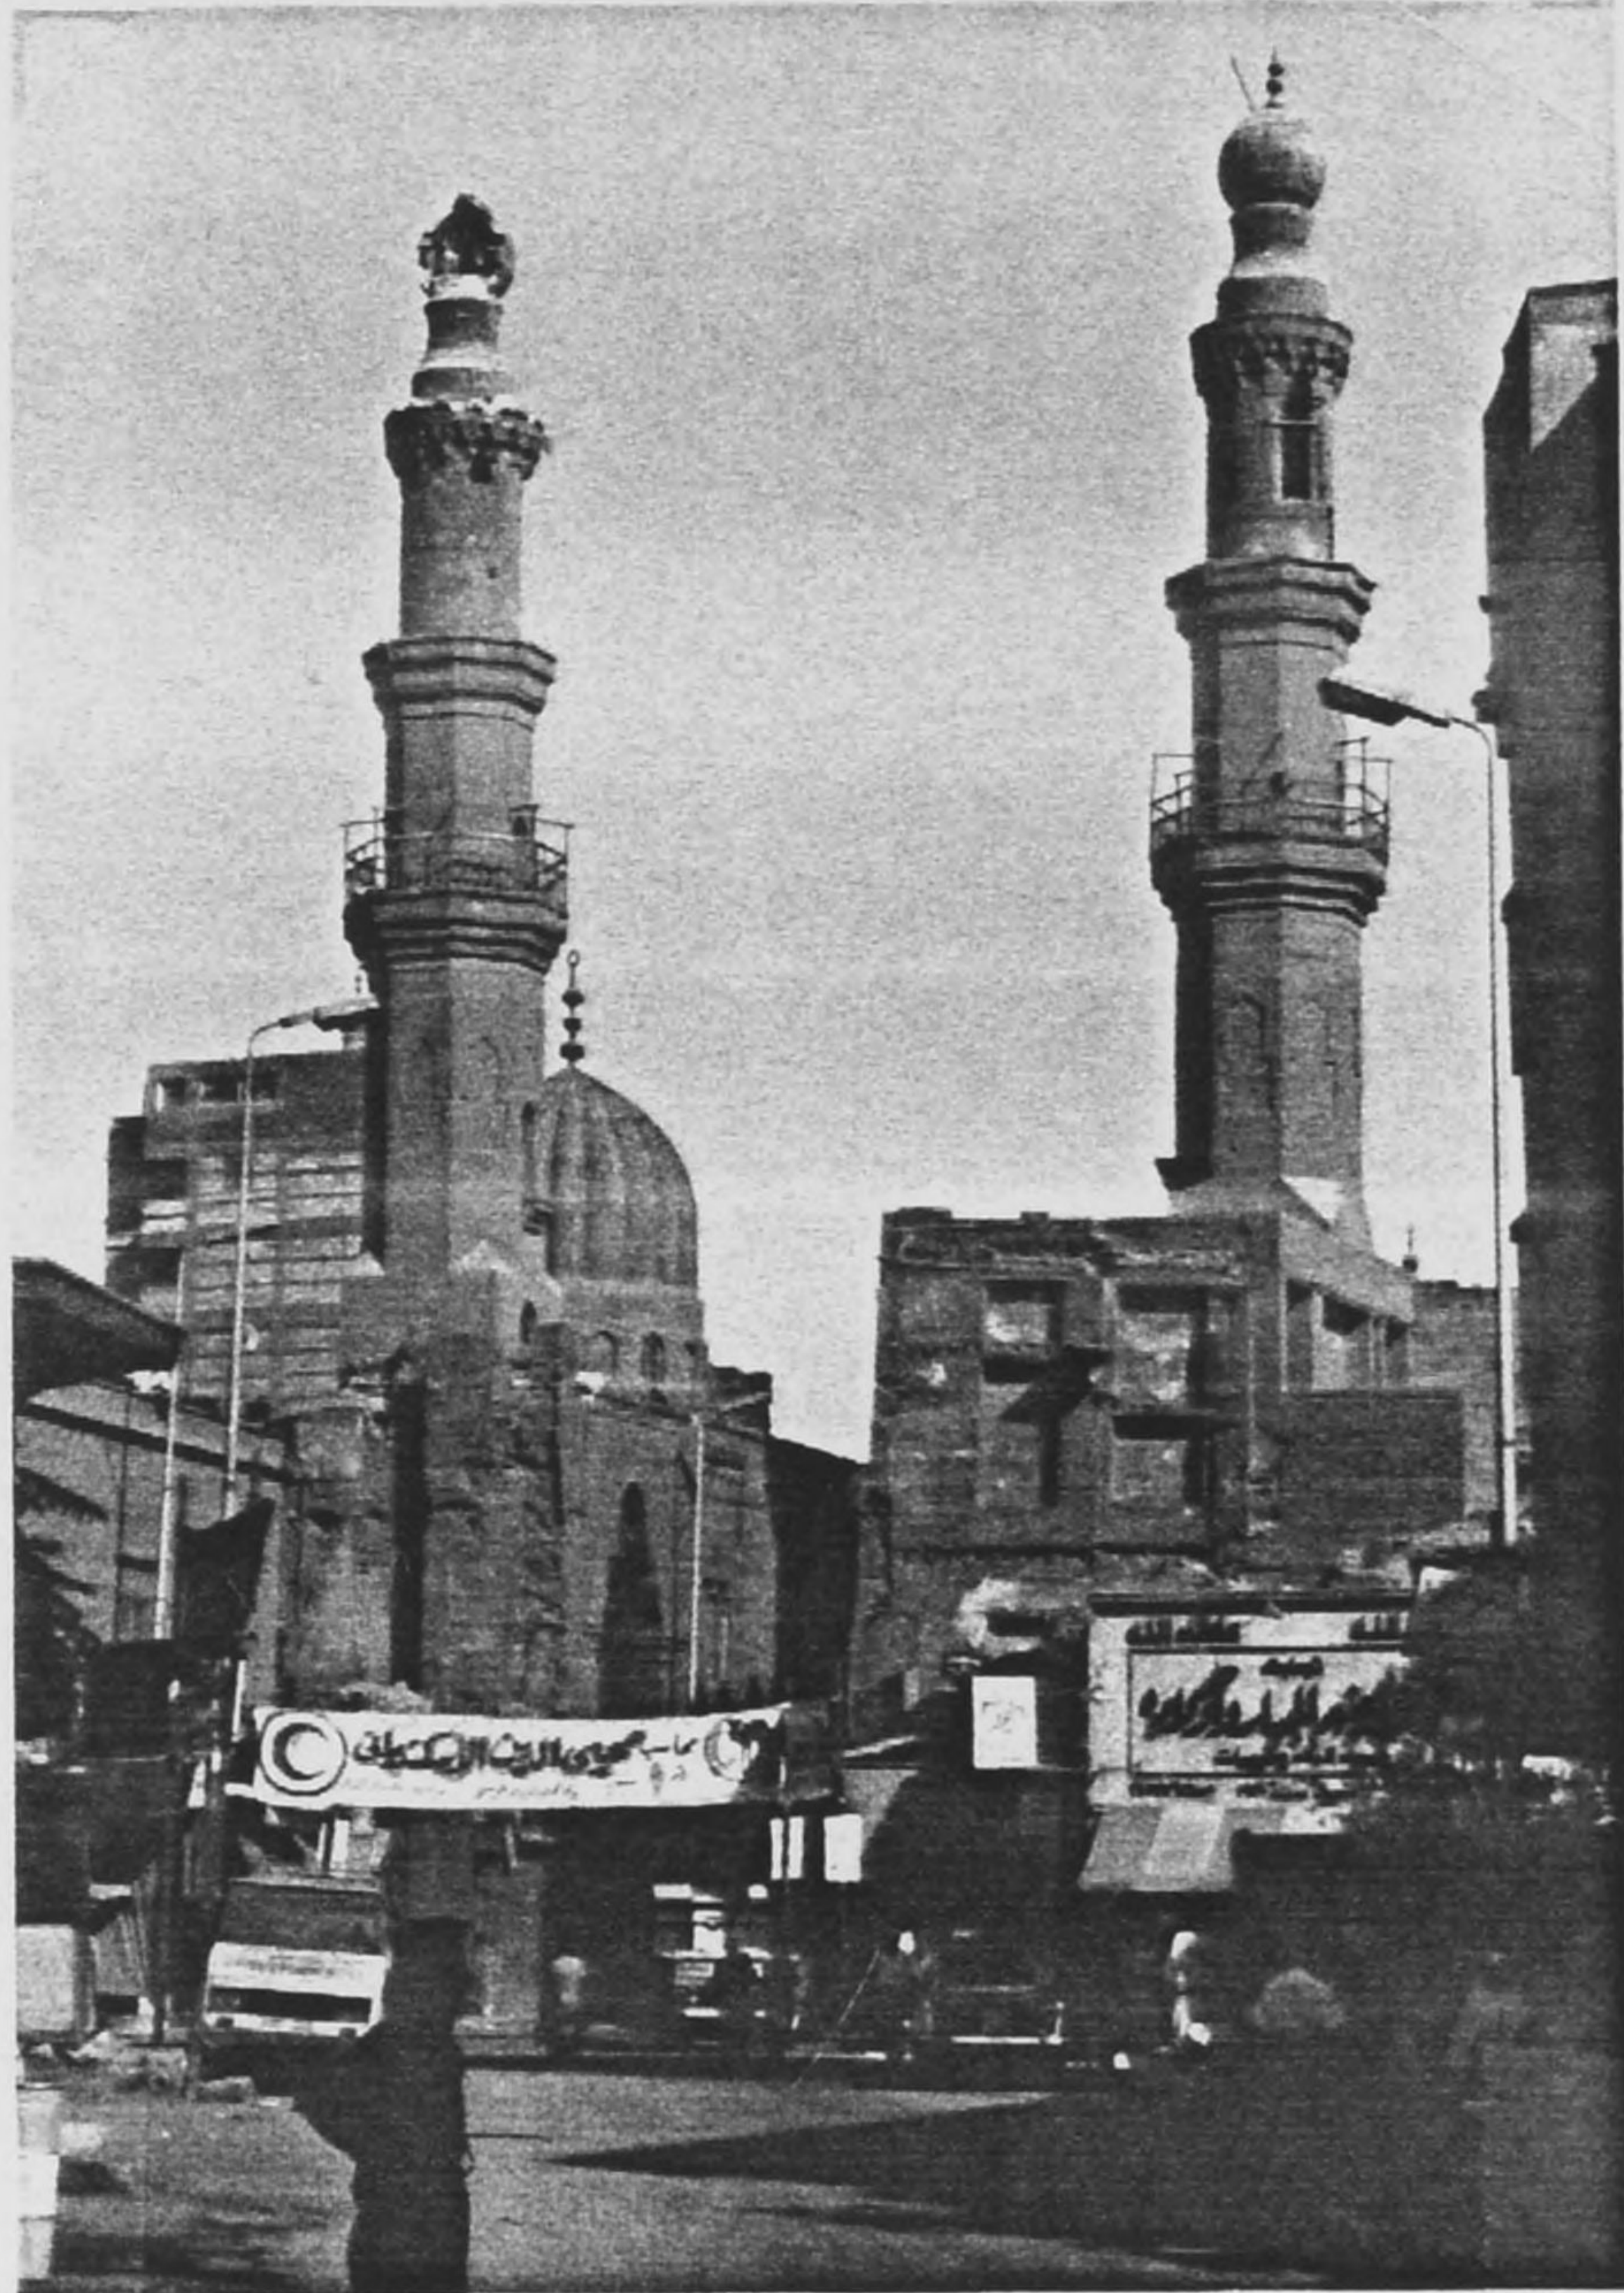
The top of the minaret tower partially collapsed during to the earthquake (Fig. 25). The team was only able to observe the failure from far away. The top

Fig. 25 Partially collapsed top of minaret at Amir Shaykhu Mosque

of this minaret should be removed and replaced with a more properly designed ornate top. A second minaret tower, which had a very similar top, was located across a narrow street from the minaret with the partially collapsed top. The top of this second minaret should be inspected and modified for increased seismic resistance.
