**EVALUATION OF GREAT LAKES
SHORE PROTECTION STRUCTURES**

Report UMCEE 88-8

**THE UNIVERSITY OF MICHIGAN
DEPARTMENT OF CIVIL ENGINEERING
ANN ARBOR, MICHIGAN**

**Michigan Department of Natural Resources
Coastal Management Program
Land and Water Division**

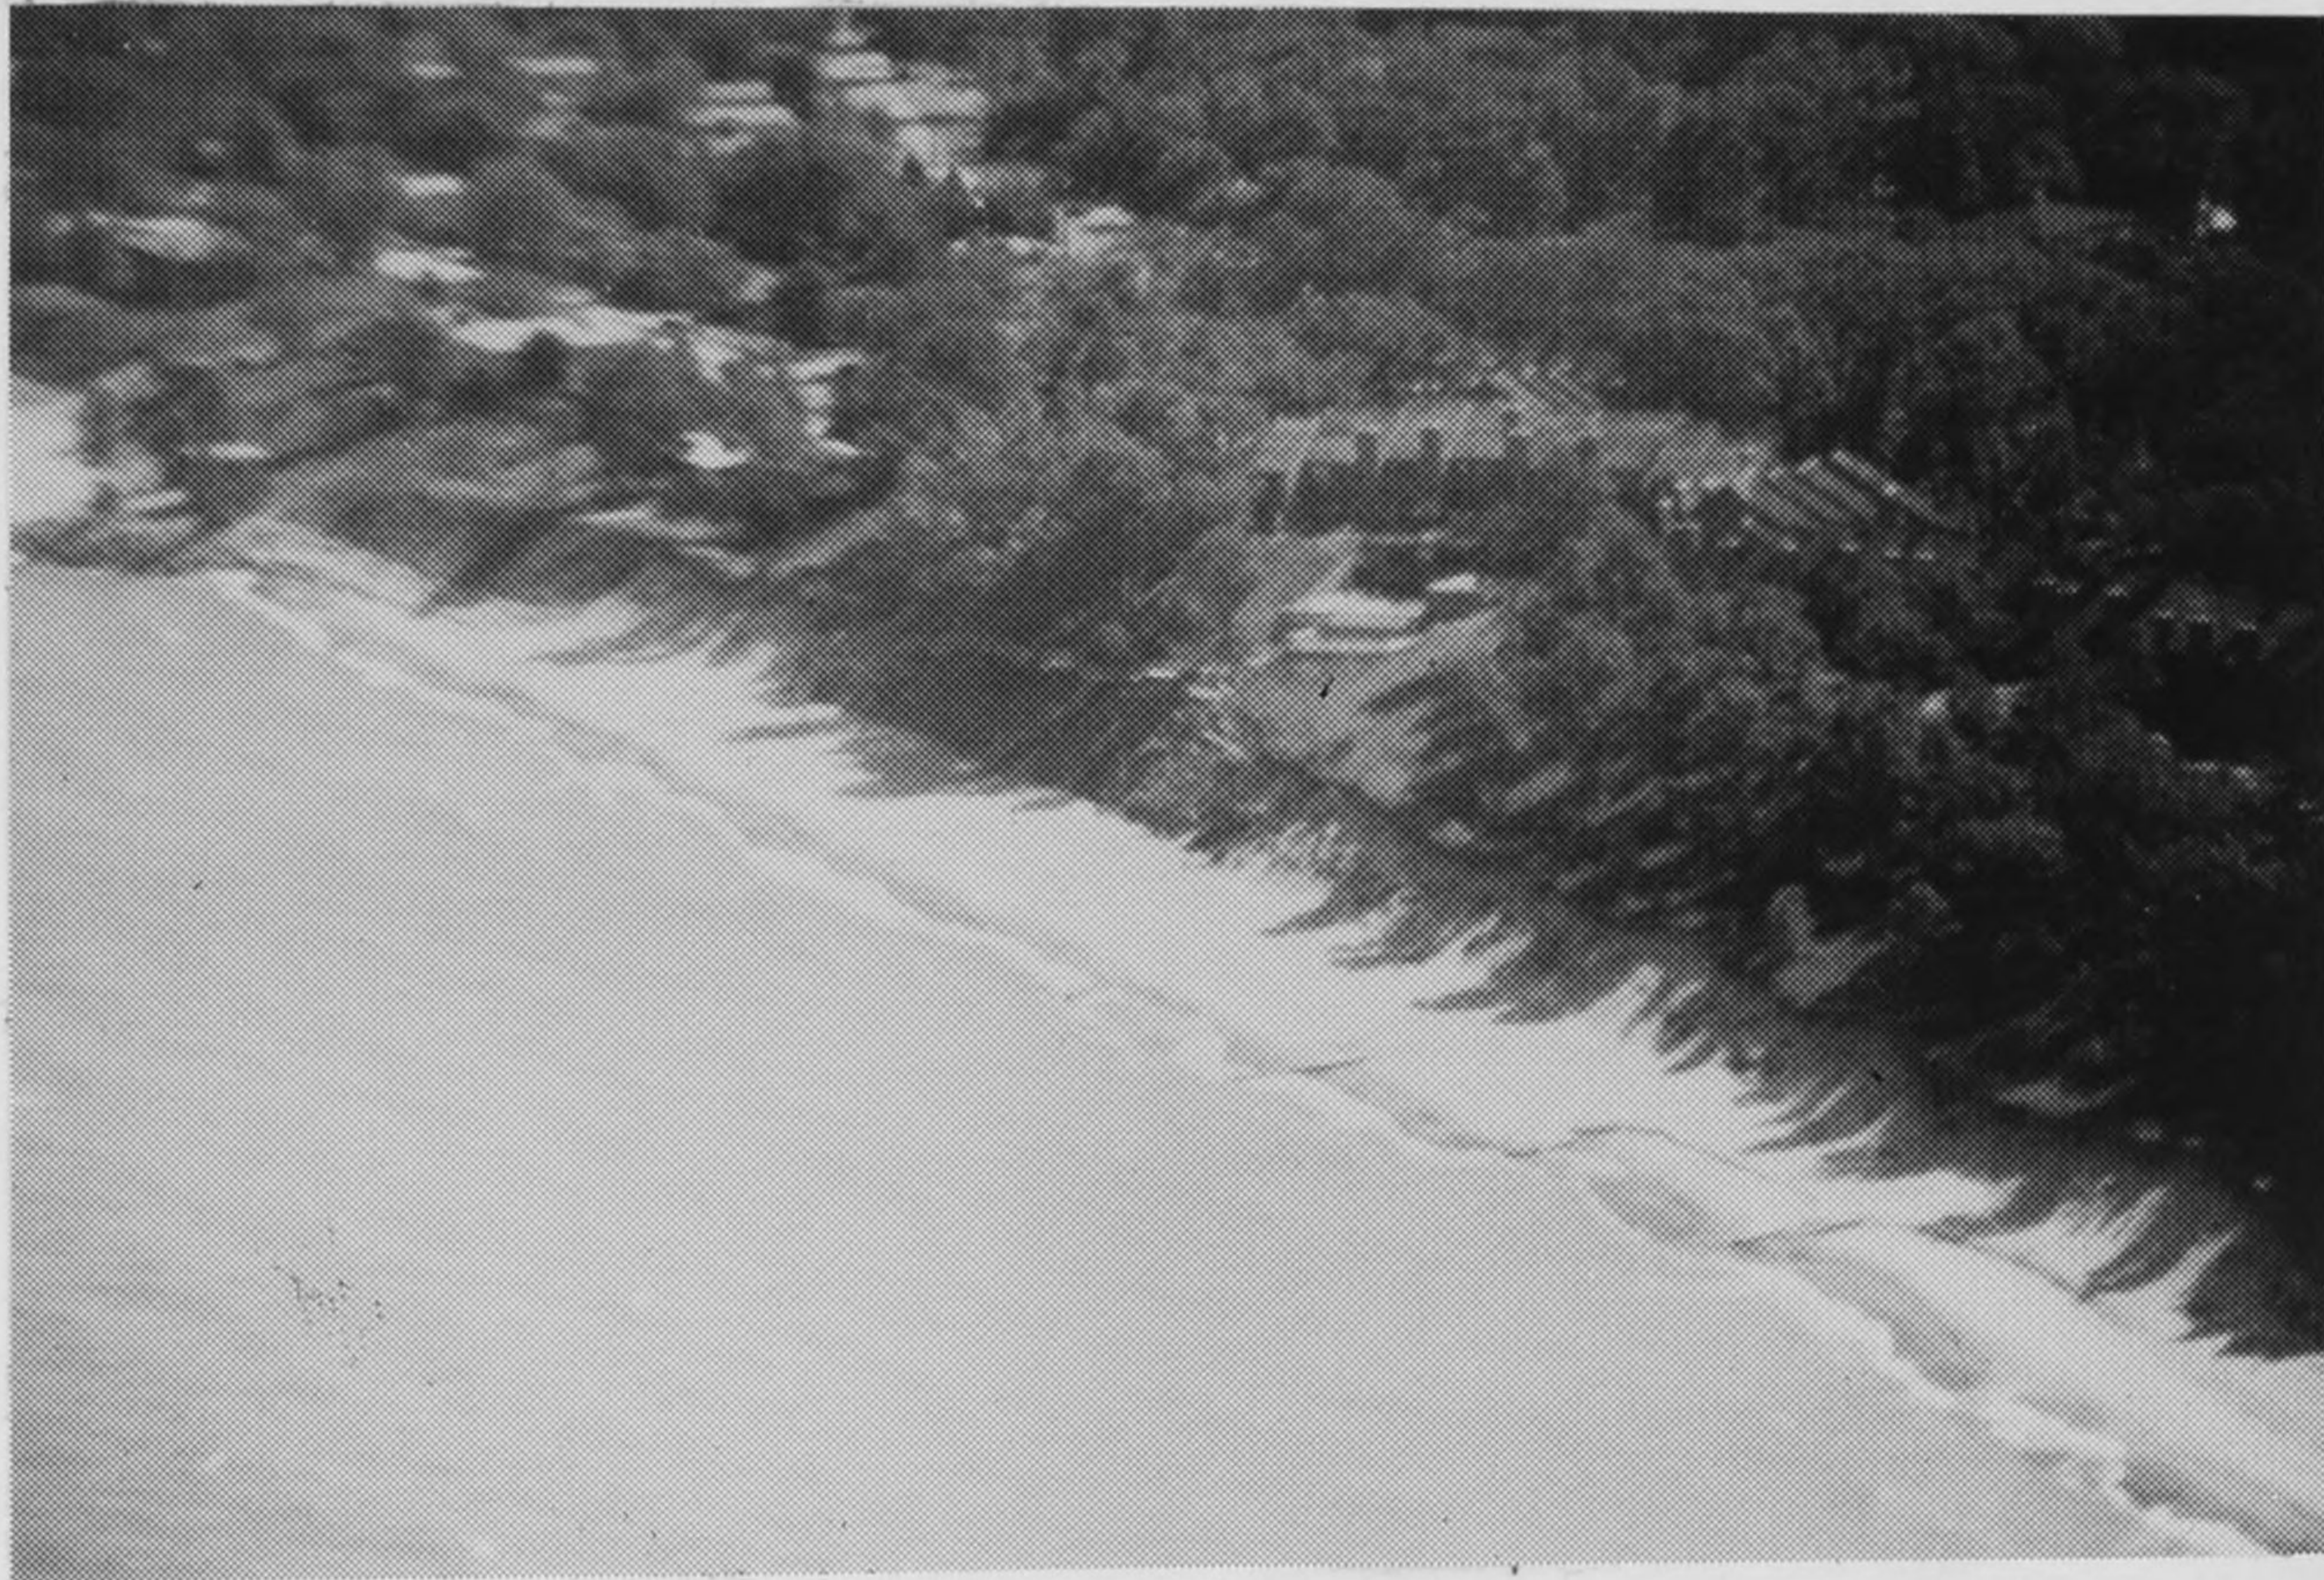
Figure B1. Site A: Aerial view of entire project. Note revetment in upper left of photograph, on northern side of property. Six to eight inch slump in beach visible as dark line in southerly two groin compartments in lower right side of photograph.

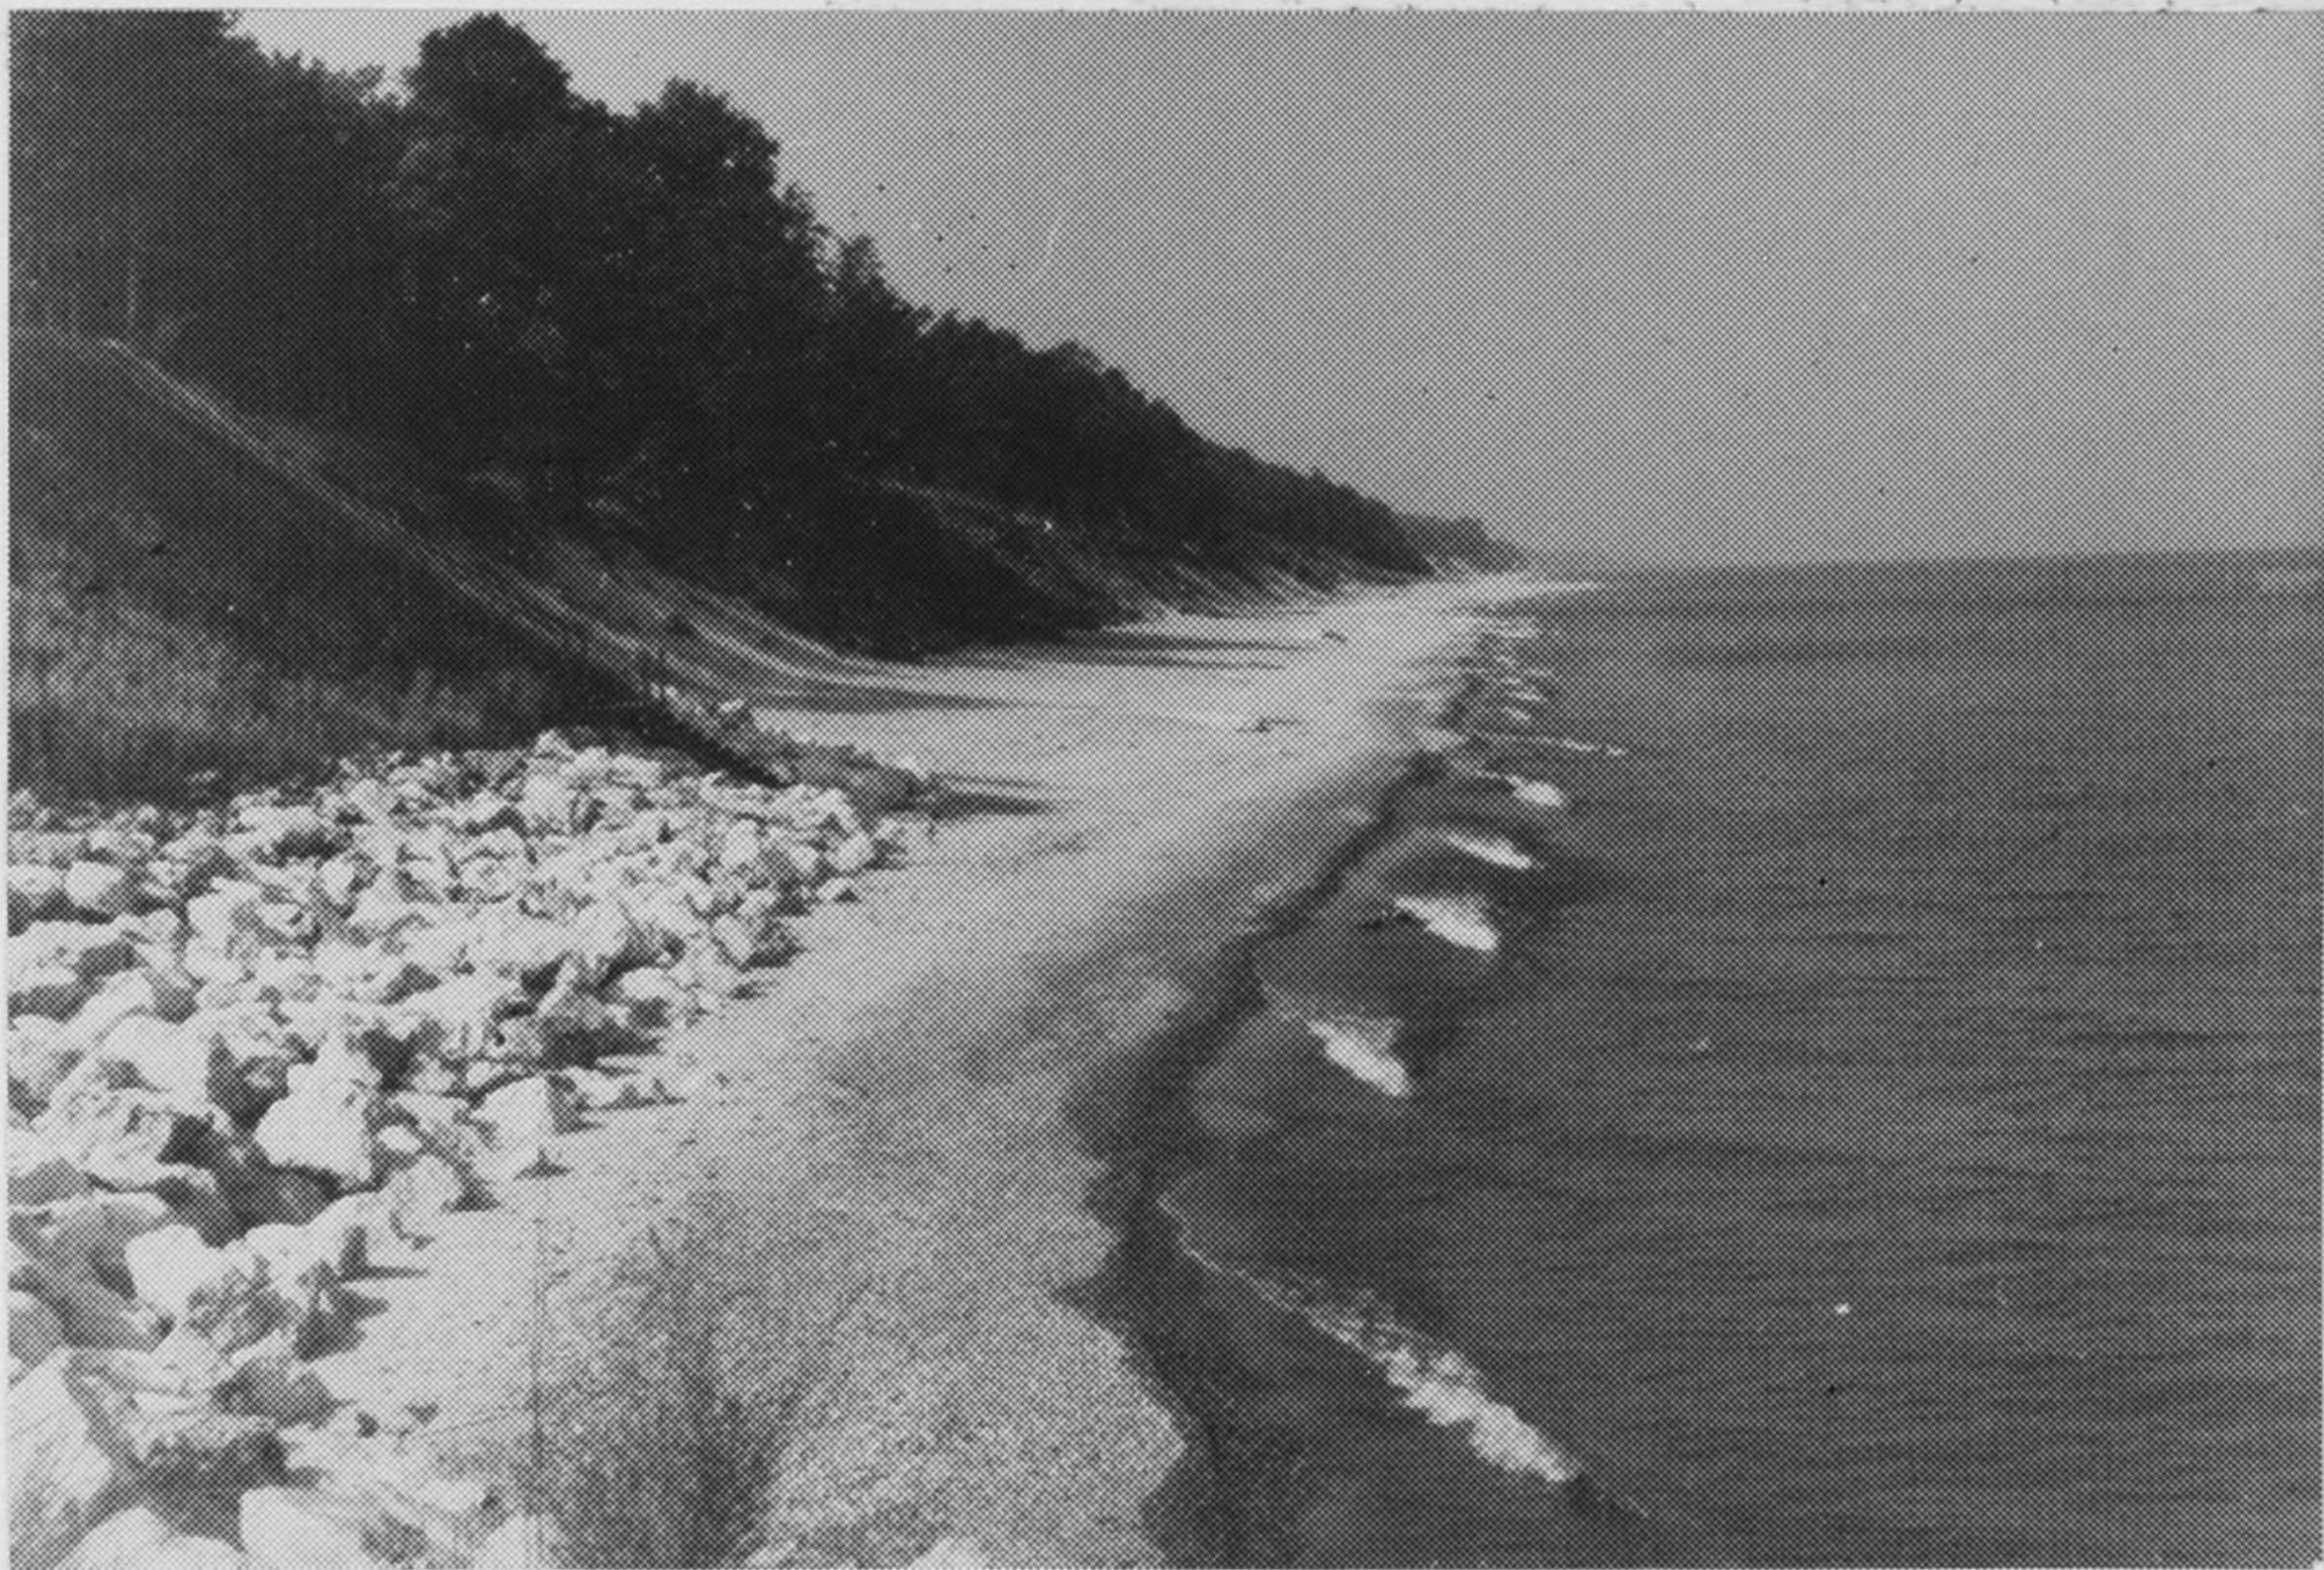
Figure B2. Site A: Looking along beach in a southerly direction from revetment just north of property. What appears to be groin ends is actually the end of the second tier of bags and groins extend into the water.

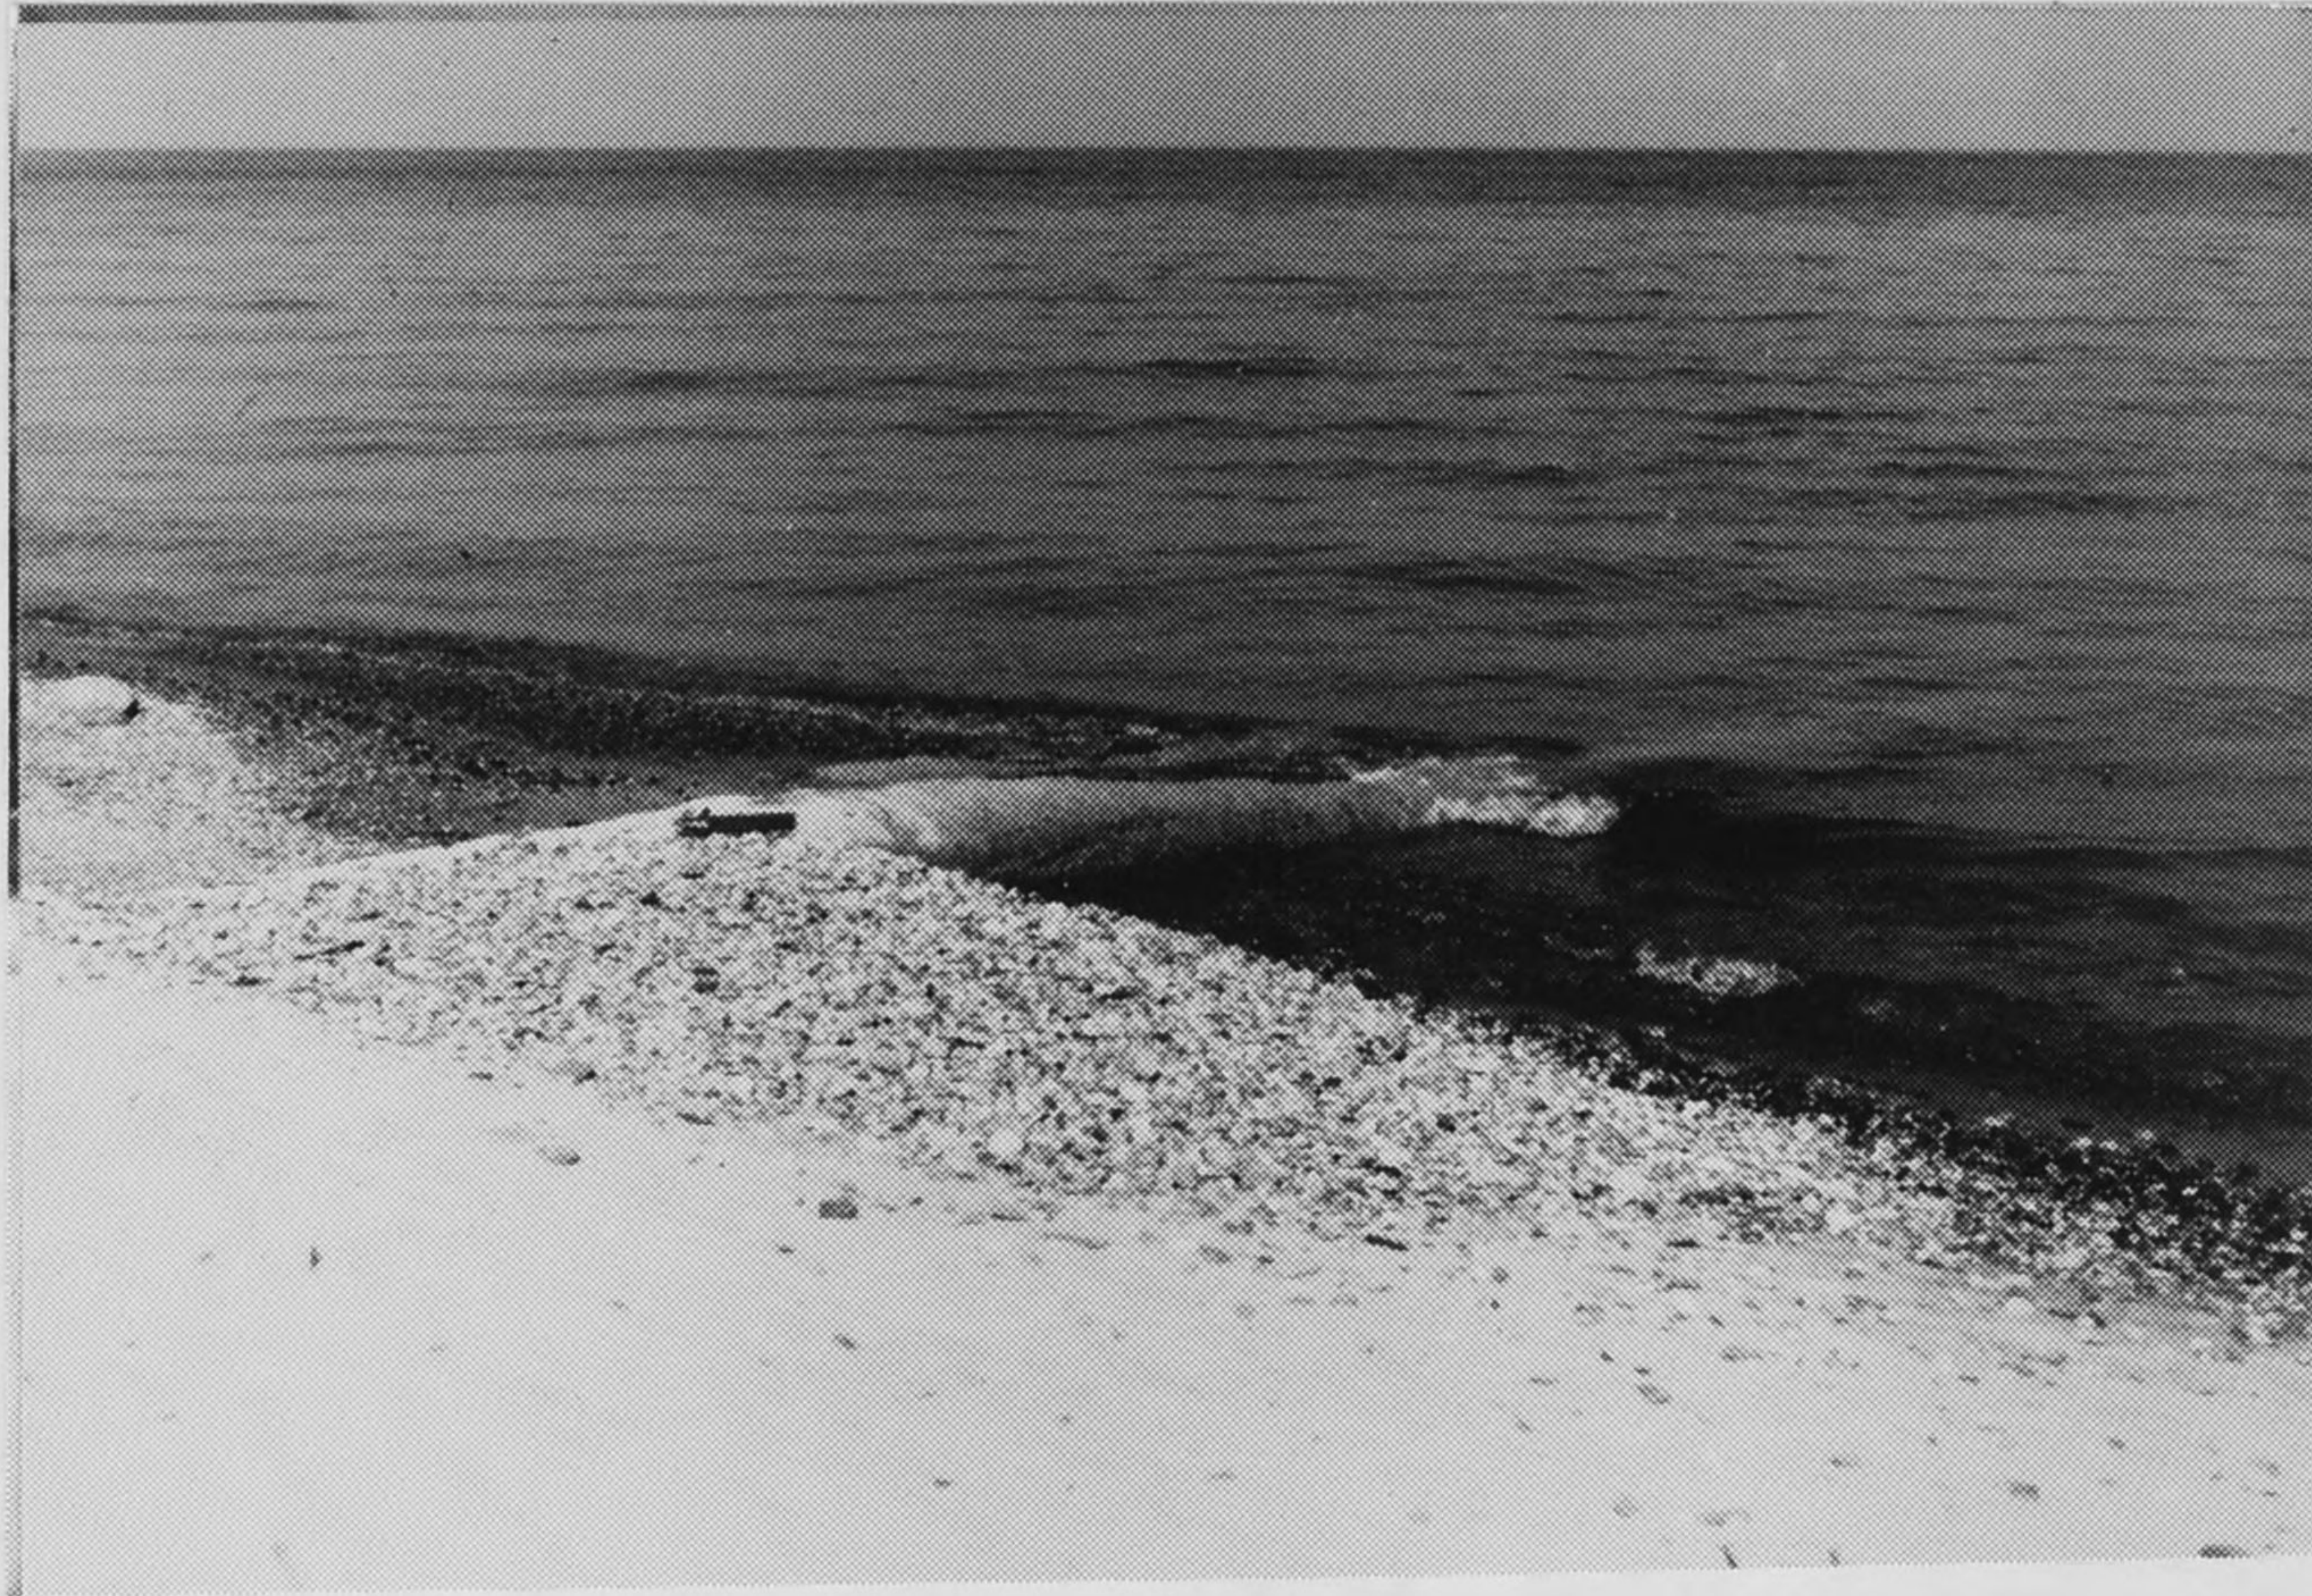
Figure B3. Site A: Third groin from northern side of property, looking only at end that is one bag high. Note significant filling of cobble on north side of groin with beach level on southern side nearly 18 inches lower.

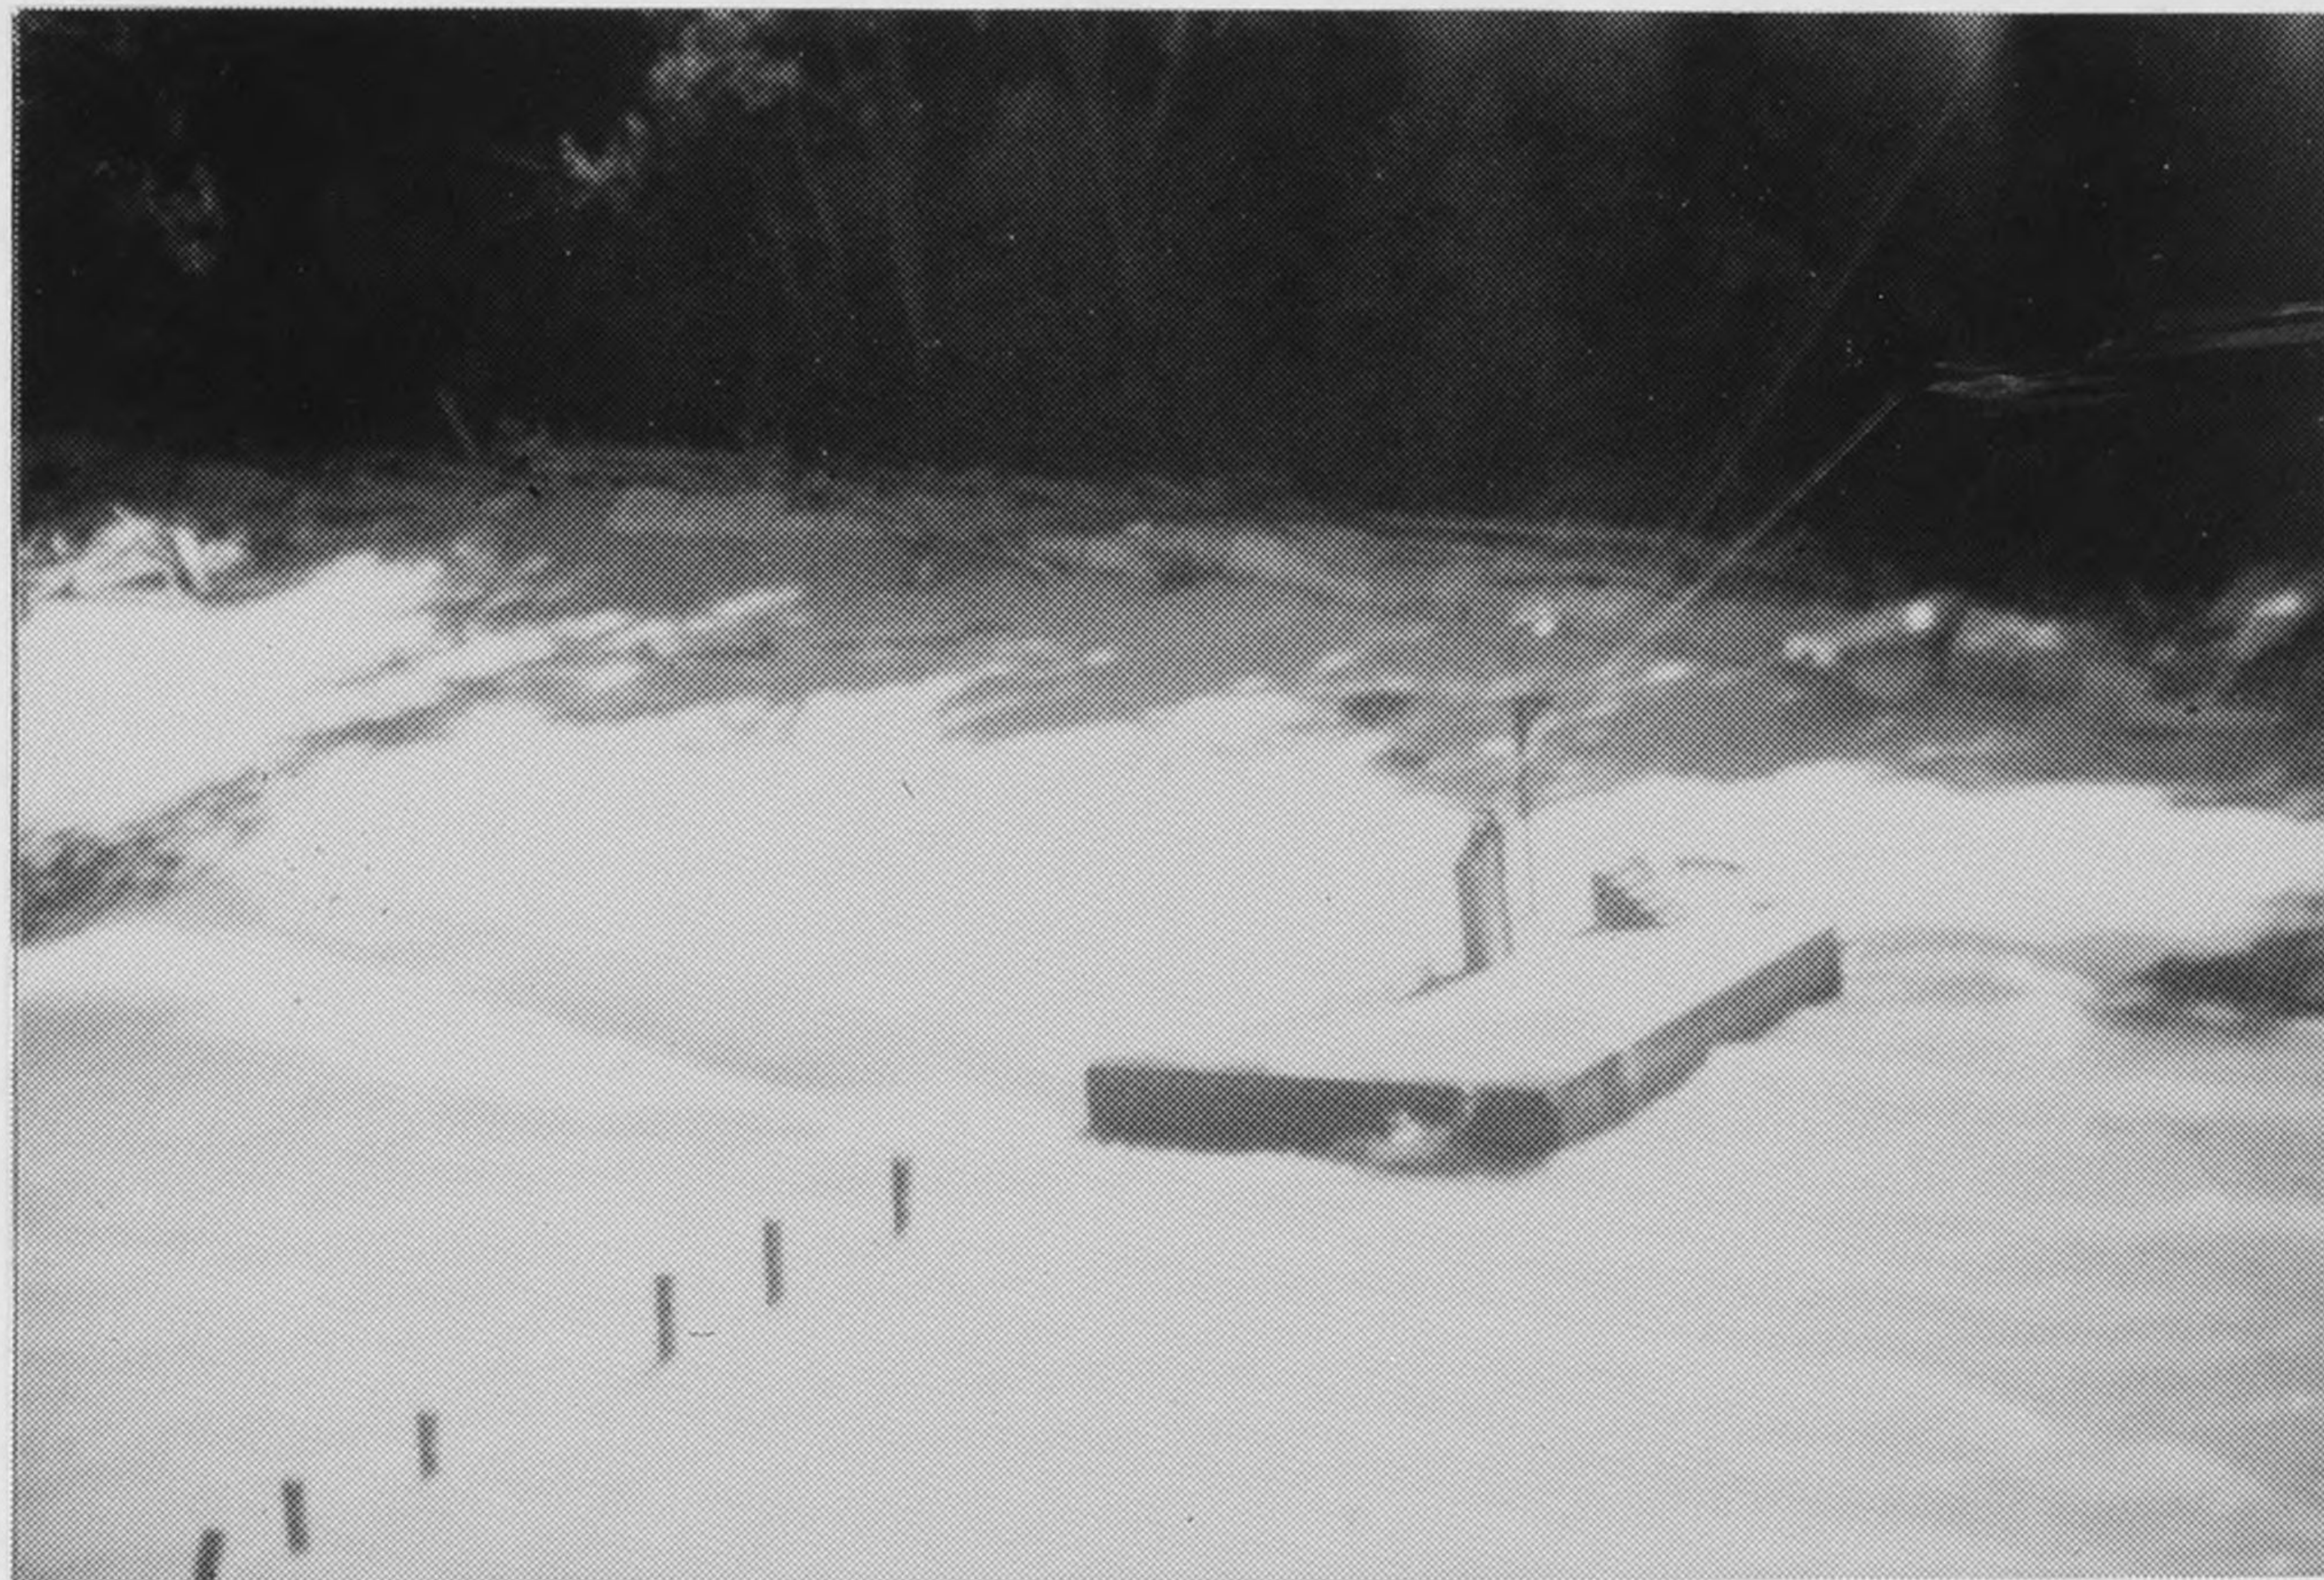
A key factor at this particular site is the presence of a large foundation block (Fig. B4) which serves as an anchor for an aerial tramway that provides transport to the top of the bluff. This foundation block is perhaps 15 by 20 feet in plan dimension and is located at the southern side of the Warren property. The farthest landward portion of this foundation is located approximately 60-70 feet seaward from the toe of the bluff. The beach is nearly 75 feet wide on the north side of the foundation block and there is essentially no beach to the south, so this is clearly acting as a groin in this region where the littoral transport is generally towards the south. This conclusion was reinforced by the inspection of aerial photographs at the Detroit District U.S. Army Corps of Engineers office. The foundation block was present in 1977, but there is almost no beach to the north with a somewhat broader beach to the south. Water is present behind the foundation block. This condition holds up to April of 1980 at which time the foundation block was approximately 100 feet offshore. No aerial photographs were available from then until April of 1986, at which time the concrete blocks are present on the shoreline and the foundation block is attached to the shoreline. Between April and October of 1986 (during which time the lake levels continued to rise) the beach increased in width and that trend has continued up to the present. It is fairly apparent that the placement of the original rows of concrete

blocks in the early 1980's stabilized the shoreline in the immediate vicinity of the foundation block and this resulted in a blockage of the southerly littoral drift at the site. This in turn has built a fairly broad beach for several hundred feet up the shoreline to the north.

It is concluded that the presence of this foundation block dominates the beach processes at the particular location. It has served as a fairly long groin and has stabilized the beach over the same location that the concrete blocks were intended to protect. Therefore, it is not possible to determine whether or not they have been effective. However, the one thing that is obvious is that on a sand beach, they would sink into the beach relatively rapidly and not be particularly useful. It is quite possible that even on the clay foundation that the blocks are apparently resting on, the absence of the sand trapped by the "groin" would result in erosion at the blocks and further undermining. This statement is made in light of the observations of beaches in front of sea walls at various locations along the Great Lakes shorelines.

Figure B4. Site B: Aerial photograph of concrete foundation block for tramway, at southern edge of property. The shoreline is at the outside edge of block on the north side and at the landward edge to the south.

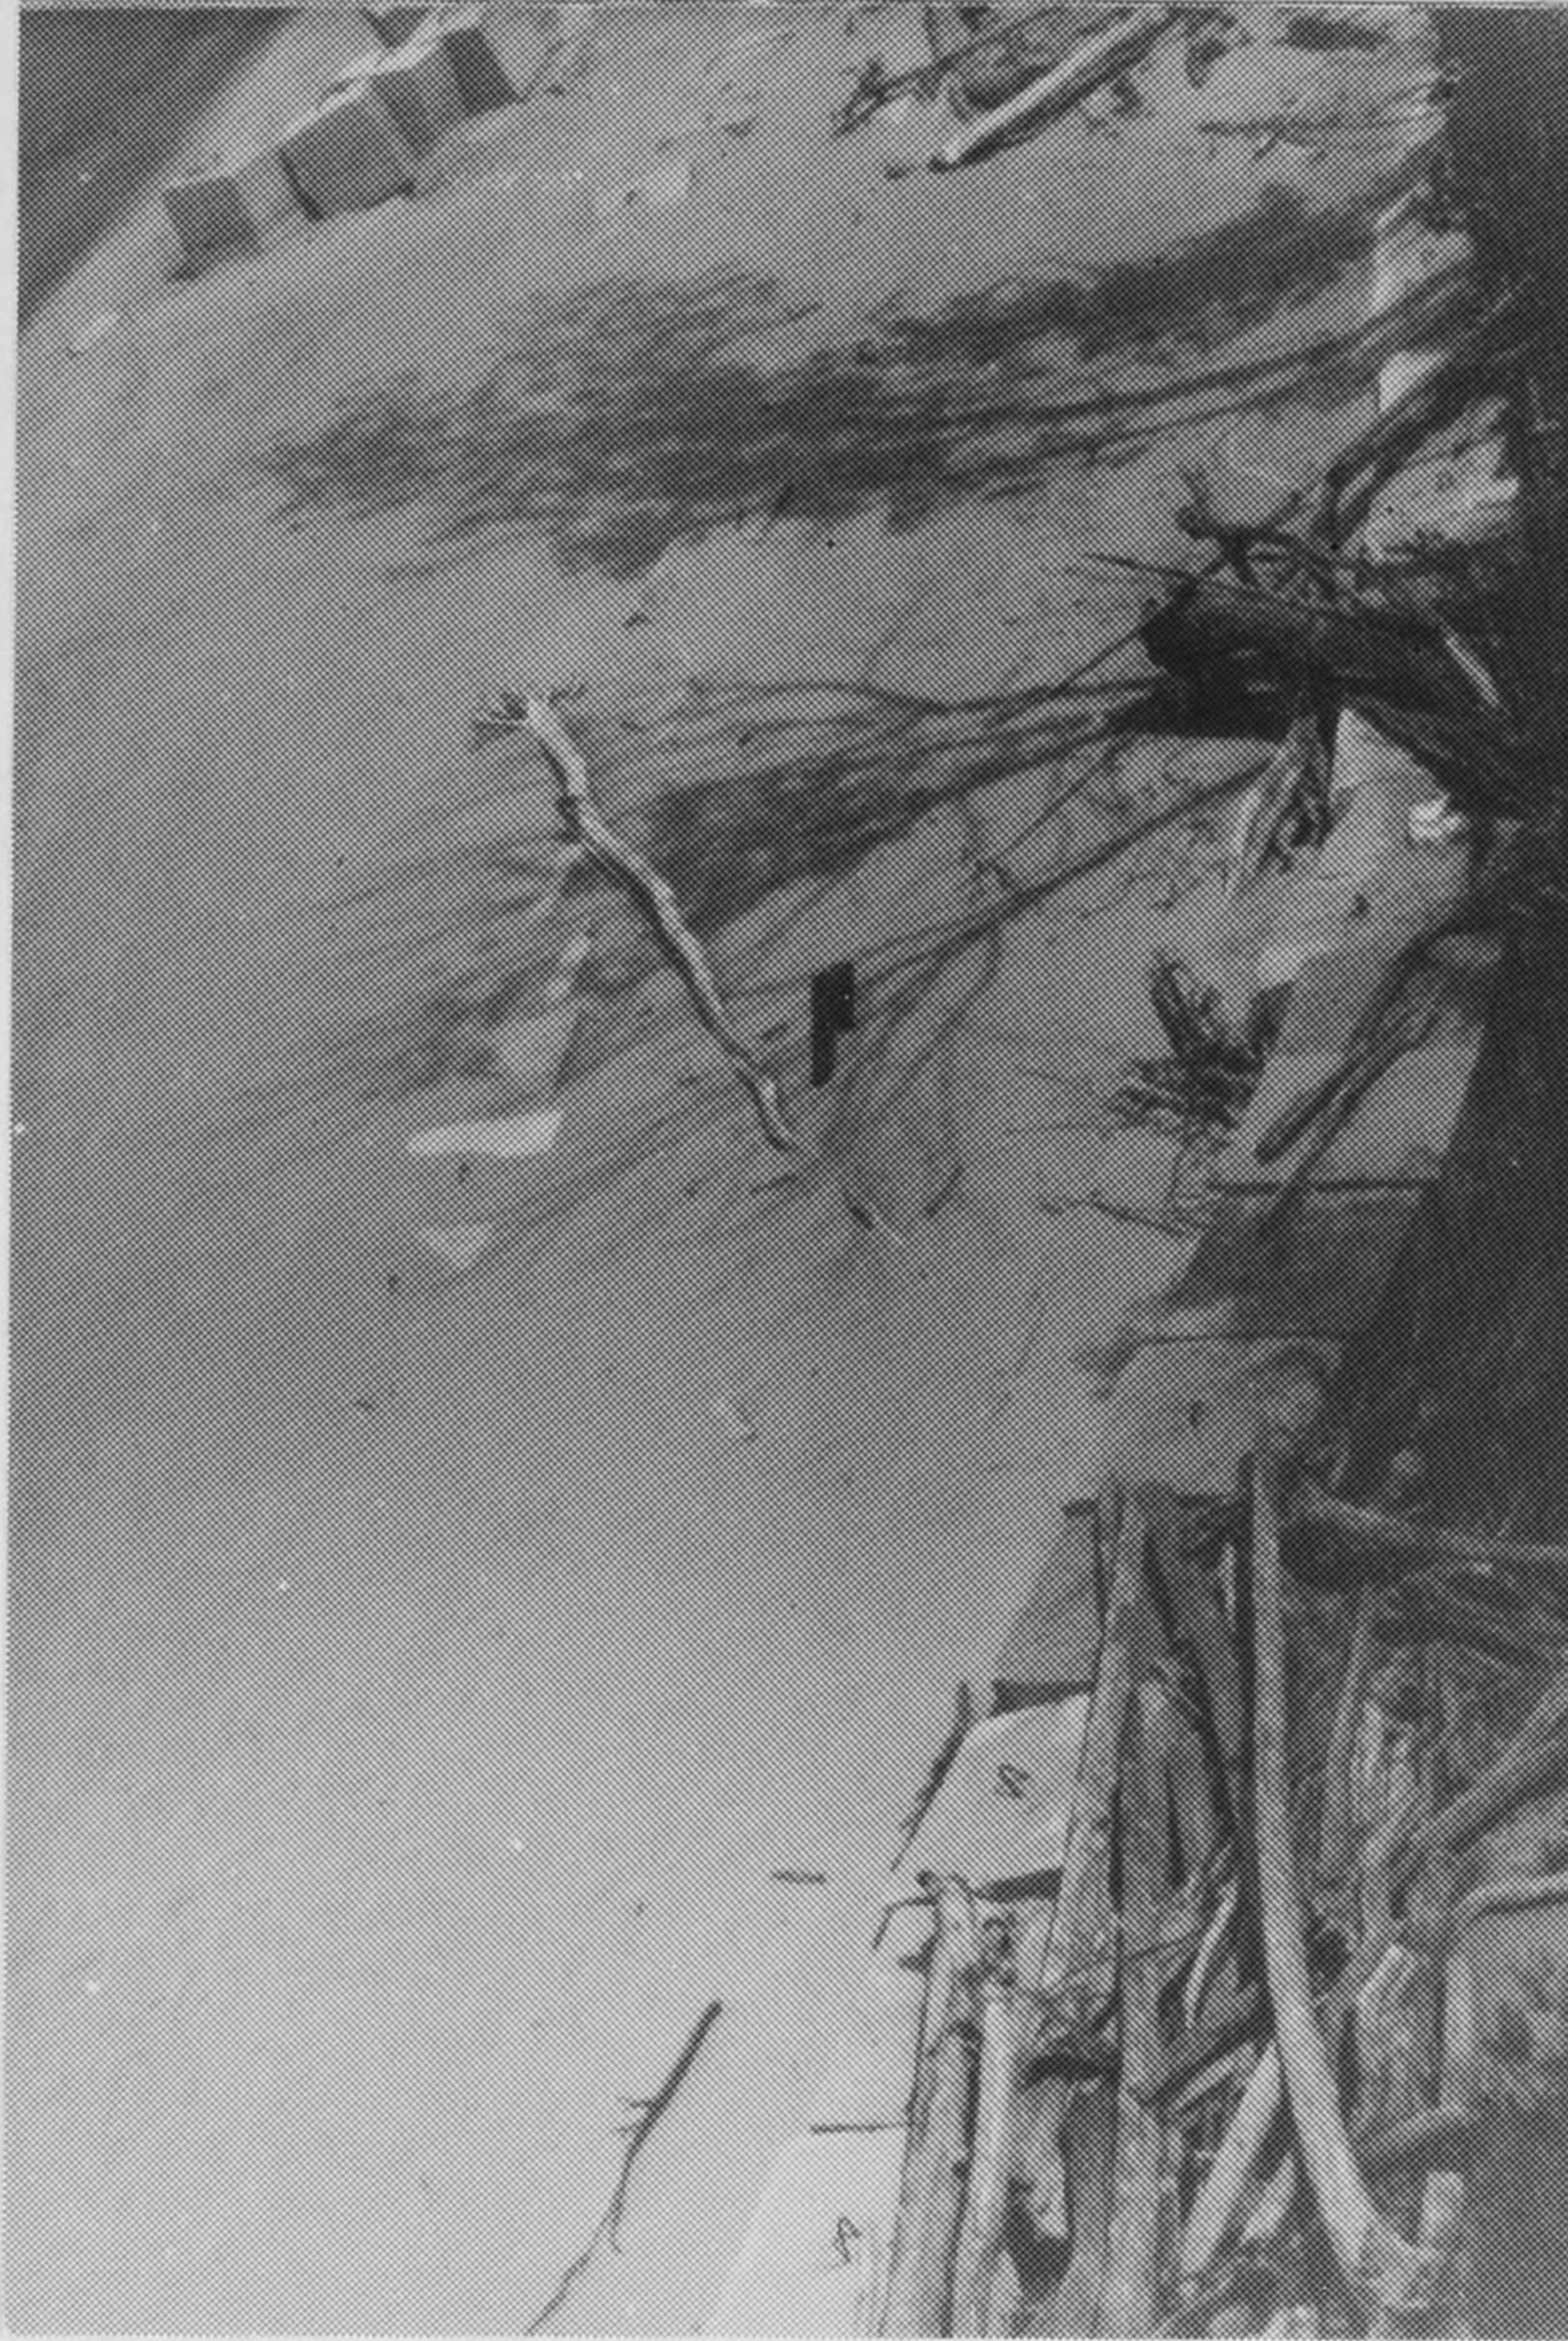
Figure B5. Site B: View of concrete blocks towards southern side of property. Note row of blocks at right, located at toe of bluff. A second row is almost completely buried in the sand to the left of the first row and a few random blocks such as those in upper left have been recently placed on existing beach.
