**EVALUATION OF GREAT LAKES
SHORE PROTECTION STRUCTURES**

Report UMCEE 88-8

**THE UNIVERSITY OF MICHIGAN
DEPARTMENT OF CIVIL ENGINEERING
ANN ARBOR, MICHIGAN**

**Michigan Department of Natural Resources
Coastal Management Program
Land and Water Division**

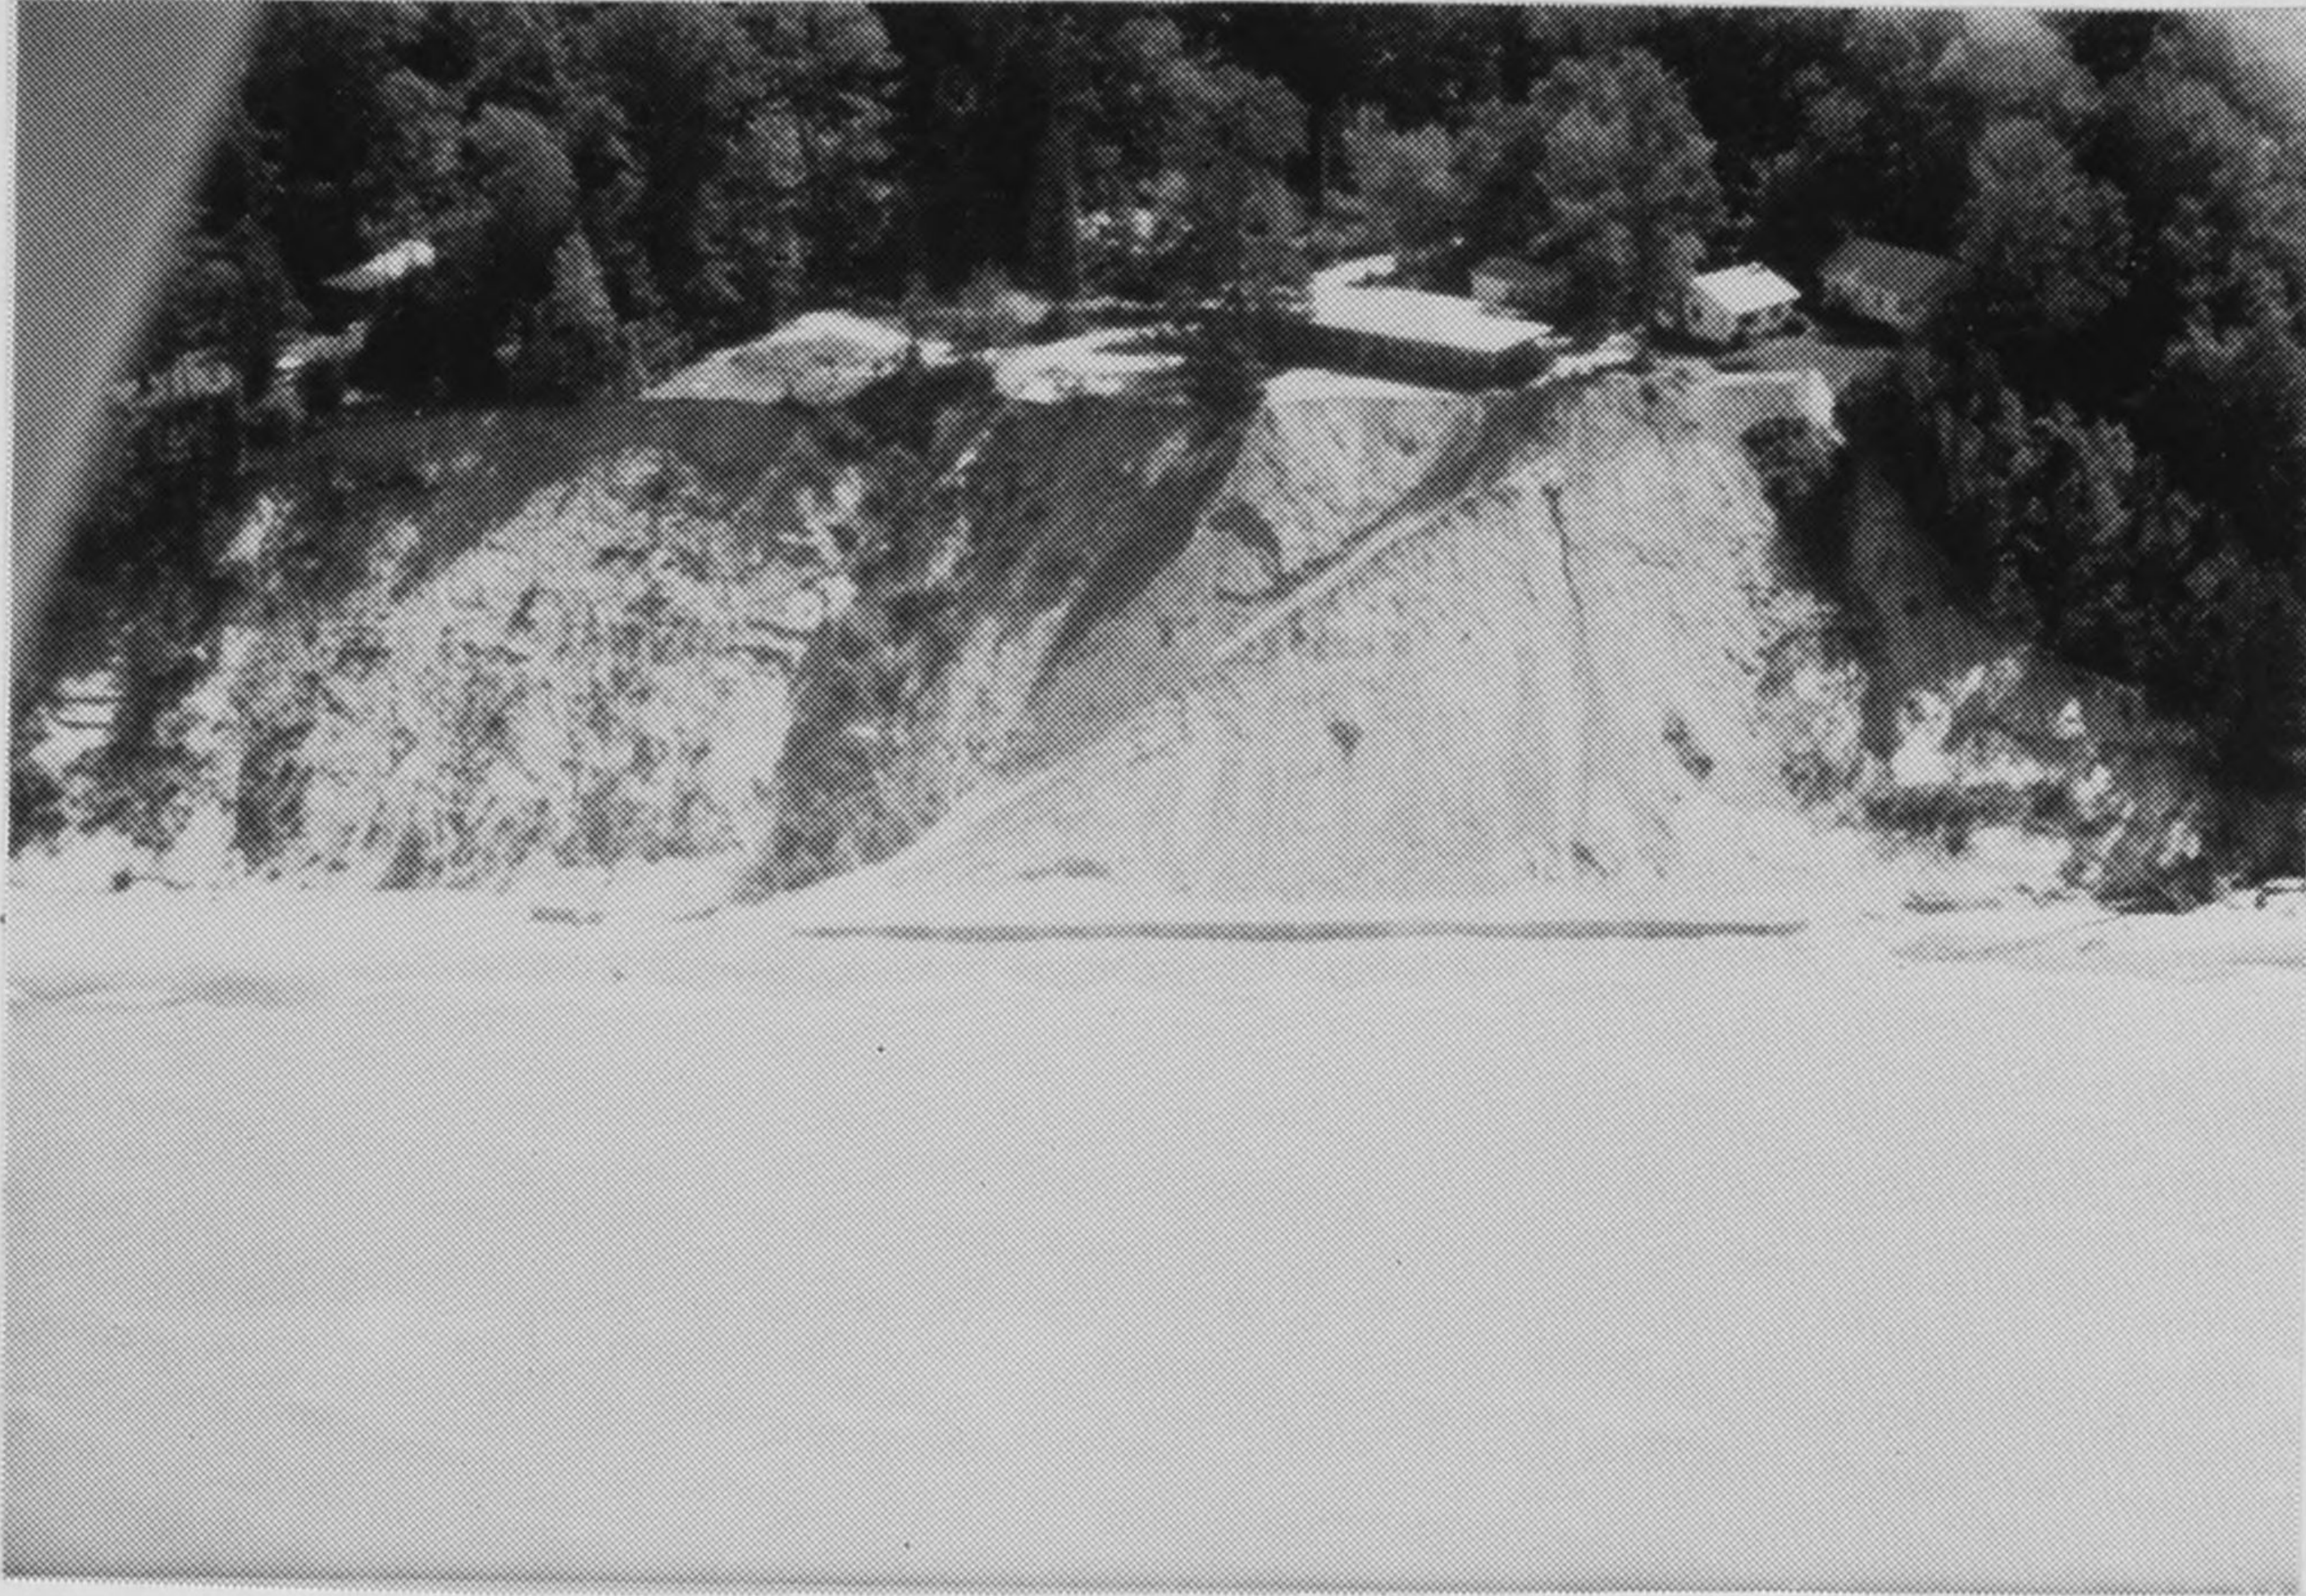
Figure B6. Site C: Aerial view of structure. Kasten property is that with diagonal path down to the left. Dark line above water's edge is the vertical sections of the modular units.

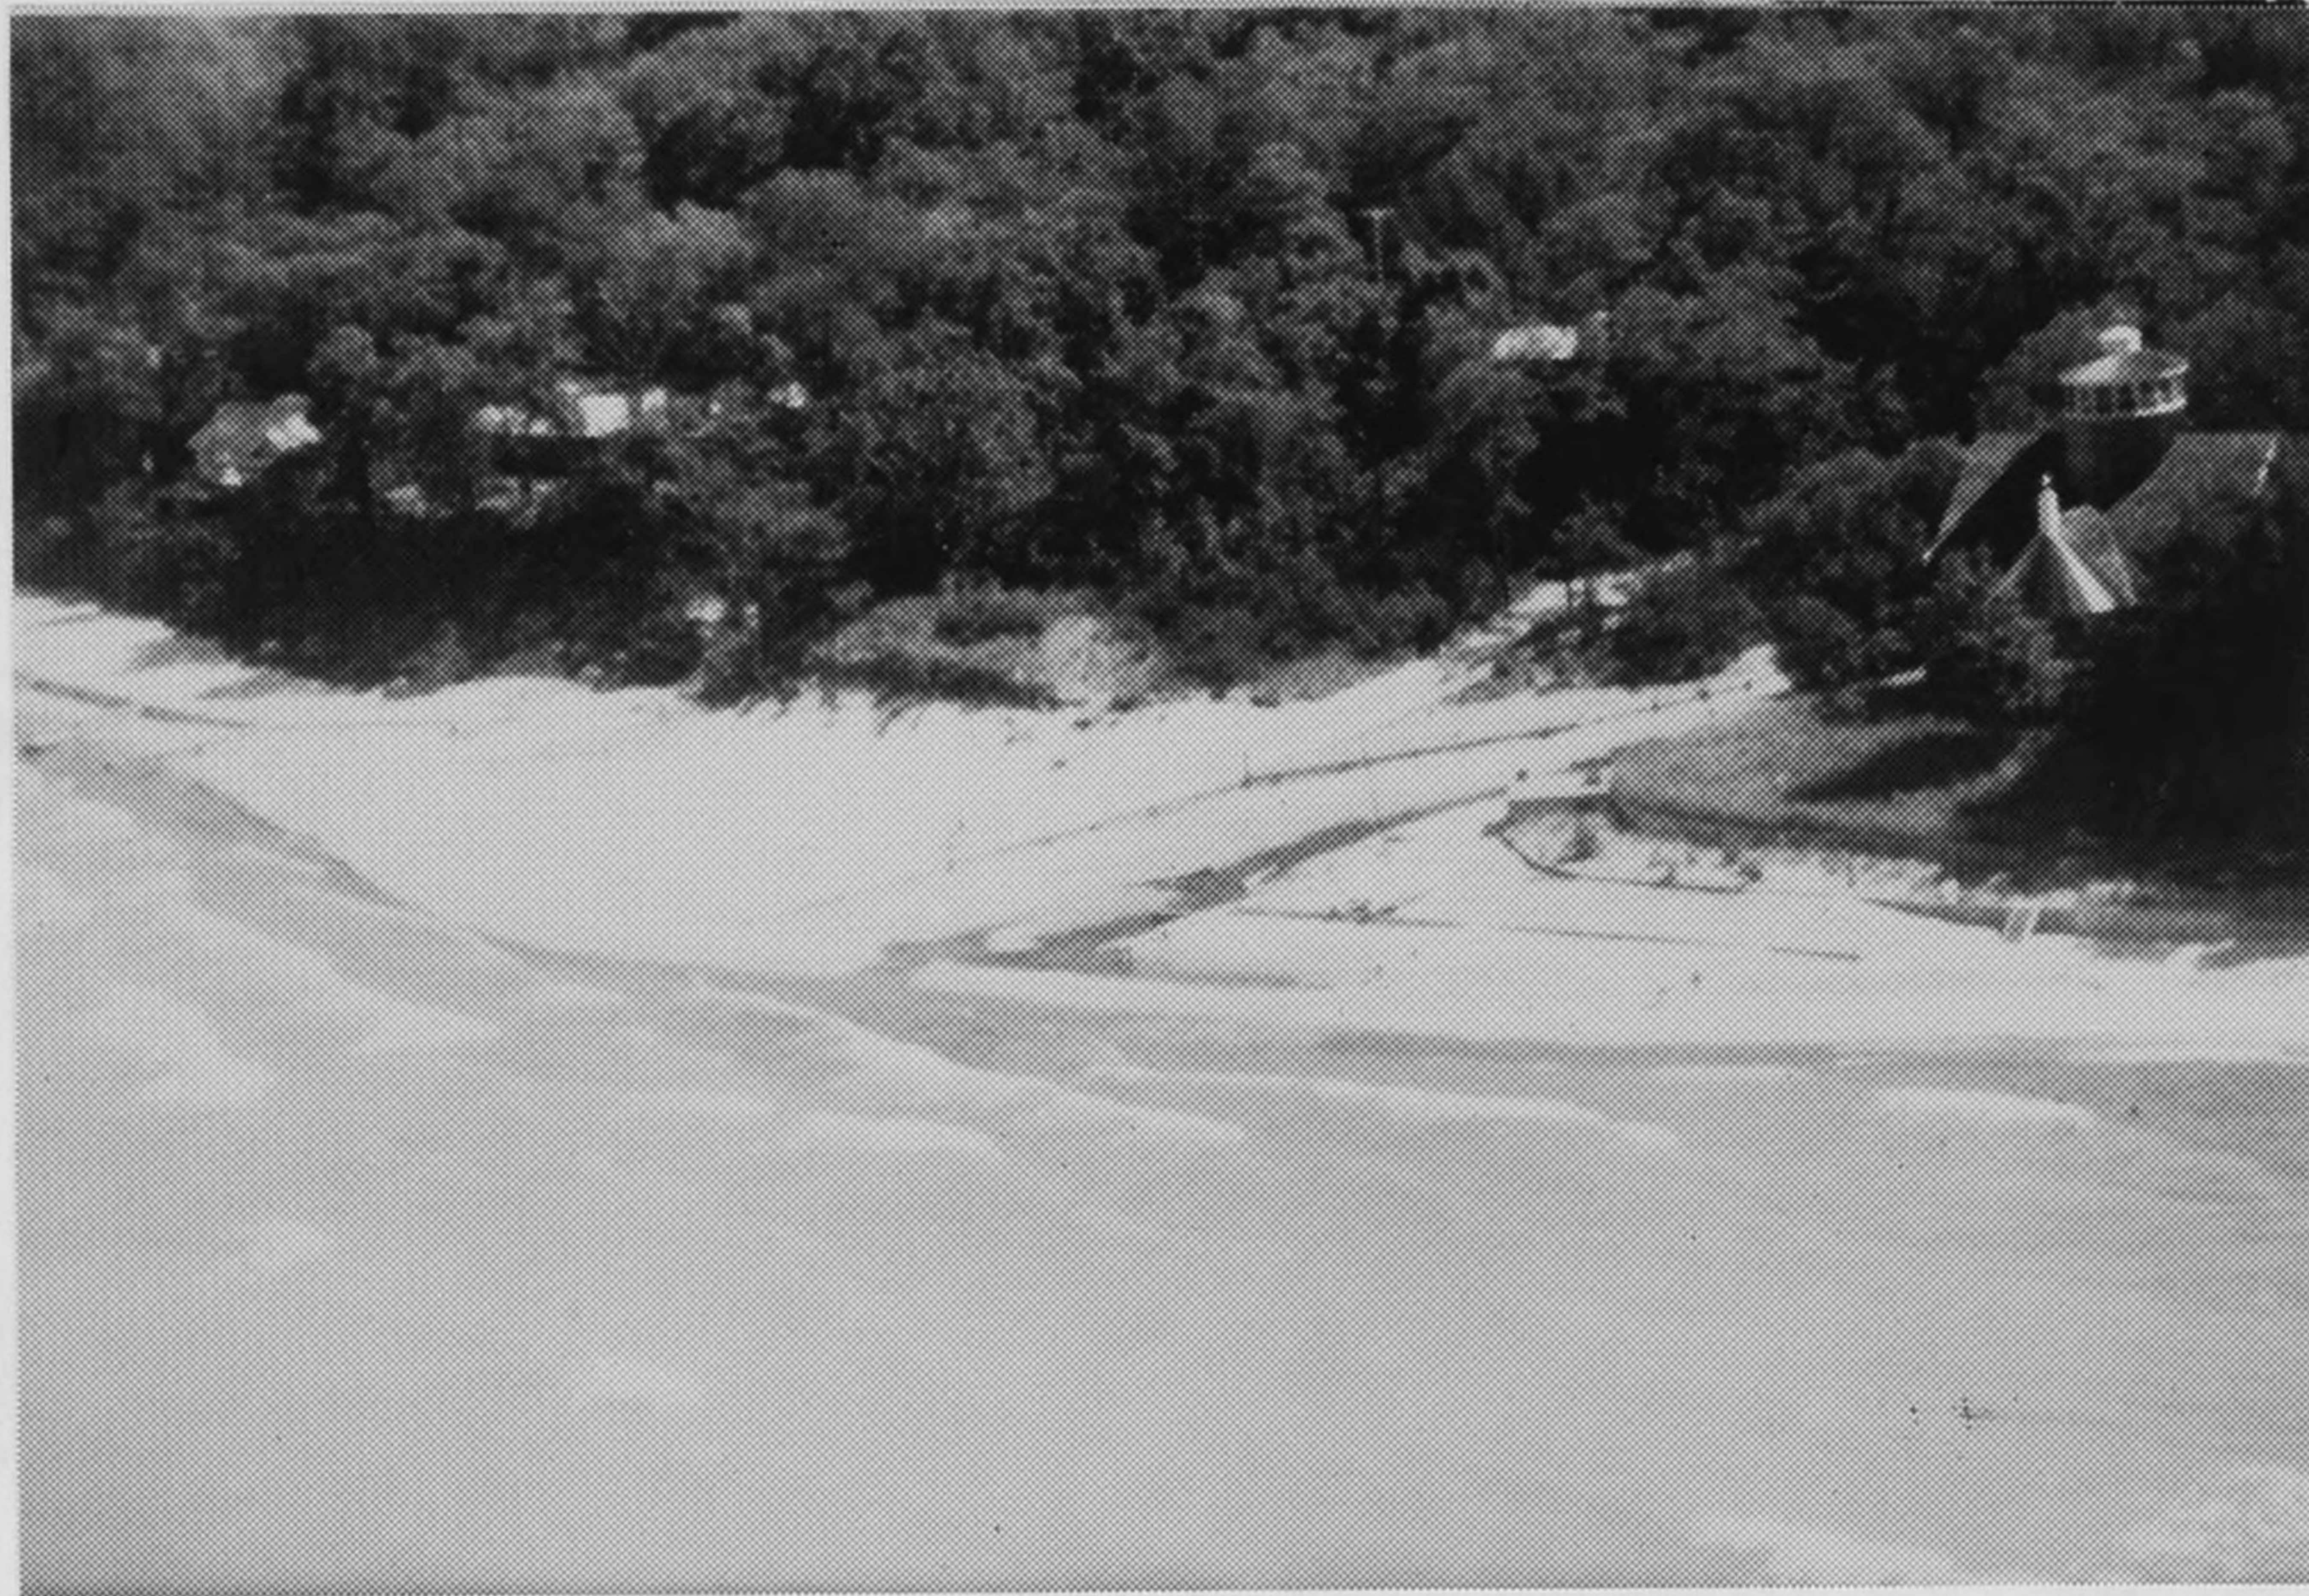
In this area, the retaining wall and the similar one along the south side of the creek along with the groin system extend farther lakeward than the surrounding shoreline and a relatively broad beach has formed, (Fig. B8) especially just to the north of this system of structures. This was apparent even during the extreme high water in 1986 at which time, it is one of the few examples of a beach along the entire southern Lake Michigan shoreline. Since this condition existed prior to the issuance of the permit, it is concluded that the structure has had no significant influence on the shoreline in the vicinity.

Figure B8. Site D: Aerial view of site. Retaining wall is dark line on north side of creek which enters lake in center of photo. Note greater width of beach compared to either side of photo, also groin and sill system on property to south of creek.

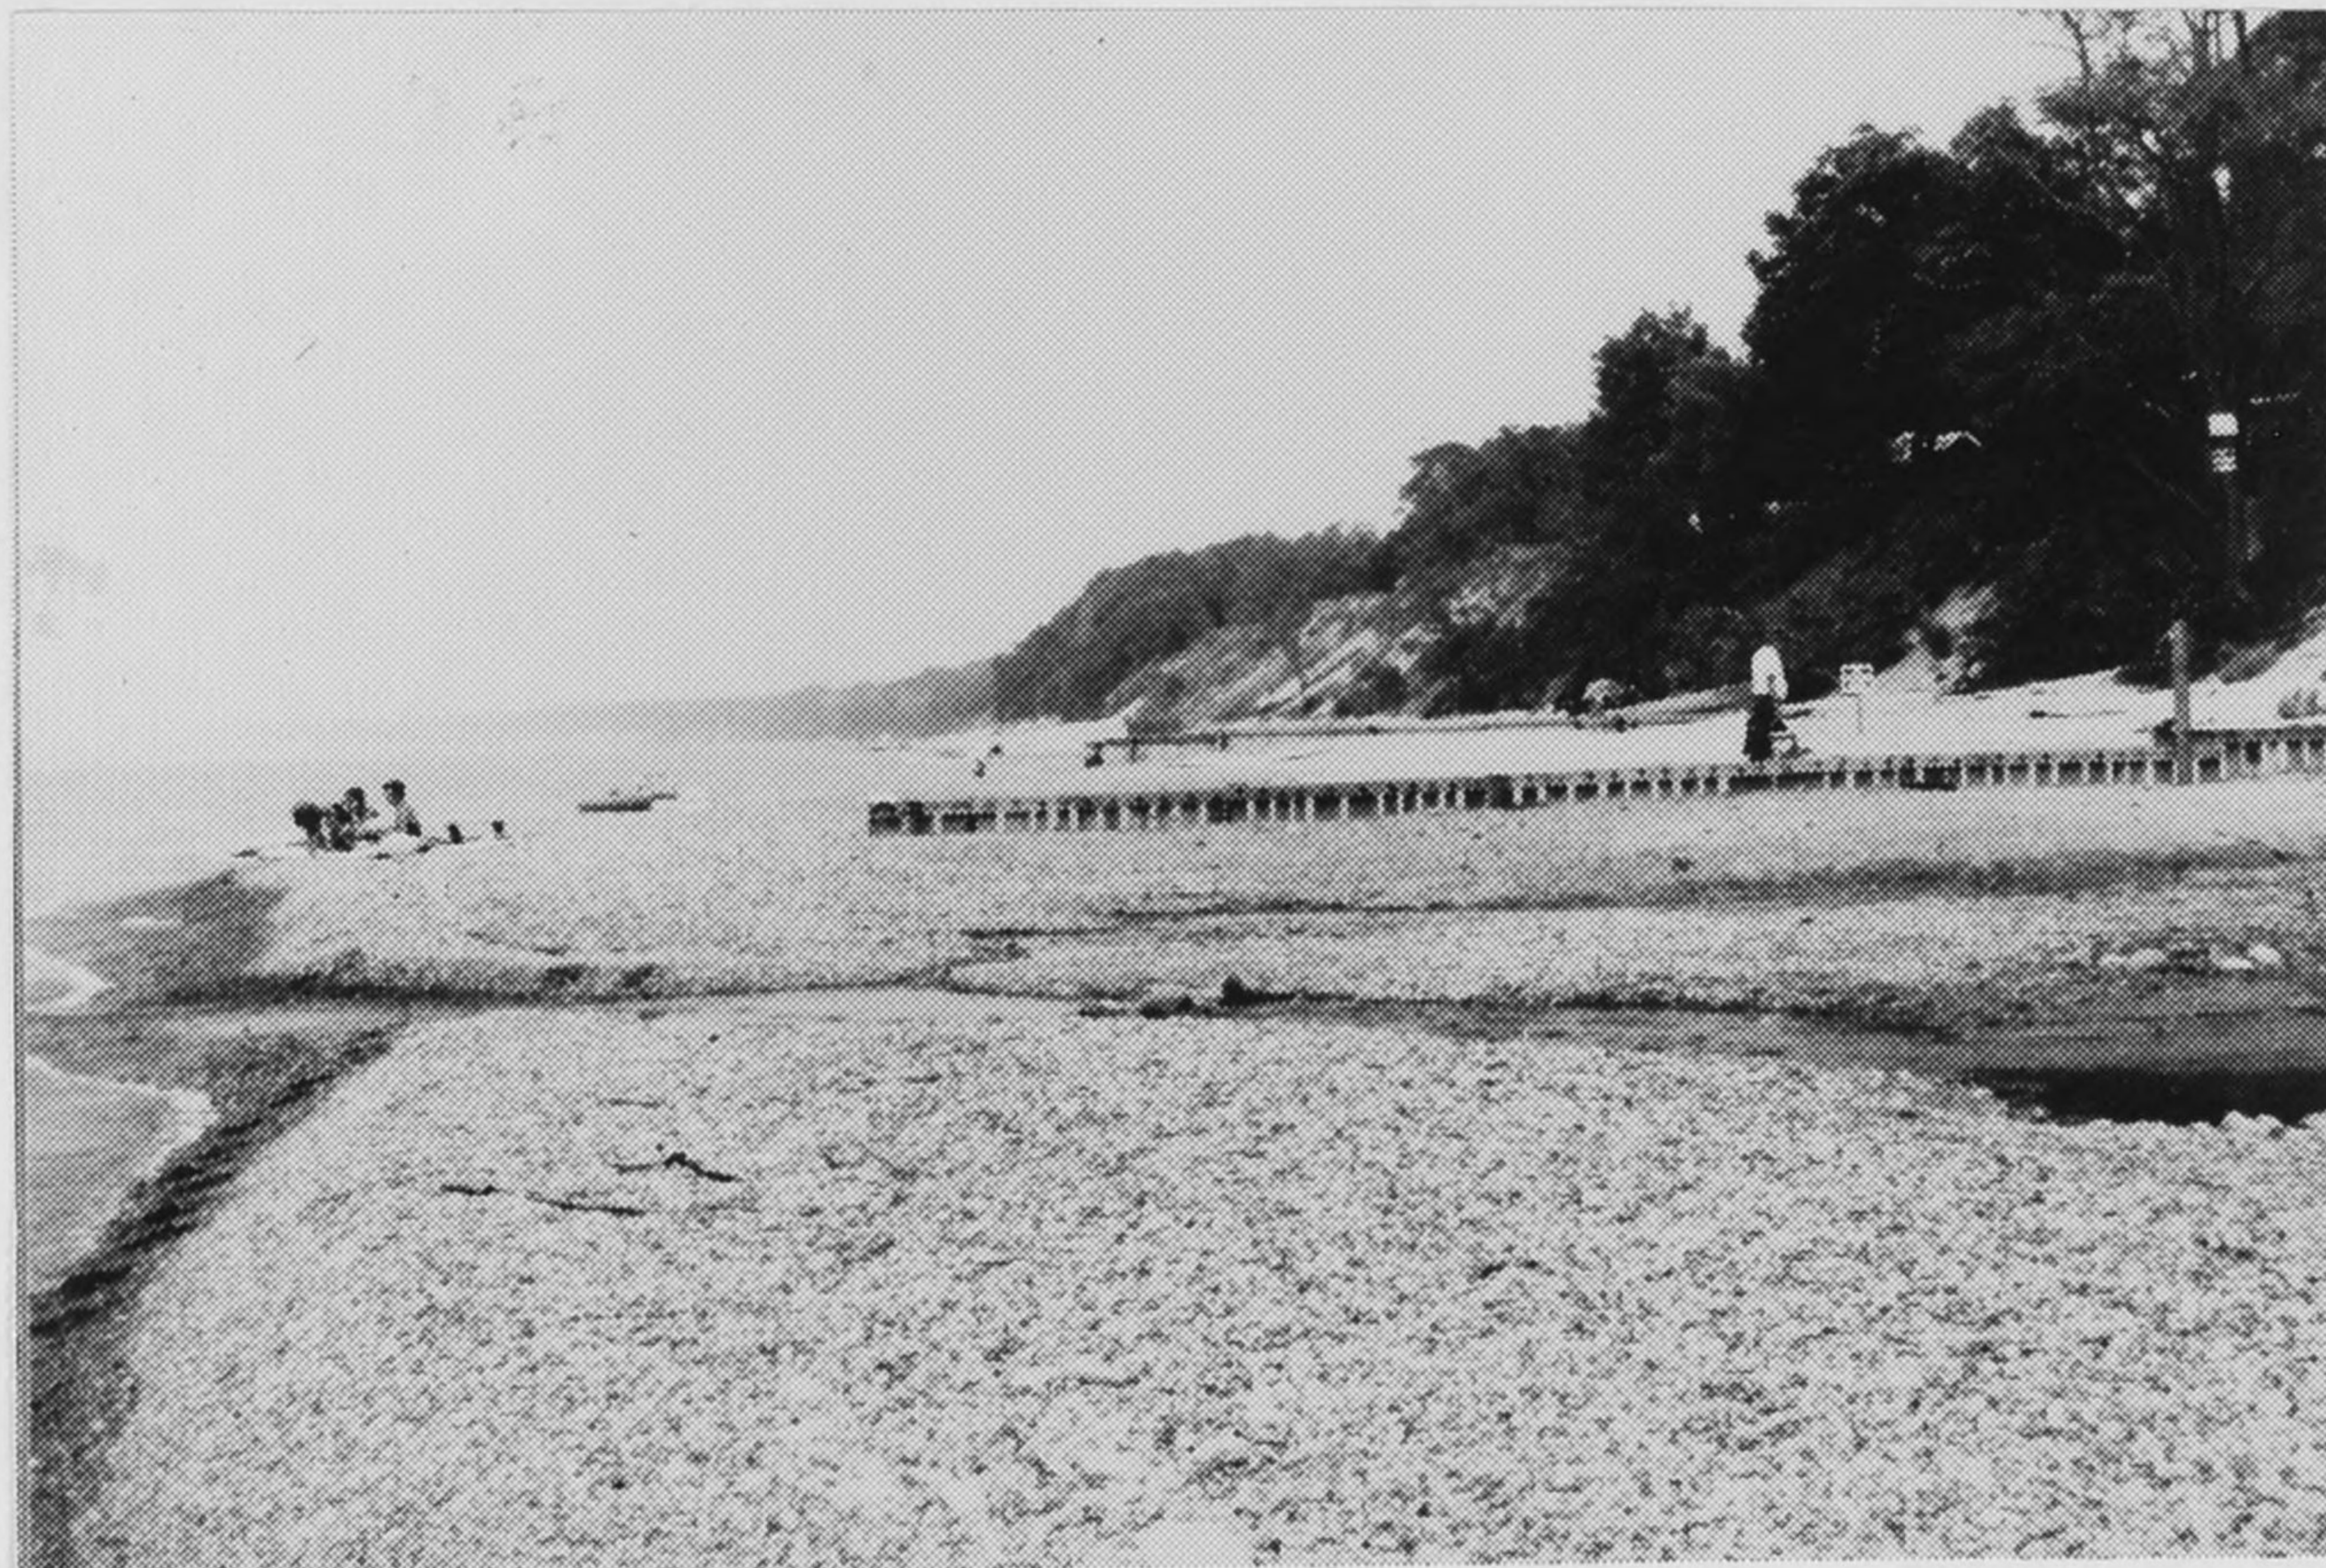
Figure B9. Site D: View of retaining wall from the south side of creek. Decrease in beach width to the north is possible to make out from photograph.

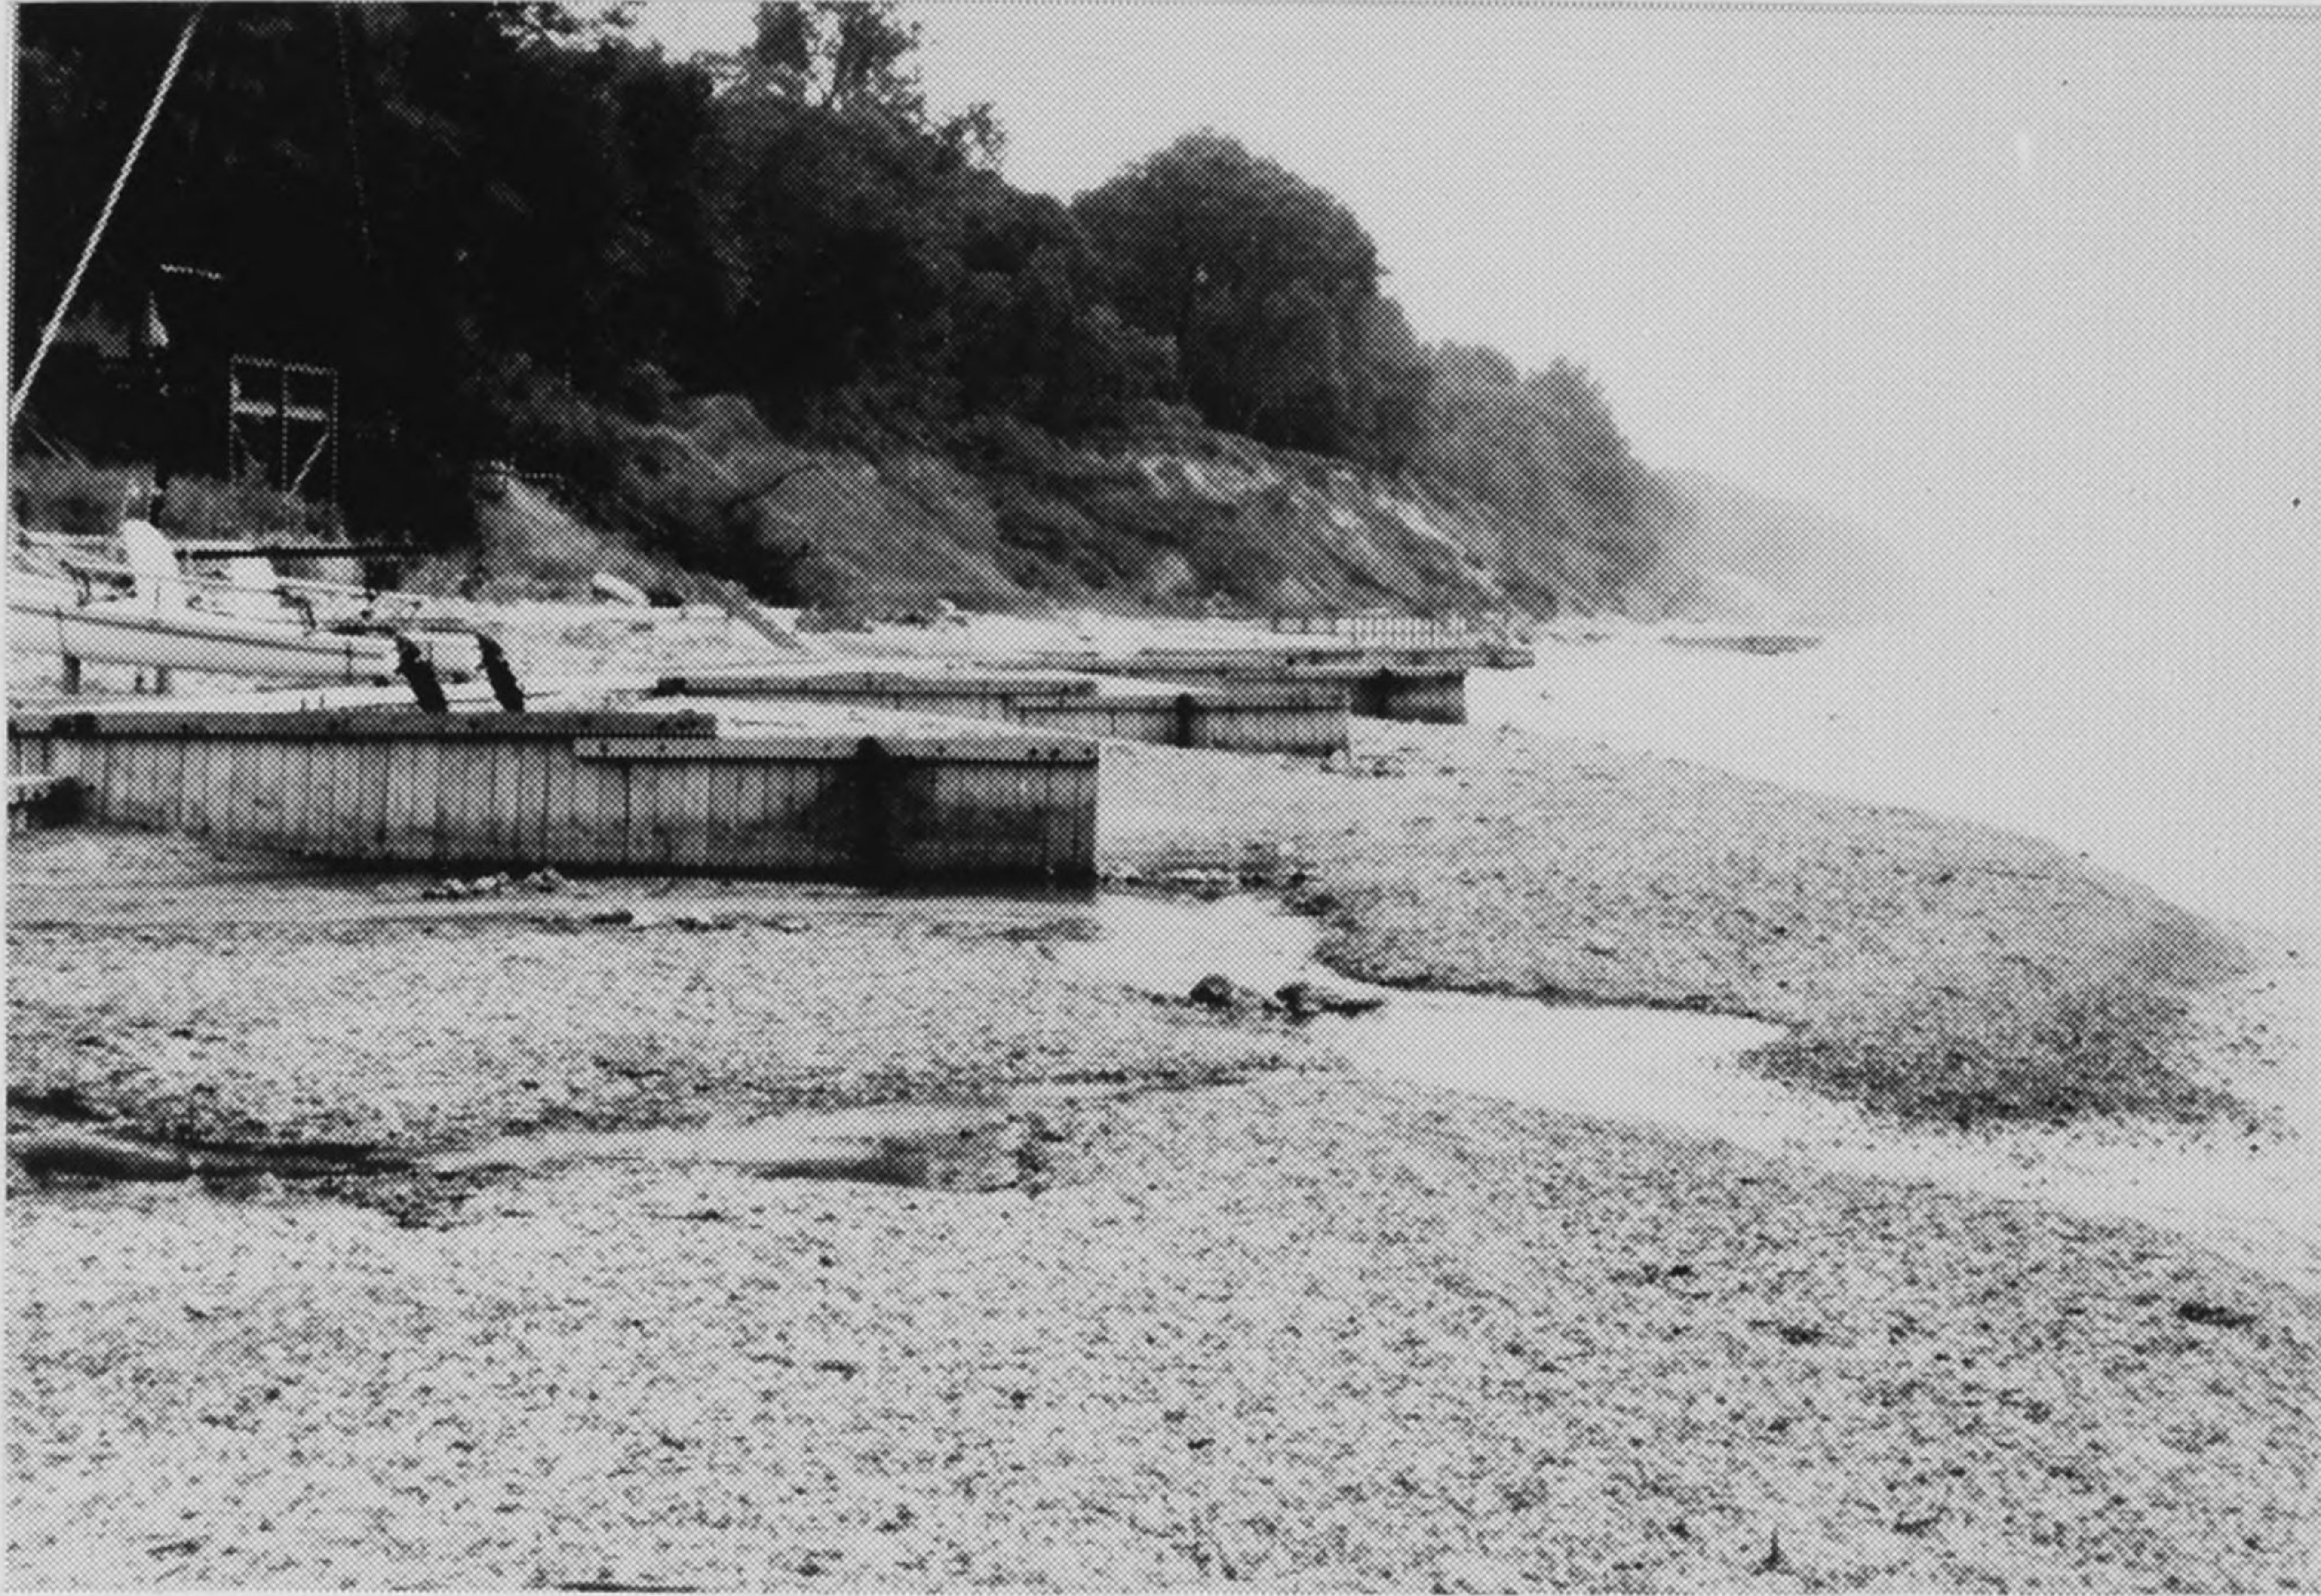
Figure B10. Site D: View of groin system on south side of creek. Decrease in beach width to the south is fairly clear in this photograph.

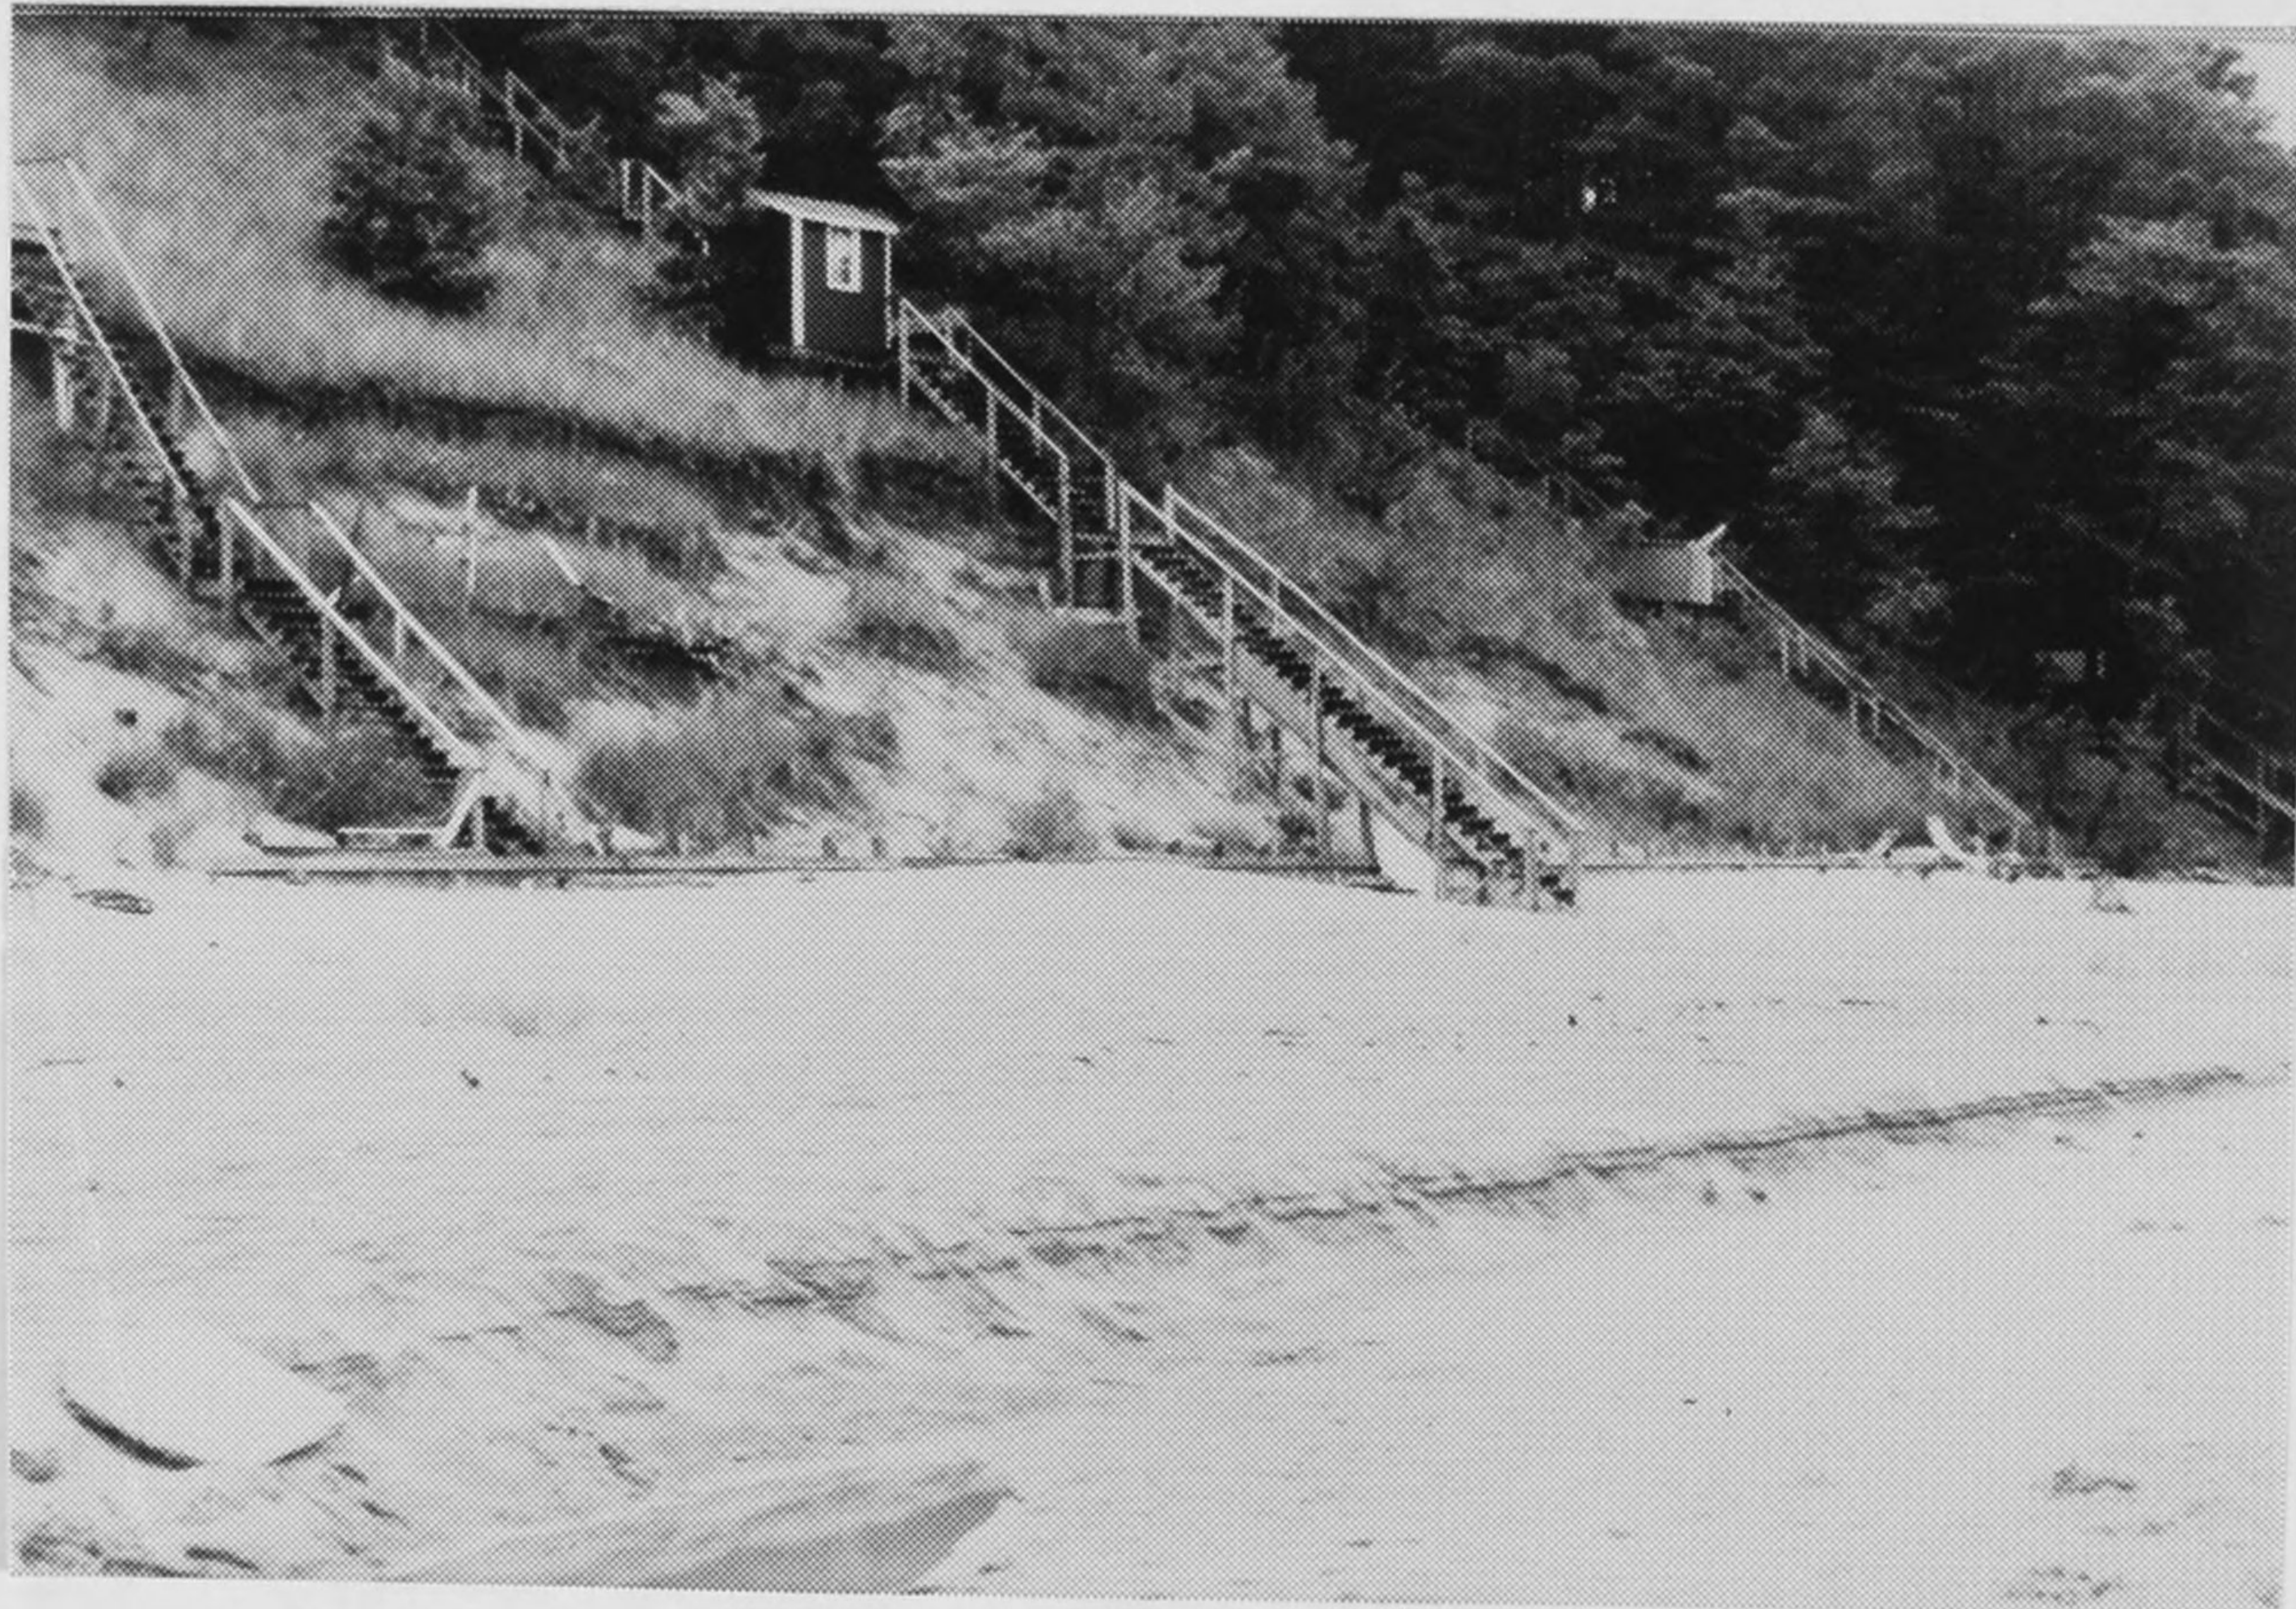
Figure B11. Site E: Top of retaining wall is visible at toe of bluff. Straight line in foreground is where beach level drops immediately at shoreline with beach perched more than 12 inches above water level. View is towards south.

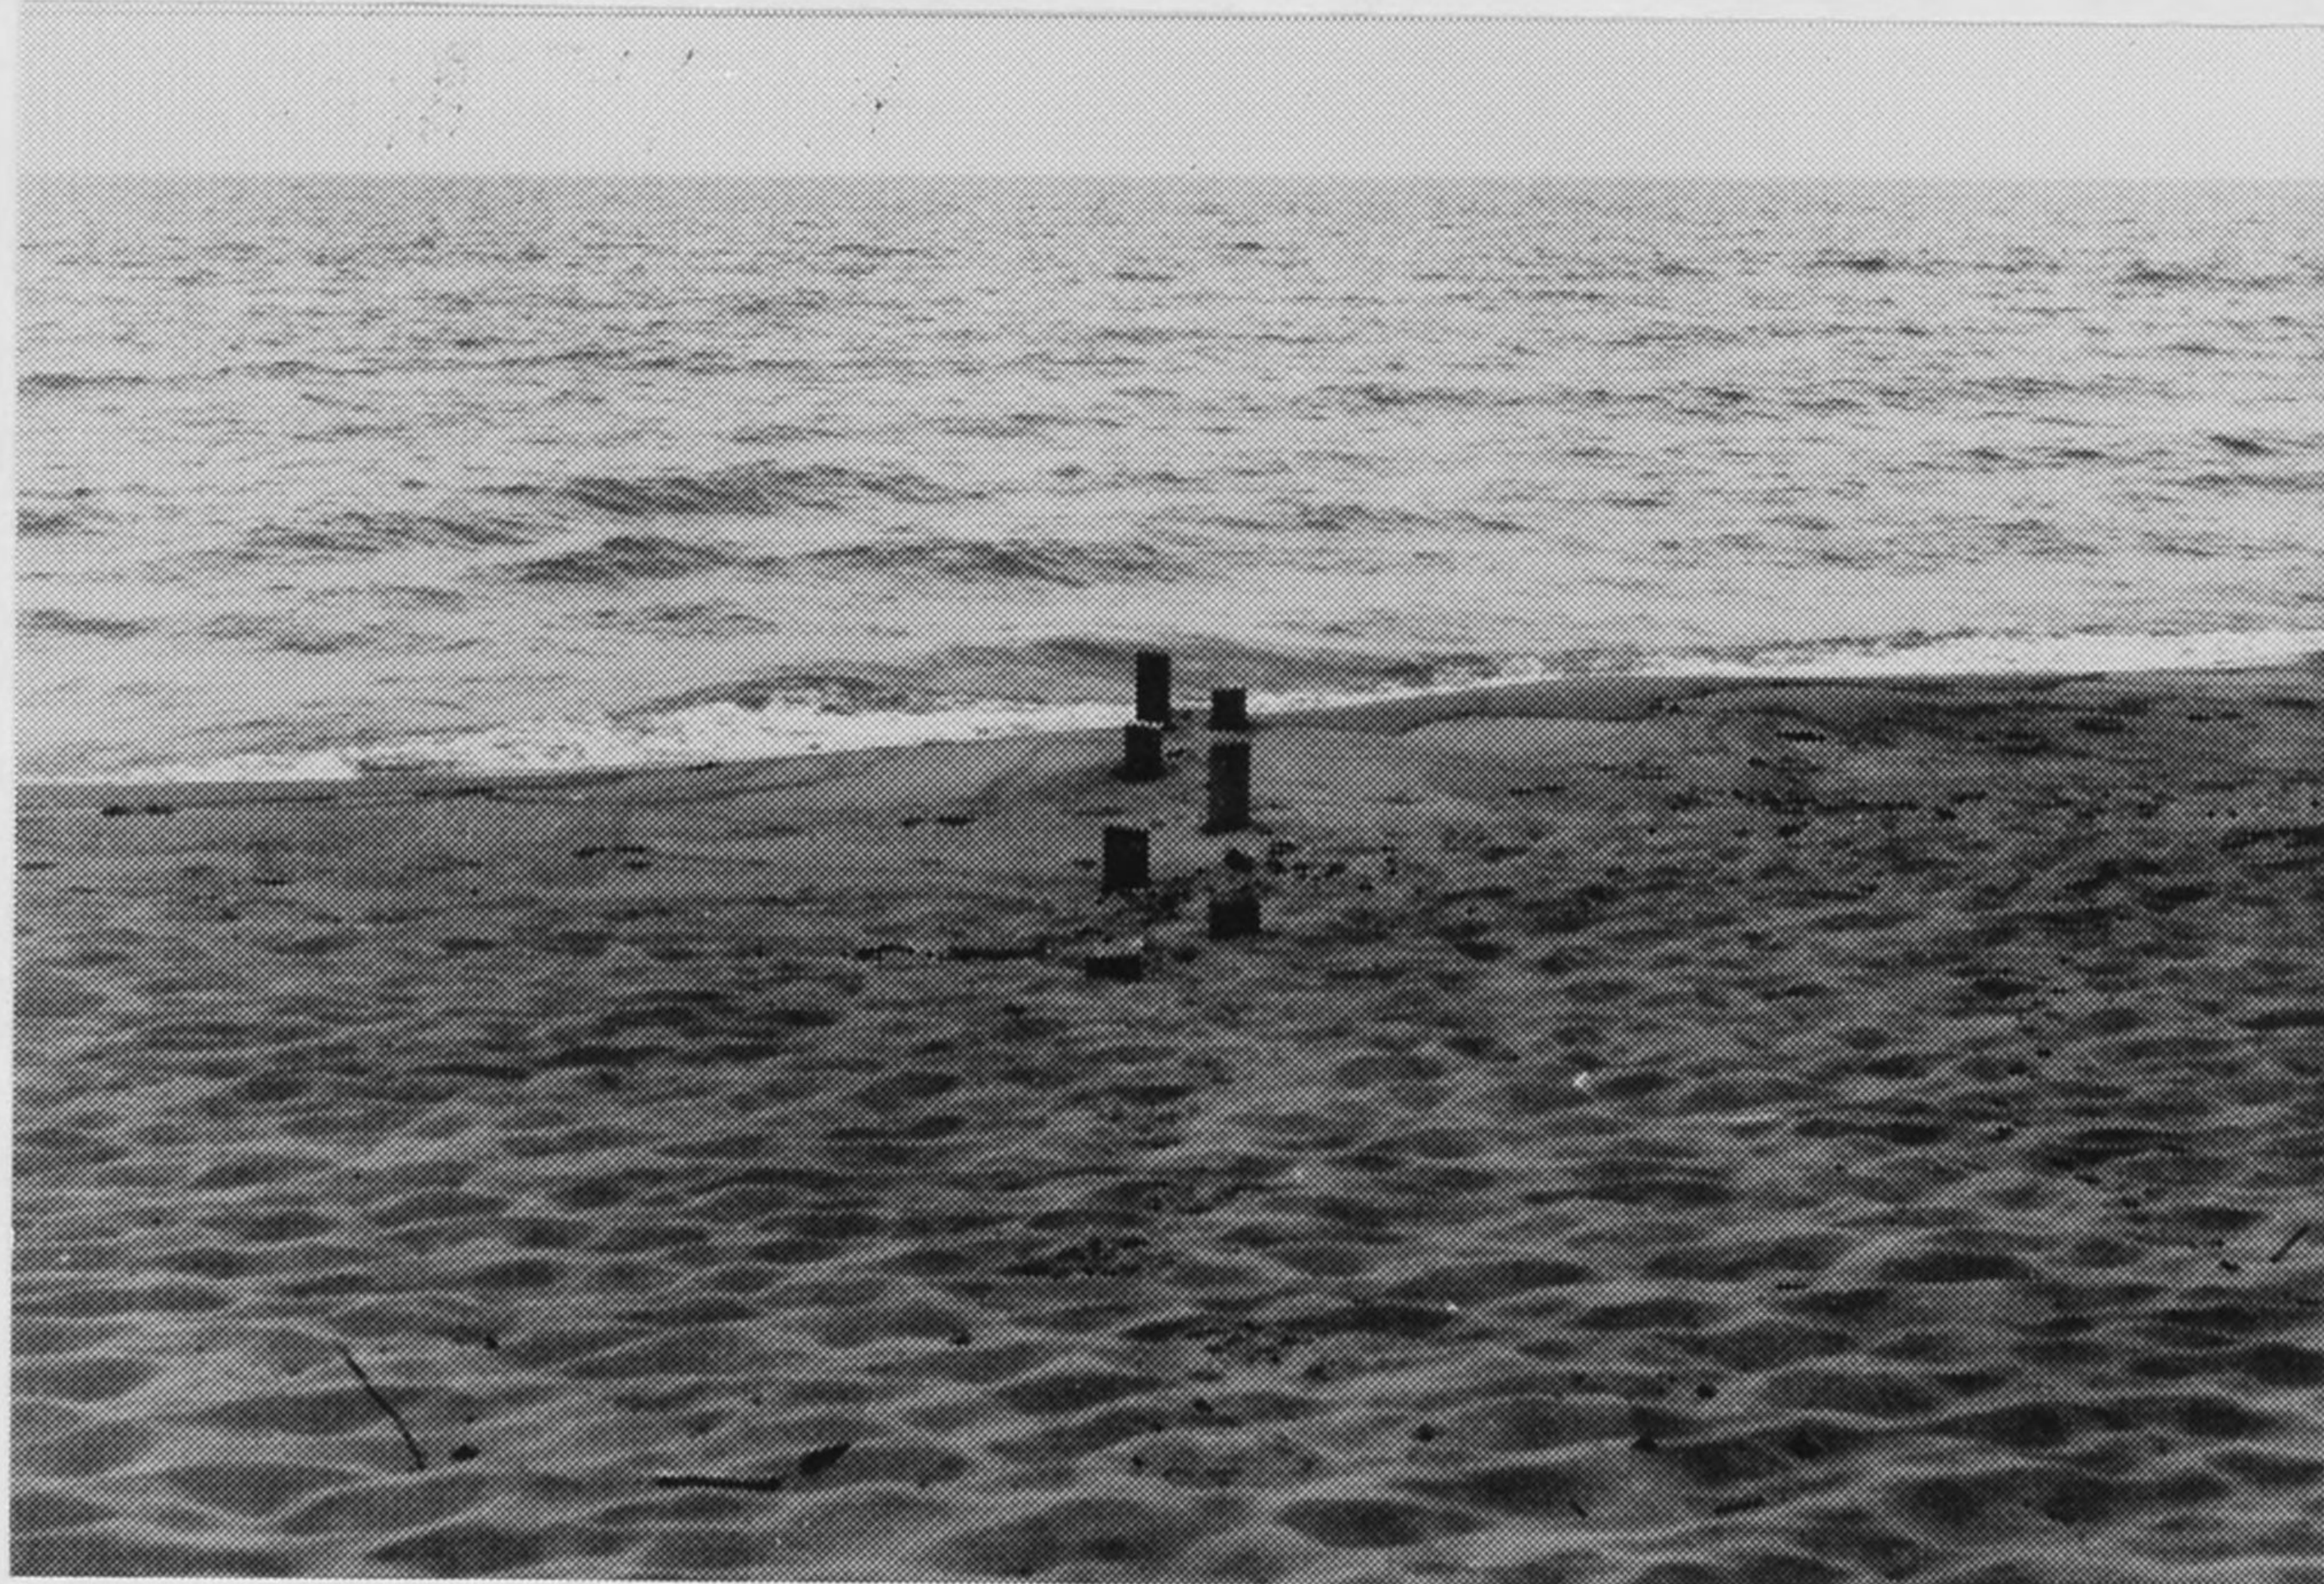
Figure B13. Site F: Looking offshore along top of nearly completely buried groin. Horizontal members are not visible.
