**EVALUATION OF GREAT LAKES
SHORE PROTECTION STRUCTURES**

Report UMCEE 88-8

**THE UNIVERSITY OF MICHIGAN
DEPARTMENT OF CIVIL ENGINEERING
ANN ARBOR, MICHIGAN**

**Michigan Department of Natural Resources
Coastal Management Program
Land and Water Division**

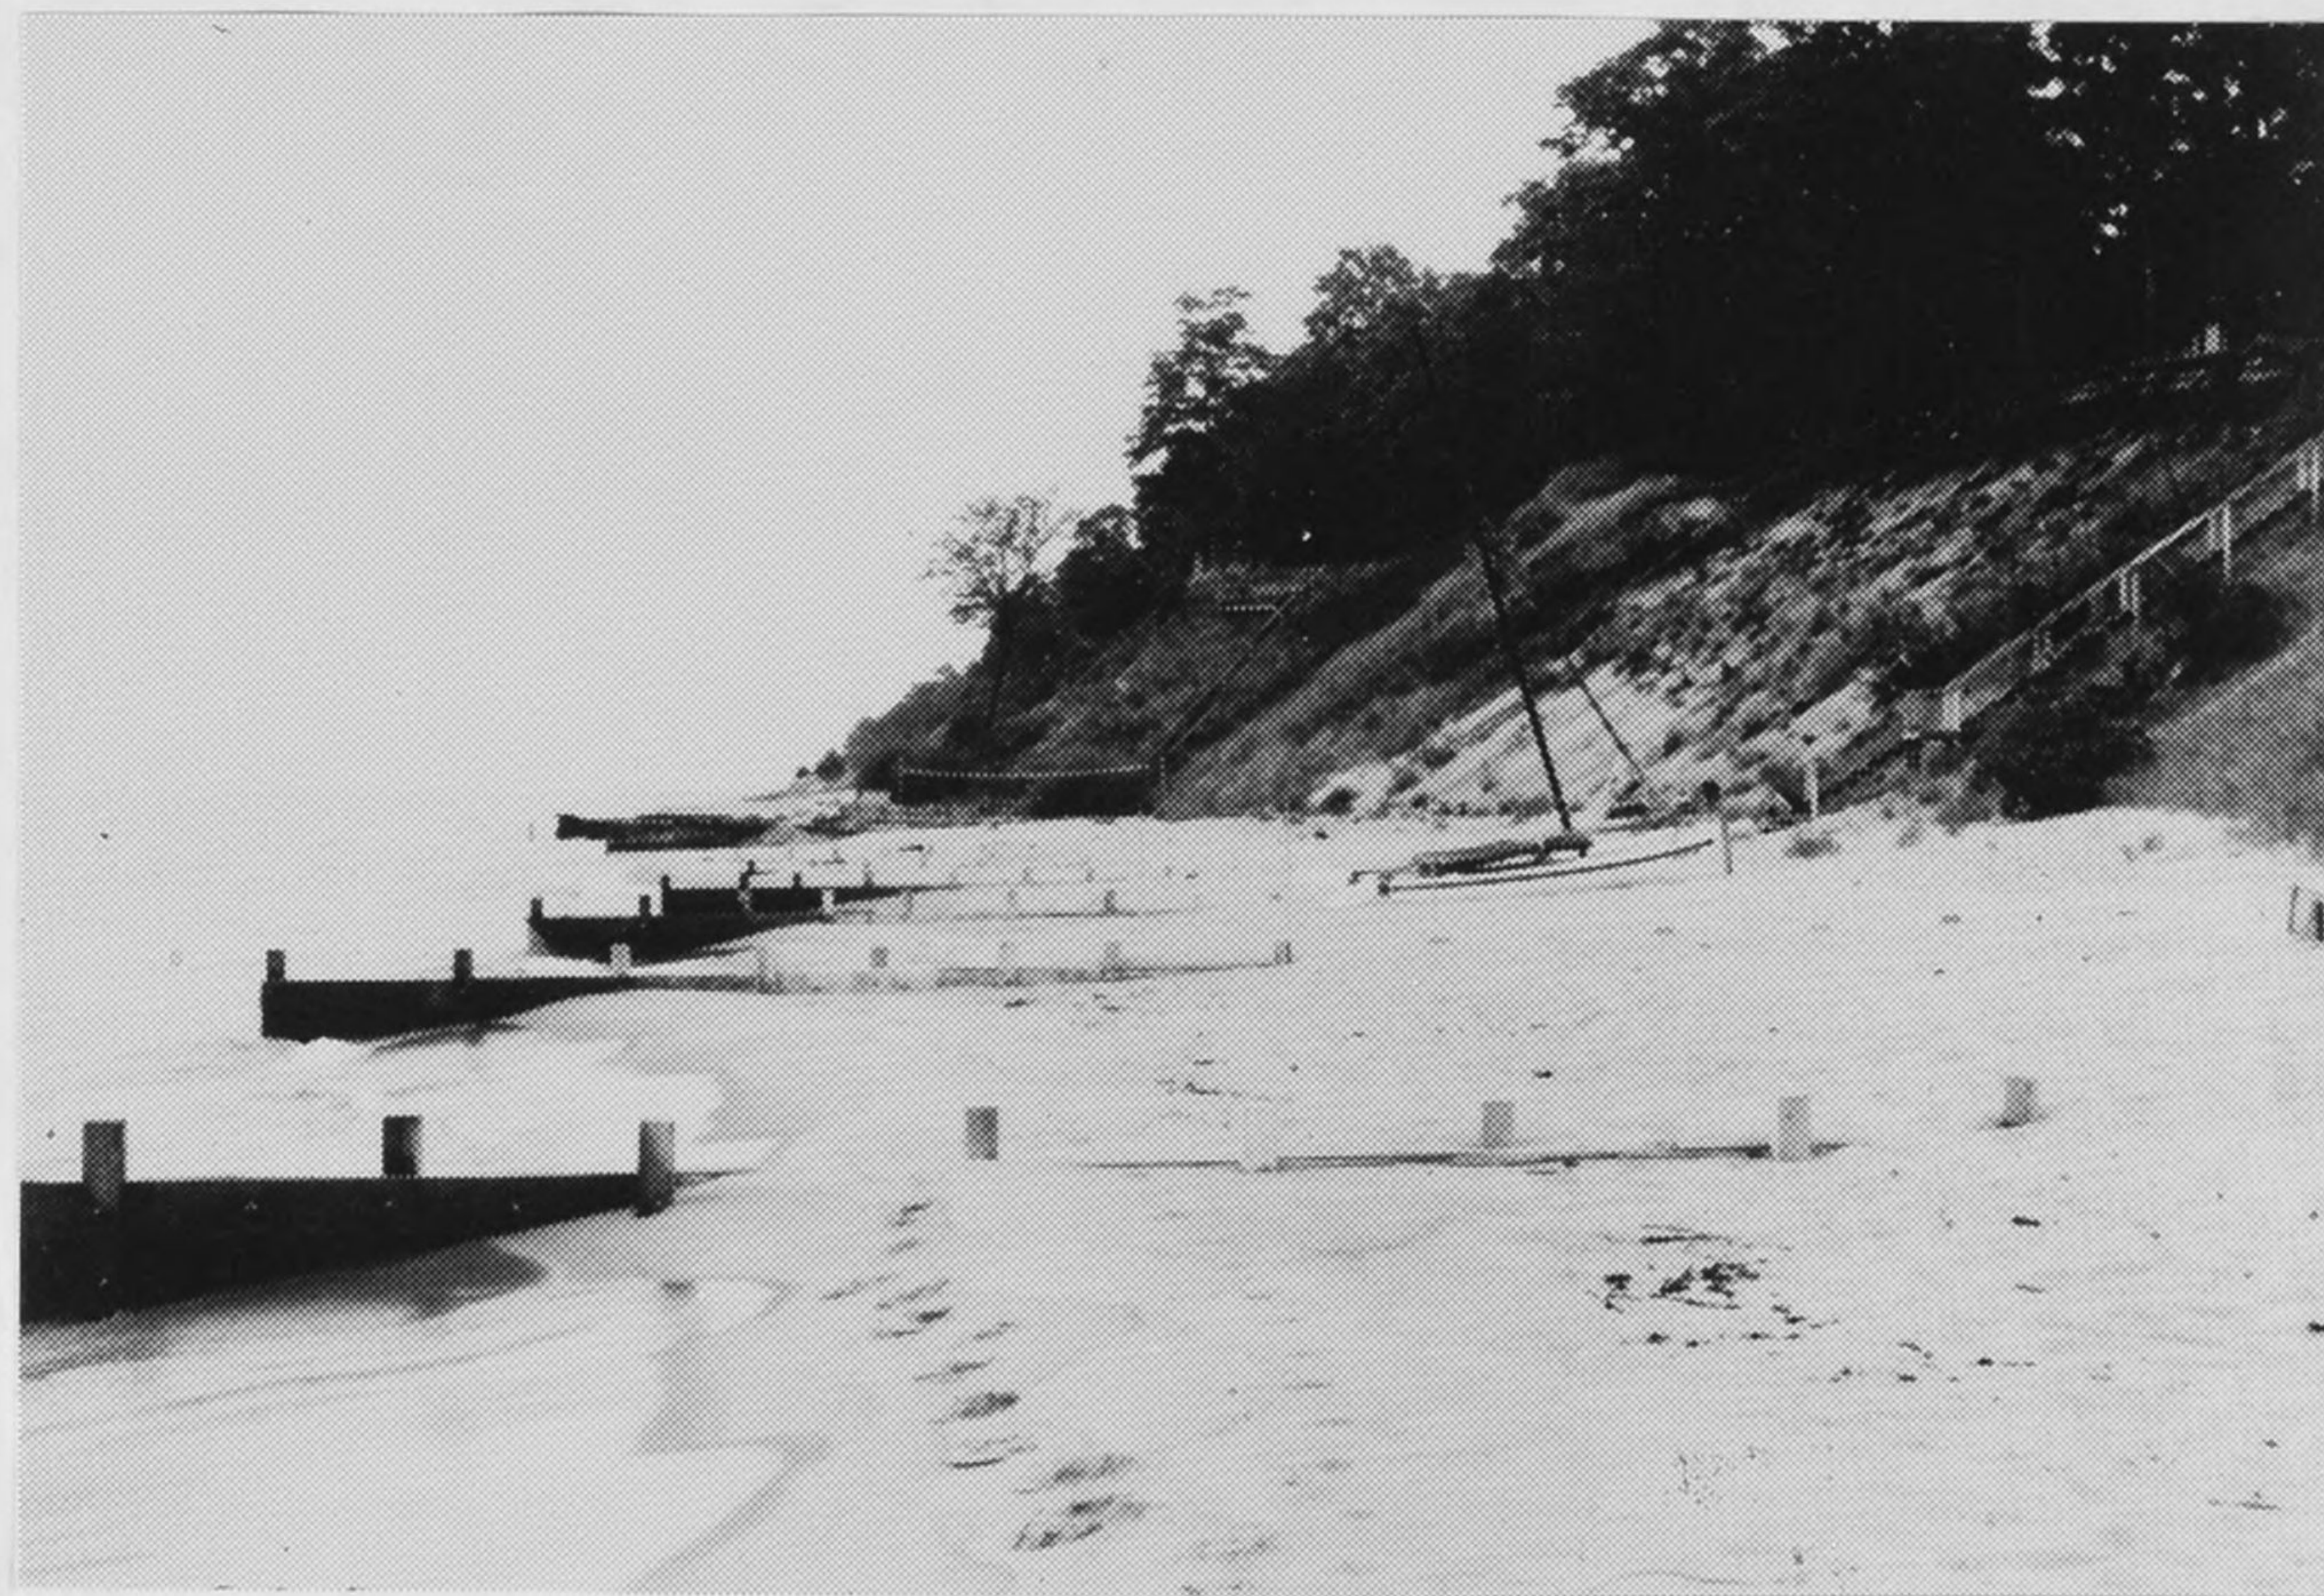
Figure B15. Site F: Looking north towards the site. Buried groin is to the north of the four groins in the foreground. Note longer and higher groins on either side of property.

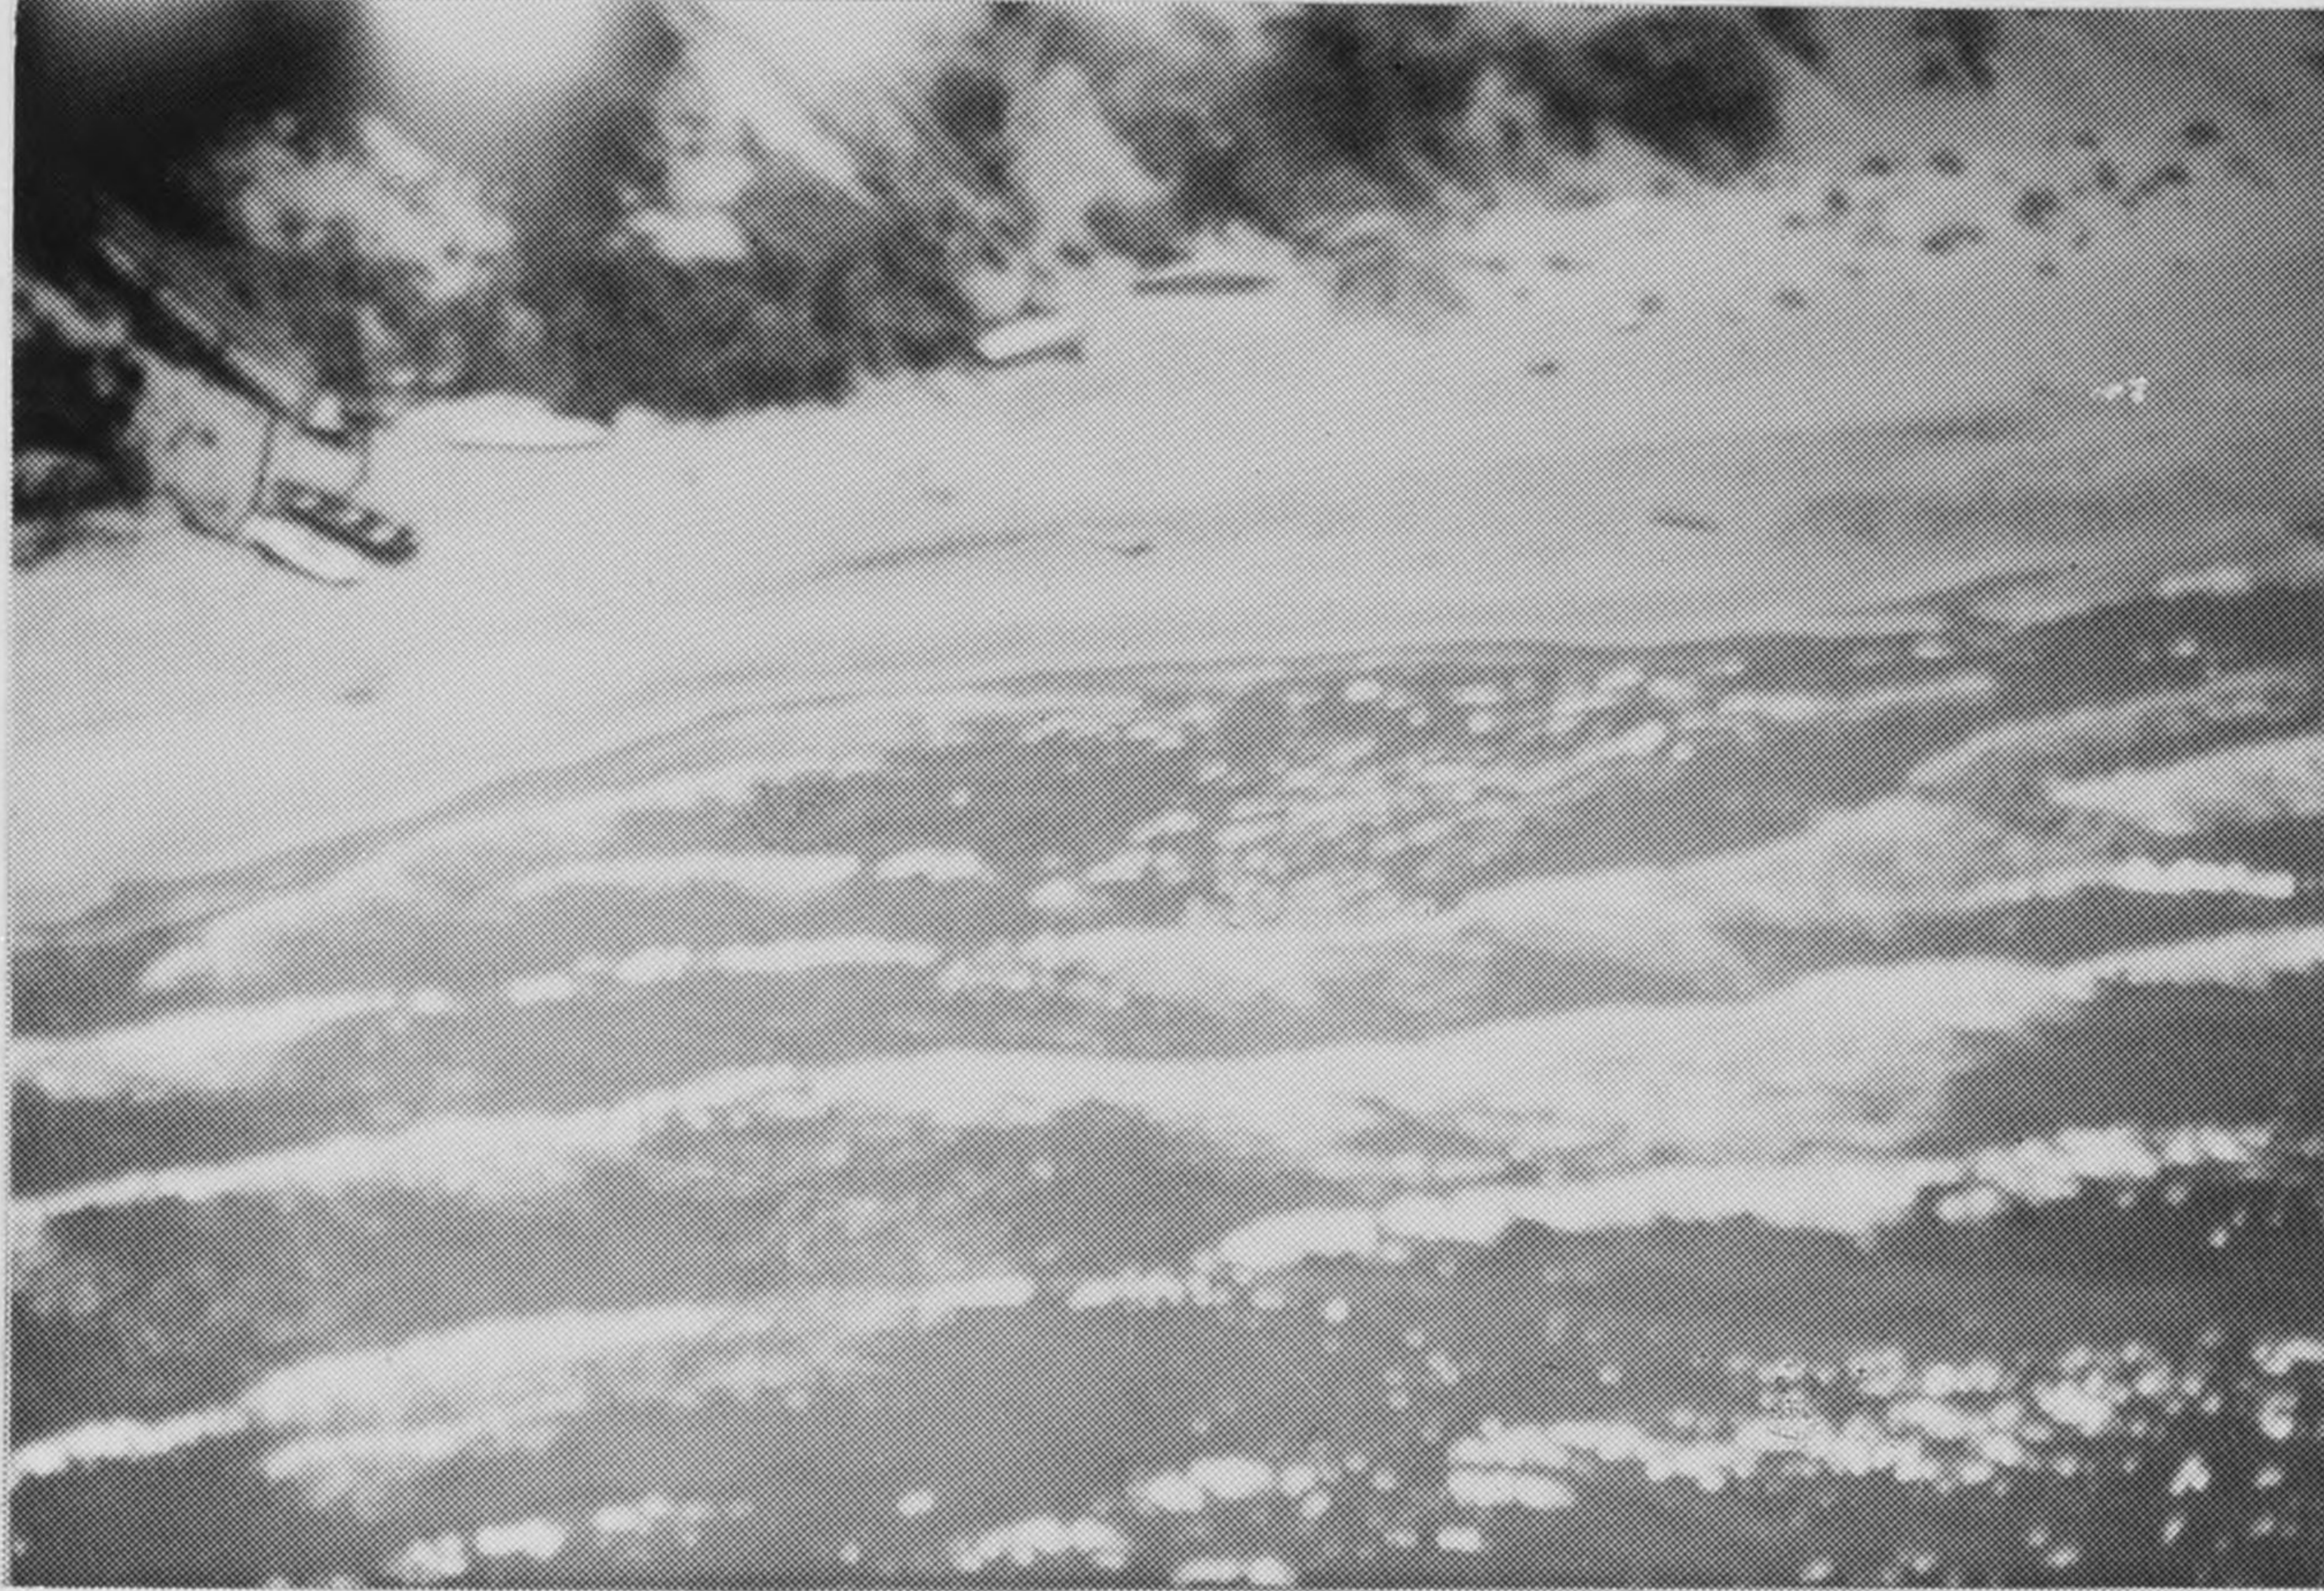
Figure B18. Site G: Aerial view of property. End of groin is visible in upper center of photograph. Beach is slightly narrower just to north of groin end.

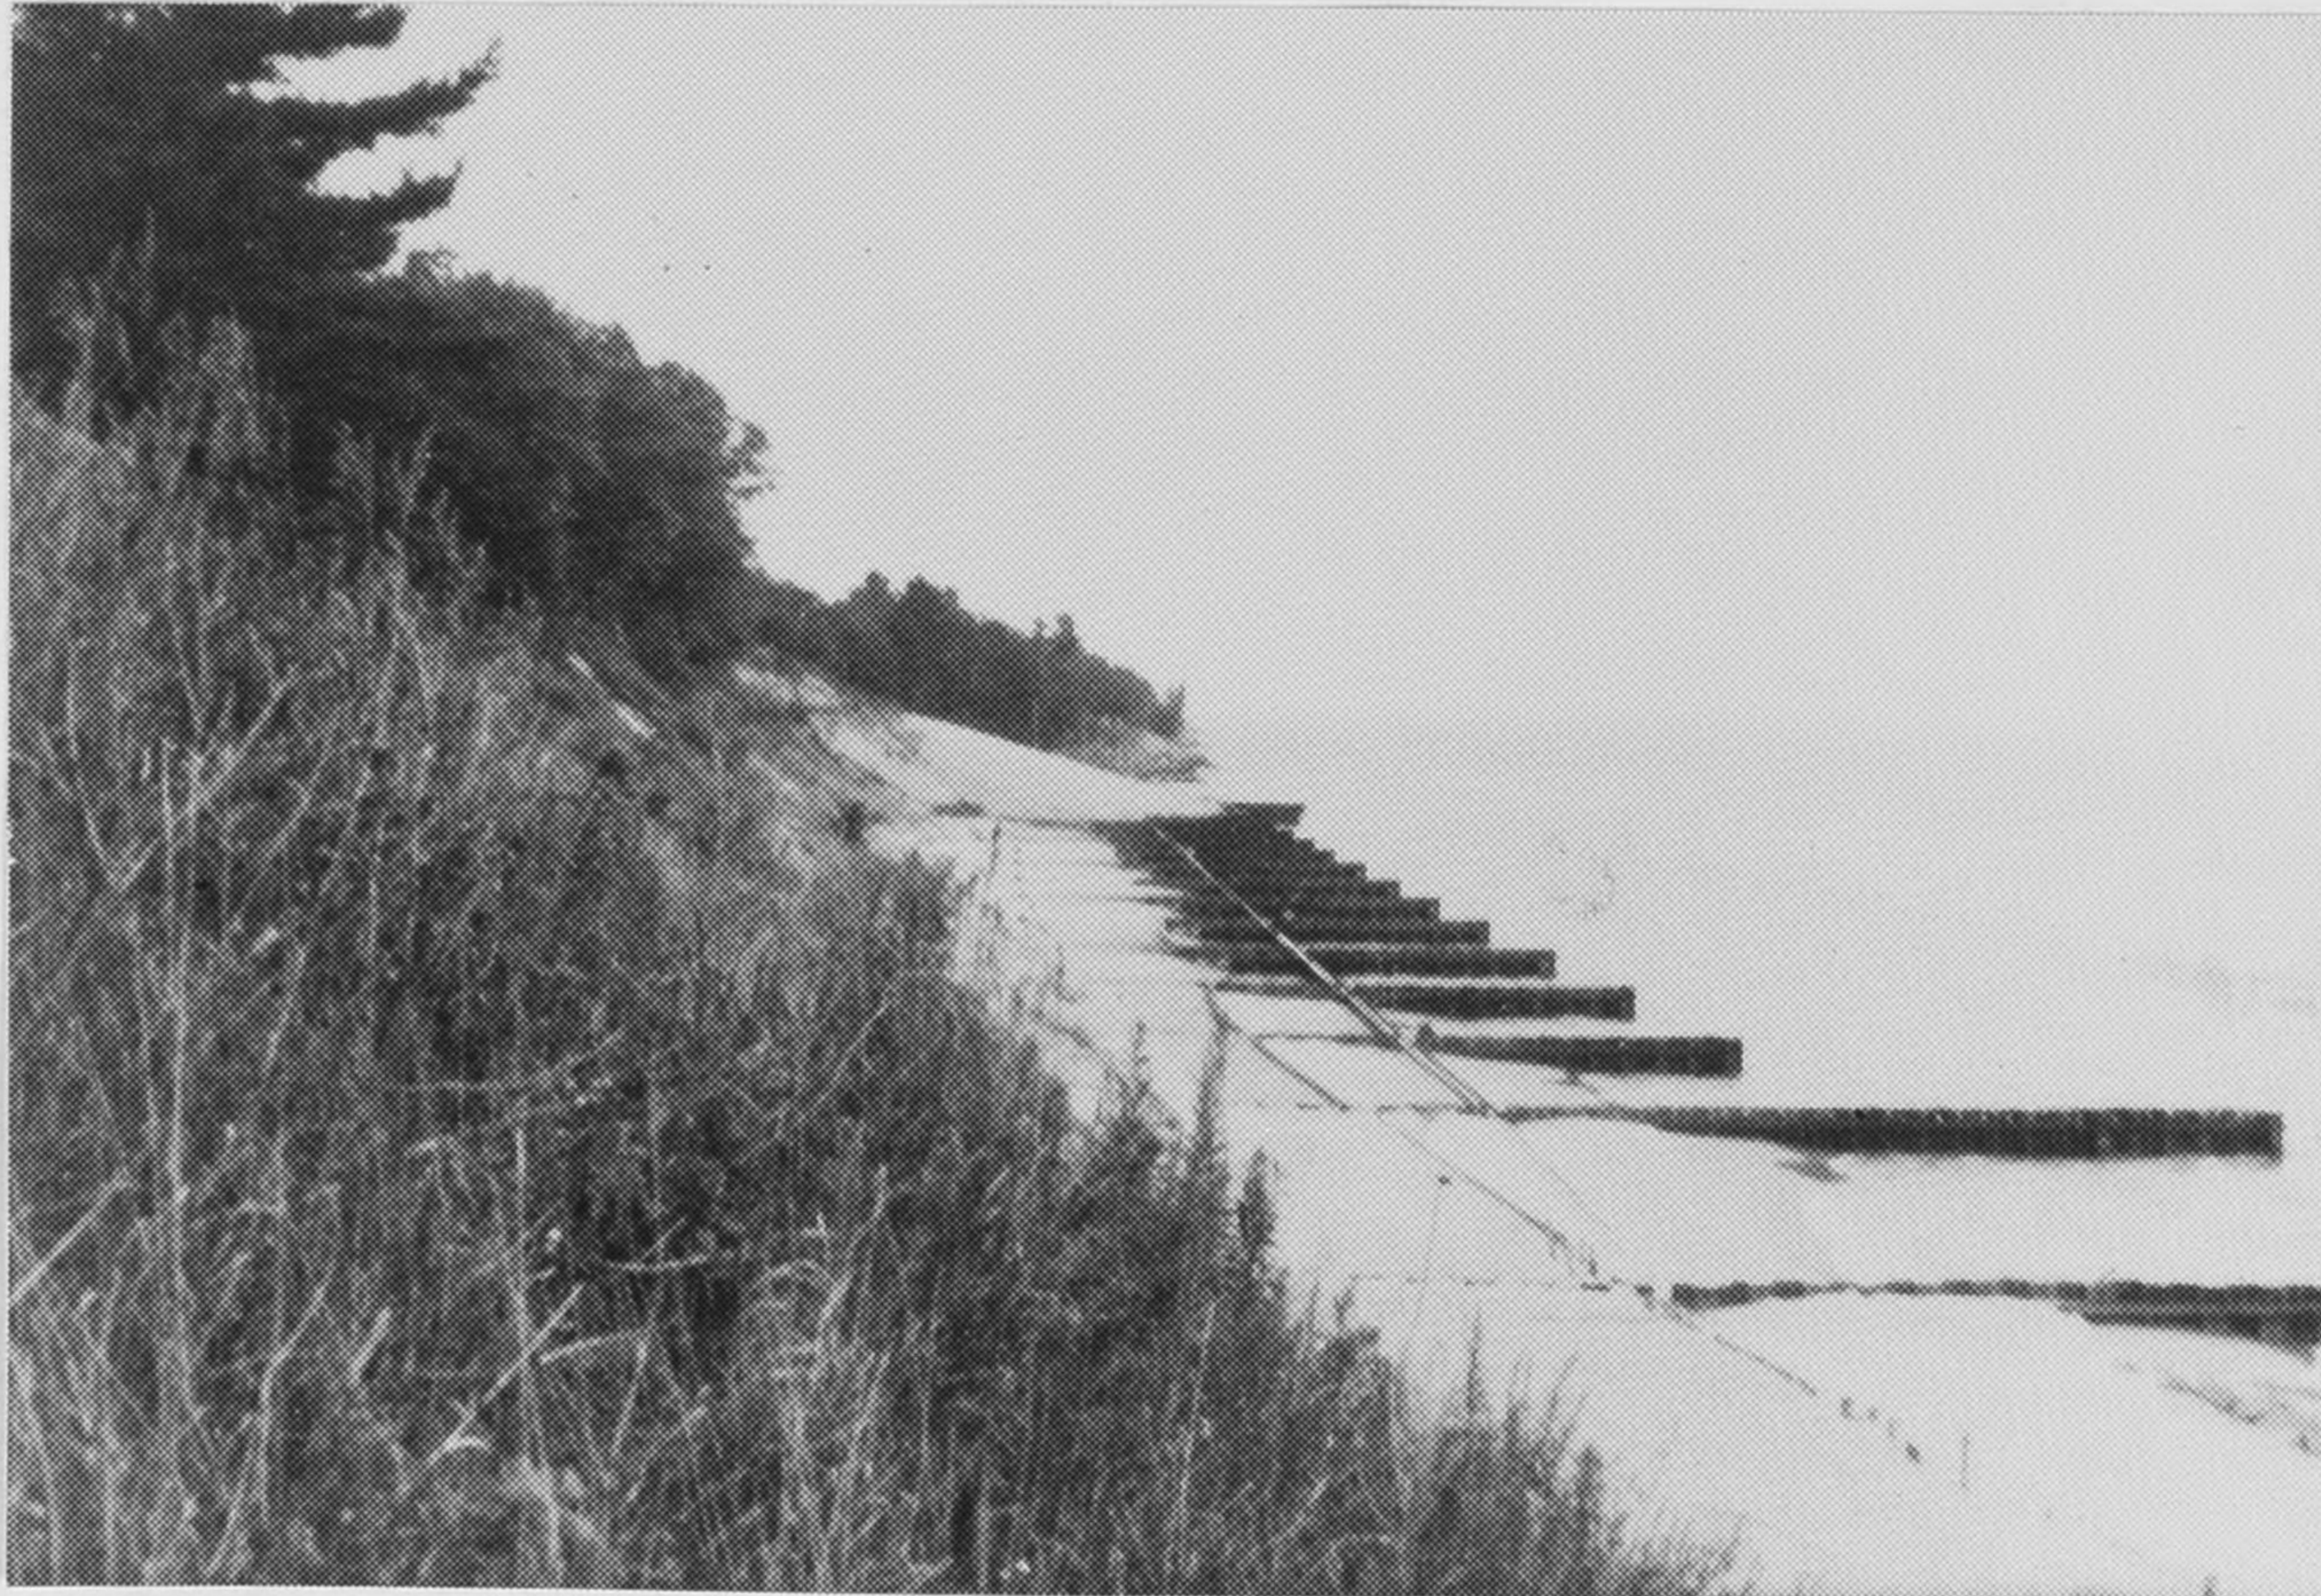
Figure B21. Site H: Looking towards southern end of property from approximately the middle of the groin system. Note that southernmost groins are shorter than the two closest ones. Wavebusters are present in lower right of photo.

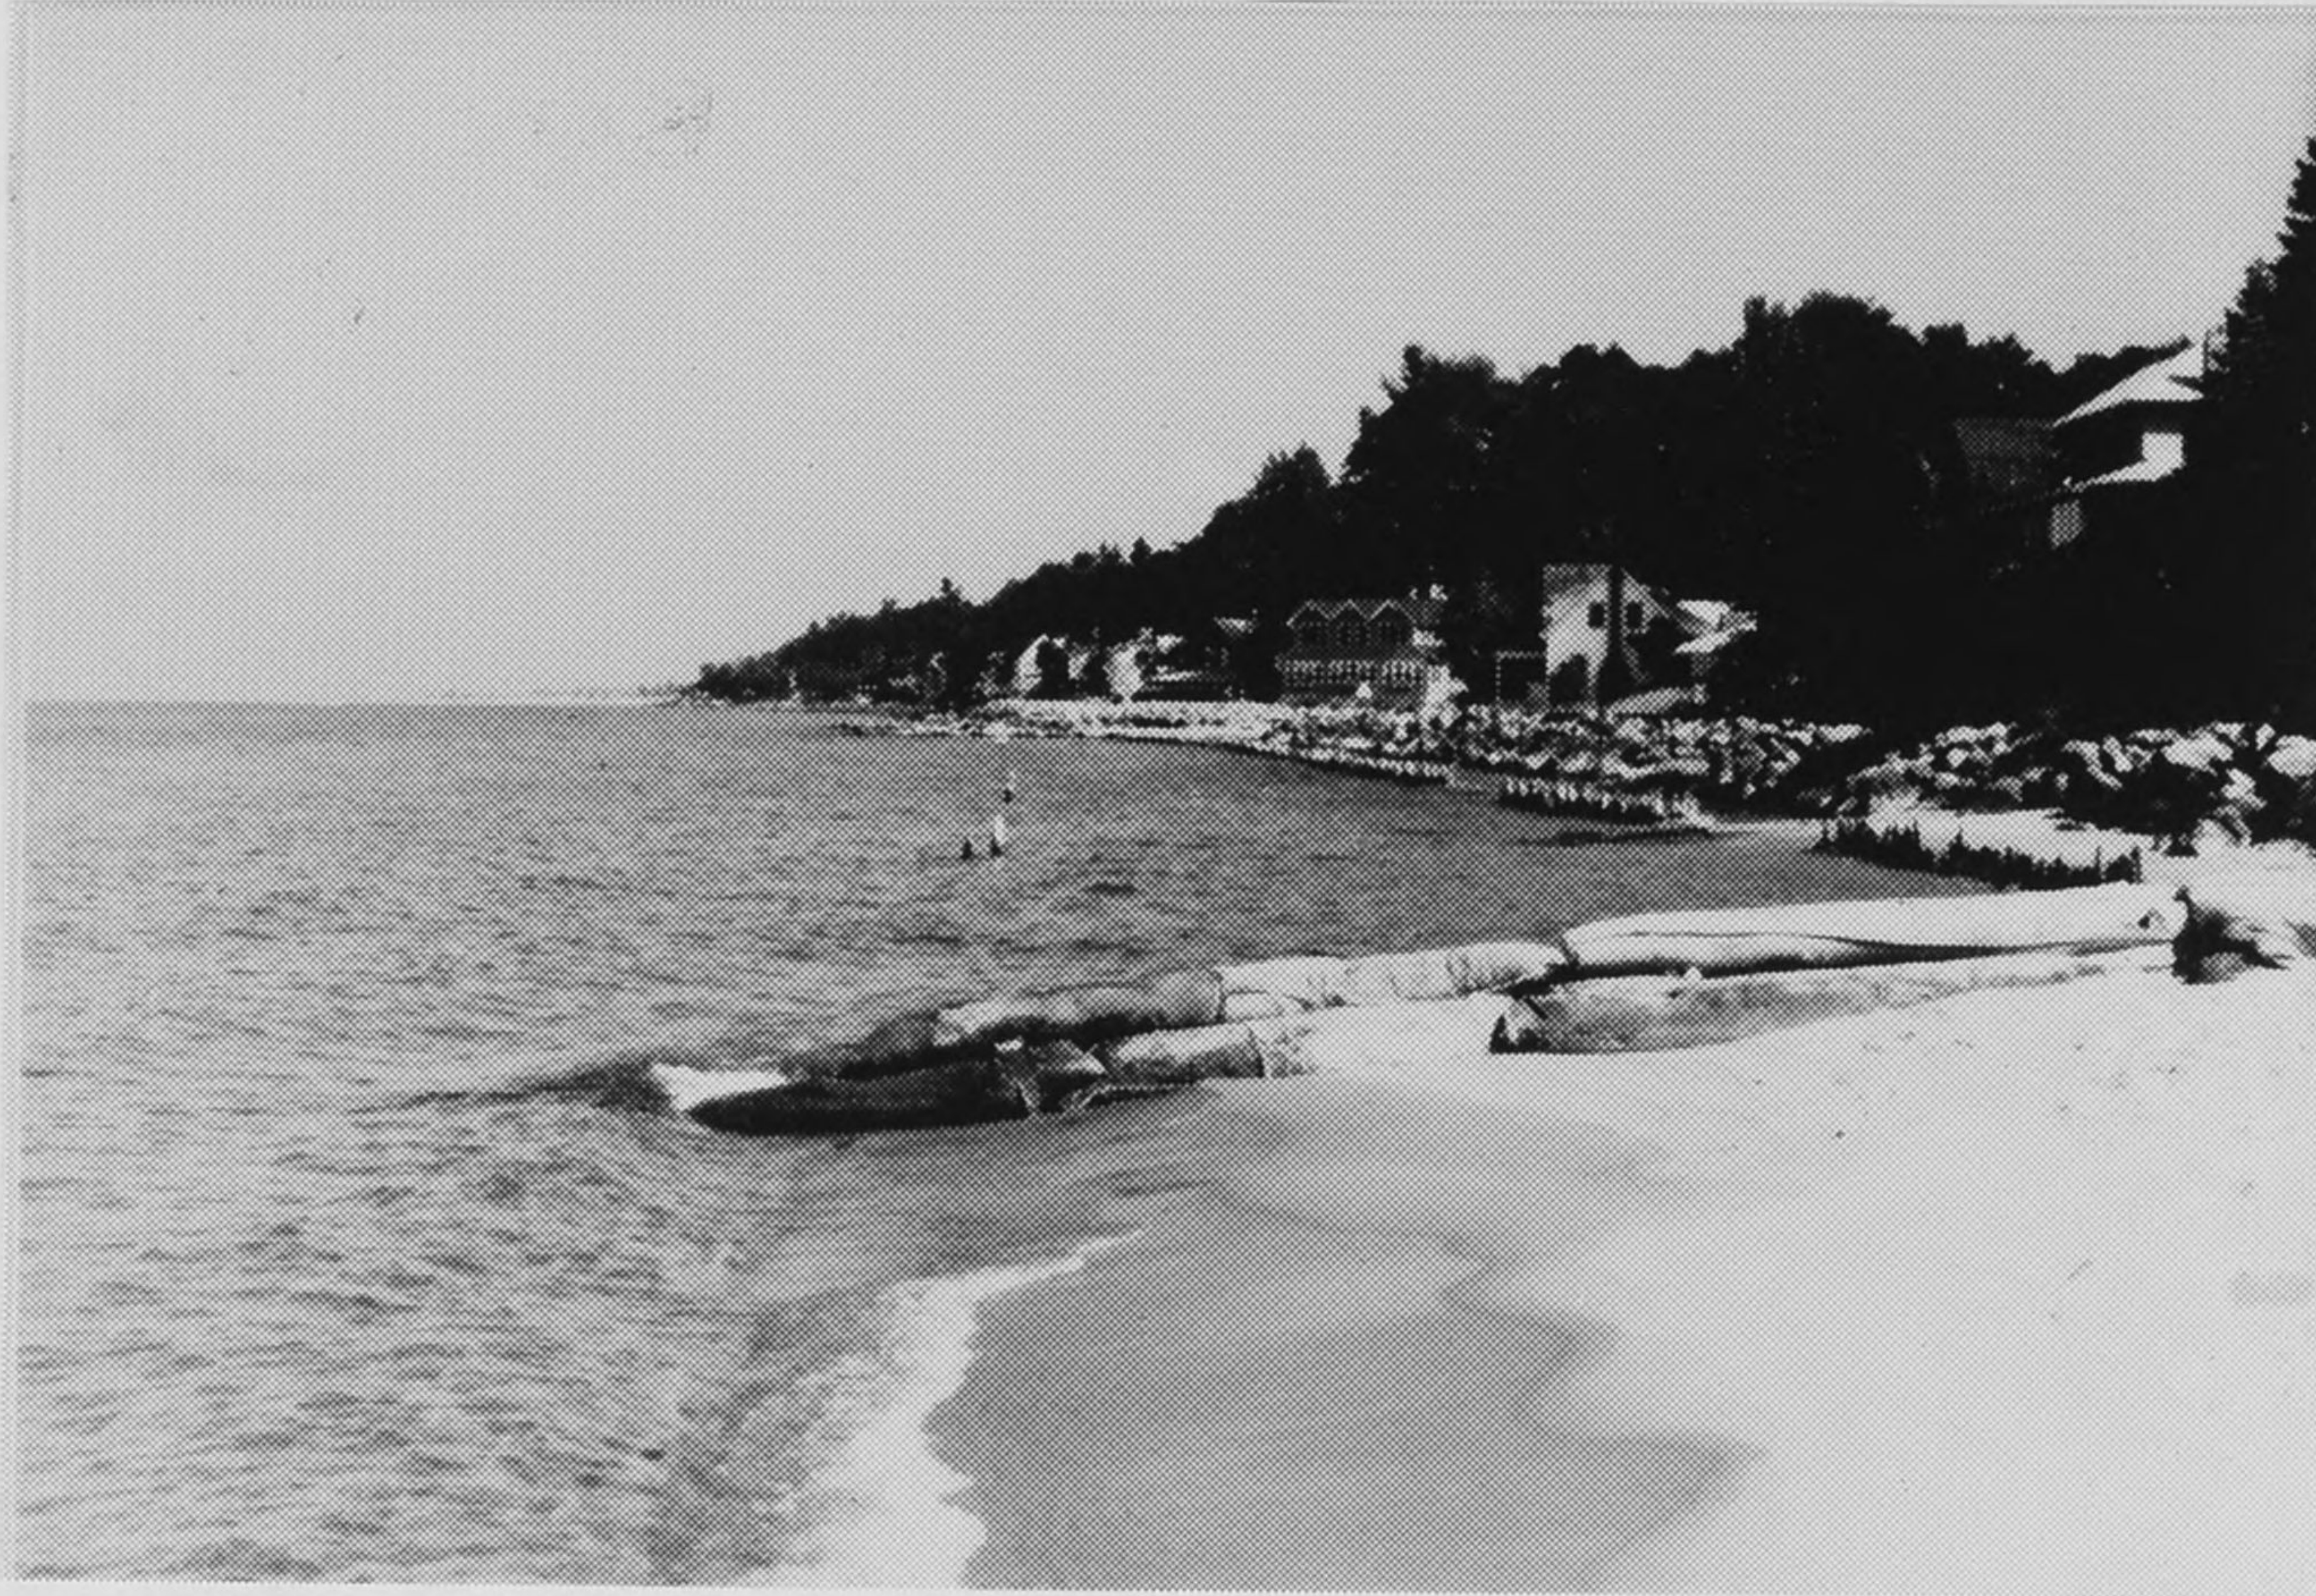
Figure B24. Sites I and J: Tube groin (part of Reid permit) on south boundary of Epworth property. Note accumulation of beach on south side of groin and slight accumulation behind other tube groins to north (in vicinity of old timber retaining wall).

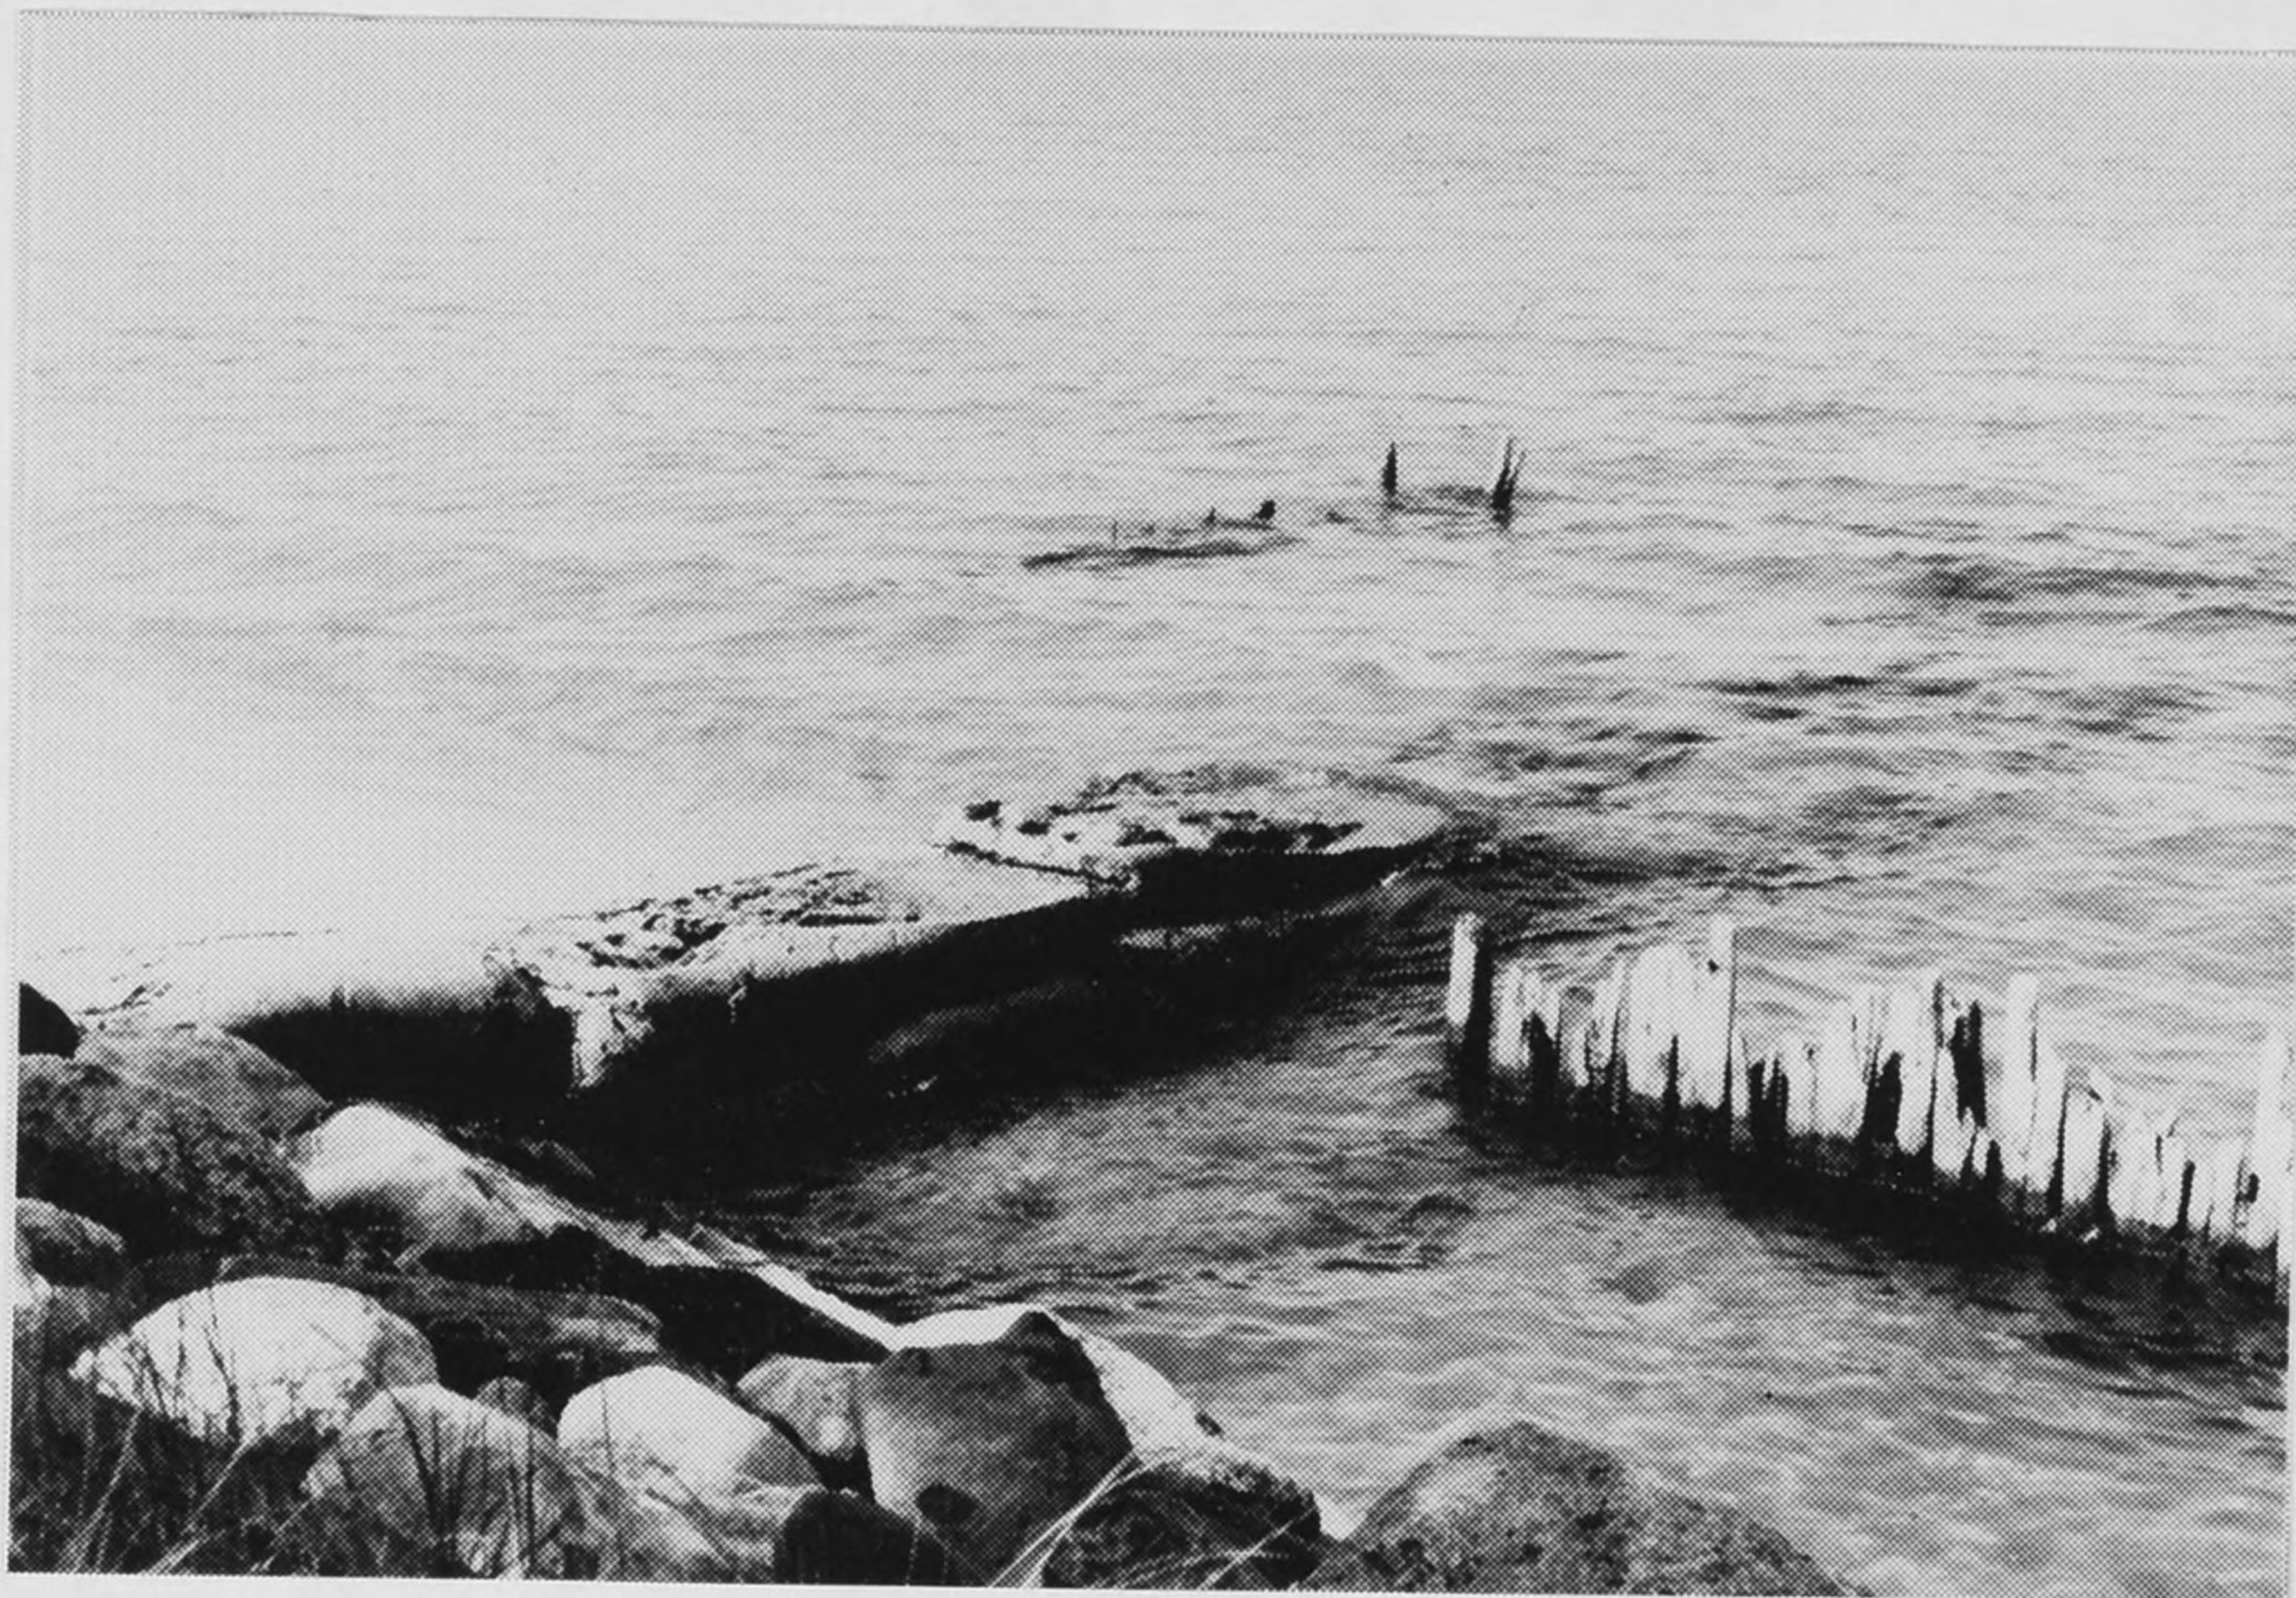
A problem that was noted with several of the concrete filled tube groins was damage to the groin surface (Fig. B25). There were five sites inspected where this type of groin had been installed sometime between July and November of 1987 and thus had been in place only a year at most at the time of the site inspection. Of these, three sites (considering the tube groin system on the Epworth and Reid properties, sites I and J, as one because they were installed at the same time) had already experienced some degree of damage, in all cases on the tops of the offshore ends of the groins. Because of the very short time since the installation at these sites, this raises some question about the long term integrity of the structures. Additional site visits in another year or two would be very valuable in determining the durability of this type of groin.

Figure B25. Site J. Tube groin just to north of one in Fig. B24. Note damage to groin top and sand accumulation on south side.

* The issue of damage to the concrete filled tube groins to see if they have as long a useful life as some of the other possible groin systems.

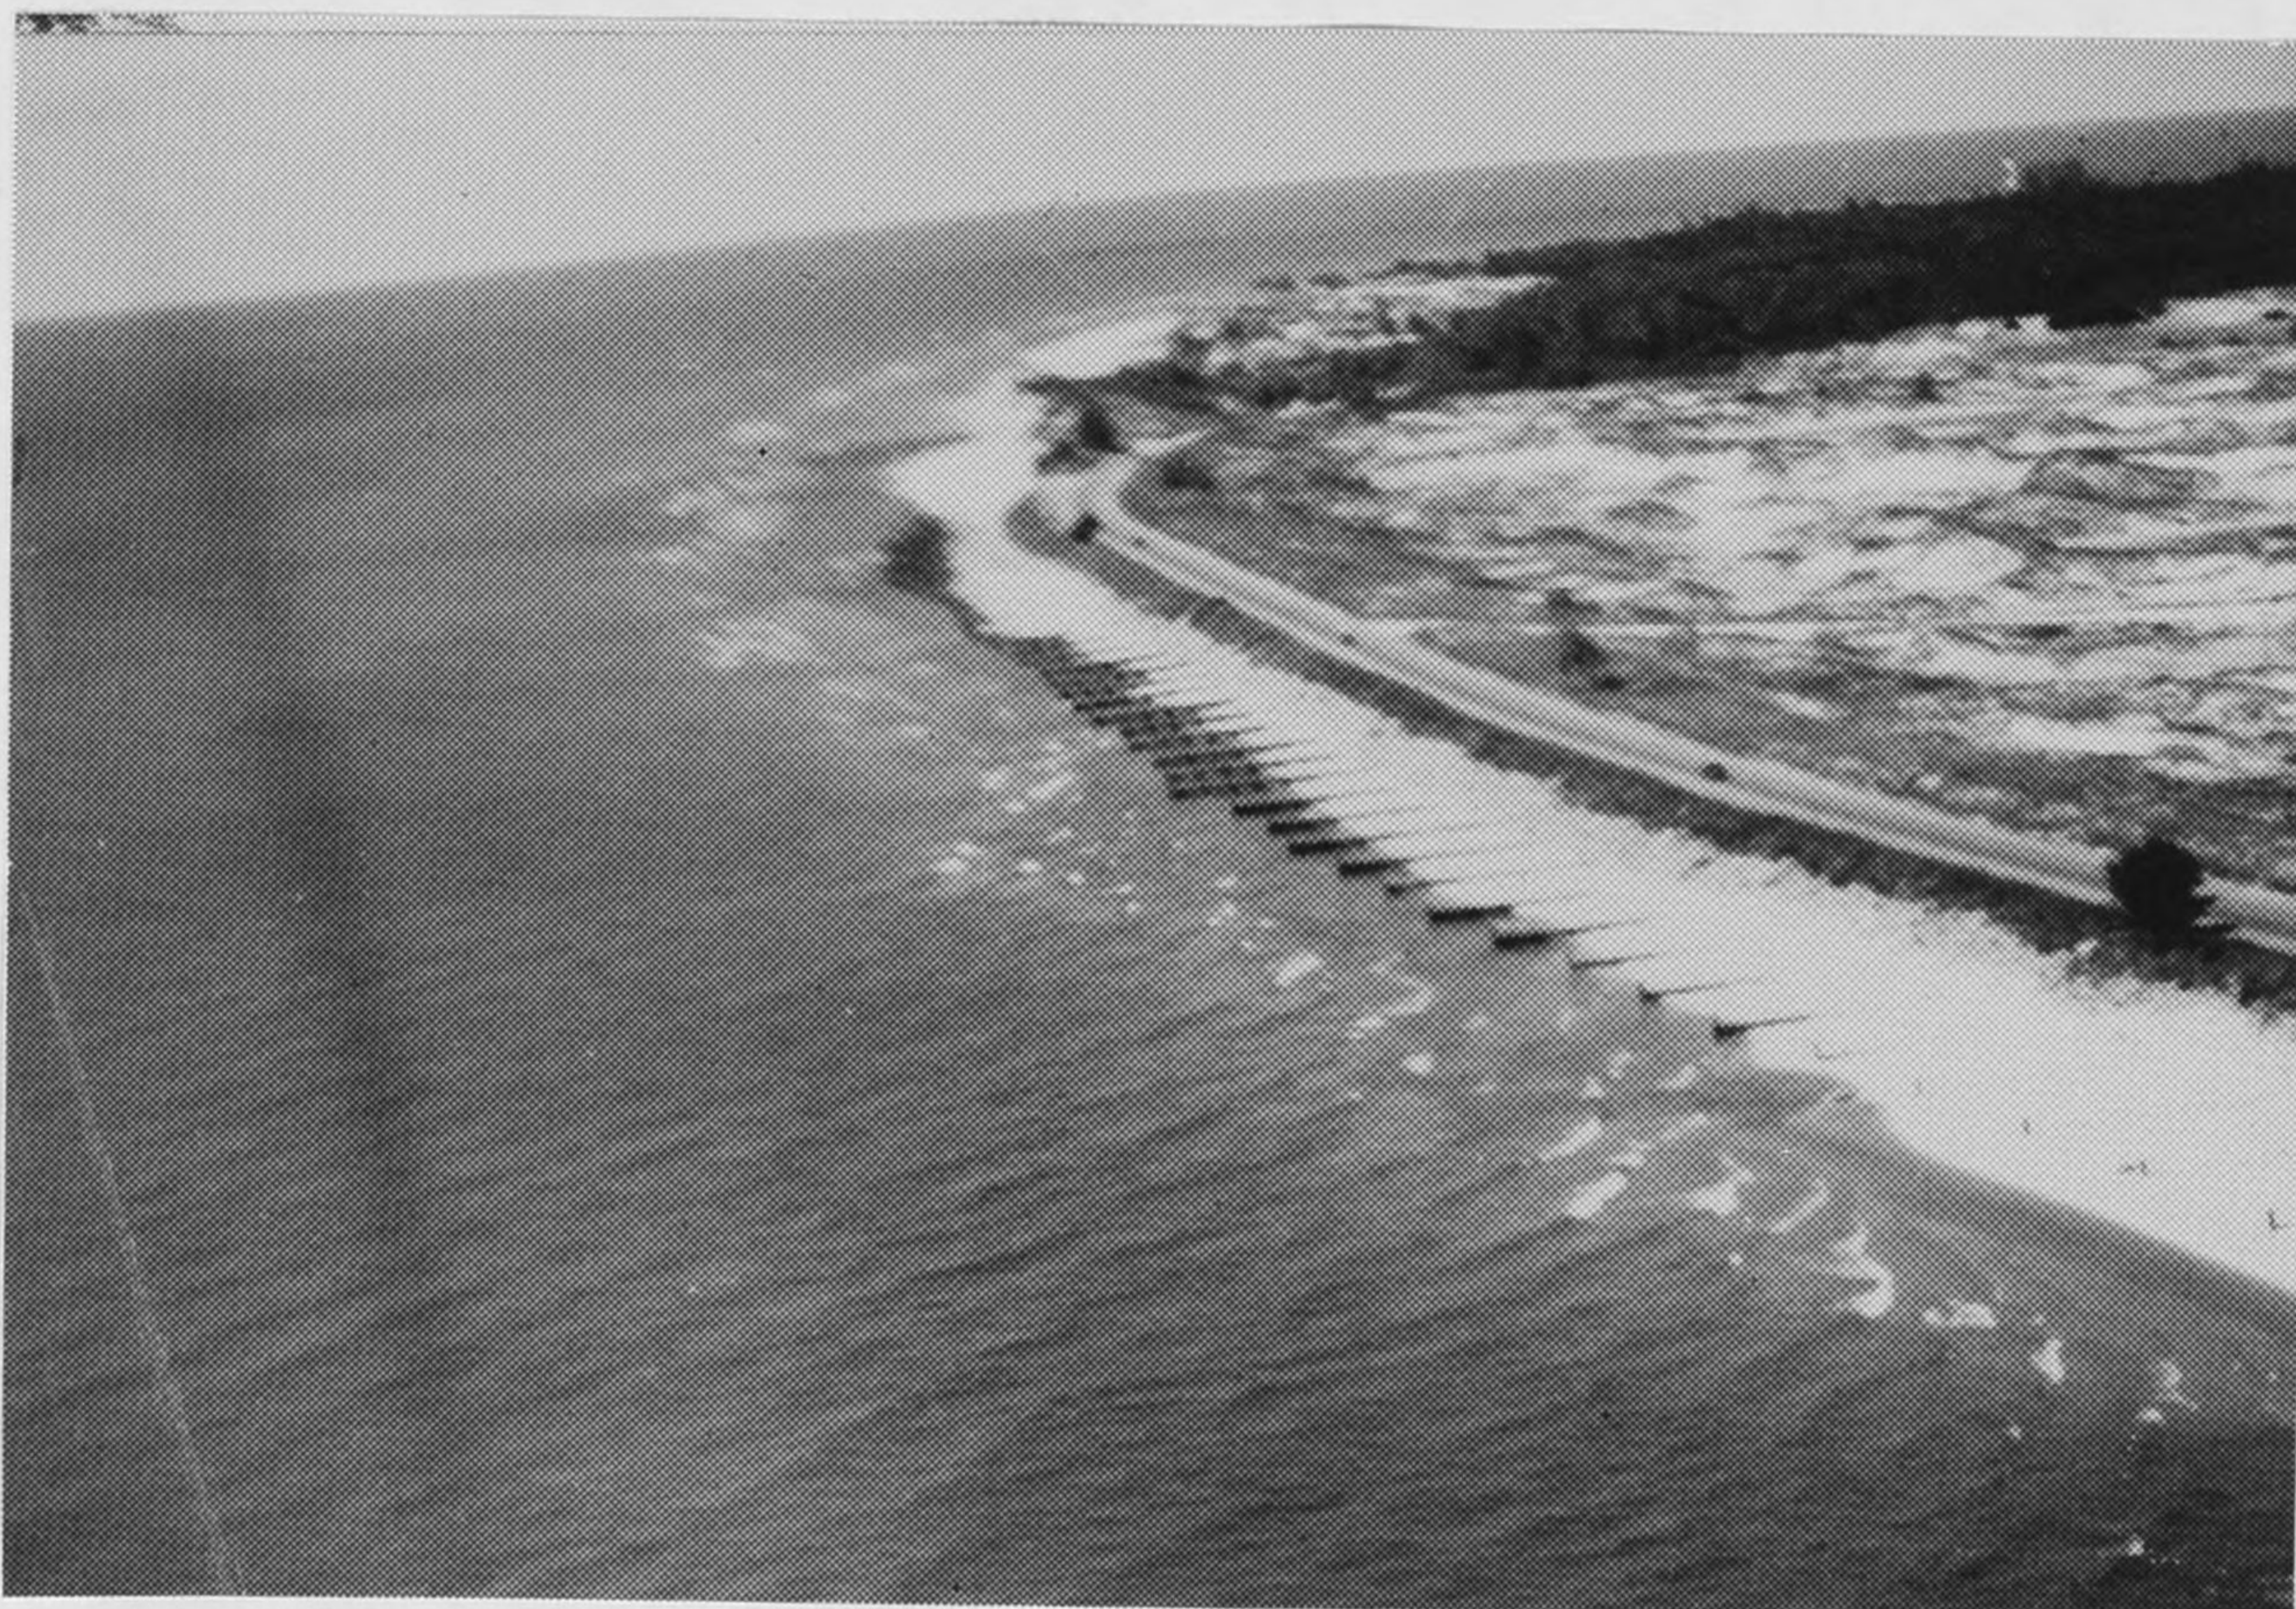
Figure B29. Site K: Aerial view of southern end of long groin field. Note that groins in southern portion of groin field at lower right are completely filled.
