**EVALUATION OF GREAT LAKES
SHORE PROTECTION STRUCTURES**

Report UMCEE 88-8

**THE UNIVERSITY OF MICHIGAN
DEPARTMENT OF CIVIL ENGINEERING
ANN ARBOR, MICHIGAN**

**Michigan Department of Natural Resources
Coastal Management Program
Land and Water Division**

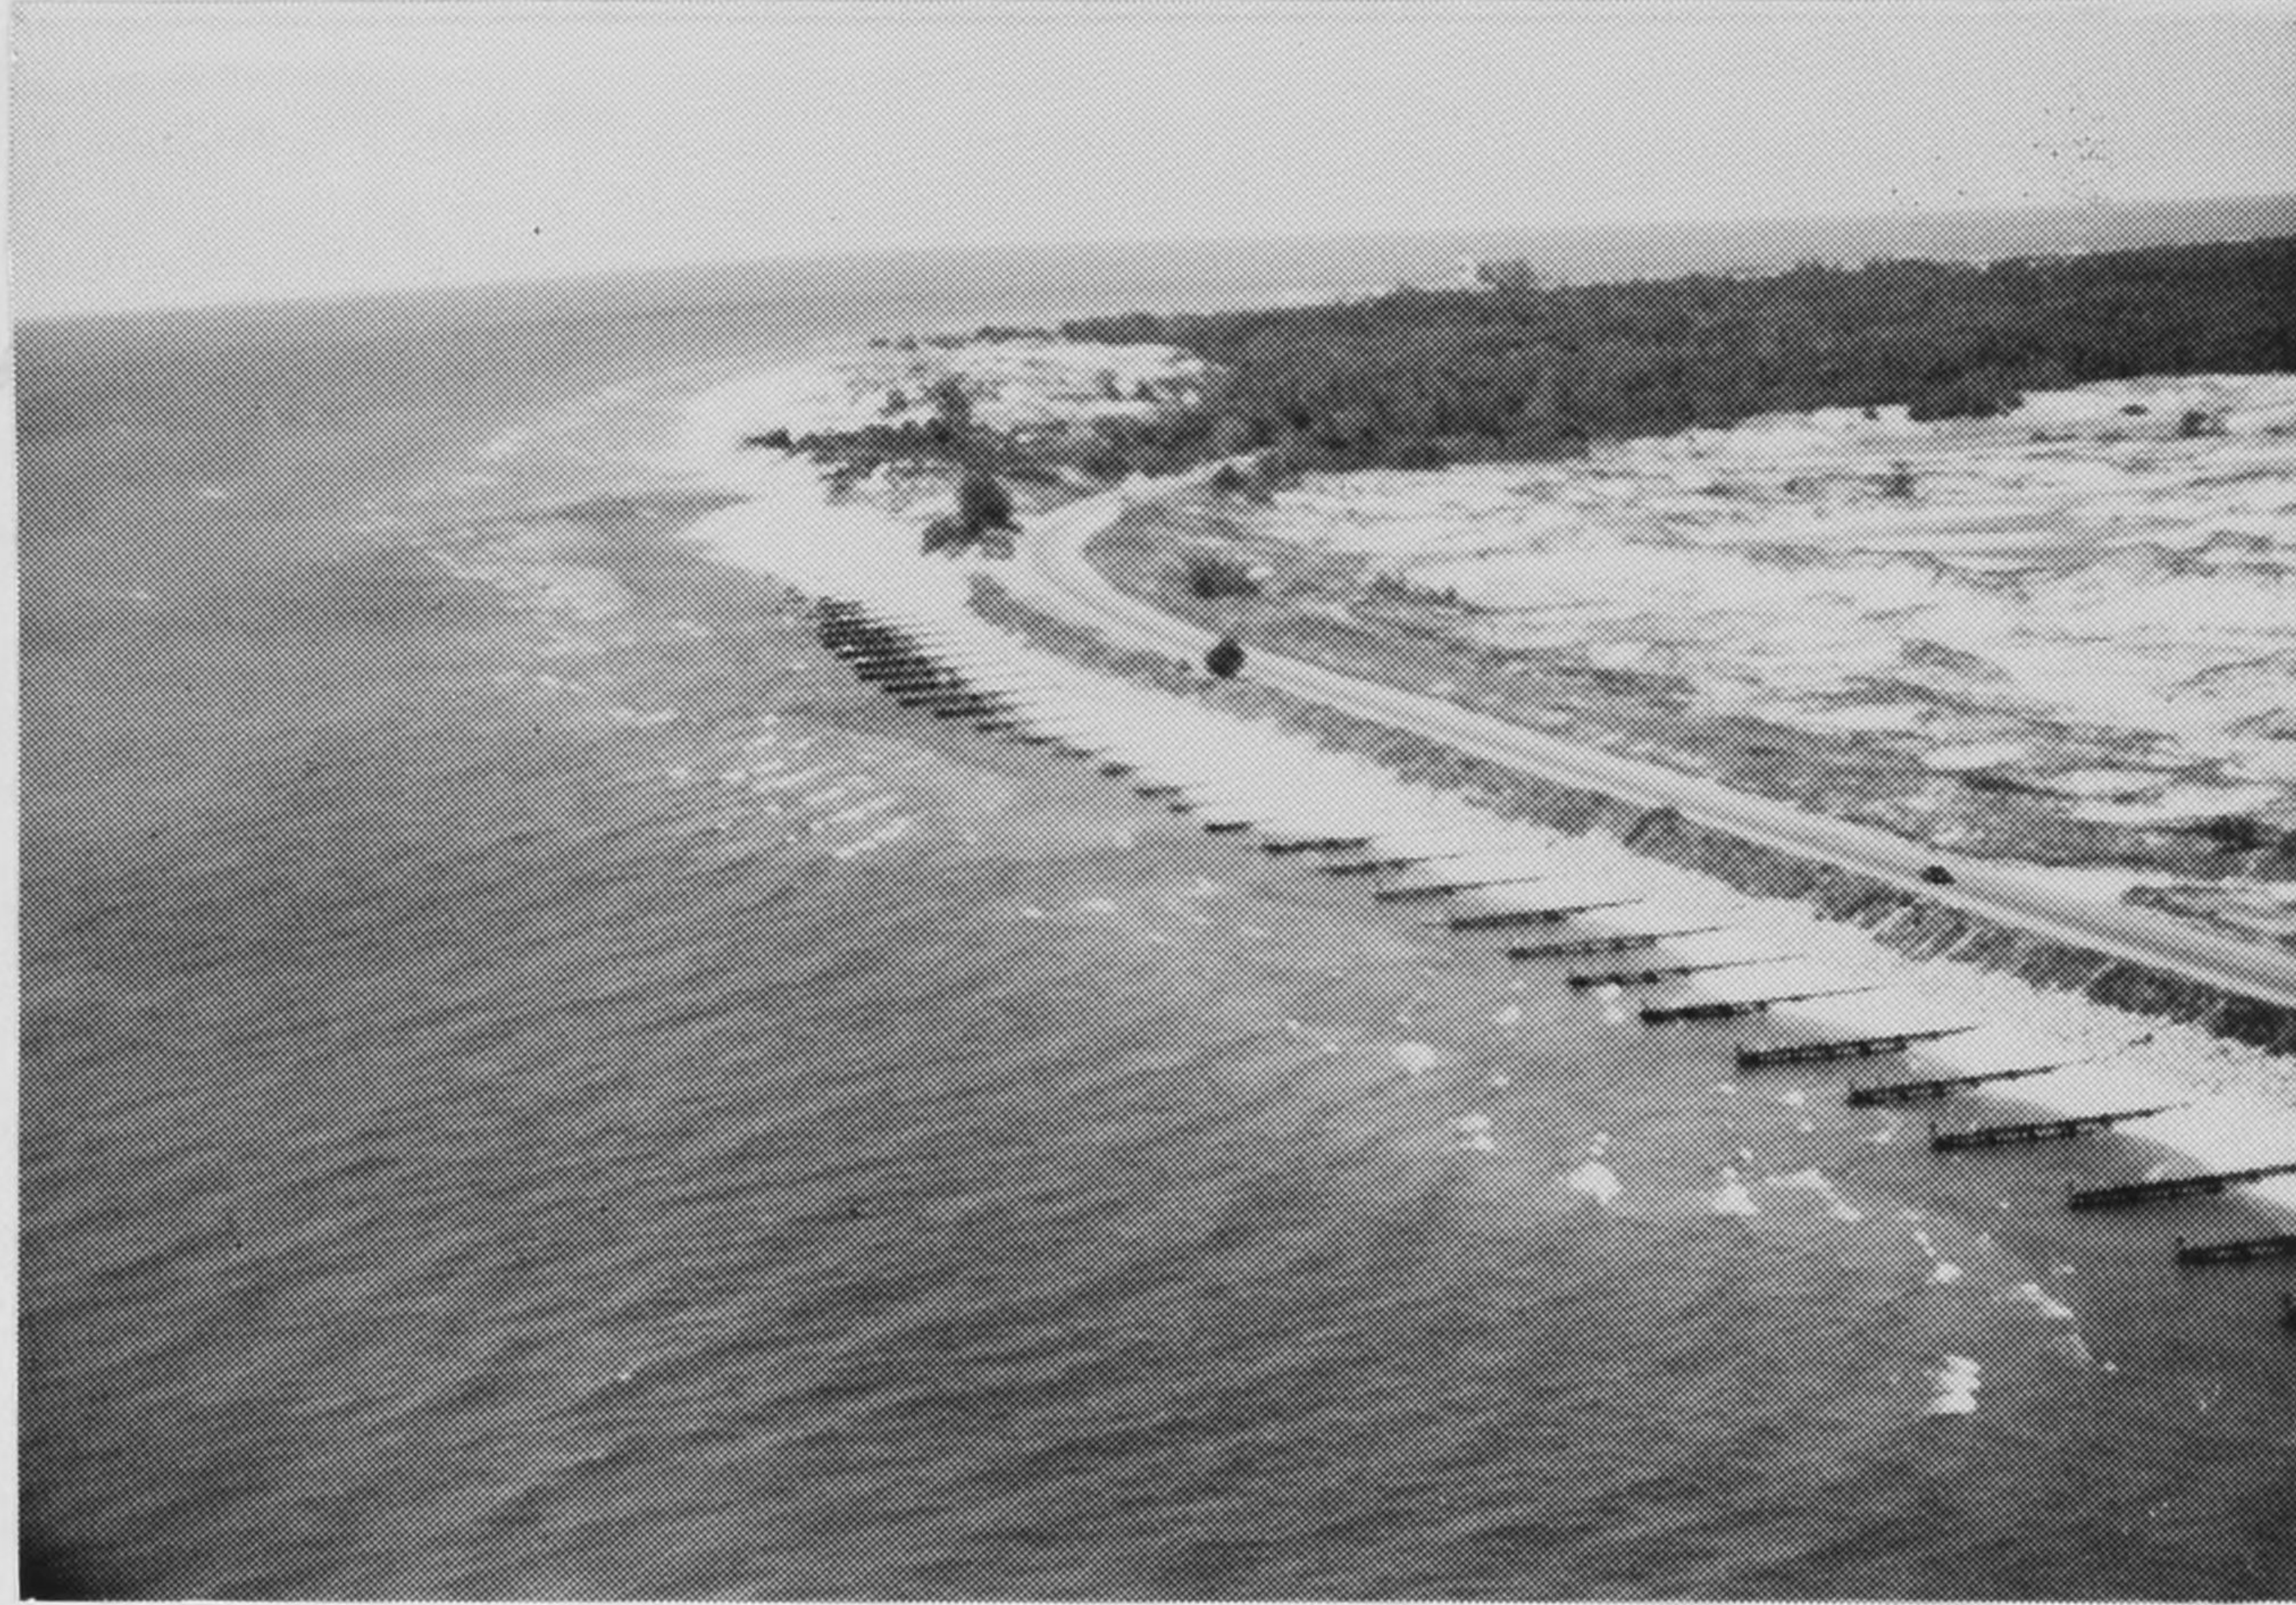
Figure B30. Site K: Aerial view somewhat to the north of Figure B29. Northern end of groin field only is visible. Note that some groins are almost completely filled.

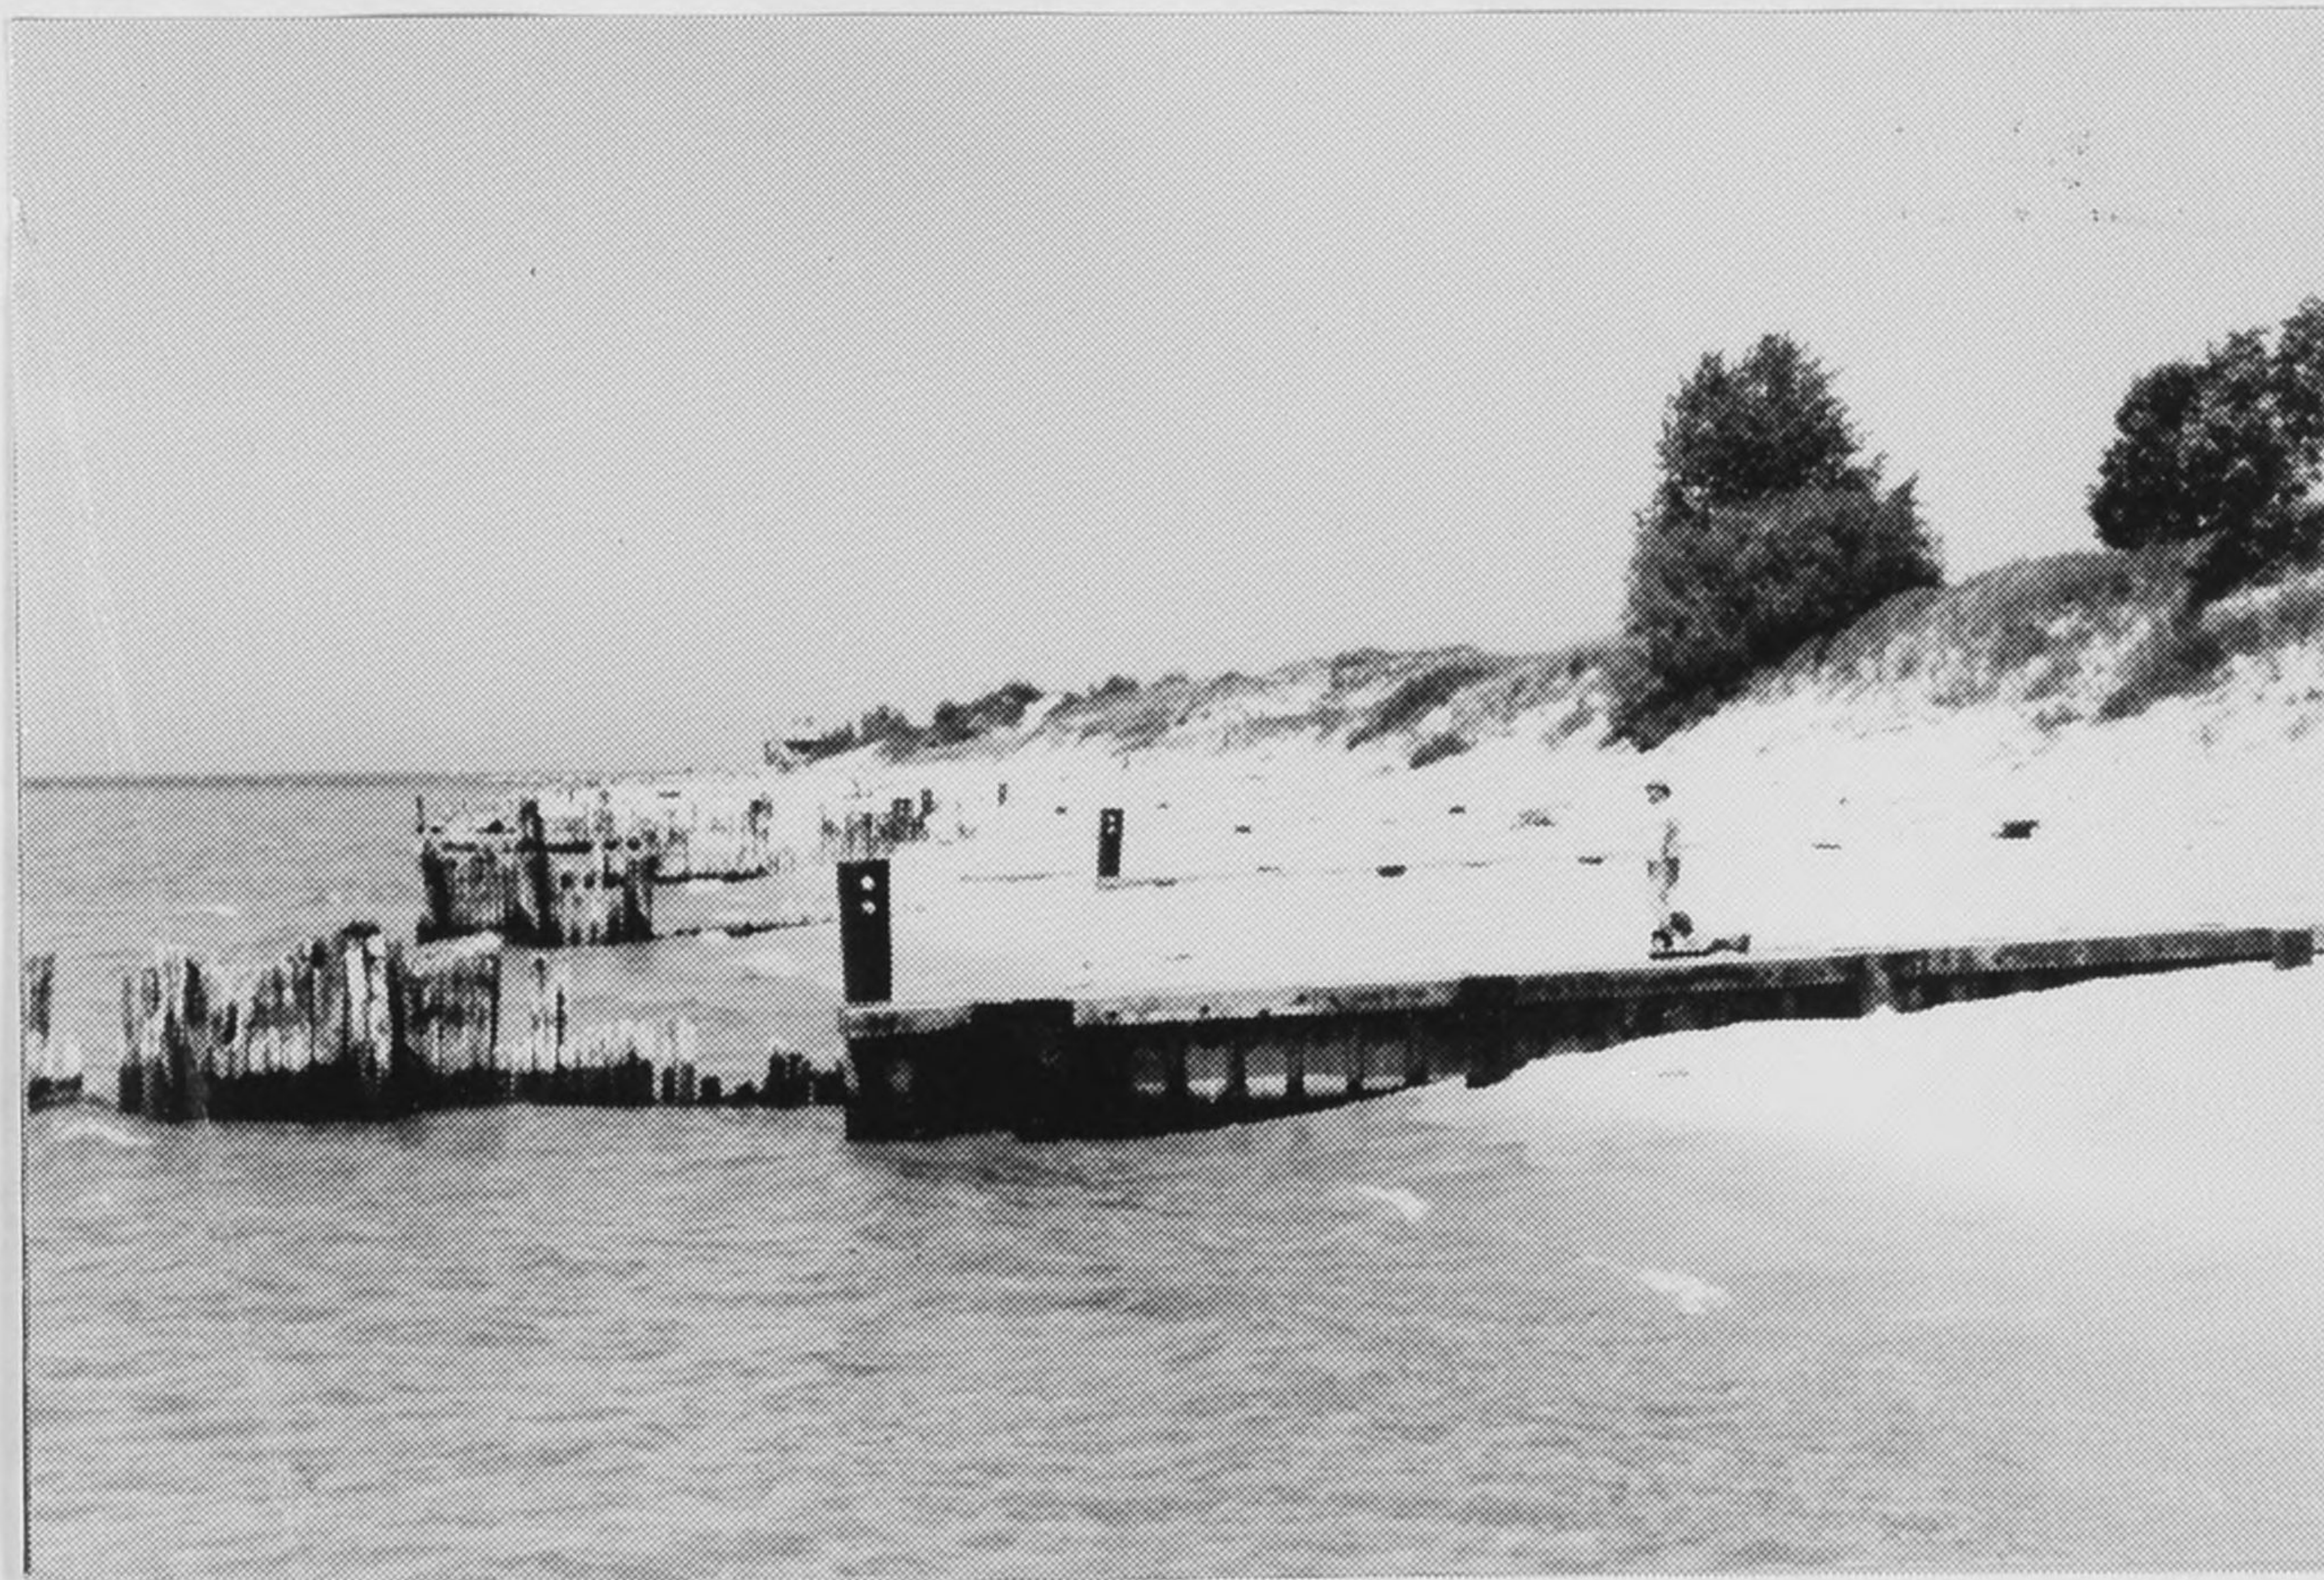
Figure B31. Site K: Looking north across southerly groin field. First groin is the seventh one from south side. Note that new groins are shorter than remnants of old system.

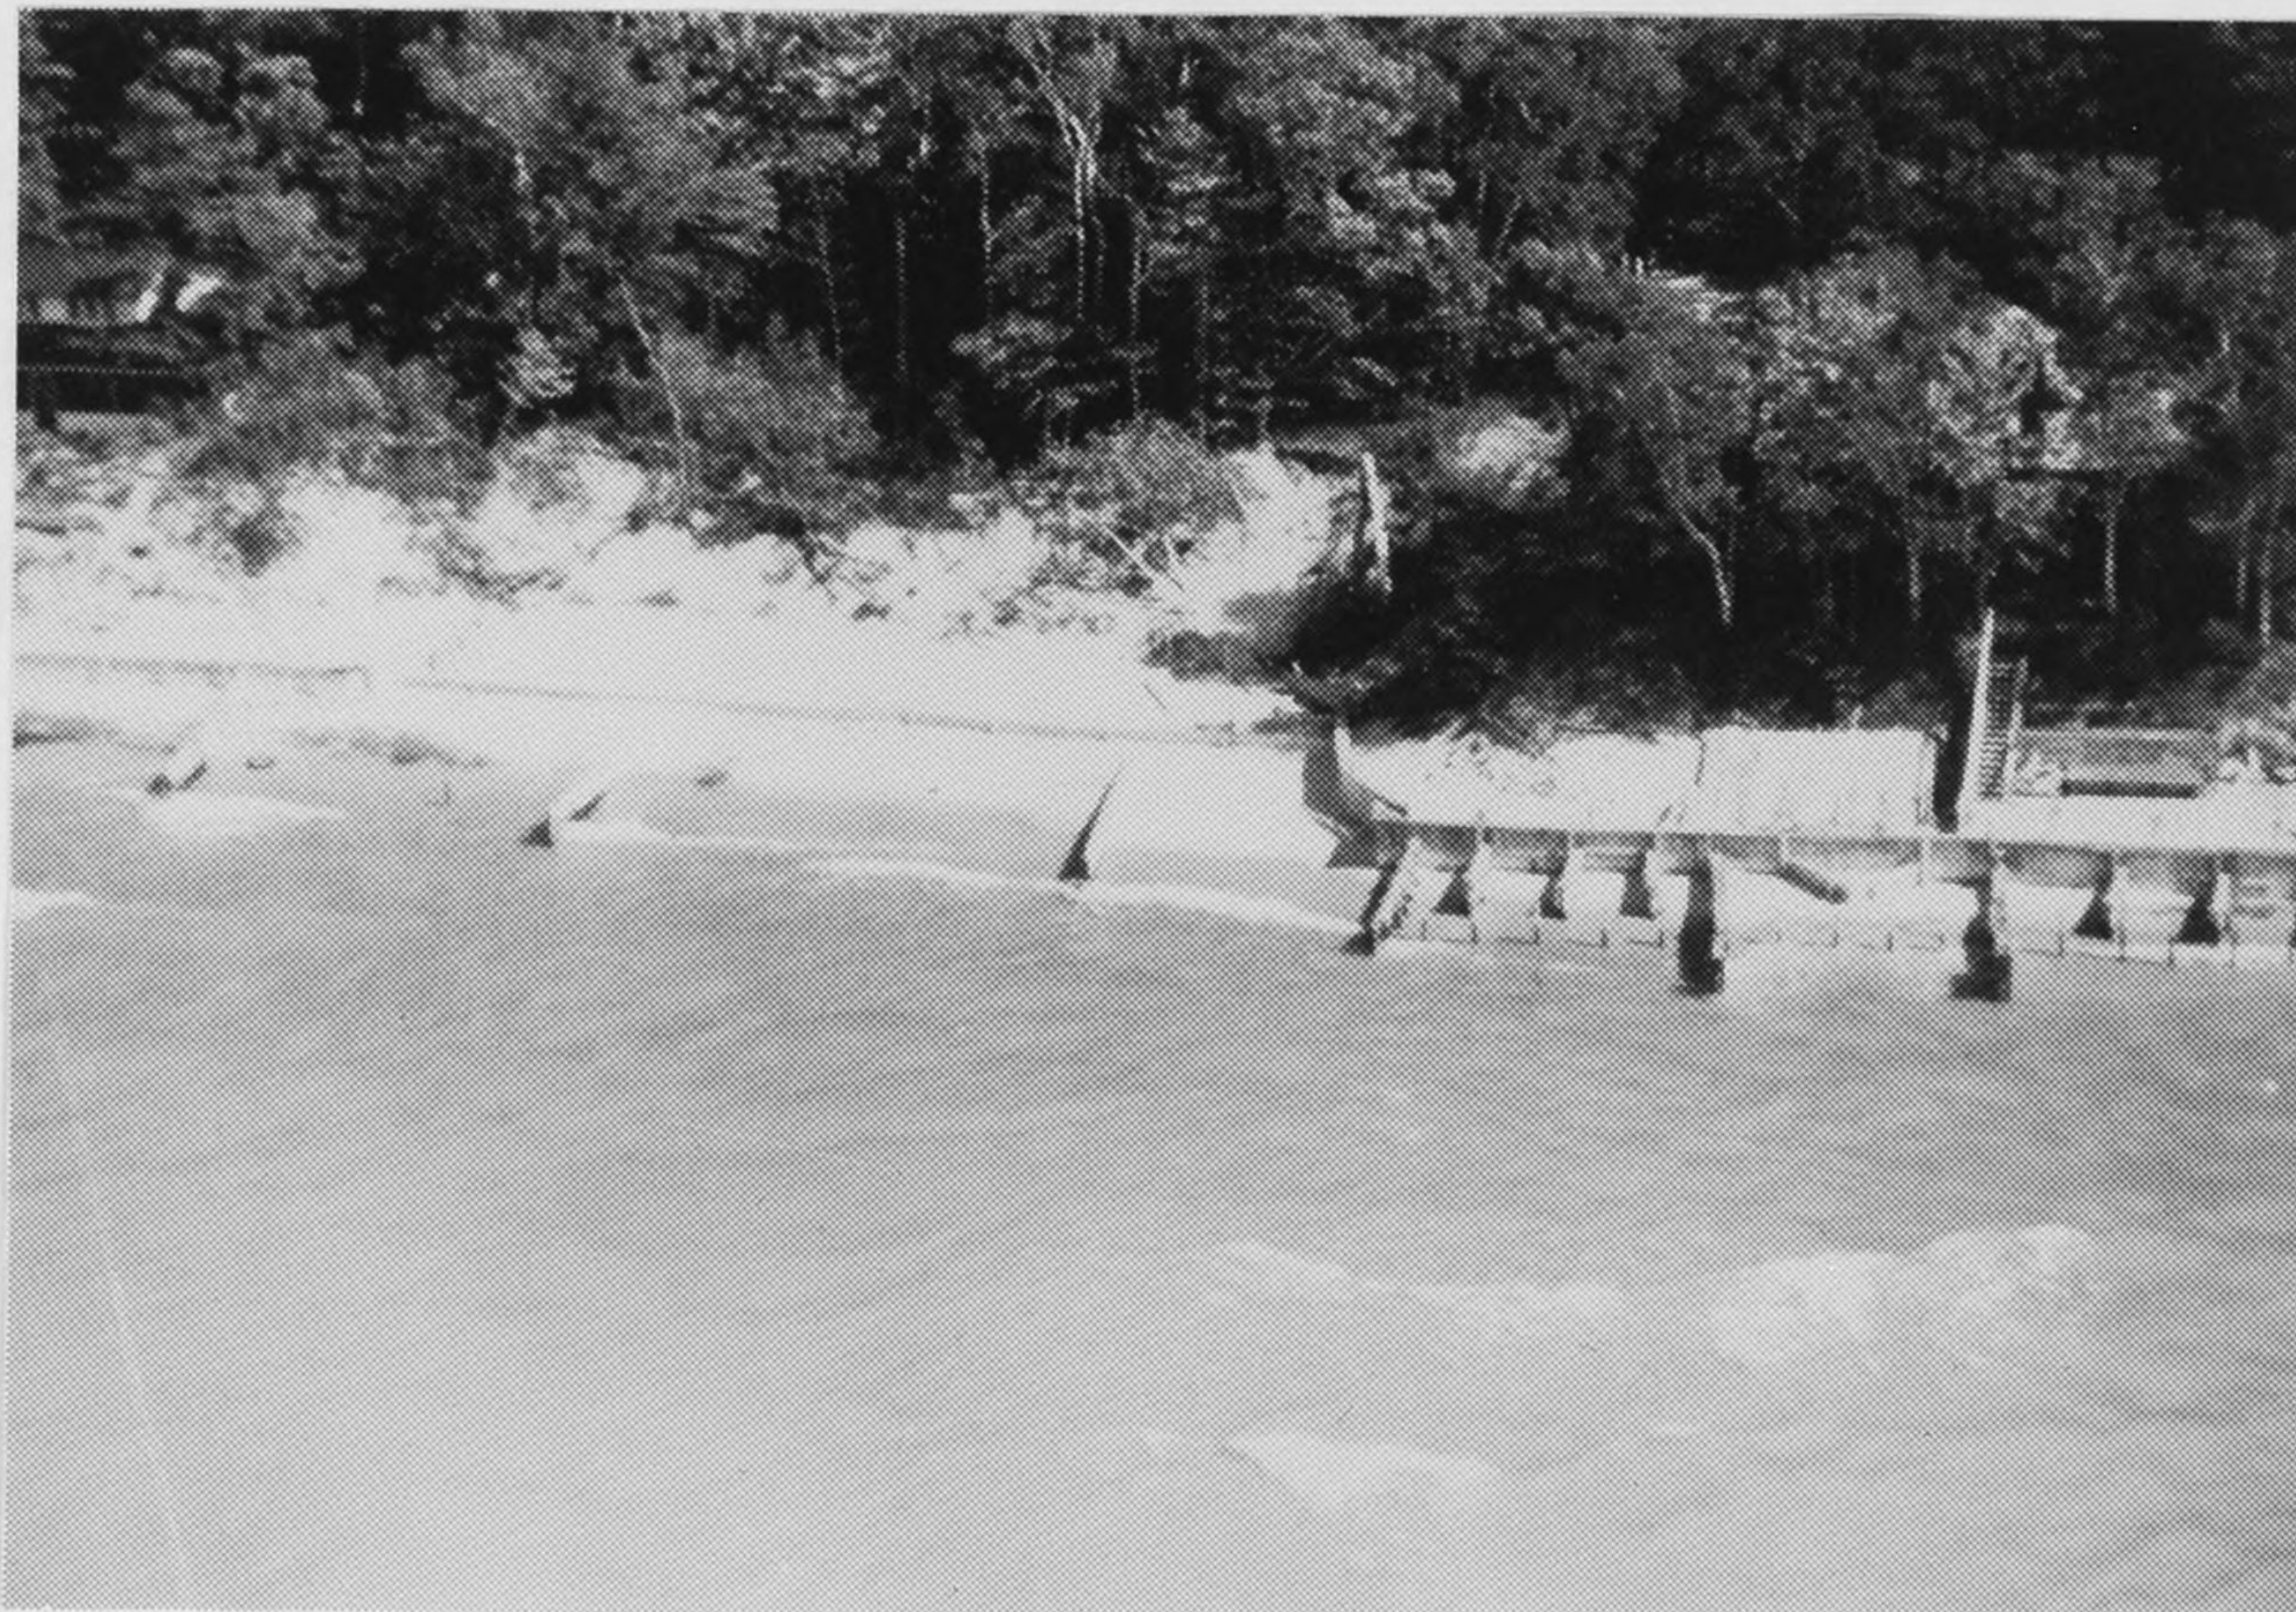
Figure B33. Site L: Aerial view of property which is just to the left of the high retaining wall on the right side of photograph. Note considerable bluff recession compared to property to the south.

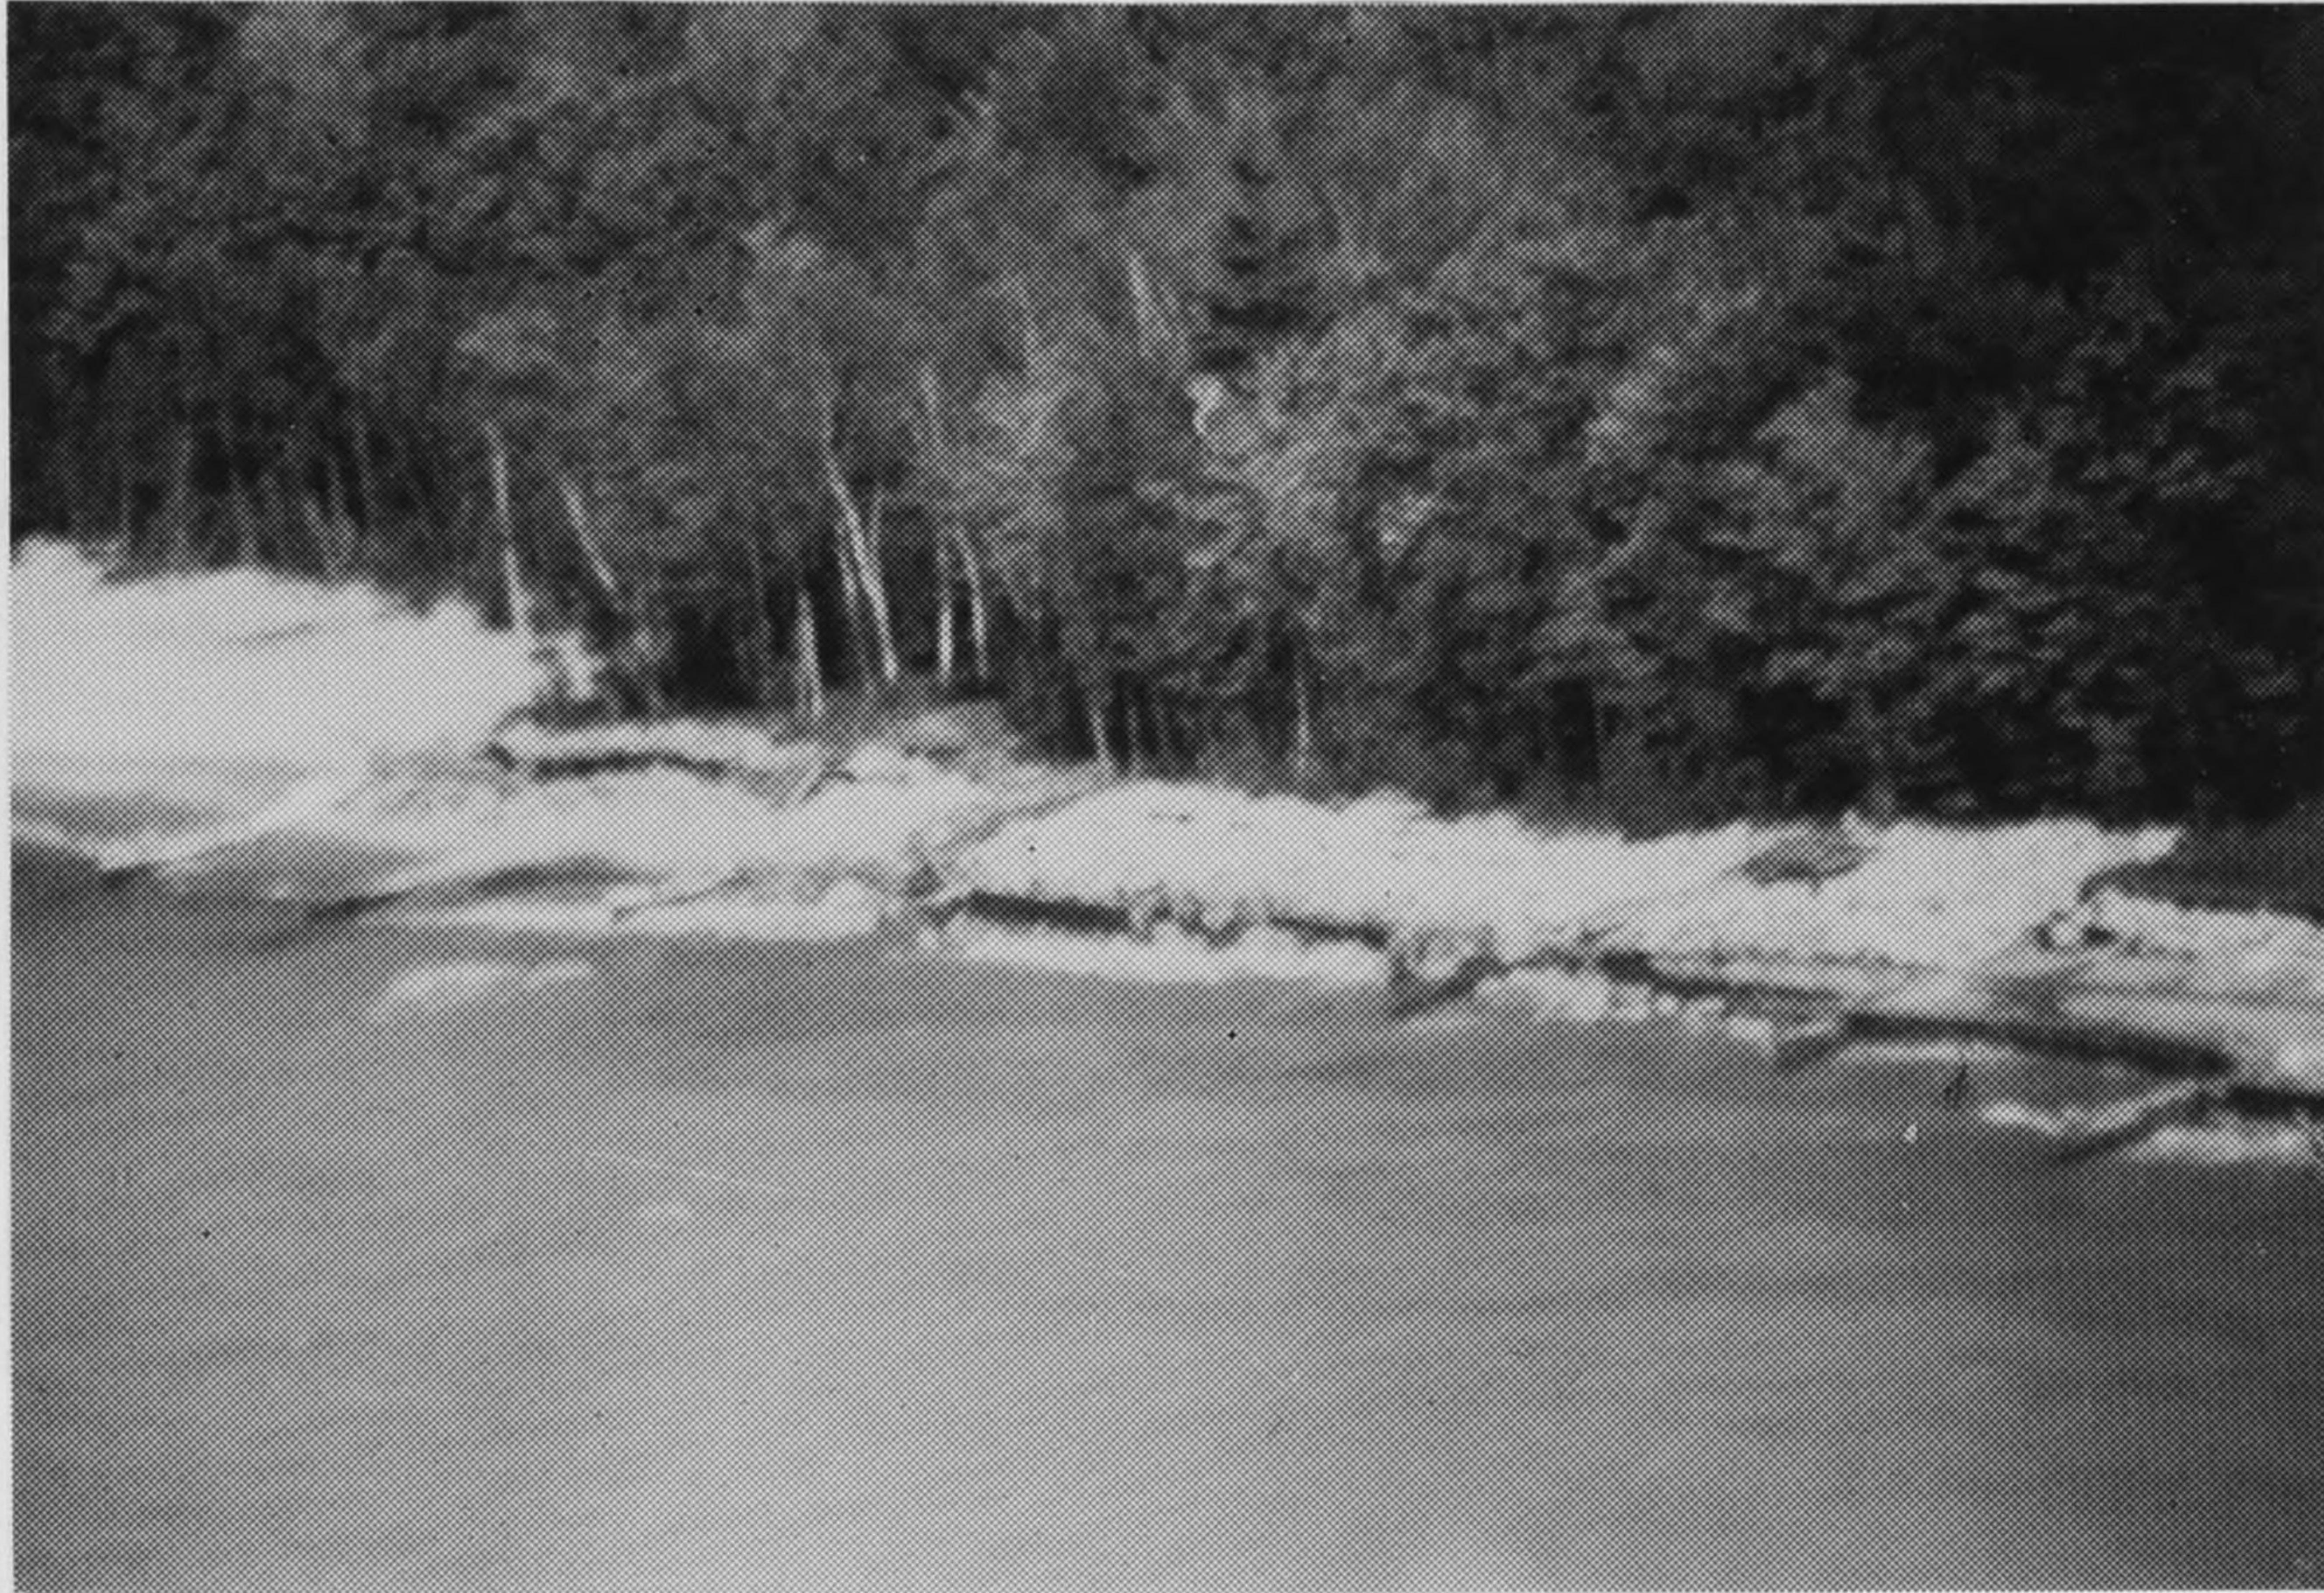
Figure B42. Site O: Aerial view of short revetment at north side of property. Recession of shoreline to north of revetment is visible at left center of photo.

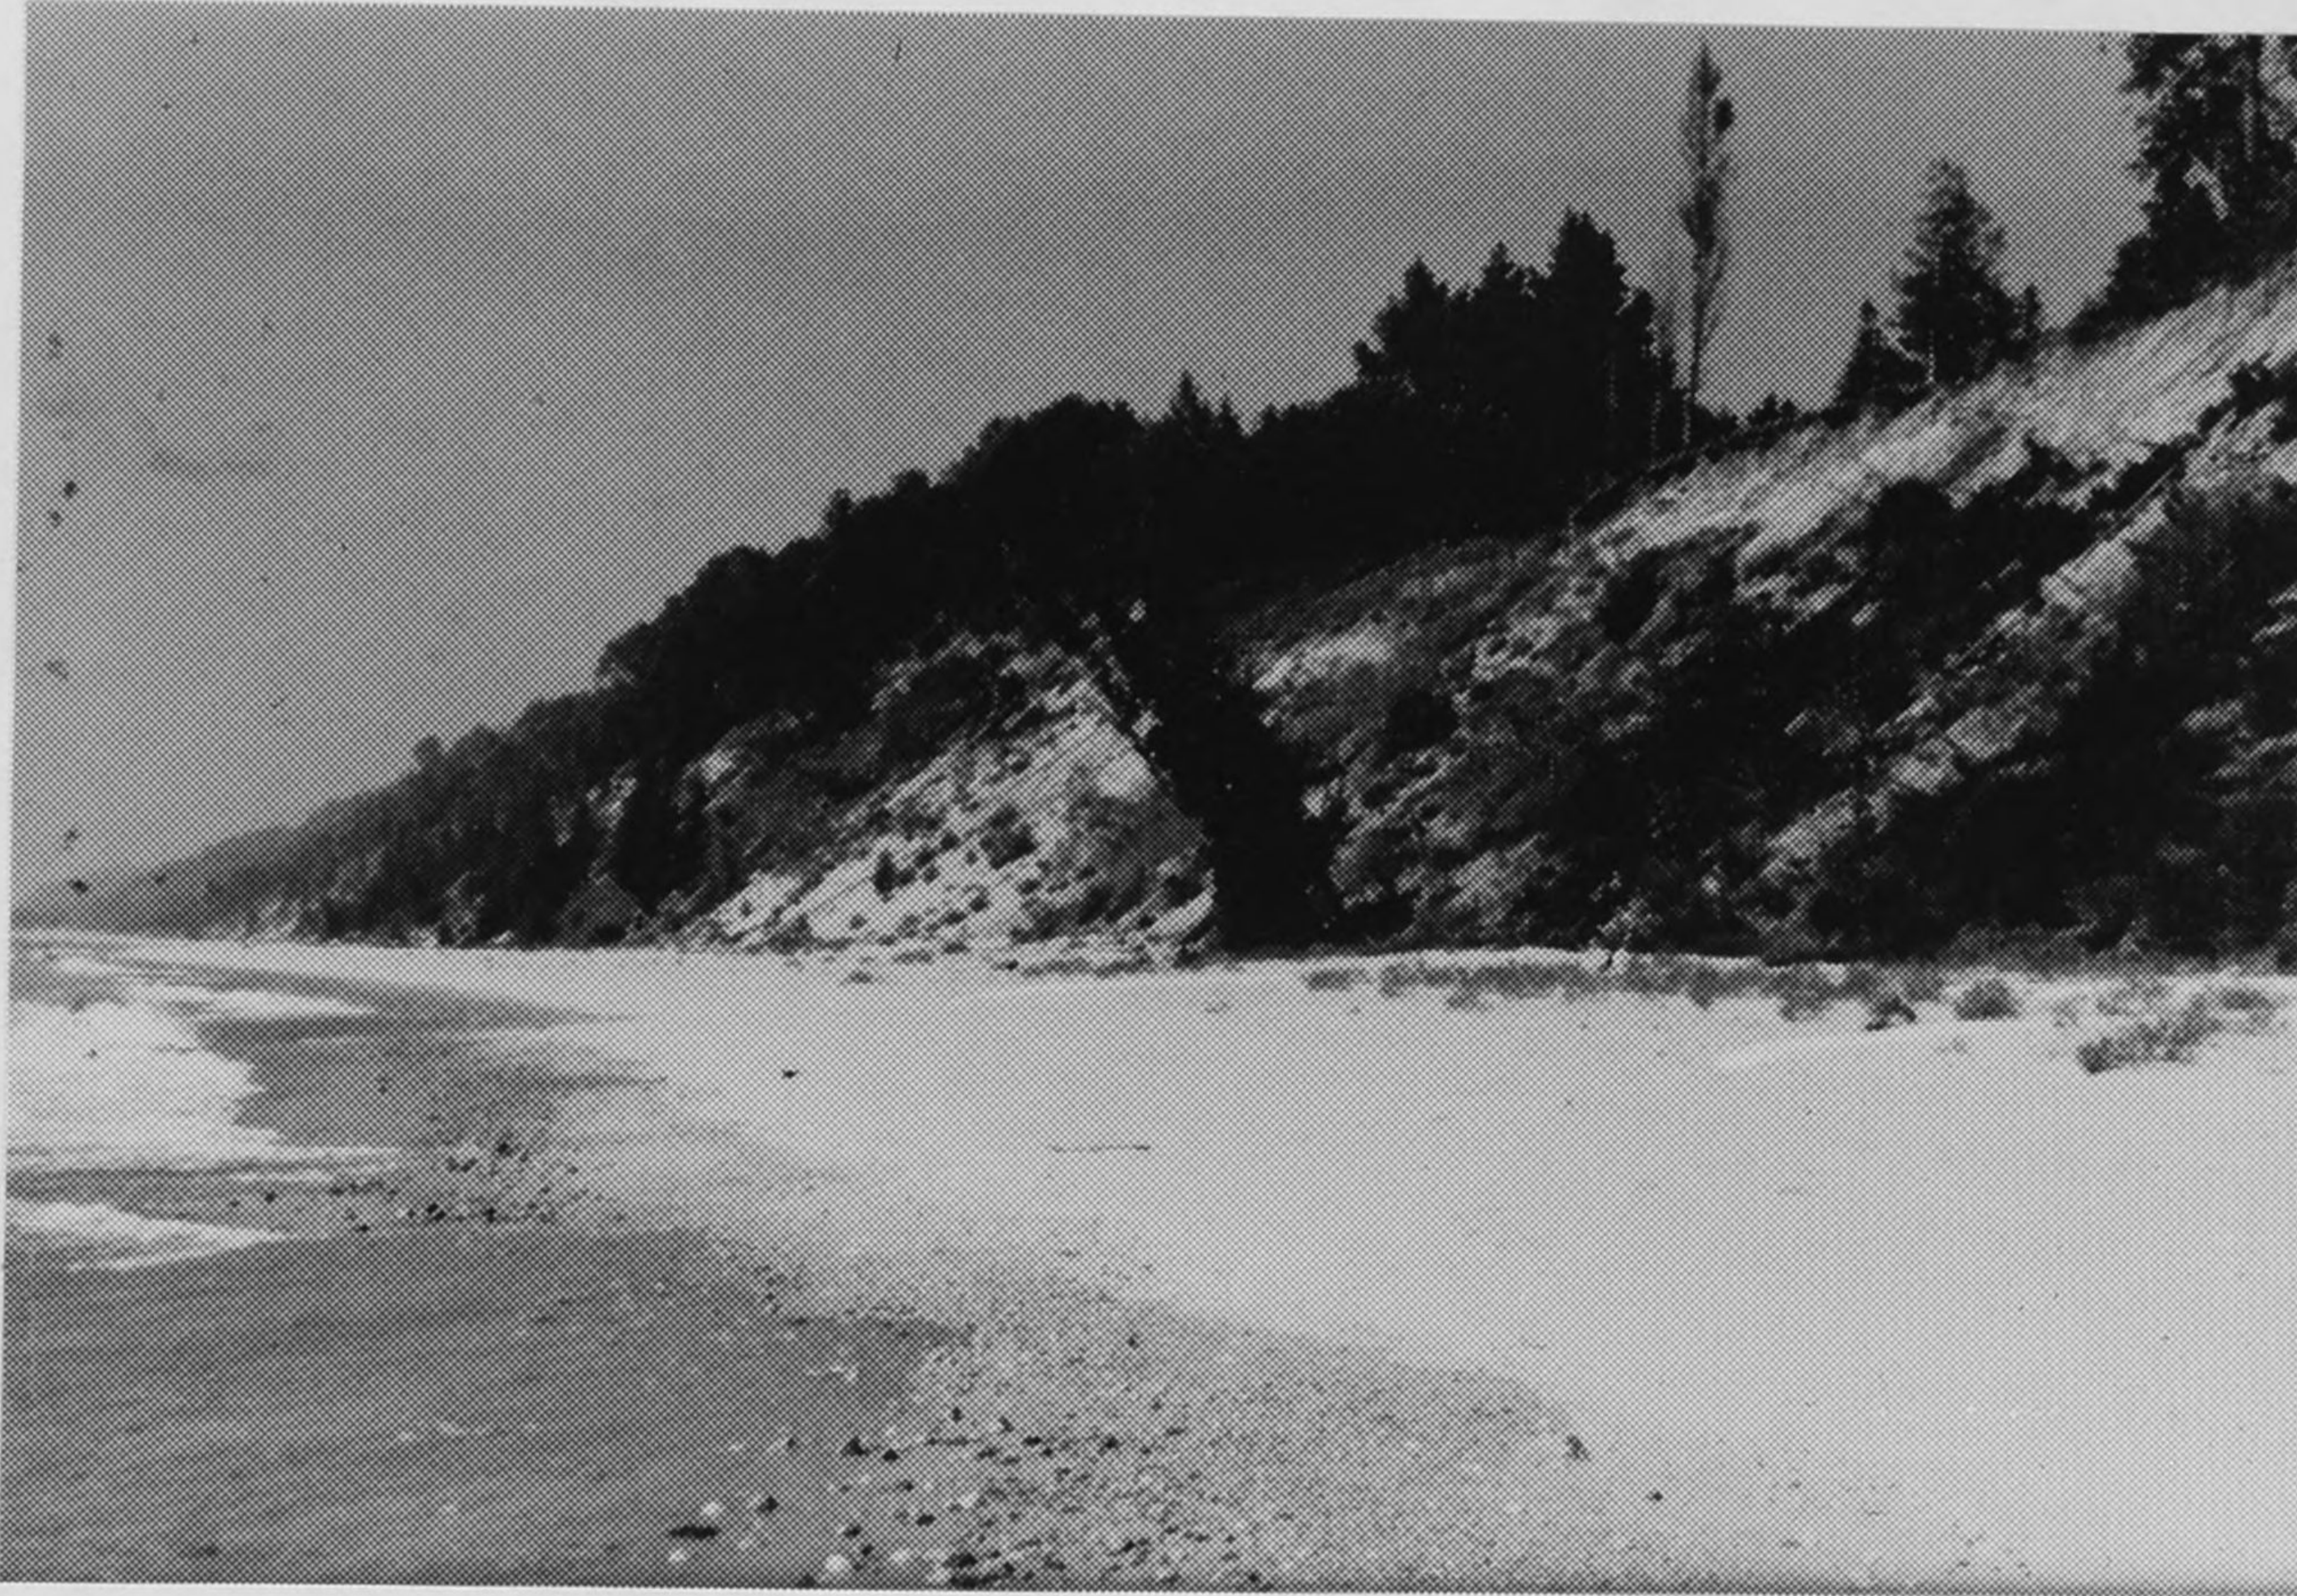
Figure B44. Site P: Looking north across site. Slight recession in beach to north of site is between this site and site Q. Still farther north, shoreline recedes again at far right of photo.

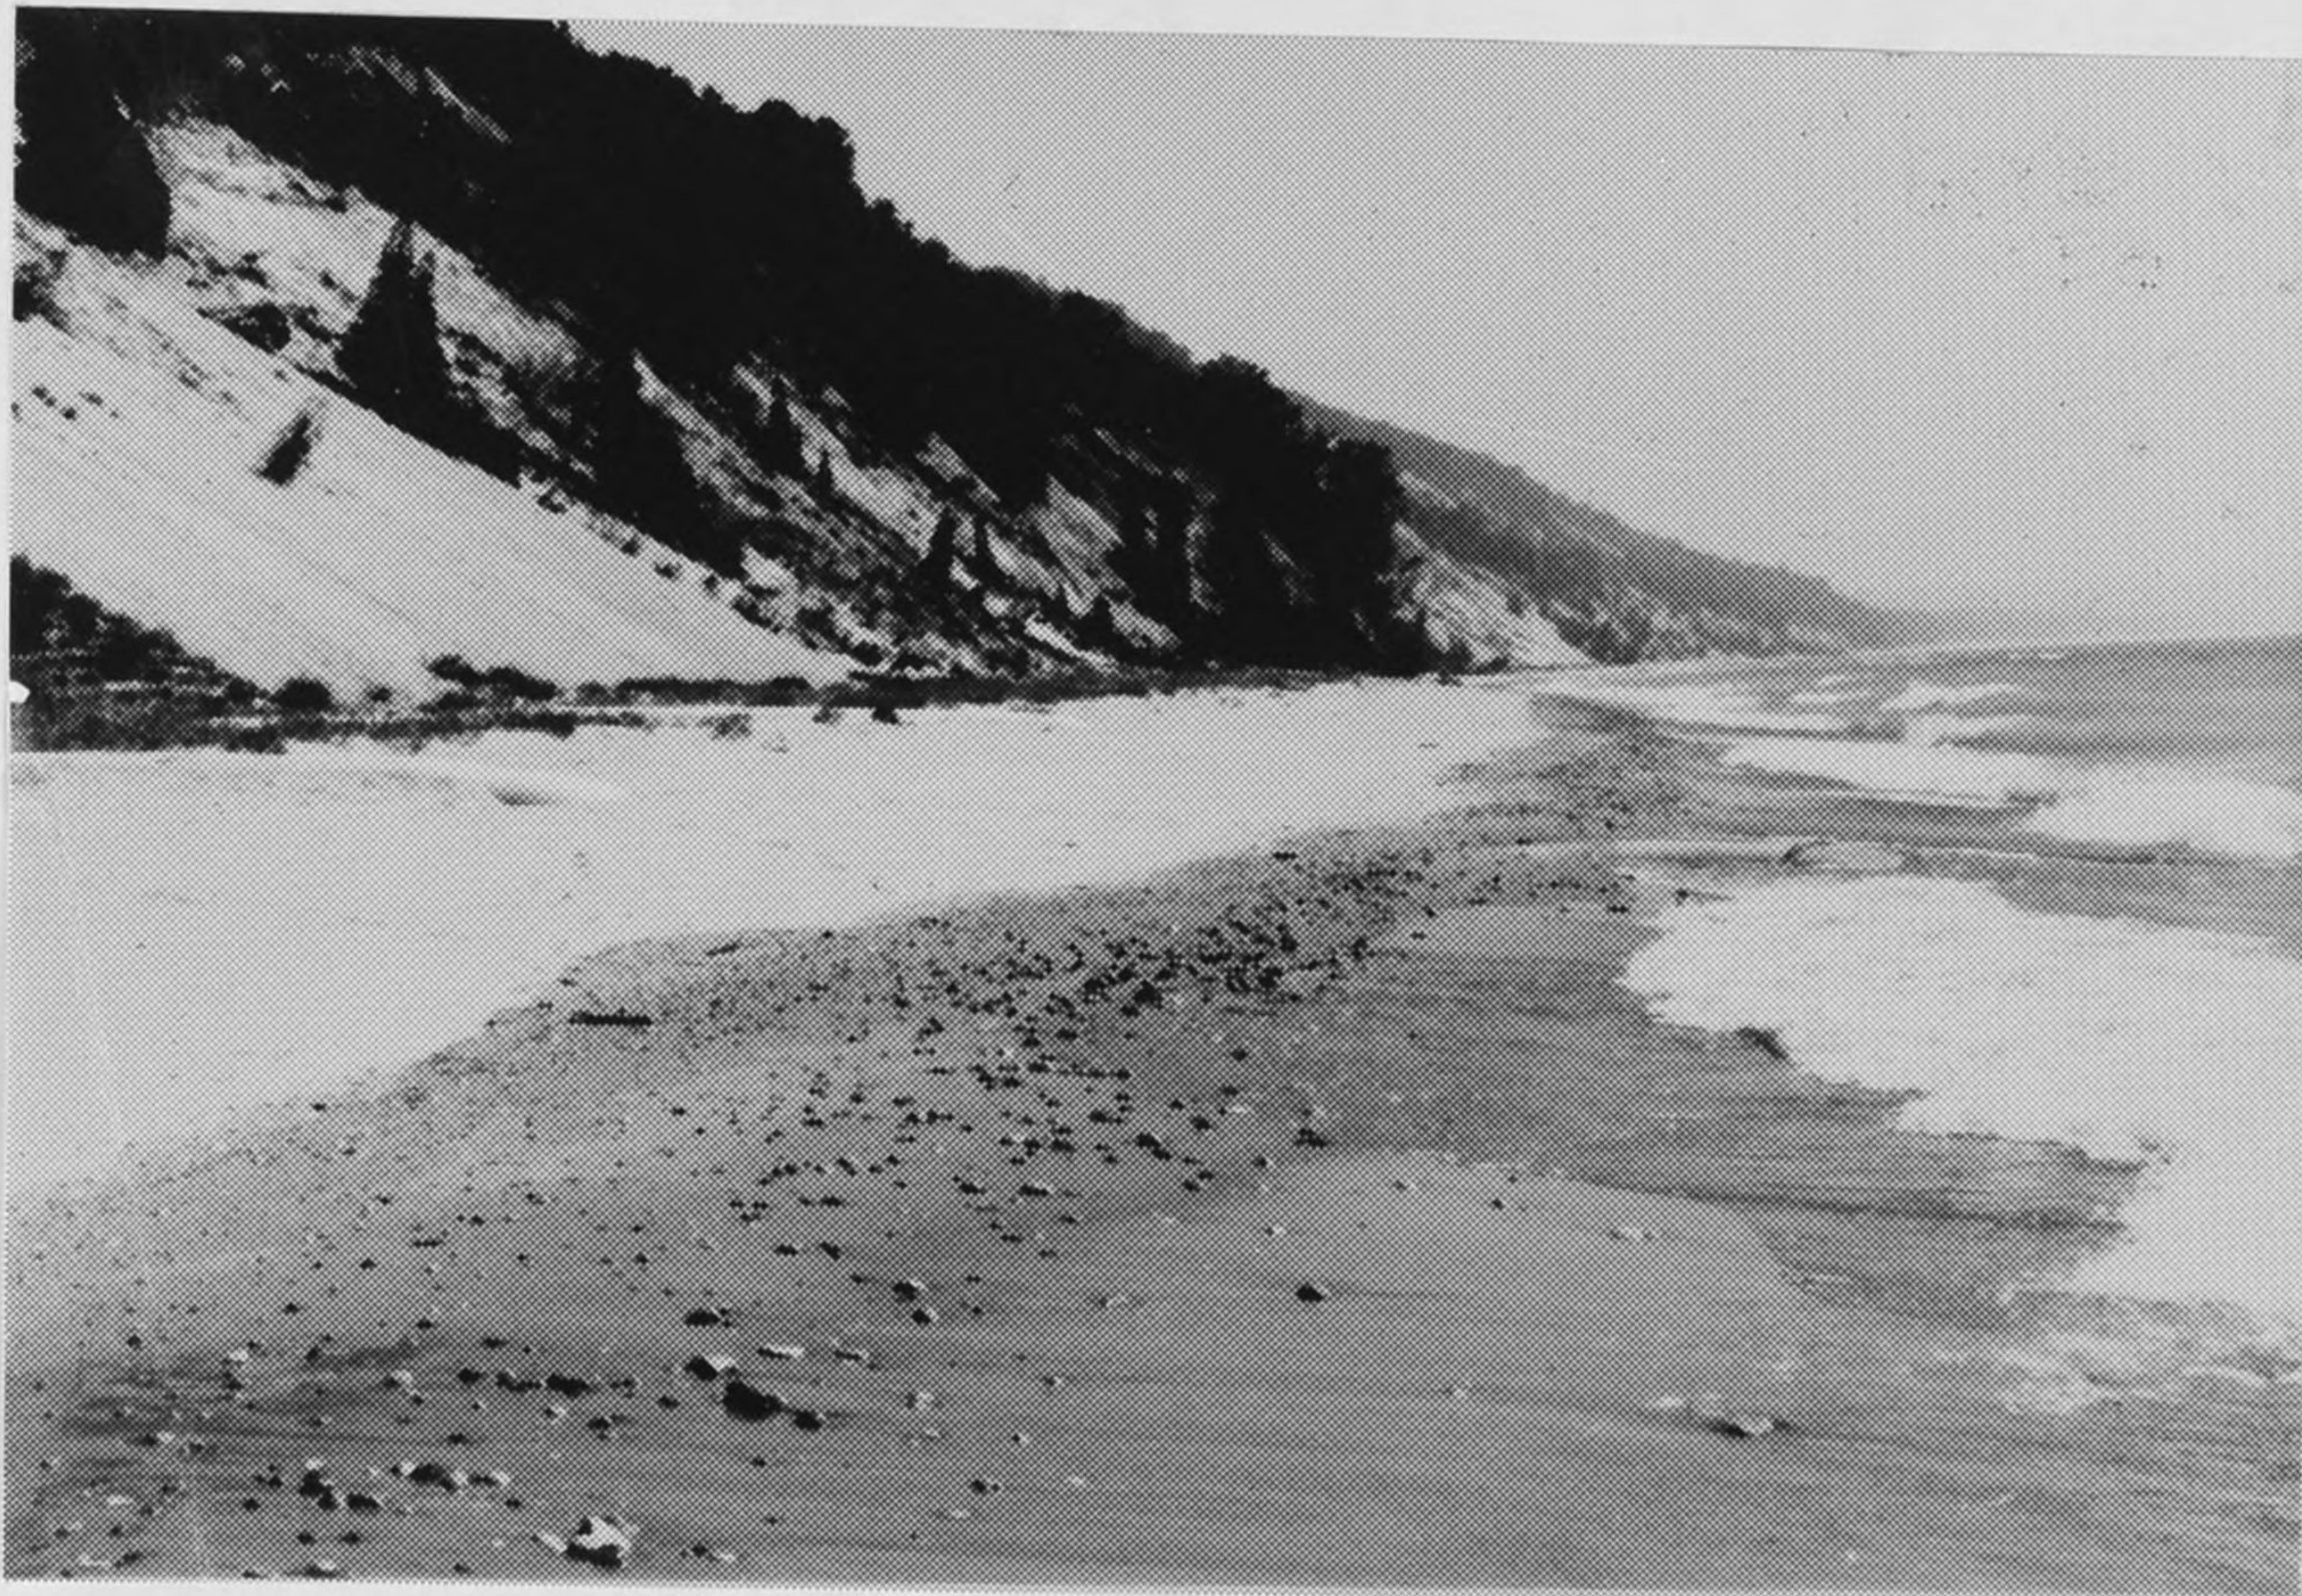
Figure B45. Site P: Looking to south across site. Beach becomes narrower to the south. Also note groin end at water's edge,
