**EVALUATION OF GREAT LAKES
SHORE PROTECTION STRUCTURES**

Report UMCEE 88-8

**THE UNIVERSITY OF MICHIGAN
DEPARTMENT OF CIVIL ENGINEERING
ANN ARBOR, MICHIGAN**

**Michigan Department of Natural Resources
Coastal Management Program
Land and Water Division**

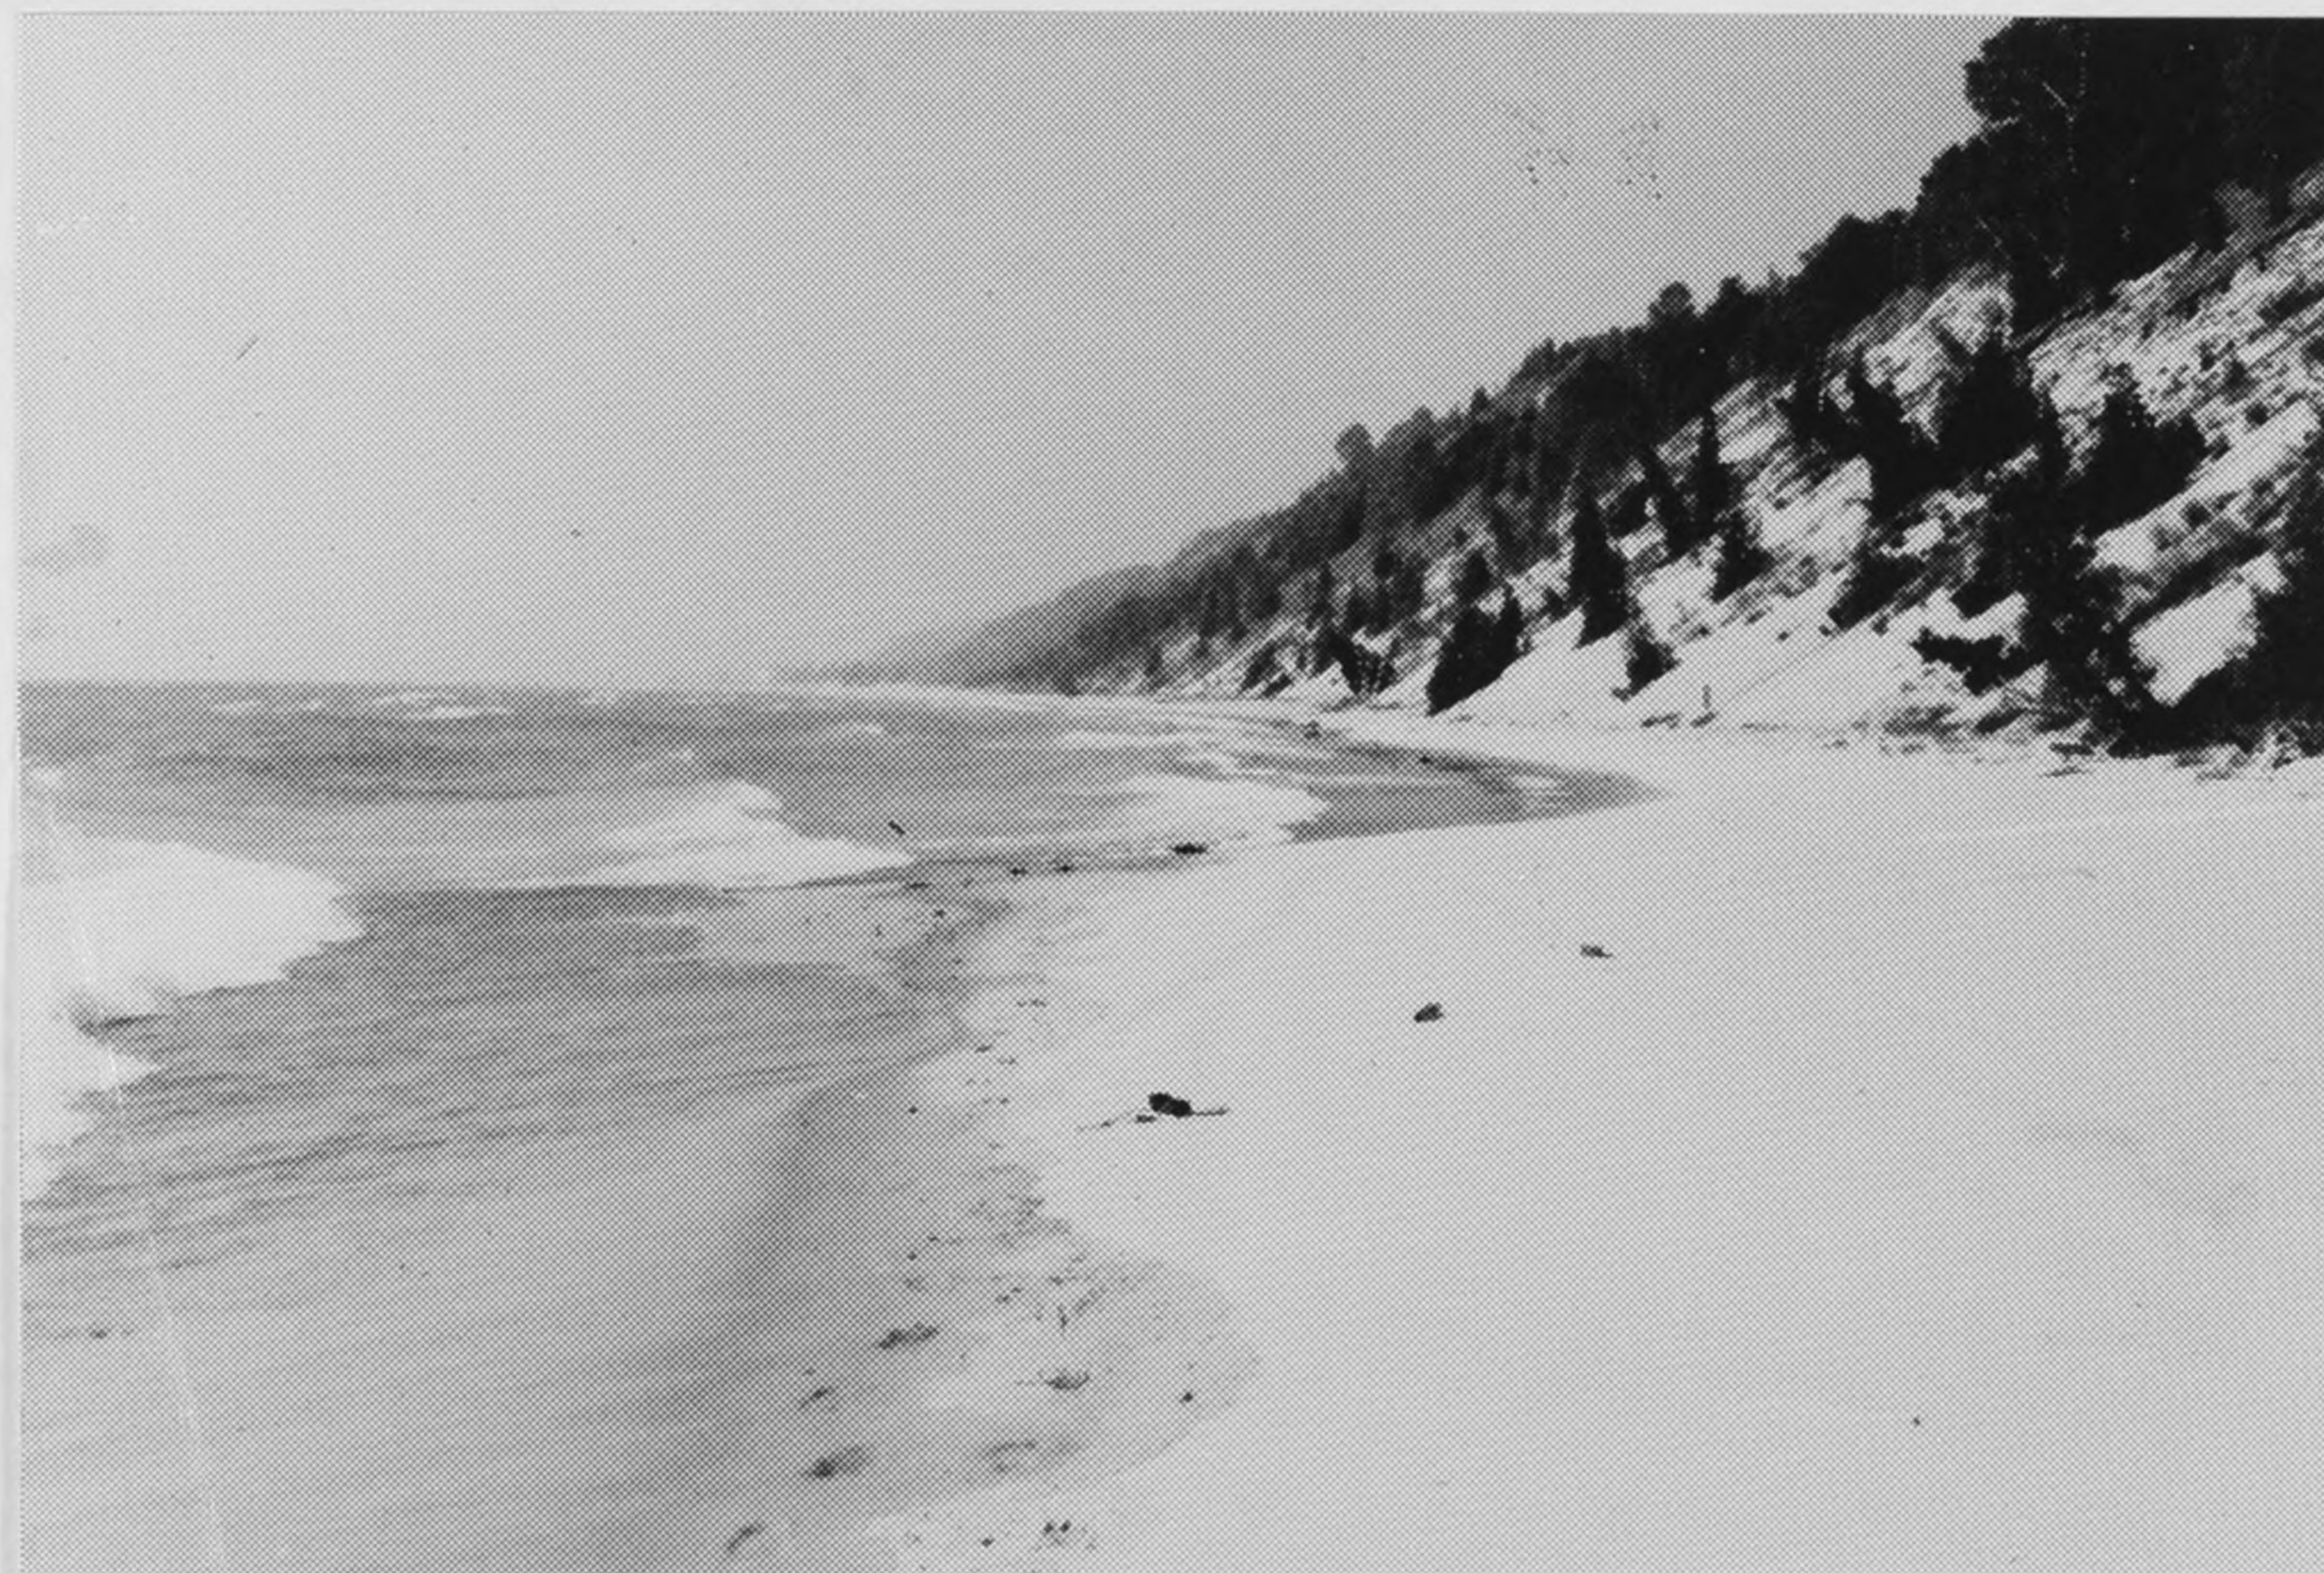
Figure B47. Site Q: Looking to the north from the southern side of the site. Note reduction in beach width immediately north of most northern groin in system.

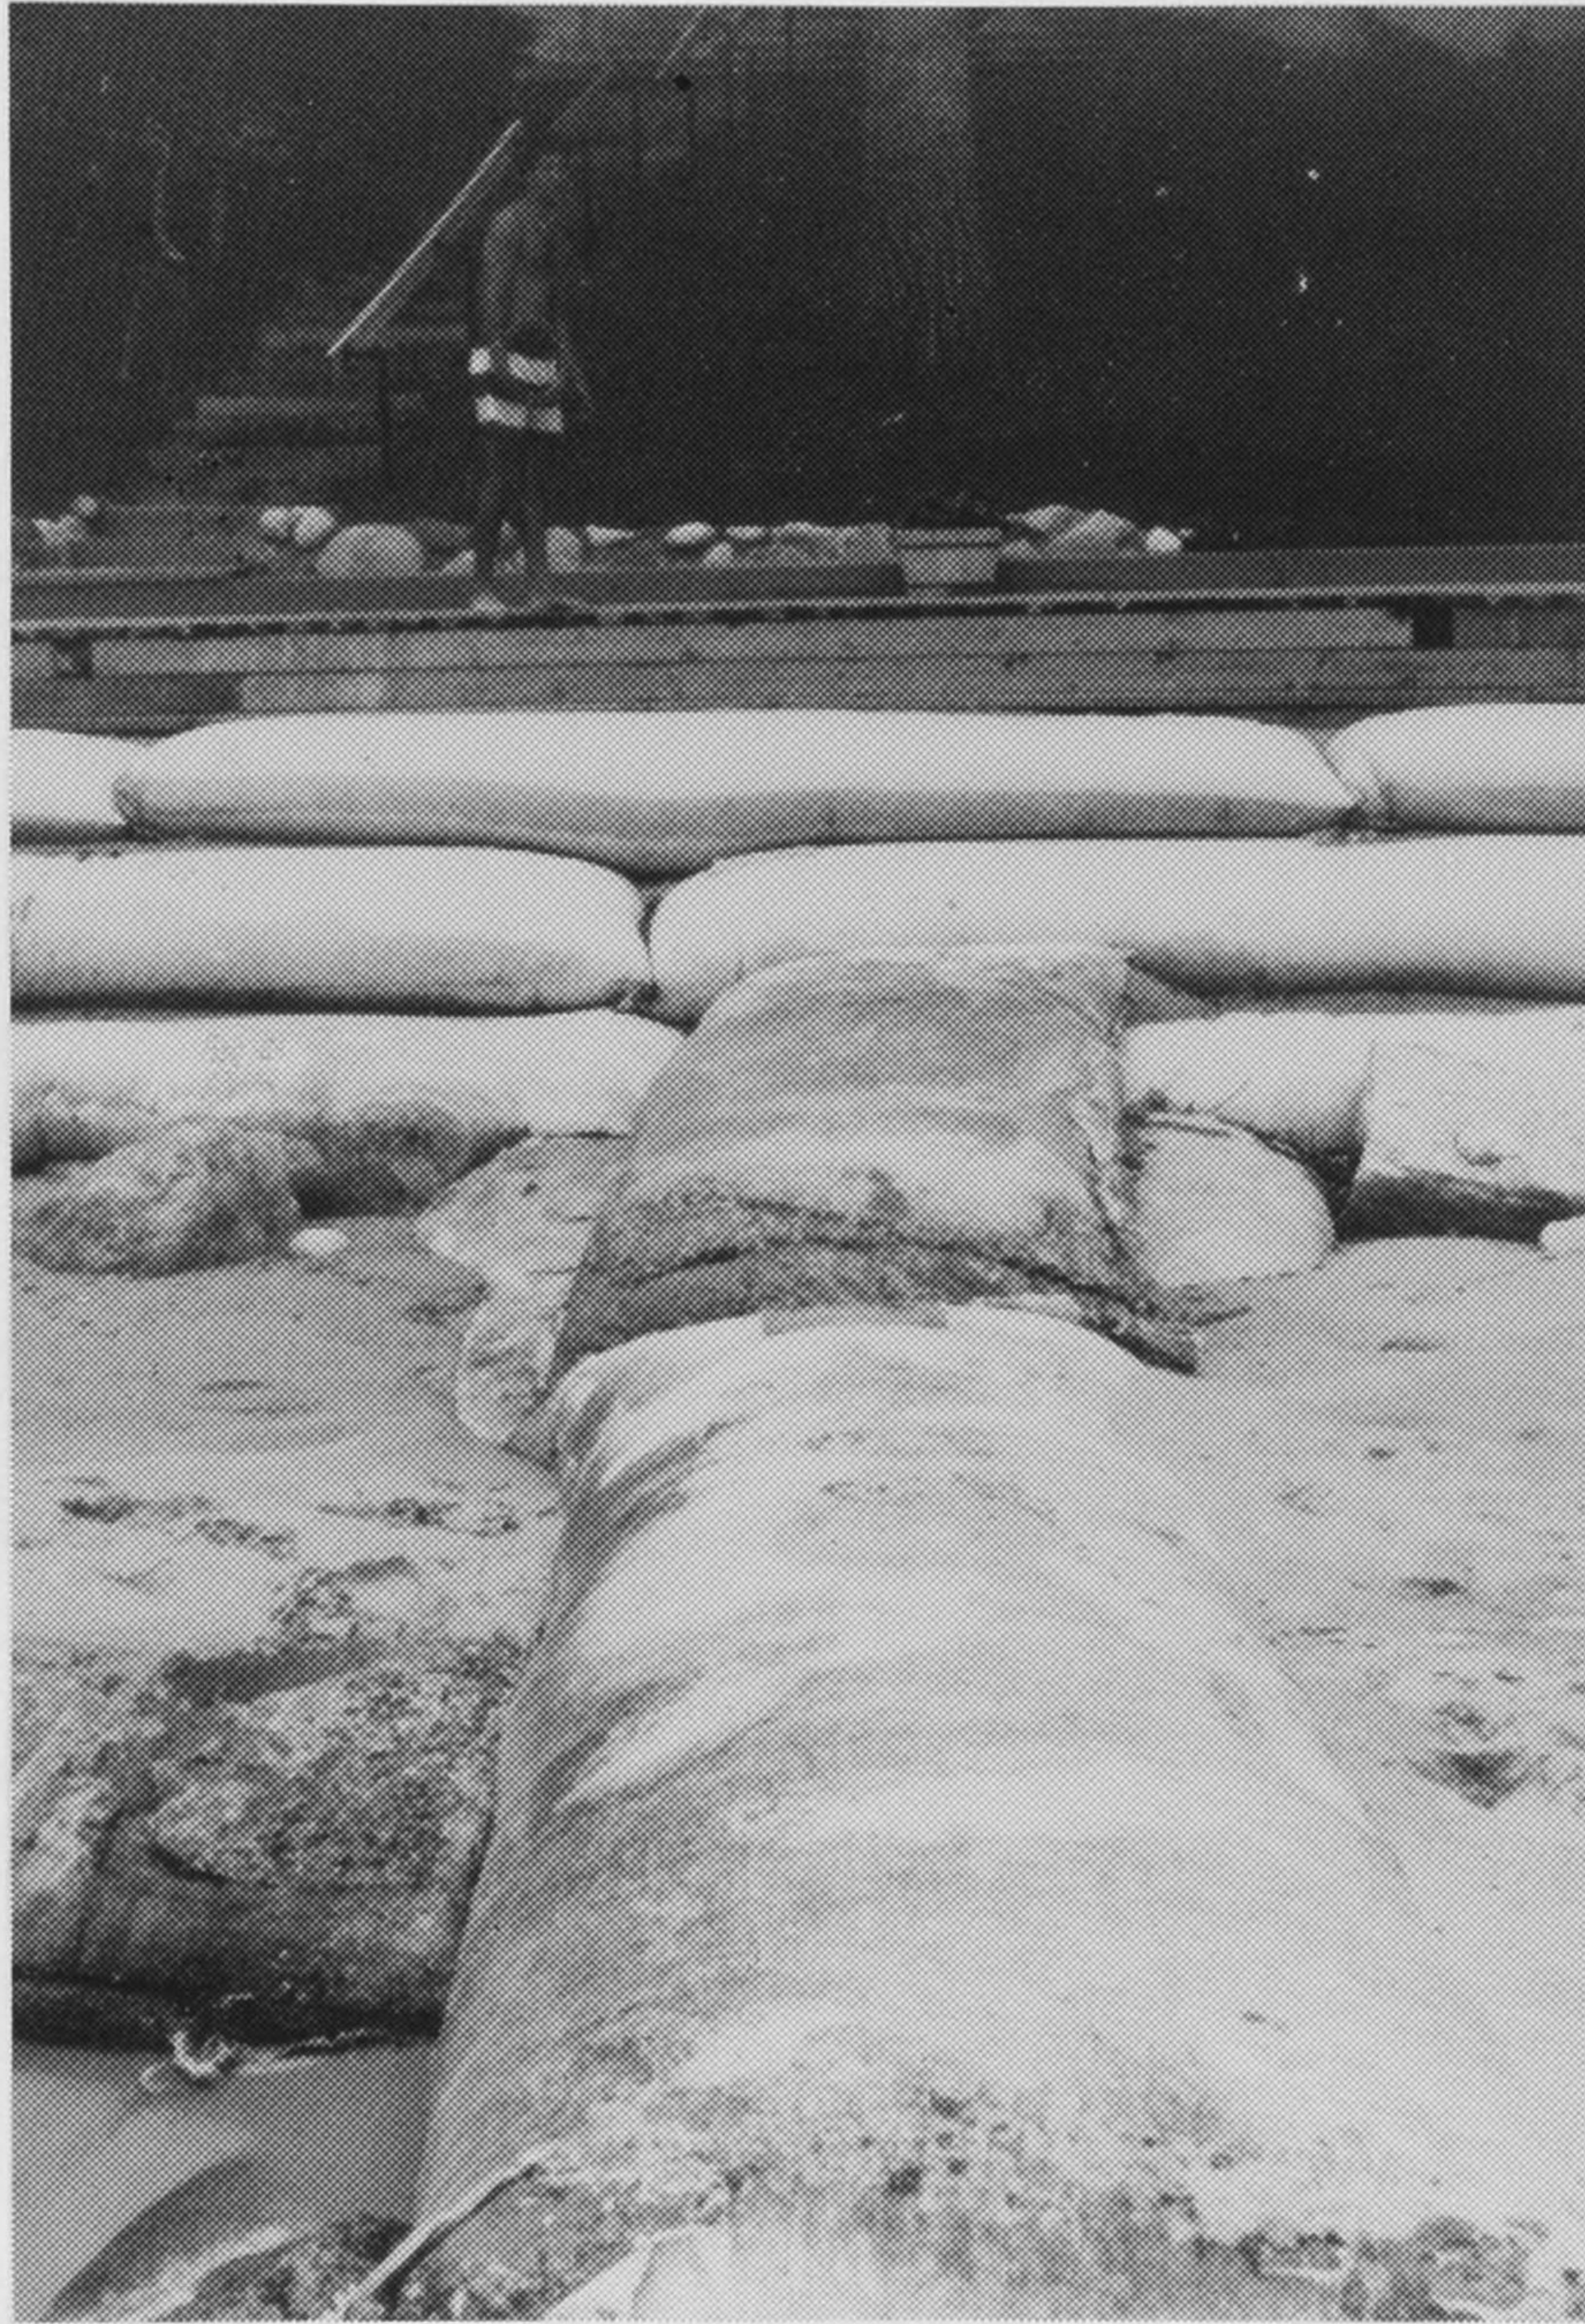
Figure B50. Site U: Looking onshore from third groin from southwest end. Note higher filling on right side of groin

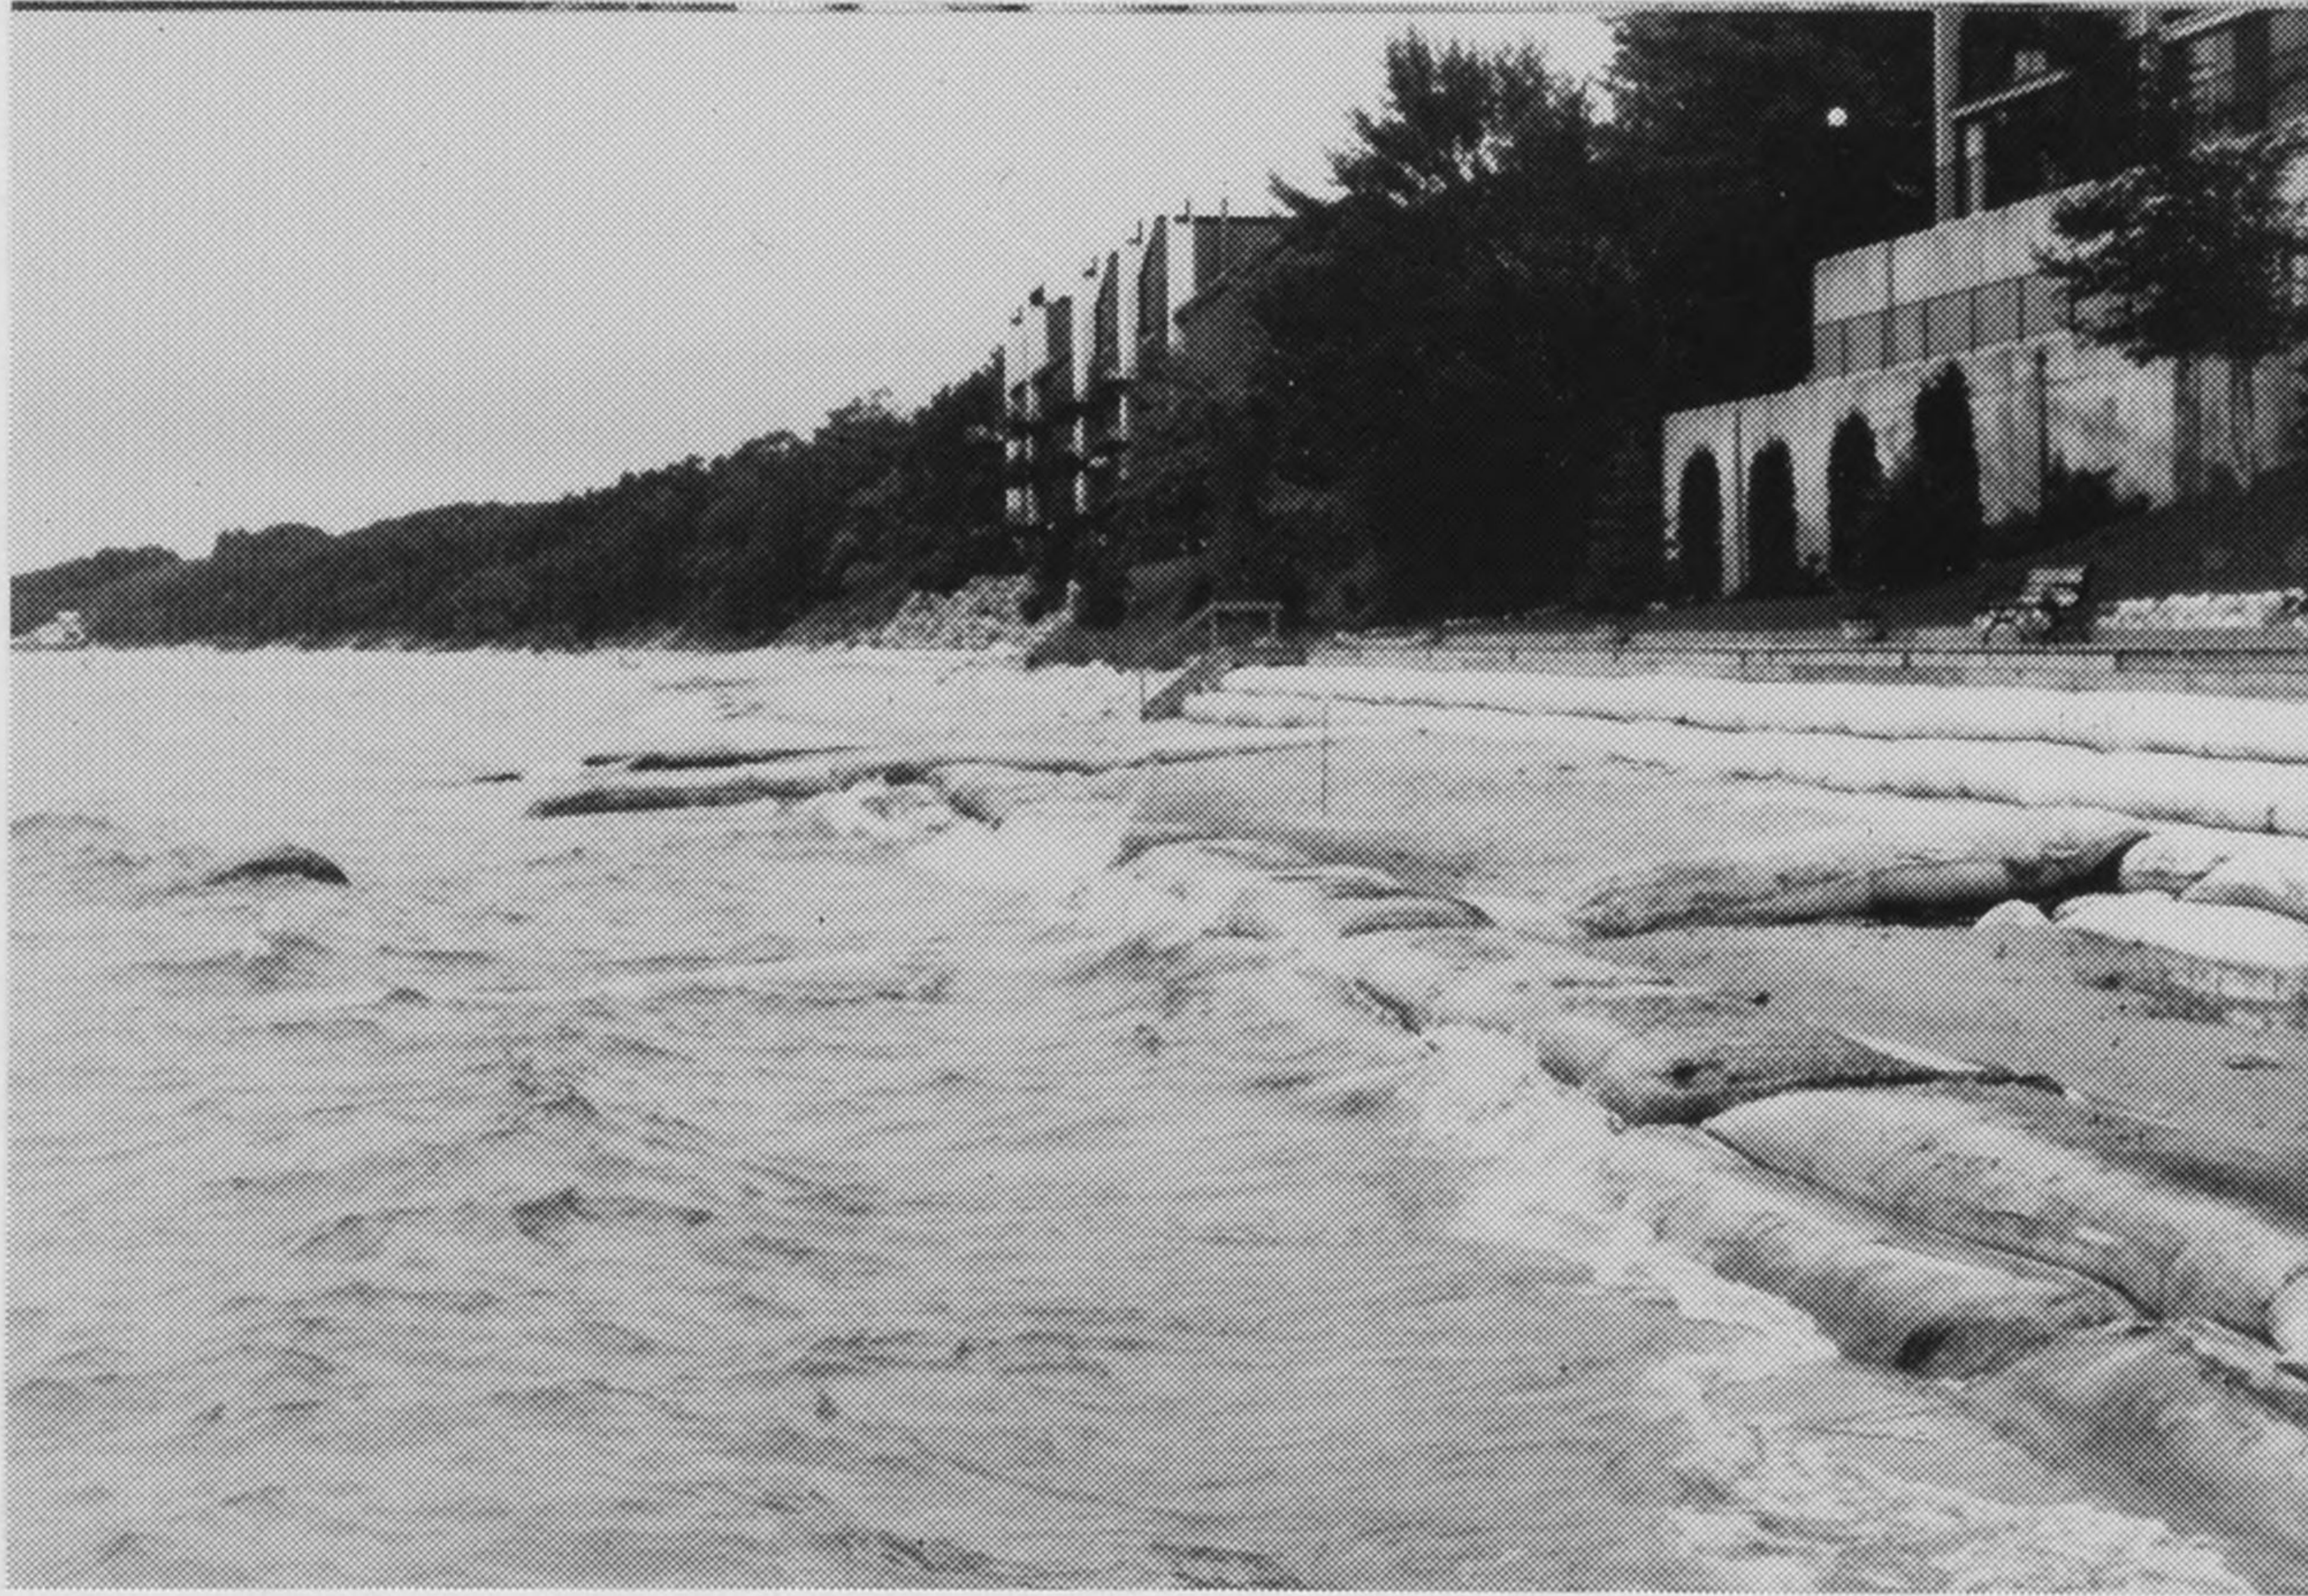
Figure B51. Site U: Looking northeasterly from same point as Fig. B50. Note sand filling behind offshore sill. Beach is beyond sill to the south of this location.

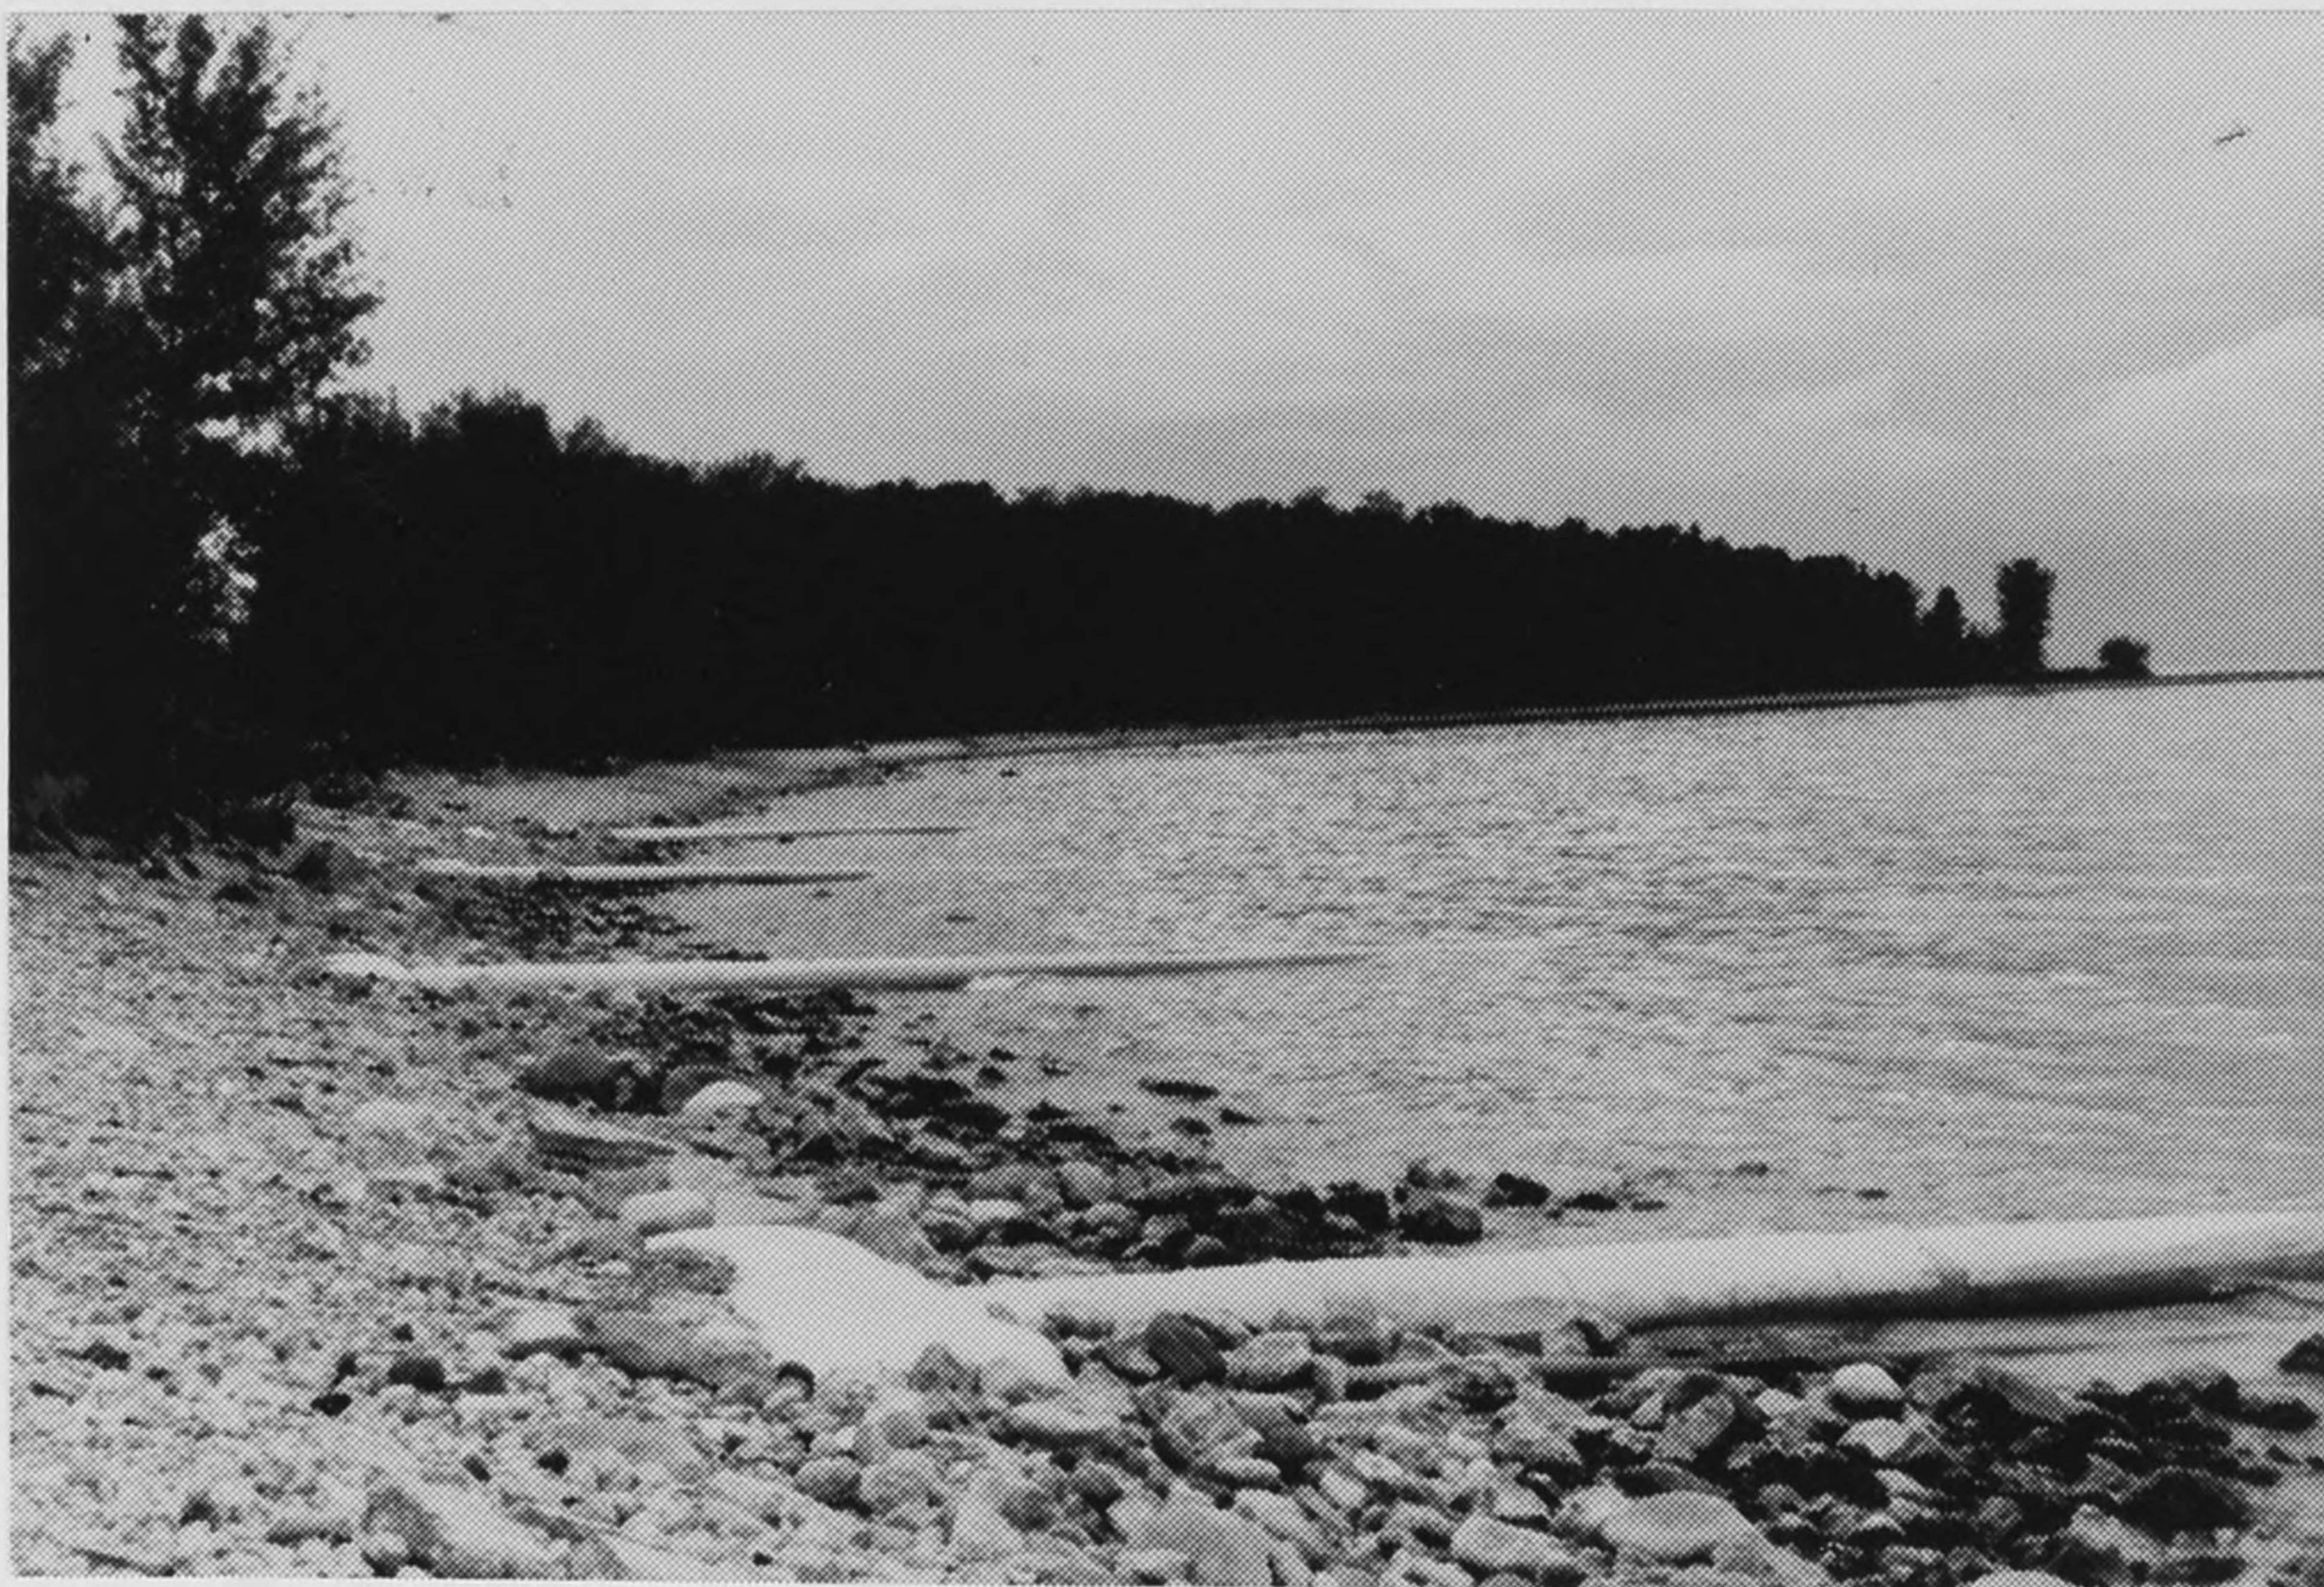
Figure B56. Site V: Four groin system, looking southwest. Note coarse beach material at this site.

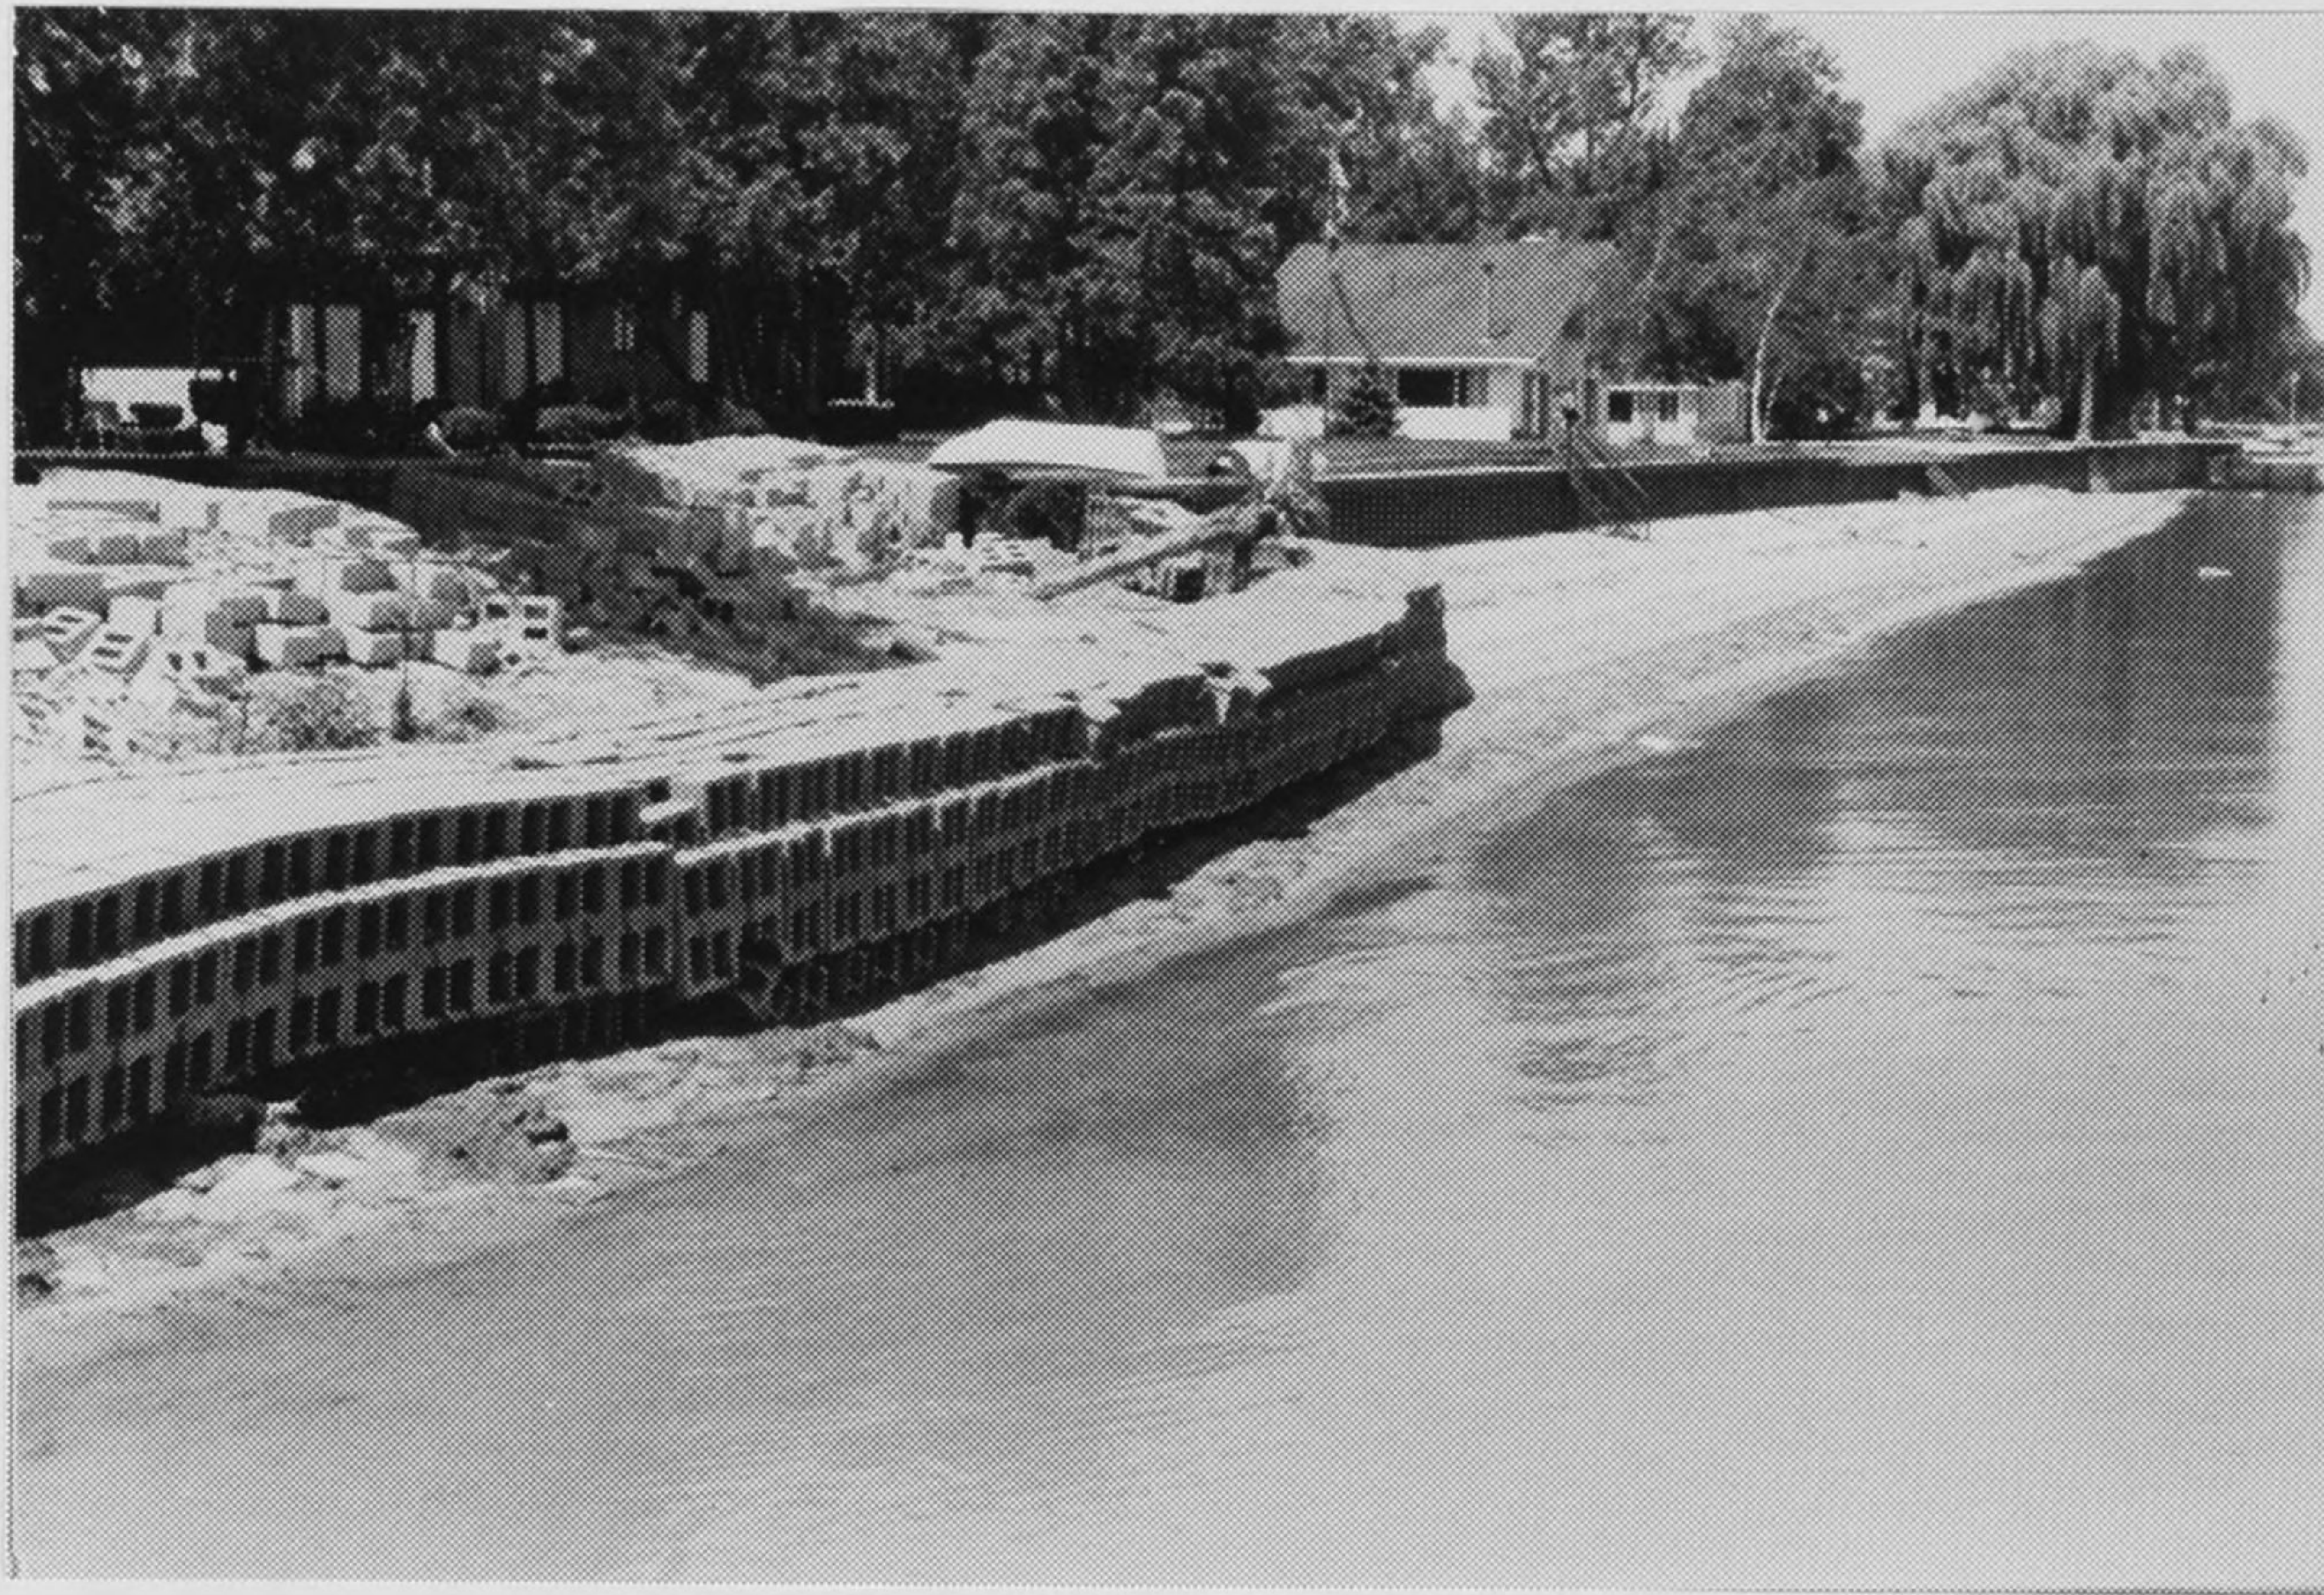
Figure B65. Site Z: Existing sandgrabber wall at site. Note lakeward displacement relative to seawall to north. Also note that only half of lower block is buried.

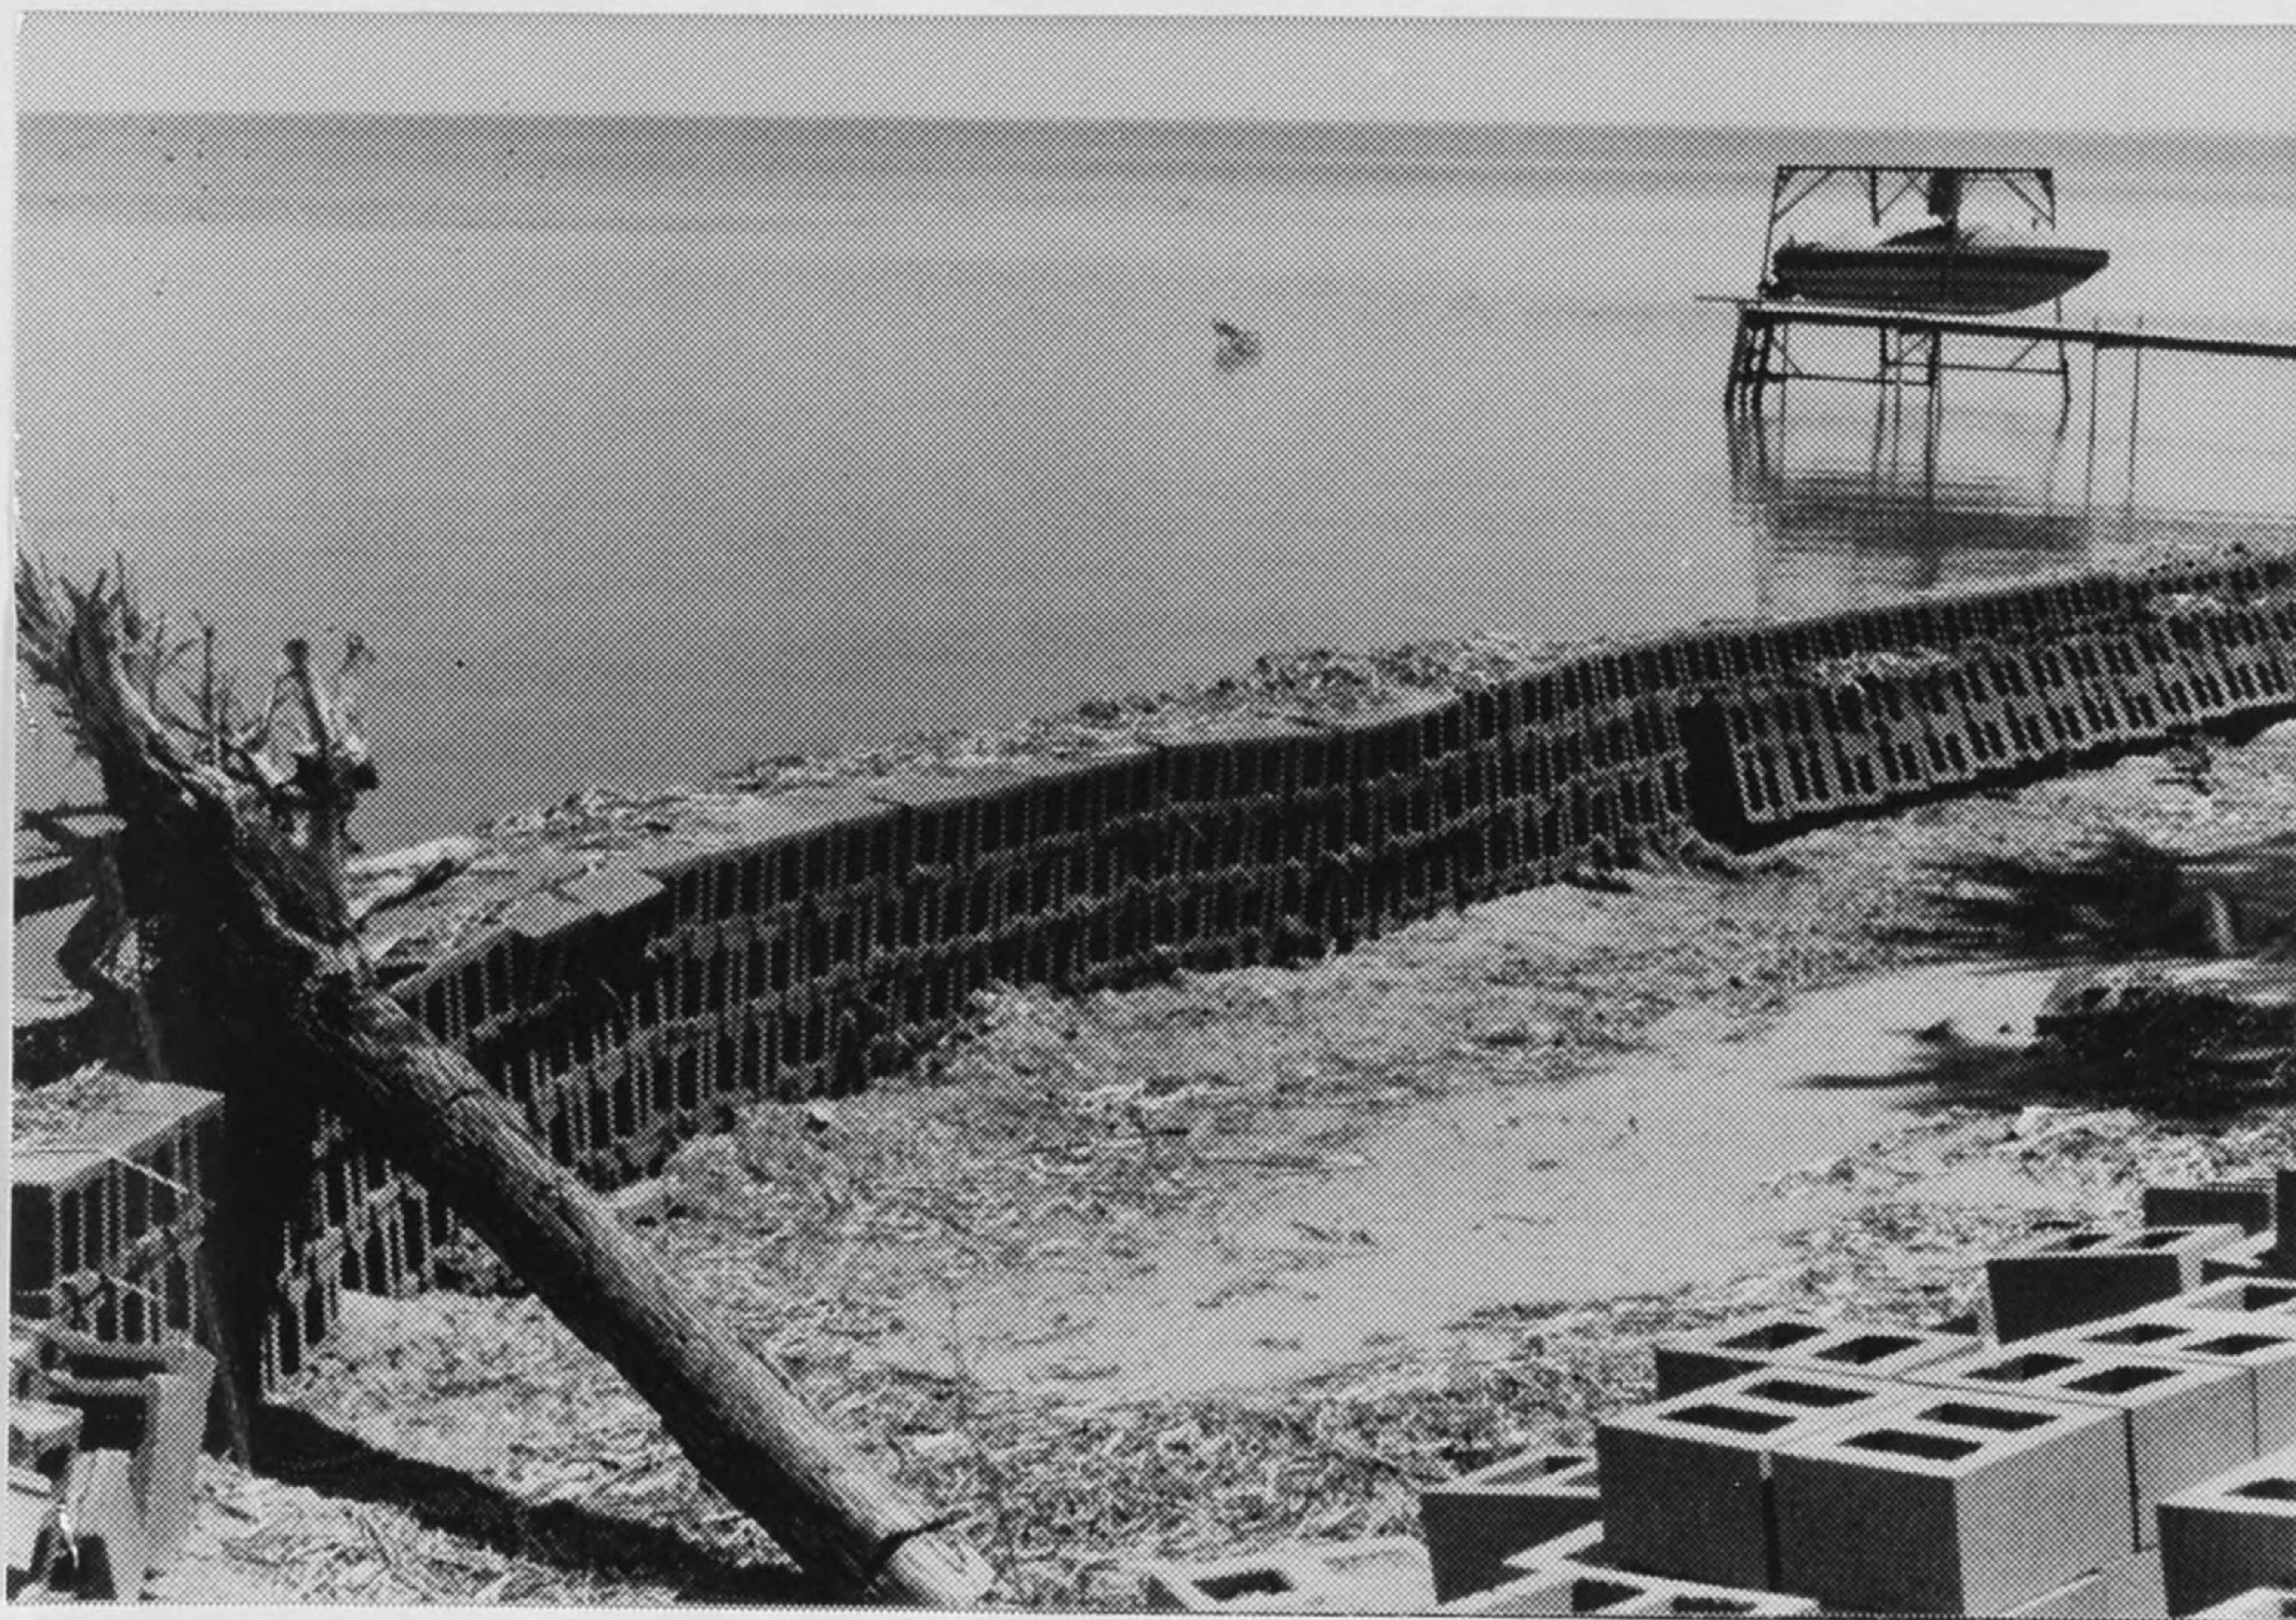
Figure B66. Site Z: Backside of sandgrabber wall, sand level behind slightly higher than in front. Also note tree trunk washed over wall during high water.
