**EVALUATION OF GREAT LAKES
SHORE PROTECTION STRUCTURES**

Report UMCEE 88-8

**THE UNIVERSITY OF MICHIGAN
DEPARTMENT OF CIVIL ENGINEERING
ANN ARBOR, MICHIGAN**

**Michigan Department of Natural Resources
Coastal Management Program
Land and Water Division**

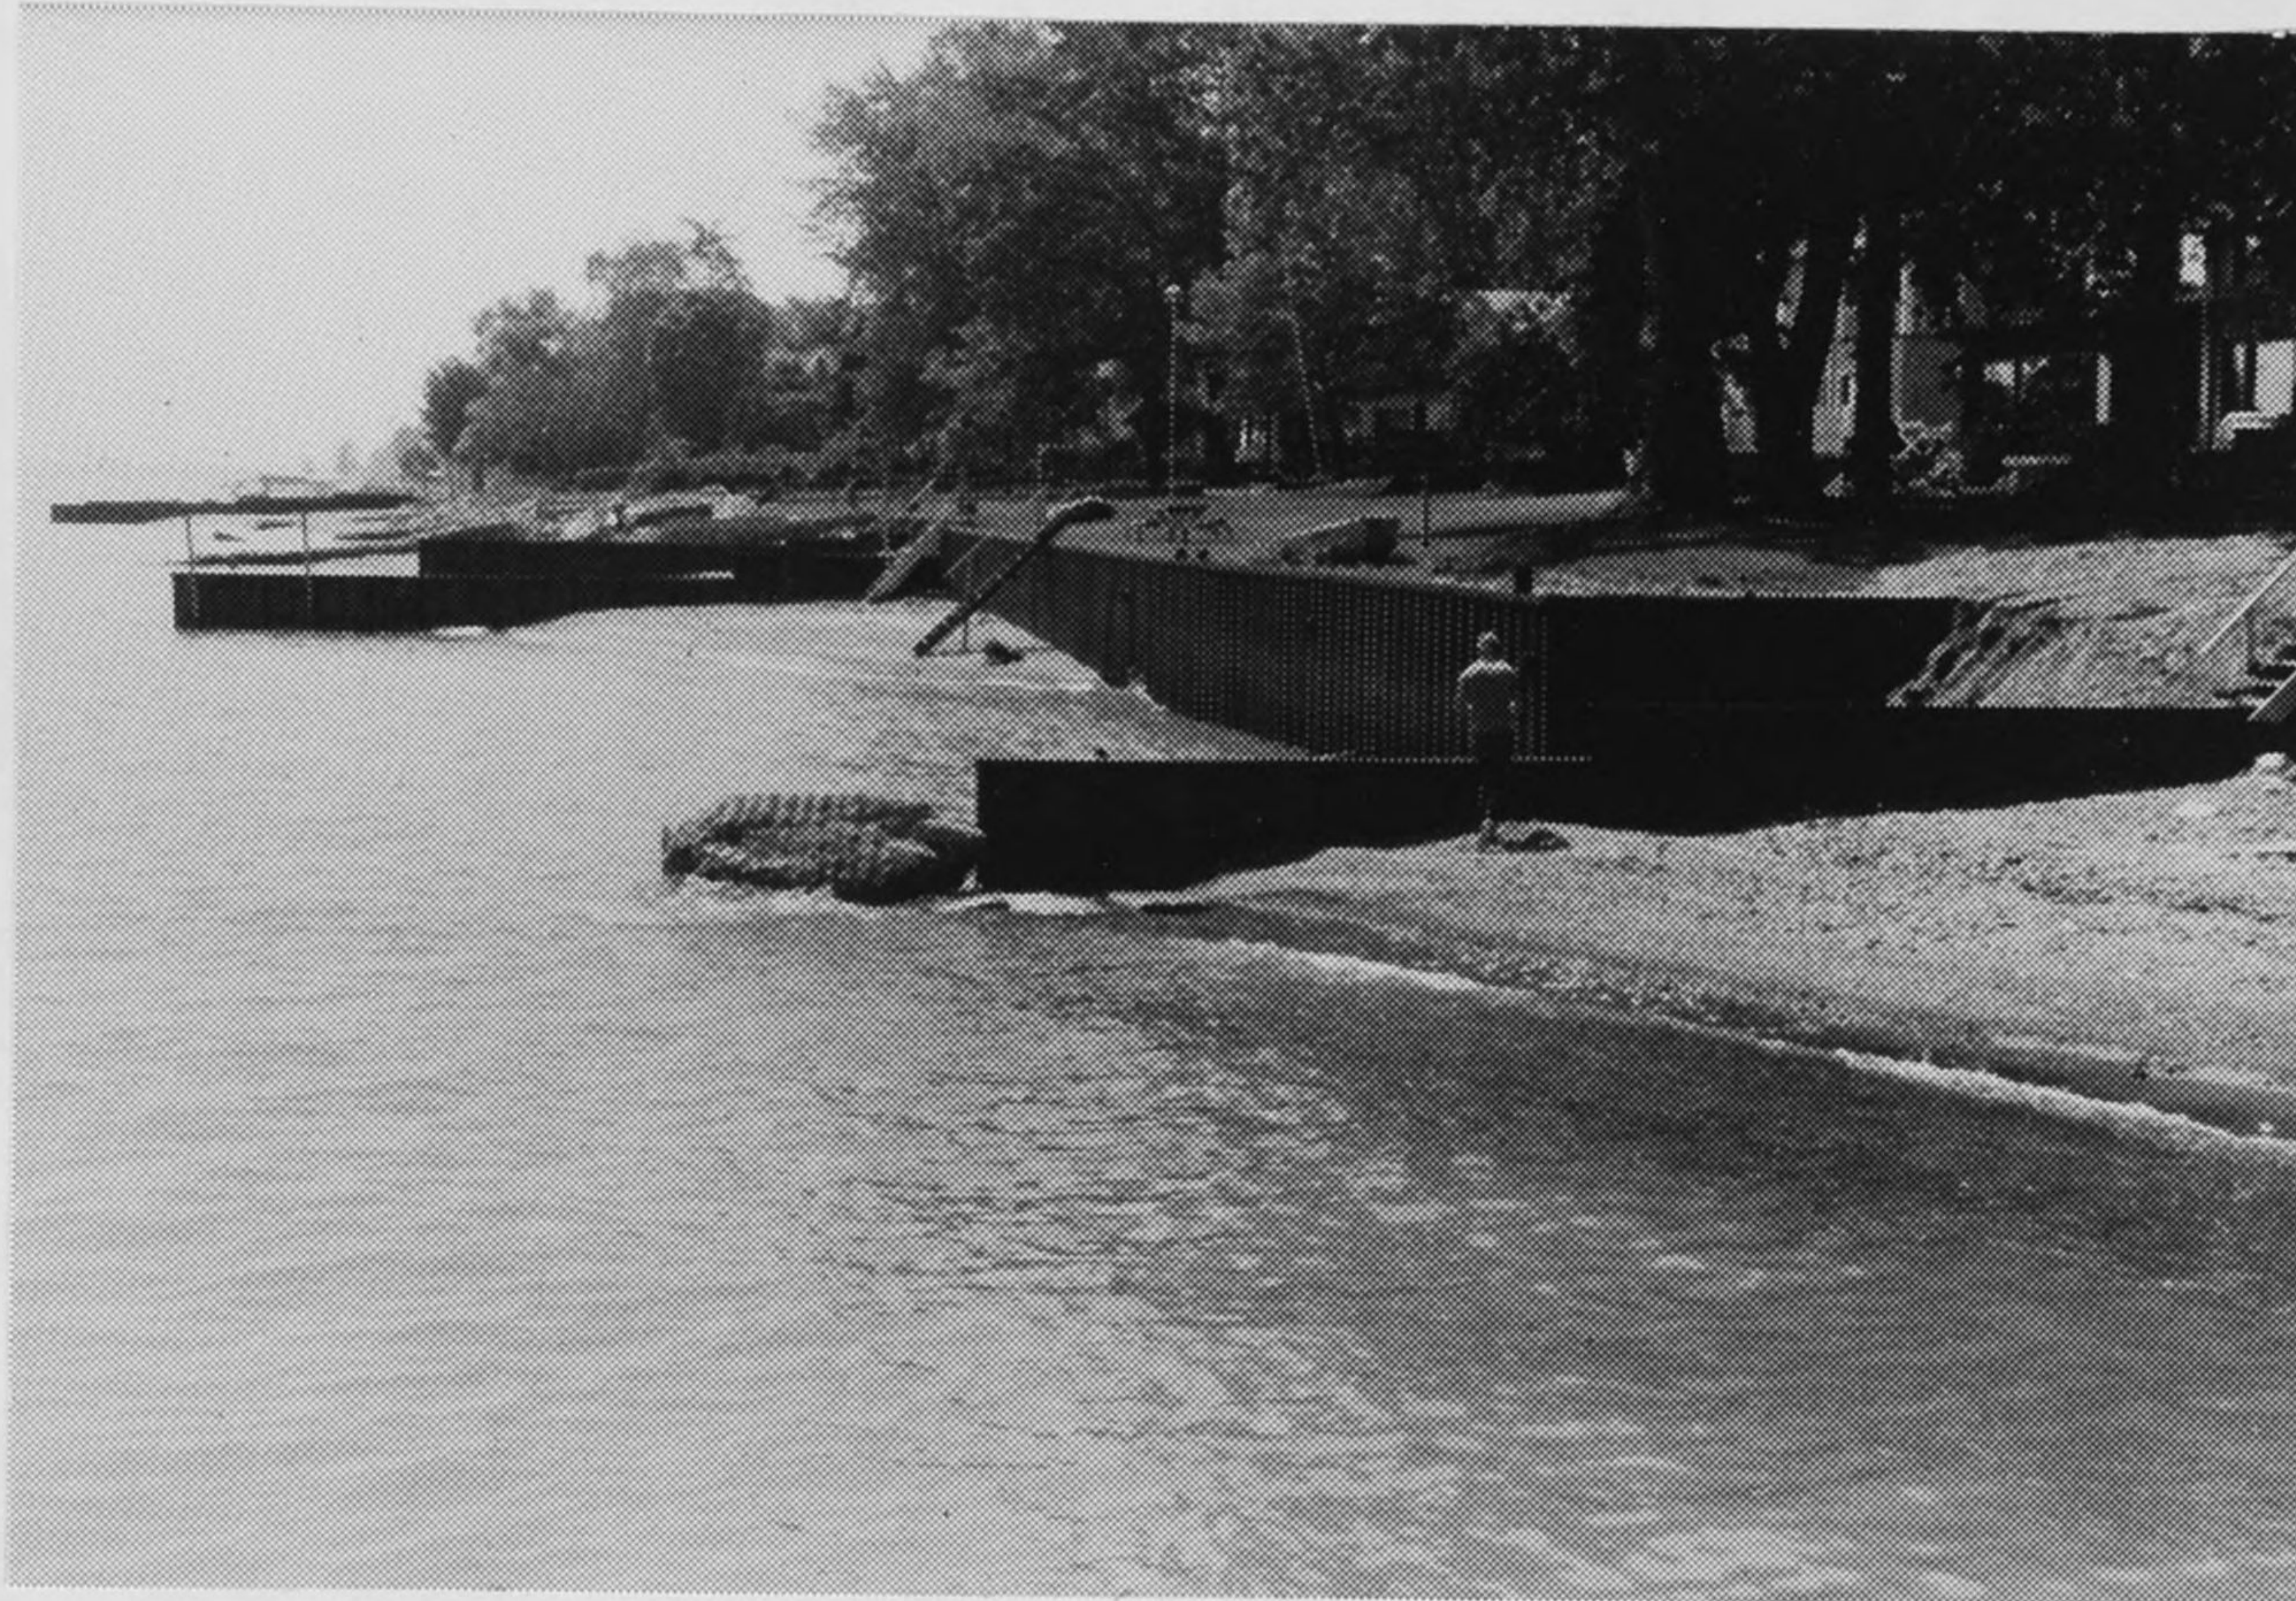
Figure B69 Site DD: Looking south across Sharpe property. Existing groin with large boulder in front is their groin. Note small sand fillet in corner of seawall-groin system immediately to the south. Also note that Sharpe groin does not project as far lakeward as the groin to the south or the groin from which the photo was taken.

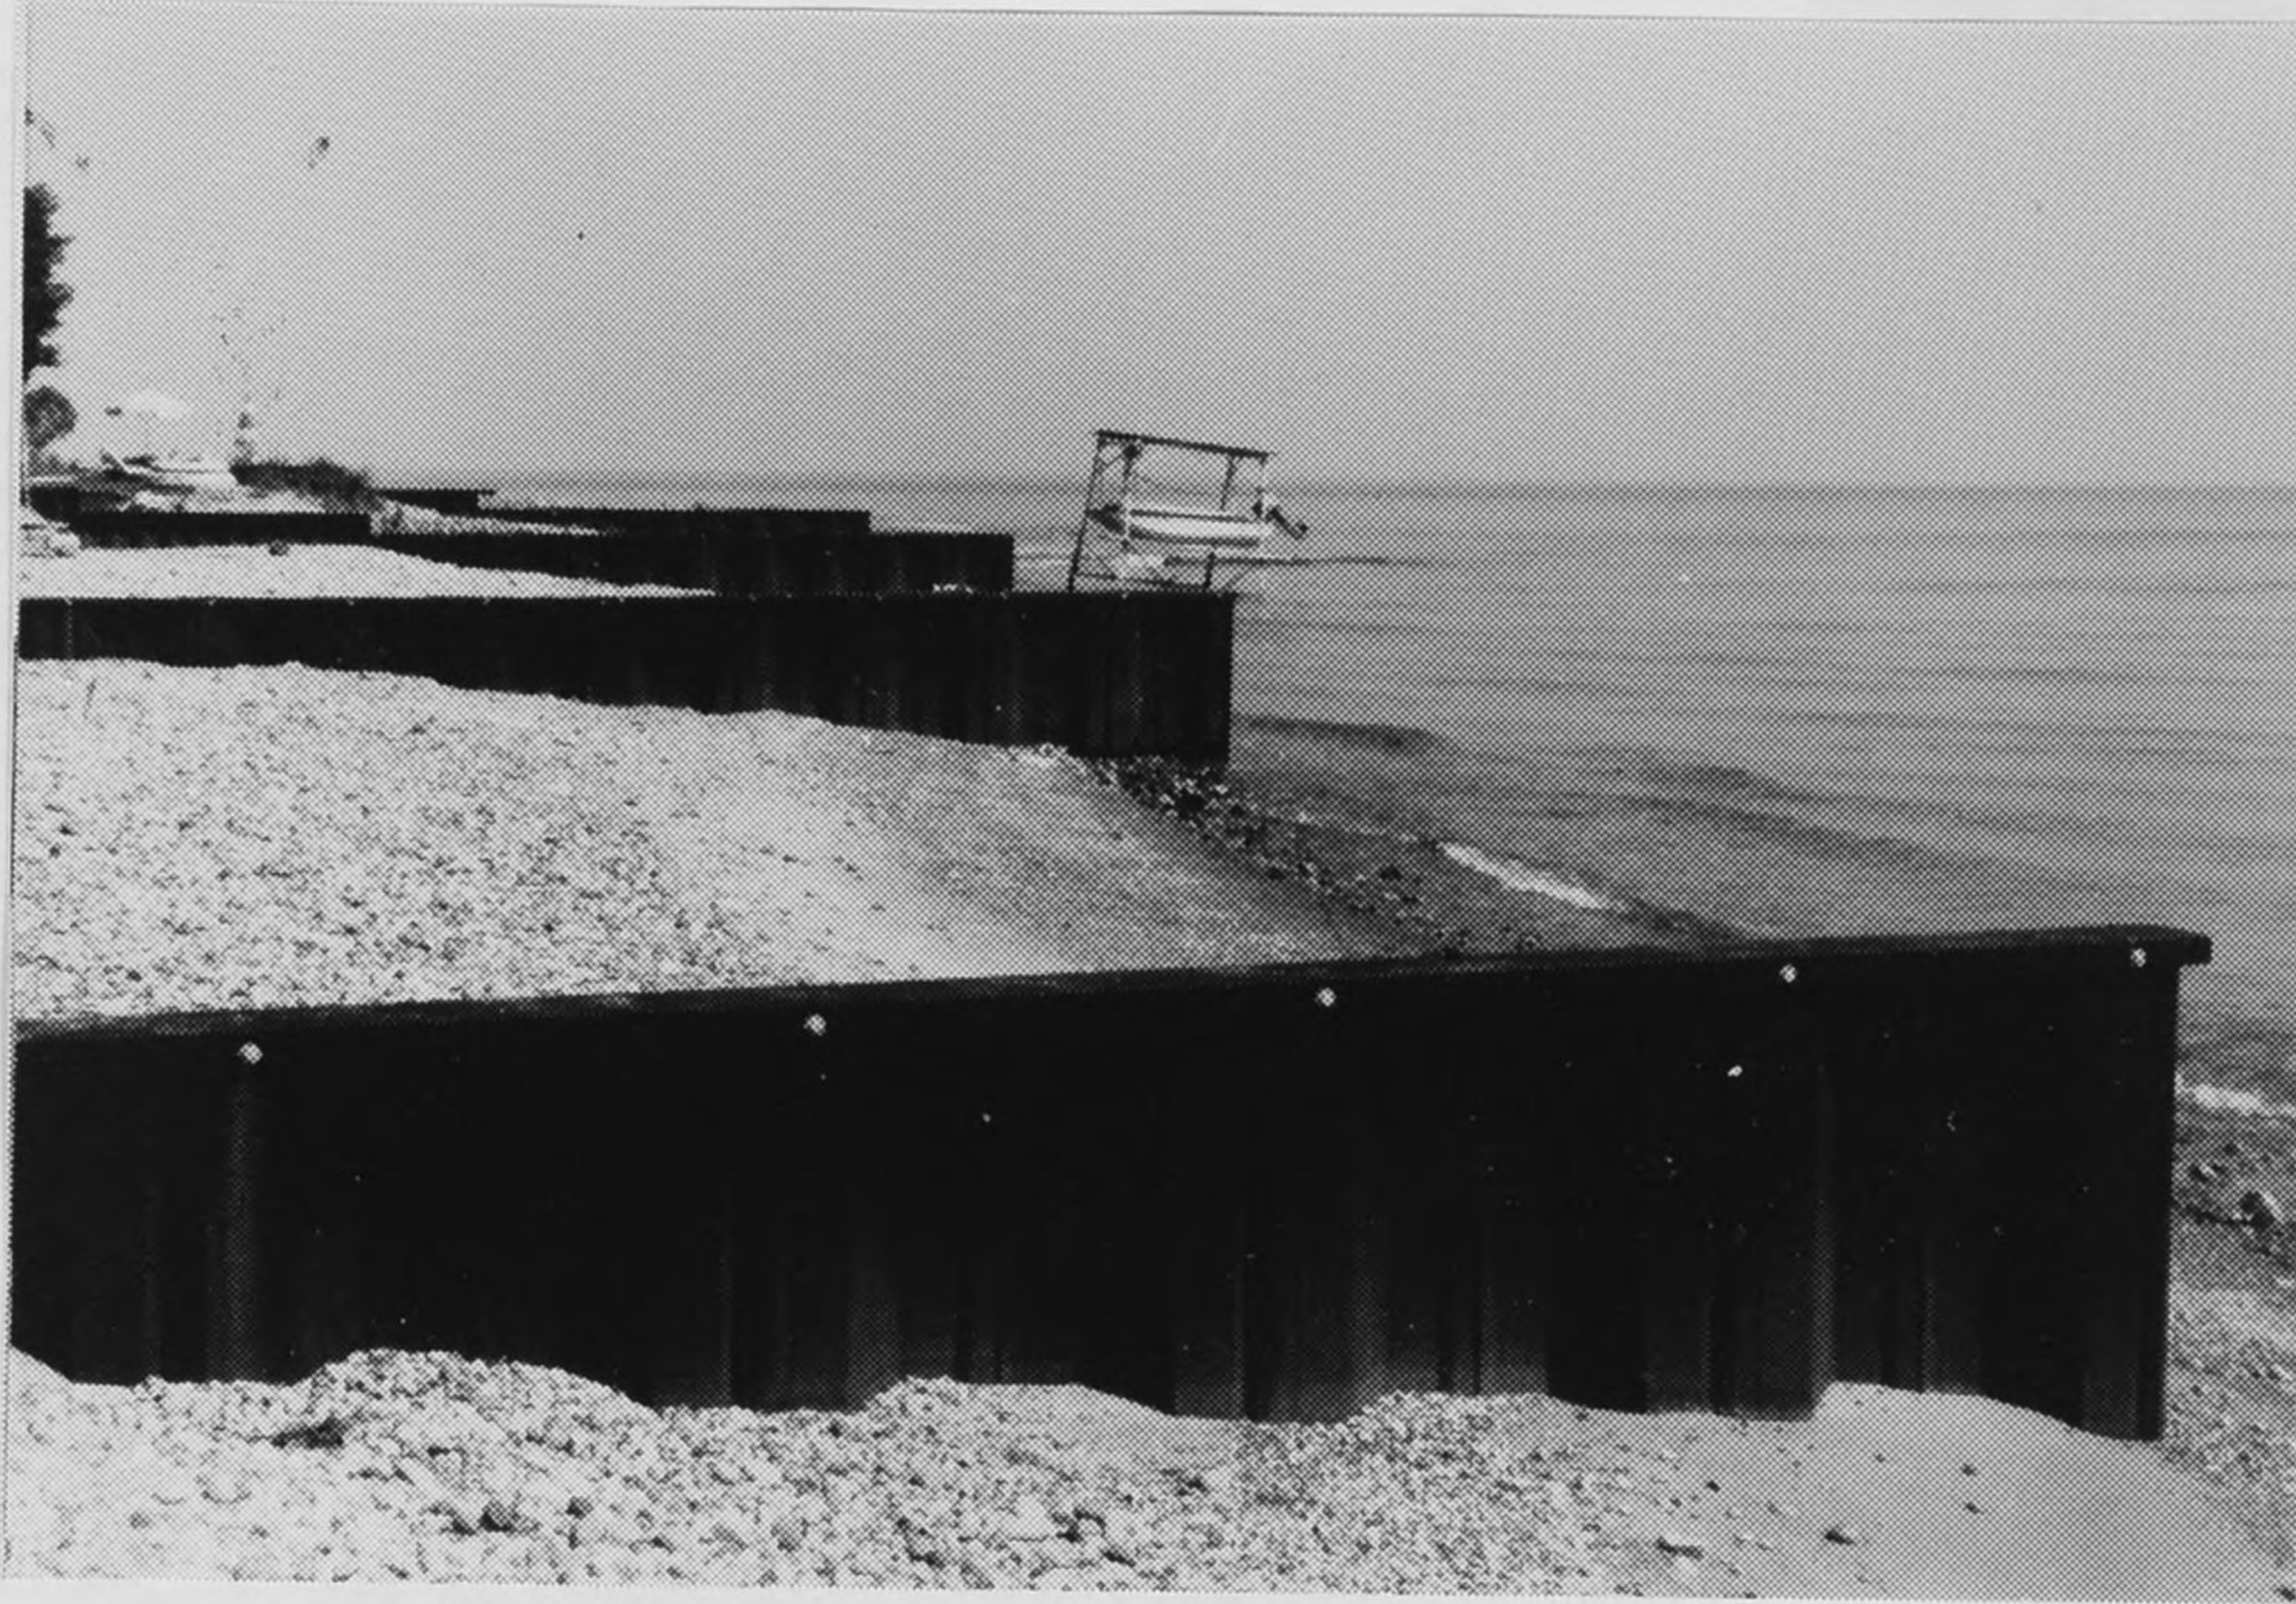
Figure B75. Site II: Looking north across system of groins from just south of property. Note beach nearly fills groin compartments and general coarse littoral material.

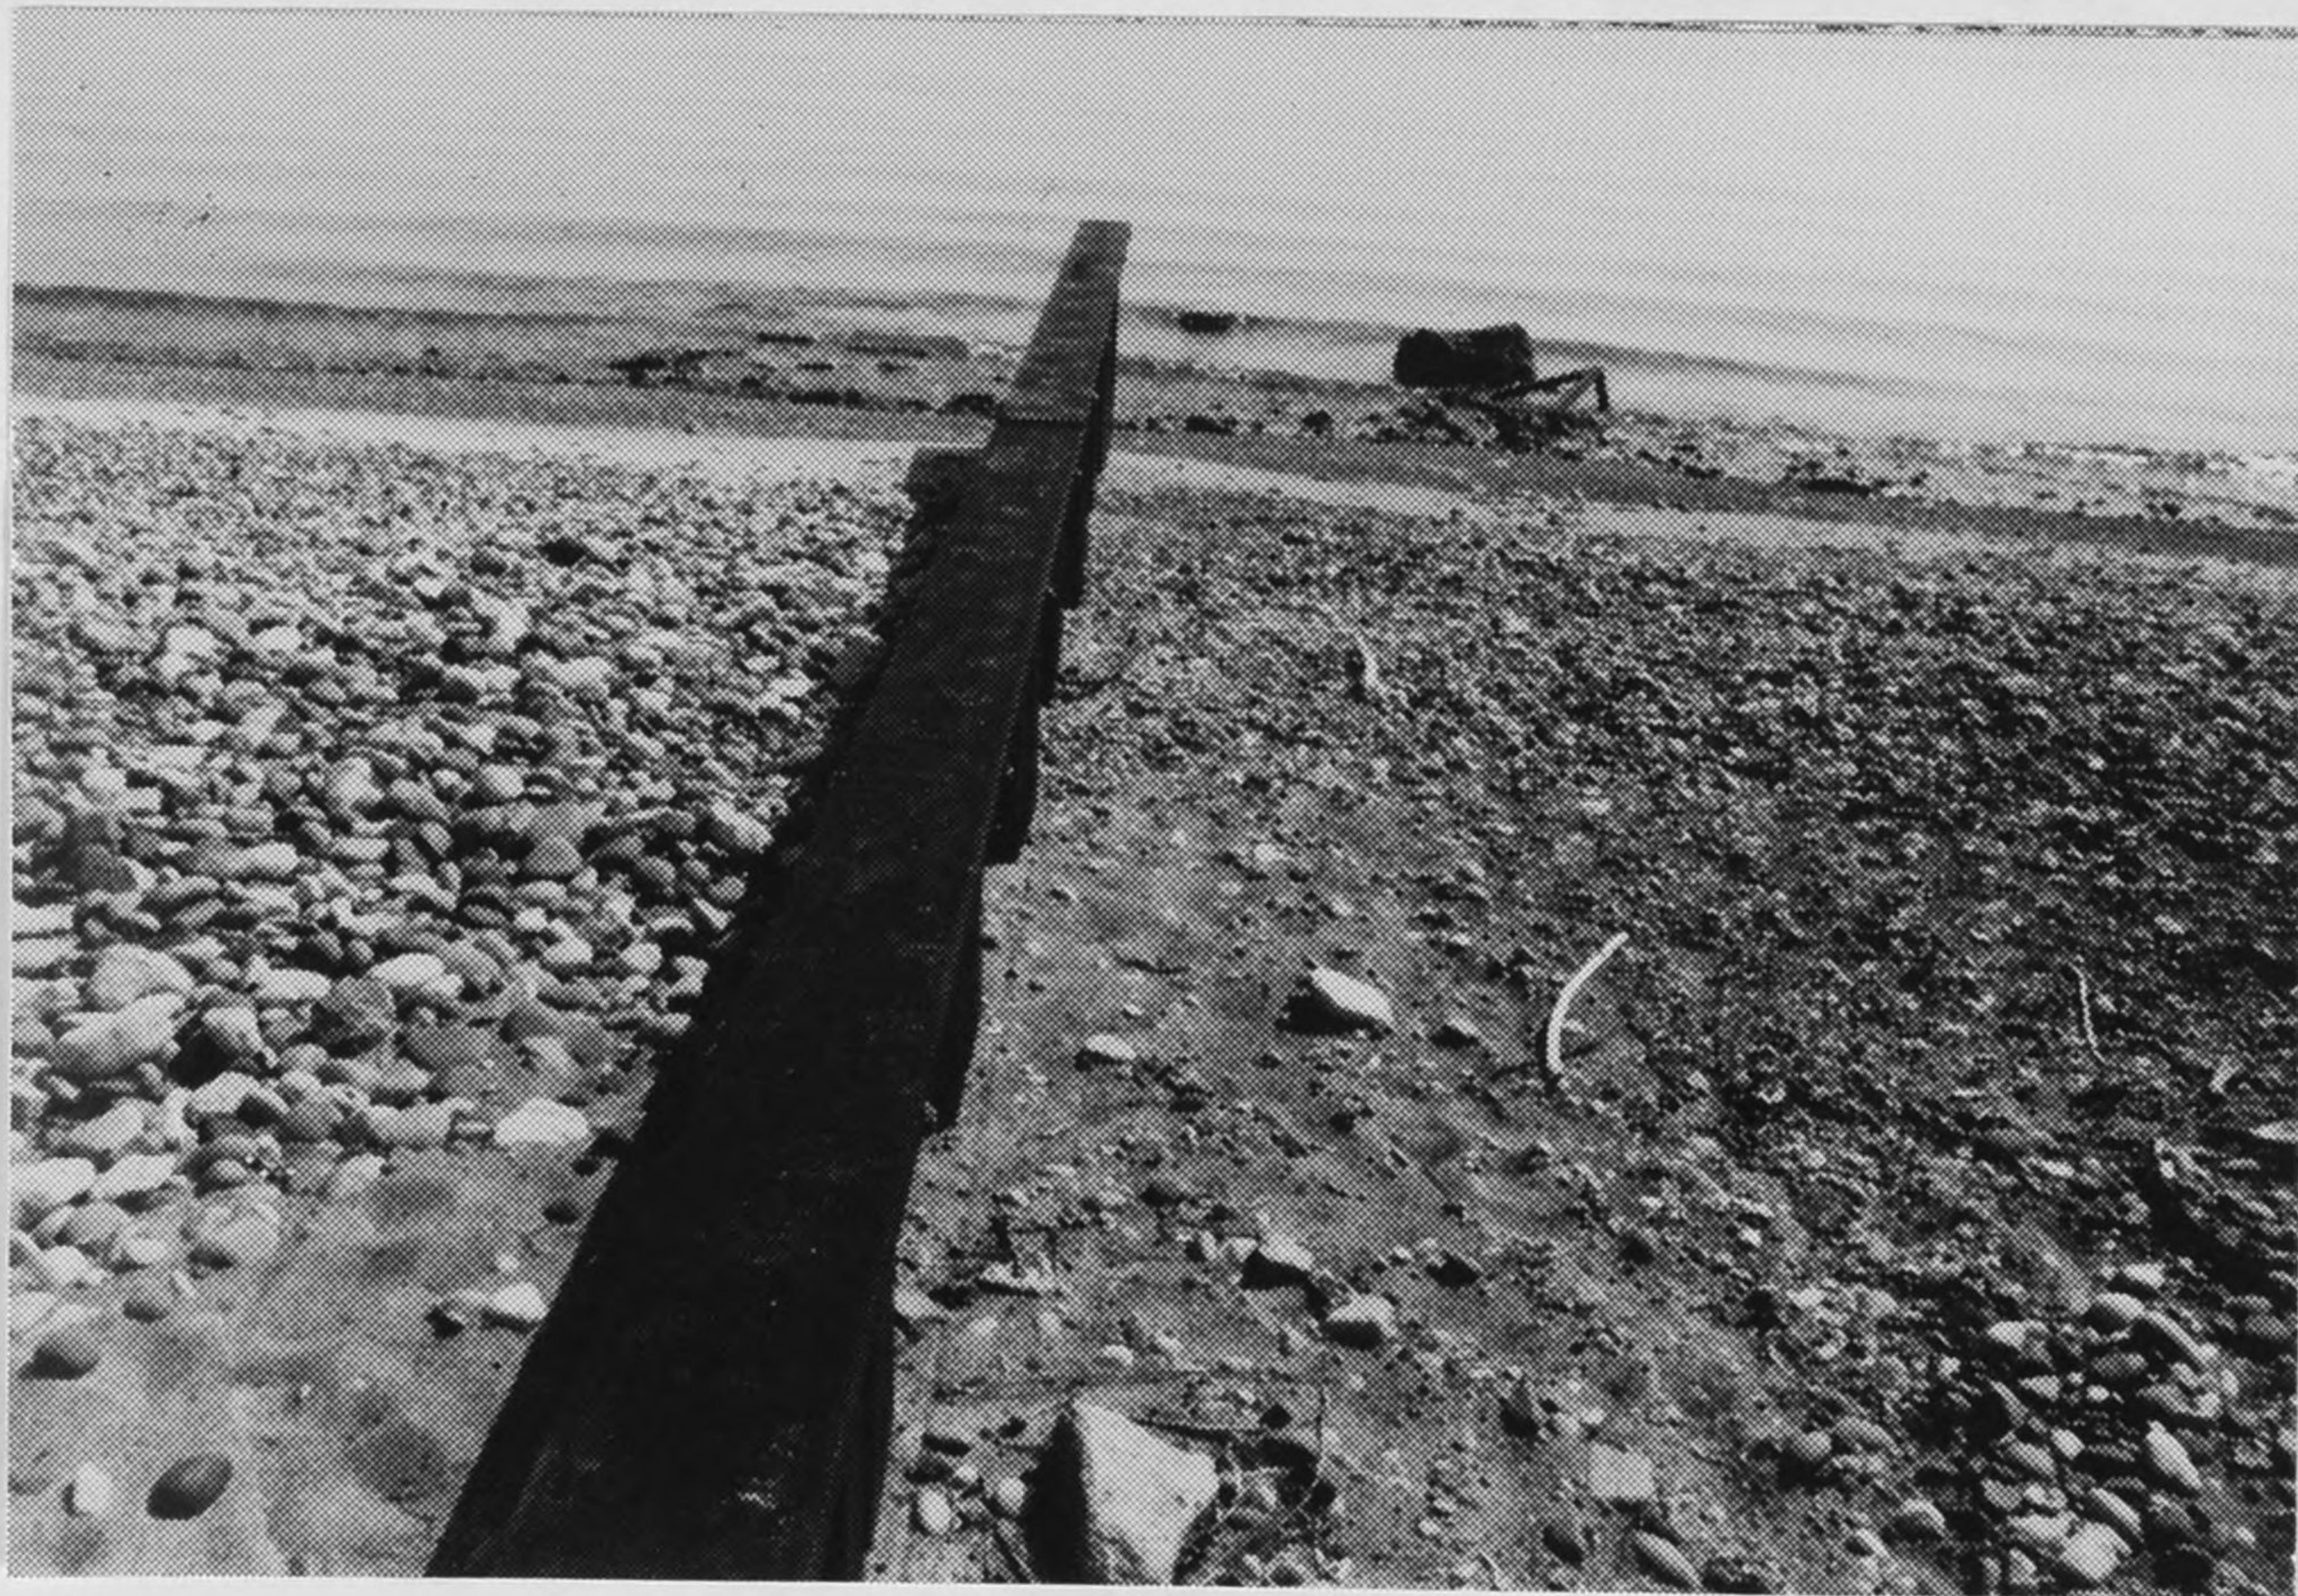
Figure B76. Site II: Looking offshore along most southern groin. Littoral drift is left to right. Note coarse cobble on updrift side of groin.
