THE ENERGY-ABSORBING STEERING COLUMN

A Study of Collision Performance
in Fatal and Nonfatal Accidents

HIGHWAY SAFETY RESEARCH INSTITUTE
The University of Michigan • Ann Arbor
1968

HSRI Report No. Bio-7

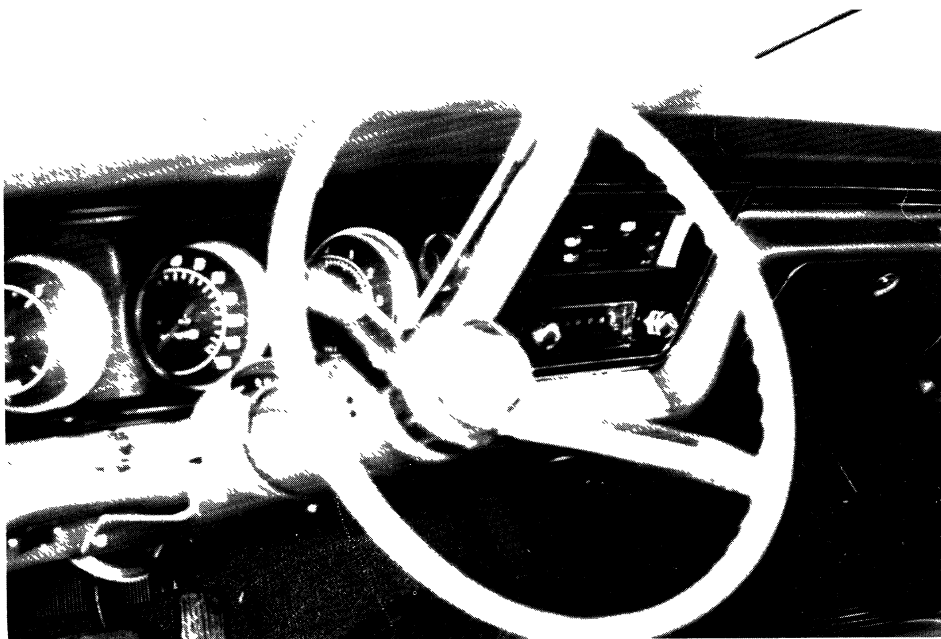
1967 Chevrolet (Figures 3 and 4). This vehicle struck a van which had turned in front of the case vehicle. The impact speed was estimated at 20-25 mph. The in-car portion of the energy-absorbing column compressed approximately $1\frac{1}{2}$ inch. The unrestrained 18-year old male driver sustained a 4 cm laceration in the left eyebrow area from steering wheel impact, a right knee abrasion (lower instrument panel), and a bruise to his right forearm (instrument panel?). (Case #182/12/8/66)

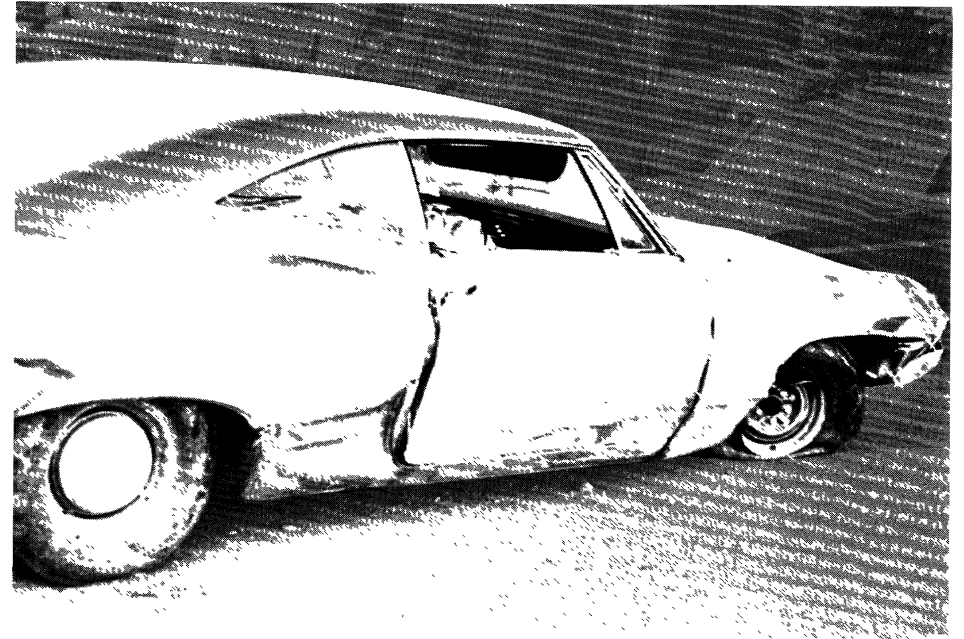
1967 Chevrolet (Figures 5 and 6). This vehicle was driven by a 21-year old male who was forced off the road into the ditch. The in-car mesh section compressed approximately $\frac{3}{4}$ inch. The right door glass was broken. The driver sustained a small ($\frac{1}{2}$ cm) laceration on the right side of his nose (steering wheel or window glass), a fracture of his nose, and a fracture of his maxilla from steering wheel impact or other interior components; he was not wearing a seat belt and was free to bounce about in the car.

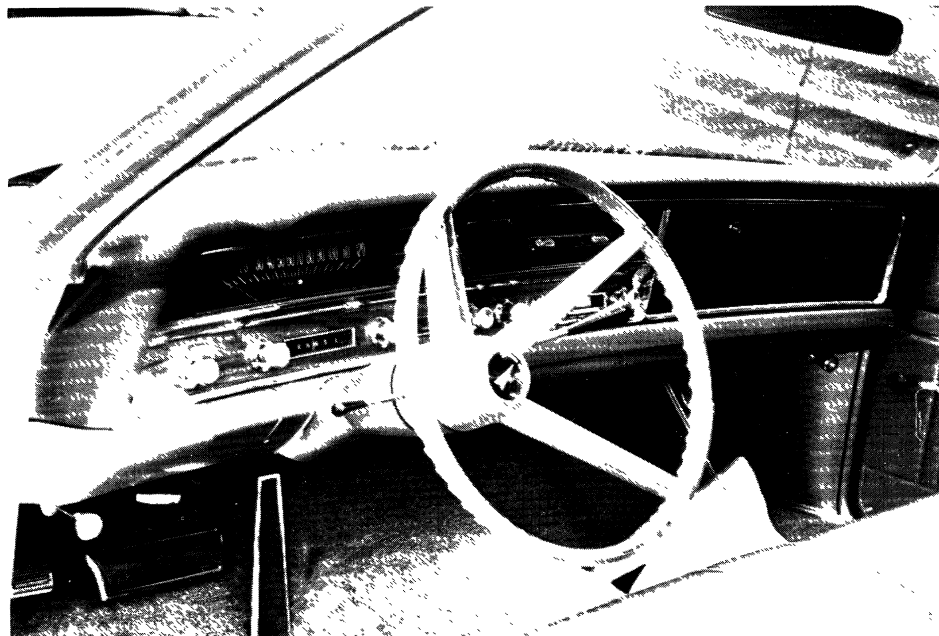
8

1967 Pontiac (Figures 7 and 8). This vehicle was driven by a 28-year old female (5 ft, 6 in., 143 lb), who was not wearing a seat belt because she was 7 months pregnant. The car had just started up from a parking space when it hit a parked car at an impact speed of approximately 15-20 mph. The driver struck the wheel and compressed the column approximately $\frac{1}{2}$ inch. She lacerated her lower lip and loosened a tooth (steering wheel) and had a right knee bruise (lower instrument panel). She also recalls hitting the steering wheel with her abdomen but did not have any bruises from this impact. Two months later, she delivered a normal, healthy baby.

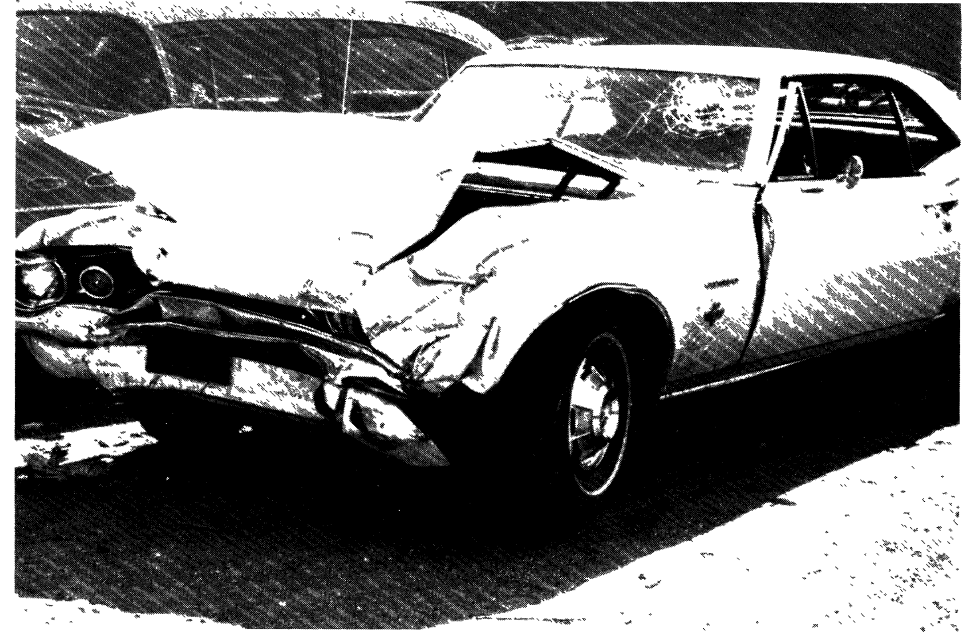
1967 Camaro (Figures 9 and 10). This is an intersection collision at an approximate impact speed of 30 mph. The 16-year old male driver (5ft, 7 in., 200 lb) sustained a 4 cm chin laceration from striking the steering wheel. The in-car portion of the energy-absorbing column was compressed 4 inches. No complaints of specific chest or abdominal injuries were indicated. The driver sustained small scratches in the hairline (windshield) and had a sore neck (rear passenger and seat back impact). He complained of a bruised, stiff left knee and stated that he was "sore all over."
(Case #227/6/11/67)

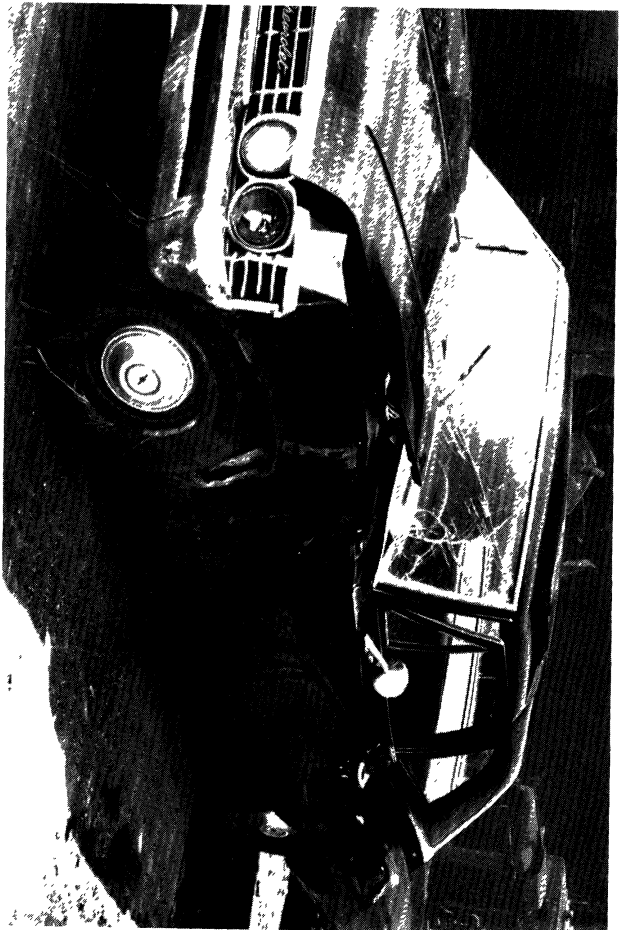
1967 Chevrolet (Figures 11 and 12). This vehicle, driven by a 21-year old male, went out of control and into a ditch after the unrestrained driver fell asleep. The vehicle rolled onto its left side. The left door window glass was broken. There was in-car column compression of approximately $\frac{3}{4}$ inch. The steering wheel was not deformed; no injuries to the chest or abdomen were noted from steering wheel impact. The driver sustained abrasions of both forearms (steering wheel, door?), fracture of the fourth metacarpal of the right hand (source unknown), abrasions of the left temporal area of the head (steering wheel, door?), and a 2 cm laceration of the eyelid (window glass).
(Case #239/8/4/67)

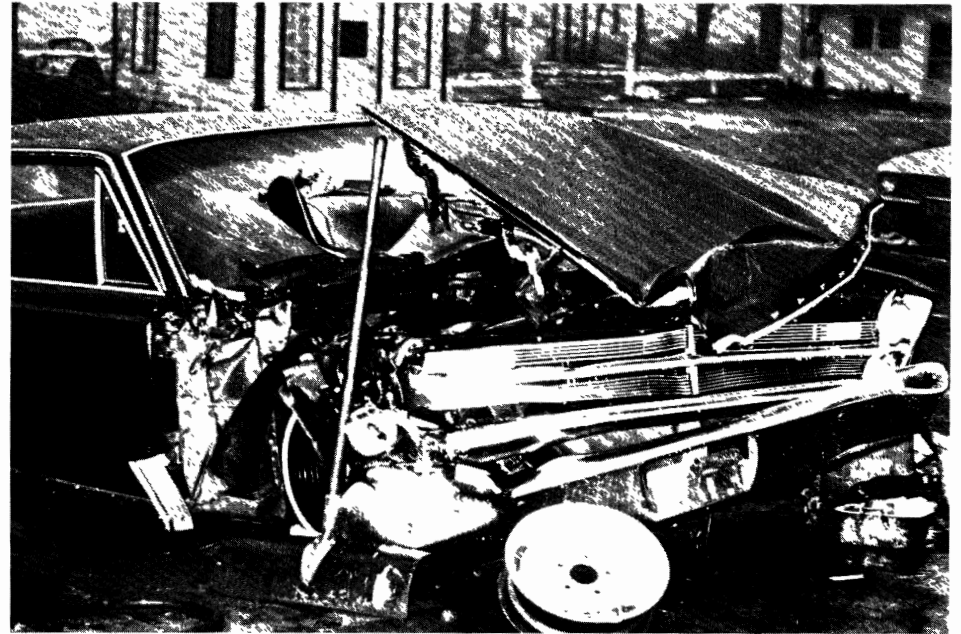
1967 Plymouth (Figures 13 and 14). This vehicle, driven by a 22-year old male, went off the roadway and struck two trees when the driver fell asleep. The unrestrained driver struck his chest on the steering wheel, compressing the column $\frac{1}{2}$ inch; he did not have any chest pain or injuries related to this impact. Both knees were bruised from instrument panel impact.
(Case #174/11/24/66)

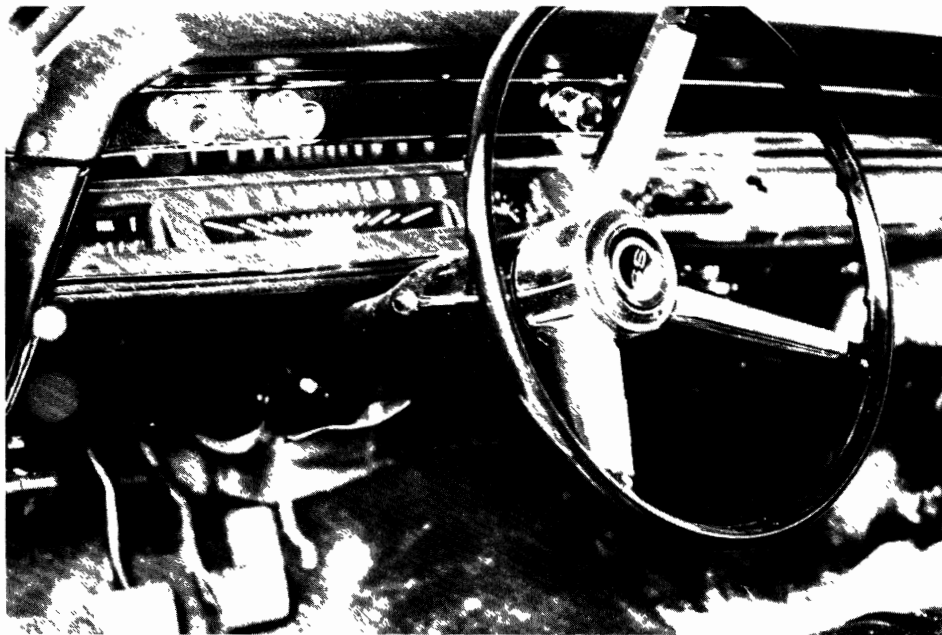
16

1967 Chevelle (Figures 15 and 16). This is an intersection collision at approximately 25 mph. There was no compression of the energy-absorbing column. The 25-year old driver complained of chest pain (steering wheel), a bump on the head (rear view mirror), and a bruised left knee (lower instrument panel).
(Case #202/3/9/67)

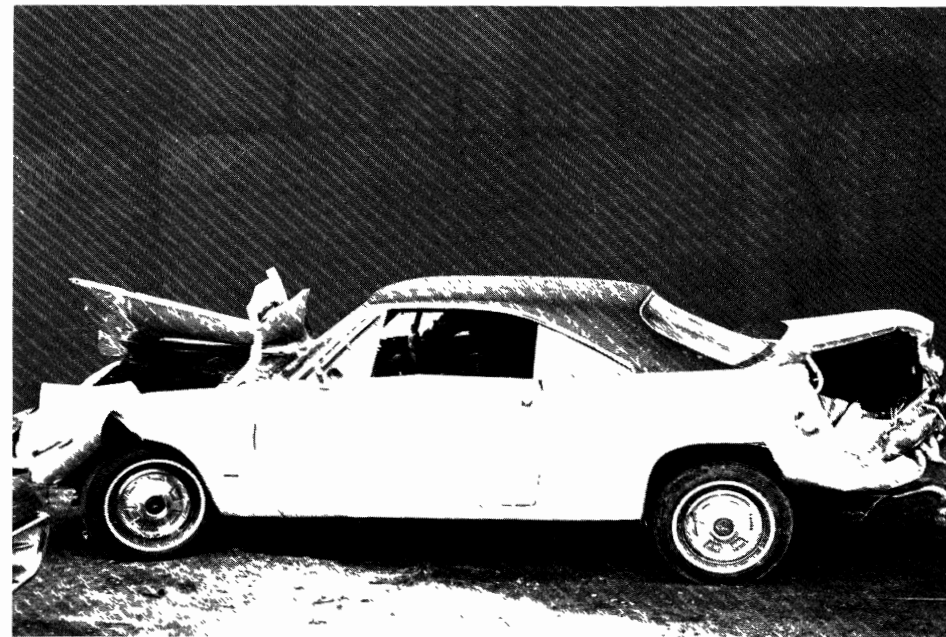
1967 Barracuda (Figures 17 and 18). This vehicle went off the roadway on a curve and flipped over, damaging both the front and rear ends. The in-car energy-absorbing column compressed approximately $\frac{1}{2}$ inch. There was some slight separation of the column from its instrument panel mounting. The 40-year old male driver, who was unrestrained, sustained facial abrasions and multiple small scalp lacerations (windshield), multiple body abrasions, and a fracture of the right tibia. He had no specific injury that could be related to steering wheel-column impact.
(Case #216/4/18/67)

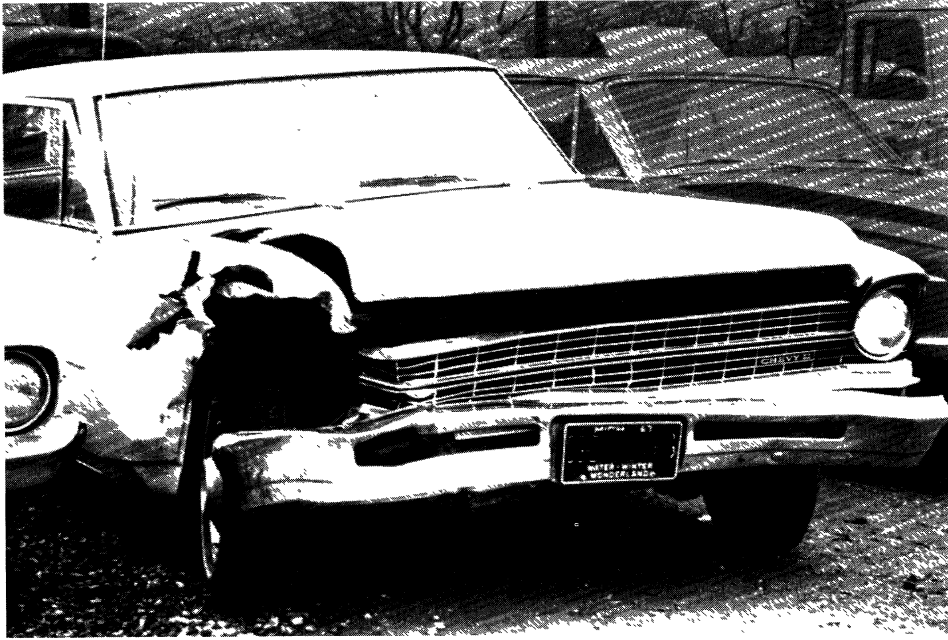
1967 Chevy II (Figures 19 and 20). This vehicle struck the rear of another car. The unrestrained 61-year old male driver had a contusion of the anterior chest wall from steering wheel impact. Two of the three wheel spokes were cracked at their attachment to the hub of the steering column. No compression of the mesh section of the column was noted.

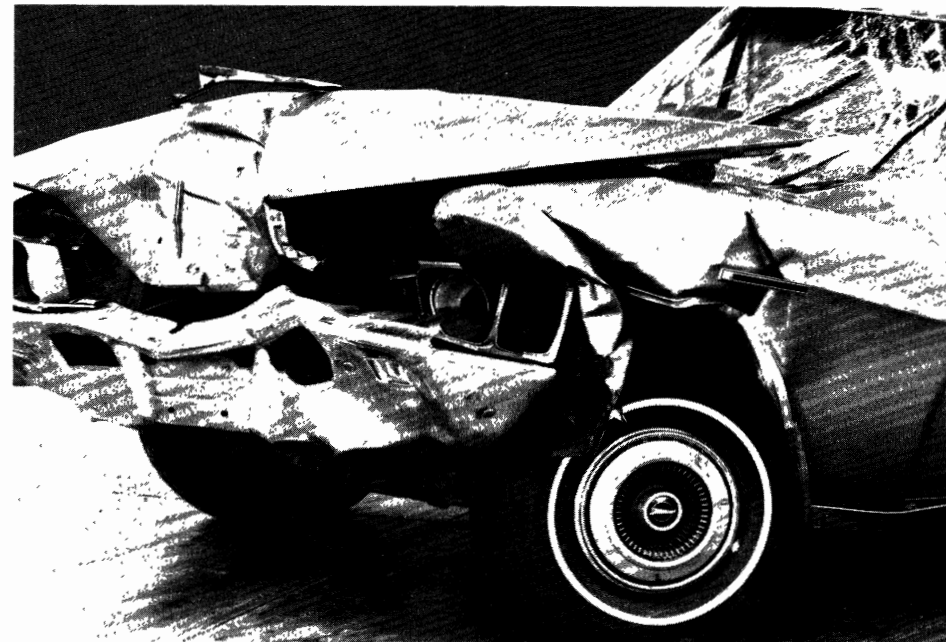
1967 Buick (Figures 21 and 22). This station wagon struck the rear of a foreign-made station wagon at approximately 60 mph. The 30-year old male driver (6 ft, 175 lb) was wearing a seat belt. He sustained a 1-inch laceration of the lower lip and gingiva, and had a sore chest. These injuries were sustained by steering wheel impact. The energy-absorbing mesh section compressed 3 inches and the underhood unit telescoped $3\frac{3}{4}$ inches. Abdominal bruising from the seat belt was noted. Right leg bruises were sustained by lower instrument panel contact.

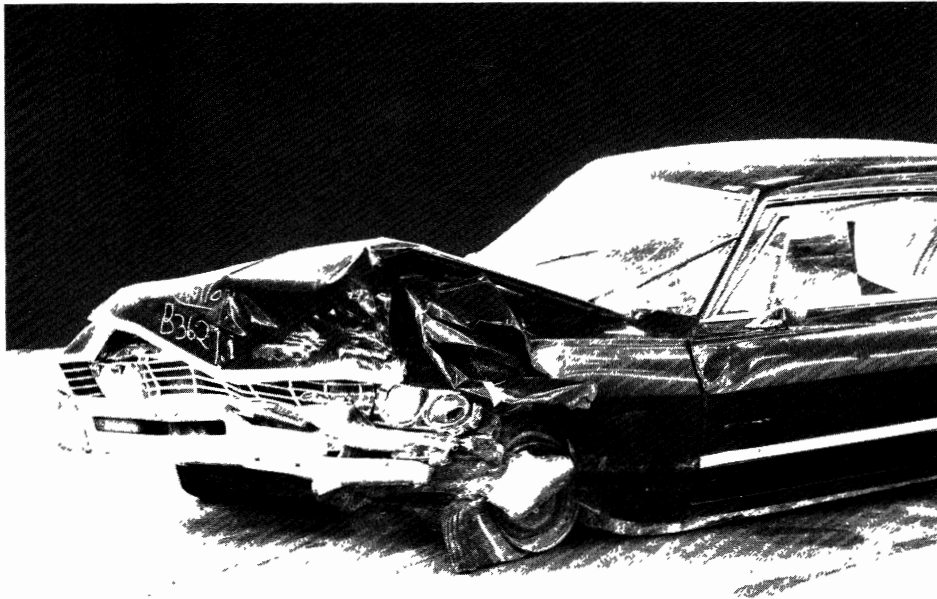
1967 Chevrolet (Figures 23 and 24). This car struck another, head-on, at 30-35 mph. The unrestrained 45-year old male driver (5 ft, 8 in., 180 lb) sustained two rib fractures, a laceration, and possible fracture of the nose from steering wheel impact. The in-car mesh section column compressed $4\frac{1}{4}$ inches. (Case #285/12/18/67)

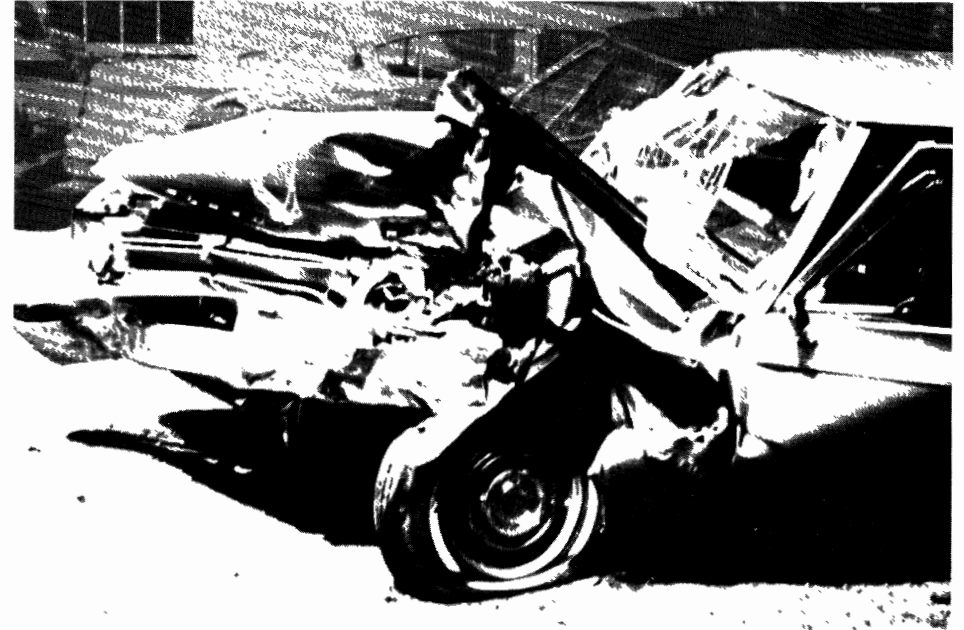
1964 Oldsmobile F-85 (Figures 25 and 26). This vehicle struck the 1967 Chevrolet shown in Figures 59, 60, and 61. The 50-year old male driver was not wearing a seat belt. He sustained lacerations to the chin and neck area (steering wheel rim and/or windshield) and fractures of several ribs. In addition, he had an injury to the colon, requiring exploratory surgery, and fractured his left tibia. The imprint of the horn button was still visible on the anterior chest wall 7 months after the accident.

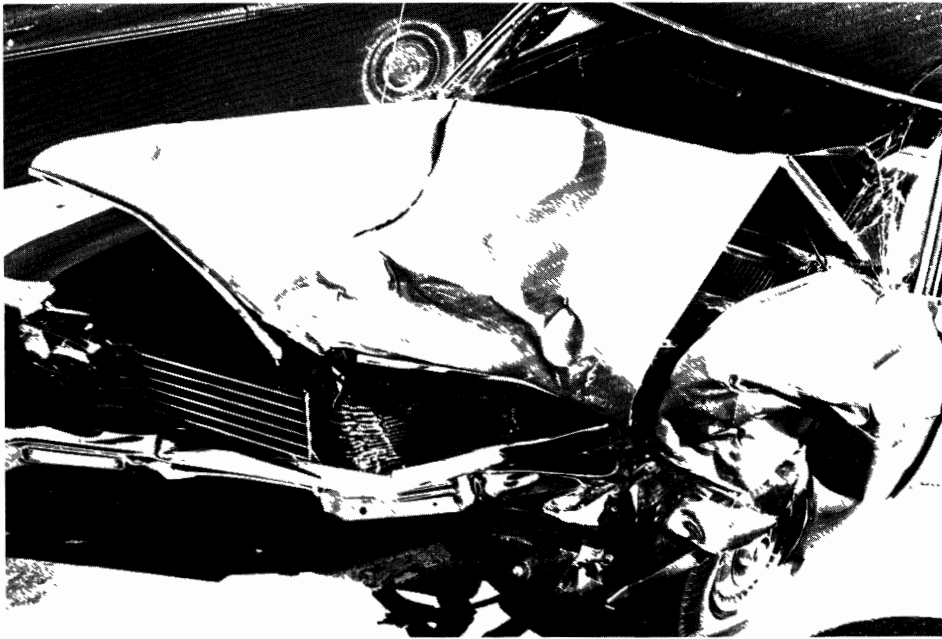
1967 Buick (Figures 27 and 28). This was a head-on glancing collision where the subject vehicle was almost stopped (5 mph) and the other car was traveling at 50 mph at impact. The 55-year old male driver (6 ft, 1 in., 175 lb) was wearing a lap seat belt; he fractured his nasal cartilage and had upper abdominal bruising from steering wheel impact. The mesh section of the column compressed $1\frac{3}{4}$ inches. He also had seat-belt bruises on the iliac crests; both legs were bruised (lower instrument panel) and minor lacerations of his left leg were noted (instrument panel or side wall beneath panel).
(Case #248/8/25/67)

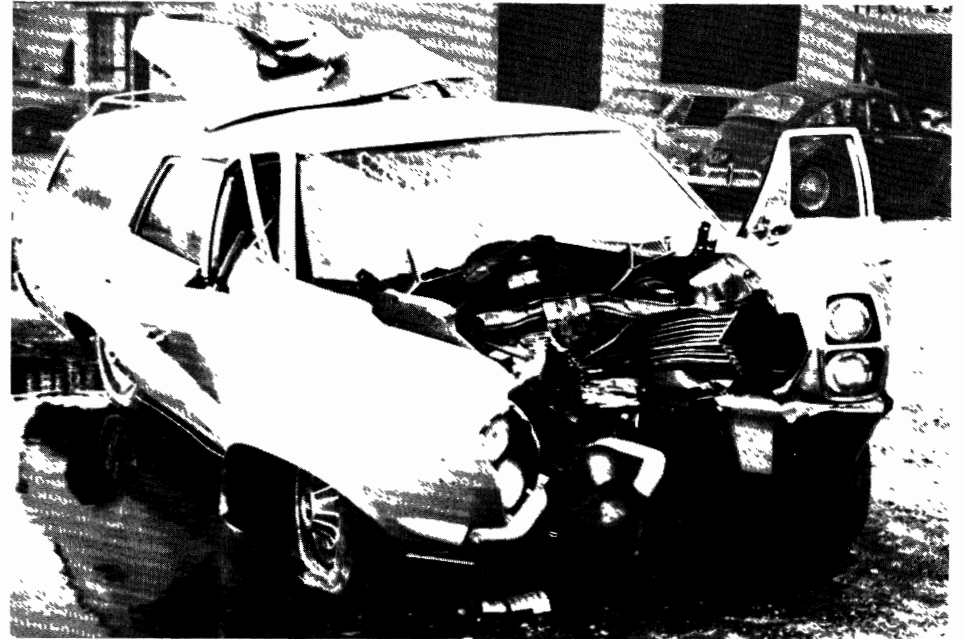
1967 Ambassador Station Wagon (Figures 29 and 30). This vehicle went off the right side of the road and hit a tree 50 feet off the road's edge, at an impact speed of 40 mph. The 17-year old male driver wore a seat belt but did not have belt bruises. He had chest bruises from steering wheel impact; the mesh section of the column compressed 1¾ inches; the underhood section also telescoped, but an accurate measurement could not be obtained. The driver had a small laceration near the hairline (sun visor-header), a fracture of his right patella (lower instrument panel), and a fracture of his right hand (instrument panel?).
(Case #270/11/4/67)

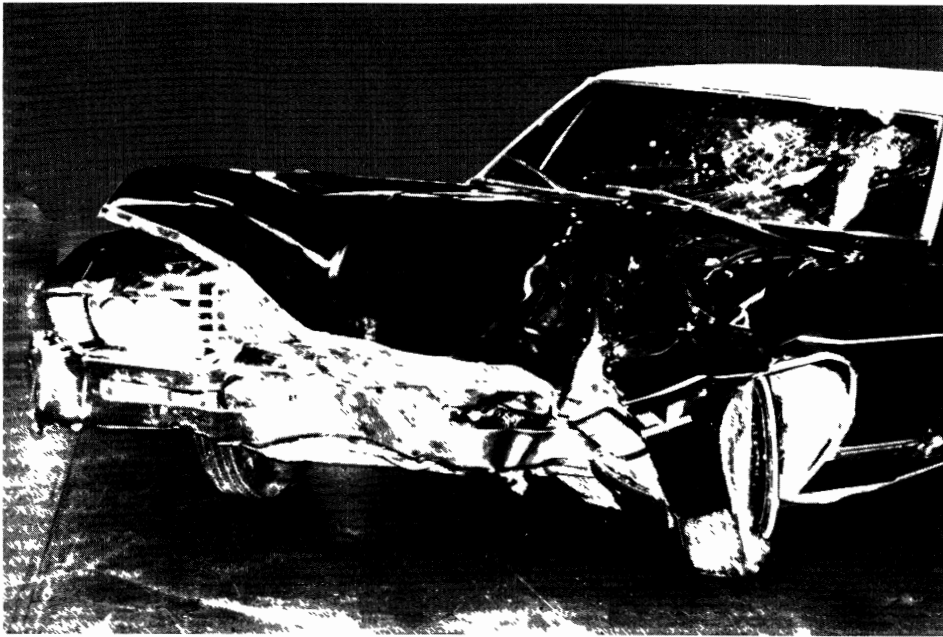
1967 Chevrolet (Figures 31 and 32). This car hit a tree at an estimated speed of 25 mph. The 30-year old female driver was not wearing a seat belt. She sustained a sore chest from steering wheel impact and also had a small laceration to her eyebrow from windshield or steering rim contact. The mesh section compressed $4\frac{3}{4}$ inches. (Case #252/8/23/67)

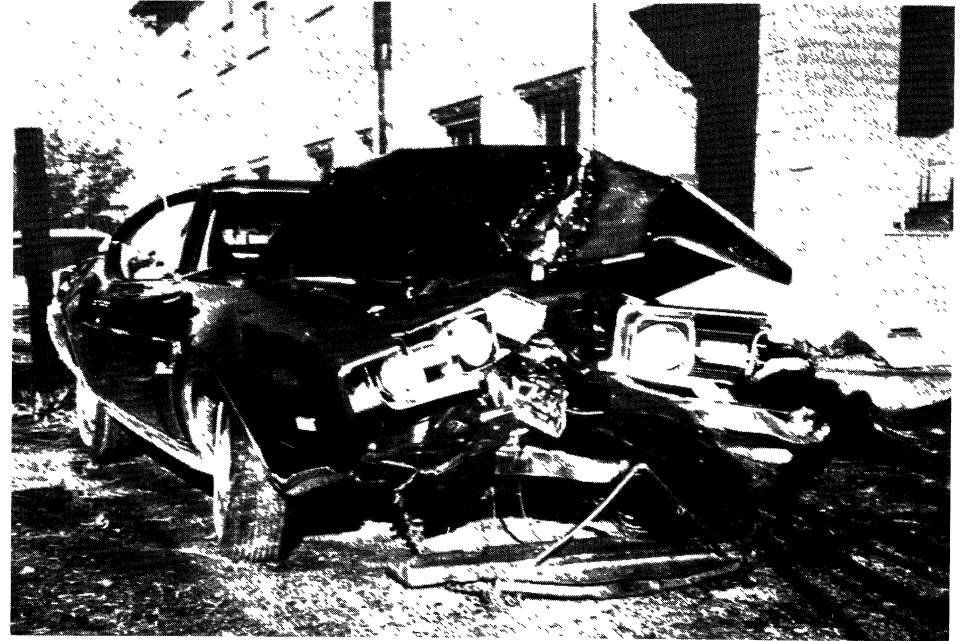
1968 Oldsmobile Cutlass (Figures 33 and 34). The driver of this car fell asleep; the vehicle went off the left side of the road and hit a tree at 35 mph. The unrestrained 27-year old male driver (5 ft, 10 in., 155 lb) struck the steering wheel (sore chest); the mesh section compressed 3 inches and the underhood section telescoped 4 inches. He also sustained a laceration above the right eye (windshield) and a left knee bruise (lower instrument panel).
(Case #264/9/24/67)

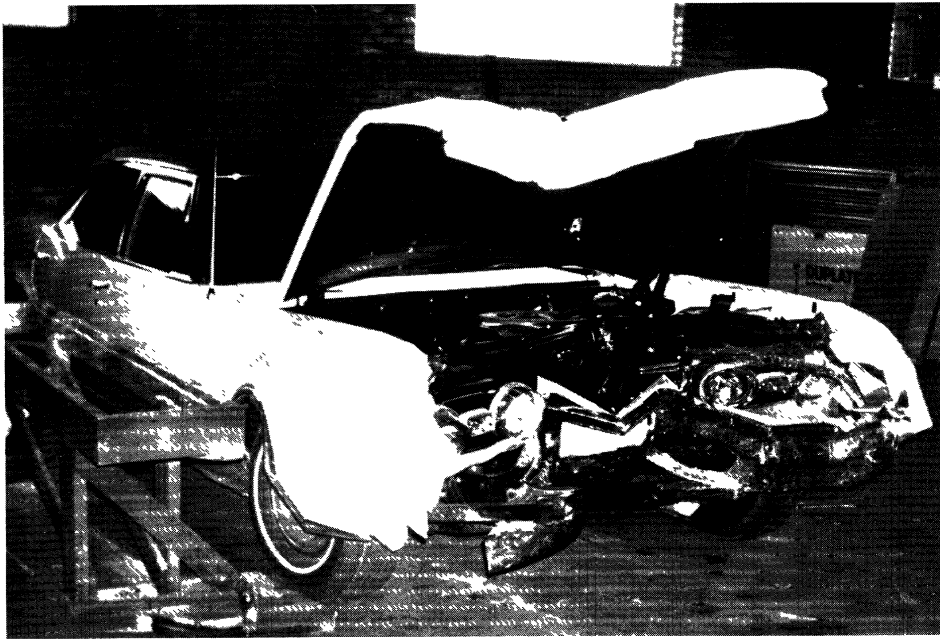
1967 Oldsmobile Delta 88 (Figures 35 and 36). This car struck another at an equivalent car-to-car speed of 25 mph. The 37-year old female driver (5 ft, 6 in.) was wearing her seat belt loosely at the time of impact. She sustained a sore chest from striking the steering wheel. She compressed the mesh section 2 inches; the underhood section telescoped $3\frac{1}{4}$ inches. She was unconscious for approximately 5 minutes and had a large bruise on her forehead from sun visor-header impact.

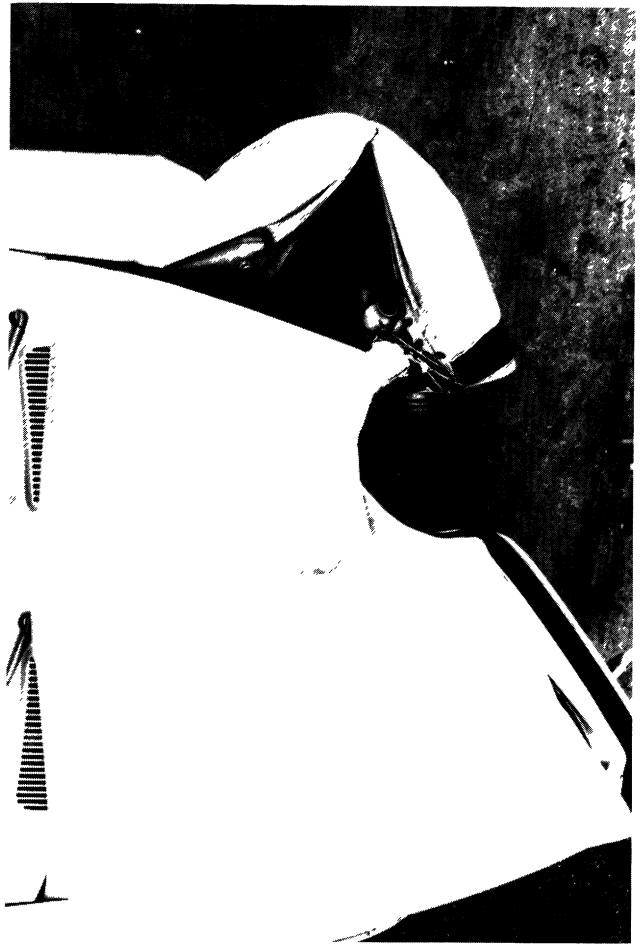
38

1967 Camaro (Figures 37, 38, 39, and 40). On a clear afternoon on a straight road, a 20-year old male driver (5 ft, 10 in., 180 lb) swerved to avoid another vehicle headed toward him. His Camaro went off the roadway and struck a utility pole at an impact speed of 25 mph. The column compressed about 1½ inches from the impact of the occupant with the steering wheel and another 7 inches because of vehicle deformation, for a total column compression of 8½ inches. The wheel rim was bent. The lap-seat belted driver sustained forehead and nasal abrasions and right chest bruises from steering wheel impact. His lower back was sore on both sides; he had a seat-belt bruise across his lower abdominal area. Instrument panel contact produced superficial abrasions of both legs. His right ankle was sprained. (Case #UM-20-68)

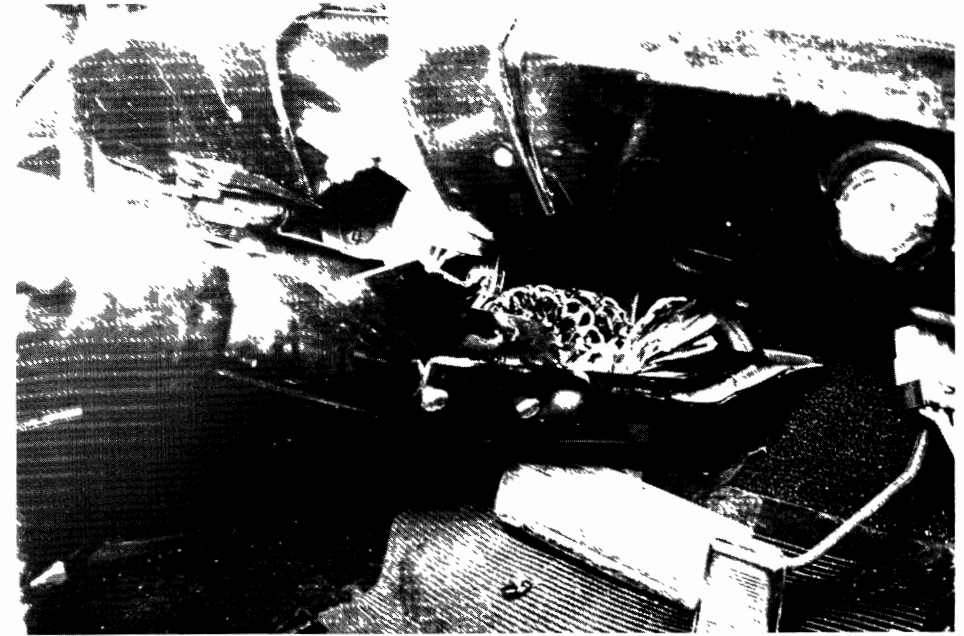
43

1967 Pontiac (Figures 41, 42, and 43). This vehicle "ran out of road" and hit a clump of trees at an estimated speed of 40-45 mph. The 40-year old male driver (5 ft, 10 in., 170 lb) sustained a laceration across his forehead (steering wheel), chest bruises (steering wheel and column), and a fracture of the right leg above the ankle. He was wearing a lap seat belt. The in-car energy-absorbing mesh section compressed 8 inches. The upper half of the wheel was markedly bent forward.

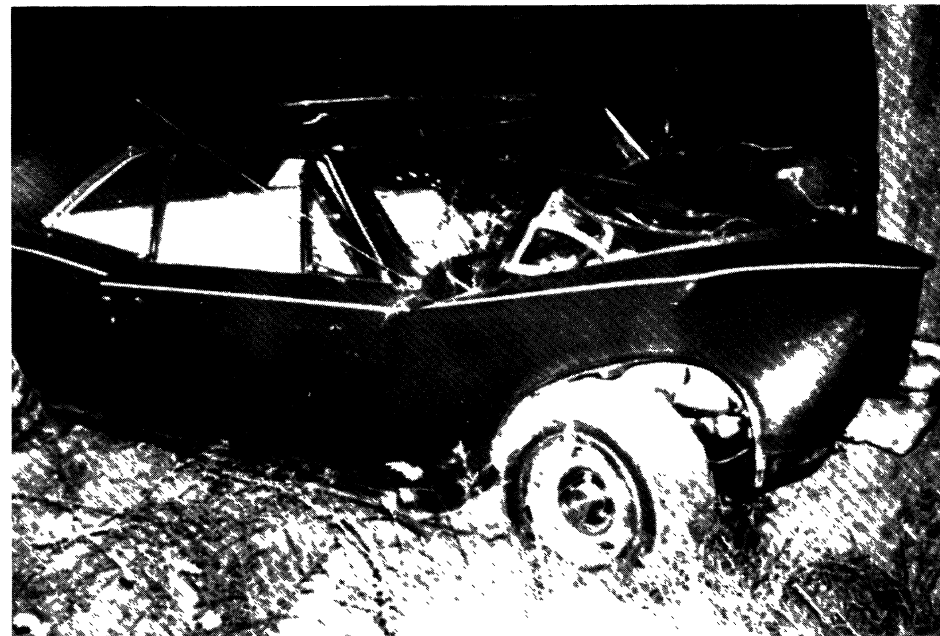
50

1967 Pontiac GTO (Figures 50, 51, and 52). This vehicle left the roadway and struck a 32-inch diameter tree at an estimated impact speed of 45-50 mph. The 23-year old male driver (6 ft, 1 in., 150-160 lb), wearing a seat belt at the time of the accident, was killed. He compressed the in-car energy-absorbing column 6 inches. The under-hood portion of the column telescoped 8 inches. He sustained a fracture of the right fifth rib (which did not perforate the pleura) probably caused by the wheel-column impact; also, slight mediastinal hemorrhage was found. There were a few slight hemorrhagic areas in the intestinal wall due to either the seat belt or steering wheel impact. He flexed over the steering wheel and struck the instrument panel in front of, and to the left of, the steering wheel. He died of a basilar skull fracture and cerebral injury. (Case #12/8/13/67)

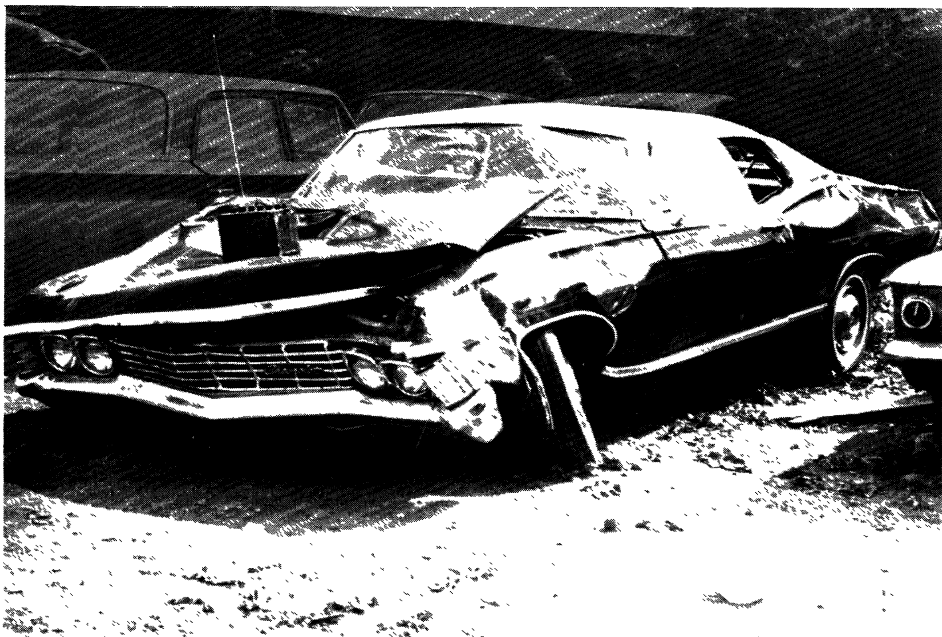
53

1967 Chevrolet (Figures 53, 54, and 55). The 19-year old male driver (5 ft, 11 in., 170 lb) lost control of this car on an expressway; the car rolled over four times in the median. The driver struck the steering column, compressing it 4 inches. No injuries were sustained from this contact. The driver was not wearing a seat belt and bounced about the interior of the car during the rollover sequence. He had chest pain, possibly from striking the steering column. He sustained a bruised left shoulder, sore posterior neck, compression fracture of L1-2 vertebrae, and a small laceration and bruise on the back of his head.

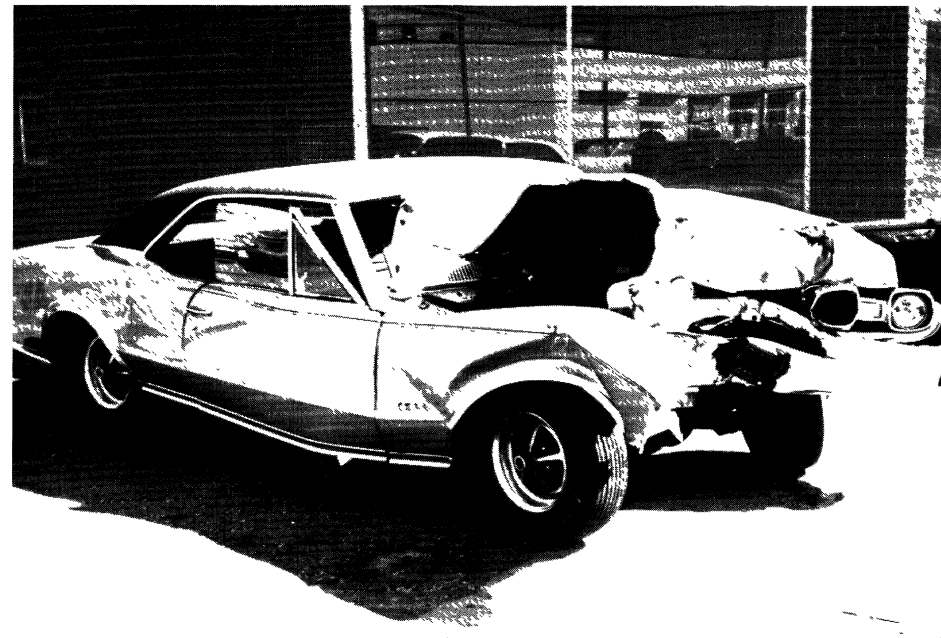
56

1967 Oldsmobile F-85 (Figures 56, 57, and 58). In this car-tree impact of 45-50 mph the energy-absorbing mesh section compressed 4 inches and the underhood unit telescoped $5\frac{3}{4}$ inches. The 21-year old driver was not wearing a seat belt. He was hospitalized one day with multiple nondescript bruises and lacerations over his entire body. He did not have a chest injury from the wheel-column contact. (Case #272/10/14/67)

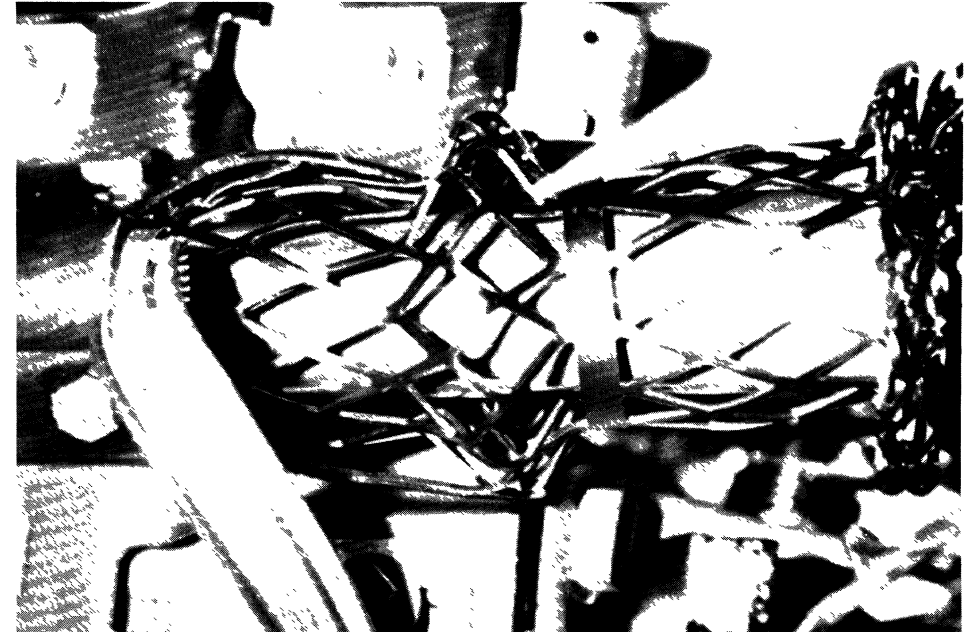
61

1967 Chevrolet (Figures 59, 60, and 61). This vehicle was involved in a head-on collision on a blind rise in the road. (See Figs. 25 and 26.) Both cars were traveling at 35-40 mph. The 24-year old male driver (5 ft, 4 in., 158 lb) was wearing a seat belt but did not have seat belt abrasions. He had a sore chest from steering wheel impact and "ached all over." The column was compressed $3\frac{3}{4}$ inches. In addition, he sustained abrasions to the face and nose (windshield), lacerations inside the mouth, a fracture of his maxilla, and a cervical sprain syndrome ("A" pillar or windshield). Both knees were bruised (lower instrument panel). He also had bruises of both arms. He was not hospitalized.
(Case #231/6/18/67)

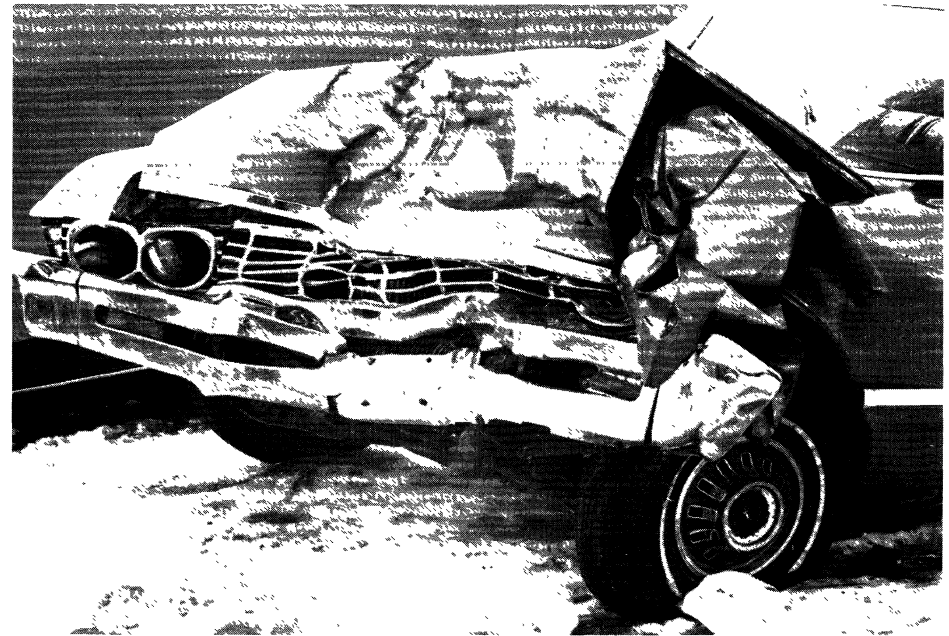
62

1967 Chevrolet (Figures 62, 63, and 64). This was a head-on collision in a snow storm. The impact speed was 20-30 mph. The unrestrained male driver (6 ft, 200 lb) "ached all over," and sustained an abrasion injury of his nose from impact to the steering wheel. The mesh section of the column compressed $6\frac{1}{4}$ inches.
(Case #277/11/23/67)

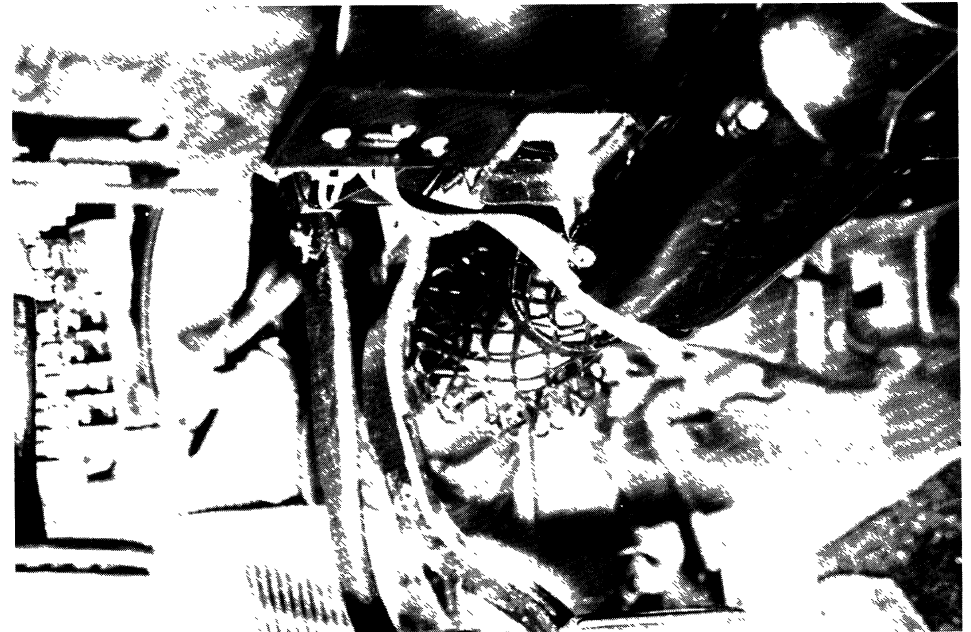
67

1967 Camaro (Figures 65, 66, and 67). A 24-year old male driver (5 ft, 11 in., 150 lb) lost control of his car on a curve and went off the roadway. In this collision, estimated at 20 mph, the column compressed approximately 2 inches. The unrestrained driver sustained bruises to his lower ribs and a laceration to the left side of his chin (steering wheel).
(Case #279/12/16/67)

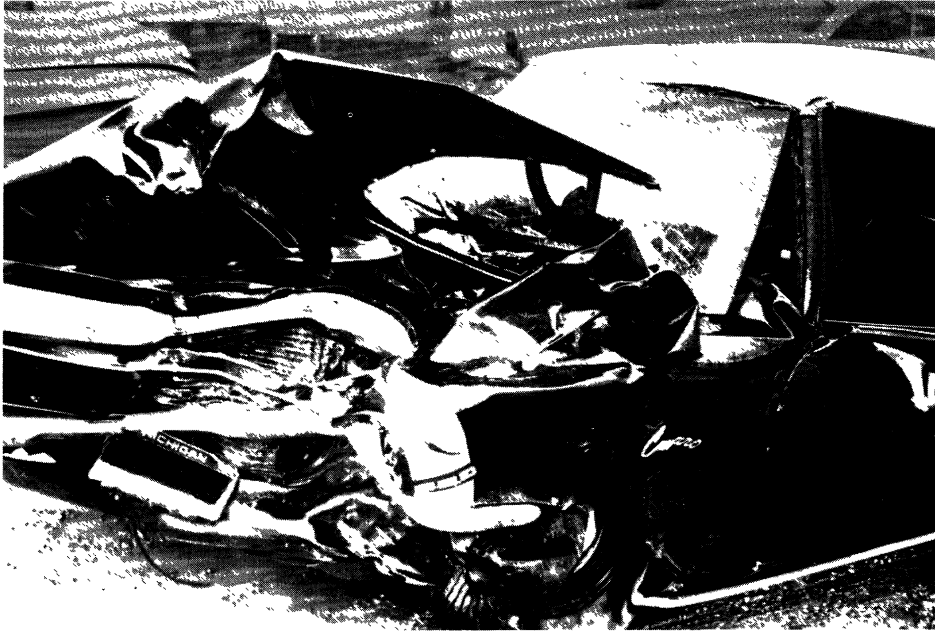
71

1968 Camaro (Figures 71, 72, and 73). On a foggy afternoon, a 1968 Camaro, driven by a 19-year old male (6 ft, 140 lb) struck an oncoming 1962 Plymouth. There was approximately a 50 percent overlap of the two cars. The driver of the Plymouth was killed by steering column impact. The energy-absorbing column in the Camaro compressed $7\frac{1}{8}$ inches from both occupant impact and vehicle frontal collapse. The steering wheel rim was bent and the column separated from the instrument panel mounts. The Camaro driver, who was not wearing a seat belt, sustained a fracture of the left twelfth rib, an abrasion to the chest, a laceration to the chin (all from steering rim impact), and knee abrasions (instrument panel impact). He had a laceration of his liver (wheel-column), but recovered after surgery. (Case #UM-14-68)

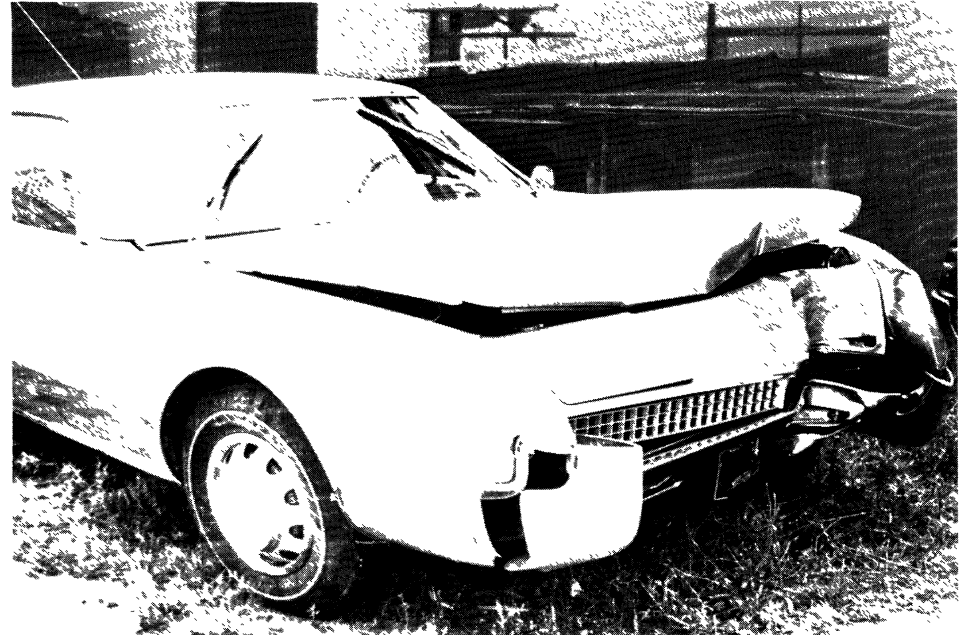
77

1967 Toronado (Figure 77). This vehicle went out of control and struck a tree at an estimated impact speed of 15 mph. No steering-column compression was found. The 54-year old female driver (5 ft, 6½ in., 145 lb), who was not wearing a seat belt, sustained a bruise on the chin (steering wheel), a contusion of the right arm (source unknown), and a bruise beneath the left knee (lower instrument panel).

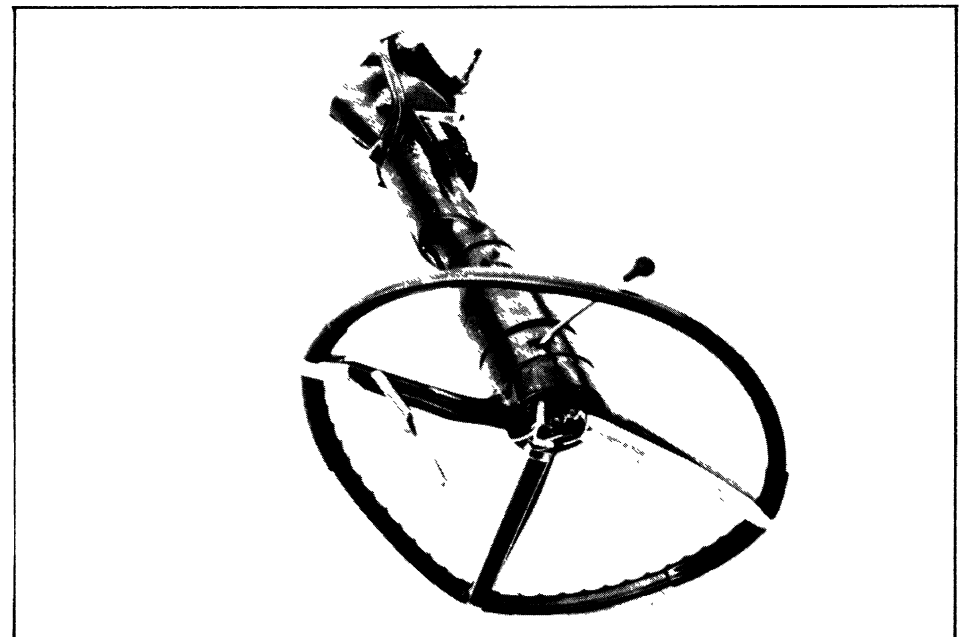
80

1967 Pontiac Firebird (Figures 78, 79, and 80). This vehicle struck a 1966 Mustang head-on, with a 40 percent left front overlap. The unrestrained 18-year old male driver of the Firebird died from multiple internal injuries. The energy-absorbing column compressed its full extent. The estimated impact speed was 40-50 mph. (Case #UM-03-68)

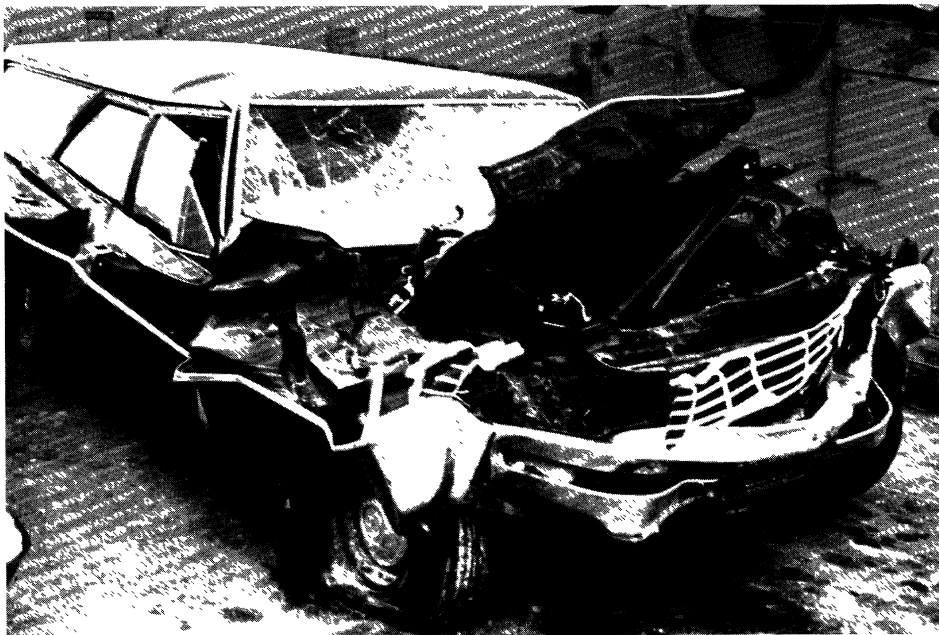
1967 Chevrolet (Figures 81 and 82). This station wagon, traveling on an expressway at a high rate of speed, hit the rear end of a tractor trailer, which was traveling at 50 mph after impact. The differential impact speed is estimated at 25 mph. The car crossed the expressway median and the opposite lanes and rotated 180 degrees to come to rest on the far shoulder of the road. The unrestrained 52-year old male driver (6 ft, 1 in., 210 lb) compressed the column a total of 1½ inches. He died 8 hours later of a laceration of the thoracic aorta; he had mediastinal hemorrhage and fractures of the right sixth and seventh ribs. These injuries are believed to have been sustained from impact with the steering wheel assembly. Facial lacerations were sustained from windshield impact.

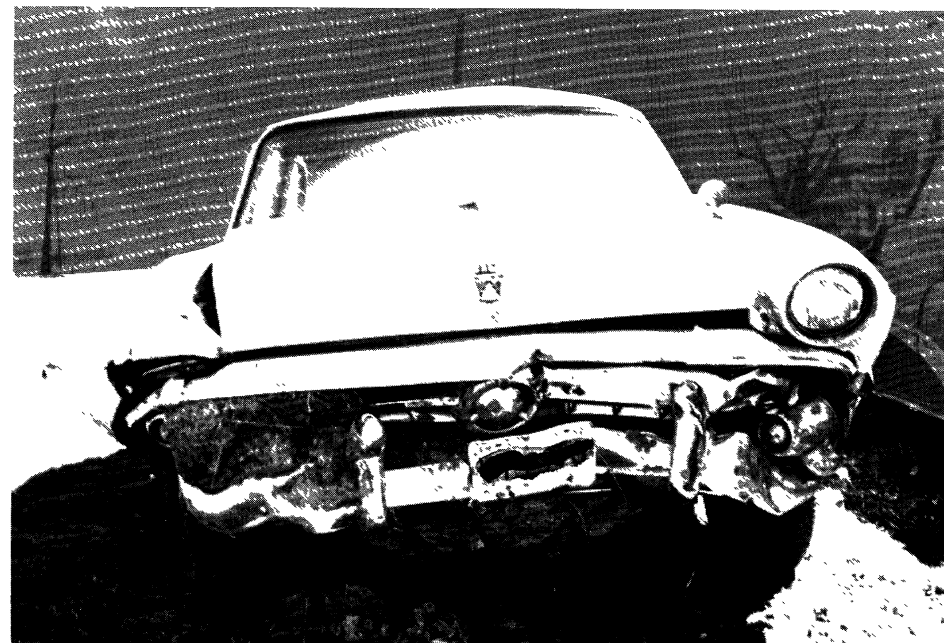
1954 Ford (Figures 83 and 84). This car struck an earth embankment head-on at approximately 25 mph. The 35-year old male driver impacted the steering column. He died from fractures of the chest wall, lacerations of the heart, aorta, and lungs.
(Case #5/4/16/62)
