THE ENERGY-ABSORBING STEERING COLUMN

A Study of Collision Performance
in Fatal and Nonfatal Accidents

HIGHWAY SAFETY RESEARCH INSTITUTE
The University of Michigan • Ann Arbor
1968

HSRI Report No. Bio-7

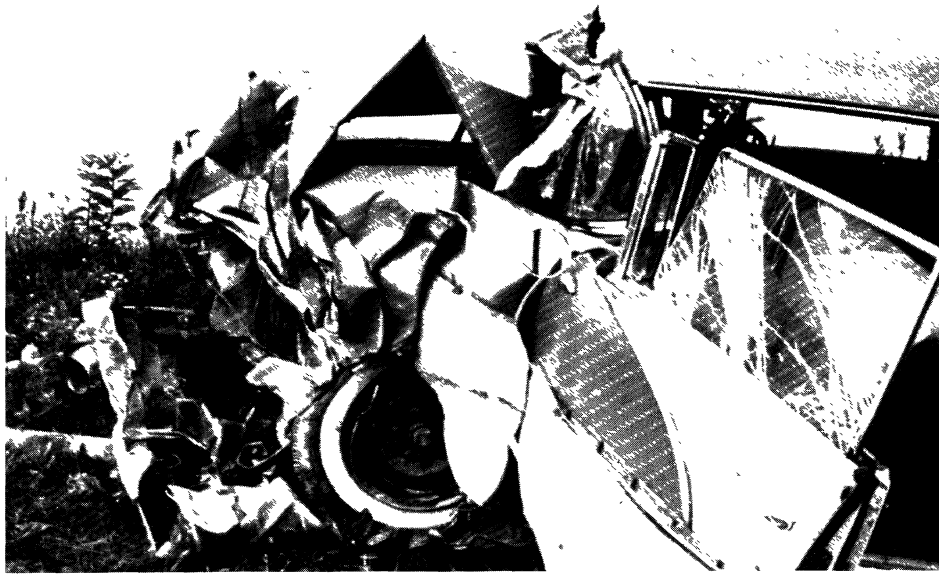
1956 Pontiac (Figures 85 and 86). This was a head-on collision of two vehicles of the same make, model and body style. Both drivers were unrestrained. The impact speed was approximately 35-40 mph. The 30-year old male driver (6 ft, 200 lb) of the one car died; he sustained multiple fractures of the ribs, rupture of intercostal and mediastinal blood vessels, hemothorax and hemomediastinum from wheel-column impact. The other male driver (5 ft, 7 in.) survived. He sustained multiple facial and scalp lacerations from impact to the horn ring and a fractured left femur from instrument panel impact. (Case #15/7/3/62)

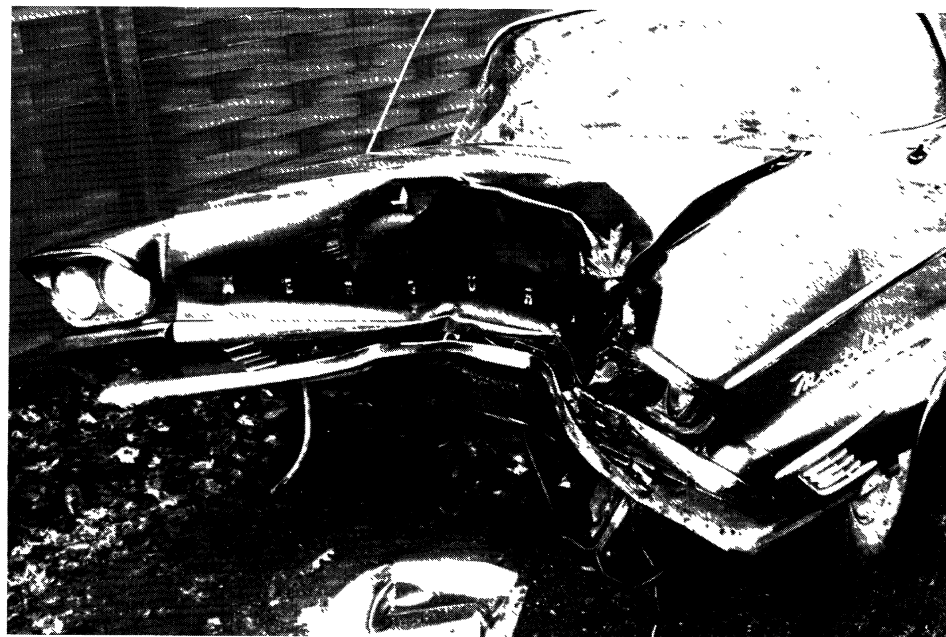
1959 Mercury (Figures 87 and 88). This vehicle went off the road and struck a tree stump at approximately 20 mph. The 21-year old male driver (270 lb) struck the steering column and sustained rib fractures and internal thoracic injuries.
(Case #34/11/15/62)

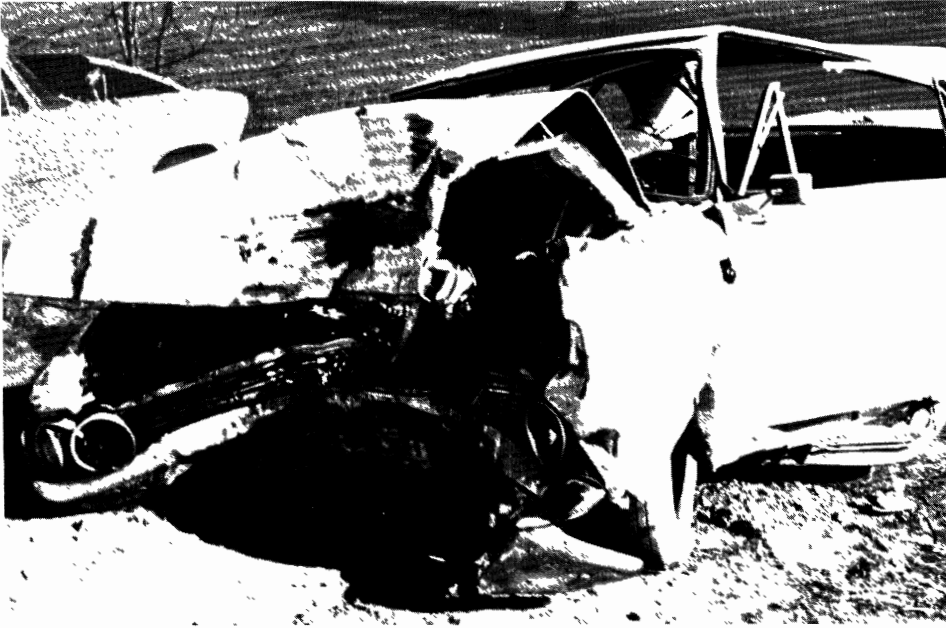
1962 Ford (Figures 89 and 90). This vehicle went off the right side of the road on a curve and struck a tree at approximately 45 mph. The unrestrained 45-year old male driver sustained multiple fractures of the sternum and ribs, bilateral hemothorax, and a lacerated liver from impact to the steering wheel and column. He died four hours after the accident.

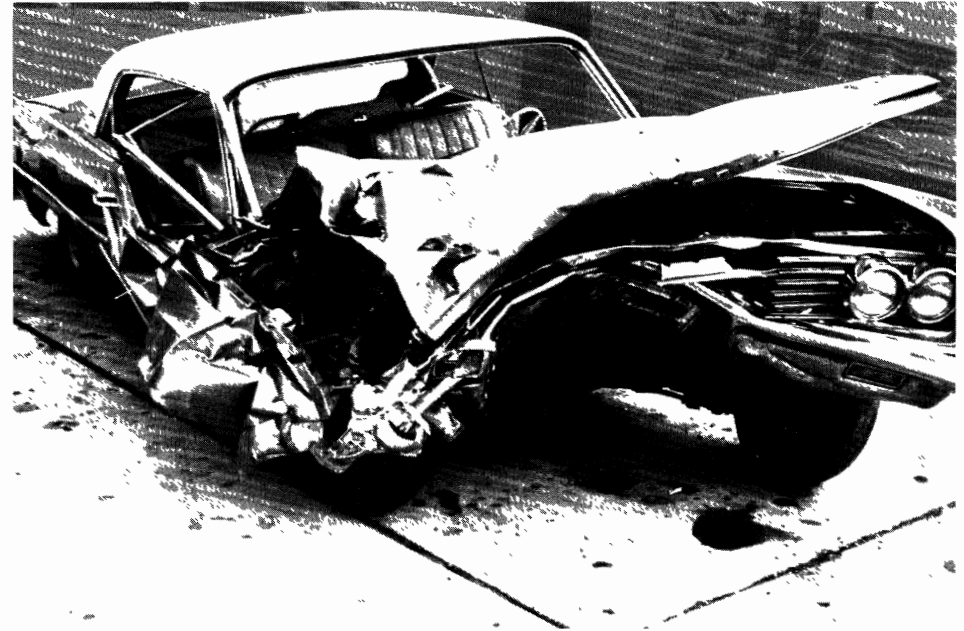
1963 Oldsmobile (Figures 91 and 92). This vehicle hit the left rear dual wheels of a dump truck. The estimated speed at impact was 40 mph. The unrestrained 28-year old male driver sustained multiple internal thoracic injuries from impact to the steering wheel and spokes. He died one hour after impact.
(Case #26/6/15/64)

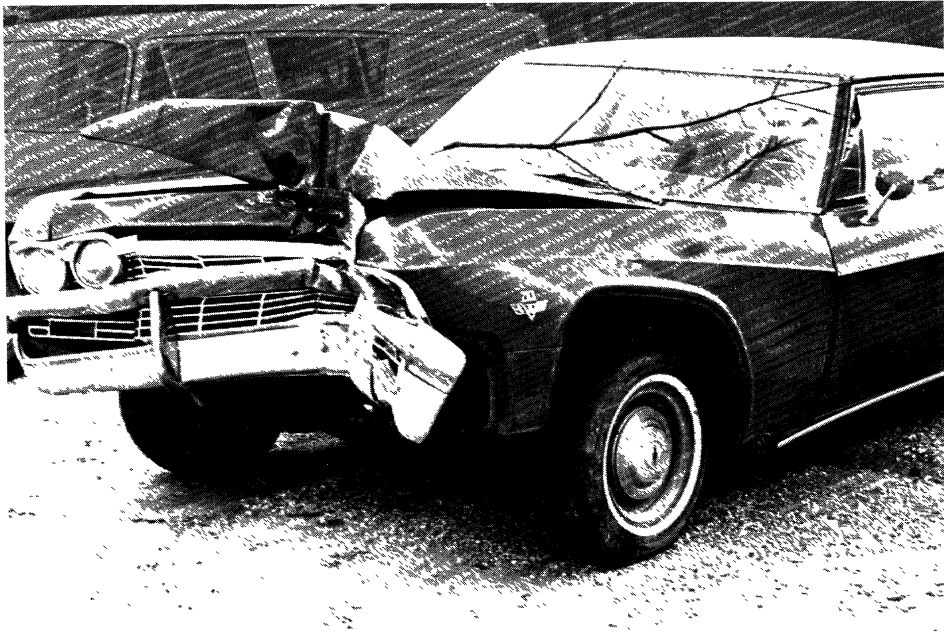
1964 Chevrolet (Figures 93 and 94). This vehicle left the roadway, went down a roadside slope, and struck a tree at an impact speed of 20-25 mph. The unrestrained 52-year old male driver sustained fractures of the fifth and seventh ribs adjacent to the sternum, a left hemothorax, and a heart injury (EKG abnormal) from steering column impact. He died two hours after the accident.
(Case #29/10/30/65)

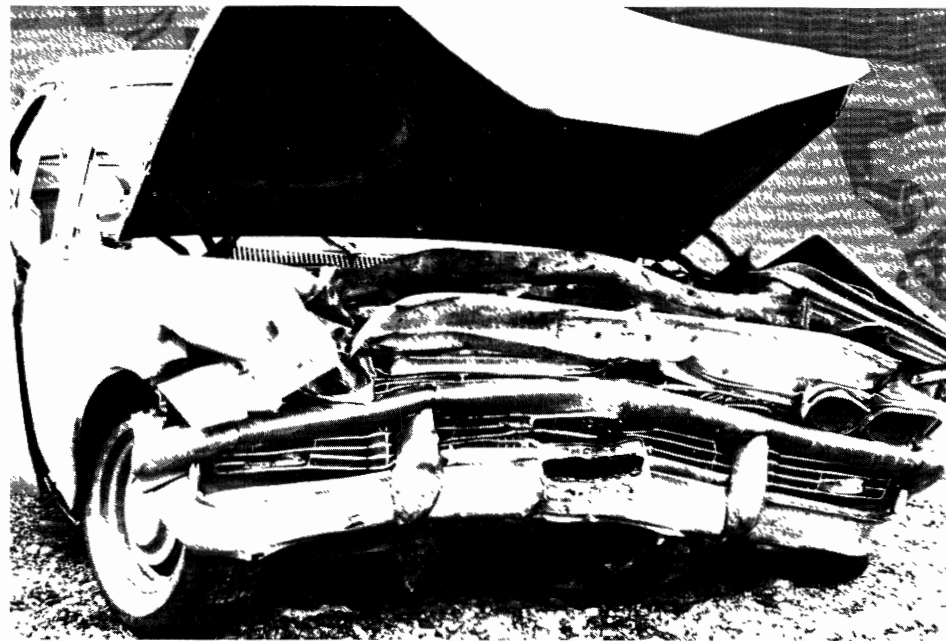
1965 Chevrolet (Figures 95 and 96). This fatal head-on, car-to-car collision occurred at an estimated impact speed of 50 mph. The unrestrained 46-year old male driver (5 ft, 10 in., 210 lb) sustained multiple rib fractures, laceration of the thoracic aorta, and lacerations of the liver and mesentery with intraabdominal hemorrhage from steering wheel and column impact.
(Case #47/12/16/66)

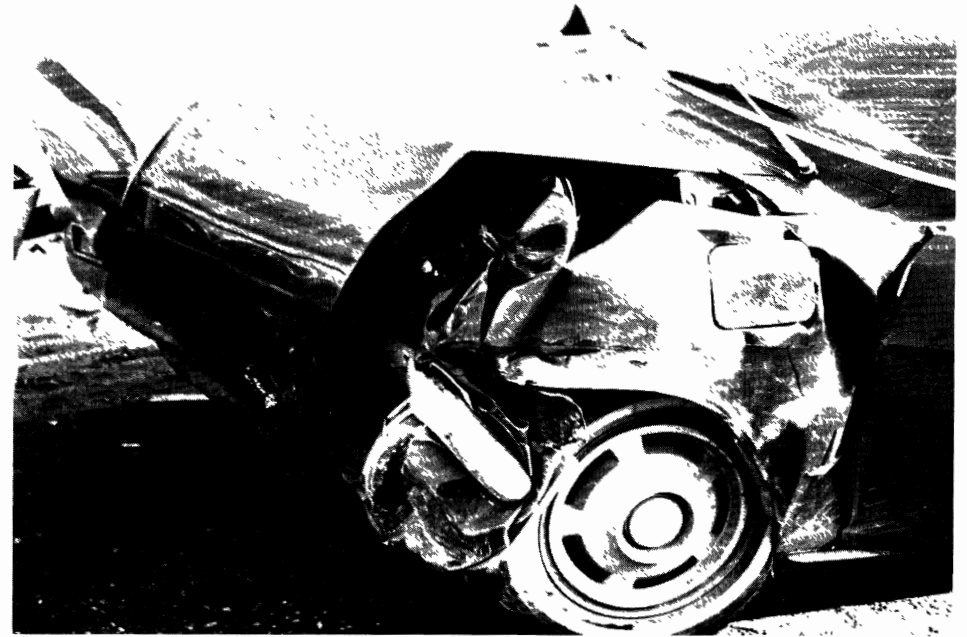
1965 Corvair (Figures 97 and 98). This vehicle was passing a truck when it struck a 1962 Oldsmobile in the left side at approximately 15-20 mph. The unrestrained 20-year old female driver suffered a long forehead laceration and chest pain due to impact to the steering wheel. Her left knee was bruised from lower instrument panel contact.

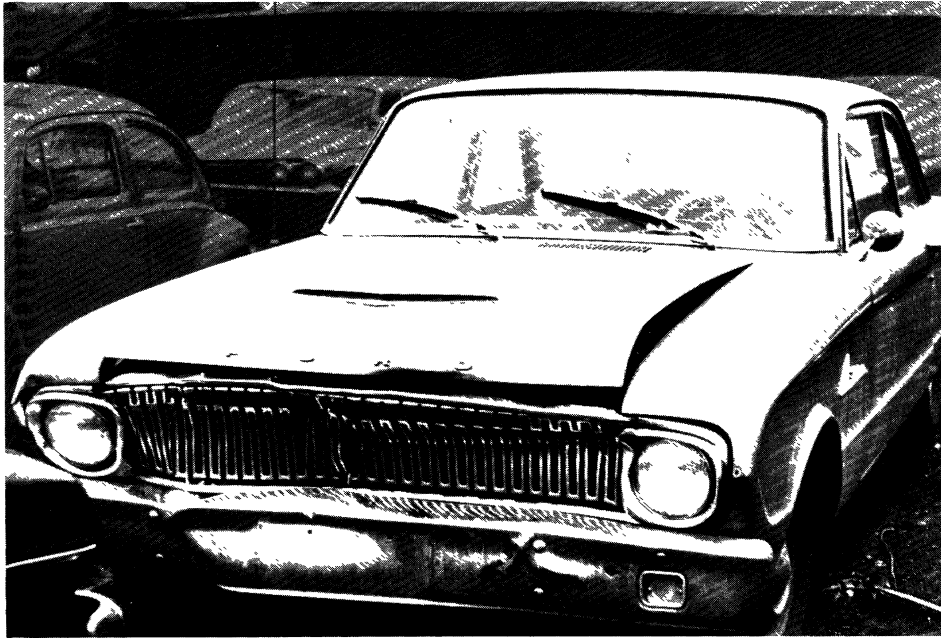
1962 Falcon (Figures 99 and 100). This vehicle struck the rear end of a stopped car at an estimated speed of approximately 10 mph. The 22-year old female driver (5 ft, 4 in., 125 lb) was wearing a seat belt; she sustained a laceration of the nose from contact with the steering wheel. No other injuries were recorded.
(Case #195/1/22/67)

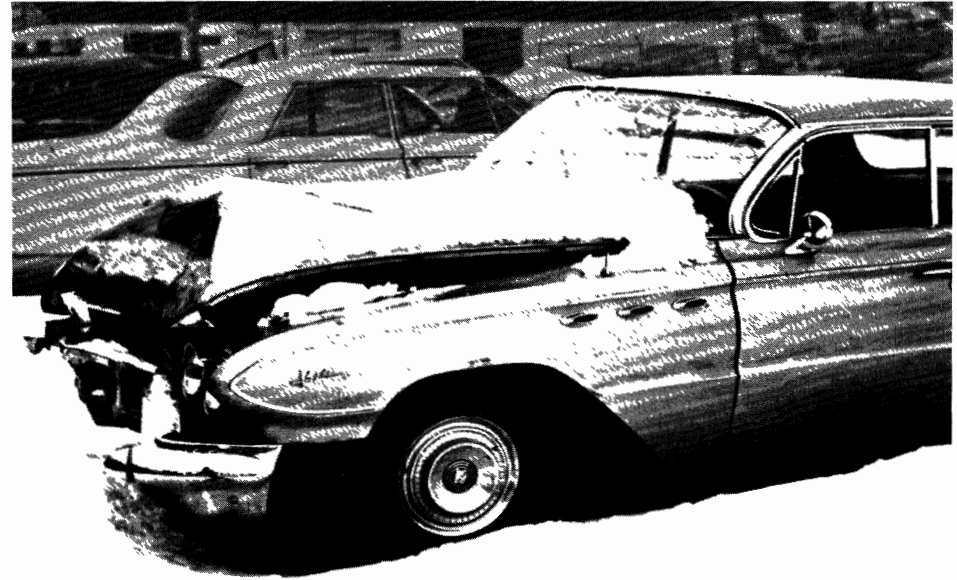
1964 Buick (Figures 101 and 102). This vehicle went through a “T” intersection and up an embankment, hitting a tree at an estimated impact speed of 20 mph. The unrestrained 48-year old male driver fractured his nose when he hit the steering wheel, or possibly the windshield. He also had a knee abrasion (lower instrument panel). (Case #188/1/6/67)
