AUTOMOBILE OCCUPANT INJURIES
from
STRIKING THE WINDSHIELD

The University of Michigan Medical School

HIGHWAY SAFETY RESEARCH INSTITUTE
The University of Michigan • Ann Arbor
1967

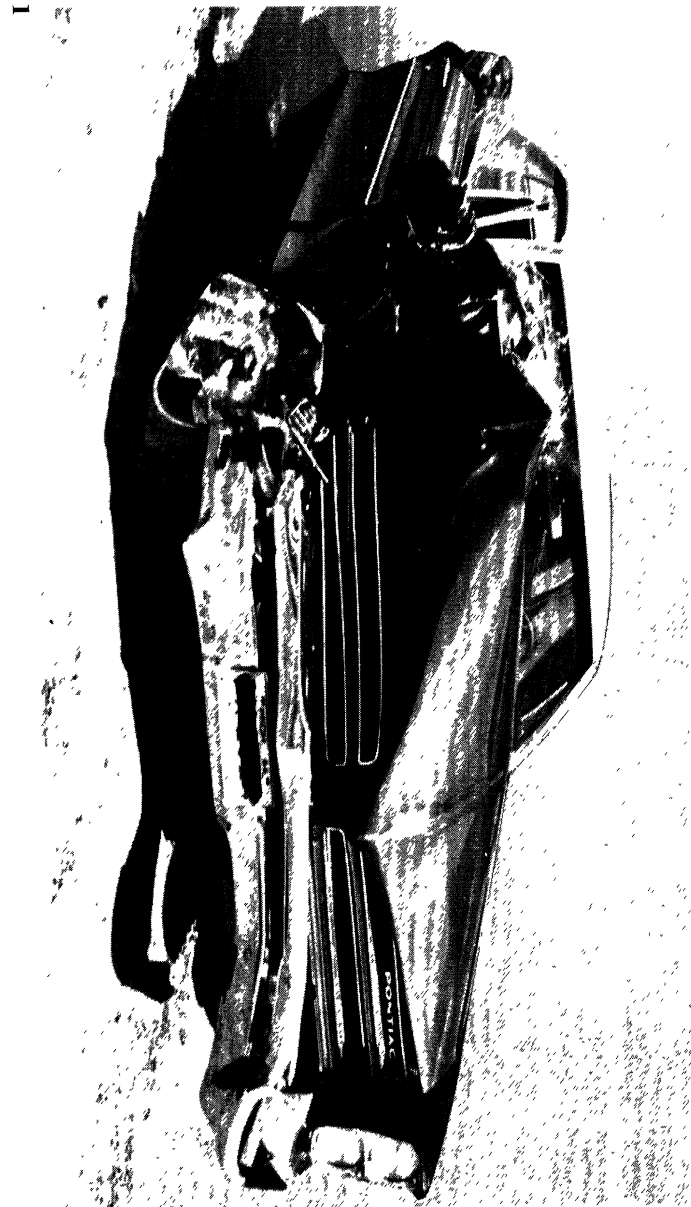
1966 Pontiac (Figures 1 and 2). Car-pole accident (impact velocity 25 mph). The left rear passenger (female, 26 years old) struck the right side of the windshield 18 inches from the right "A" pillar and 3 inches below the header. She sustained an abrasion to the right side of her head. She refused medical treatment.
(Case #101/5/2/66)

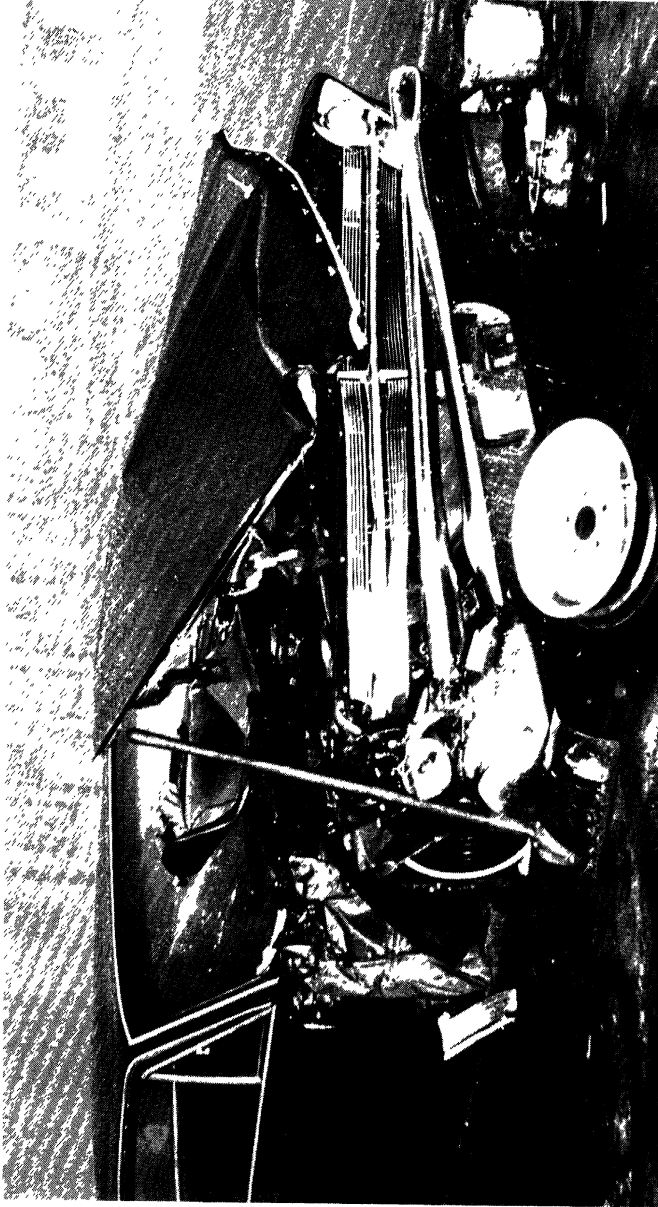
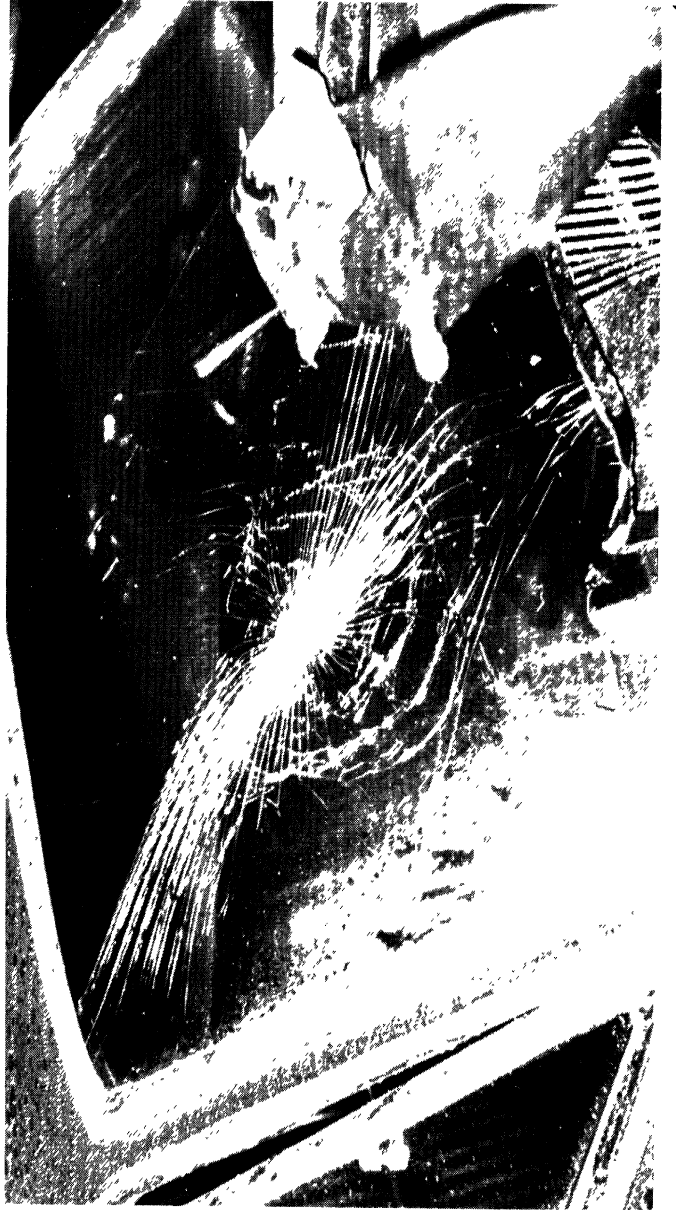
1967 Plymouth (Figures 3 and 4). Car-
tree accident (impact velocity 25-30
mph). The passenger (male, 22 years
old) struck the windshield, sustaining
a contused nose and a laceration of the
lip. Head impact area was 9 inches
from the right "A" pillar and 12 inches
below the header. The windshield im-
pact area was not bulged outward. Seat
belts were not worn.
(Case #174/11/24/66)

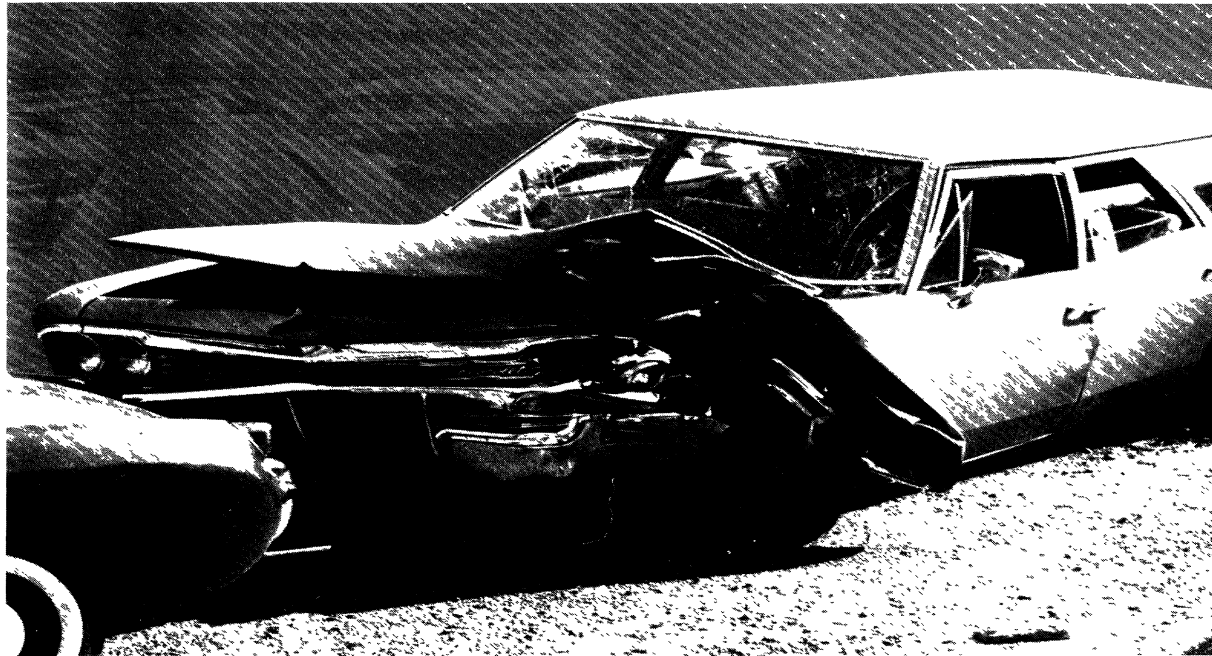
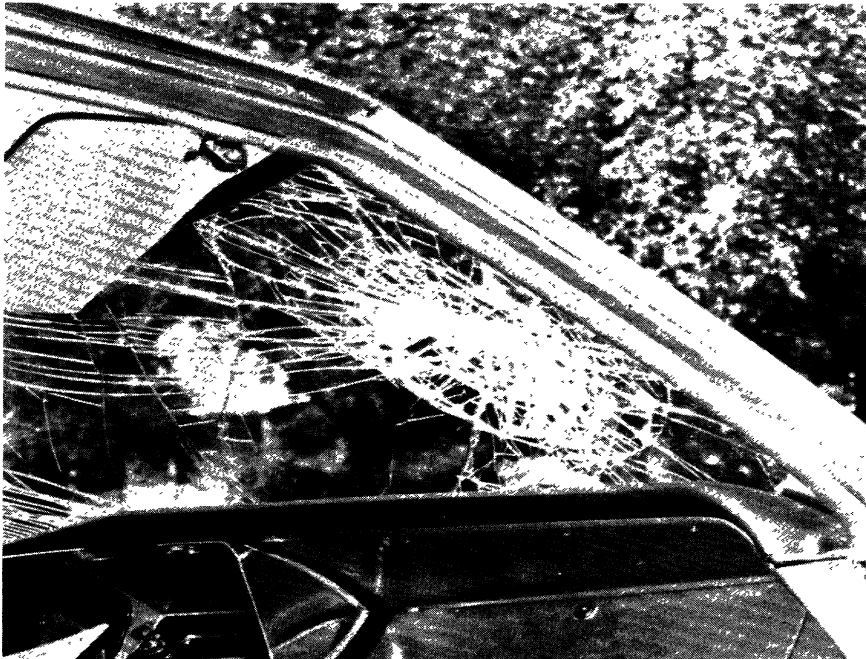
1966 Chevrolet (Figures 7 and 8). This station wagon left the roadway, went into a ditch, and struck a tree (impact velocity 25-30 mph). The front passenger (male, 14 years old) struck the windshield 10 inches from the right "A" pillar 9 inches below the header. He bulged the windshield outward at the point of impact. He had a mild concussion (unconscious for a short period of time) but no facial or scalp lacerations. Seat belts were not worn.
(Case #124/6/27/64)

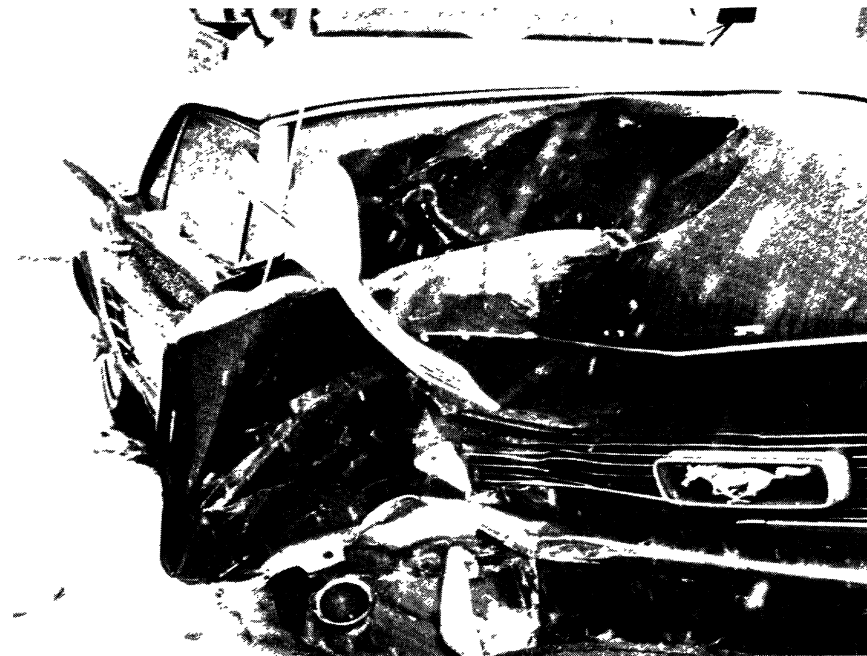
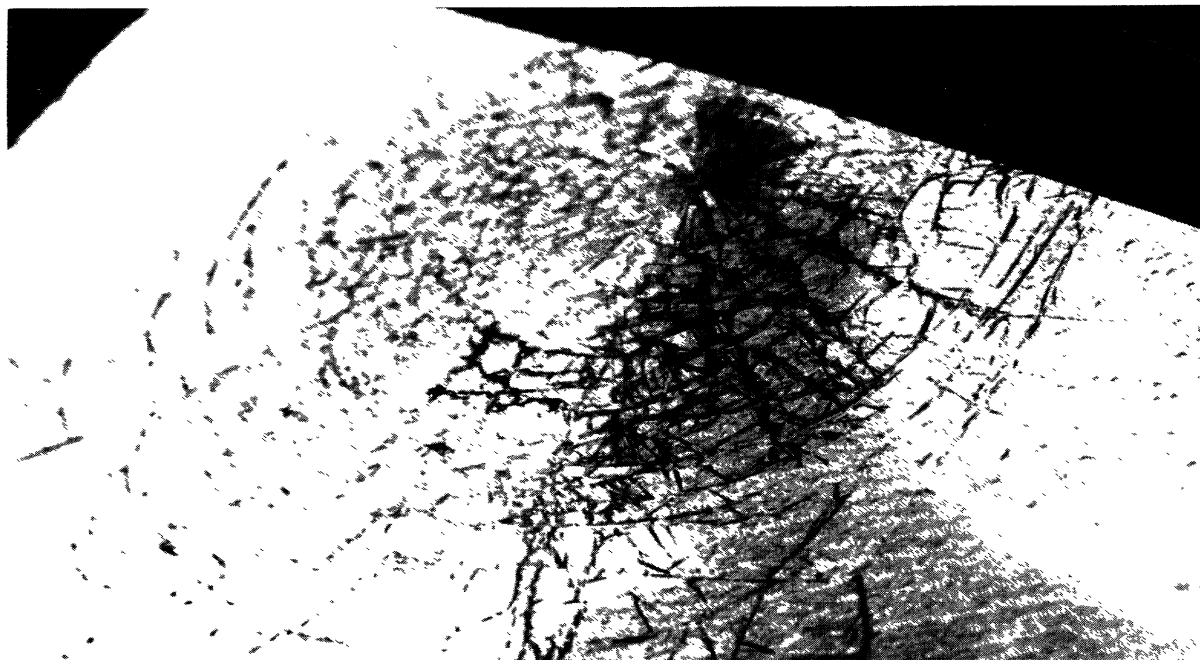
1966 Mustang (Figures 9 and 10). Car-tree accident (impact velocity 25 mph). The driver (male, 40 years old, 6 feet 1 inch, 180 pounds) struck the windshield 3 inches below the header and 10 inches from the left "A" pillar. He sustained minor abrasions to his forehead at the hairline.
(Case #190/2/24/67)

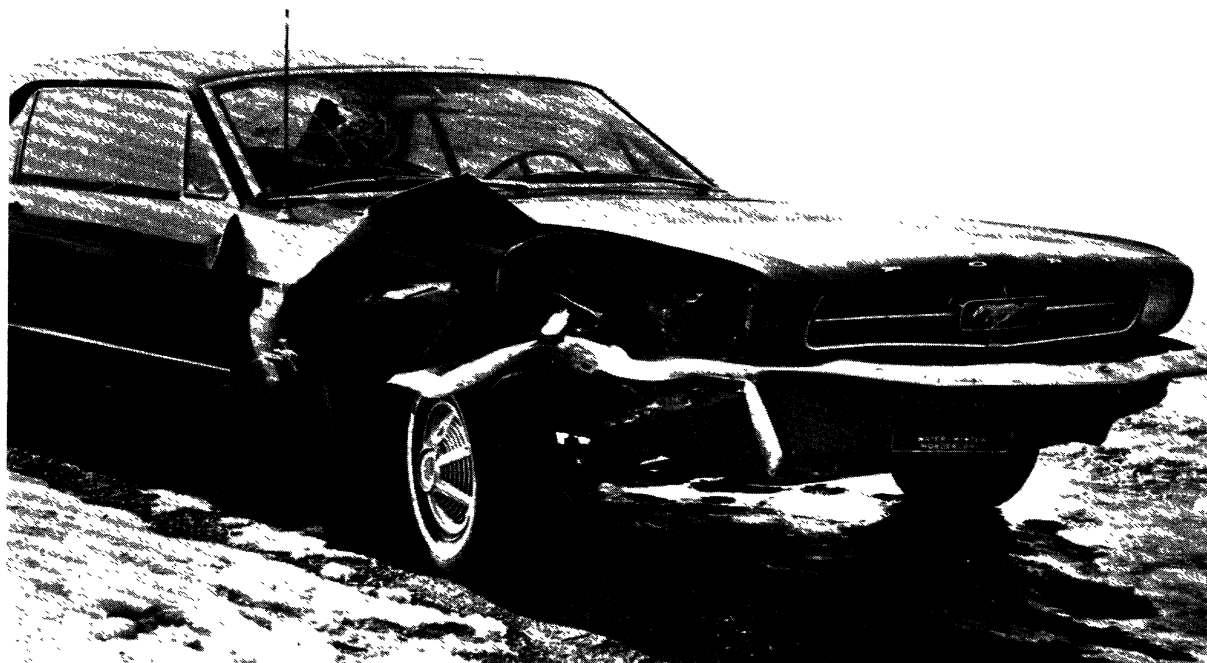
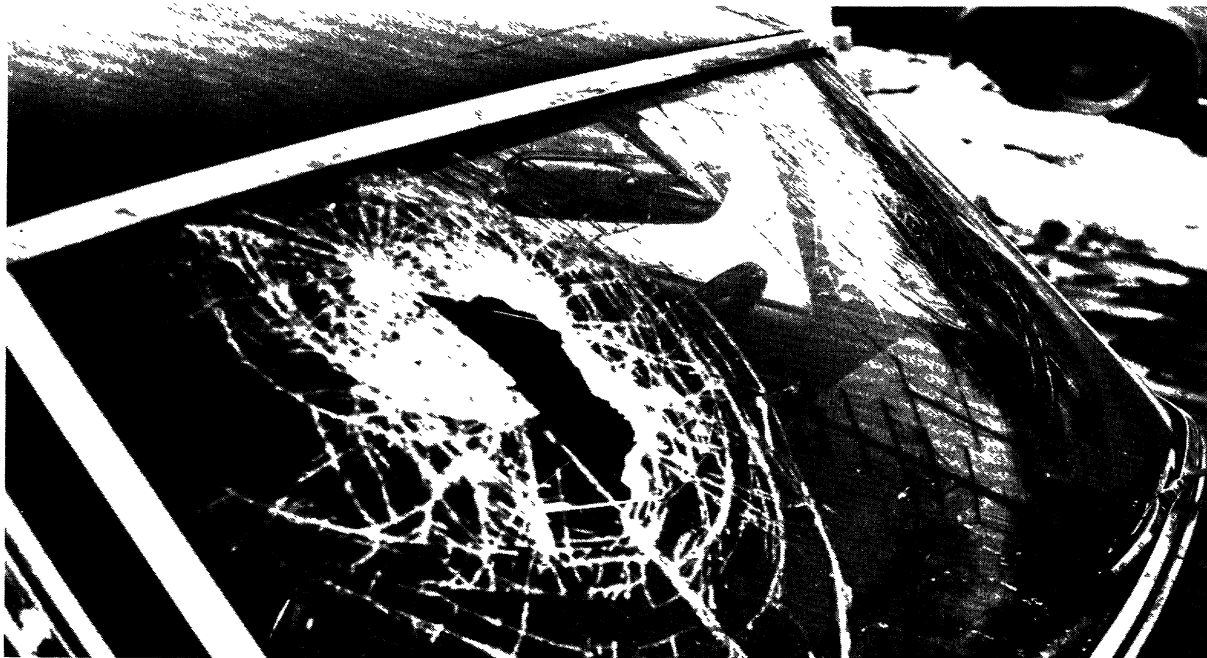
1965 Mustang (Figures 11 and 12). This vehicle hit the rear of a parked car (impact velocity 20 mph). The passenger (female, 23 years old) struck the windshield 7 inches from the right "A" pillar and 3 inches below the header. She sustained a 5-cm laceration to her forehead. Seat belts were not worn. (Case #199/2/18/67)

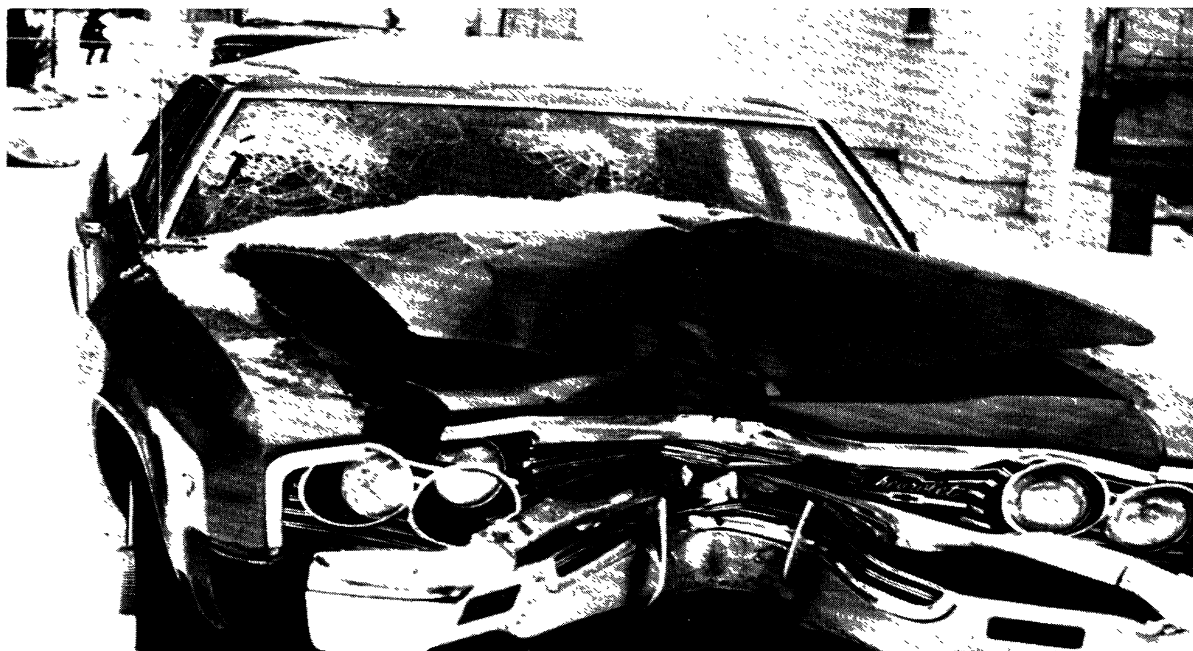
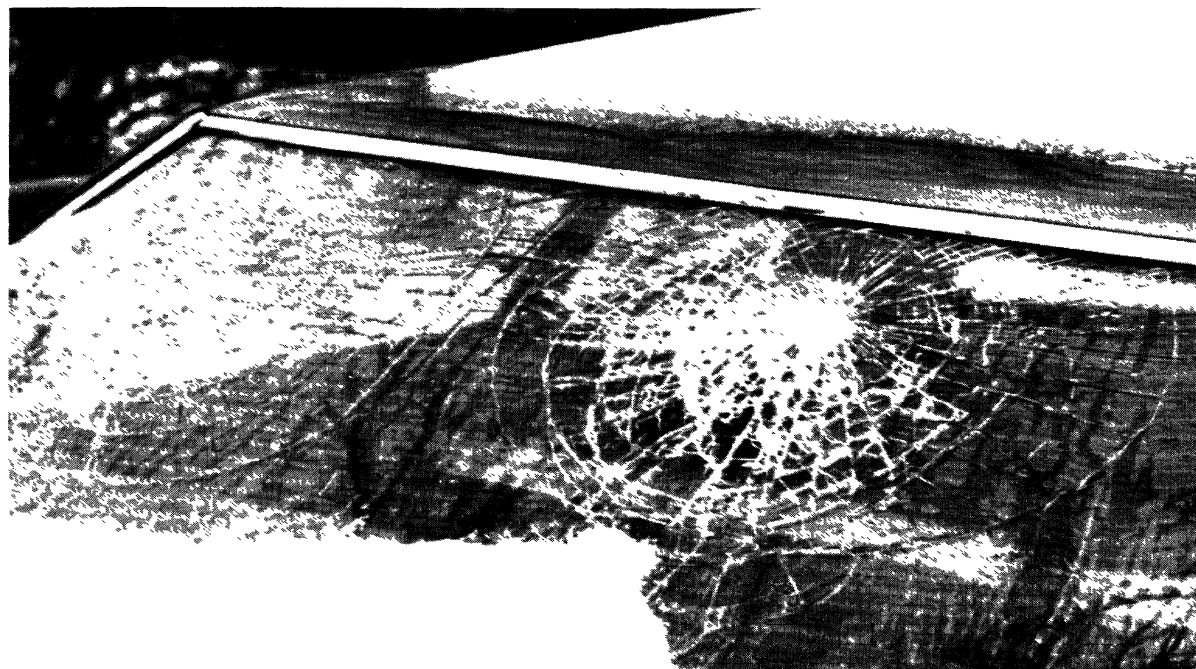
1966 Chevrolet (Figures 13 and 14). Car-pole accident (impact velocity 30 mph). Three distinct windshield impact sites were found. The driver (male, 41 years old) sustained small forehead lacerations from impact to the windshield just to the left of the rear view mirror. The passenger (female, 40 years old), struck her head on the windshield 8 inches below the header and 11 inches from the right "A" pillar. She sustained small cuts and scratches to the right side of her face. Adjacent to the right "A" pillar was an impact site not typical of a head impact. Here, the laminate was torn, with blood and tissue on the glass, and the area was markedly bulged forward. This may have been produced by the rear right passenger who sustained a laceration of the hand. Seat belts were not worn.

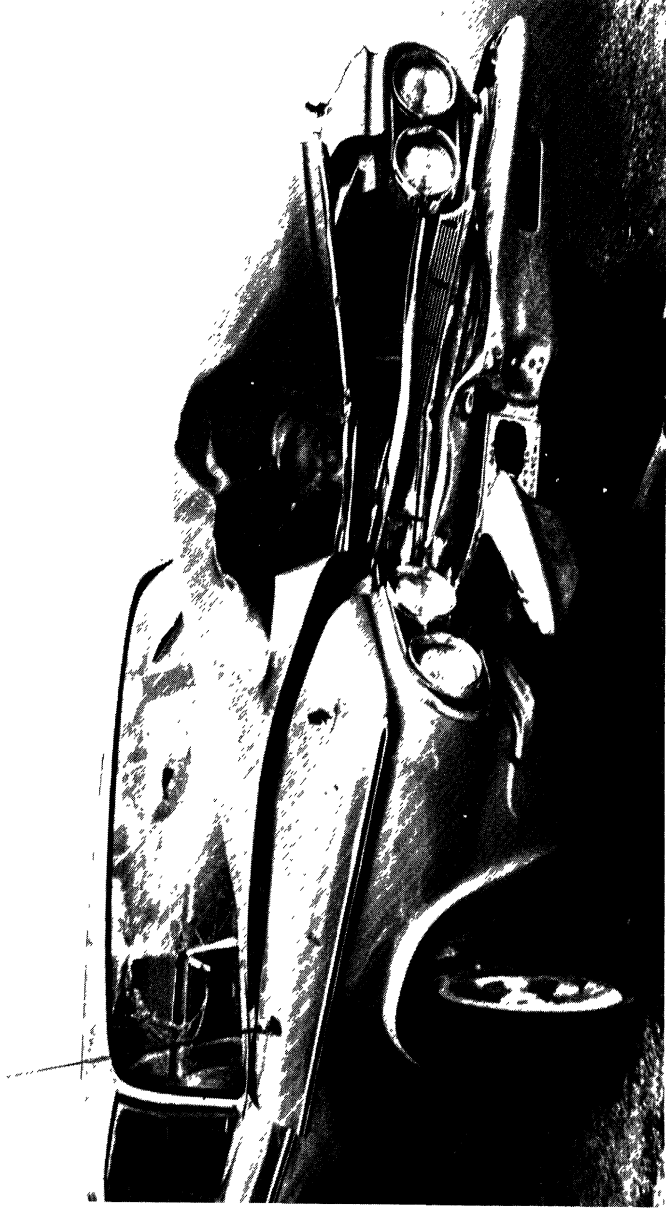
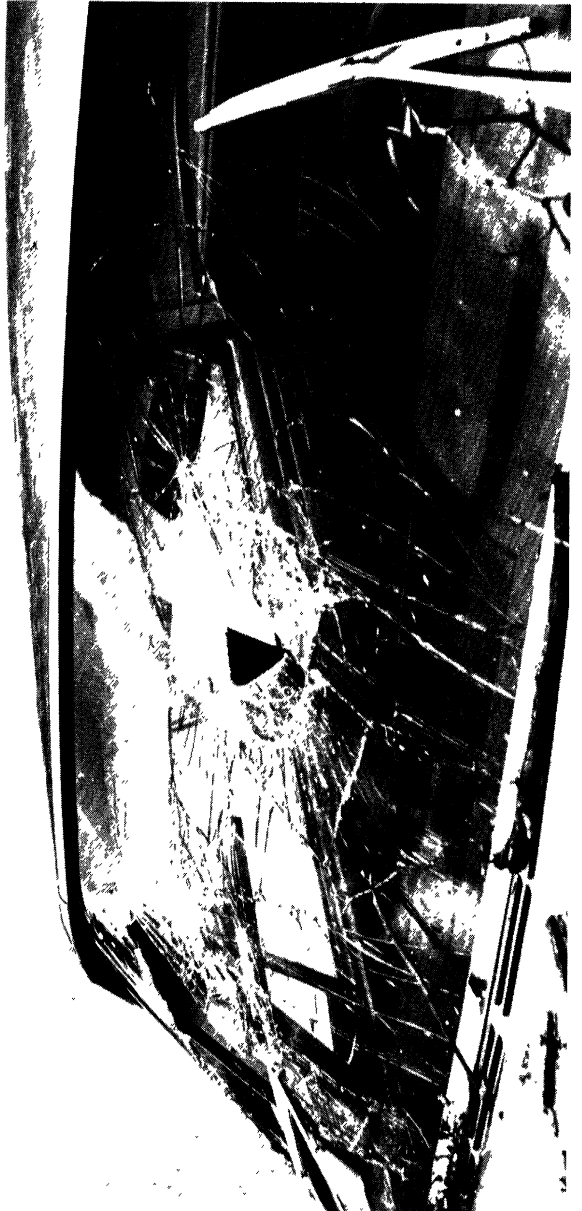
1964 Dodge (Figures 15 and 16). Car-tree accident (impact velocity 25 mph). The driver (male, 57 years old) struck the center of the windshield, sustaining a long, undermined, flap-like laceration to the right cheek and lacerations to the chin, upper lip, left cheek, and back of the head. The passenger (female, 55 years old) struck the windshield 13 inches from the right "A" pillar and 6 inches below the header. She sustained lacerations of the scalp and both arms, and a frontal bone fracture. Seat belts were not worn.
(Case #69/6/15/66)

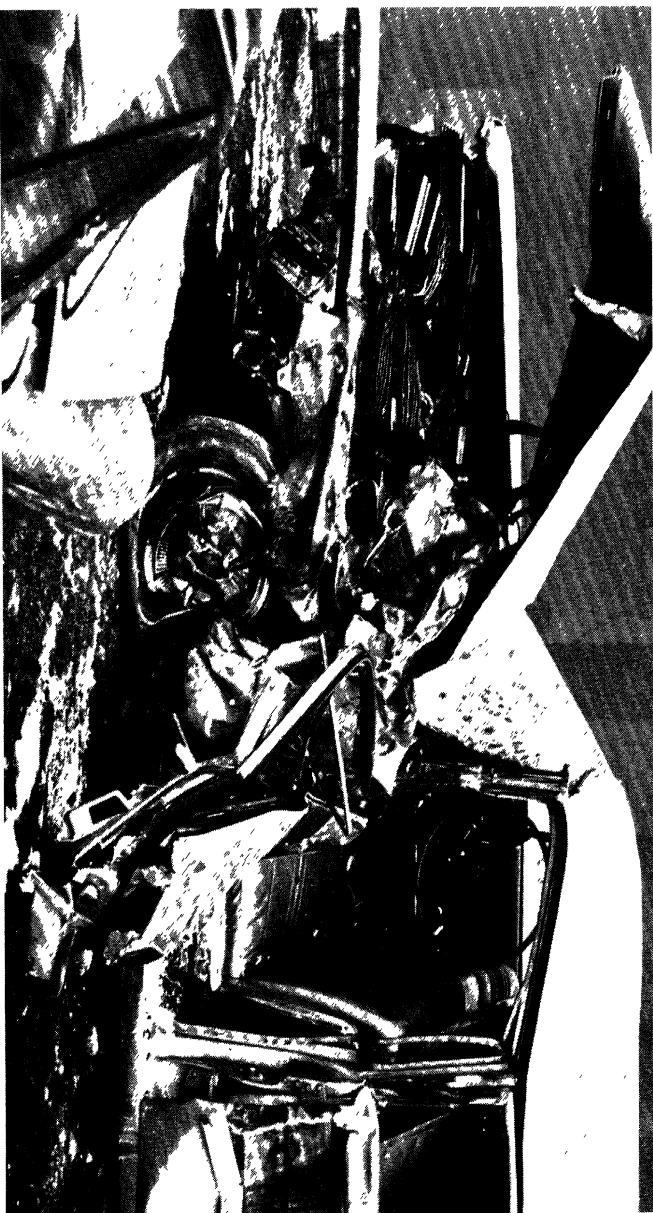
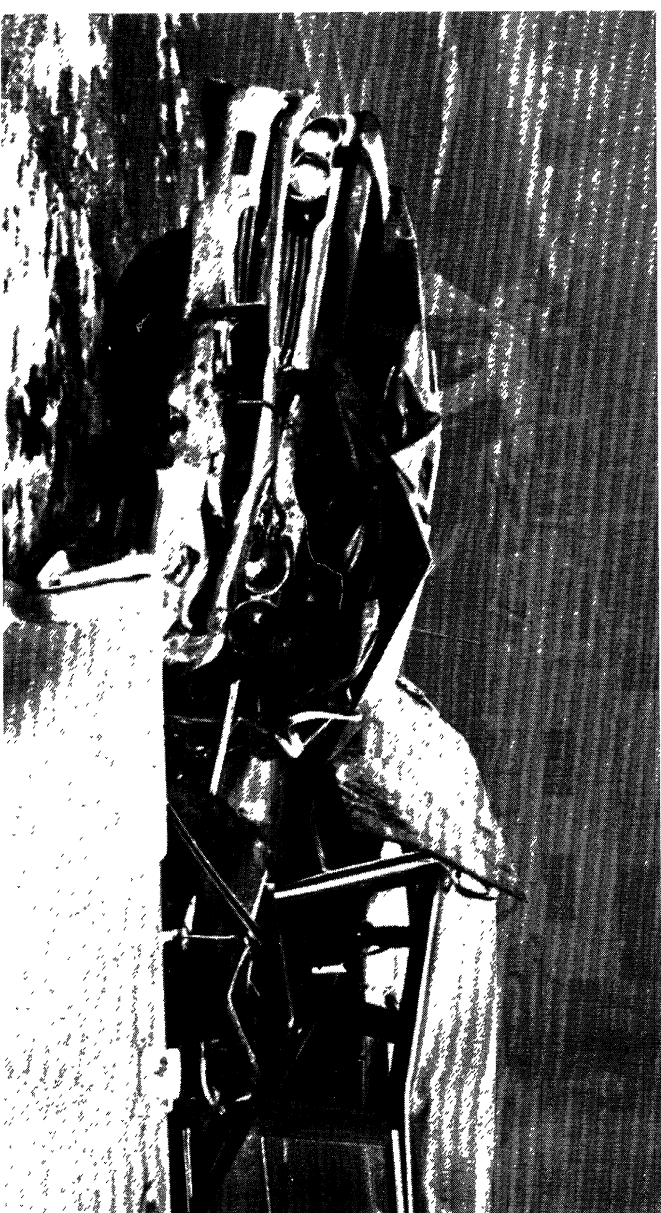
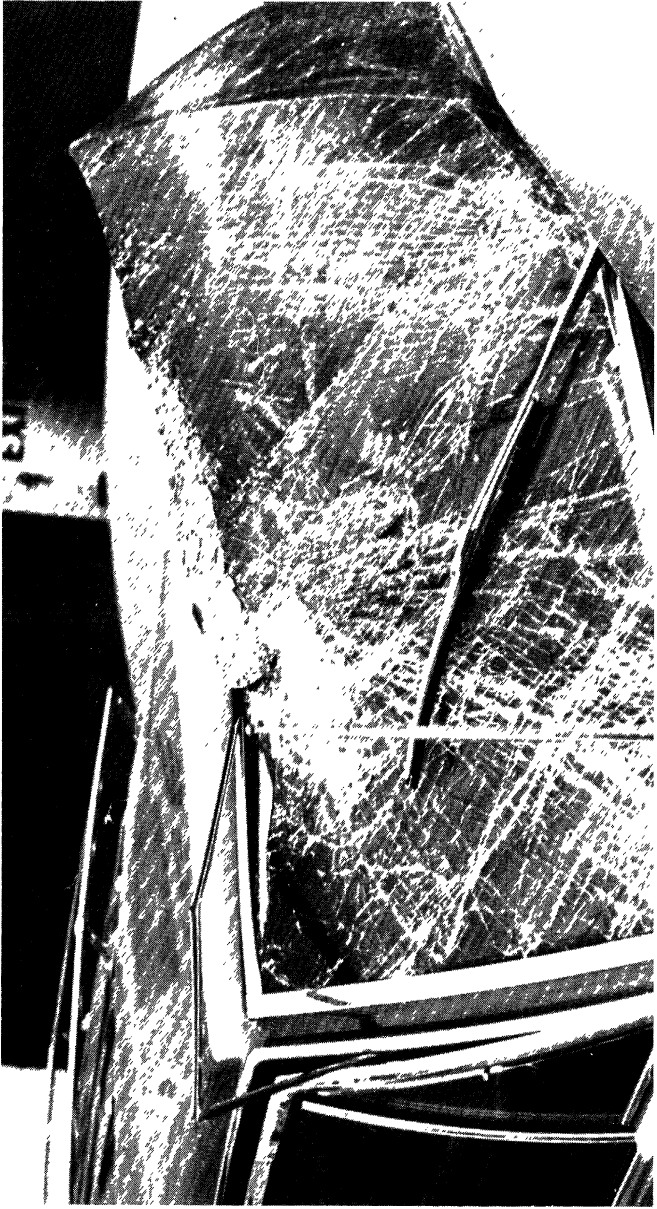
1966 Ford Station Wagon, 1966 Chevrolet Station Wagon (Figures 17, 18, 19). A head-on collision with approximately a 50 percent overlap between the two vehicles (impact velocity 45-50 mph). Both windshields were cracked throughout (matted) and partially out of the frame due to frame distortion. The passenger in the Chevrolet (female, 40 years old) struck the windshield 12 inches to the right of the "A" pillar and 7 inches below the header. She sustained a small laceration at the bridge of her nose. The passenger in the other car (female, 33 years old) sustained a 7-cm laceration of the left ear and adjacent areas, and a 6-cm laceration in the center of the forehead. In the latter case no typical head impact area could be found on the matted windshield, but the lacerations were typical of glass impact. The laminate was intact in both windshields. Seat belts were not worn. (Case #8/2/20/66)

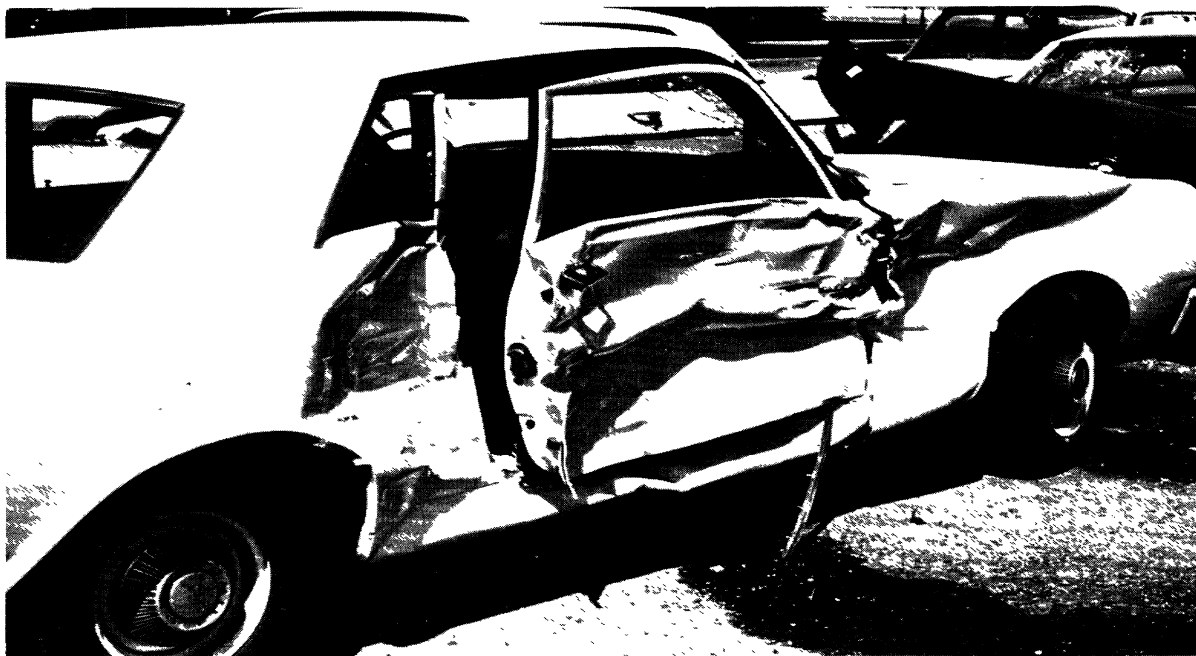
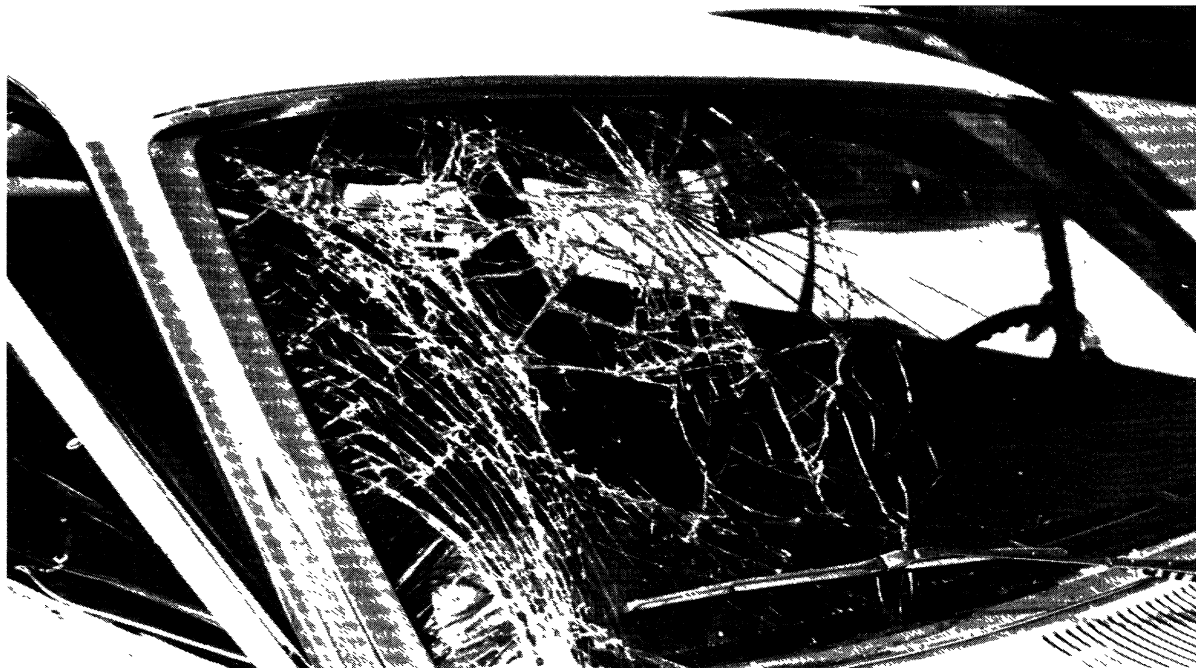
1966 Falcon (Figures 20 and 21). This car was turning left when it was struck in the right side by a 1965 Chevrolet (impact velocity 20-25 mph). After impact, the car spun out; the driver (female, 44 years old) struck the right side of the windshield 14 inches from the right "A" pillar and 5 inches below the header. She sustained a small laceration to the left scalp area.

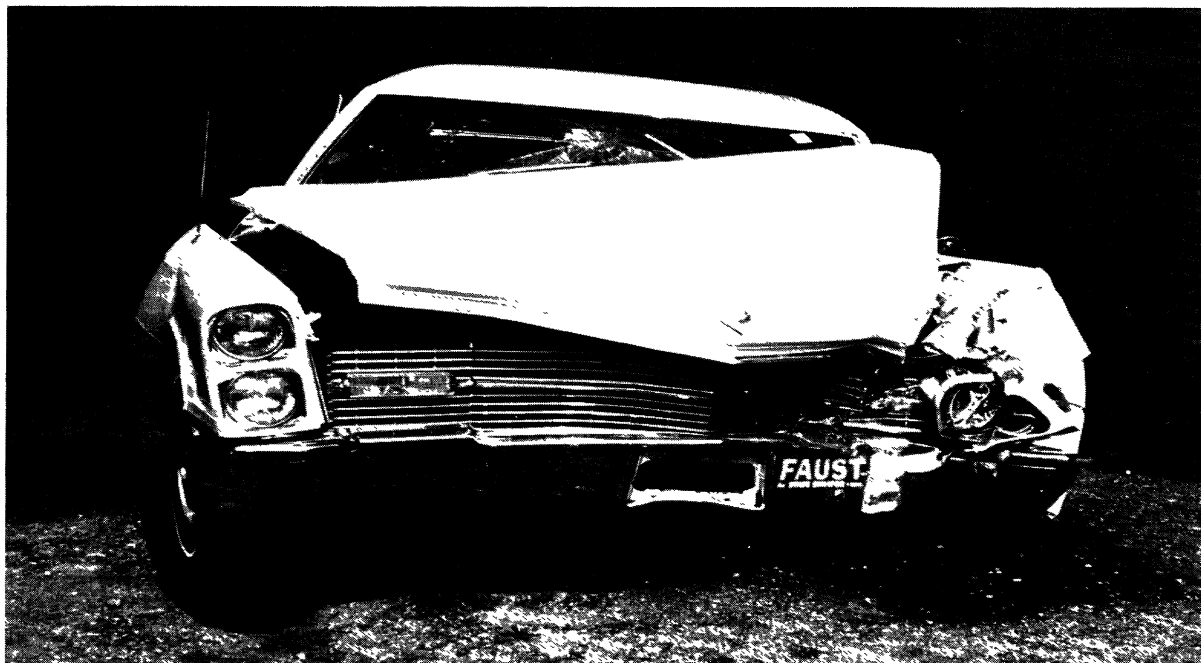
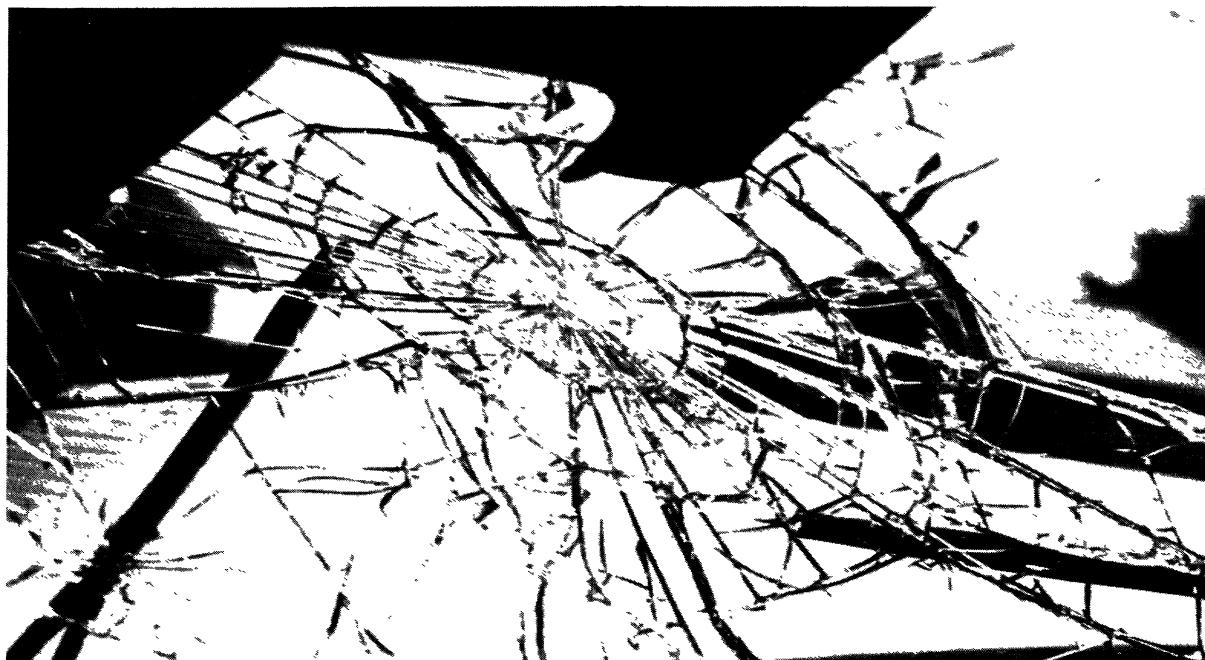
1966 Cadillac (Figures 22 and 23). This vehicle, after being struck in the rear fender, hit a guard rail (impact velocity 25-30 mph). The passenger (male, 64 years old) sustained a laceration of his left elbow and forearm. He struck the windshield with his head but did not have any injuries from this impact. The windshield was fractured (matted) in many areas from frame distortion. Seat belts were not worn.
(Case #127/7/1/66)

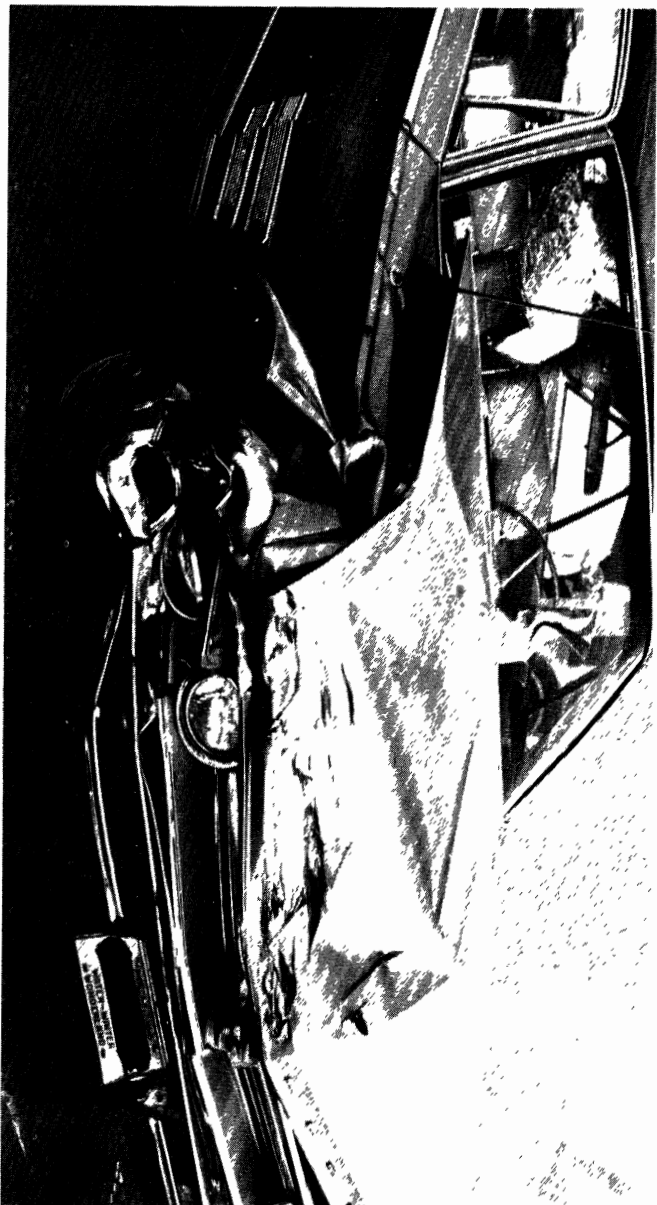
1966 Chrysler (Figures 24, 25, 26). This vehicle was struck by another that had turned in front of it (impact velocity 35 mph). The front passenger (male, 24 years old) struck the windshield, 6 inches from the left "A" pillar and 5 inches below the header, markedly bulging it outward. He sustained minor superficial lacerations to the right side of his forehead. Seat belts were not worn. (Case #145/9/5/66)

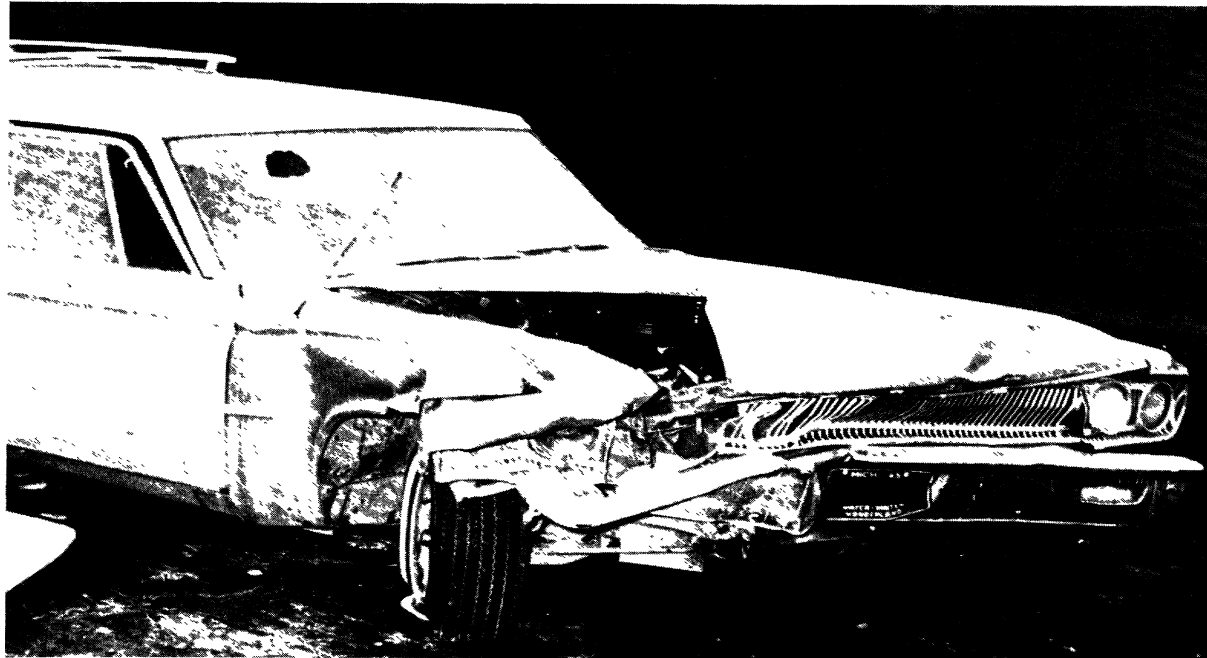
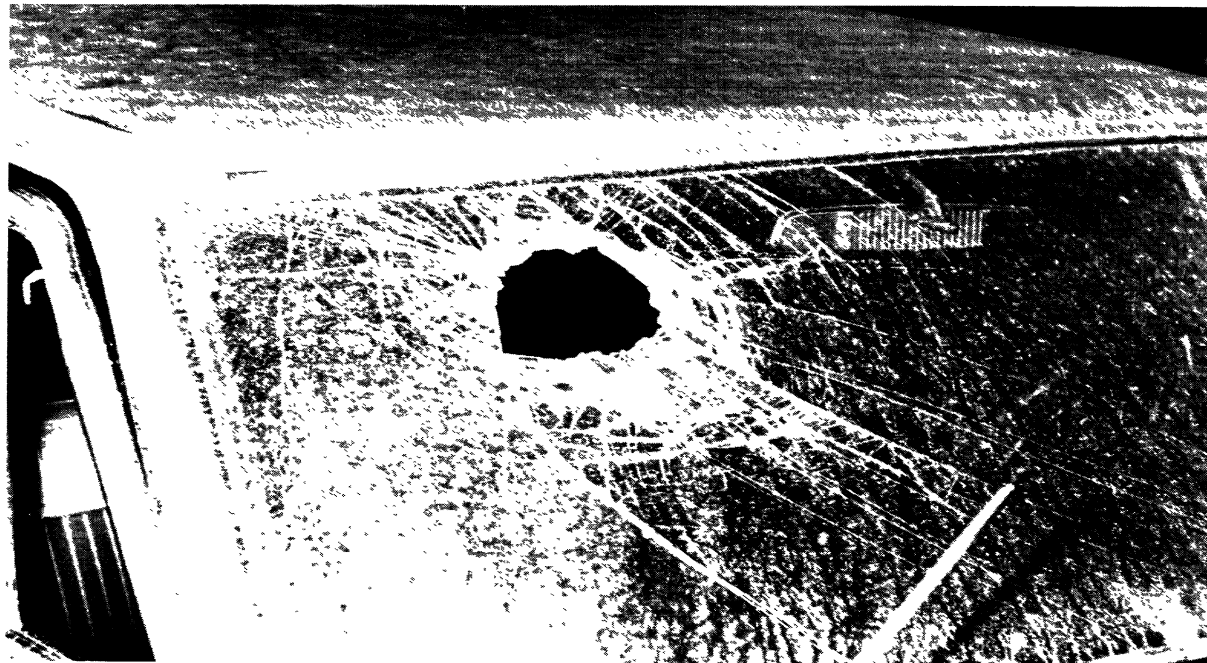
1965 Dodge (Figures 27 and 28). This vehicle turned in front of another at an intersection and was struck (impact velocity 30-35 mph). The front center passenger (female, 35 years old) contacted the windshield 9 inches from the right "A" pillar and 4 inches below the header. She sustained a laceration of the forehead. Seat belts were not worn. (Case #80/12/2/65)

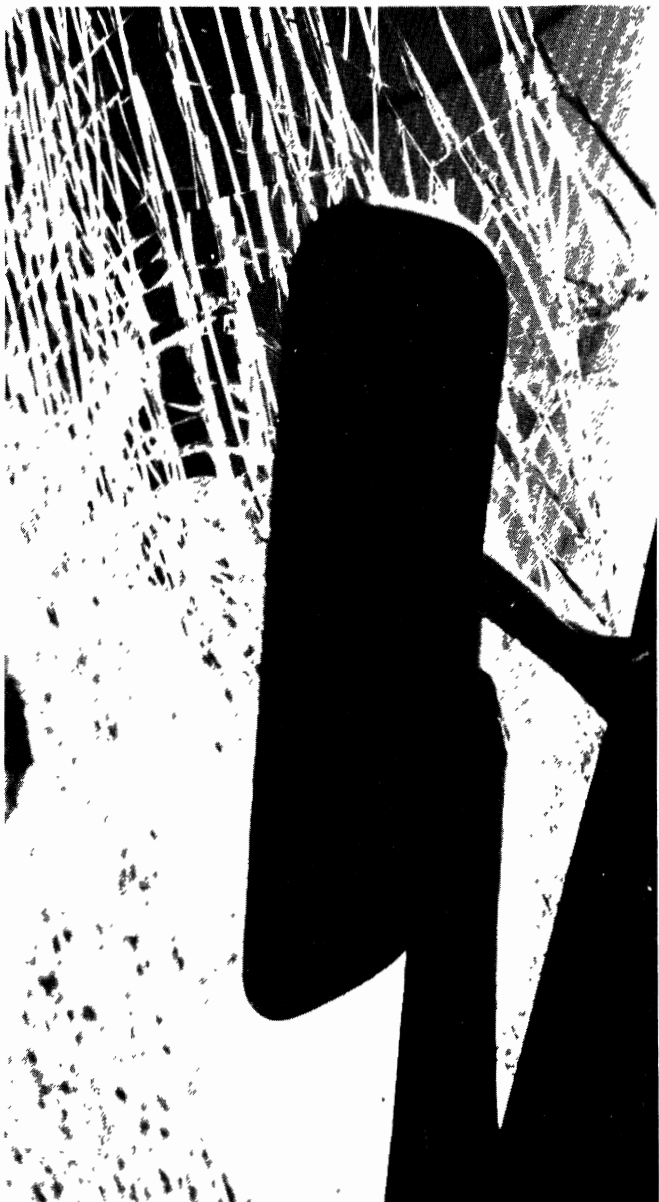
30

1966 Chevrolet (Figures 29 and 30). Car-tree accident (impact velocity 20-25 mph). The driver (male, 5 feet 9 inches, 160 pounds) lost control of this car when he reached over to close the right door window while driving. He struck the windshield to the right of the rear-view mirror, markedly bulging it outward. He sustained a 5-cm laceration to his right cheek.

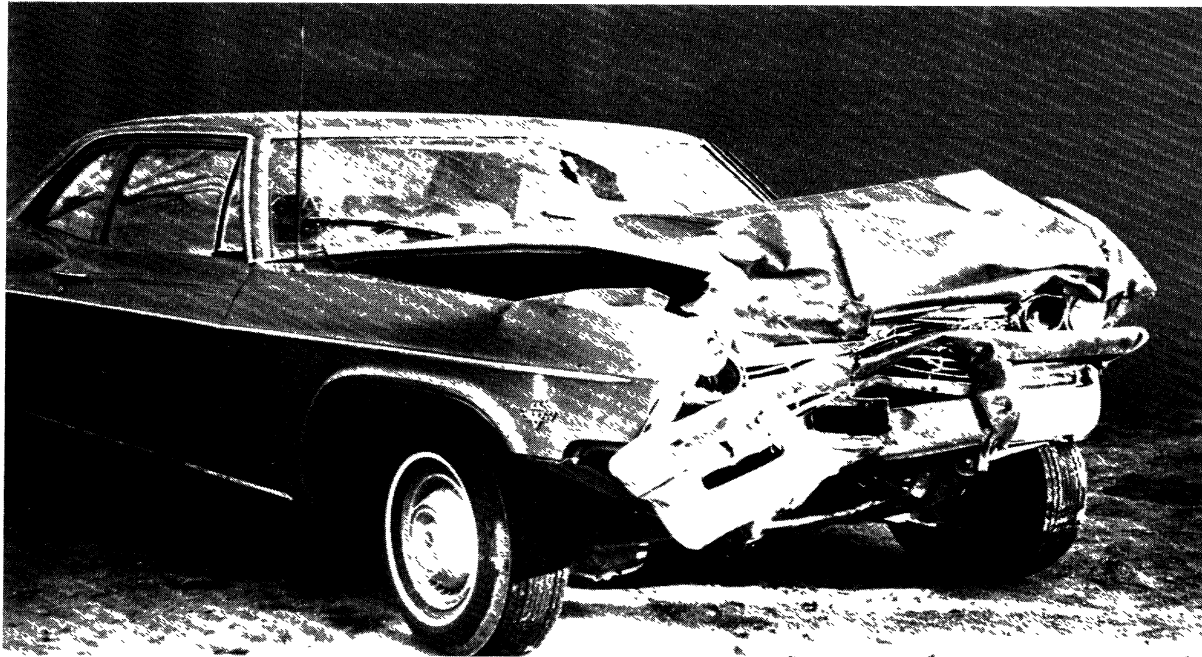
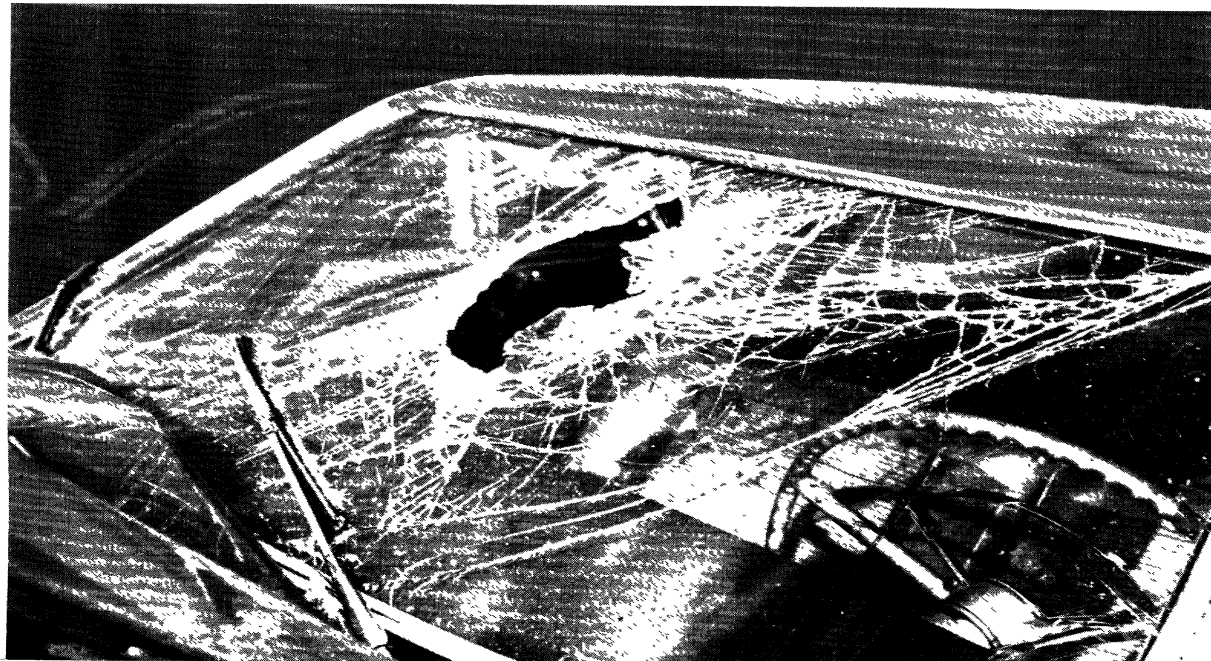
1965 Chevrolet (Figures 31 and 32). A head-on collision with the front corner of a van truck (impact velocity 35 mph). The driver (male, 54 years old) struck the center of the windshield and sustained multiple facial lacerations and a frontal bone skull fracture involving the frontal sinus. Seat belts were not worn. See figure 79.
(Case #222/5/14/67)
