AUTOMOBILE OCCUPANT INJURIES
from
STRIKING THE WINDSHIELD

The University of Michigan Medical School

HIGHWAY SAFETY RESEARCH INSTITUTE
The University of Michigan • Ann Arbor
1967

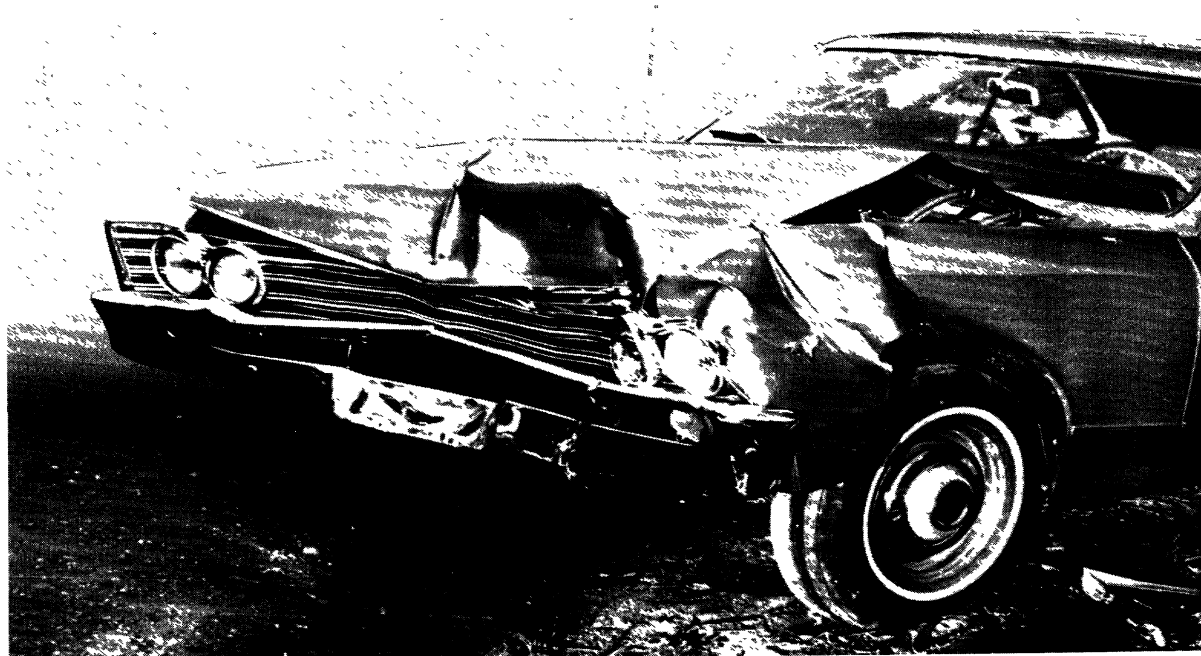
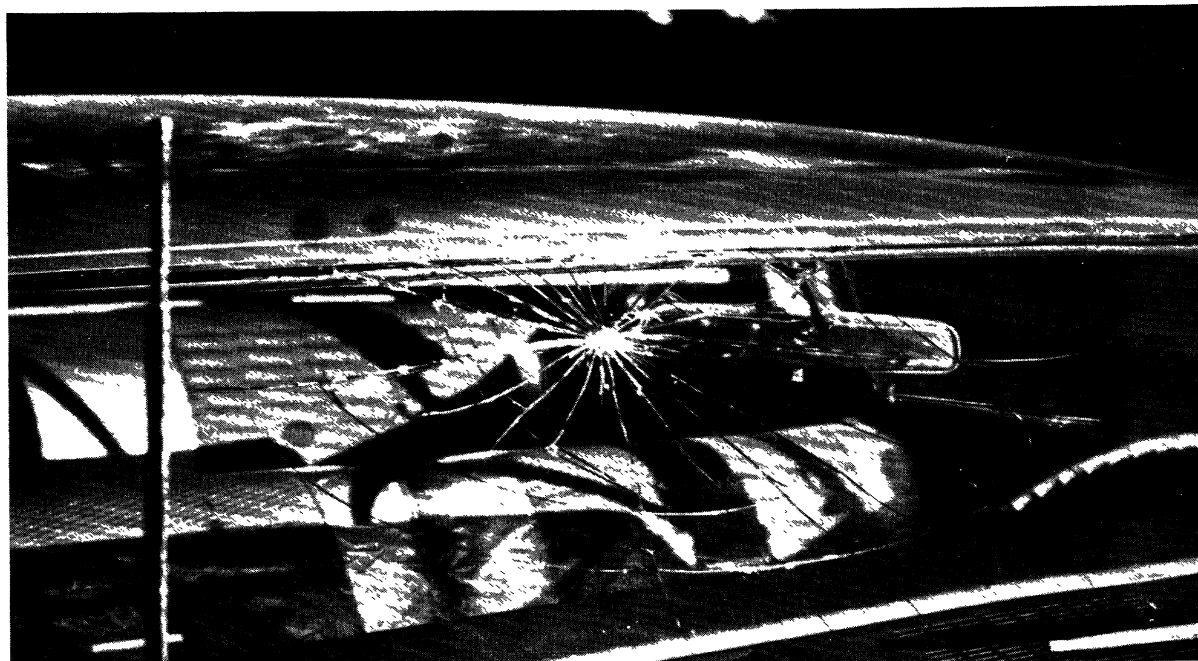
1967 Chevrolet (Figures 33 and 34). An intersection collision (impact velocity 25 mph). The front right passenger (female, 24 years old) struck the windshield 17 inches from the right "A" pillar and 4 inches below the header. She sustained a bruised forehead. Seat belts were not worn.
(Case #156/10/6/66)

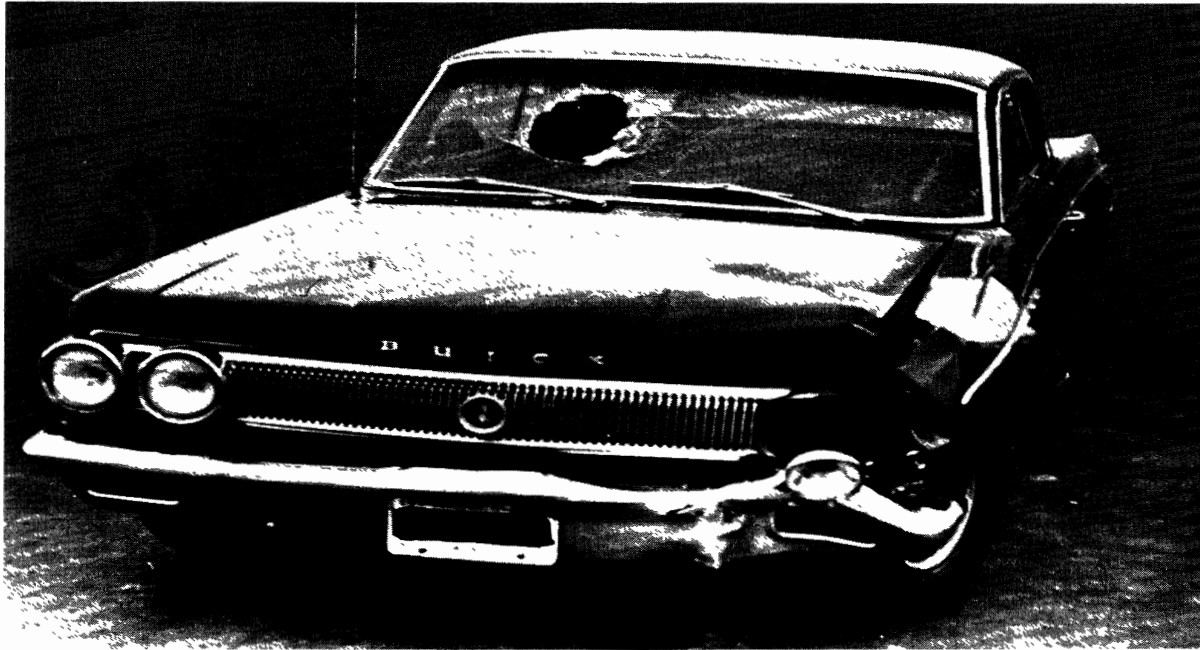
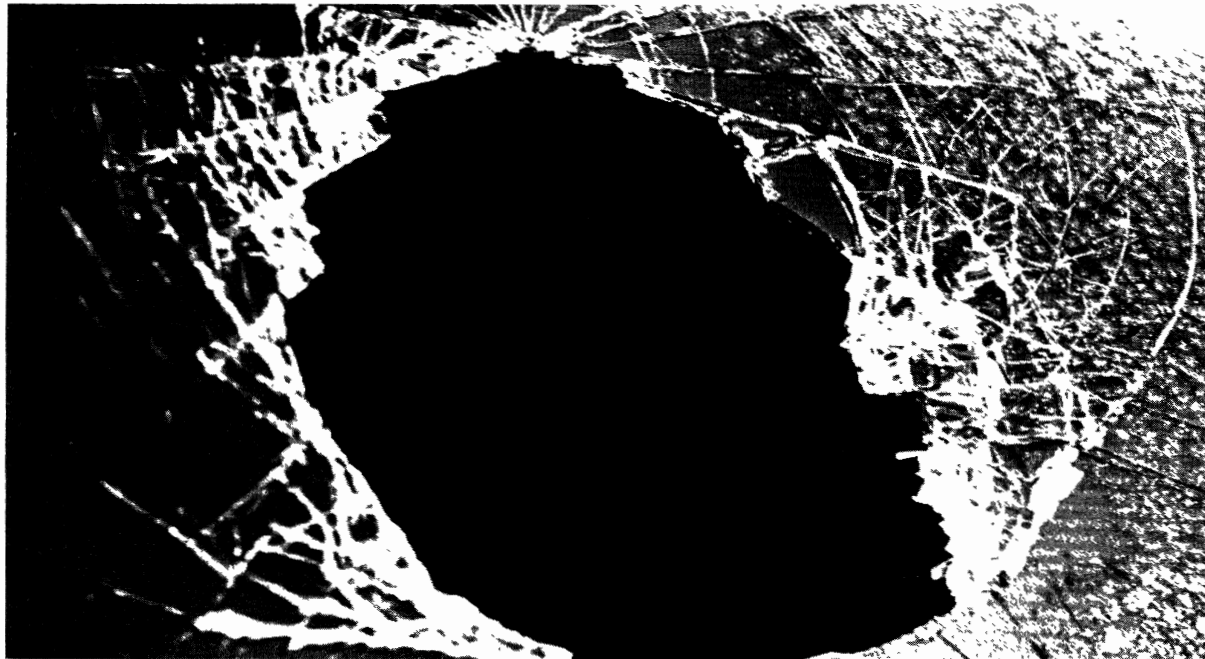
1963 Buick (Figures 35 and 36). Car-tree accident (impact velocity 15 mph). The driver (male, 25 years old) struck the windshield on the passenger's side. He sustained lacerations of the forehead, right cheek, tip of nose, and of the right ear and preauricular area. Seat belts were not worn.
(Case #44/12/18/66)

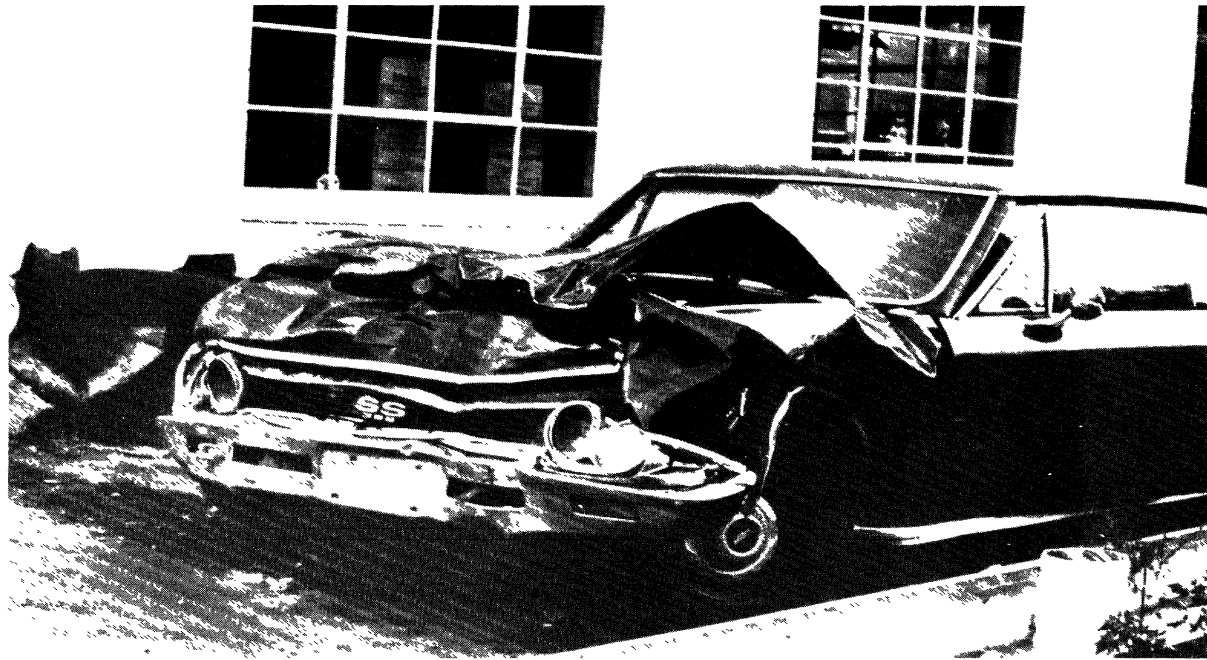
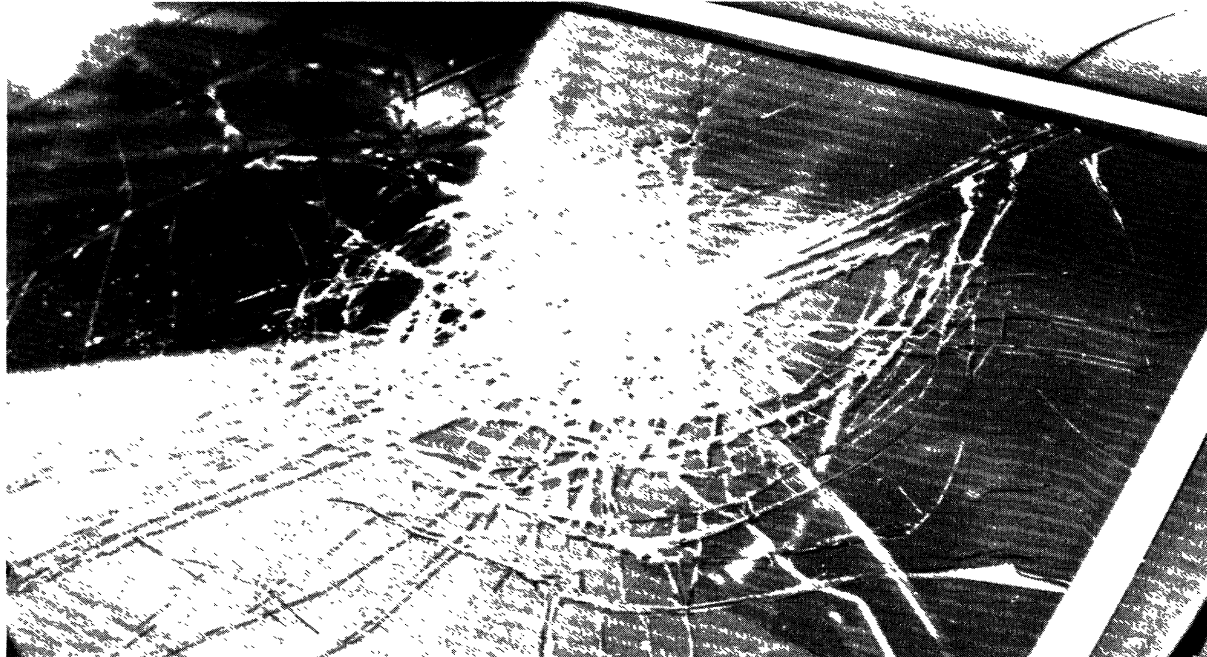
1966 Chevrolet (Figures 37 and 38). An intersection collision (impact velocity 45 mph). The windshield of the Chevrolet had a head impact imprint 8 inches below the header and 9 inches from the left "A" pillar. The driver (male, 20 years old) sustained a 6.5-cm laceration on the back of his head. He flexed over the steering wheel to contact the windshield (hair found on the inner glass). There was only a slight outward bulge at the impact site. Seat belts were not worn.

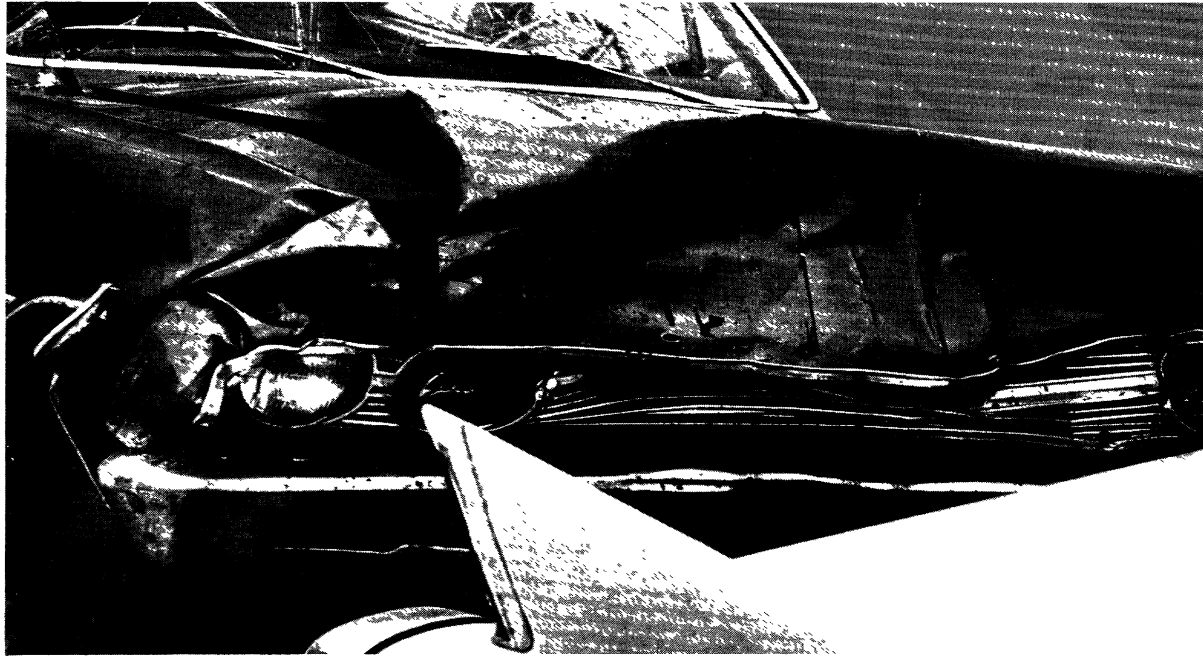
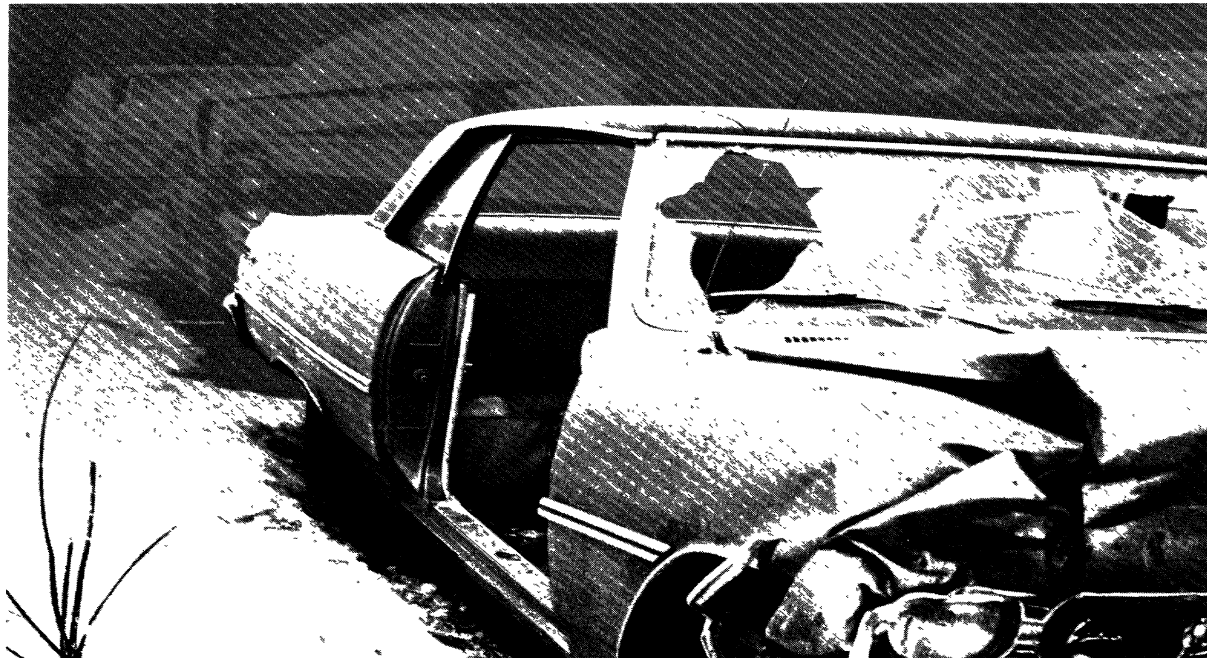
1965 Chevrolet (Figures 39 and 40). A head-on, car-to-car collision (impact velocity 20-25 mph). The driver (male, 49 years old) struck the windshield 14 inches from the left "A" pillar and 3 inches below the header. He sustained multiple lacerations of the forehead and chin. The passenger (female, 46 years old) struck the windshield 5 inches from the right "A" pillar and 4 inches below the header. She sustained a 5-cm laceration of the left forehead, a 5-cm laceration behind the left ear, and a 3-cm laceration behind the right ear. Seat belts were not worn.

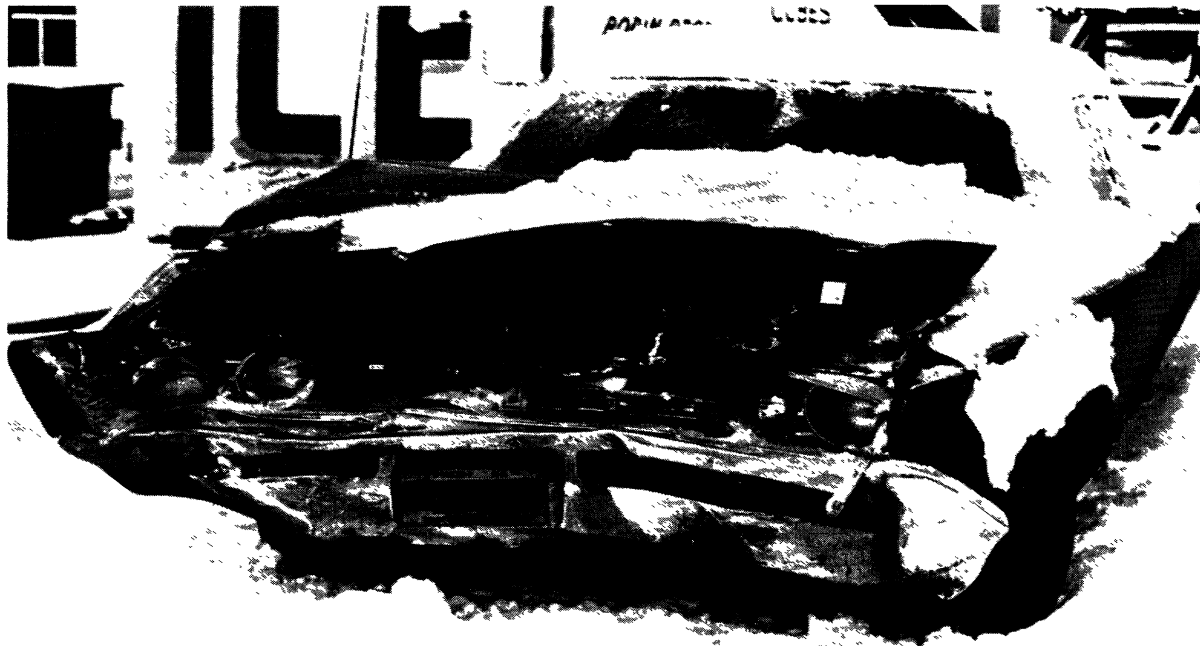
1966 Chrysler (Figures 41 and 42). A 1961 Ford Van turning left was struck by an oncoming Chrysler (impact velocity 40-45 mph). The driver of the Chrysler was not injured. His passenger (female, 33 years old) struck her forehead on the windshield 18 inches from the "A" pillar and 9 inches below the header. The windshield impact area was bulged outward; the laminate was not perforated. The attending physician stated that her forehead was "chewed up." After removing small glass particles from the multiple small lacerations, the area was bandaged and the patient sent home. No sutures were required to close the wounds. Seat belts were not worn. (Case #50/12/18/66)

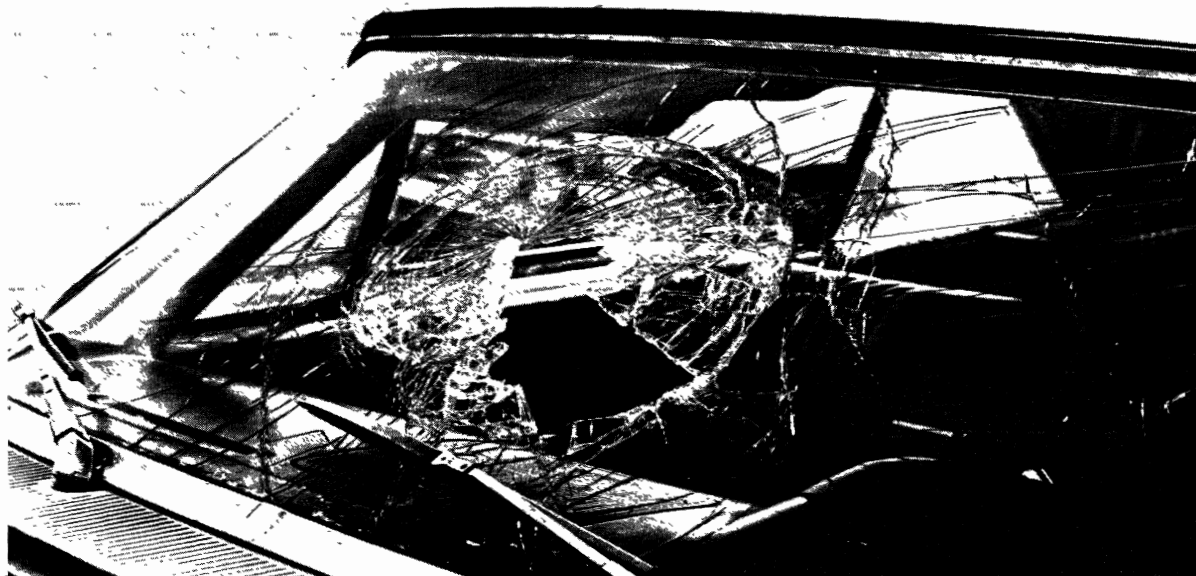
44

1964 Mercury (Figures 43 and 44). This vehicle struck a guard rail (glancing impact at 40-50 mph). The passenger (female, 11 years old) struck the windshield 29 inches from the left "A" pillar and 11 inches below the header. She sustained a long laceration at the hairline. Seat belts were not worn.
(Case #167/10/9/66)

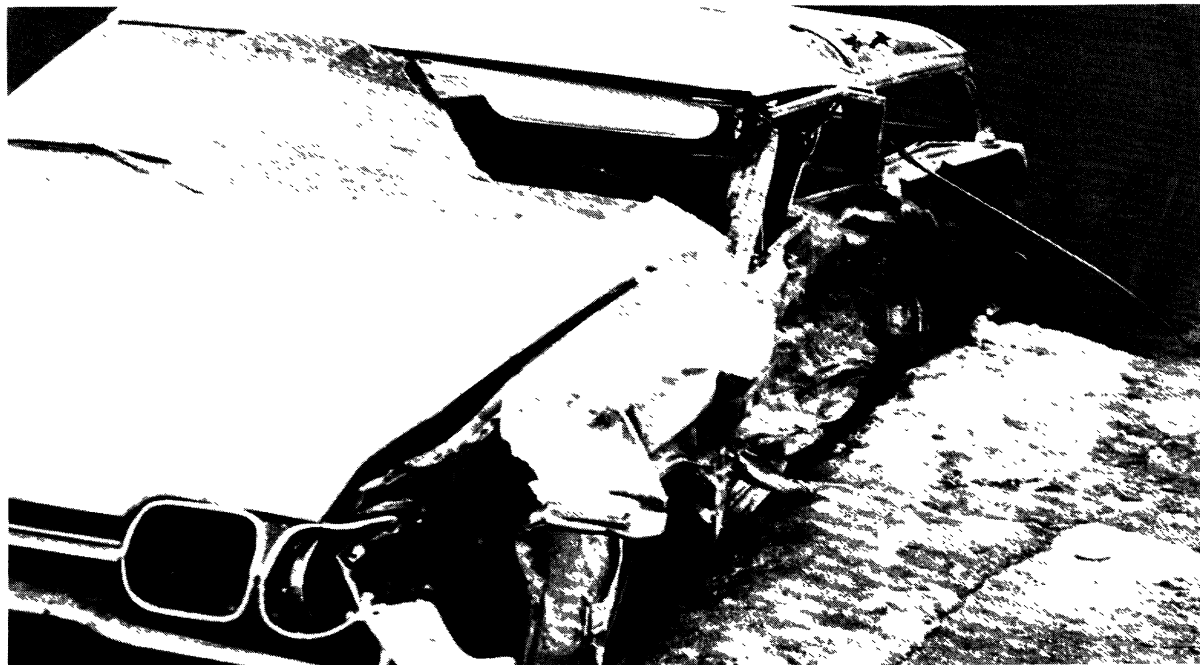
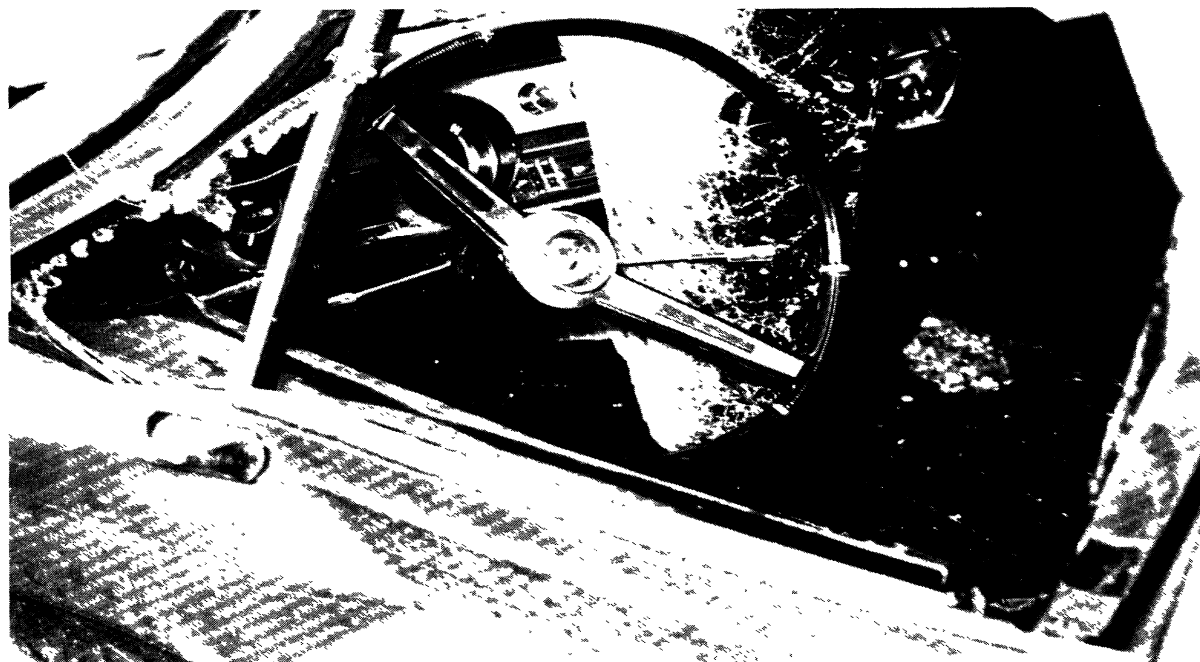
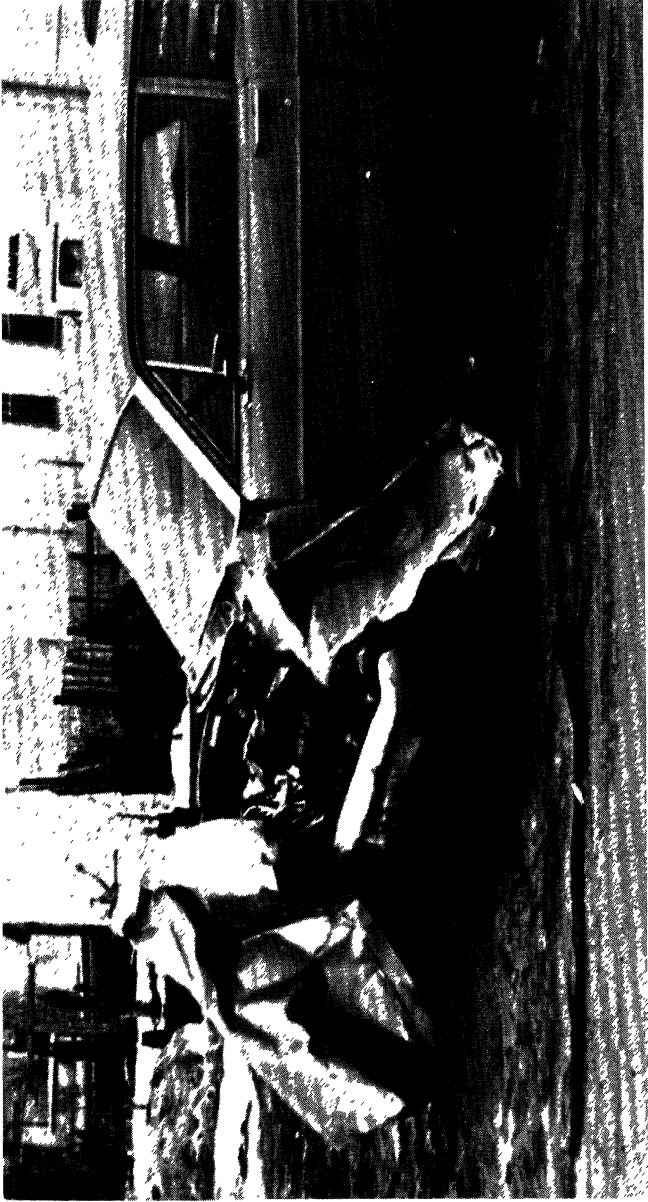
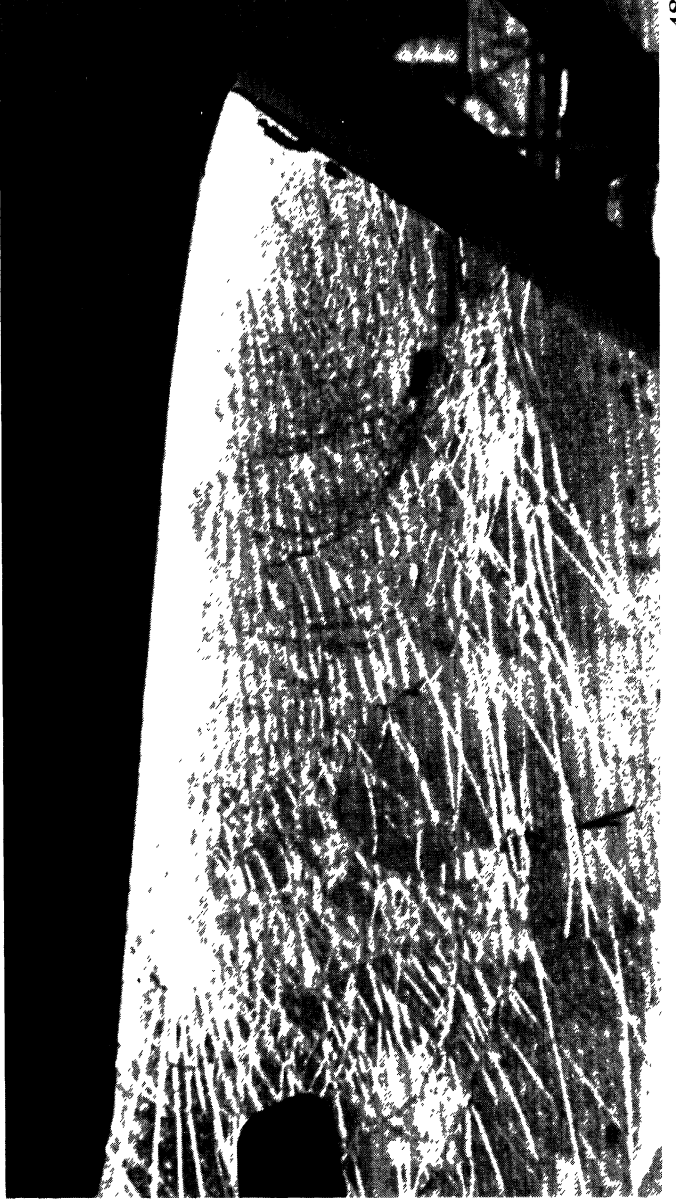
1966 Oldsmobile, 1966 Ford (Figures 45, 46, 47 and 48). The Ford went out of control, crossed an expressway median, and struck the Oldsmobile in the side (glancing impact at 50 mph). Because of frame deformation, especially at the "A" pillar, the windshield of the Oldsmobile was matted; the left half of the windshield had fallen rearward into the occupant area. The driver sustained lacerations of the lower lip and hand from side window glass. No injuries were sustained from windshield glass. Seat belts were not worn. The passenger in the Ford (male, 26 years old) struck the windshield 3 inches below the header and 3 inches from the "A" pillar. The laminate was perforated. He sustained a cervical sprain. The driver of the Ford (male, 28 years old) struck his right elbow against the windshield just to the right of the mirror; a minor elbow-forearm laceration was sustained from this impact. Seat belts were not worn.

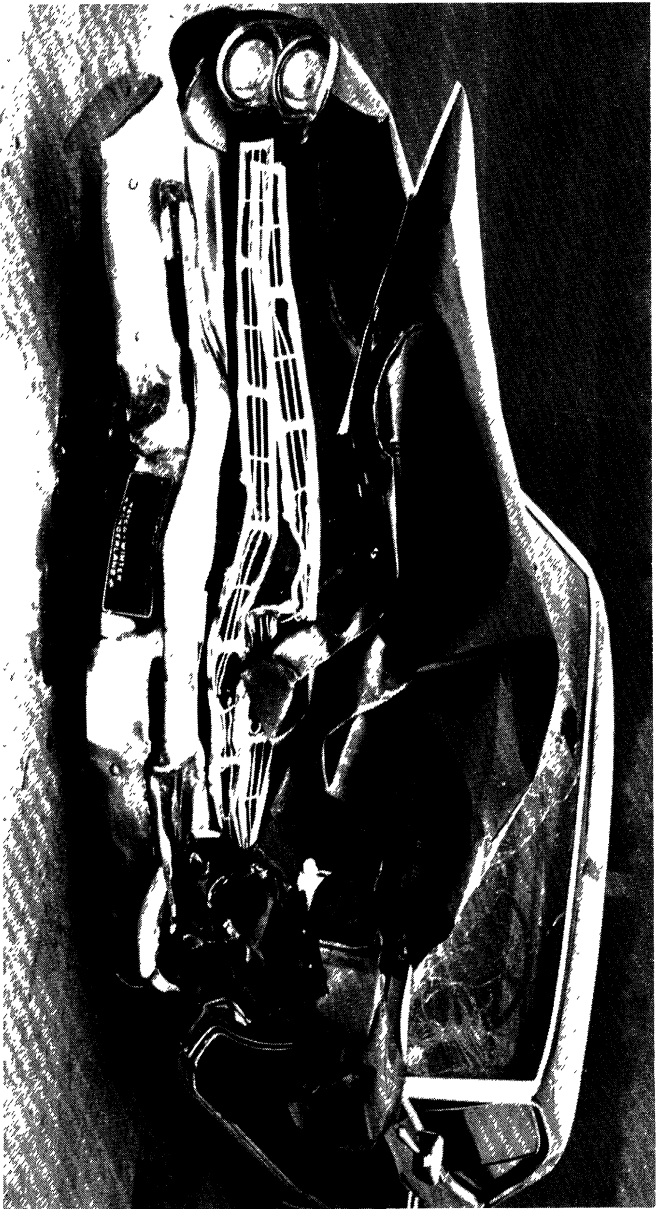
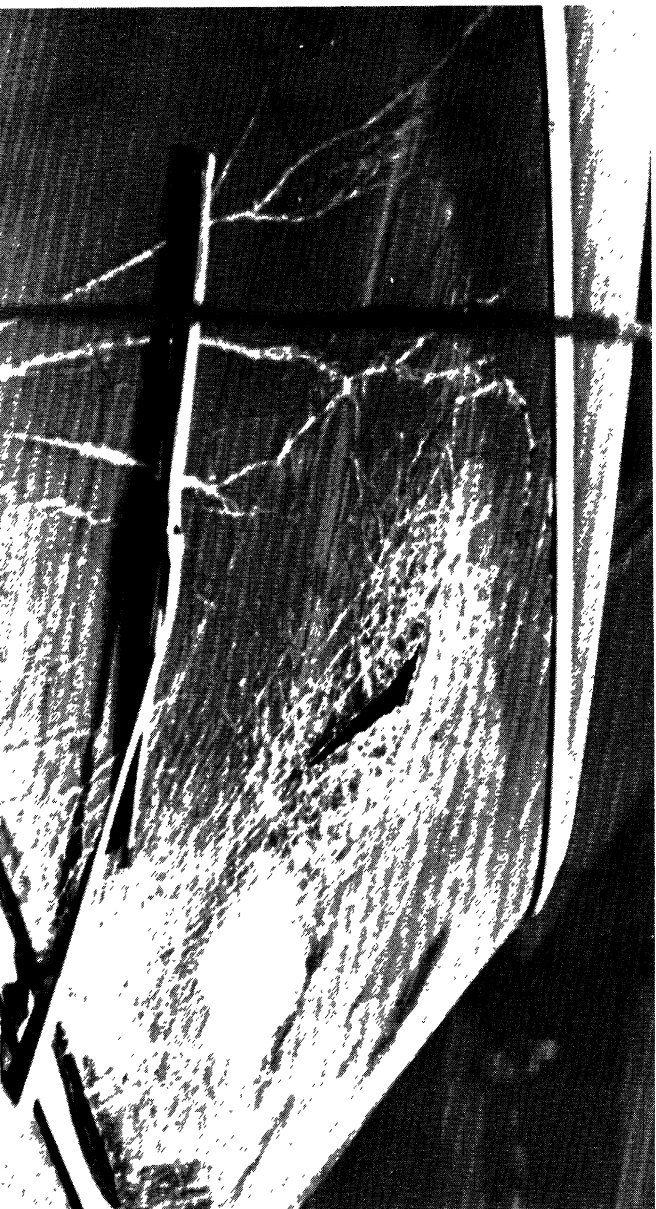
1967 Ford (Figures 49 and 50). A head-on, car-to-car collision (impact velocity 30 mph). The front passenger (female, 45 years old) struck the center of the windshield bulging it outward and tearing the laminate. She sustained abrasions of the forehead from this impact. Seat belts were not worn. (Case #206/5/10/67)

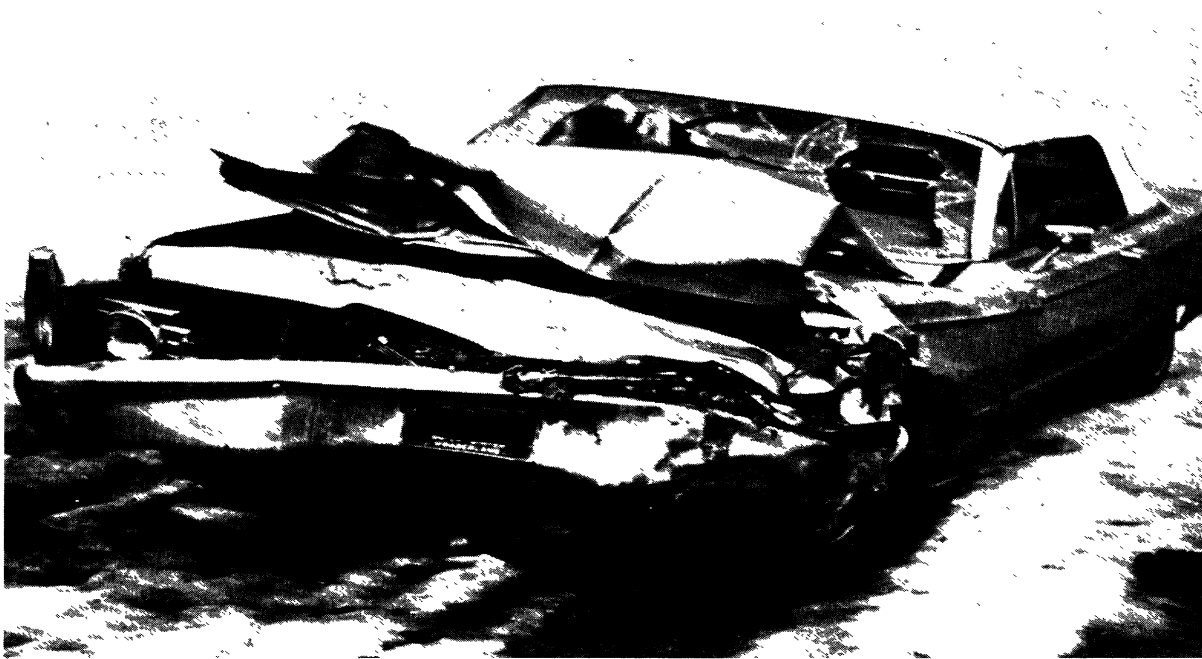
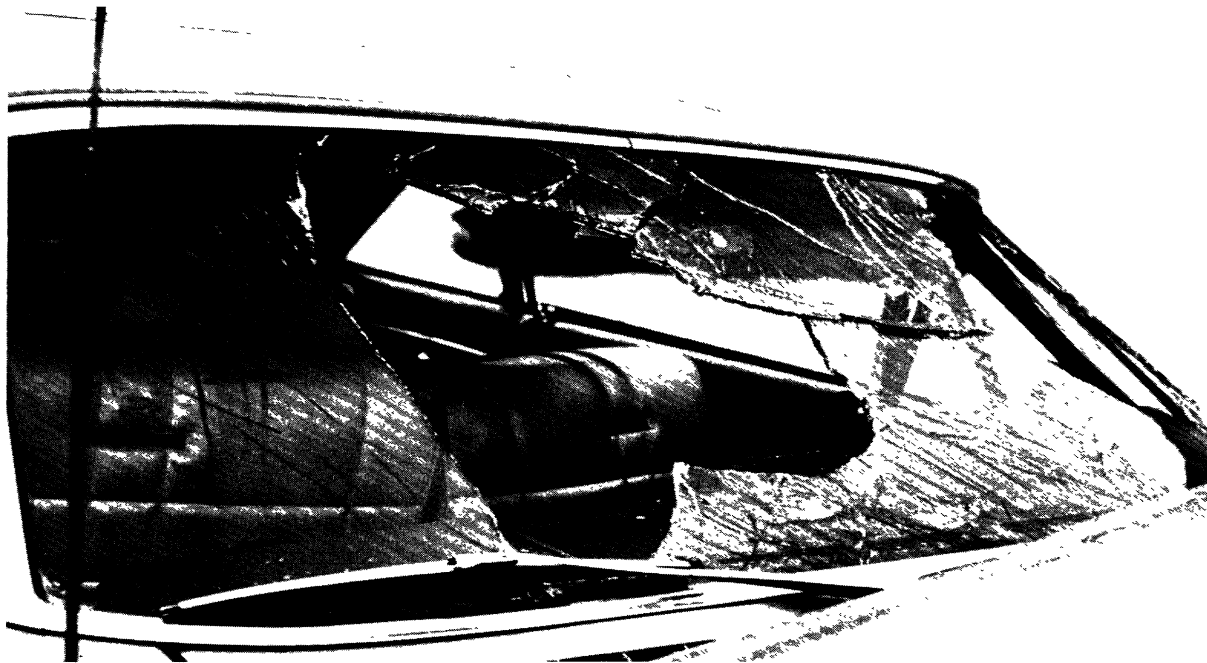
1965 Mercury (Figures 51 and 52). A head-on, car-to-car collision (impact velocity 35 mph). The driver (male, 34 years old) struck the windshield above the steering wheel and sustained a large vertical scalp laceration and a laceration to the forehead. The passenger (female, 31 years old) struck the windshield, sustaining minor lacerations and abrasions about the face. Seat belts were not worn.

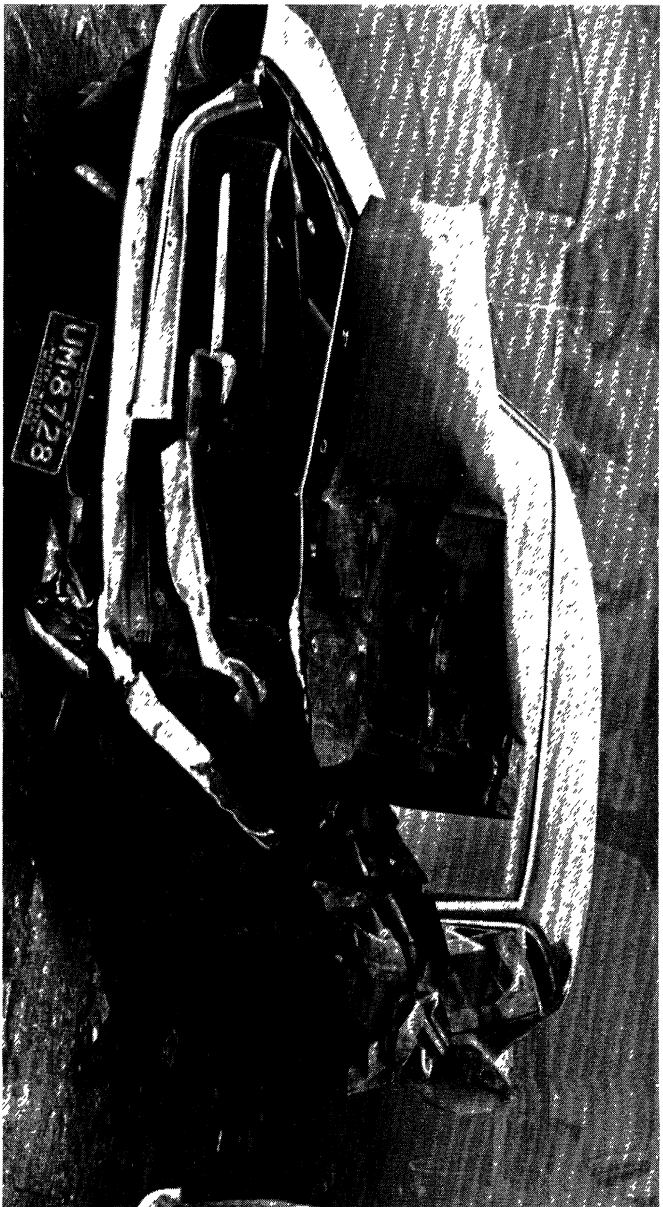
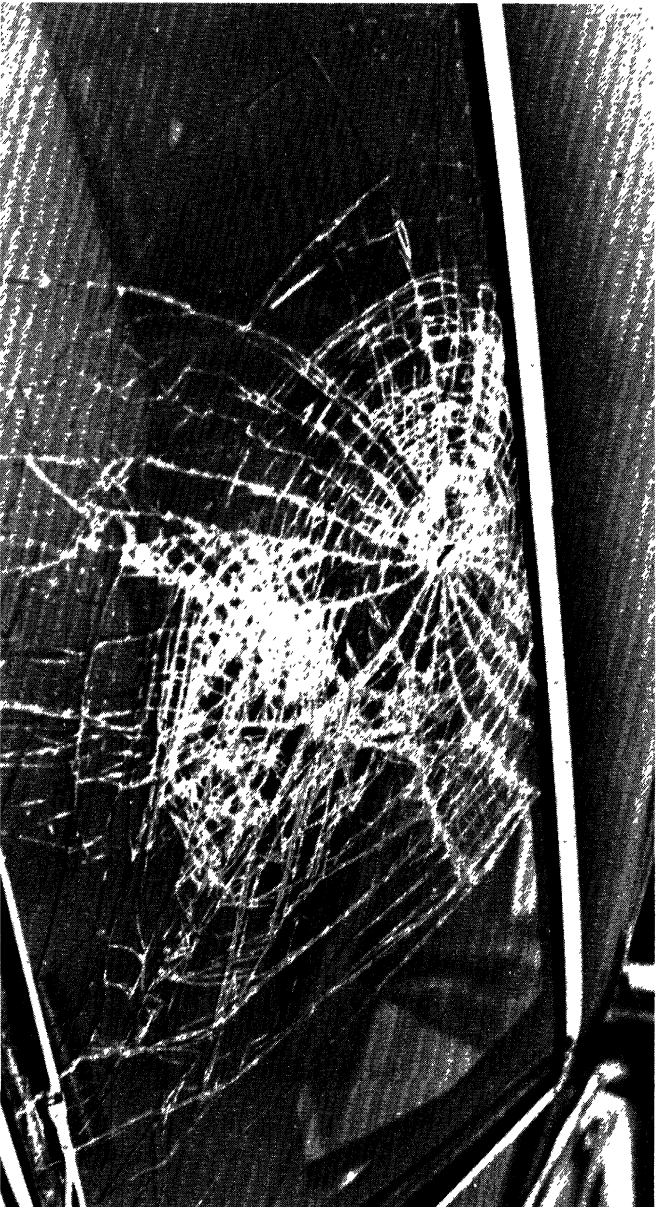
1967 Mustang (Figures 53 and 54). A head-on, car-to-car collision (impact velocity 35 mph). The driver of the Mustang (male, 18 years old, 5 feet 10 inches, 155 pounds), struck the rear-view mirror and slid off of it into the windshield. He sustained a 2-cm, U-shaped laceration above the left eyelid. Seat belts were not worn.
(Case #211/3/26/67)

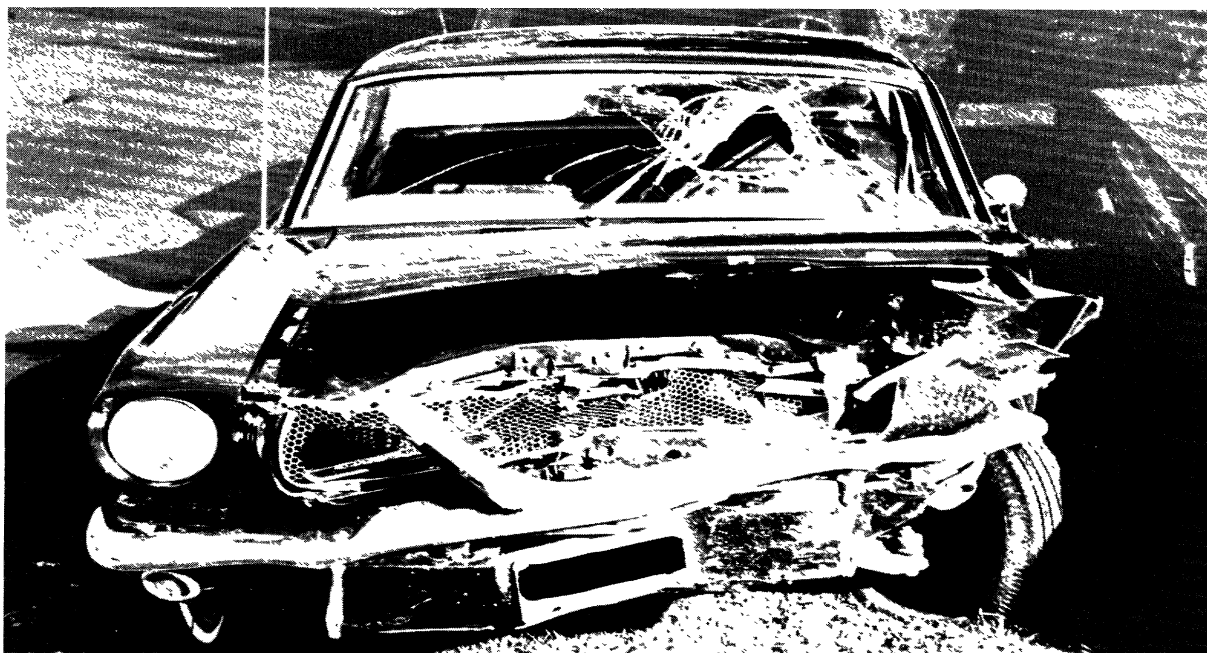
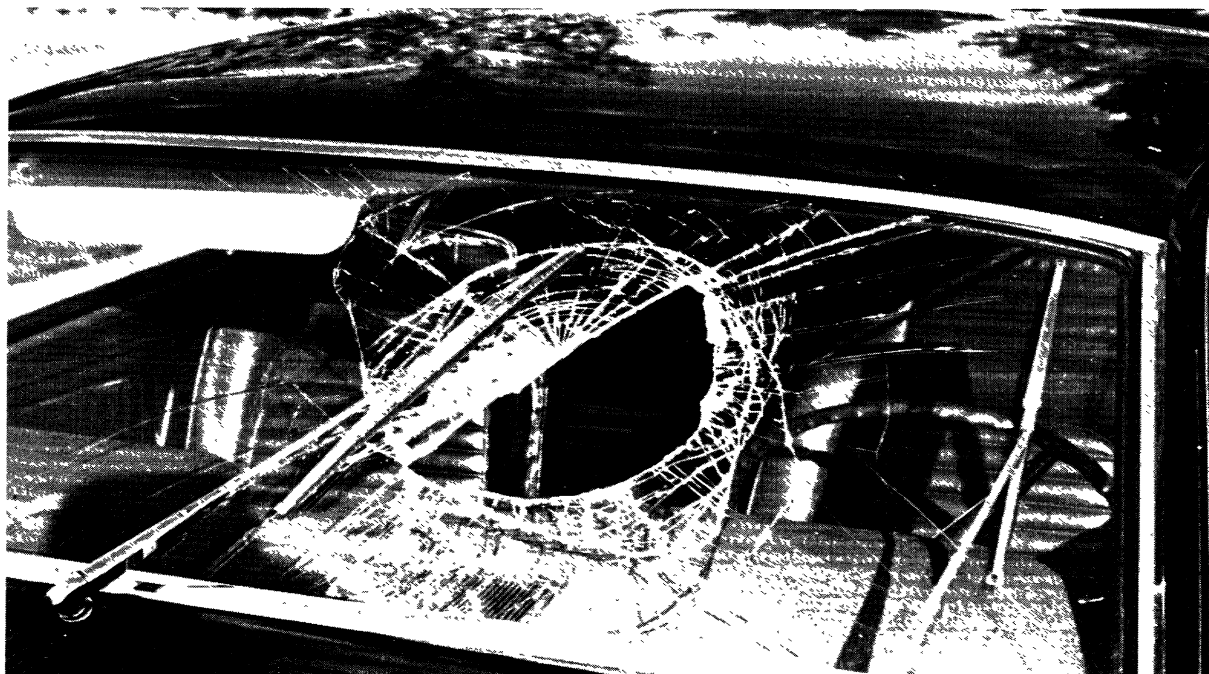
1965 Mustang (Figures 55 and 56). This vehicle struck the right front of another that turned in front of it (impact velocity 25 mph). The passenger (female, 23 years old, 5 feet 5 inches, 125 pounds) struck the windshield 18 inches from the left "A" pillar and 9 inches below the header. She sustained a 5-cm laceration on the top of the left side of her head. Seat belts were not worn. (Case #73/10/18/65)

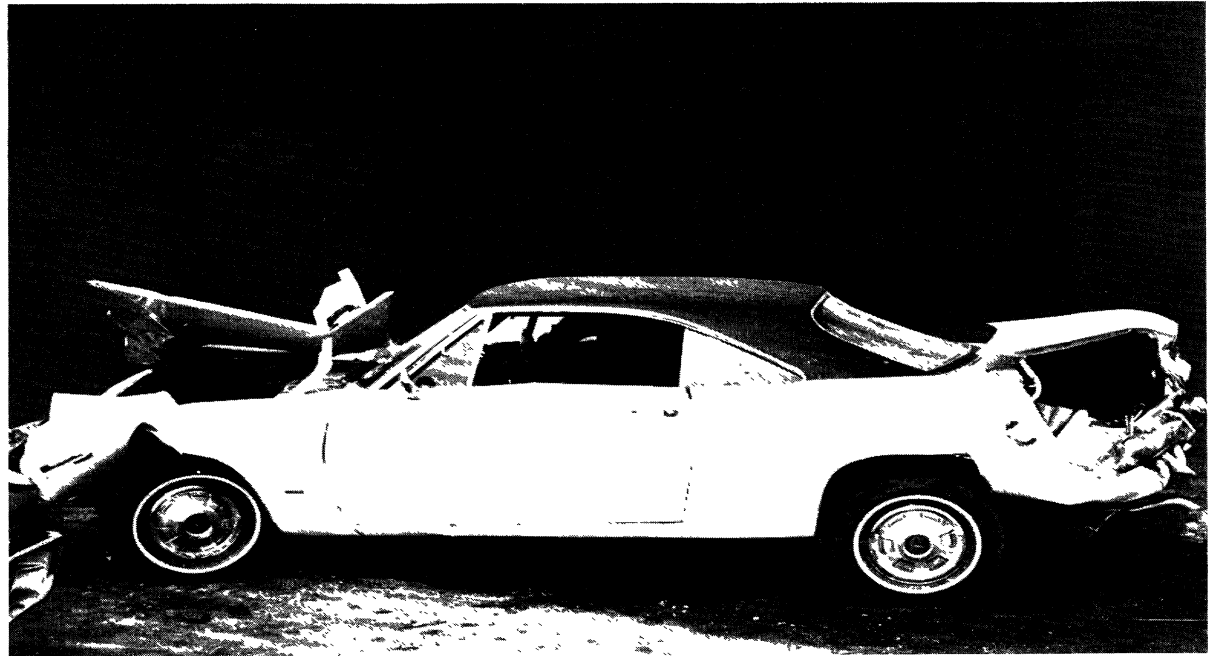
1967 Barracuda (Figures 57 and 58). This vehicle went off the roadway, rolled and flipped over several times. The driver (male, 40 years old) struck the windshield just to the left of the rear-view mirror, and sustained multiple lacerations and abrasions of his forehead and face, one of which required sutures. The matted windshield is partially separated from the molding in the header area. No seat belts were worn.

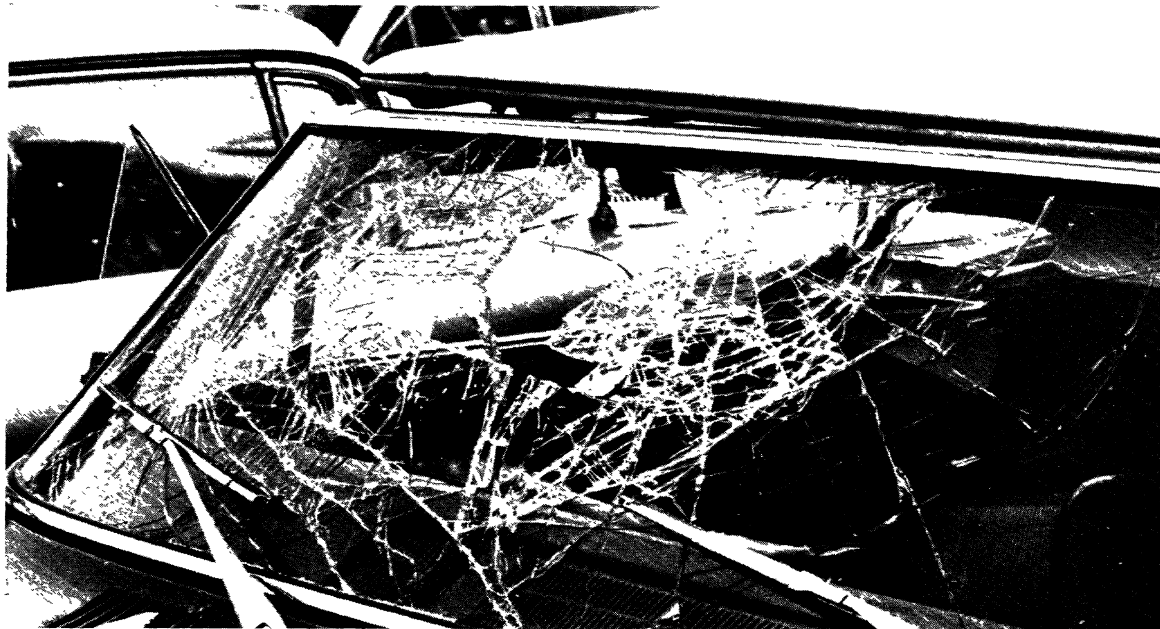
60

1963 Chevy II (Figures 59 and 60). A head-on, car-to-car collision (impact velocity 30 mph). The passenger (female, 24 years old) struck the windshield 11 inches from the right "A" pillar and 12 inches below the header. An adjacent windshield imprint was produced by the rear-view mirror striking the glass. She sustained a 20-cm laceration to the scalp. Seat belts were not worn.

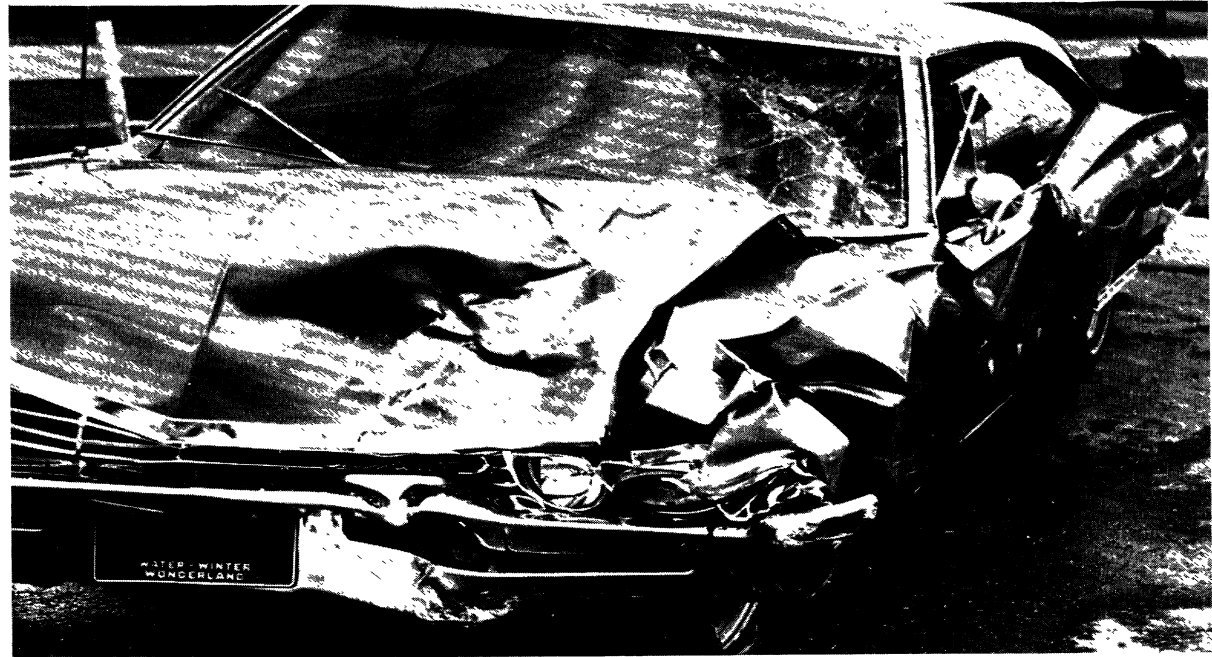
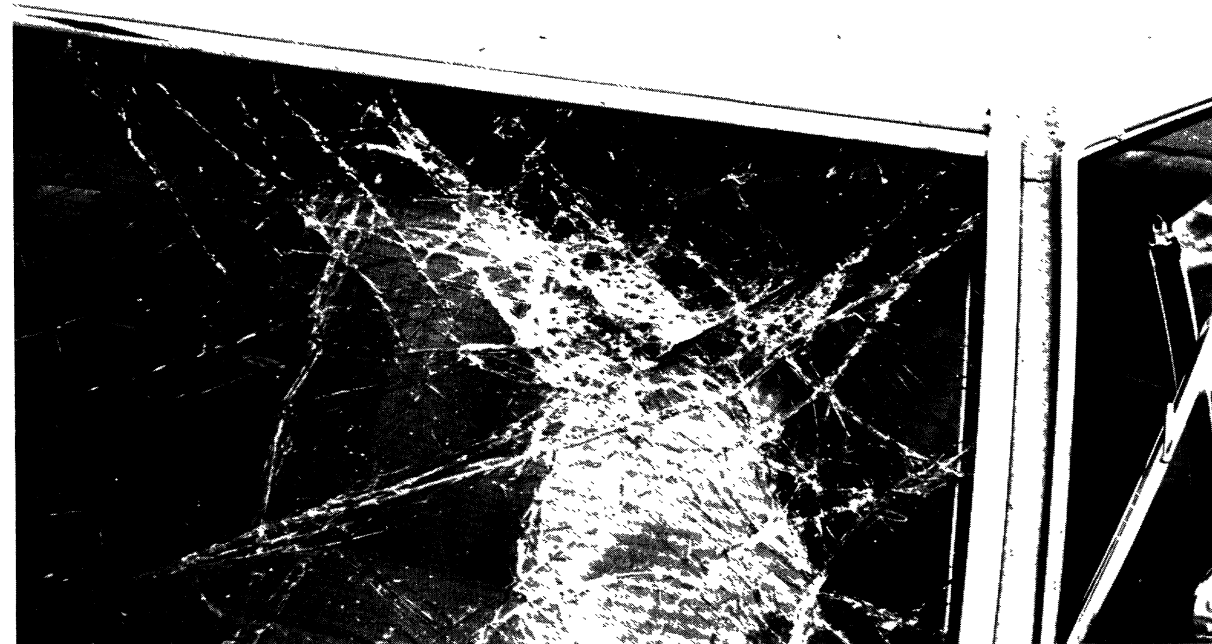
1967 Chevrolet (Figures 61 and 62). An intersection type collision (impact velocity 30 mph). The driver (male, 52 years old), struck the windshield 7 inches below the header and 8 inches from the left "A" pillar. The laminate was perforated. He sustained a scalp laceration above the left eyebrow. No seat belts were worn.
(Case #219/5/5/67)

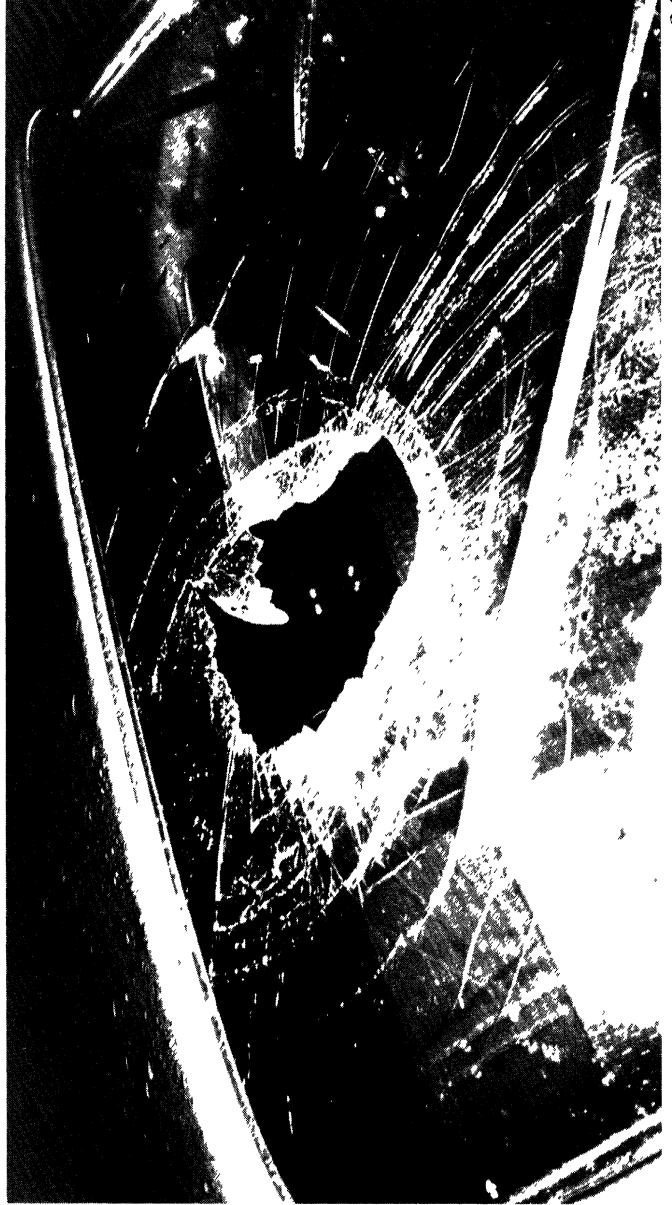
1963 Chevrolet (Figures 63 and 64). A head-on, car-to-car collision (impact velocity 10 mph). The passenger (female, 18 years old) struck the windshield to the right of center, sustaining multiple lacerations of the forehead, right zygoma, and other smaller facial lacerations. Seat belts were not worn. (Case #47/12/28/64)
