AUTOMOBILE OCCUPANT INJURIES
from
STRIKING THE WINDSHIELD

The University of Michigan Medical School

HIGHWAY SAFETY RESEARCH INSTITUTE
The University of Michigan • Ann Arbor
1967

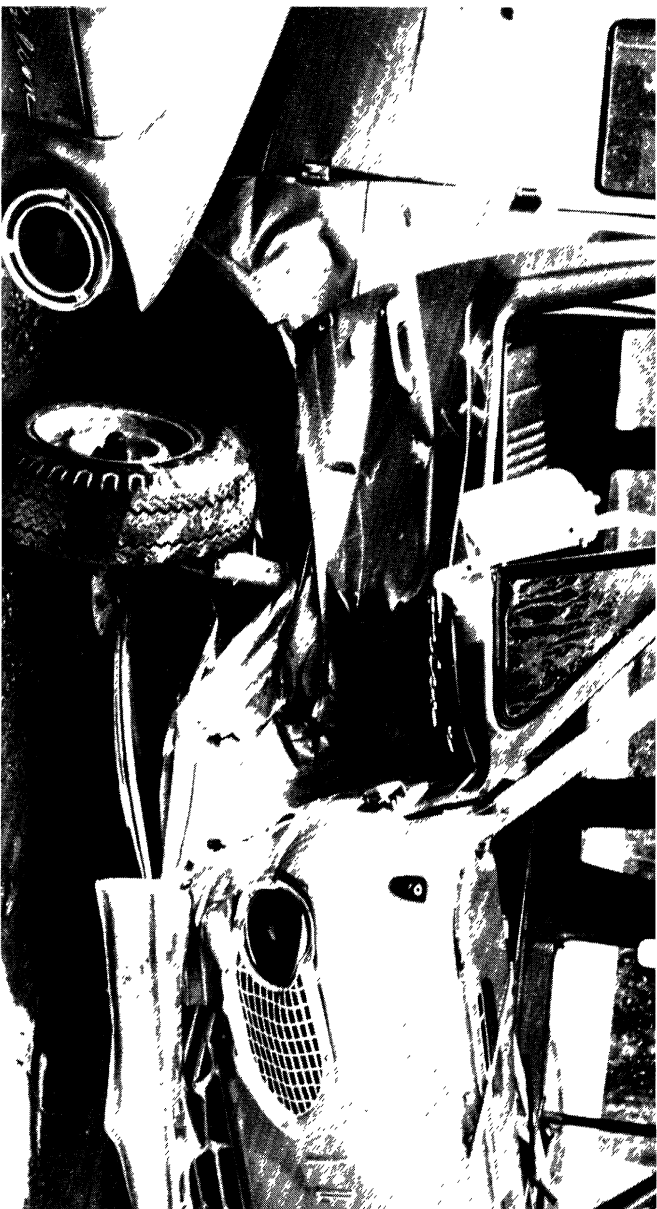
1966 Ford Van (Figures 65 and 66). This van was involved in an intersection collision (impact velocity 30-35 mph). The windshield was broken out completely and was found cracked, but intact, in the rear of the van (it had been placed there by the wrecker crew). The driver was ejected through the windshield opening. He sustained multiple lacerations to the face and ears; it is not known whether his facial injuries were due to ejection or windshield impact. (Case #157/10/7/66)

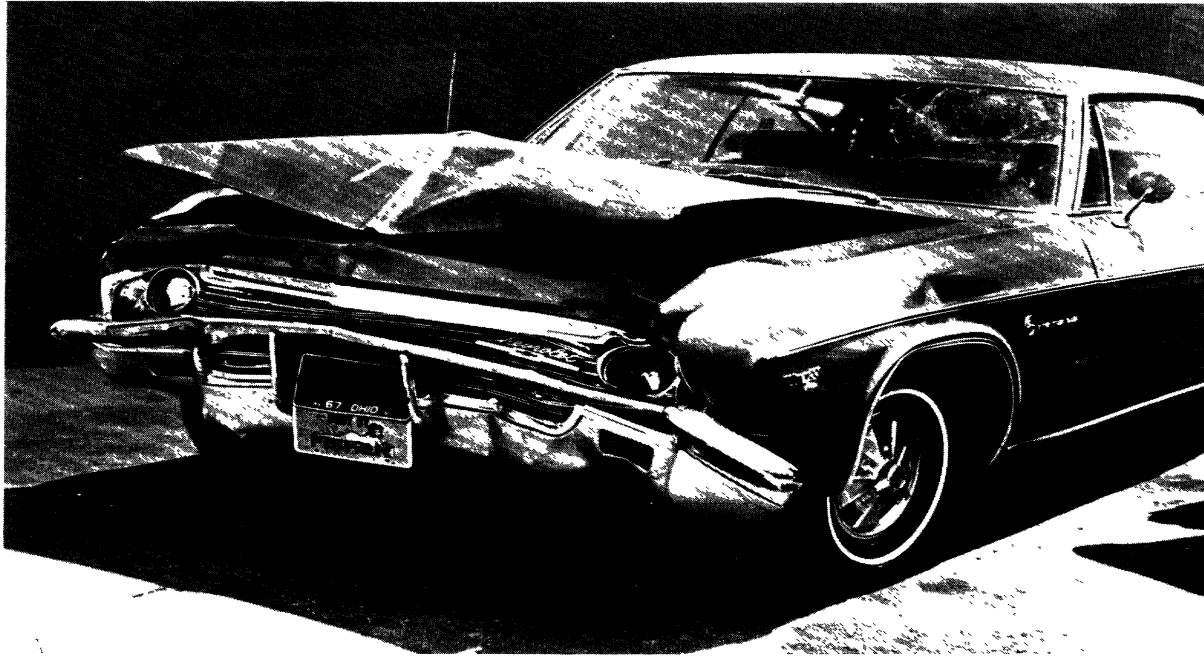
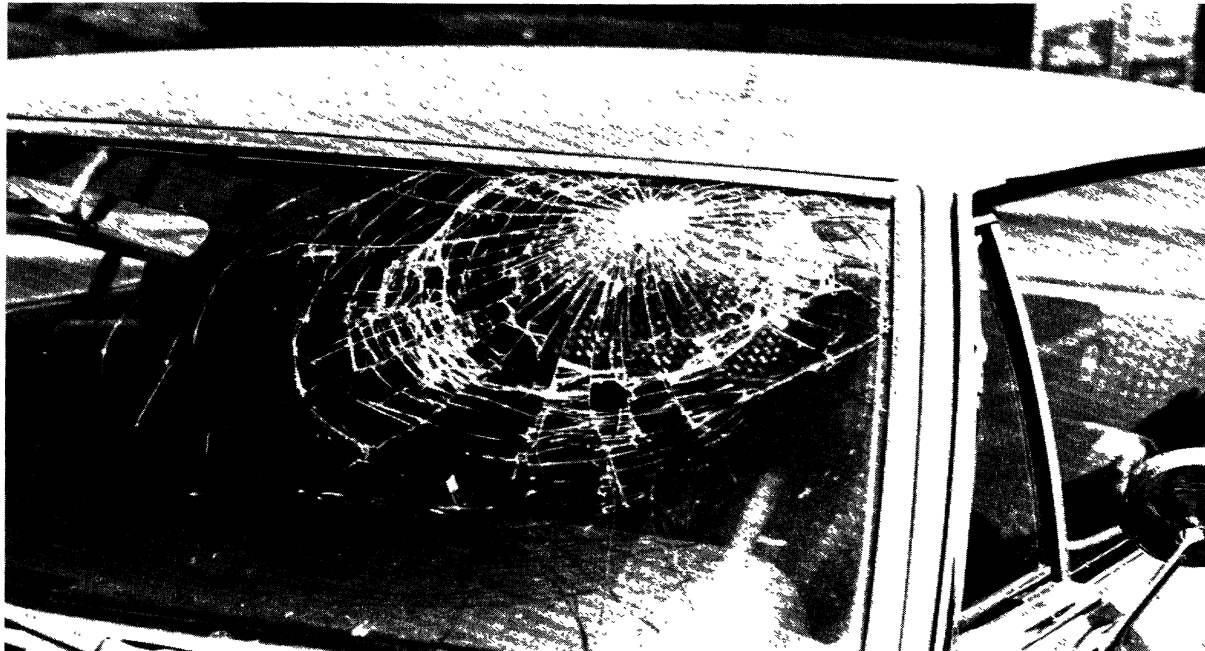
1966 Chevrolet (Figures 67 and 68). This vehicle struck another in the rear (impact velocity 20 mph). The driver (male, 29 years old) hit the windshield 3 inches below the header and 8 inches from the left "A" pillar. The impact site was bulged outward. He sustained abrasions of the face and had mild neck pain. Seat belts were not worn.
(Case #228/7/2/67)

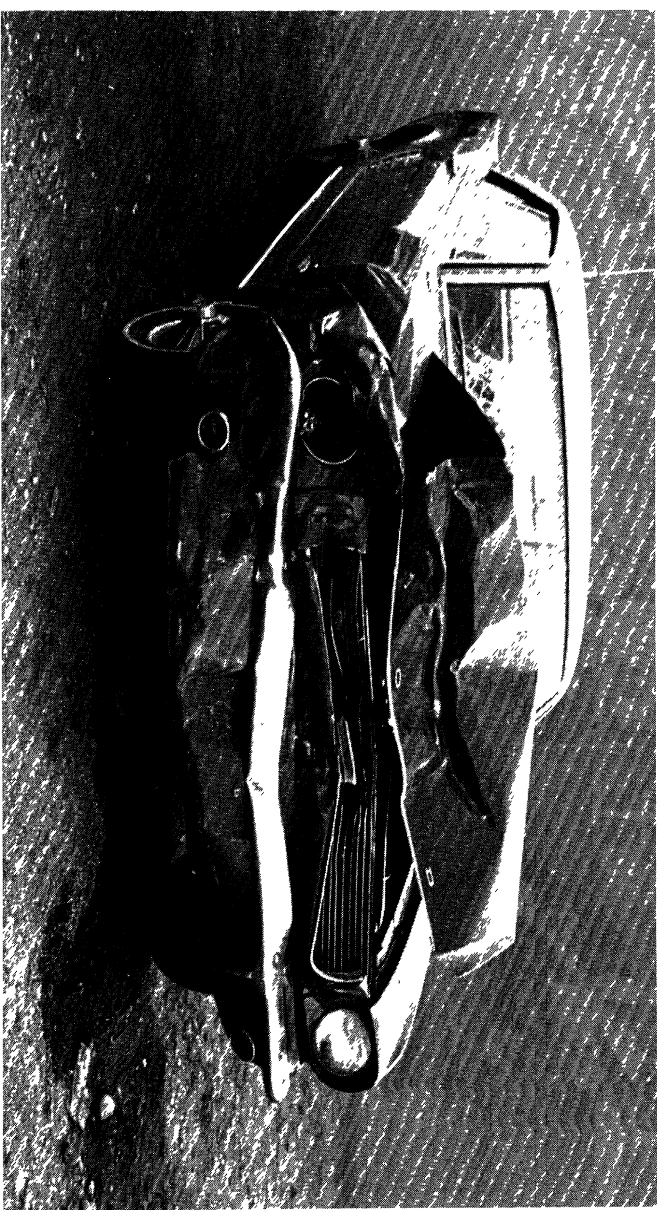
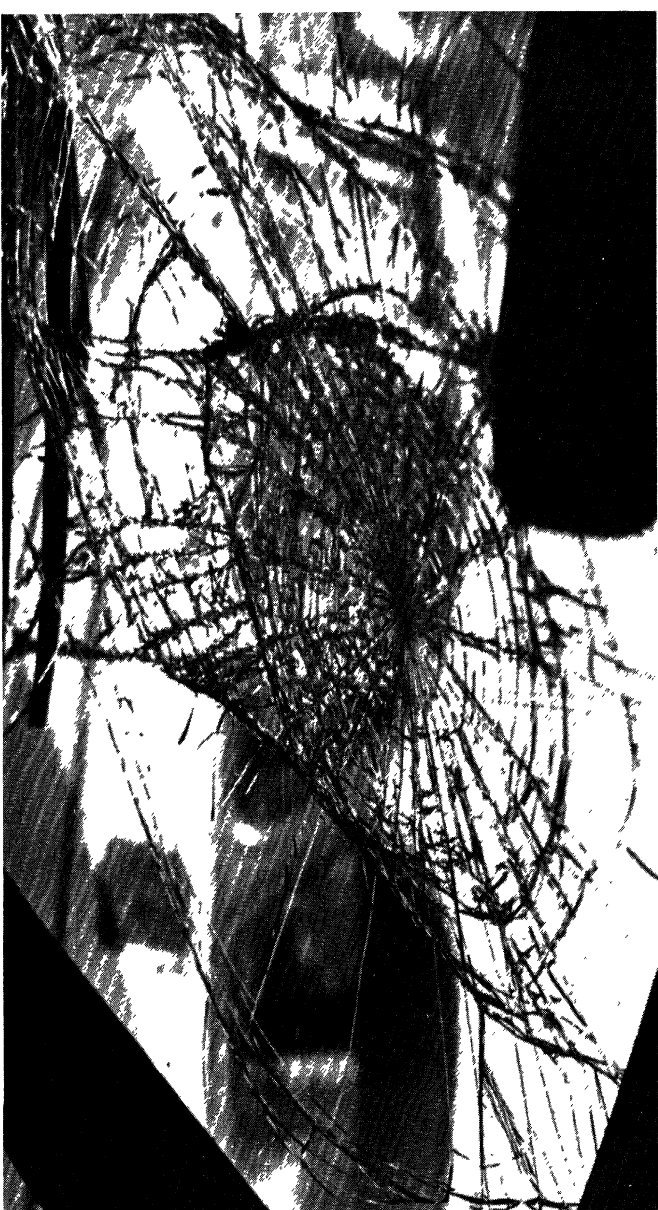
1966 Mustang (Figures 69, 70 and 71). The driver of this car fell asleep and hit two parked cars (impact velocity 25 mph). The passenger (male, 24 years old) struck the windshield 7 inches below the header and 12 inches from the right "A" pillar. The windshield at the impact area was noticeably bulged outward. He sustained small lacerations to his forehead and the top of his head. The driver (male, 29 years old) struck the windshield 8 inches below the header and 12 inches from the left "A" pillar. He sustained small forehead lacerations. Both refused medical treatment. No seat belts were worn. (Case #223/5/20/67)

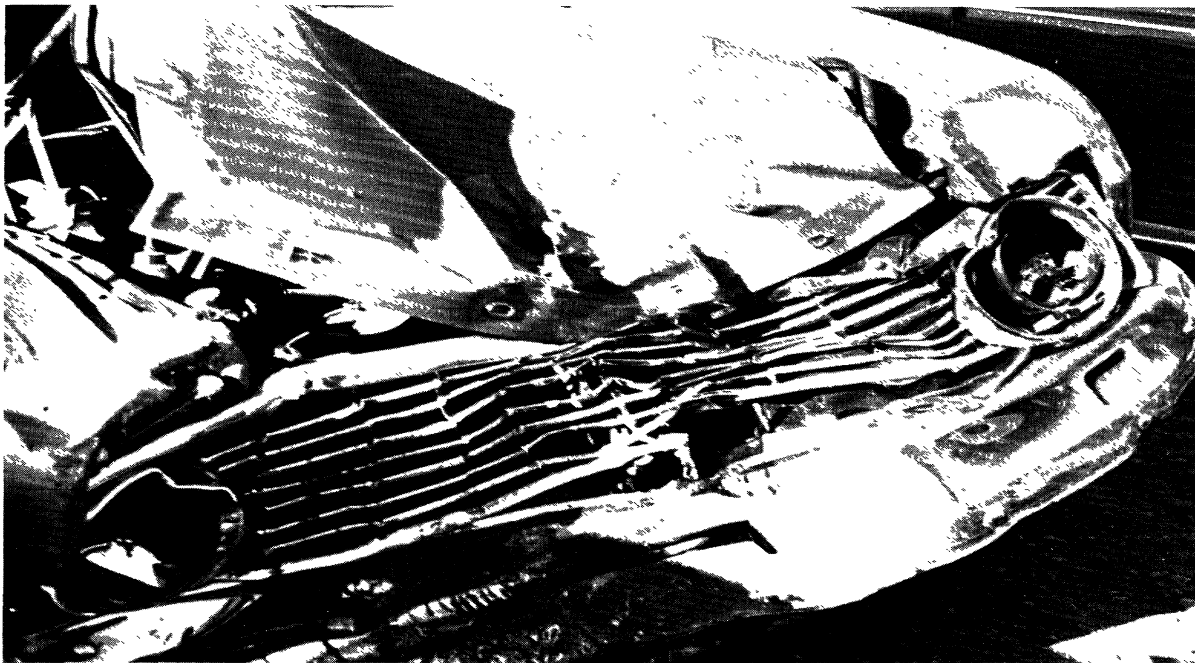
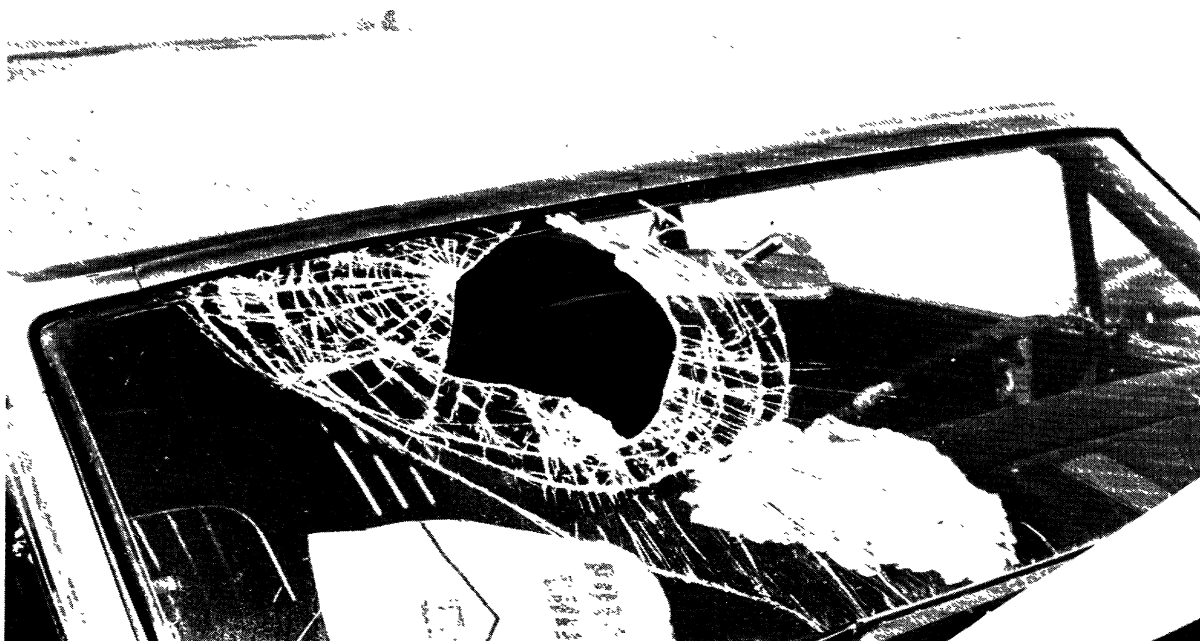
1964 Falcon (**Figures 72 and 73**). A head-on, car-to-car accident (impact velocity 30 mph). The passenger (female, 19 years old) struck the windshield 14 inches from the right "A" pillar and 5 inches below the header. She sustained multiple lacerations of the left cheek and a mandibular fracture. Seat belts were not worn.
(Case #68/5/24/66)

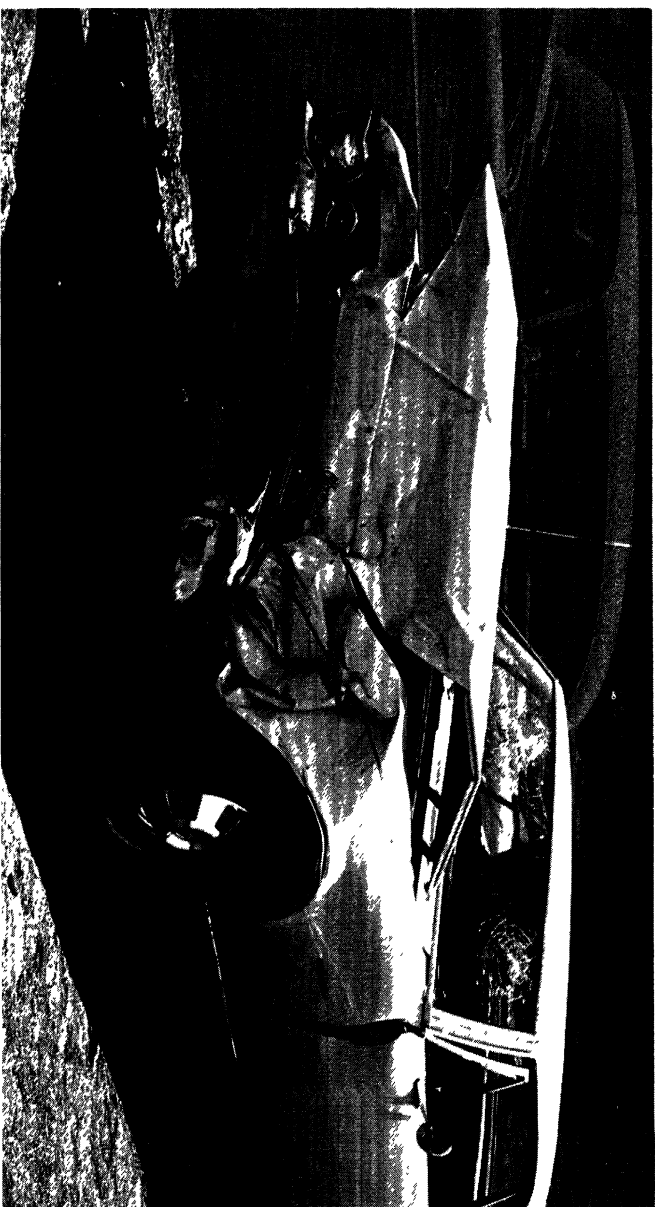
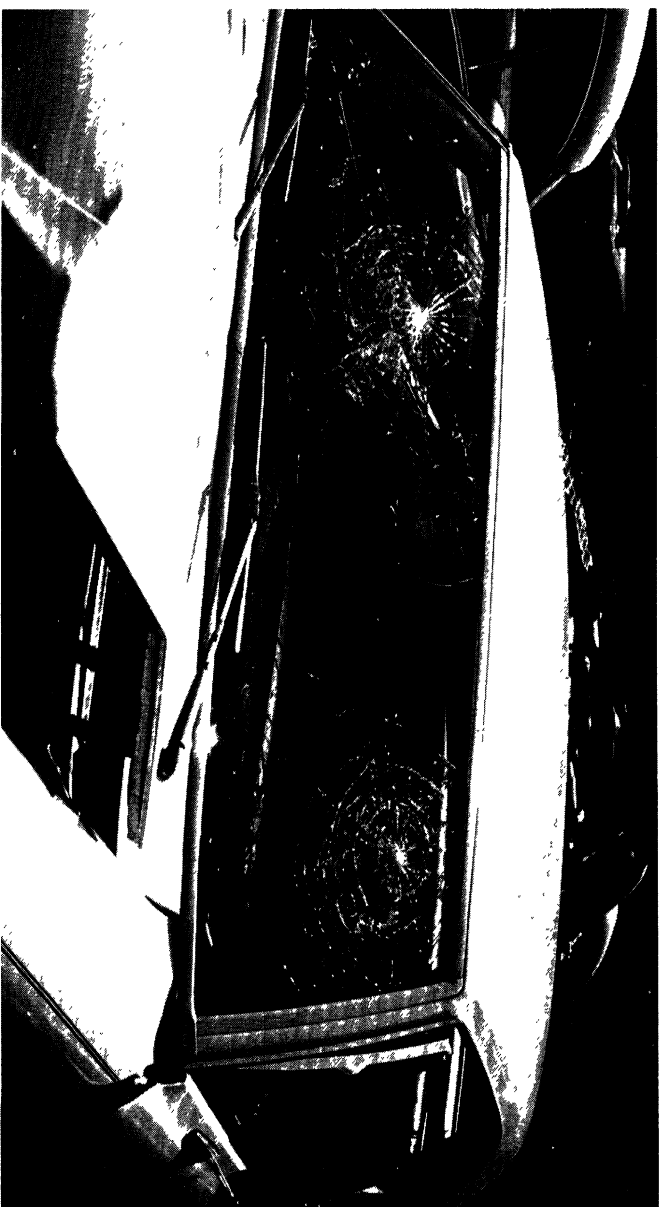
1967 Camaro (Figures 74 and 75). An intersection collision (impact velocity 35 mph). The driver (male, 16 years old, 5 feet 7 inches, 200 pounds) struck the windshield 6 inches below the header and 7 inches from the left "A" pillar. The impact area was bulged outward. He sustained forehead abrasions near the hairline. The passenger (male, 18 years old, 6 feet, 155 pounds) struck the windshield 7 inches below the header and 19 inches from the right "A" pillar. He sustained abrasions about the hairline. No seat belts were used by either occupant.
(Case #2927/6/11/67)

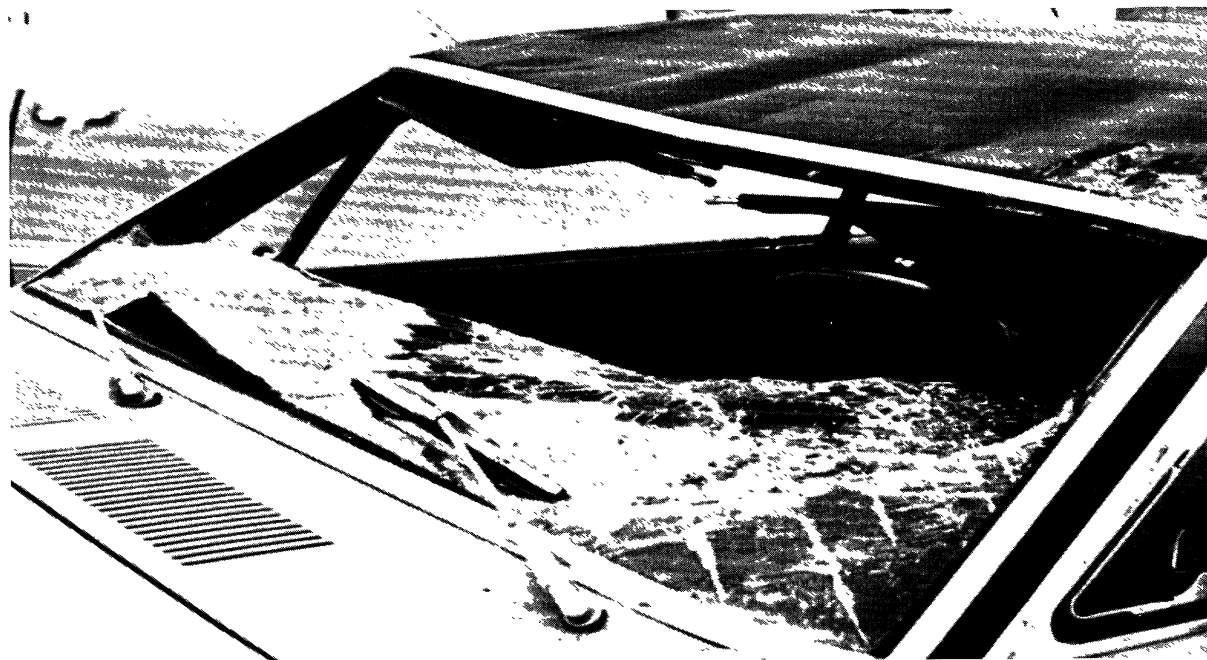
78)

1967 Mustang (Figure 78). This vehicle was forced off the road and flipped over in the snow. The matted windshield fell into the occupant area. No injuries were sustained from the windshield glass. Seat belts were worn. (Pre-1966 windshields usually shattered in rollover accidents, leaving sharp glass edges as potential injury areas.)
(Case #191/2/1/67)

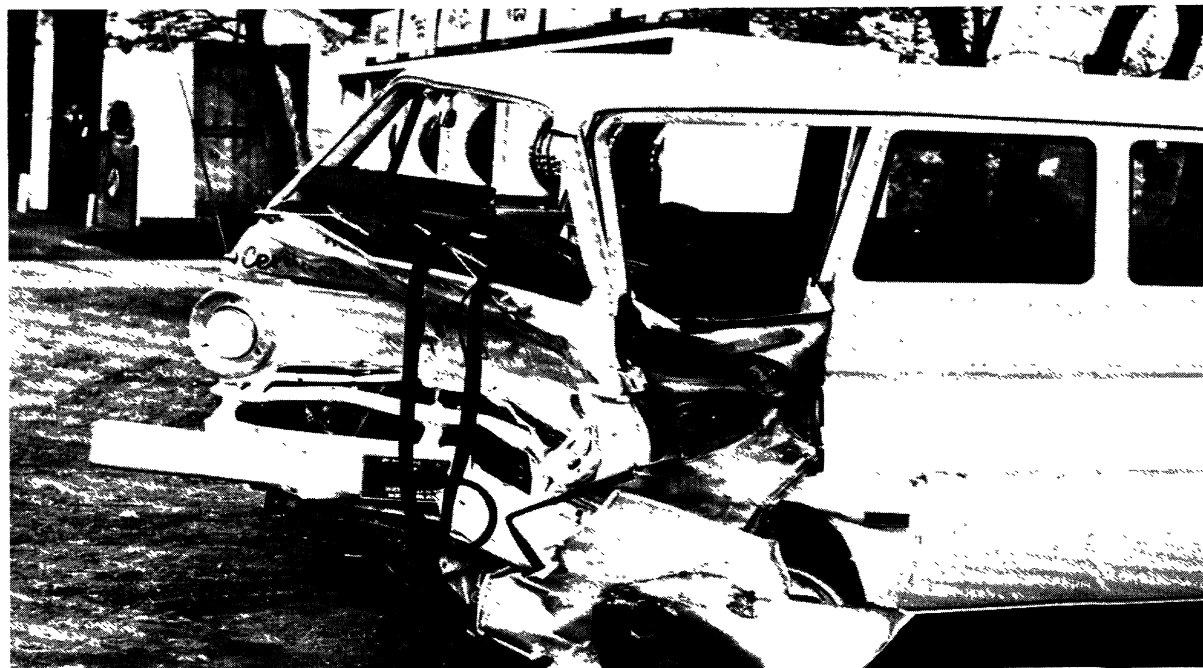
79)

1967 Dodge Van (Figure 79). This van was struck by a car that turned in front of it (impact velocity 35 mph). The entire windshield of the van "popped out" of its frame. The passenger in the van sustained a laceration of the nose from the windshield glass. See figures 31 and 32.
(Case #222/5/14/67)
