CAVITATION EROSION OF CAST IRON DIESEL ENGINE LINERS

YU-KANG ZHOU*, JIU-GEN HE[†] and F. G. HAMMITT

Summary

Photomicrographs from vibratory facility cavitation specimens and from an eroded liner of a field diesel engine are compared. The causes of erosion are similar. Corrosion tests show that the results are different from those from cavitation. This further confirms that liner erosion of a diesel engine is primarily due to cavitation erosion caused, in most cases, by vibration of the liner wall.

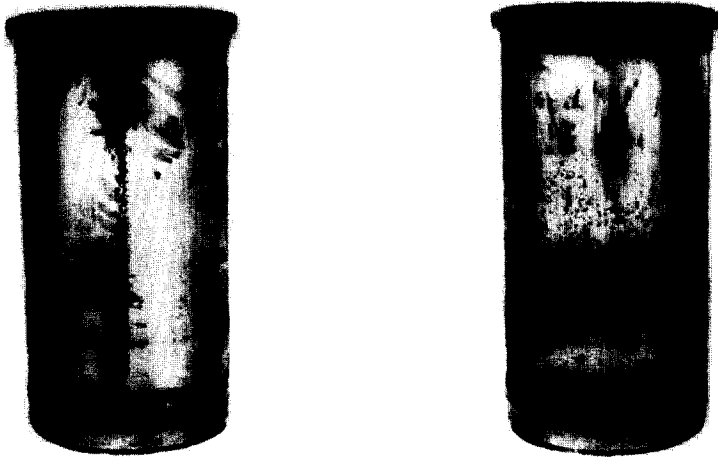
Fig. 1. Cavitation damage on (a) the thrust side and (b) the antithrust side of the liner of a type 12V180 diesel engine (bore, 180 mm); the liner surface is chrome plated (hardness, 748 - 726 HV).

was made [7]. The results confirm that liner cavitation erosion in this particular engine was the result of radial vibrations of the liner wall caused presumably by piston slap under certain operating conditions. It was concluded that chemical corrosion had little effect on forming the honeycombed structure of the eroded surface.

appearance of the eroded surface is characteristic of cavitation erosion. Comparing Figs. 1 and 2, it is evident that the appearance of the damaged liner is similar to that of the vibratory specimen.

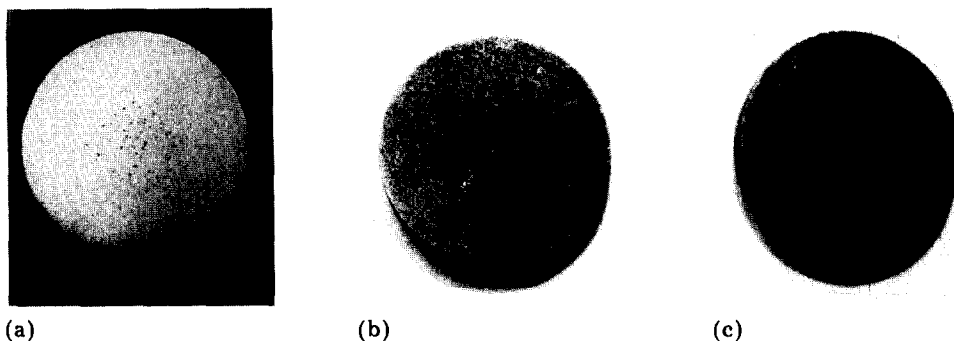
The vibratory experiments were performed in a magnetostrictive transducer assembly with a vibratory frequency of 15 kHz and a power supply of 100 W. The specimens were exposed to cavitation erosion for 90 min in tap water at 25 °C. The vibration amplitude (peak to peak) was about 20 μm (0.79×10^{-3} in). Figure 2(b) shows the specimen after subjection to the above vibratory cavitation environment. The honeycombed and deeply pitted

Fig. 2. Macrophotographs for phosphorous cast iron specimens: (a) before test; (b) after exposure for 90 min to vibratory cavitation; (c) after immersion for 30 min in 25% nitric acid.

A corrosion test of specimens of the same material (cast iron from the same heat) was performed along with the vibratory test to compare erosion form, appearance and metallography. In this test the specimens were immersed in a solution of 25% nitric acid at 25 °C for 30 min. The appearance of a corroded specimen from this test is shown in Fig. 2(c). Material was removed evenly from the surface, which is different from the cavitation result (Fig. 2(b)).

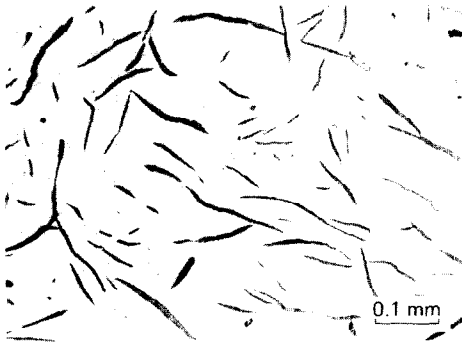
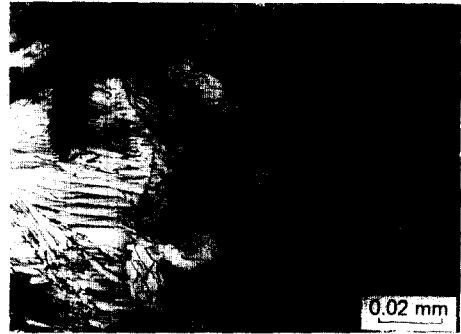
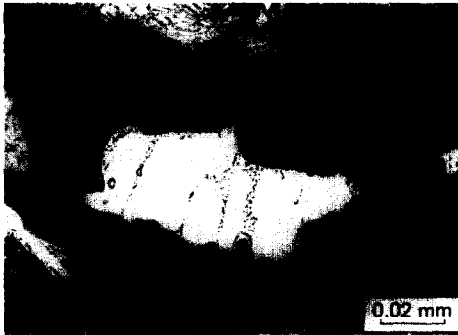
The before-test photomicrographs (Fig. 3) indicate the surface microstructure of the phosphorous cast iron used. The after-test photomicrographs are from the cross section through the center of the maximum damage region (Figs. 4(a) - 4(c)). Figures 4(a) and 4(b) are from the cavitation test specimen (Fig. 2(b)) while Fig. 4(c) shows the corrosion specimen (Fig. 2(c)). The most evident difference between these (Figs. 4(a) and 4(c)) is that microcracks and their progressive development are found on the cavitated surface while metal removal is uniform for the corrosion surface.

Fig. 3. Surface microstructure of the cavitation test specimens (material, phosphorous cast iron): (a) irregular orientation of flake graphite; (b) pearlite; (c) phosphide eutectic.

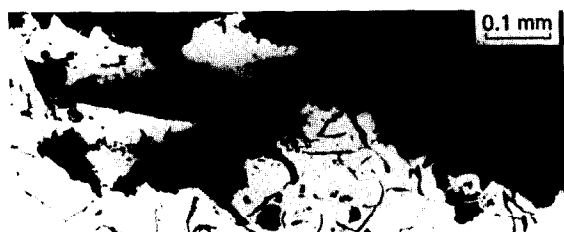
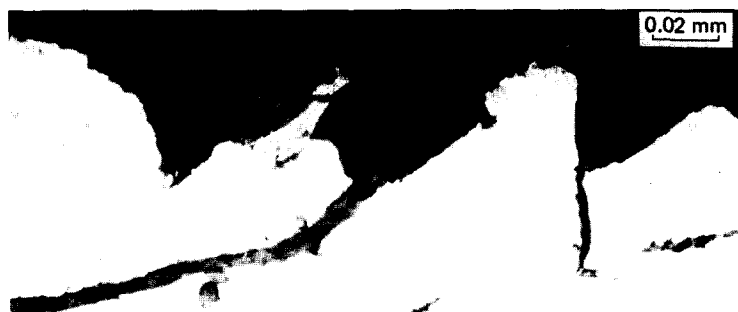
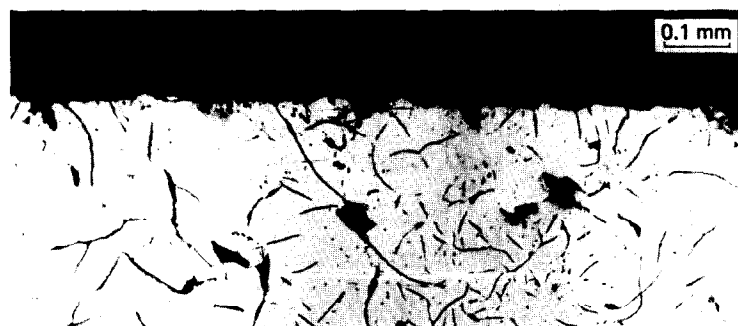
From macrophotographs (not included), the most distinctive difference between cavitation and corrosion specimens was the development of discrete pits on the cavitated surface, forming a honeycombed and deeply pitted structure, while the corrosion surface remained essentially flat but slightly roughened. Photomicrographs for both cavitation and corrosion were taken before and after the tests (Figs. 3 - 5). They were consistent with the different mechanisms for these two types of erosion, *i.e.* cavitation results from mechanical damage and corrosion from molecular chemical reactions (Figs. 4(a) and 4(c)).

Fig. 4. Micrographs of the eroded specimens; (a), (b) cavitation damage of the specimen in Fig. 2(b); (c) corrosion of the specimen in Fig. 2(c).

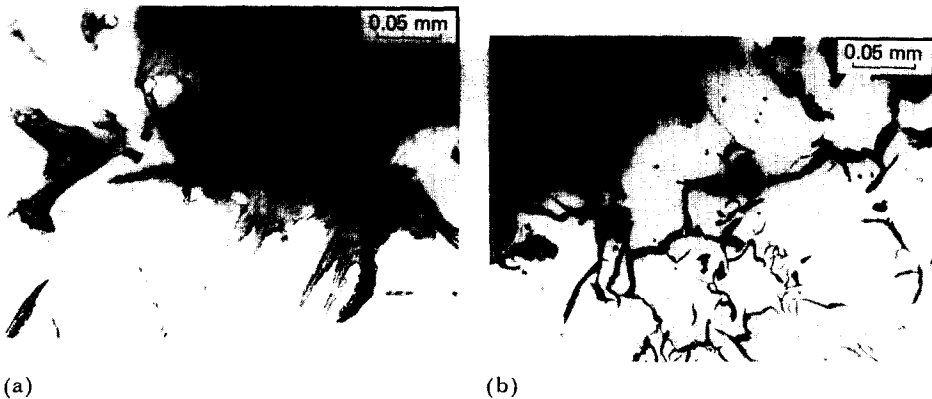
Figures 5(a) and 5(b) are micrographs through the damaged surface layer of a wet cylinder liner from a field diesel engine. The following points are significant.

(1) Figure 5(b) is similar to Fig. 4(a). In both cases it appears that particles of irregular shape and different sizes were eroded from both the test specimen and the liner.

(2) Cavitation erosion of the liner surface (Fig. 5(a)) develops, and extends along the graphite flakes. A network of cavities is formed apparently as graphite is broken up and removed in the initial stage of the erosion process. This is presumably due to repeated surface loading by bubble collapse. Cracks around the particles then appear so that, as the cracks further develop, metal particles are isolated and removed from the liner surface. Such metal particles are often found in the vibratory facility vessel.

Fig. 5. Micrographs of the cross section of the wet cylinder liner showing the cavitation-damaged surface layer.
