UM-HSRI-81-32

**A STUDY OF
WINDSHIELD-RELATED INJURIES
IN CARS OF
JAPANESE MANUFACTURE**

Appendices

**FINAL REPORT
JUNE 1981**

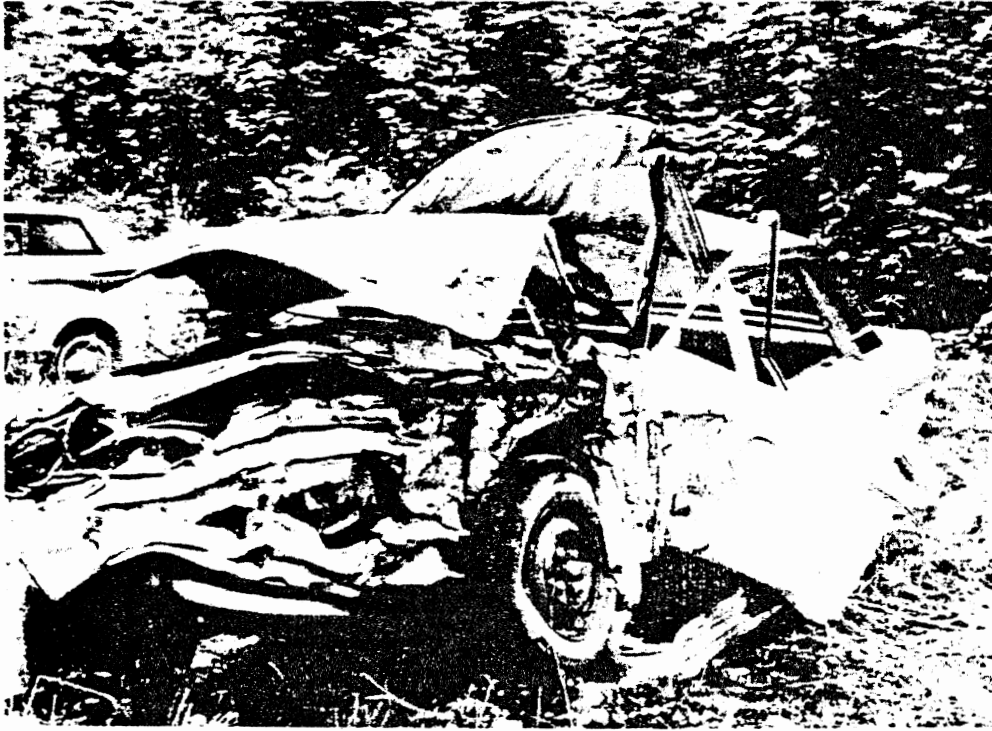
5

Three-quarter left front view Vehicle 2.

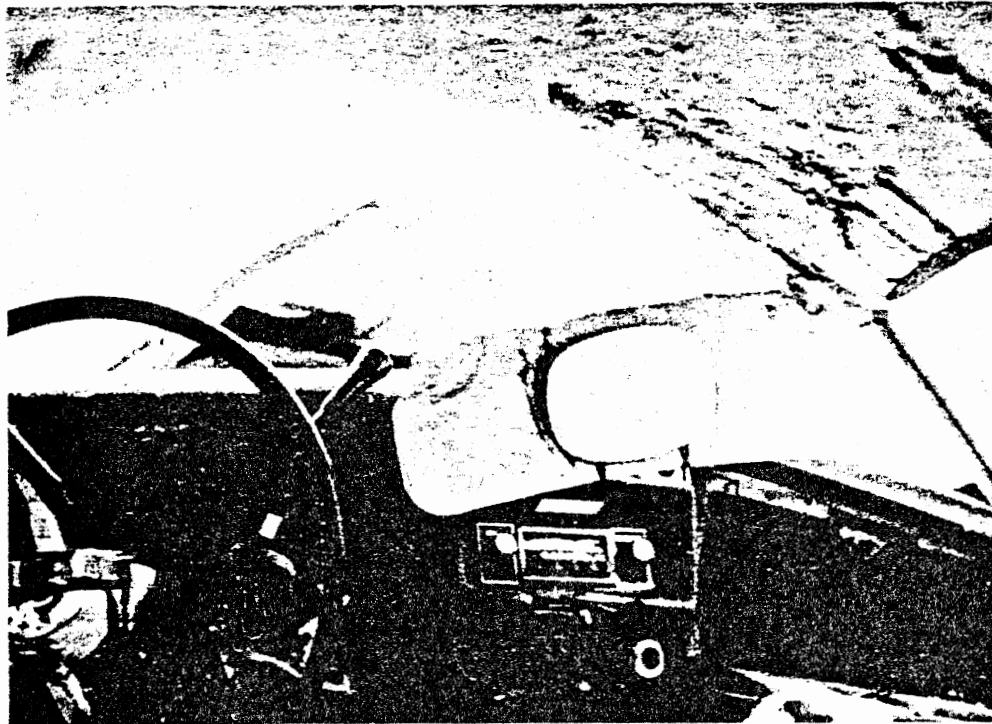
6

Interior view of instrument panel windshield area Vehicle 2.

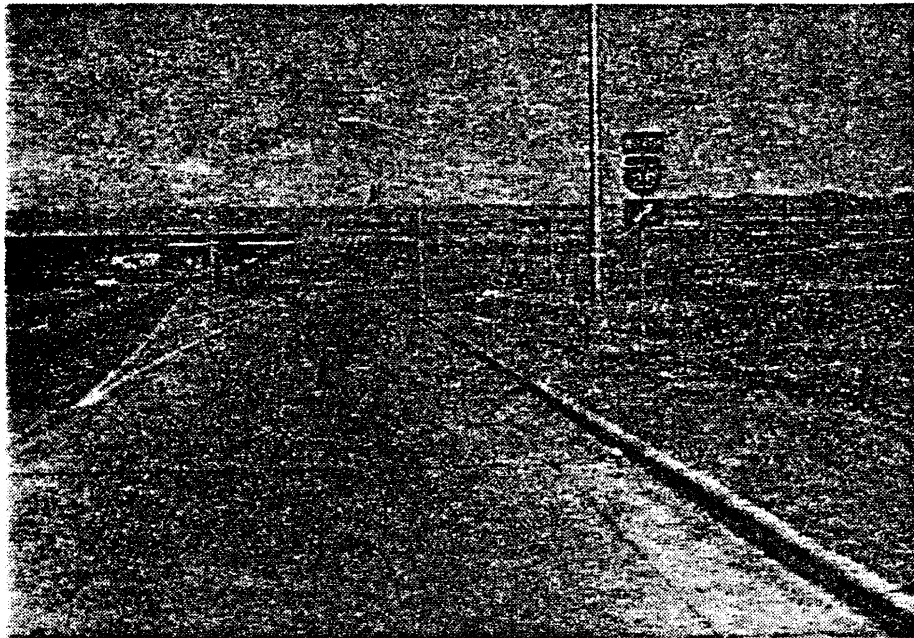
#4 Miles Road onramp as seen by driver of vehicle #2. Traffic cone in lane marks point of impact; other traffic cone shows final position of vehicle #2. The I-25 directional sign had been replaced.

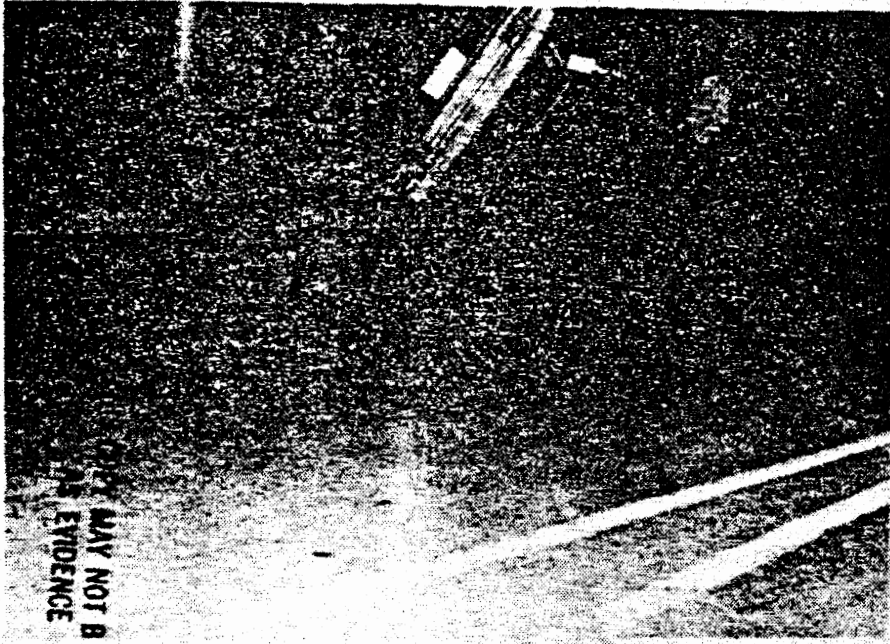
#5 Accident scene showing scuff marks caused by lateral sliding of vehicle #1, angles in scuff marks at point of impact and final position of cars.

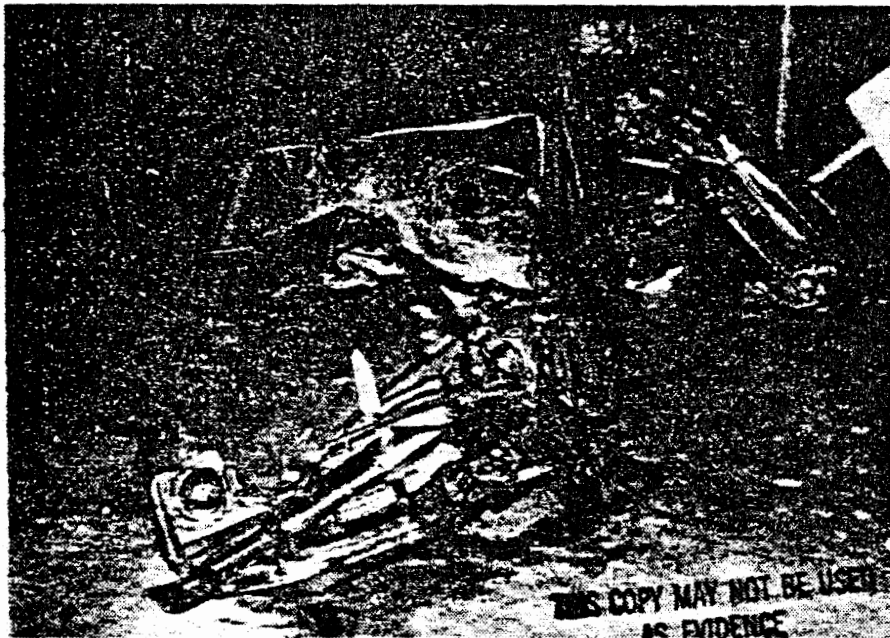
#6 Accident scene showing final positions. Vehicle #2 is in foreground. Note front end damage including windshield separation.

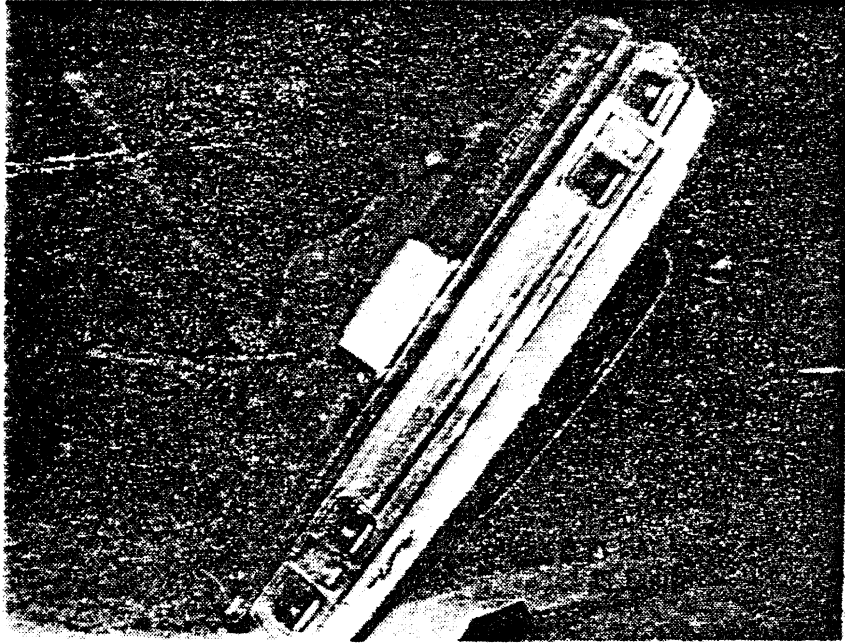
#7 Vehicle #1 in final position. Note broken spring shackle and bending of left rear wheel.

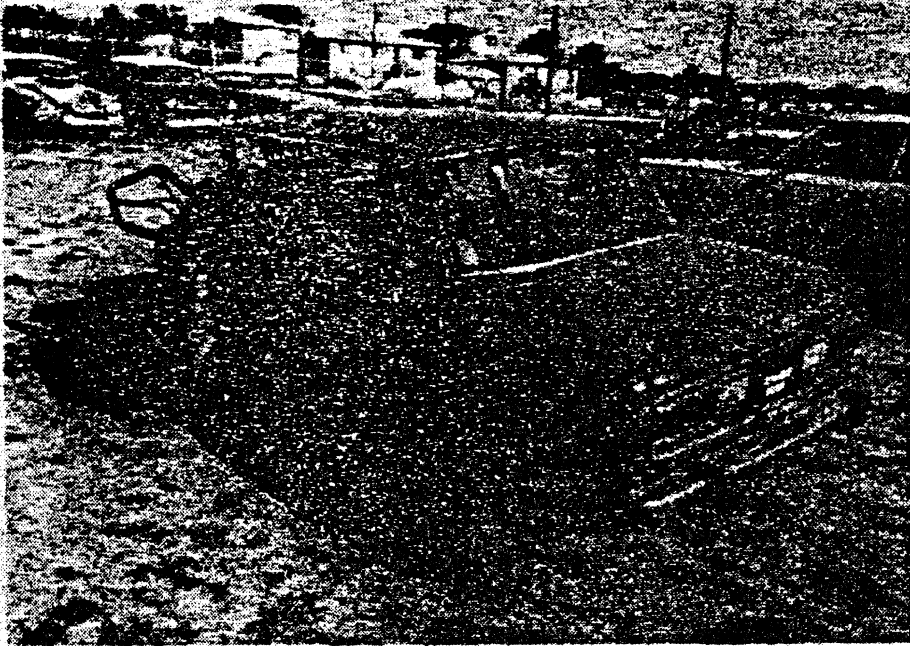
#9 Rear quarter view of case vehicle showing absence of damage.

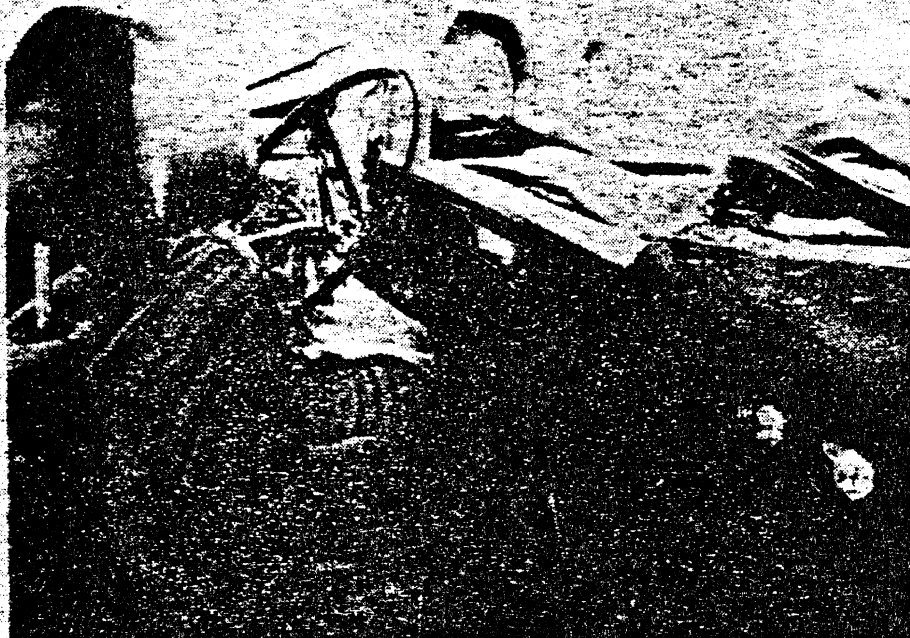
#10 Case vehicle showing rearward displacement of instrument panel and reduction in space available for driver.

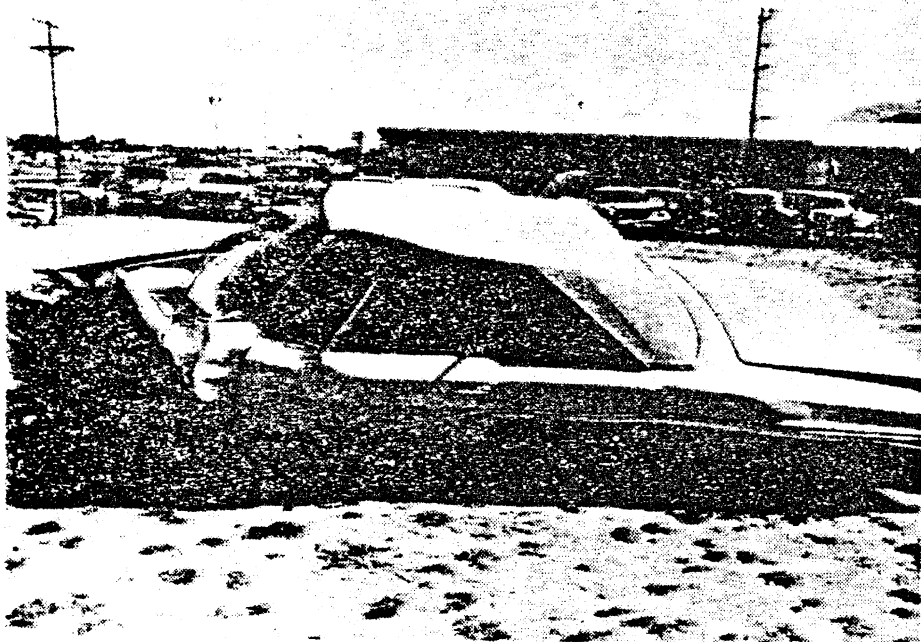
#12 Left side of vehicle #1 showing general damage.

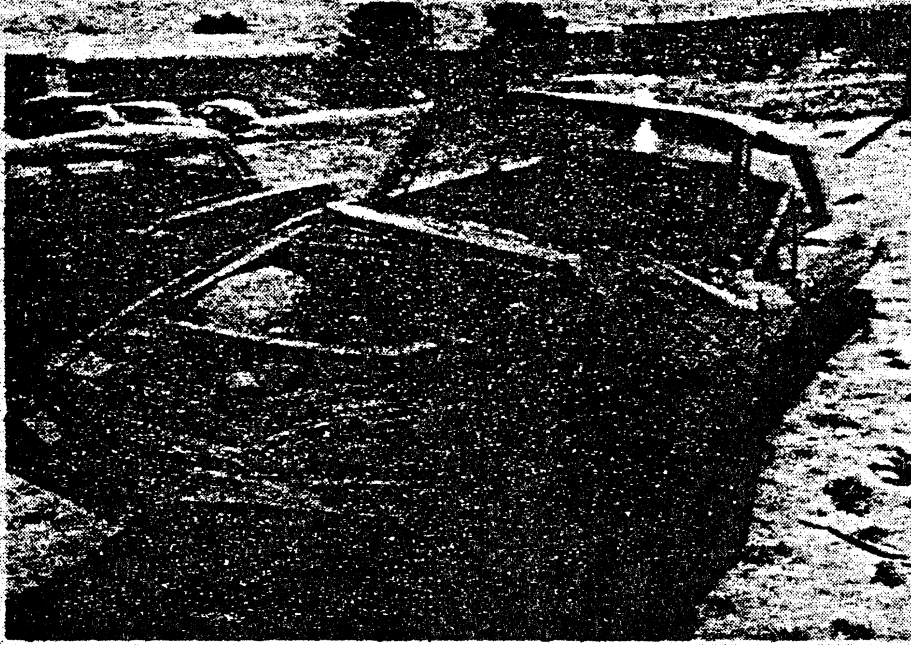
#13 Vehicle #1 front view showing empty engine compartment as engine and radiator were thrown clear of car at impact and subsequent rollover.

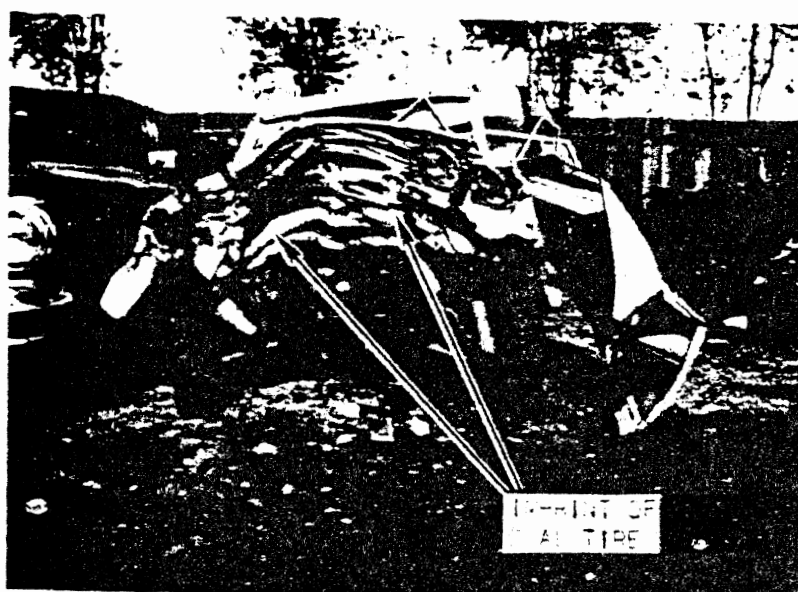
Figure 12. Front view, Vehicle #1

After the dock bumper had penetrated Vehicle #1 a distance of 16", the left rear dual tire of Vehicle #2 contacted the front of Vehicle #1 straight on in the center. The tire penetrated the front of Vehicle #1 a distance of 14", through the radiator, into the front of the engine. This impact with the trailing edge of the tire, which had an upward velocity of approximately 35 mph, caused an impulsive upward force to be applied to the front of the car, while at the same time the right side of the front of Vehicle #1 was held down by the dock bumper which had already engaged it. This force separated the engine from its front mounts, tipping it up toward the front of the car at an angle of approximately 24° to the horizontal (see Fig. 10) and severing the bell housing from the transmission (see Fig. 11). The entire center and left side portion of the front of the car was bent upwards (see Fig. 12).

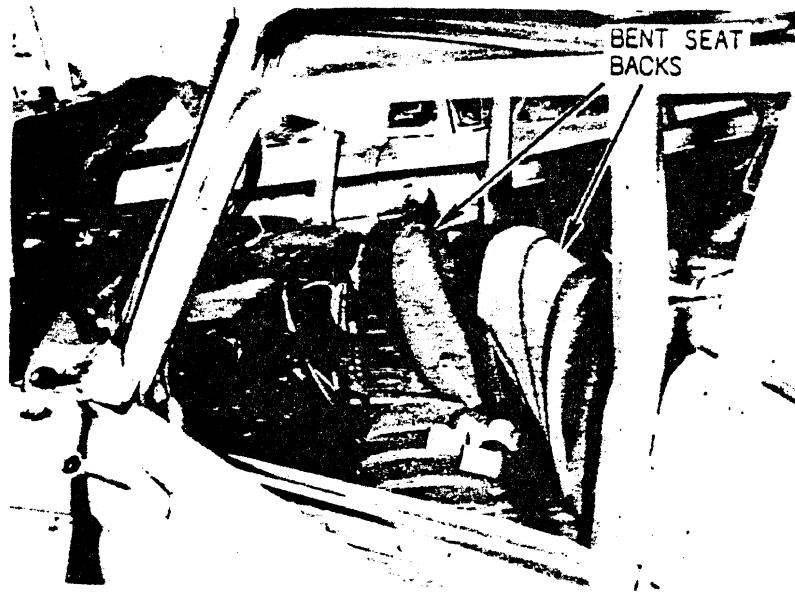
Figure 13. Interior, Vehicle #1

In addition to this exterior damage, the loose spare tire in the back of the car impacted the backs of the front seats, bending the backs forward (see Fig. 13). The back of the driver's seat in the vicinity of his right hip was bent forward a distance of 2" with respect to the lower cushion. The right-hand rail of the driver's seat was moved forward on the track a distance of 3". The total effect was to force the backrest of the driver's seat in the vicinity of his right hip forward a distance of 5". By the time of the impact of the tire, the dashboard just above the right knee of the driver had come back 6" and down 1-1/2". Thus his right upper leg was caught between the dashboard and the seatback. The results of this were a dent 1-1/2" deep in the dashboard of Vehicle #1, made by the driver's knee (see Fig. 14), and a severe fracture of the right acetabulum of Driver 1D with subluxation of the head of the right femur (i.e., the right hip joint was shattered, as shown in Fig. 15), along with moderate lacerations to both knees.

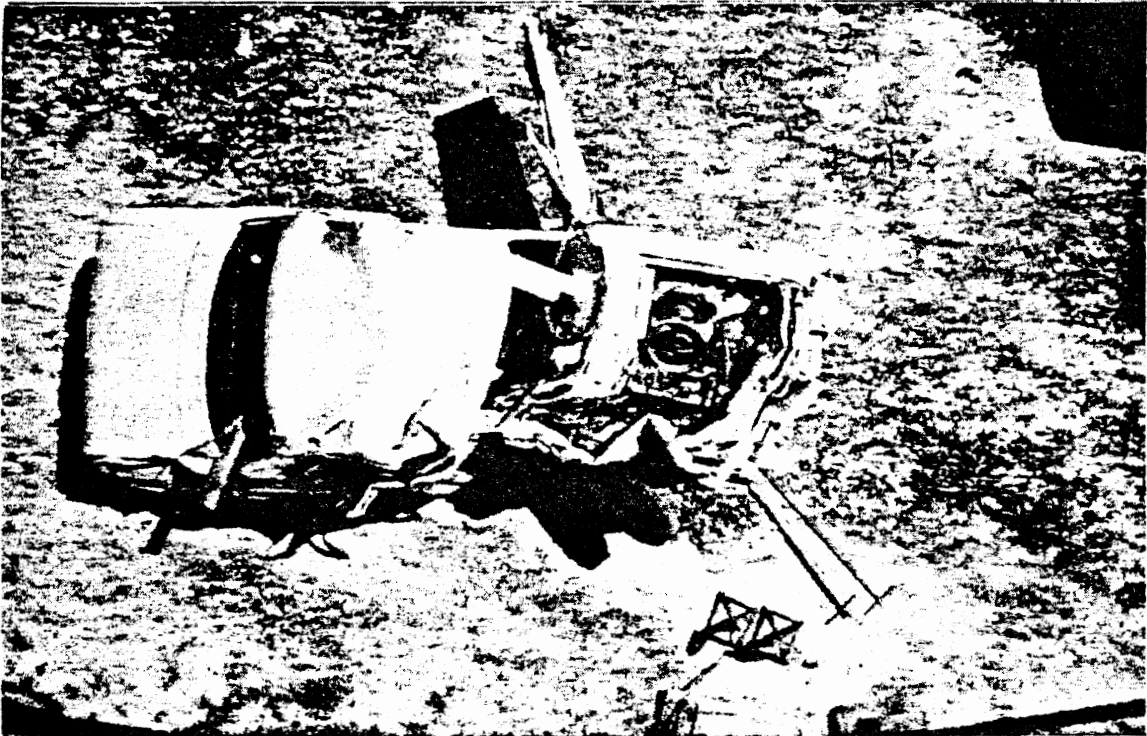
OVERHEAD EXTERIOR VIEW OF DAMAGE TO VEHICLE NO. 2

Vehicle No. 2 is a 1967 Toyota 1900 Automatic, two-door grey hardtop with black interior. It is equipped with a standard 116-cu in. gasoline four-cylinder engine. The vehicle suffered major external damage to the right front with a maximum sheet metal deformation of 19 in., damaging the rocker panel,

frame, engine mounts, engine, exhaust system, sheet metal, seat tracks, seats, pillars, doors, locks, and hinges. The primary vehicle damage index was O2RYAW4. Secondary damage was to the left side with 2-in. sheet metal deformation and a vehicle deformation index of OOLYHO1. Interior damage resulting from occupant contact was noted on the steering wheel rim, midpanel, air-conditioner outlets, ignition key, right sunvisor, left "A" pillar, left side door, and right side door. Other areas of contact without damage are numerous due to the vehicle dynamics and injuries to the occupants; however, because of the extent of the damage and amount of dirt, blood, and glass in the occupant compartment, they are indistinguishable. Vehicle data are presented in the attached "Collision Performance and Injury Report" Long Form (Revision No. 3) Report No. 7147-2, and "Vehicle Condition and Maintenance Report Form." The vehicle replacement cost was estimated at \$1,000.

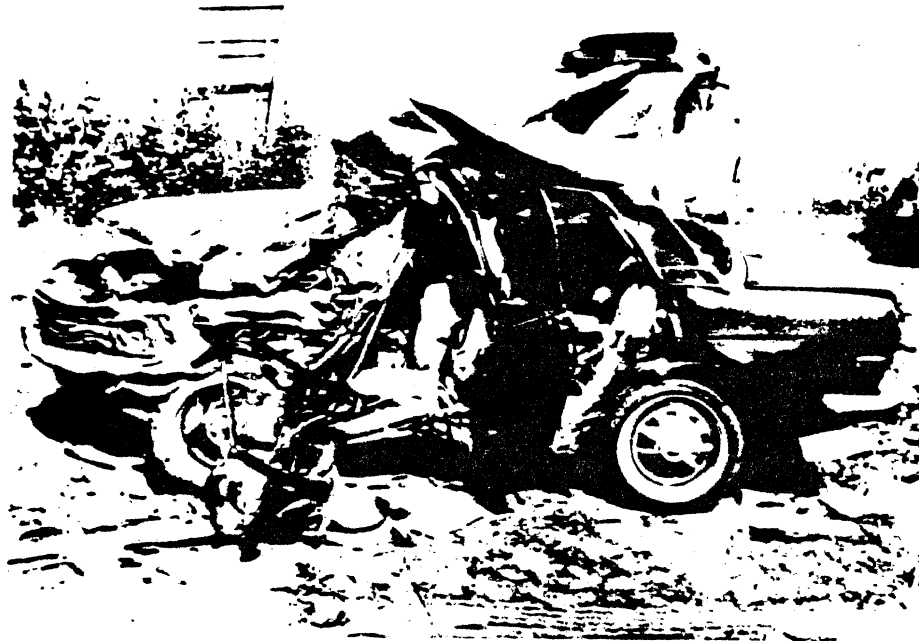
Figure 11 - Overall view of damage to left side of Datsun.

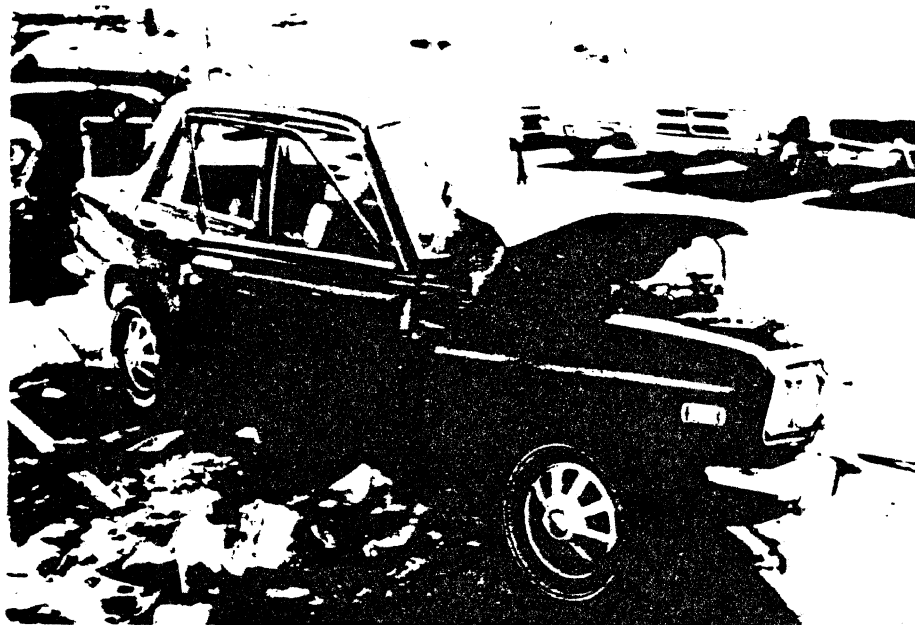
Figure 12 - Overall view of damage to right side of Datsun.

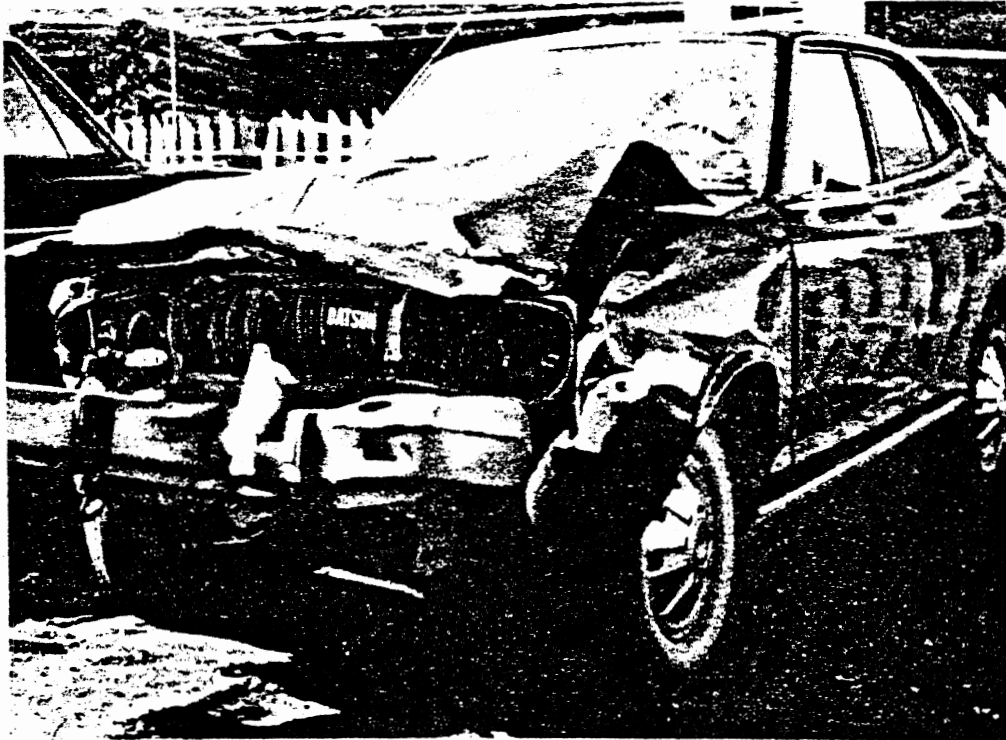
3

Left front 3/4 view of Vehicle 1 showing extent of direct impact damage above frame, and lack of reduction in passenger compartment size.

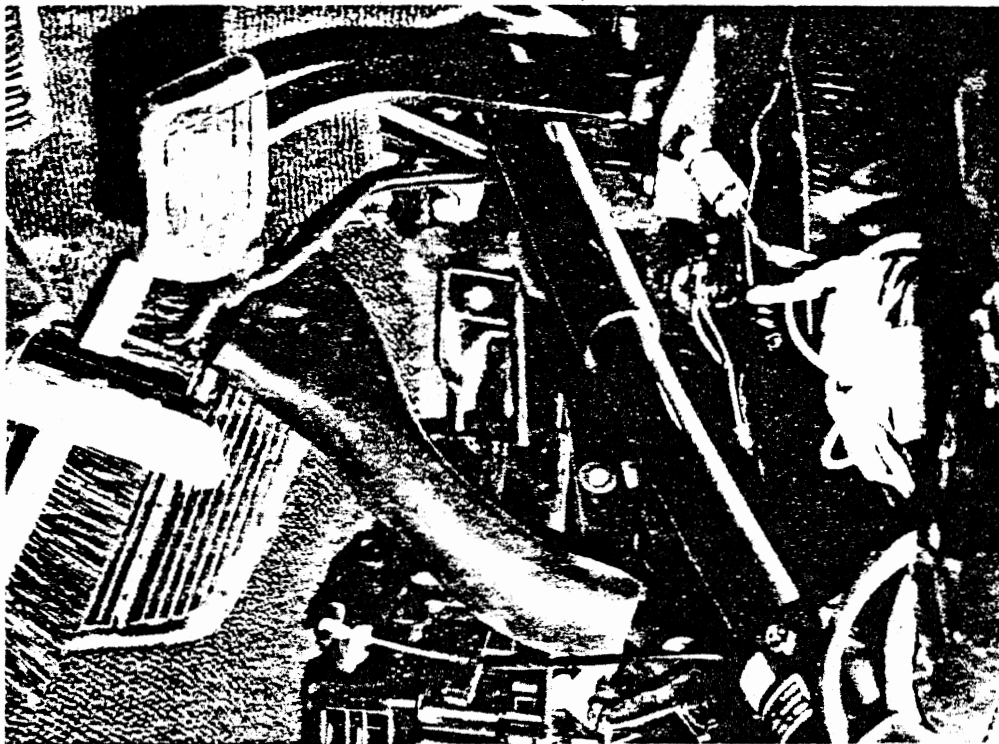
4

Left front interior of Vehicle 1, showing steering column displaced upwards, and damage to underside of instrument panel.

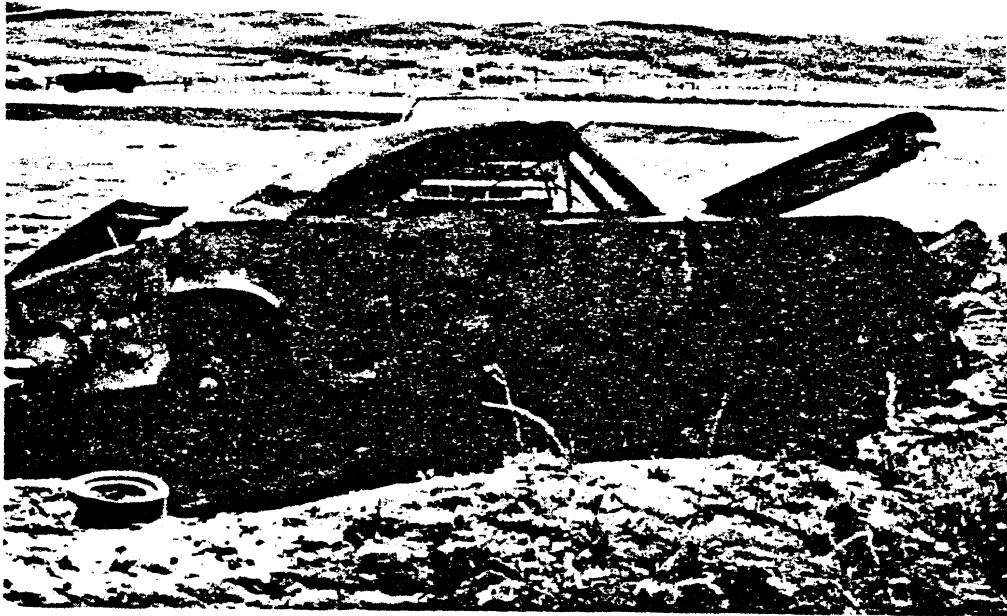
5

Right side of Vehicle 2, showing extent of fire damage, direct impact damage to front right and indirect buckling to the rear fender.

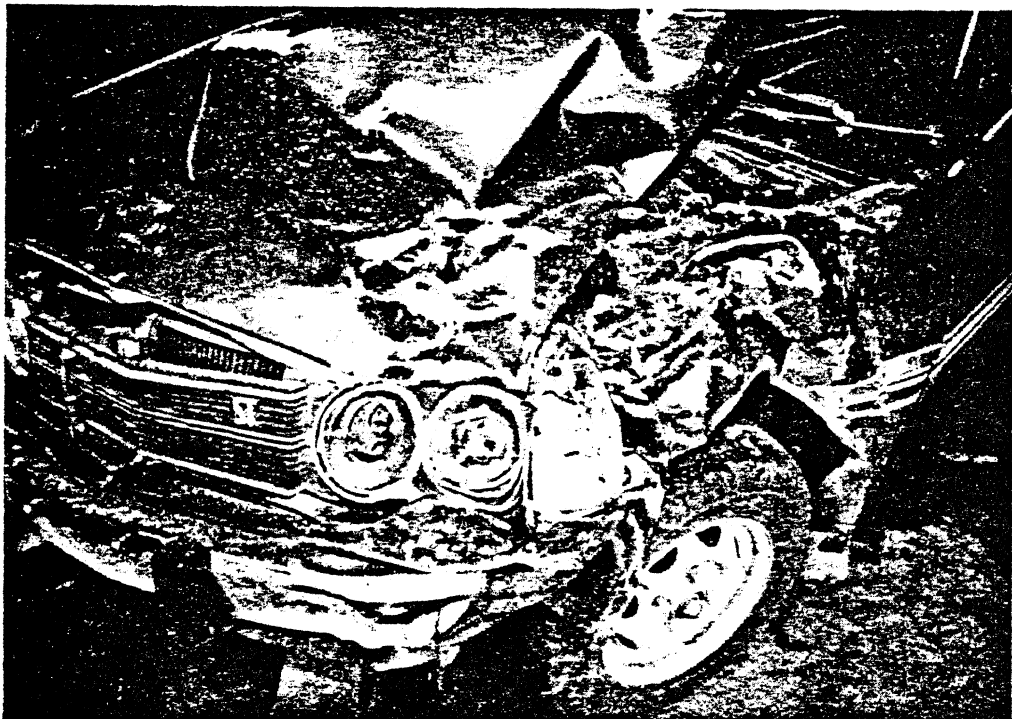
6

Close up of direct damage to left front corner of Vehicle 3, and indirect buckling of the hood.

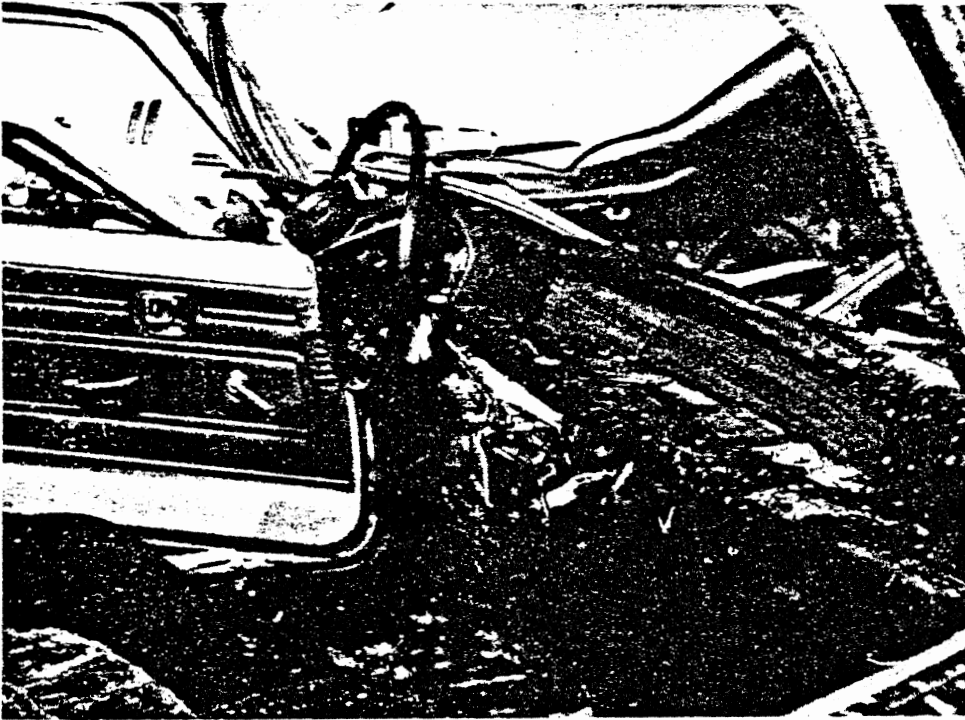
3

Interior of Vehicle 1 showing instrument panel and steering column rotation and damage.
