DYNAMIC TESTING OF RESTRAINT
SYSTEMS AND TIE-DOWNS FOR USE
WITH VEHICLE OCCUPANTS SEATED IN
POWERED WHEELCHAIRS

INTERIM REPORT

Lawrence W. Schneider
The Highway Safety Research Institute
The University of Michigan
Ann Arbor, Michigan 48109

August 1980

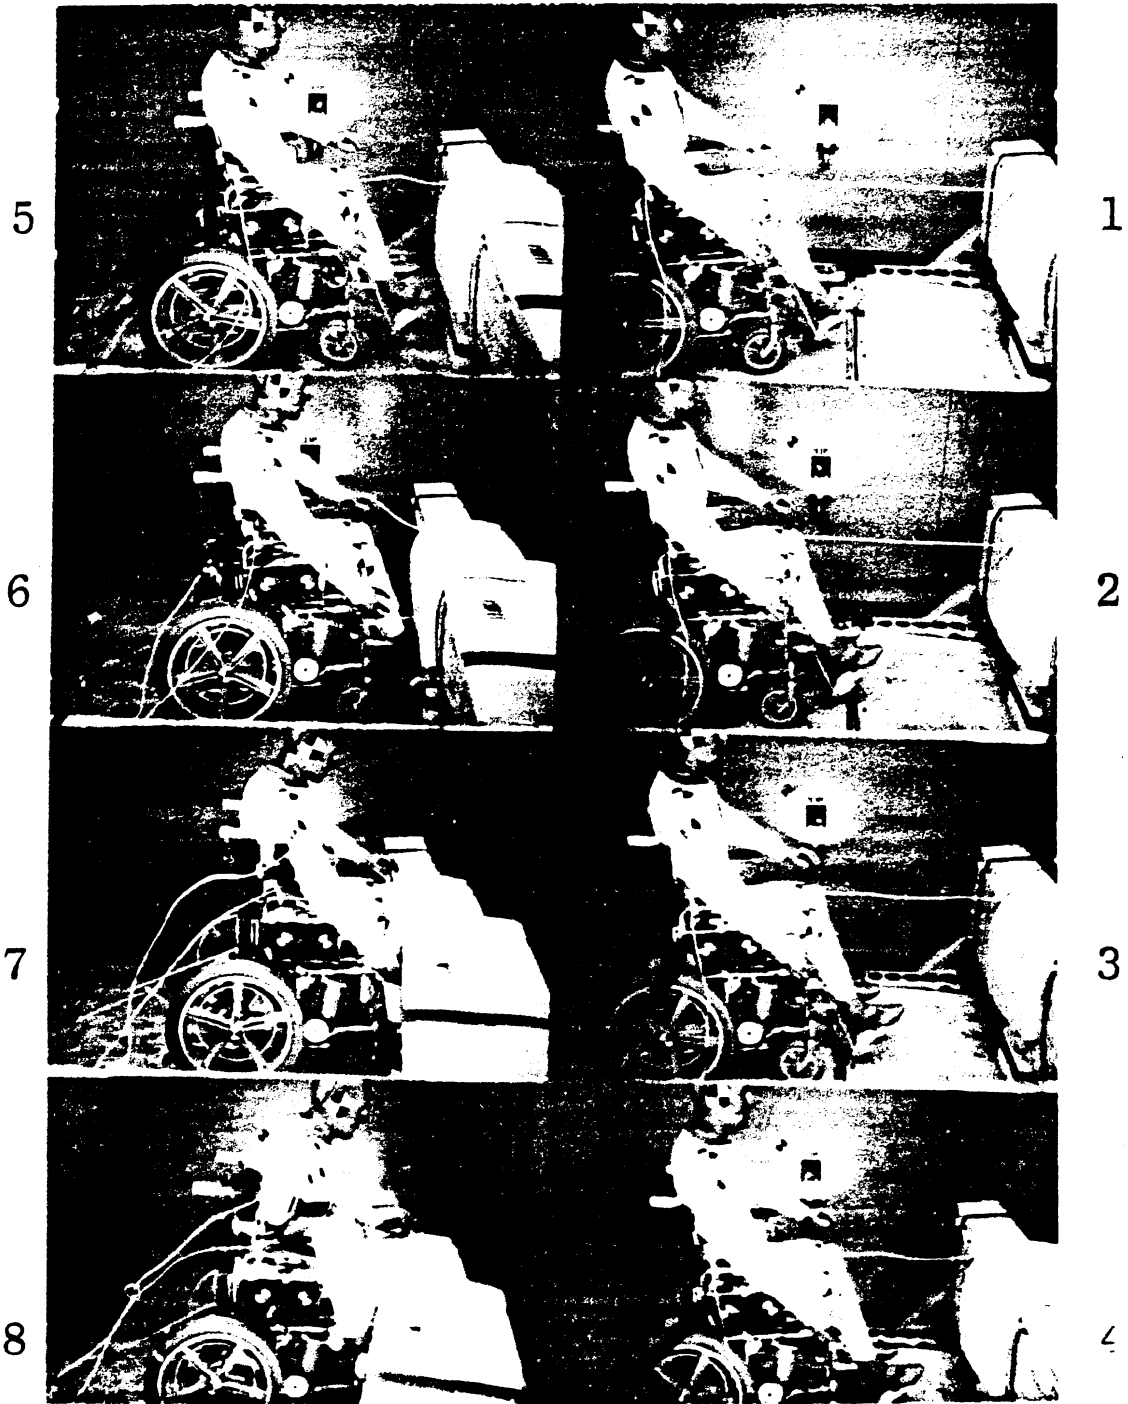
Time Sequence Photo for Test 80M001

Prior to impact the chair moved backward on the sled due to the sled acceleration (approx. .5 G) producing slack in the lap belt. The ring of the right lift ring assembly broke at the sharp bend on impact releasing the lap belt and allowing the wheelchair to move unrestrained into the padded front of the sled. The velcro fastening on the chest belt did not hold. The chair sustained little or no damage.

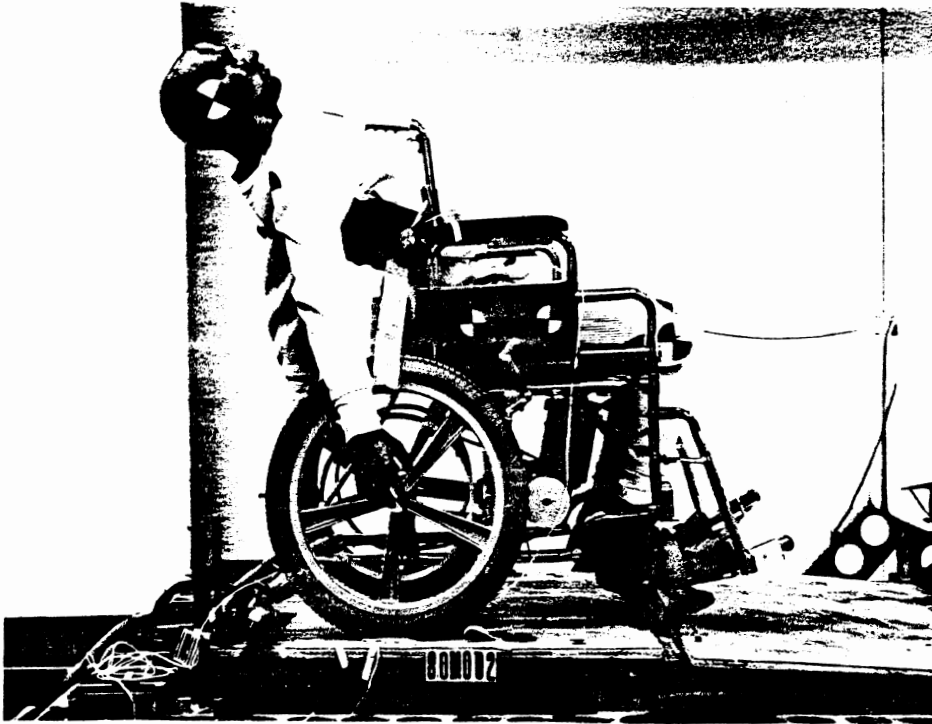
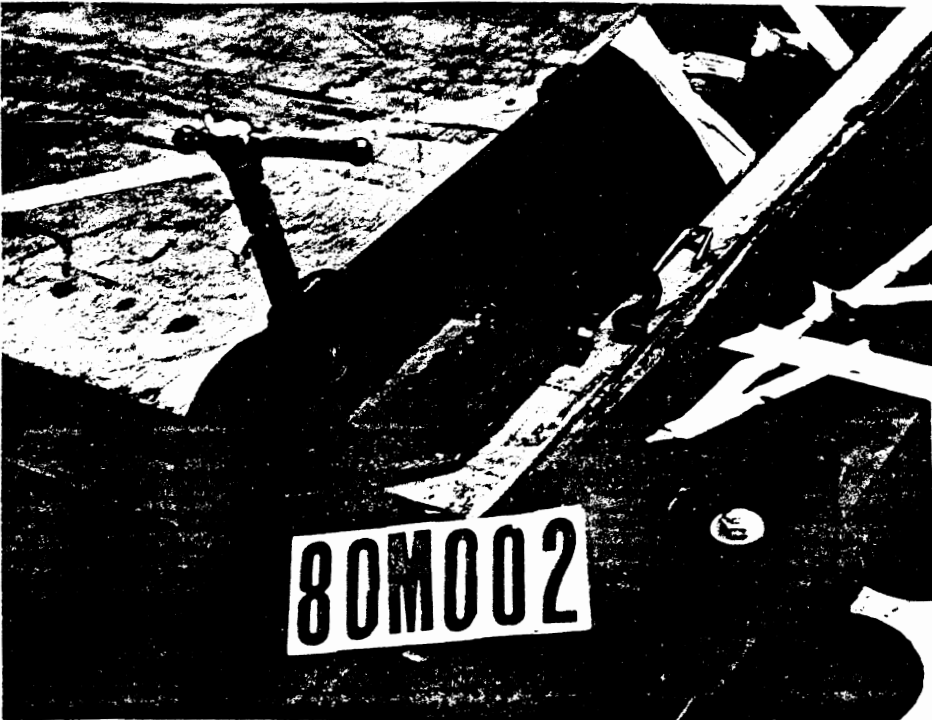
Set-Up Photo for Test 80M002

The chair did not move on sled acceleration and the lap belt remained taut until impact. Upon impact the ring of the left ring assembly broke at the sharp bend releasing the chair and dummy which moved forward and impacted with the padded front of the sled. The velcro belt released allowing the dummy's torso to flex forward. The chair back upholstery was torn loose on dummy rebound. The chair sustained little or no damage to the frame.

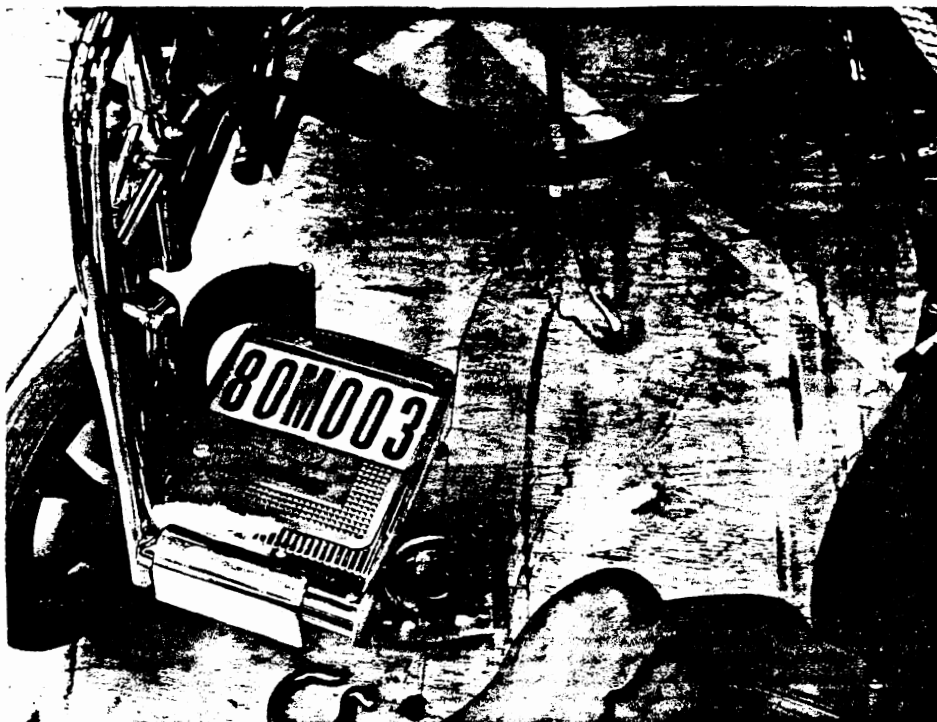
Post-Test Photos for Test 80M003

The ring of the lift ring assembly broke at the sharp bend releasing the wheelchair to move forward into the padded front of the sled. The T-bar and hook bolt bent significantly and the velcro belt came loose allowing the dummy to fall to the floor.

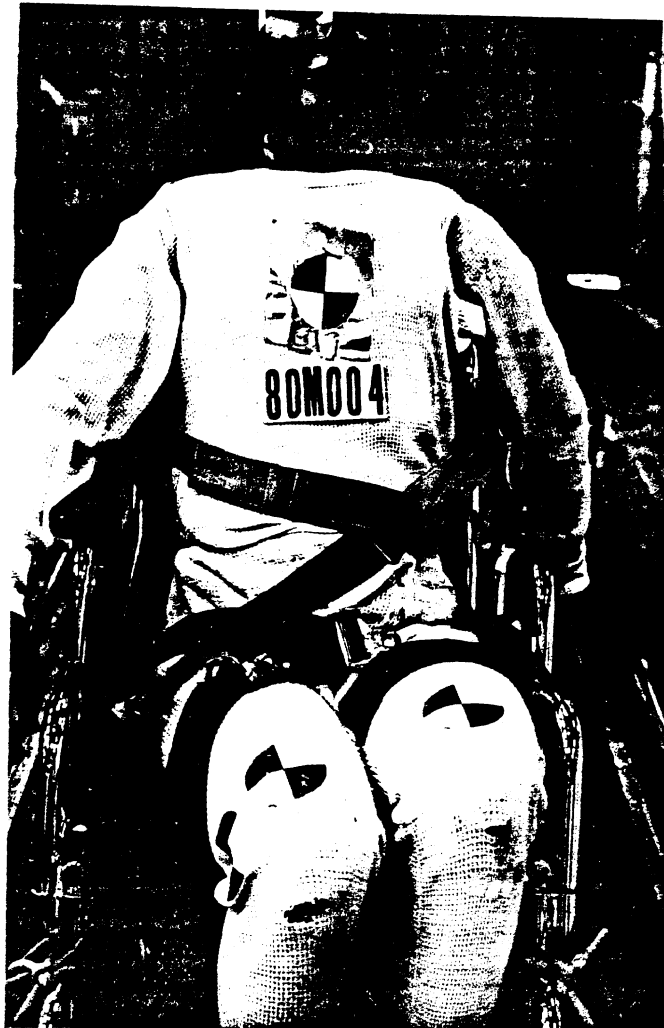
Post-Test Photo for Test 80M004

The rings from the lift ring assemblies securing the T-bar and one side of the lap belt broke at the sharp bends allowing the wheelchair to move into the padded front of the sled. The T-bar itself bent and fractured, and the lap belt also unbuckled. Although the velcro on the chest belt held, the stitching tore out allowing the belt "D" ring to slide through the double webbing and result in significant belt slack.

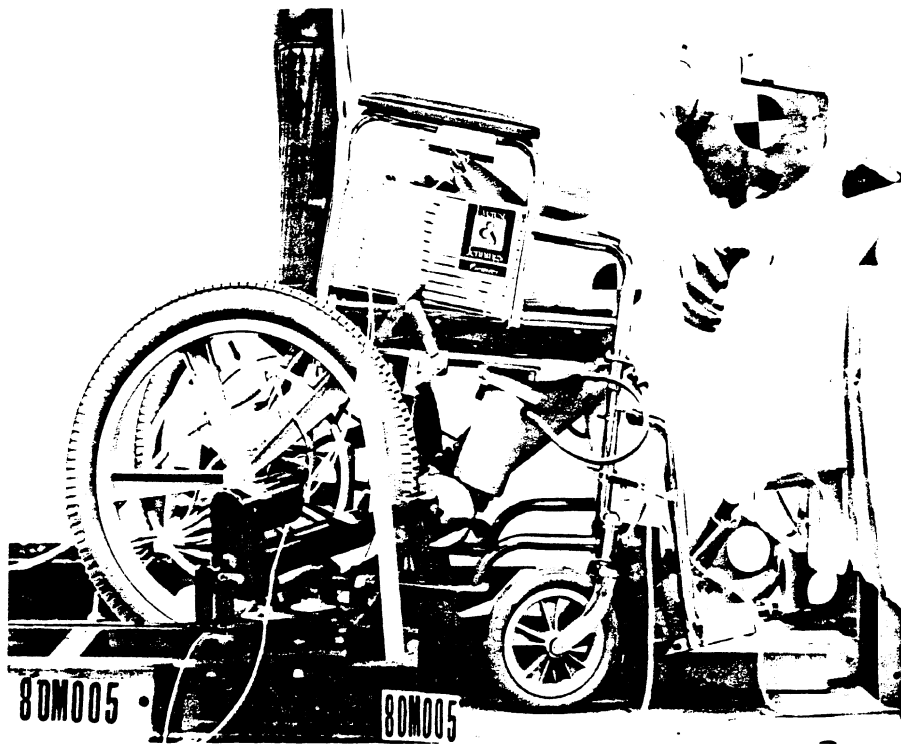
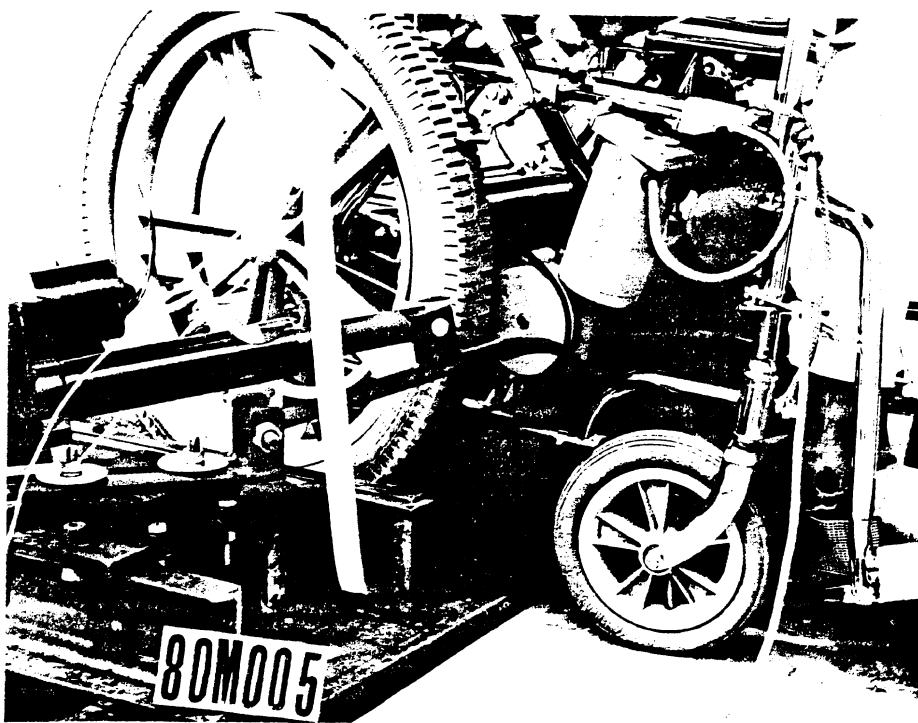
Post-Impact Photos for Test 80M005

There was no significant restraint of the chair by the power lock-down. The lock-down arm slid off the frame with little apparent effect on wheelchair movement. When the arm did interact with the chair frame at the cross-bars, the power lock-down rotated out of the way as the chair moved forward. The chair moved into the padded front of the sled with little or no turning so that the dummy's knees absorbed most of the energy. During the test the lap belt stayed secure and the dummy remained in the chair. The chair sustained little damage other than bending of the motor brackets.

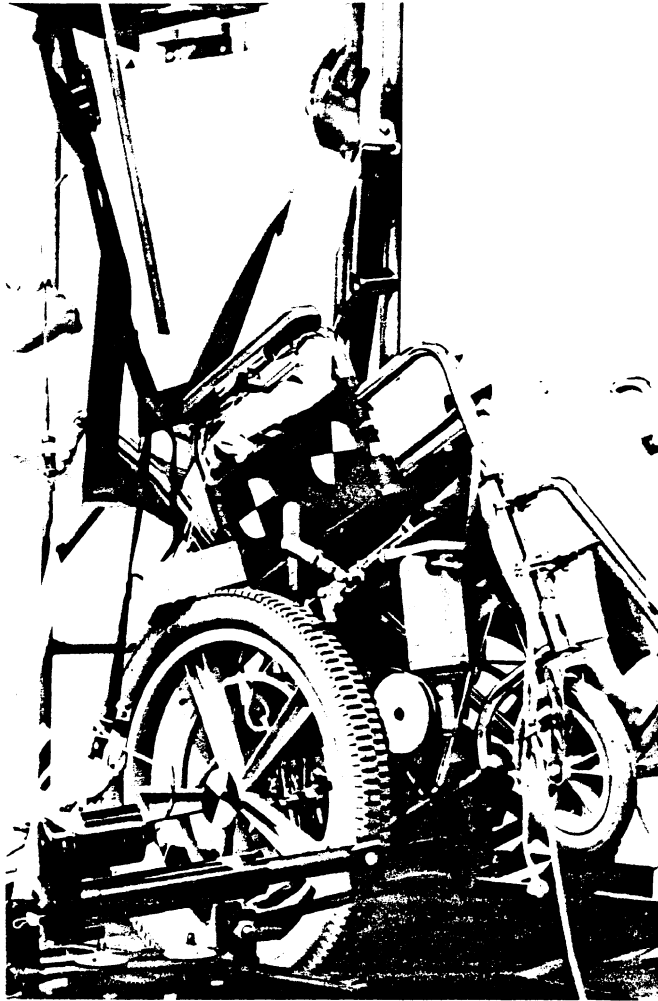
Post-Test Photo for Test 80M006

The power lock-down did not secure the chair which became restrained by the passive belt system through loading on the dummy. The lower part of the chair, being unrestrained, moved forward, causing the dummy and chair to tilt backwards. A tether rope caught on a sled bolt preventing the chair from flipping to the floor. The lap belt stayed secure. High forces in the floor to roof belt caused the steel structure used to simulate the vehicle roof anchor point to collapse.

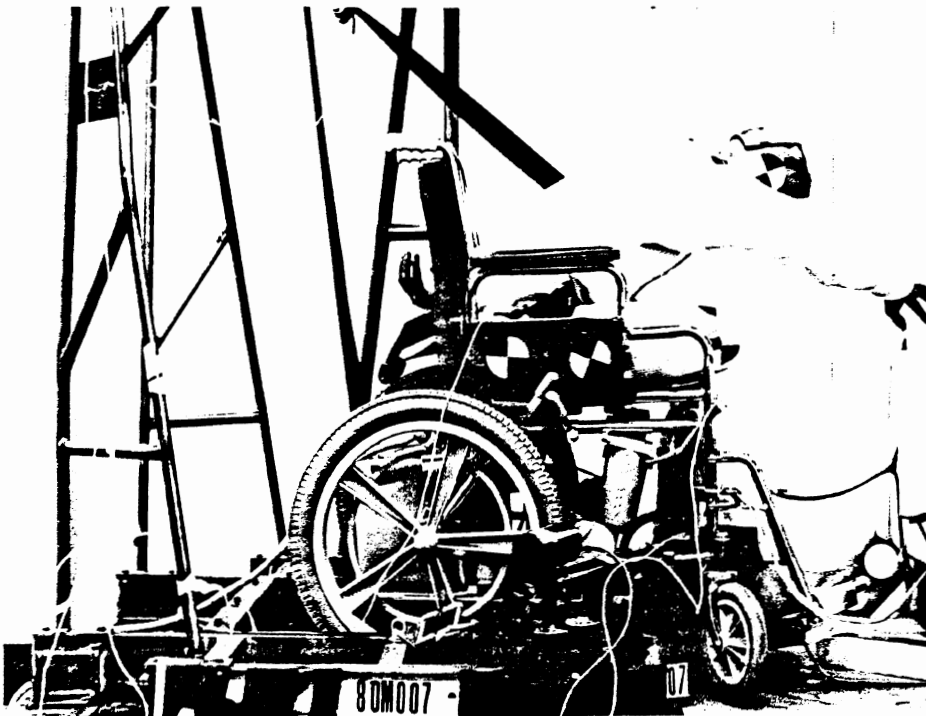
Post-Test Photo for Test 80M007

The power lock-down did not restrain the chair. The chair and dummy moved forward into the passive belt system causing the stitching around the metal ring in the floor mounted belt to break releasing the chair to move out of the power pan and into the front of the sled. The chair sustained little damage.

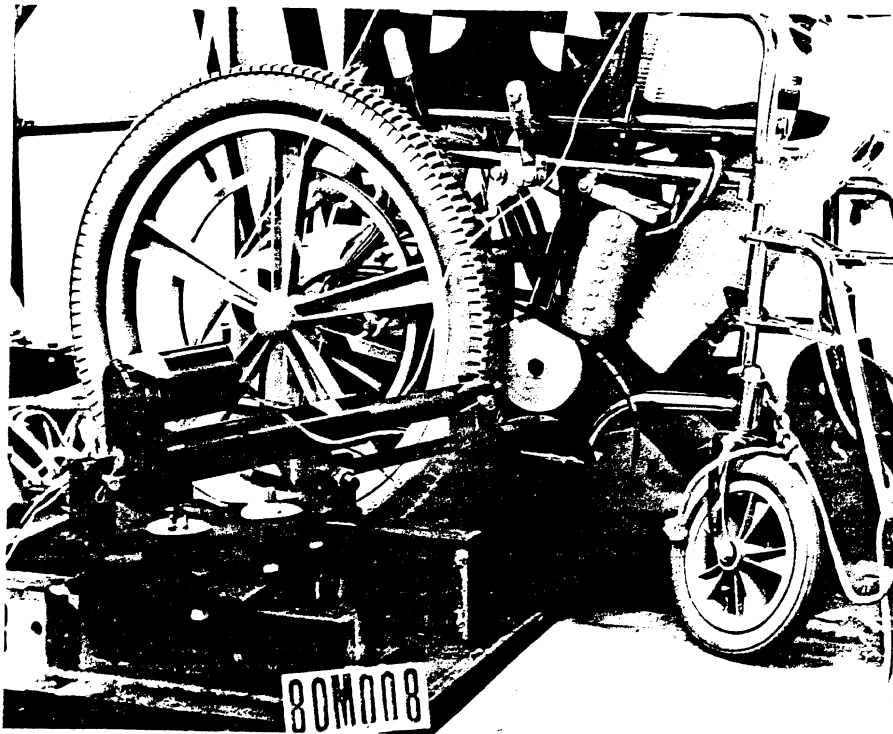
Post-Test Photos for Test 80M008

The results were the same as test 80M007 except that higher belt loadings were achieved before the belt webbing ripped through the bolts at the metal ring releasing the chair and dummy. The chair arms and frame were bent during impact.

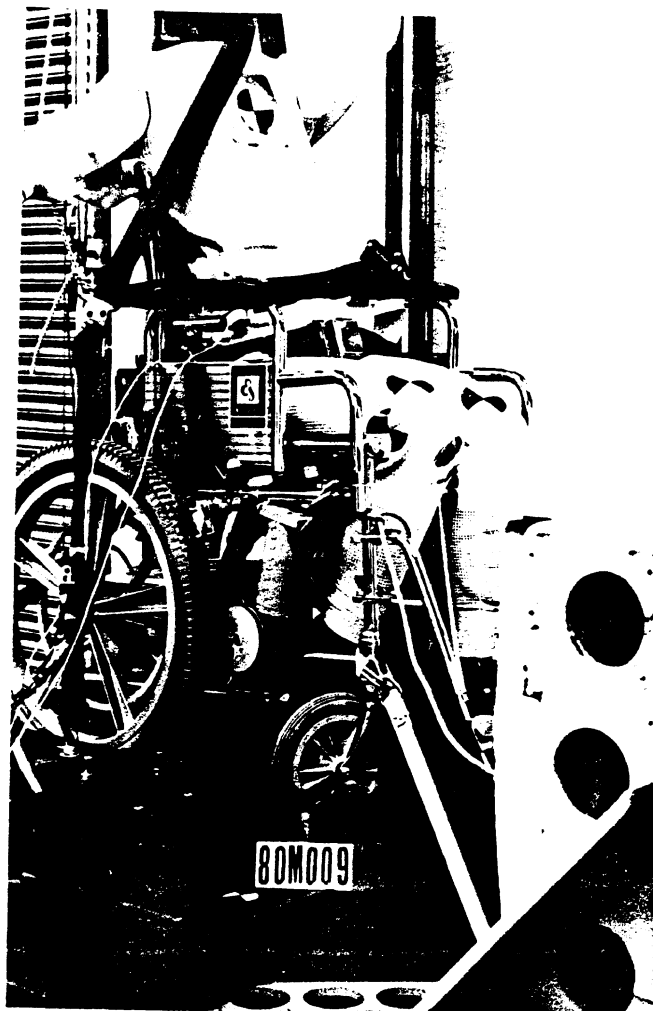
Post-Impact Photo for Test 80M009

The Aeroquip straps provided good restraint of the wheelchair and the chair moved only a couple of inches due to stretching of the straps. There was no apparent damage to the chair frame and the passive belt system with lap belt to chair provided good upper and lower torso restraint for the dummy.

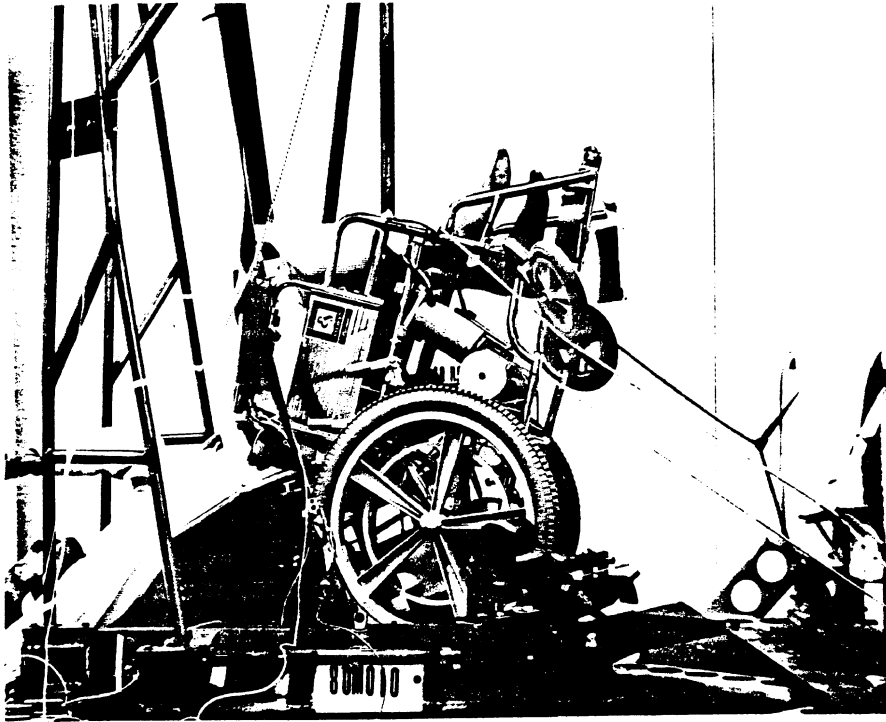
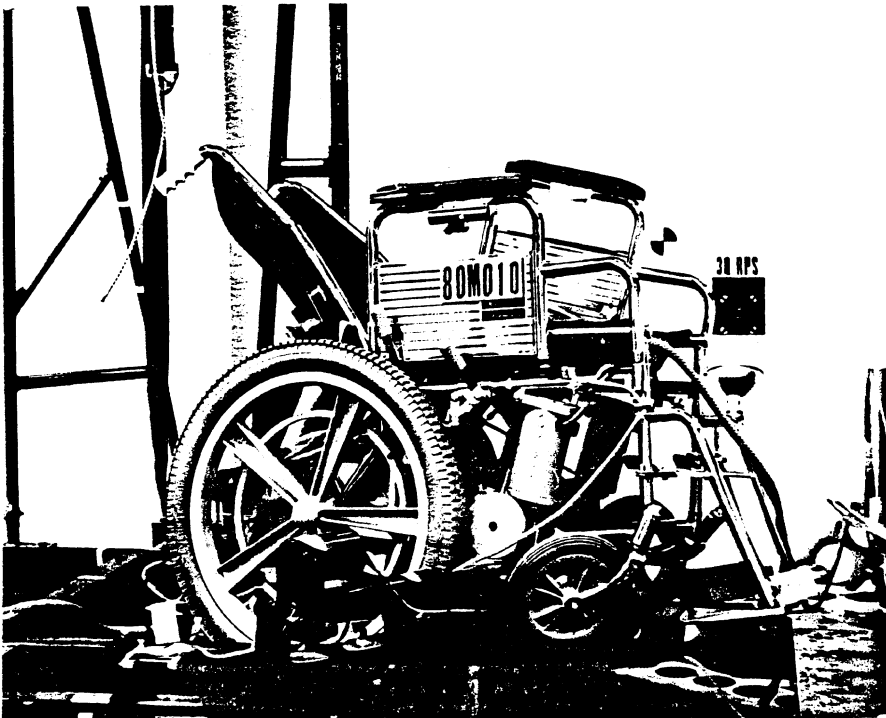
Post-Impact Photos for Test 80M010

The wheelchair jumped the wheel stop bar almost as if it were not there and the dummy's knees impacted with the front of the sled. The dummy was restrained at the upper torso by the passive belt system causing the chair to flip over backwards so that the back of the dummy's head impacted the sled floor. The rear posts of the chair were bent backward during the impact.

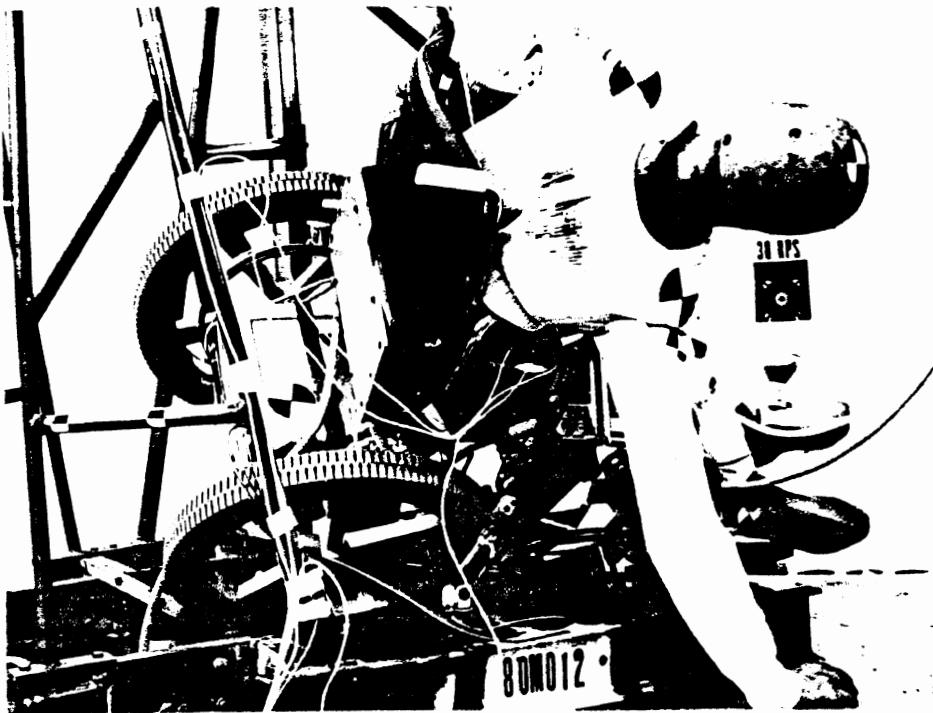
Post-Impact Photos for Test 80M012

As with test 80M011, the chair was restrained from forward motion by the passive belt system. Because the loading was mainly on the right side of the chair, the tubing of the right arm was bent significantly into the abdominal region of the dummy. The upper torso and head of the dummy showed greater excursions than in test 80M011 since the dummy slid sideways through the torso belt.

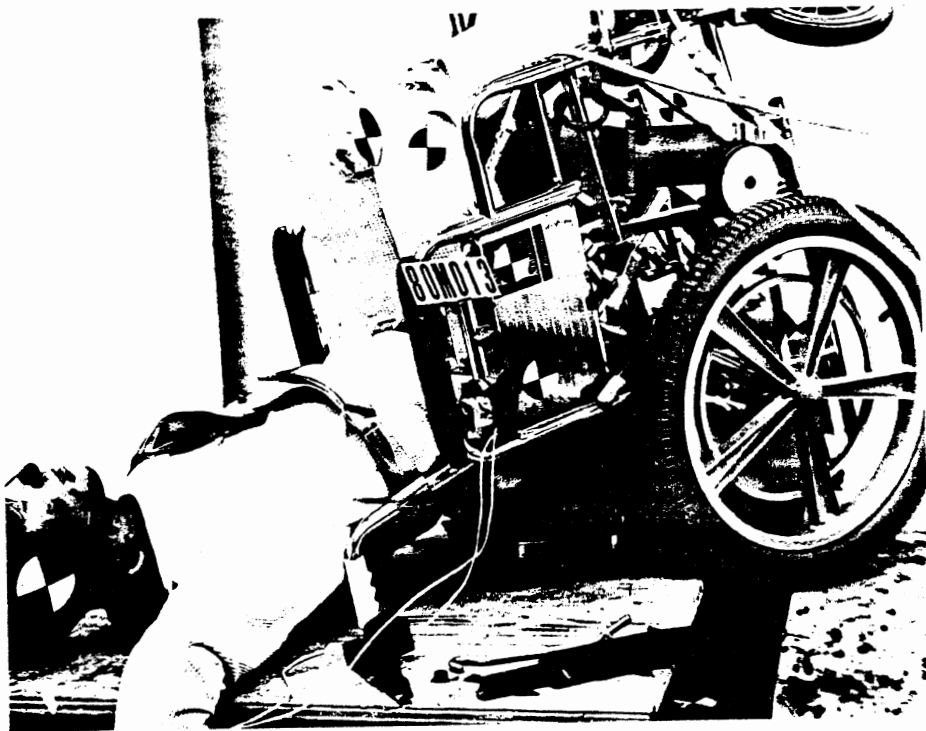
Post-Impact Photo for Test 80M013

The T-bar broke in half at the center hook bolt hole and the chair moved unrestrained into the padded front of the sled. The lap belt came unlatched at the buckle during the test but the velcro fastening on the chest belt held and the dummy stayed in the chair. After impact the chair flipped over backwards.

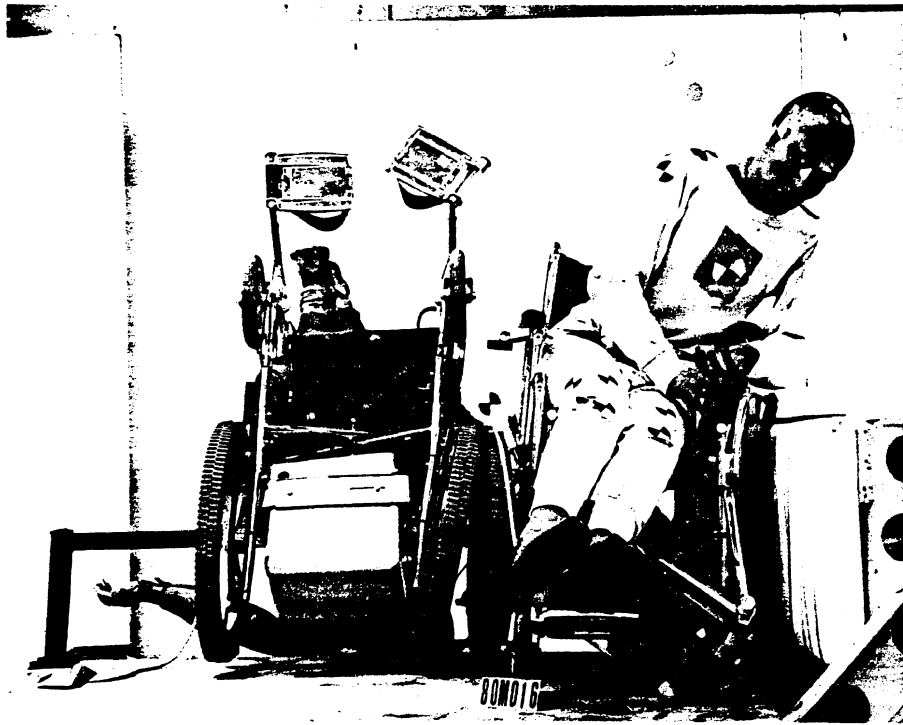
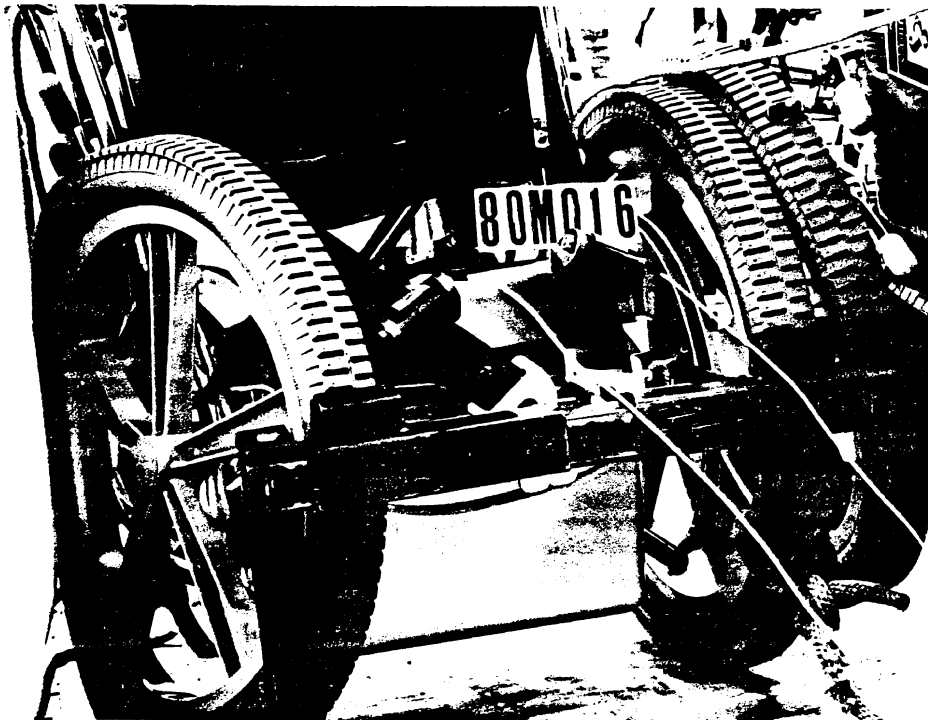
Post Impact Photos for Test 80M016

The rim pin fixtures of the stanchion slid along the bar to the front of the stanchion bar. The front chair impacted into the padded front of the sled fracturing the left magnesium wheel rim and badly bending the chair. The rear chair impacted into the front chair and then flipped backward over the stanchion with the dummy ending upside down and hanging off the side of the sled. Both lap belts held the dummy's in the chairs.

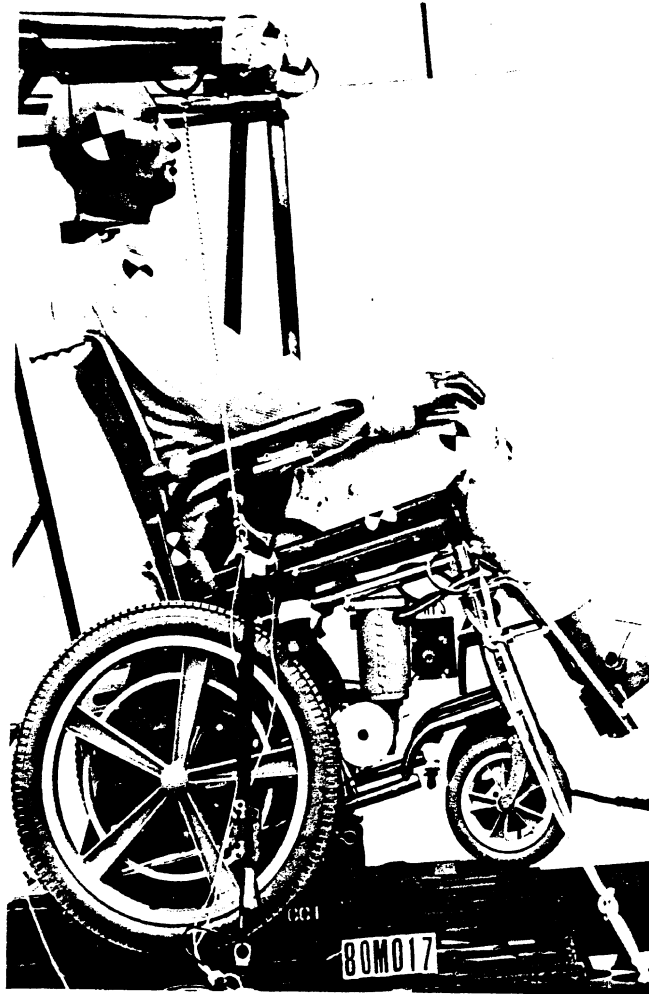
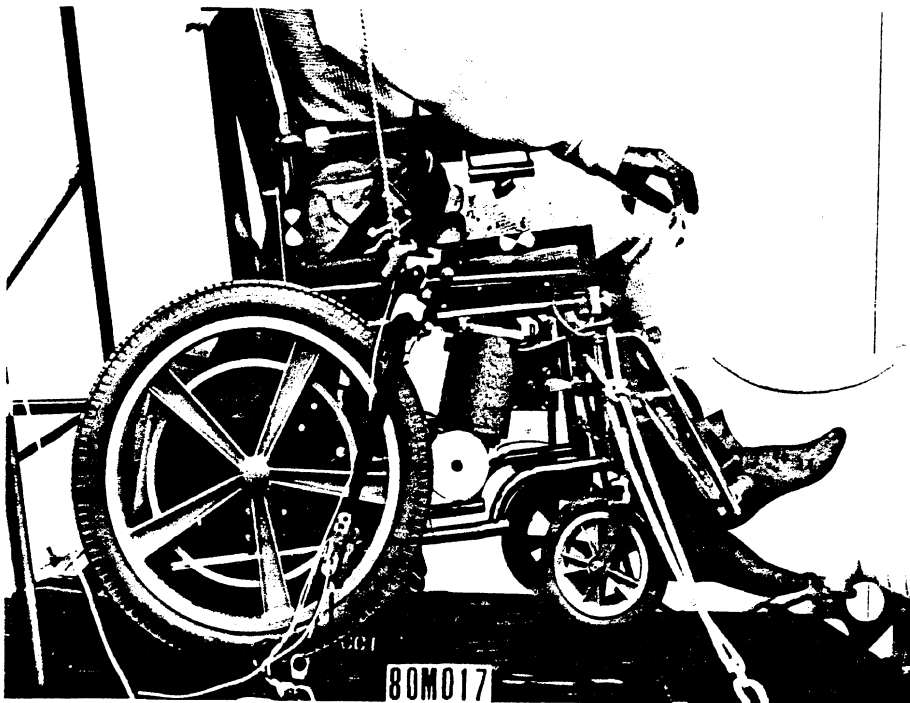
Post-Impact Photos for Test 80M017

This system provided excellent wheelchair and occupant restraint. The sheet metal deformed slightly and the rear CCI retaining bar bent slightly at both ends.

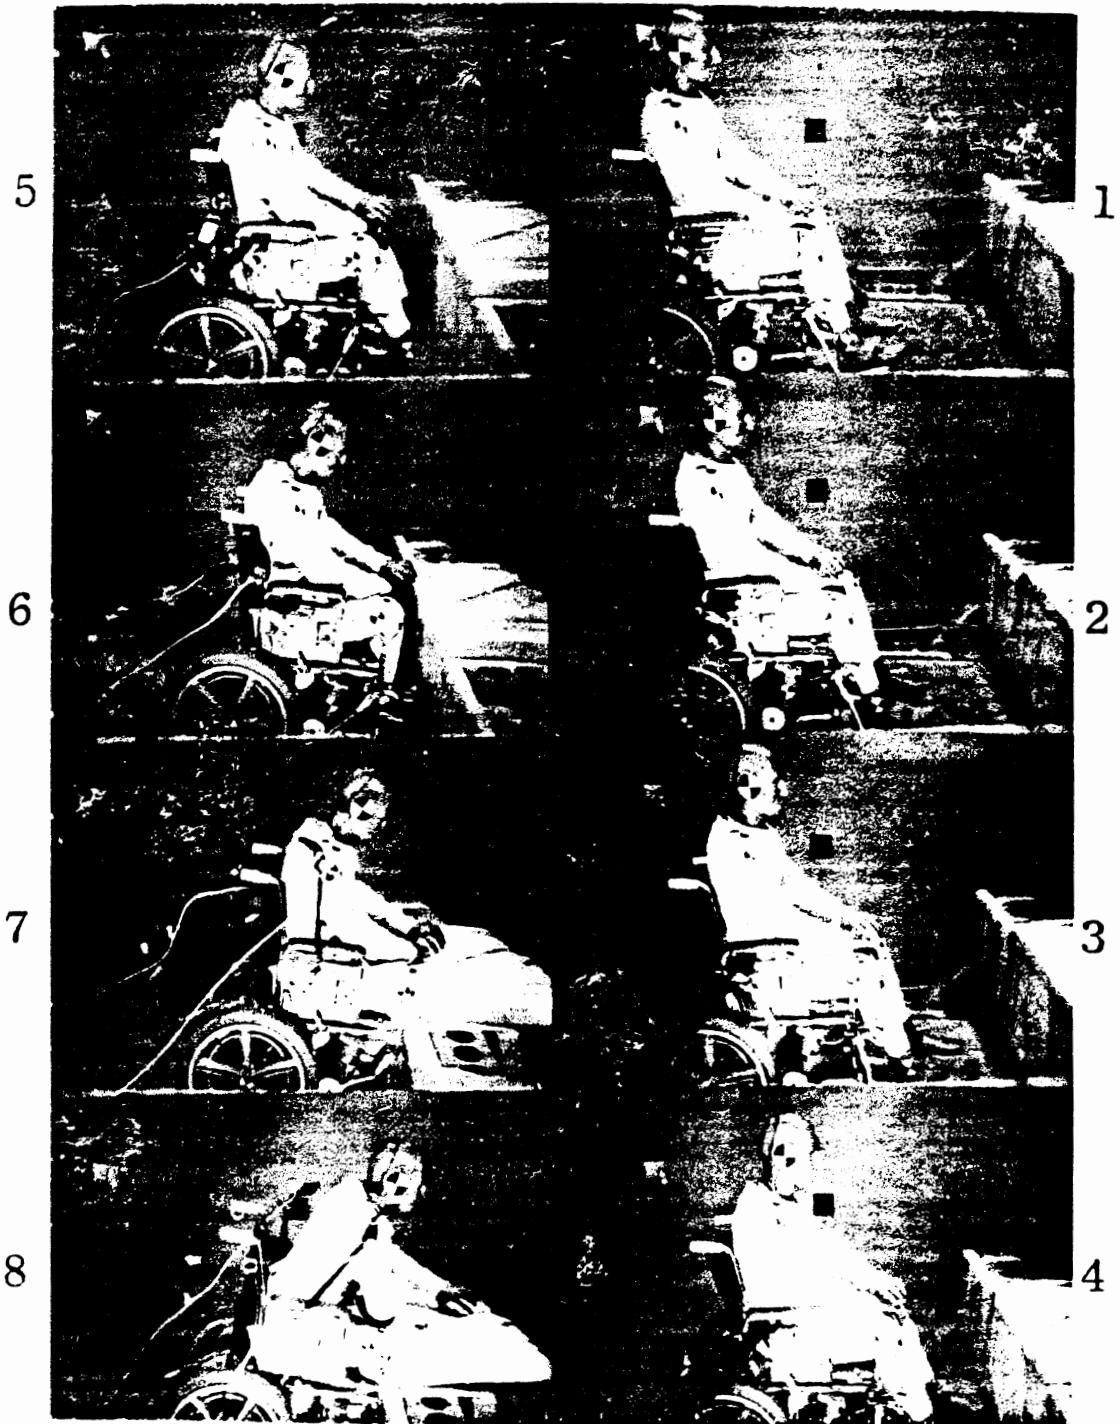
Time Sequence Photo for Test 80M021

All three of the lift rings broke at the sharp bend completely releasing the chair and dummy to impact into the padded front of the sled. After impact the dummy fell to the floor unrestrained. The wheelchair sustained little or no damage.

The lift ring assemblies currently in use for anchoring lap belts and T-bar bolts were simply not intended for forces generated by a 110 pound wheelchair in any kind of a crash. These are "off-the-shelf" trap door rings which can be purchased in most any hardware store. The weak point is clearly the sharp bend in the ring which appears to have been cold bent from a piece of standard rod. Replacement of these ring assemblies by heavy duty eye bolts or some other strengthened hardware is essential for wheelchair restraint and occupant protection.
