# **PROFILE ANALYSIS OF THE LTPP SPS-9P SITE IN ARIZONA**

**STEVEN M. KARAMIHAS**

1. Report No. UMTRI-2007-18		2. Government Accession No.		3. Recipient's Catalog No.	
4. Title and Subtitle Profile Analysis of the LTPP SPS-9P Site in Arizona				5. Report Date May 2007

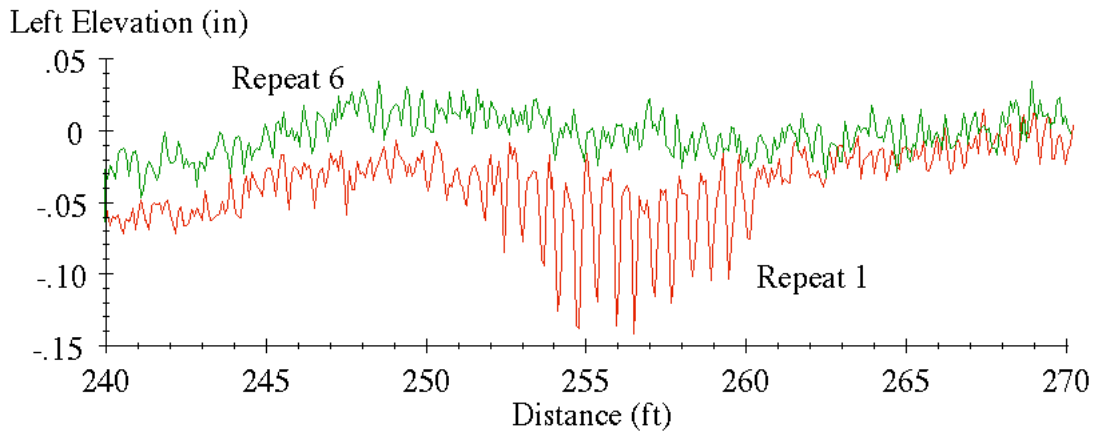
**Figure 6. Periodic chatter found in the left side profiles from section A901.**

The chatter in the profile corresponds to a narrow scuff that runs along the left wheelpath over most of the section, but runs off to the edge near the end. It is present in the photos, and appears as a long series of indents about a third the width of the lane edge stripe. (See Figure 7.)

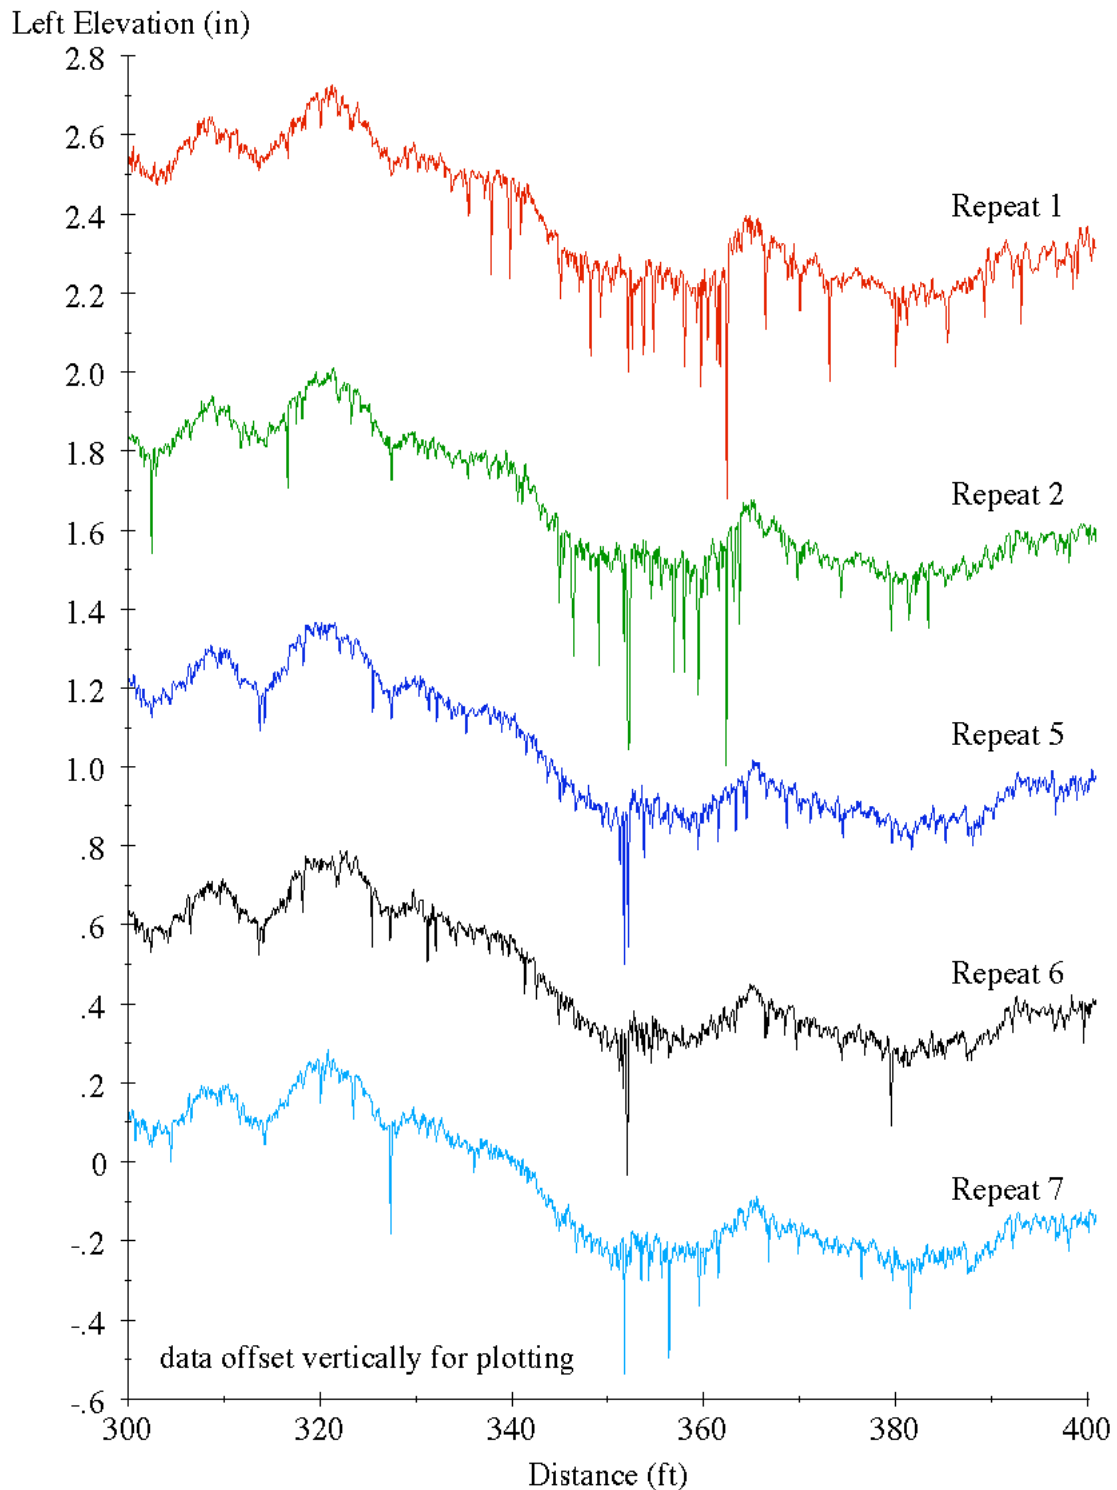
**Figure 8. Narrow downward spikes in visit 13 of section 0903.**

Elevation profile plots: Profiles did not change much over visits 05 through 07. Unfiltered profiles from visits 11 and 13 included several downward spikes throughout the length of the section that appeared in only one repeat measurement in some locations, and up to three locations in others. With the exception of the spikes, the profiles from visits 09, 11 and 13 were consistent with each other.

Profiles from sections 0903 and A903 in visits 11 and 13 included several downward spikes that often appeared in only one or two repeat measurements of each location. These were caused by cracking and raveling, which covered both wheelpaths. The spikes were more prevalent in the right wheelpath. The spikes did not appear to affect the IRI significantly.
