**Report to the Test Director**

**DAMAGE TO COMMERCIAL  
AND INDUSTRIAL BUILDINGS  
EXPOSED TO NUCLEAR EFFECTS**

February 1956

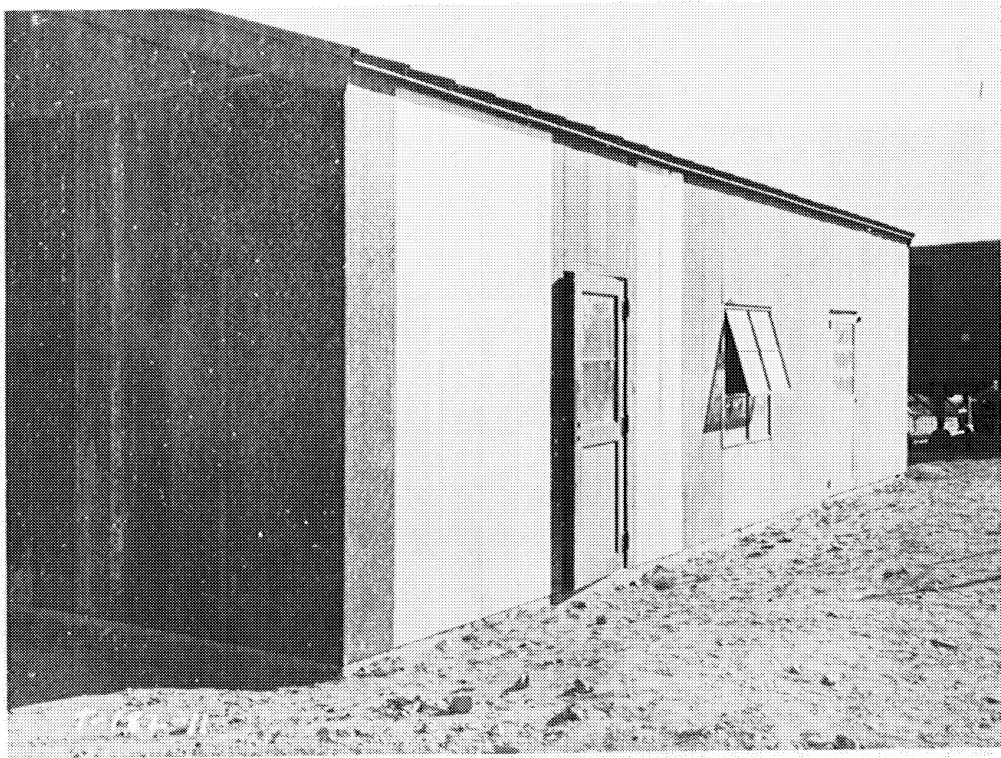
Fig. 1.22— Armco Building 31.2-d1 repaired after unexpected test.

after repair of the north wall damage, was previously illustrated in Fig. 1.22. Appendix B provides an analysis of the dynamic behavior of Building 31.2-d1.

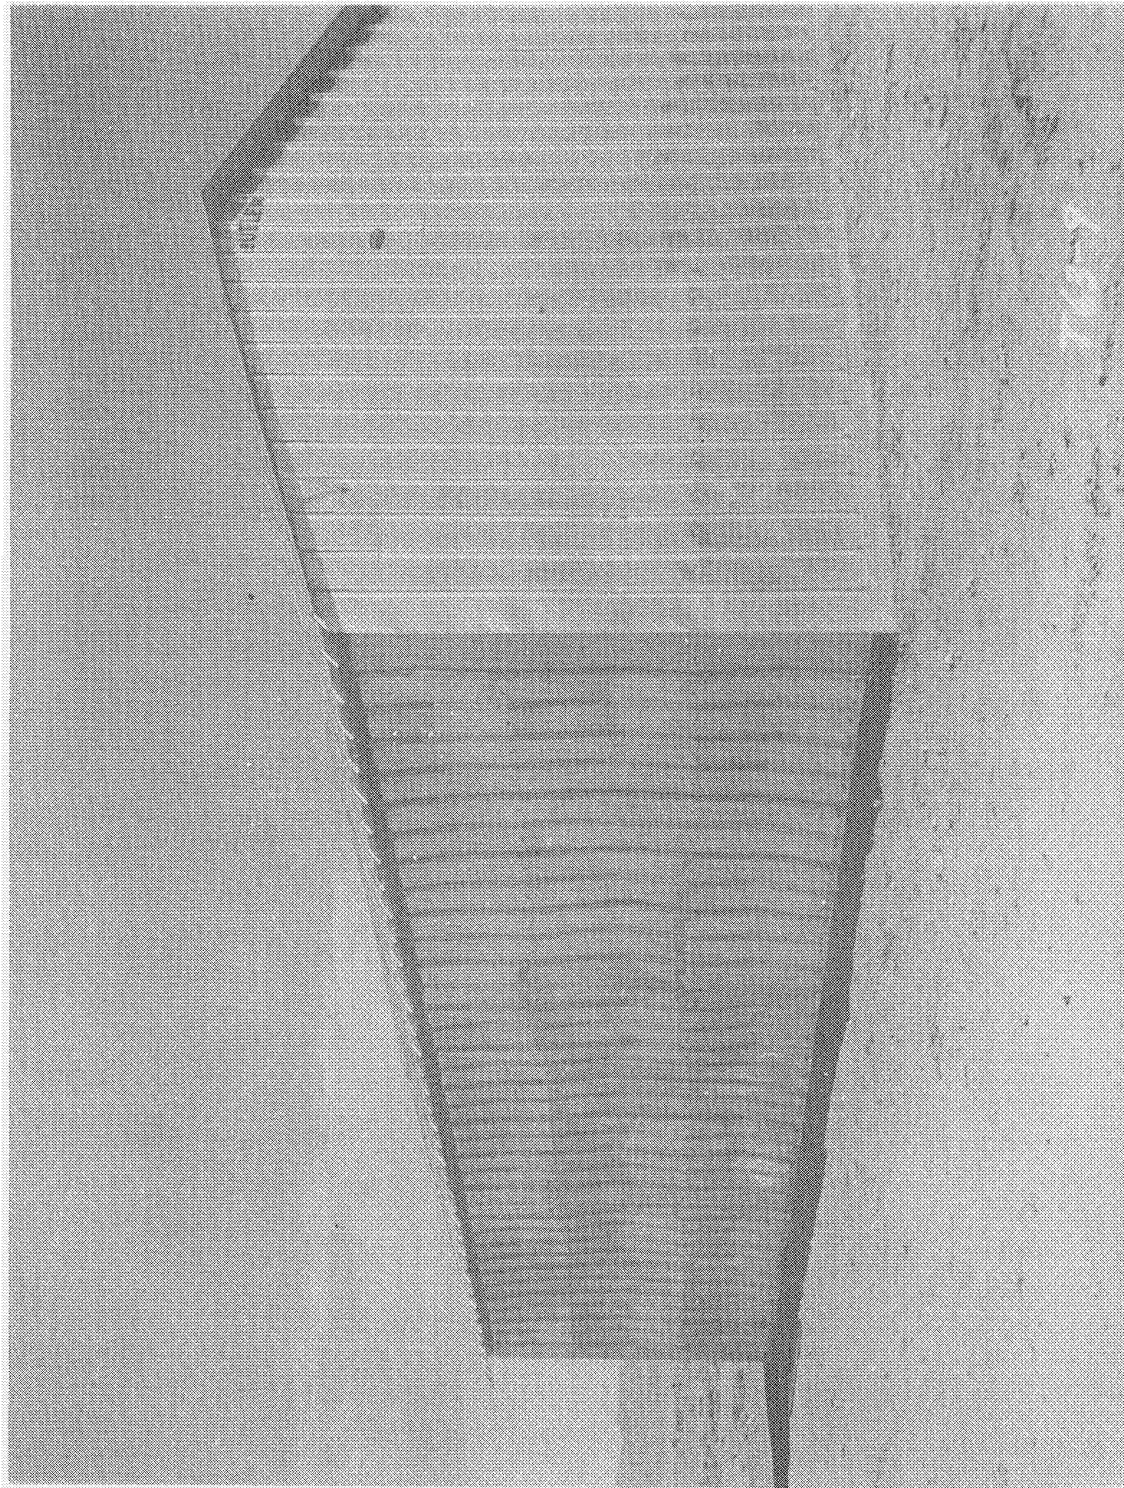
Figure 2.1 gives a general indication of the damage from the unexpected test to the north wall of Reynolds-Butler Building 31.2-a1, which was left with permanent inward deflections up to 5 in. The offset measurements, as recorded at the site, are tabulated in Fig. 2.2 for both the unexpected and planned tests. The two wall girts were bent in along with the paneling, and the bolt heads of the panel fasteners were generally pulled through the sheeting. Washers had been omitted along these two lines of bolts, and hence no definite conclusion can be made as to the probable extent of pull through if they had been included. The roof sheeting was left with downward permanent sets, especially in the span immediately adjacent to the eaves, where the permanent deflections, as shown in Fig. 2.3 and recorded in Fig. 2.2, were measured up to 3 in. The roof purlins were not deformed appreciably. The interior view of the wall (Fig. 2.4) shows how twisting of the girts occurred with measured values up to 43°. It is also of interest to note the imprint of the wind-bracing ties on the wall paneling, indicative of the initial deflections that were experienced. A dynamic analysis of wall behavior in both the unexpected and planned tests is provided in Appendix A.

As shown in Fig. 2.1, the panels on the west end of the building suffered very little permanent deformation. The unexpected test involved a moderate northeast exposure, and at the east end, as indicated in Fig. 2.5, the panels were bent inward to a degree comparable with those on the north side. This picture was made during the process of repair, with damaged north and south wall panels removed but with the bent and twisted wall girts still in position.

Fig. 2.1 — General view of north and west end walls, showing damage from unexpected test to Reynolds-Butler Building 31.2-a1.

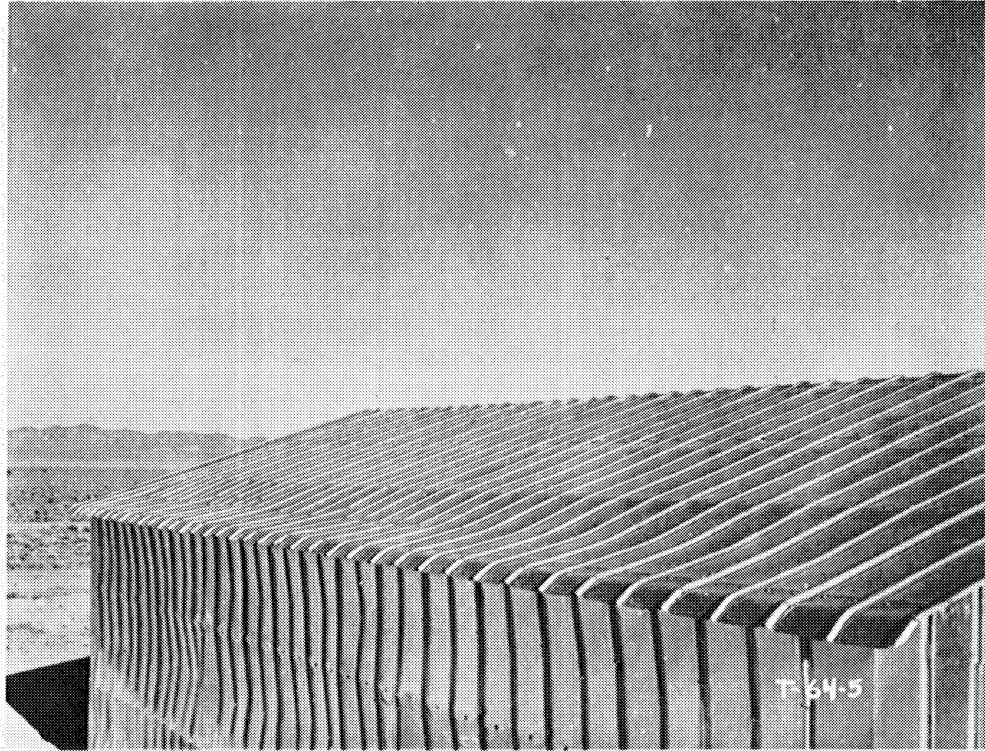
Fig. 2.3—Damage to roof of Reynolds-Butler Building 31.2-a1 from unexpected test.

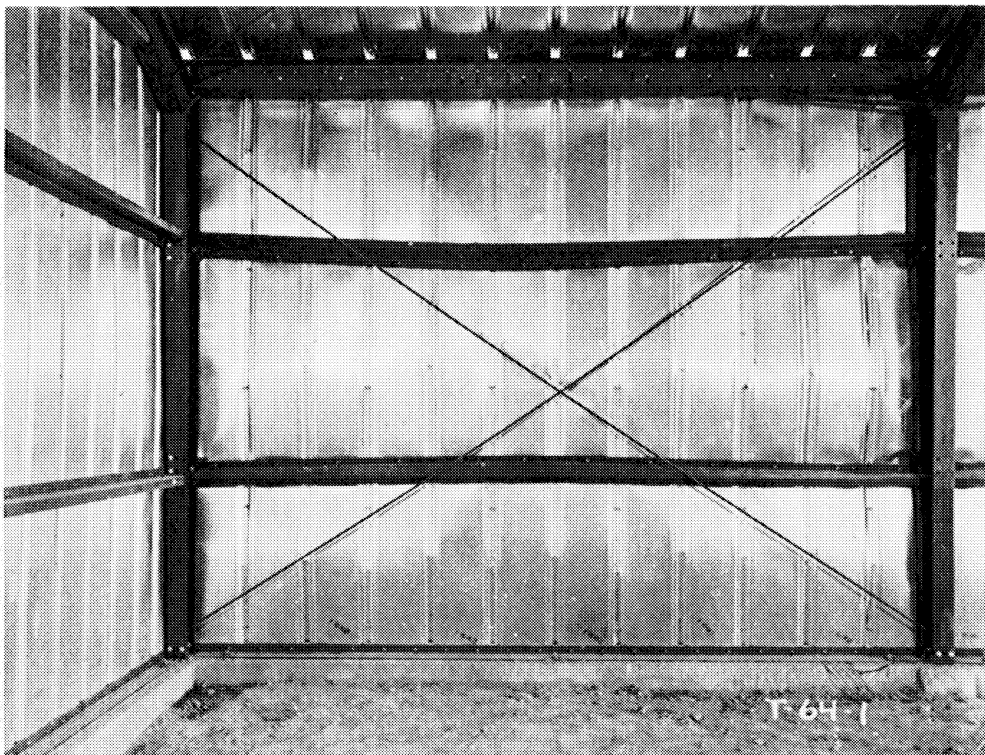
Fig. 2.4—Interior view of damage to north wall in Reynolds-Butler Building 31.2-a1 from unexpected test.

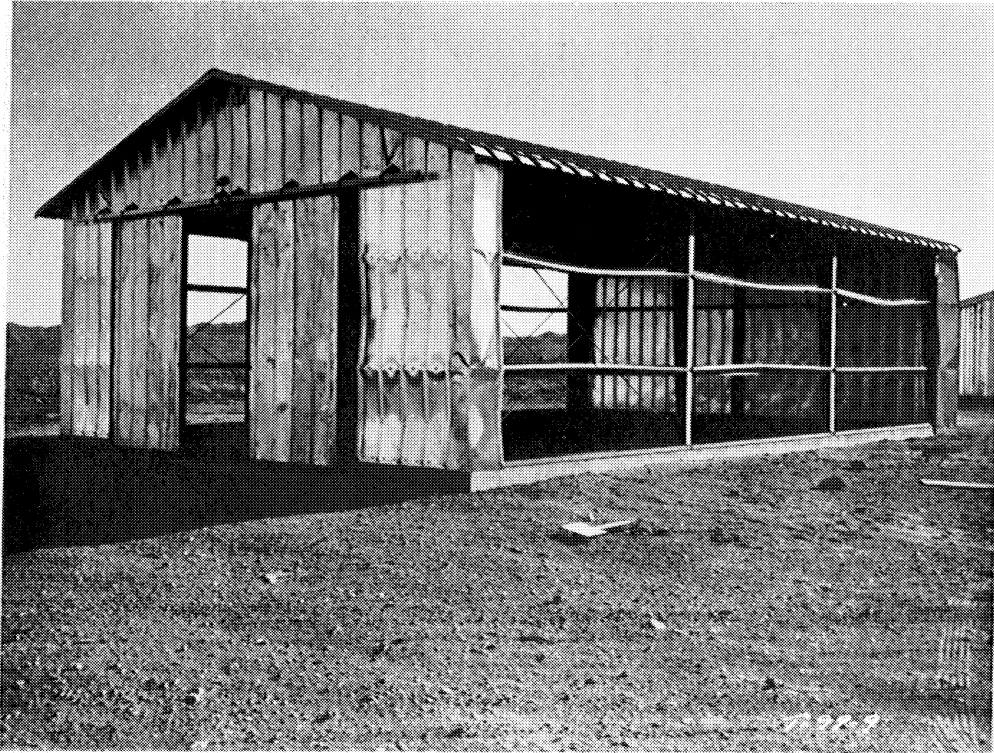
Fig. 2.5—North and south sides of Reynolds-Butler Building 31.2-a1 during repair of damage from unexpected test.

All wall panels on the north and south faces of Reynolds-Butler Building 31.2-a1, together with eight damaged girts, were replaced. Several damaged panels on the east end were allowed to remain in place since they had retained fully their original strength. All the first course of roof sheeting on the north side, next to the eaves, was replaced.

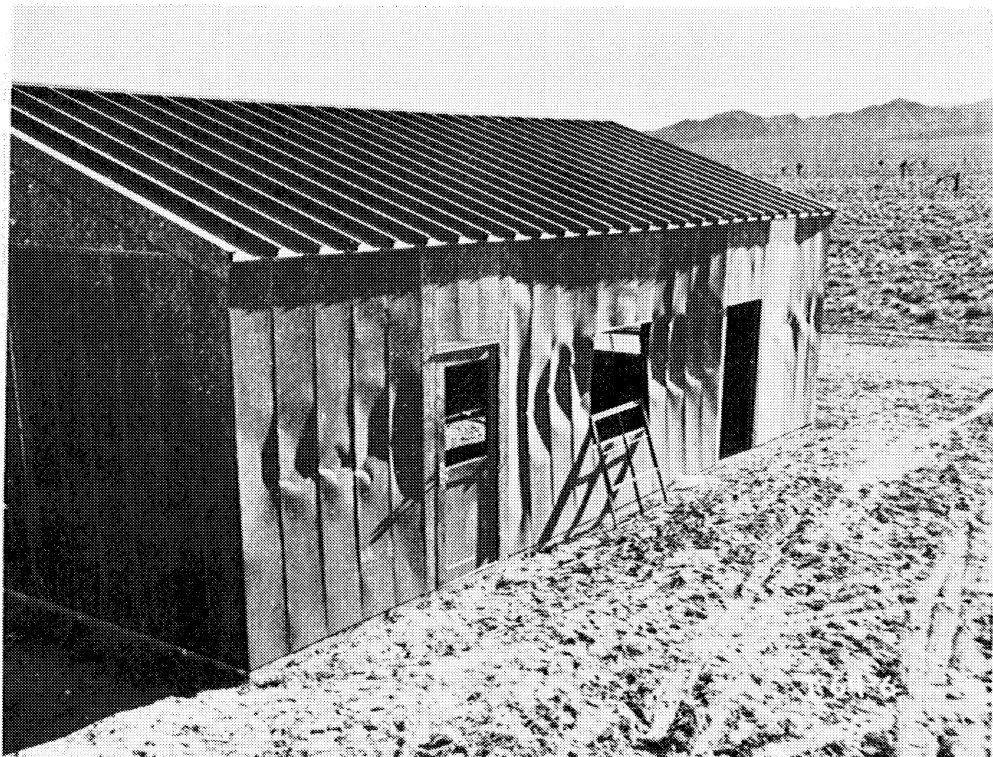
Fig. 2.6—Damage to north walls of Armco Building 31.2-d1 from unexpected test.

Permanent deflections along the north side of Armco Building 31.2-d1 are shown in Fig. 2.6 and are recorded in Fig. 2.7. The first five wall panels on the east and nearest the blast origin were damaged to a lesser extent. Maximum permanent deflections of the north wall, amounting to 4.8 in., were measured adjacent to the north window. Figure 2.8 shows the local buckling on the inside of the north wall near the location of maximum deflection. This building,

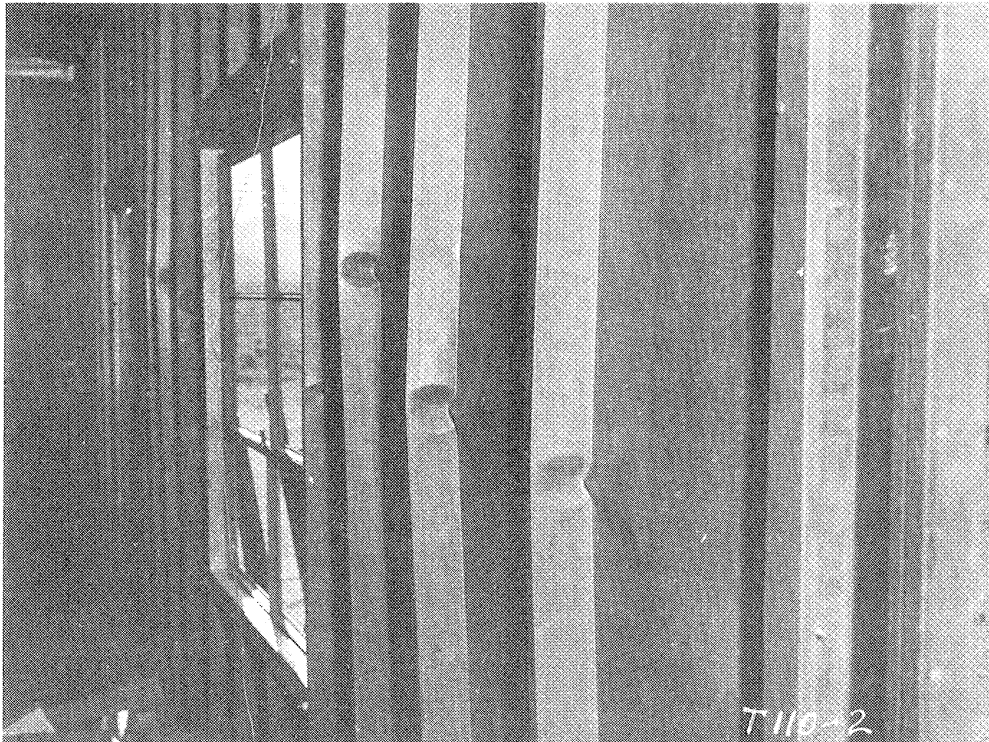
Fig. 2.8—Interior view of damage to north wall of Armco Building 31.2-d1 from unexpected test.

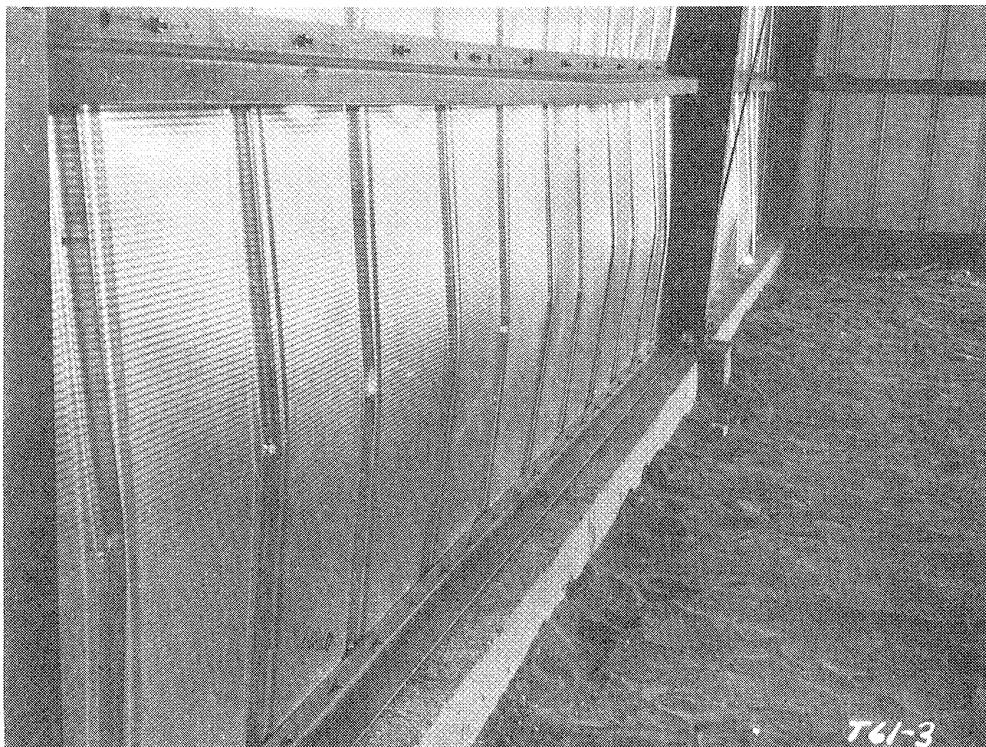
Fig. 2.9—Interior view of wall damage in Reynolds-Butler Building 31.2-a2 from unexpected test.

The roof sheeting on Reynolds-Butler Building 31.2-a2 had not been placed, and the blast caused movement of both walls away from the blast origin, damaging both paneling and girts to a very minor extent. Deflections of the wall paneling on the north side amounted to as much as 2 in. in the lowest space, as shown in the interior view (Fig. 2.9). Washers had been installed properly with all bolts, and no bolts pulled through the sheeting on the north face, although two bolts with washers did pull through the south face sheeting due to the negative aspect of the behavior with an open roof.

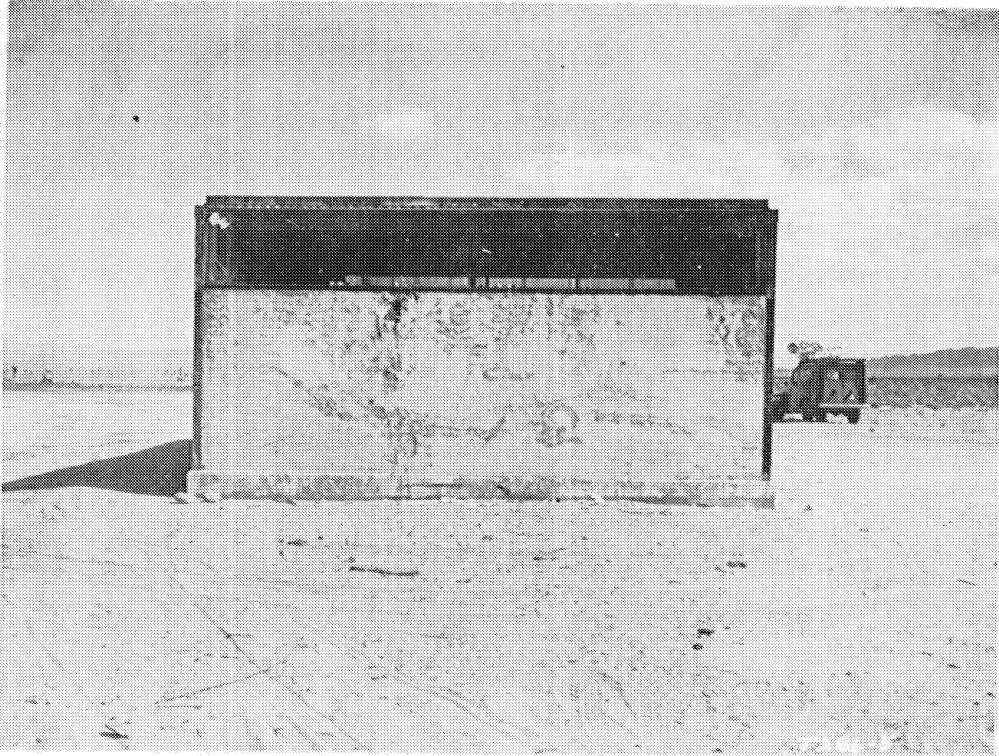
The trajectory of the window pieces from the north wall appeared to be downward. Although there were indications that small particles had struck the south wall window, most

Fig. 2.10—North wall of Union Carbide building after planned test.

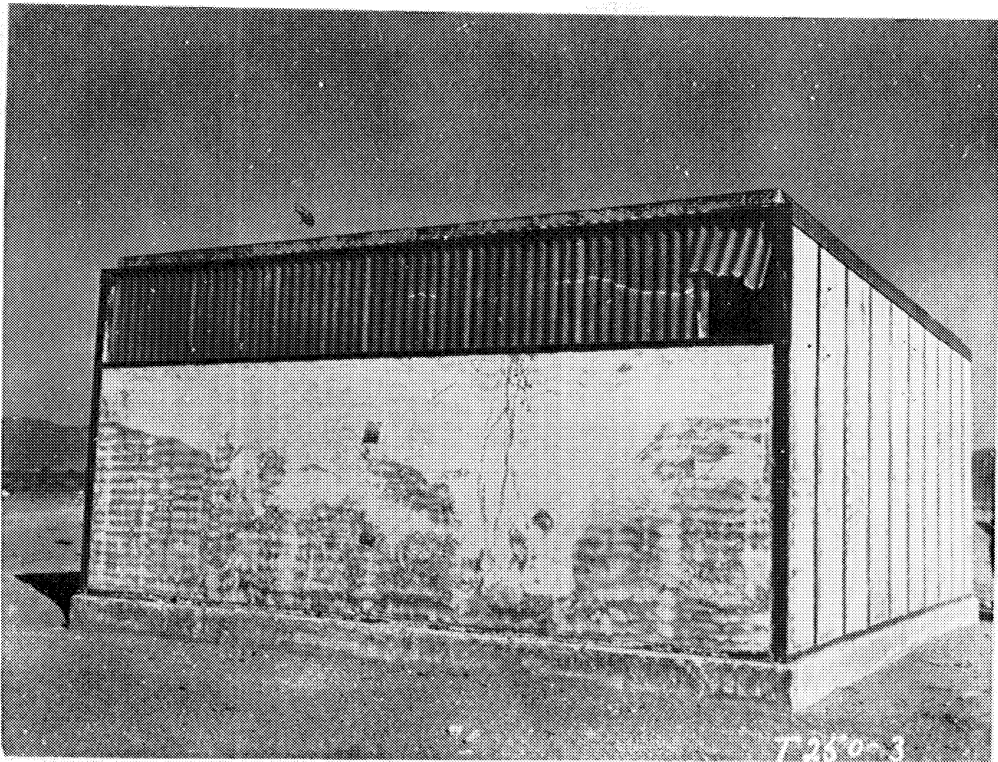
Fig. 2.11—South wall of Union Carbide building after planned test.

marks were made on the gypsum portion of the south wall. The portion of the south window that was broken outward could have been damaged by a piece of the north window. The marks left by the plastic pieces were not sharp and penetrating.

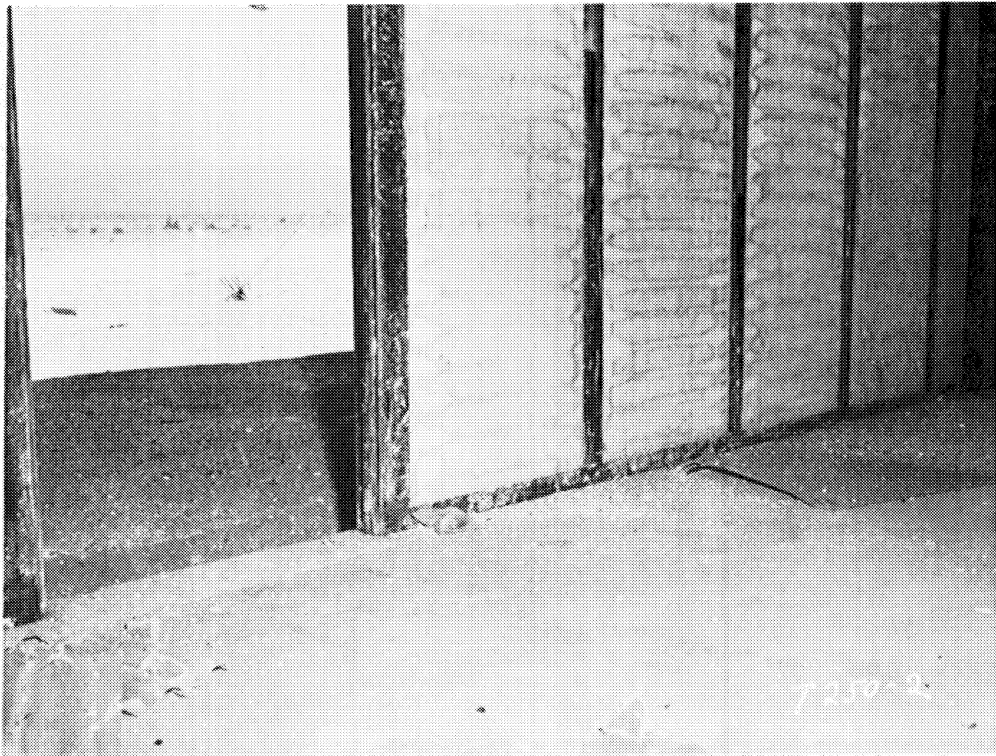
Fig. 2.12—Interior view looking out doorway of Union Carbide building after planned test.

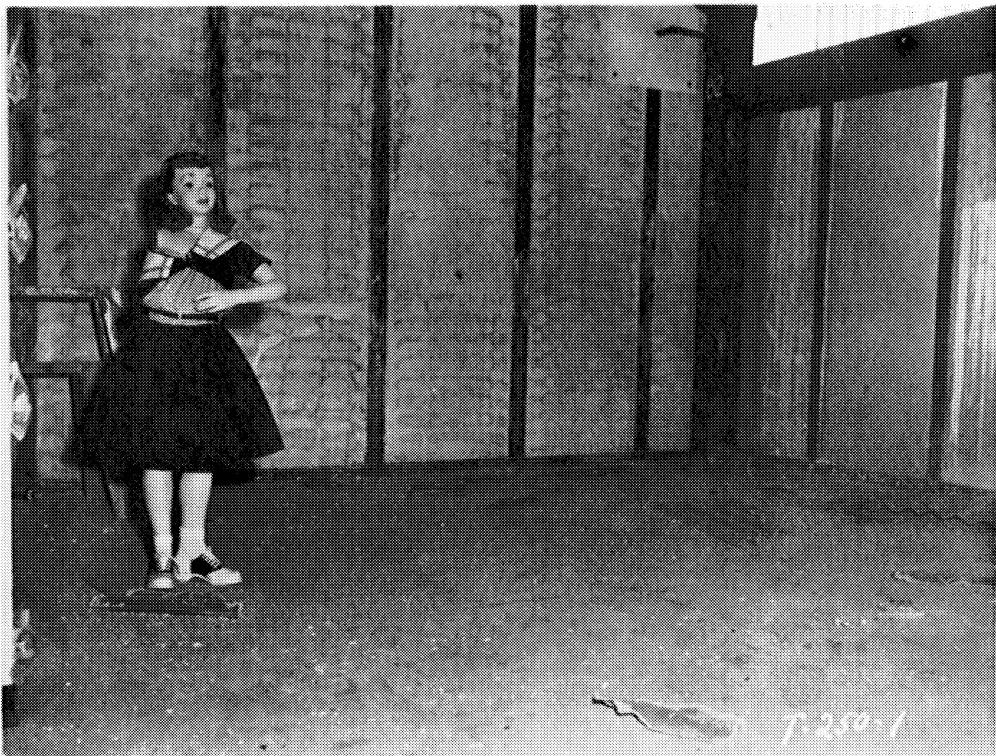
Fig. 2.13—Interior view of southeast corner of Union Carbide building after planned test.

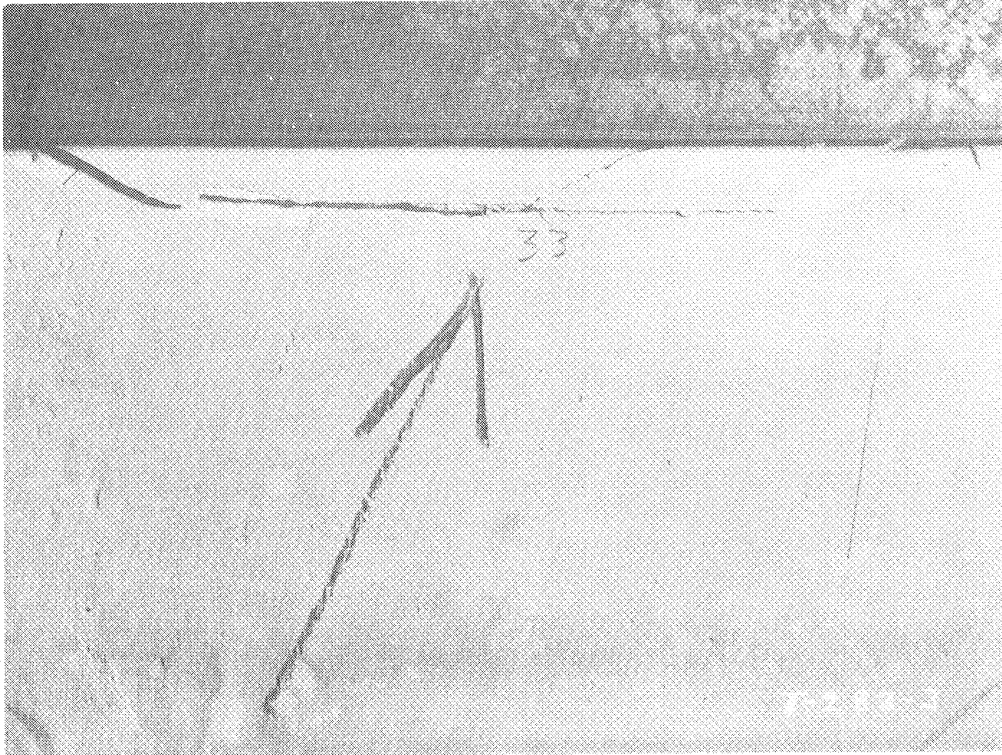
Fig. 2.16—Shear crack at top of west wall north of Union Carbide building.

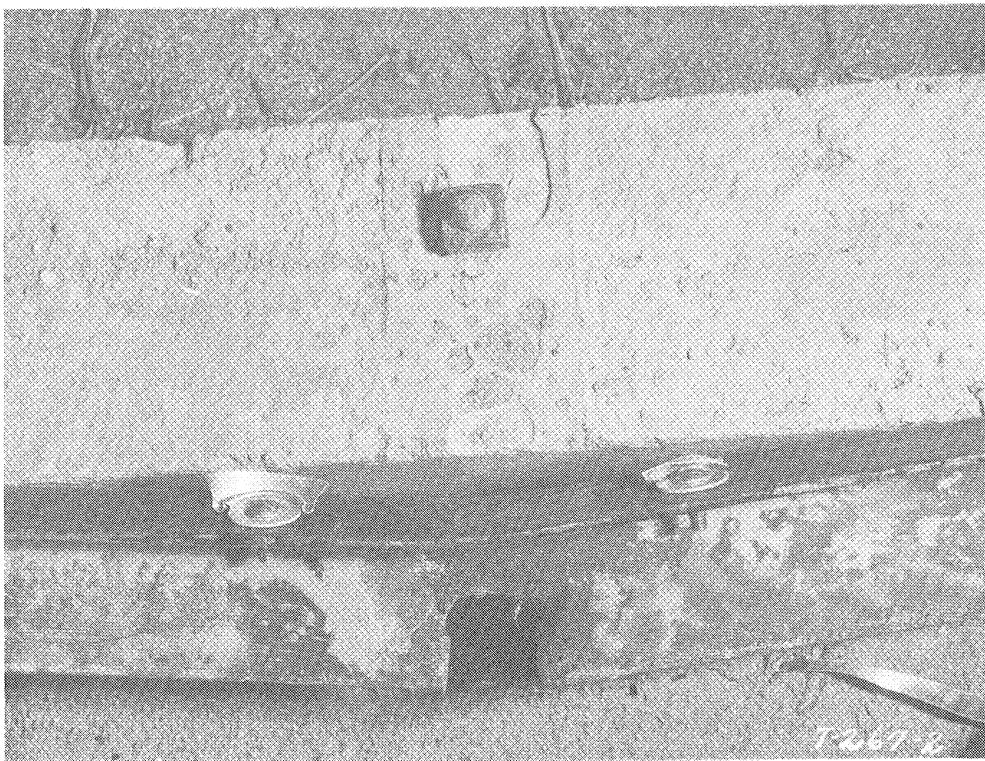
Fig. 2.20—View looking down on sill angle in Reynolds-Butler Building 31.2-a1 after planned test.

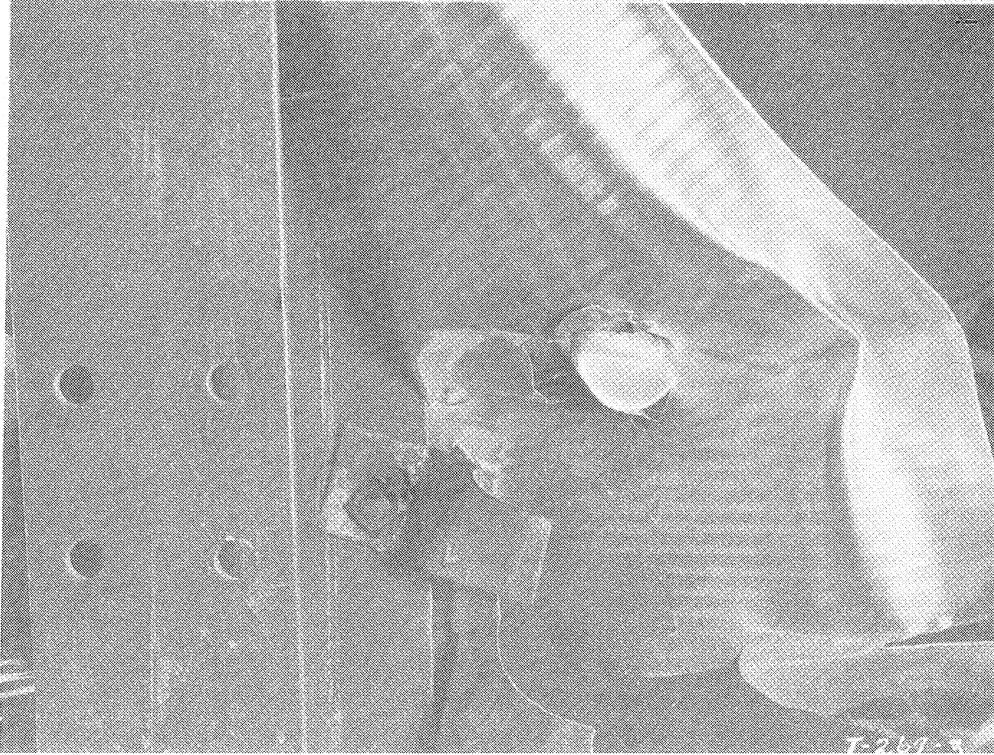
Fig. 2.21—Interior detail of torn girt connector north of Reynolds-Butler Building 31.2-a1 after planned test.

Figure 2.21 shows the detail of a torn girt connector which is typical of the end failures of this member. Approximately one-half of the total girt area is cut away at this point to provide sufficient coping of the Z bar in order to eliminate interference between the exterior panel and the front face of the columns. The girt is then attached by a single  $\frac{1}{2}$ -in.-diameter bolt passing through a slotted hole. Initially, the slotted hole permits a longitudinal movement of the girt which is resisted only by the friction between the bolt and the girt material. Then at the sharp internal cut, the girt starts to tear at the end. As it does so, the torn piece of girt that remains attached to the column is twisted almost  $90^\circ$ , as shown in Fig. 2.21. There is some information available on the strength of eccentrically loaded tension members of steel which fail by tearing that starts at one side, due to a notch or stress concentration, and information<sup>1</sup> is also available on the strength of bolts in shear. The fact that the bolts did not fail

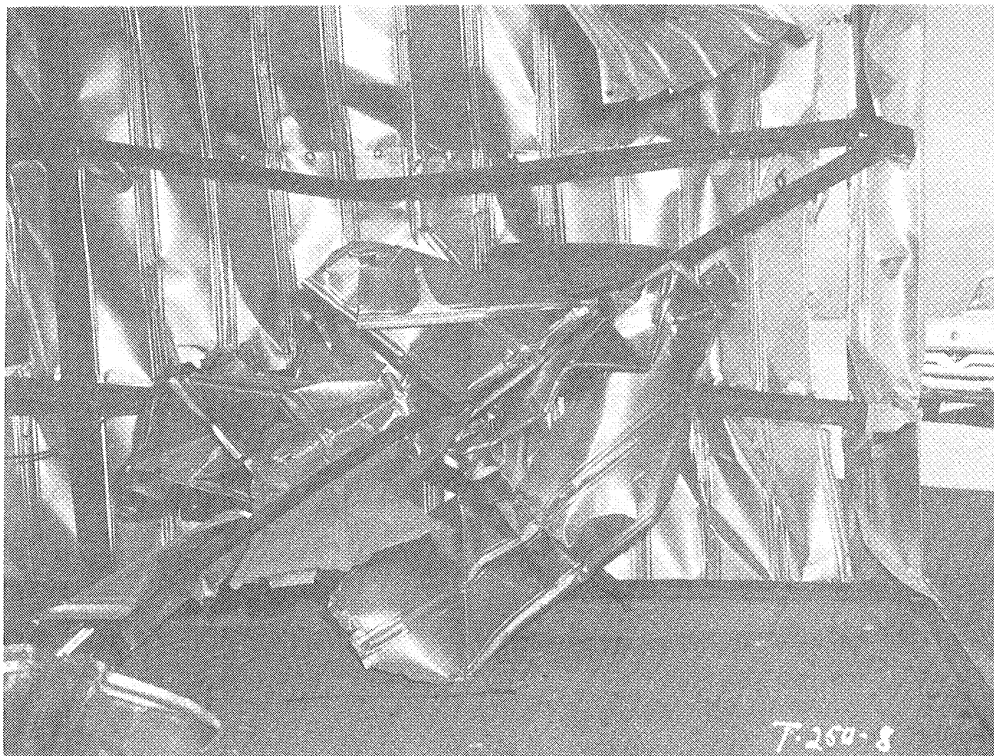
Fig. 2.22—Interior view of Reynolds-Butler Building 31.2-a1 after planned test. (Note that west girts and panels of north wall have been thrown against west end.)

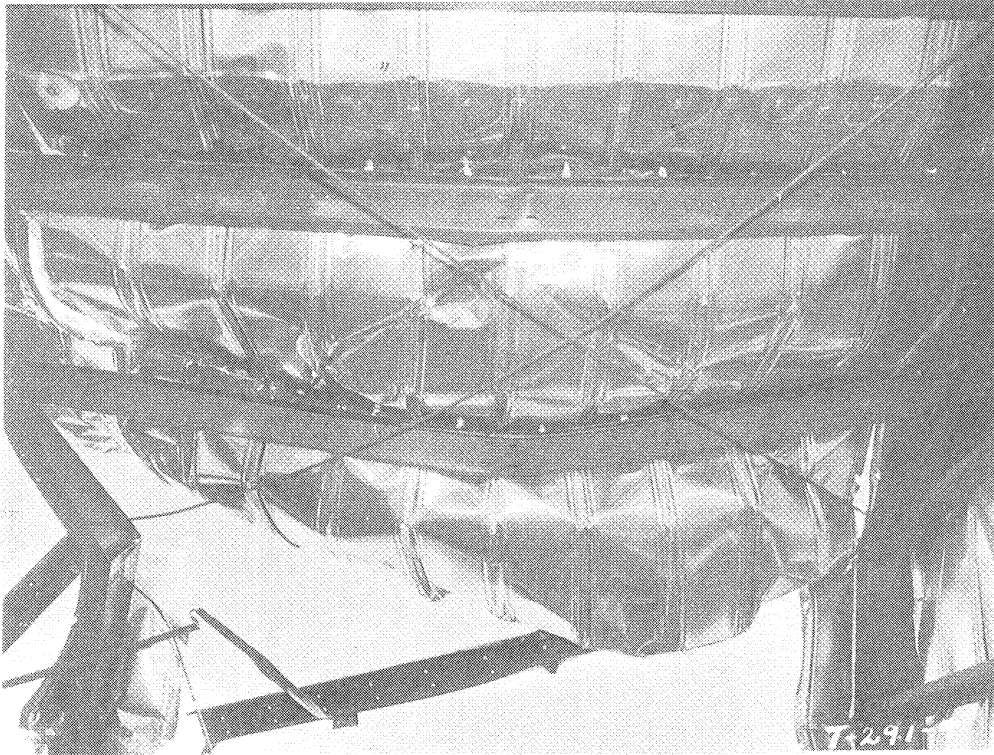
Fig. 2.23—Roof purlins at northeast corner of Reynolds-Butler Building 31.2-a1 after planned test.

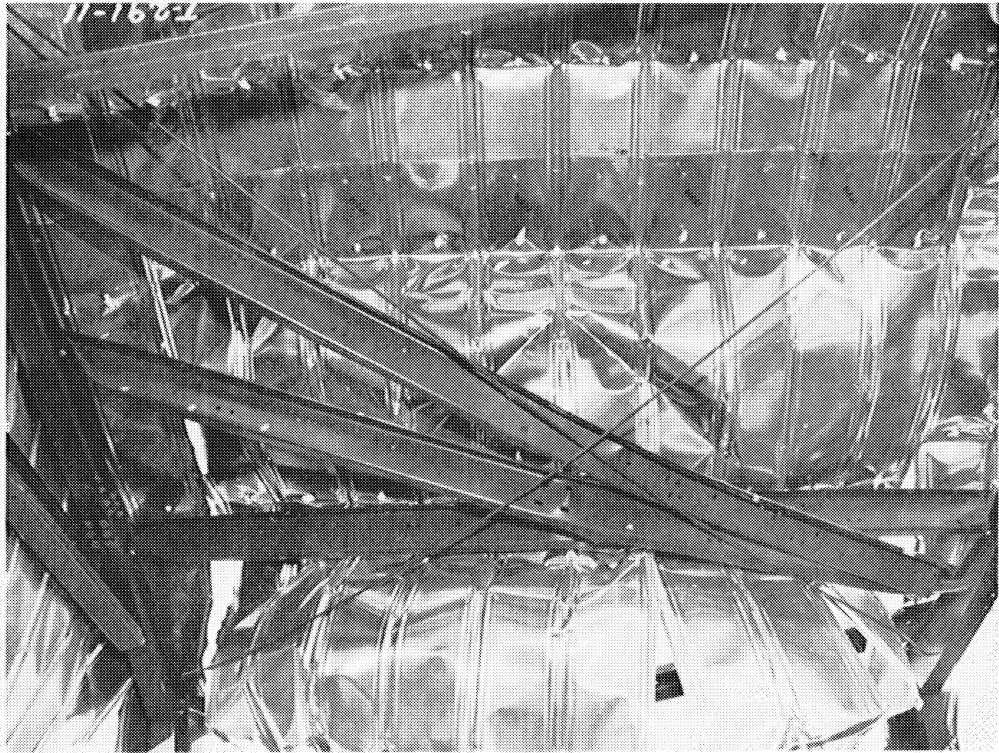
Fig. 2.25 — Underside of roof at northwest corner of Reynolds-Butler Building 31.2-a1 after planned test.

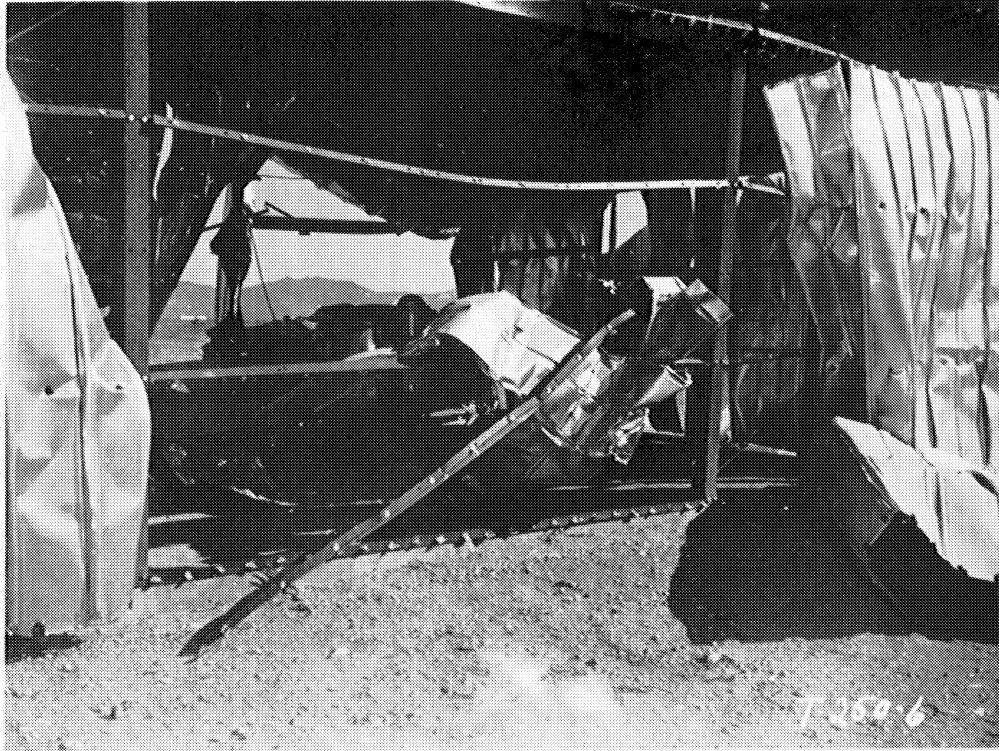
Fig. 2.27—North girts and siding blown through south wall of Reynolds-Butler Building 31.2-a1 after planned test.

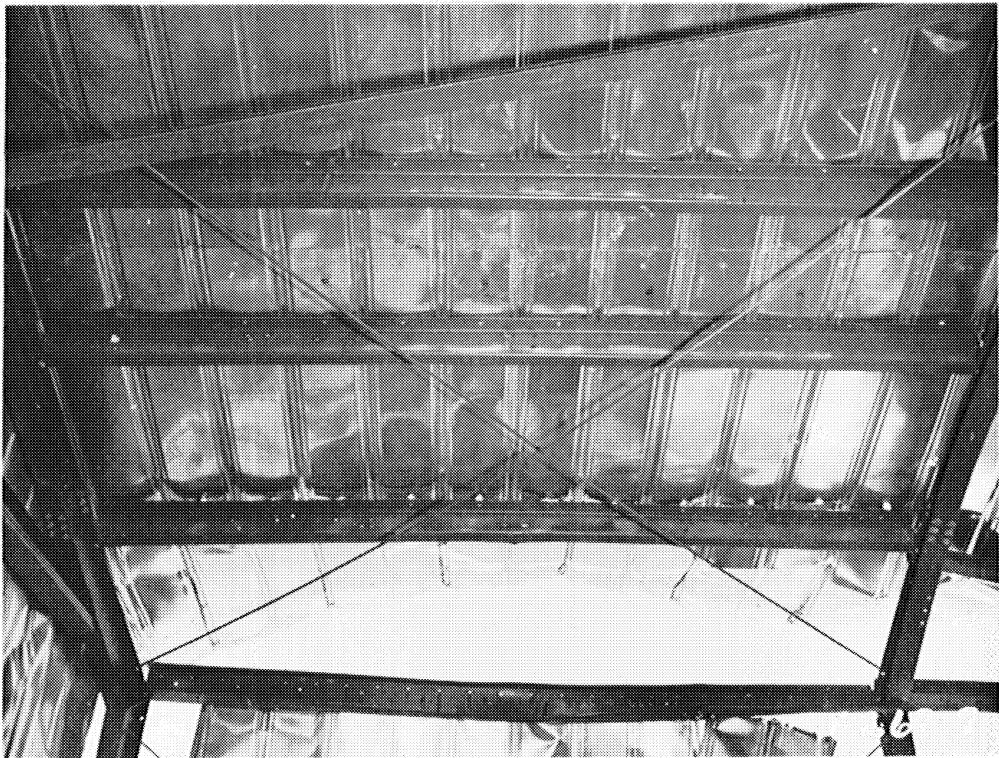
Fig. 2.28—Underside of southeast roof section of Reynolds-Butler Building 31.2-a1 after planned test.

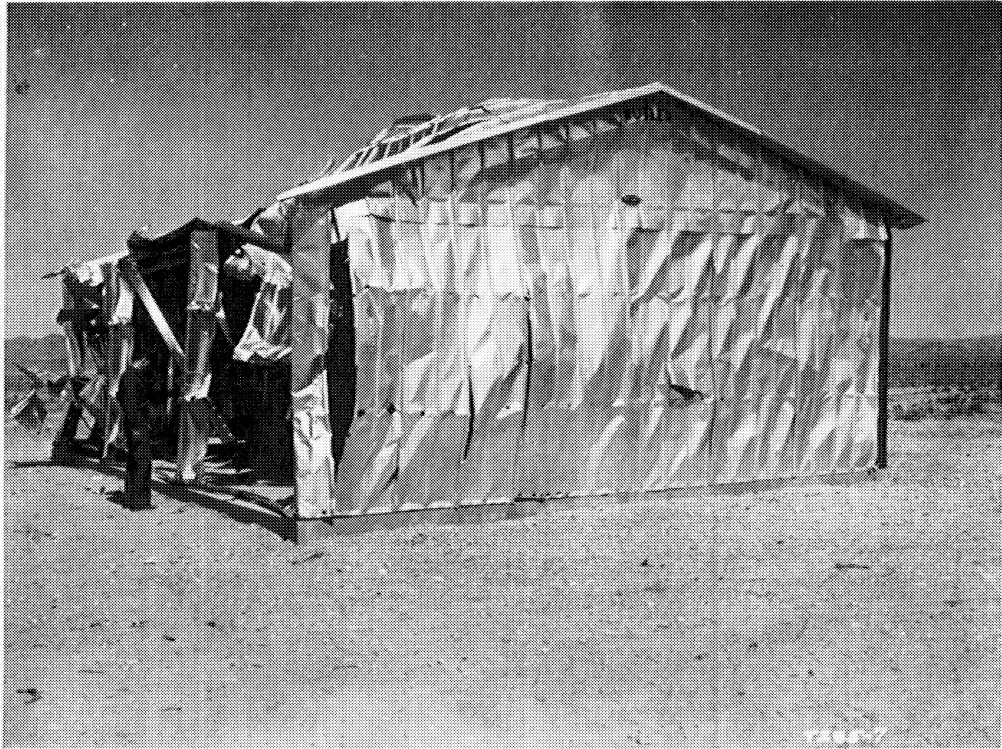
Fig. 2.29—West end of Reynolds-Butler Building 31.2-a1 after planned test.

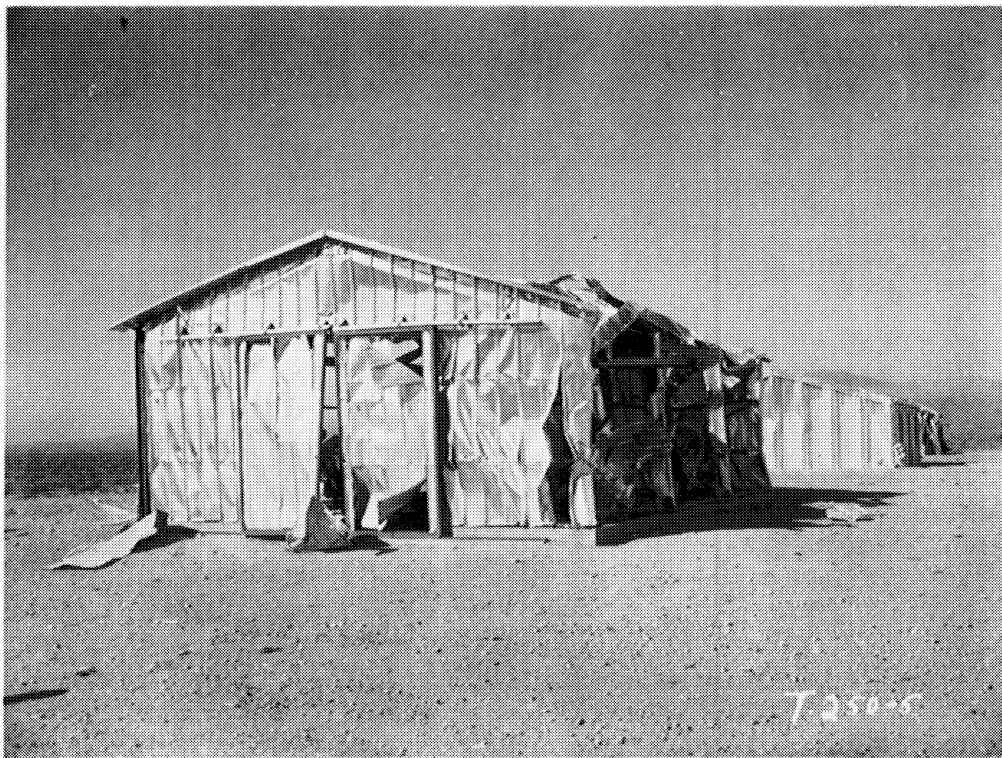
Fig. 2.30—East end of Reynolds-Butler Building 31.2-a1 after planned test.

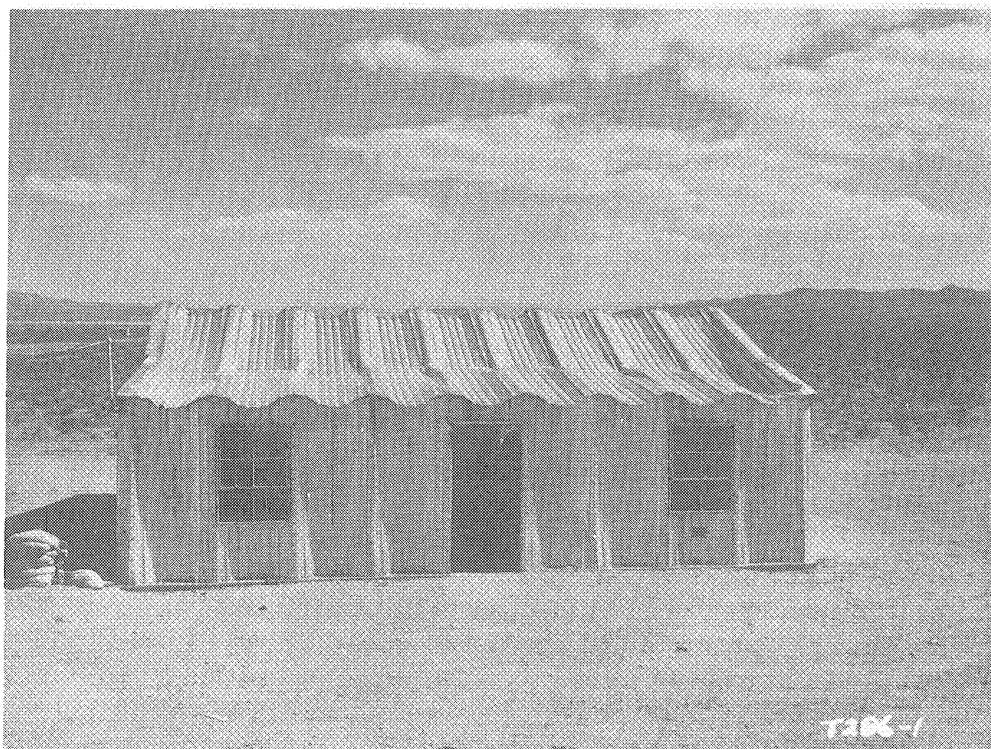
This building, at 6800 ft, was practically destroyed; the roof collapsed and rested at the center on machinery within the building. Front wall segments were wrapped around the machinery, and this provided a block that at least partially prevented additional movement of building wreckage in the downblast direction.

Fig. 2.31—North side of Behlen Building 31.2-b1 after planned test.

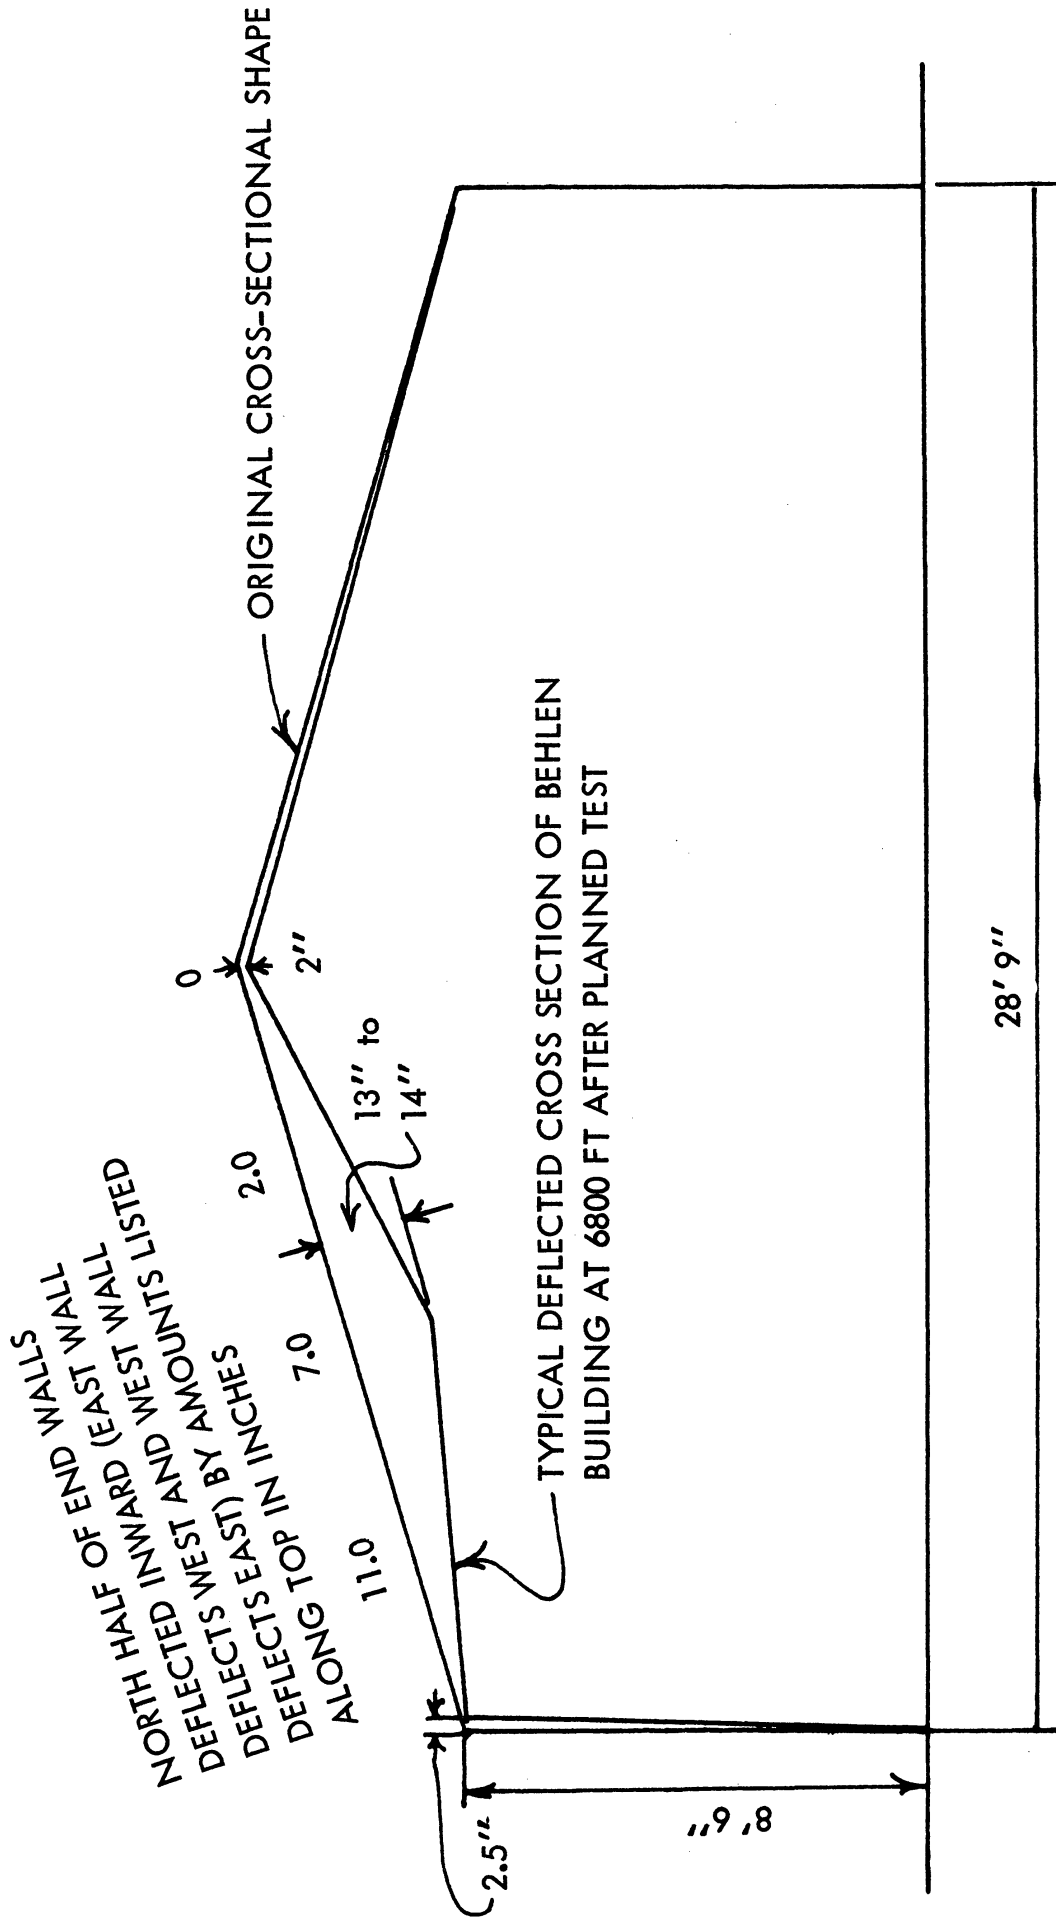
Fig. 2.33 — Permanent deflection of Behlen Building 31.2-b1 at 6800 ft after planned test.

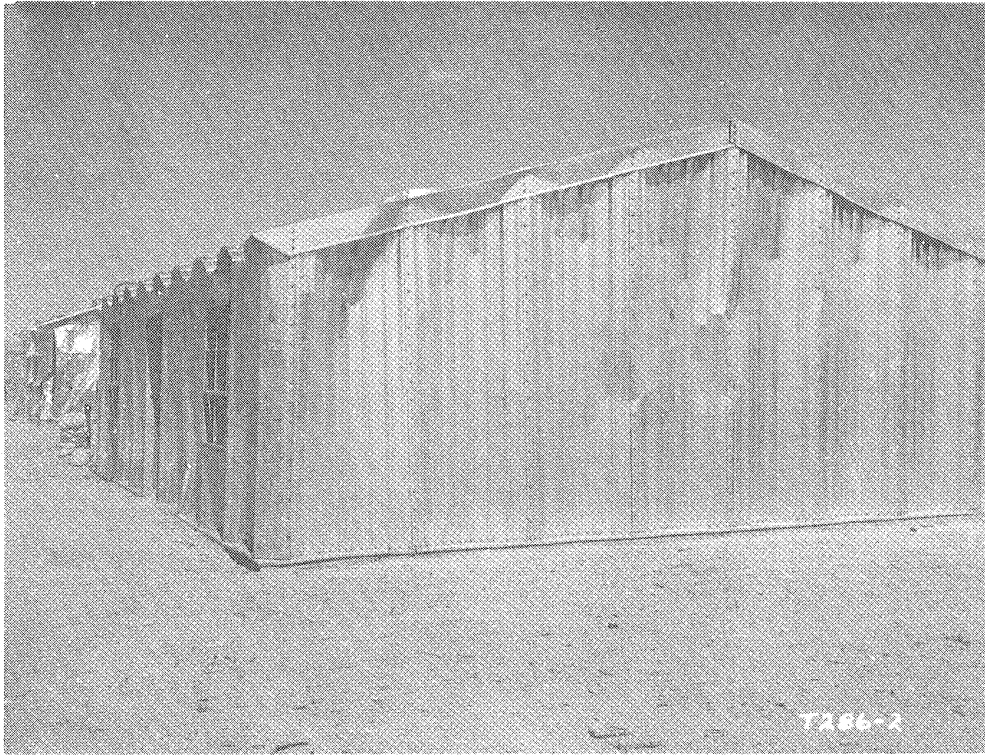
Fig. 2.34 — West end of Behlen Building 31.2-b1 after planned test.
