**Report to the Test Director**

**DAMAGE TO COMMERCIAL  
AND INDUSTRIAL BUILDINGS  
EXPOSED TO NUCLEAR EFFECTS**

February 1956

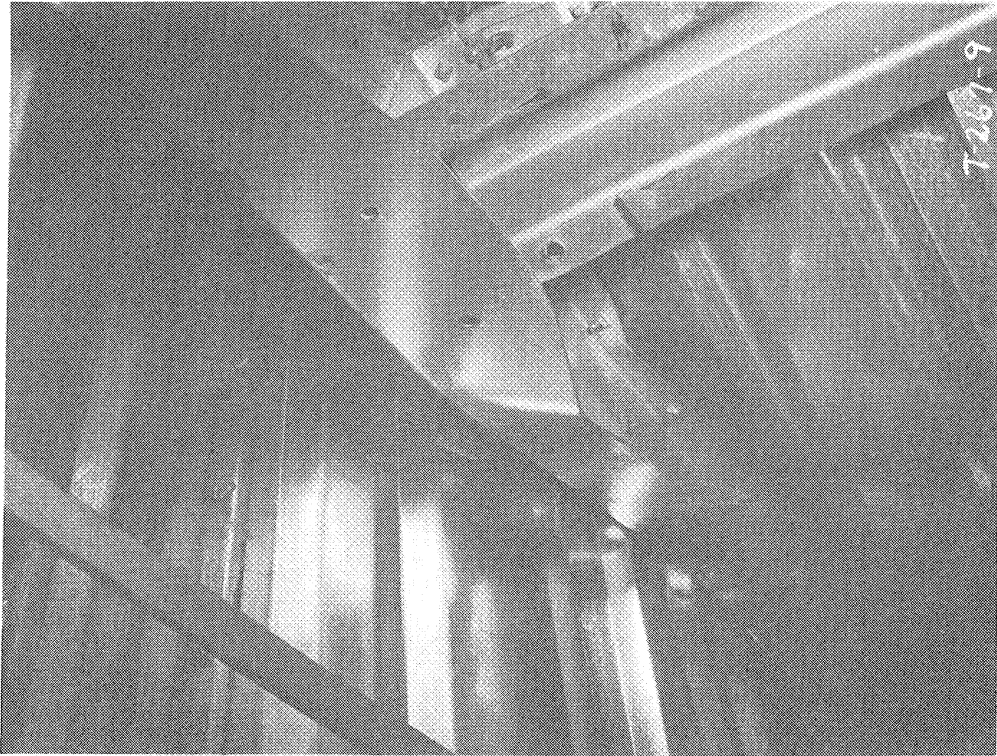
Fig. 2.36—Interior ridge detail at west end of Behlen Building 31.2-b1 after planned test.

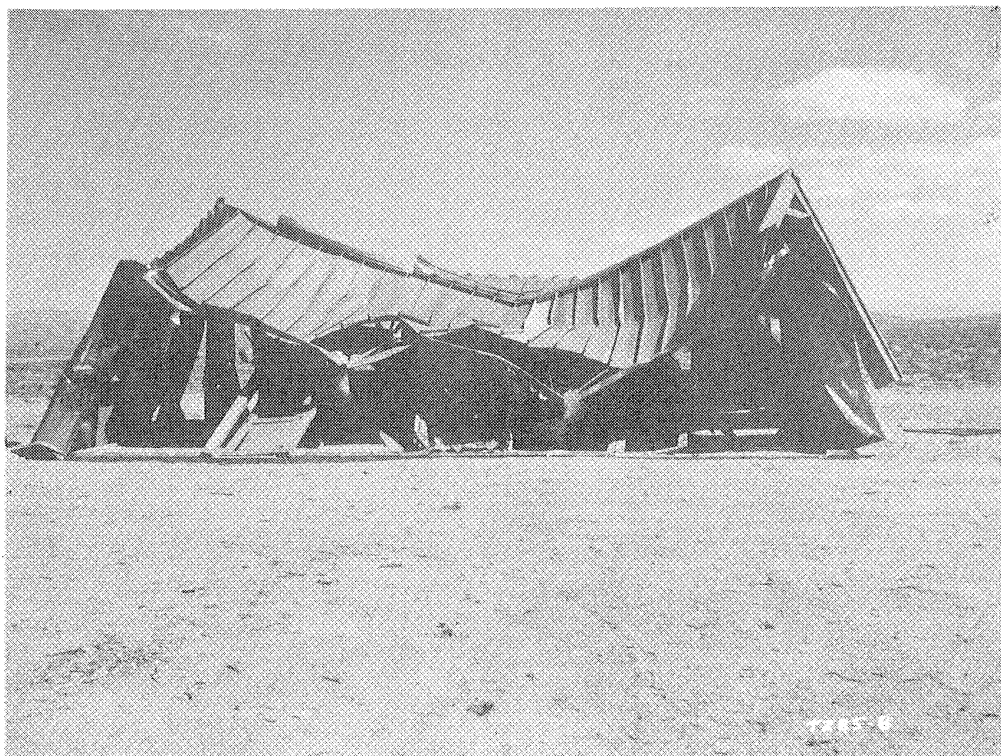
Fig. 2.37—North side of Armco Building 31.2-d1 after planned test.

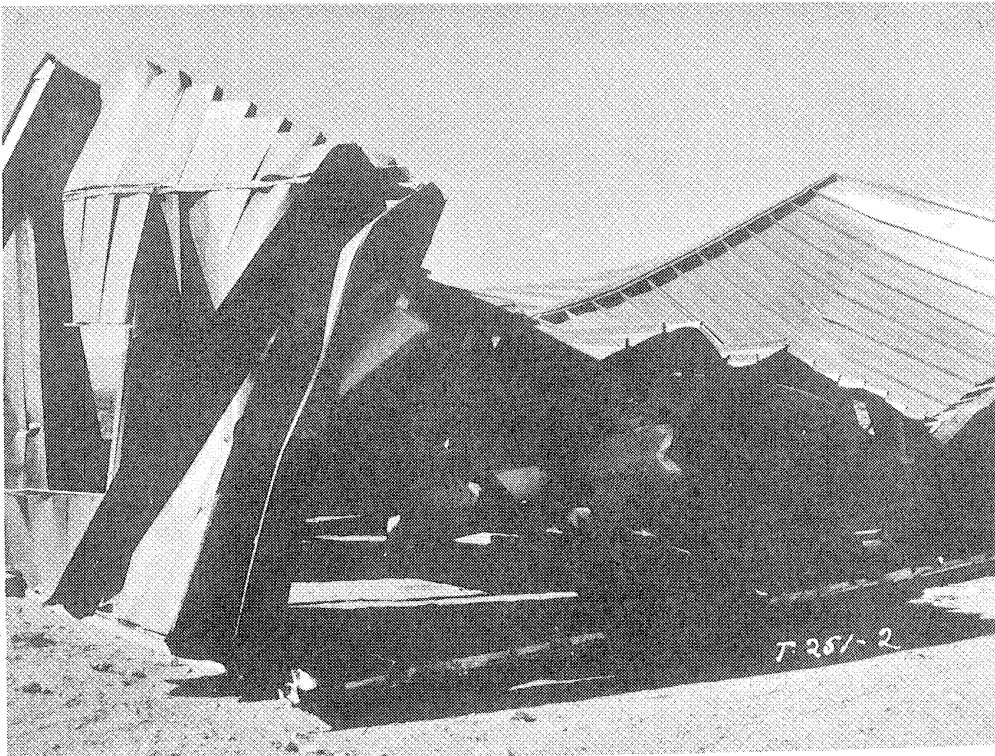
Fig. 2.39 — Northeast corner of Armco Building 31.2-d1 after planned test.

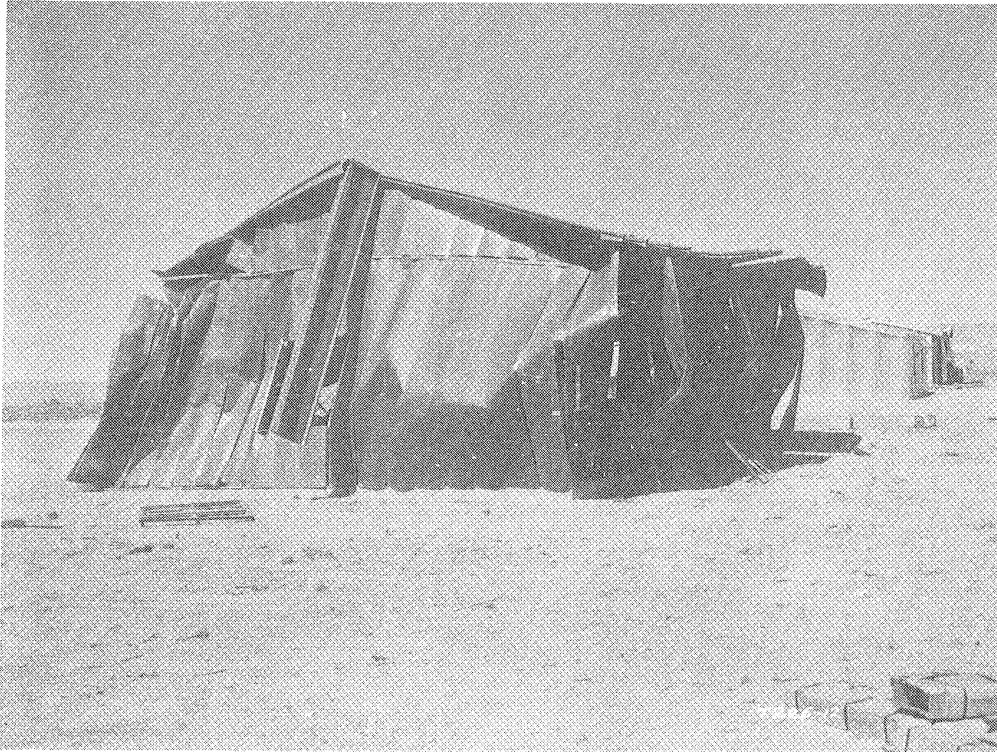
Fig. 2.40 — West end and south side of Armco Building 31.2-d1 after planned test.

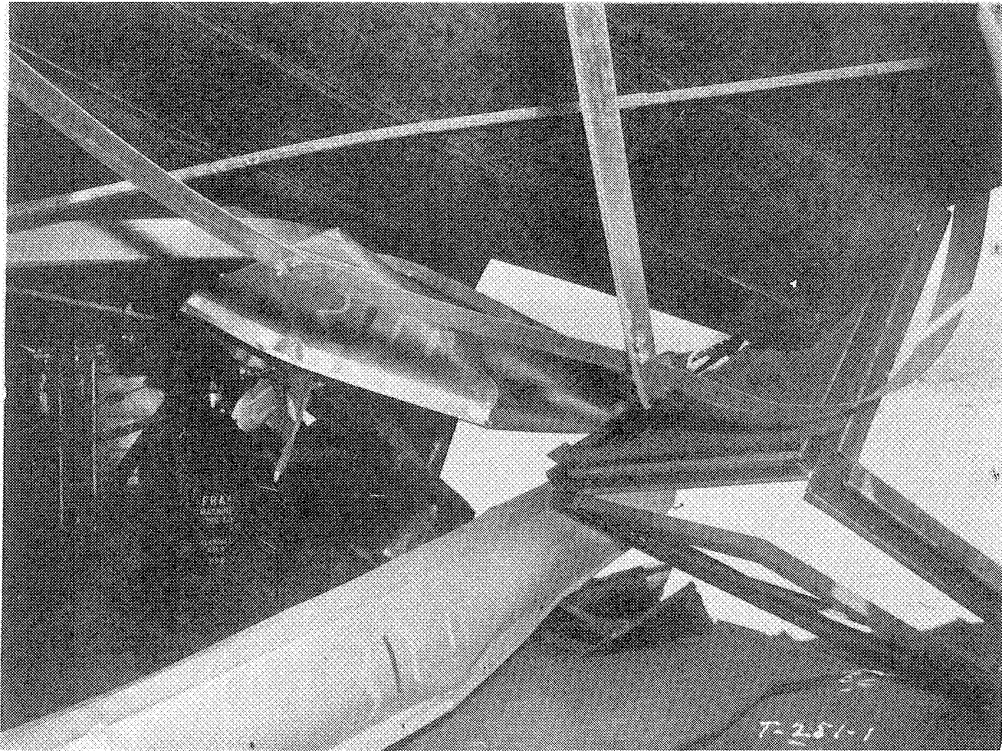
Fig. 2.44—Interior view toward northeast door frame of Armco Building 31.2-d1 after planned test.

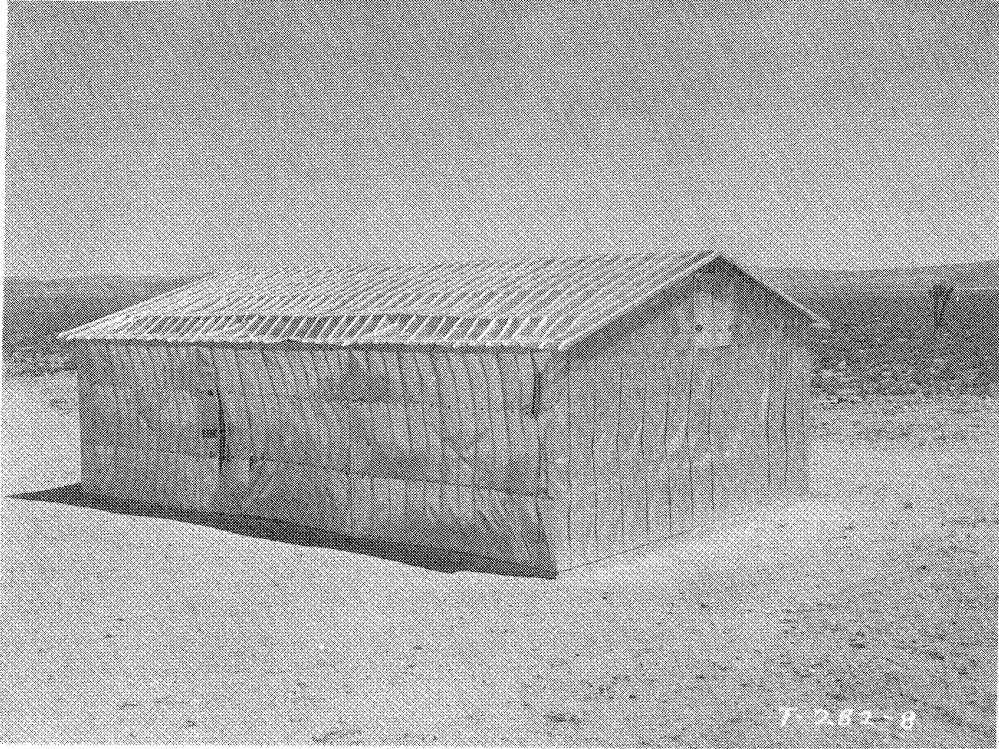
Fig. 2.46—North side and west end of Reynolds-Butler Building 31.2-a2 after planned test.

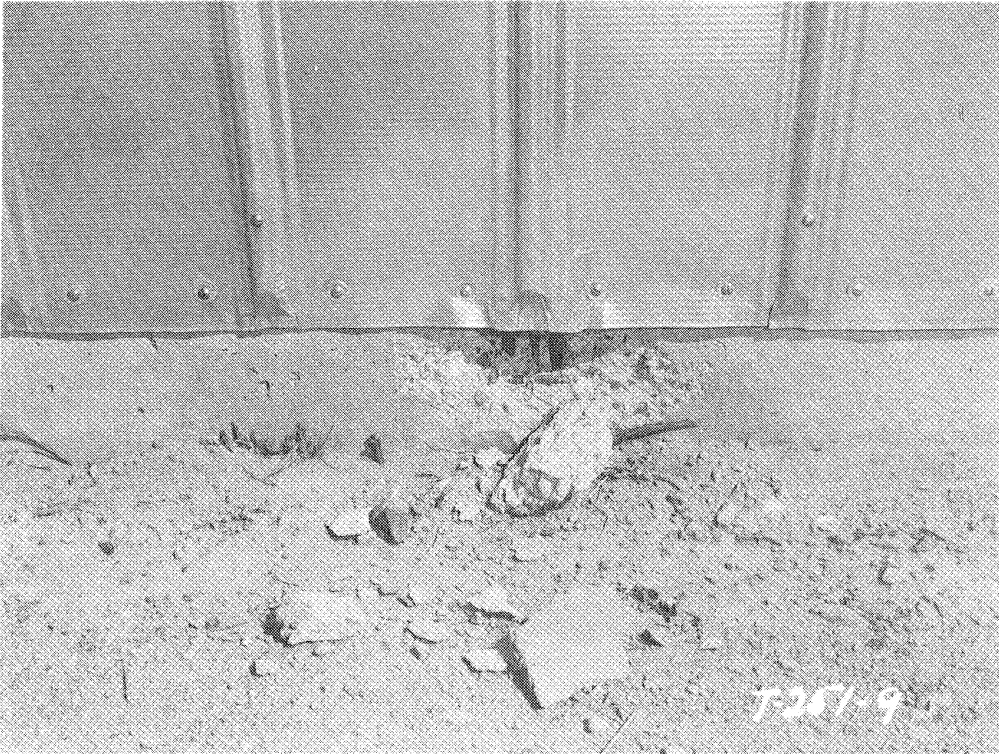
Fig. 2.47—South side of east interior column footing of Reynolds-Butler Building 31.2-a2 after planned test.

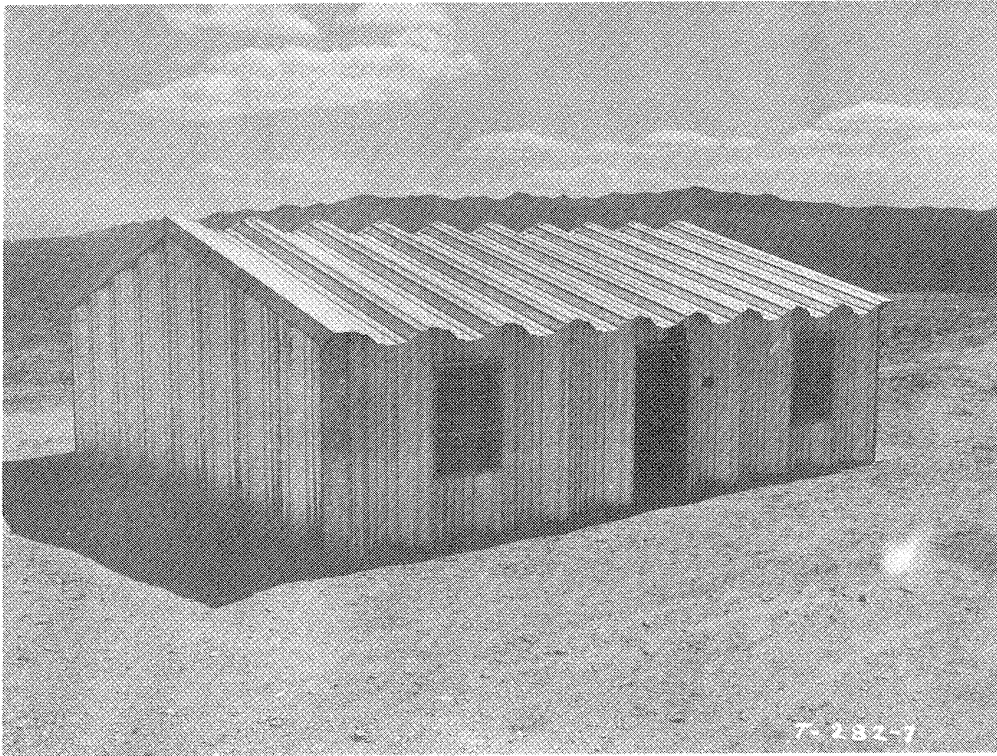
Fig. 2.50 — East end and north side of Behlen Building 31.2-b2 after planned test.

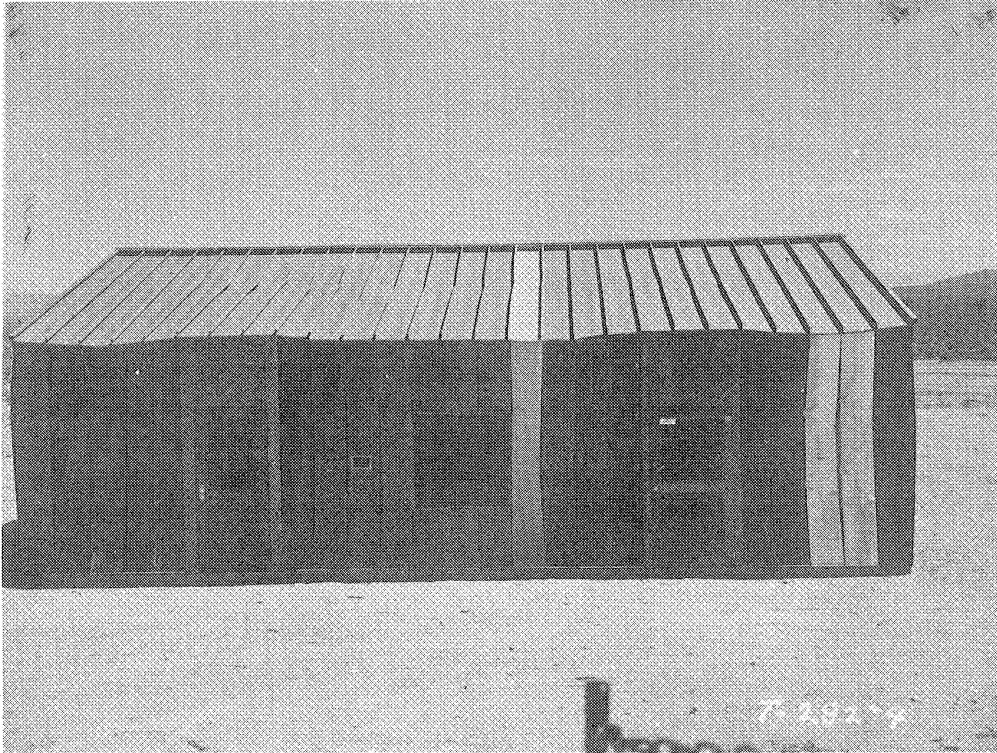
Fig. 2.51 — North side of Armco Building 31.2-d2 after planned test.

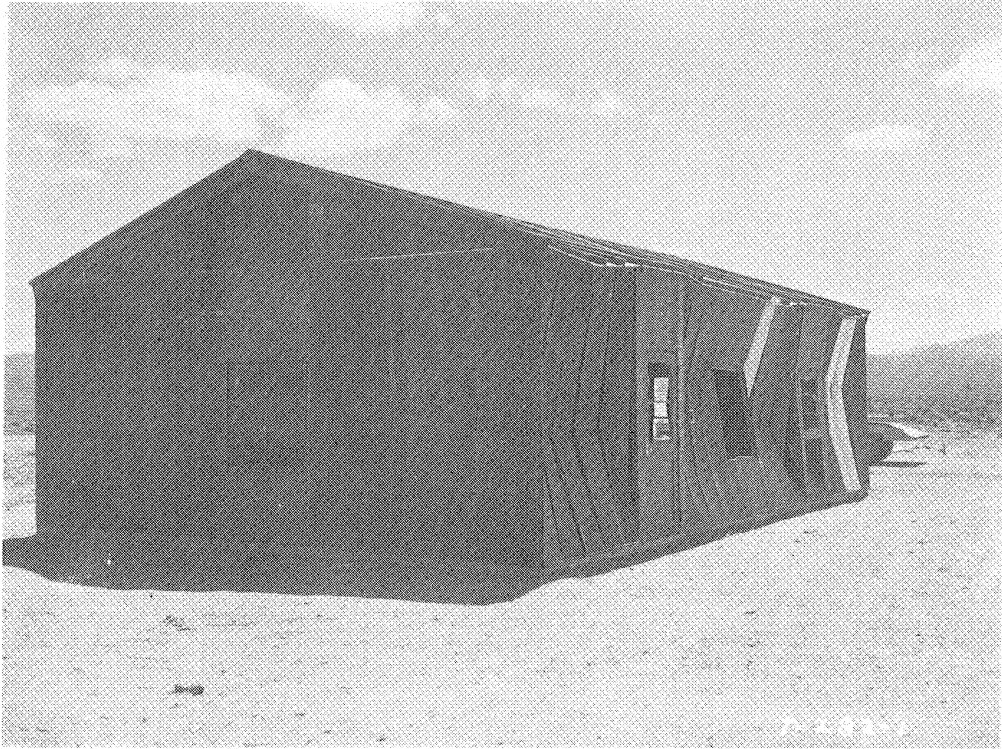
Fig. 2.52—East end and north side of Armco Building 31.2-d2 after planned test.

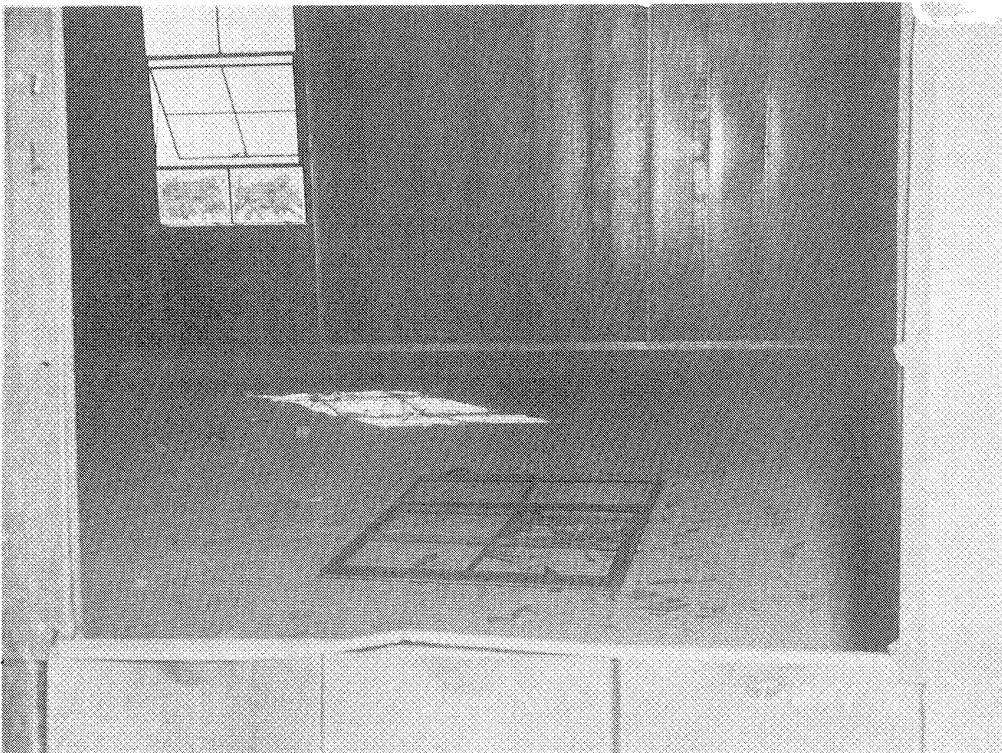
Fig. 2.53—View looking south into interior of Armco Building 31.2-d2 after planned test.
