RUPTURE PROPERTIES OF 2-1/4 Cr - 1 Mo, CMo, 3 Cr - 1 Mo, AND TYPE
347 STAINLESS STEEL PIPES FROM ESSEX, SEWAREN, BURLINGTON AND
KEARNY GENERATING STATIONS OF THE PUBLIC SERVICE ELECTRIC AND
GAS COMPANY

A. I. Rush

J. W. Freeman

July 18, 1955

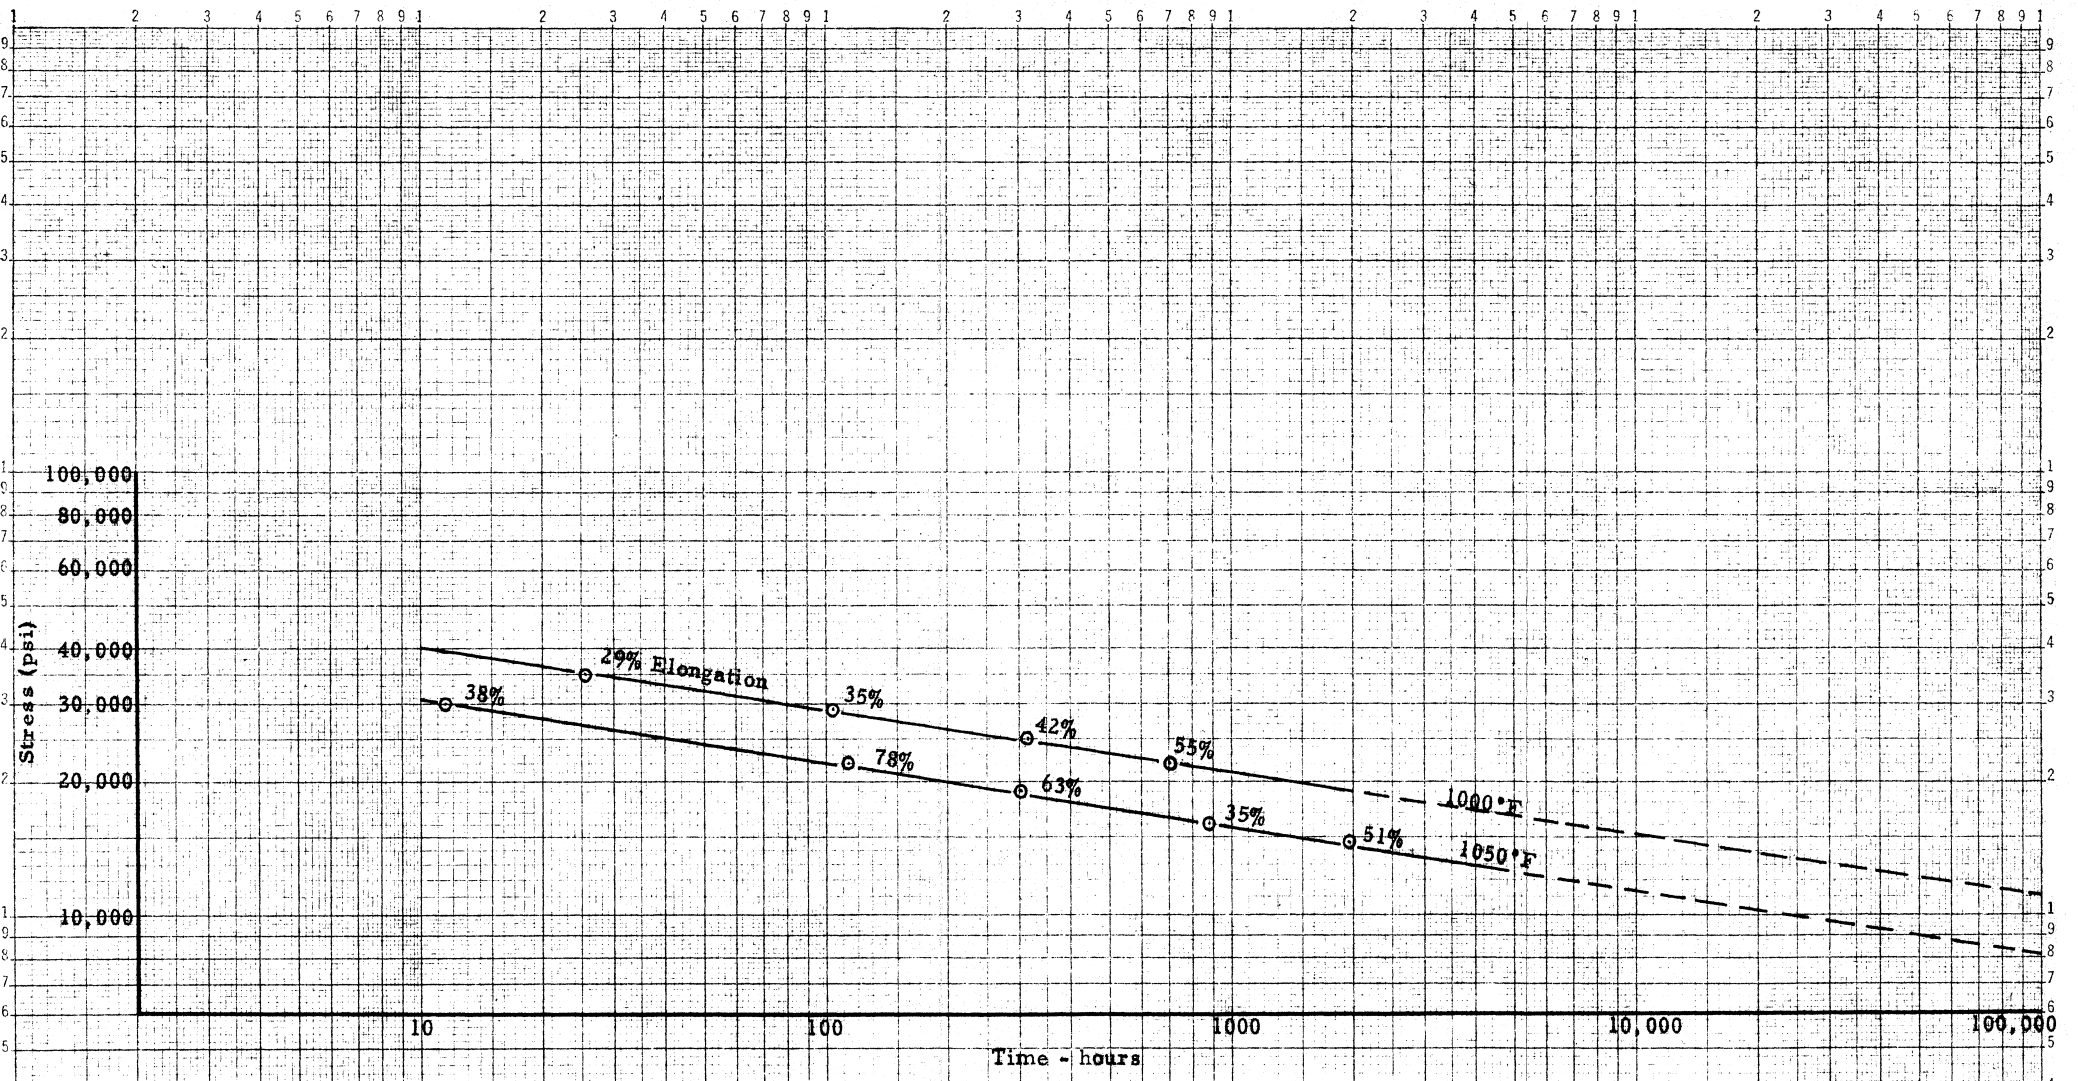
Figure 1. - Stress-Rupture Time Curves at 1000° and 1050°F for 2 1/4 Cr - 1 Mo Steel Main Steam Pipe Prior to Service in Number 1 Unit, Essex Generating Station.

Figure 1 shows that for tests of about 1000 hours duration at 1000°F and 2000 hours at 1050°F no evidence of breaks in the stress-rupture time curves was observed and that the two curves are parallel. A longer test was not conducted at 1000°F because the absence of a break at 1050°F and the parallel relationship of the curves indicated beyond any normal question of doubt that a longer test at 1000°F would have fallen on the curve as drawn.

No difference in rupture strength was observed between specimens taken near the outer and inner surfaces of the pipe. This is shown by the points plotting on the same curves in Figure 1.

The estimated 100,000-hour rupture strength at 1000°F of 11,000 psi is 2.25 times the reported hoop stress of 4,890 psi. The rupture time under 4,890 psi, according to extension of the 1000°F curve in Figure 1, would be in the millions of hours. The ratio is also near the normal for the ratio of stress for rupture in 100,000 hours to 0.01-percent per 1000 hour creep strength. There

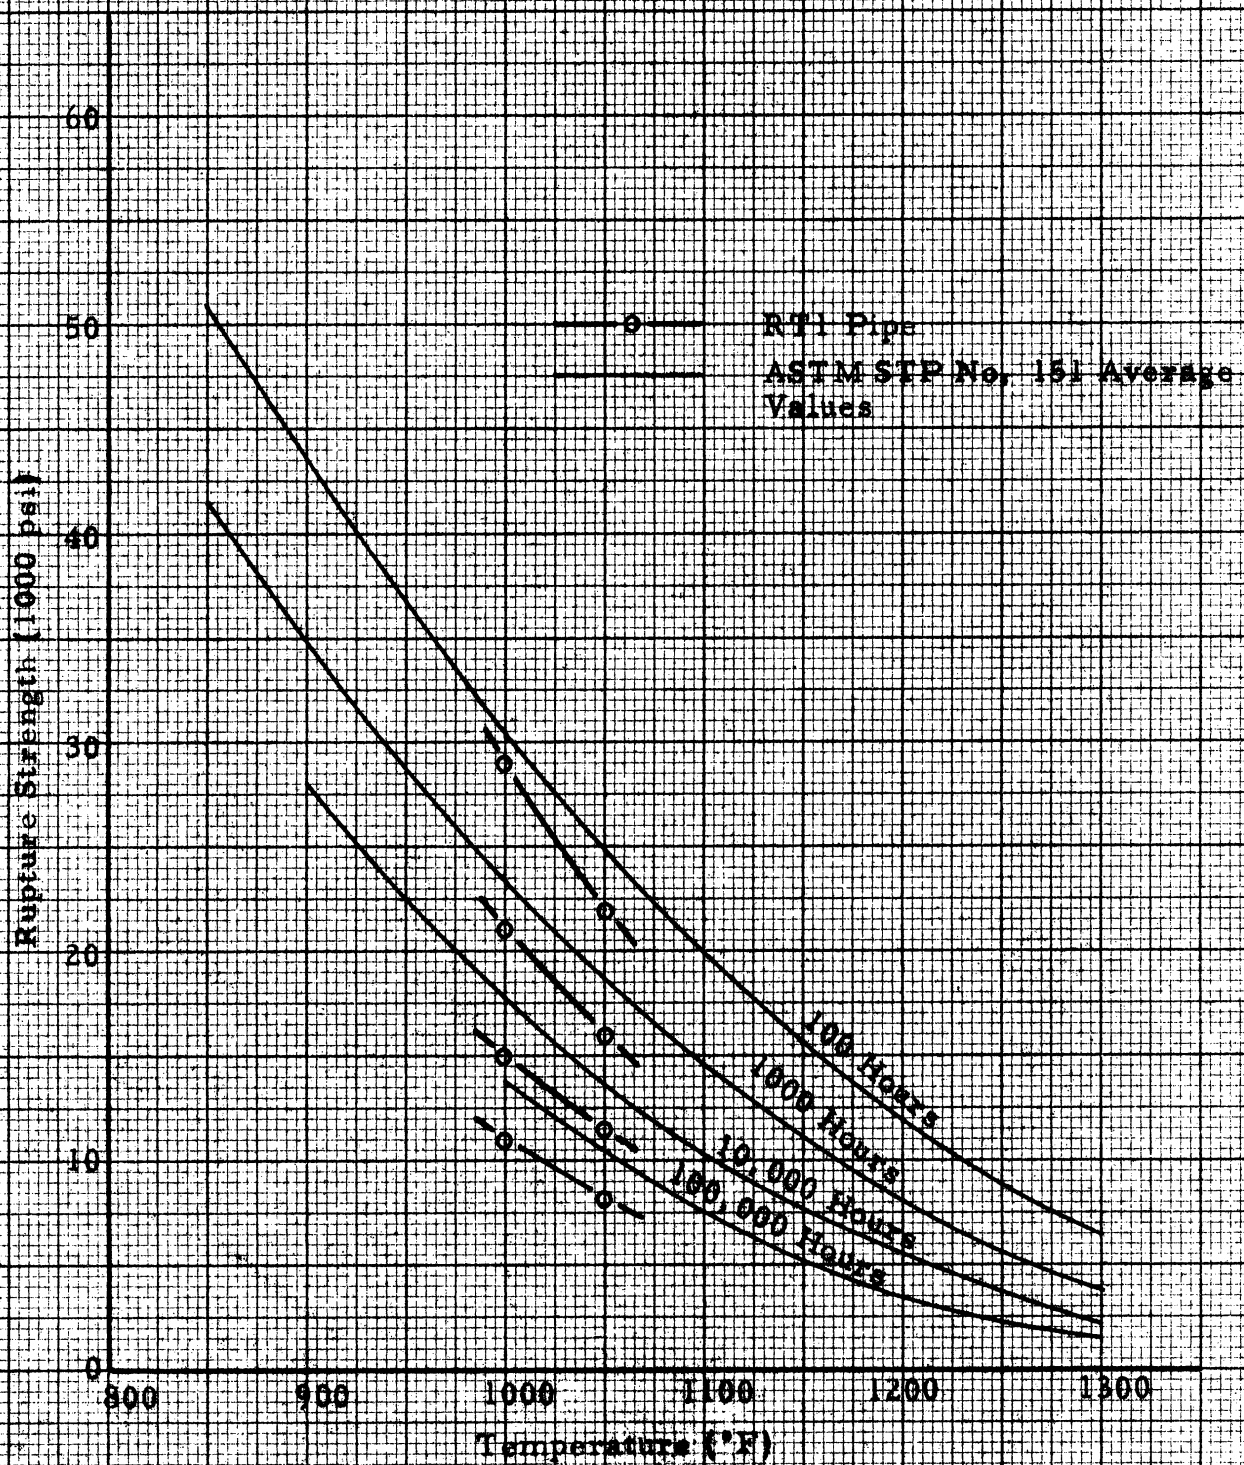
Figure 2. - Comparative Rupture Strengths for 2-1/4 Cr - 1 Mo Pipe RTI and Average Values for Annealed 2-1/4 Cr - 1 Mo Steel.

The rupture strengths of the pipe are compared in Figure 2 with the average strengths for annealed 2-1/4 Cr - 1 Mo steel as given in Reference 1. The pipe material exhibited 2000 to 3000 psi lower strength than the average and was also lower than any of the individual test points on which the average was based. Numerical comparative values are included in Table III.

The steel had relatively low carbon content in comparison to that for most published data. This in itself would be expected to result in slightly low comparative rupture strengths. There is also uncertainty as to the effect of annealing within the two phased ferrite plus austenite range. The structure of the steel, Plate 1, shows that the temperature of annealing was not sufficiently far into the two phased region, due to the low carbon content, to break up the as-rolled structure.

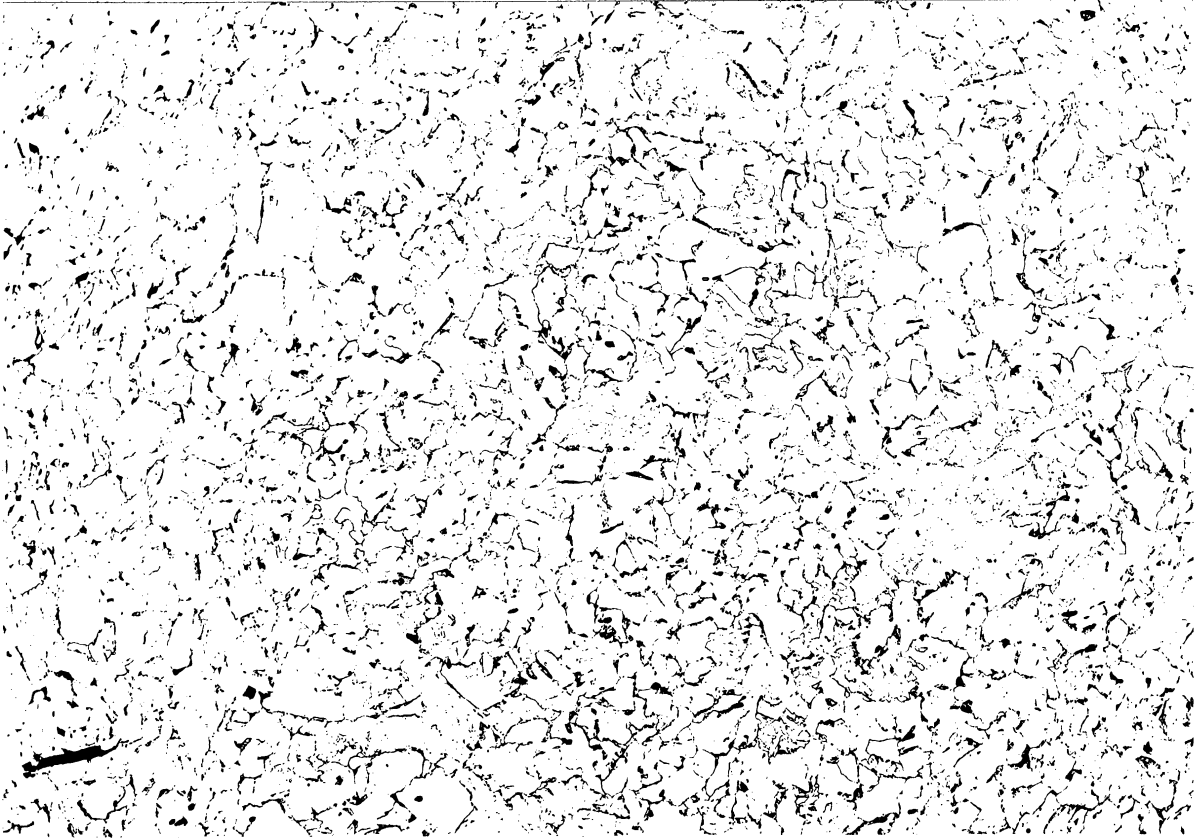
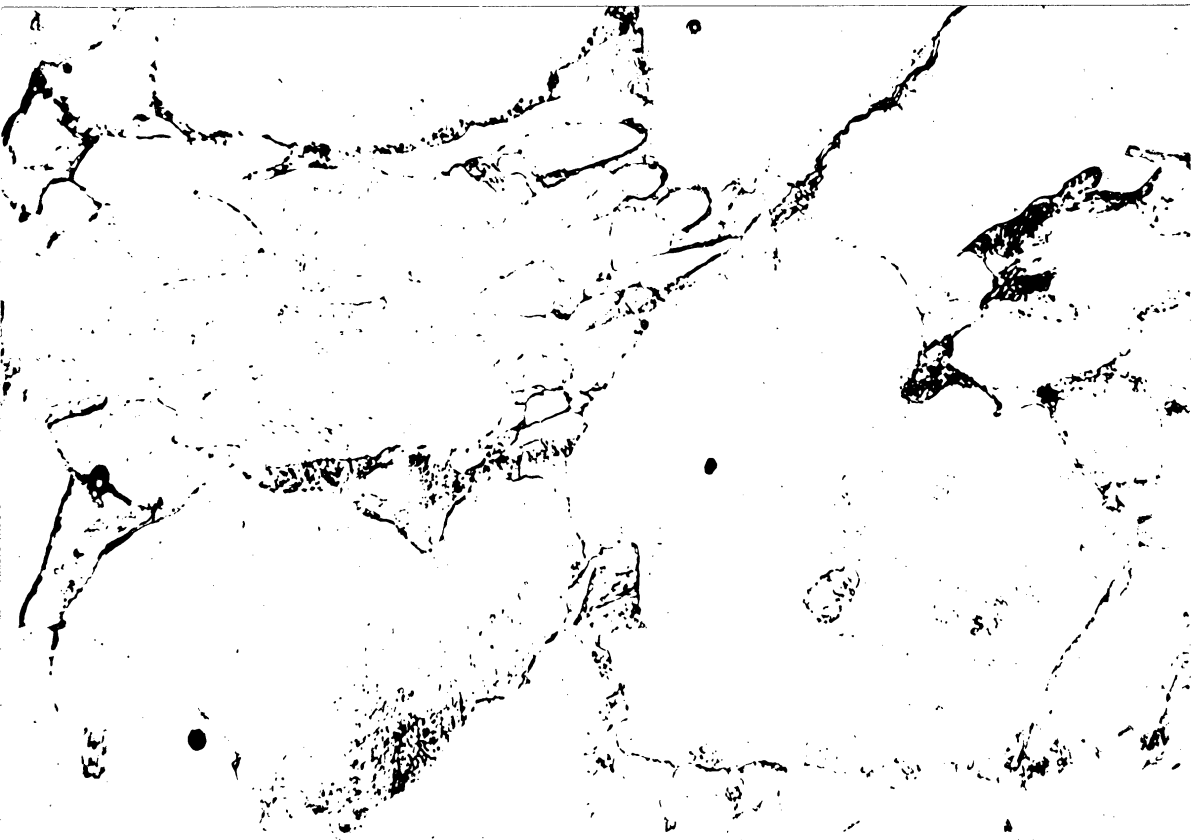
Plate 1. - Original Microstructure of 2-1/4 Cr - 1 Mo Steel Pipe (RT-1) from Essex Generating Station, No. 1 Unit. No Time in Service.

The microstructure of the as-received 2-1/4 Cr - 1 Mo pipe material is shown in Plate 1, and Plates 2 and 3 illustrate the microstructure at the fracture and at the surface of the specimen after prolonged testing at 1000° and 1050°F, respectively.

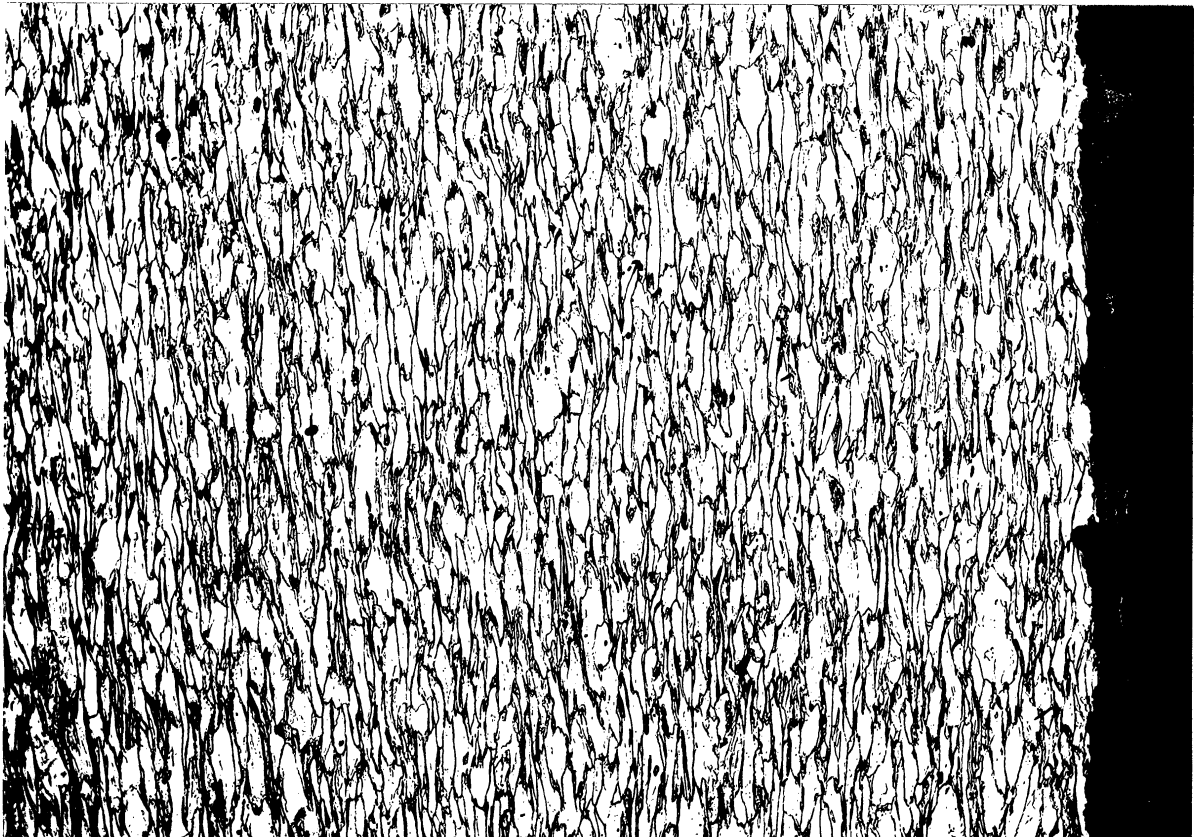
Plate 2. - Microstructure of Stress-Rupture Specimen from 2-1/4 Cr - 1 Mo Steel Pipe (RT-1) Fractured in 703 Hours Under 22,000 Psi at 1000°F.

During testing at 1000° and 1050°F the grains were extensively elongated in the direction of the applied stress, and at 1050°F the pearlite spheroidized during the test. No evidence of intergranular separation at either the fracture or adjacent to the fracture was observed for the specimens tested at 1000° or 1050°F. Both specimens showed evidence of the light general surface oxidation which occurred during the test.

The structures of the rupture specimens were typical of 2-1/4 Cr - 1 Mo steel with the initial structure exhibited by the pipe. The extensive deformation of the grains was due to the high elongation at fracture. At 1000° and 1050°F fracture would be expected to occur with little or no evidence of intergranular separation, and carbide spheroidization would be expected in the highly deformed area near the fracture after 2000 hours at 1050°F.

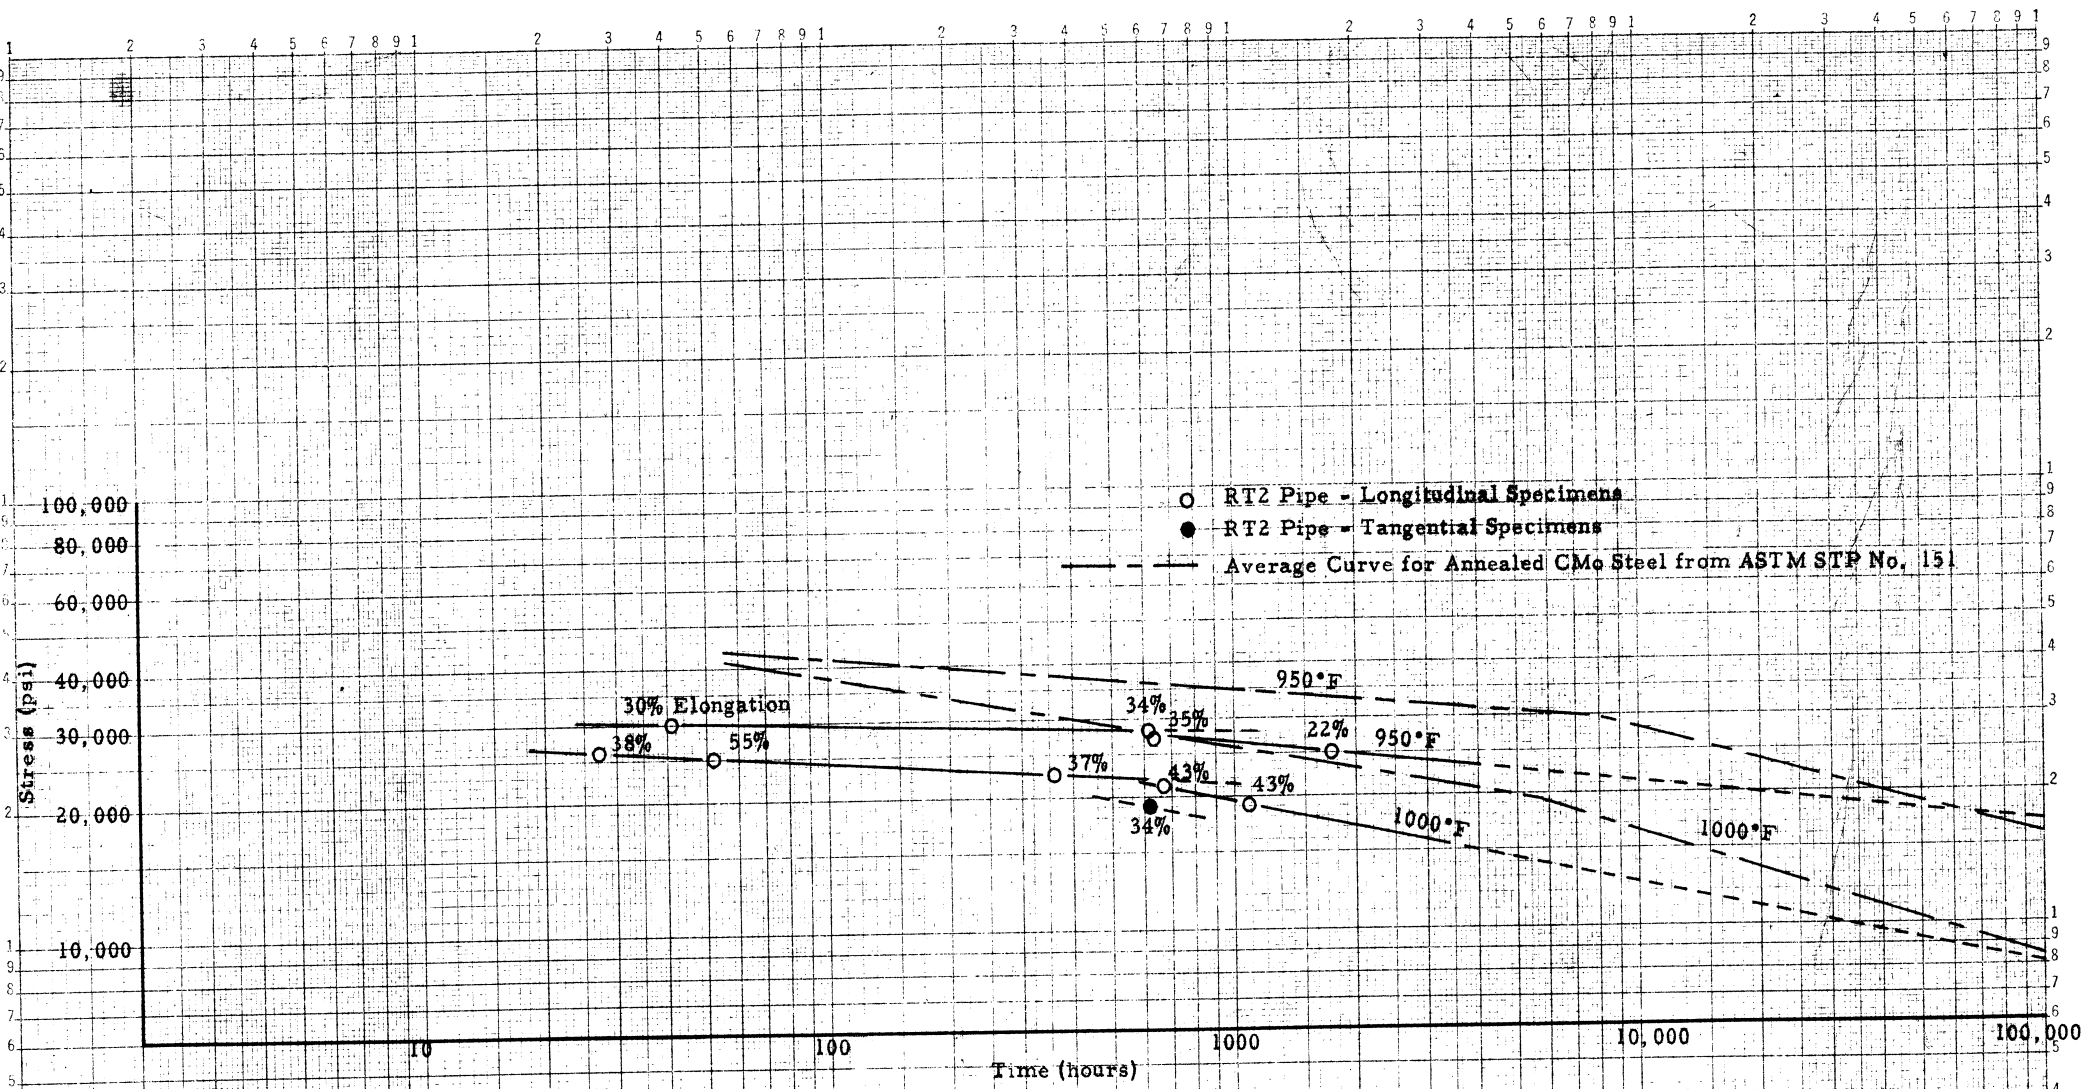
Figure 3. - Stress-Rupture Time Curves at 950° and 1000°F for CMo Steel Steam Pipe after 75,054 Hours of Service in Number 7 Unit of the Essex Generating Station.

The extrapolation of the stress-rupture time curves of Figure 3 beyond the test points is open to considerable question. The curves were extended by strict adherence to the available test points. There is no question but that the data show a change in slope in the curves between 600 and 700 hours. Such changes in slope are usually found in rupture testing 0.5 Mo steel at these temperatures. The uncertainty of extrapolation arises from the considerable differences in slope between the 950° and 1000°F curves for time periods beyond the change in slope. Usually it would be expected that such curves should be nearly parallel. It is, therefore, uncertain whether the curves are correct as drawn or if one or the other of the curves has an incorrect slope. Two additional tests, one of at least 3000 hours duration at 950°F and one of 2000 hours at 1000°F would have been required to resolve this uncertainty. As discussed later, however, it is felt that the 1000°F curve is drawn with a steeper slope than was actually the case; and the 950°F curve is probably nearly correct.

The one tangential specimen tested had about one half the rupture time of the longitudinal specimens at 1000°F.

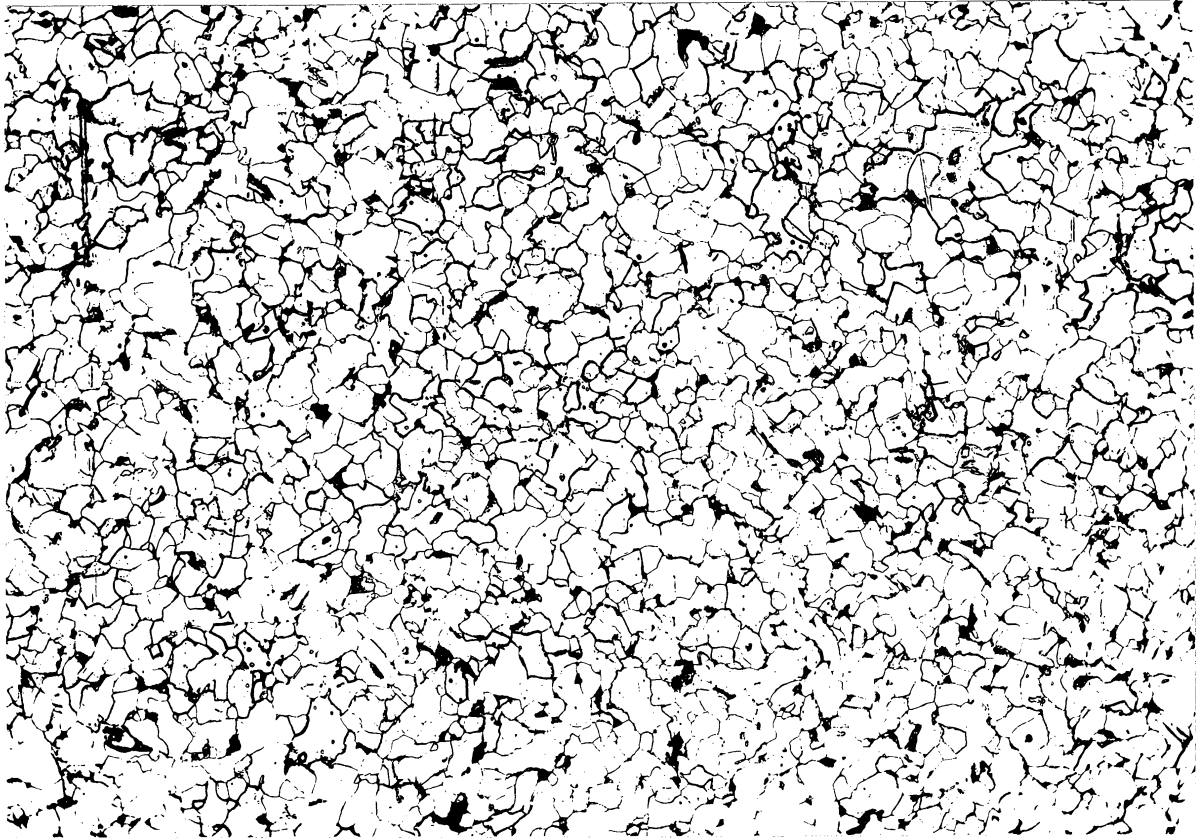
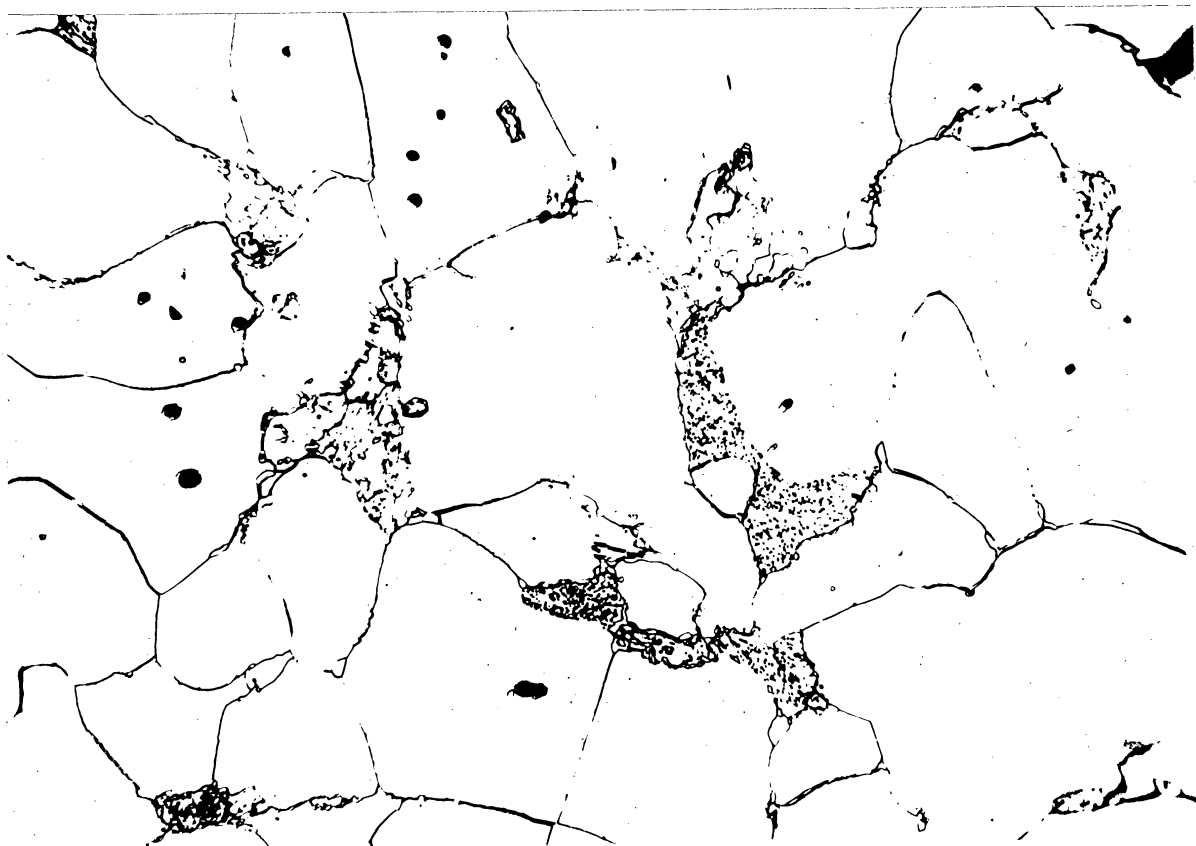
Plate 4. - Original Microstructure of Carbon-Molybdenum Steel Pipe (RT-2) from Essex Generating Station, No. 7 Unit. In Service 75,054 Hours at Normal Operating Temperature of 950°F.

The microstructure of the as-received CMo pipe material is shown in Plate 4, and the microstructure after prolonged testing is illustrated by Plates 5, 6, and 7. Plate 8 shows the appearance at 100 and 1000 diameters magnifica-

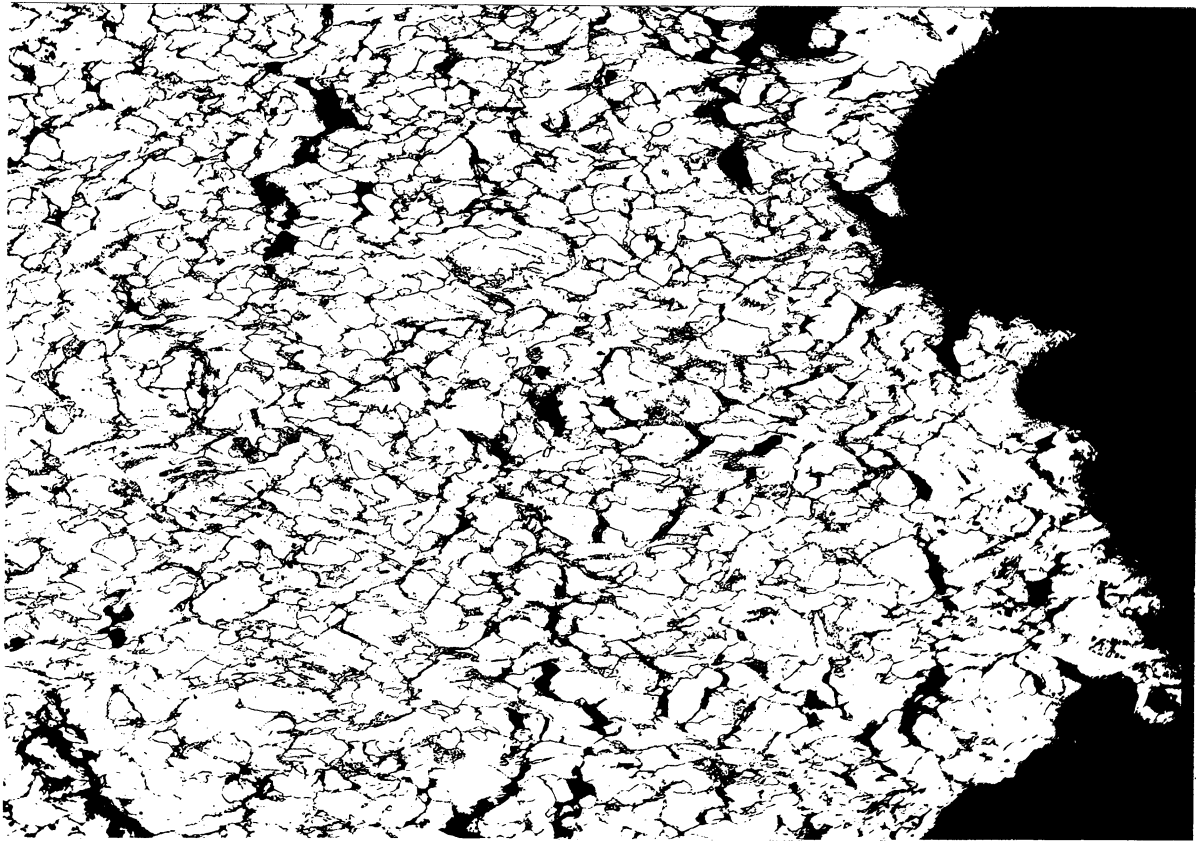
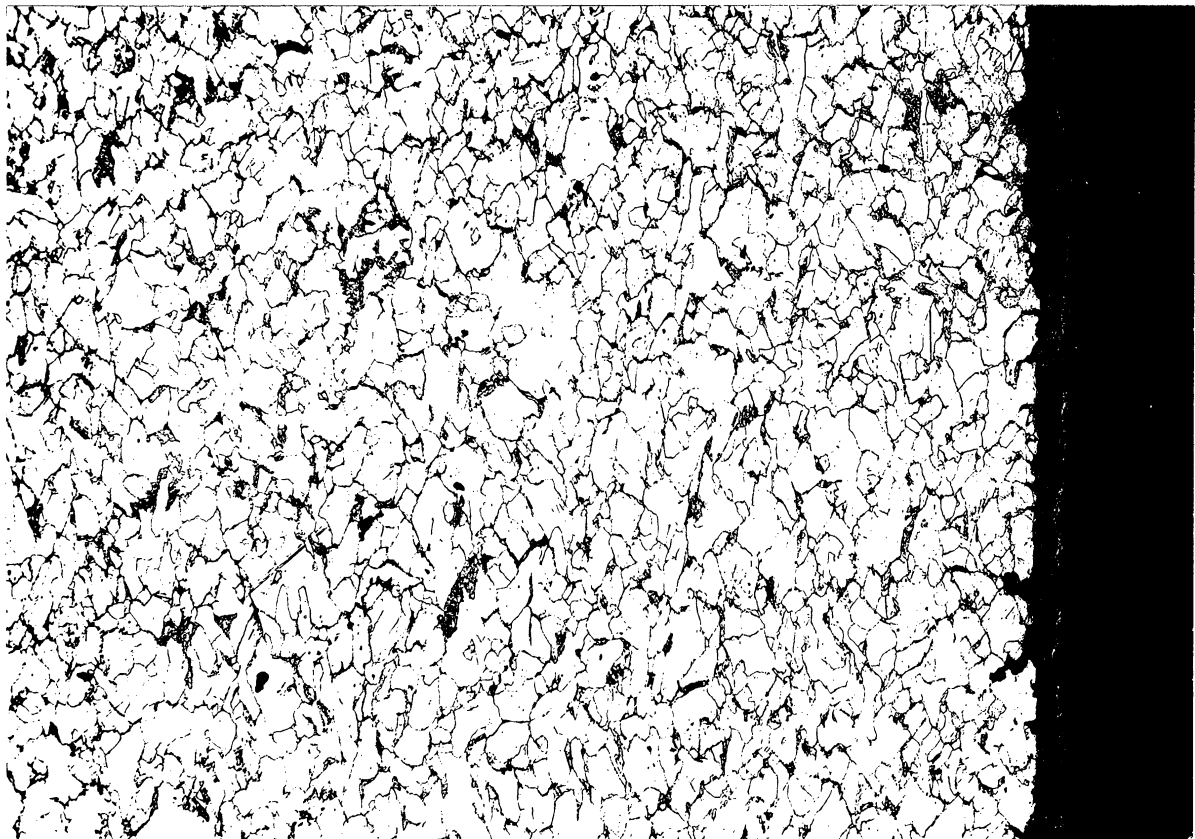
Plate 5. - Microstructure of Stress-Rupture Specimen from Carbon-Molybdenum Steel Pipe (RT-2) Fractured in 1780 Hours Under 25,000 Psi at 950°F.

The microstructures of the most prolonged longitudinal rupture test specimens show that fracture was both intergranular and transgranular with a medium amount of intergranular cracking adjacent to the fracture. Oxidation of the surface was normal for the testing conditions and only slightly intergranular. No significant differences were noted between the longitudinal and tangential specimens. Although no appreciable spheroidization of the pearlite during testing at 950°F could be discerned, considerable occurred during testing at 1000°F.

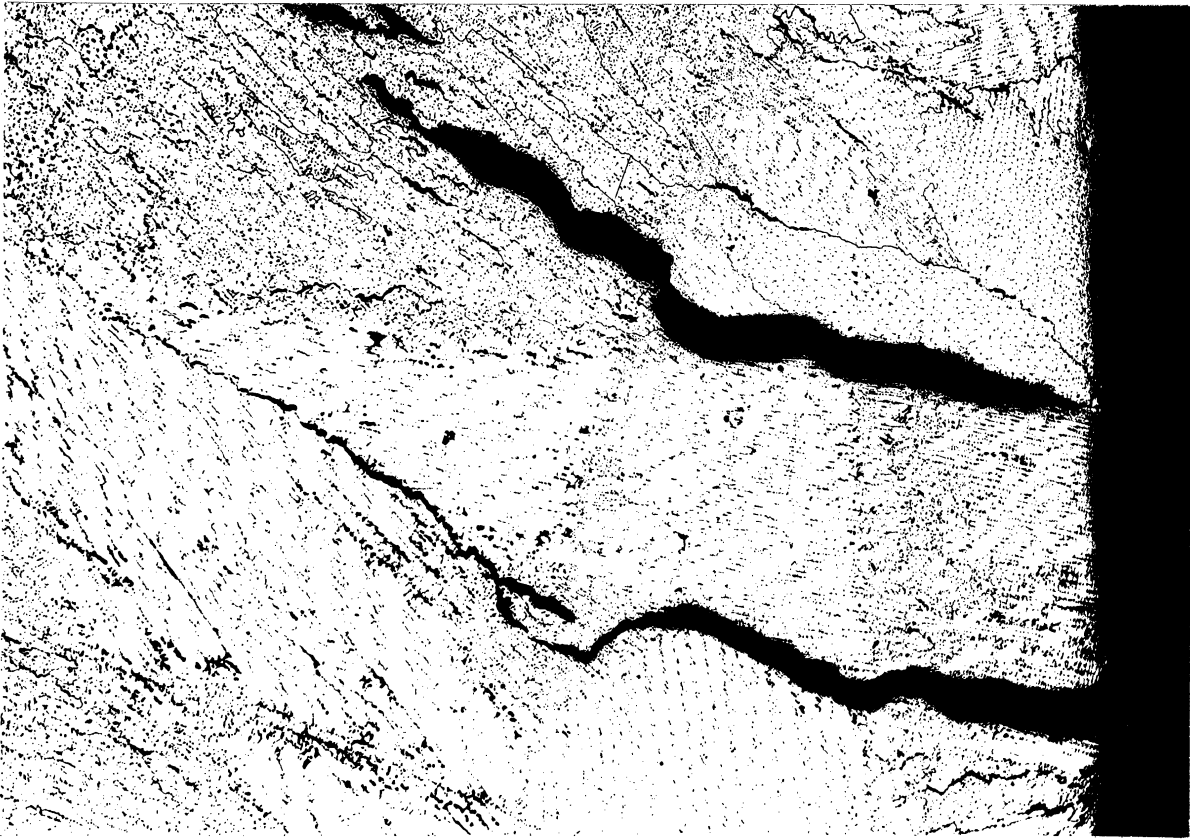
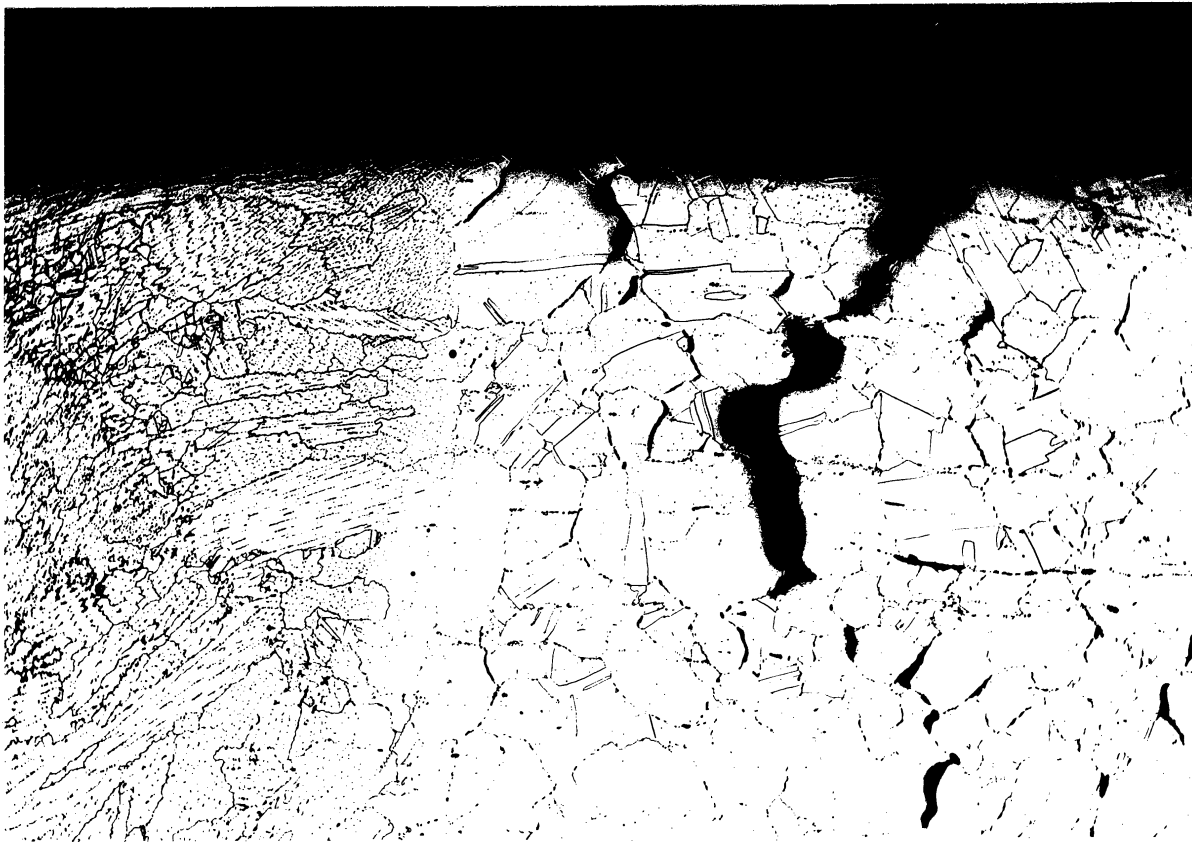
Plate 27.- Photomicrographs of Cracks in the 18-8 Cb Steel Specimen (RT-6) Which Fractured in 708 Hours Under a Stress of 33,000 Psi at 1050°F.

a. Cracks in Weld Metal of Fractured Stress-Rupture Specimen - X100D

b. Cracks in Base Metal Near Weld Bond Line of Fractured Stress-Rupture Specimen - X100D
