ENGINEERING RESEARCH INSTITUTE
THE UNIVERSITY OF MICHIGAN
ANN ARBOR

SMALL GASOLINE ENGINE DEVELOPMENT PROGRAM

ERI Project 2481

TECUMSEH PRODUCTS COMPANY
TECUMSEH, MICHIGAN

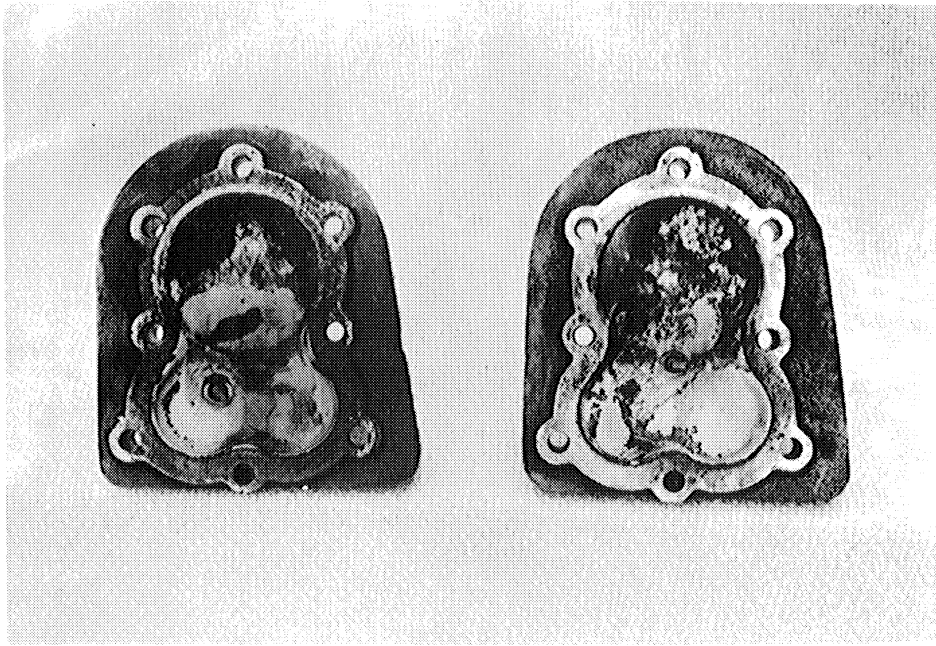
Because the power output was higher than originally anticipated, this engine was redesignated as V-40. After 143 hr of operation, the maximum horsepower output at 3600 rpm had dropped to 3.8 hp. The cause of this power loss was a heavy accumulation of carbon on the spark plug which caused misfiring. Even with a clean spark plug this engine had a tendency to run rough. Although the engine produced considerably more horsepower than its intended rating, the roughness and poor spark-plug life could not be tolerated. To determine the cause of the roughness, a strain-gage pressure transducer was placed in the combustion chamber so that the instantaneous cycle pressures could be displayed on the face of an oscillograph. While the engine was run under several load conditions, the ignition timing and spark-plug position were changed. A study of the oscillograph traces obtained during these runs showed that engine roughness was primarily due to the location of the spark plug. By relocating the spark plug, the roughness of the engine was almost entirely eliminated, as indicated by the

smooth cycle-pressure curve of the oscillograph. The new position of the plug, however, did not allow optimum power output. Nevertheless, since ample reserve power (above the intended rating) was available, it was decided to sacrifice a small amount of power output to obtain an engine which would run smoother and have a longer life than engines of the older design. The change in spark-plug position also eliminated fouling tendencies of the plug. The new location allowed a greater flow of gases over the electrode, which enabled the plugs to be self-cleaning. Furthermore, at the new location it was no longer susceptible to piston-oil splashing. Figure 2 is a photograph of both the old and the new cylinder heads showing spark-plug location. The old spark-plug location is on the right. Note the heavier accumulation of carbon on the spark-plug in the original cylinder head. Figure 3 shows a V-40 cylinder head which has completed the 500-hr endurance run. Note the lack of carbon deposits on this head.

Fig. 2. V-40 cylinder heads. Original design on right, modified design on left.

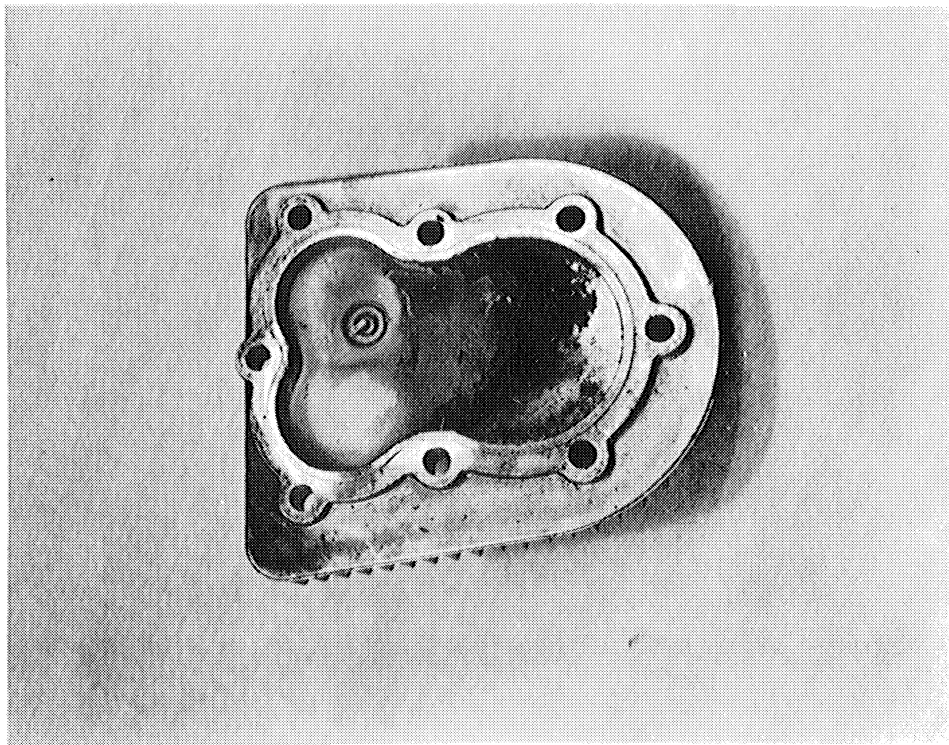
Fig. 3. V-40 cylinder head after 500-hr operation.

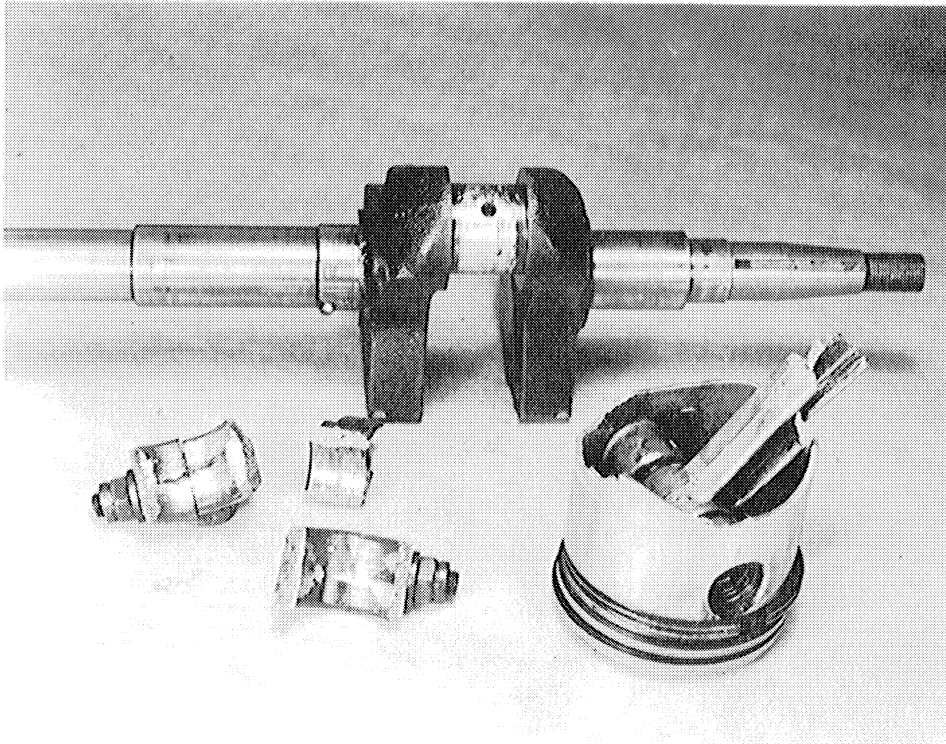
Several connecting-rod failures have occurred during the evaluation of the V-40 engine. The first failure was traced to a porous sand-cast connecting rod and a high stress concentration in the connecting rod near the cap bolt. The other failures were caused by the connecting-rod bearings seizing on the crankshaft throw. It is extremely important that a slight chamfer be placed at the parting line between the connecting rod and its cap. If this chamfer is not present or is not located at the part line, the sharp edge of the part line tends to scrape the oil film from the journal and promote seizing of the bearing. All recent connecting-rod failures may be traced to the lack of a chamfer or to an improperly located chamfer. Figure 4 shows a V-40 rod failure due to an improperly located chamfer. We are now investigating the effect of providing a slight circumferential groove in the connecting-rod bearing, located at the oil supply hole in the crank pin, to trap any foreign matter that may be present in the oil.

Fig. 4. V-40 connecting-rod failure.

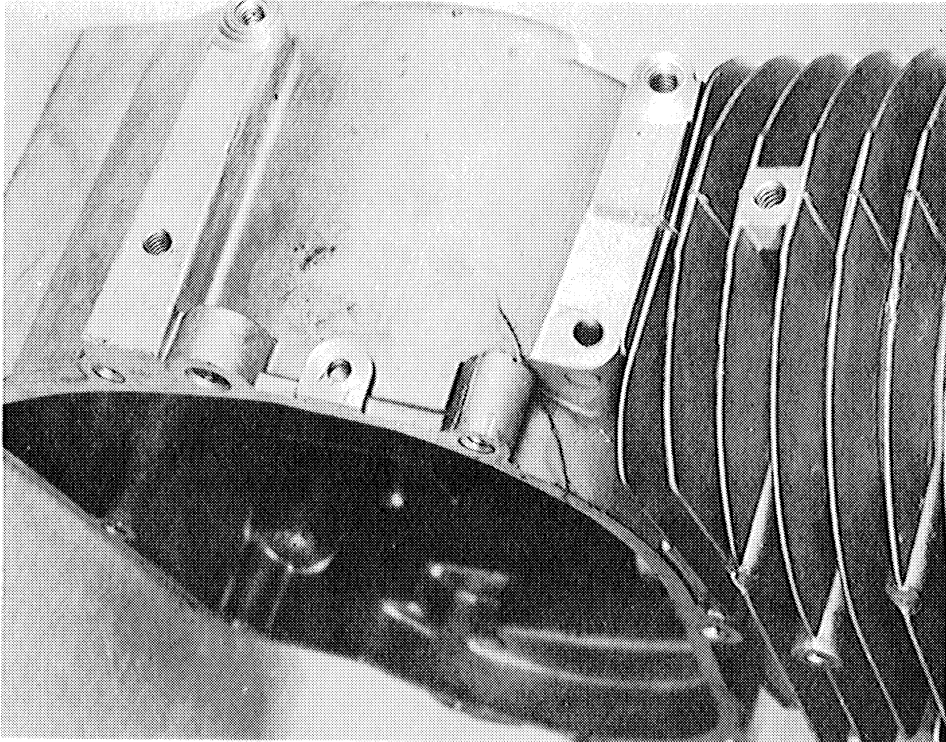
Two V-40 die-cast pre-production engines were delivered to our labs for evaluation in January, 1958. After 138 hr of operation, the entire cylinder parted from the remainder of the cylinder casting. The nature of the crack very definitely indicated a fatigue failure although at this time the origin of the failure could not be detected. The metal quality in this particular test was very poor, indicating either a cold die or insufficient pressure when cast. We were informed that steps had already been taken to strengthen the cylinder casting. After 192 hr of operation on the second V-40, we were able to detect the origin of a fatigue failure at a junction of the starter motor boss and the cylinder mounting-cap screw boss (see Fig. 5). The crack then proceeded to the edge of the casting and eventually caused failure. This design weakness was corrected

Fig. 5. V-40 cylinder-casting failure.

by providing a generous fillet at this junction and increasing the wall thickness at the section where failure occurred.
