ENGINEERING RESEARCH INSTITUTE
UNIVERSITY OF MICHIGAN
ANN ARBOR, MICHIGAN

FINAL
NUCLEAR RESEARCH AND DEVELOPMENT
REPORT
(For the Period April 2, 1957 to June 3, 1957)

Project 2505
Chrysler Corporation
June 3, 1957

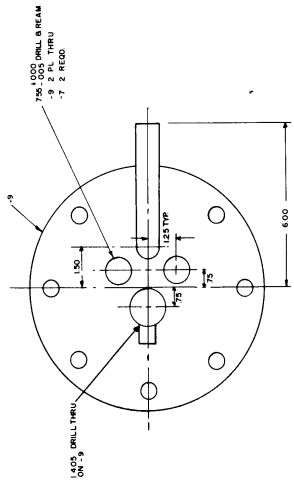
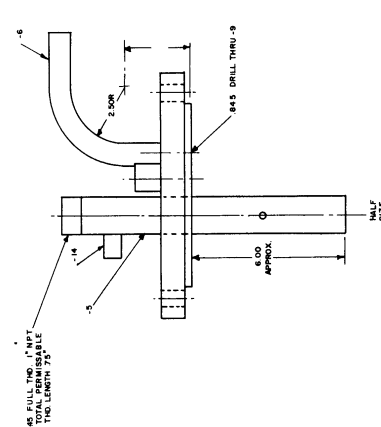
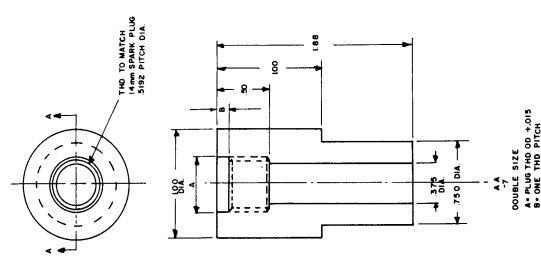
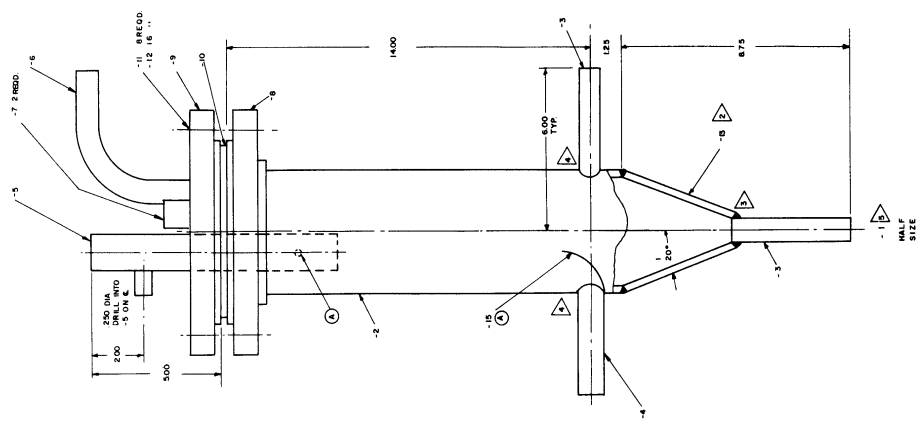
BILL OF MATERIALS	
PROJECT	2505
REVISION	REVISED SAMPLER
UNCLASSIFIED	UNCLASSIFIED
DATE	2505-90-1004A

The riser pipe in the sampler was cut off above the maximum practical liquid level. This was done because the bismuth rose and solidified in the risers as results of operational errors as described in section 5 of this report.

The original purpose of the riser in the sample was to insure that the samples taken were removed from the flowing bismuth stream and not from the stagnant metal inside the sampler. This was accomplished by forcing all stagnant bismuth out of the riser pipe with inert gas pressure and lowering the sample capsule into the entrance stream and permitting it to fill with the recirculating bismuth.

Revisions in the loop sampler, pump cell and instrumentation were begun to improve general performance. The sampler riser was removed and an internal baffle installed to prevent recurrence of sampler operating errors. The gap between the pump pole pieces and cell will be substantially reduced for subsequent operation. Shutdown instrumentation was changed to permit a 3 minute delay between power outage and loop dumping. This would prevent any outage shorter than this period from shutting down the loop and eliminate shutdowns from all brief power outages. The sump tank was removed from the loop and a new filter installed.

Since it was necessary to cut off the riser pipe as mentioned, some other means had to be found to obtain samples of the flowing bismuth such that the bismuth level could be kept at a reasonable distance above the inlet and outlet of the sampler. A baffle plate was installed at the inlet side of the sampler as shown in Drawing 2505-90-1004A. It was believed that this would create enough turbulence in the sampler that a representative sample could be obtained.

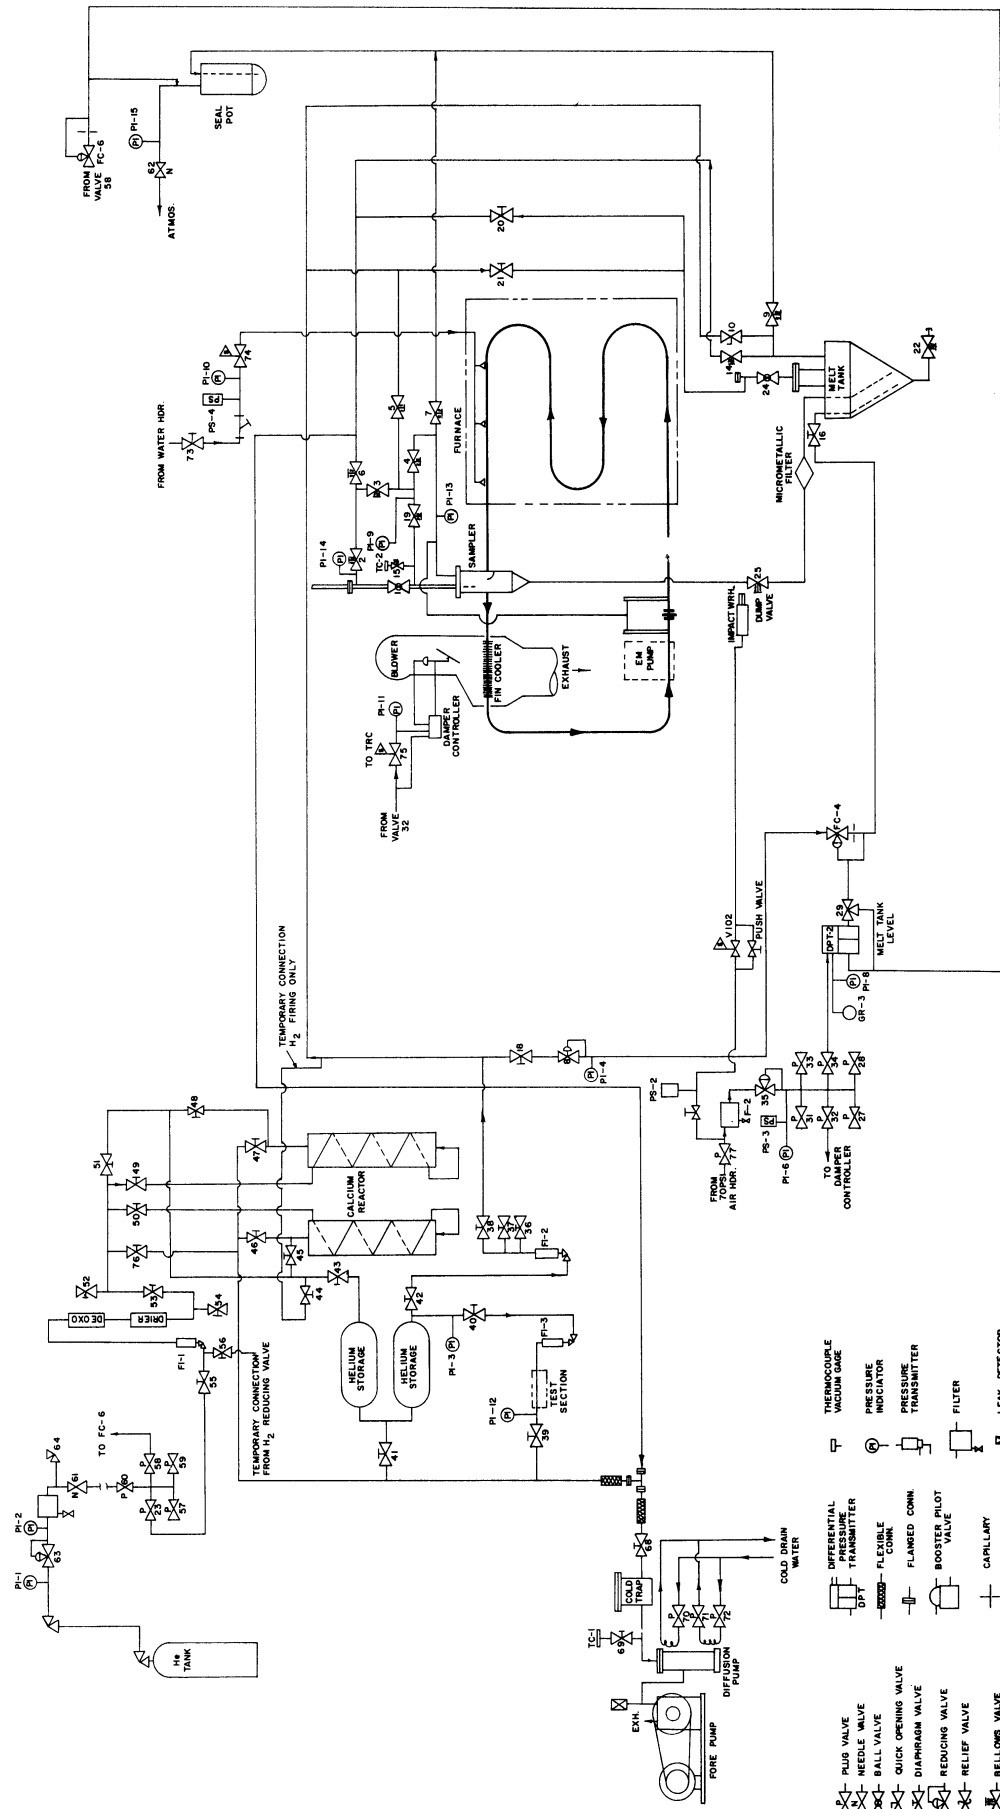
D-2505-92-1006A

A leak was suspected in the sump tank; so this tank was removed from the system. A new dump line was installed between the dump valve on the loop and the melt tank. The line was provided with a micro-metallic filter of type 304 stainless steel with a mean pore opening of 10 microns so that the impurities in the charged bismuth would be retained on the filter. The original transfer line between the melt tank and sump tank was removed. This new system is shown schematically in Drawing 2505-92-1006A.

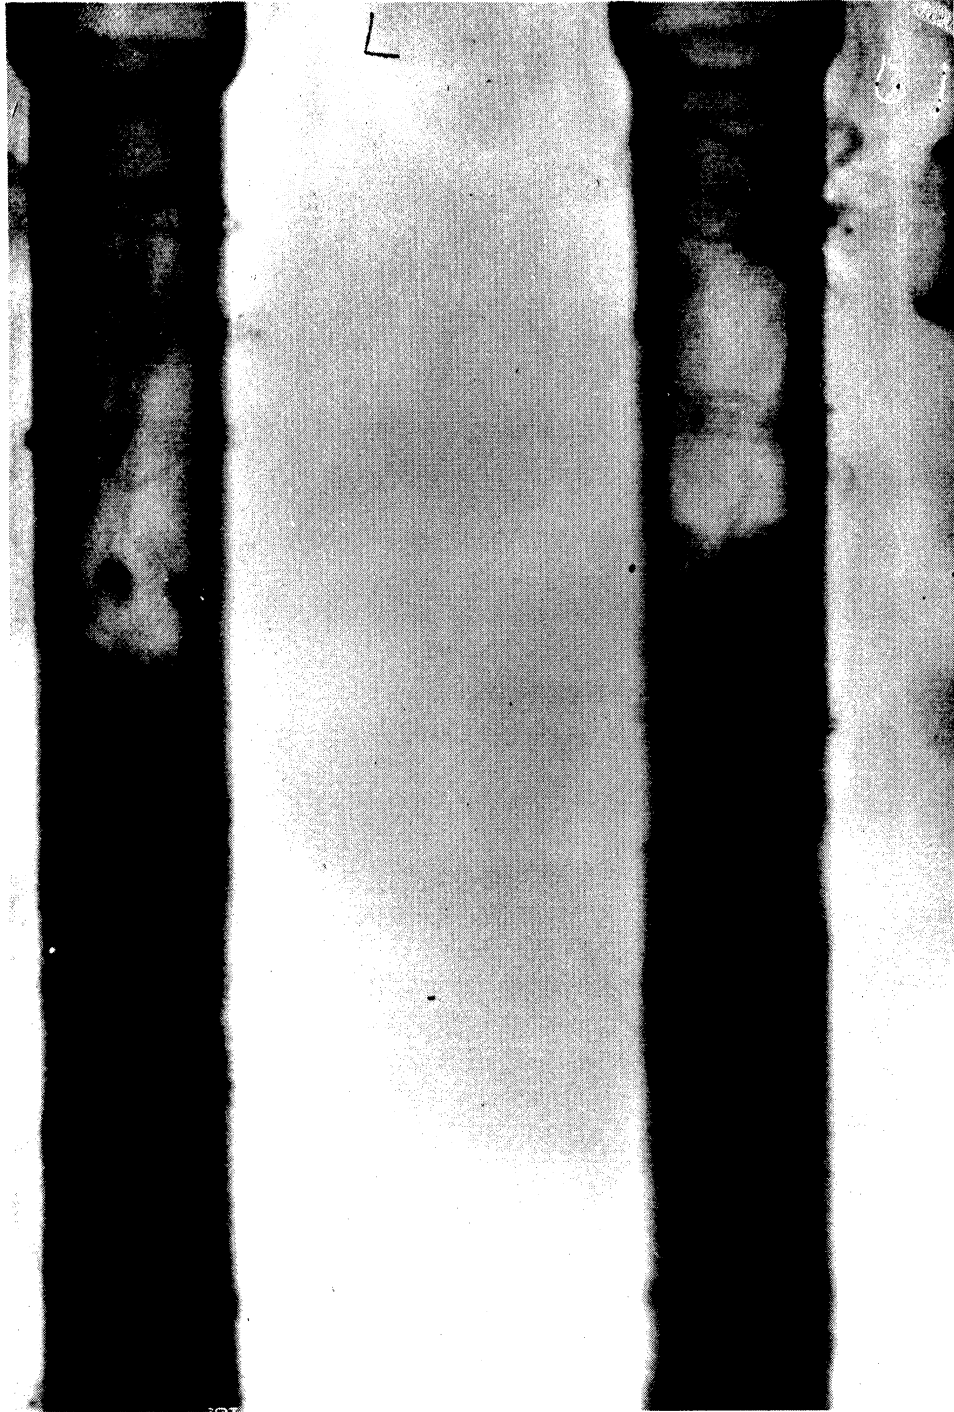
FIGURE 2.
RADIOGRAPH OF ORIFICE
RISERS AFTER CLEANING

Methods were perfected for taking radiographs of the loop sections. On the basis of these graphs, the orifice risers in the flowmeter section were opened and cleaned after slag inclusions in the melt were shown to exist. This cleaning made possible the first accurate determination of flowrates that had been made in the loop. A poor weld in front of the orifice may be contributing to the flowrate determination difficulties. No plugs or slag inclusions were found in the loop after dumping by these techniques.

As mentioned earlier, an attempt was made to calibrate the voltages setting of the EM pump versus flowrate of the bismuth in the loop. Radiographs which were taken of the flowmeter risers, showed that some slag had collected in the riser pipes, and the liquid level could not be determined with any accuracy. The tops of the riser pipes were, therefore, cut off and the slag was removed with an auger, while under a continuous purge of an inert gas. When the slag was removed, the calibrations were repeated using a conductivity probe for measuring the liquid level in the risers. This was also done under a purge with an inert gas.

The risers were then welded close with extensions on each leg so that the ends would be above the insulation and thereby permit easier removal of slag in the future.
