**The University of Michigan • Office of Research Administration**  
**Ann Arbor, Michigan**

Final Report

TYPE 321 (18-8+Ti) STAINLESS STEEL TUBING IN THE  
REHEATER OF NUMBER 2 STEAM GENERATOR AT THE  
RIVER ROUGE STATION OF THE DETROIT EDISON COMPANY

The Detroit Edison Company  
2000 Second Avenue  
Detroit 26, Michigan

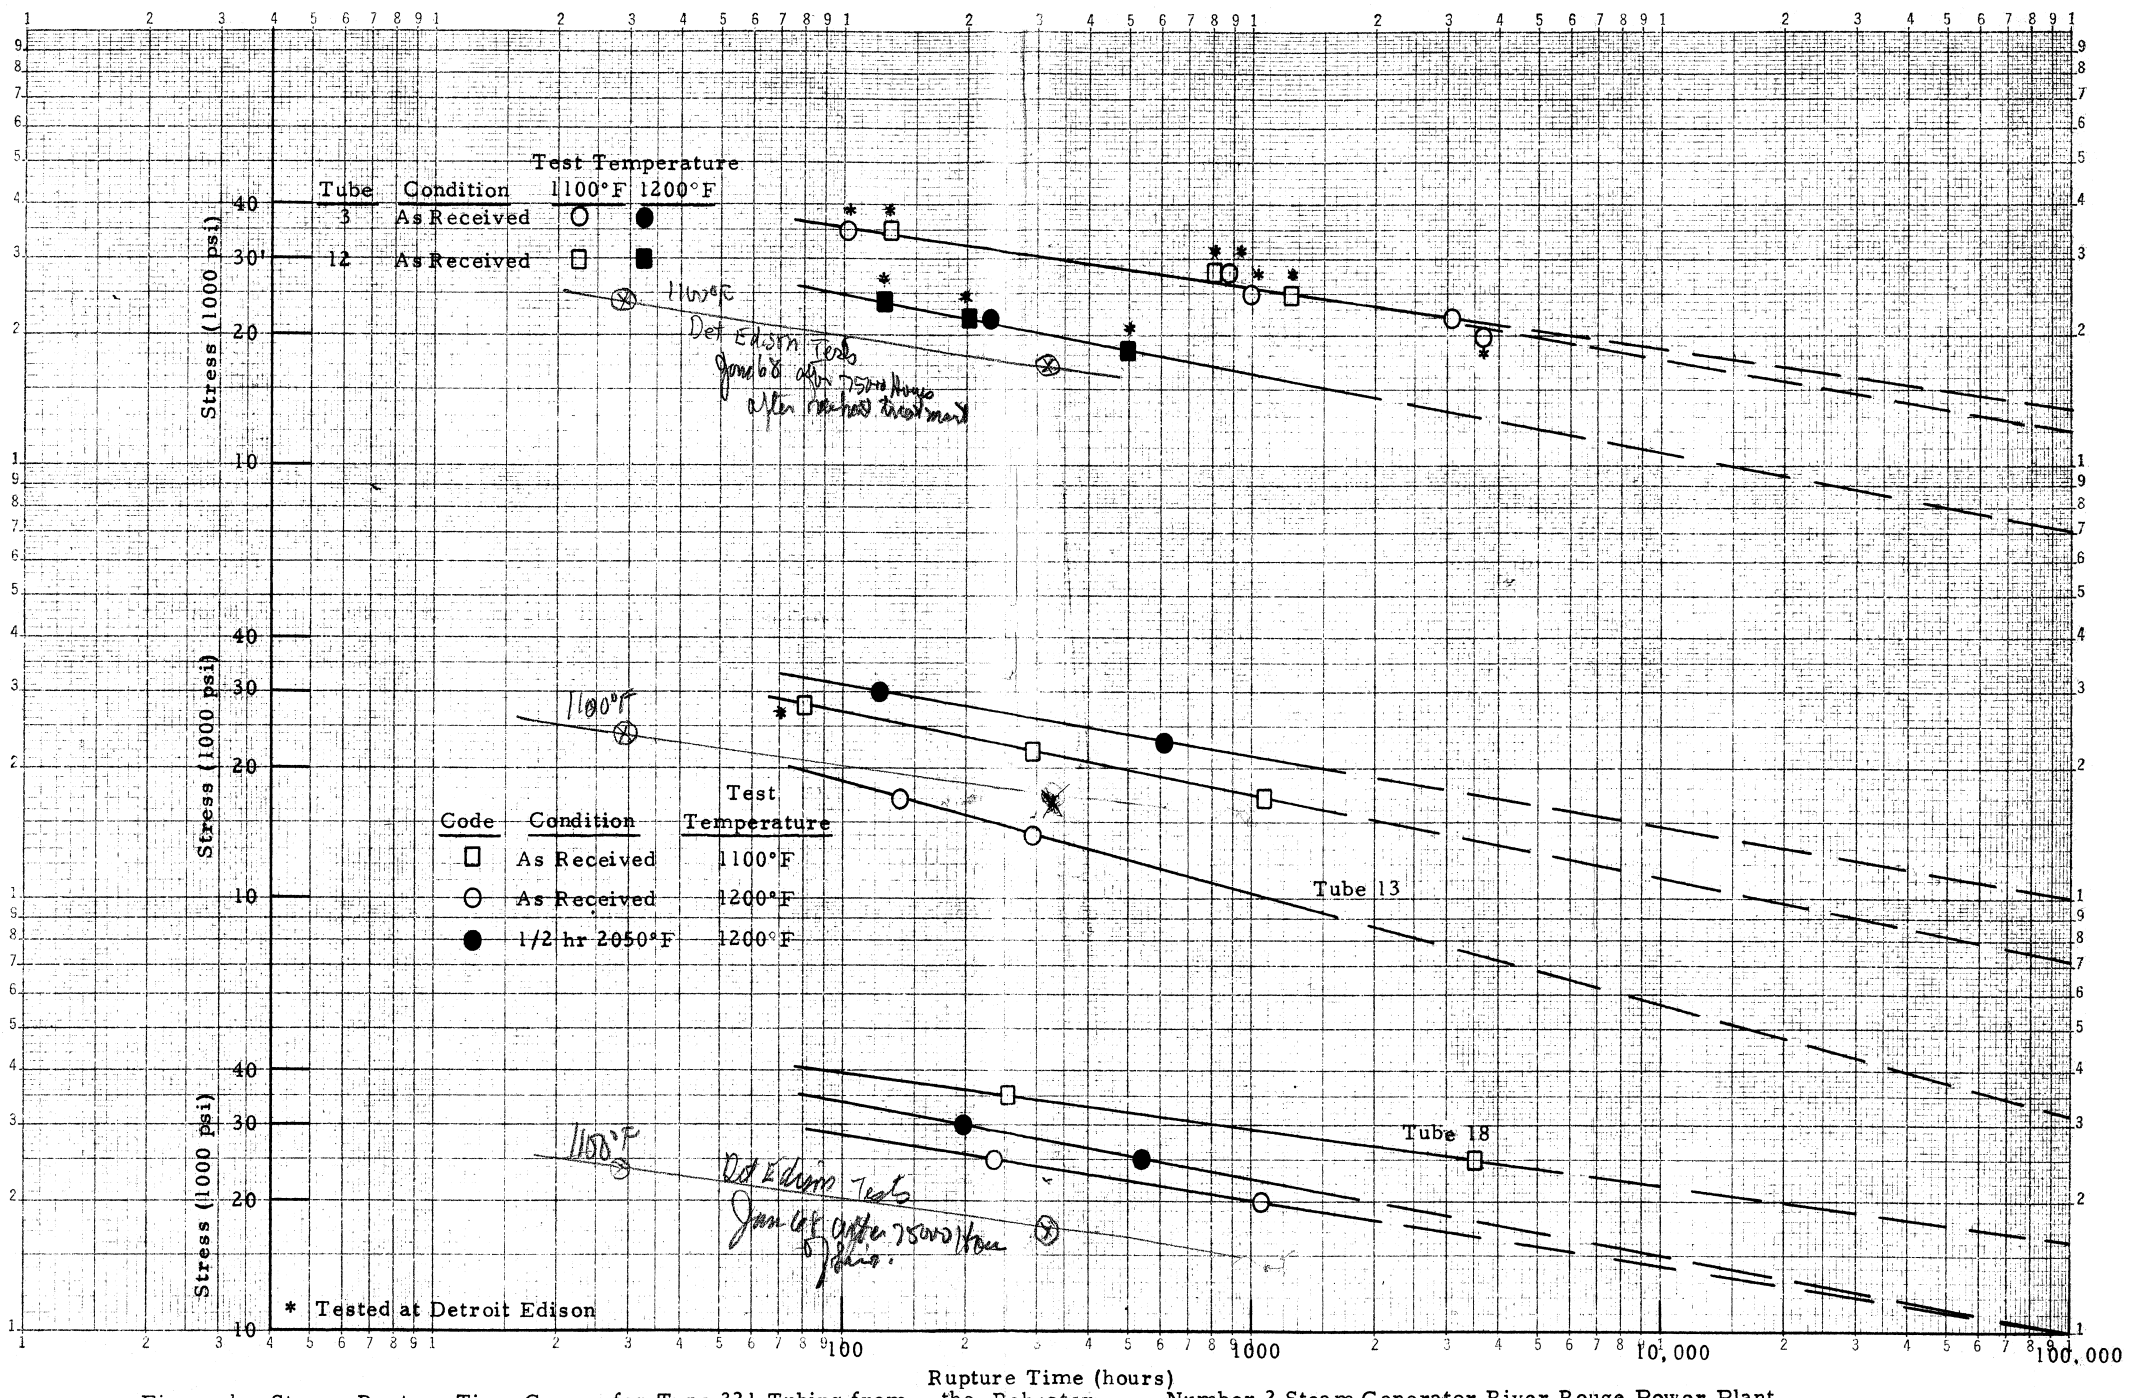
Figure 1 Stress-Rupture Time Curves for Type 321 Tubing from the Reheater. Number 2 Steam Generator River Rouge Power Plant.

The rupture strengths derived from the tests are given in Table 1. The test data for Tubes Number 3 and 12 are given in Table 2, Tube Number 13 in Table 3, and Tube Number 18 in Table 4. The rupture strengths given in Table 1 were read from the stress-rupture time curves of Figure 1. The rupture properties show the following:

(1) A wide range in rupture strengths of the tubes as-removed from service with the specimens from the failed Tube Number 13 being very weak, Tubes 3 and 12 intermediate, and Tube Number 18

having nearly expected strengths for the alloy. Type 321 alloy when properly heat treated should have a stress for rupture in 100,000 hours at 1200°F of 9000 or 10,000 psi or higher. Only Tube Number 18 indicated strengths at this level. Tube Number 13 had the lowest rupture strengths known to the authors for Type 321 alloy.

(2) The slopes of the curves indicated by the tests at 1200°F were similar to those of the curves defined by the tests at 1100°F. This indicates that the curves at 1100°F would not show a decrease in slope if longer tests were conducted and, therefore, can be extrapolated with confidence. The only exception to this was Tube Number 13 where the slope at 1200°F was sufficiently greater than at 1100°F to raise a question as to whether indicated strengths from extrapolation at 1100°F might even be lower than shown by the extrapolation in Figure 1.

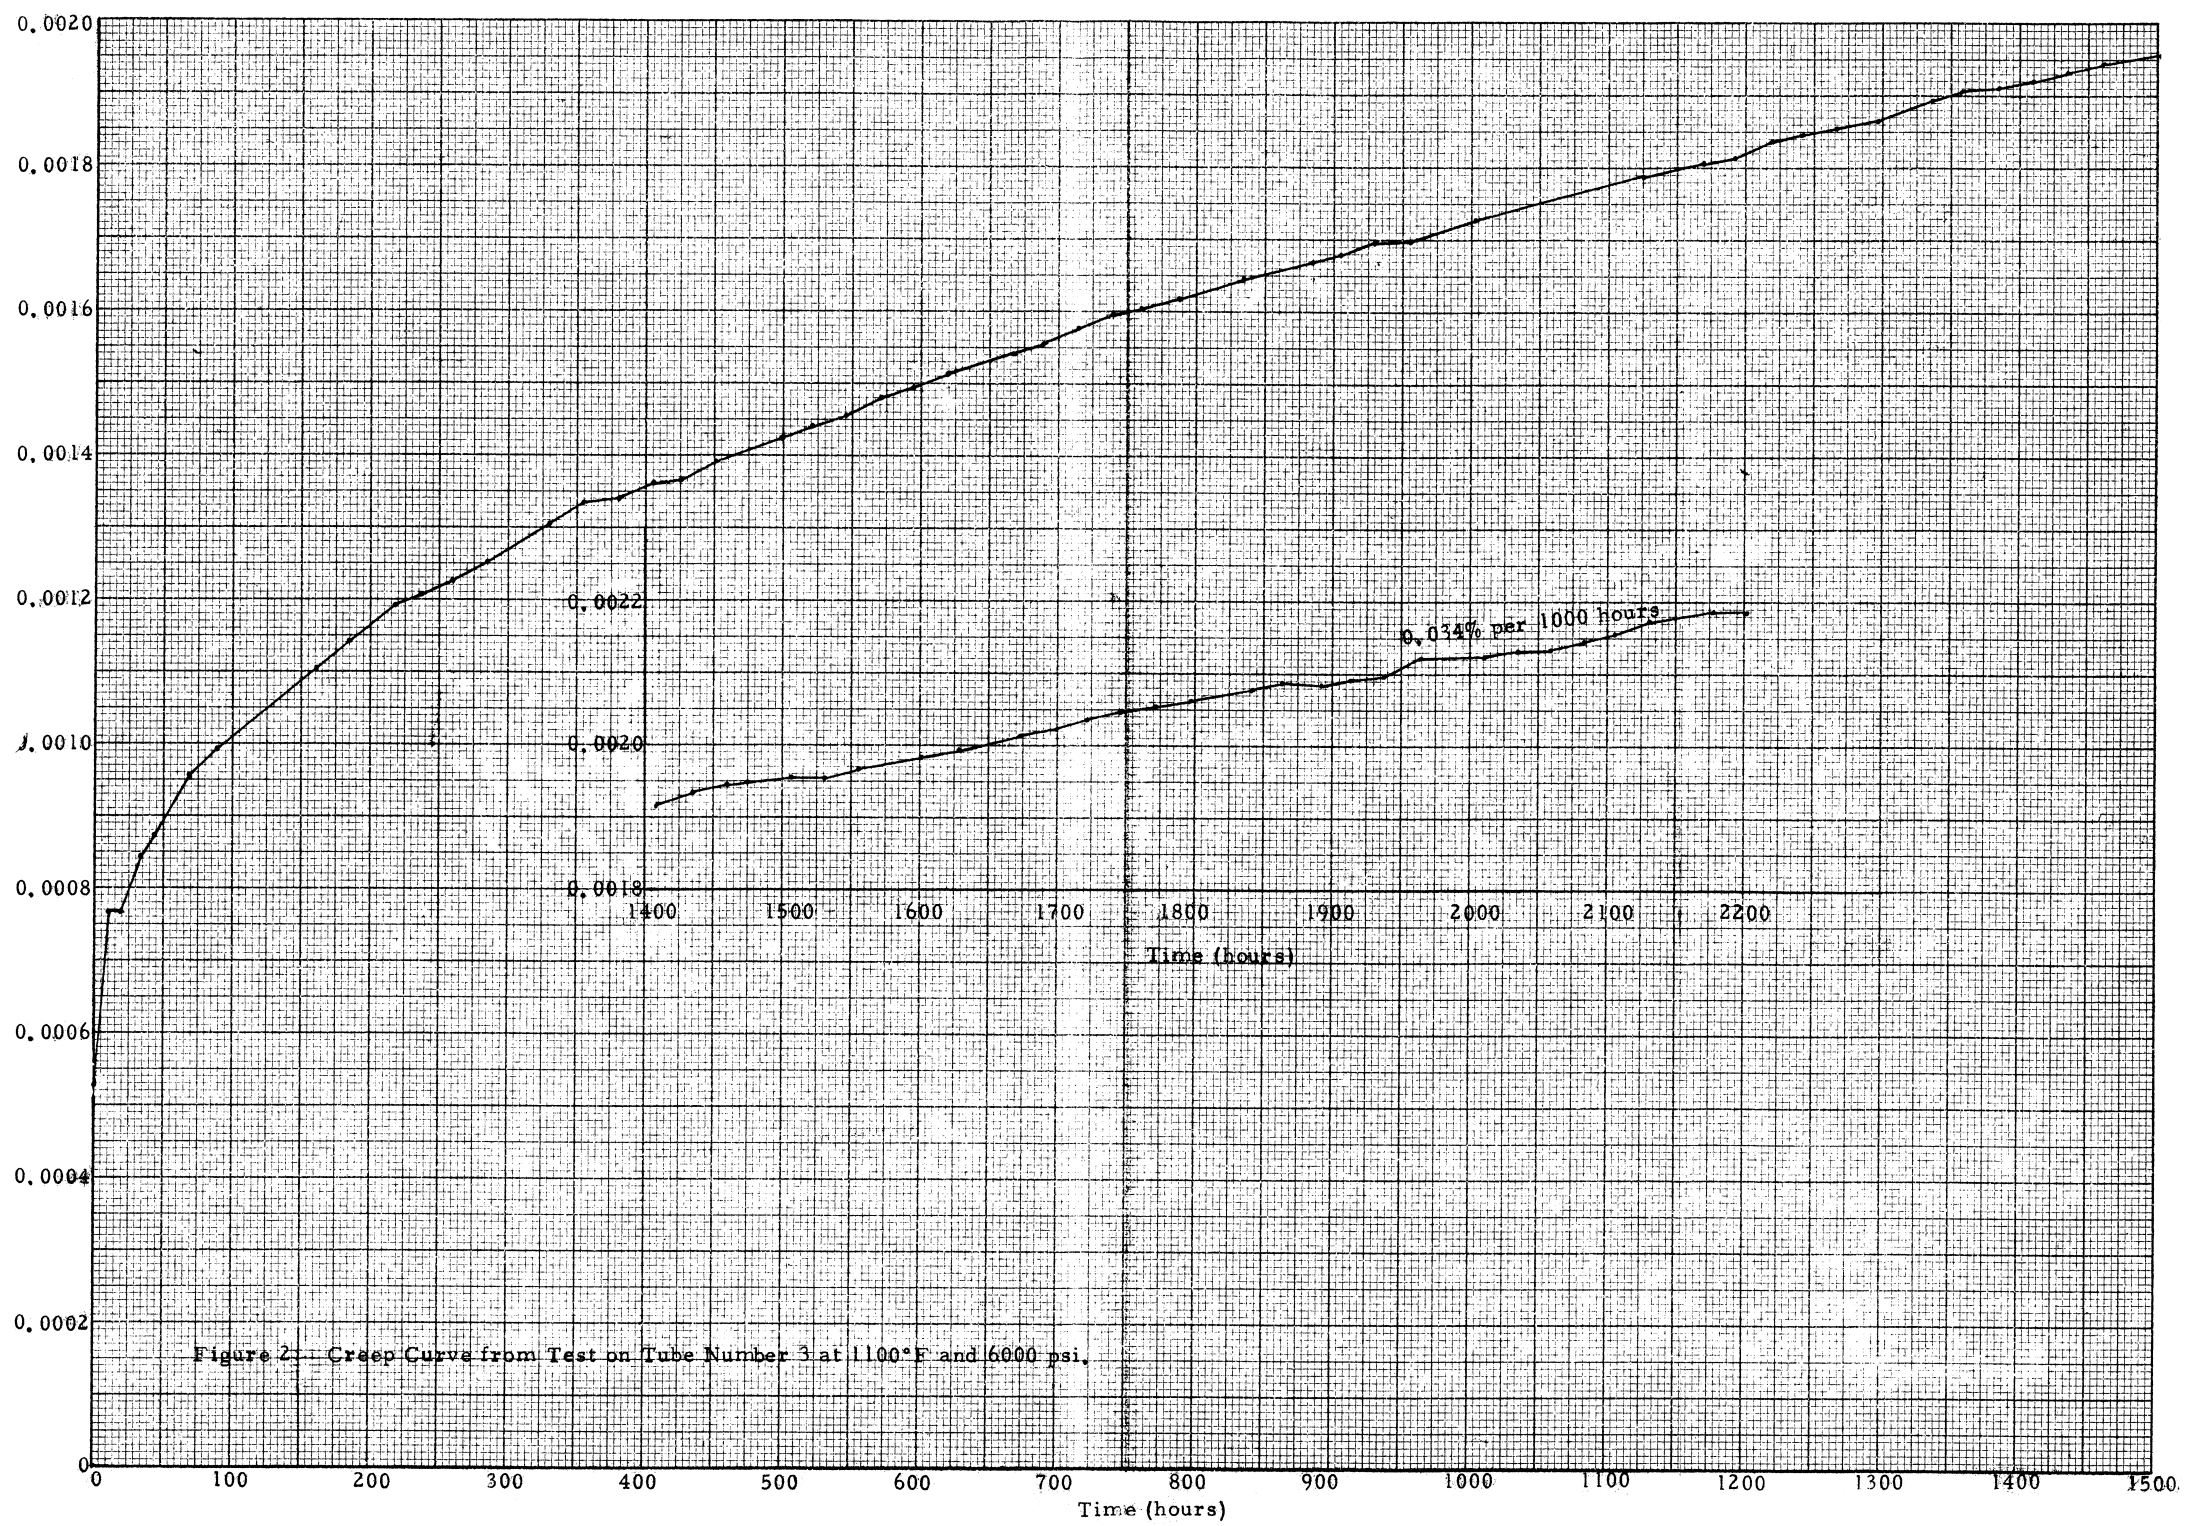
Figure 2 - Creep Curve from Test on Tube Number 3 at 1100°F and 6000 psi.

The creep curve for the 6000 psi test at 1100°F on Tube Number 3 is shown in Figure 2. The creep rate at about 2000 hours was 0.034 percent per 1000 hours, a value consistent with the rupture strength. In theory, there should not have been the long period of decreasing creep rate in this test if the test conditions of 6000 psi at 1100°F had matched the service stress and temperature. Presumably, the main reason the prolonged decrease in creep rate occurred was due to the service conditions prior to removal being less severe. It is known, however, that when specimens are cut from a piece after prior creep that there is a period of readjustment during which creep rates decrease down to the actual levels in service. The test, therefore, demonstrates quite well what the creep rate is for tubes in the reheater at 1100°F with the strength level of Tube Number 3.

(2) The operating stress of 6000 psi is 50 percent of the estimated 100,000 hour rupture strength of Tube Number 3 at 1100°F. Thus, on the basis of rupture strength, the strength of all tubes in the reheater down to that of Tube Number 3 should be adequate for the future of the reheater. The creep test on the specimen from Tube Number 3 at 6000 psi gave a creep rate of 0.034 percent per 1000 hours. The use of creep data for Type 321 steel is difficult. Very prolonged testing is usually required to develop true secondary creep in tests on the alloy. It usually exhibits a period of relatively rapid creep rate soon after the stress is applied to a new specimen. It was

expected, in this case, that the prior service would have eliminated this period and the test at 6000 psi should give near true minimum creep. It is thought that this had not occurred in service for unknown reasons and the test did not give true minimum creep. On the other hand, if it did, the creep test indicates that difficulty due to excessive creep should not start to occur in tubes as weak as Tube Number 3 in 60,000 to 100,000 hours with a metal temperature of 1100°F.

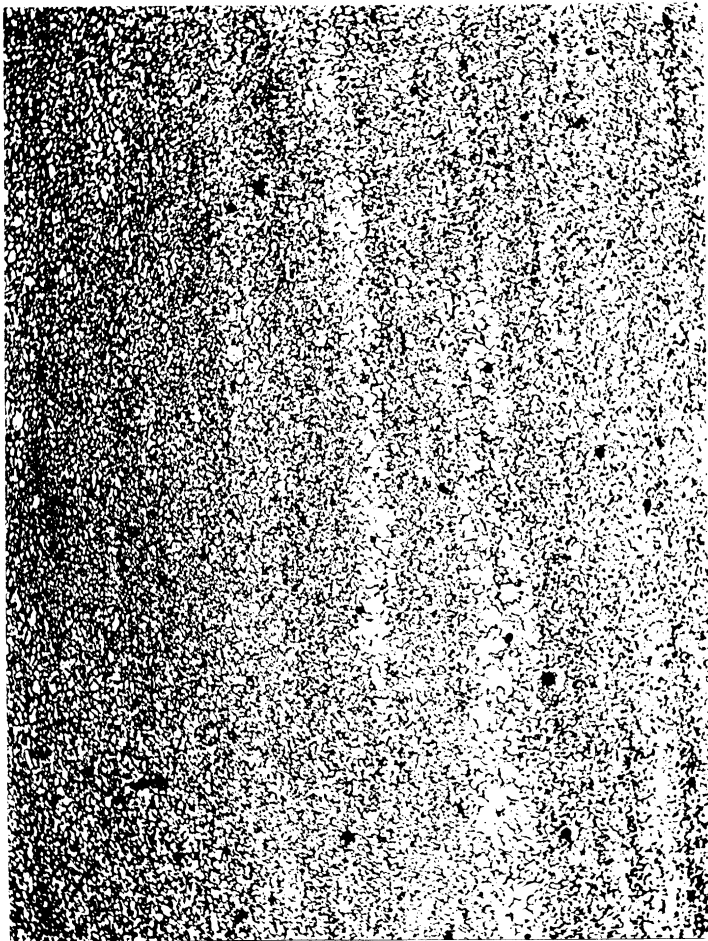
(a) Tube Number 13 As-Removed from Service After Failure in March 1961.

The structure of Tube Number 13 was initially very fine grained (Figure 3a) with a considerable amount of sigma phase as particles in the grain boundaries. The tube which failed in March 1960 (Figure 3b) had a similar structure and was possibly even finer grained. Tubes Number 3 and 18 had structures (Figures 4 and 5) consisting of mixtures of severely cold-worked coarse grains plus very fine grains derived from partial recrystallization. The recrystallization was more extensive in Tube Number 3 than 18.

It is evident that Tubes Number 3 and 18 retained a substantially higher hardness than annealed material as a result of the cold work present. The high hardness of Tube Number 13 could be due to the exposure and creep during service. The expected hardness for complete recrystallization for heat treatment at 1600°F is about 160 VHN.

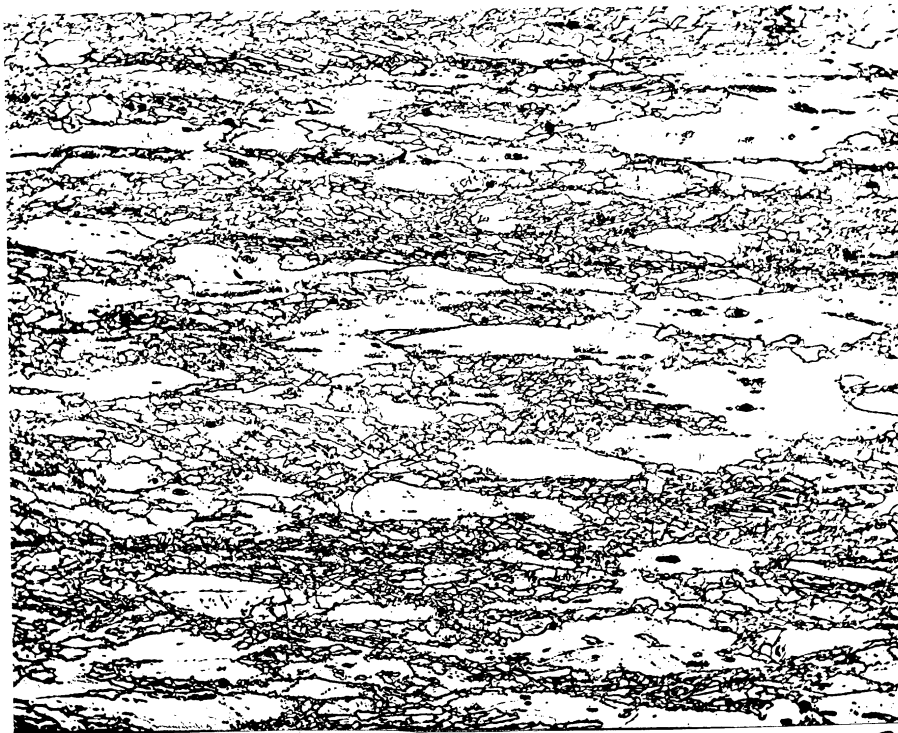
(b) As-Removed from Service Plus 1057 Hours at 1200°F Under 20,000 psi - X100D 62-008

Specimens were examined microscopically after testing without disclosing any features significant to the purposes of this investigation. No evidence was found to indicate that further recrystallization (Figure 5) had occurred in either Tube Number 3 or 18 during tests at 1100° or 1200°F.

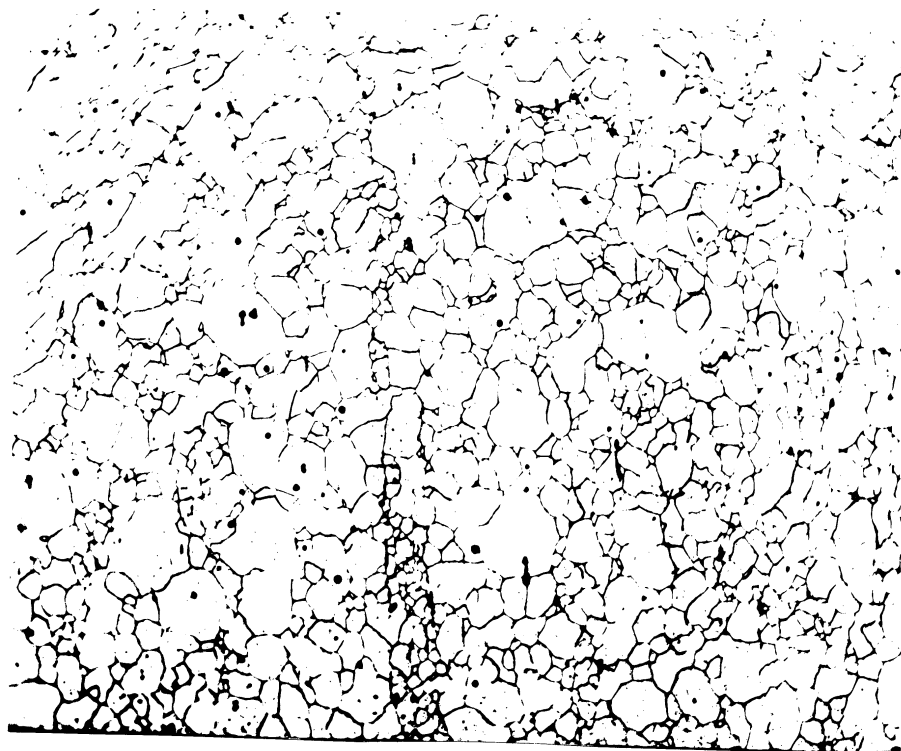
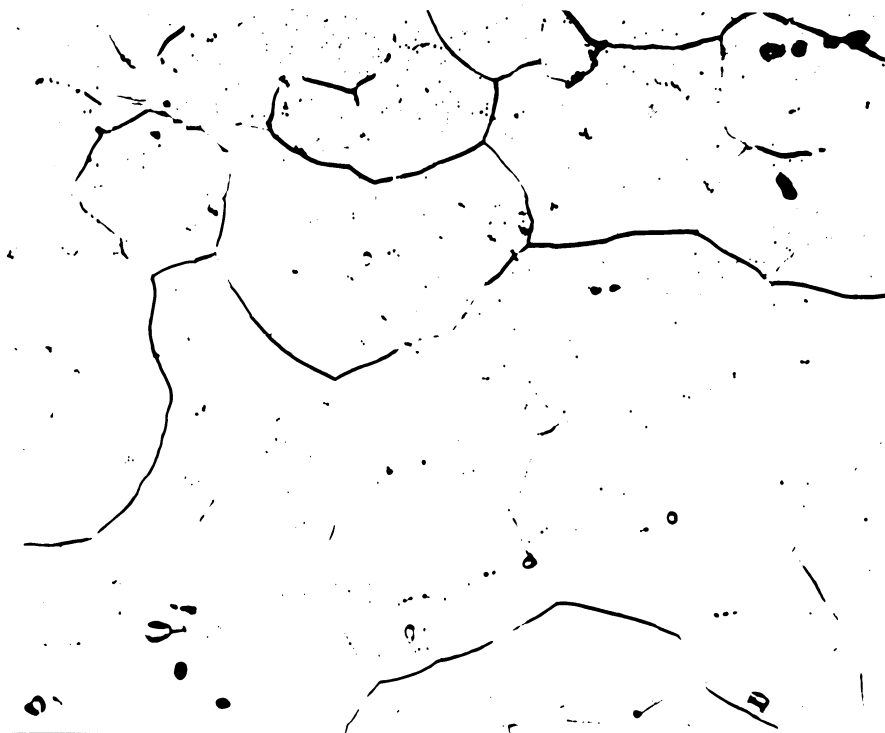
Figure 6 Microstructure of Tube Number 13 After Heat Treatment at 2050°F for One-Half Hour and Water Quenching.

Heat treating Tube Number 13 at 2050°F for  $\frac{1}{2}$  hour and water quenching coarsened the grains (Figure 6). It did not, however, result in complete solution of all carbides. The same heat treatment applied to Tube Number 18 caused complete recrystallization and grain growth (Figure 7). The grain size of Tube Number 18 was mixed and finer than Tube Number 13 after heat treatment.
