Munro Lake Shoreline Survey 2014

University of Michigan Biological Station

Biology 482: Limnology

8/13/14

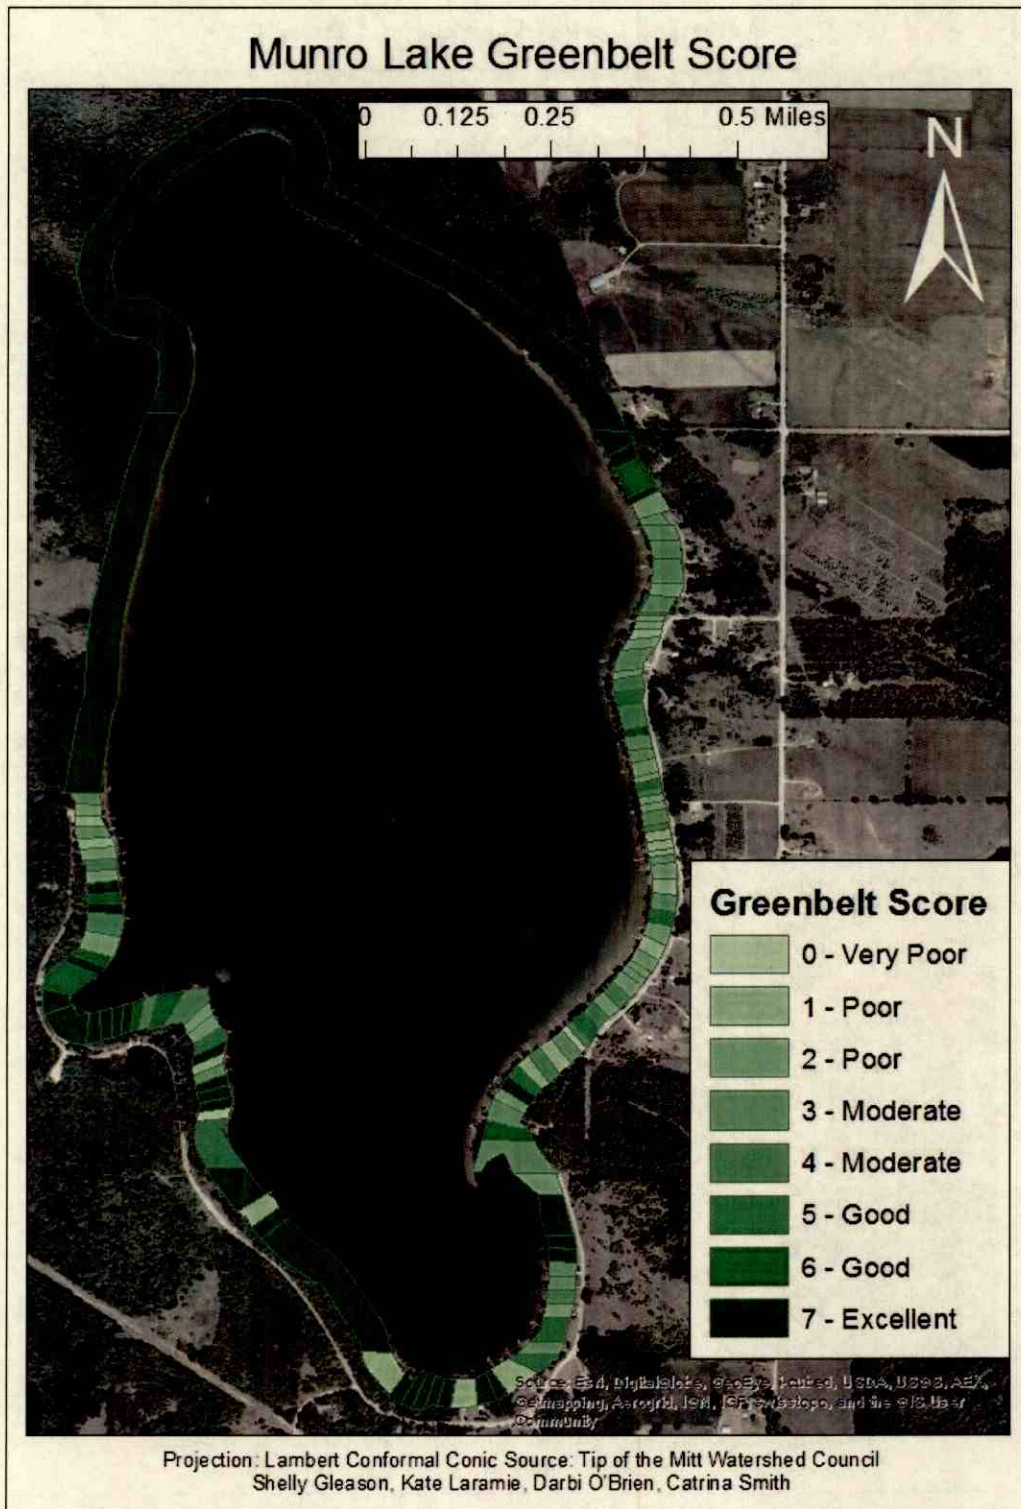
Figure 1. Lake-wide greenbelt scores.

Munro Lake consisted of 127 parcels ranging from 1800 ft (about 1/3 of a mile) to less than 20 ft. The largest parcels, 1 and 2, were located on the northern and western portions of the lake and predominately undeveloped. Of the 127 parcels, 90 (70.87%) were privately owned and either fully or partially developed. The remaining 37 plots were managed by Michigan's Department of Natural Resources, and classified as undeveloped. In undeveloped parcels, greenbelt scores tended to be higher. A majority of the high greenbelt scores were found on large, undeveloped parcels with natural habitat (Fig. 1). Parcels with poor and moderate greenbelt scores, 59.05% of the 127 parcels, tended to be located along the eastern shore of Lake Munro (Table 4, Fig. 1). Only two developed parcels on the lake were considered to have very poor greenbelt scores.

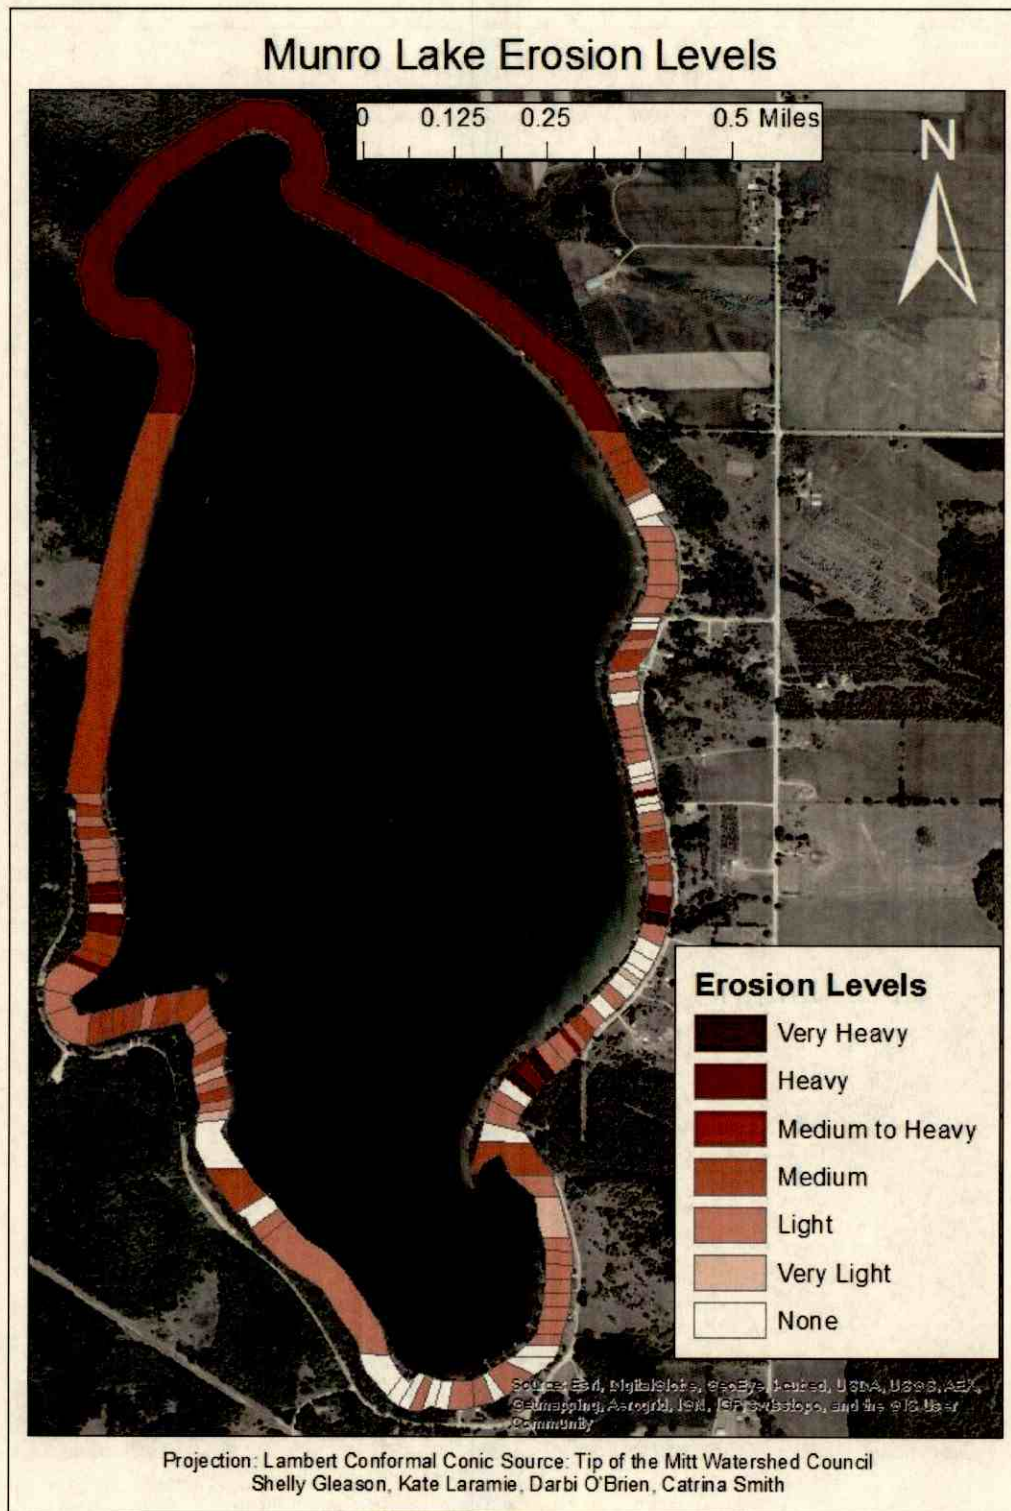
Figure 2. Erosion rating per parcel.

In undeveloped areas erosion levels tended to be the higher than developed areas with alterations (Fig. 2 and 3). Lower levels of erosion coincided with certain types of alterations made to the shoreline, namely rock riprap or boulder bulkhead in 57.48% of the parcels (Table 5 and Fig. 4). 11.02% of parcels contained beach sand alterations, which unlike boulder bulkhead or rock rip-rap, determined the habitat less suitable for *Cladophora*. Presence of hard-substrate parcels often coincided with the presence of *Cladophora* on that same parcel (Fig. 3). Nine parcels collectively accounted for heavy and very heavy erosion, but were predominately undeveloped on the northern shorelines of Lake Munro (Fig. 2). Despite the large sections of heavy erosion, 70.86% of the parcels had None to Light levels of erosion (Table 6).

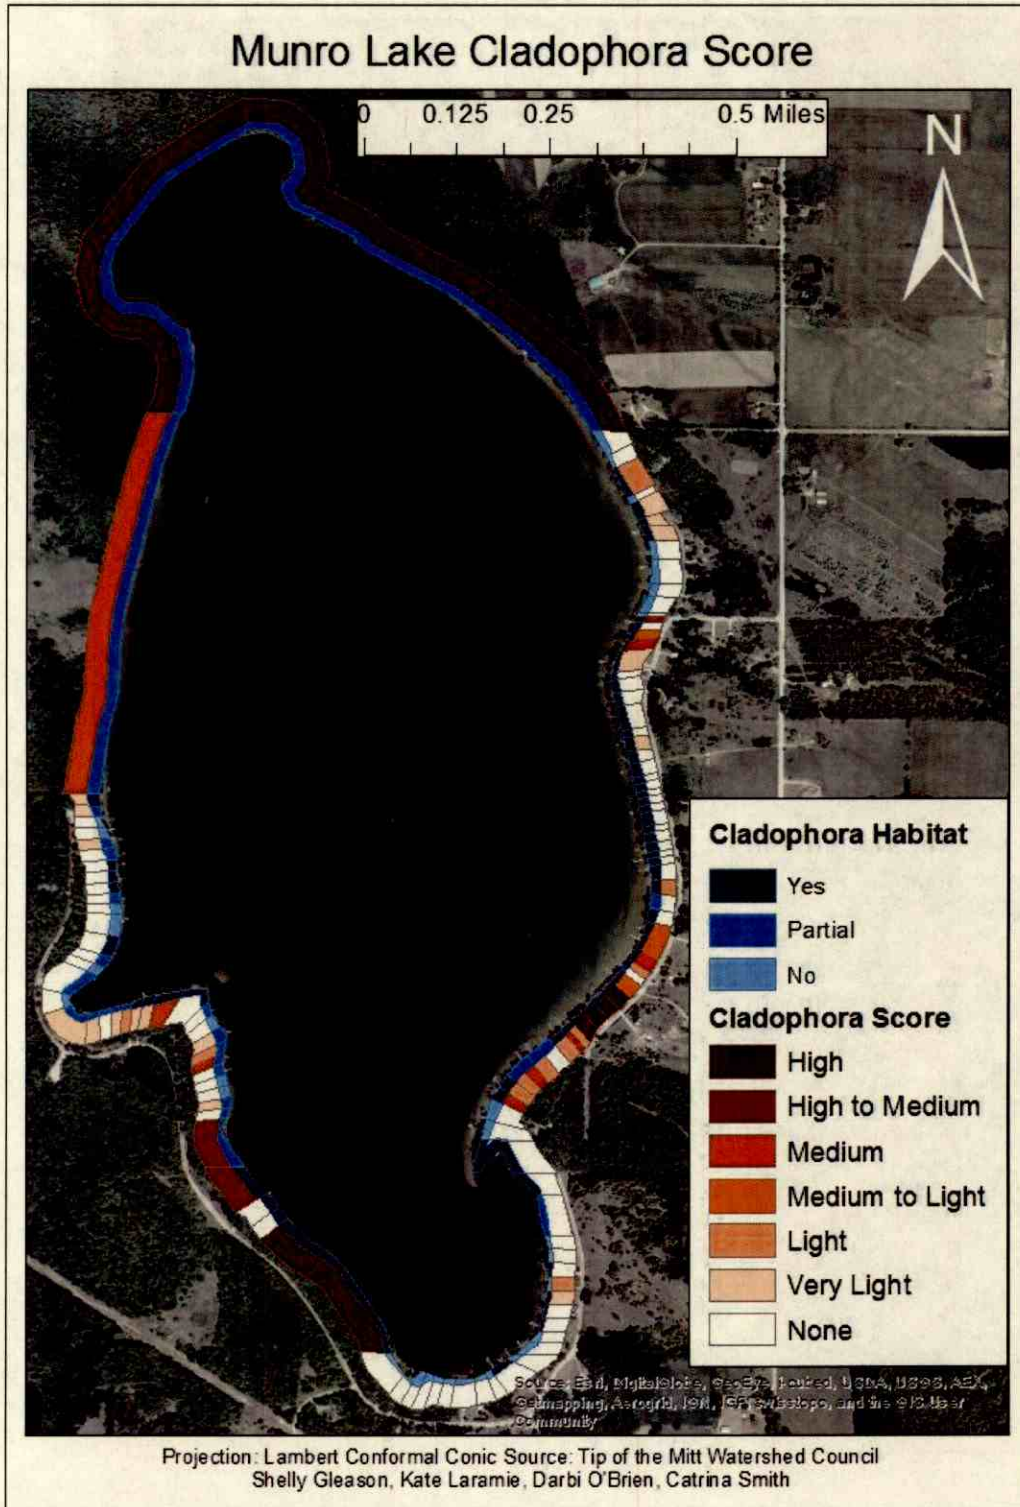
Figure 3. Cladophora rating and habitat. A "yes" in habitat indicates the potential for *Cladophora* to grow in parcels.

79 of 127 parcels (62.20%) contained habitats for *Cladophora*, however *Cladophora* was found in only 48 of 127 parcels (37.80%, Table 7). The majority of *Cladophora* density levels were either Very Light or Light (33.33% and 22.92%, respectively, Table 7). Higher *Cladophora* densities were predominately located in natural habitats along the northern and southern portions of Lake Munro, in addition to a section of parcels along the eastern shoreline (Fig. 3).
