## Radiographic pseudofracture of the Medtronic bipolar polyurethane pacing lead

Thomas E. Dunlap, M.D., Kishor D. Popat, M.B., and Richard P. Sorkin, M.D. *Westland, Mich.*

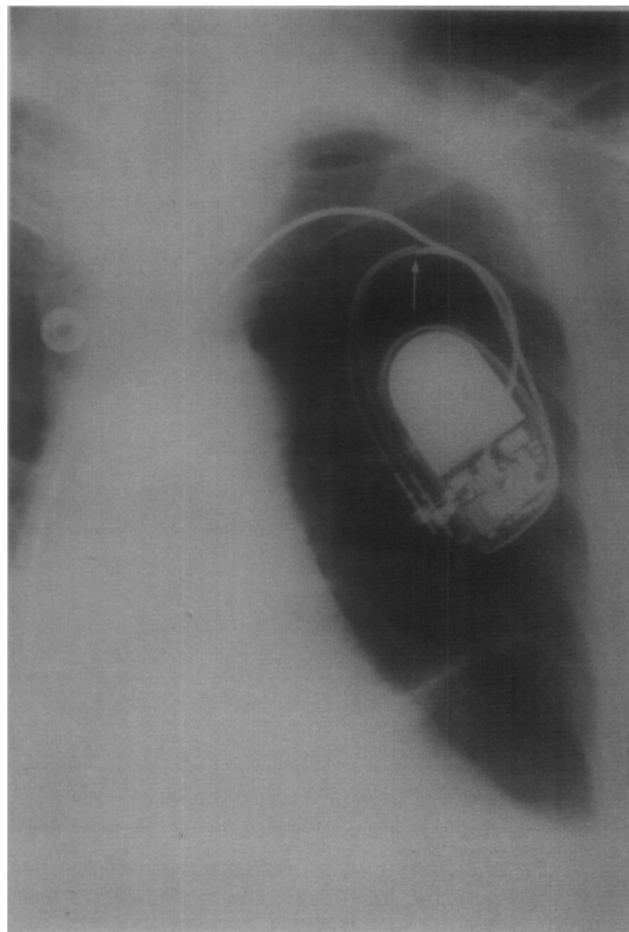
**Fig. 1.** Standard posteroanterior chest radiograph demonstrating the appearance of the Medtronic 6972 lead in one patient. Note areas of discontinuity (arrows). The system performed normally, ruling out lead fracture.

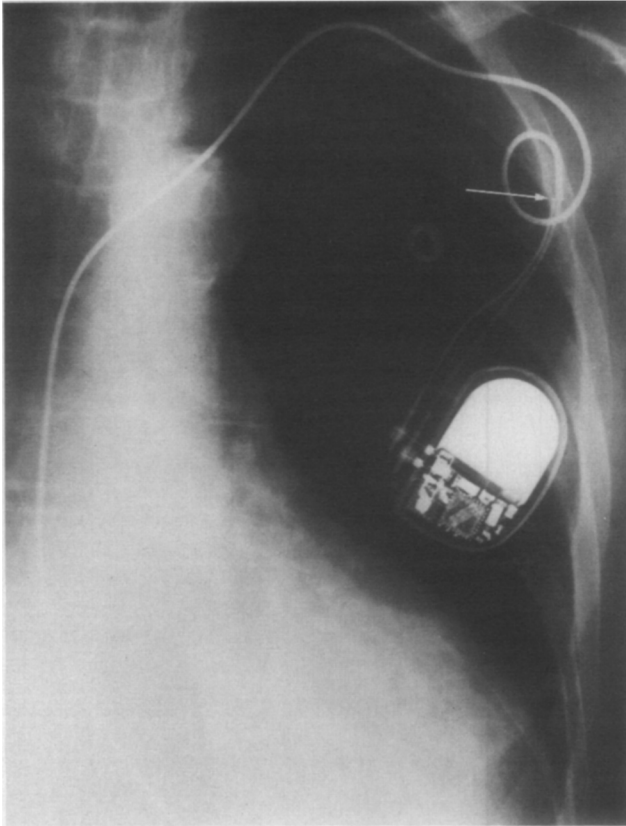
**Fig. 2.** Posteroanterior chest radiograph from another patient, showing the 6972 lead. The system performed normally, ruling out lead fracture. See legend to Fig. 1.

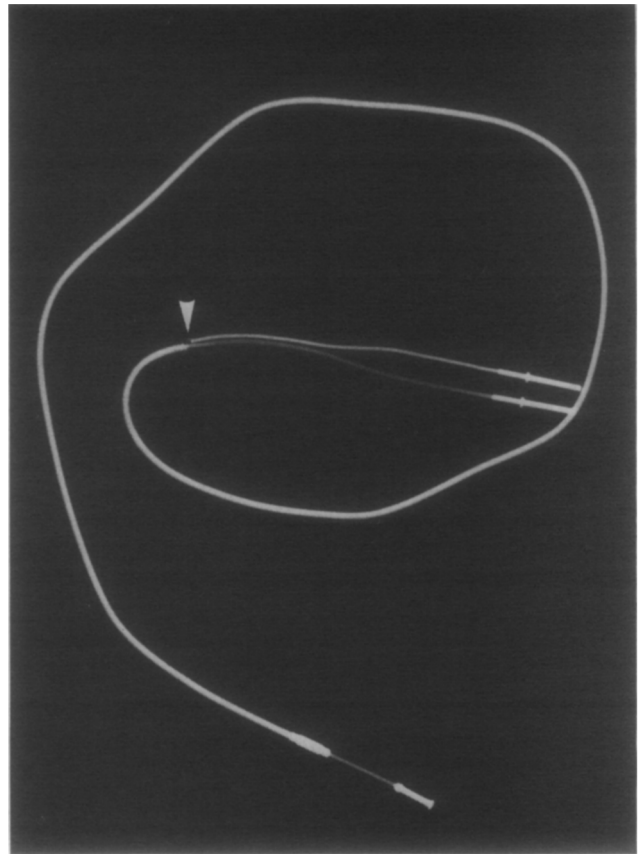
The construction of the lead is of a coaxial design, and at the bifurcation of the outer coil from the inner coil the outer coil is offset from the inner coil (Figs. 3 and 4). It is at this offset area that the wire can appear discontinuous, thus simulating lead fracture on a standard radiographic view. In fact, this is the normal appearance. We present these data to familiarize physicians working with pacemakers and pacemaker radiography about this "pseudofracture" appearance. It is important to recognize this feature in order to avoid an unnecessary lead explantation.

**Fig. 3.** Radiograph of the 6972 lead alone. Note area of discontinuity (*arrowhead*).

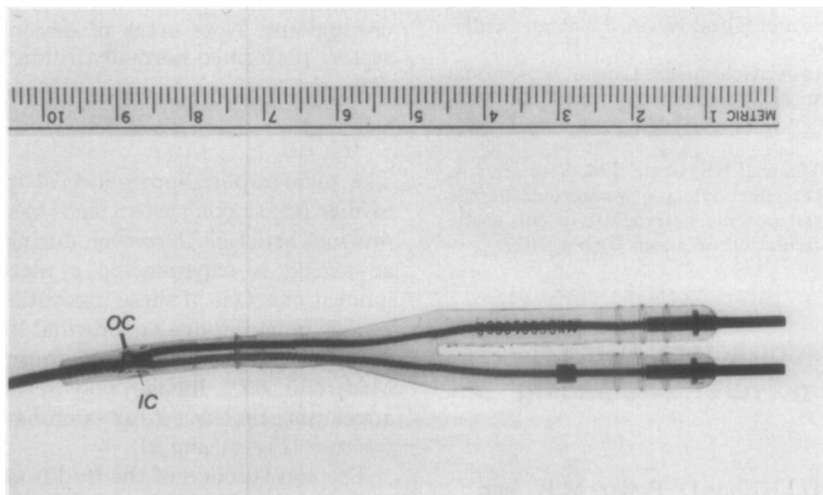
**Fig. 4.** Photograph of the 6972 lead. Note area where the outer coil (*OC*) crosses over to form a bifurcation. *IC* = inner coil.
