Semiannual Progress Report No. 2

SHOCK ON ELECTRICAL COMPONENTS IN
TRACK-LAYING AND WHEELED VEHICLES

July, 1954, to January, 1955

DETROIT ARSENAL, DEPARTMENT OF THE ARMY
CONTRACT NO. DA-20-089-ORD-36543
CENTER LINE, MICHIGAN

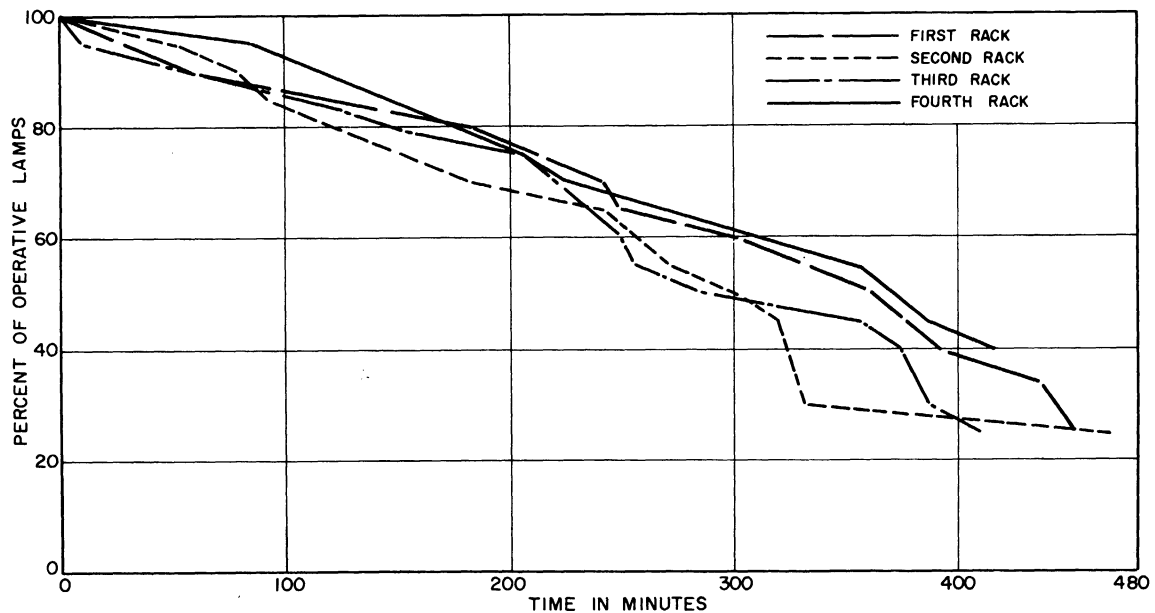
Fig. 1. Mortality Curves of Four Racks of Lamps Operated on the Arsenal Impact Tester.

A fairly reliable indication of the improved performance of the Arsenal tester, with the structural changes which have been described, can be obtained by referring to the lamp mortality curves of Fig. 1. Four groups of type 1251 lamps were tested at 28 volts, employing the customary 25-minute-on-5-minute-off operating cycle and an average peak acceleration of 50 g. It will

be noted that only during the final part of the test did the curves separate by more than 10 percent.

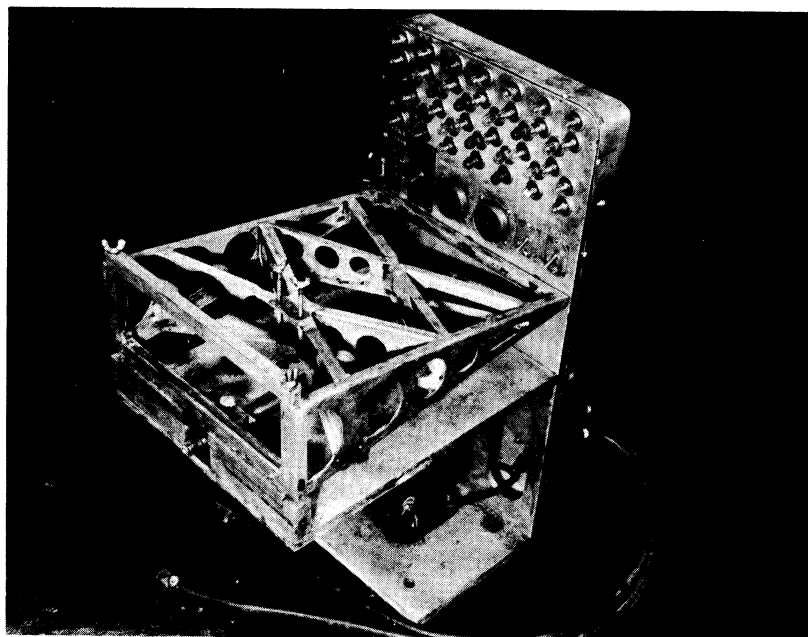
Fig. 2. Auto-Lite Impact Tester.

both machines for the purpose of indicating the amount of correlation to be expected in their performance. Accordingly, the Auto-Lite tester was removed from its base and shipped to the University of Michigan on August 30, 1954. Figure 2 shows the tester as received.

Careful inspection of the machine revealed the following features needing attention:

1. The cam speed was 915 rpm.
2. The anvil surfaces were rough and deformed, making contact on only one side.
3. The anvil drop was 0.115 inch.
4. The cam started lifting the upper anvil about 100 degrees ahead of the normal position.
5. The amount of upward force needed to separate the anvils 0.002 inch was 6.5 pounds with a 5-pound lamp-holder plate on the arm, and 4 pounds without the plate.
6. Several welded joints in the arm frame were fractured.

1. Pulleys were substituted to produce a cam speed of 700 rpm.
2. The structural changes necessary to accommodate the new elastic hinge were completed.
3. The lamp-holder plate mounting was converted to the new design.
4. A new cam was installed having the same general shape as the cam in the Arsenal machine.
5. The centers of the bearing blocks were lowered by 0.030 inch.
6. The anvil surfaces were reground.
7. The frame cracks were rewelded.

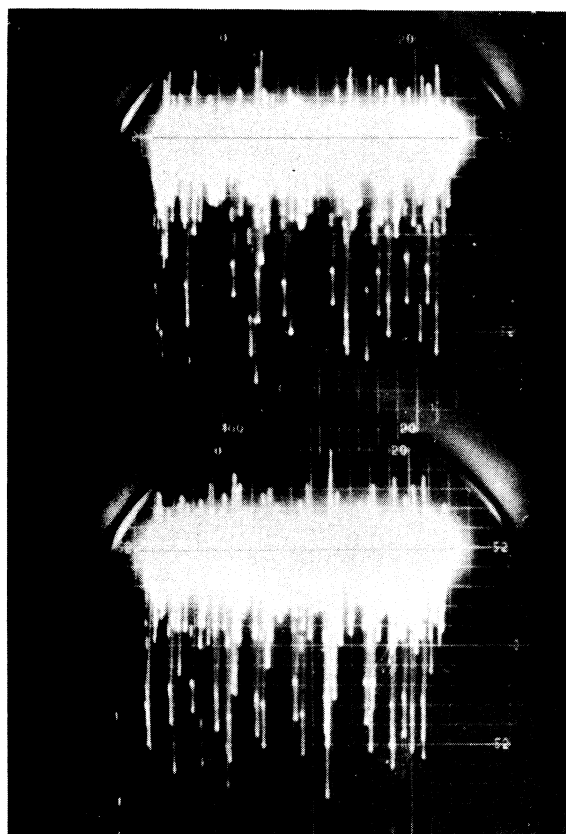
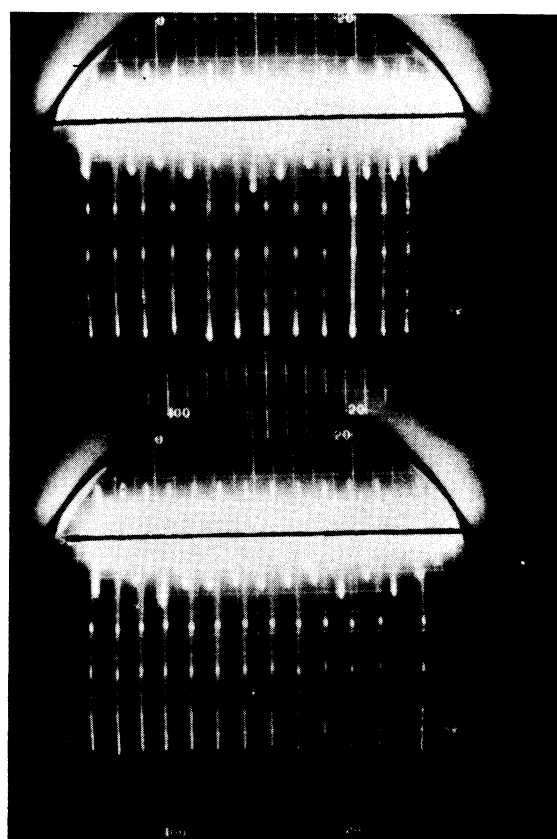
Fig. 3. A, Acceleration Pattern of Tester as Received; B, Acceleration Pattern after Modification.

Preparations were made for several tests on the machine as received. A Statham A5A accelerometer was mounted on the frame and a number of oscillograms were taken with the cam operating at 915 rpm. Two typical recordings are shown in Fig. 3, in which the very irregular performance pattern can be clearly observed. The average peak acceleration was 44 g, with a high of 53 and a low of 27. The cam speed was then reduced to 700 rpm, resulting in an average peak acceleration of 56 g, and a much narrower spread of peak values, 4.3 g. Substitution of the "S" cam (a special cam designed for the Arsenal tester having a spiral contour and 0.0625-inch lift) gave an average peak acceleration of 41 g.

0.066 inch, producing a peak acceleration of 66 g. This was reduced to 50 g by reducing the drop to 0.030 inch.

The impact tester was then transported to the Electric Auto-Lite plant and assembled on its own base. Initial test runs showed erratic performance which was finally traced to anvil distortion caused by tightening the two side brackets clamped on the lamp-holder plate. When these brackets were removed consistent acceleration values were observed and the machine appeared to be in satisfactory working order.

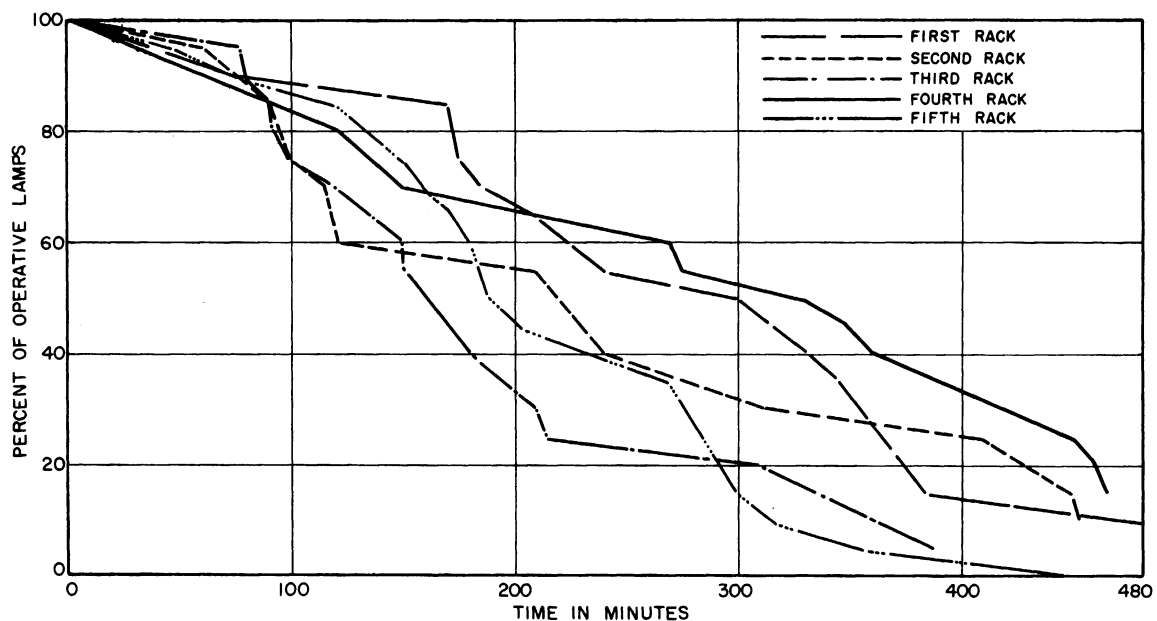
Fig. 4. Mortality Curves of Five Racks of Lamps Operated on the Auto-Lite Impact Tester.

Preparations were then made to obtain data for mortality curves on several groups of type 1251 lamps taken from the same batch as the groups tested on the Arsenal machine (see Fig. 1). During the test of the first group the Auto-Lite machine developed an erratic behavior which was traced to a defective hinge. When this condition was remedied testing was resumed and five groups of twenty lamps each were tested. The mortality curves for these five groups are shown in Fig. 4.

On comparing these with the curves of Fig. 1, it will be evident that the tests on the Auto-Lite machine showed considerably more spread, for reasons which are not yet understood. It is also evident that the Auto-Lite tester subjects the lamps to higher stresses, as the average slope of the mortality curves is steeper. Further study of this tester is being undertaken.

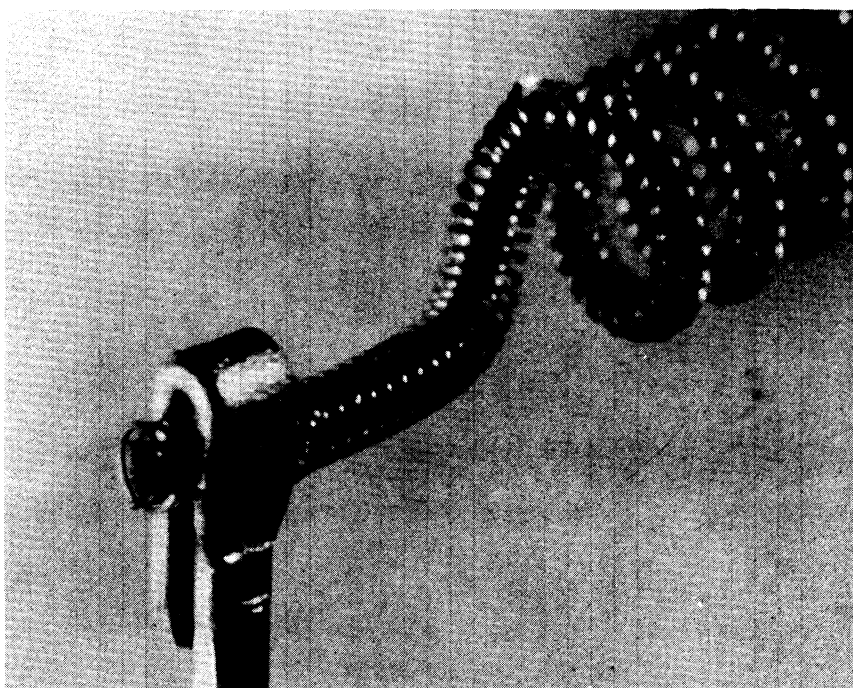
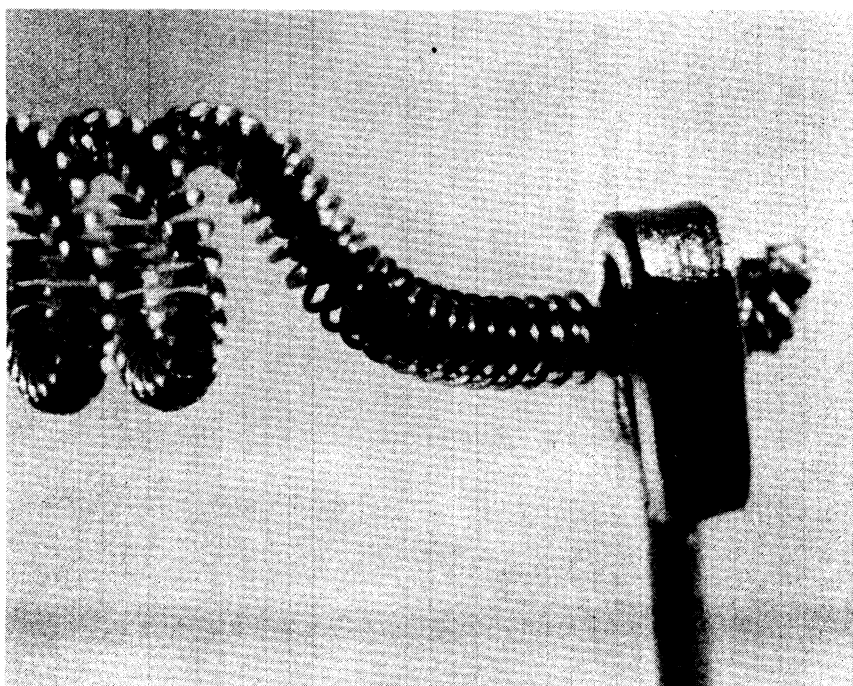
Fig. 5. Auxiliary Coils: A, 7 mg/200 mm; B, 11 mg/200 mm.

In response to our request two lamp companies provided the project with some lamps in which slip coils had been included. The first group submitted for test consisted of 50-watt, coiled coil-filaments similar to type 2416 with an RP11 bulb and a single contact bayonet base. Figure 5 shows the filament and slip-coil assembly for typical lamps of this group.

The data indicate that filaments with the heavier slip coils had a longer life than those with lighter coils or with no slip coils. Nearly all of these lamps had their secondary coils somewhat compressed and distorted. The average barrel length was about 50 mils shorter than in regular production lamps of the same type. Most of the failures on the test were due to shorting between turns rather than fatigue, and our limited experience indicates that this type of failure is expected to predominate if the coiled coils have a nonuniform pitch.

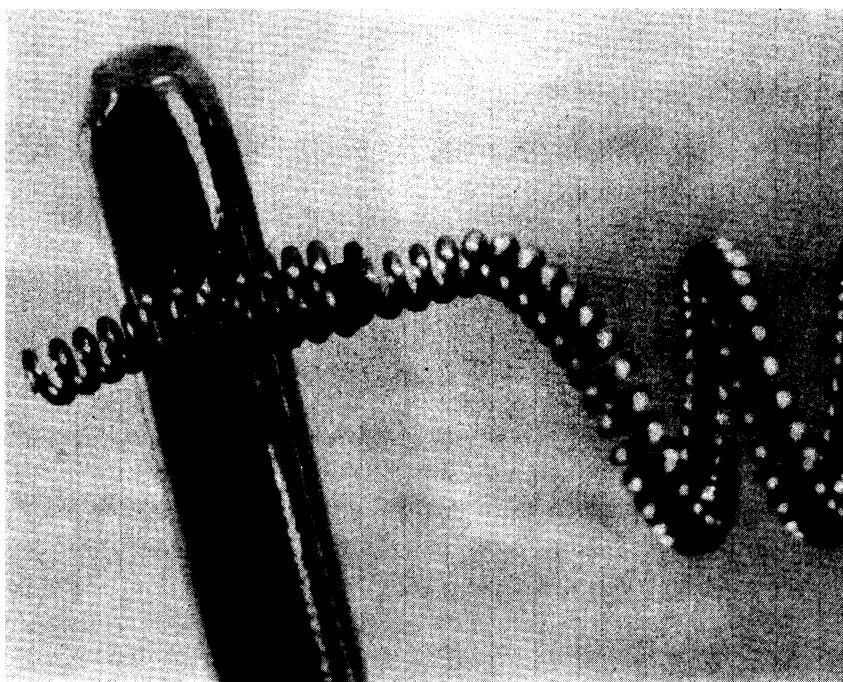
Fig. 6. Filament with Slip Coil

In the second group of lamps the auxiliary coils were screwed over the ends of the primary coil for distances ranging from three to seven turns beyond the weld point. No leg inserts were used (see Fig. 6).

When this group of lamps was tested on the impact machine in the same manner as the first group a much longer average life was observed. Every failure was a fatigue failure; no failures due to shorted turns were observed. The lamps all showed early blackening, however, due to improper degassing. A similar group, more carefully evacuated, will be supplied by the manufacturer for further testing.

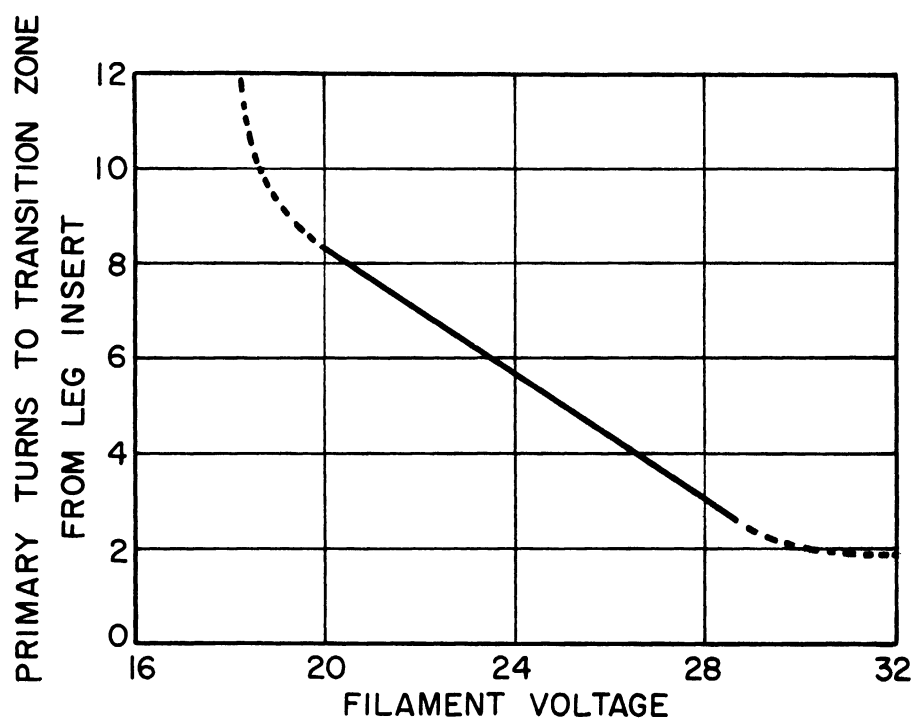
Fig. 7

A group of 50-watt lamps with coiled-coil filaments that had never been burned was flashed at various voltages ranging from 28 volts down to 20 volts. The filaments were then mounted, polished, and subjected to metallographic examination. The results are plotted in Fig. 7. It will be noted that there is quite a consistent relationship between operating voltage and the location of the transition zone marking the boundary between cold-worked structure and coarse-grained structure. As the voltage is lowered the transition zone moves farther away from the leg insert.
