# Toughening mechanisms in elastomer-modified epoxies

## Part 2 *Microscopy studies*

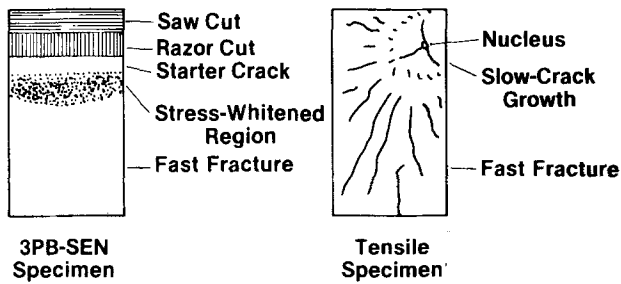
Figure 1 Schematic representation of fracture surface morphological features.

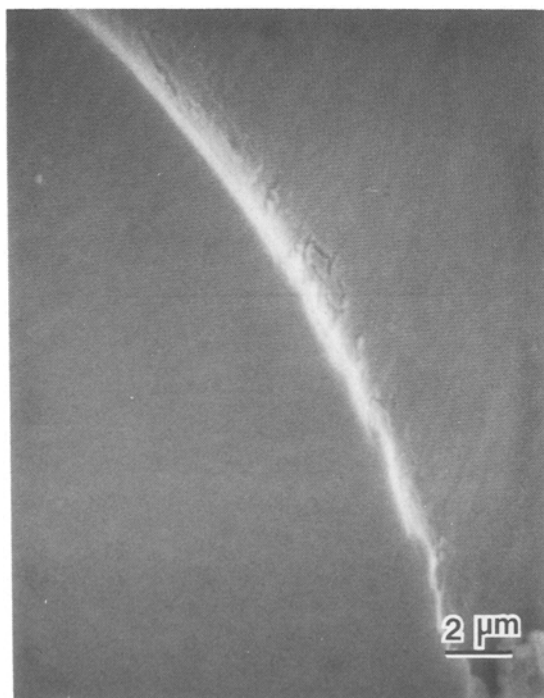
Figure 2 SEM of fracture surface of Epon 828 cured with piperidine.

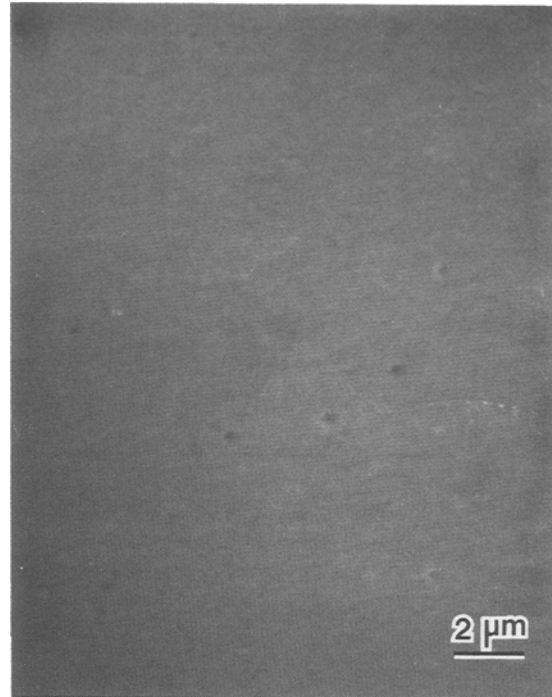
Figure 3 SEM of fracture surface of 828-13(5). No dispersed phase is present.

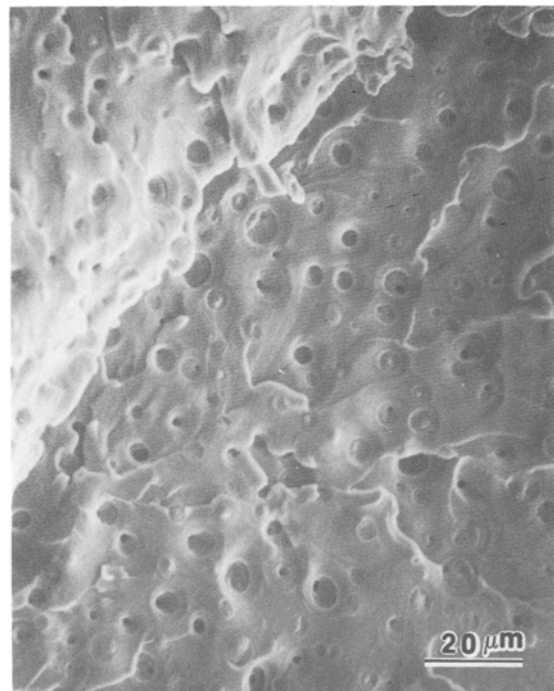
Figure 4 SEM from the stress-whitened area of fractured SEN-3PB specimen of 828-15(10). The white lines are due to tearing of the material between two crack planes, causing a surface step.

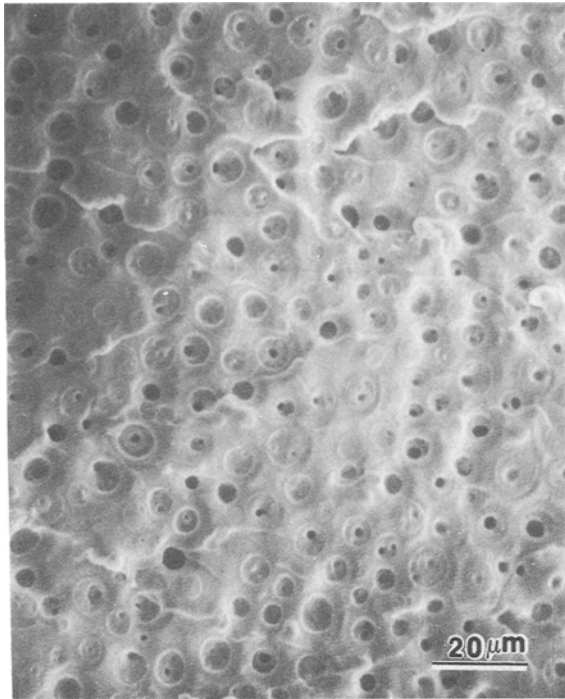
Figure 5 SEM from the stress-whitened area of fractured SEN-3PB specimen of 828-15(20).

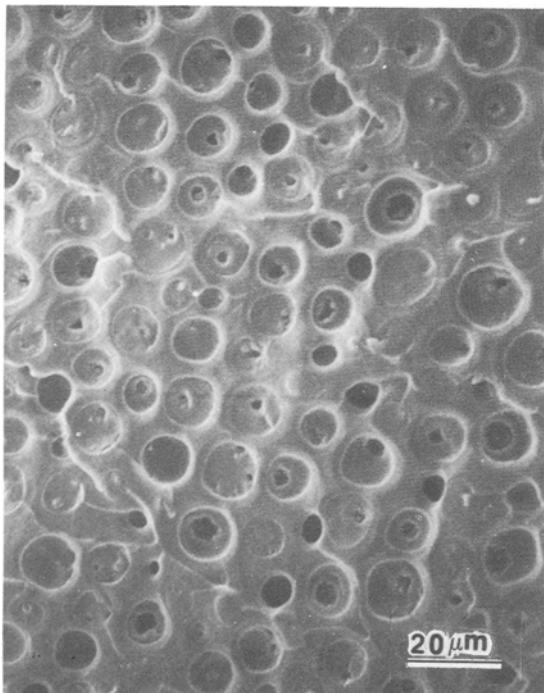
Figure 6 SEM from the stress-whitened area of fractured SEN-3PB specimen of 828-15(30).

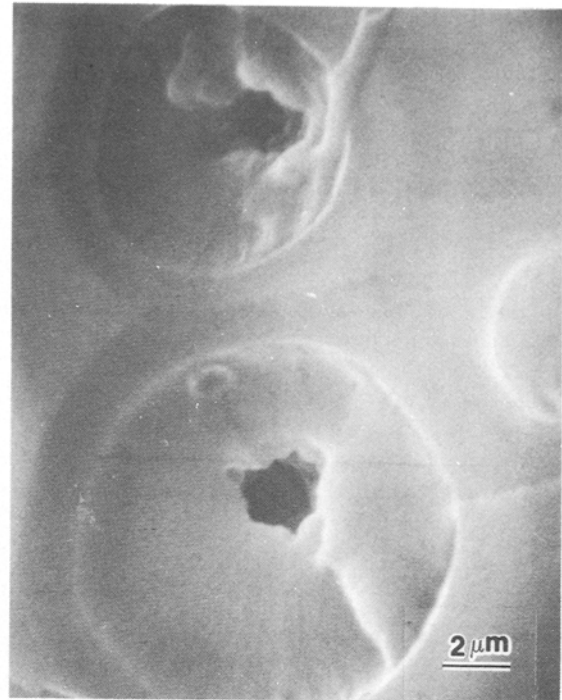
Figure 7 Higher magnification SEM of Fig. 6. Note the non-circular outline of the cavities due to particle-particle interactions. The edges of the cavities slope upward to meet the crack plane and form ridges.

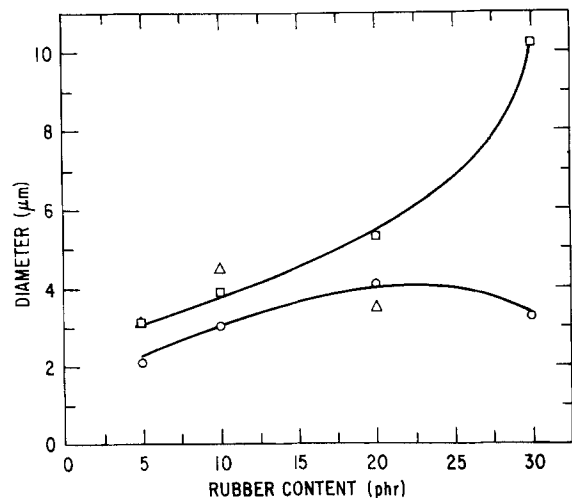
Figure 8 Dependence of diameters of rubber particles and fracture surface cavities on rubber content for the 828-15 system. (○) TEM, (□) SEM 3PB-SEN, stress-whitened area, (Δ) SEM, tensile specimen.

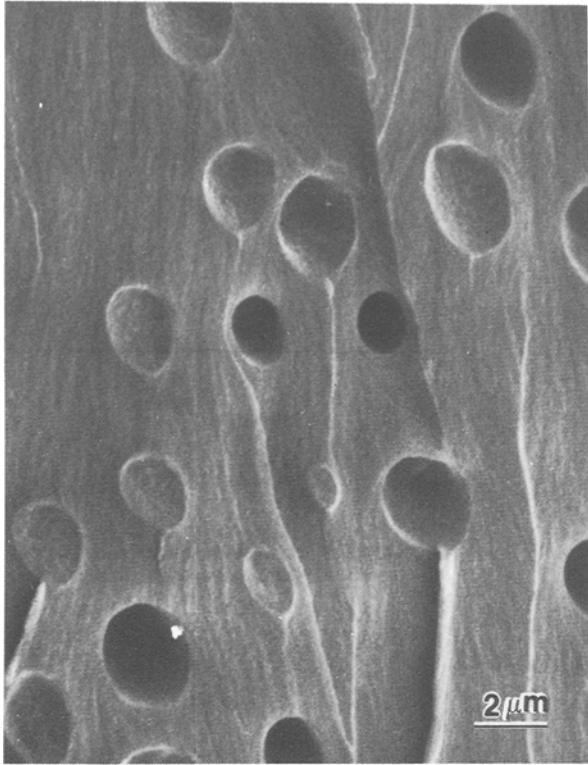
Figure 9 SEM from the stress-whitened area of fractured SEN-3PB specimen of 828-8(10). The striations have the same origin as those in Figure 4.

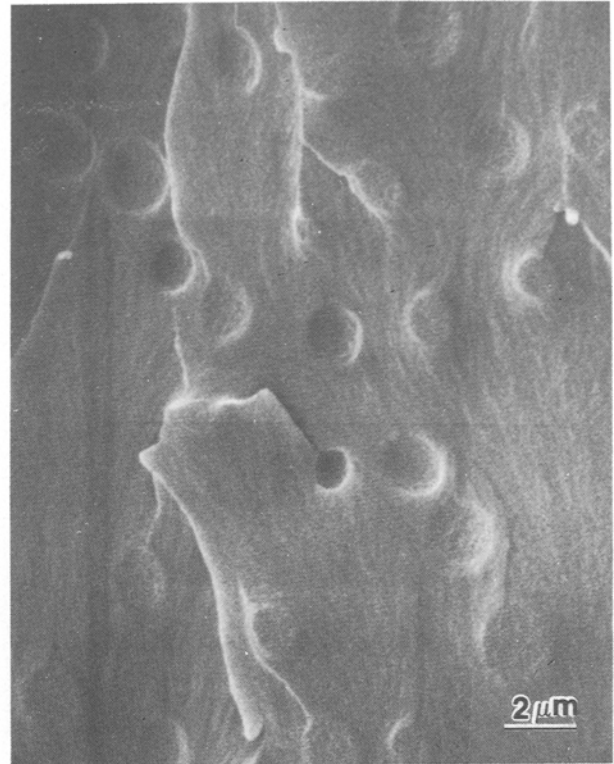
Figure 11 SEM from the fast fracture area of fractured SEN-3PB specimen of 828-8(10).

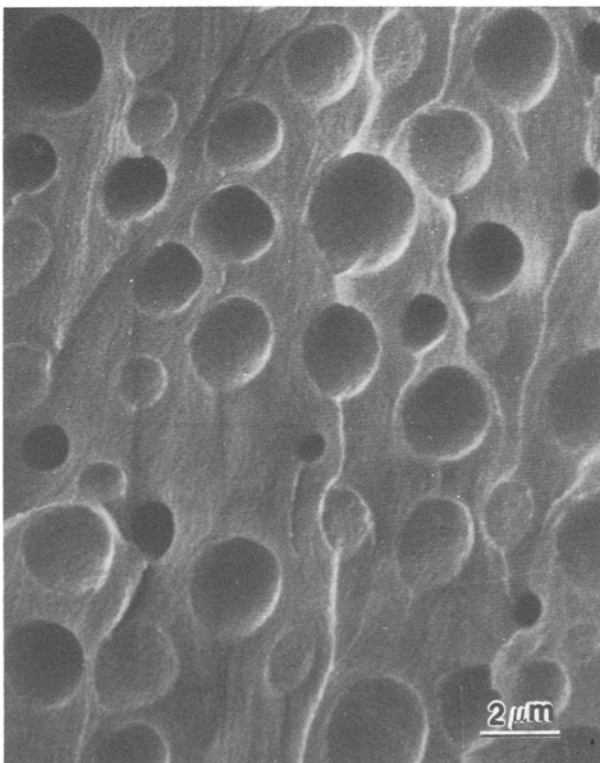
Figure 10 SEM from the stress-whitened area of fractured SEN-3PB specimen of 828-8(20).

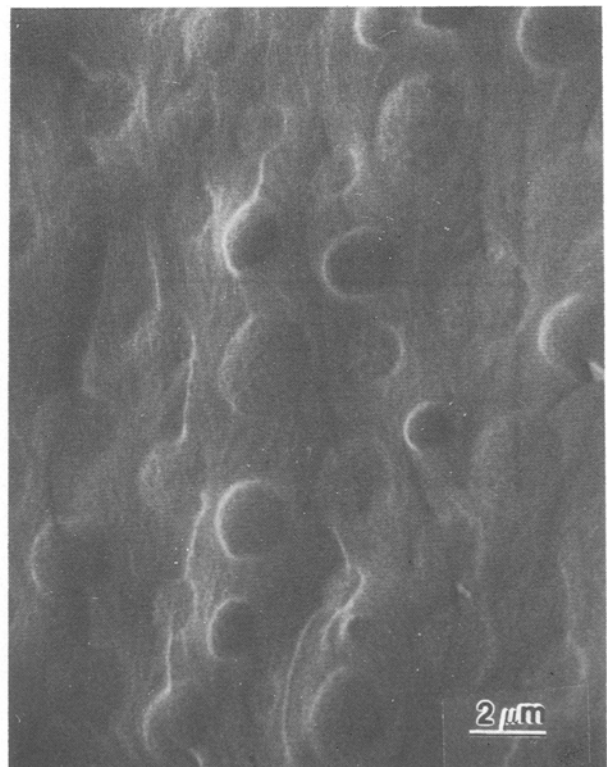
Figure 12 SEM from the fast fracture area of fractured SEN-3PB specimen of 828-8(20).

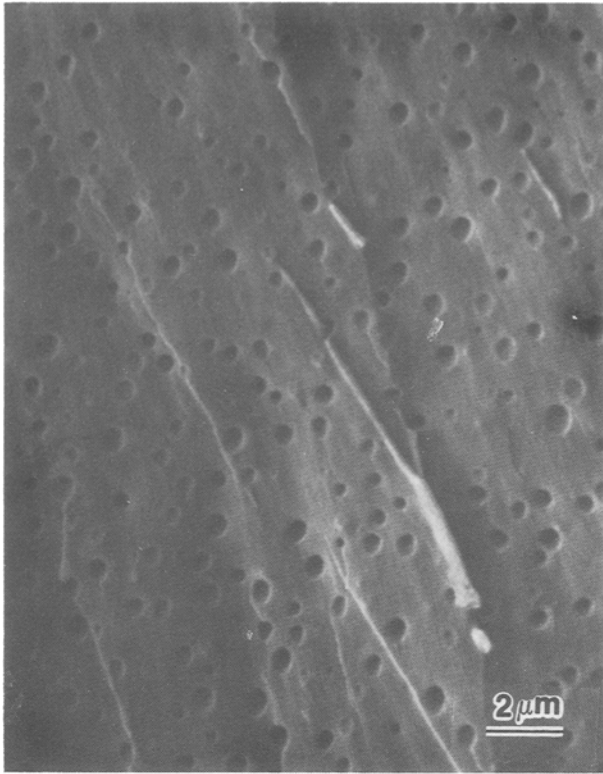
Figure 13 SEM from the stress-whitened area of fractured SEN-3PB specimen of 828-BPA(24)-8(5).

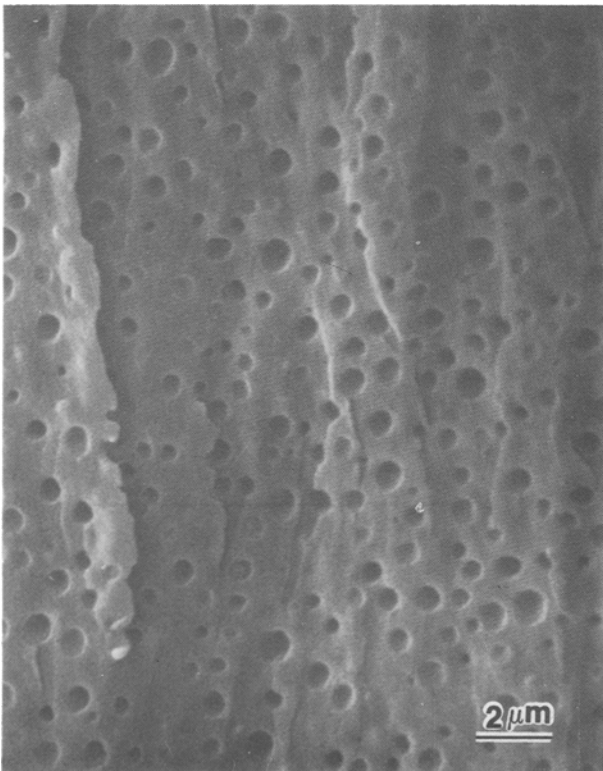
Figure 14 SEM from the stress-whitened area of fractured SEN-3PB specimen of 828-BPA(24)-8(10).

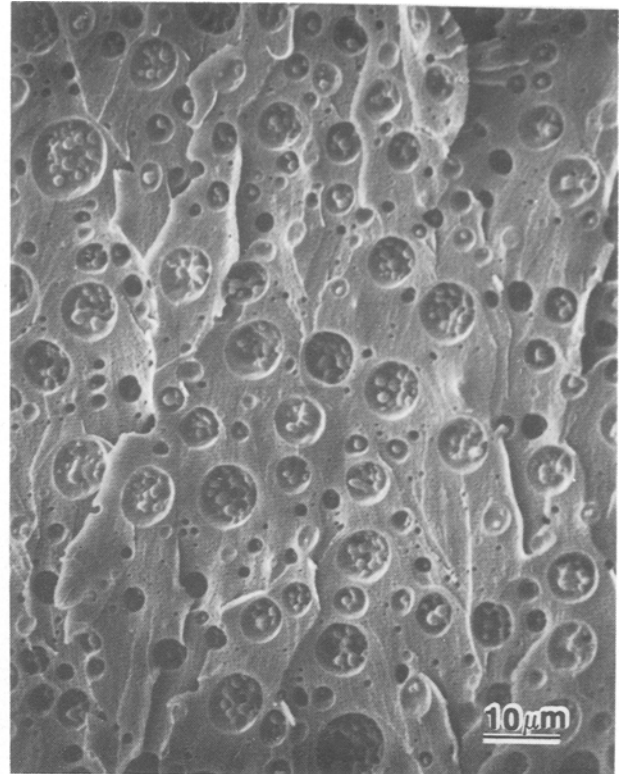
Figure 15 SEM from the stress-whitened area of fractured SEN-3PB specimen of 828-BPA(24)-8(15). Note the glassy occlusions in the fractured rubber particles.

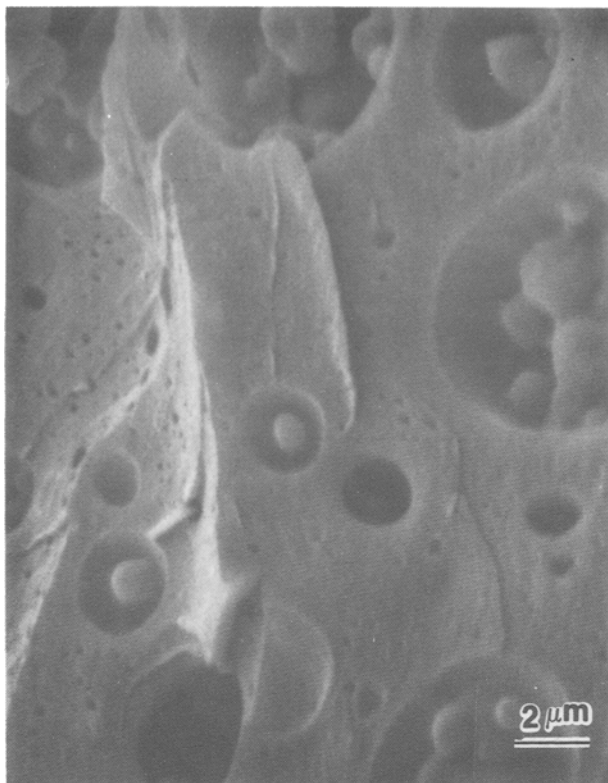
*Figure 16* Higher magnification SEM of the fracture surface in Fig. 15. Note the cavities formed by the small particles in the interstitial space between the large particles.

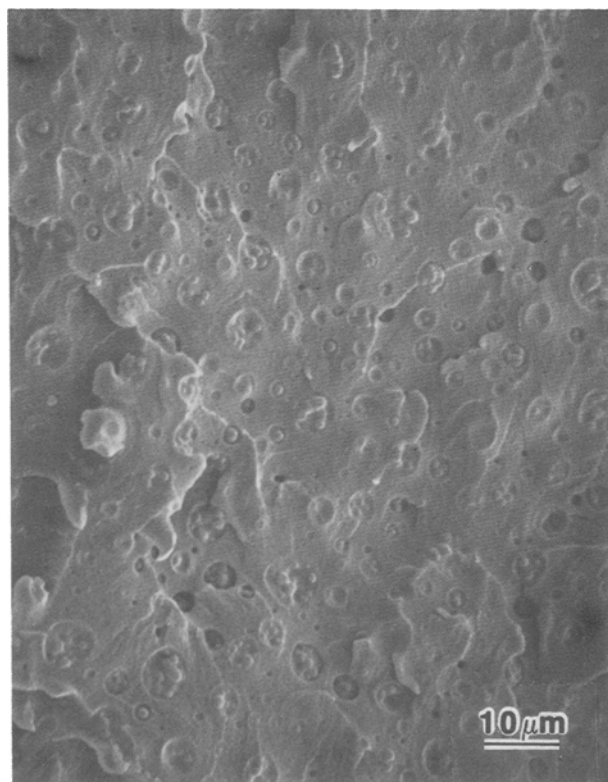
*Figure 17* SEM from the fast fracture area of fractured SEN-3PB specimen of 828-BPA(24)-8(15). Compared with Fig. 15, the cavities are shallower and the cavity diameters are smaller.

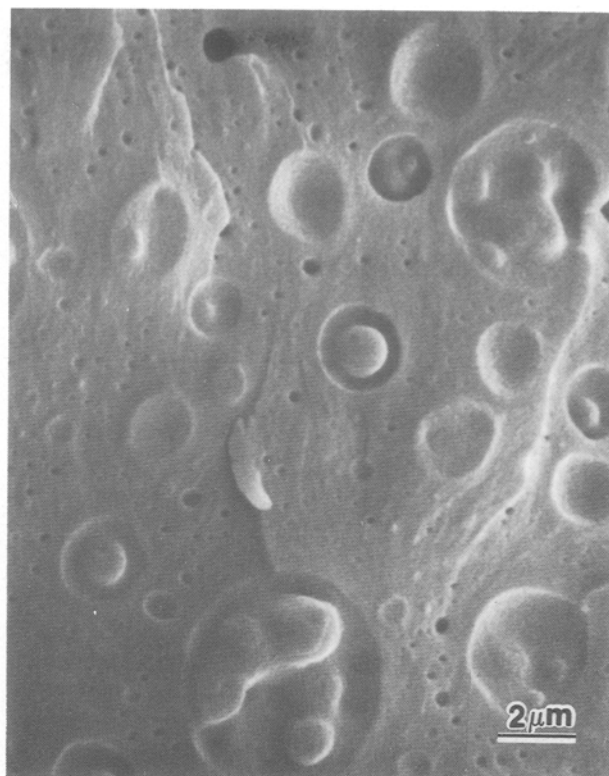
*Figure 18* Higher magnification SEM of the fracture surface in Fig. 17.

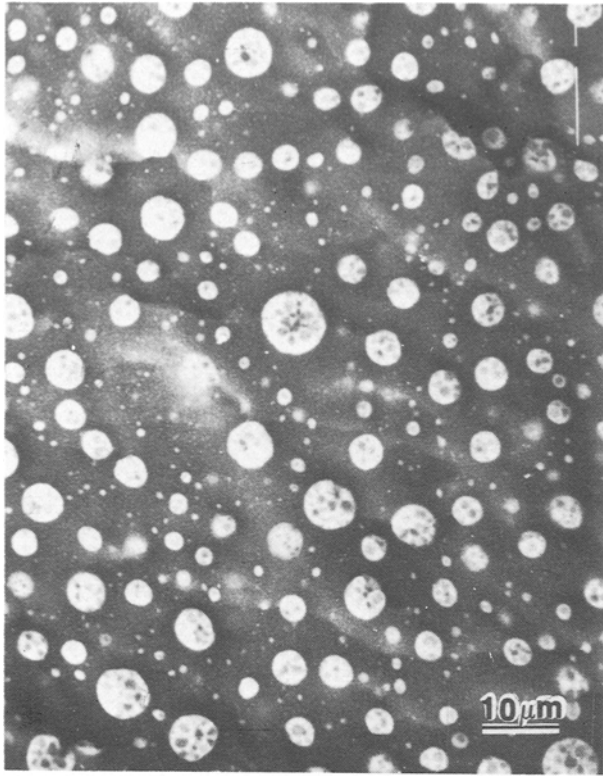
*Figure 19* SEM in the back-scattered electron mode from the same type of fracture surface as in Fig. 15. The fracture surface has been stained with  $\text{OsO}_4$ . The rubber particles appear lighter than the epoxy because the osmium is concentrated on the unsaturated rubber.

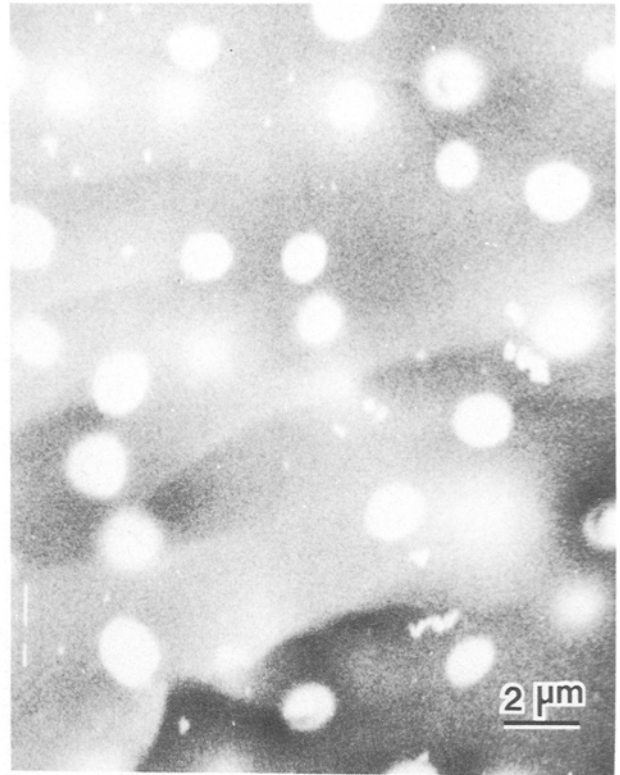
*Figure 21* SEM in the back-scattered electron mode from the fracture surface of 828-8(10). The fracture surface has been stained with  $\text{OsO}_4$ .

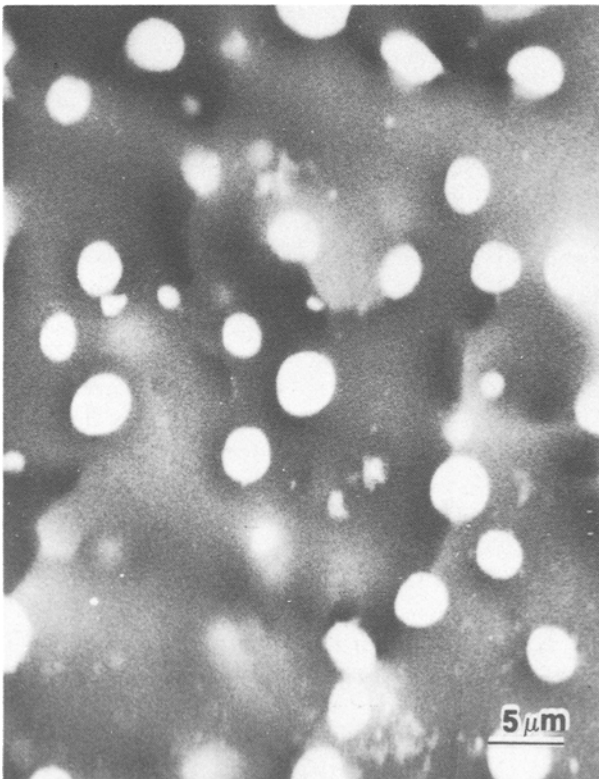
*Figure 20* SEM in the back-scattering electron mode from the fracture surface of 828-15(10). The subsurface rubber particles are faintly visible because the  $\text{OsO}_4$  stain can penetrate beyond the surface.

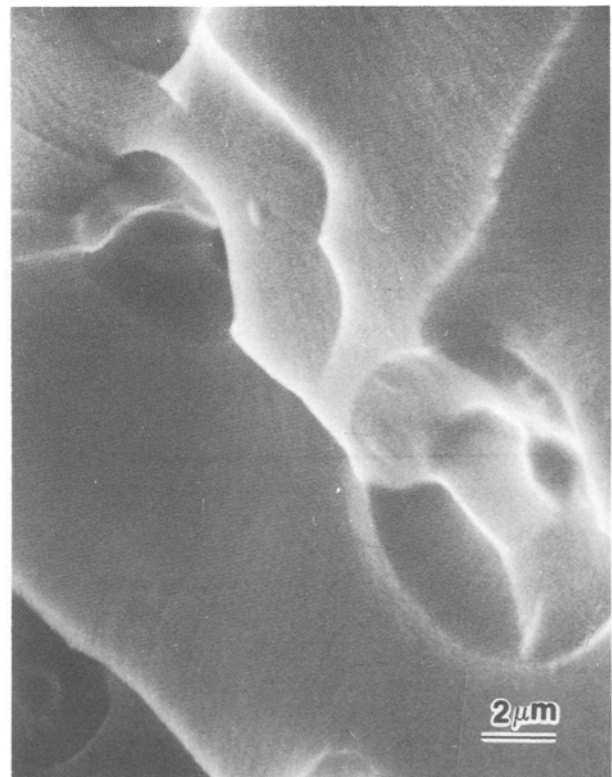
*Figure 22* SEM from the slow crack growth area of a fractured tensile specimen of 828-15(10).

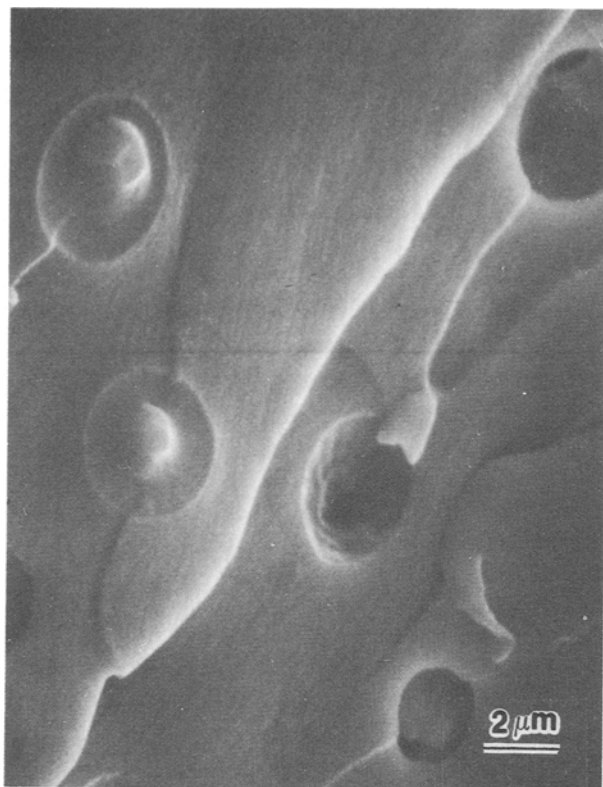
Figure 23 As in Fig. 22, but for 828-15(15).

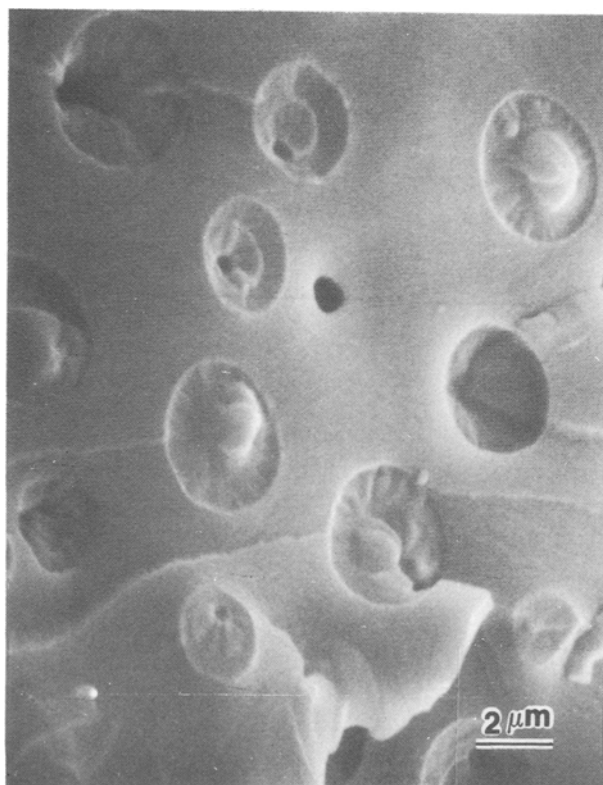
Figure 24 As in Fig. 22, but for 828-15(20). Note that the cavity diameters are smaller than those in Fig. 23. This is because at this level of rubber and strain rate, the deformation is essentially by shear.

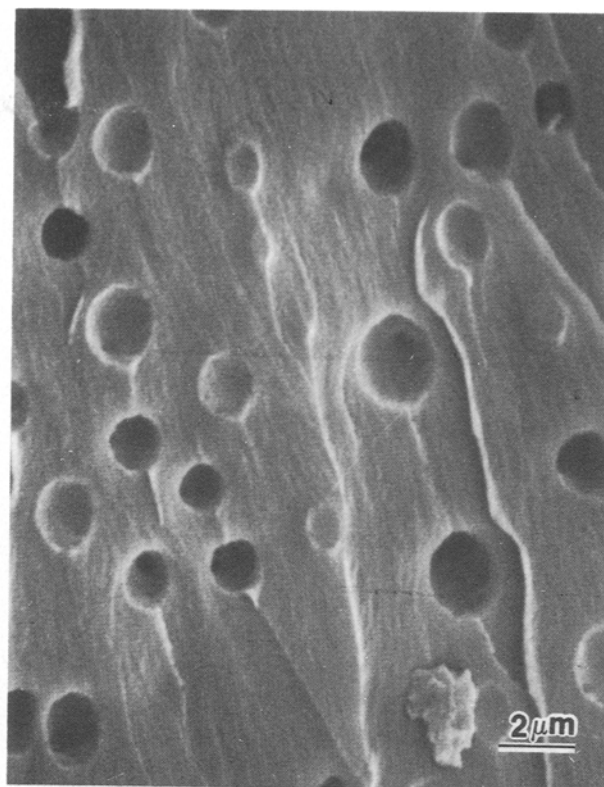
Figure 25 SEM from the slow crack growth area of a fractured tensile specimen of 828-8(10).

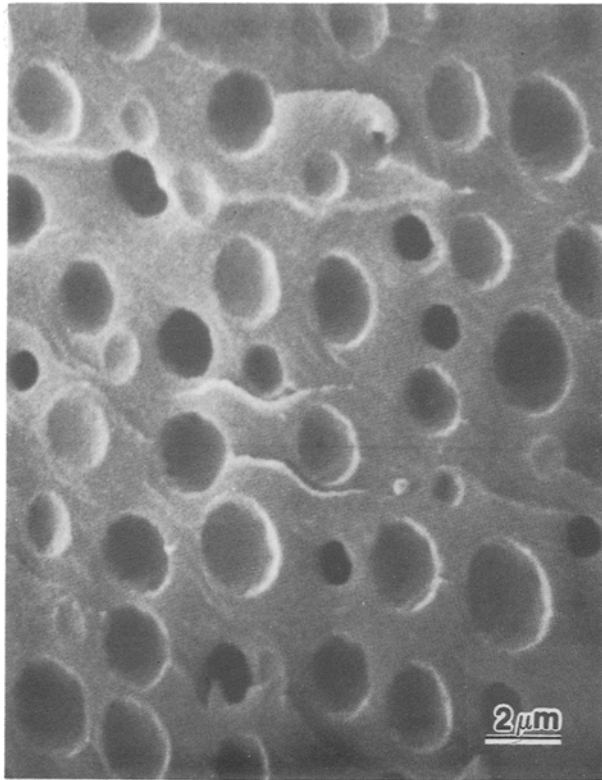
Figure 26 As in Fig. 25, but for 828-8(20).

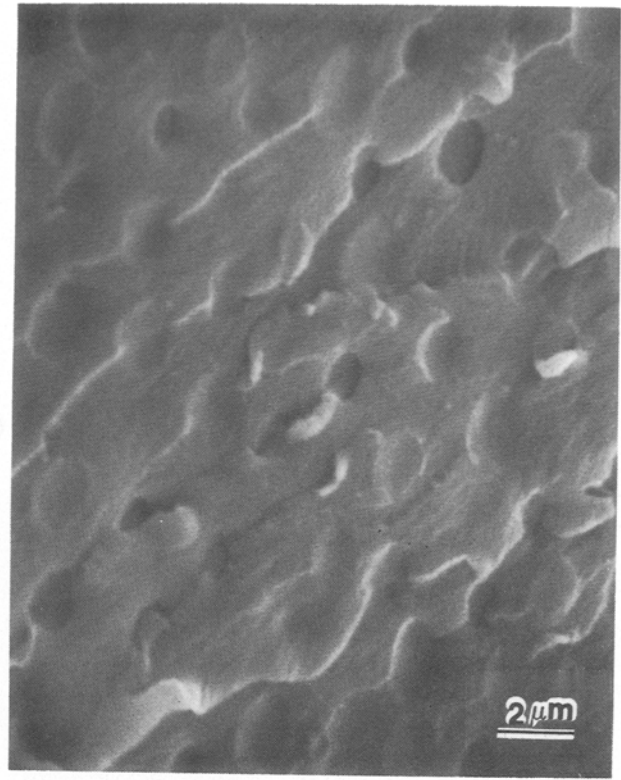
Figure 28 As in Fig. 26, but from the fast fracture area.

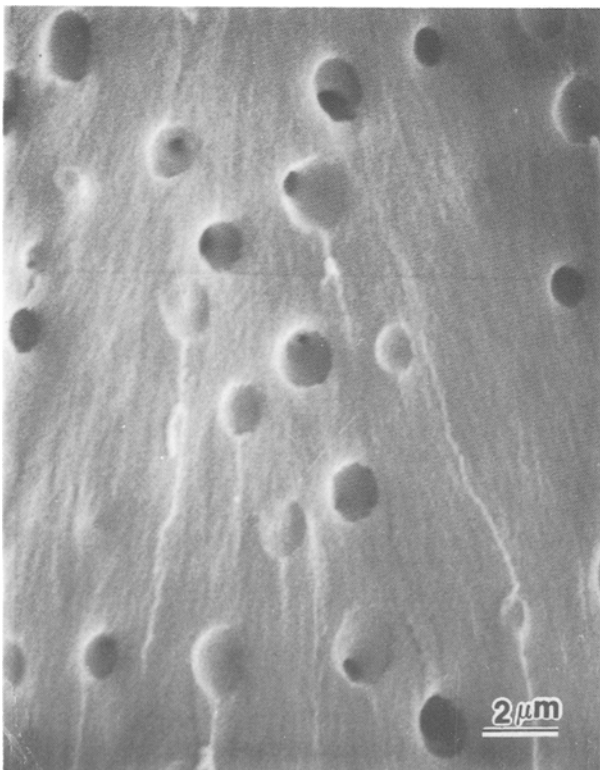
Figure 27 As in Fig. 25, but from the fast fracture area.

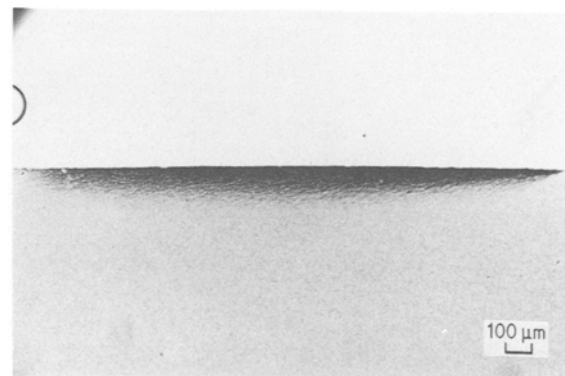
Figure 29 Bright-field OM of thin section perpendicular to the fracture surface showing subsurface damage in SEN-3PB specimen of 828-8(20). The crack ran from right to left. The dark region is the plastic zone caused by voids and shear bands.

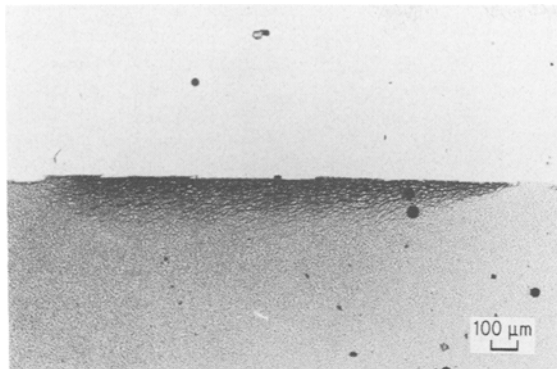
Figure 30 As in Fig. 29, but for 828-BPA(24)-8(15). Note the larger plastic zone corresponding to higher toughness.

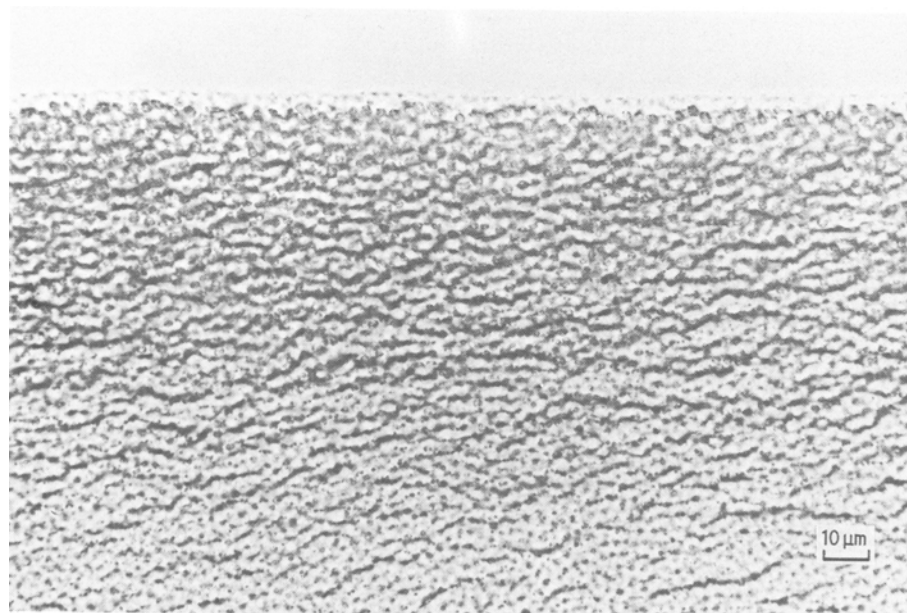
Figure 31 As in Fig. 29, but at a higher magnification. The rubber particles near the fracture surface are cavitated more than those further away from the fracture surface. The density of the shear bands is also higher near the fracture surface.

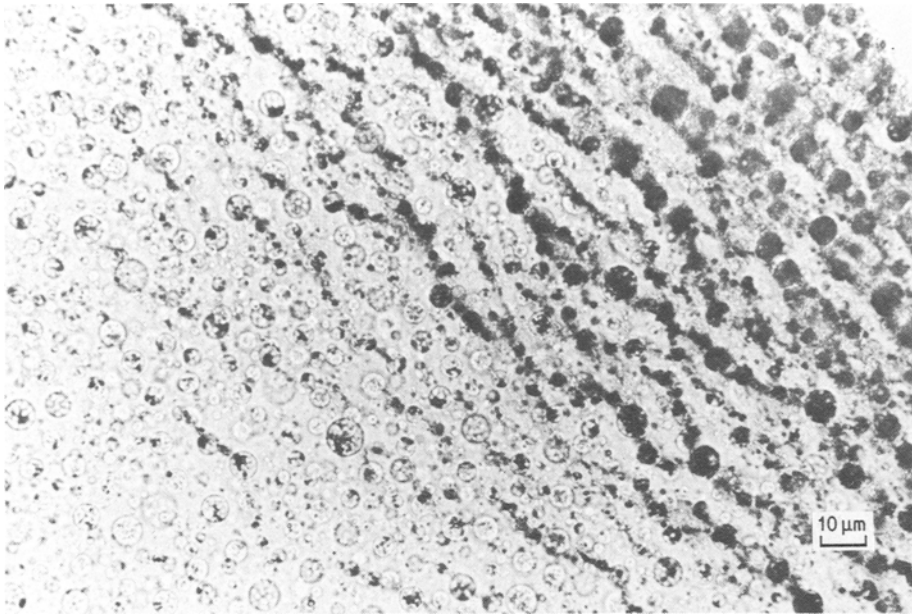
*Figure 32* As in Fig. 30, but at a higher magnification and viewed between crossed polarizers. The fracture surface is at the upper right hand corner. The cavitated particles appear dark because of light diffraction. Near the fracture surface the cavitated particles are also somewhat elongated. Shear bands, which are birefringent, span the particles. The rubber particles furthest away from the fracture surface (lower left hand corner) are not cavitated. In the intermediate zone the cavitated particles are not always associated with shear bands.

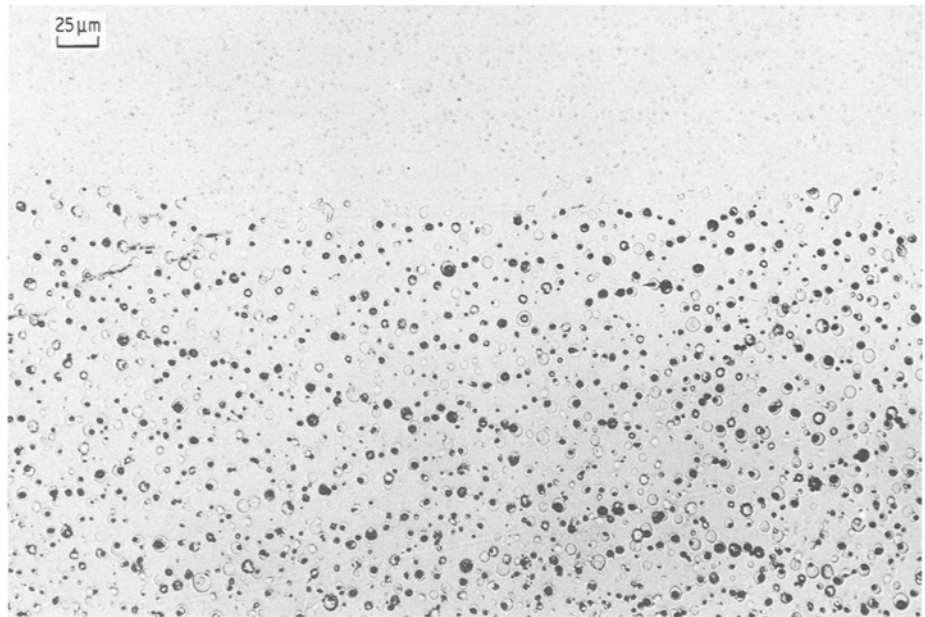
*Figure 33* Bright-field OM of thin section perpendicular to the fracture surface of a tensile specimen of 828-15(10). The cavitated rubber particles are dark because of light diffraction.

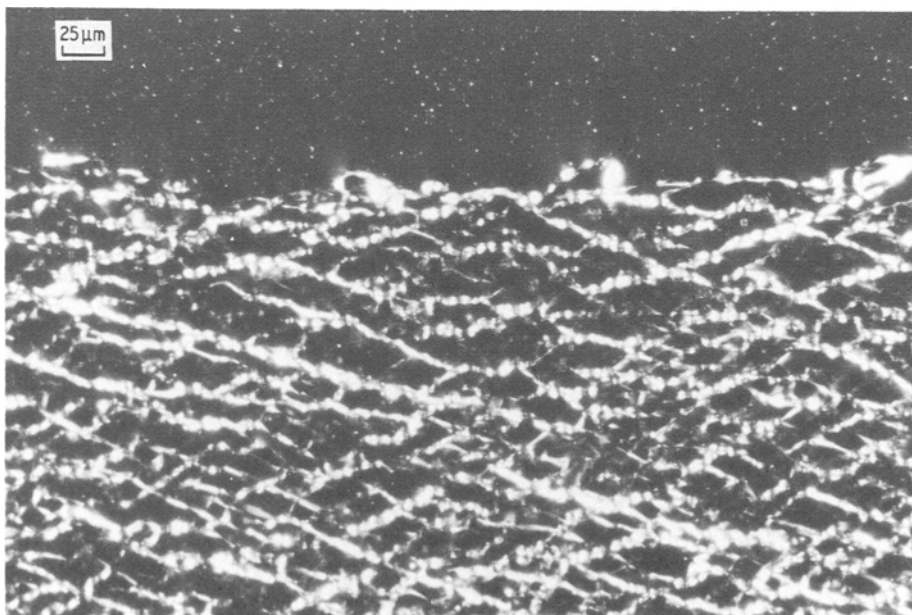
*Figure 34* The same thin section in Fig. 33 viewed between crossed polarizers. The shear bands are highly birefringent and appear as bright bands. Not all the cavitated particles in Fig. 33 are associated with shear bands.

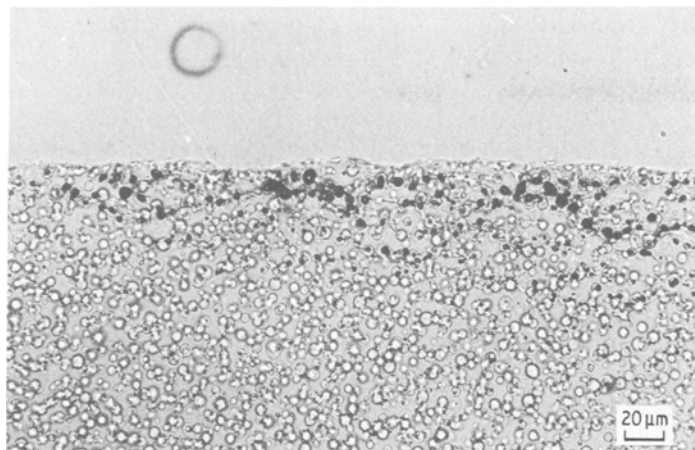
Figure 35 Bright field OM of thin section perpendicular to the fracture surface of a SEN-3PB specimen of 828-15(10). The cavitated rubber particles are confined to a zone near the fracture surface.

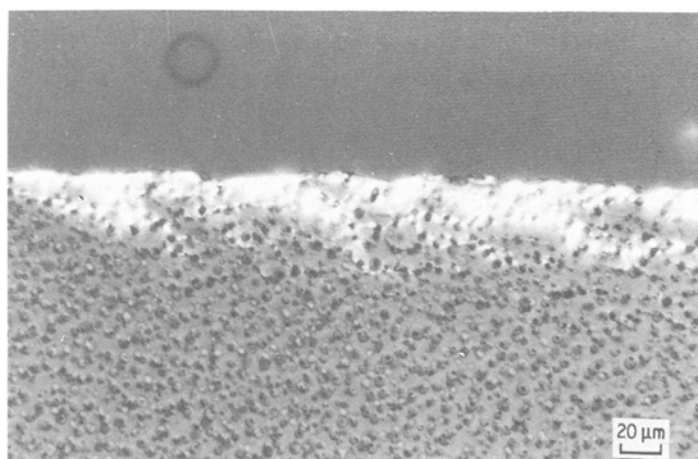
Figure 36 The same thin section in Fig. 35 viewed between crossed polarizers. The birefringent shear bands are confined to an even narrower zone near the fracture surface than the cavitated particles.

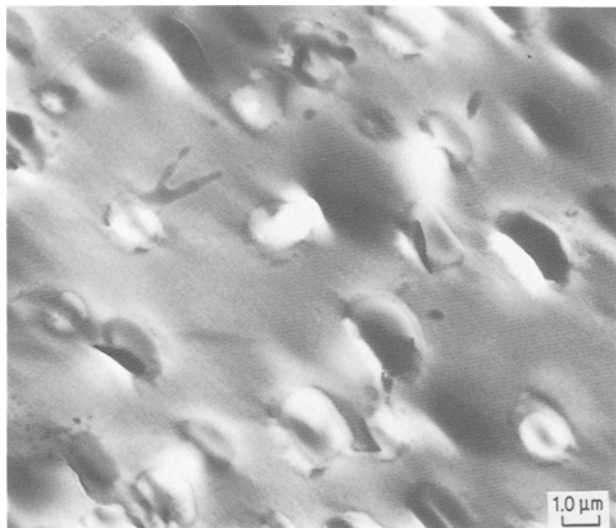
Figure 37 TEM of  $\text{OsO}_4$  stained thin section of a SEN-3PB specimen. The fracture surface is near the top of the micrograph. The rubber particles, which appear dark due to the staining, are cavitated.
