Electron Microscopy of Gold Soldered Joints

M. KAMAL EL-EBRASHI, KAMAL ASGAR, and W. C. BIGELOW
University of Michigan, School of Dentistry, Ann Arbor, Michigan

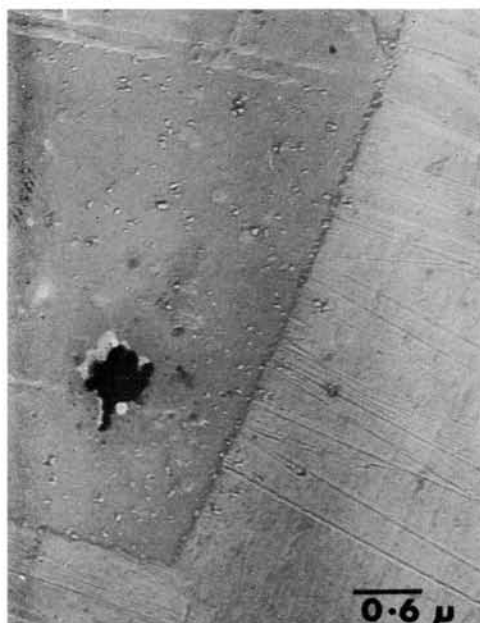
FIG 3.—Properly heated gold-solder interface, showing no diffusion. Note the solder pit (orig mag $\times 33,000$).

PROPERLY HEATED GOLD SOLDERED JOINT.—The gold-solder interface was examined at a magnification of $\times 24,000$. No diffusion occurred along this interface (Fig 3, 4).

Scratches shown in Figure 3 went across the softer parent gold alloy and stopped at the junction between the solder and the gold

alloy. This distinct demarcation confirmed the finding of previous investigations¹ that a solder joint could be obtained without diffusion between the solder and the parent alloy. A soldering pit can be seen in Figure 3 near the interface.

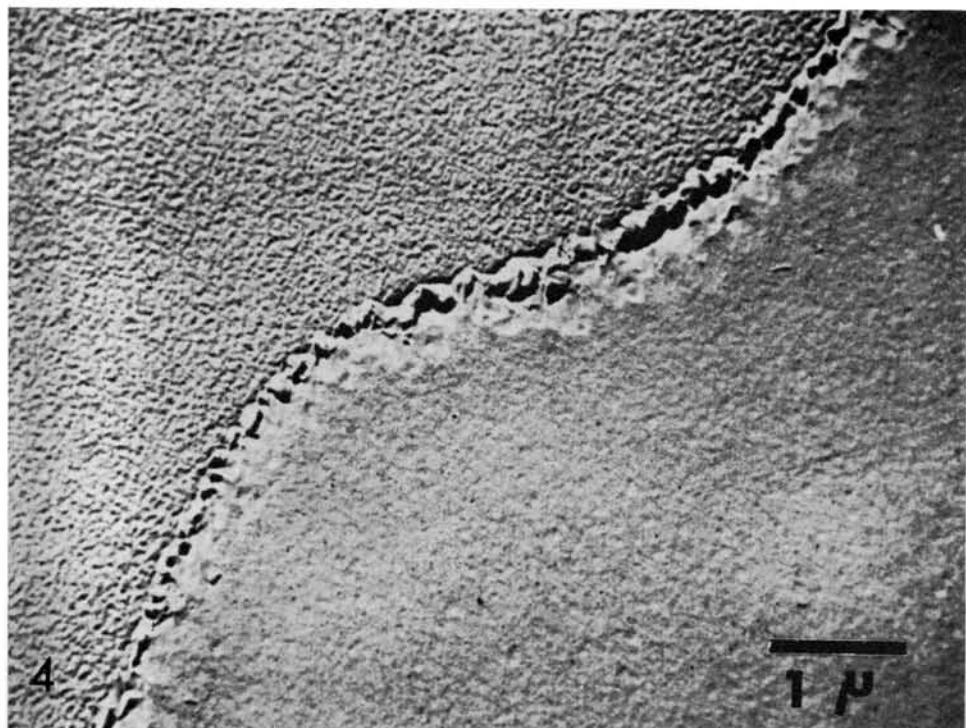
FIG 4.—A portion of the interface shown in Figure 4 (orig mag $\times 65,000$).

The gold alloy along the border of the solder was photographed at $\times 13,000$, (Fig 4). A three-sided grain structure formation was observed (Fig 5). No diffusion was seen along the grain boundaries.

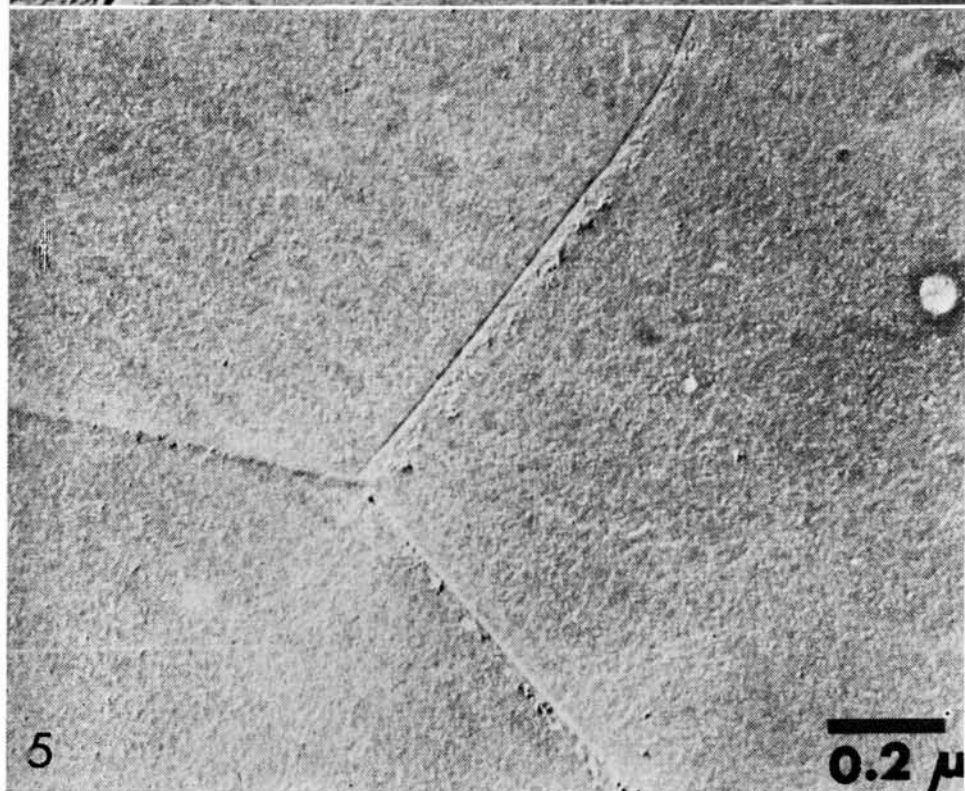
FIG 5.—Properly heated solder joint showing no diffusion along grain boundaries (orig mag $\times 78,000$).

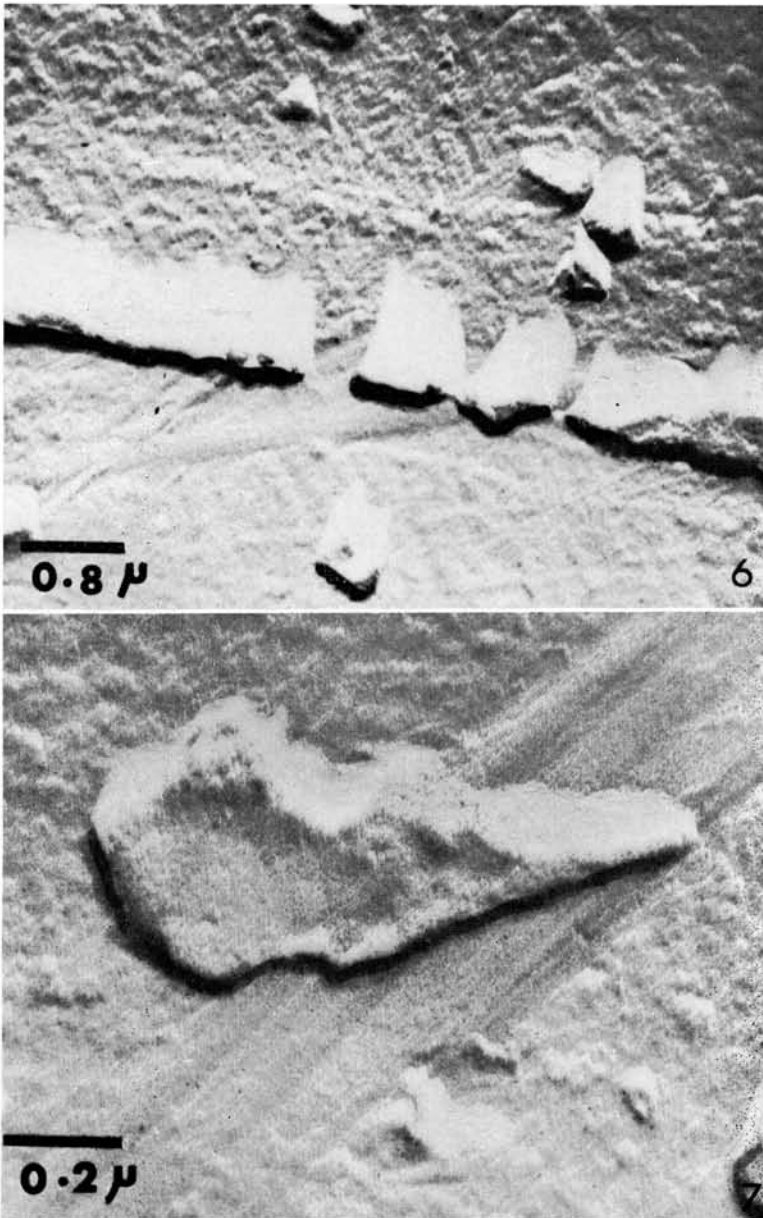
FIG 6.—Assumed oxide formation along interface (orig mag $\times 27,000$).

FIG 7.—Assumed oxide particle shown in Figure 6 (orig mag $\times 93,000$).

ation is shown in Figures 6 and 7. According to the theories of surface energy, this structure was not a solder pit, but rather an oxide formation at the gold-solder interface. Oxides are usually resistant to etching; the ultrastructure of these assumed oxides resembles that of the parent alloy (Fig 7). Improper fluxing may have been the reason for this oxide formation.

There was oxide formation in both the properly heated and overheated joints. It was more pronounced, however, in the latter. Properly used fluxes could prevent oxidation.

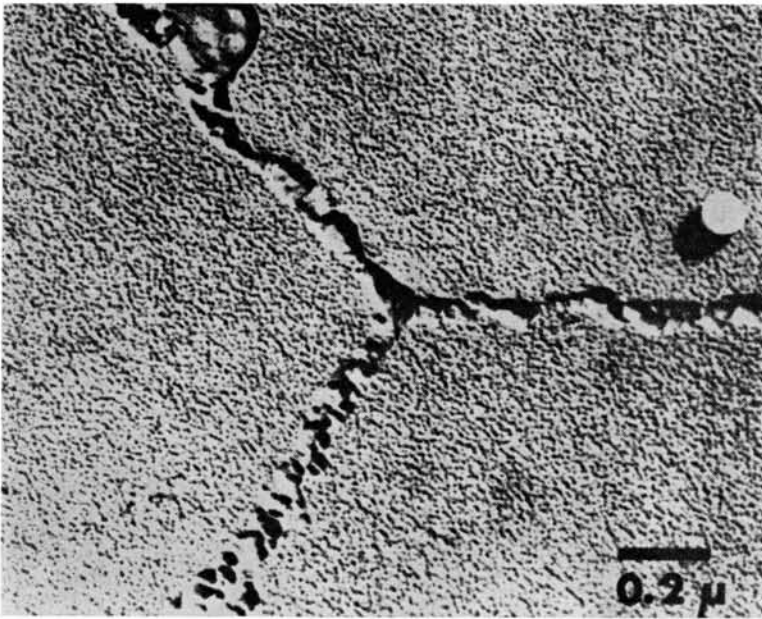
FIG 8.—Overheated solder joint showing partial diffusion of the solder along grain boundaries (orig mag $\times 78,000$).

OVERHEATED GOLD SOLDERED JOINT.—Some diffusion along the grain boundaries was observed when overheating occurred (Fig 8). No distinct interface of solder and parent alloy was seen. When Figure 8 is compared with Figure 5, it can be seen that there is more microporosity in the overheated joint. A greater irregularity of the grains was also observed.

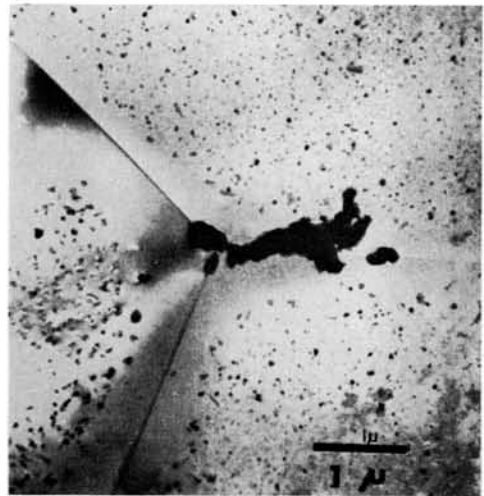
FIG 9.—Evidence of oxide formation and microporosity in overheated solder joints (orig mag $\times 69,000$).

These products contaminate the gold castings and make them brittle,^{9,11,12} and may also cause microporosities (Fig 9). In Figure 9, there can also be seen some evidence of microporosity and oxide formation that may have resulted from the overheating of

tin and zinc in the solder, together with an increased amount of copper which, during overheating, tends to oxidize. The configuration of these structures, which are assumed to be oxides, resembles those in Figures 6 and 7.

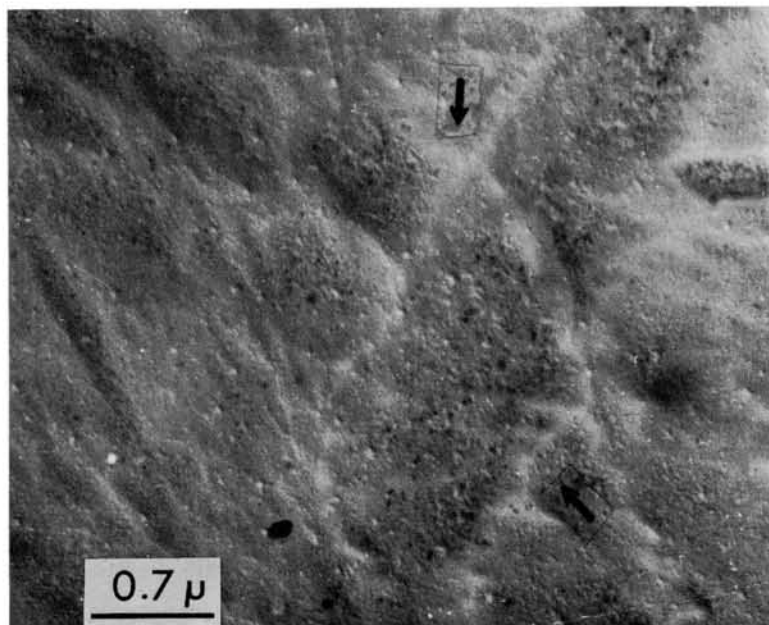
Complete diffusion, which is indicated by the absence of interface, may take place between the parent alloy and the solder under extremely high temperatures (Fig 10). From a theoretical point of view, diffusion by itself should not produce an inferior joint.^{13,14} To achieve complete diffusion, however, extremely high temperatures should be employed. Unfortunately, under such circumstances, pitting of the joint, microporosity, and oxide formation appear to be unavoidable. These factors in turn will cause inferior physical properties of the soldered joint in terms of modern concepts of metallurgy.

FIG 10.—Complete diffusion of the solder and the parent alloy (orig mag $\times 93,000$).
