Improving precision and safety in the use of beam modifying devices in radiation therapy

R. W. Miller and J. van de Geijn

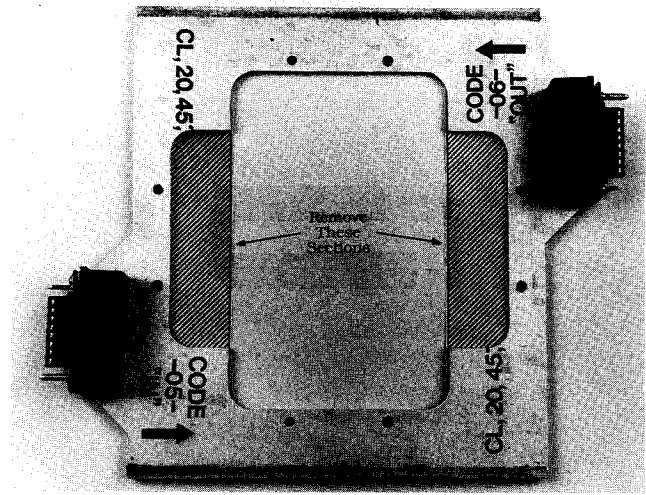
FIG. 1. Wedge mounting plate showing additional areas to be removed when reorienting wedges.

When reorienting each wedge of a pair on its mounting plate, one must pay close attention to proper alignment and centering. Both wedges of a corresponding pair must yield the same wedge factor, that is, have the same thickness at the center of the beam. In practice, remounting requires locating the position of and drilling new holes in the mounting plate to accept the wedge mounting screws. It is important that the position of these holes be referenced to the beam axis rather than to the edges of the plate. This may be facilitated by temporarily covering the cutout in the base plate and marking the location of the center using collimator's rotational axis as the reference point. Once the mounting holes have been drilled, tapped and countersunk, the cutout itself must be enlarged in the new direction, as shown in Fig. 1, to eliminate extra attenuation at the edges of large fields. In addition, some accelerators, in particular the Varian Clinac[®]-18/20 series, require an additional hardware modification so that the new wedge configuration is properly recognized by the fault logic circuits. Detailed instructions for performing this modification are available upon request from the authors. As a note of caution, one should consult with the appropriate factory service representative before attempting this, or any other modification to an accelerator. Failure to do so may void existing warranties and/or service agreements.
