# Path Dependencies and Emergent Design Failure in the NA470 Ship Design Course

Engineering Honors  
*Capstone Final Report*

Matthew Georgy<sup>1</sup>  
Faculty Advisor: Professor David J. Singer<sup>2</sup>  
Department of Naval Architecture & Marine Engineering  
The University of Michigan

April 20, 2021

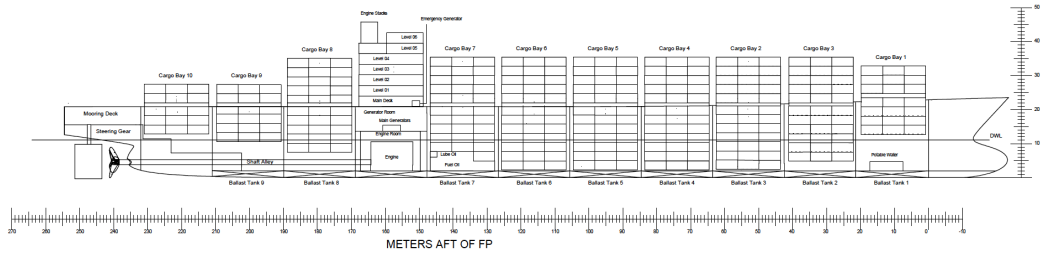
**Figure 2.1:** The inboard profile of the *SS Steel Ducky* .

Notice in figure 2.1 that the aft most container hull is not used and the two nearest to it have containers only stacked two rows high. In order to fit all the containers on board this was compensated for by stacking the containers in the middle most hulls five rows high above the deck. As will later be described this was part of the the design failure.

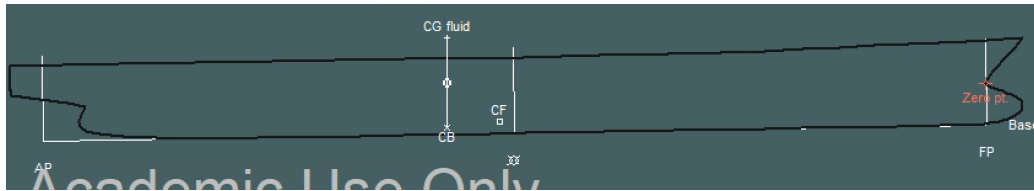
**Figure 4.1:** This depicts trim towards the bow or positive trim.

While this is still preferable to trim towards the stern or negative trim, the goal of this design was to have near zero trim. When I put in my weights into Maxsurf and ran the simulation I could see that the trim was positive. This led to an excessive rework, where the new input of information was what the software indicated. As a result I began to move the containers from the aft 3 container bays to the container bays amidship. Each rework would see a different combination of the number of container rows in the aft. This ended up not working to make the trim zero. In fact in some cases specifically the 14 ton arrival load case the trim ended up being negative. The following table shows the final values of the trim and the difference in weight

When looking back, it seems like part of this problem was due to the lack of buoyancy in the bow of the ship. This partially led to the excessive reworking. These final values are the result of excessively reworking and running out of time forcing me to settle with a configuration of containers that passed each test case as best as possible. Furthermore, it is important to note the negative trim in the 14 Ton Arrival case. This is a great demonstration of the results of an excessive rework design failure as depicted in the graphic. This is because I was not able to explore the knowledge structure around the required emergent path. As a result the design failed severely in this case and affected the rest of my design.

One of the most important aspects of this project is considering how this design failure could have been avoided. In this case, as with many others experience in ship design would have been key to avoiding this situation in the future. I should've been able to understand the hull lines a bit better and understand the lack of buoyancy in the aft of the ship. This would have helped educate my initial cargo hold placements. I also would have avoided spending a lot of time in the excessive reworking stage of this design. Ideally, with a more optimal placement of cargo holds I would have been able to balance the weight of the containers and the deck house in a more optimal manner to minimize the trim of the load cases. As I will discuss in the next section, this could have also been done by implementing the information gained from the floodable length curve. From a theoretical perspective, if I began making design

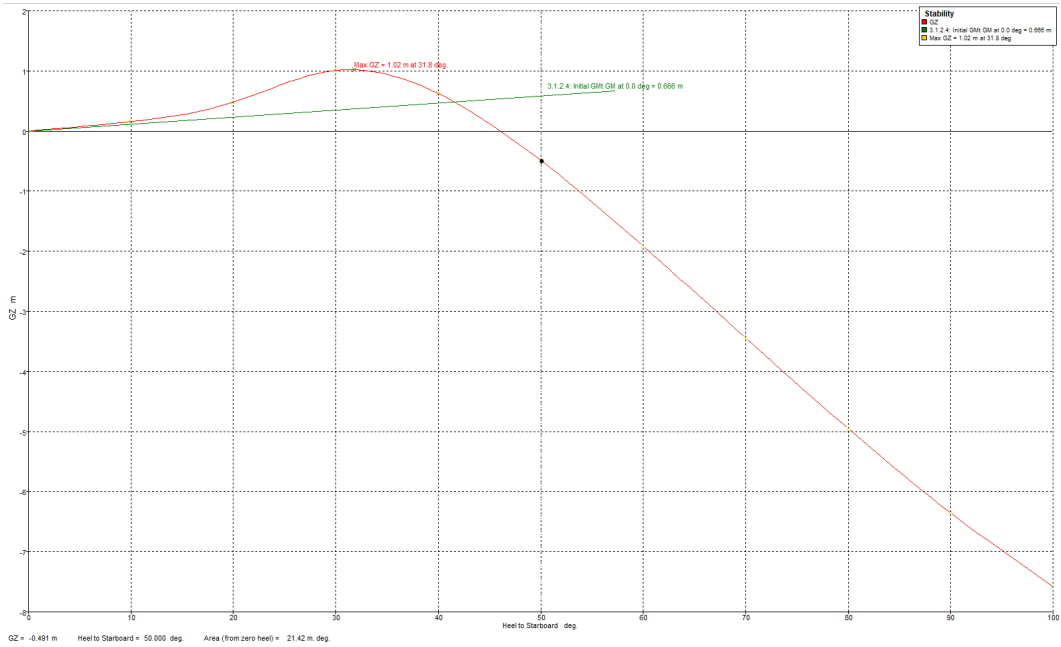
**Figure 4.3:** Intact Stability Righting Arm Curve for 14 Ton Arrival

Figure 4.3 shows the sub optimal shape of the righting arm curve. First, note that the trend in positive stability is not very dramatic. This indicates that as the ship heels the righting arm moment will not increase as quickly as would be the case for a ship with a more optimum design, while this is typically indicative of good seakeeping the rate of increase is low enough to the point where it would be preferable to have a more stable ship in these heel angles than a comfortable ship to be on. This will be demonstrated in the next section when damage stability is discussed.

Second, the majority of the heel angles that are possible will be in negative stability. As shown in the figure the point of vanishing stability is about 47 degrees. This means that if the ship heels by this amount it will sink. This may pass less strict regulations but it does not inspire confidence in the safety of the ship. This result is again due to the shape of the curve specifically the rapid decrease between the maximum GZ and the point of vanishing stability.

To avoid design churn I should have focused on finding an extremely optimal solution to either of the problems that was being created by configuring the containers in different manners, either trim or the righting arm curve. This would have allowed me to iterate again through the configurations to make find the optimal solution to both problems in a much more timely manner. As a result, my emergent path would not have had dramatic swings through the design space and I would have been able to not spend so much time on the design churn of this aspect of the ship. Complex system engineering problems such as ships will always present these design failure paths, but with an increase of experience, the ability to have a more accurate and rich foresight into the process before going about solving these problems will make probability of being stuck in a design churn much less.

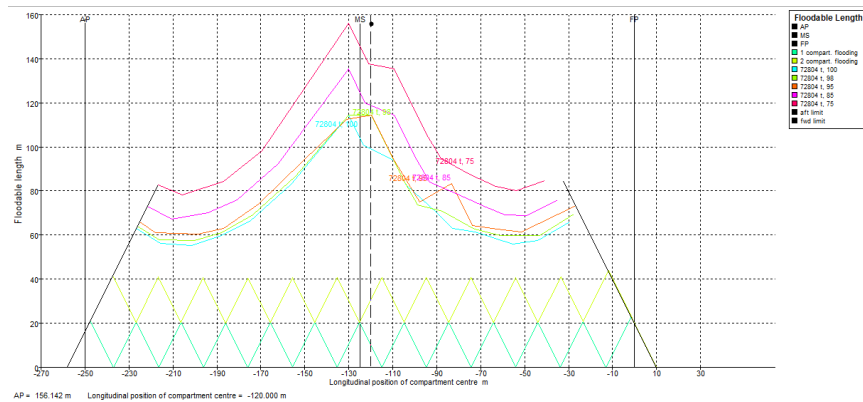
**Figure 4.6:** A demonstration of the double compartment floodable length curve.

Despite currently having a good working knowledge of floodable length curves, at the time of the project I greatly lacked this knowledge. As shown in figure 4.6, I not only made found the floodable length curve but I also found the triangles that denote the volume flooding for the single compartment cases and the double compartment cases.

This graph clearly shows that I had a lot more design space to explore in terms of how I spaced my compartments. For example, I could have made the middle compartments much larger, and made the aft and fore compartments smaller. This would mean that my damage stability analysis for the aft and fore compartments would have had a greater chance of passing. However, due to my failure to integrate this information in my design decisions I continued on the red path exploring knowledge structures that would have great consequences when damage stability was analyzed.

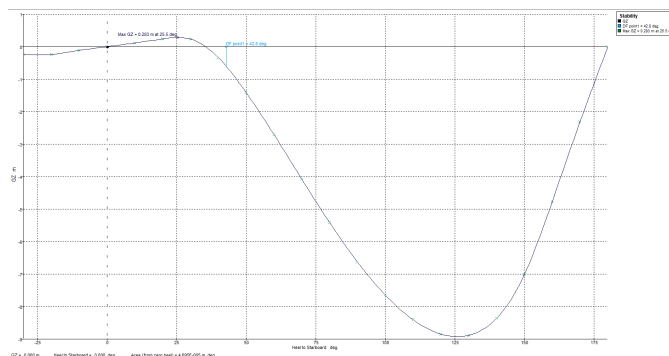
**Figure 4.8:** Damage stability curve when the two aft compartments are flooded the maximum GZ is 0.283 at 25.5 degrees.

The two figures above depict which compartments were damaged and the resulting righting arm curve. These each make the dubious assumption that the permeability is 75% which is not the standard for container holds which should be around 95% but as a result of not being able to pass the regulations for these damage cases I had to artificially deflate the values of the permeability.

Important aspects to note in both righting arm curves is that the curve begins with negative stability. This is an incredibly discouraging result as this means that if the ship is damaged and it is in rough seas the ship will begin to tip it self over with any perturbation. This means that even when it gets to a heel angle where the righting arm curve is positive it will also have to overcome the initial moment of that heel cycle. Furthermore, the maximum GZ and its heel angle for the first case is way below the IMO requirements.

Failure to integrate is the most dramatic design failures because it can lead to a complete disregard for the knowledge structures surrounding the required emergent path. This is demonstrated quite well when looking at the damage stability of the *SS Steel Ducky*, as it lead to the design being completely infeasible when studying its damage stability. The solution would have of course been to use all the information that was available to me in an effective manner so I would be able to explore the knowledge structures and design options surrounding the required emergent path. In retrospect, it would have been wise to make the middle compartments longer and the compartments on the extents shorter. This would incorporate the floodable length curve and would likely ensure that the damage case righting arm curves would have had a much more optimal shape and a higher maximum GZ.

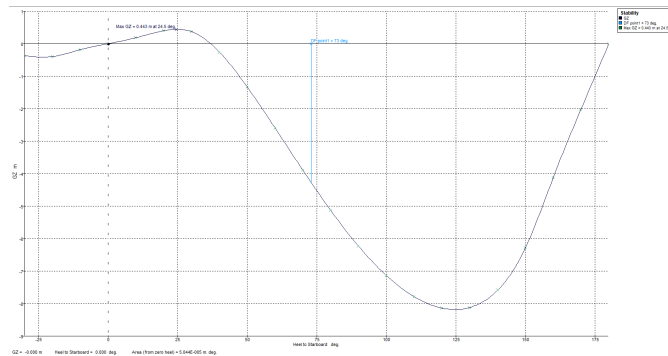
**Figure 4.10:** Damage stability curve when the two aft compartments are flooded the maximum GZ is 0.443 at 24.5 degrees.
