**STRESS CORROSION CRACK INITIATION OF ALLOY 600 AND ALLOY 690 IN  
HYDROGENATED SUPERCRITICAL WATER**

A dissertation submitted in partial fulfillment  
of the requirements for the degree of  
Doctor of Philosophy  
(Materials Science and Engineering)  
in The University of Michigan  
2015

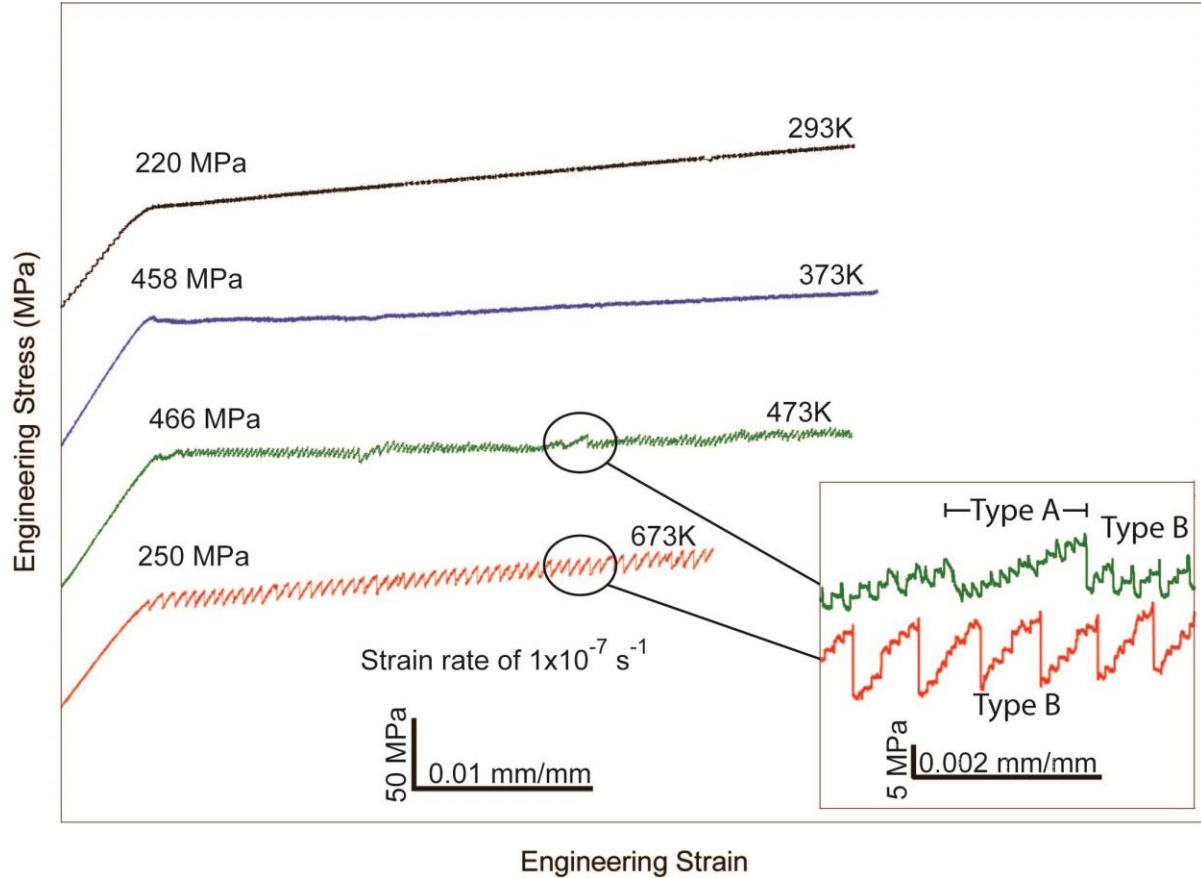
Figure 2.1. Engineering stress-strain curves at a strain rate of  $10^{-7} \text{ s}^{-1}$  for sample 800H-2. The inset is a magnification of the 673K and 473K stress-strain curves showing the type of serrations. The 673K curve shows only type B serrations. The 473K curve shows a type A serration in the middle and type B on either side.[8]

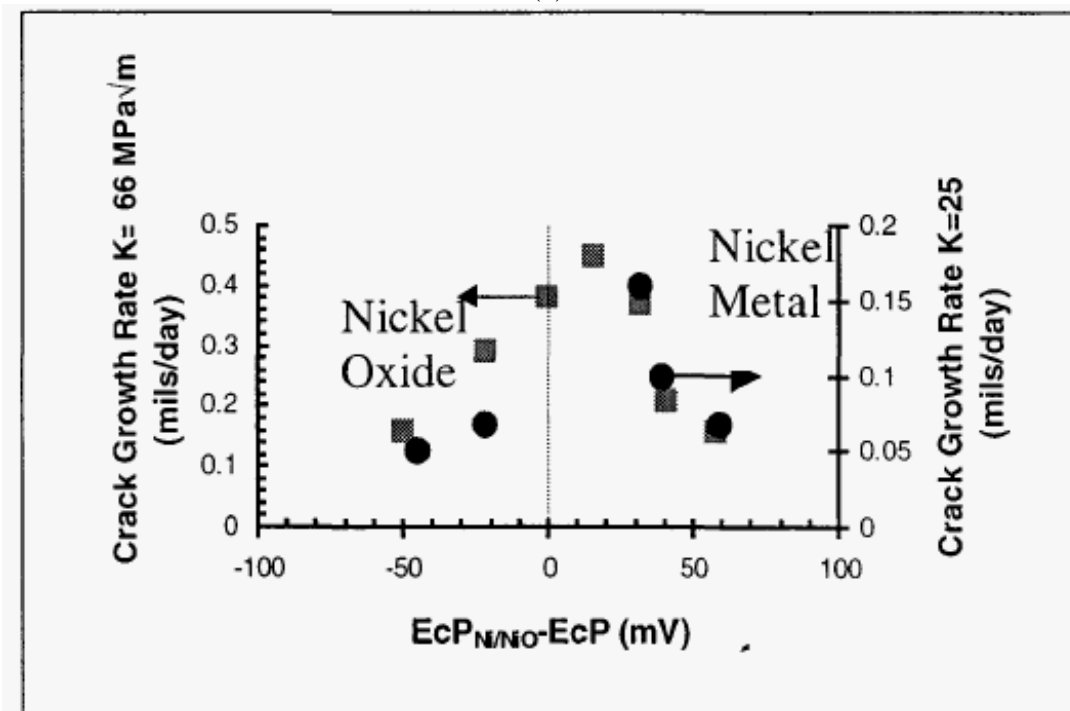
Figure 2.2. Alloy 600 crack growth rate at 338°C (a) plotted versus the aqueous hydrogen concentration and (b) the electrochemical potential difference versus the measured Ni/NiO transition.[9]

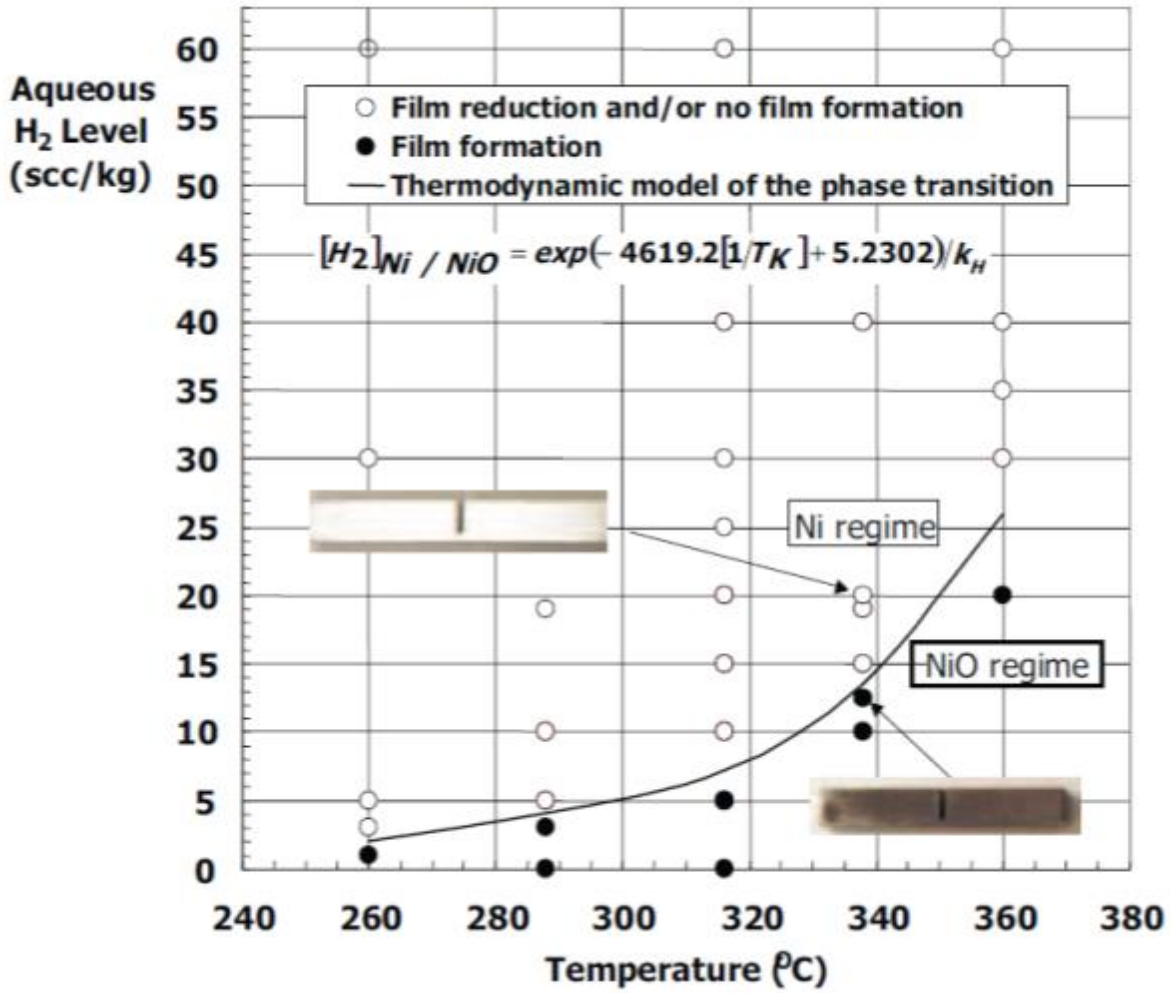
Figure 2.3. Summary of CER and corrosion coupon data.  $[H_2]_{Ni/NiO}$  is the phase transition in cc/kg.  $T_K$  is the temperature in Kelvin and  $k_H$  is the Henry's law coefficient in atm/(cc/kg).[10]

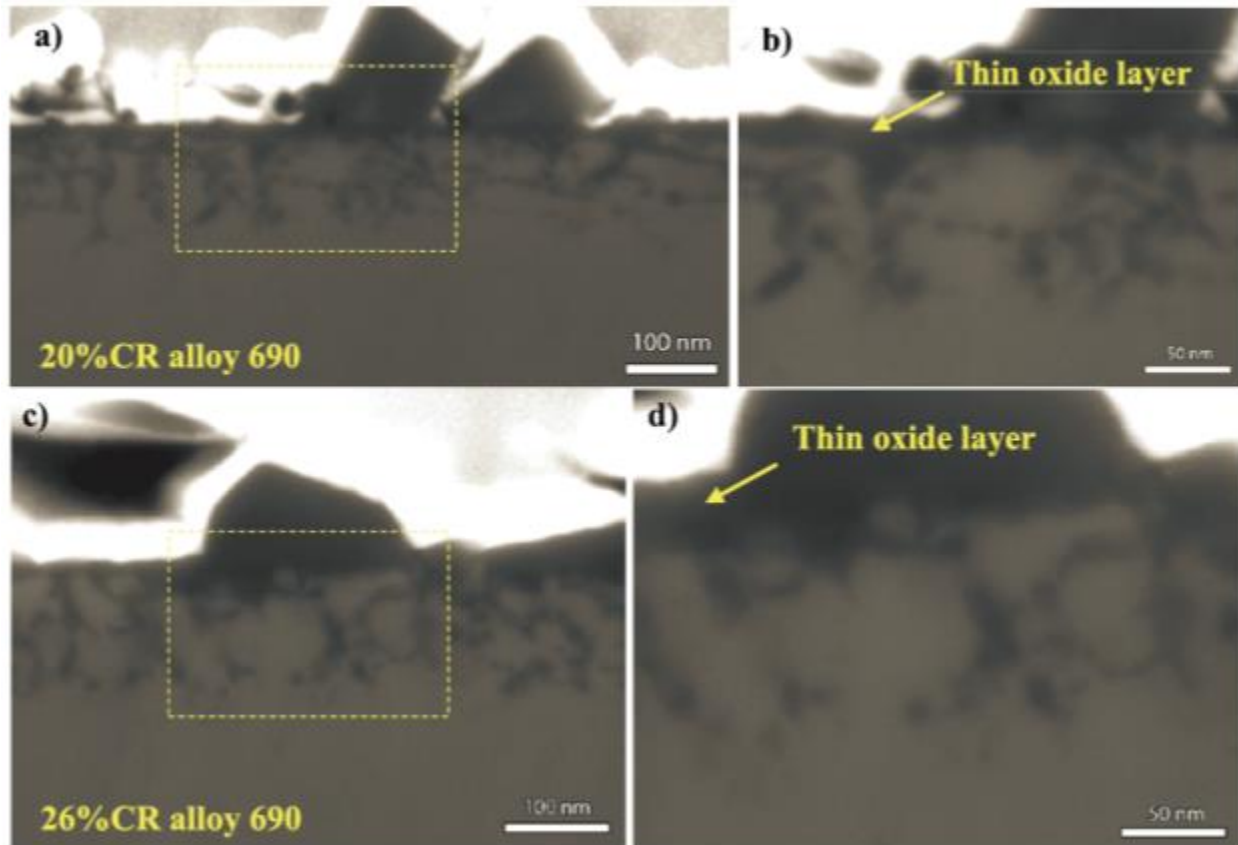
Figure 2.21. SEM backscatter electron micrographs of surface cross sections of Alloy 690 corrosion coupons exposed to 360°C PWR primary water for 1000h. Higher magnification images of the highlighted regions show a thin oxide layer above oxide filaments as small as ~5nm. [26]

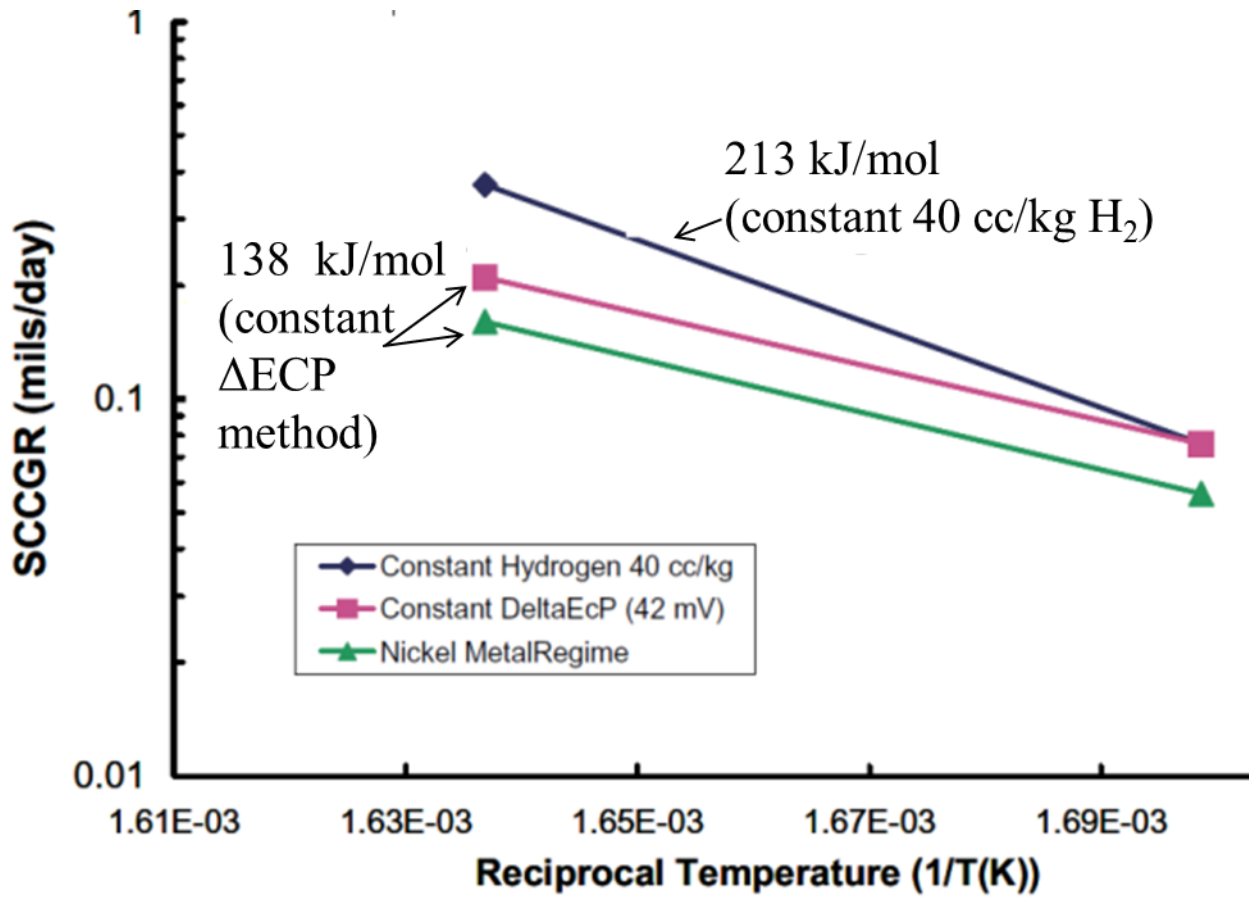
Figure 2.25. Alloy 600 thermal activation energies (kJ/mol) determined using a constant hydrogen content of 40 cc/kg shown in blue triangles and a fixed electrochemical potential from the Ni/NiO boundary in green triangles and purple squares. [42]

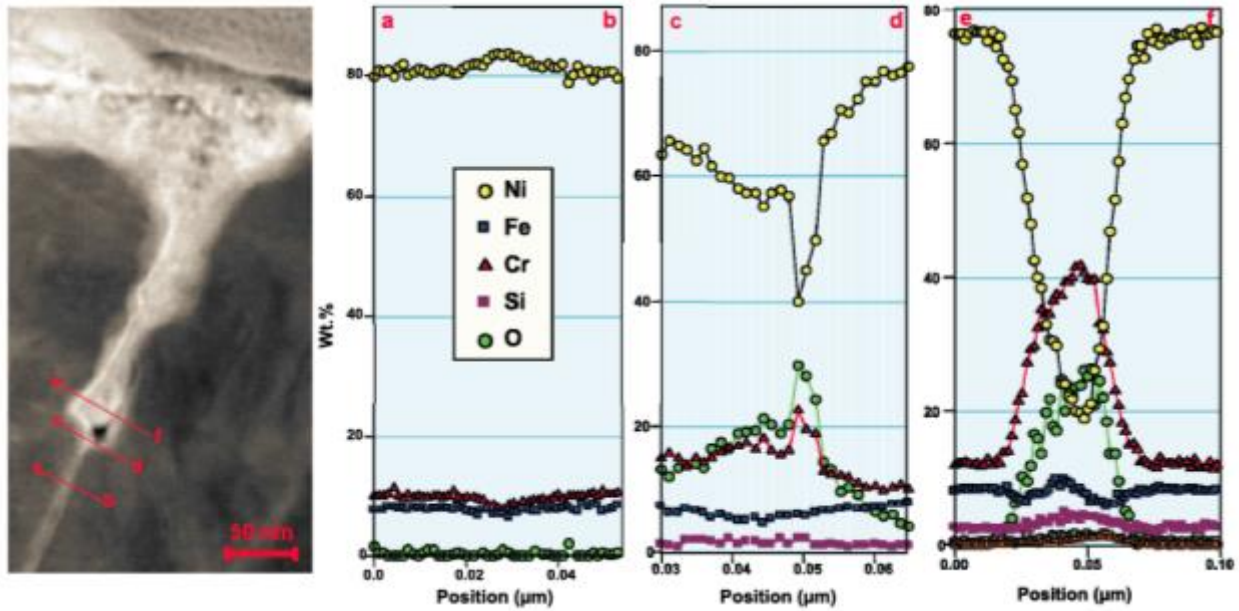
Figure 2.27. STEM high angular bright field micrograph and EDS composition profiles of an intergranular oxide penetration in Alloy 600 exposed to 325°C hydrogenated water. [44]

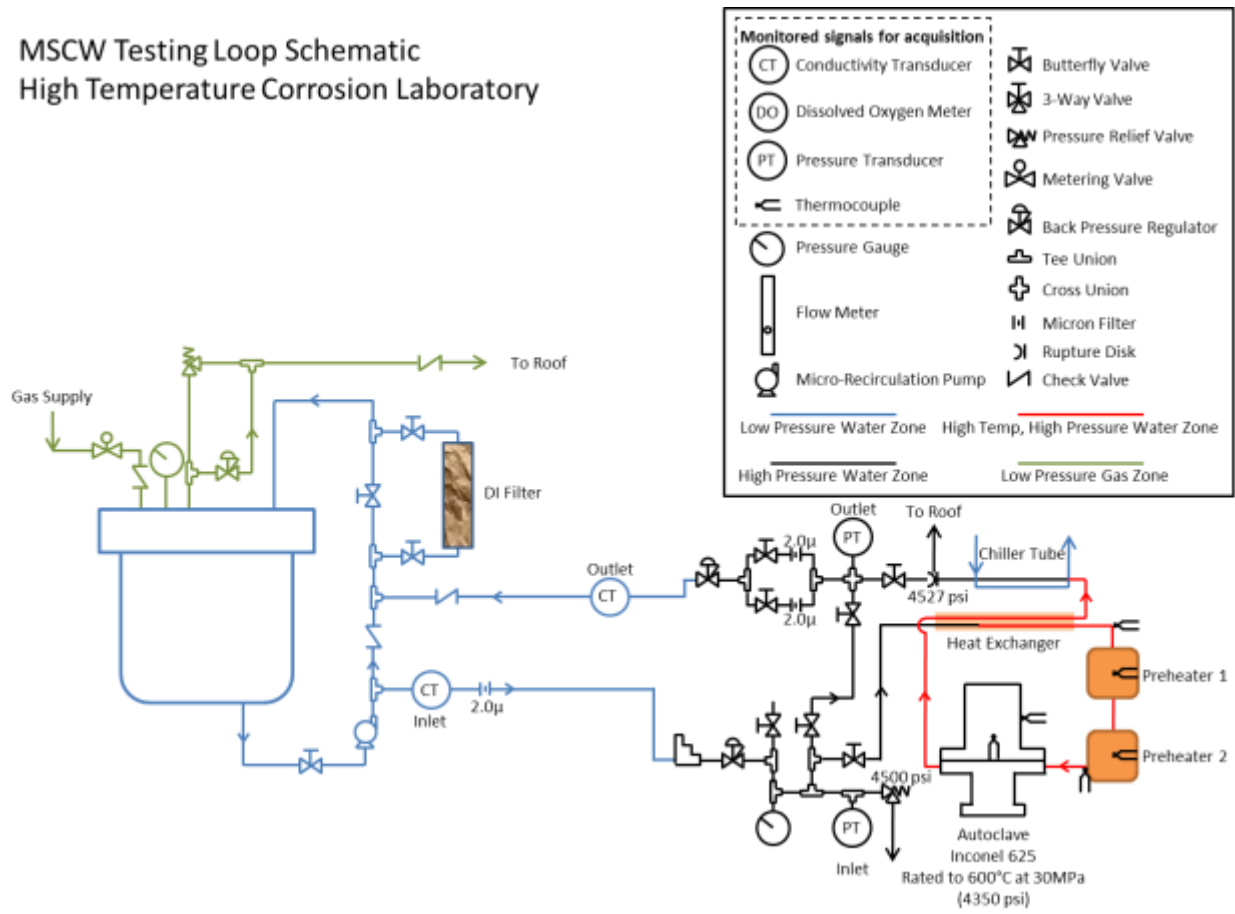
Figure 3.5. Schematic of the MSCW with the high pressure water reservoir attached.

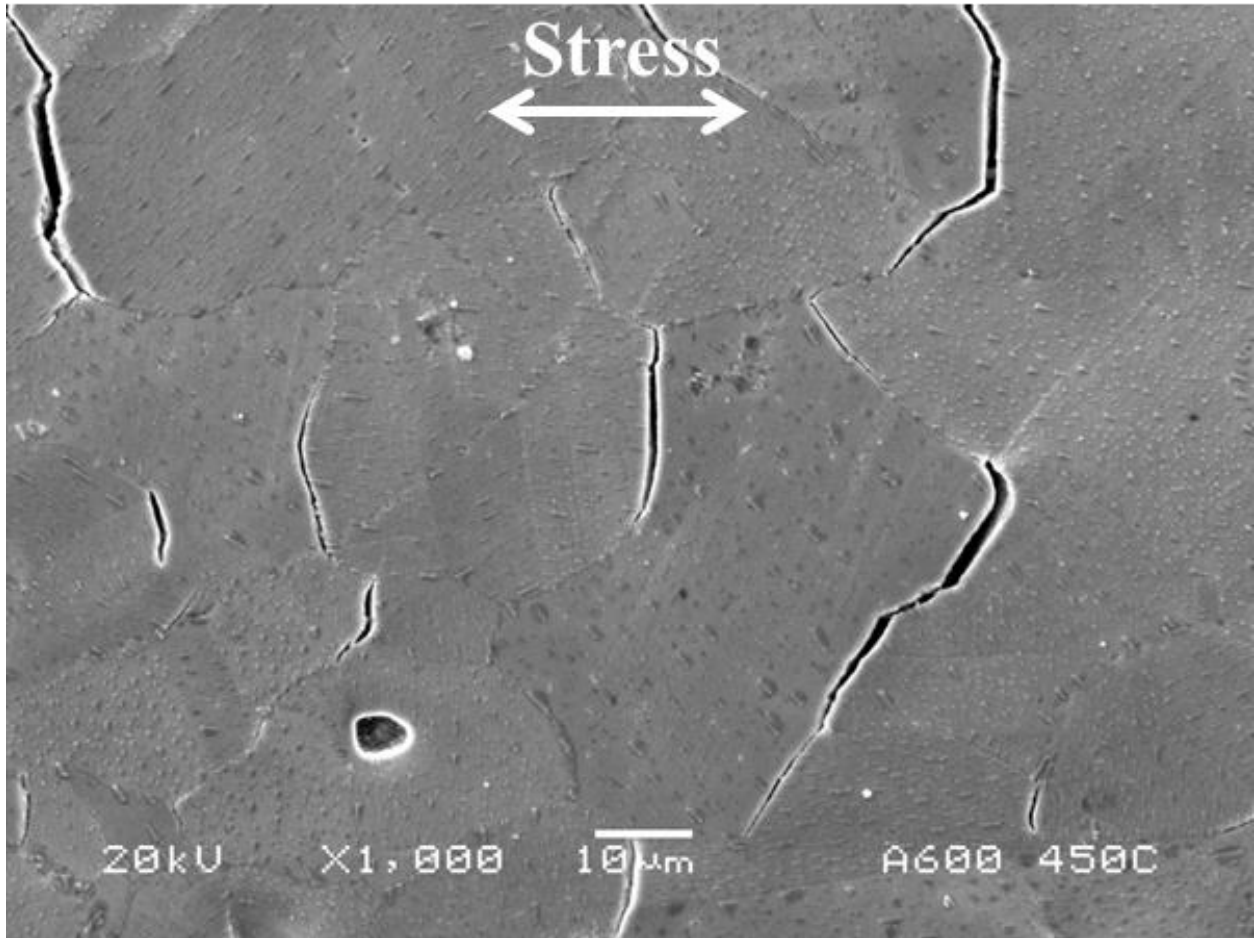
Figure 3.10. Gauge surface of Alloy 600 strained at 450°C in CERT to 8% at  $3 \times 10^{-7} \text{ s}^{-1}$  showing cracking saturation.

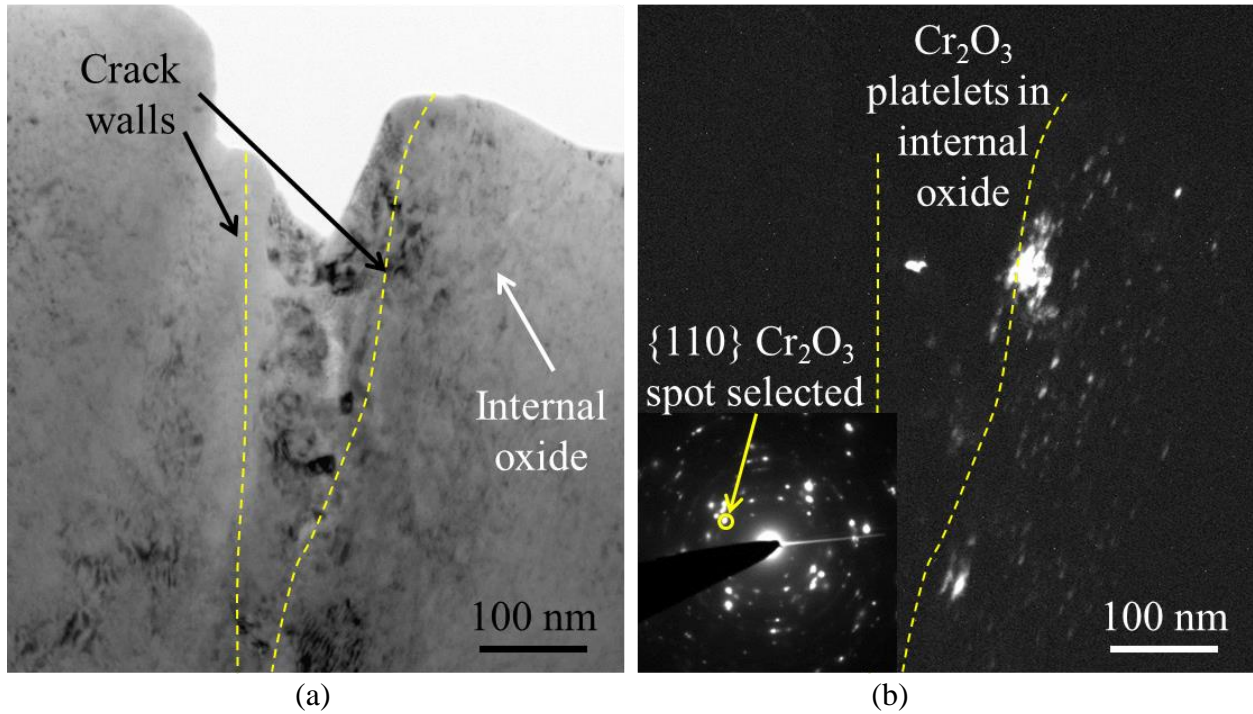
Figure 4.33. Bright field image (a), and dark field image (b) of the crack shown in Figure 4.30 (20% pre-strained Alloy 690 strained in hydrogenated subcritical water at 360°C to 7% at  $5 \times 10^{-8} \text{ s}^{-1}$ ) showing the presence of  $\text{Cr}_2\text{O}_3$  platelets in the internal oxide of the crack wall.
