London-Bahrain Archaeological Expedition excavations at Saar: 1993 season

During 1993, the London-Bahrain Archaeological Expedition conducted a fourth season of excavations at the early second millennium settlement of Saar, Bahrain. A lower level of the temple was cleared, and a range of buildings to its north-west discovered. A new street was found opposite the temple entrance, and several of the buildings along the main street were further investigated. Further environmental research included a new programme of micromorphology and the start of research into the fish remains.

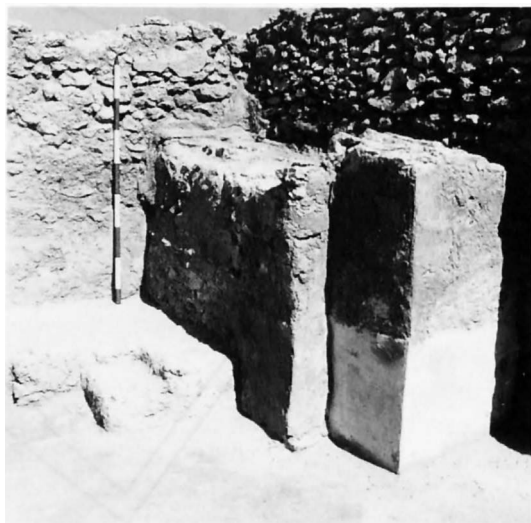
Fig. 3. Benches in north-east corner of temple.

The benches in the north-east corner were in excellent condition, with clean gypsum plaster (Fig. 3). The one against the north-east wall is the highest, at 1.22 m, with steps leading up to it. It is abutted by a larger platform along the north-west wall, which in turn has a small, square platform joined to the opposite end. The middle bench bore a square impression on top. On analogy with Mesopotamian temples, statues of worshippers may have stood on these platforms 'praying' on their owners' behalf. Or perhaps the statue of the deity itself stood here, with the generous area of benches needed to accommodate offerings. If so, the area was kept remarkably clean, as the plaster is in very good condition. Fragments of red painted plaster were found in the area of the benches both this season and last (3). Though clearly out of context, they probably belonged to this end of the building, as none have been found elsewhere in the temple.

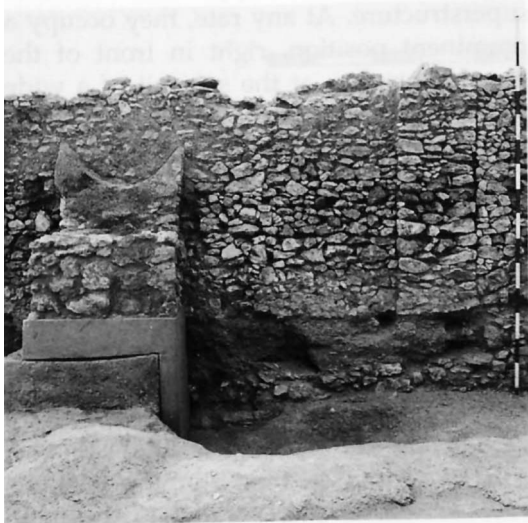
Fig. 4. Hole next to early altar in temple.

On the west side of the earliest altar is a large, irregular hole next to the wall (Fig. 4). It is dug through the floors, and as the resulting spoil is still lying in untidy heaps around it, this probably happened immediately before the floor was covered over. The purpose of the hole is unknown, but it may have been dug to retrieve (officially or otherwise) a foundation deposit, in advance of the first major renovation of the temple.

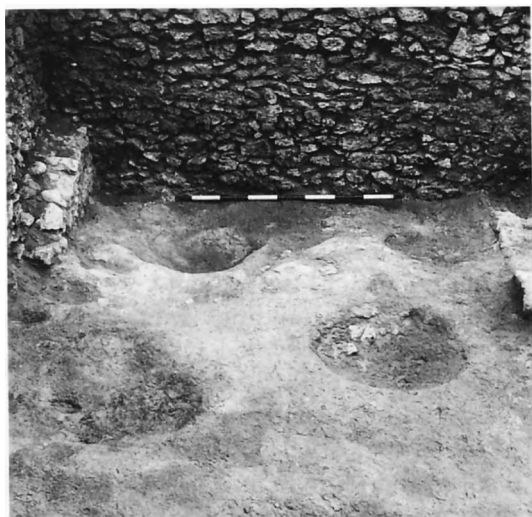
Fig. 5. Jar depressions in temple.

temple had nine round depressions of around 0.7 m diameter (Fig. 5), presumably to hold heavy storage vessels. In contrast to the rest of the building, the floors in the storage area were littered with fish bones and sherds. The two depressions against the south wall of the adjacent store-room, Area 220, were flanked by stumps of two thin walls lying under mortar debris, and the floor underneath was separately plastered. This suggests that there was a shelf or cover above these two particular jars.

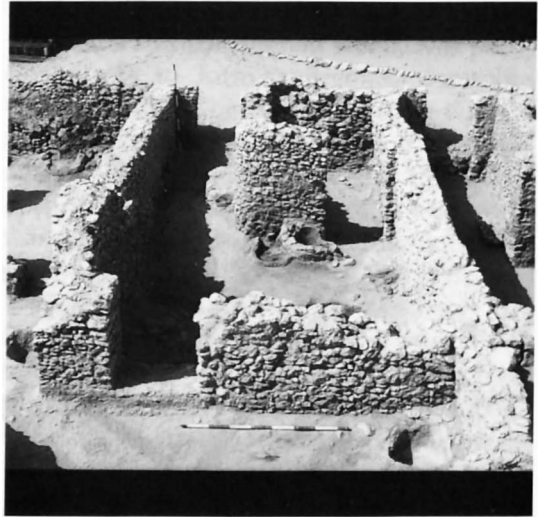
Fig. 7. House 204.

this season. Entered from the same street as its neighbours to the south, its plan is similar to houses in other parts of the town. That is, the basic shape is a rectangle with one corner partitioned off as an internal area (234), and the resulting L-shape (233) left open. As is often, but not always, the case with houses at Saar built to this plan, there is access from the back of the courtyard into a further open area (232), sometimes shared, as this one is.

The internal Area 234 had clean, compacted floors, while the courtyard, Area 233, was covered with bone, ash and shell, and was obviously an area of intense activity. There were several installations, which must have made the area very cramped: by the street door, a basin made out of a re-used jar, and adjacent basin installation. The *tannur*, and adjacent hearth with tripod, were right next to the door into Area 234, and it must have been difficult to get in or out when the fire was lit without burning oneself. In the shared rear yard (Area 232) was a plastered basin identical to that in House 203's portion.

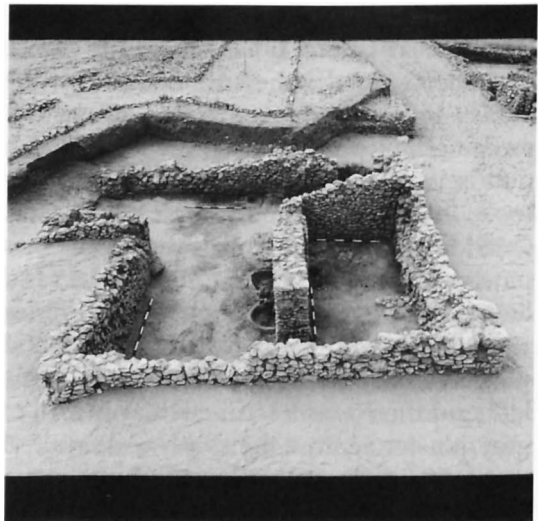
Fig. 9. House 222.

On the opposite corner of the junction between the main street and the 'new' one, stood House 222 (Figs. 8 and 9). The plan comprised the usual single inner room and courtyard, but certain variations distinguish this house from those already found. The main doorway is tucked round the corner from the main street, rather than opening on to it. The courtyard has an eastward protrusion from its L shape, and in the corner another door led into an adjoining structure, not yet investigated.

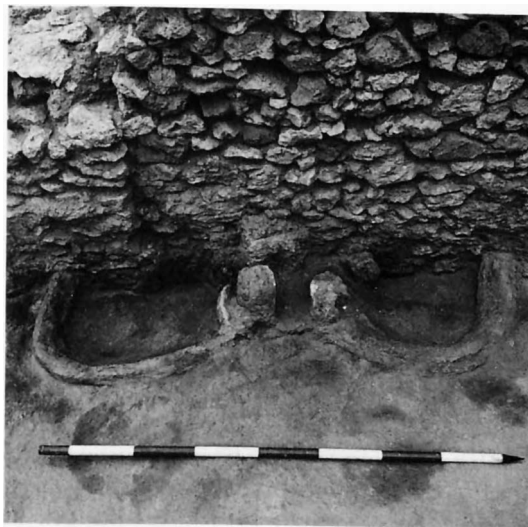
Fig. 11. Fireplaces in House 222.

In the outer area, 305, the placement of internal buttresses similarly suggests there may have been partitions, or perhaps supports for awnings or shades of some kind. Three floor surfaces were excavated, and earlier ones were observed below. On the earliest of the three, a semi-circular hearth was built along the long wall of the inner room, with a tripod feature next to it. A second clay semi-circle was added to the other side of the tripod during the lifetime of the second floor (Fig. 11). There was a small pit, of unknown function, in front of each hearth. Next to the cooking area a low stone bench was built against the wall. There was another similar one just inside the doorway.

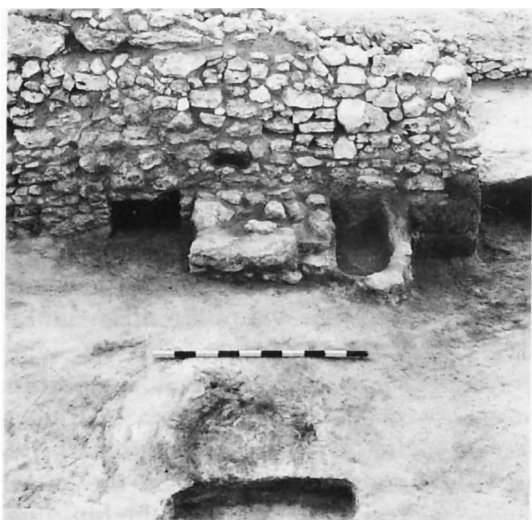
Fig. 13. House 200: basin, platform and wall-niche.

Another installation used throughout the life of the open area was a plastered basin with adjacent stone platform, situated inside the main entrance on the right. There was a niche in the wall beside it during the earliest phase (Fig. 13). The feature was re-built once, and a large grindstone was still standing near one corner of the later version. A stone shelf in the north corner of the yard was introduced at the level of the third floor and re-built once.

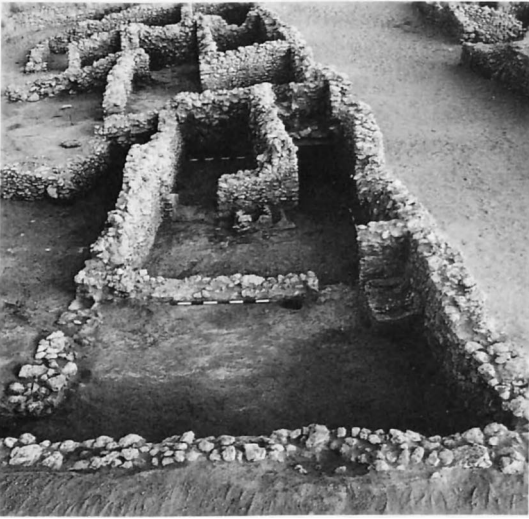
Fig. 14. House 211.

the main street, giving onto a narrow passage which leads into a square open area, the whole forming an L-shaped courtyard, Area 212. In the east corner of the yard is a door through to an open area, 213, which in turn has a doorway to the outside in its south-west corner. Access to the single inner room, Area 211, was from the opposite, west corner of the wider end of the courtyard.

Right inside the street door was a *tannur*. Six floors were removed from this narrow arm of the courtyard, and three from the main area. The slope up to the doorway from the main courtyard had increased during the lifetime of the building, and the doorway has at least five superimposed thresholds, testifying to a continual struggle to reconcile the floor-level inside the building with the rising street-level outside.
