Clinical Evaluation of Chairside CAD/CAM Nano-Ceramic Restoration: Five Year Status

Department of Cariology, Restorative Sciences, and Endodontics  
School of Dentistry  
University of Michigan

(1) Objectives: This investigation was a longitudinal, randomized clinical trial to measure the clinical performance of a nano-ceramic material (Lava Ultimate/3M) for chairside CAD/CAM fabricated restorations.

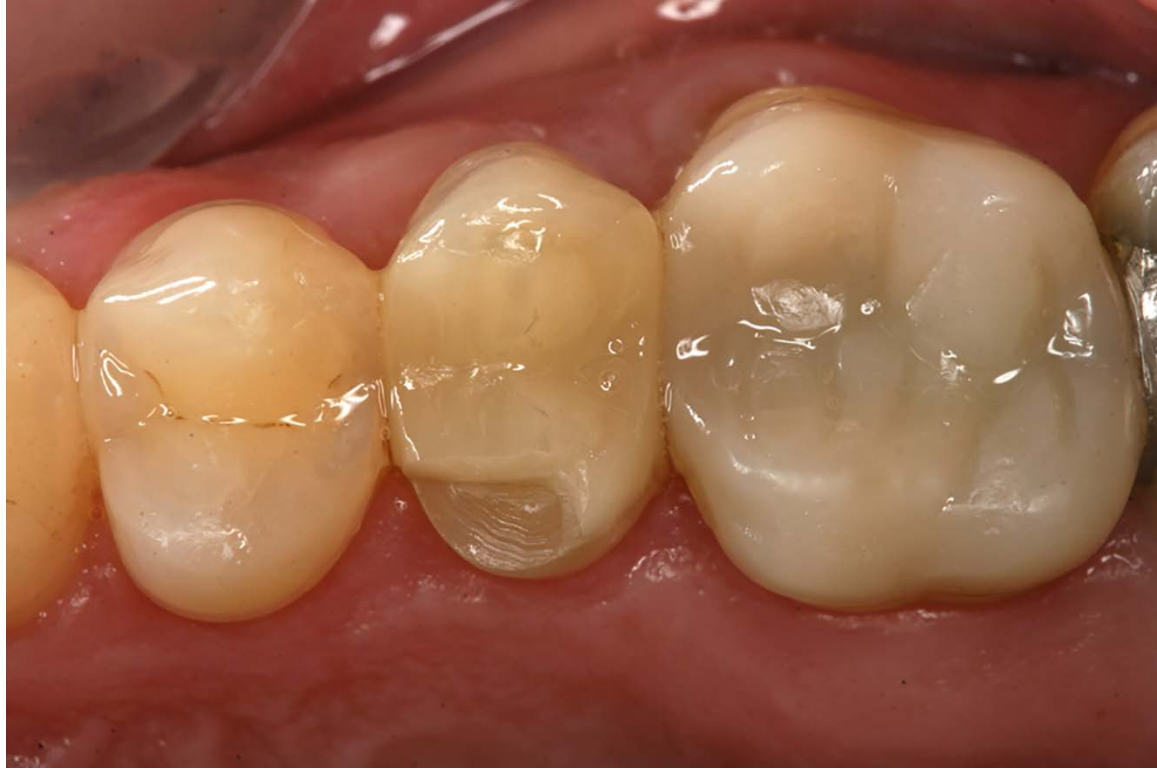
JERD\_12516\_Fig.1. Empress frac #13 10 mos.tif

Figure #1: Fractured leucite-reinforced onlay on the lingual cusp of #13 at 10 months.

The fractures observed in the study were from both materials. Four EmpressCAD onlays fractured and required replacement; one at 10 months, one at 34 months, one at 37 months, and one at 40 months. (Figure 1, 2) One Lava Ultimate onlay fractured and required replacement at 19 months. Two Lava Ultimate onlays were lost due to fracture of the adjacent tooth structure at 38 months and 43 months and required replacement. (Figure 3) Two additional onlays showed evidence of surface chipping that did not require treatment; one Lava Ultimate onlay at 24 months and one EmpressCAD onlay at 24 months. Two teeth with Lava Ultimate onlays required endodontic treatment; one at 6 months and one at 25 months. (Figure 4A, 4B) Both onlays had the endodontic access preparations restored with direct composite restorations (Filtek Supreme Ultra/3M) and the onlays remained in the study recall with no further negative outcomes.

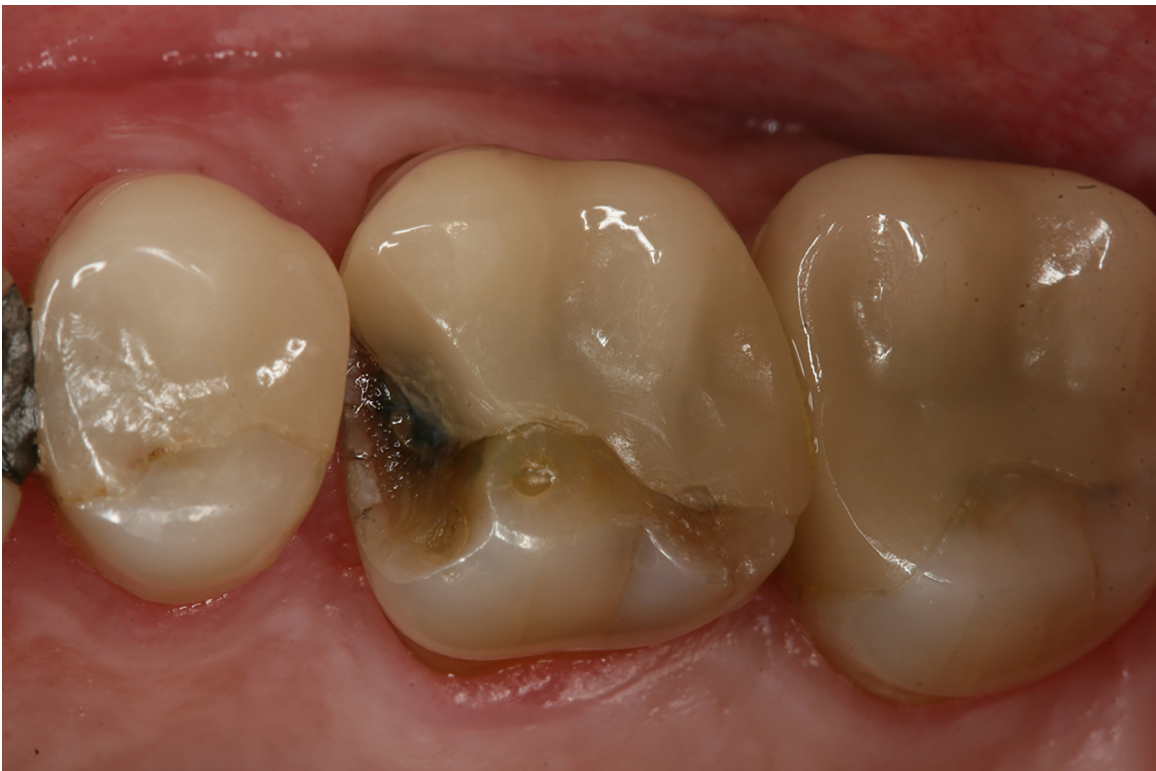
JERD\_12516\_Fig.2 Empress frac #14 34 mos.tif

Figure #2: Fractured leucite-reinforced onlay on the mesial marginal ridge of #14 at 34 months.

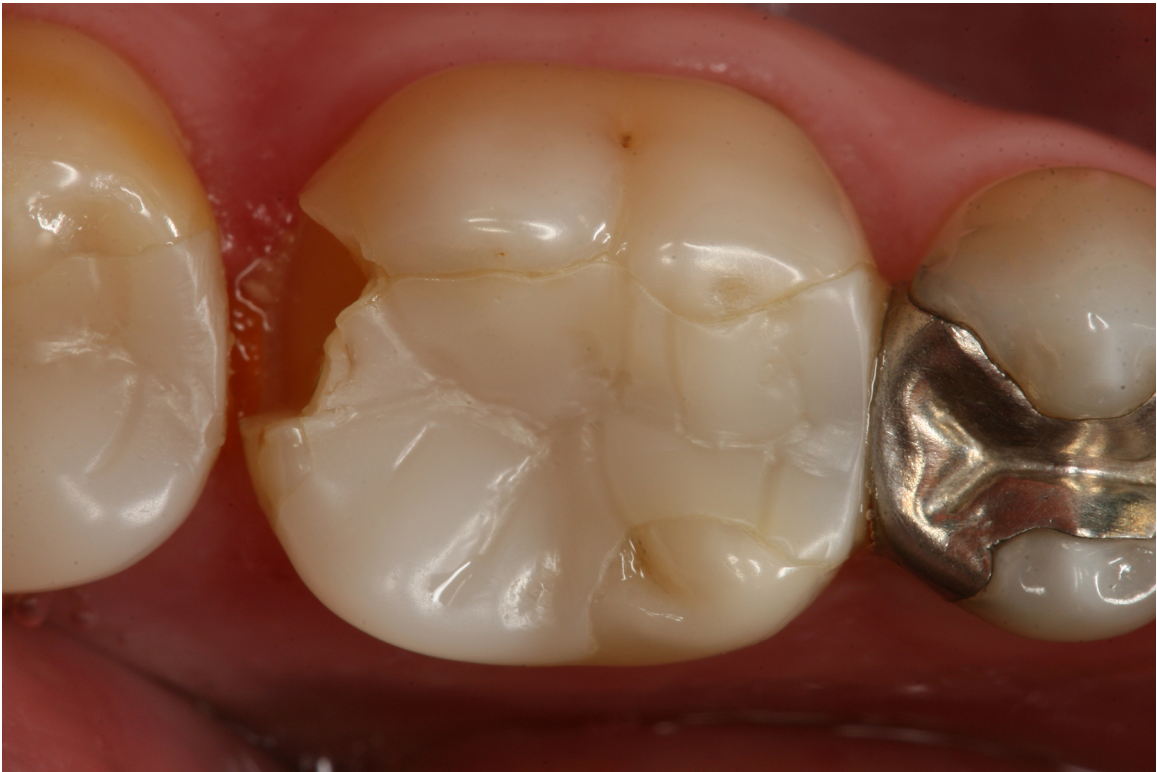
JERD\_12516\_Fig.3 LU frac #19 43 mos.tif

Figure #3: Fractured distal marginal ridge adjacent to nano-ceramic onlay #19 at 43 months.

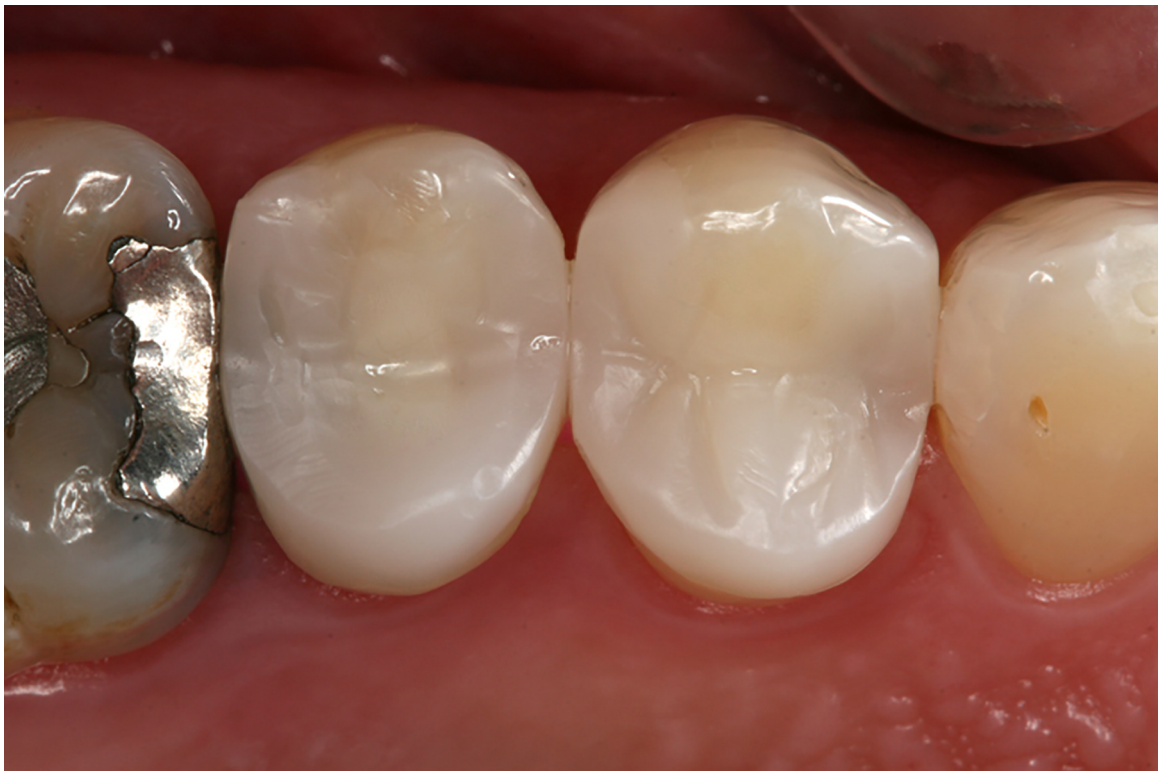
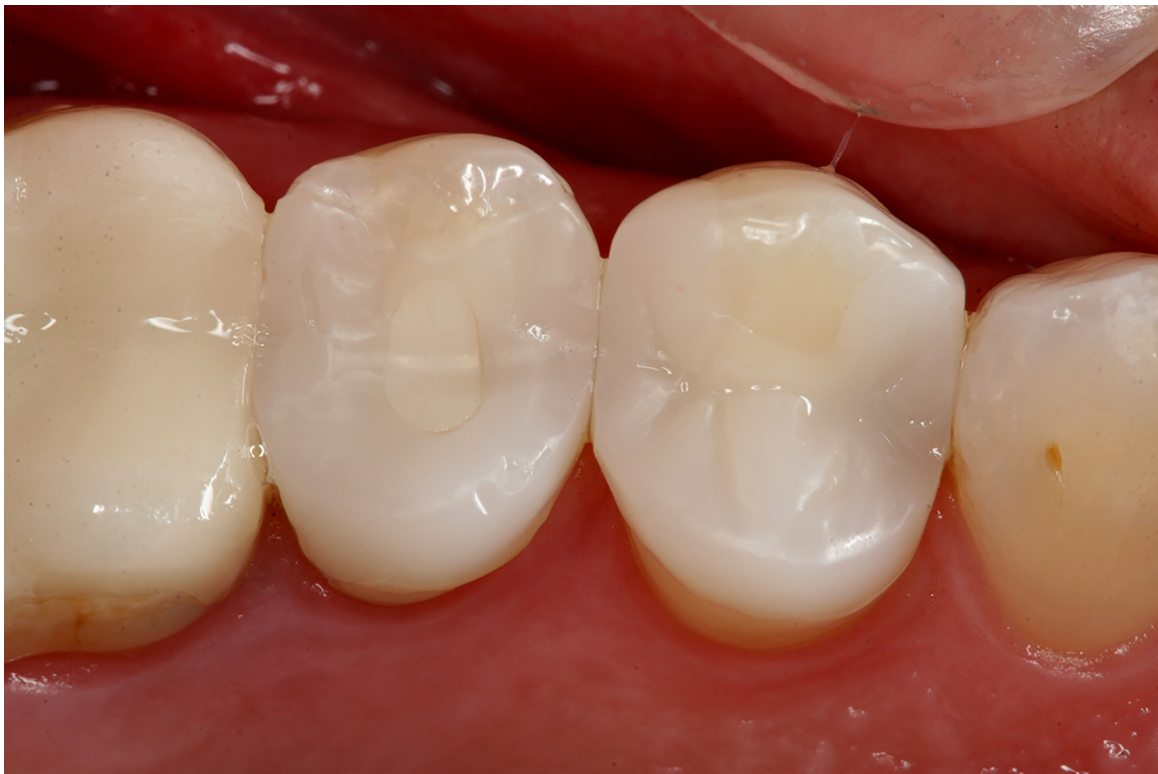
JERD\_12516\_Fig.4A LU RCT #4 comp 1 yr pot.tif

Figure #4A, B: Nano-ceramic onlays on the first and second premolars at the 1 year and 3-year recall with the endodontic access in the onlay #4 restored with composite stable over time.

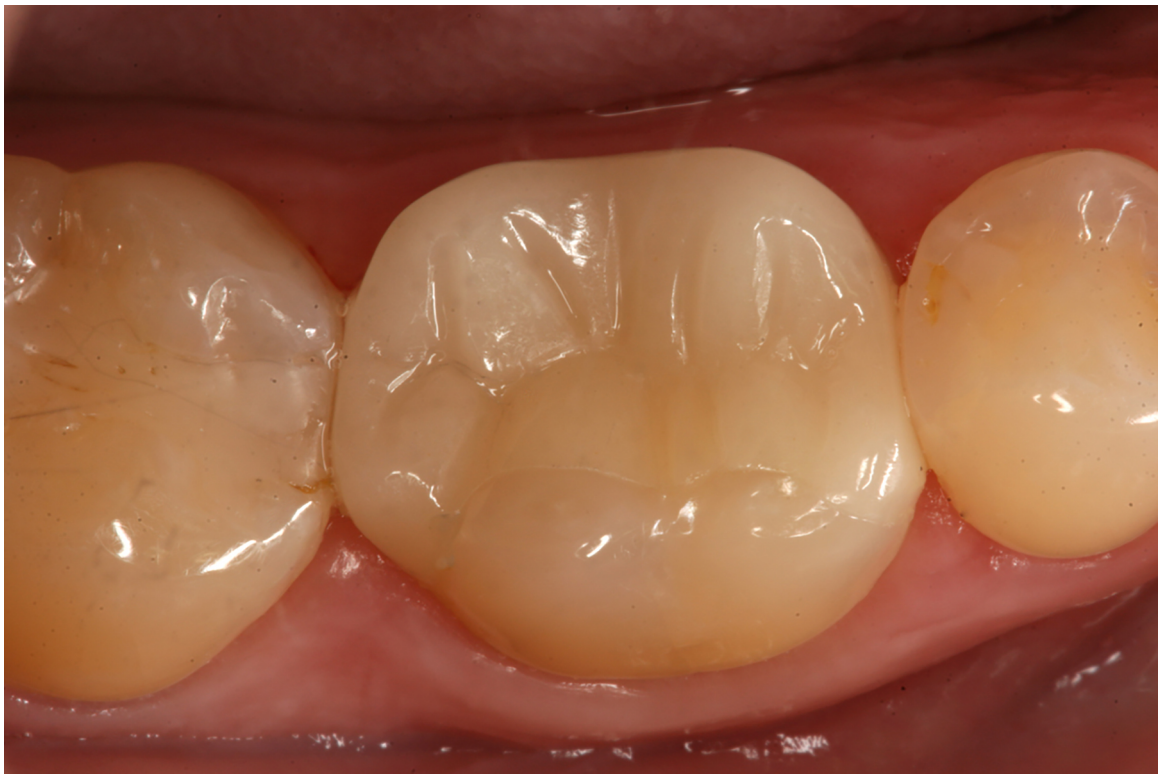
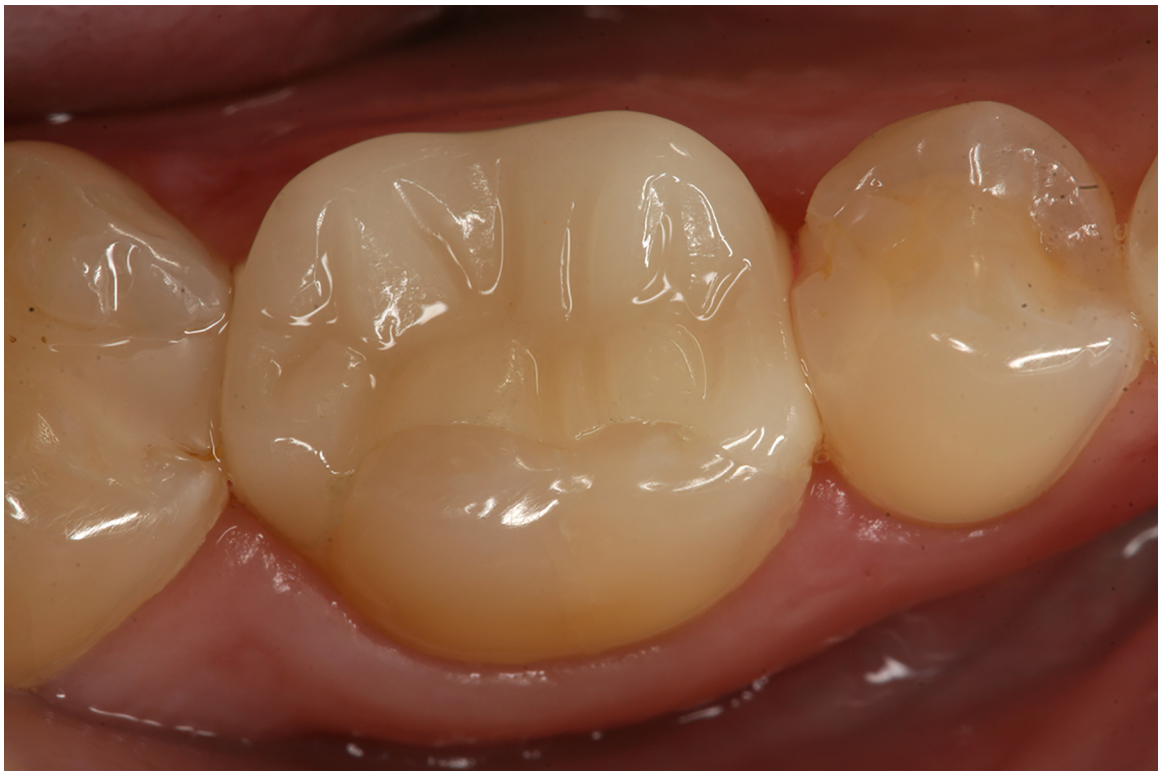
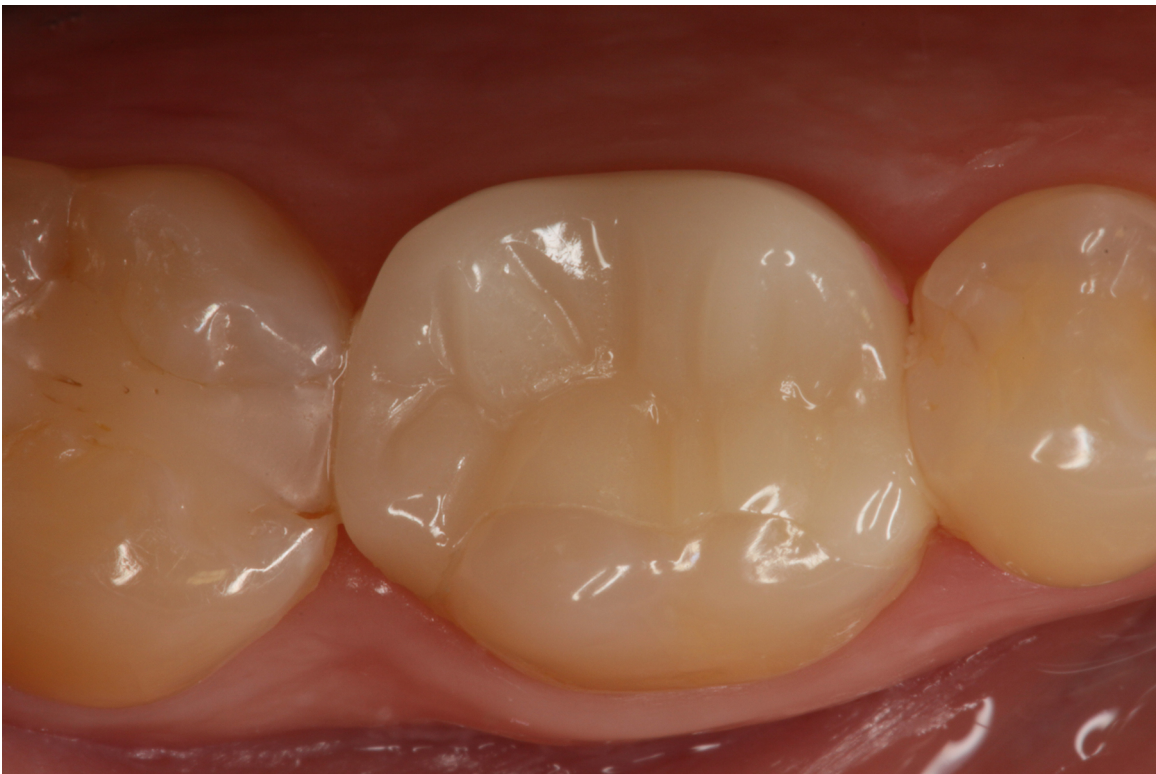
JERD\_12516\_Fig.5A Empress #30 prep.tif

Figure #5A-D: Leucite-reinforced onlay tooth #30 with defect-oriented, adhesive preparation at 1 year, 3 years and 5 years of clinical service.

A: Preparation      B: 1-year recall      C: 3-year recall      D: 5-year recall

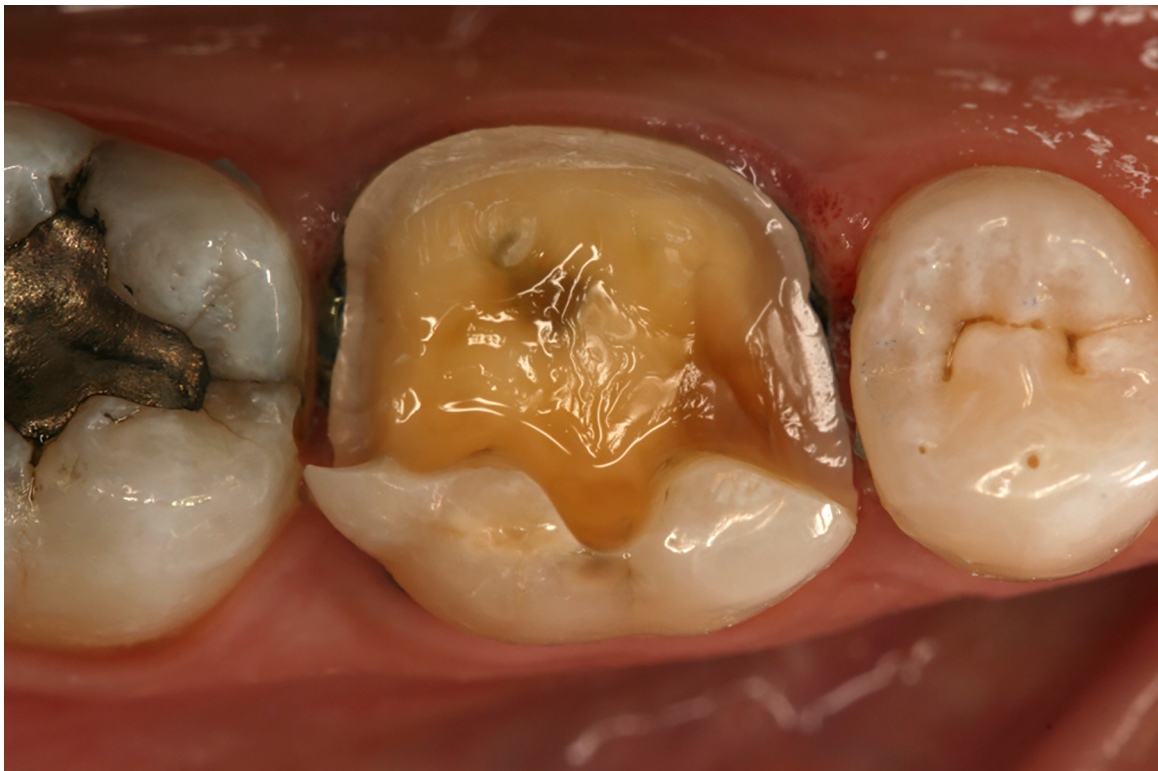
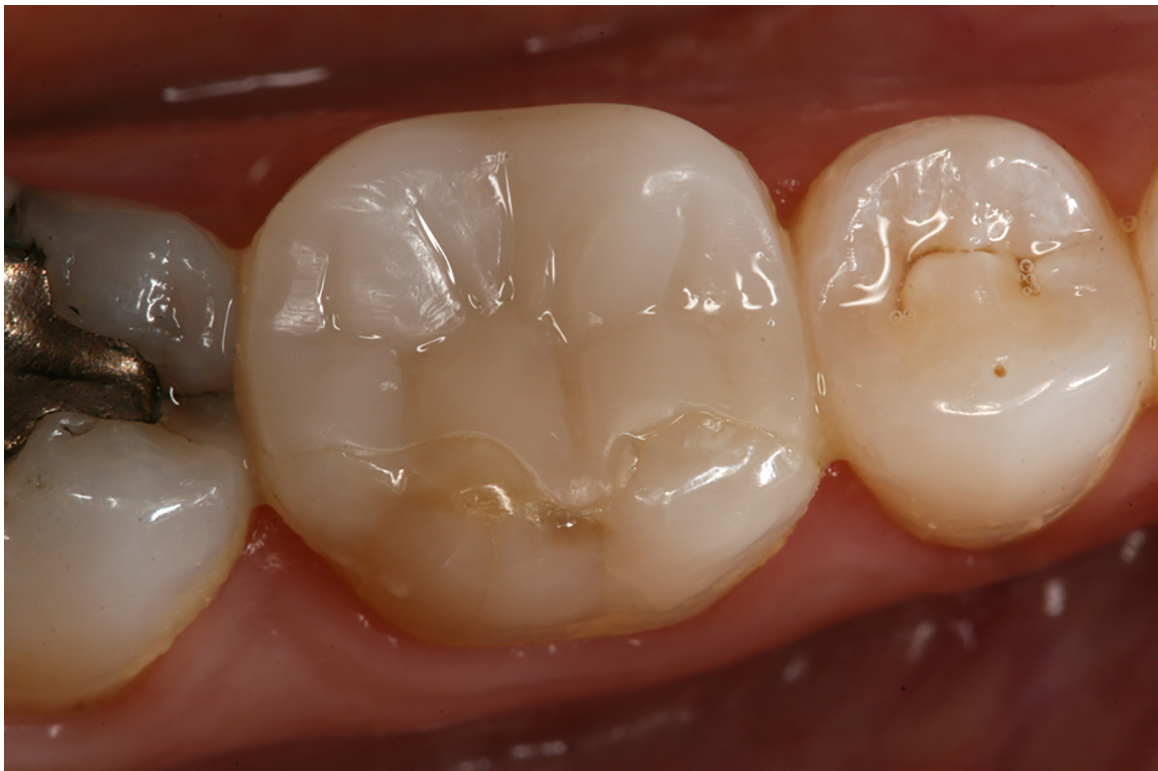
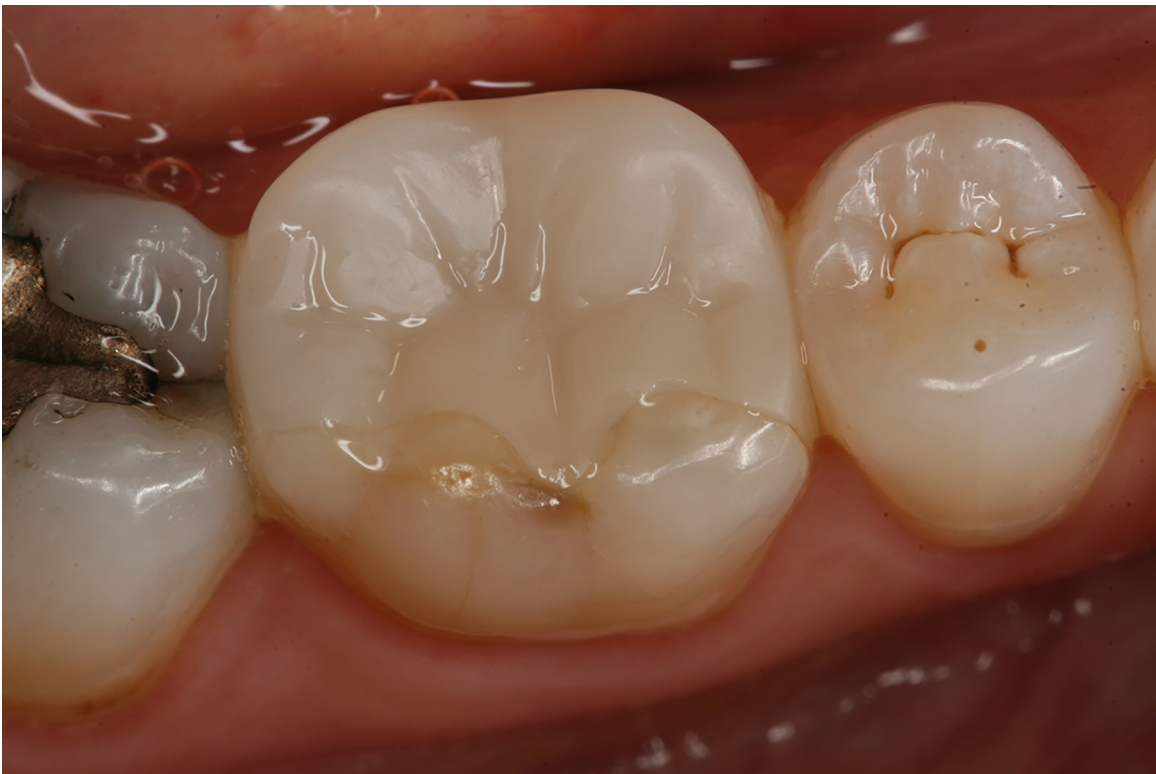
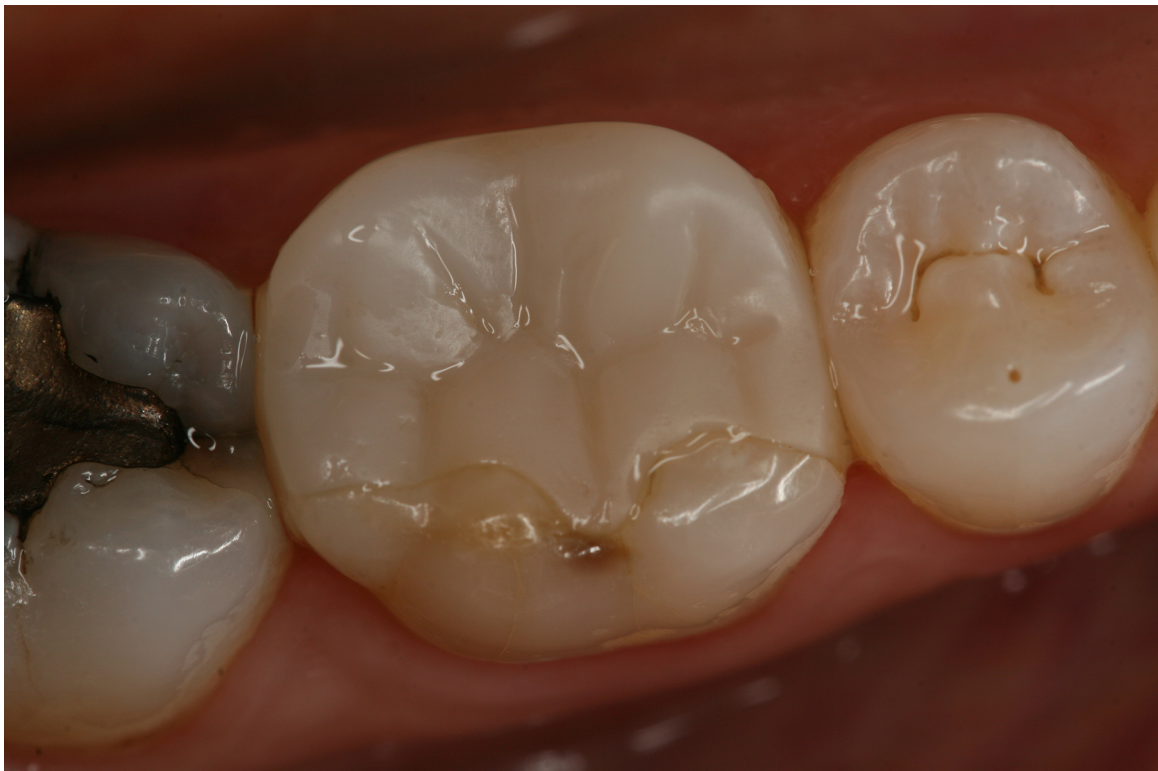
JERD\_12516\_Fig.6A LU #30 prep.tif

Figure #6A-D: Nano-ceramic onlay tooth #30 with defect-oriented, adhesive preparation at 1 year, 3 years and 5 years of clinical service.

A: Preparation      B: 1-year recall      C: 3-year recall      D: 5-year recall

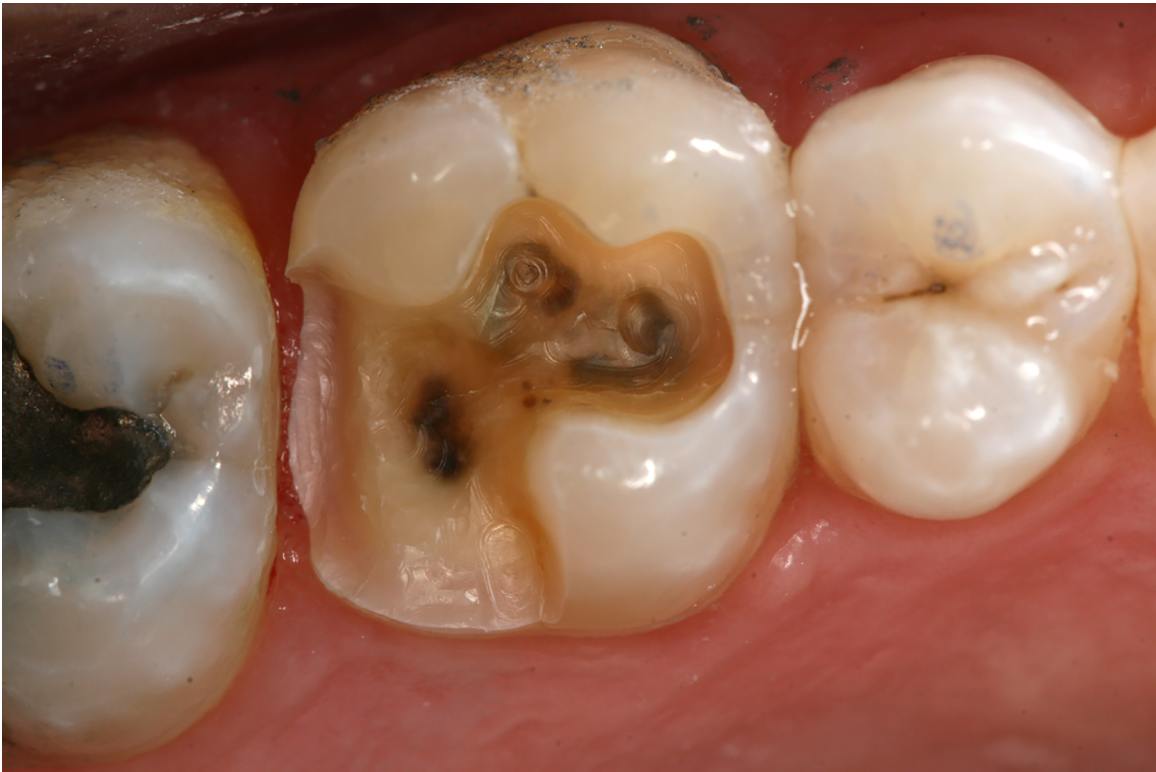
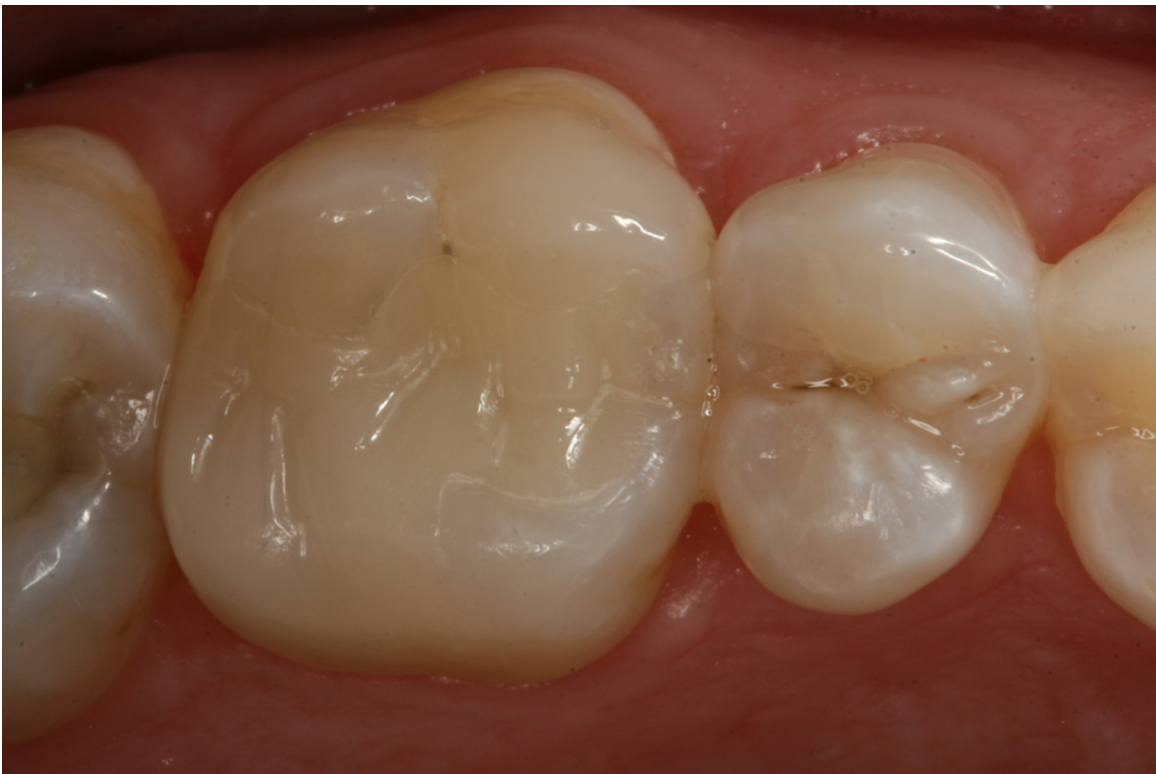
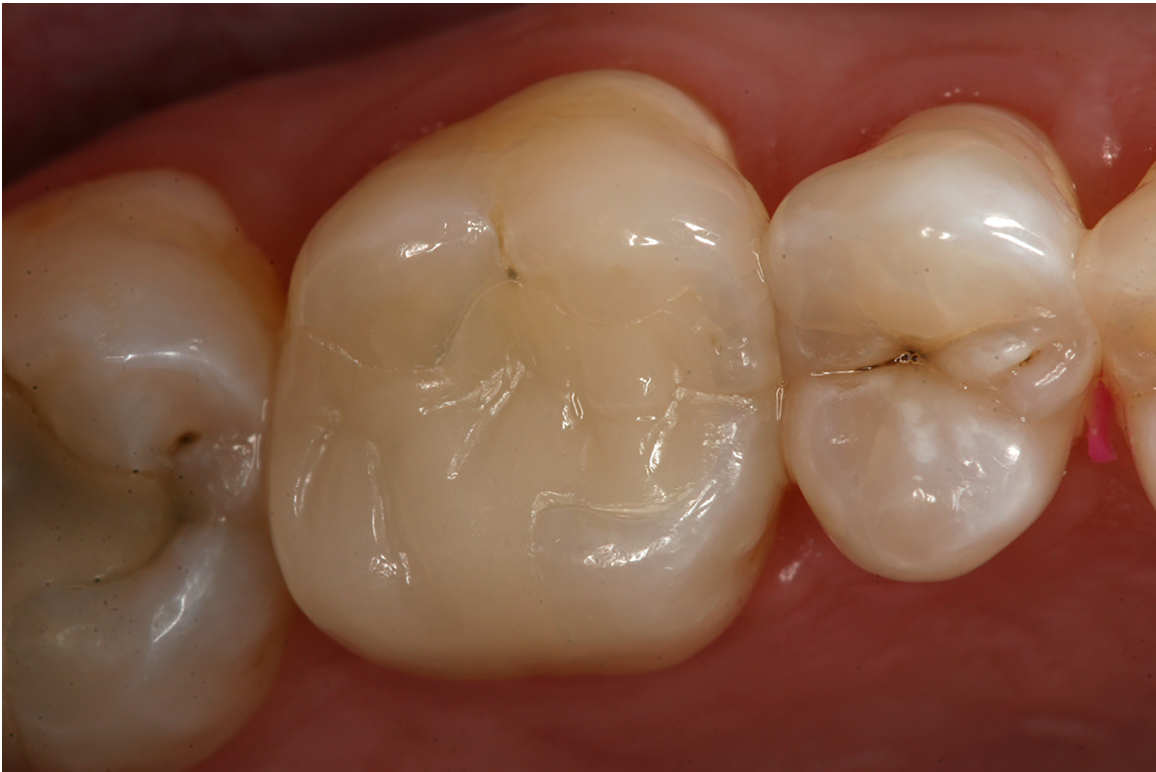
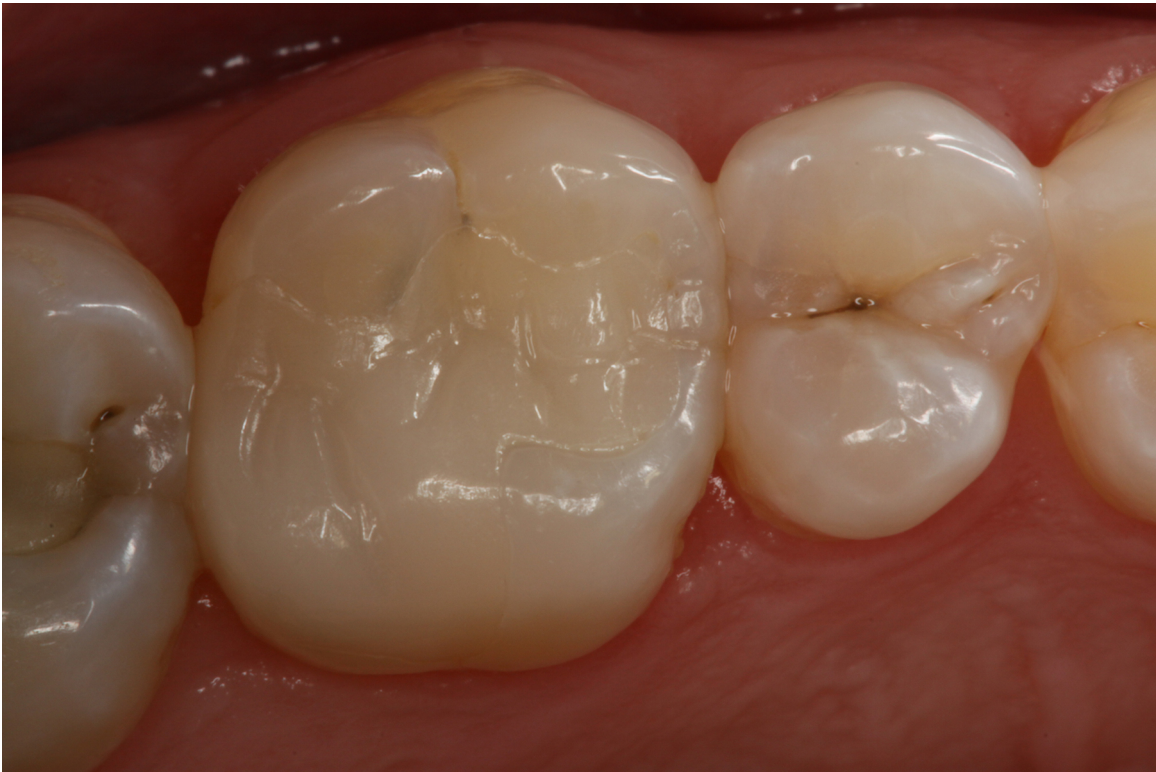
JERD\_12516\_Fig.7A Empress #3 prep.tif

Figure #7A-D: Leucite-reinforced onlay tooth #3 at 1 year, 3 years and 5 years of clinical service.

A: Preparation      B: 1-year recall      C: 3-year recall      D: 5-year recall

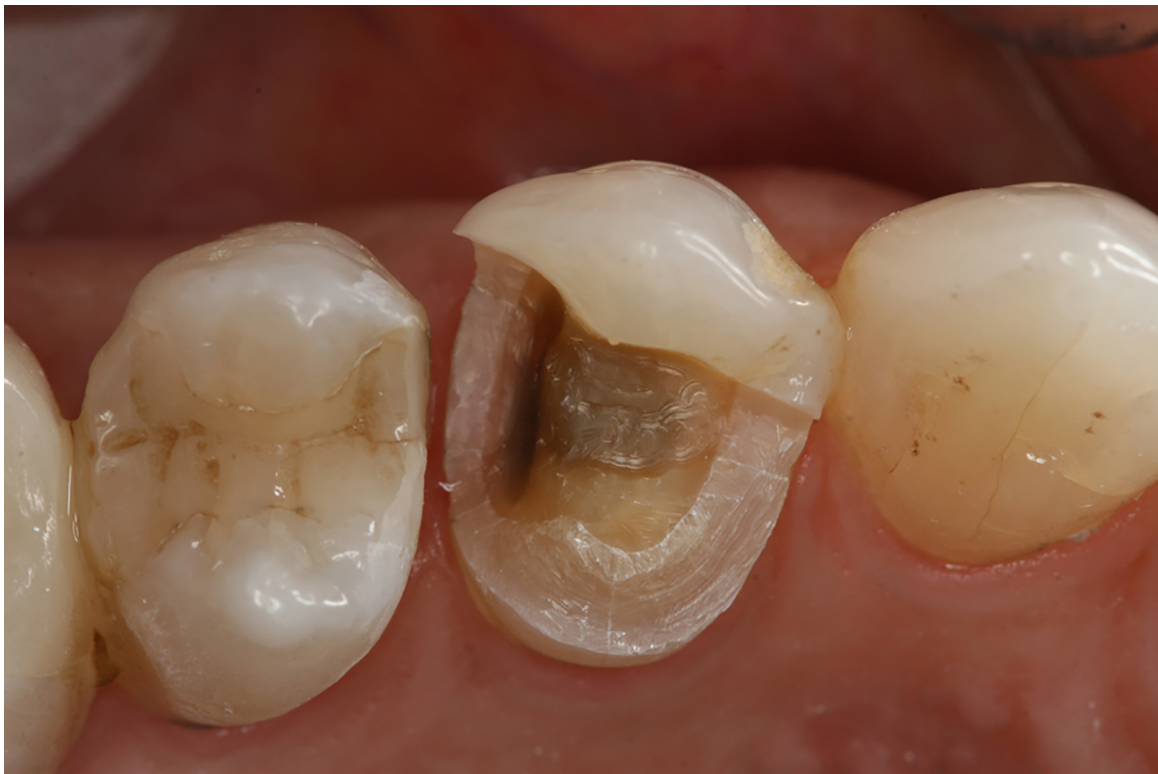
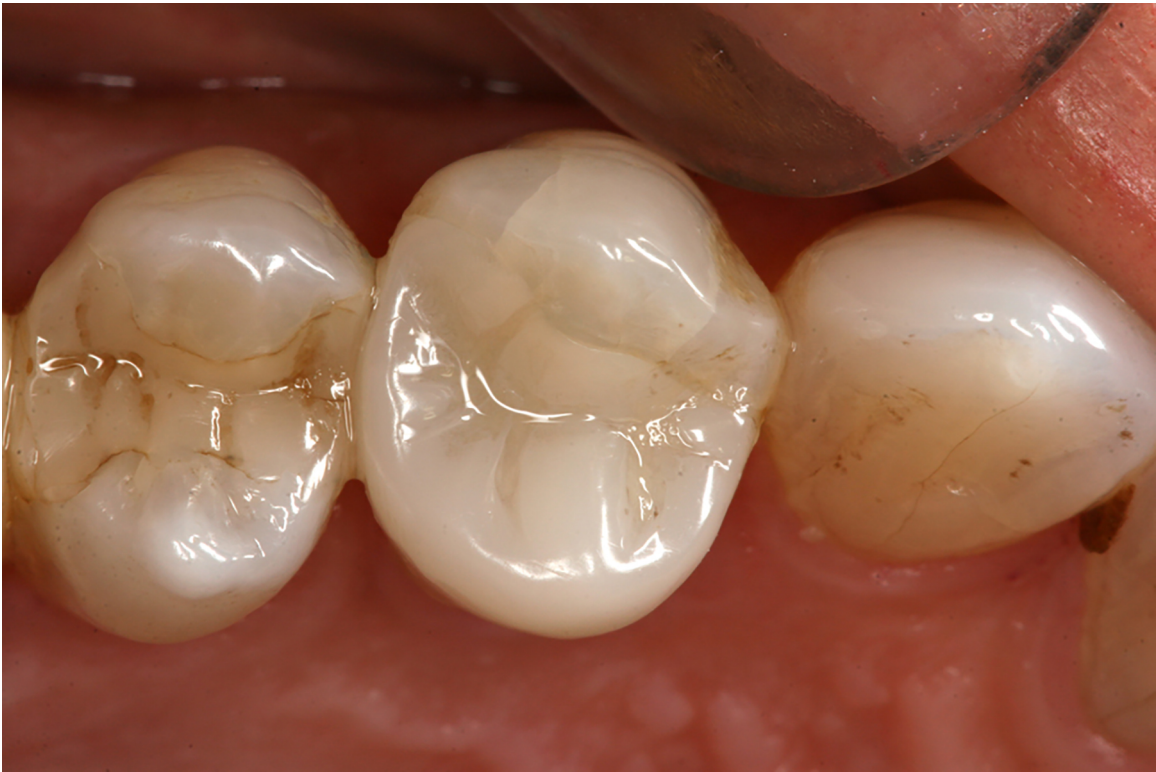
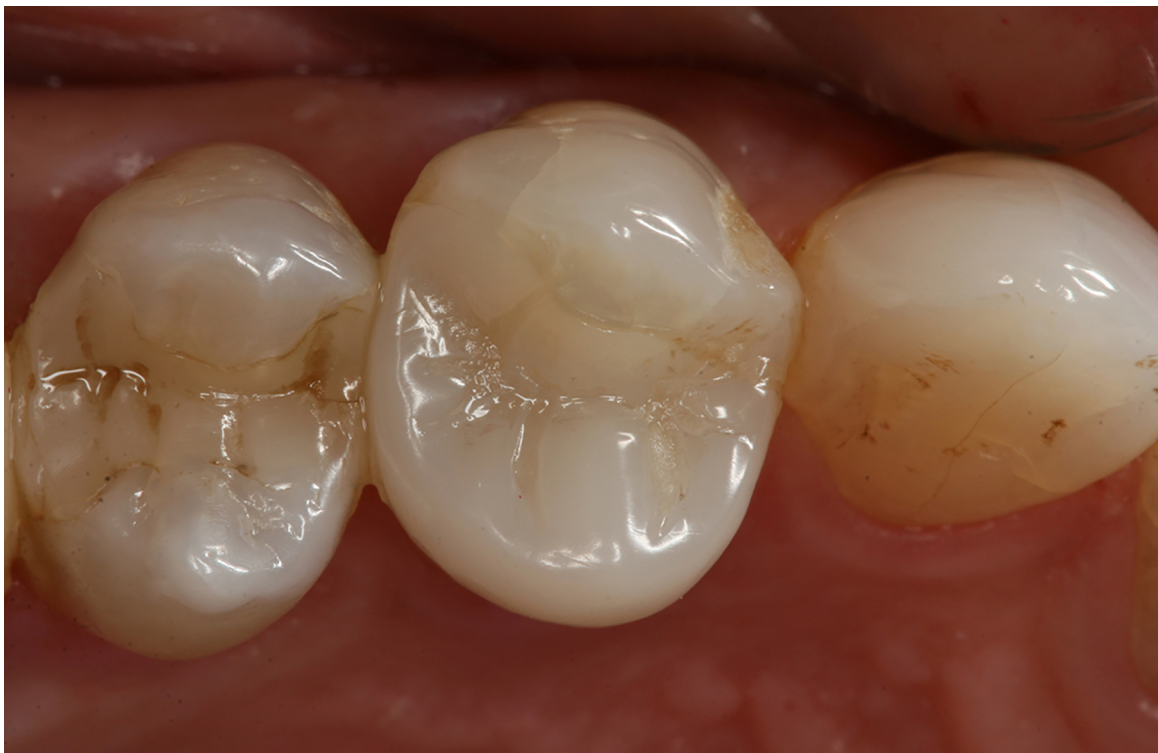
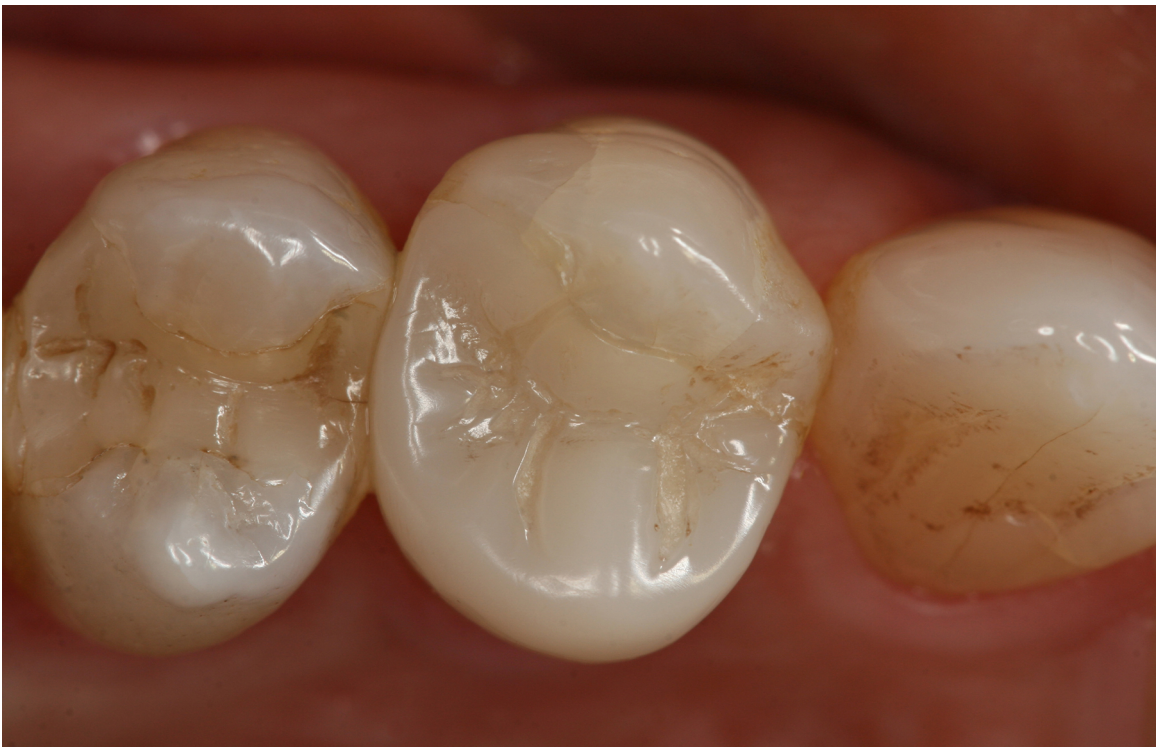
JERD\_12516\_Fig.8A LU prep.tif

Figure #8A-D: Nano-ceramic onlay tooth #5 at 1 year, 3 years and 5 years of clinical service.

A: Preparation      B: 1-year recall      C: 3-year recall      D: 5-year recall

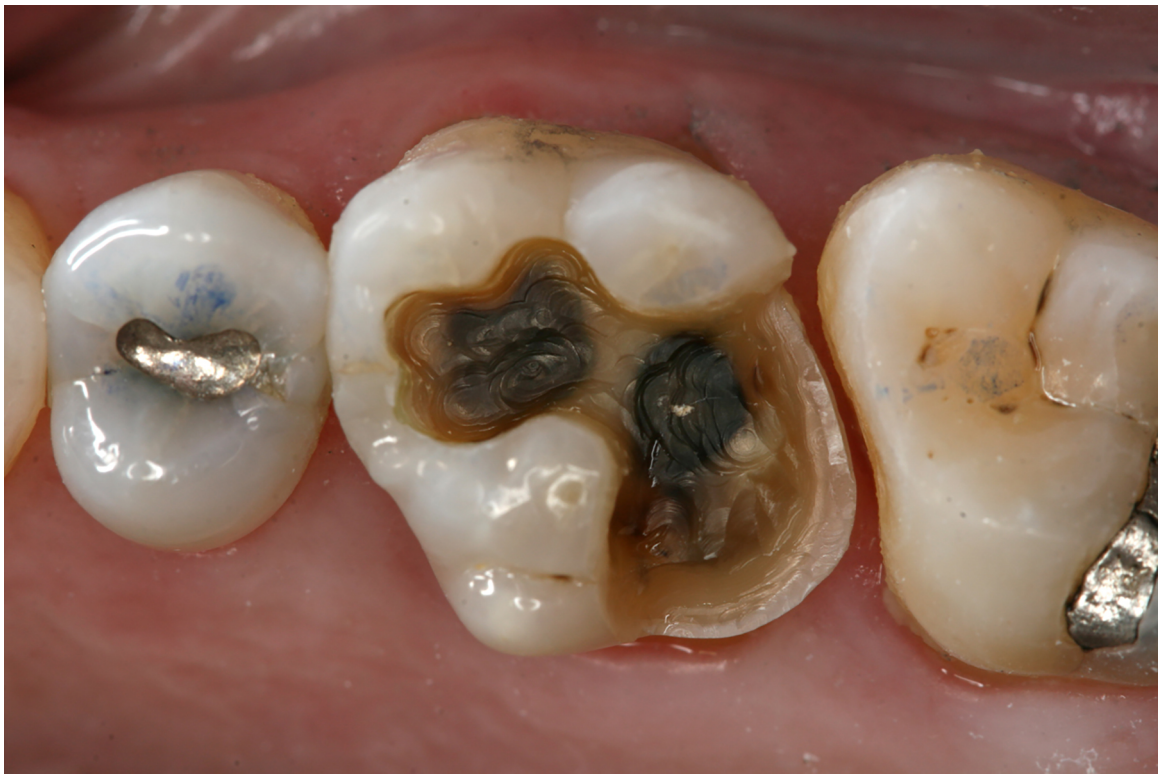
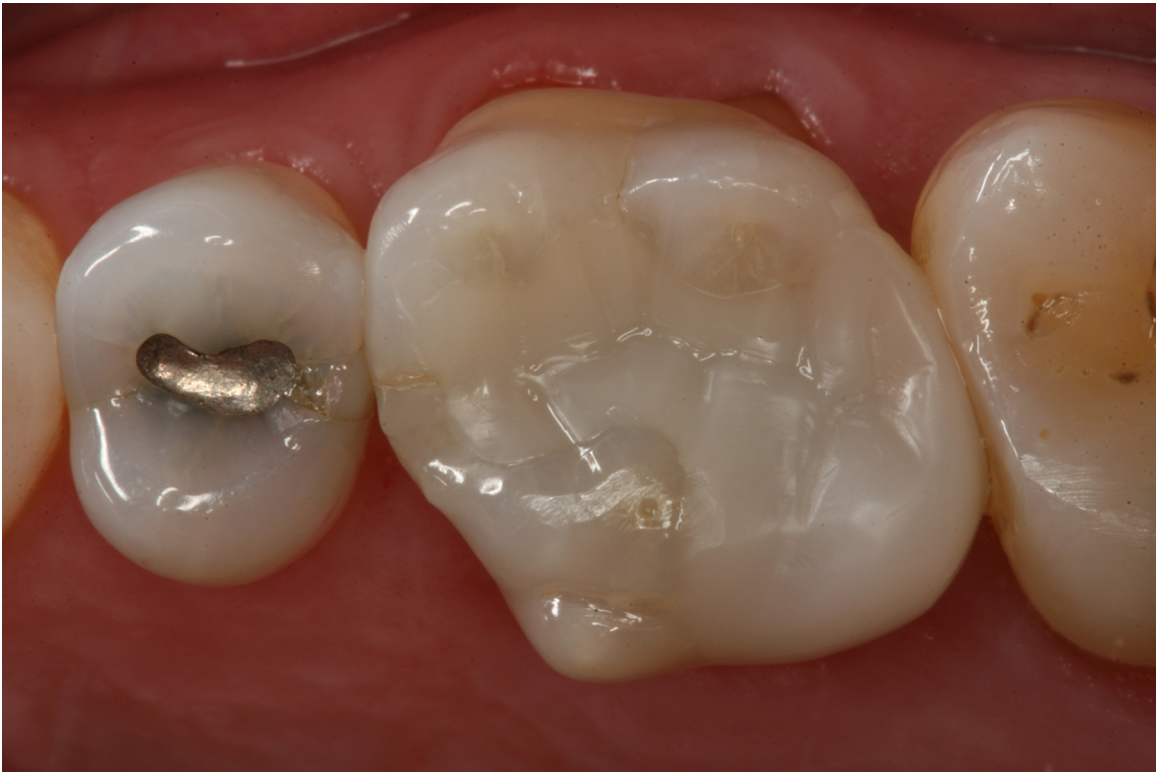
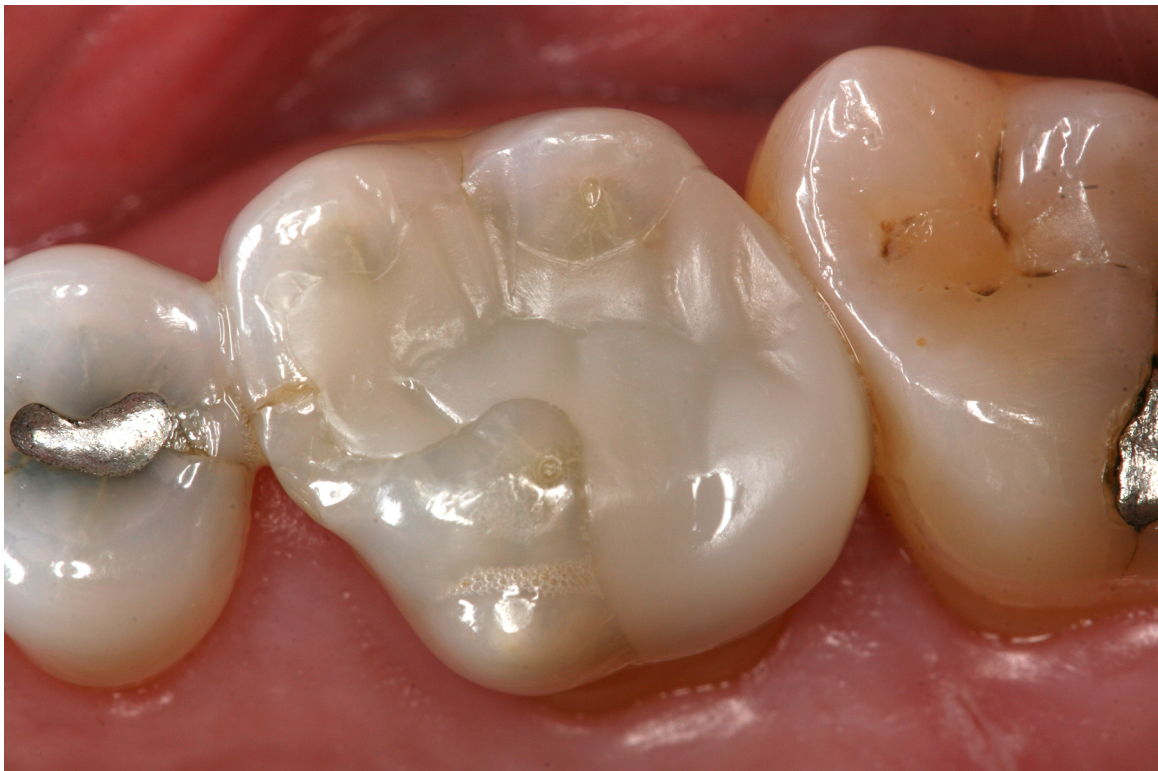
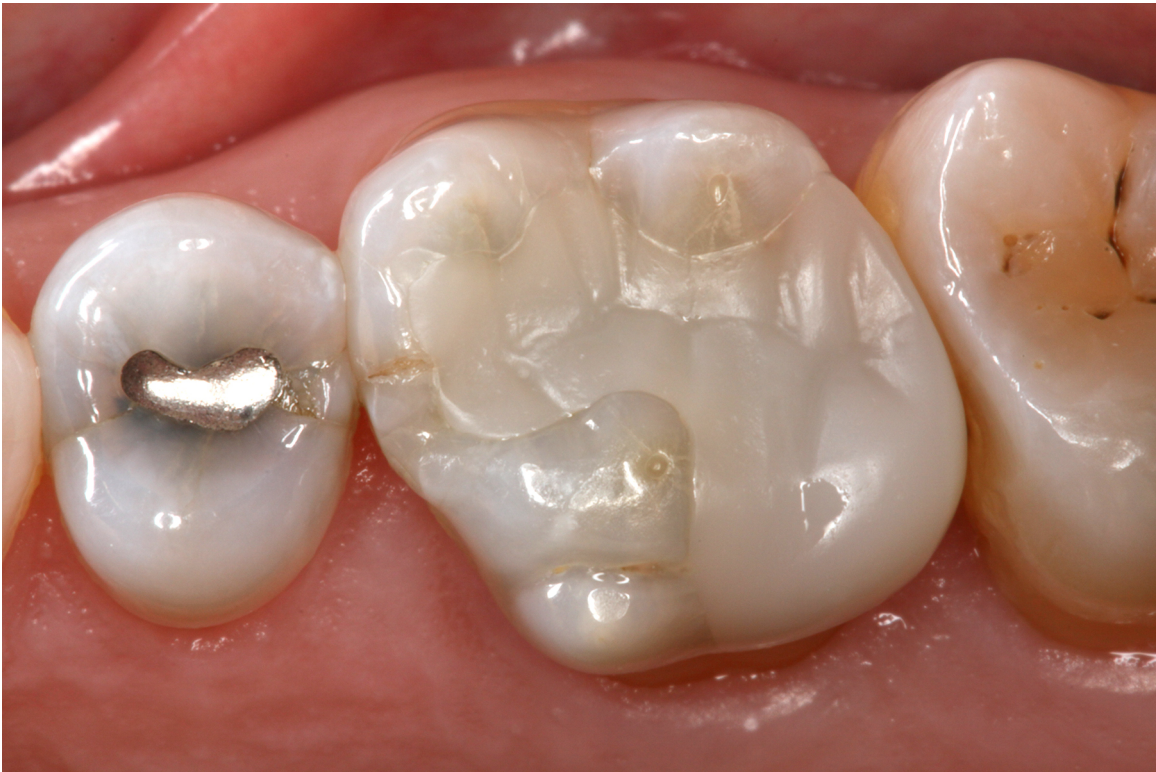
JERD\_12516\_Fig.9A LU #14 prep.tif

Figure #9A-D: Nano-ceramic onlay tooth #14 at 1 year, 3 years and 5 years of clinical service.

Note matte finish to onlay surface after desiccated with air.

A: Preparation      B: 1-year recall      C: 3-year recall      D: 5-year recall

results in a matte surface appearance when desiccated. (Figure 9A-D) There have been a limited number of onlays that developed broader wear facets over the five years of clinical service. (Figure 10A-D) These were occasionally detected on Lava Ultimate onlays but not the EmpressCAD onlays. This is consistent with the less abrasive nature of the nano-ceramic material compared to ceramic materials and could be considered an advantage in high wear cases to avoid surface chipping or fracture.
