Clinical Evaluation of Chairside CAD/CAM Nano-Ceramic Restoration: Five Year Status

Department of Cariology, Restorative Sciences, and Endodontics  
School of Dentistry  
University of Michigan

(1) Objectives: This investigation was a longitudinal, randomized clinical trial to measure the clinical performance of a nano-ceramic material (Lava Ultimate/3M) for chairside CAD/CAM fabricated restorations.

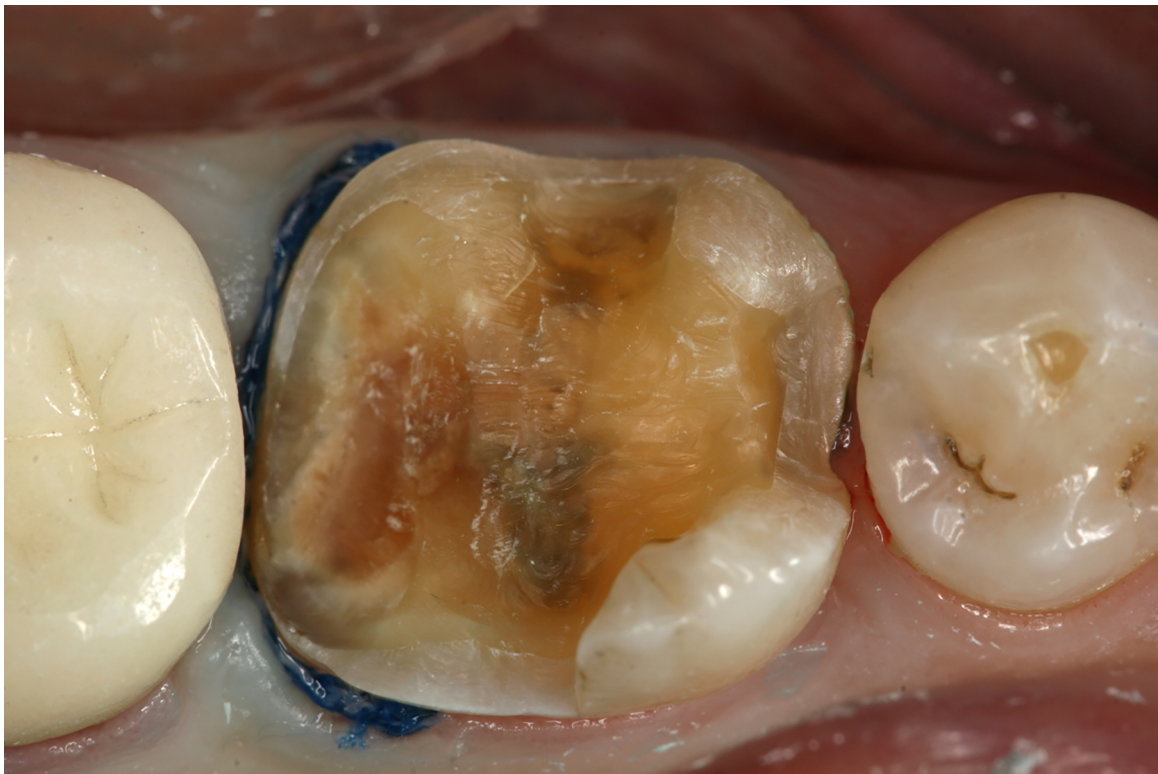
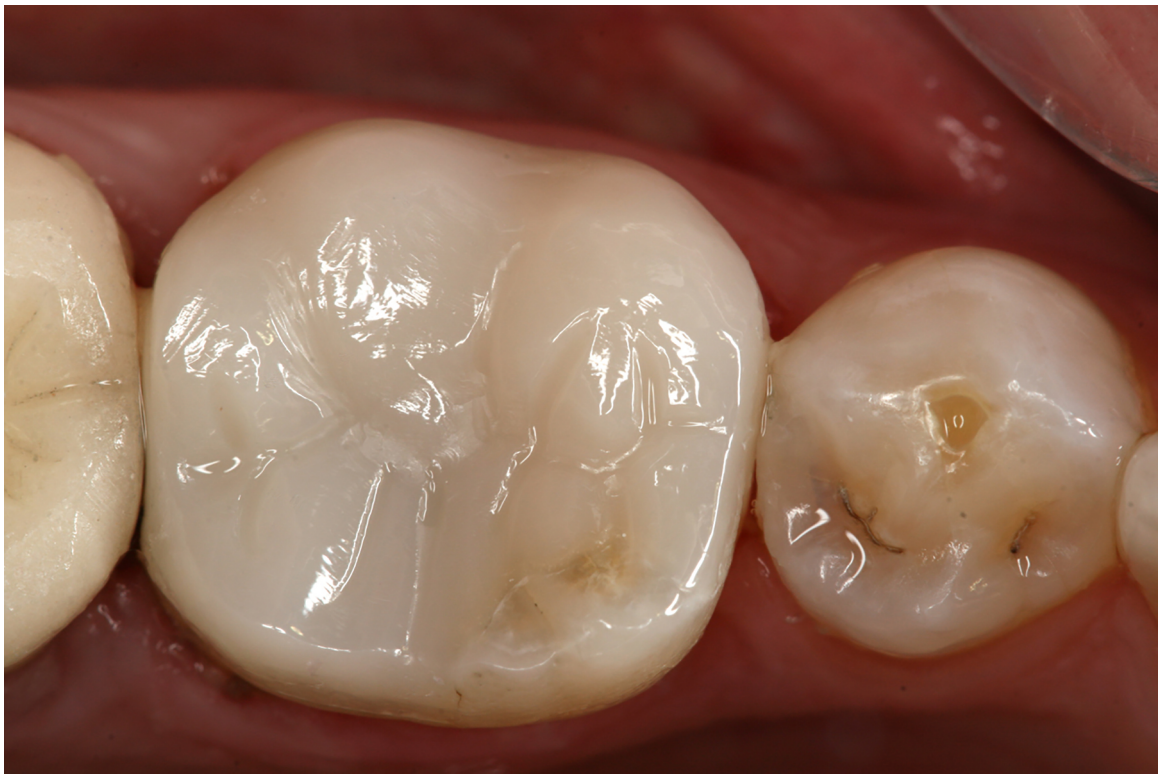
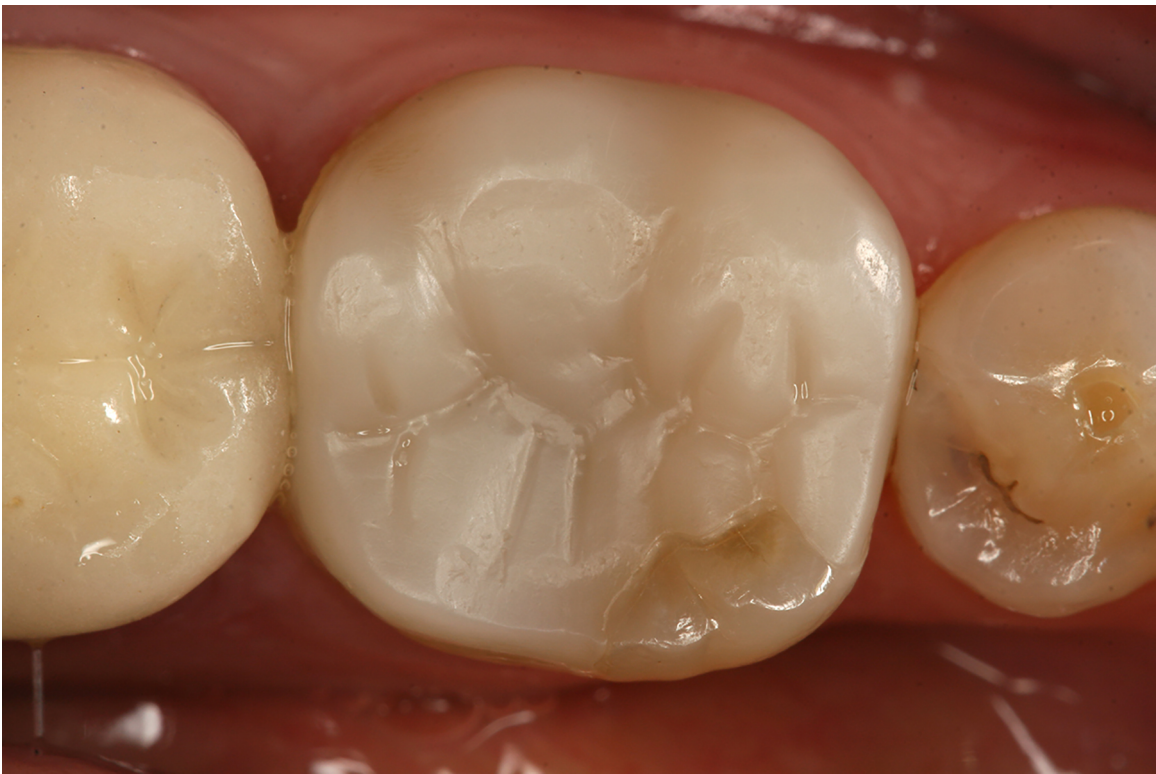
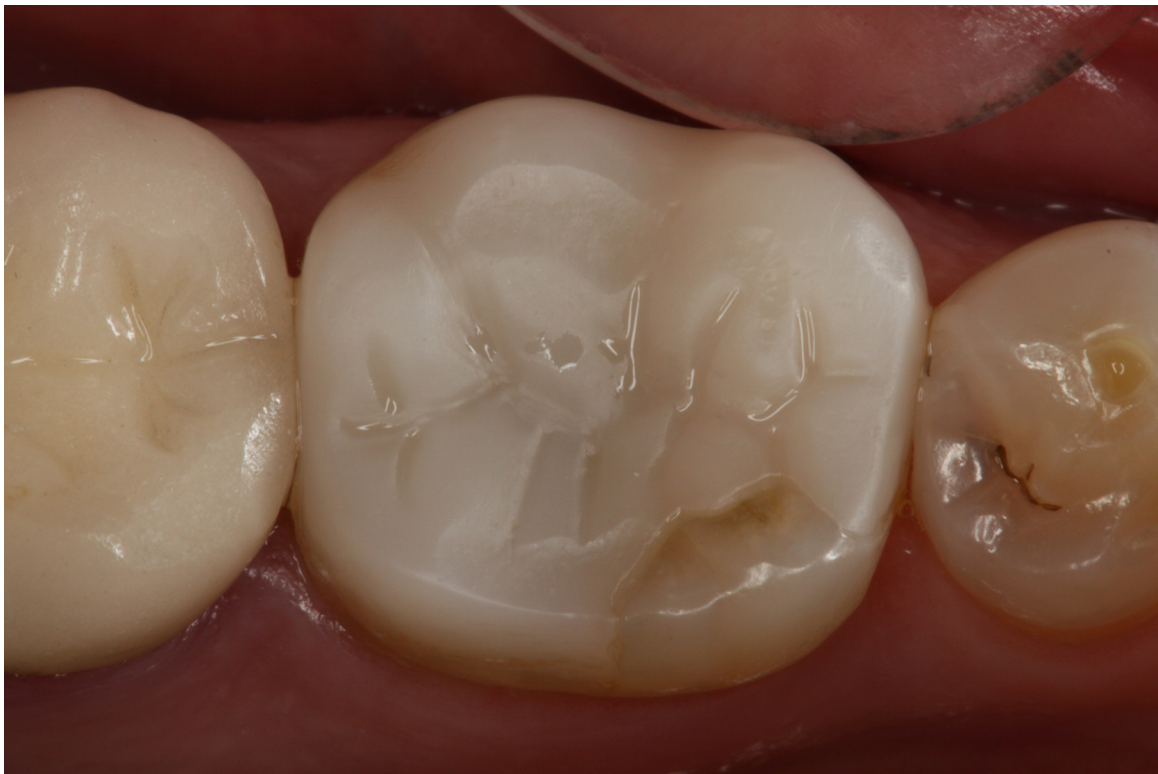
JERD\_12516\_Fig.10A LU #19 prep.tif

Figure #10A-D: Nano-ceramic onlay tooth #19 at 6 months, 3 years and 5 years of clinical service. Note wear facet development on the mid-facial cusp after 6 months.

A: Preparation      B: 6 month recall      C: 3-year recall      D: 5-year recall

results in a matte surface appearance when desiccated. (Figure 9A-D) There have been a limited number of onlays that developed broader wear facets over the five years of clinical service. (Figure 10A-D) These were occasionally detected on Lava Ultimate onlays but not the EmpressCAD onlays. This is consistent with the less abrasive nature of the nano-ceramic material compared to ceramic materials and could be considered an advantage in high wear cases to avoid surface chipping or fracture.
